Long-period fiber grating corrosion sensors for life-cycle monitoring and assessment of reinforced concrete structures

LONG-PERIOD FIBER GRATING CORROSION SENSORS FOR LIFE-CYCLE
MONITORING AND ASSESSMENT OF REINFORCED CONCRETE STRUCTURES

A DISSERTATION

CIVIL ENGINEERING

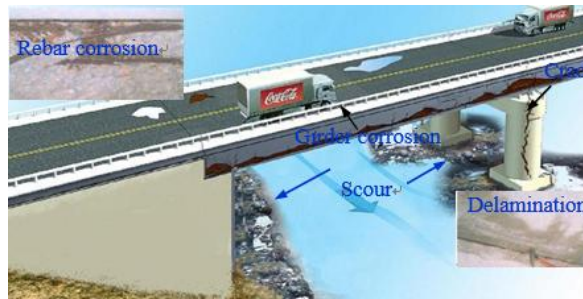
Figure 1.1. Schematic view of various structural behaviors.

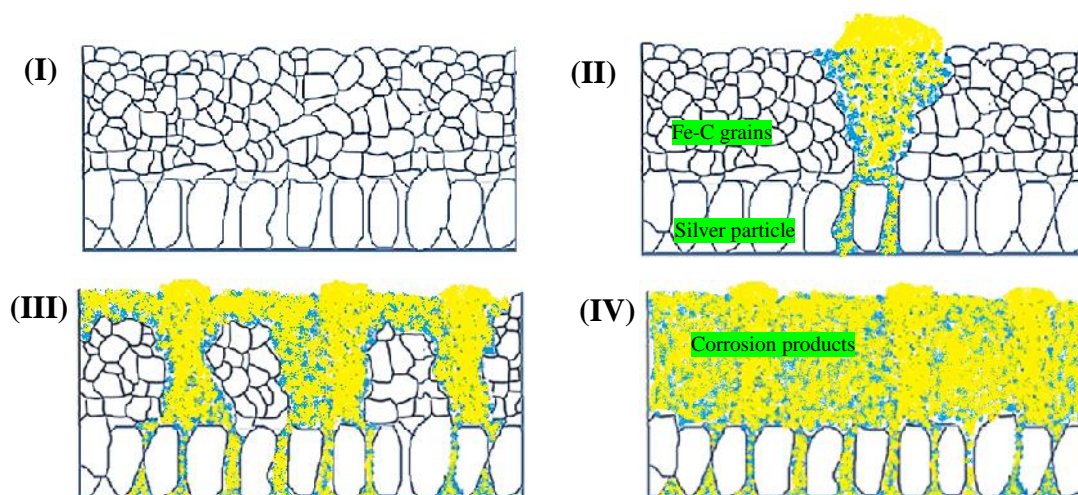
Figure 2.11. Schematic illustration of various stages of corrosion.

and other ions is penetrated through the Ag pores to the surface of the fiber cladding. The air among the Ag particles beneath the active corrosion sites is replaced with the electrolyte, resulting in the change in refractive index of the surrounding medium. In Stage III, the corrosion continued until most of the pores among the Ag particles is filled with such electrolyte. This occurs when 60~90% of the Fe-C corroded as discussed previously. In Stage IV, all the Fe-C grains are turned into iron oxides or iron hydroxides and the pores among the Ag particles are filled with the salt solution and the corrosion products dissolved.

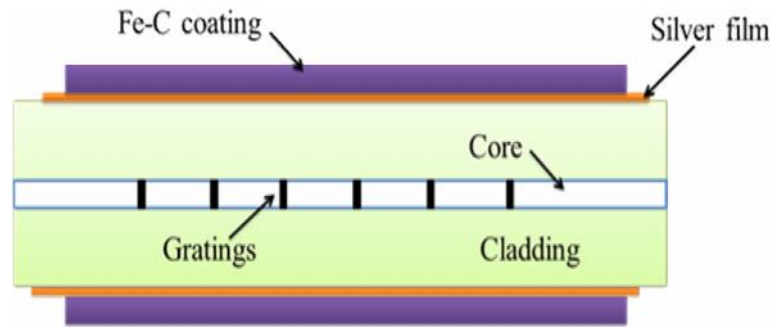
Figure 3.1. Schematic view of the structure of a Fe-C coated LPFG.

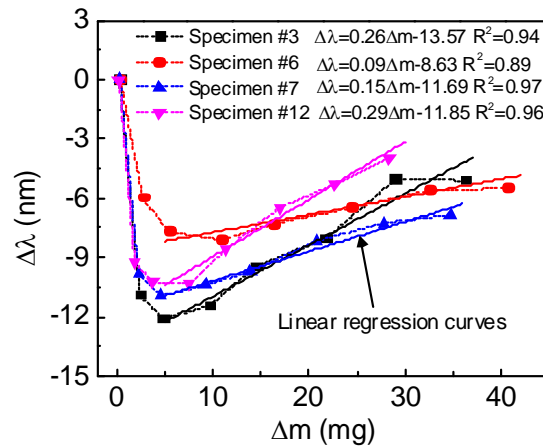
Figure 4.9. Change of resonant wavelength as a function of corrosion-induced mass loss of steel bars.

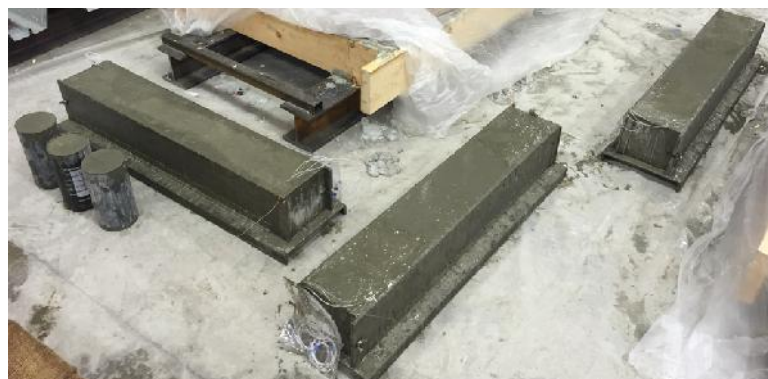
Figure 7.3. RC beams and cylinders for corrosion test.
