Damage detection through acoustic emission of fracture processes in concrete masonry units

DAMAGE DETECTION THROUGH ACOUSTIC EMISSION OF FRACTURE
PROCESSES IN CONCRETE MASONRY UNITS

A THESIS

Presented to the Faculty of the Graduate School of the
MISSOURI UNIVERSITY OF SCIENCE AND TECHNOLOGY
In Partial Fulfillment of the Requirements for the Degree
MASTER OF SCIENCE IN CIVIL ENGINEERING

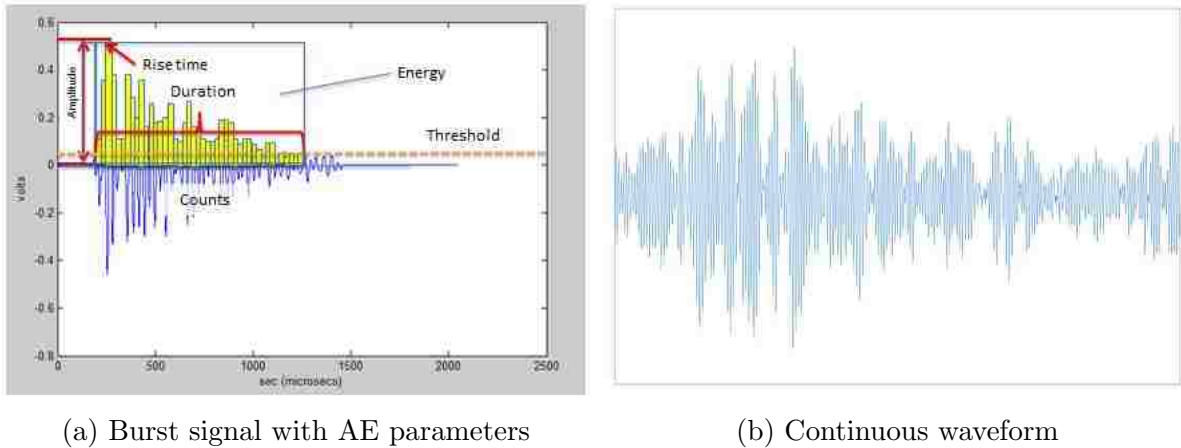
where V is the recorded wave amplitude in volts. Figure 2.1b shows a continuous signal which is representative of significant AE activity. From the research conducted in this study, these signals were encountered at moments of significant cracking such as at the peak of a new load step.

Figure 2.1. Recorded acoustic emission Hits

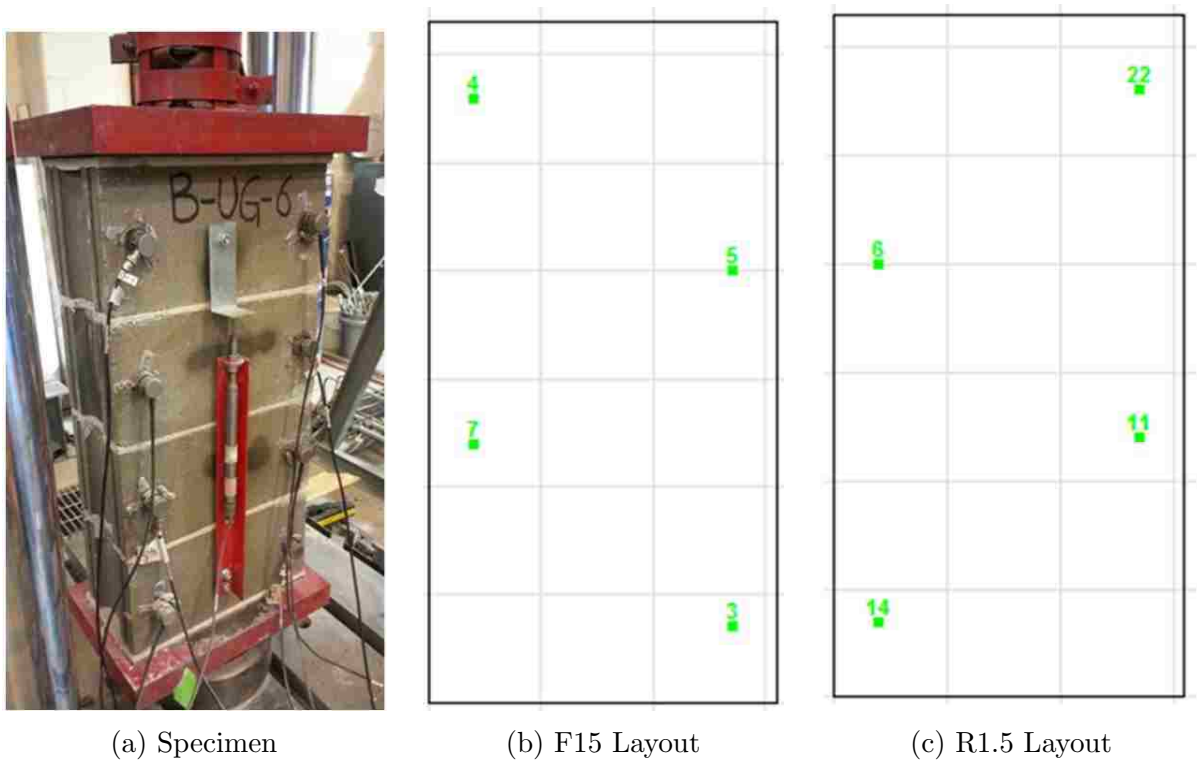
The sensor parameters are listed in Tables 3.2 and 3.3. The threshold type was defined as floating. The floating threshold helps account for a high noise environment by raising the threshold by as much as 6 dB. The gain was set to 40 dB because it is a common setting for a preamplified sensor. The filters were set to higher levels to avoid recording unwanted noises. The length of the file was set so that it recorded the entire typical wave, a wave more intense than a pencil lead break.

Figure 3.3. Sensor layouts and test setups of masonry prism tests

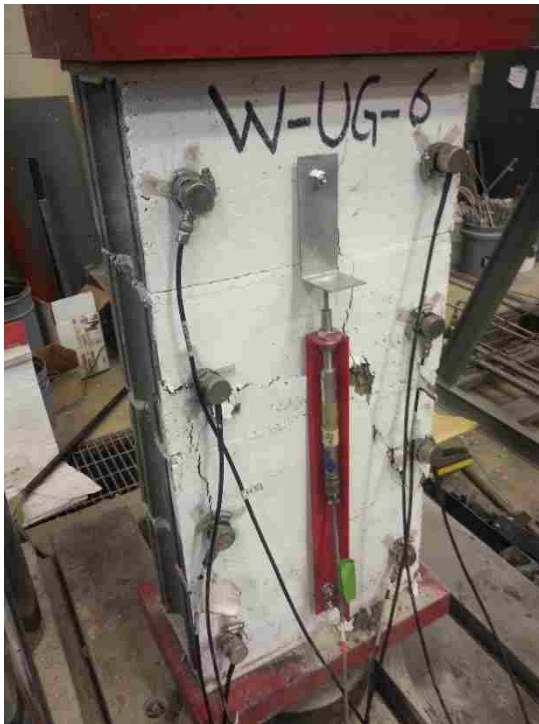
Figure 3.6. Damaged specimens with and without grout from the completion of cyclic test with and without Rubber

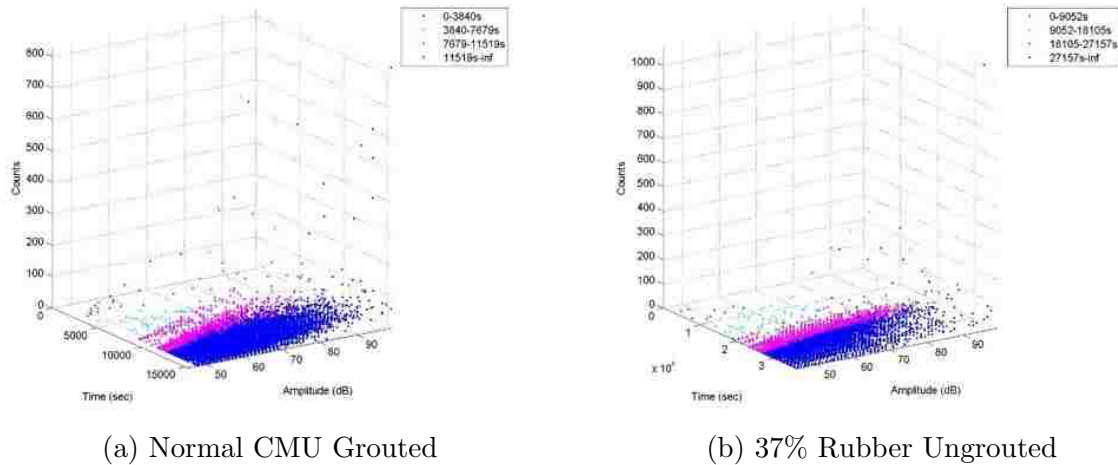
Figure 3.9. R sensors grouted specimens amplitude-counts-time

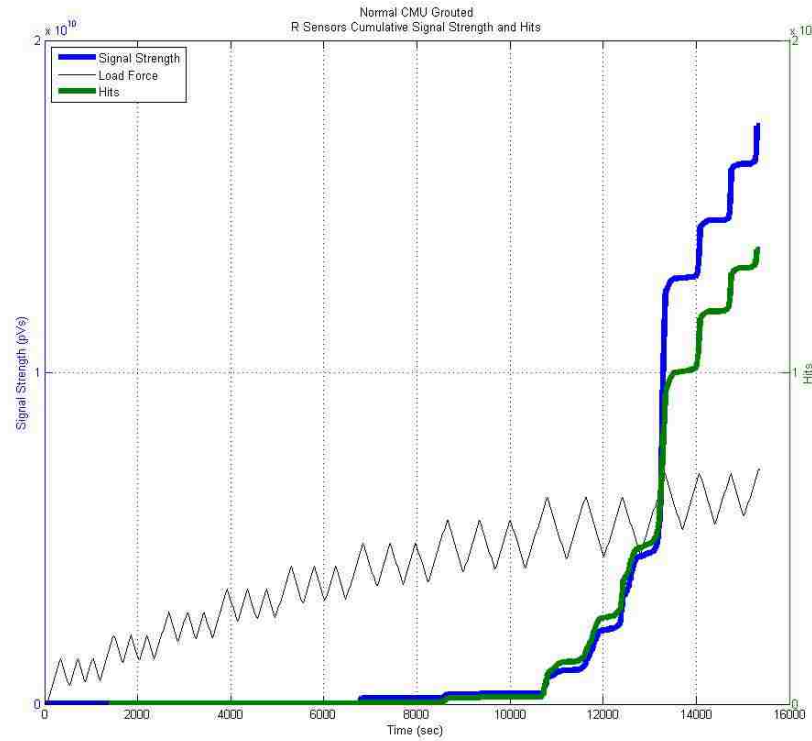
cumulated hits and signal strength for the R sensors. This agrees with the notion that elastic wave energy released by cracking is proportional to recorded hits. From studying all of the plots it appears that fewer cumulated hits corresponded to a smaller cumulated signal strength. The specimens that had a larger rubber content showed the highest attenuation of frequencies in the upper spectrum. This finding can be seen in plots that compare both the two sensors hits in Figure 3.14 and in Appendix A23. The ungrouted normal CMU had the least attenuation. Both types of sensors collected sounds at the same given moments in time, which is represented by the shape of these curves (see Figure 3.15). The signal strength is a relative term because specimens without grout seemed to produce higher signal strength. Comparing specimens in Appendix A23 this came as a surprise, since it would be expected that a grouted specimen would have cracked more surface area thus accumulated more recorded damage. One possible reason for this behavior was the higher amount of sound reflections from the small element thickness.

Figure 3.15. Normal grouted cumulative signal strength and hits R sensor group

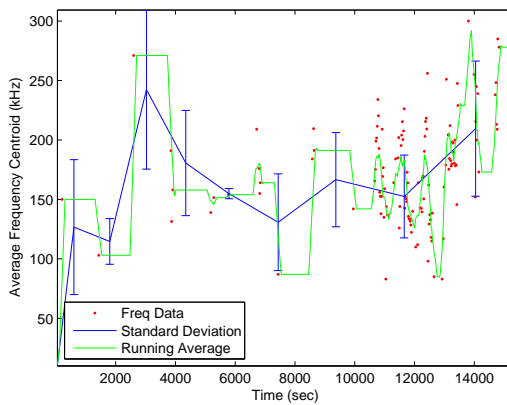
Figure 3.16. Average frequency centroid of individual channels normal CMU prism grouted

any noticeable patterns in the change of the frequency as the cracks were developing. When analyzing the results of the average frequency distribution an interesting behavior existed between the two sensors. The R sensor was in general better at capturing the behavior of decreased signal frequencies at the onset of failure shown in Figures 3.16 through 3.19. Frequencies of the F sensor were not as likely to show this trend as can be seen in Appendices A25 and A26. The results of the R sensors at the end of the test clearly showed a decrease in the frequency centroid from 30 kHz to 18 kHz for channels 6, 22 and 11 with a standard deviation of less than 3kHz.

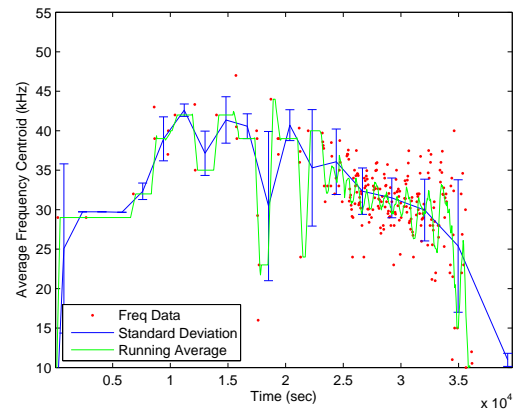
Figure 3.17. Average frequency centroid of individual channels 37% rubber CMU grouted prism

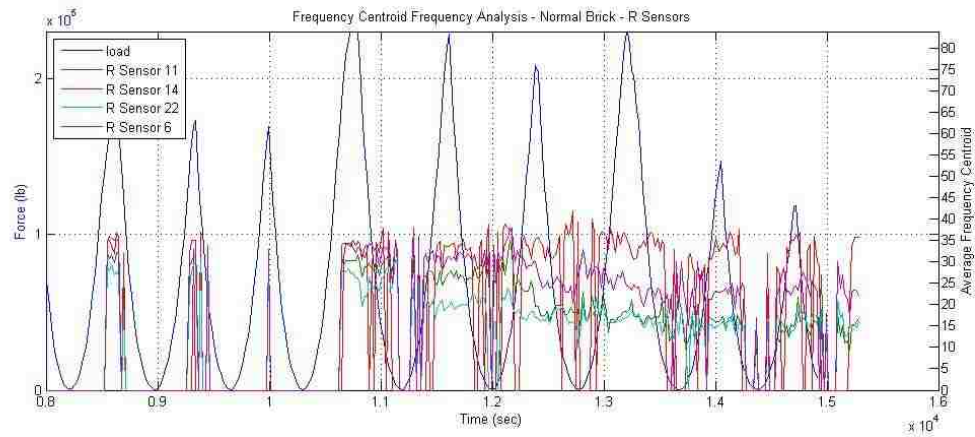
Figure 3.20. Average frequency centroid of R sensors and force (lb) for normal CMU grouted

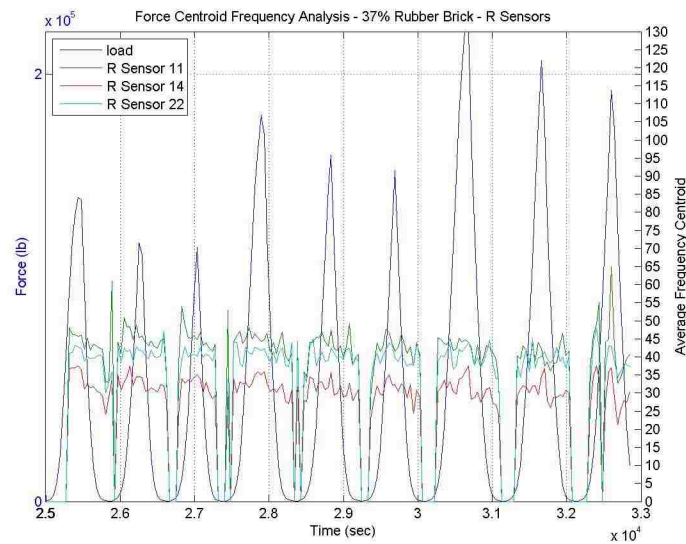
Figure 3.21. Average frequency centroid of R sensors and force (lb) for 37% CMU grouted

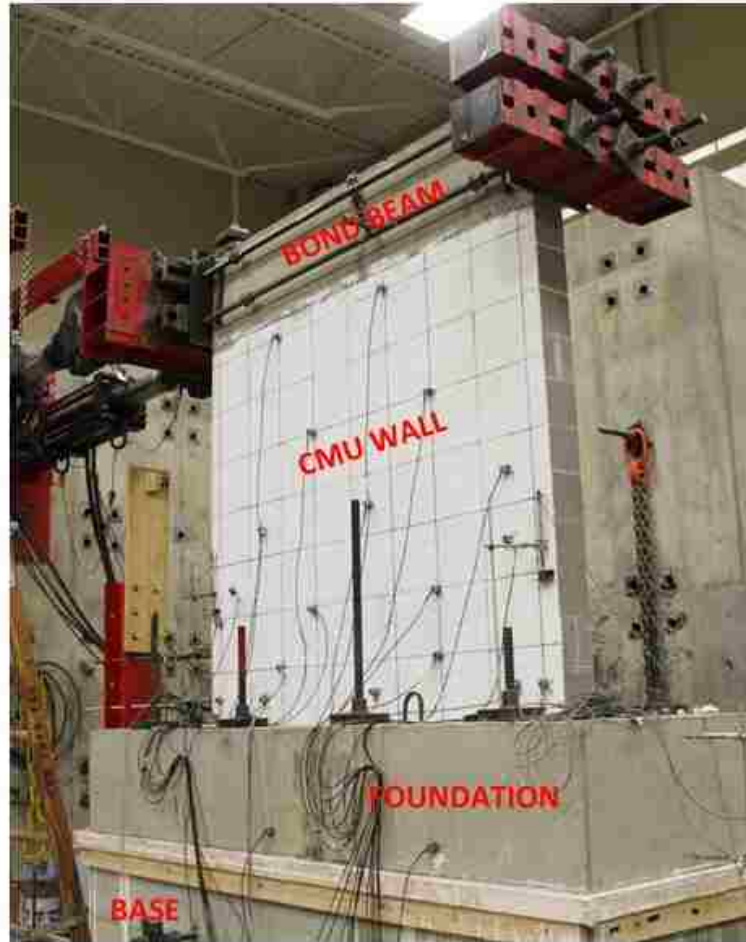
4.2.1. Wall Specimens. Two walls were tested with two different post-tensioning configurations. A running bond pattern was used to construct the masonry shear walls. Each wall was fully grouted with 8-inch nominal concrete masonry units (CMU). An image of the setup is given in Figure 4.1.

Figure 4.1. Masonry shear wall setup showing components

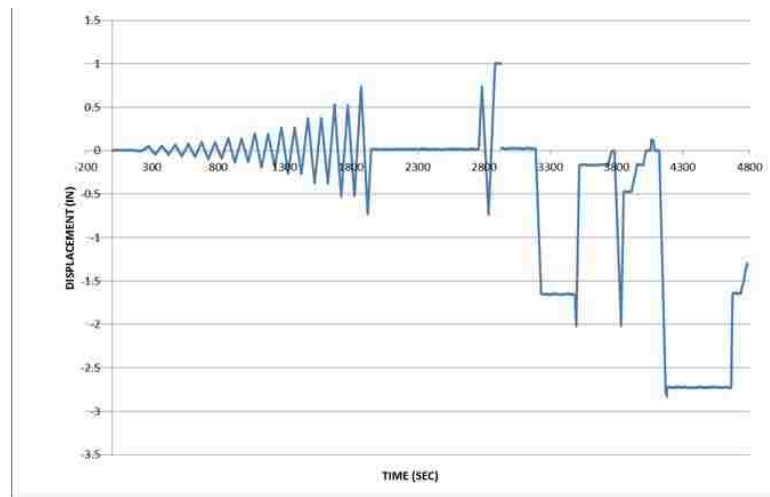
Both walls were tested cyclically according to the prescribed loading protocol. The actuator's displacement over time for the first wall with four post-tensioned Dywidag bars is given in Figure 4.4. Figure 4.5a represents force of the pushing and pulling behavior of the wall up until the wall could no longer be pushed. Structural stability decreased with material failure. Figure 4.5b shows the complete force displacement relationship for the entire loading.

Figure 4.4. Actuator displacement applying force to the shear wall

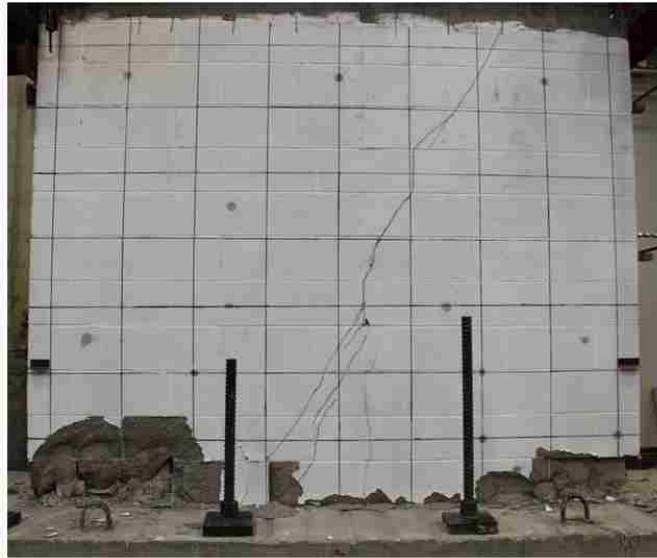
A large diagonal shear crack propagated spontaneously as the wall reached a peak displacement of 2.8. This crack can be seen in Figure 4.6. Extensive damage can be seen in both of the walls' toe areas as those areas were subjected to large amounts of compressive force. It should be noted that the wall's damage was primarily related to the wall's compressive force as it was rocked back and forth. From visual inspection, the wall behaved as a rigid body instead of as a flexural member because of the lack of fixity at the base. As the wall was rocked in the north/south direction, compression built up at the toe in that particular direction as the other toe separated at the bed joint. The tensile forces that occurred due to the cantilever action was resisted by post-tensioning. The effect of the additional post-tensioning was additional frictional force between the wall-foundation and higher stiffness seen in the scope of the load hysteresis.

Figure 4.6. Shear Wall One damaged (the shear crack is indicated in green)

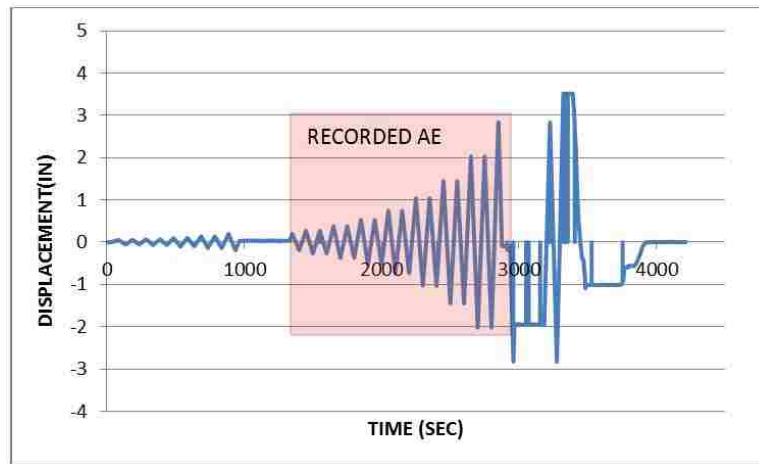
Shear Wall Two with two post-tension rods followed the same loading profile as the first wall. The actuator's displacement over time of test are illustrated in Figure 4.8. The testing was paused to attach a crane to the specimen and then resumed. Just as in the previous experiment, there was more damage on the north end. The largest step was a pulling movement putting this toe into compression. In looking at the force of the actuators in Figure 4.9a it can be seen that the resistance of the wall was not as high as the first test. The softening behavior can be seen clearly in Figure 4.9b as the damage progressed. This behavior would be optimal in most designs because of the energy absorbed correlated to a larger area bounded by the hysteresis. A significant amount of sliding occurred between the wall and the base. Noises created by friction should be considered during this analysis.

Figure 4.8. Displacement of actuator applying force to the shear wall

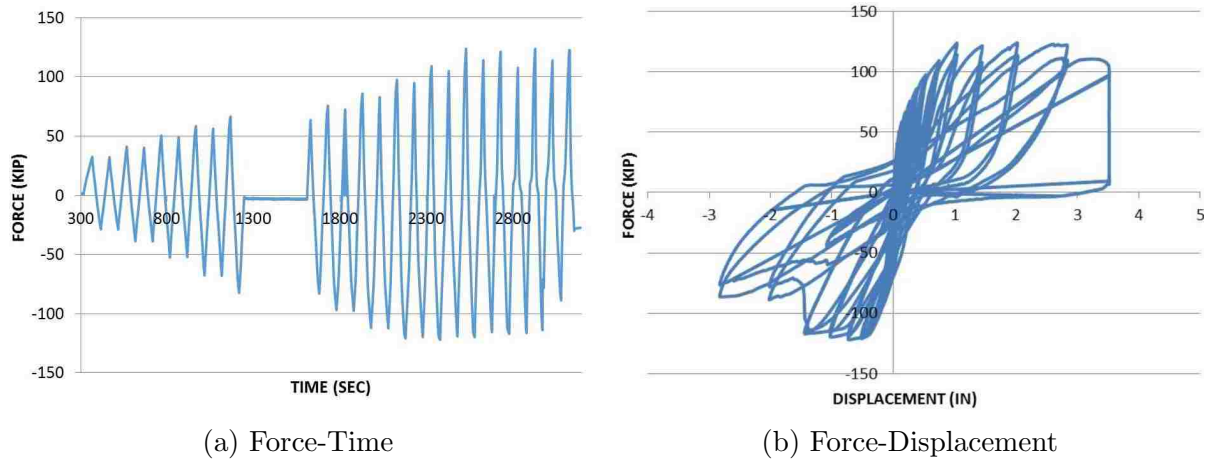
Figure 4.9. Shear Wall Two load results

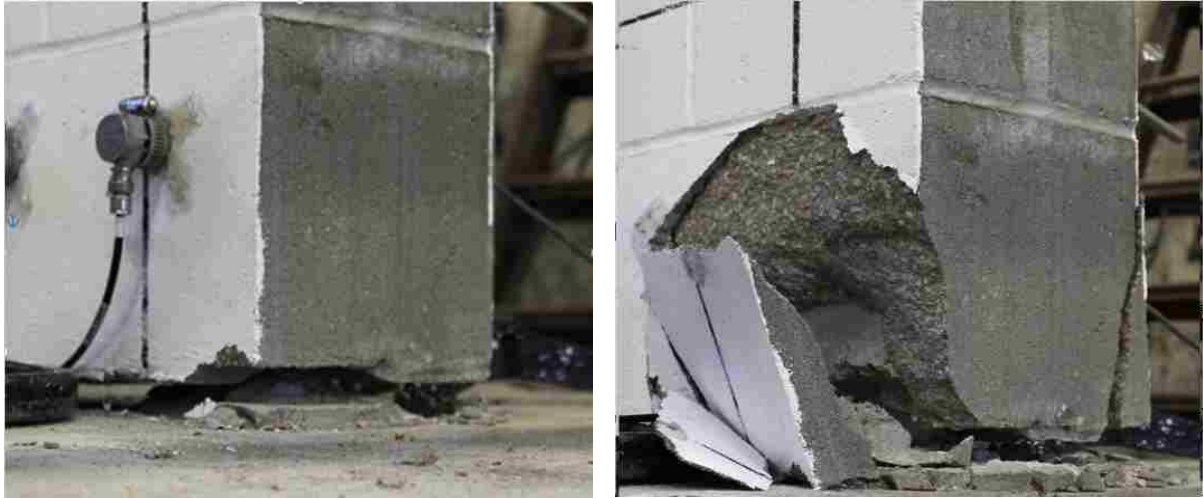
the wall is consistent with the previous test. The wall's rocking can be seen in Figure 4.11a. The toe in tension separated from the base at the bed joint, this separation is shown in Figure 4.11a. In Figure 4.11b the cracking behavior was quite similar between both walls. The cracking at the toes began as vertical cracks and progressed until there were significant brick spalling and grout crushing.

(a) Separation at the Bed Joint

(b) Spalled Brick

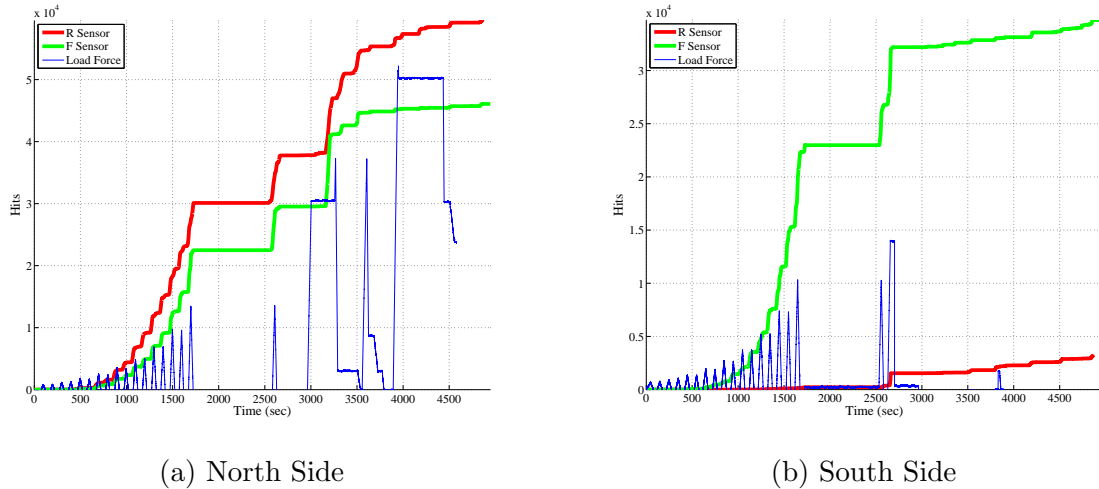
The cumulative number of Hits for groups of sensors is shown in Figure 4.12. The groups were located in specific toe areas. The scaled force output from the actuator is represented as the blue line. These plots are a good representation of the damage on the wall, the plots are for both the north and south sides. The force readout has been flipped to show the negative values as positive when representing the north side of the wall. The sensors captured the wall's microcracking stage. This stage refers to low amplitude short bursts signals collected by both sensor types. The Hits detected in both sensor groups increased nonlinearly as the new load steps increased. No new hits were recorded at moments when no force was applied which is shown by plateaus.

Figure 4.12. Shear Wall One cumulative hits

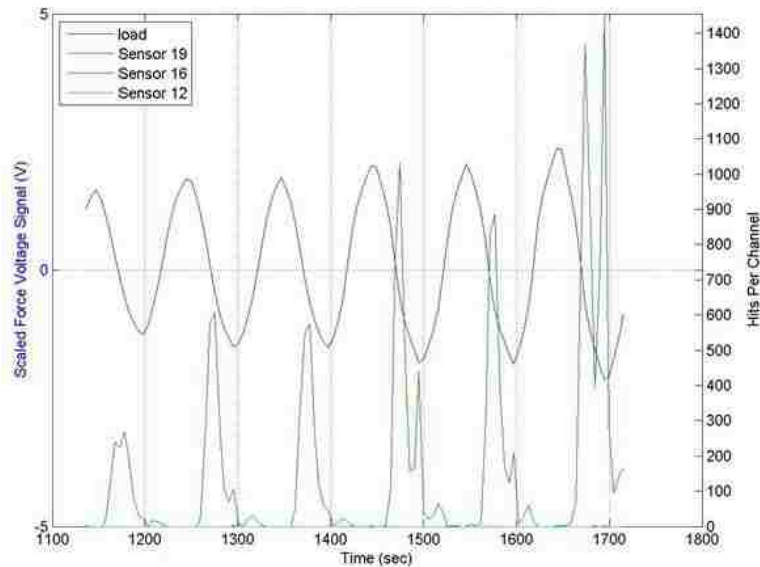
can be seen in Figure 4.13 and those located in Appendices B7 that a higher number of Hits comes at the first of the two cycles, when new cracks were forming. After damage accumulated around 2700 seconds, more signals were recorded by the R sensors than the F sensors. This would be due to the attenuation of the higher frequencies by the cracked material. Sensors that were in areas of high damage recorded more Hits, the frequency analysis of these Hits show that as more force was applied, the average frequency centroid changes due to the effect of crack closing from compressive stresses. Frequency distributions can be seen for the sensor groups located at the different areas of interest in Appendix B8 thru B12. The trend of the average frequency centroid decreased for all of the R sensors, regardless of position when the amount of damage increased.

Figure 4.13. Shear wall one force and hits (channels 12,16 and 19 were located around the north (left) toe
