Use of high volume fly ash-wood fiber and polyurea layers for blast mitigation

**USE OF HIGH VOLUME FLY ASH-WOOD FIBER AND POLYUREA LAYERS
FOR BLAST MITIGATION**

In Partial Fulfillment of the Requirements for the Degree
MASTERS OF SCIENCE IN CIVIL ENGINEERING

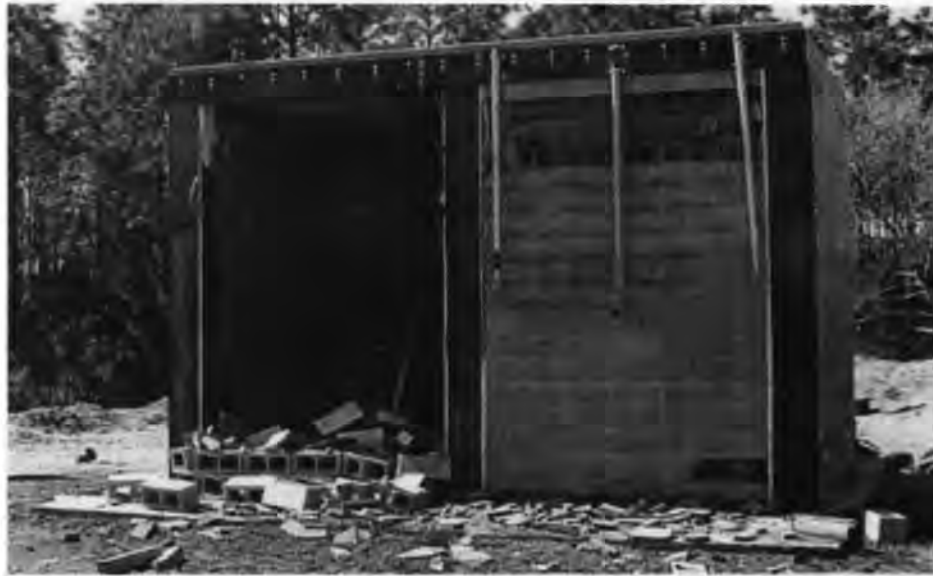
Figure 2.4 – External Test 1 Results. (Davidson, et al. 2004)

Research done by Davidson et al in 2004 investigated using polyurea on masonry walls. Davidson built dual wall sections at the AFRL at TAFB and then applied the polyurea to one wall. He then detonated a charge outside the structure and then analyzed the results. **Figure 2.4** illustrates post-event behavior after one of the events. The section of the wall on the right side in **Figure 2.4** was coated with polyurea, while the wall section on the left that was reduced to rubble was not coated with polyurea. Davidson found that the polyurea was very effective at strengthening a masonry wall against blast (Davidson, et al. 2004).

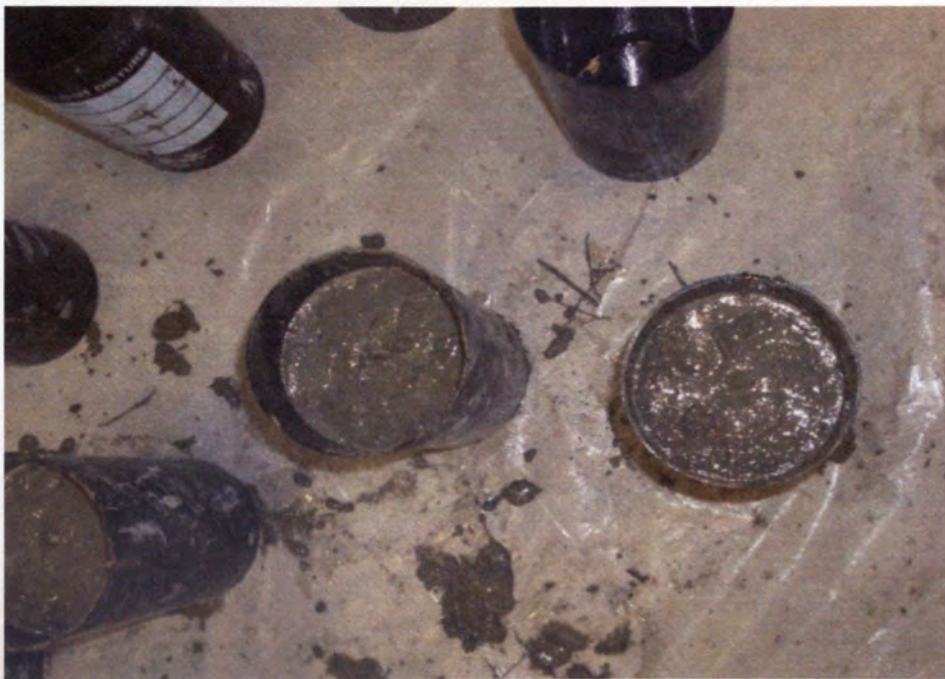
Figure 3.13 – Wet Concrete in Cylinder Molds

3.2.1 Compressive Strength. The compressive strength was determined using 100 x 200 mm (4 x 8 in) cylinders, tested at 7, 14, and 28 days and on the test date. The cylinders were prepared in accordance with ASTM C192/C192M-07. The only deviation with the ASTM was the use of plastic single use molds for more than one use (ASTM C470/C470M-09 2009). To allow the plastic molds to be used multiple times the inside was lightly coated with bar chain oil and a small hole was punctured in the bottom so the cylinder could be extracted with pressurized air. The cylinders were made in two lifts with 25 rods and 25 exterior taps using a 6.4 mm (0.25 in) diameter tamping rod then finished with a trowel. **Figure 3.13** illustrates the cylinders being made. The cylinders were prepared in the lab and then removed from the molds after at least 24 hours. They were then cured next to the panels in the laboratory until testing to match panel curing as closely as possible.

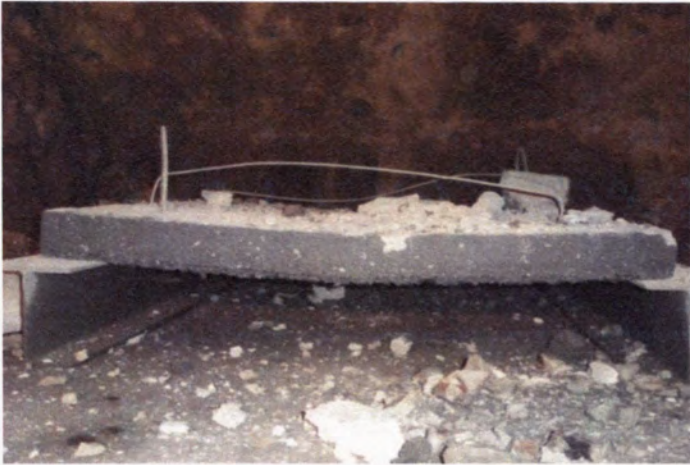
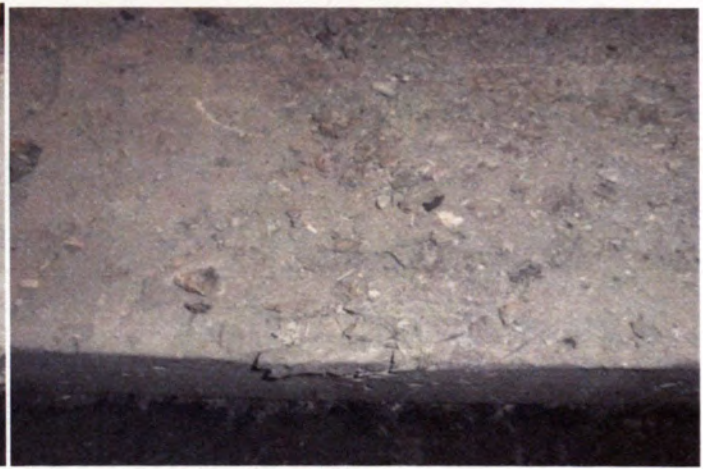
in **Figure 4.27c** and indicates the panel may have failed in flexural strength meaning the reinforcement has yielded. However, the flexural cracks in **Figure 4.27c** do not appear to propagate through the member. This and rough surface of the SFRC in **Figure 4.27d** make it difficult to determine if there is any surface cracking on the SFRC but the large residual deflection suggests there was significant cracking. **Figure 4.27e** shows the tension face of the panel and as it is apparent there was no bulging. **Figure 4.27f** illustrates that there was no cratering or sign of shear punching near the center of the panel. As mentioned before much of the reason for limited damage in these panels is due to the increased stand-off distance from the air-gap. The decreased damage may be additionally attributable to shock impedance mismatch between the layers. Overall, this panel system performed very well and the best of the hybrid systems.

(c) Flexural Crack Back Face

(d) Rough Top Surface From Back
