Corrosion resistance of enamel-coated steel reinforcement for concrete

CORROSION RESISTANCE OF ENAMEL-COATED
STEEL REINFORCEMENT FOR CONCRETE

A THESIS

MASTER OF SCIENCE CIVIL ENGINEERING

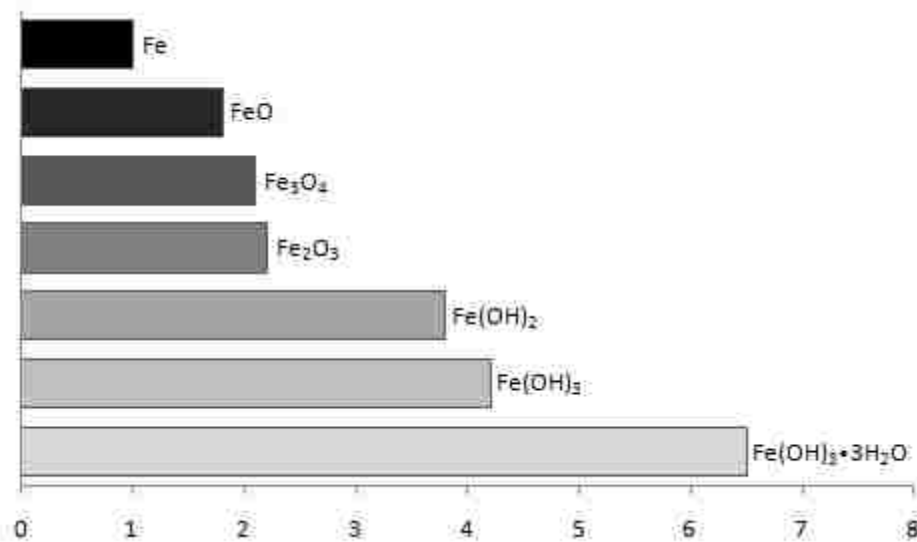
Figure 2.1: Volumes of various iron oxides relative to iron [Broomfield, 2007].

Due to this increase in volume at the steel-concrete interface, tensile stresses will form within the concrete and cracks will begin to appear along the surface of the structure. In some cases, spalling of the concrete may be observed. At times black rust (Fe_3O_4) may form instead of the typical red rust and as a result no visual signs of cracking may be seen along the concrete surface. This is due to the fact that black rust is less expansive than red rust, as shown in Figure 2.1.

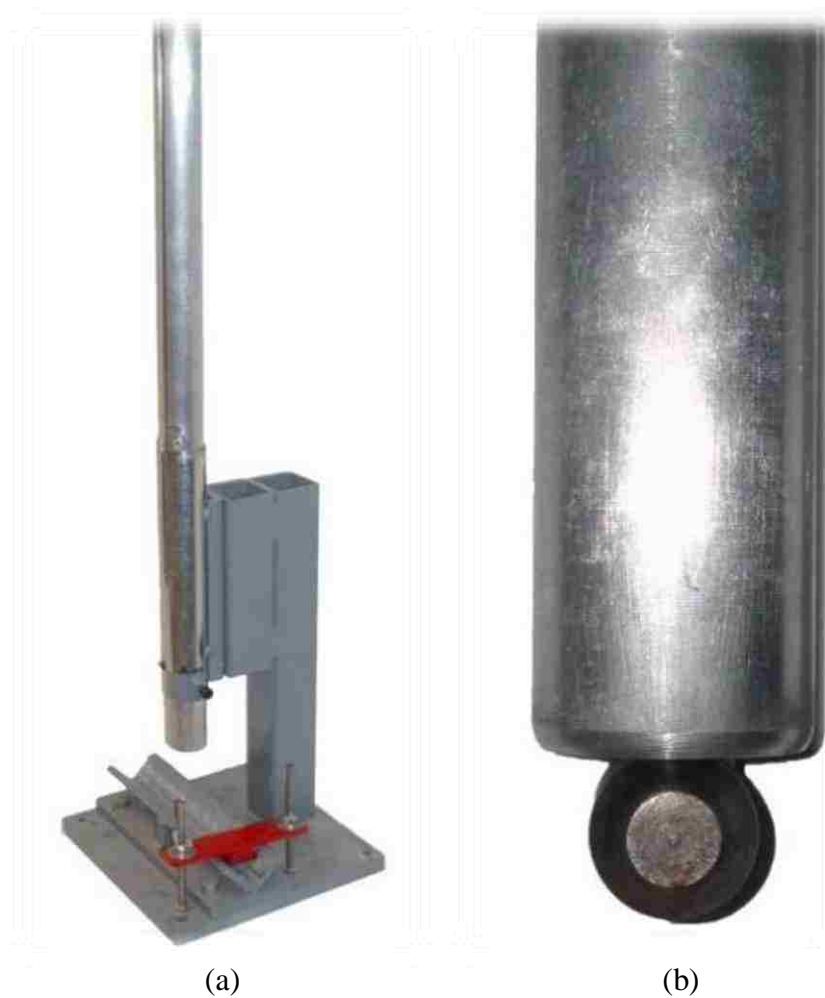
Figure 3.2: Apparatus used to damage coated bars. (a) Overall view. (b) Tip of the tup aligned within the hollow aluminum tube.

section of hollow aluminum tubing to guide the tup, and a horizontal section of steel angle to position the rebar. The bars were secured to the steel angle with clamps, and the tup was dropped from a height of 36 in. (91 cm) to damage the coatings. As shown in Figure 3.3, the 50/50 enamel coating exhibited an average area of damage that was approximately 3/8 in. x 1/2 in. (1.0 cm x 1.3 cm), whereas the epoxy coating showed an average area of damage that was approximately 1/16 in. x 1/8 in. (0.16 cm x 0.32 cm).

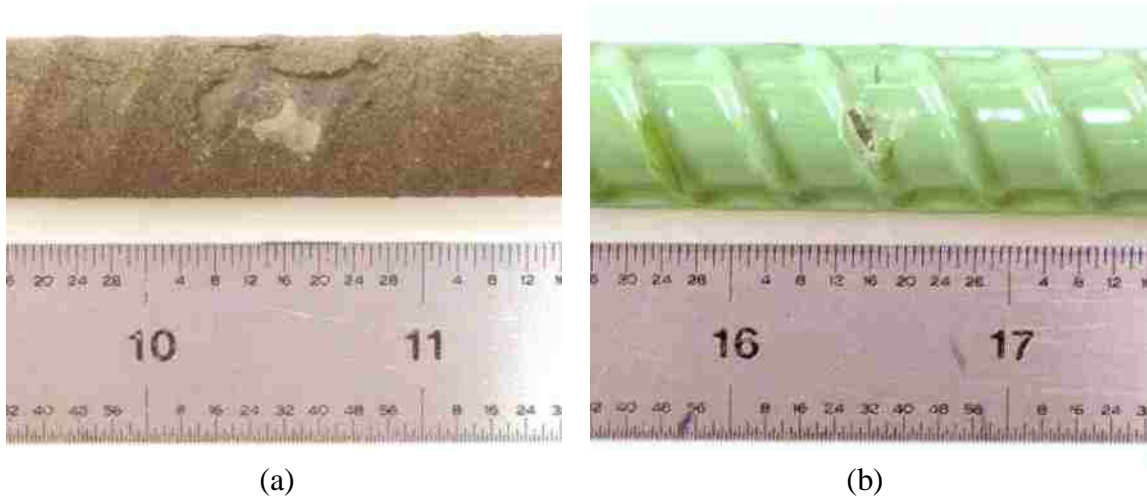
Figure 3.3: Representative view of an average intentionally damaged area along the two tested coatings. (a) 50/50 enamel. (b) epoxy.

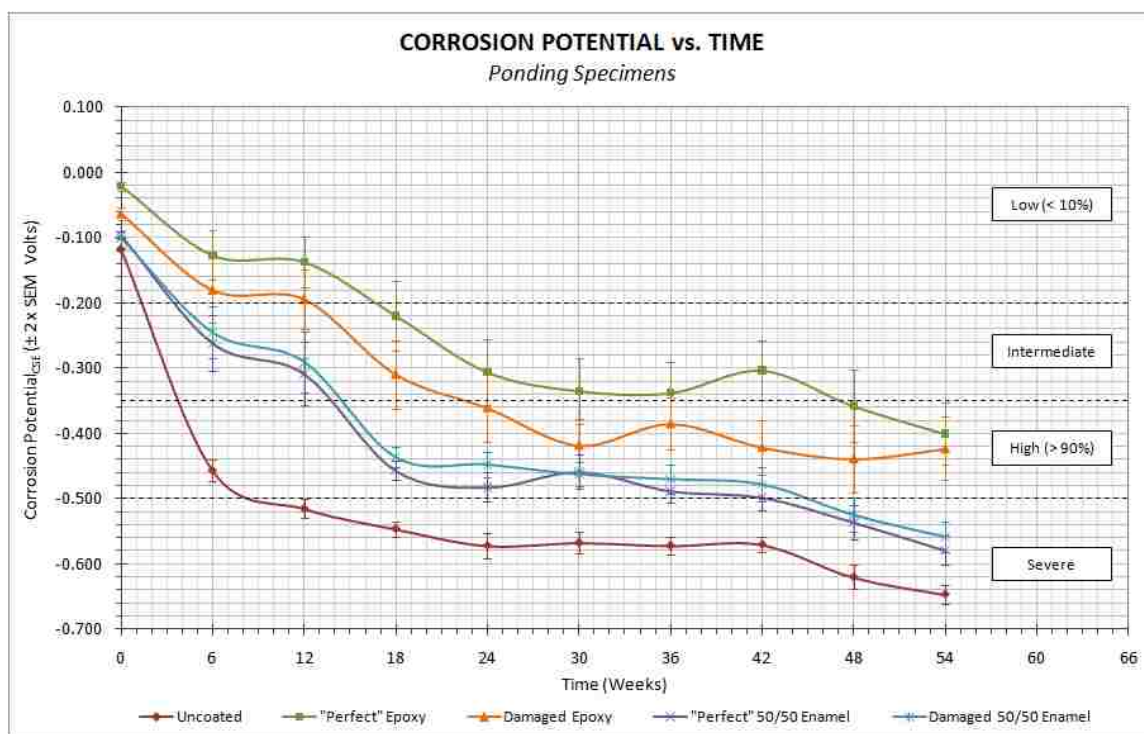
Figure 3.14: The trend of the average corrosion potential of each specimen group during the 54 weeks of testing.

reported by the uncoated group. The two 50/50 enamel groups reported a corrosion resistance (half-cell potential) between the epoxy and uncoated specimens. Furthermore, the two enamel groups reported similar potential values throughout the test, with the “perfect” 50/50 enamel group consistently reporting the lower (more negative) of the two potential values.

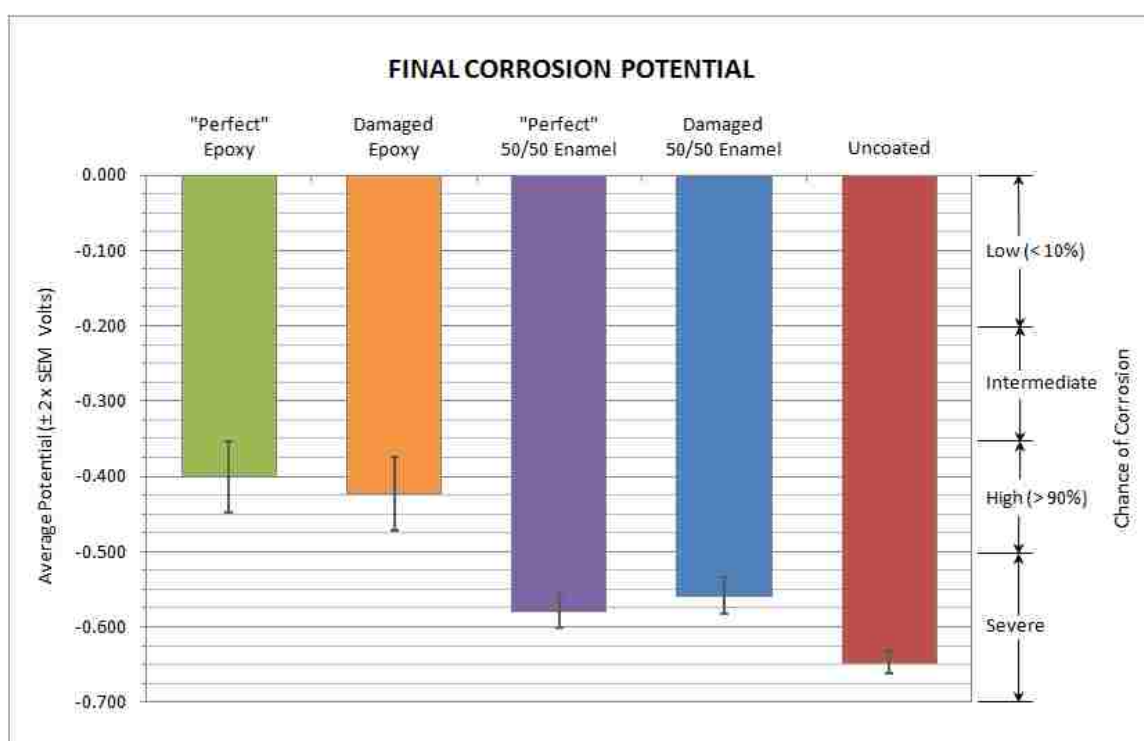
Figure 3.15: An average representation of the final corrosion potential of each specimen group at week 54.

final potential measurements collected from each specimen contained within a specimen group. Using error bars, the standard error within a specimen group's final potential value is also shown in Figure 3.15. Of the five groups, both the "perfect" epoxy group and damaged epoxy group reported the greatest distribution in potential measurements; whereas the potential measurements collected from the uncoated group showed the smallest distribution.

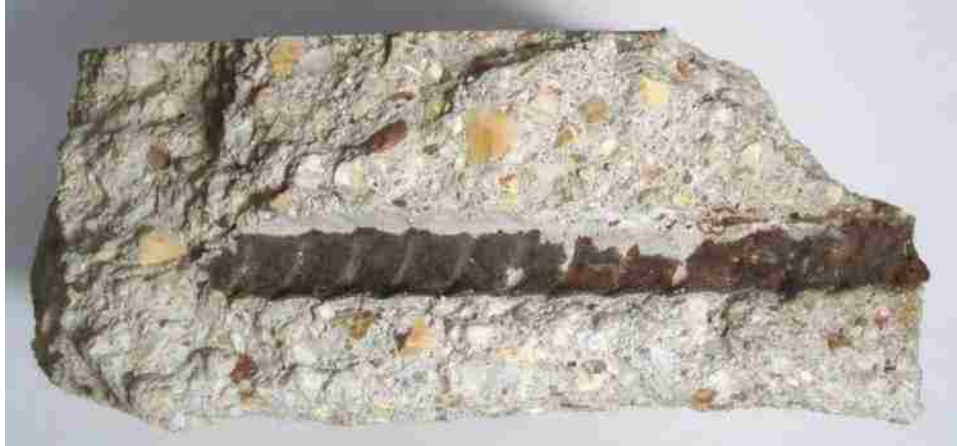
Figure 3.19: Red rust observed along the inner surface of a segment of 50/50 enamel that remained attached to a section of concrete.

3.4.3.3 50/50 enamel bars. During the forensic evaluation of the specimens containing 50/50 enamel-coated rebar, a significant amount of the 50/50 enamel coating was unintentionally removed from each bar during the forensic examination. On average, a typical bar lost approximately 50 percent of its coating while being removed from a specimen. The majority of the coating that was detached from a bar was well adhered to the surrounding concrete. Portions of the coating that was attached to the concrete indicated red rust stains along its inner surface, as shown in Figure 3.19.

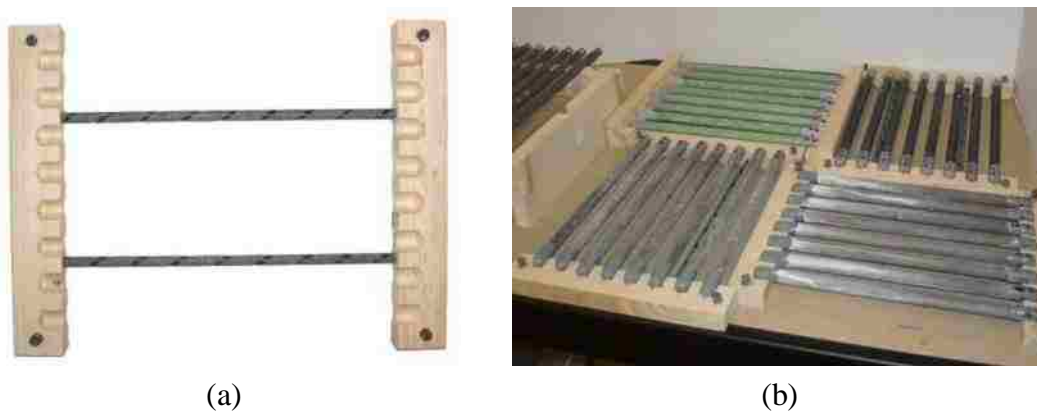
Figure 4.4: Specimen layout during the dry phase of testing. (a) Rack used to support a set of salt spray specimens. (b) Overall layout.

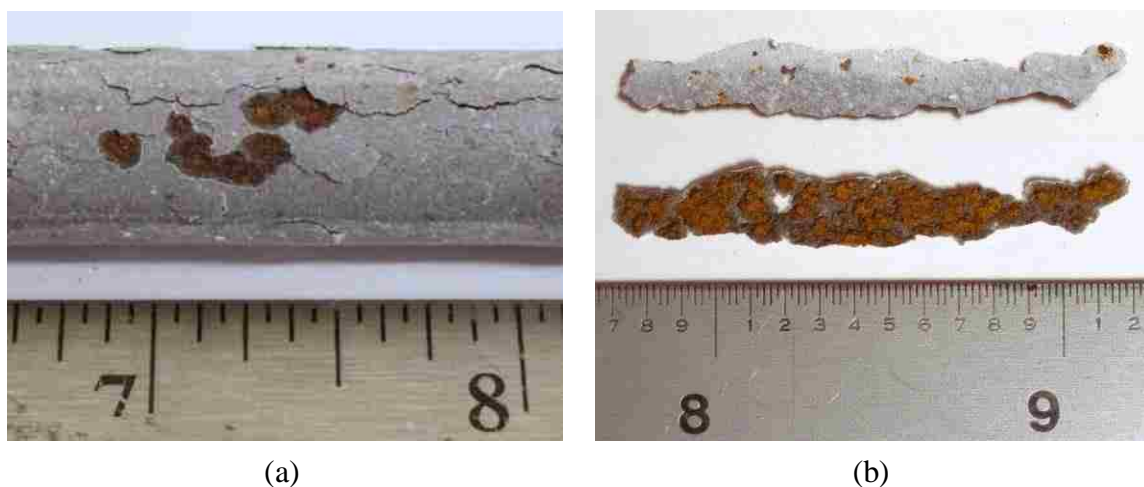
Figure 4.6: The condition of the 50/50 enamel coating along a smooth specimen after twelve weeks of testing. (a) Spalling of the 50/50 enamel coating. (b) The top and bottom view of a typical piece of the 50/50 enamel coating that had fallen off of a smooth specimen shortly after completion of the testing.

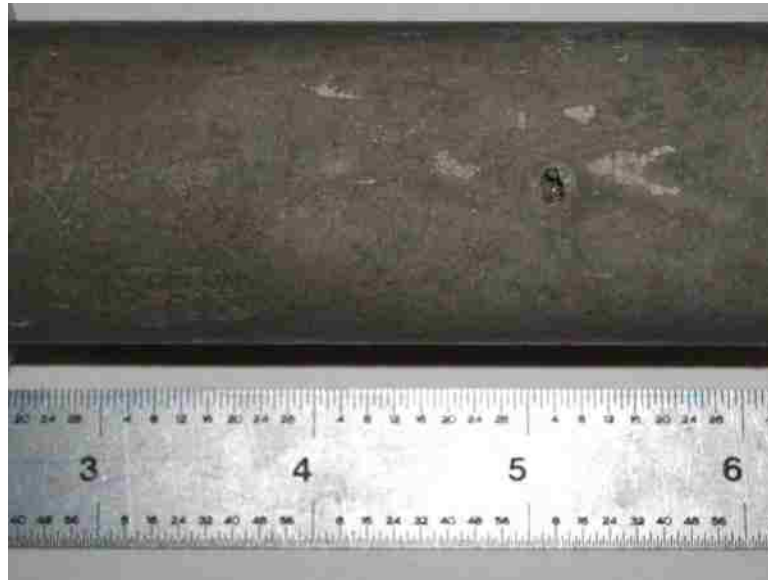
Figure 5.5: A void considered to be detrimental to the grouted specimen's performance in the ACT test.

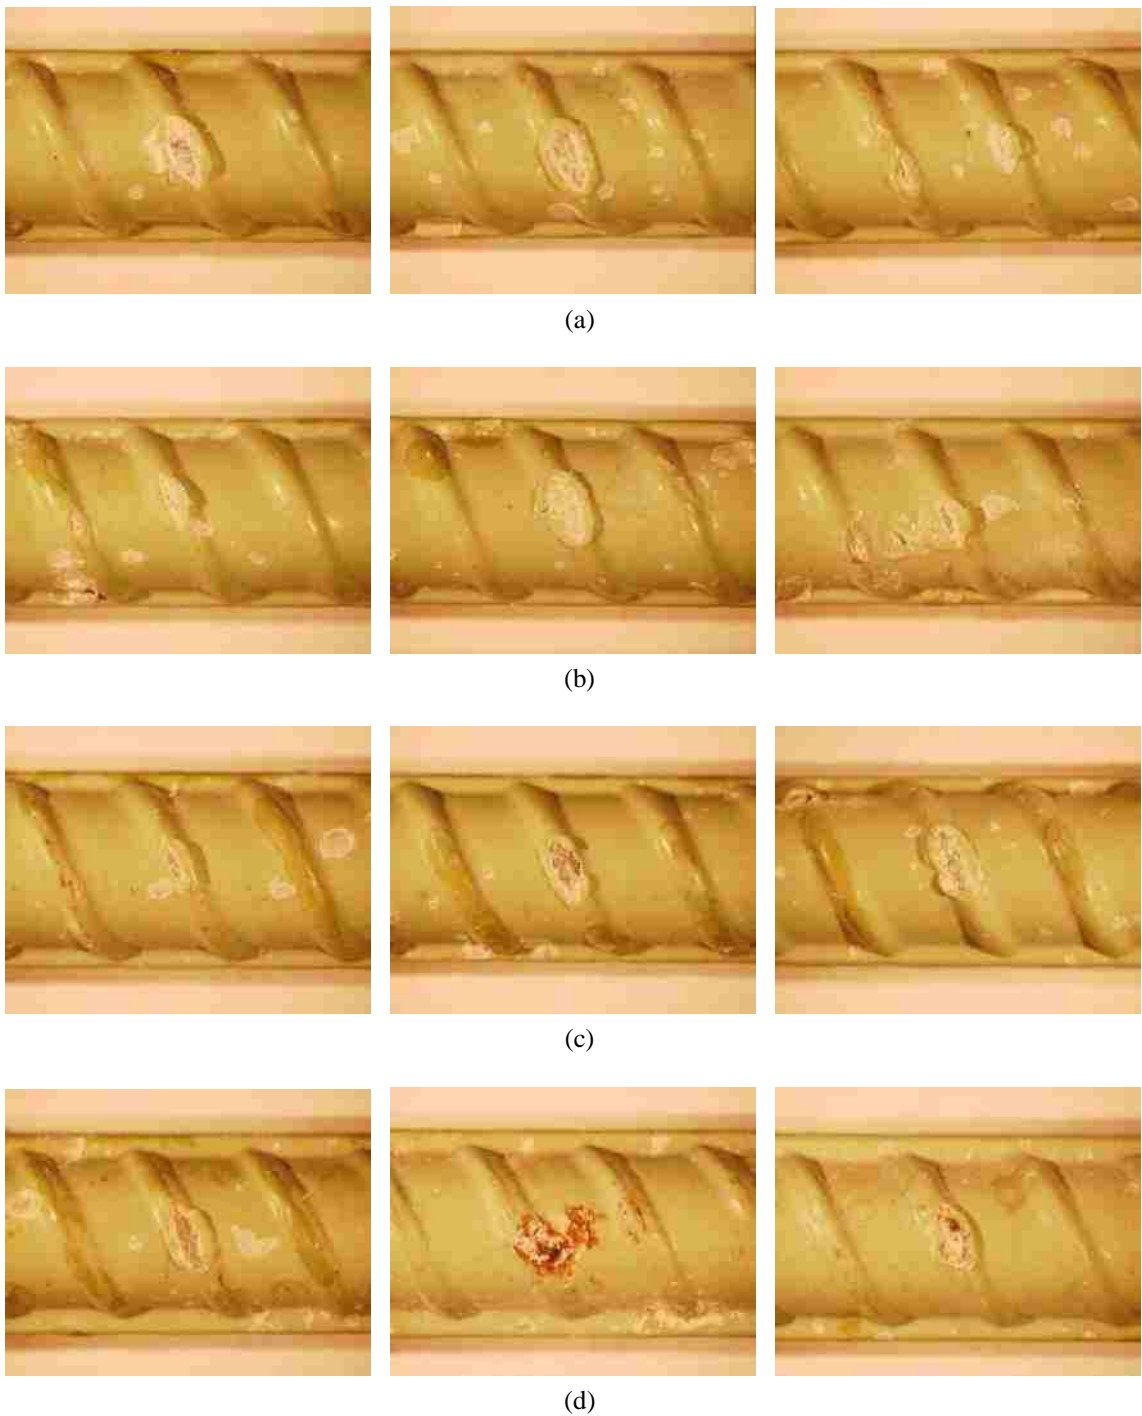
Figure A - 32: The three intentionally damaged areas along (a) bar-1; (b) bar-2; (c) bar-3; and (d) bar-4 of ponding specimen EP-D-4.

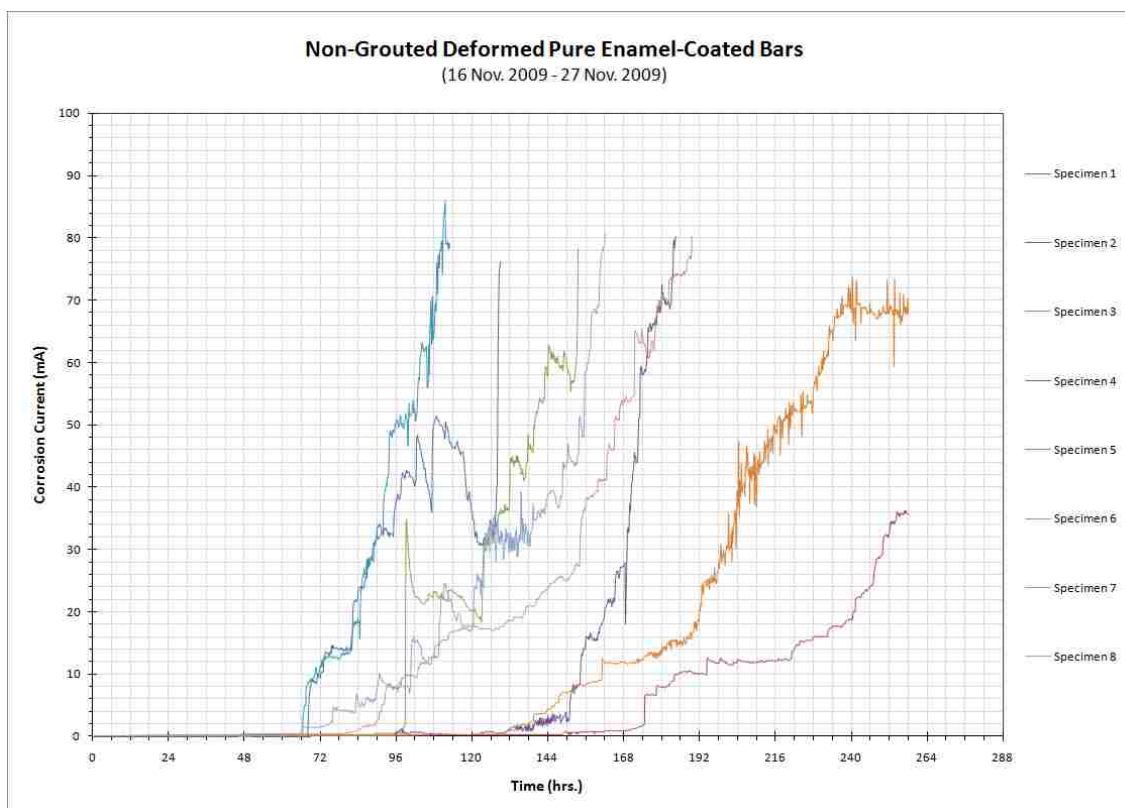
Figure C - 4: Corrosion current versus time plot for the non-grouted deformed pure enamel-coated ACT specimens.

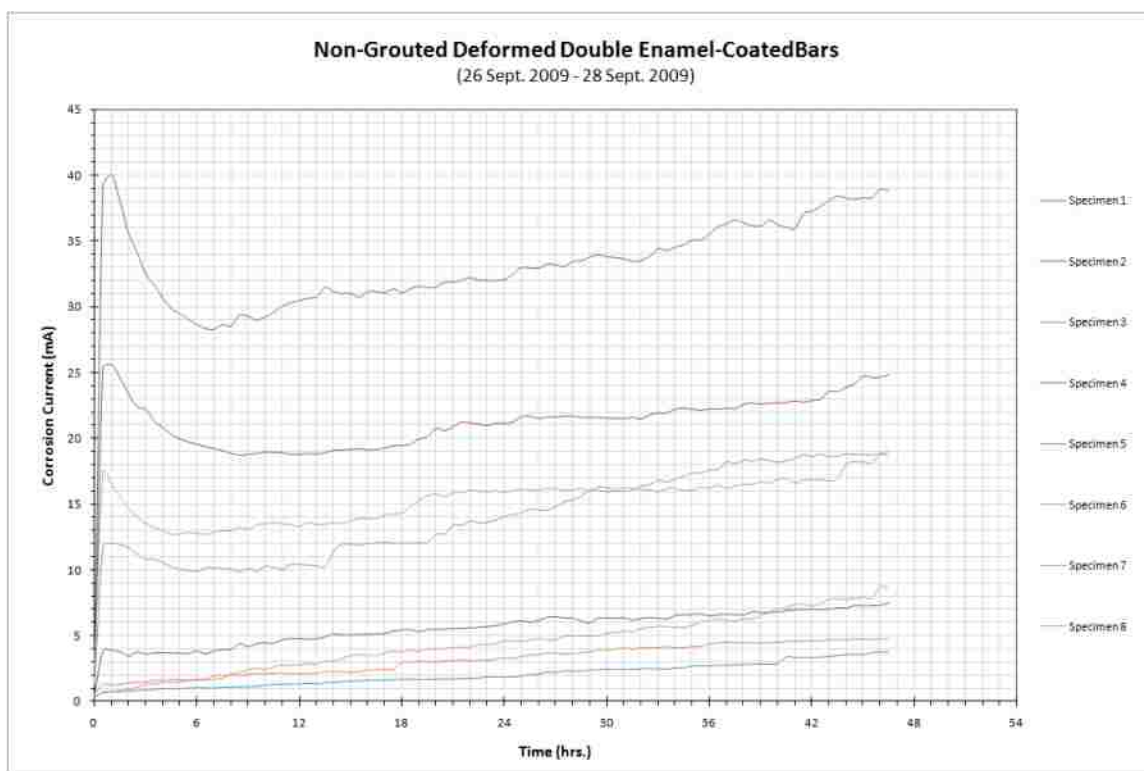
Figure C - 6: Corrosion current versus time plot for the non-grouted deformed double enamel-coated ACT specimens.

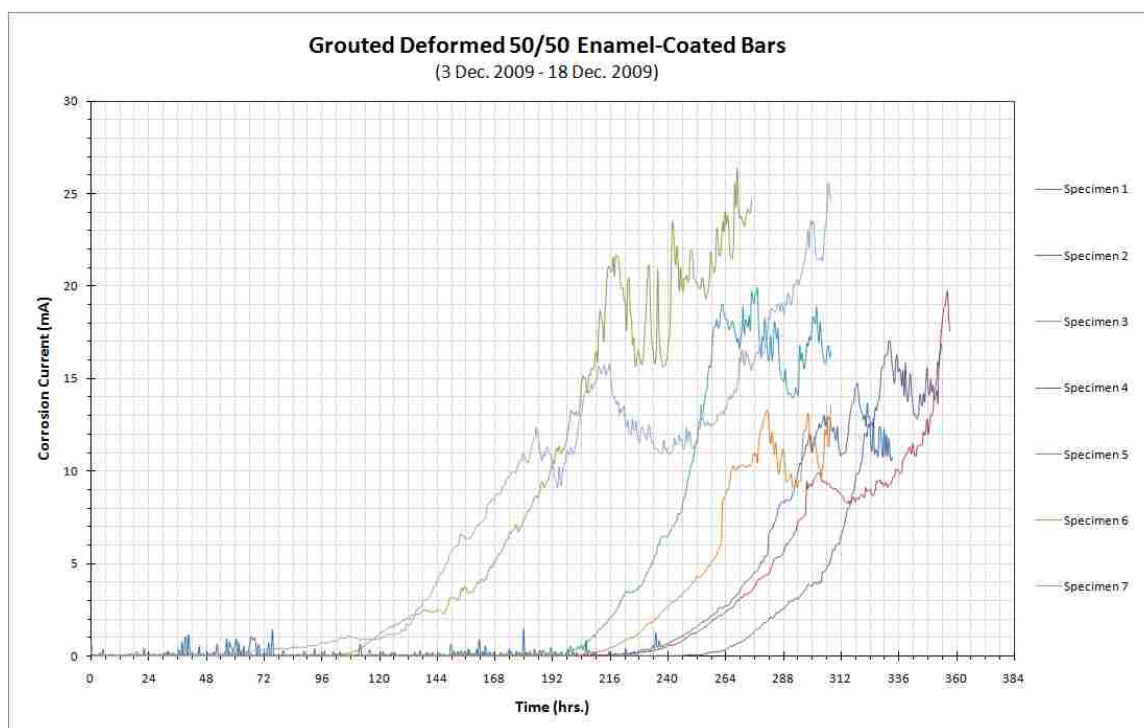
Figure C - 12: Corrosion current versus time plot for the grouted deformed 50/50 enamel-coated ACT specimens.
