Installation and performance evaluation of coaxial cable sensors for crack and corrosion detection

A THESIS

MASTER OF SCIENCE IN CIVIL ENGINEERING

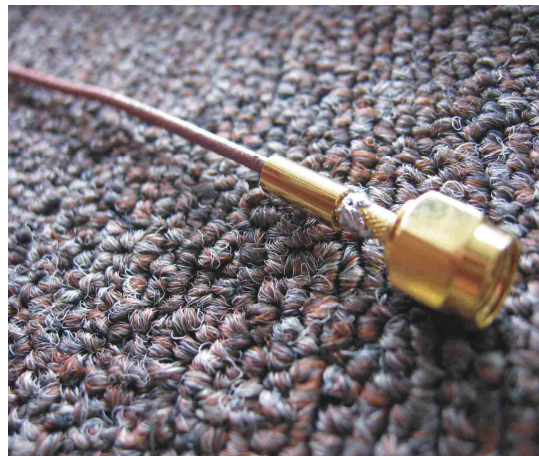
In an attempt to enable the application of topology-based coaxial cable sensors in composite structures with layer configurations, the size of the sensors must be reduced. In this study, a target diameter of 0.067 in. (1.7 mm) of the miniature prototype sensor as shown in Figure 4.1 was considered, which is slightly less than half the diameter of the previous prototype of 1.5 in. (4 mm) in diameter (Mu, 2003). Similar to the previous prototype, a miniature coaxial cable sensor can be fabricated with spirally wrapped outer conductor spirals. The distance between two adjacent spirals, referred to pitch in this thesis, is also half that of the previous prototype as summarized in Table 4.1.

Figure 4.1. Miniaturized crack sensor

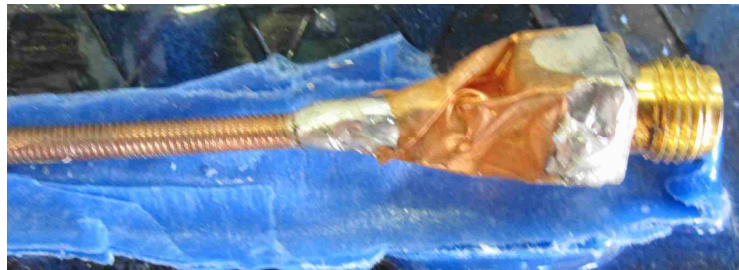
unless it is loaded. At the same time, the grooves on its outer conductor make the cable much more susceptible to cracking under external loads.

Figure 4.2. Die-cut crack sensor

Since it is relatively rigid, the sensor remains its original shape during installation and uncontrolled bending is minimized. In addition, the die-cut sensor has a finely ribbed surface, promoting a better bond between the sensor and the host material in applications and eliminating their potential relative slippage or ambiguity in data interpretation. The baseline ETDR measurements of a spirally-wrapped and a die-cut crack sensor are compared in Figure 4.3 and Figure 4.4. As one can see, the waveform from the die-cut sensor has fewer aberrations caused by fabrication defects than that of the sensor with the spirally-wrapped outer conductor around its dielectric.

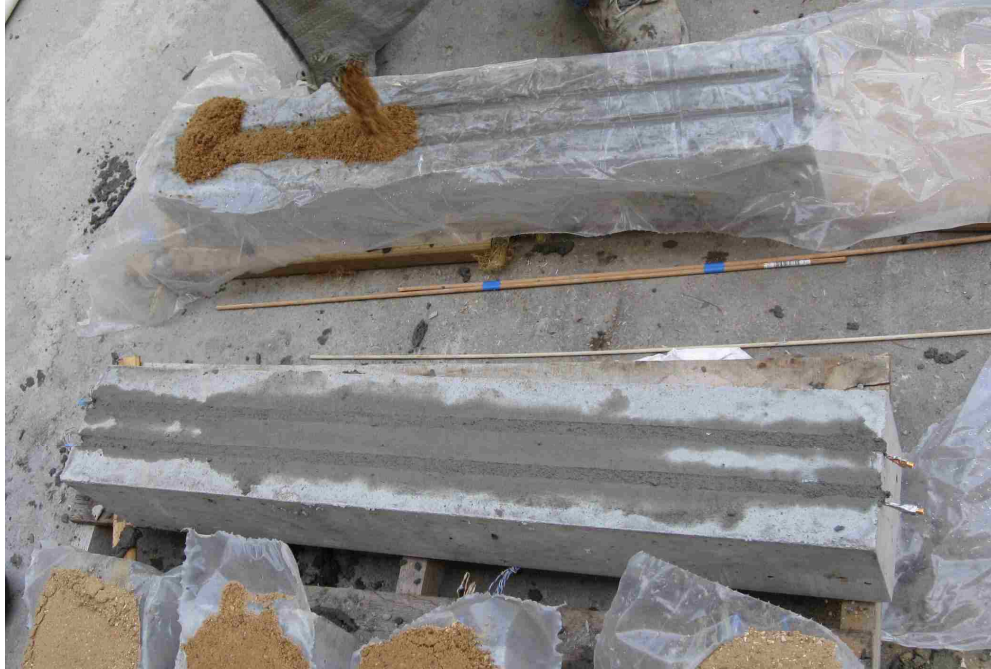
All sensors were placed along the tension face of the tested beams. Each beam was instrumented with three (3) topology-based sensors. As shown in Figure 4.5, two sensors were embedded into 0.5 in deep precut grooves and one sensor was attached to the tension face of the beam along its center line. The goal of this study was to select the best way for installation of the above mentioned crack sensor. Two types of installation (embedded vs. surface attached) were compared. For each installation type, various types of adhesive materials are compared, including grouting (SikaGrout212), epoxy (HoldTight®102), structural resin (M_BRACE Saturant), and mortar with a weight mixture of 1 part of Portland cement, 0.5 part of hydrated lime (type S), and 3.5 to 4.5 parts of masonry sands according to ASTM-C-144. The test matrix is given in Table 4.2.

Figure 4.5. Grouting procedure

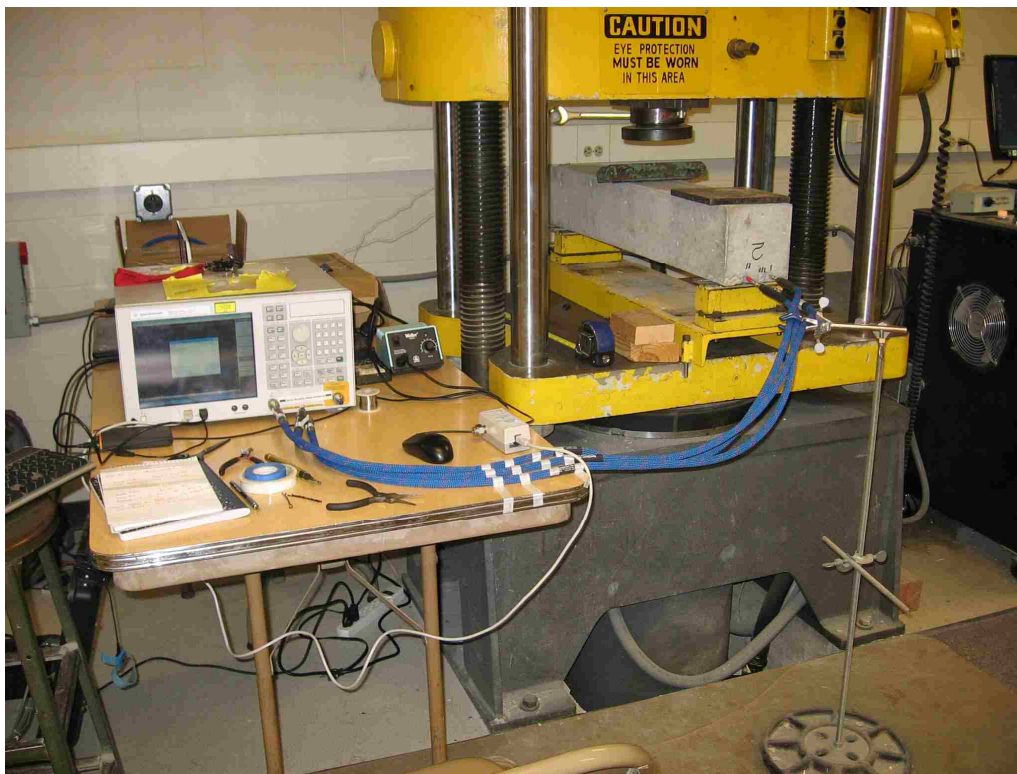
recorded. A linear variable differential transformer (LVDT) was set up between the crosshead and the specimen platform of the test machine, giving the mid-span deflection of the beam. Data was acquired with an Agilent Technologies E-5071C 100 kHz - 8.5 GHz Network Analyzer that was operated in the Time Domain Reflectometry (TDR) mode.

Figure 4.7. Three-point bending test setup

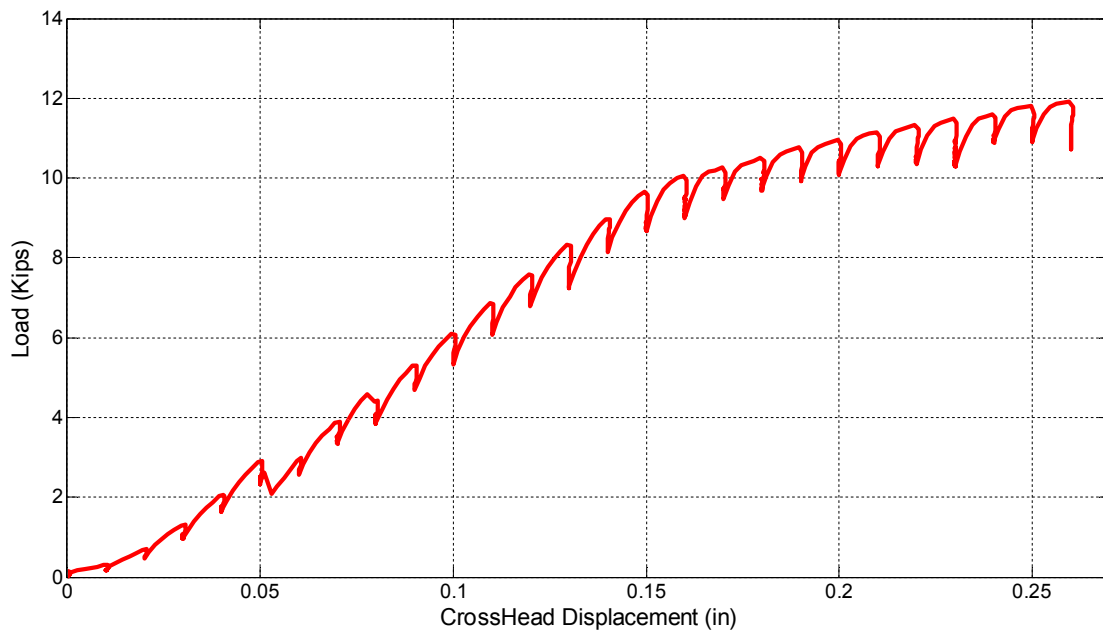
The load-crosshead displacement curve of the Beam #2 is illustrated in Figure 5.1. It can be seen that the slope of the curve changes at 0.15 in crosshead displacement, indicating the upper limit of elastic behavior. Section of the curve bounded by 0.15 in corresponds to the behavior when tensile stresses at the bottom of the beam have gradually reached the tensile strength of the concrete. Most of the cracks have been developed in this region. It should be noted that the kinks on the curve are results of an applied load relaxation due to pauses taken to record TDR signatures from the sensors installed on the tested beam.

Figure 5.1. Load-displacement curve

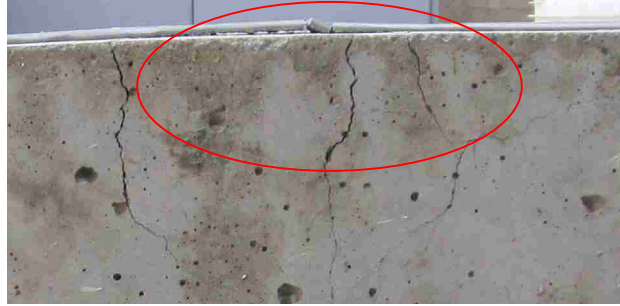
Figure 5.7 HoldTight 102 spalling at the midspan of Beam # 2

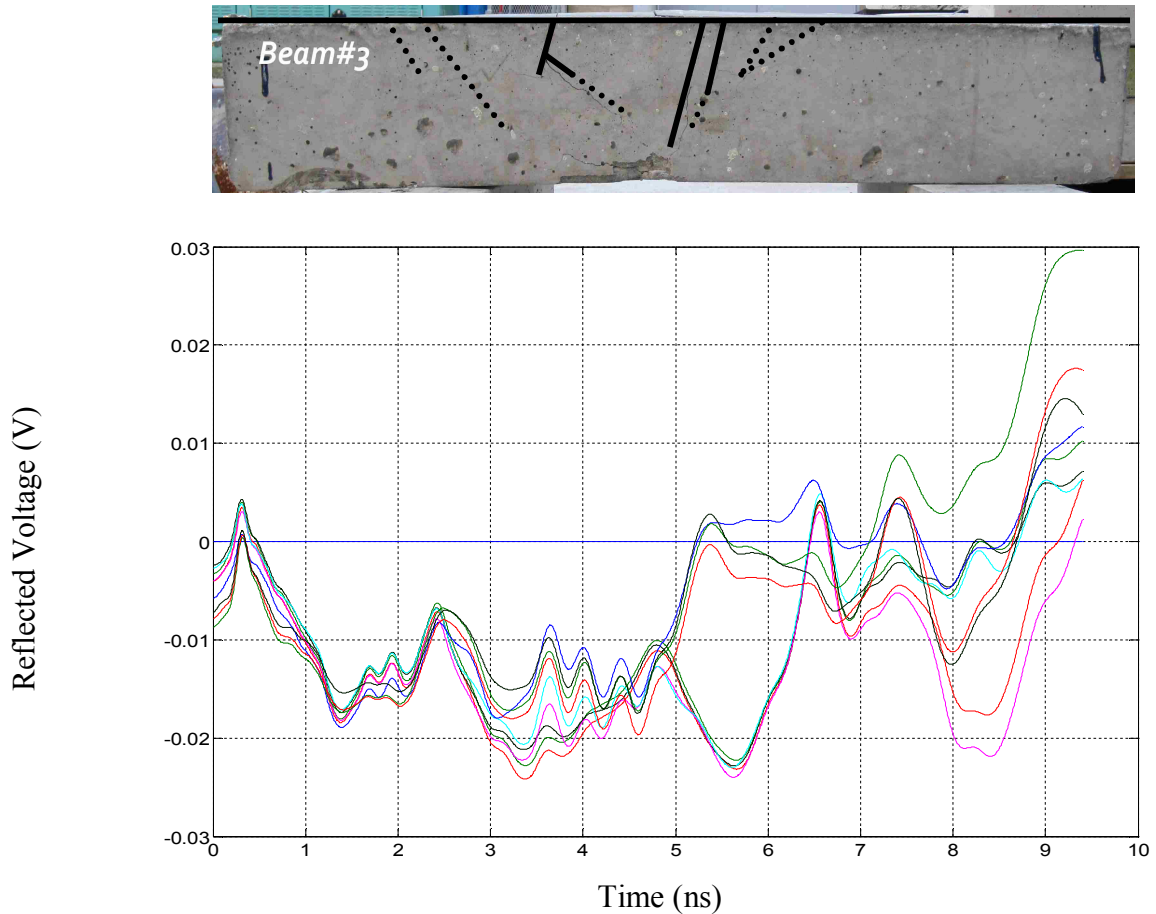
Figure 5.8 and Figure 5.9 illustrate the crack patterns and the TDR waveforms acquired from Beam #3 with two embedded crack sensors that were installed with SikaGrout 212 adhesives. As indicated in Figure 5.8, the correlation between the crack pattern within the beam and Sensor #1 response is considered to be satisfactory. All significant cracks were detected correspondingly.

Figure 5.9. Crack pattern of Beam # 3 and TDR signatures from Sensor # 2: embedded with SikaGrout 212

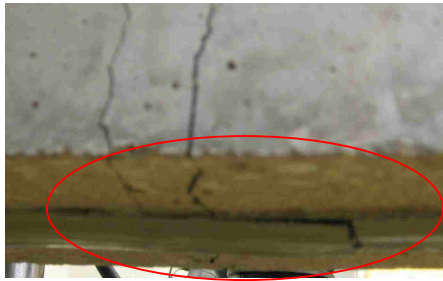
Sensor #3 was surface attached to Beam #3 with Hold Tight ® 102 adhesives. As shown in Figure 5.10 and Figure 5.11, the adhesives delaminated at midspan. The crack patterns on the beam and the sensor are different. The surface attached sensor tended to respond to the crack patterns from both materials and is thus ineffective.

Figure 5.10. Crack pattern difference between Beam # 3 and Sensor # 3 and delamination of HoldTight 102 adhesives at midspan

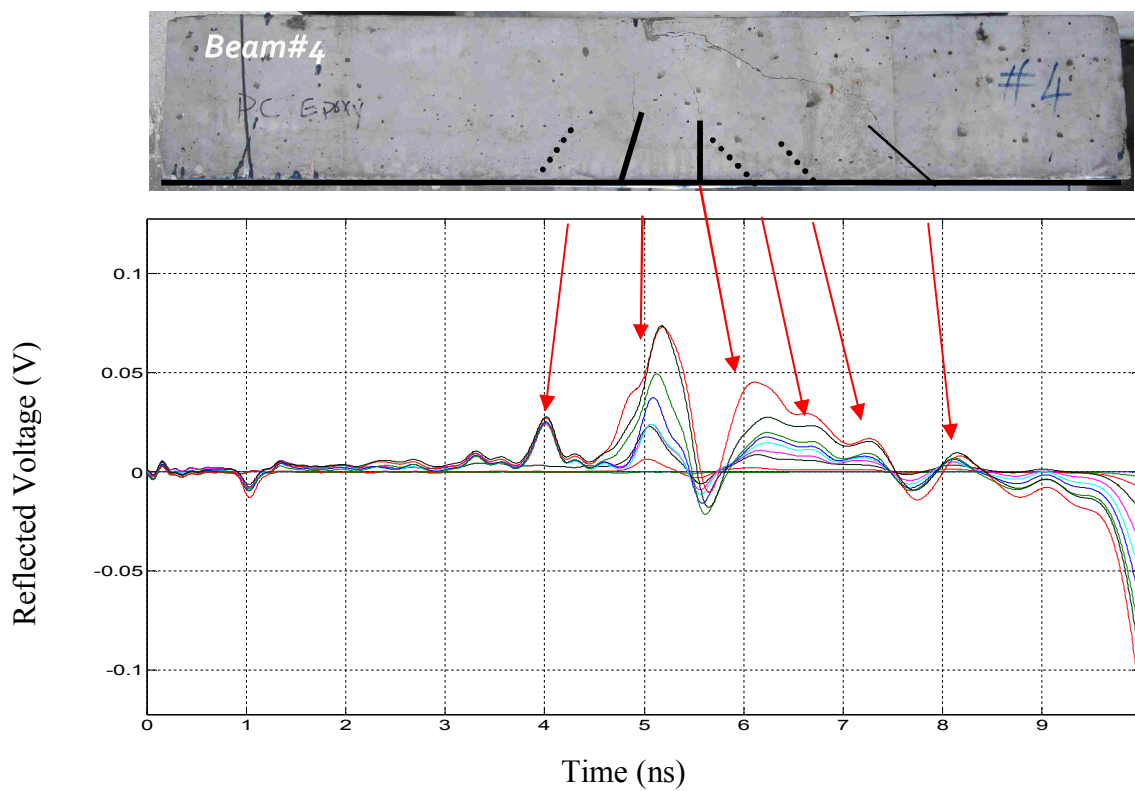
The crack patterns developed on the surface of Beam #4 together with the waveforms acquired from the miniaturized crack sensors are illustrated in Figure 5.12 and Figure 5.13. To enhance attraction between grouting and the host materials, the grooves molded on the tension face of the beam were brushed with the primer. The sensors were grouted with the mortar. During the beam transportation, one of the embedded sensors was damaged. As seen in Figure 5.12, location of all cracks within the beam is reflected fairly accurately by the TDR signatures. In addition, the sensor suggests the presence of the crack zones missed by visual inspection.

Figure 5.12. Crack pattern of Beam # 4 and TDR signatures from Sensor # 1: embedded with mortar

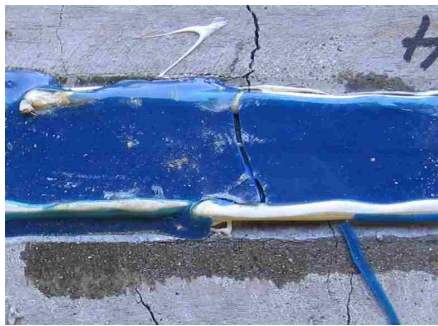
The close-up view of the middle section of the beam is shown in Figure 5.14. In this case, no delamination is observed of the structural epoxy (M_BRACE Saturant). However the fact that the sensor does not respond to the crack pattern within the structural element itself suggests that the adhesive material cannot be used for the crack sensor surface attachment.

Figure 5.14. Crack pattern difference between Beam # 4 and Sensor # 3

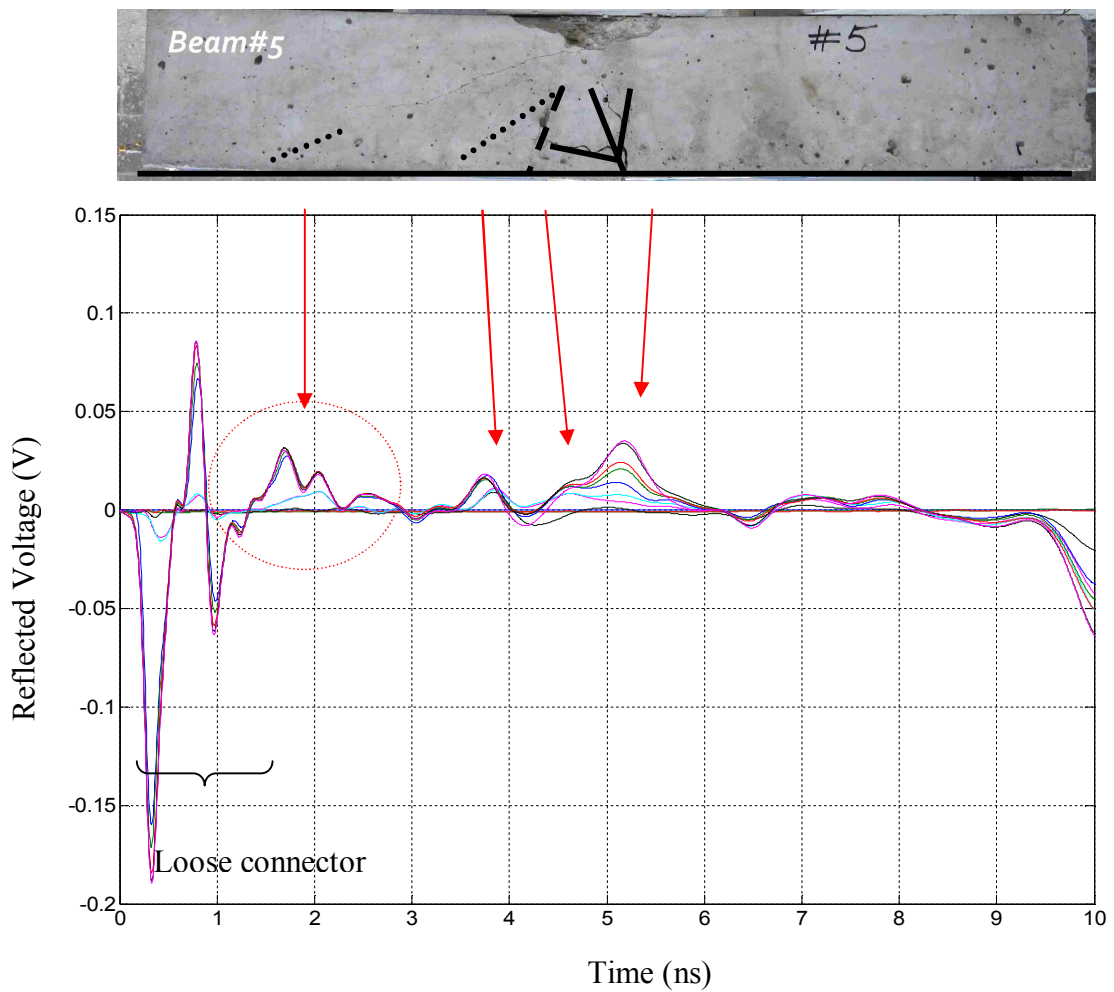
Figure 5.15. Crack pattern of Beam # 5 and TDR signatures from Sensor # 1: embedded with mortar

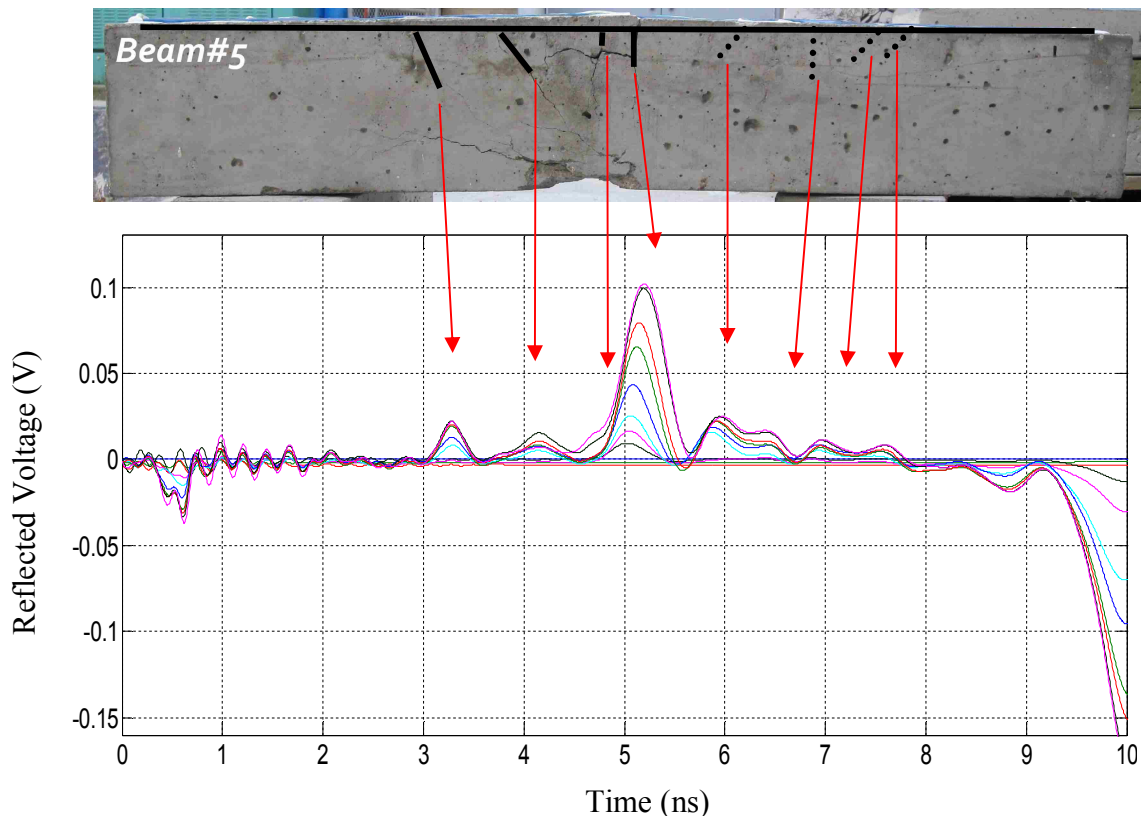
There were cracks observed on the side surface of the beam that had not reached at the tension fibers of the beam where the sensor was grouted. The fact that all visually available cracks were identified correctly, suggests that the additional spikes on the TDR signatures (at 6.5 ns and 7 ns) are produced by smaller cracks that were not visually seen on the beam's surface, Figure 5.16.

Figure 5.16. Crack pattern of Beam # 5 and TDR signatures from Sensor # 2: embedded with mortar

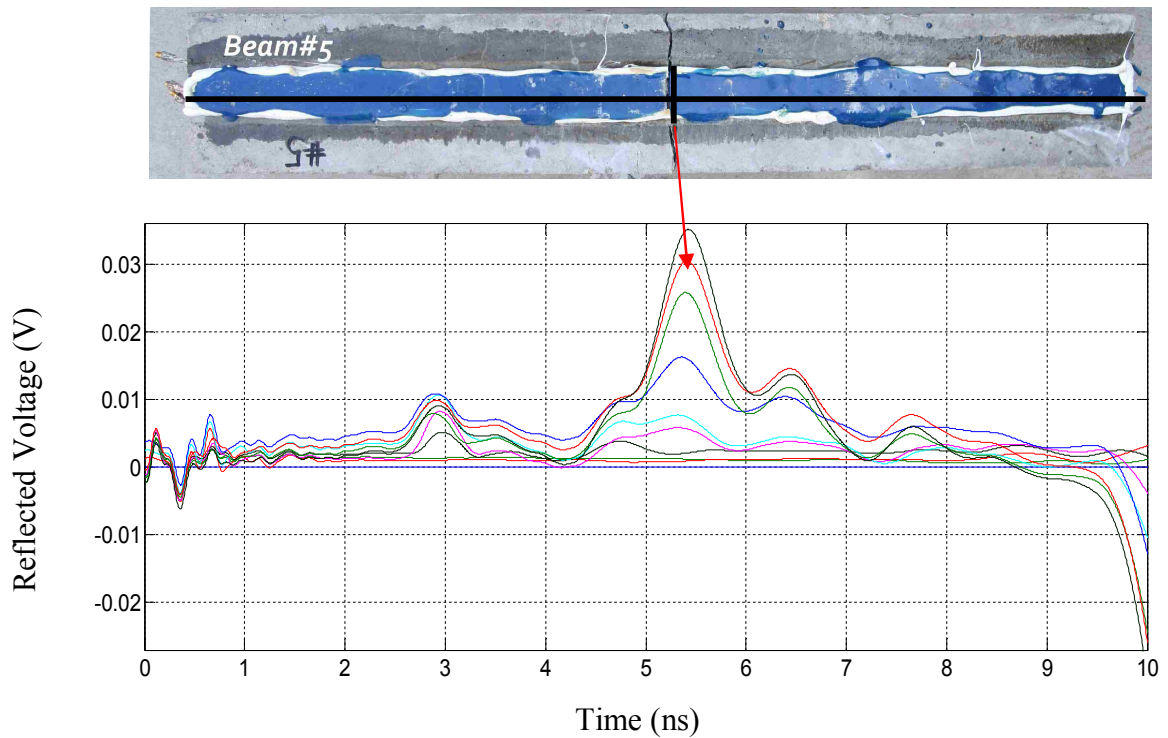
Figure 5.17. Crack pattern of Beam # 5 and TDR signatures from Sensor # 3: surface attached with structural epoxy (M_BRACE Saturant)

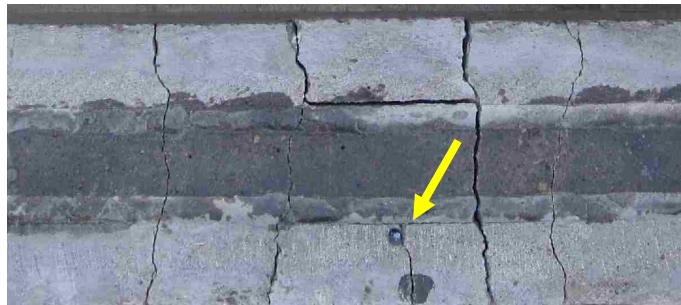
Figure 5.20. Close-up view of the crack pattern within the midspan of the tension face of the Beam # 6

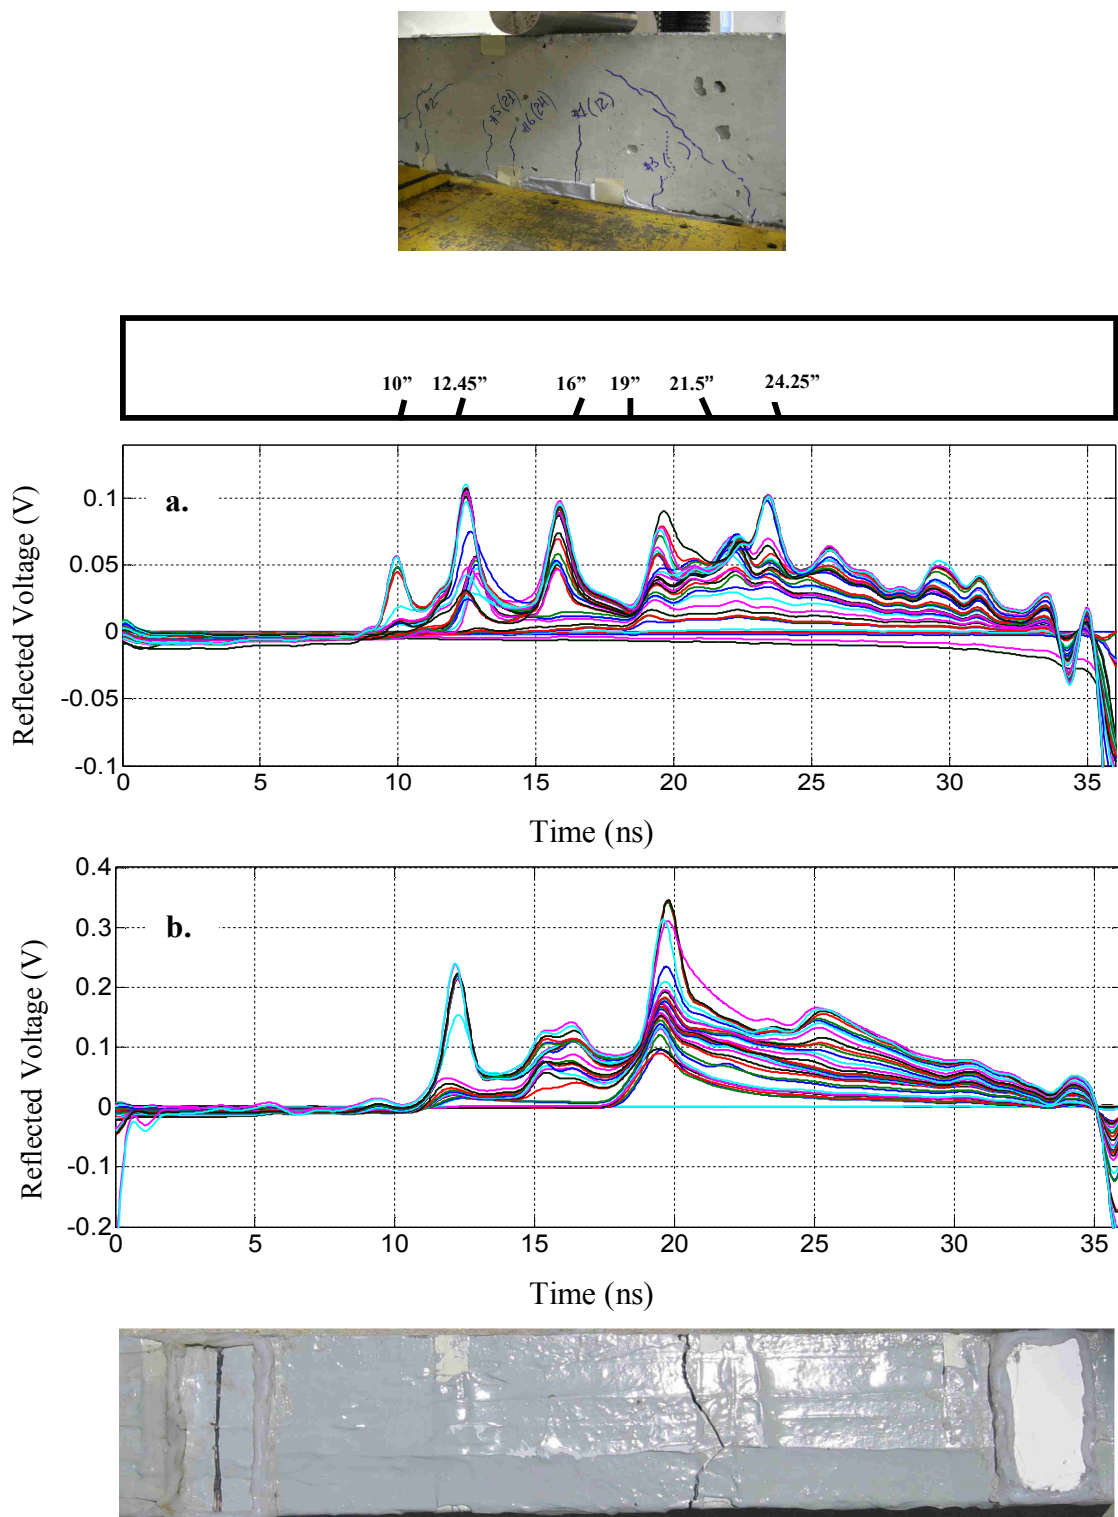
For Bean #7, one embedded sensor was installed with mortar, and one surface attached sensor was installed with HoldTight®102. Figure 5.21 presents the crack pattern and TDR signatures from the embedded and the surface attached sensors. It can be seen from Figure 5.21 that the embedded sensor successfully detected all visible cracks.

Figure 5.21. Crack pattern of Beam # 7 and TDR signatures from the Beam # 7 from (a) embedded sensor, and (b) surface attached sensor

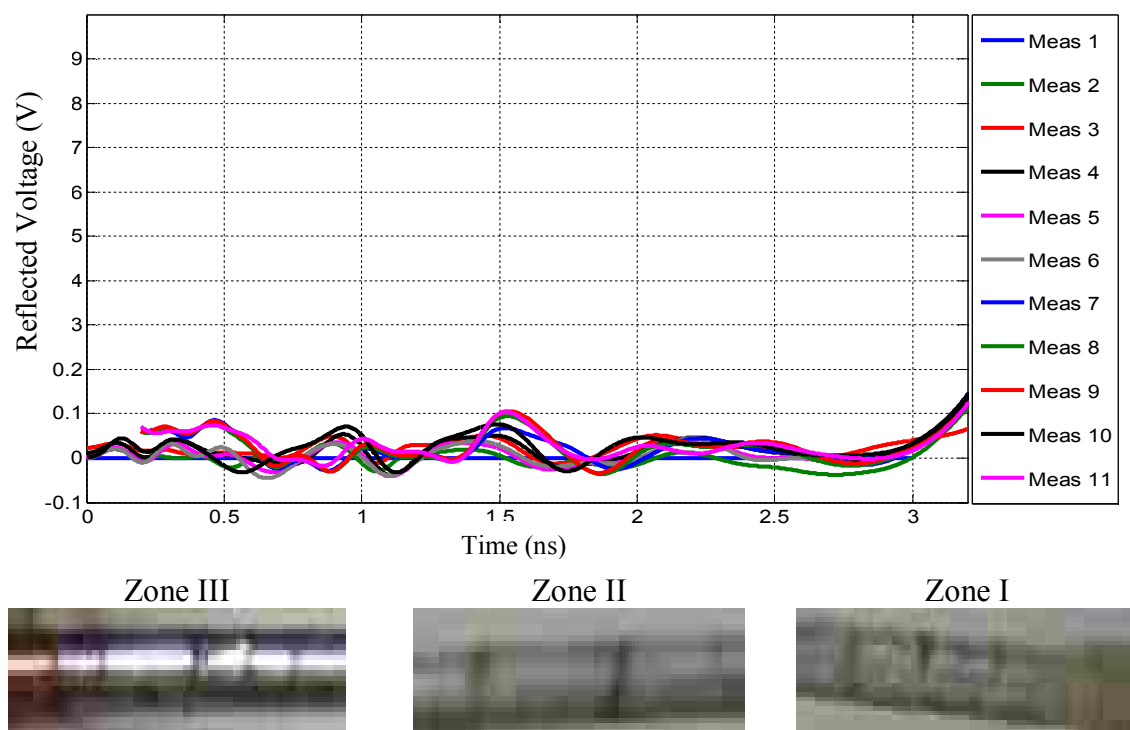
Figure 6.6 presents the normalized reflection coefficients of the sensor placed into distilled water that were measured during the corrosion tests.

Figure 6.6. Normalized signatures and images of the sensor placed into distilled water

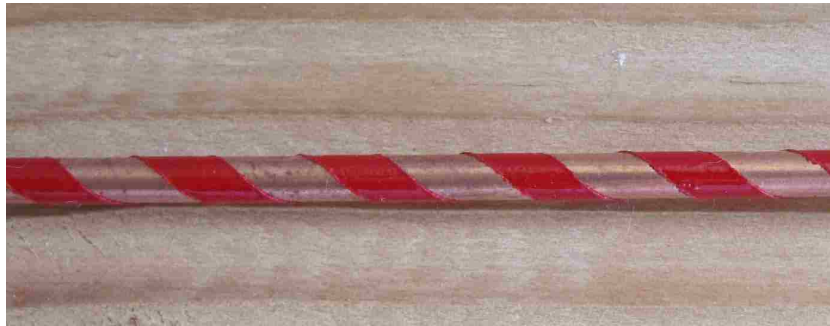
Figure 6.9. Corrosion resistant helical paints over a coaxial cable sensor

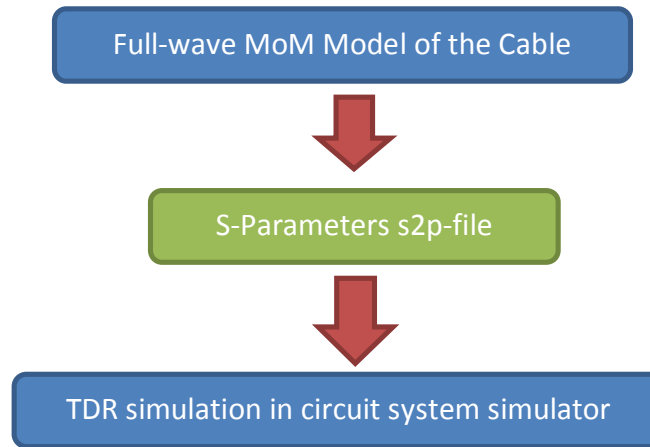
Figure B.1. Simulation flow chart

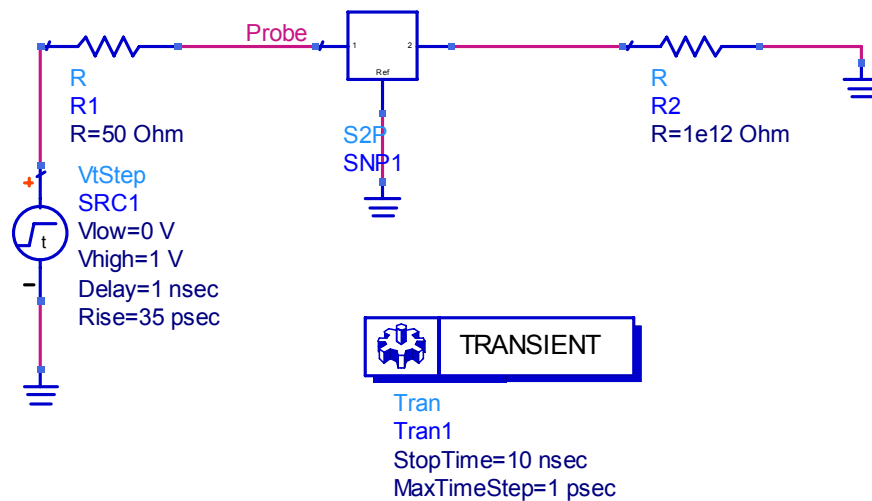
Figure B.11. ADS model of the setup with TDR and the sensor
