# Unbonded Pre-tensioned Bridge Columns with Rocking Detail

A thesis

Master of Science in Civil Engineering

University of Washington

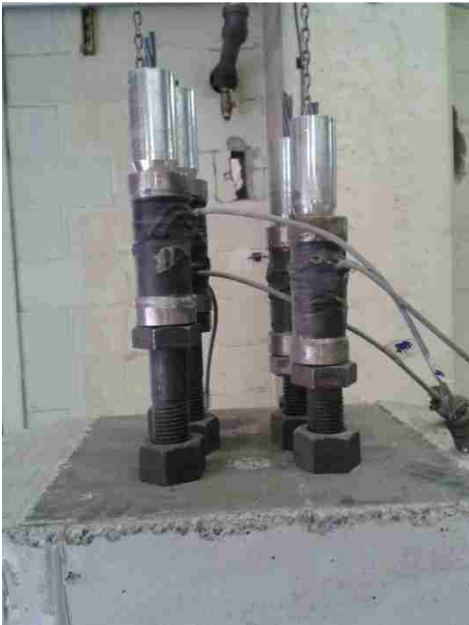
**Figure 2.5** Photograph (Left) and schematic (Right) views of the system to detect and prevent the strands from slipping.

To anchor the strands during the tests, each strand was fitted with a prestressing chuck at each end. Each strand had a load cell at its top end, in between the chuck and the column face (Figure 2.5). Using 7/8" diameter ASTM A490 bolts and a plate with welded nuts of complimentary size (STD Plate), each end of the strand was stressed to four kips by turning the bolts against the resisting chucks (Figure 2.4). During the tests, the load cell would detect any slip in the strand, while the chuck would guarantee continued anchorage. Load cells were only placed at the top of the column, because the bond length was shorter at the top end. Any slip that would occur in the footing portion of the column would occur in the actuator end, and the load cell would detect it.

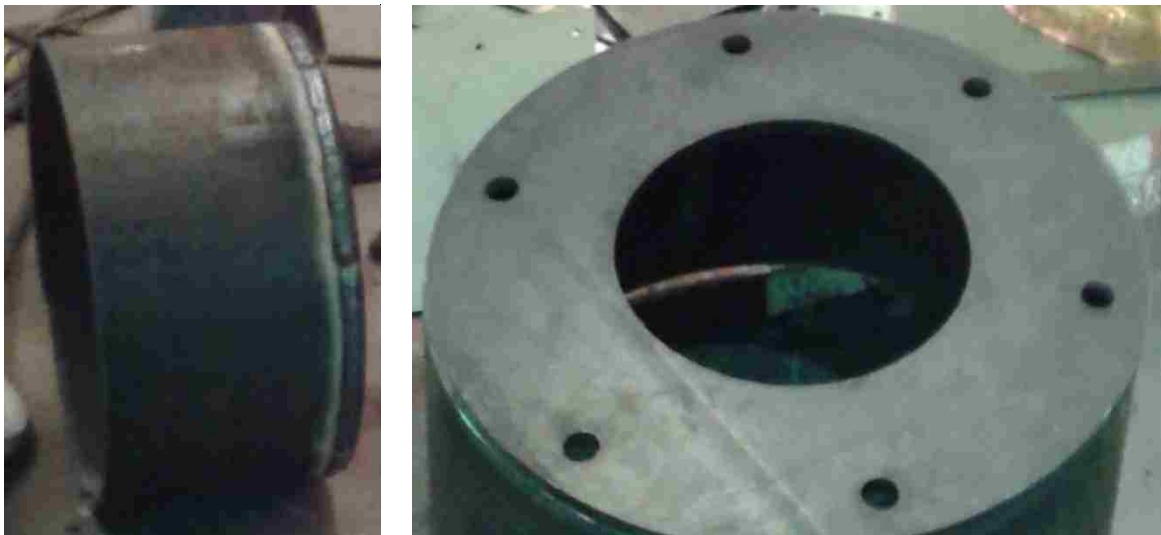
**Figure 2.6** Steel shoe. On left is an elevation view of the shoe while on right is a bottom view of the shoe.

The column had a special connection (“steel shoe”) at the location of the column-footing interface to encourage rocking and to minimize damage. The rocking connection consisted of a shoe annular plate, a shoe wall, discontinuous welded bars, and through bars.

No. 4 bars extended the full height of the column and through the rocking connection. To delay bar fracture, the No. 4 reinforcing bars were encased in 8-in. long plastic sleeves, which extended 4” above and 4” below the interface. This unbonded region delayed bar fracture by distributing the bar elongation over the debonded length.

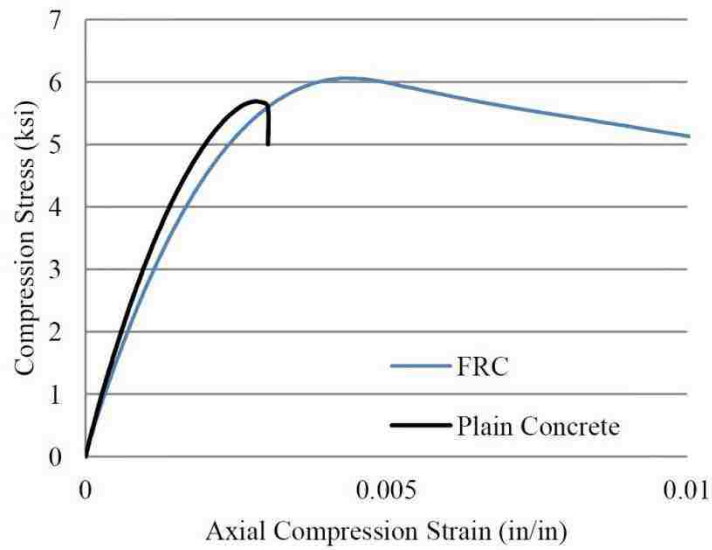
**Figure 2.8** Typical axial compression stress vs. strain for HyFRC compared to conventional concrete, Ostertag et al. (2013).

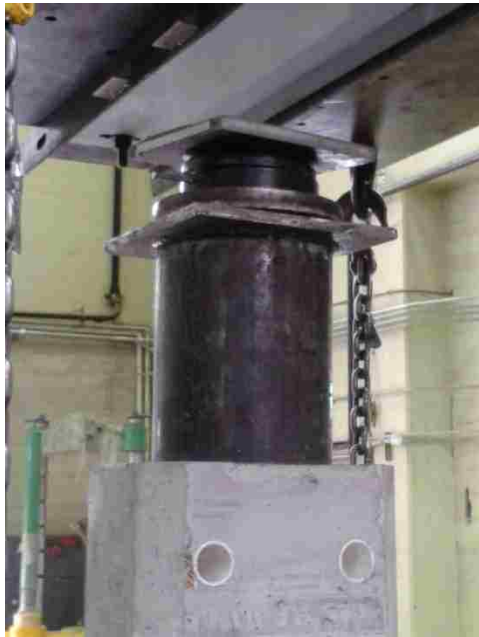
**Figure 3.2** Actual (Left) and Schematic (Right) views for the system that transfers load from the Baldwin to the specimen while safely covering prestressing load cells and chucks.

A system was needed to keep the column aligned in the correct vertical plane as it underwent cyclic loading. The system consisted of a steel encasing tube, spherical bearing head, greased PTFE plate and stainless steel channel, arranged in accordance with Figure 3.2. This steel encasing tube was necessary because space was required above the column for the chucks that anchored the prestressing strands and the load cells that detected potential slip. The steel tube had an inside diameter of 12" and wall thickness of 0.5". The square steel plate welded atop the tube had length of 16" and thickness of 7/8". Above the steel plate was a spherical bearing on which rested a greased PTFE pad. When the column rotated during the test, the PTFE plate slid against a stainless steel channel fixed to the head of the Baldwin and the spherical bearing adjusted for the relative rotation.

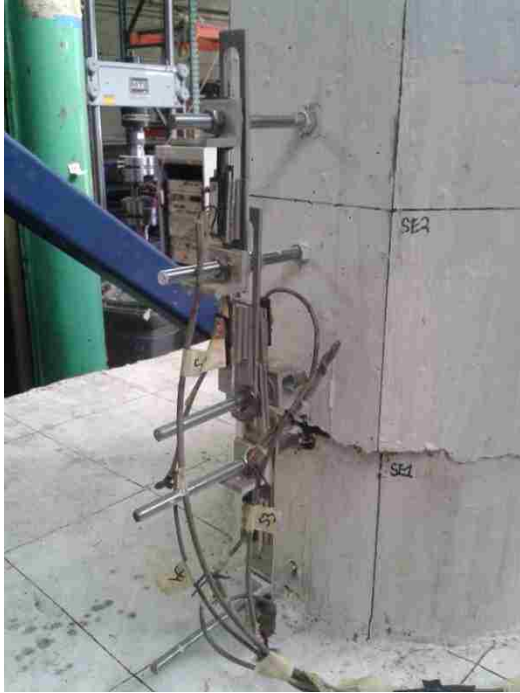
**Figure 3.6** Photograph (Left) and schematic (Right) views of the curvature rod system used on the north face.

The system consisted of a series of linear potentiometers attached to metal plates. These metal plates, in turn, were connected to a set of threaded rods that protruded from the column. The threaded rods were located on both the north and south face at 2.5", 9", 12", 18" and 24.5" above the column-to-footing interface. The lowest linear potentiometer measured the change in height between the footing and the lowest threaded rod.

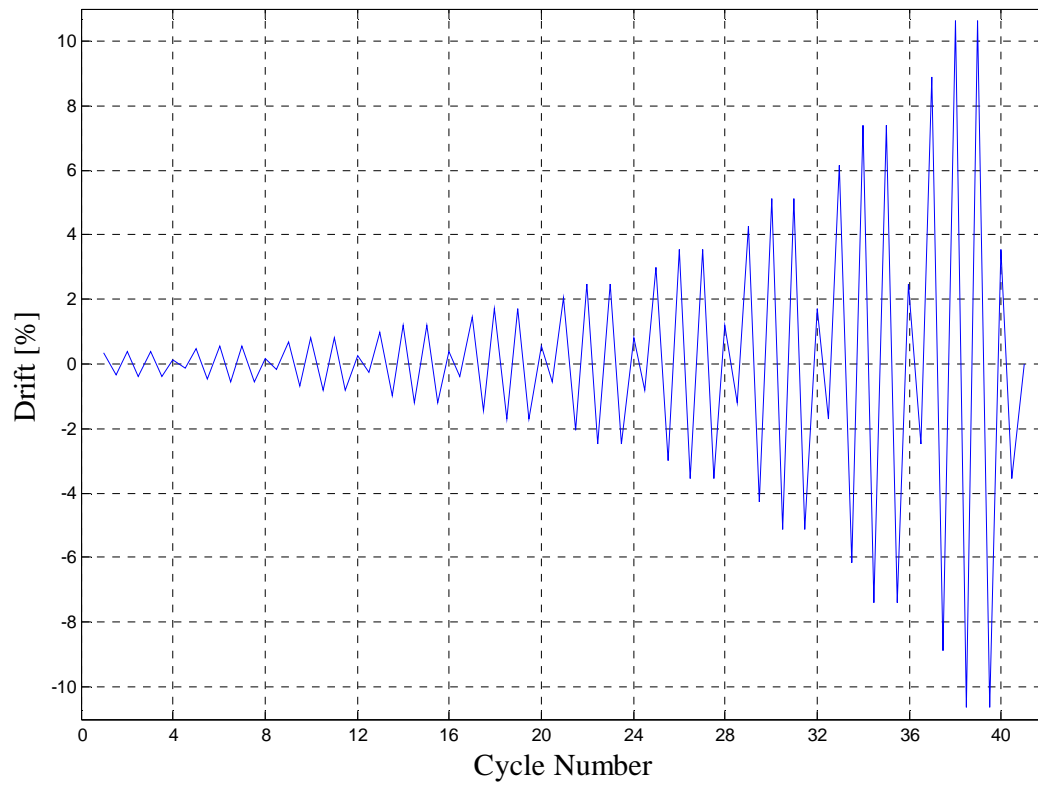
**Figure 3.11** Graphical representation of the target displacement history.

Set	Cycle	Drift [%]	Displacement [in.]
6	1	± 2.06	± 1.24
	2	± 2.48	± 1.49
	3	± 2.48	± 1.49
	4	± 0.83	± 0.50
7	1	± 2.97	± 1.78
	2	± 3.57	± 2.14
	3	± 3.57	± 2.14
	4	± 1.19	± 0.71
8	1	± 4.28	± 2.57
	2	± 5.14	± 3.08
	3	± 5.14	± 3.08
	4	± 1.71	± 1.03
9	1	± 6.16	± 3.70
	2	± 7.40	± 4.44
	3	± 7.40	± 4.44
	4	± 2.47	± 1.48
10	1	± 8.87	± 5.32
	2	± 10.65	± 6.39
	3	± 10.65	± 6.39
	4	± 3.55	± 2.13

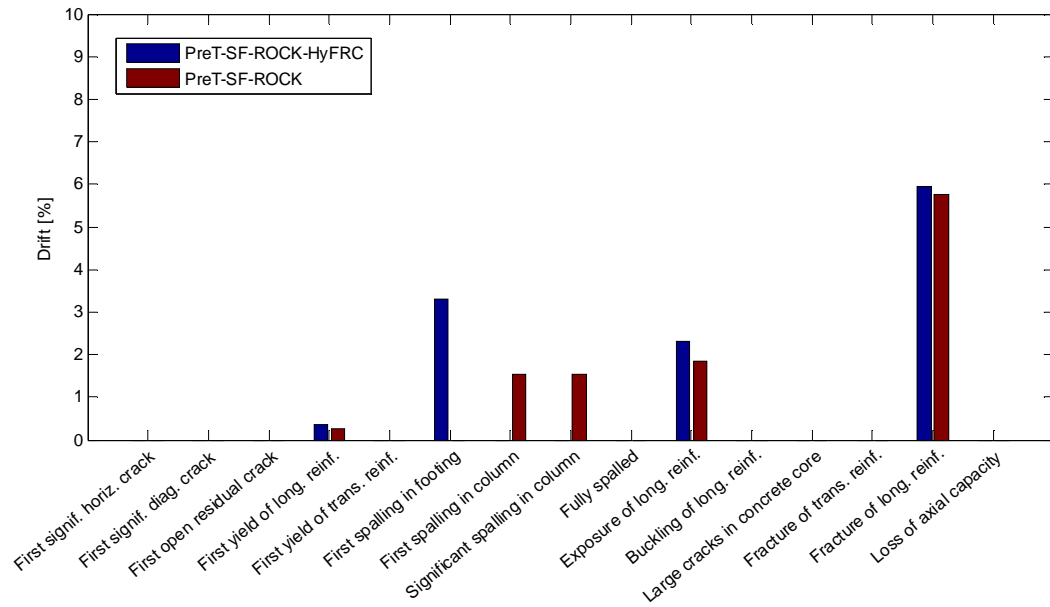
**Figure 4.1 Comparison of drift levels at which both columns reached the defined damage states.**

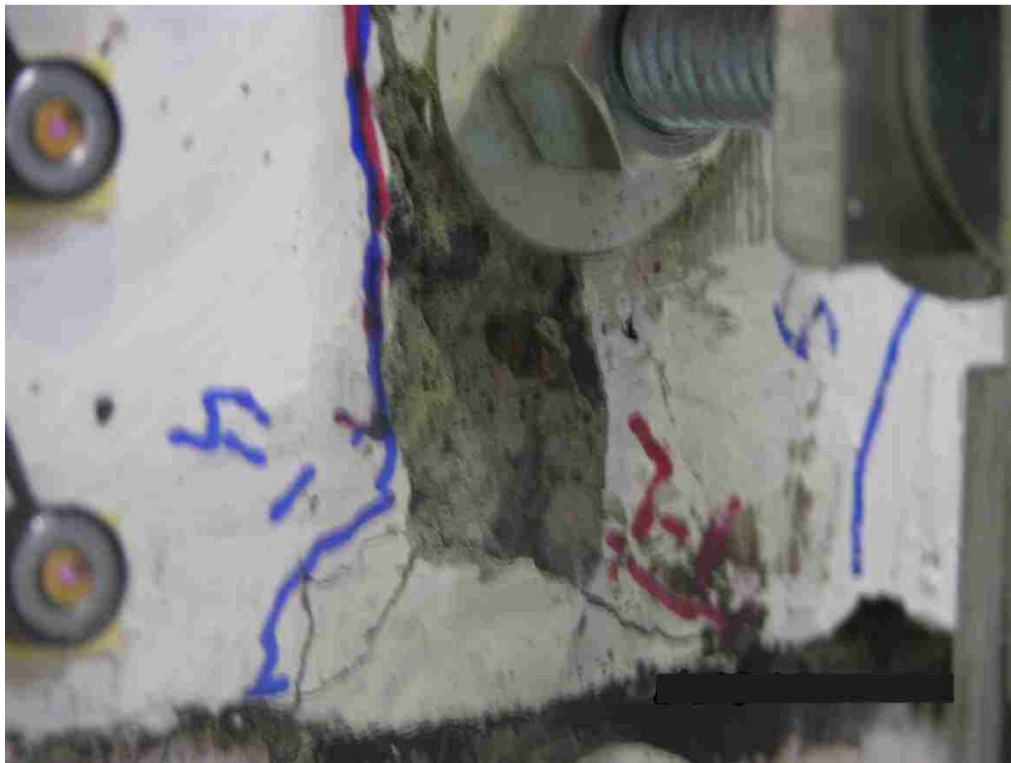
**Figure 4.5** South view of PreT-SF-ROCK after cycle 8-4 showing spalling damage above the steel shoe.

The higher tensile strength of HyFRC prevented this architectural spalling from occurring in PreT-SF-ROCK-HyFRC.

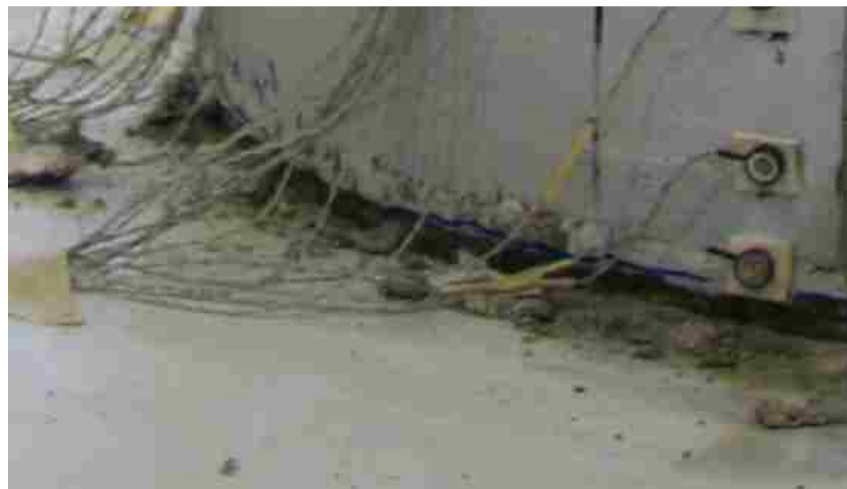
**Figure 4.7** South view of PreT-SF-ROCK-HyFRC showing the fillet spalling of the footing induced by the rocking action of the steel shoe.

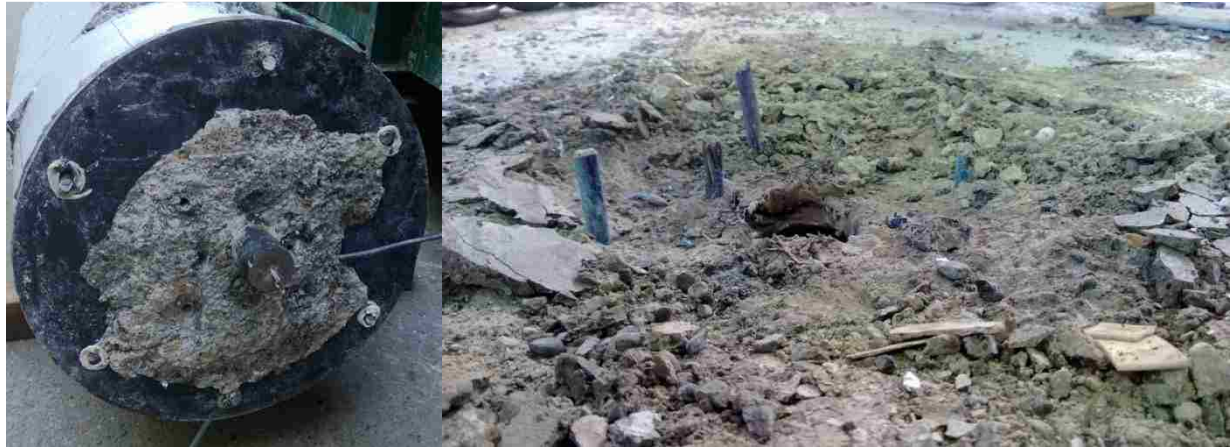
**Figure 4.8** Jagged portion of HyFRC that seeped through steel-wire mesh (Left). Column-footing interface after top portion of column was removed (Right).

perfectly rigid or impermeable. As a result, a small amount of HyFRC seeped underneath the bottom of the steel shoe, forming a jagged surface. During the test, this portion of HyFRC was crushed between the base of the steel shoe above and the conventional concrete beneath it. After both tests were complete, researchers detached the column from the footing in specimen PreT-SF-ROCK-HyFRC for closer observation of the column-footing interface (Figure 4.8).

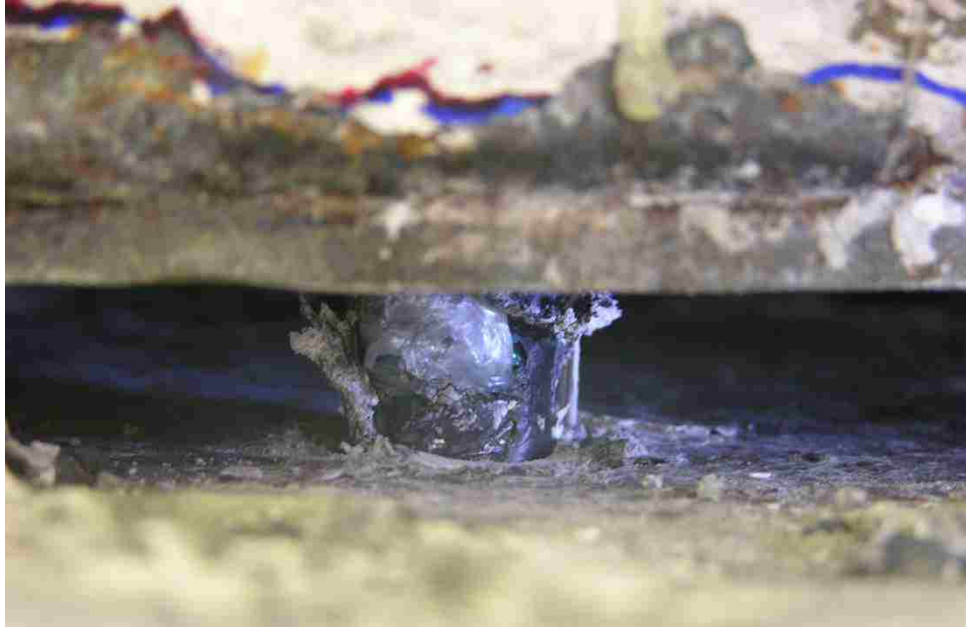
**Figure 4.9** Exposed north bar of PreT-SF-ROCK.

In earlier tests (Finnsson et al. 2013, Davis et al. 2011 and Haraldsson et al. 2011), the base of the column was not confined externally by a steel shoe. As the cover spalled, the bars lost lateral support and consequently buckled. Conversely, no bars ever buckled in the footing due to the large quantity of concrete that provided significant lateral support. Thus, the steel shoe appears to offer an effective means of lateral support that consequently prevented bar buckling.

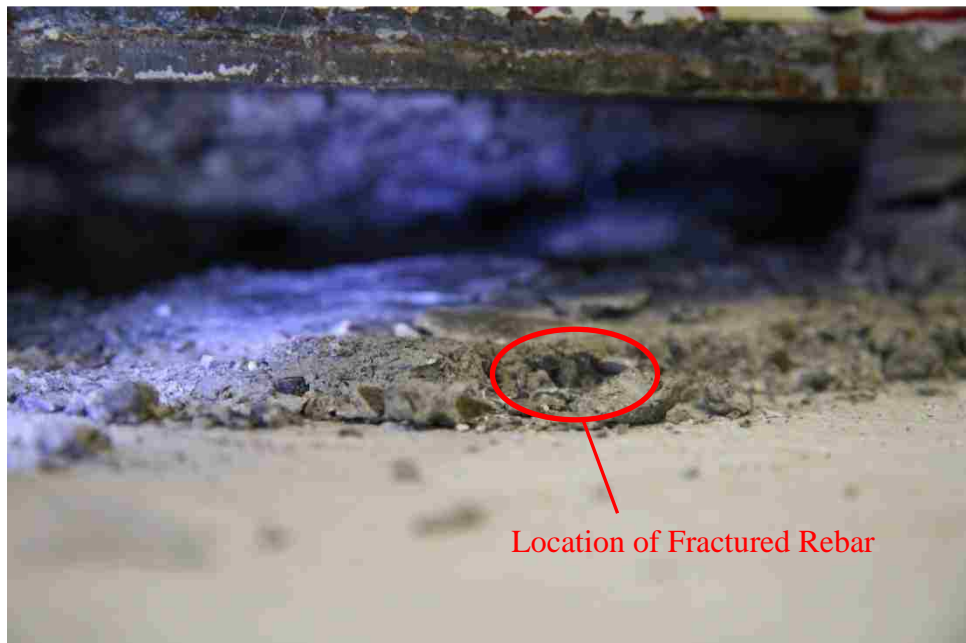
**Figure 4.10** Fractured northwest bar of PreT-SF-ROCK-HyFRC (fractured in footing).

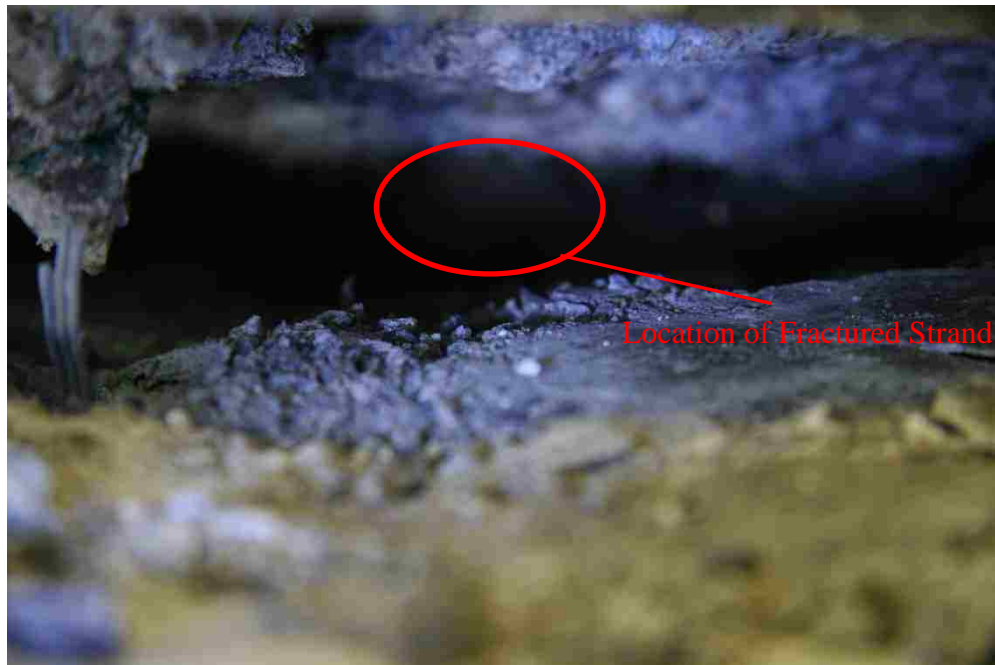
**Figure 4.12**      **Northwest view of PreT-SF-ROCK-HyFRC showing location of missing strand (fractured).**

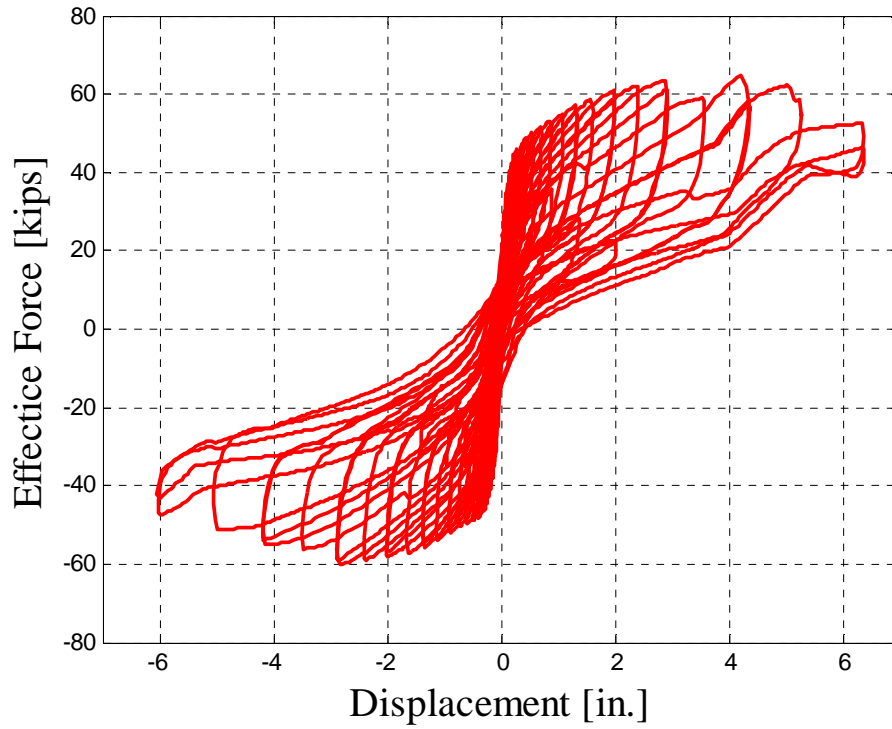
**Figure 5.8** Effective force-displacement response for Specimen PreT-SF-ROCK-HyFRC.

Figures 5-8 and 5-9 illustrate the effective force versus displacement plots, whereas Table 5.7 lists the maximum effective forces observed and the corresponding drift levels.

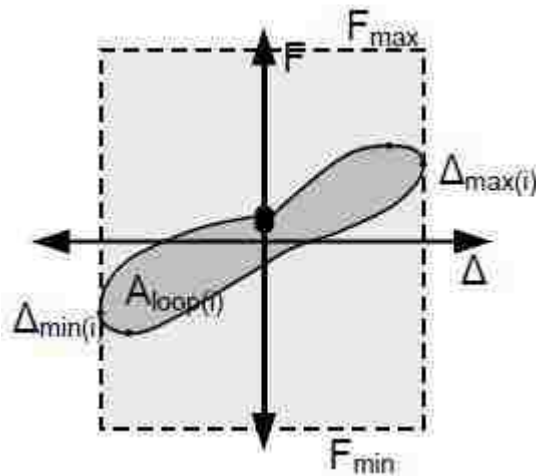
**Figure 6.5** Normalization method for energy dissipation, Pang et al. (2008).

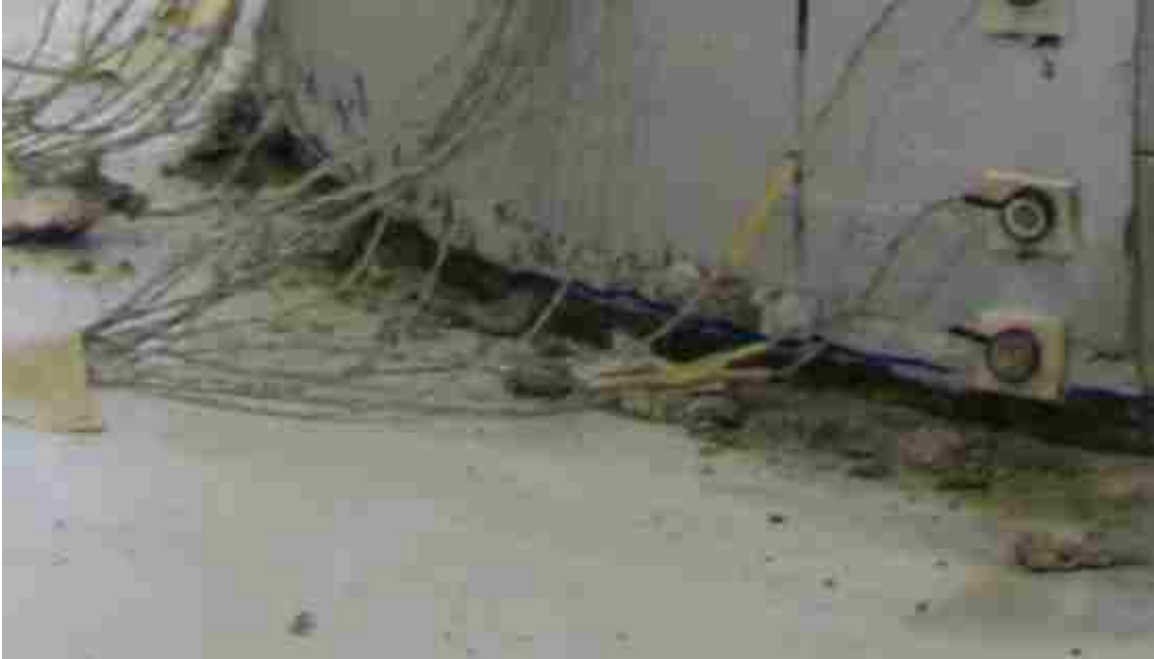
**Figure C.2 Footing fillet-spalling.**

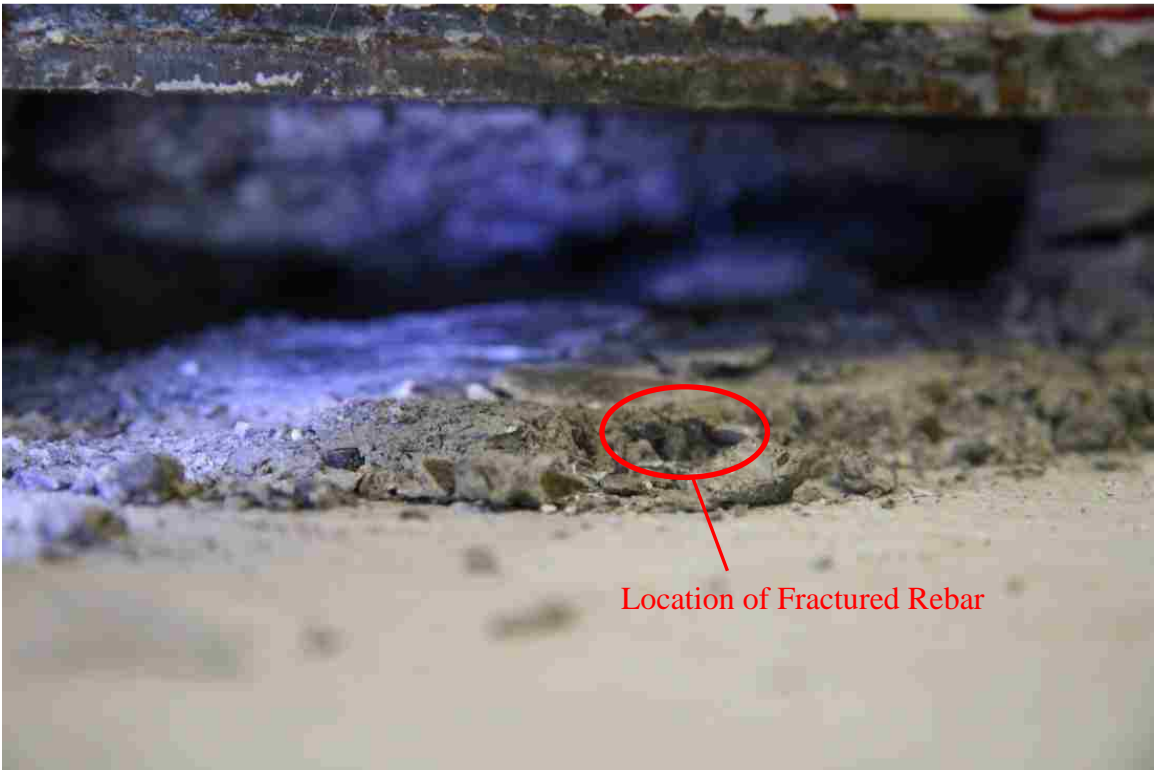
**Figure C.3 Fractured Rebar, cycle 9-1.**

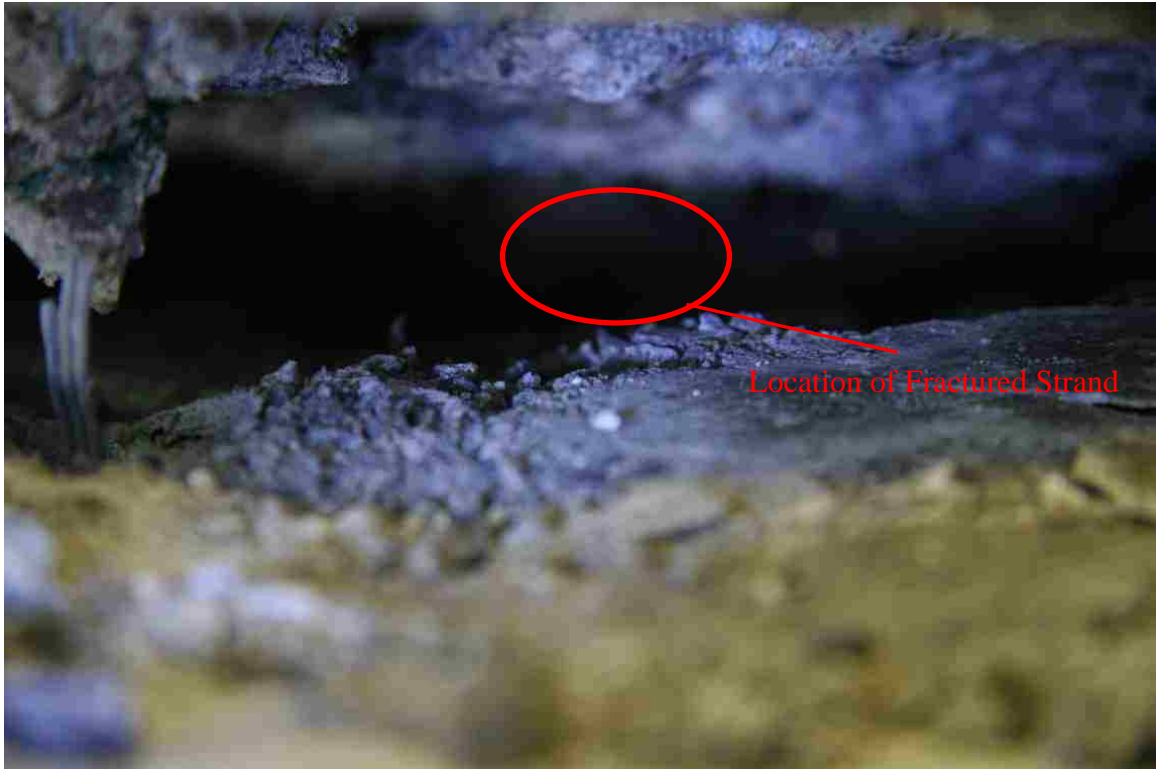
**Figure C.4** Fractured Strand, cycle 9-2.

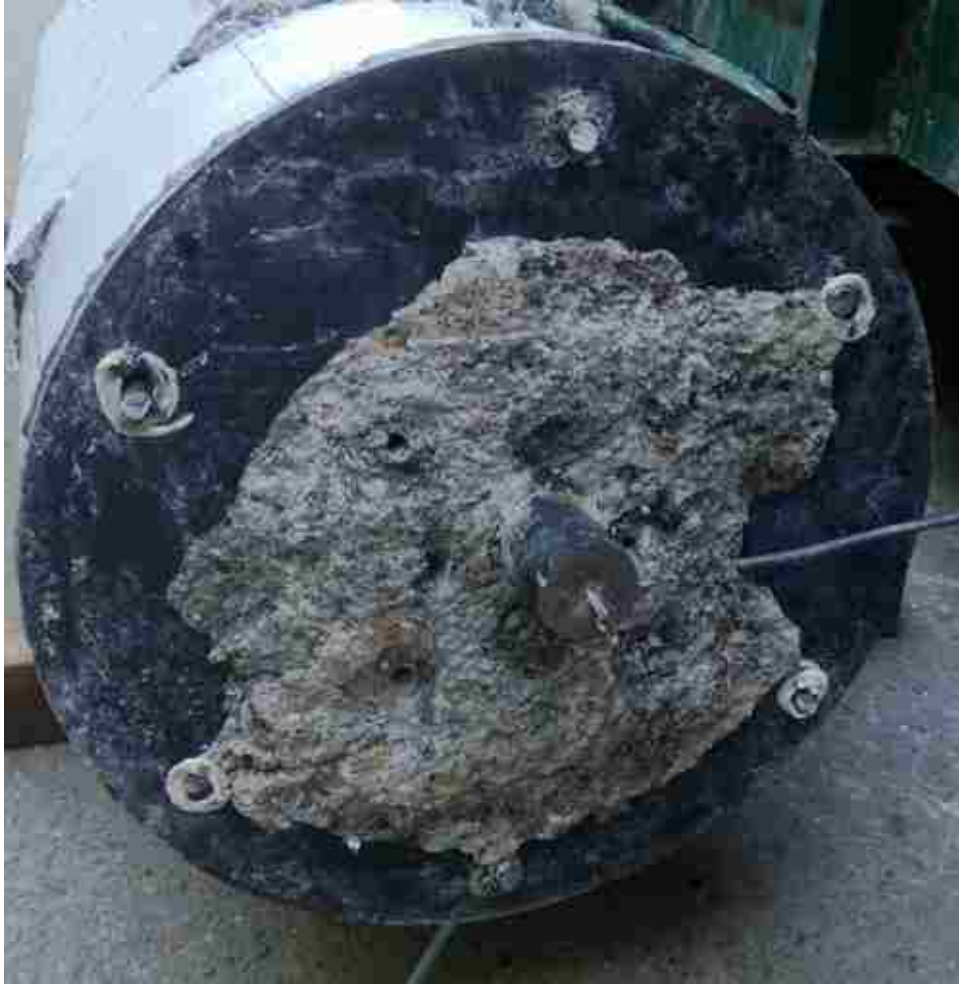
**Figure C.6** Bottom of shoe after testing.

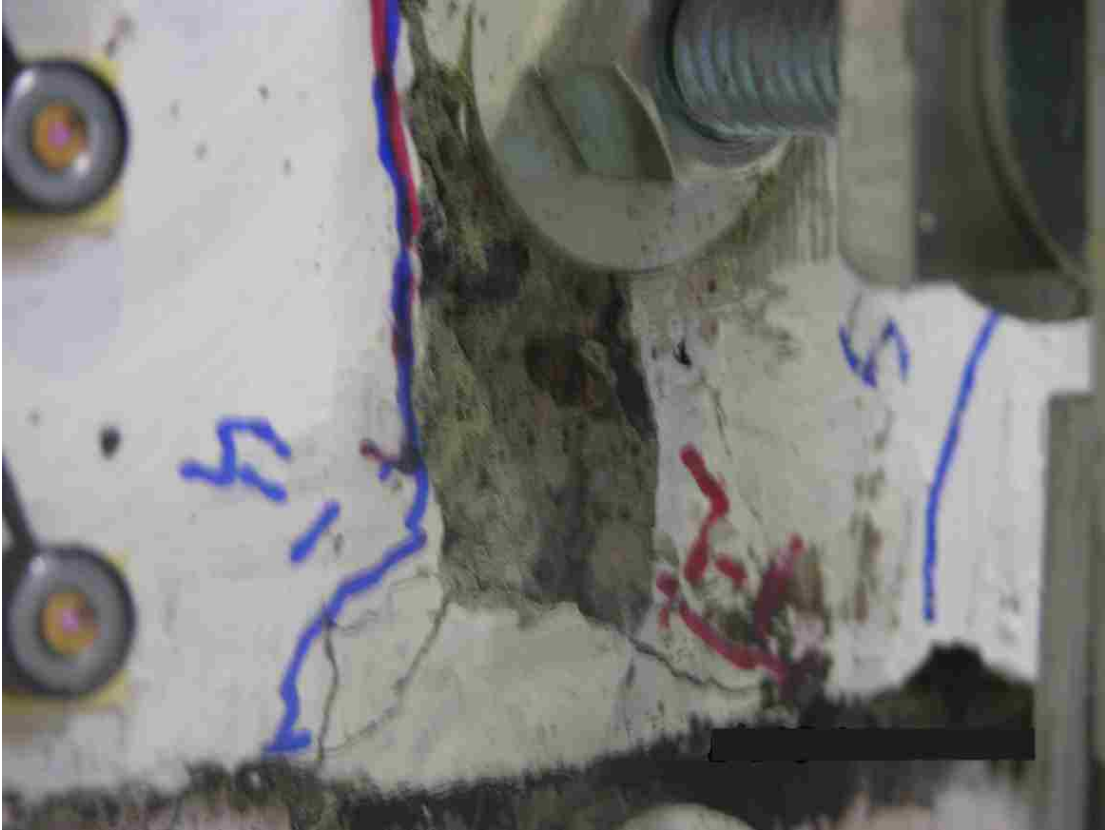
**Figure C.9** Cosmetic spalling at top of shoe.

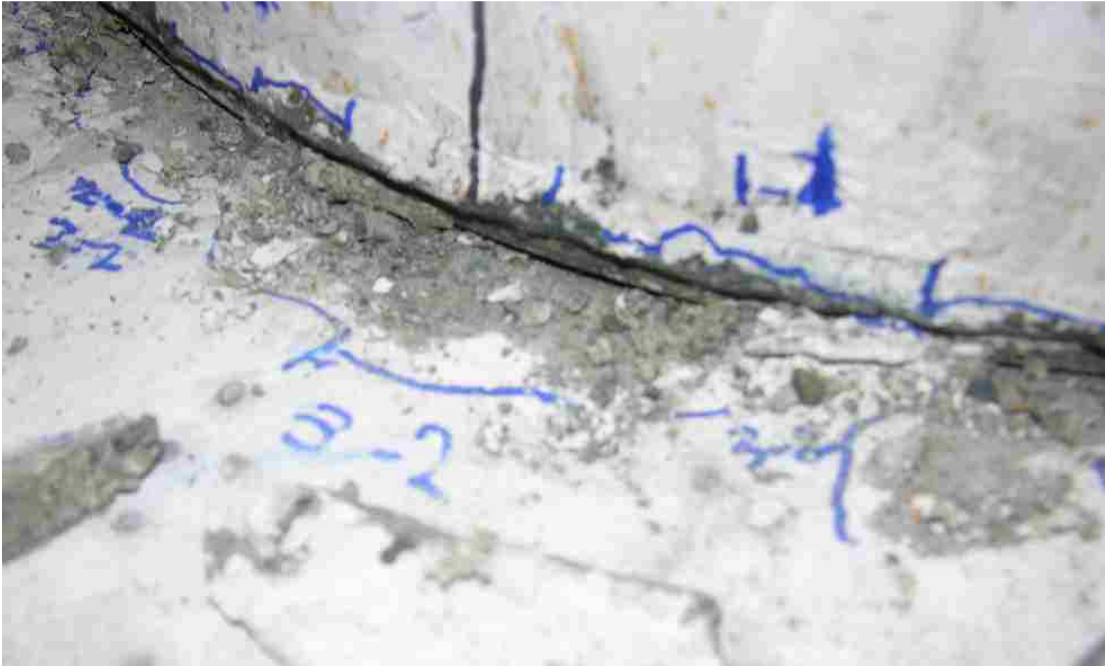
**Figure C.10** Footing fillet-spalling.

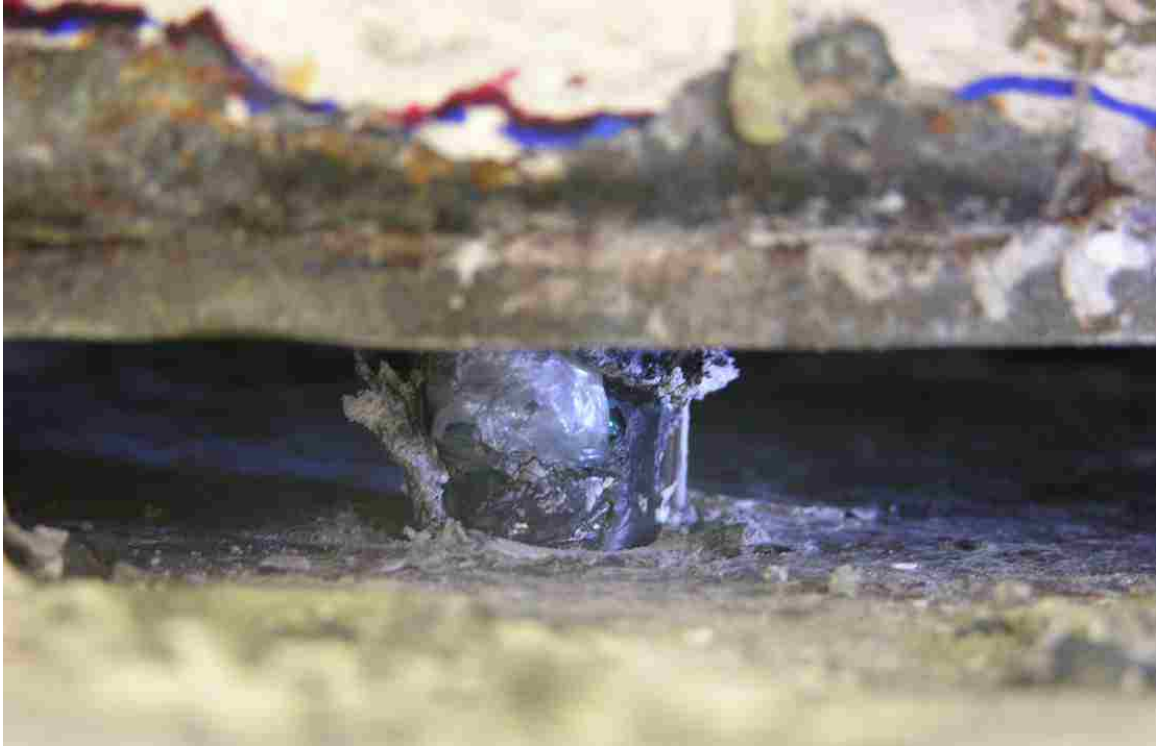
**Figure C.11 Exposure of rebar.**
