CFT Column-to-Cap Beam Connections for  
Accelerated Bridge Construction in Seismic Regions

Master of Science in Civil Engineering

University of Washington

2014

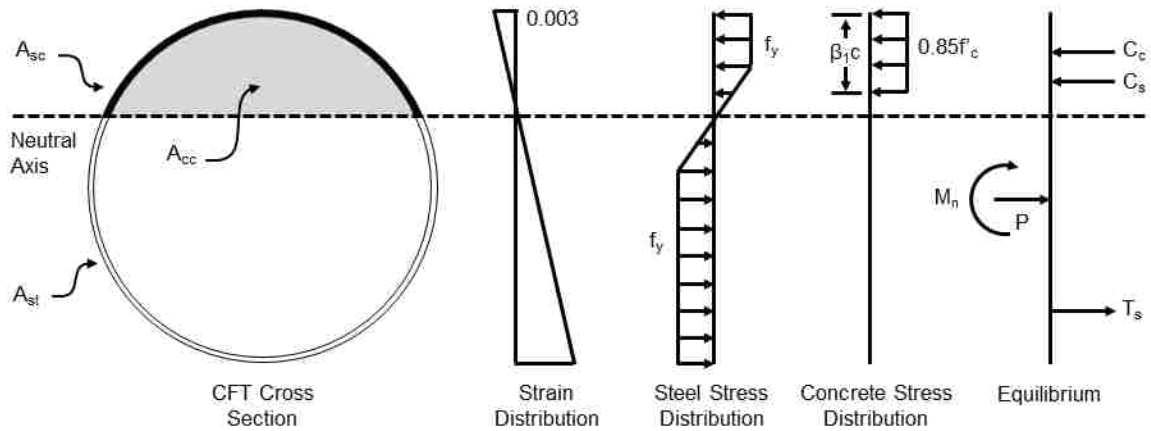
The ACI procedure to calculate the strength of a composite member is similar to the AISC strain compatibility method, except the ACI method permits the use of an equivalent rectangular compressive stress block to replace the more exact concrete stress distribution. The equivalent stress block is assumed to have a uniformly distributed stress of  $0.85f'_c$  that acts over a depth of  $\beta_1 c$ , where  $\beta_1$  is dependent on the specified compressive strength of the concrete, and  $c$  is the distance from the extreme compression fiber to the neutral axis. Figure 2.3 shows the ACI stress distribution models.

**Figure 2.3:** ACI Model for Strength Prediction

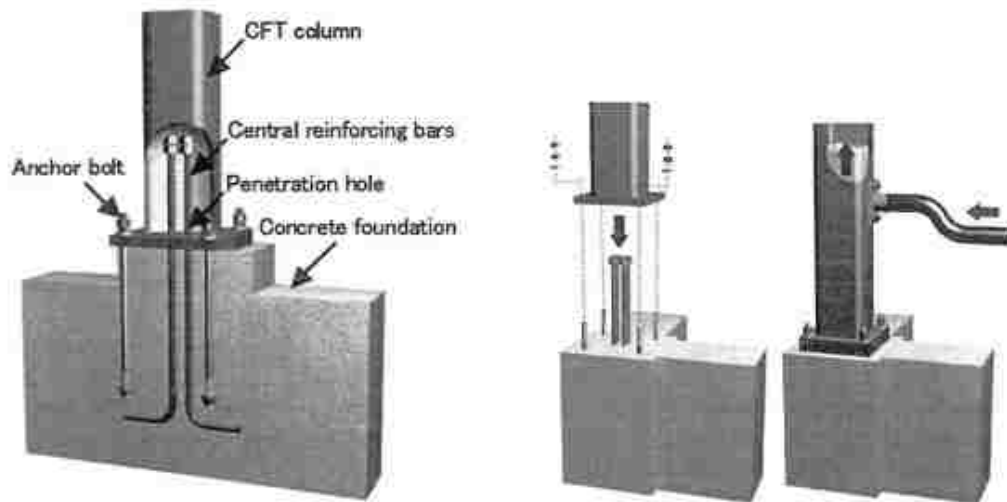
Kawaguchi and Morino (2006) developed a CFT-foundation connection consisting of an exposed base plate with anchor bolts and central reinforcing bars. The central reinforcing bars are embedded into the concrete foundation, and they extend into the CFT column through a hole in the base plate. The reinforcing bars are intended to increase the strength and stiffness of the connection when compared to those without the reinforcing bars. Figure 3.1 shows an overview of the proposed connection detail, as well as the construction procedure.

**Figure 3.1:** CFT-Footing Connection Configuration by Kawaguchi and Morino (Kawaguchi and Morino, 2006).

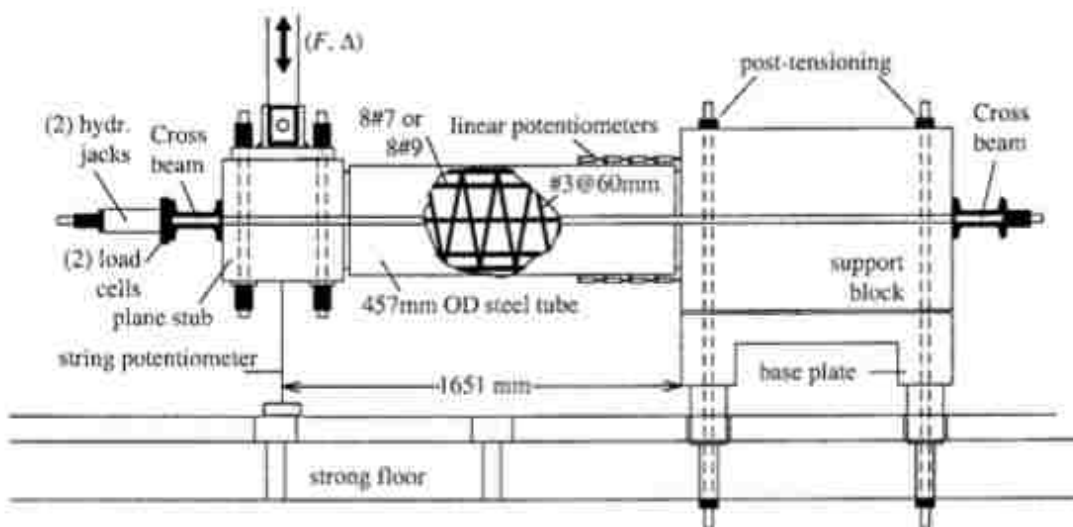
Montejo (2012) tested a series of reinforced concrete-filled steel tube (RCFST) column-cap beam connection specimens. In a RCFST column, a conventional steel cage inside of the tube provides the primary flexural strength of the specimen. A gap is left between the base of the steel tube and its adjacent cap element such that the need for a special joint connection is avoided, and the contribution of the steel tube on shear strength and concrete confinement is maximized. In this test program, the specimens were designed to replicate a half-scale bridge column. The columns were 18-in. in diameter and 3/8-in. thick, such that the resulting  $D/t$  ratio replicated that used in actual practice. Varying amounts of longitudinal reinforcing was used between specimens. Figure 3.5 shows an overview of the specimen geometry and test setup.

**Figure 3.5:** RCFST Geometry and Test Setup by Montejo (2012)

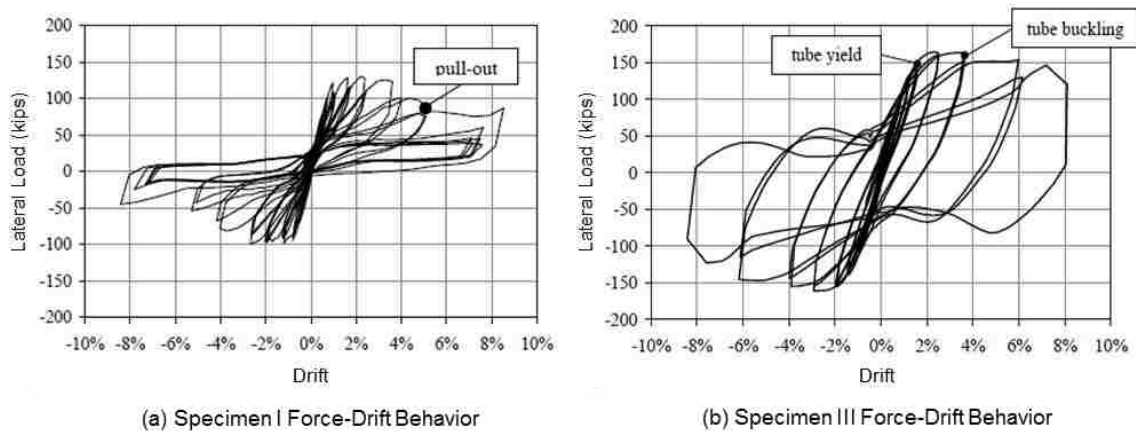
The force-drift hysteretic behavior of Specimens I and III is presented in Figure 3.8. By comparing the two hysteresses, it can be seen that the overall strength and ductility of the connection is greatly influenced by the embedment depth of the column.

**Figure 3.8:** Force-Drift Response from adequately and inadequately embedded specimens (Kinsley, 2005)

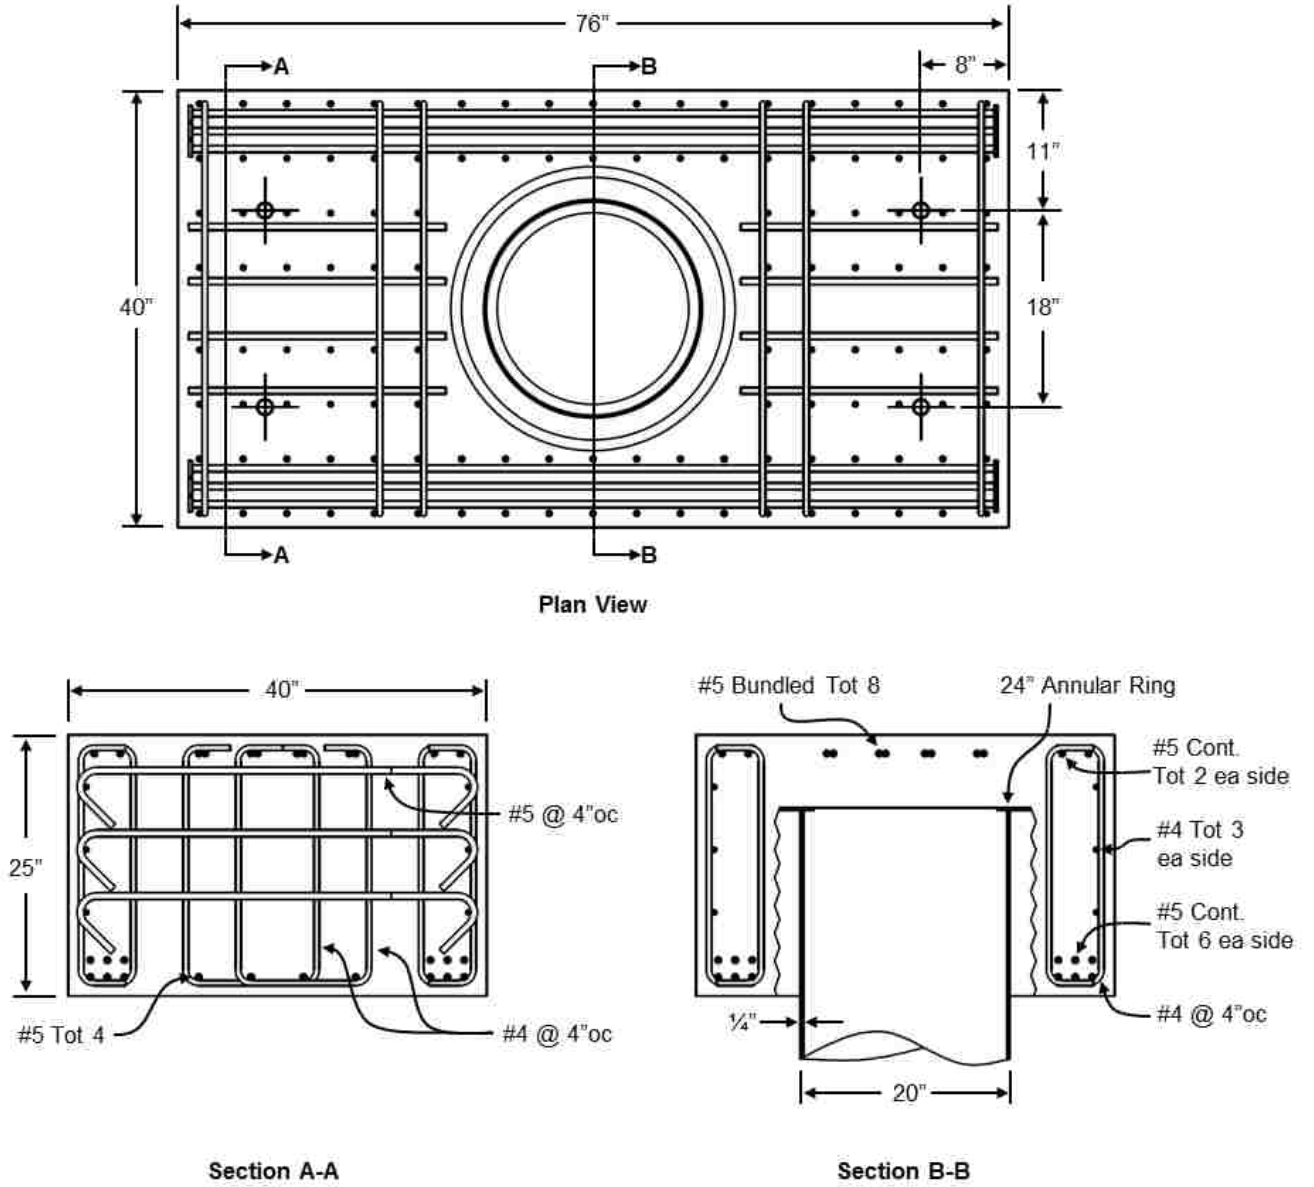
In order to minimize inelastic deformations in the cap beam, the primary flexure reinforcing was designed to resist the plastic moment capacity of the CFT with an additional 20% overstrength factor. The shear reinforcing was selected to meet Caltrans Seismic Design Criteria (SDC) requirements, as well as design recommendations from the embedded foundation connection in which the concrete was assumed to take  $2\sqrt{f'_c}$  of the shear demand (Lehman and Roeder, 2012). Horizontal stirrups were included on either side of the column per Caltrans SDC requirements, as well as on the extreme ends of the specimen to provide additional confinement around the hold-down regions. The complete reinforcing and connection details for Specimens EMB80 and EMB96 are shown in Figures 4.4 and 4.5, respectively.

Figure 4.4: Specimen EMB80 Reinforcing Details

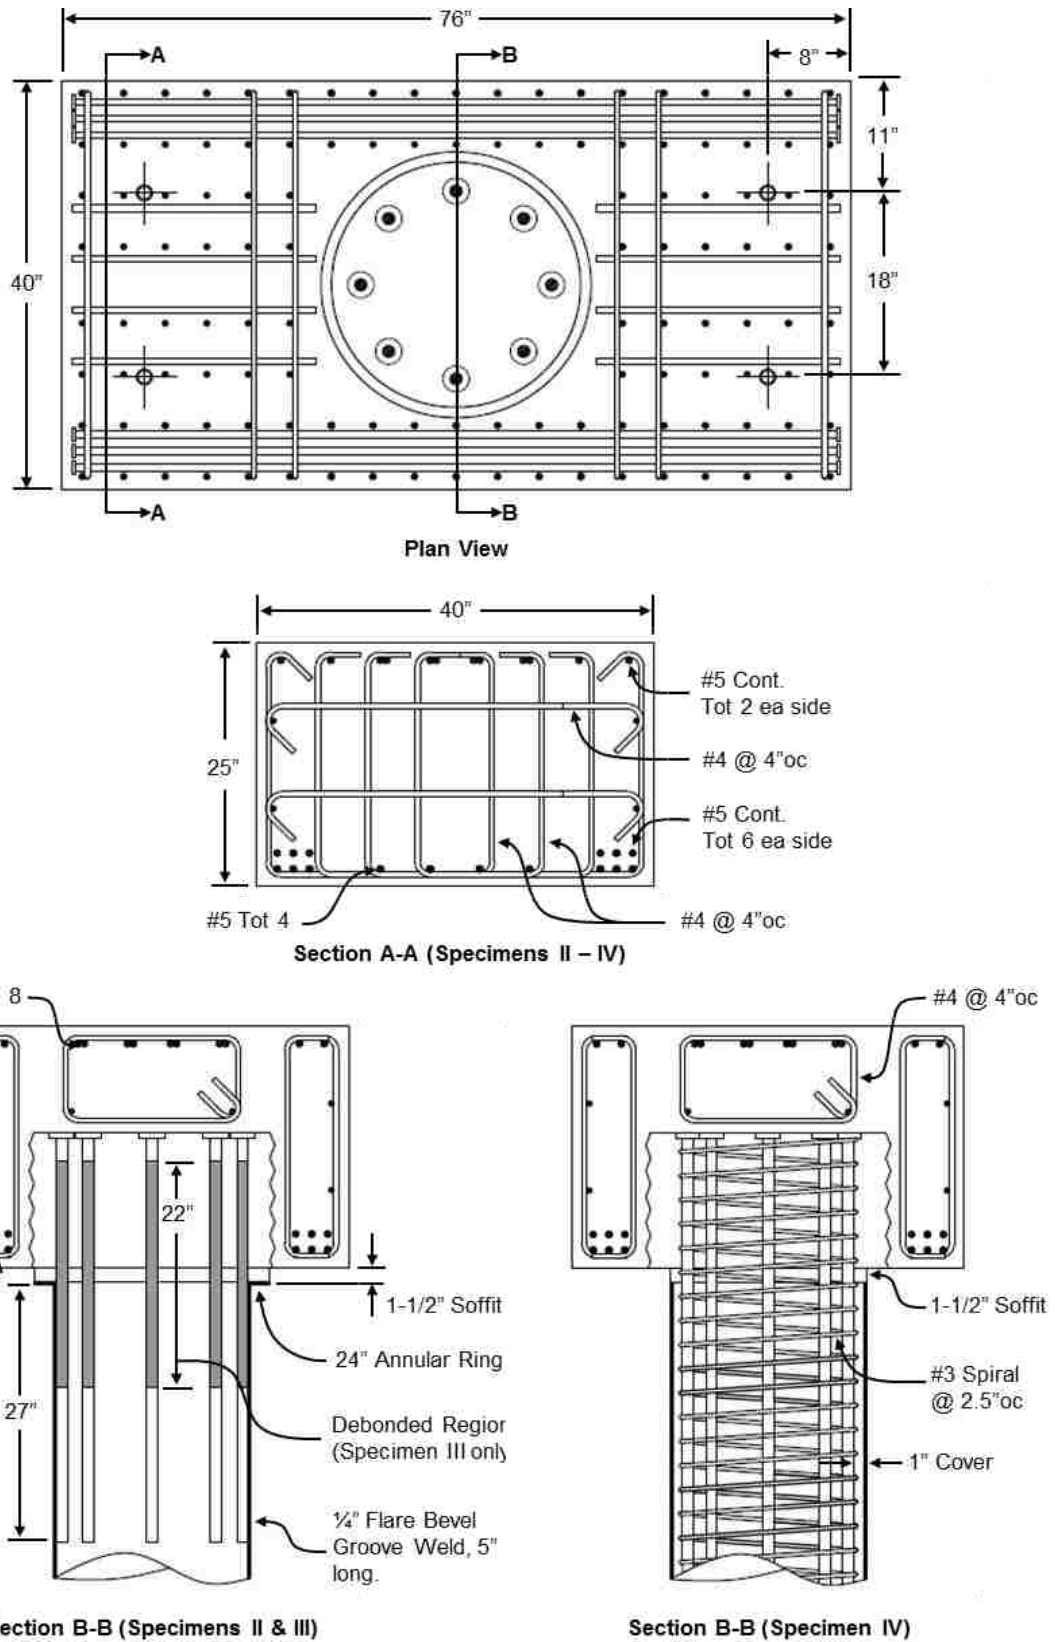
The flexure reinforcing for the welded RC connections was again designed to exceed the plastic moment capacity of the CFT, while the shear reinforcing was designed according to Caltrans SDC requirements. The complete reinforcing details for both welded connection specimens are presented in Figure 4.9.

Figure 4.9: Specimens WRC, WRCUB, and RC Reinforcing Details

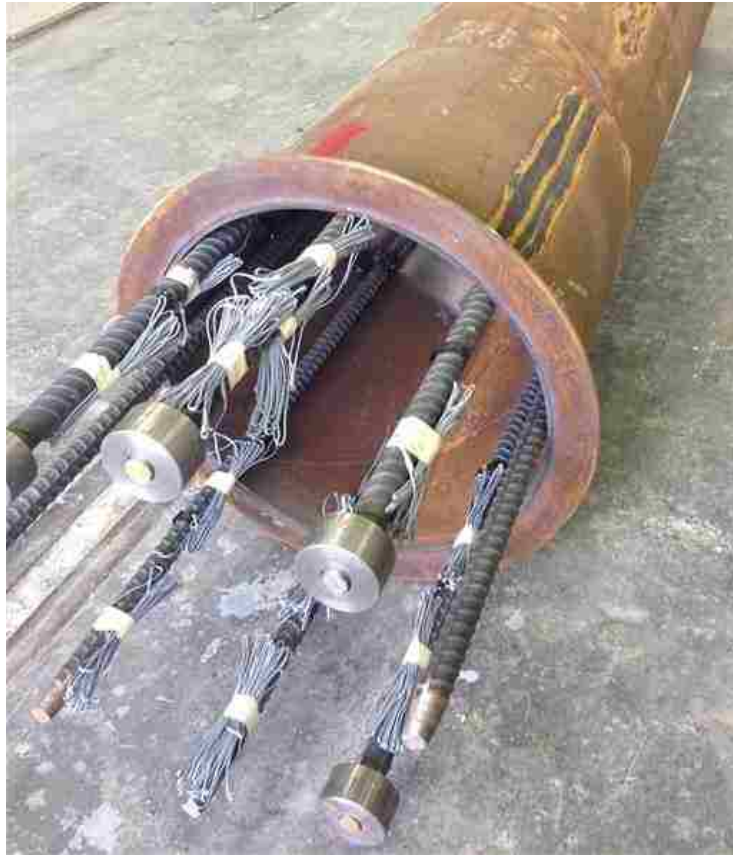
As the concrete cured, the annular ring was welded to the base of the steel tube using a ¼-in. fillet weld, and the longitudinal reinforcing bars were welded to the inside of the steel tube such that the heads of the bars projected 15.5-in. from the end of the column. This projection accounts for the 14-in. embedment into the cap beam, as well as the 1.5-in. grouted soffit. Figure 4.11 shows Specimen WRC after the annular ring and reinforcing bars had been welded to the steel tube.

**Figure 4.11:** Specimen WRC annular ring and reinforcing bars

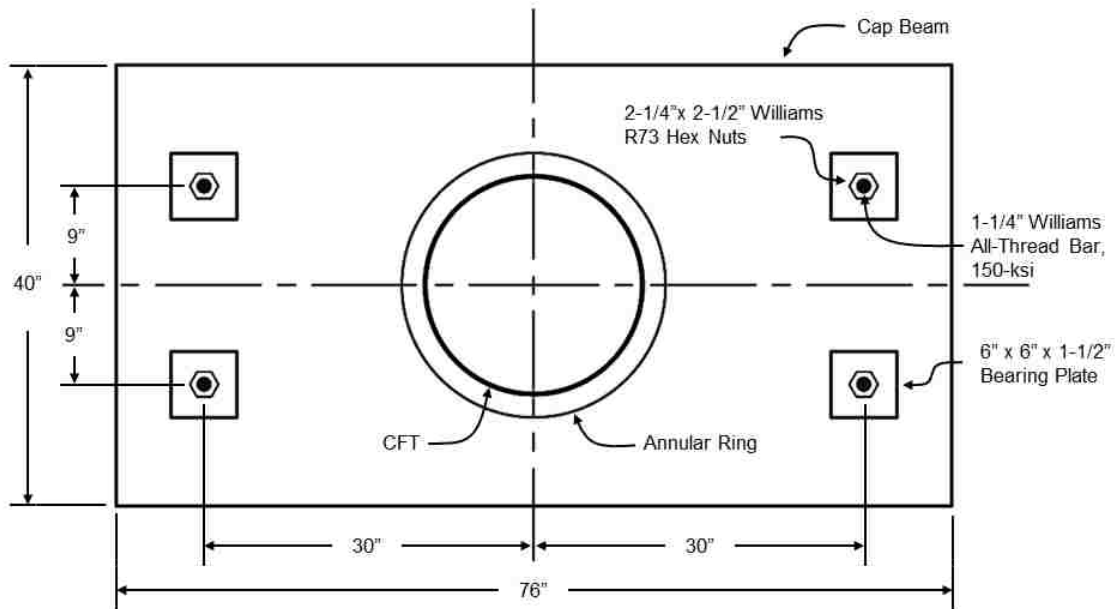
post-tensioned to 120-kips to prevent any uplift or slip from occurring during testing. A layer of hydrostone was placed between the surface of the reaction block and the underside of the cap beam to ensure a level bearing surface.

**Figure 4.15:** Williams Rods Layout

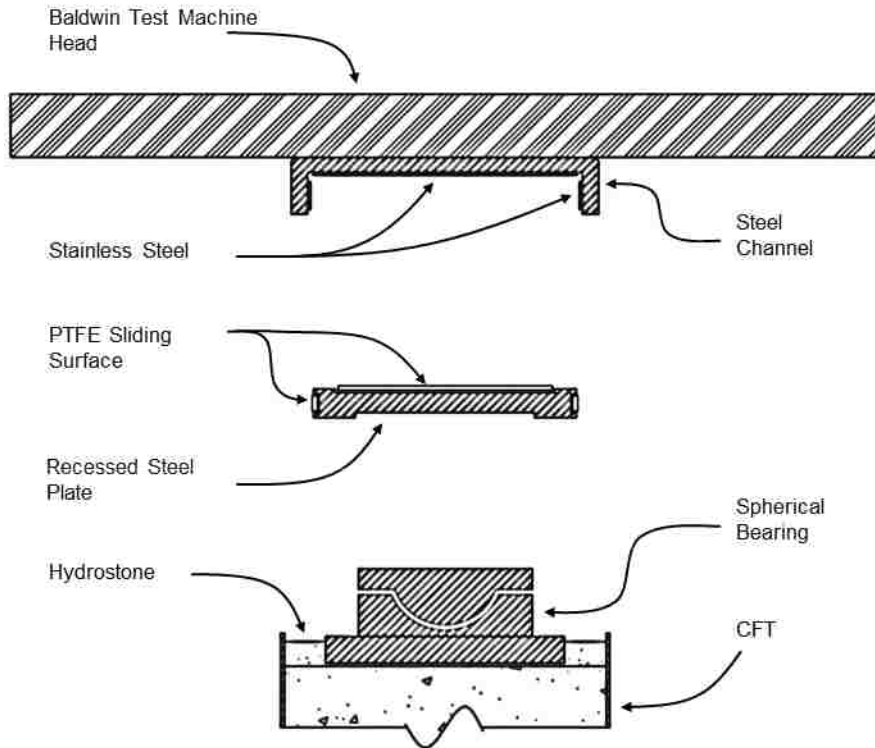
A spherical, swivel-head bearing was fixed to the top of the CFT column to allow for lateral displacements while still maintaining a constant axial load. The bearing sat within a recessed steel plate, which was lined with a polytetrafluoroethylene (PTFE) sliding surface, as shown in Figure 4.16. Under lateral loading, the PTFE slid within a stainless steel-lined channel, which was fixed to the bottom of the Baldwin head to prevent out-of-plane drifts. A silicone lubricant was applied between the PTFE and stainless steel to create a low-friction sliding surface.

**Figure 4.16:** Axial Load Apparatus

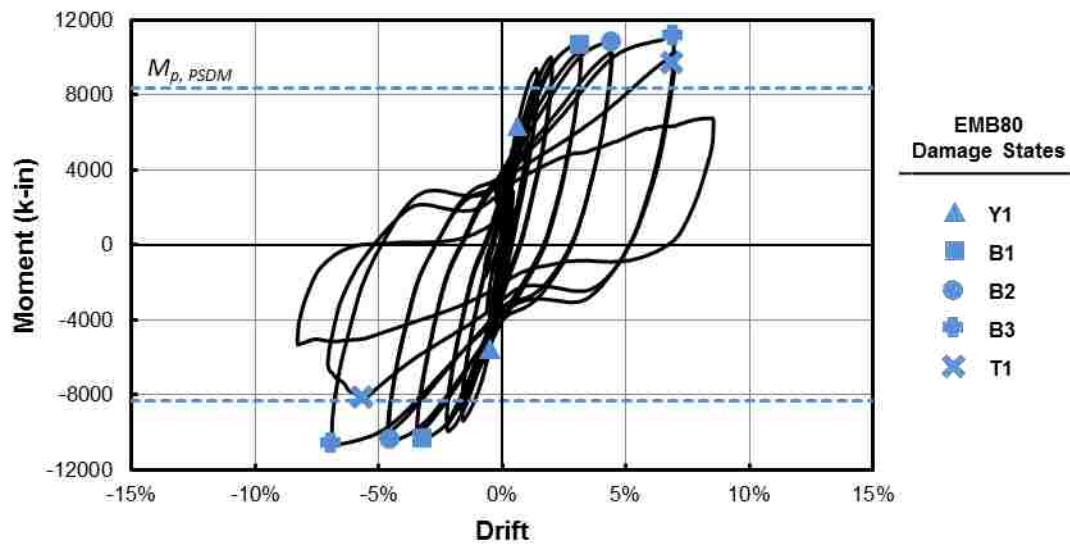
The general behavior of the specimen consisted of yielding of the steel tube, followed by local buckling at the base of the column. Failure consisted of subsequent ductile tearing at the apex of the buckled region on both the North and South sides of the column. The moment-drift response of the specimen, with noted damage states, is shown in Figure 5.4. The dashed line represents the plastic moment capacity of the CFT, calculated using the PSDM method with specified design strengths.

Figure 5.4: EMB80 Moment-Drift Response

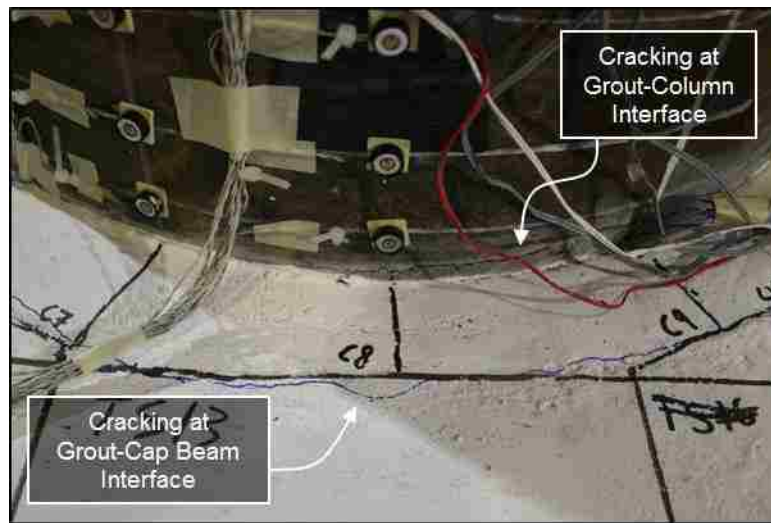
There was no visual damage observed to the column or cap beam during the first three sets of loading. At an imposed drift of 0.41%, circumferential hairline cracks initiated on the South side of the specimen along the grout-cap beam interface and the column-grout interface, as shown in Figure 5.5. During the next load set at 0.57% drift, yielding of the steel tube was measured by strain gauges located 3-in. above the surface of the cap beam on both the North and South sides of the column.

**Figure 5.5:** EMB80 Cracking on South side of Column at 0.41% drift (Column displaced to the North)

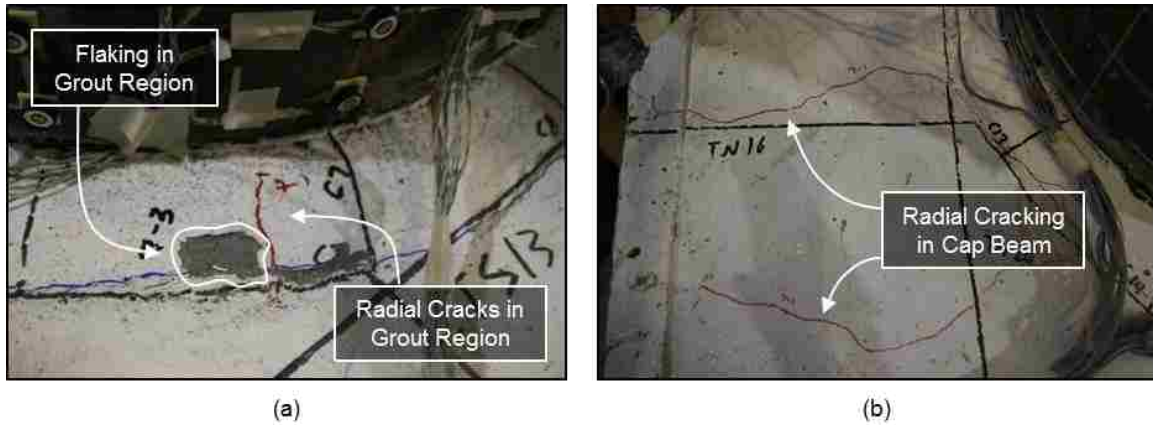
grout that flaked off ranged between ½-in. and 1-in. in diameter, and were less than ¼-in. in thickness.

Figure 5.6: EMB80 Radial cracking at 1.45% drift in (a) grout region, and (b) cap beam

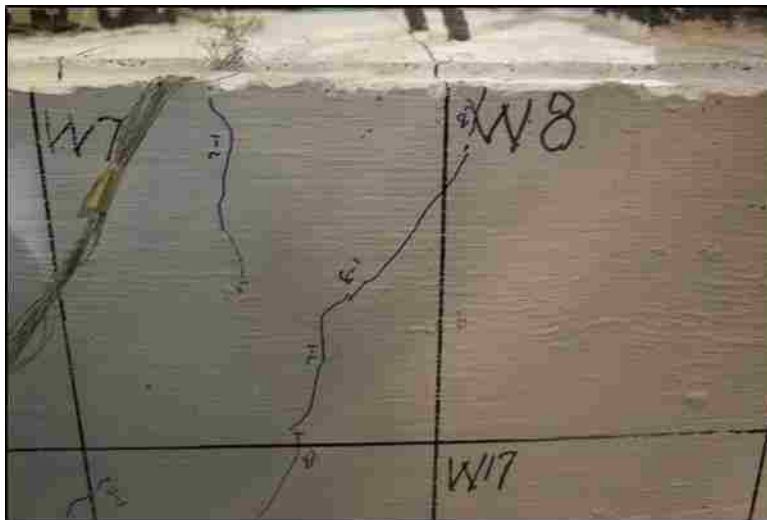
During the 8<sup>th</sup> load set, additional hairline cracks continued to develop radially from the column and diagonally down the East and West sides of the cap beam. Figure 5.7 shows cracking on the west side of the cap beam after the column was subjected to 2.25% drift in the North direction.

Figure 5.7: EMB80 hairline cracking on the west side of the cap beam at 2.25% drift

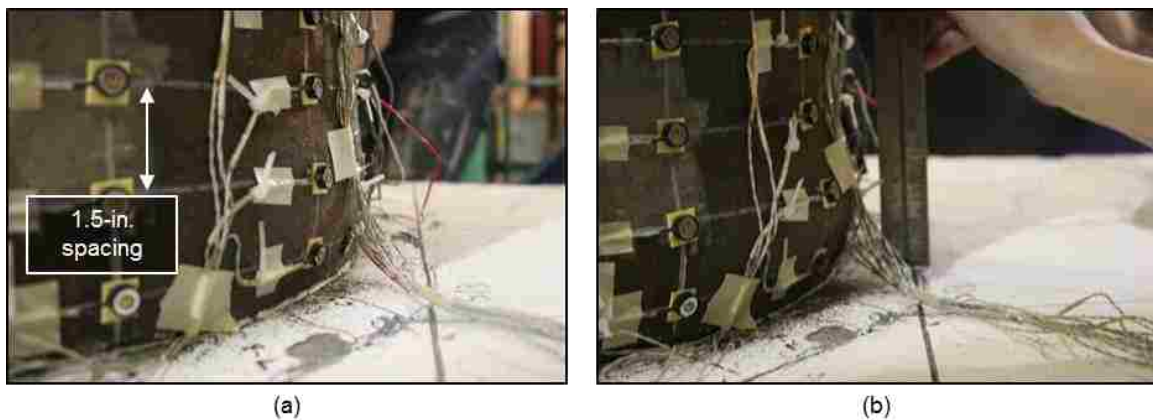
The magnitude of the residual out-of-plane displacement (measured at zero drift) of the buckled region increased with subsequent cycles. Figure 5.8b shows the buckled region on the South side of the column as it was subjected to 4.43% drift. Again, the apex of the buckled region was approximately 1.75-in. above the surface of the cap beam, and the total height of the buckled region was approximately 3.5-in.

**Figure 5.8:** EMB80 South tube buckling at (a) 3.19% drift, and (b) 4.43% drift

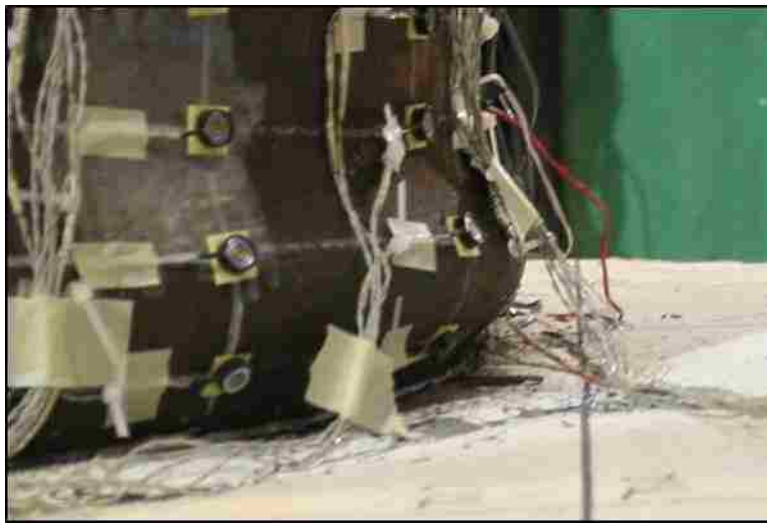
During the first complete cycle of the 13<sup>th</sup> load set, the magnitude of the out-of-plane displacement of the buckled region on both the North and South sides of the column increased without any tearing observed. Figure 5.9 shows the buckled region on the South side of the tube after the column was subjected to 7.0% drift to the North. The lateral load resistance remained stable through the first cycle of this drift set.

**Figure 5.9:** EMB80 South tube buckling at 7.0% drift

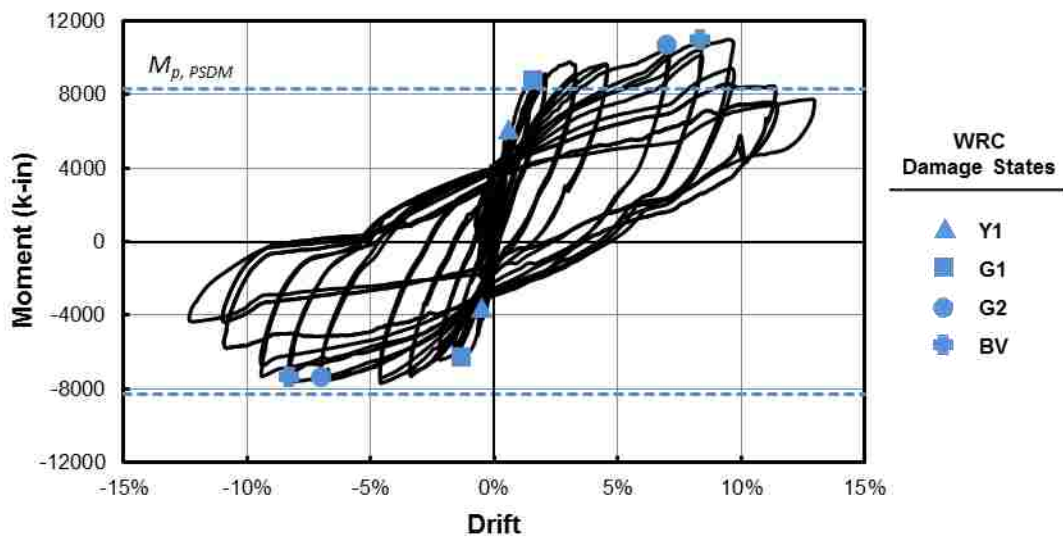
The behavior of the specimen consisted of yielding of the reinforcing bars, followed by crushing of the grouted soffit region. Failure of the specimen consisted of concrete cracking and uplift in the cap beam, with no reinforcing bar fracture. The moment-drift response of the specimen, with noted damage states, is shown in Figure 5.15. The dashed line represents the plastic moment capacity of the RC section, as calculated by the PSDM method using specified design strengths.

Figure 5.15: WRC Moment-Drift Response

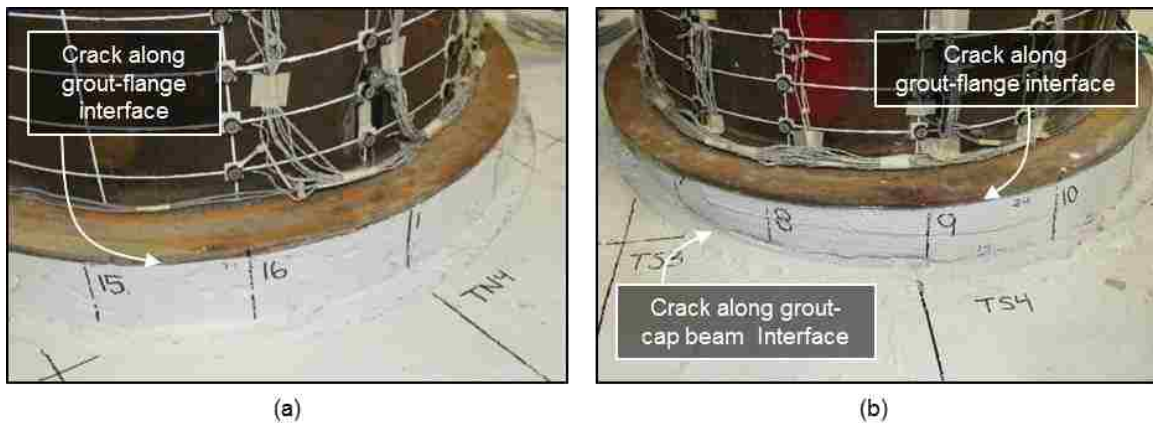
There was no observed damage to the specimen during the first two cycle levels. During the third cycle level, a hairline crack initiated circumferentially along the grout soffit-steel flange interface on both the North and South sides of the specimen. On the South side of the specimen, a circumferential hairline crack also initiated along the base of the soffit, at the grout-cap beam interface. Figures 5.16a and 5.16b show the initiation of cracking on the North and South sides of the specimen, respectively.

**Figure 5.16:** WRC soffit cracking at 0.3% drift on the (a) North side of specimen, and (b) South side of specimen

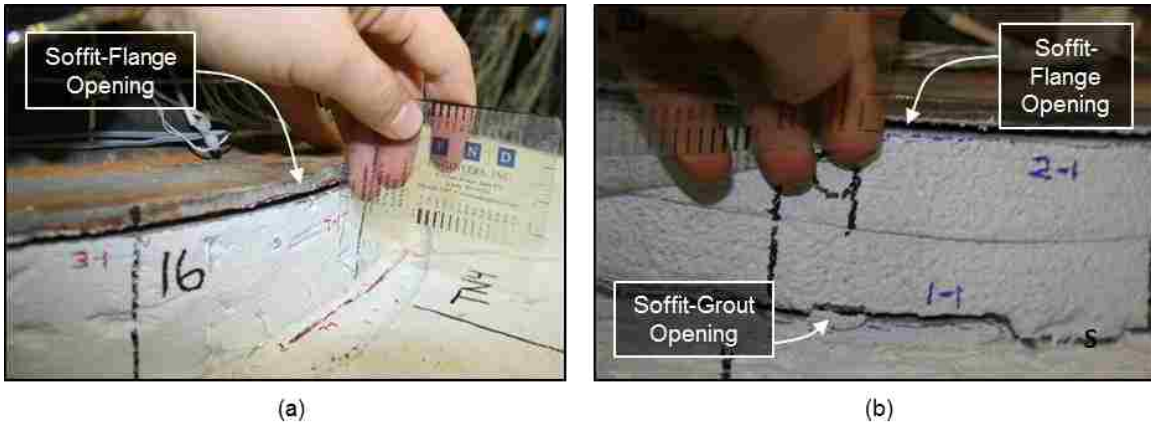
The existing circumferential cracks along the grout soffit gradually widened with increasing drift levels. During the 7<sup>th</sup> drift set, the openings between the soffit and the flange on both the North and South sides of the column measured approximately 4-mm while they were each subjected to tensile loading. The cracks between the soffit and cap beam on the South side of the specimen increased to approximately 3-mm, while circumferential hairline cracks initiated at the base of the soffit on the North side of the specimen. Figures 5.17a and 5.17b show the increased soffit openings on the North and South sides of the specimen at 1.48% and 1.62% drift, respectively.

**Figure 5.17:** WRC soffit openings on (a) North side of column at 1.48% drift, and (b) south side of column at 1.62% drift

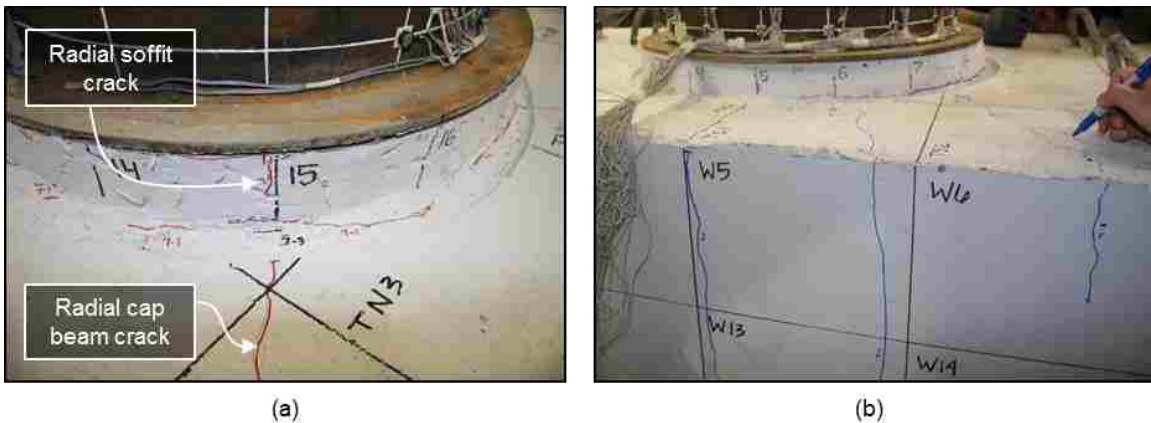
During the same drift set, hairline cracks initiated radially in the grouted soffit, as well as in the cap beam. The cap beam cracks formed at approximate angles of 30-45° of one another, and continued vertically down the East and West faces of the cap beam. Figures 5.18a and 5.18b show the radial cap beam cracking on the North and South sides of the specimen, respectively.

**Figure 5.18:** WRC radial cracking on (a) North side of column at 1.48% drift, and (b) south side of column at 1.62% drift

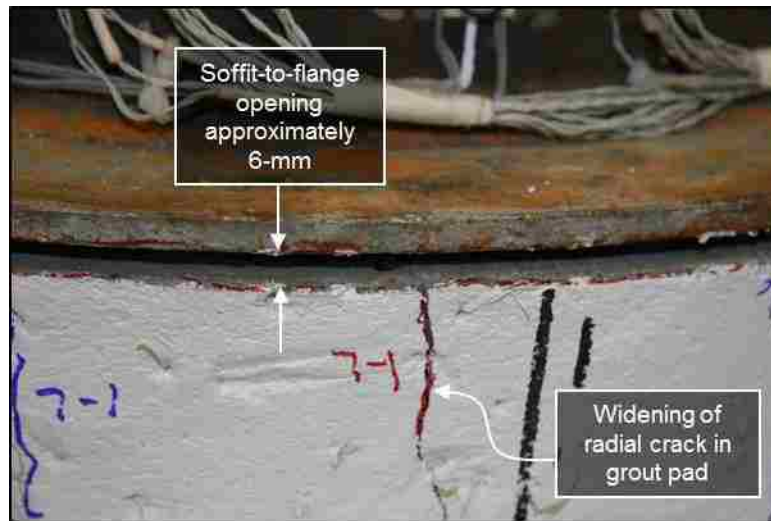
beam and grout pad were observed to have widened slightly, such that they were no longer hairline in width. In addition, the opening between the grout pad and the column flange increased to approximately 6 mm when the side of the specimen was in tension. Figure 5.19 shows this soffit-flange opening and increased grout pad crack width on the North side of the specimen as it was subject to 2.08% drift in the South direction.

**Figure 5.19:** WRC North grout pad cracking at 2.08% drift

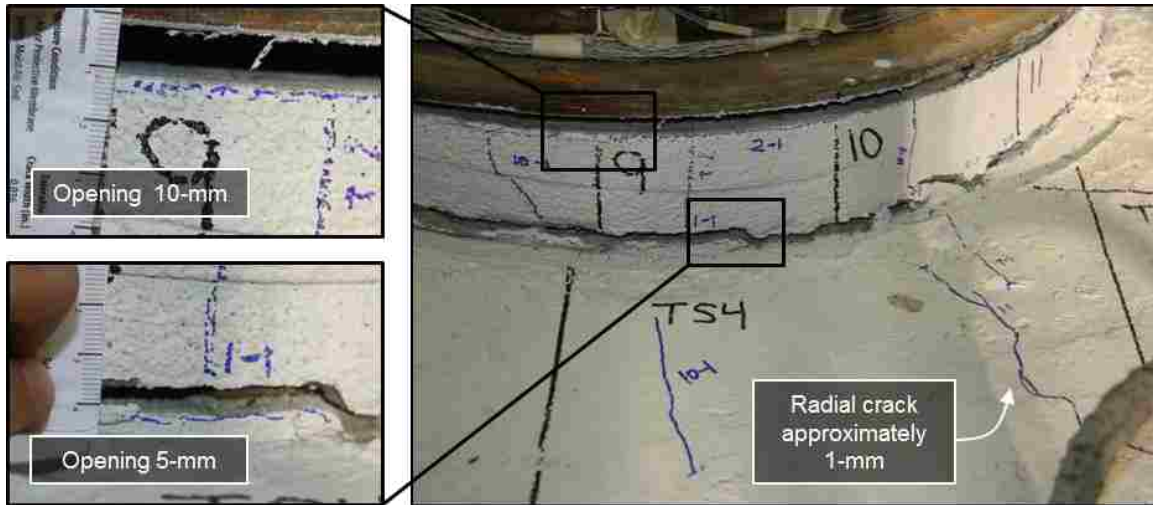
openings and increased radial crack widths on the South side of the specimen at 3.43% drift in the North direction.

**Figure 5.20:** WRC South grout pad cracking at 3.43% drift North

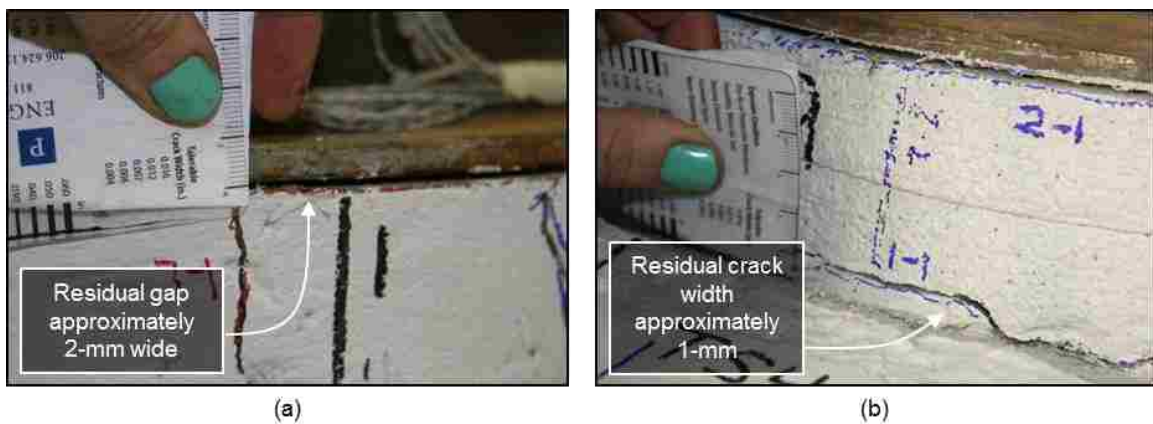
After the cycle was complete and the column returned to zero drift, the widths of the residual soffit openings were measured. As shown in Figures 5.21a and 5.21b, both the North and South sides of the specimen had a residual soffit-flange opening of 2-mm. Similarly, the opening between the soffit and cap beam on the South side of the specimen had a residual width of approximately 1-mm, also shown in Figure 5.21b.

**Figure 5.21:** WRC Residual soffit openings after 10<sup>th</sup> load set (a) North side of column, and (b) south side of column

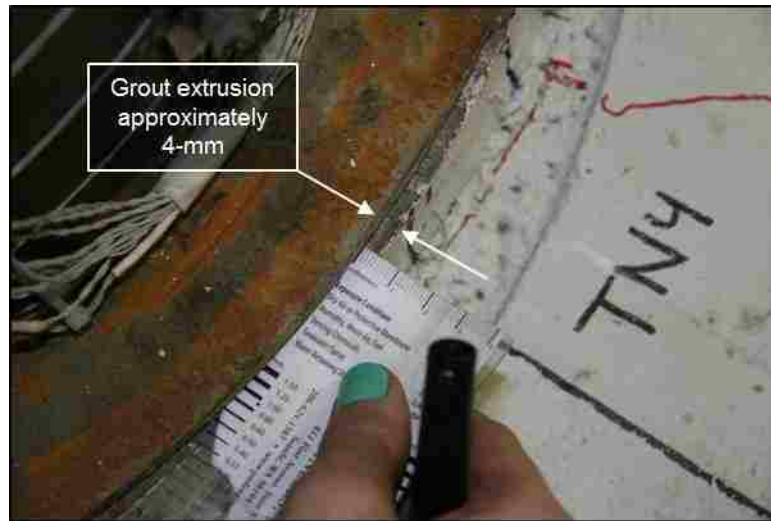
After the cycle was completed, it was also observed that the grout pad had deformed laterally from underneath the column flange. As shown in Figure 5.22, the width of the grout extending beyond the edge of the flange approximately 4-mm.

**Figure 5.22:** WRC residual grout extrusion after 10<sup>th</sup> load set

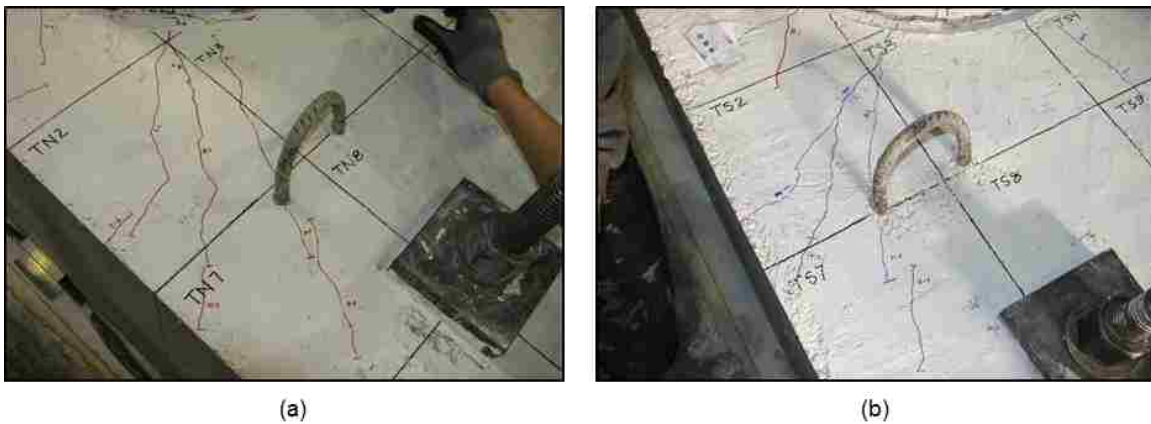
During the 11<sup>th</sup> cycle level, new hairline cracks developed radially from the column towards the rebar lifting loops located in the four corners of the cap beam, shown in Figures 5.23a and 5.23b.

**Figure 5.23:** WRC cap beam cracking during the 11<sup>th</sup> cycle level (a) North side of specimen, (b) South side of specimen

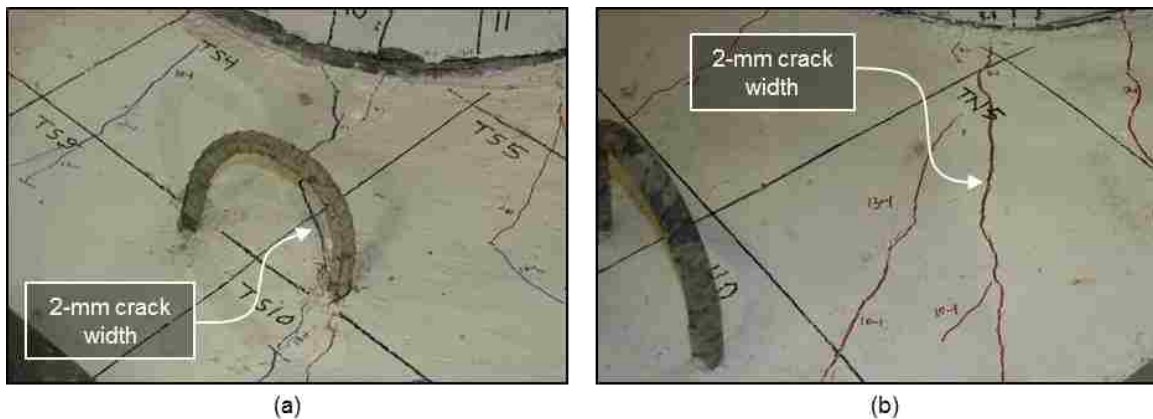
**Figure 5.25:** WRC cap beam cracking on (a) South side of specimen, and (b) North side of specimen

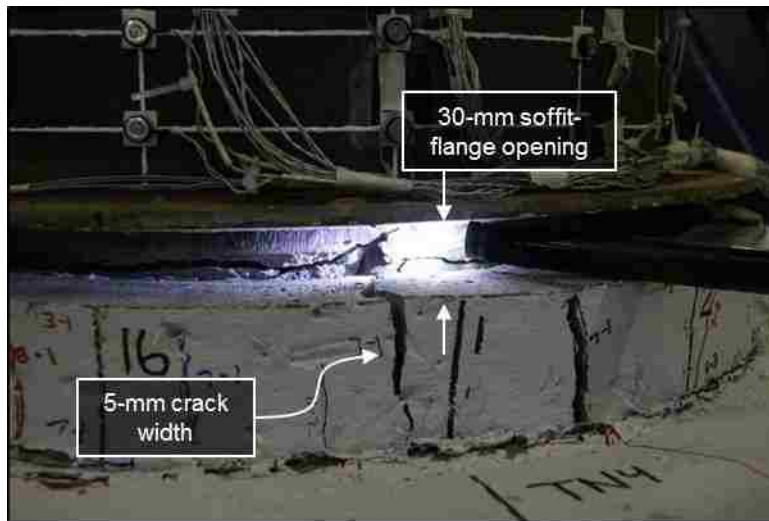
**Figure 5.26:** WRC North soffit cracking at 7.08% drift South

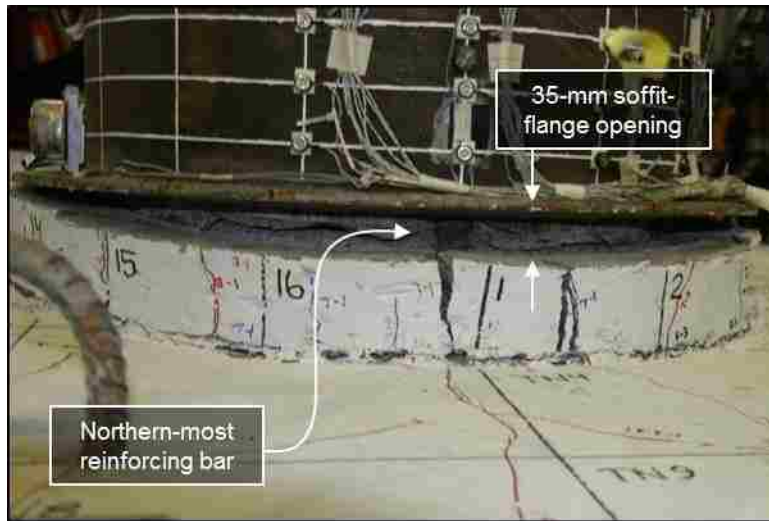
**Figure 5.27:** WRC exposed reinforcing bar at 8.43% drift South

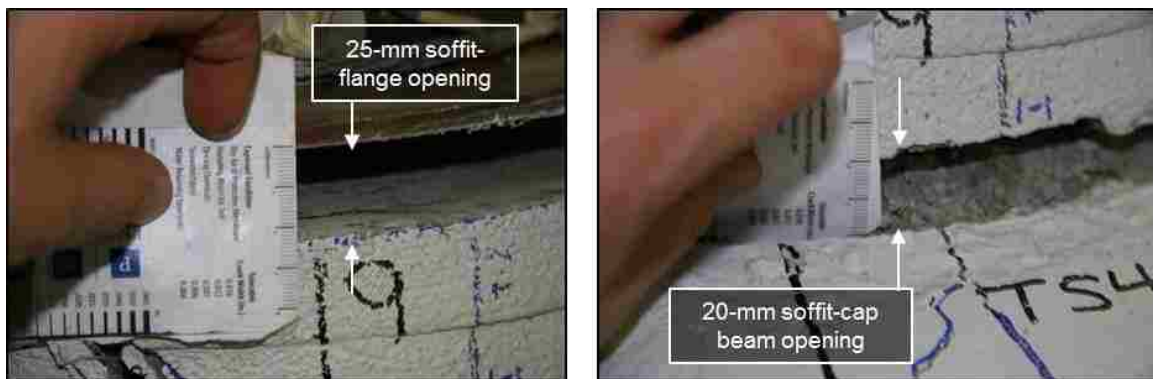
**Figure 5.28:** WRC South soffit openings at 8.33% drift North

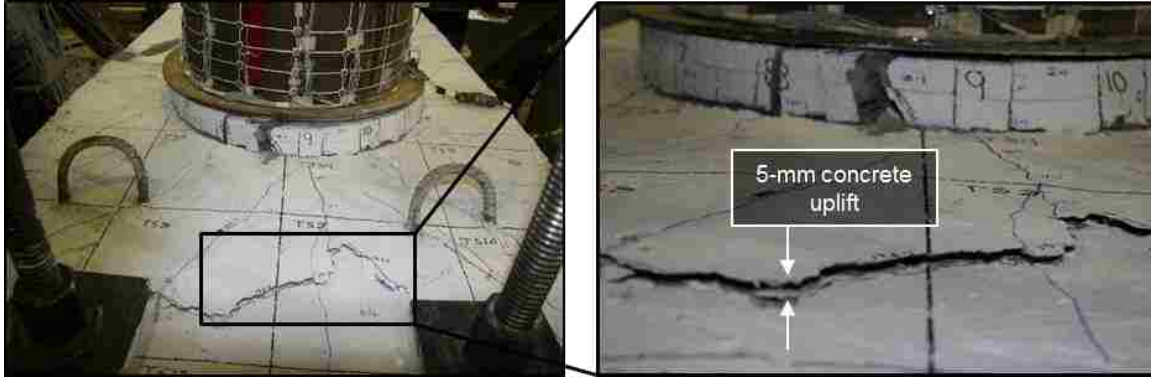
**Figure 5.29:** WRC South cap beam concrete uplift at 8.33% drift North

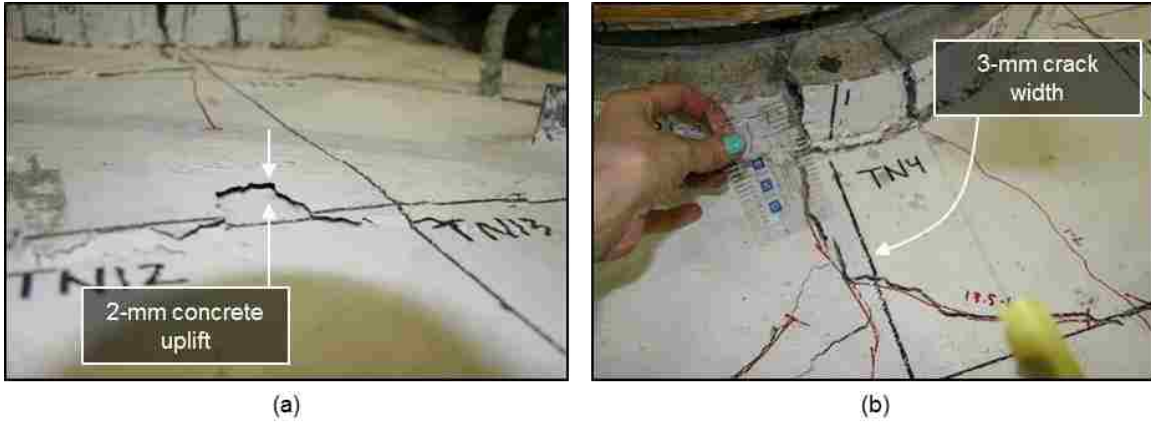
**Figure 5.30:** WRC North cap beam damage at 9.71% drift South (Cycle 1)

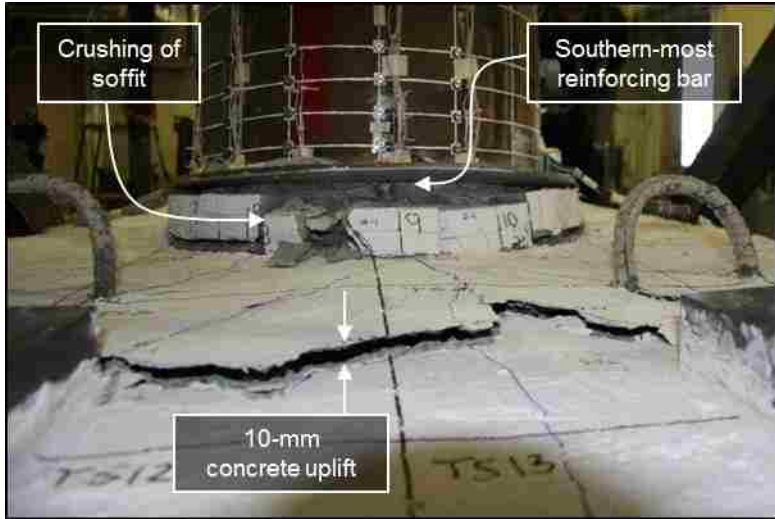
**Figure 5.31:** WRC South cap beam damage at 9.46% drift North

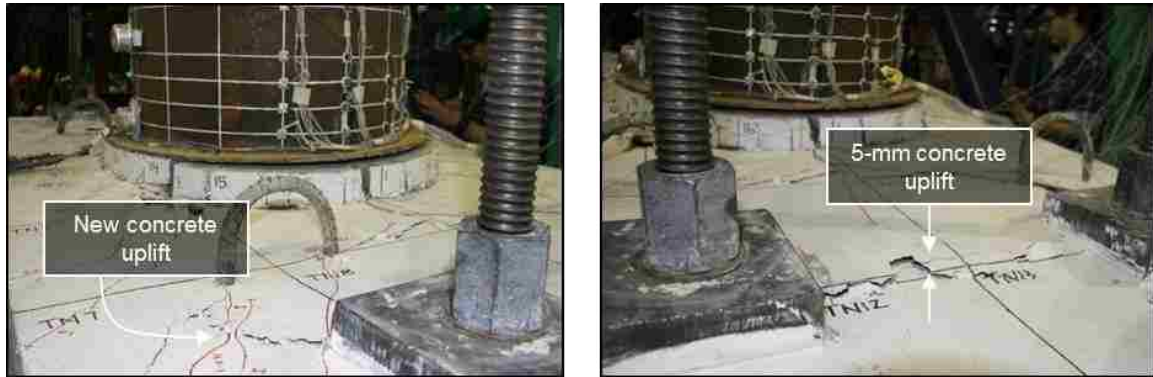
**Figure 5.32:** WRC North cap beam uplift at 9.71% drift South (Cycle 2)

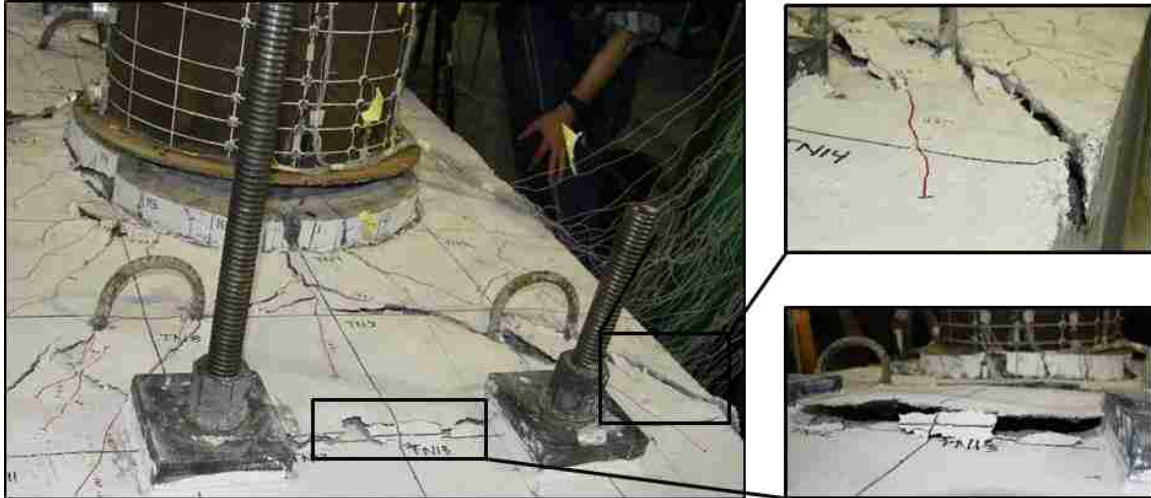
**Figure 5.33:** WRC North cap beam damage at 11.47% drift South

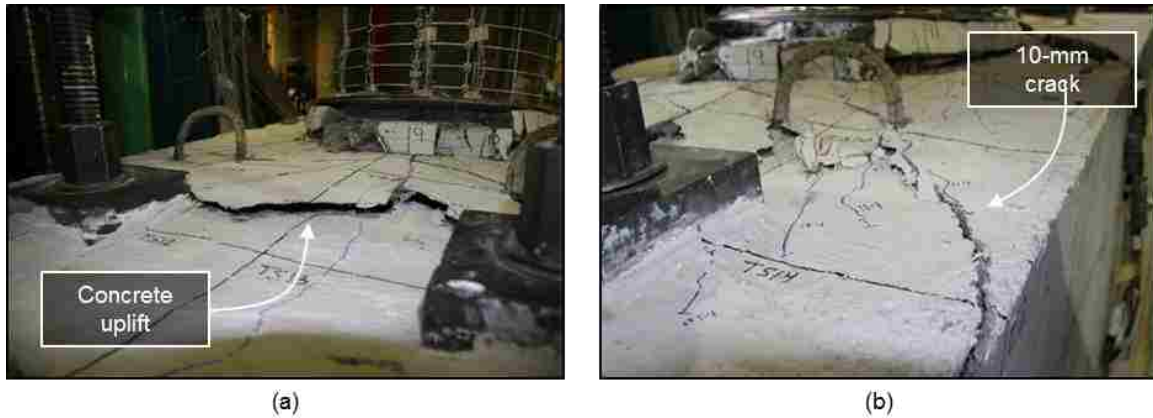
**Figure 5.35:** WRC South cap beam (a) uplift and (b) cracking at 11.01% drift North
