CFT Column-to-Cap Beam Connections for  
Accelerated Bridge Construction in Seismic Regions

Master of Science in Civil Engineering

University of Washington

2014

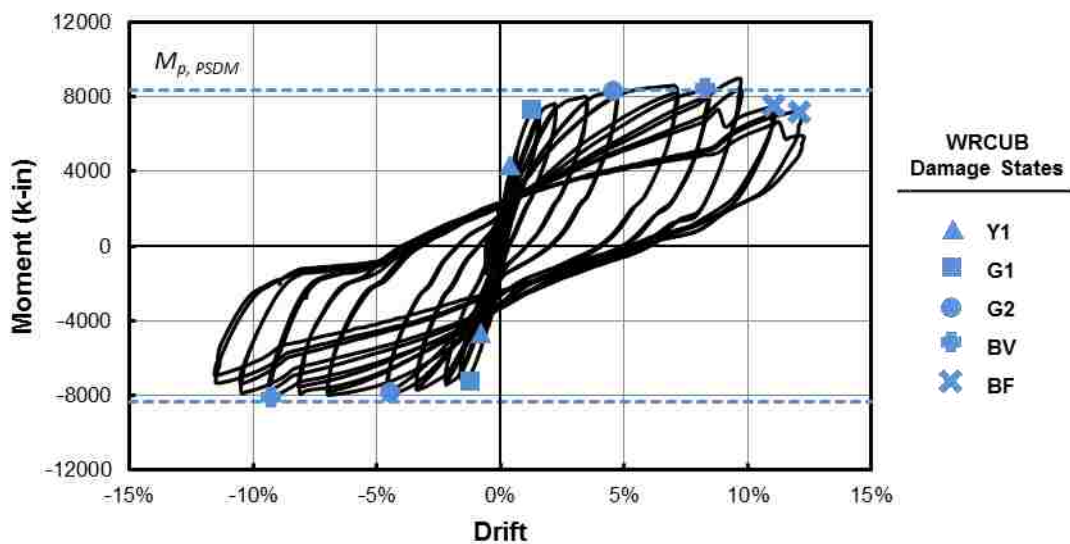
Figure 5.38: WRCUB Moment-drift response

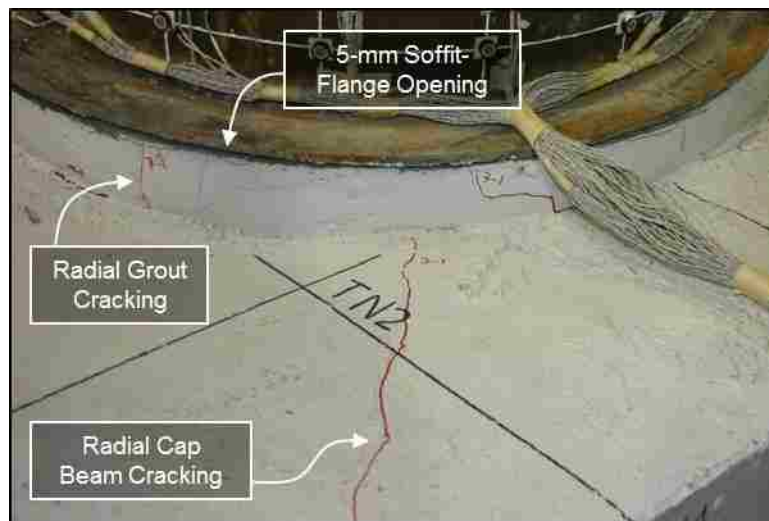
Figure 5.39: WRCUB North cap beam damage at 1.58% drift South

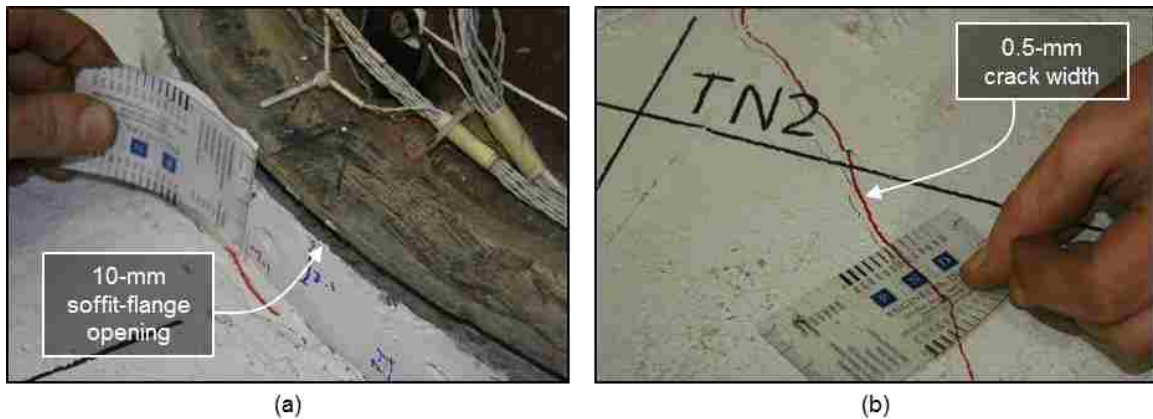
**Figure 5.40:** WRCUB North (a) soffit-flange opening, and (b) cap beam crack widths at 2.24% drift South

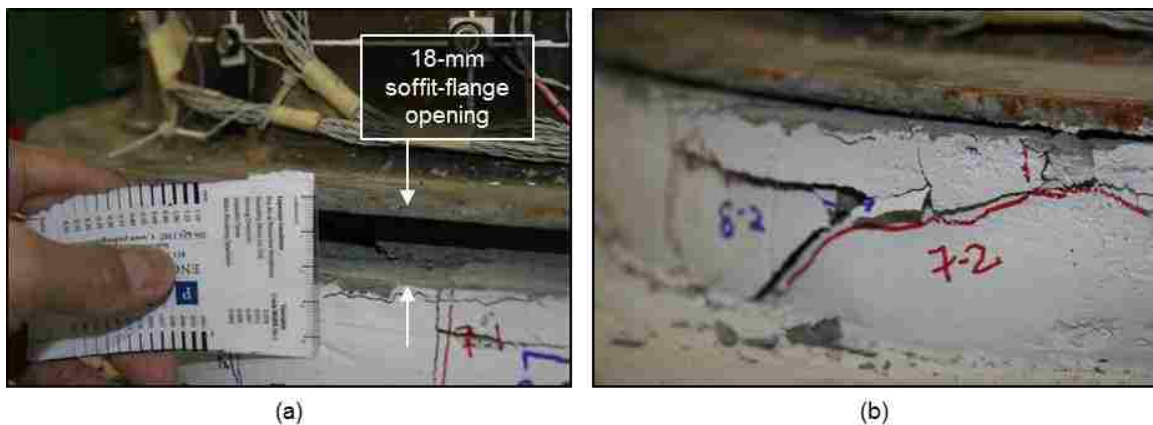
**Figure 5.42:** WRCUB (a) soffit-flange opening, and (b) grout crushing at 4.72% drift South

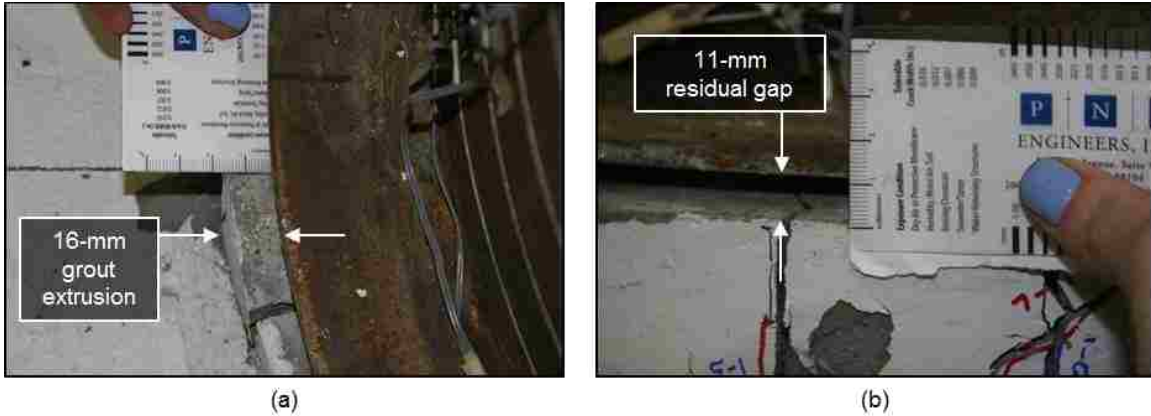
**Figure 5.44:** WRCUB (a) grout extrusion, and (b) residual soffit-flange opening after 13th cycle level

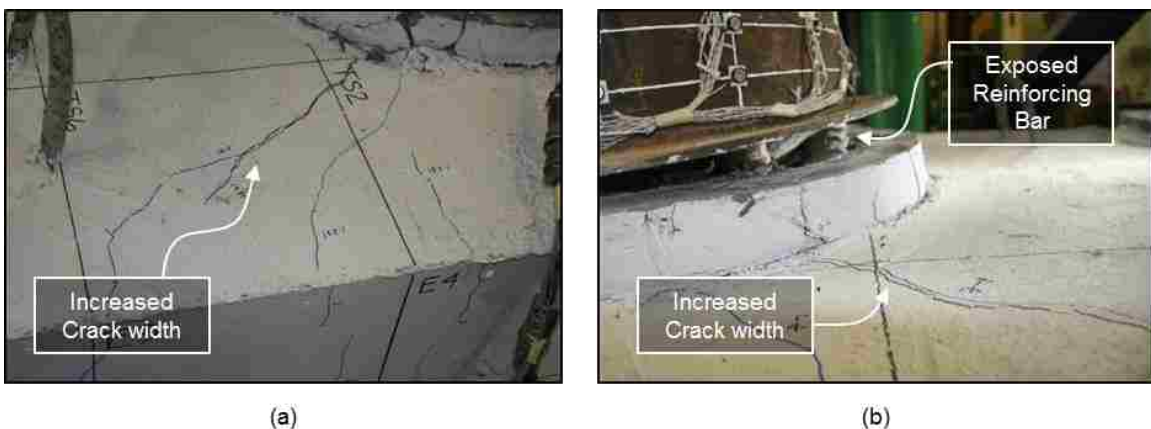
**Figure 5.45:** WRCUB South (a) cap beam cracking, and (b) exposed reinforcing bar at 8.19% drift North

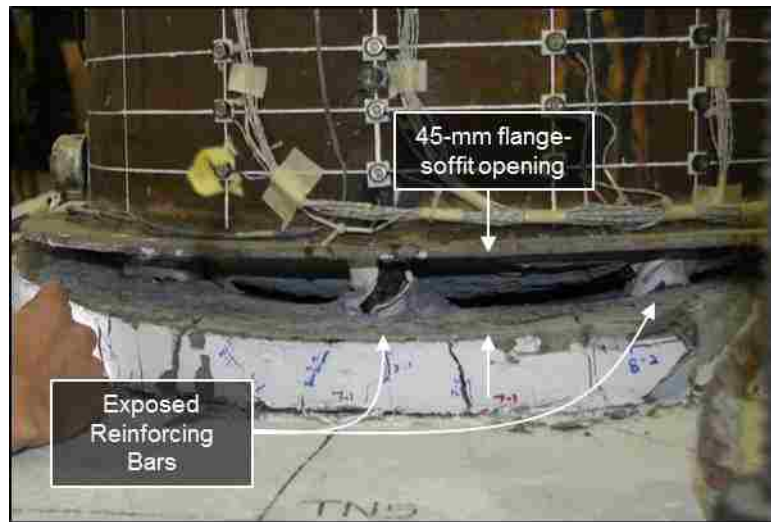
**Figure 5.46:** WRCUB North exposed reinforcing bars at 9.76% drift South

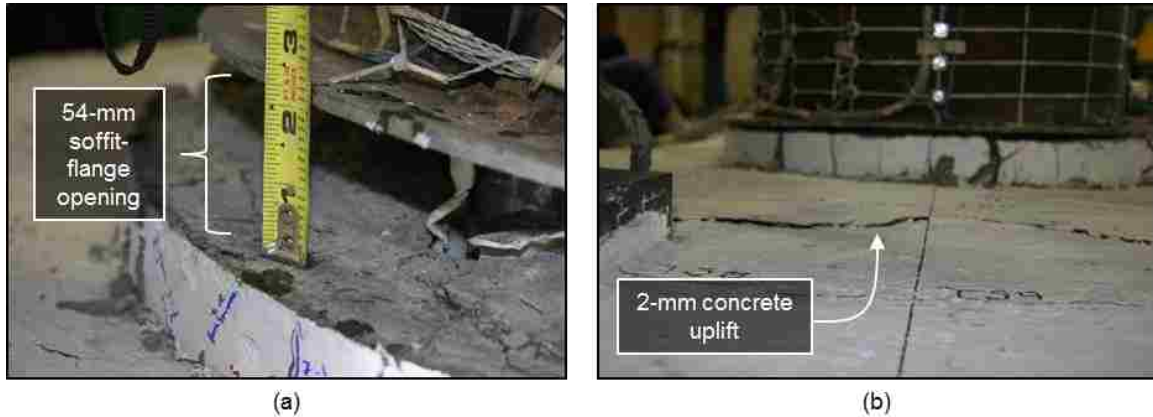
**Figure 5.47:** WRCUB (a) Soffit-flange opening at first bar fracture, and (b) South concrete uplift at 10.53% drift North

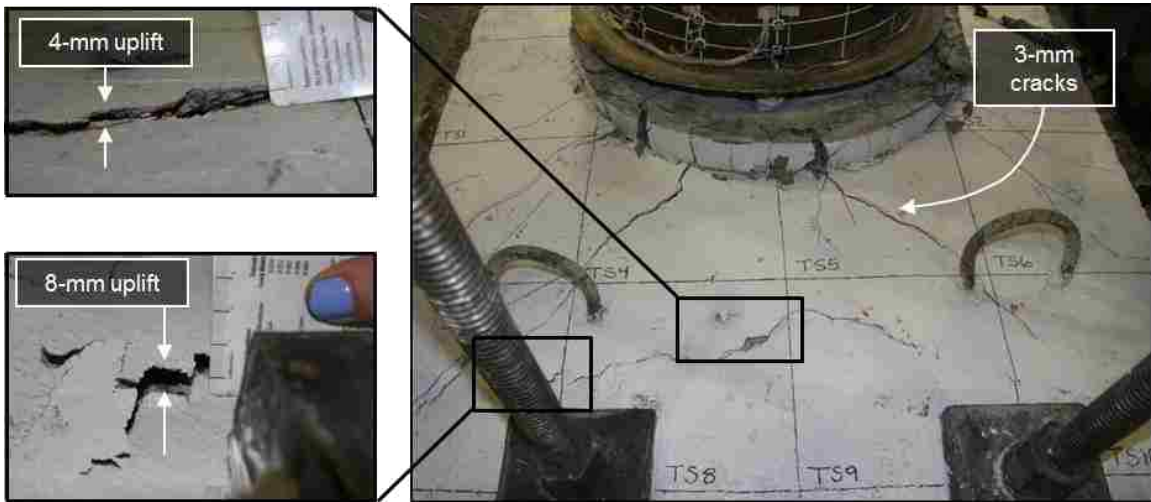
**Figure 5.49:** WRCUB South cap beam damage at 11.58% drift North

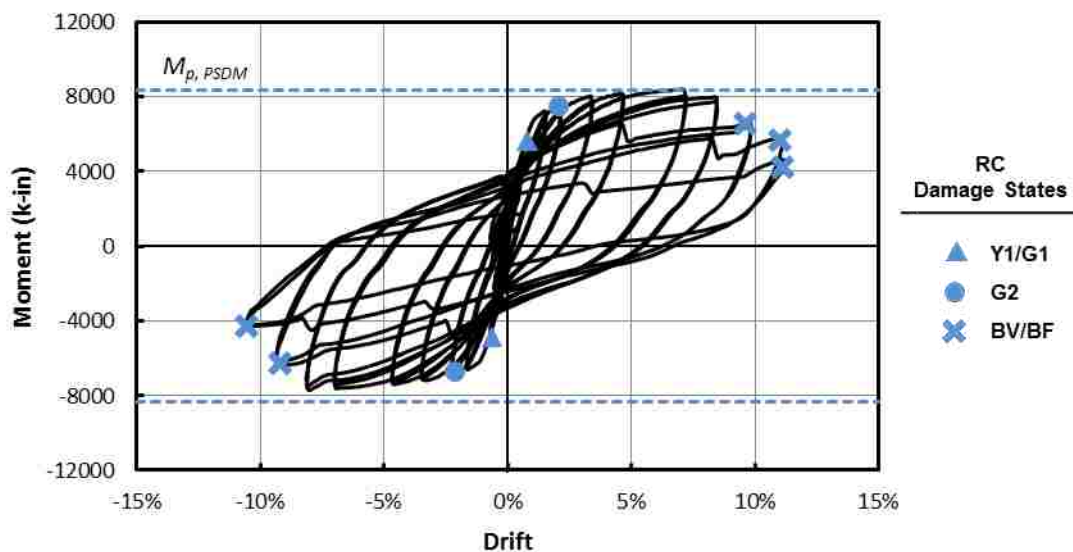
Figure 5.51: RC Moment-Drift Behavior

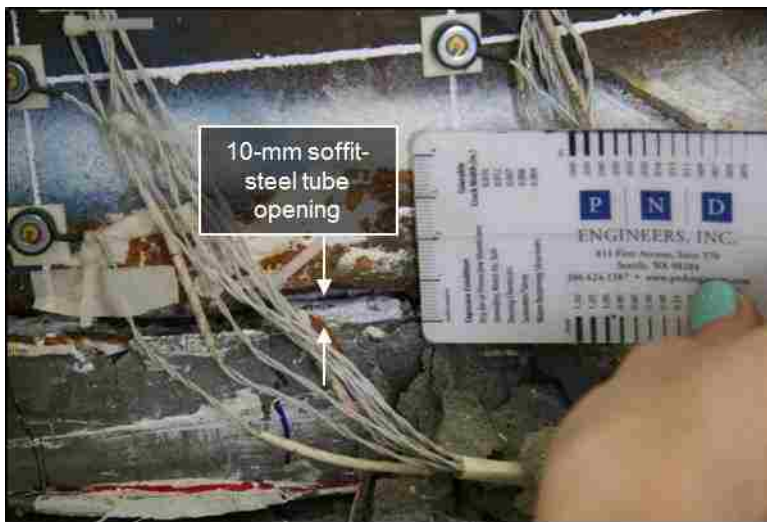
**Figure 5.55:** WRC North soffit-tube opening at 4.67% drift South

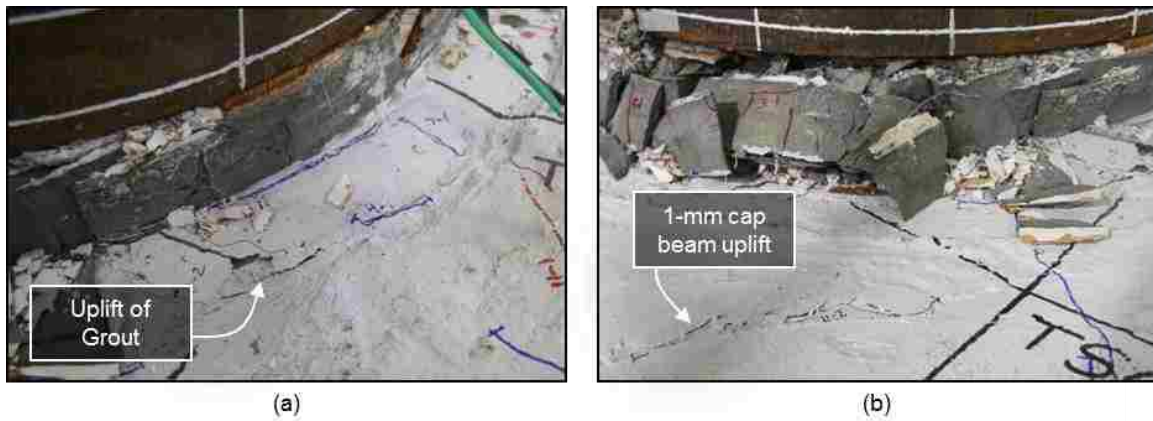
**Figure 5.56:** WRC initial uplift in (a) South grout region, and (b) South cap beam

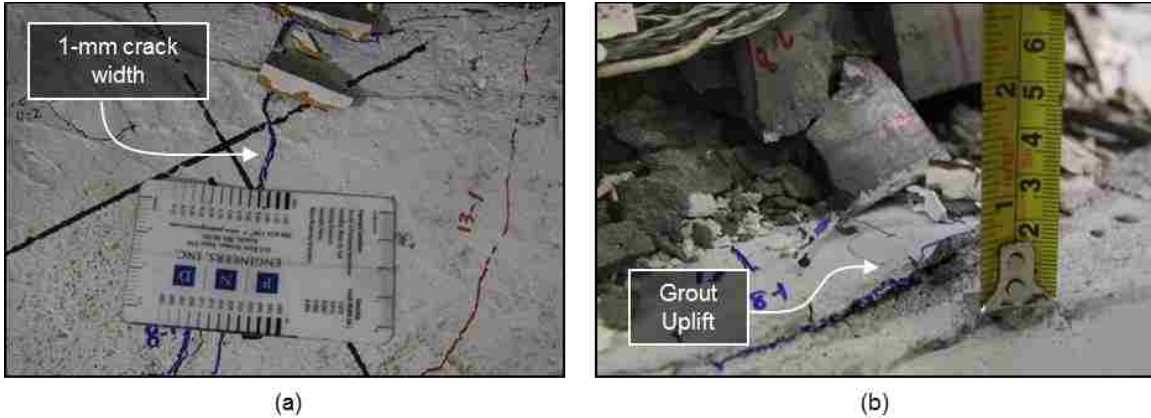
**Figure 5.57:** RC (a) Cap beam crack widening, and (b) South grout uplift at 7.02% drift North

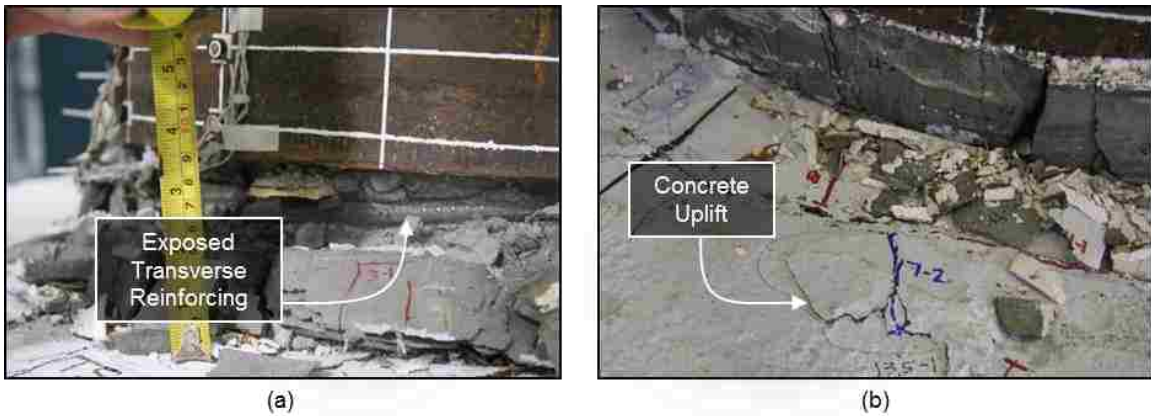
**Figure 5.58:** WRC (a) South transverse reinforcing, and (b) North concrete uplift at 8.15% drift

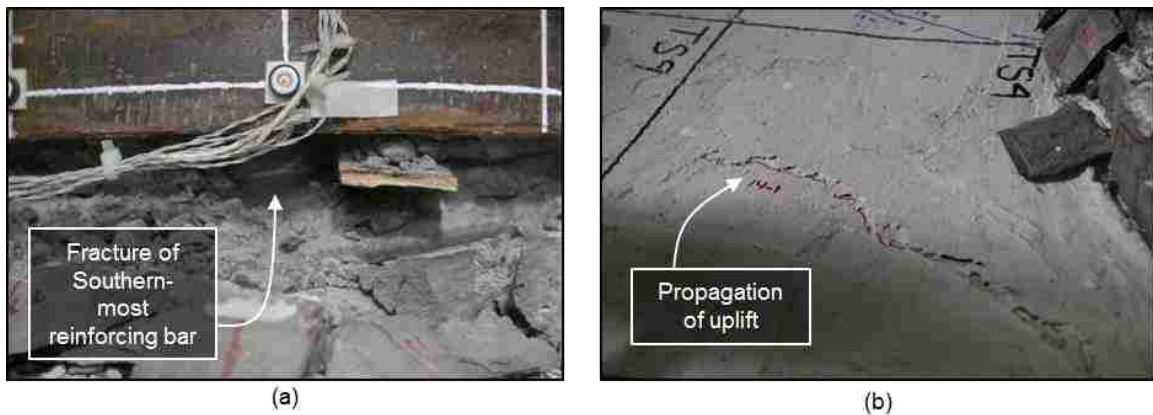
**Figure 5.59:** WRC South (a) reinforcing bar fracture, and (b) Cap beam concrete uplift at 9.40% drift North

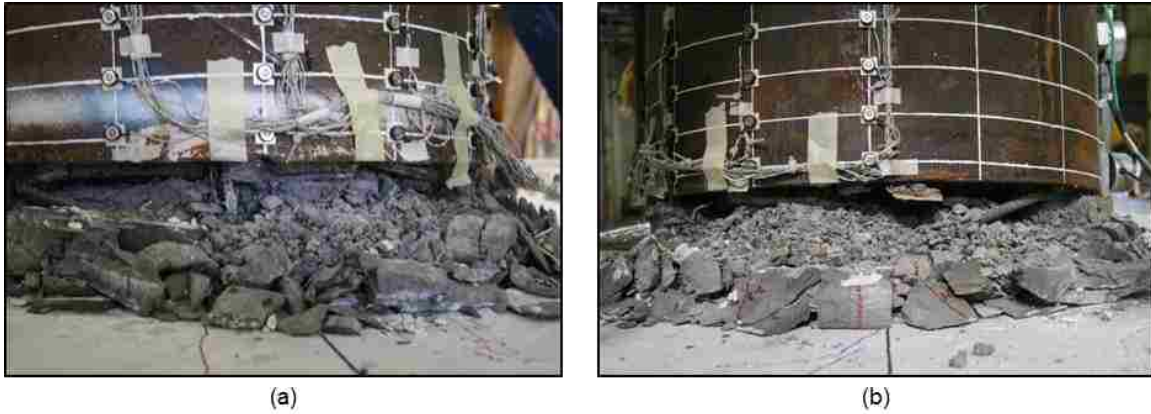
**Figure 5.60:** WRC Reinforcing bar fractures (a) North, and (b) South

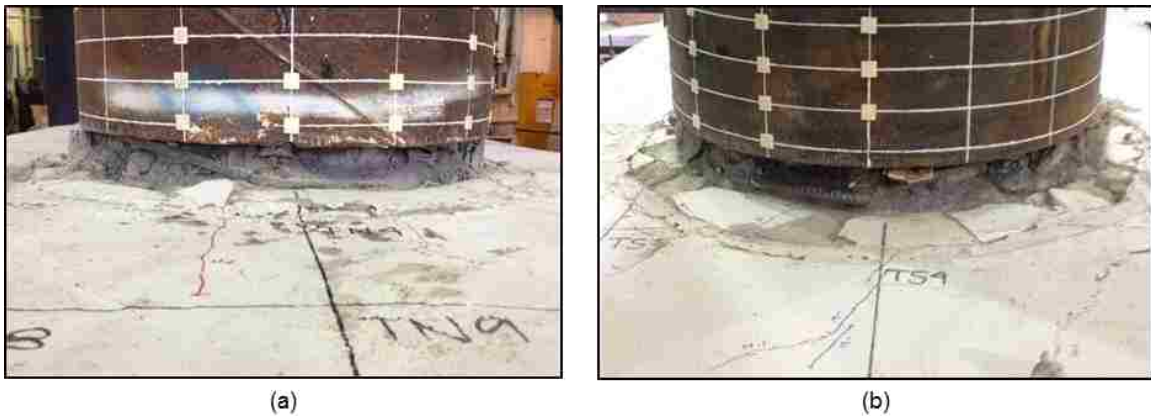
**Figure 5.61:** WRC(a) North and (b) South side of specimen after removal of spalled grout

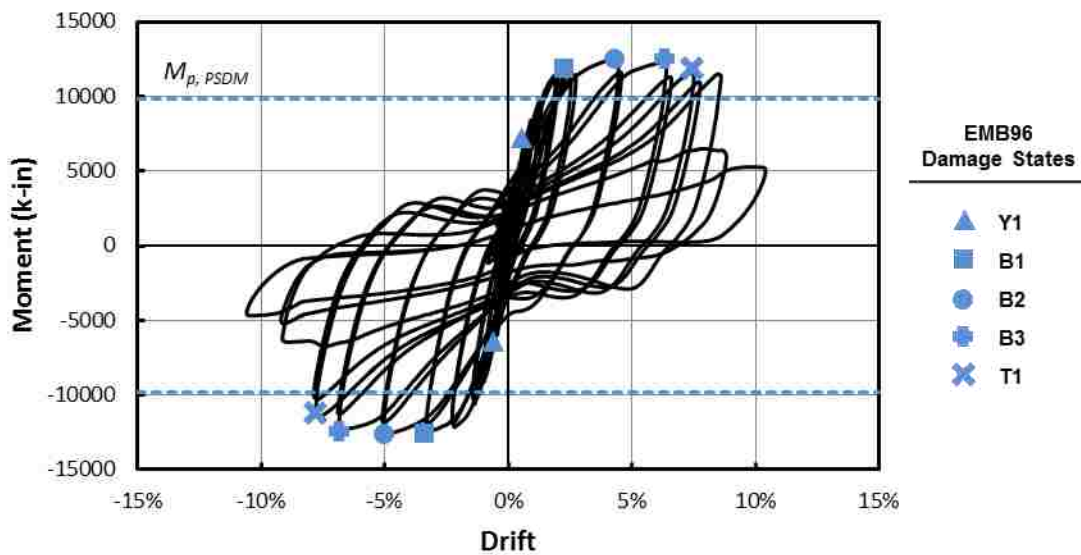
Figure 5.63: EMB96 Moment-Drift Response

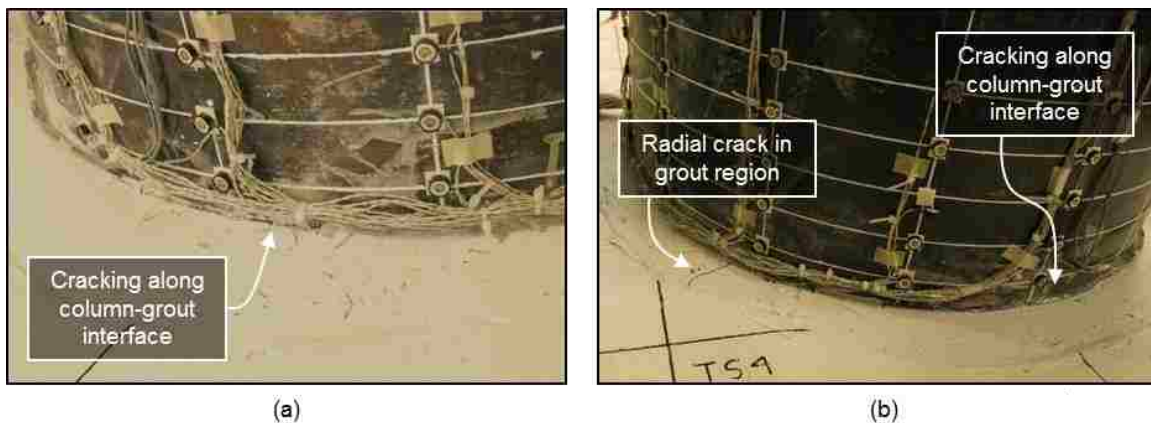
**Figure 5.64:** EMB96 (a) North and (b) South grout pad cracking at 0.5% drift

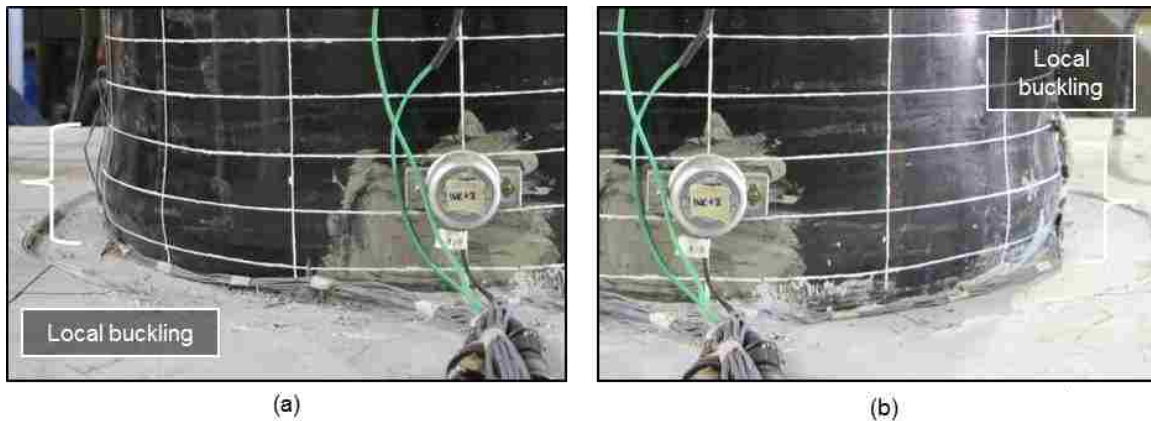
**Figure 5.66:** EMB96 Onset of local buckling on (a) South and (b) North side of the column

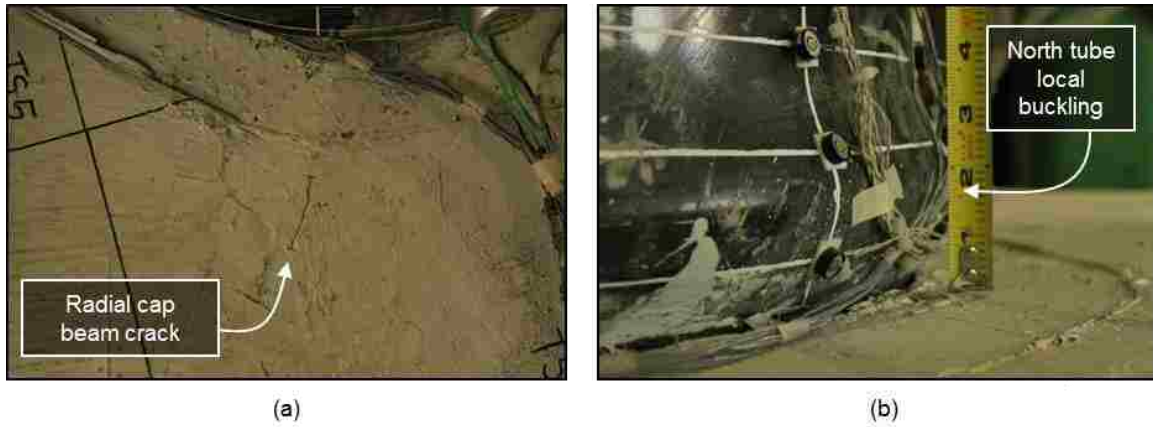
**Figure 5.67:** EMB96 (a) South cap beam cracking and (b) North column buckling after 13<sup>th</sup> load set

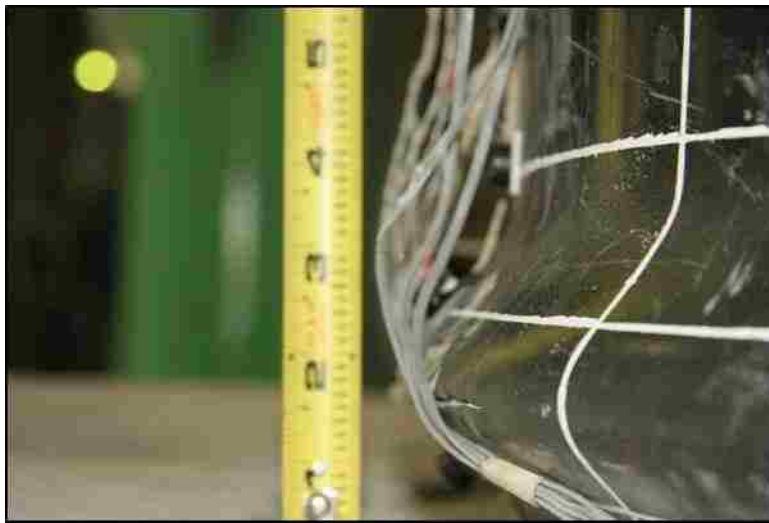
**Figure 5.69:** EMB96 Initiation of South tube tearing

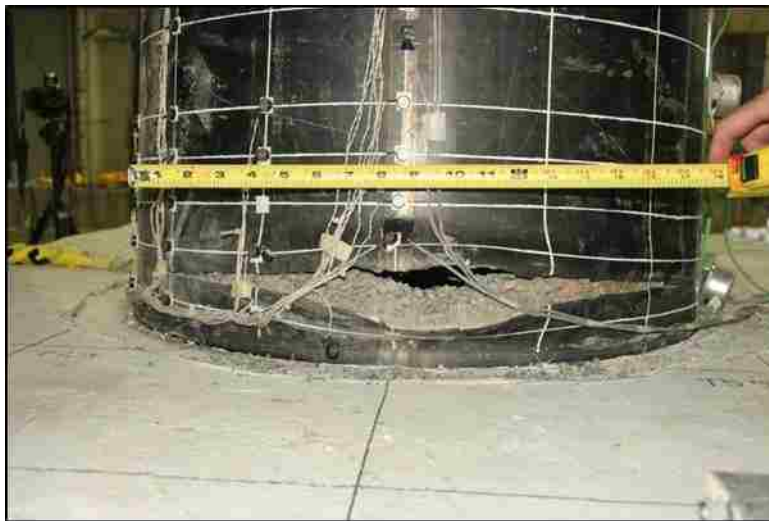
**Figure 5.71:** EMB96 South tear propagation at 9.15% drift North

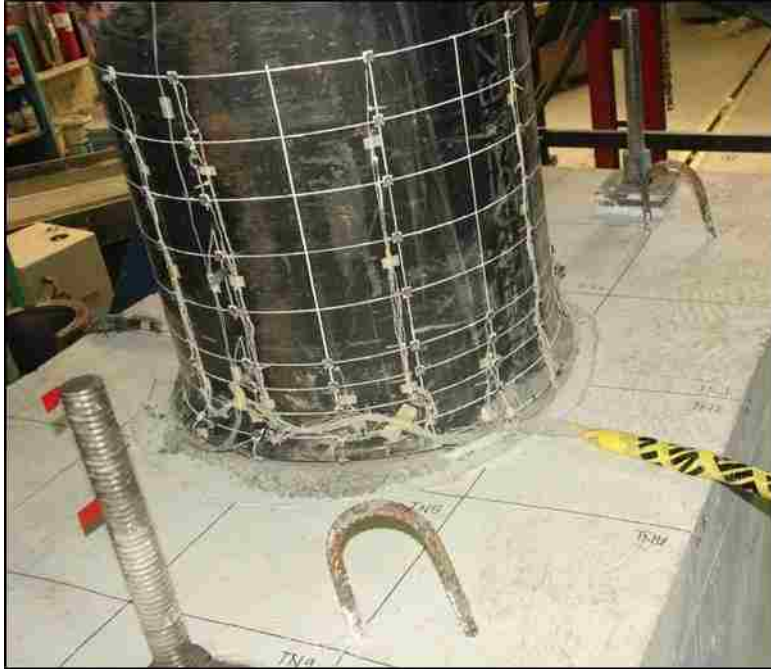
**Figure 5.73:** EMB96 Specimen damage at termination of test

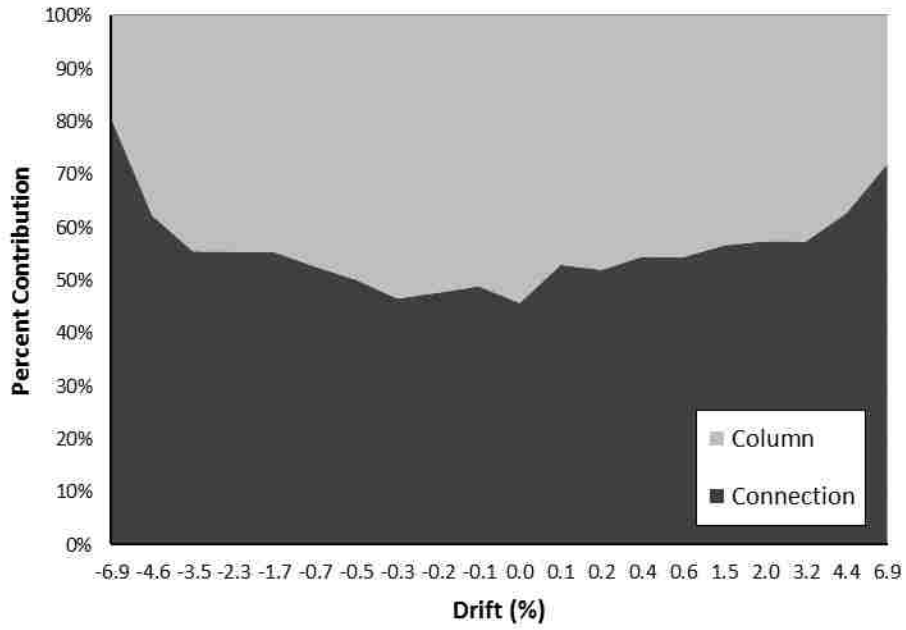
Figure 6.38: EMB80 Rotation Contributions from column & connection

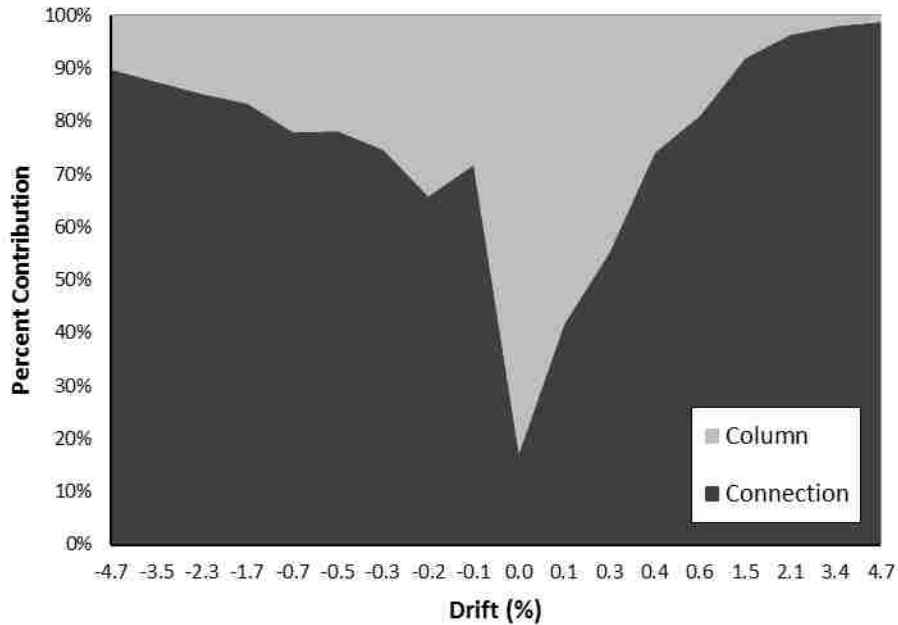
Figure 6.38: RC Rotation Contributions from column & connection

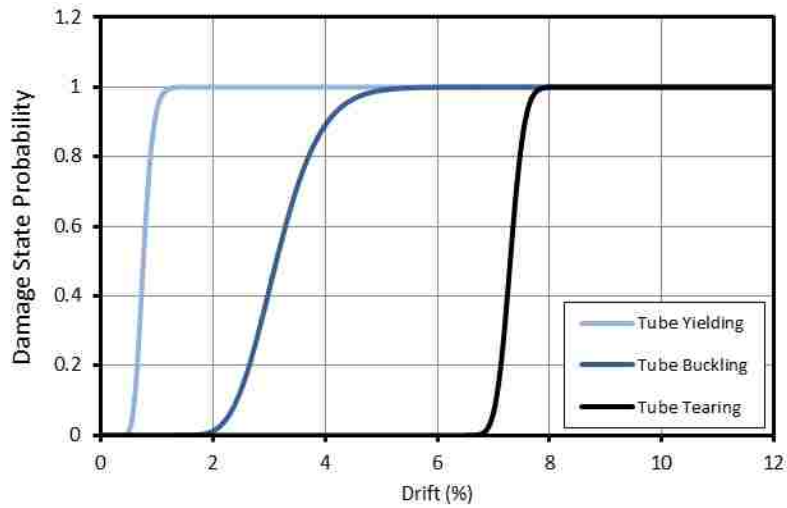
**Figure 6.50:** Fragility curves for tube yielding, buckling, and tearing of spiral-welded CFT specimens

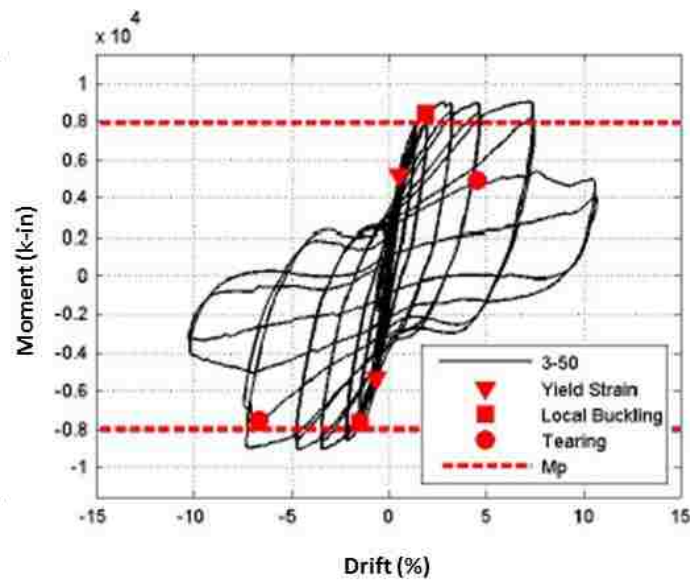
**Figure 6.52:** Moment-drift behavior of Specimen 3-50 (Adapted from Lee, 2011)
