Impact of Beam Strength on Seismic Performance of Chevron Concentrically  
Braced Frames

A thesis

Master of Science in Civil Engineering

University of Washington

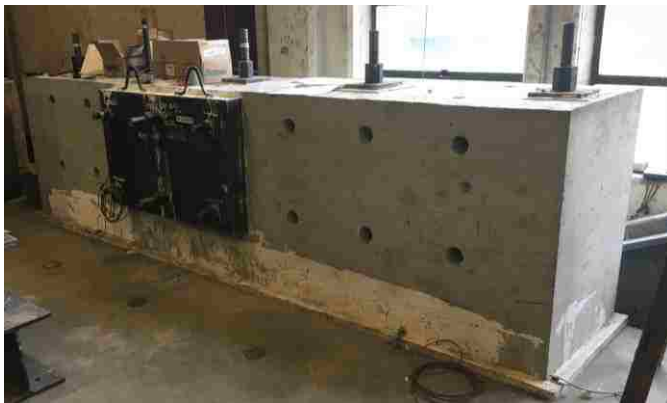
The new reaction block, shown in Figure 3.2, is the same width as the strong wall and is secured to the strong floor with 5 2-inch diameter threaded rods each tensioned to 200 kips. A layer of Hydrostone was placed under the entire block and on top of the block underneath the rod bearing plates to ensure proper bearing surface area. Embedded conduits are placed in an 18-inch grid, offset 9 inches from the strong floor and strong wall grid because those spots were occupied by the threaded rods used to clamp the block to the strong floor. The conduits were designed to mimic those in the strong wall so that the connections between the columns and the reaction components would be consistent. A detailed drawing of the block and its reinforcing steel is in Appendix 1.

Figure 3.2: Reaction block used for N column anchorage.

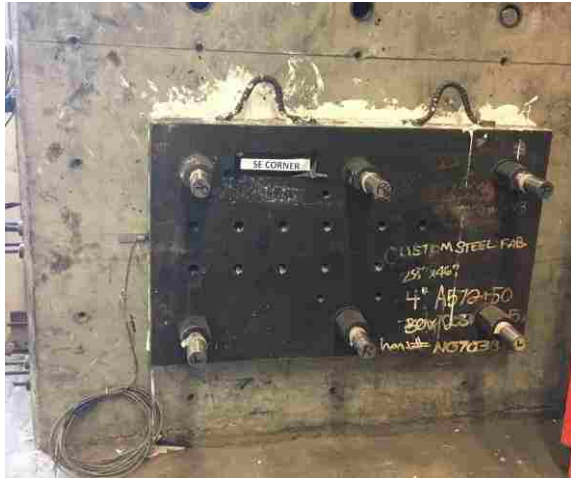
Figure 3.7: Interface plate attached to strong wall.

An anchorage system was designed to connect the columns to the reaction block and strong wall. It was decided that the columns would be restrained at the base to avoid uplift of the columns and to simulate boundary conditions for the lower story of a braced frame. A column base plate and an interface plate to connect the base plate to the concrete block and wall were designed in tandem; Figure 3.7 and 3.8 shows photos of these components and detailed drawings are in Appendix 1. The interface plate was needed because the only means of attaching components to the strong wall and reaction block is through the conduits which are spaced 18 inches apart, and the thick interface plate transfers reactions from the smaller base plate to the reaction block and strong wall. The interface plate was connected to the reaction block and strong wall via the embedded conduits, and it had threaded holes in an efficient layout to attach the column base plate. The interface plates were reused but the columns and base plates were replaced for each test.

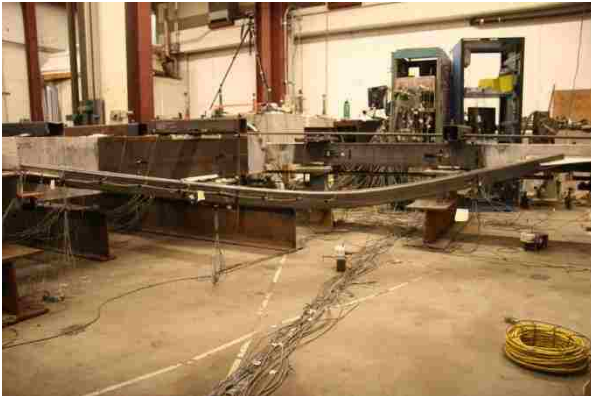
Figure 4.9: N brace buckling at  $+1.1\%$  drift (B2).

- At  $\pm 1.1\%$  story drift, the braces buckled out of plane more than twice the depth of the brace (B2)
- At  $\pm 1.1\%$  story drift, the shear plates began to yield (Y1)
- At  $\pm 1.4\%$  story drift the columns began to yield (Y1) in the plastic hinge region
- At  $-1.65\%$  story drift, tears initiated at the toes of the south brace-to-mid-span gusset plate welds (WT1)
- At  $\pm 1.9\%$  story drift the columns experience moderate yielding (Y2) in the plastic hinge region
- At  $+1.9\%$  story drift, cracks initiated in the gusset plate at the toes of the north brace-to-mid-span gusset plate welds (PC1)
- At  $+1.9\%$  story drift, a tear initiated in the north toe of the mid-span gusset-to-beam weld (WT1)
- At  $-1.9\%$  story drift, slight cupping was observed at mid-span of the south brace (B3-PH)

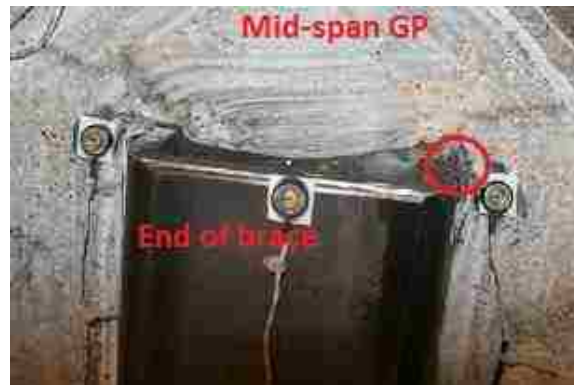
Figure 4.12: GP crack at N brace-to-gusset weld (PC1).

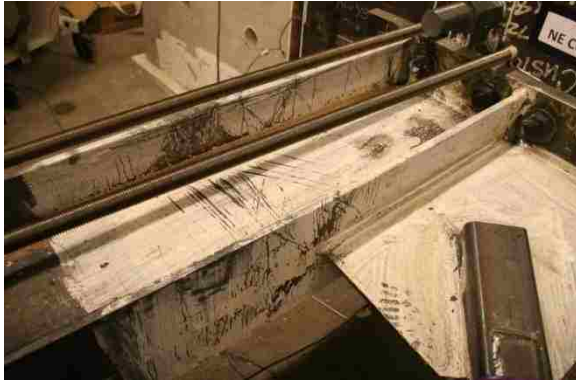
Figure 4.13: N col. moderate yielding at +1.9% drift (Y2-PH).

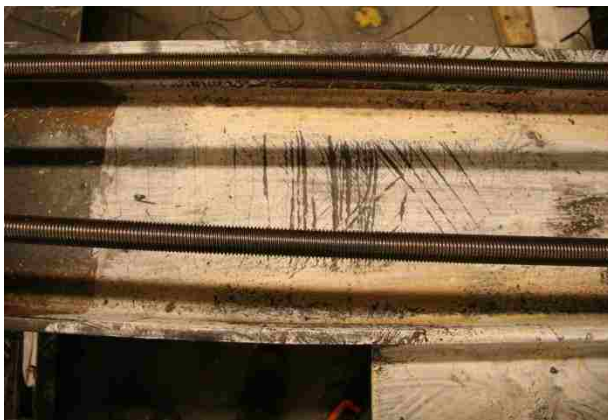
Figure 4.17: Initial local buckling in N (left) and S (right) column flanges at  $+2.2\%$  drift (LB1-OF/IF).

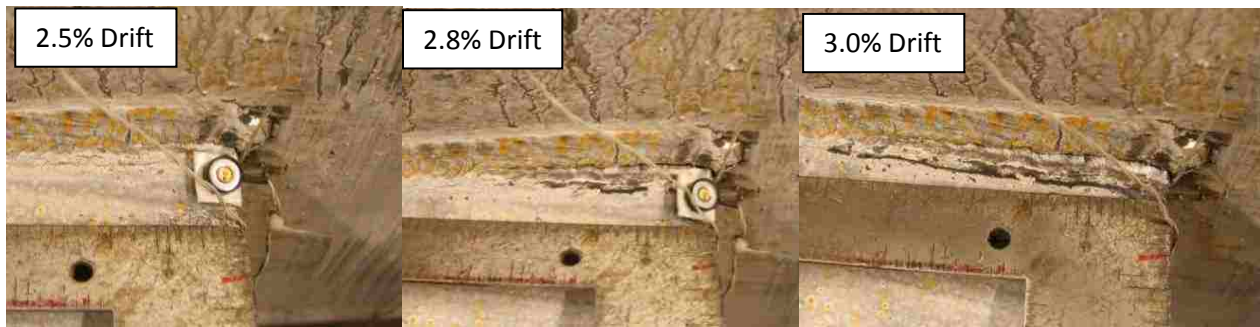
Figure 4.18: Crack propagation in N toe of mid-span gusset-to-beam weld (WT1,2).

Half Cycle #	Drift (%)	N mid-span gusset-to-beam	S mid-span gusset-to-beam	NE gusset-to-column	SE gusset-to-column
49	1.93	1/4"	-	-	-
53	2.2	1"	-	-	-
57	2.48	2"	-	2"	-
58	-2.48	2"	-	2"	1/4"
60	-2.48	2"	-	2"	1/2"
61	2.76	2-3/4"	-	3-1/4"	1/2"
63	2.76	2-3/4"	-	3-1/2"	1/2"
64	-2.76	2-3/4"	7/8"	3-1/2"	1/2"
65	3.03	3"	7/8"	4"	1/2"
66	-3.03	3"	1-1/2"	4"	1/2"
67	3.03	3-1/2"	1-1/2"	4-1/2"	1/2"
69	3.31	4"	1-1/2"	5"	1/2"

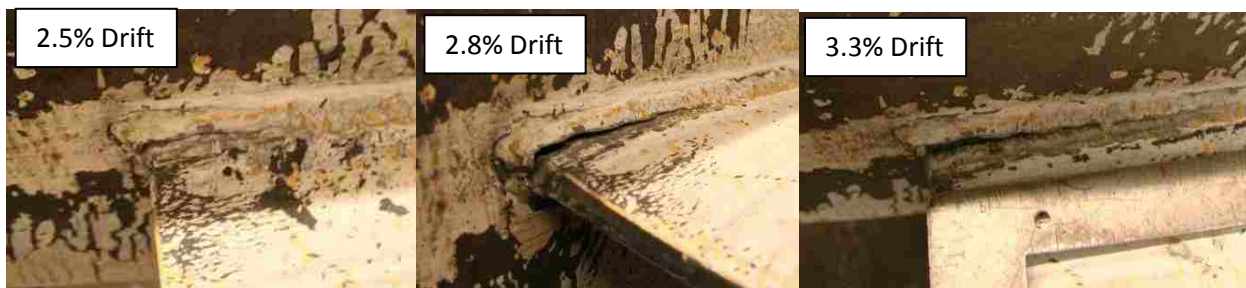
Figure 4.19: Crack propagation in NE corner gusset-to-column weld (WT1,2,3).

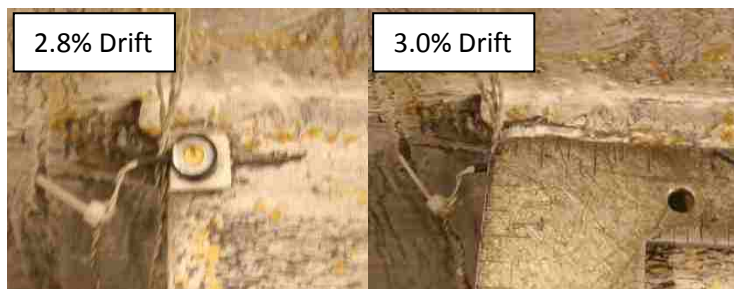
Figure 4.20: Crack propagation in S mid-span gusset-to-beam weld (WT1).

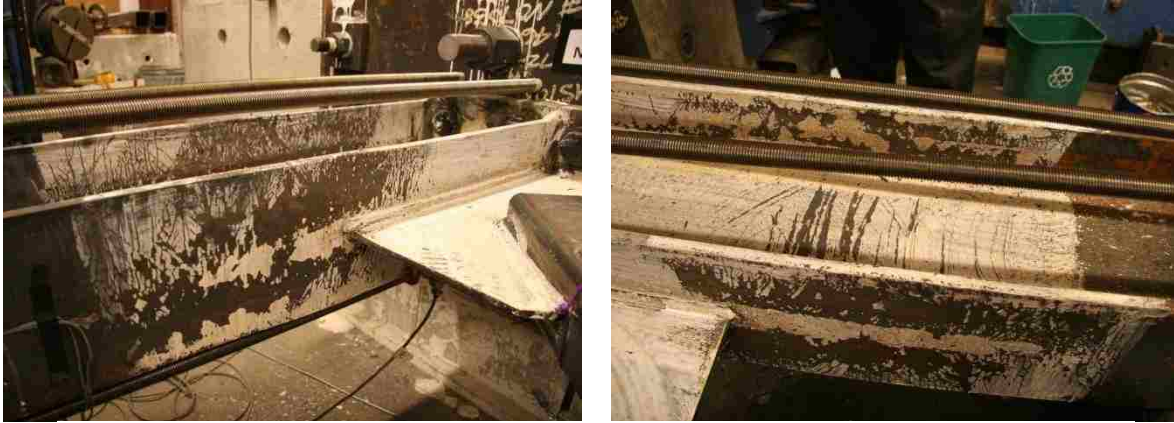
Figure 4.22: Severe yielding in N col. (left) and S col. (right) at 2.76% drift (Y3-PH).

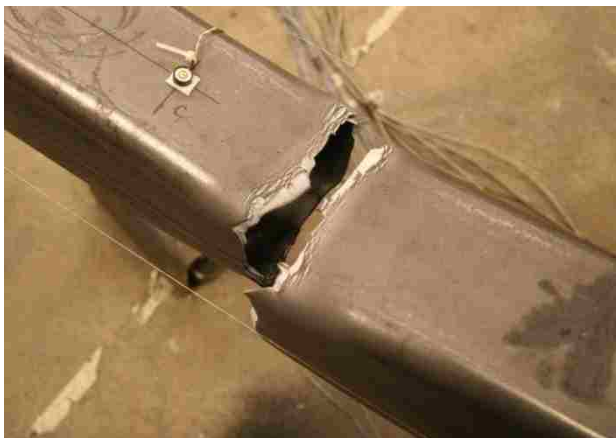
Figure 4.24: S brace fracture at second cycle of +3.0% drift (B4-BF).

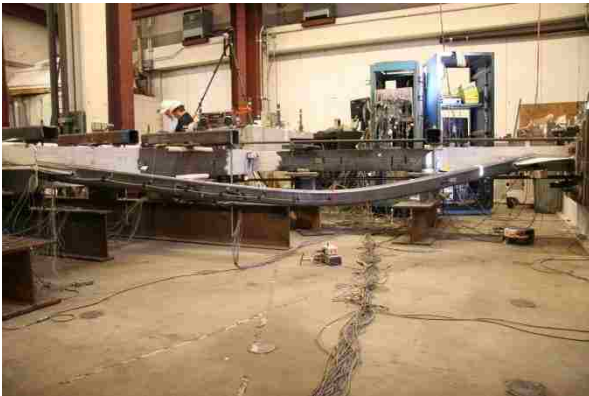
Figure 4.37: N brace buckling at  $+1.1\%$  drift (B1).

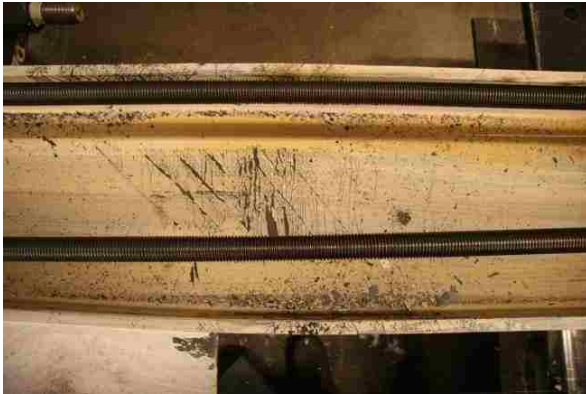
Figure 4.45: Initial col. local buckling at 2.2% drift (LB1-OF/IF).

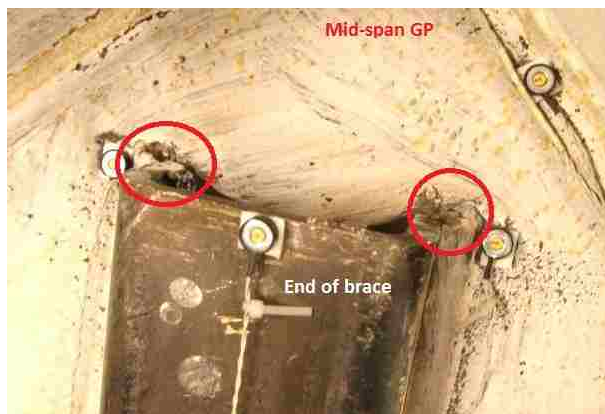
Figure 4.48: Plate cracking at toe of brace-to-mid-span gusset weld (PC1).

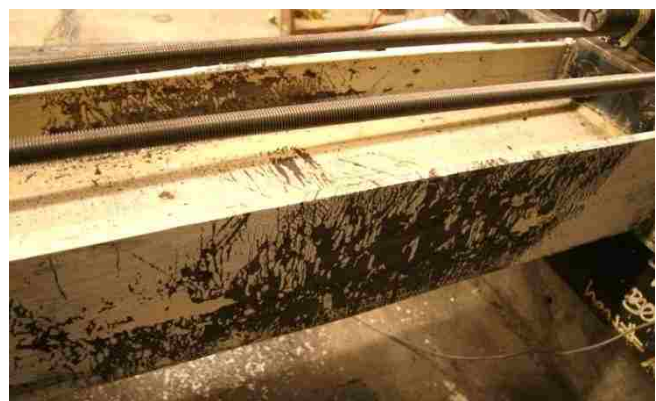
Figure 4.49: S col. severe yielding at 2.8% drift (Y3-OF/IF).

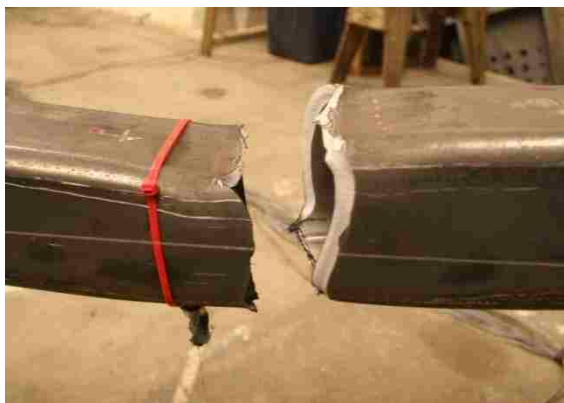
Figure 4.52: S brace fracture 1<sup>st</sup> cycle at 3.3% drift (B4-BF).

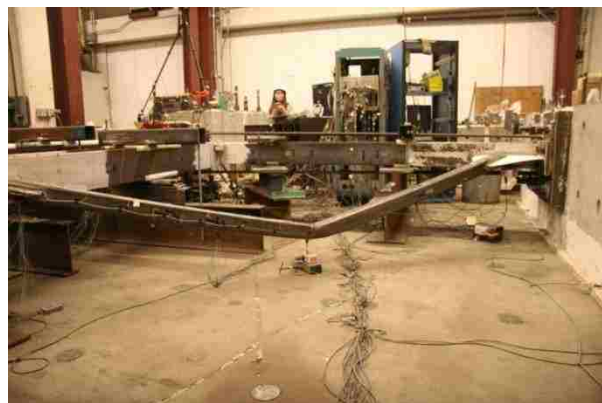
Figure 4.53: N brace buckling at 3.3% drift (B3-PH).

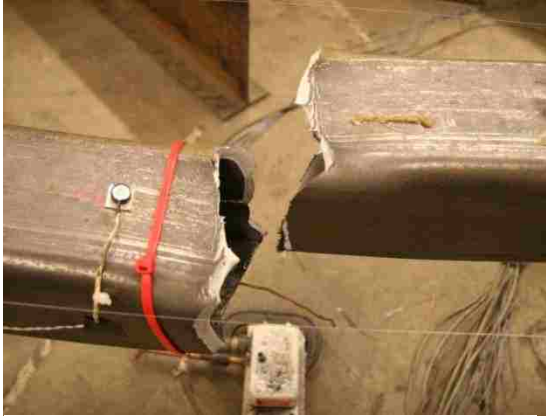
Figure 4.54: N brace fracture at -3.3% drift (B4-BF).

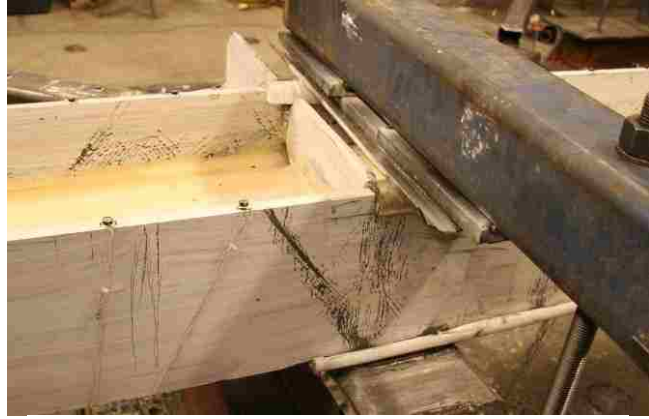
Figure 4.55: Extent of beam yielding at end of test (Y1-OF/IF).

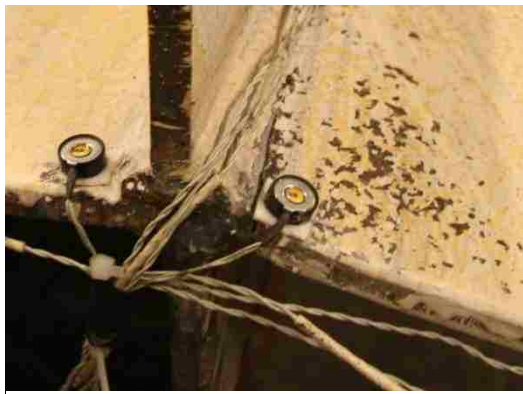
Figure 4.80: Plate crack at N mid-span gusset-to-stiffener weld at 3.3% drift (PC2).

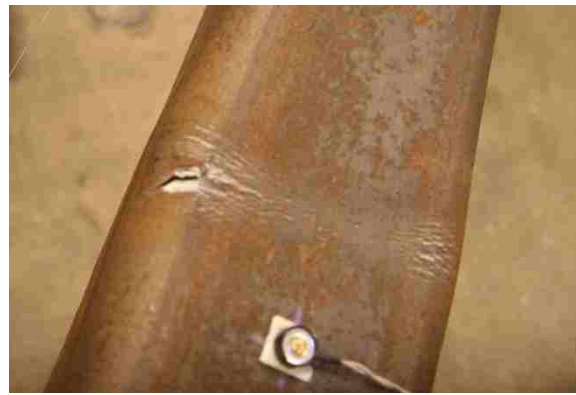
Figure 4.81: N brace crack/striations at -3.3% drift.

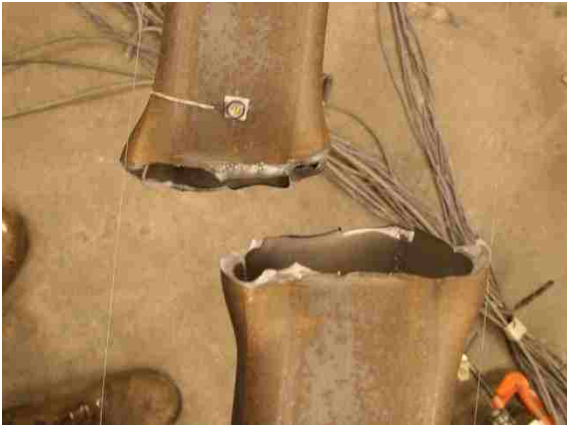
Figure 4.88: N brace fracture at -3.6% drift (B4-BF).

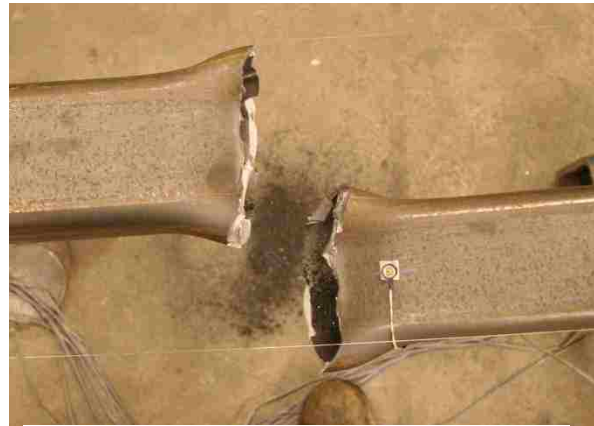
Figure 4.89: S brace fracture at +3.6% drift (B4-BF).

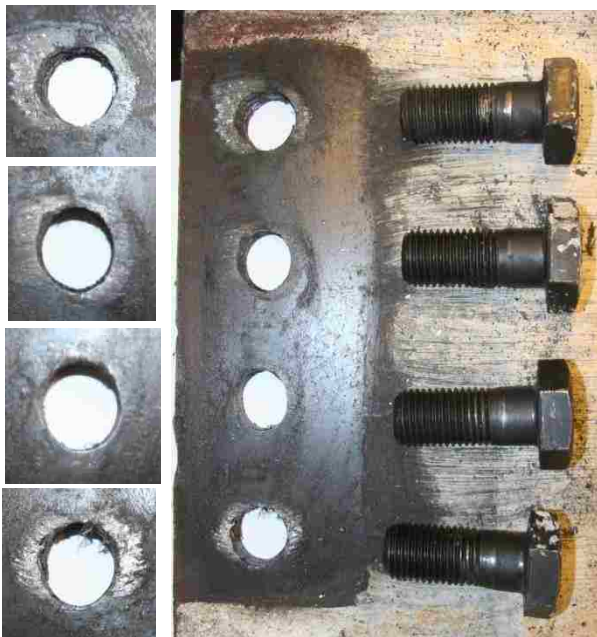
The frame was cycled to  $\pm 5\%$  drift after both braces had fractured. The columns continued sustain yielding and local buckling, reaching the performance state of severe local buckling (LB3). After the test the frame was disassembled and it was noted that slight bolt hole elongation had occurred in the top and bottom holes in the beam web, as shown in Figure 4.90 and 4.91.

Figure 4.90: S beam web bolt hole elongation.

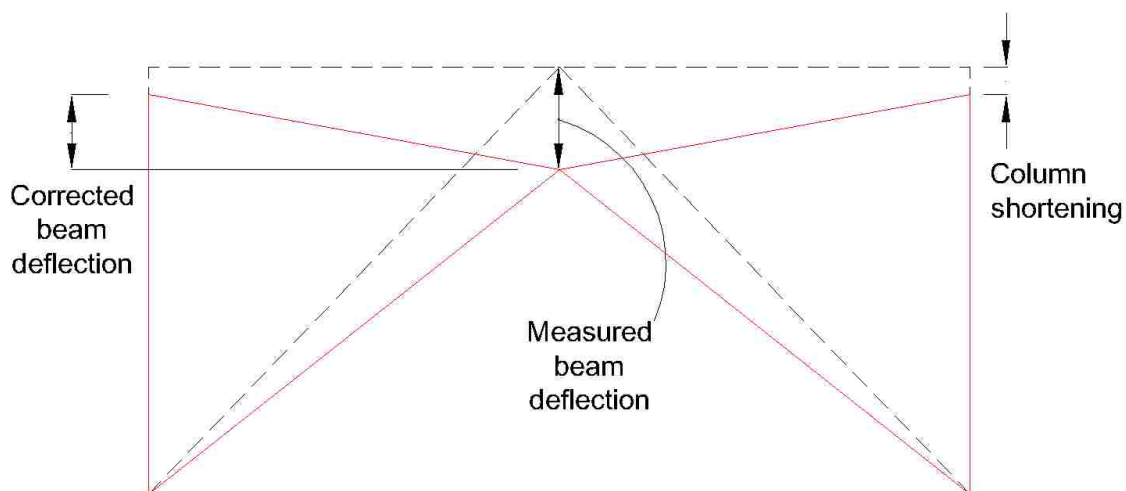
Figure 5.25: Beam deflection correction for column shortening.
