Estimating Phase Durations for Chloride-Induced Corrosion Damage of Concrete Bridge Decks in Utah

Master of Science

Department of Civil and Environmental Engineering

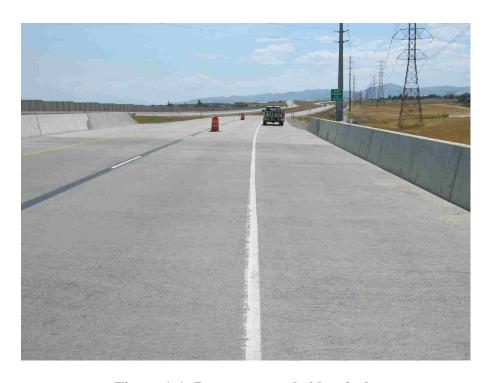
Figure 1-1: Bare concrete bridge deck.

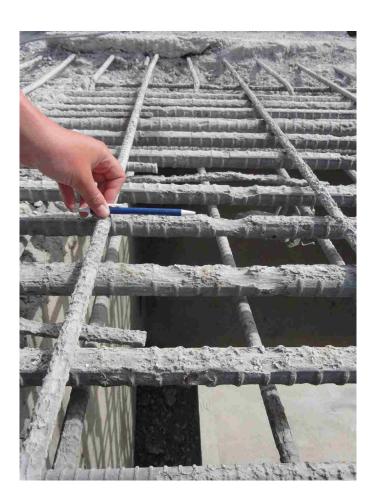
During the corrosion period, the cross-sectional area of the intact reinforcing steel decreases as illustrated in Figure 2-2, which shows heavily corroded reinforcing steel exposed during hydrodemolition of a concrete bridge deck that had been subject to deicing salt applications for more than 40 years (Guthrie et al. 2014). The reduction in cross-sectional area is attended by the development of tensile stresses in the concrete due to the expanding volume of the corrosion products, which can occupy two to six times the volume of the original steel (Fanous et al. 2000, Suda et al. 1993, Mindess et al. 2003). These tensile stresses can cause the concrete to crack and separate from the reinforcement, resulting in delamination as depicted in

Figure 2-2: Corroded reinforcing steel in a concrete bridge deck.

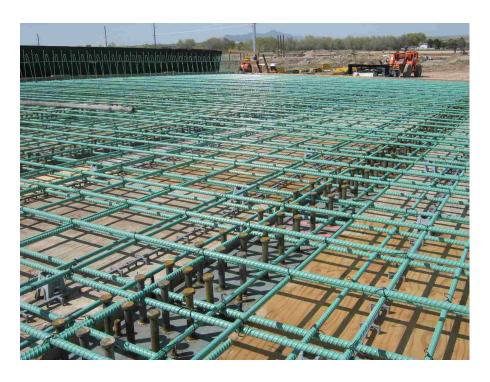
Over the past 50 years, the use of epoxy-coated reinforcement has been a standard practice in many cold regions to mitigate corrosion in concrete bridge decks. The epoxy coating is specifically intended to protect the rebar from exposure to oxygen, water, and chloride ions (Brown et al. 2003). Figure 2-5 shows the top and bottom mats of epoxy-coated reinforcement installed during construction of a new bridge deck, prior to concrete placement. In one study based on extensive field experimentation, the expected service life of a bridge deck with epoxy-coated reinforcement has been estimated to be nearly double that of decks with uncoated reinforcement (Boatman 2010). However, other studies also based on field experimentation have concluded in one case that the use of epoxy-coated reinforcement extends the service life of a bridge deck by only 5 years and in another case that it may provide protection for only 5 percent of all bridge decks (Brown et al. 2003, Weyers et al. 1998). The apparent discrepancy may be attributable not only to variation in the quality of epoxy coating applications but also to varying levels of care during handling by contractor personnel during rebar placement at the time of deck

Figure 2-5: Epoxy-coated reinforcement.

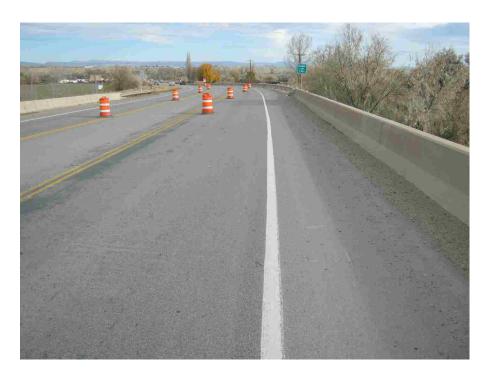
Historically, asphalt overlays were frequently applied to bridge decks in Utah. An asphalt overlay system typically consists of a bonding primer, a waterproofing membrane, and two hot mix asphalt layers (Krauss et al. 2009). The waterproofing membrane is placed at the interface between the deck surface and the lower asphalt layer to serve as a barrier against moisture and chloride ion penetration. The typical thickness of an asphalt overlay is 2.5 in. to 3.0 in. (Lachemi

Figure 2-6: Deck with asphalt overlay.

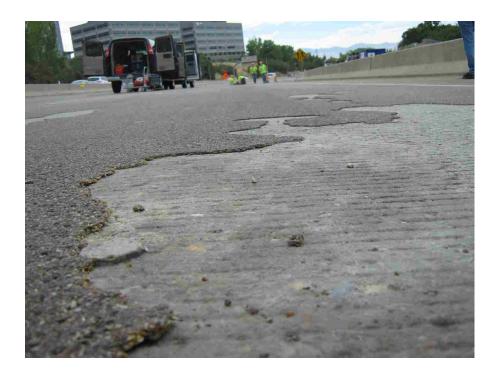
Polymer overlays are becoming increasingly popular in Utah due to their minimal thickness and rapid installation (De Leon 2018). A polymer overlay consists of a thin layer of usually epoxy-based polymer and a surface coating of fine aggregate (Shearrer et al. 2015). The typical thickness of a polymer overlay is 0.25 in. to 0.75 in., and the installation process takes less than 24 hours (Krauss et al. 2009, Tabatabai et al. 2016). Polymer overlays are approximately 10 times more effective in resisting chloride ingress than bare concrete (Pan et al. 2017). However, re-application of a polymer overlay approximately every 10 years is required to maintain effectiveness (Guthrie et al. 2005). Premature failure is usually manifest as delamination of the overlay, as illustrated in Figure 2-9 (Guthrie et al. 2005, Rogers et al. 2011).

Figure 2-9: Delamination of polymer overlay.

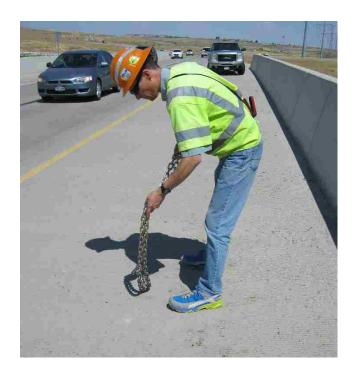
Chain dragging and hammer sounding were performed to investigate the presence of delamination at each test location. Sounding procedures were performed in general accordance with American Society for Testing and Materials (ASTM) D 4580 (Standard Practice for Measuring Delaminations in Concrete Bridge Decks by Sounding). During chain dragging, which is depicted in Figure 3-3, a steel chain was dragged several times across the deck surface at each test location, and, in most cases, at least two researchers simultaneously listened to the acoustic response. For both chain dragging and hammer sounding, intact concrete was

Figure 3-3: Chain dragging.

characterized by a clear ringing sound, while delaminated concrete produced a dull, hollow sound (Sun 2017).

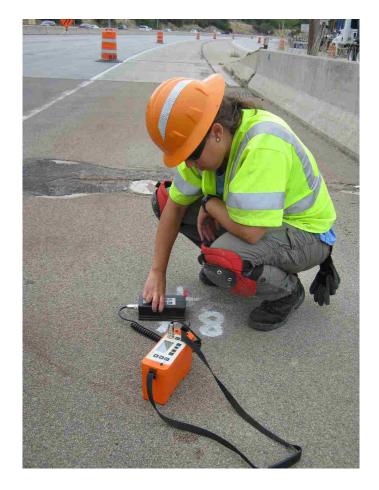
In this testing, researchers utilized a cover meter to determine the concrete cover depth at each test location, as shown in Figure 3-4. A cover meter is an instrument that uses pulse-

Figure 3-4: Cover depth measurements.

induction to locate the steel reinforcement embedded in the concrete and accurately measure the concrete cover depth when the rebar size has been entered (Sivasubramanian et. al 2013). Cover depth measurements were generally obtained above two adjacent longitudinal and two adjacent transverse bars at each test location.

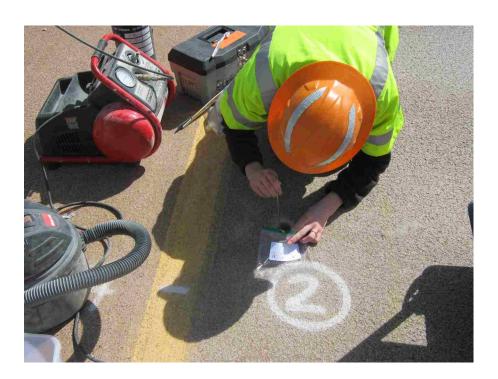
reinforcing bars and the maximum drilling depth permitted by UDOT on the given bridge deck. A rotary hammer was used to pulverize the concrete in 0.5-in. to 1.0-in. depth intervals, or lifts. The bit size was decreased with each lift to eliminate contamination of deeper samples that may have otherwise resulted from scraping of the bit against the inside of the hole at depths of shallower lifts during drilling. After the pulverized concrete from each lift was manually removed from the hole and placed in a bag, as shown in Figure 3-5, the hole and all tools were cleaned with a vacuum and/or compressed air before the next lift was drilled. Following sample collection, the hole was generally patched using an air-entrained, non-shrink grout, and the pulverized concrete was delivered to the BYU Highway Materials Laboratory for chloride concentration testing. The chloride concentration of each concrete sample in units of pounds of chloride per cubic yard of concrete was then determined in general accordance with ASTM

Figure 3-5: Concrete sampling for chloride concentration analysis.

C1152 (Standard Test Method for Acid-Soluble Chloride in Mortar and Concrete), assuming a concrete density of 145 or 150 lb per cubic foot, depending on the bridge deck.
