Understanding Soil Liquefaction of the 2016 Kumamoto Earthquake

A thesis submitted to the faculty of
Brigham Young University
in partial fulfillment of the requirements for the degree of
Master of Science

Department of Civil and Environmental Engineering
Brigham Young University

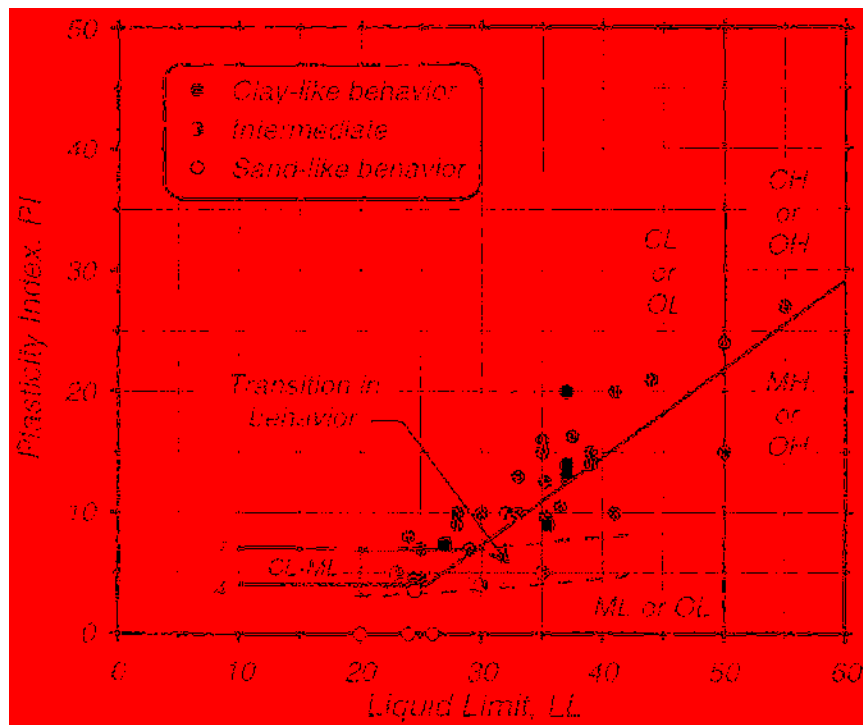
Figure 2-1: Liquefaction susceptibility criteria for fine-grained soils (Boulanger & Idriss, 2006)

set a plasticity index of seven and higher as not susceptible, with the four to seven range being possible, and less than four being susceptible. Bray et al. (2004) sets a plasticity index of 20 and above as not susceptible, 20 to 12 being possible, and less than 12 being increasingly susceptible. Bray et al. (2004) evaluates water content and liquid limit in conjunction with soil plasticity. Often times, both methods are used when evaluating liquefaction susceptibility of fine-grained soils. This paper will use the Boulanger and Idriss (2006) cutoff point of plasticity index of seven and higher as soil that is not susceptible to liquefaction for soils with significant fines content.

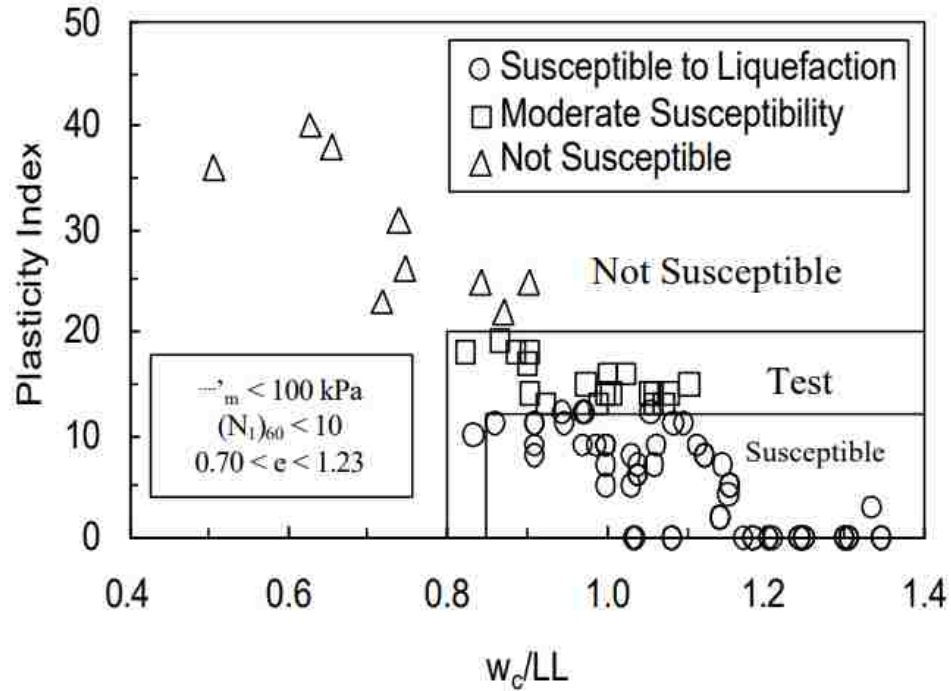
Figure 2-2: Liquefaction susceptibility criteria for fine-grained soils (Bray et al., 2004)

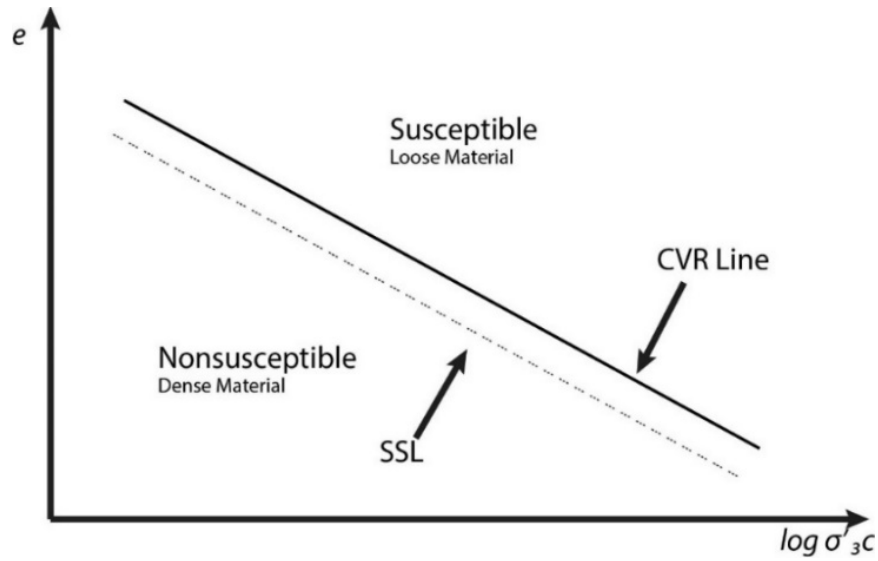
Figure 2-3: Initial State Criteria. Drawn after Kramer (1996)

The position of the SSL is unique to a soil and is dependent on its density, gradation, particle angularity, and other compositional criteria. While useful, finding the SSL of a soil requires specialized lab equipment and can be time consuming and expensive. In addition, in-situ soil conditions must be closely replicated for accurate results. Different testing procedures will yield slightly different values for the SSL (Vaid et al., 1990).

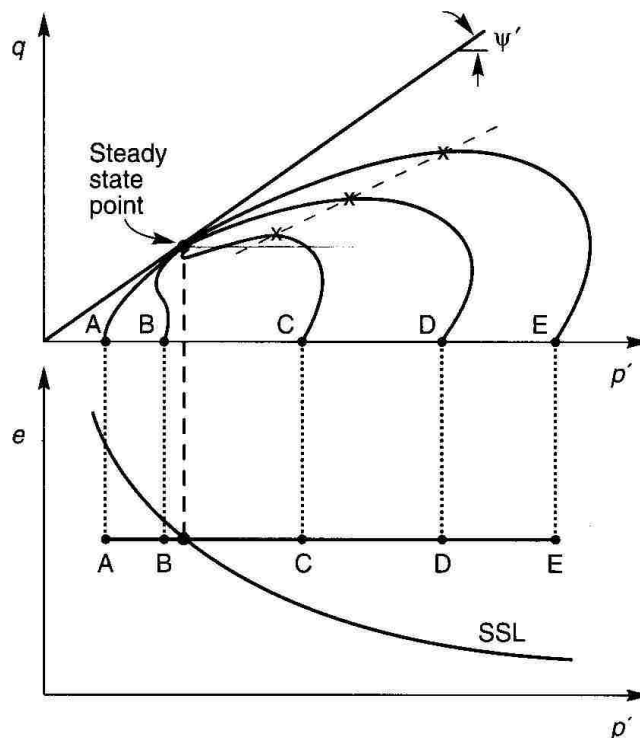
Figure 2-6: Flow liquefaction surface (dashed line) and SSL (Kramer 1996)

Soils will tend toward the SSP when undergoing large strains (Kramer, 1996); however, the stress paths of soils will vary as shown in Figure 2-6 (Kramer, 1996). Points below the SSL will dilate until they reach the SSP. Points above the SSL will have a contractive behavior. The peak of the contractive curves is called the flow liquefaction surface and is represented by the dashed line (Kramer 1996). When the flow liquefaction surface is reached, the soil rapidly loses strength and converges to the SSP passing a point of no return and flow liquefying.

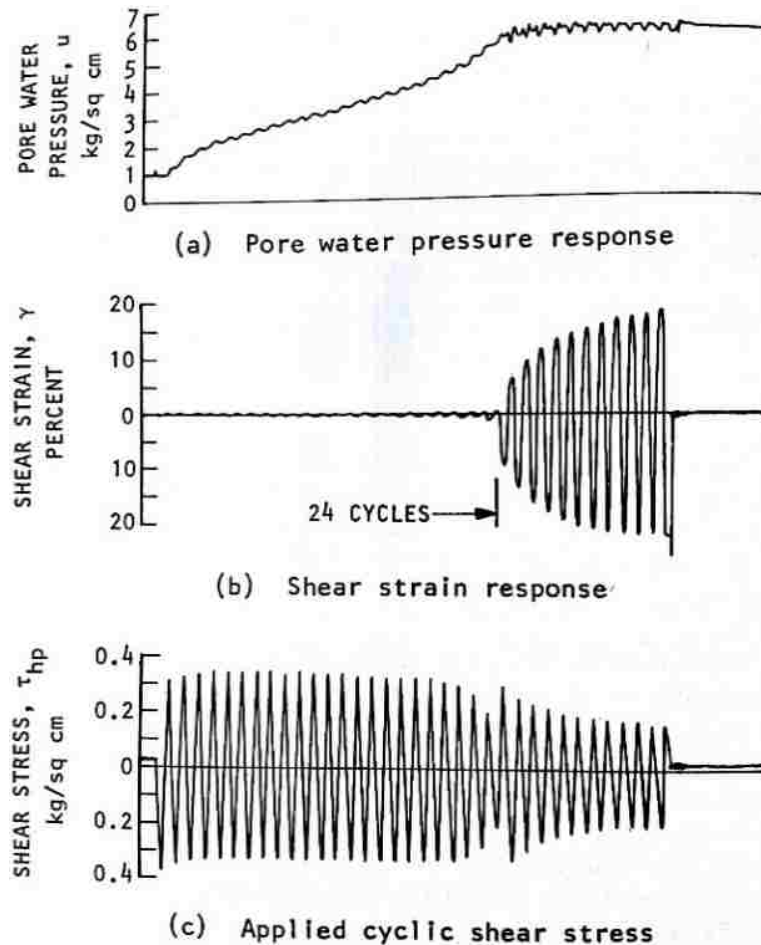
Figure 2-7: Cyclic loading test of loose sand (Seed and Idriss, 1982)

Soil liquefaction was first reported during the 1964 Niigata, Japan and Alaska earthquakes, and has been extensively studied since. Although earthquake engineering has significantly advanced with the advent of the seismograph, these earthquakes caused the soil, not steel and concrete, to fail. Not all earthquakes result in major liquefaction, but some liquefaction typically occurs in every sizeable earthquake. Minor liquefaction in earthquakes is not surprising. Some recent earthquakes with major liquefaction are the 2011 Tohoku, Japan and 2011 Christchurch, NZ earthquakes. Figure 2-7 provides an illustration of a soil that has liquefied (Seed & Idriss, 1982). There is a gradual increase in pore pressure followed by an abrupt change in shear strain and strength (Seed & Idriss, 1982).

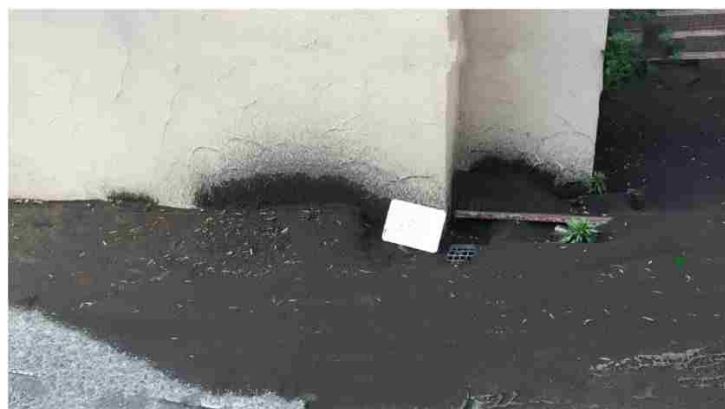
Figure 2-9: Sand boils on side of house in Kumamoto, showing volcanic material that was plastic and pumiceous in origin (Kayen 2017)

Perhaps the most common liquefaction hazard is the sand boil, a phenomenon in which a liquefied soil layer releases pore pressure by cracking through a surface layer and leaving behind a sand volcano or gaping hole. Sand boils are often accompanied by large depressions filled with water and soil from layers that were eroded. Oftentimes, the edges of foundations are perfect exits for water and will have sand boils. See Figure 2-9 for an picture of a sand boil from Kumamoto City that was dark and contained pumiceous materials (Kayen et al., 2017). The dark color of the soil is typical of the Kumamoto volcanically derived soils.

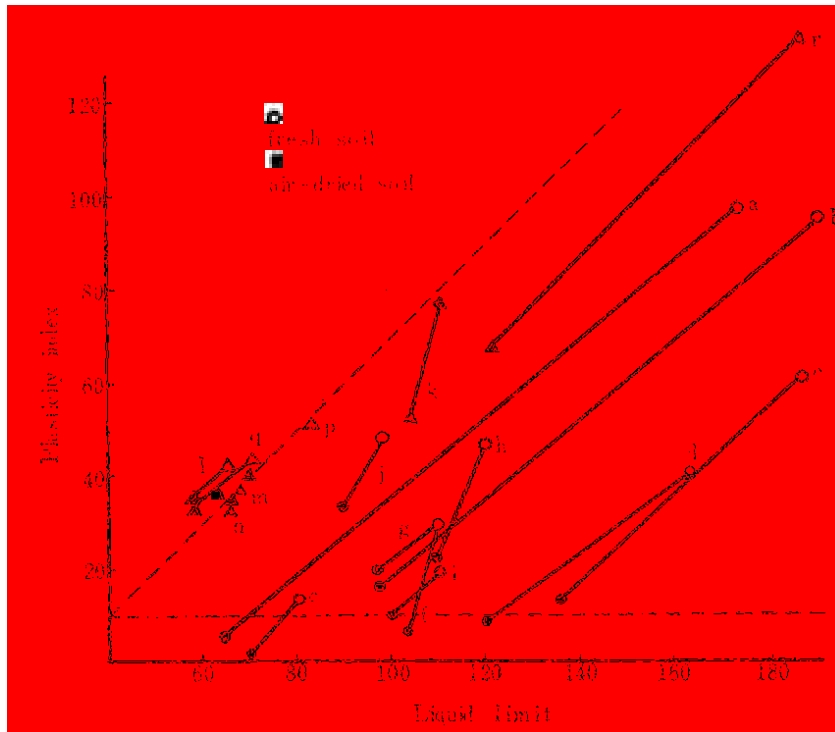
Figure 4-8: Effects of soil drying on volcanic soil plasticity (Yamazaki & Takenaka, 1965)

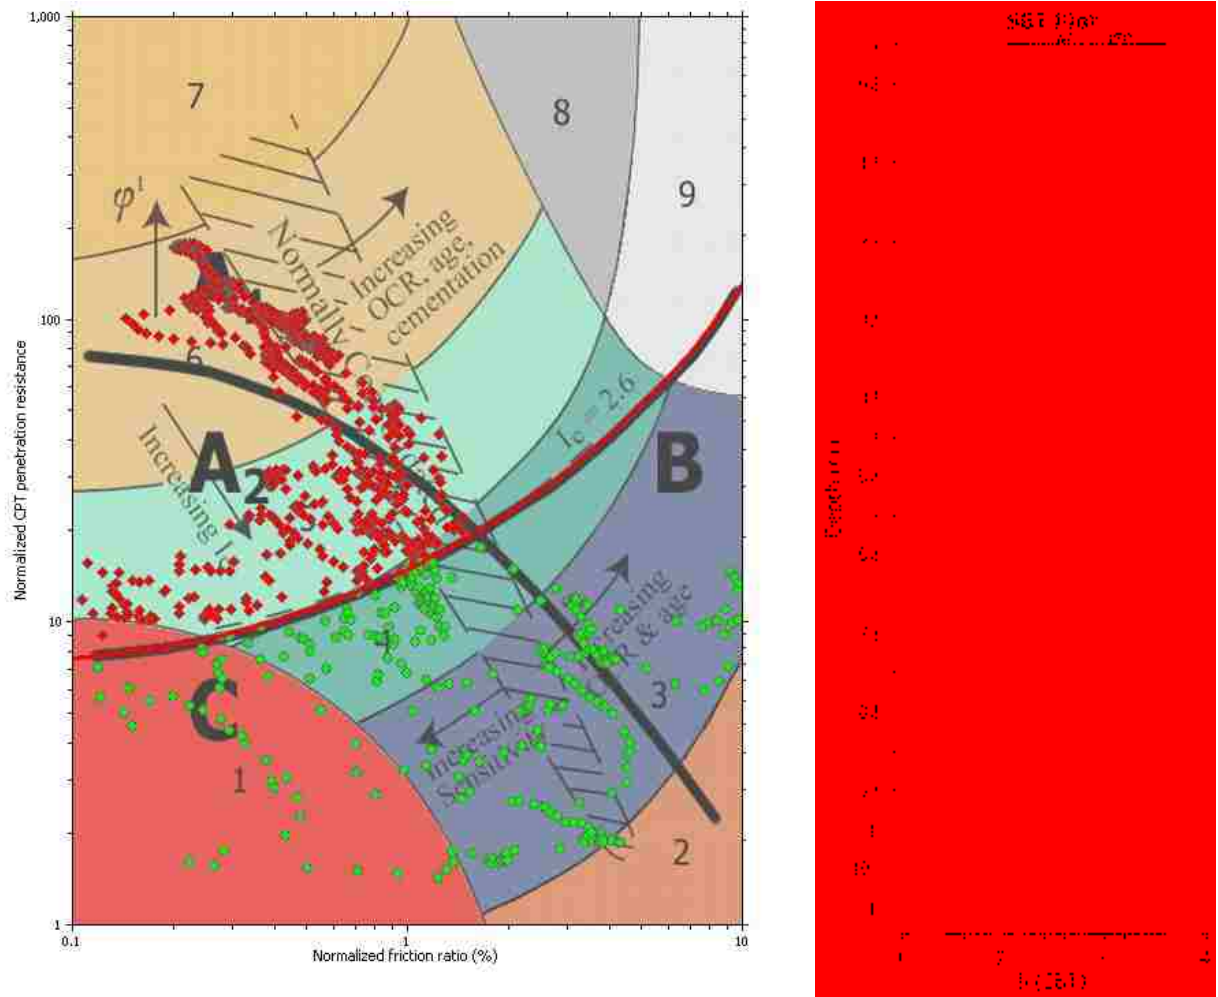
Figure 6-20: Site 2-2 normalized CPT penetration resistance plotted against normalized friction ratio and I_c with depth

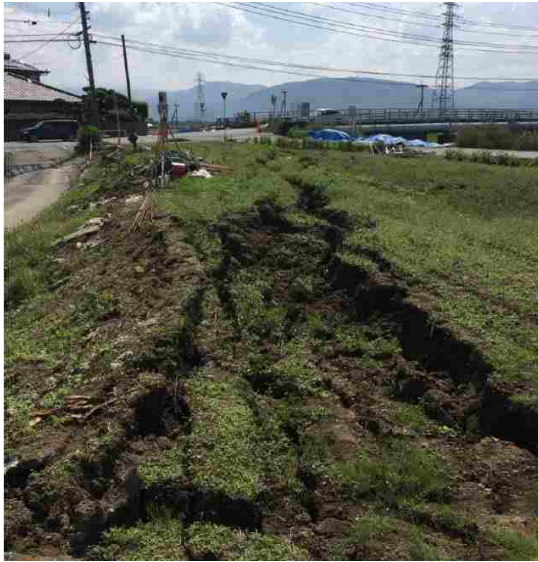
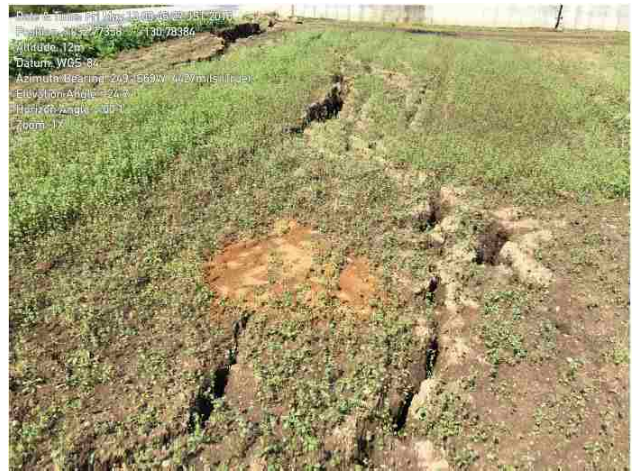
Figure 6-26. Hypothesized lateral spread at site 4 and observed fissures and ejecta (Kayen et al., 2017)

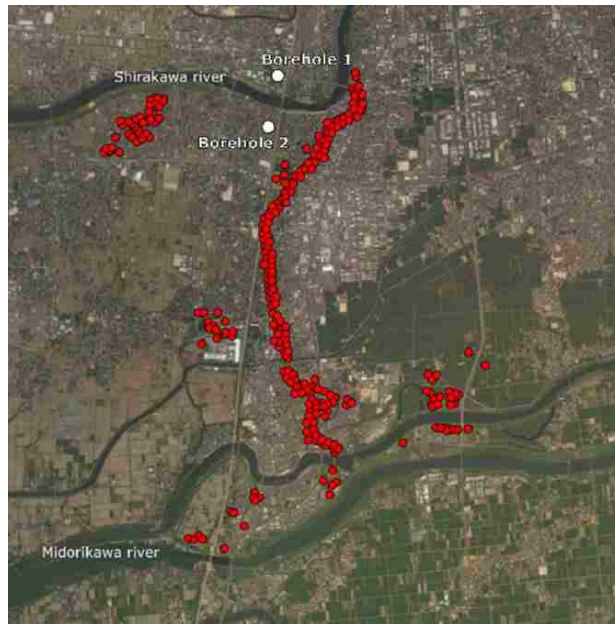
Figure A-7: Observed soil liquefaction in Kumamoto City (Bhattacharya et al., 2018)
