Estimating Phase Durations for Chloride-Induced Corrosion Damage of Concrete Bridge Decks in Utah

Kaylee Dee Bateman Brigham Young University

A thesis submitted to the faculty of
Brigham Young University
in partial fulfillment of the requirements for the degree of

Department of Civil and Environmental Engineering

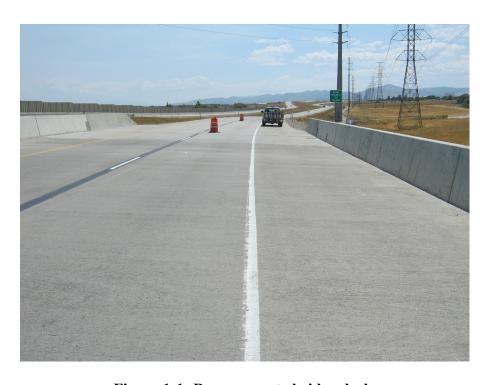
Figure 1-1: Bare concrete bridge deck.

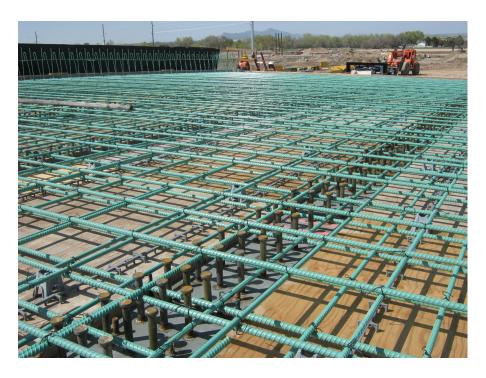
Over the past 50 years, the use of epoxy-coated reinforcement has been a standard practice in many cold regions to mitigate corrosion in concrete bridge decks. The epoxy coating is specifically intended to protect the rebar from exposure to oxygen, water, and chloride ions (Brown et al. 2003). Figure 2-5 shows the top and bottom mats of epoxy-coated reinforcement installed during construction of a new bridge deck, prior to concrete placement. In one study based on extensive field experimentation, the expected service life of a bridge deck with epoxy-coated reinforcement has been estimated to be nearly double that of decks with uncoated reinforcement (Boatman 2010). However, other studies also based on field experimentation have concluded in one case that the use of epoxy-coated reinforcement extends the service life of a bridge deck by only 5 years and in another case that it may provide protection for only 5 percent of all bridge decks (Brown et al. 2003, Weyers et al. 1998). The apparent discrepancy may be attributable not only to variation in the quality of epoxy coating applications but also to varying levels of care during handling by contractor personnel during rebar placement at the time of deck

Figure 2-5: Epoxy-coated reinforcement.

construction (Guthrie et al. 2008). If the epoxy coating on the reinforcement is damaged, the reinforcement will be unprotected, and localized corrosion can ensue (Fanous et al. 2000). Given that some data suggest that corrosion can occur even under an apparently intact epoxy coating when the chloride concentration is sufficiently high (Weyers et al. 1998), epoxy coatings must be applied to rebar with uniformly high quality, and epoxy-coated reinforcement must be handled with care during construction operations to ensure optimal corrosion protection.

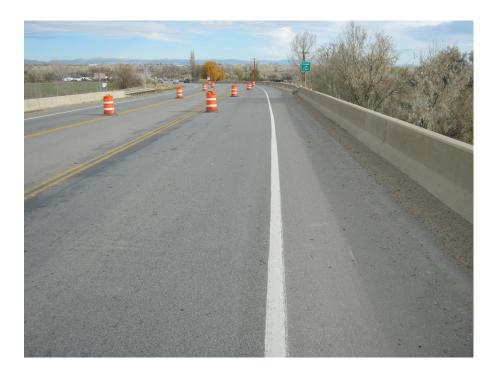
Historically, asphalt overlays were frequently applied to bridge decks in Utah. An asphalt overlay system typically consists of a bonding primer, a waterproofing membrane, and two hot mix asphalt layers (Krauss et al. 2009). The waterproofing membrane is placed at the interface between the deck surface and the lower asphalt layer to serve as a barrier against moisture and chloride ion penetration. The typical thickness of an asphalt overlay is 2.5 in. to 3.0 in. (Lachemi

Figure 2-6: Deck with asphalt overlay.

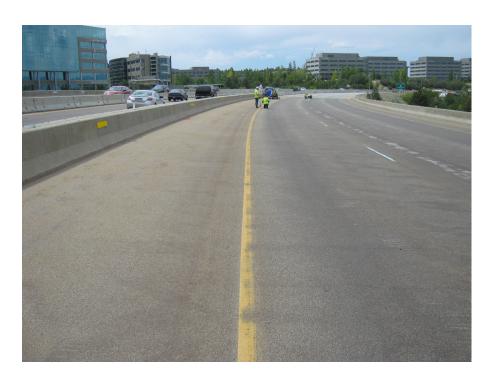
Figure 2-7: Deck with polymer overlay.

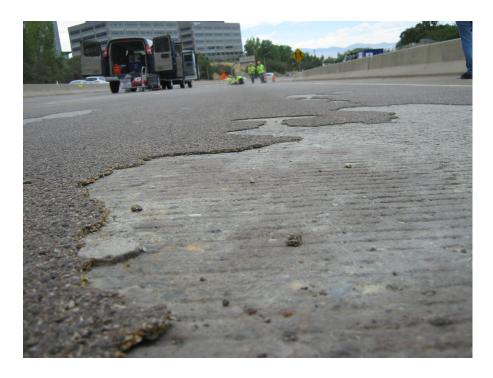
Polymer overlays are becoming increasingly popular in Utah due to their minimal thickness and rapid installation (De Leon 2018). A polymer overlay consists of a thin layer of usually epoxy-based polymer and a surface coating of fine aggregate (Shearrer et al. 2015). The typical thickness of a polymer overlay is 0.25 in. to 0.75 in., and the installation process takes less than 24 hours (Krauss et al. 2009, Tabatabai et al. 2016). Polymer overlays are approximately 10 times more effective in resisting chloride ingress than bare concrete (Pan et al. 2017). However, re-application of a polymer overlay approximately every 10 years is required to maintain effectiveness (Guthrie et al. 2005). Premature failure is usually manifest as delamination of the overlay, as illustrated in Figure 2-9 (Guthrie et al. 2005, Rogers et al. 2011).

Figure 2-9: Delamination of polymer overlay.

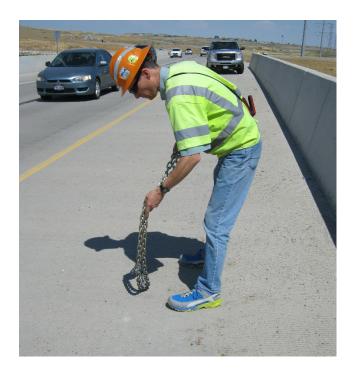
Chain dragging and hammer sounding were performed to investigate the presence of delamination at each test location. Sounding procedures were performed in general accordance with American Society for Testing and Materials (ASTM) D 4580 (Standard Practice for Measuring Delaminations in Concrete Bridge Decks by Sounding). During chain dragging, which is depicted in Figure 3-3, a steel chain was dragged several times across the deck surface at each test location, and, in most cases, at least two researchers simultaneously listened to the acoustic response. For both chain dragging and hammer sounding, intact concrete was

Figure 3-3: Chain dragging.

characterized by a clear ringing sound, while delaminated concrete produced a dull, hollow sound (Sun 2017).

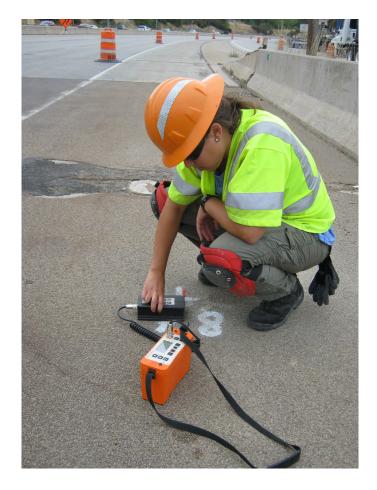
In this testing, researchers utilized a cover meter to determine the concrete cover depth at each test location, as shown in Figure 3-4. A cover meter is an instrument that uses pulse-

Figure 3-4: Cover depth measurements.

induction to locate the steel reinforcement embedded in the concrete and accurately measure the concrete cover depth when the rebar size has been entered (Sivasubramanian et. al 2013). Cover depth measurements were generally obtained above two adjacent longitudinal and two adjacent transverse bars at each test location.

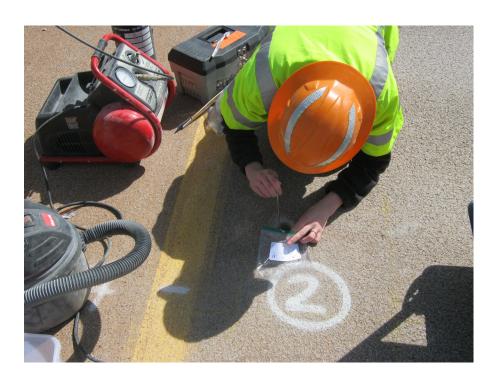
reinforcing bars and the maximum drilling depth permitted by UDOT on the given bridge deck. A rotary hammer was used to pulverize the concrete in 0.5-in. to 1.0-in. depth intervals, or lifts. The bit size was decreased with each lift to eliminate contamination of deeper samples that may have otherwise resulted from scraping of the bit against the inside of the hole at depths of shallower lifts during drilling. After the pulverized concrete from each lift was manually removed from the hole and placed in a bag, as shown in Figure 3-5, the hole and all tools were cleaned with a vacuum and/or compressed air before the next lift was drilled. Following sample collection, the hole was generally patched using an air-entrained, non-shrink grout, and the pulverized concrete was delivered to the BYU Highway Materials Laboratory for chloride concentration testing. The chloride concentration of each concrete sample in units of pounds of chloride per cubic yard of concrete was then determined in general accordance with ASTM

Figure 3-5: Concrete sampling for chloride concentration analysis.

C1152 (Standard Test Method for Acid-Soluble Chloride in Mortar and Concrete), assuming a concrete density of 145 or 150 lb per cubic foot, depending on the bridge deck.
