Evaluation of Effectiveness of Streambank Stabilization Practices and Flood Impact on Cedar River, Nebraska

A THESIS

Major: Environmental Engineering

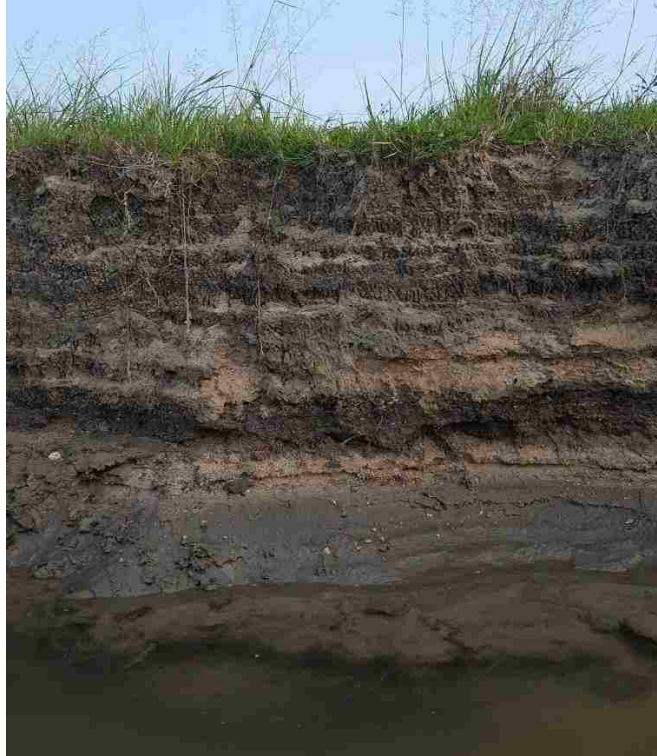
Figure 2.2 Typical streambank on Cedar River. Note the transition from sandy soil at the top to silty loam in the bottom.

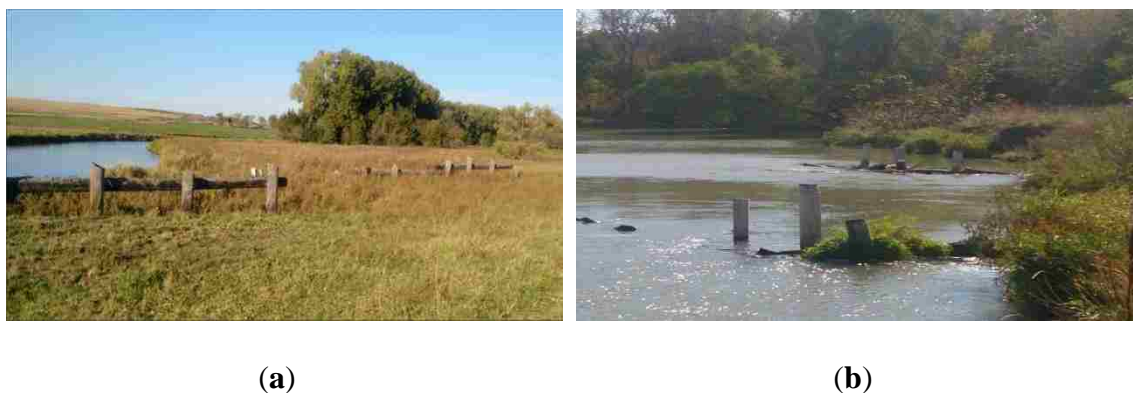
Figure 2.3 Jetties installed in 1950 at Site 5 (a) and in 2000 at Site 4 (b). Note the sediment that has accumulated over time in front of the jetties installed in 1950.

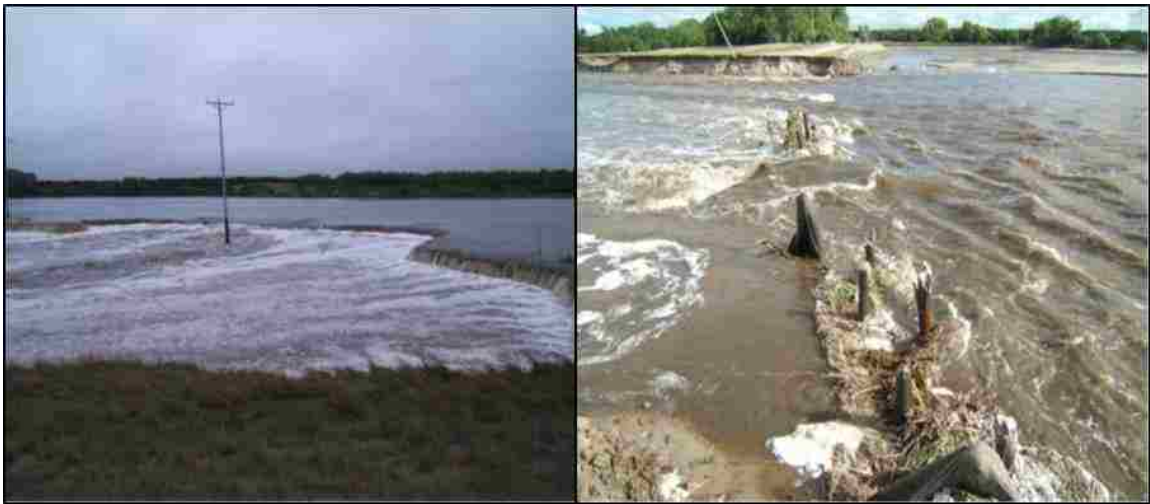
Figure 3.2 Flooding on Cedar River due to dam failure on June 14, 2010. Pictures by: Nebraska Department of Natural Resources.

dam increased the peak flow and created major destruction downstream of the dam (Figure 3.2). The flow peaked at $190.4 \text{ m}^3 \text{ s}^{-1}$, nearly three times greater than the next highest recorded discharge (Figure 3.3). Stream discharge was used to calculate the stream power and return period for the flood and pre- and post-flood periods.

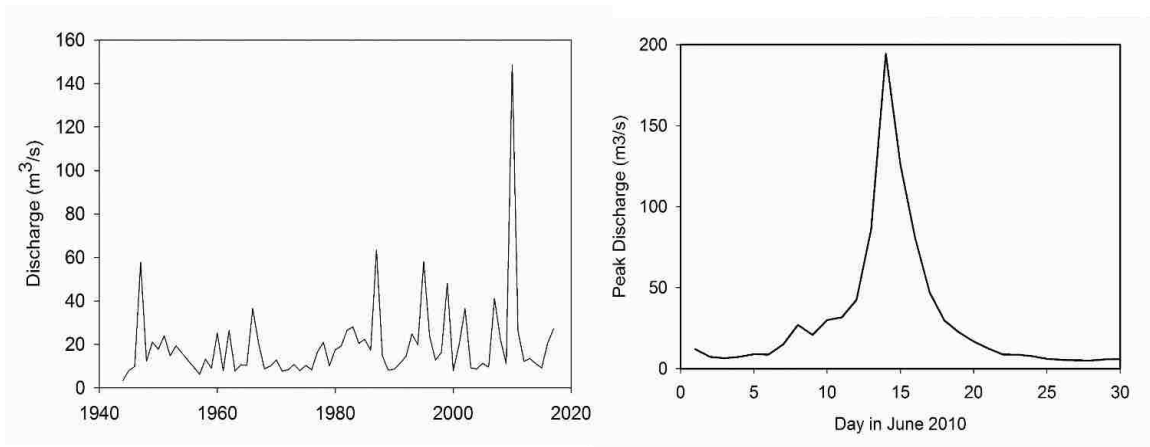
Figure 3.3 Stream flow with daily average discharge near Spalding from 1944 to 2018 (left) and the flood event with daily peaks caused by the breached dam in June 2010 (right).

Streambank erosion is strongly influenced by stream discharge and stream power. Stream discharge from 1944 to 2017 was available at the stream gage near Spalding (DNR, 2018). On June 14, 2010, heavy rains led to the failure of Ericson dam. The breached

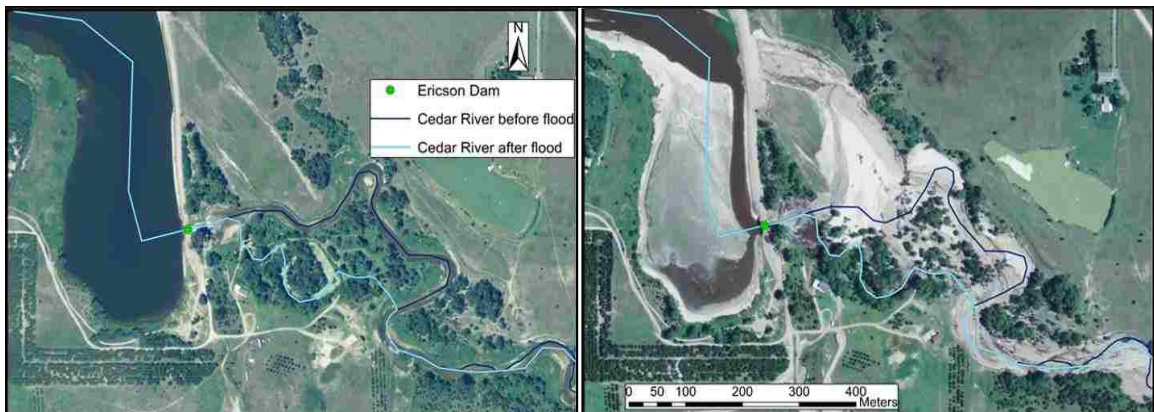
Figure 3.7 Aerial images illustrating the location of Cedar River just below Ericson Dam before the flood event in 2009 (left) and after the flood event in 2010 (right).

Streambank retreat was calculated on the 45 km river for each 1 kilometer interval downstream of Ericson Dam in each of the three time periods: pre-flood (2006-2009) flood (2009-2010) and post-flood (2010-2016). The first calculation began 500 m downstream of the dam since the erosion just below the dam was too massive to quantify (Figure 3.7).

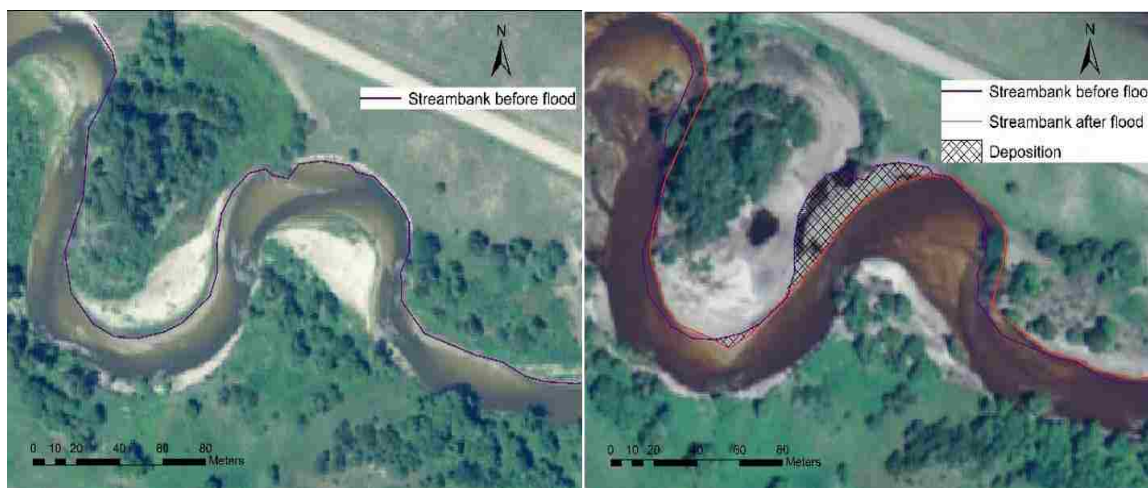
Figure 3.9 A reach on Cedar River illustrating the deposition of sediment in post-flood period (right) compared to pre-flood period (left).

Though there has been a lot of streambank erosion on Cedar River, specifically during the flood period, not all the sediment reaches Lake Spalding. Much of the sediment is deposited in the river downstream from where it eroded. Due to limitations of aerial images, deposition rates were not calculated. Though deposition can easily be observed, measuring historical accumulated depth with aerial imagery is not possible. Figure 3.9, from a 2010 aerial image, illustrates the large quantity of sediment deposited during the flood period. For this study, erosion was typically observed at critical banks and deposition was observed on the corresponding opposite bank. However, during the floods, as water levels increased, aerial images could not identify the deposition at banks distinctively. In the post-flood periods, when the water receded, a significant amount of sediment deposition was observed on the river, which might have been brought by the flood event. However, since the depth of sediment deposit is unknown, there is a possibility of overestimating or underestimating total accumulation. Because of the bias and uncertainty of aerial imagery, deposition was not quantified.

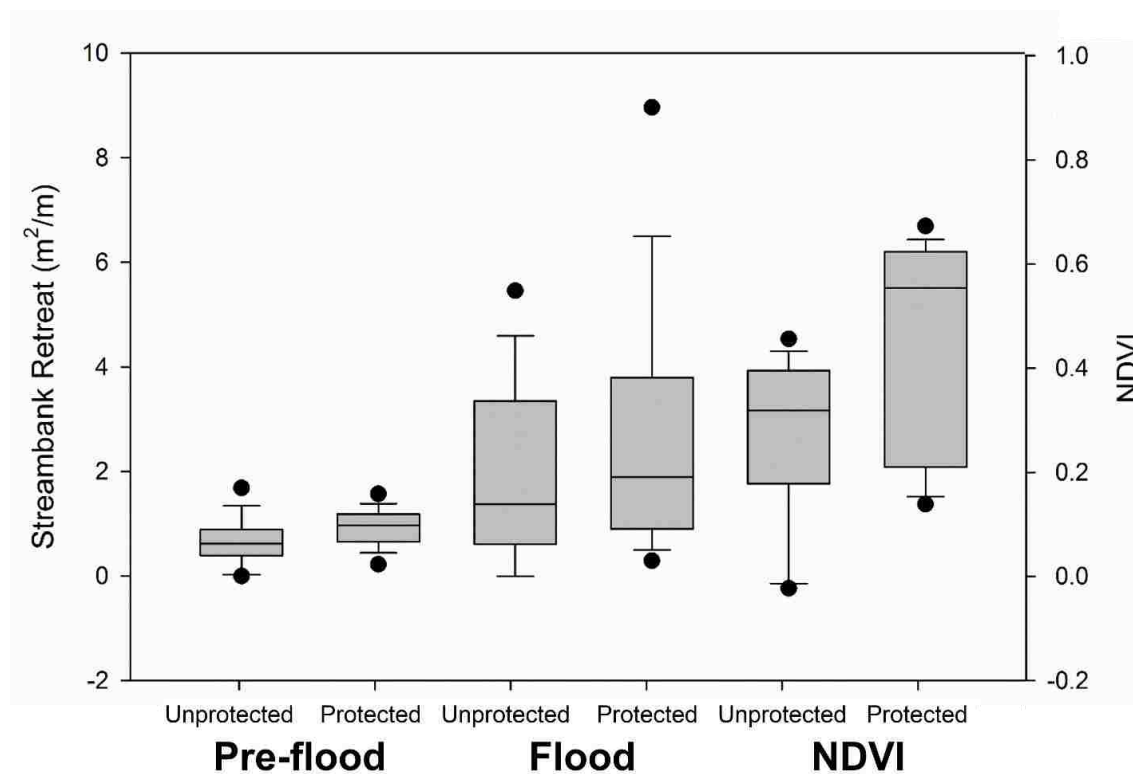
Figure 3.11 The relationship between streambank protection by vegetation, Normalized Difference Vegetation Index (NDVI) and average annual streambank retreat. The first four whisker plots from left, show the relationship with streambank retreat, and the last two show the relationship with NDVI.

The average NDVI for the protected streambanks was 0.42, (range: 0.14 to 0.66) and 0.28 (range: -0.02 to 0.45) for the unprotected. There was a significant difference with a p-value of 0.019. This shows that NDVI can be used to aid in the identification of protected streambanks and to avoid visual bias. Relationship between NDVI and erosion did not show any signs of correlation during flood or pre-flood period. For example, during the flood period, out of the top five streambanks with maximum erosion, three were protected banks with NDVI values of 0.49, 0.21 and 0.15.
