Internal Curing of Concrete Bridge Decks in Utah: Mountain View Corridor Project

A thesis submitted to the faculty of
Brigham Young University
in partial fulfillment of the requirements for the degree of
Master of Science

Department of Civil and Environmental Engineering
Brigham Young University

July 2013

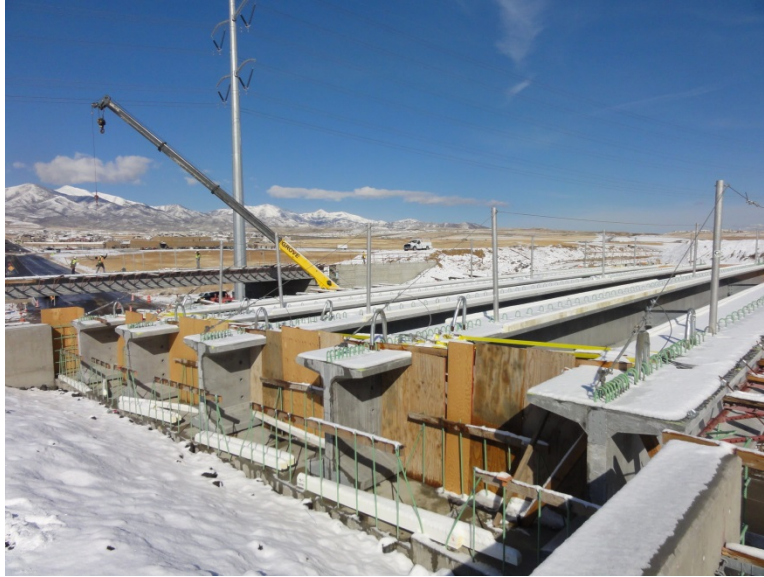
Figure 3-2 Pre-stressed, pre-cast, single-span concrete girders.

Each of the four bridges shared a similar design. Each structure incorporated five pre-stressed, pre-cast, single-span concrete girders, as shown in Figure 3-2. Pre-cast half-deck concrete panels, with a width of 7 ft 11 in. and a length of 8 ft, were placed between the girders along the majority of the length of the bridge; at the ends of the decks, smaller panels were used as necessary to terminate the panels at the appropriate locations. Each panel extended 6 in. onto each girder, as shown in Figure 3-3, and was supported by rigid foam that was placed between the girder and the pre-cast panel as illustrated in Figure 3-4; by design, the panels were not connected across the transverse butt joints between them on any of the decks but were simply placed close together as shown in Figure 3-5 for the Dannon Way NB bridge. A mat of No. 5 reinforcing steel was then placed over the tops of the half-deck panels and girders in preparation

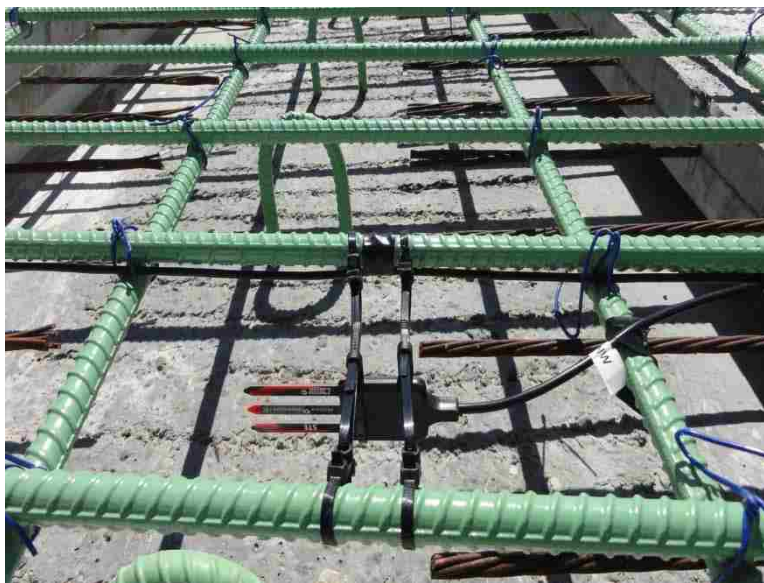
Figure 3-6 Sensor installed at level of top mat of reinforcement.

The three sensors were installed in each deck at the level of the top mat of reinforcing steel, as displayed in Figure 3-6. The sensor cables were routed out of each deck through the nearest diaphragm wall to a location generally between the concrete girders, as illustrated in Figure 3-7, where they could be conveniently terminated in a secure box. A battery-powered data logger was mounted inside the box, as shown in Figure 3-8, to facilitate data collection.

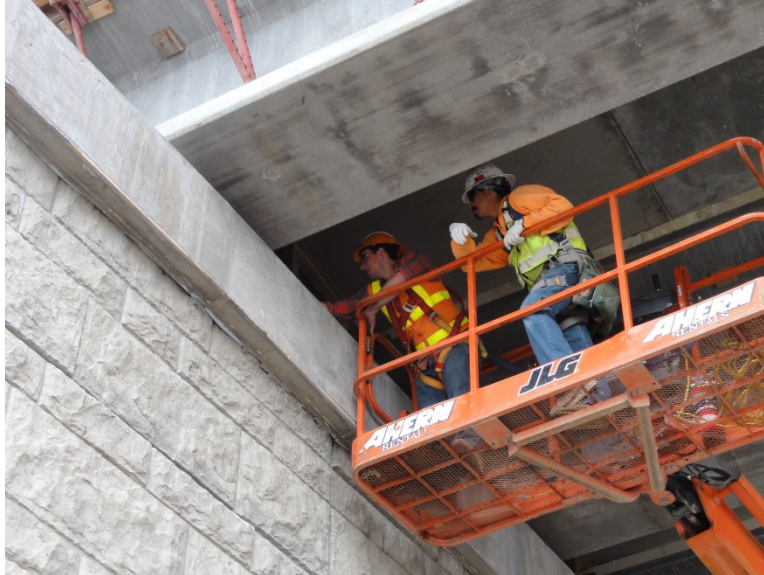
Figure 3-7 Mounting of data logger box on diaphragm wall.

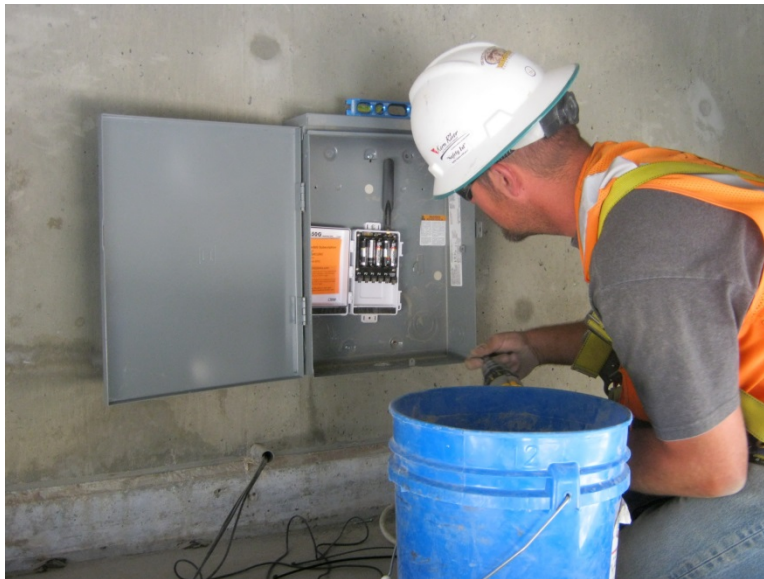
Figure 3-8 Data logger mounted in box.

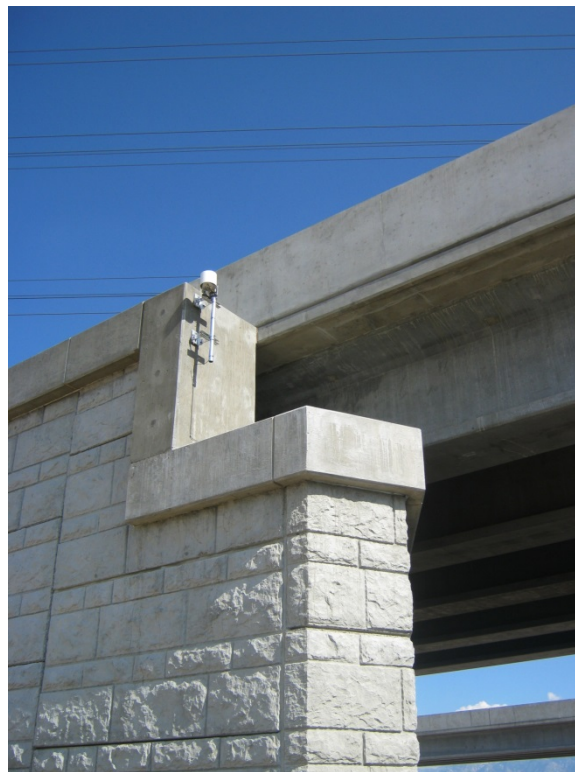
Figure 3-9 Precipitation gauge mounted on bridge.

In addition, air temperature, relative humidity, and precipitation gauges were mounted on the bridges to document the ambient conditions to which the bridge decks were exposed. Air temperature and relative humidity gauges were mounted at 8200 South SB and Dannon Way NB, while precipitation gauges were mounted at 8200 South NB and Dannon Way SB. A typical installation is shown in Figure 3-9.

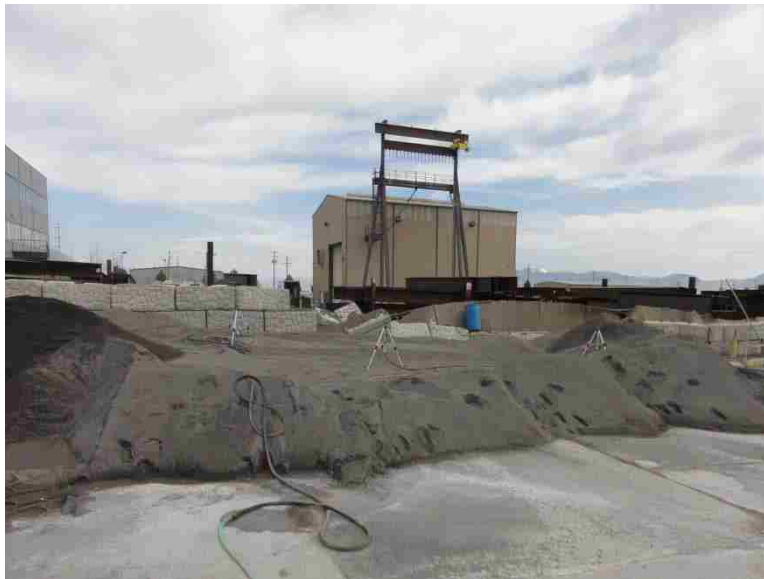
Figure 3-10 Pre-wetting of lightweight fine aggregate at concrete batch plant.

For the internally cured concrete, the LWFA was pre-wetted for a minimum of 2 days at the batch plant using a sprinkling system to achieve a minimum moisture content of 15 percent, and excess water was then allowed to drain prior to concrete batching, as shown in Figure 3-10.

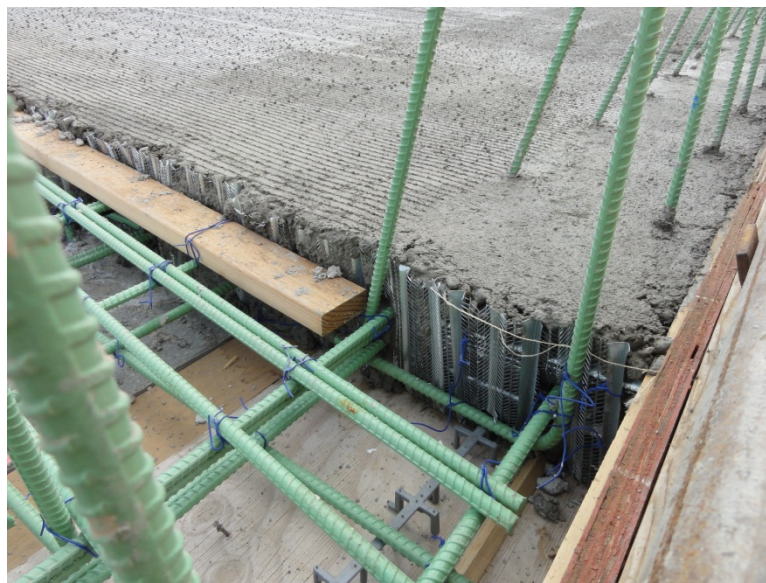
Figure 3-11 Metal shoring used in deck construction process.

To allow the girders to reach their fully deflected positions before the diaphragm walls were cast around the ends of girders, the deck was placed first. To accomplish this phasing, metal shoring was placed near one end of the deck, as depicted in Figure 3-11, to establish an initial starting point for the deck pour. Following concrete placement from that point to the other end of the bridge span and into the opposite diaphragm wall, the contractor returned to the original starting point to place the remaining deck section and diaphragm wall. In this process, the metal shoring was often only partially removed or allowed to remain entirely in place for convenience. A curing agent was sprayed onto the deck following concrete placement, and the deck was then covered, as shown in Figure 3-12, for a specified 14-day curing period, after

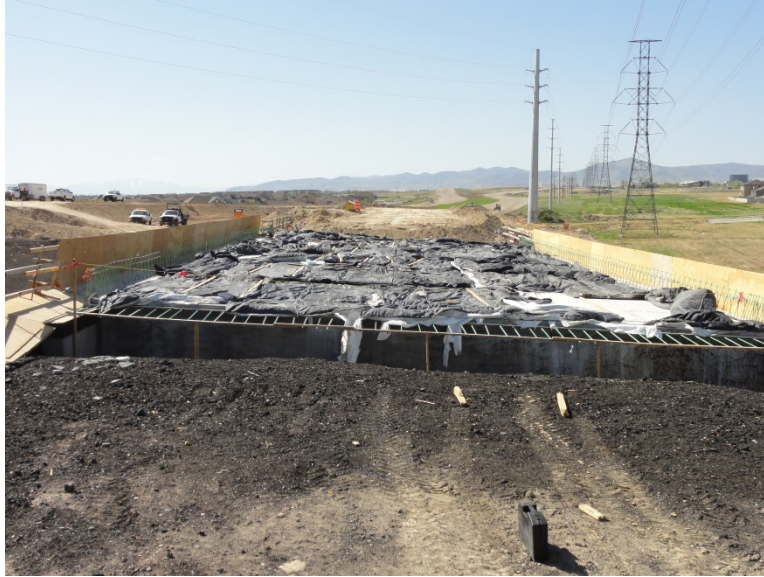
Figure 3-12 Covered bridge deck during curing.

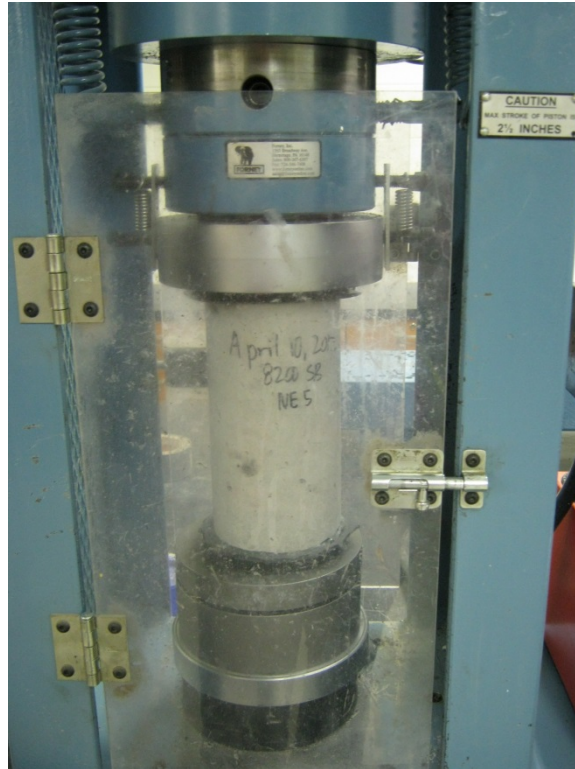
Figure 3-13 Compressive strength testing.

As illustrated in Figure 3-13, the cylinders were capped with sulfur and tested at a strain rate of 0.05 in./minute at the Brigham Young University (BYU) Highway Materials Laboratory. For the freeze-thaw cycling, each cycle consisted of 12 hours of freezing at 4°F and 12 hours of

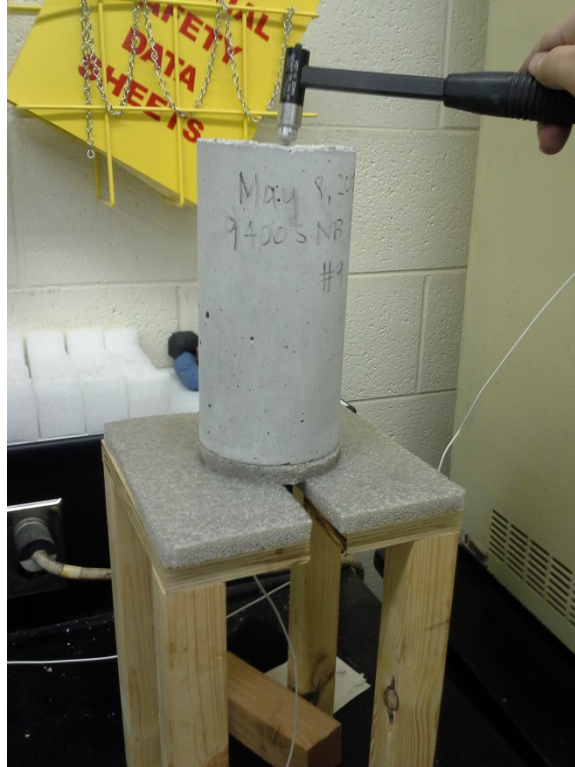
Figure 3-15 Free-free resonant testing.

For testing, each concrete cylinder was placed on a stand as depicted in Figure 3-15, and the upper end of the cylinder was tapped lightly with a small hammer instrumented with a load cell that triggered data acquisition by an attached computer. An accelerometer mounted in a foam disk placed beneath the cylinder measured the amplitude and frequency of the stress waves induced in the concrete by the hammer strike, and the data were recorded and analyzed by the computer. Three frequency measurements were recorded on each end of each concrete cylinder,

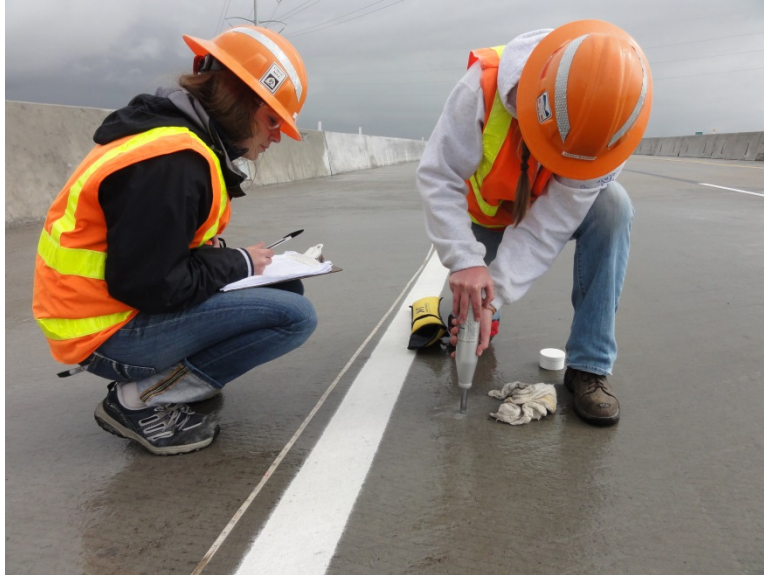
Figure 3-16 Schmidt rebound hammer testing.

Schmidt rebound hammer testing was performed to non-destructively estimate the in-situ compressive strength of the concrete. In the test, which involves impacting the concrete surface with a spring-loaded hammer as shown in Figure 3-16, higher rebound numbers correspond to higher concrete compressive strengths. Seven locations on each bridge deck were evaluated. Three were positioned over each of the three sensor locations, as shown in Appendix A, and four were positioned as shown in Figures 3-17 and 3-18 for the Dannon Way and 8200 South structures, respectively. Among these latter four locations, regardless of the direction of traffic on the deck, two were consistently located 25 and 75 ft from the north end of the west lane and

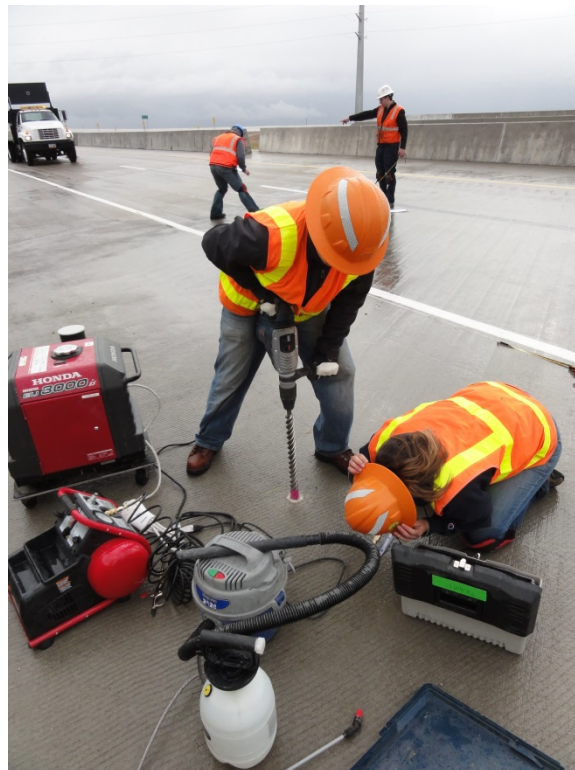
Figure 3-19 Concrete sampling for chloride concentration testing.

Chloride concentration testing was conducted on each bridge deck 1 year after deck construction. In order to comply with Utah DOT requirements, testing was limited to only four locations, including two on the east shoulder and two on the west shoulder of each deck that coincided with the Schmidt rebound hammer test locations shown in Figures 3-17 and 3-18 for the Dannon Way and 8200 South structures, respectively. At each location, a hole was drilled to a depth of 1 in. in two 0.5-in. lifts with a hammer drill as depicted in Figure 3-19; the holes were deliberately situated away from the underlying reinforcing steel, which was located using a cover meter. The shallower lift was drilled with a 1.5-in.-diameter bit, while the deeper lift was drilled with a 1.0-in.-diameter bit. Use of a smaller bit for the deeper lift prevented inadvertent scraping

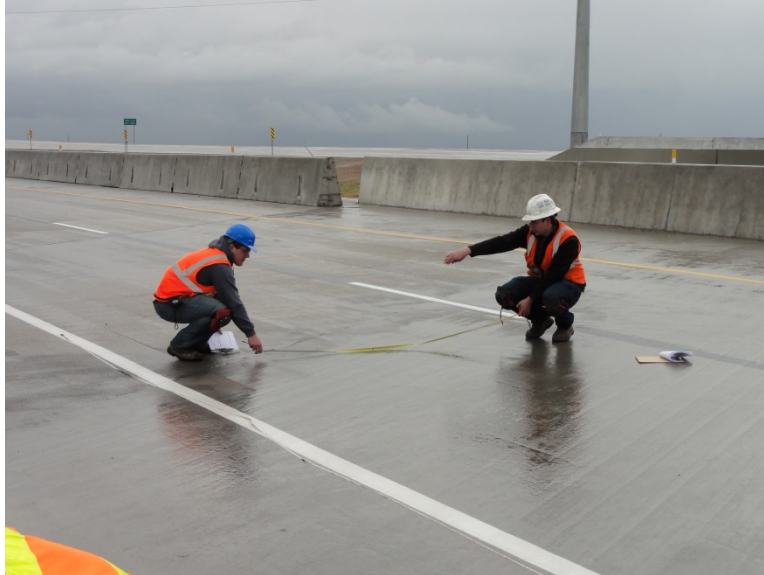
Figure 3-20 Distress survey.

As suggested in Figures 3-16, 3-19, and 3-20, the 1-year distress survey was conducted in rainy conditions for the first few hours of testing. The wet condition of the deck surface may have prevented identification of some cracking on the SB decks, which were tested first. However, the order of the inspections ensured that the effect of the rain was distributed as evenly as possible across both decks in that direction, as both right lanes were inspected before both left lanes; furthermore, another inspection performed during a subsequent visit to these bridges during dry weather revealed no significant cracking that was not previously documented. The same order of inspections was repeated on the NB decks but in the opposite direction.

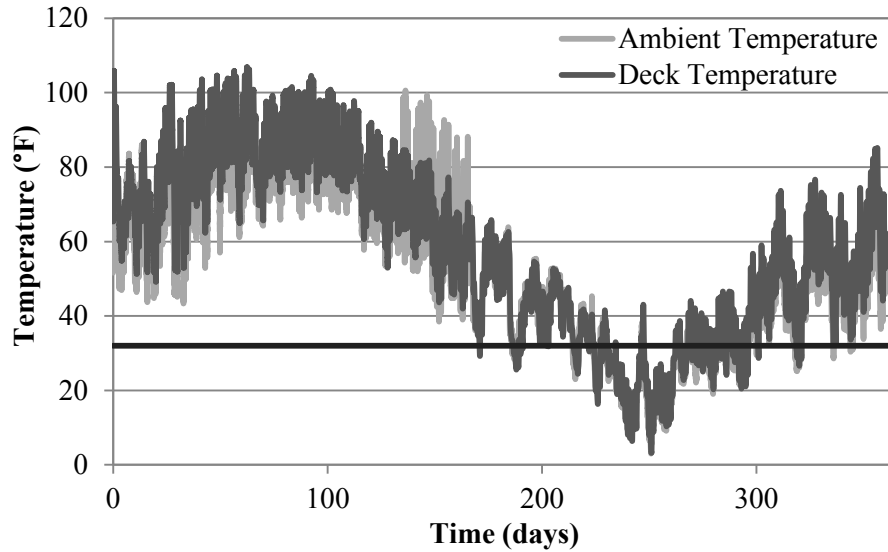
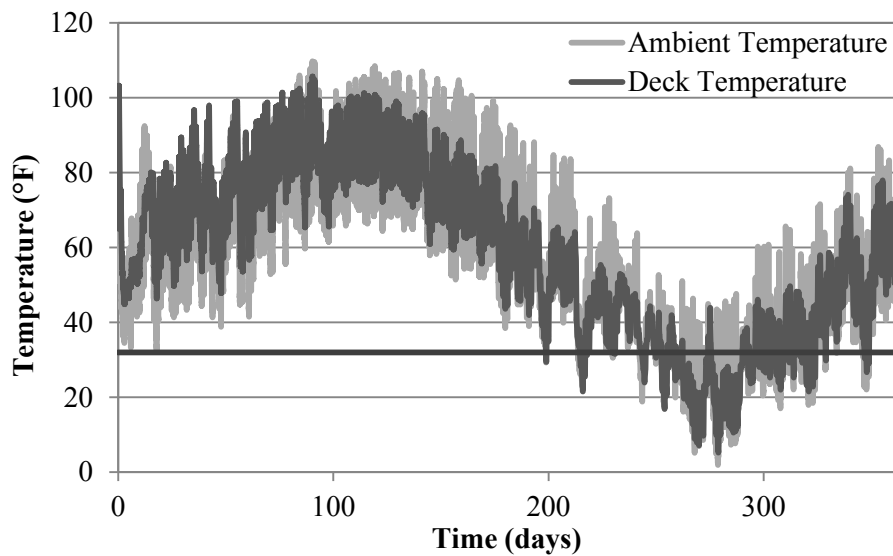
Figure 4-3 Average temperatures for decks located at Dannon Way.

Figure 4-4 Average temperatures for decks located at 8200 South.

Figures 4-3 and 4-4 show the internal concrete deck temperatures at Dannon Way and 8200 South, respectively, compared to the ambient temperatures. As the deck temperatures decreased below 32°F, indicated by a black line in Figures 4-3 and 4-4, the apparent moisture contents shown in Figures 4-1 and 4-2 also decreased. The reduction in water content is attributable to the fact that the in-situ sensors measure only liquid water, not ice; while water in the fine gel pores within the cement paste seldom freezes under typical service conditions, water in the larger capillary pores can change to ice at subfreezing temperatures and would then be essentially invisible to the sensors (23). The frequent oscillations of temperature above and below 32°F and the corresponding oscillations in moisture content indicate the occurrence of freezing and thawing of the concrete bridge decks throughout the winter months.

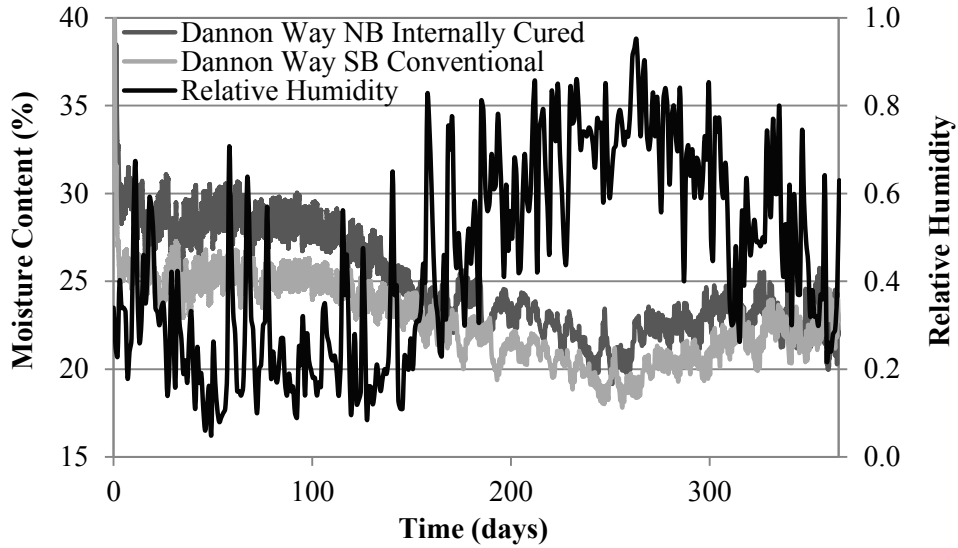
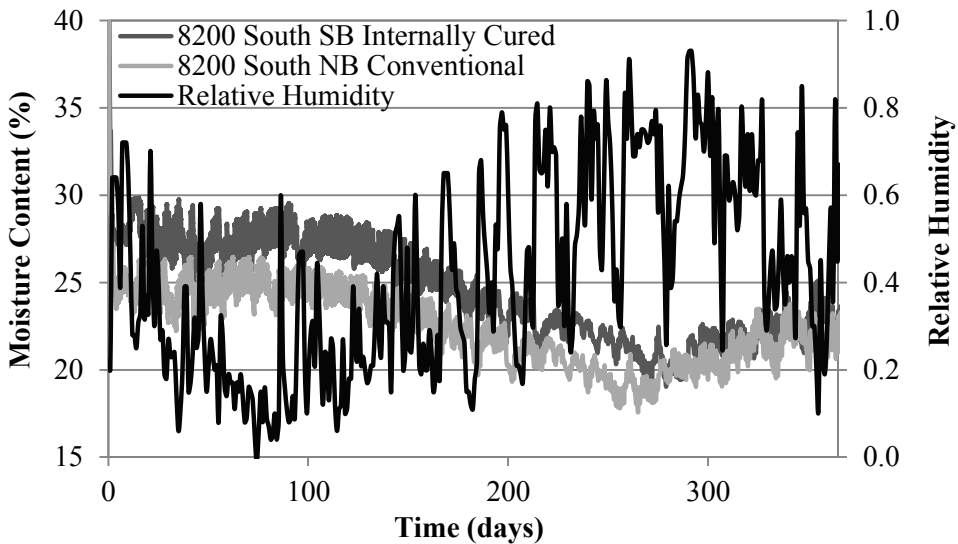
Figure 4-5 Moisture content and relative humidity for decks located at Dannon Way.

Figure 4-6 Moisture content and relative humidity for decks located at 8200 South.

The influence of relative humidity and precipitation on the measured in-situ moisture contents of the concrete bridge decks can be evaluated in Figures 4-5 through 4-8. (The precipitation gauges were not installed until approximately 5 months after deck construction,

so Figures 4-7 and 4-8 show data beginning at 150 days.) Although higher ambient relative humidity values correspond to lower water evaporation rates from the surface of concrete, the measured internal moisture contents are not apparently affected by changes in relative humidity.

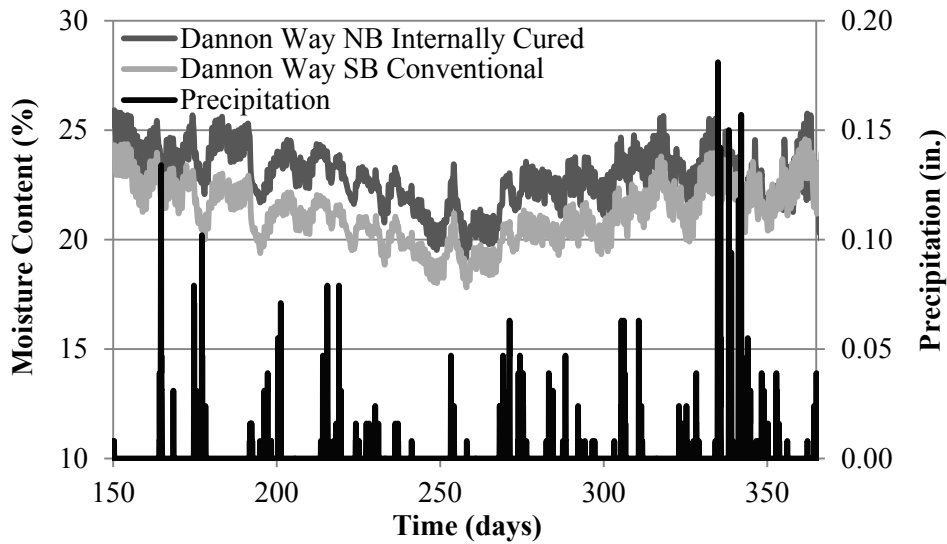
Figure 4-7 Moisture content and precipitation for decks located at Dannon Way.

Figure 4-8 Moisture content and precipitation for decks located at 8200 South.

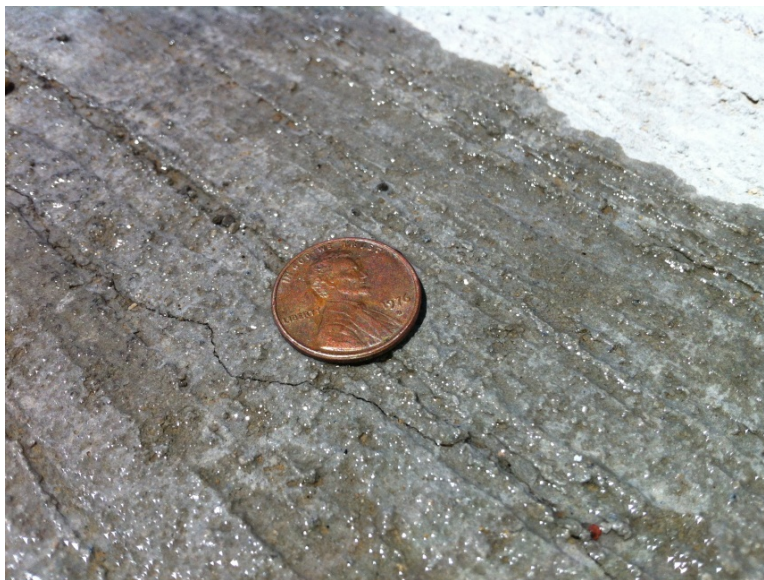
Figure 4-13 Cracking in Dannon Way southbound conventional concrete deck at 2 months.

Table 4-9 shows the results of the distress surveys performed at 5 and 8 months and 1 year, while Appendix C provides pictorial evidence of typical crack lengths and widths and also provides full distress survey maps prepared for each deck upon completion of these inspections. At 5 months, the average total crack lengths for the conventional and internally cured concrete bridge decks were 192 and 42 in., respectively. At 8 months, following significant drops in temperature as winter commenced, the average total crack lengths increased to 2538 and 118 in.,

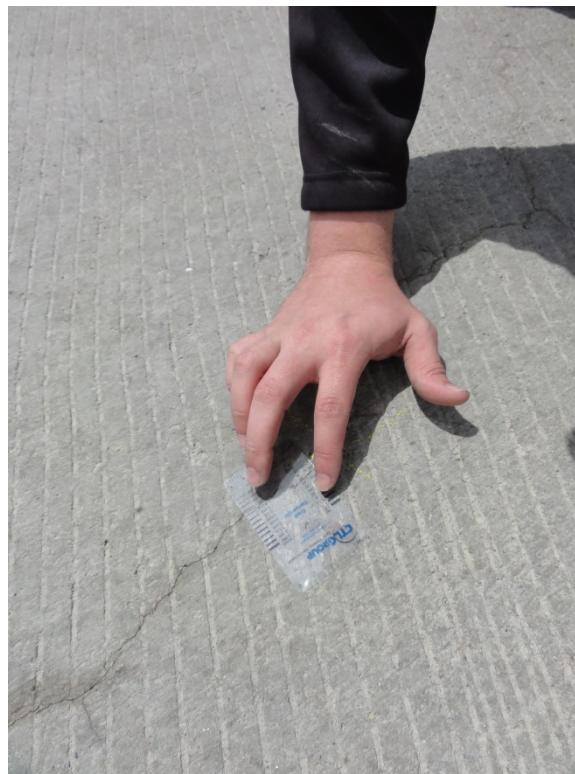
Figure 4-15 Cracking in 8200 South northbound conventional concrete deck at 1 year.

the 8200 South NB deck, but none was observed on the internally cured concrete decks. The internally cured concrete decks also exhibited significantly less offshoot cracking stemming from the transverse reflection cracking. In most cases, the reflection cracking on the internally cured concrete decks had little to no offshoot cracking, while the conventional concrete decks had significant offshoots creating a web-like pattern. Total cracking amounts at 1 year, which were not easy to compute especially due to the offshoots, indicate that the conventional concrete decks had 2.8 times more cracking than the internally cured concrete decks. As shown in Figure 4-15, cracks were typically 0.005 to 0.035 in. in width for both deck types 1 year.

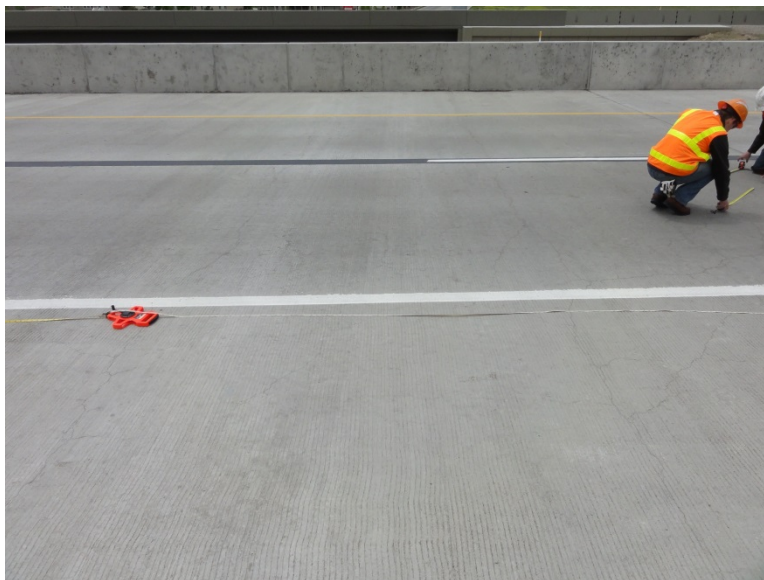
Figure C-1 Reflection cracking from half-deck concrete panels in 8200 South northbound conventional concrete deck at 1 year.

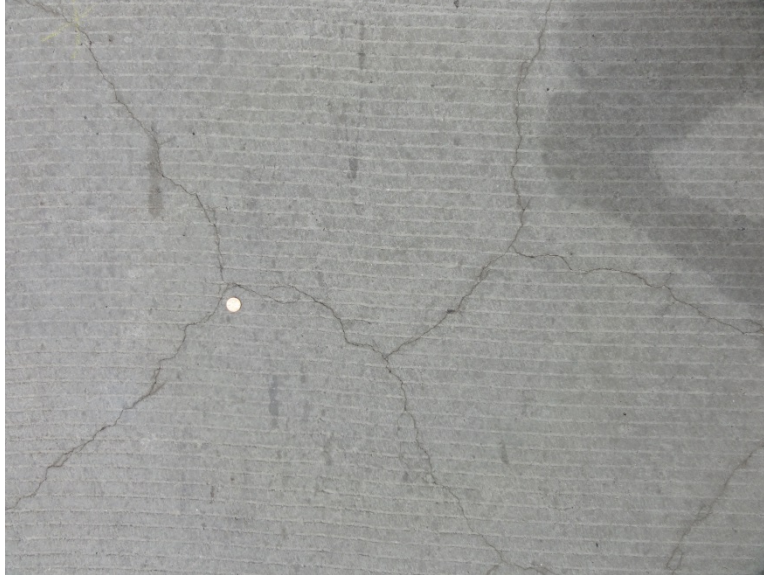
Figure C-2 Cracking in 8200 South northbound conventional concrete deck at 1 year.

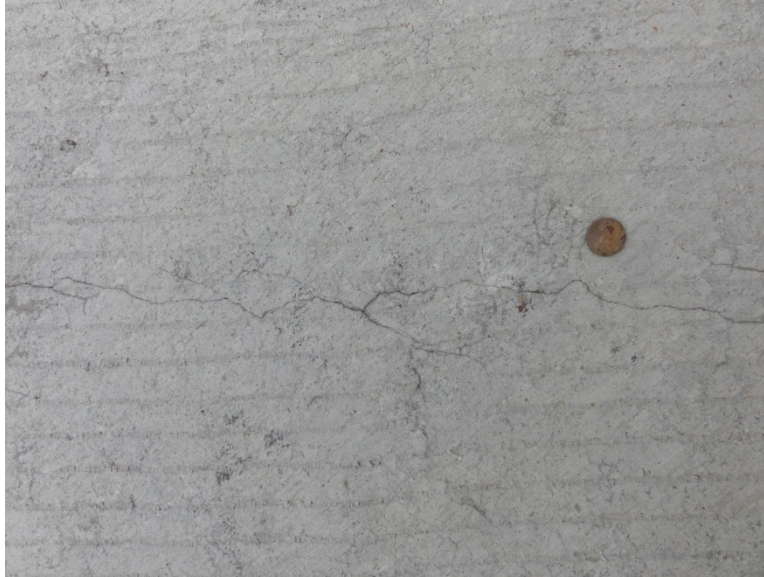
Figure C-4 Cracking in Dannon Way southbound conventional concrete deck at 1 year.

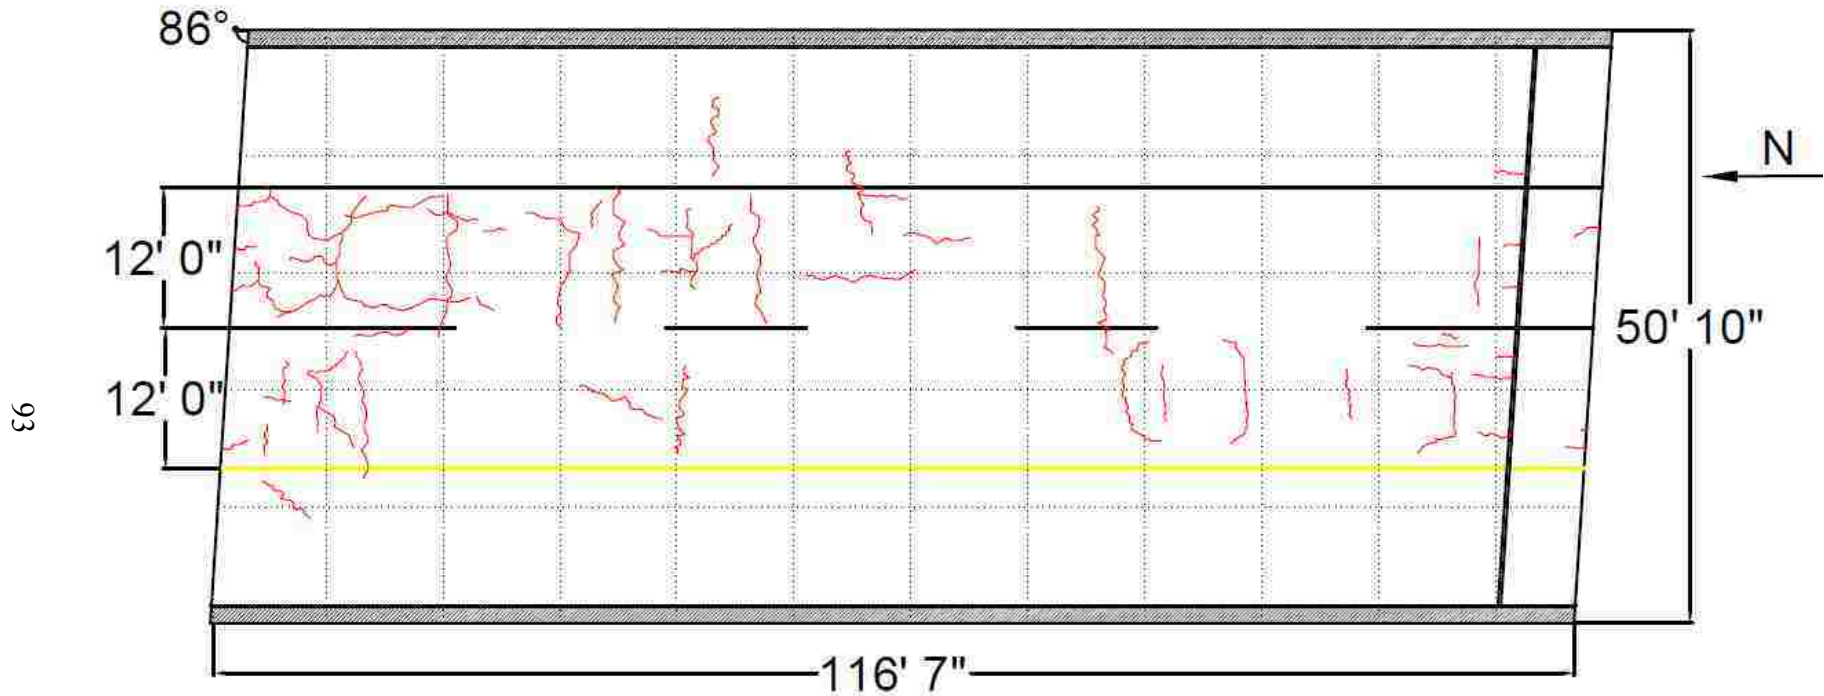
Figure C-13 Distress map for 8200 South northbound conventional concrete deck at 8 months.

Appendix C provides pictorial evidence of typical crack lengths and widths and also provides full distress survey maps prepared for each deck upon completion of these inspections. The honeycomb pattern at selected locations on the distress maps represents map cracking. The thick solid line on each distress map positioned approximately 5 to 6 ft from the end of the deck and oriented parallel with the bridge skew represents the location of the metal shoring used in construction.

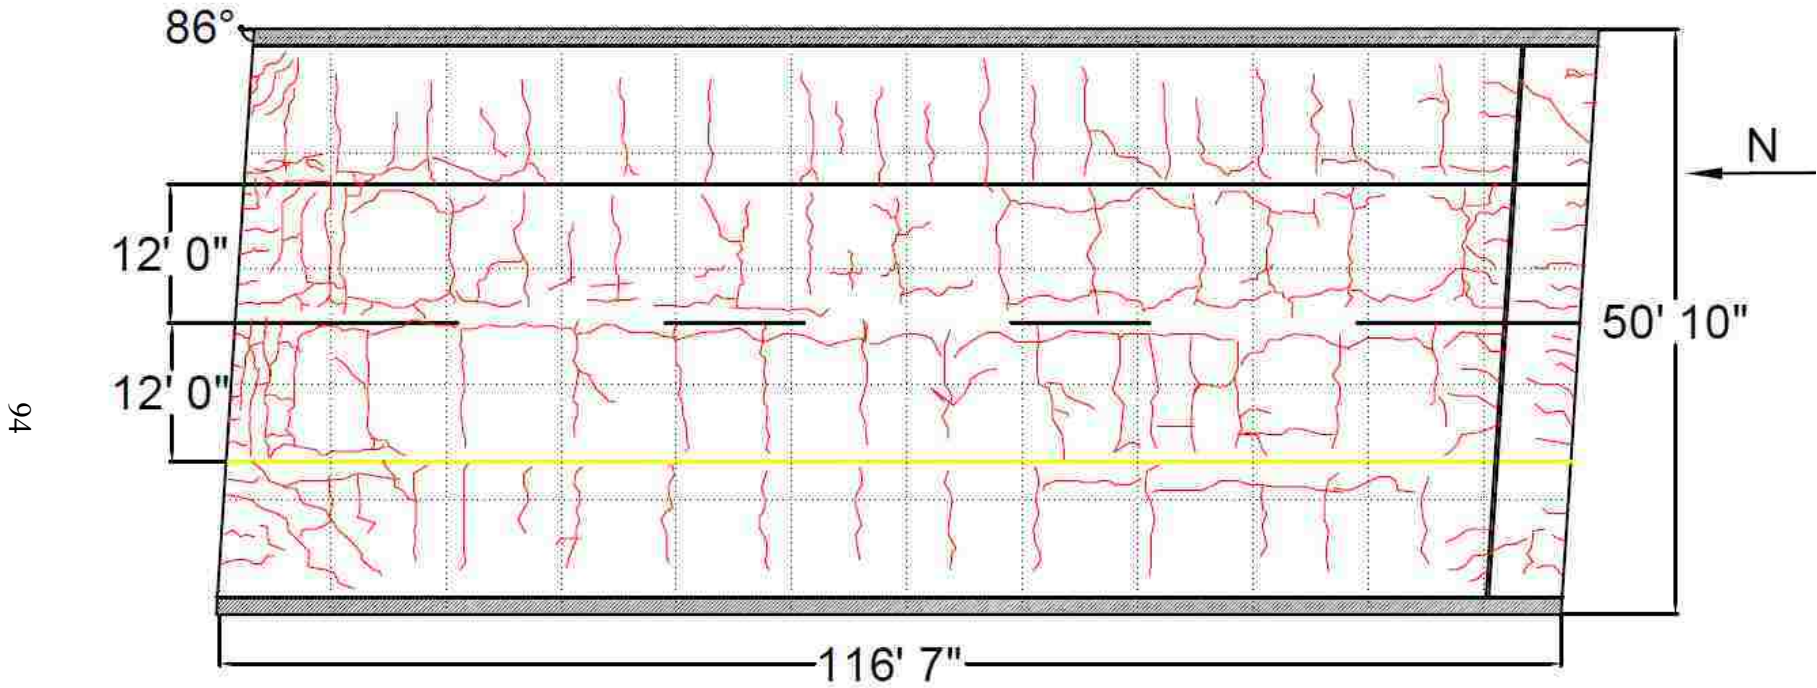
Figure C-14 Distress map for 8200 South northbound conventional concrete deck at 1 year.

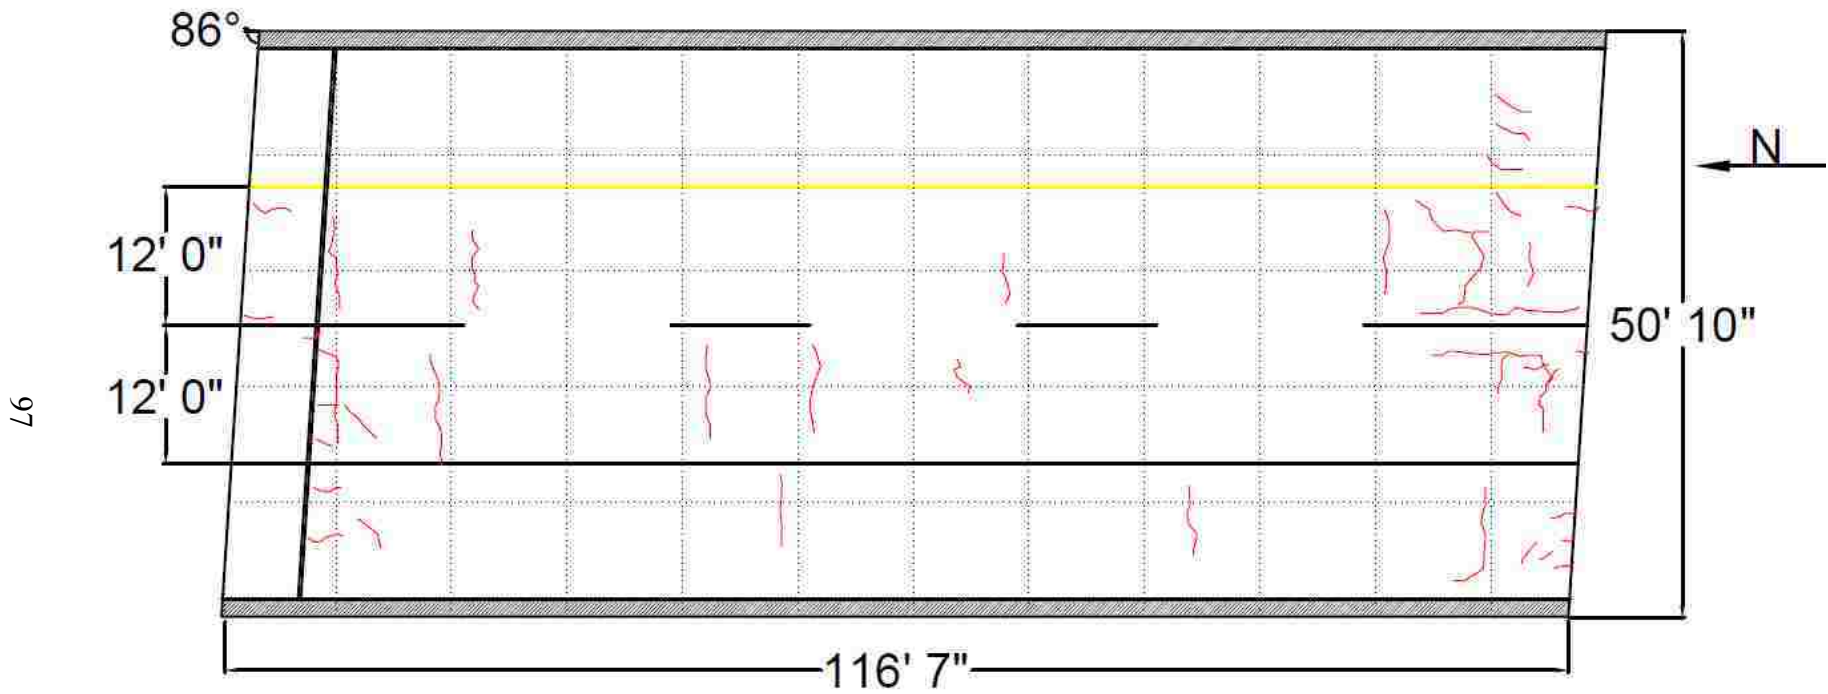
Figure C-17 Distress map for 8200 South southbound internally cured concrete deck at 1 year.
