Frost Susceptibility of Base Materials Treated with Asphalt Emulsion

A thesis submitted to the faculty of
Brigham Young University
in partial fulfillment of the requirements for the degree of
Master of Science

Department of Civil and Environmental Engineering

December 2013

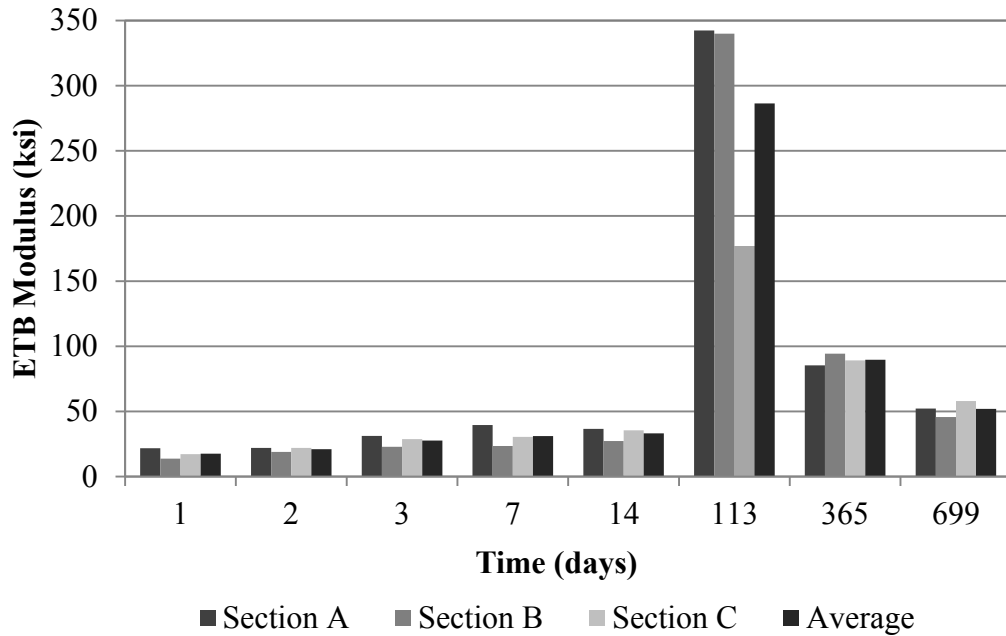
Figure 1-1: Field-measured modulus values for emulsion-treated base on Redwood Road.

In Utah, research on two roads that were reconstructed using FDR in conjunction with emulsion treatment documented slow rates of strength gain in the field, rutting susceptibility under early trafficking, and thaw weakening during spring (8, 9). These roads, Redwood Road (SR-68) just north of Saratoga Springs and 7800 South (SR-48) in West Jordan, showed similar trends in stiffness through the seasons as the field study performed in Virginia (7, 8, 9). Specifically, as shown in Figure 1-1 (8), the ETB modulus values on Redwood Road, which was reconstructed during the summer, were consistently low during the first 2 weeks after construction, increased dramatically by 4 months as winter commenced, and then decreased considerably by 1 year. The average ETB structural coefficient measured at 1 year, which included a winter with freezing temperatures, was only 47 percent of the design value. Additional data were collected 2 years after construction, which included an additional winter, and the ETB modulus, on average, was 42 percent lower than that measured 1 year after

construction. One possible explanation suggested for these results is the occurrence of freeze-thaw damage to the ETB layer during the winter. On 7800 South, after a few days following construction, the asphalt emulsion in the base layer was not curing sufficiently, and significant rutting, more than 4 in., was occurring under construction trafficking. The ETB layer was therefore removed except for one section that was retained for research purposes. Data collected from that section provided no evidence that the ETB layer experienced any sustained increase in strength as a result of emulsion curing; instead, the ETB modulus was shown to be greatly dependent on season, experiencing a reduction in modulus during the spring, consistent with Redwood Road (9). Although these studies suggest that ETB layers may experience frost damage during winter, no research specifically evaluating the effect of frost action on ETB was identified in the literature review performed for this research.

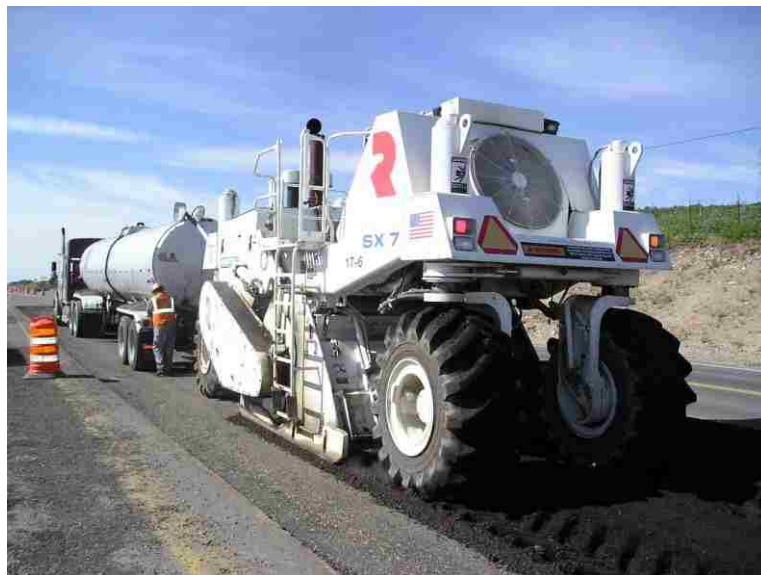
Figure 2-1: Asphalt emulsion injection at Redwood Road.

the new base layer, and 6) applying the pavement surface (8). Figures 2-1 and 2-2 show an asphalt emulsion being added to a RAP-base blend, and Figures 2-3 and 2-4 show compaction of the treated material. The intended benefits of using FDR in road repair and reconstruction include an improvement of the pavement's structural integrity without altering the geometry; a more uniform pavement, leading to improved ride quality; a possible reduction in frost susceptibility; and a reduction in engineering cost, materials, and energy associated with removal and landfill storage of old asphalt and importing of new materials (4, 21, 31).

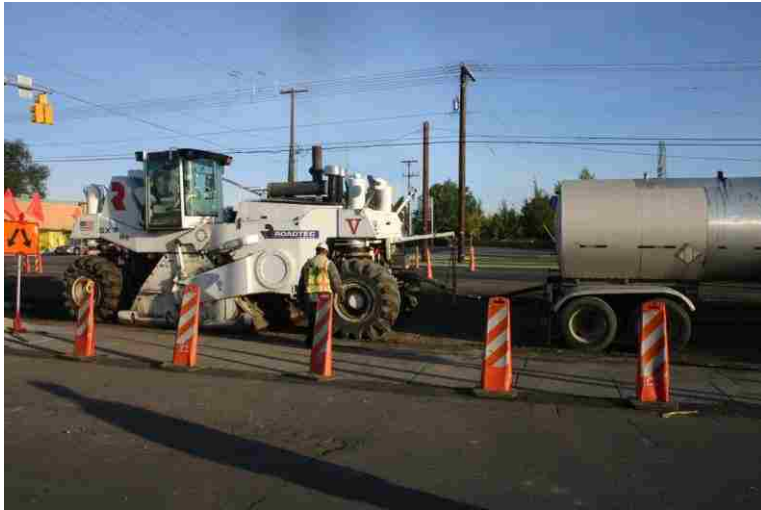
Figure 2-2: Asphalt emulsion injection at 7800 South.

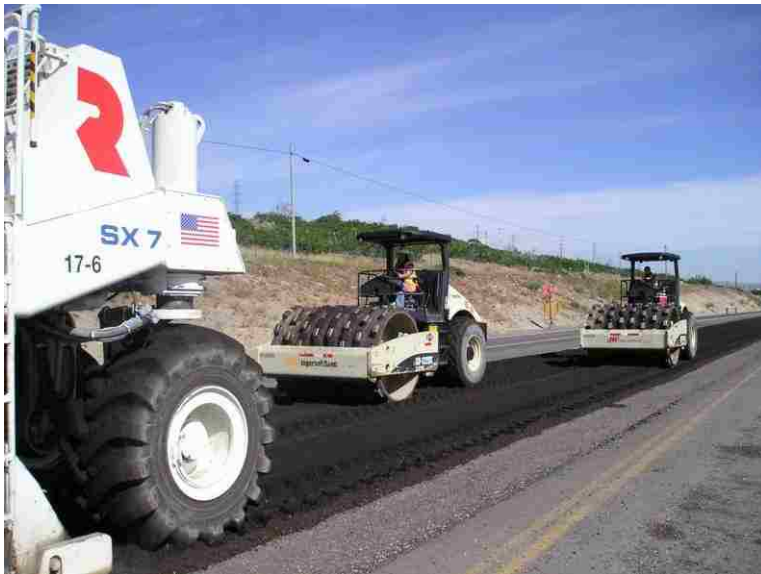
Figure 2-3: Compaction of emulsion-treated base layer at Redwood Road.

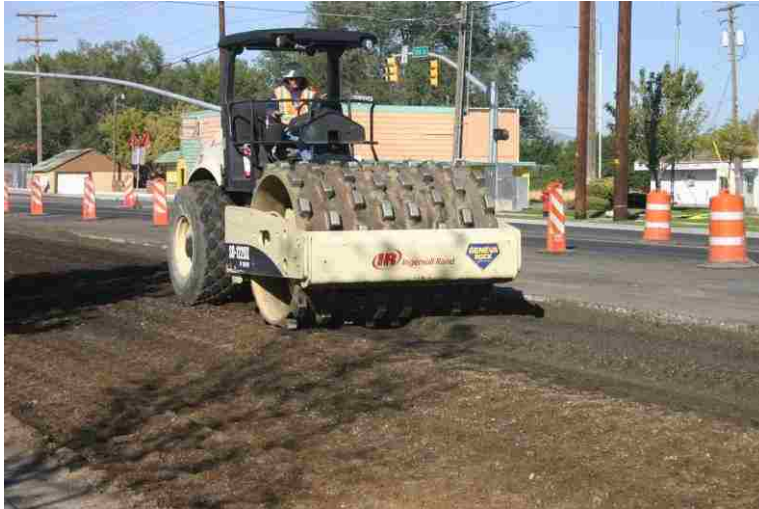
Figure 2-4: Compaction of emulsion-treated base layer at 7800 South.

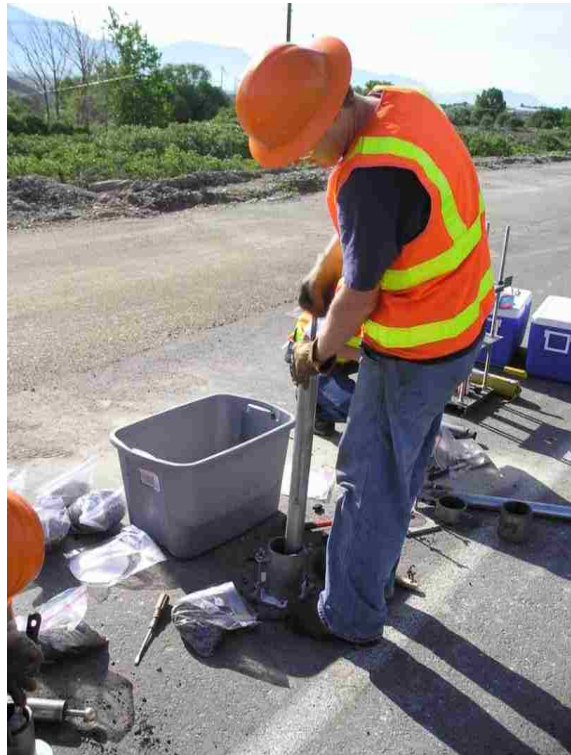
Figure 3-2: Compaction of emulsion-treated base specimen at Redwood Road.

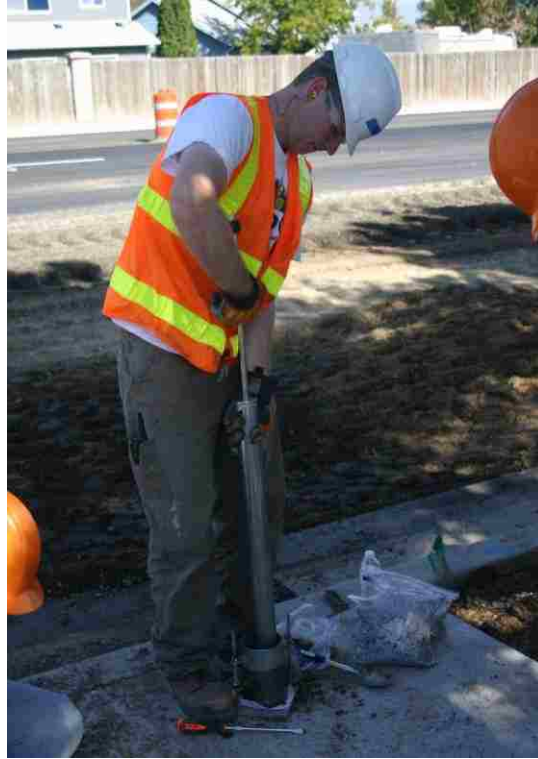
Figure 3-3: Compaction of emulsion-treated base specimen at 7800 South.

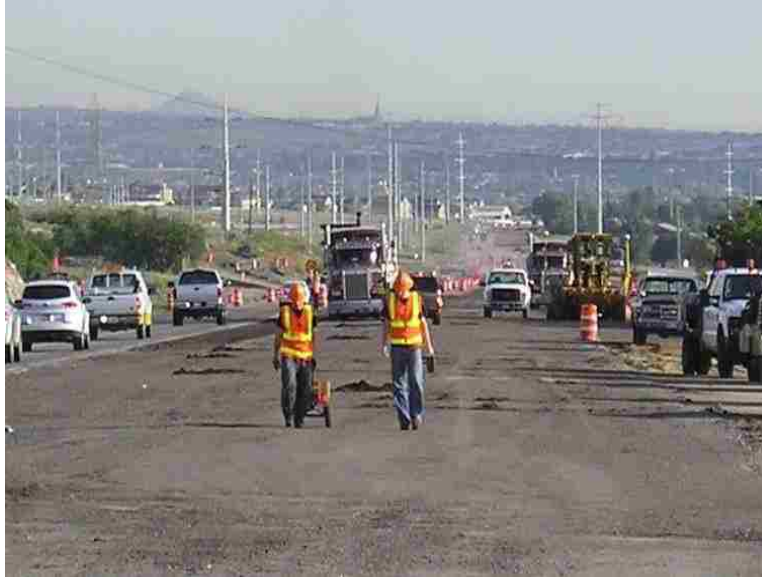
Figure 3-4: Sample collection at Redwood Road.

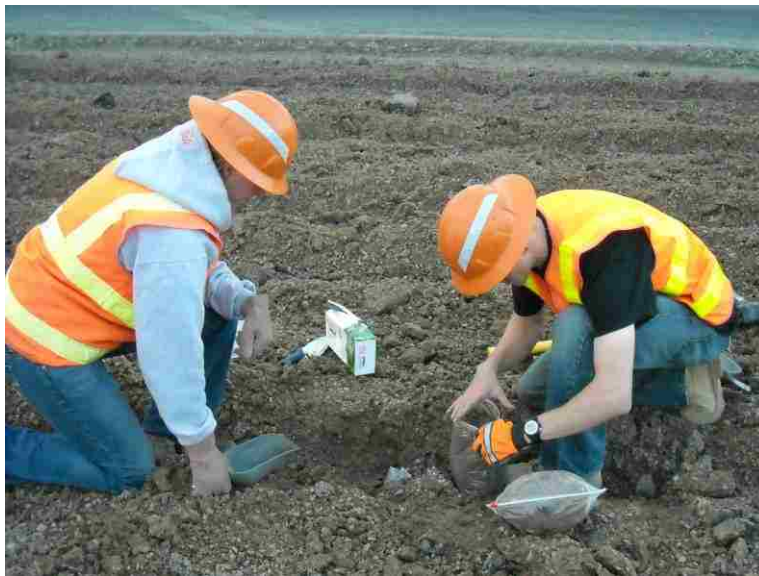
Figure 3-5: Sample collection at 7800 South.

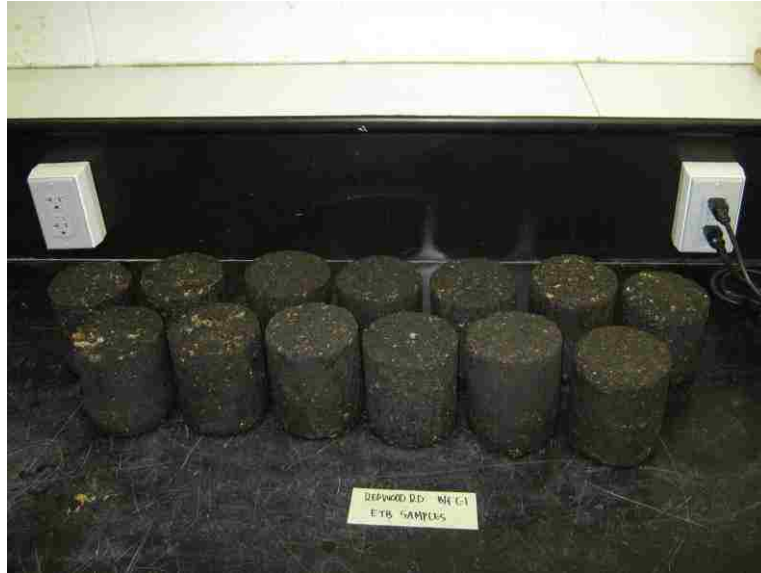
Figure 3-6: Freeze-thaw specimens from Redwood Road.

For freeze-thaw testing, the Redwood Road and 7800 South specimens were tested in two separate groups. Freeze-thaw testing was able to proceed only 30 days after construction for the 7800 South specimens since no curing was allowed. Since the Redwood Road specimens were allowed to cure for 2 years, freeze-thaw testing of those specimens was performed 2 years after construction. Figures 3-6 and 3-7 show selected Redwood Road and 7800 South specimens,

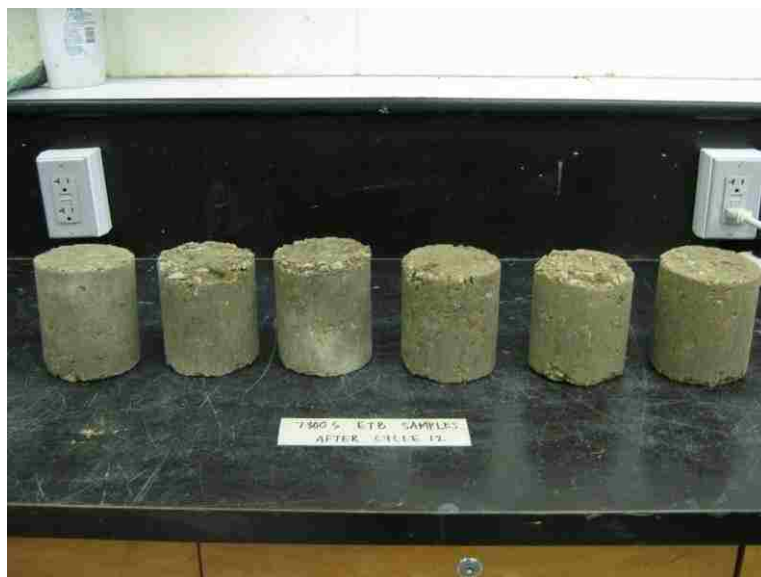
Figure 3-7: Freeze-thaw specimens from 7800 South.

respectively, prepared for freeze-thaw testing. The group of Redwood Road specimens and the group of 7800 South specimens were subjected to the same testing procedures.

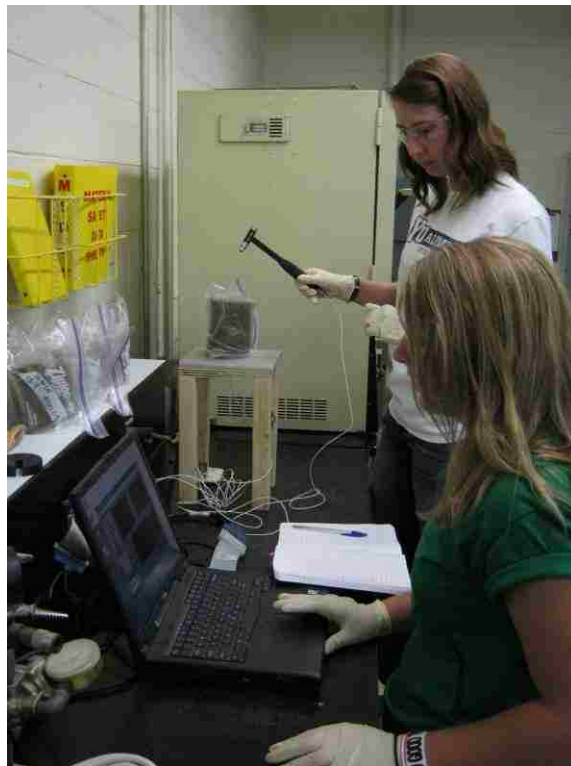
Figure 3-8: Modulus testing of a freeze-thaw specimen.

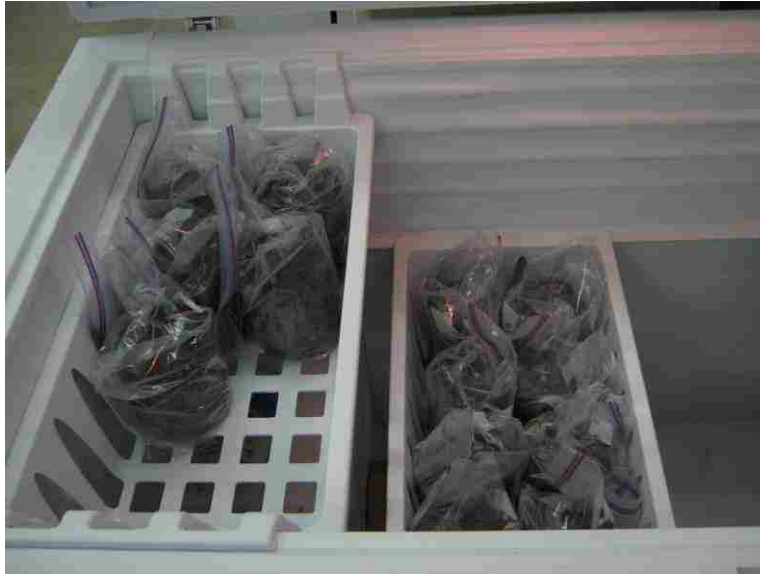
Figure 3-9: Freezing of specimens.

After the initial stiffness testing was completed, the specimens were placed in a freezer, as shown in Figure 3-9, which was maintained at a temperature not warmer than -10°F.

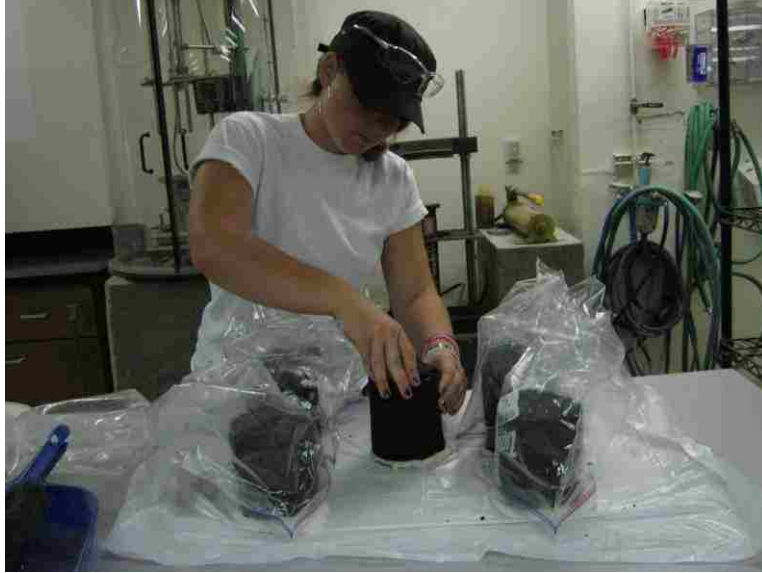
Figure 3-10: Capping of a freeze-thaw specimen.

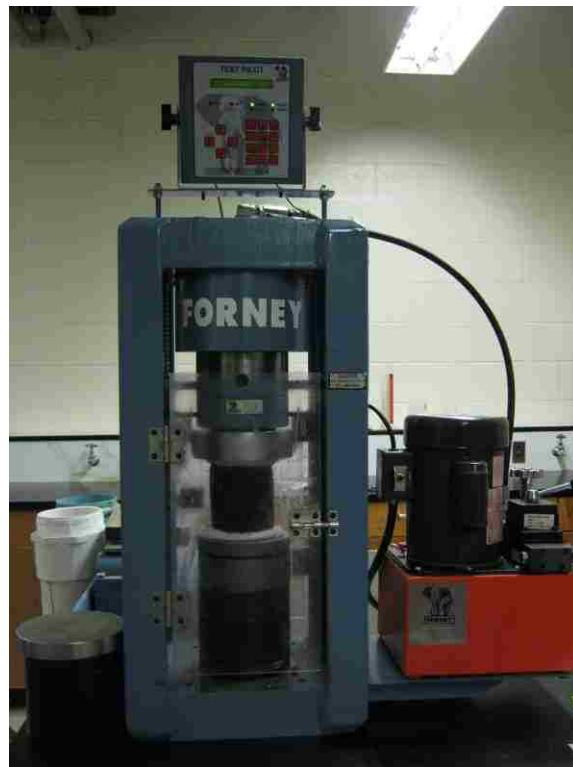
Figure 3-11: Unconfined compressive strength testing of a freeze-thaw specimen.

Once the freeze-thaw testing was finished, the specimens were removed from their bags and subjected to UCS testing in general accordance with ASTM D1633 (Standard Test Methods for Compressive Strength of Molded Soil-Cement Cylinders). After being capped with high-strength gypsum, as shown in Figure 3-10, the specimens were loaded at a strain rate of 0.05 in./minute in a testing frame as shown in Figure 3-11. The maximum load recorded during testing of a given specimen was divided by the initial cross-sectional area of the specimen to compute the compressive strength. The caps were then removed, and the specimens were weighed and placed in an oven at 140°F for drying to constant weight. The final weight of each specimen was then compared to the initial weight to obtain the moisture content.

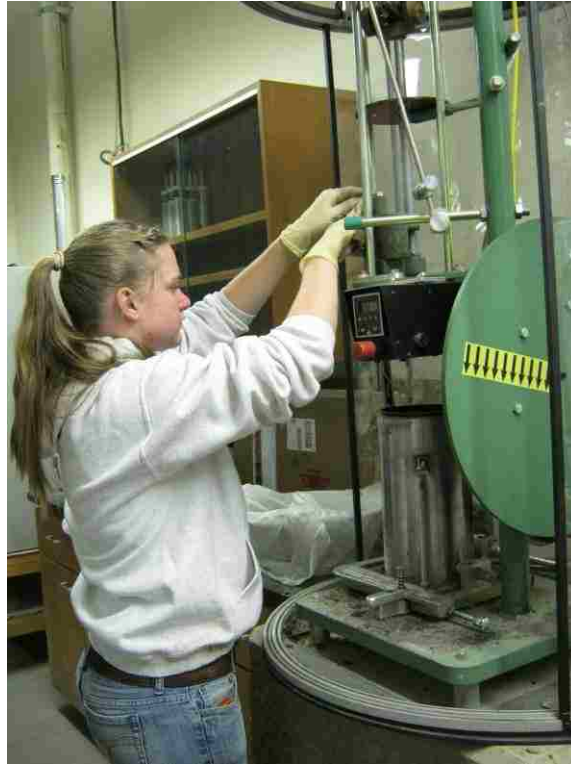
Figure 3-12: Compaction of a frost heave specimen.

After the appropriate amount of emulsion was thoroughly mixed into a sample, as required, compaction was performed in general accordance with ASTM D1557. This step involved compaction of the samples in 6-in.-diameter plastic molds in 10 lifts of 56 blows each to a target height of 9.2 in. Several 0.125-in.-diameter holes were pre-drilled into the bottom of the molds to facilitate water flow from the frost heave bath into the specimens during testing. In addition, several slits were cut into selected molds to enable placement of thermocouples through the mold walls into the specimens for monitoring of temperature profiles. The insides of the molds were oiled to minimize adfreezing, or adhesion of the specimen to the inside of the mold due to ice formation, during frost heave testing. The prepared plastic molds were then weighed and individually placed inside a steel mold for compaction of each specimen as shown in Figure 3-12. Afterwards, the steel mold was removed, and the weight and height of each compacted specimen, still in the plastic mold, were recorded. The specimen height was measured at four locations using a micrometer, and the individual readings were then averaged.

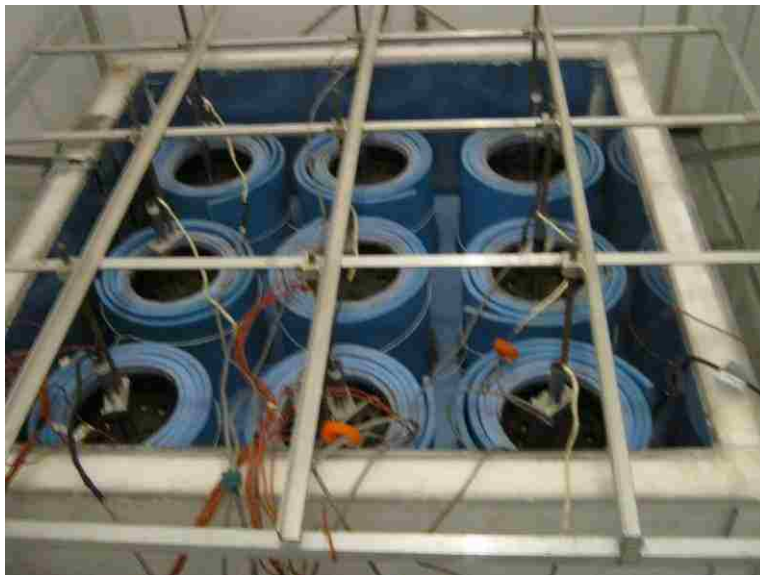
Figure 3-13: Frost heave test configuration.

35.6°F. A 10-lb overburden weight was placed on each specimen to simulate the presence of a pavement surface layer, and linear variable differential transformers (LVDTs) were then positioned over each specimen to monitor frost heave during testing. Figure 3-13 shows a complete setup ready for testing.

In this research, 10-day frost heave tests were performed. During the testing, the air temperature in the test chamber was set at 21.5°F. To supplement the computer-automated data collection, manual recordings of the LVDT data, in particular, were made daily. At the end of the testing, the specimens were removed from the bath; the overburden weights, insulation, and thermocouples, as applicable, were removed, and final weights and heights were measured and recorded. Frost heave was computed by subtracting the initial height from the final height in each case.

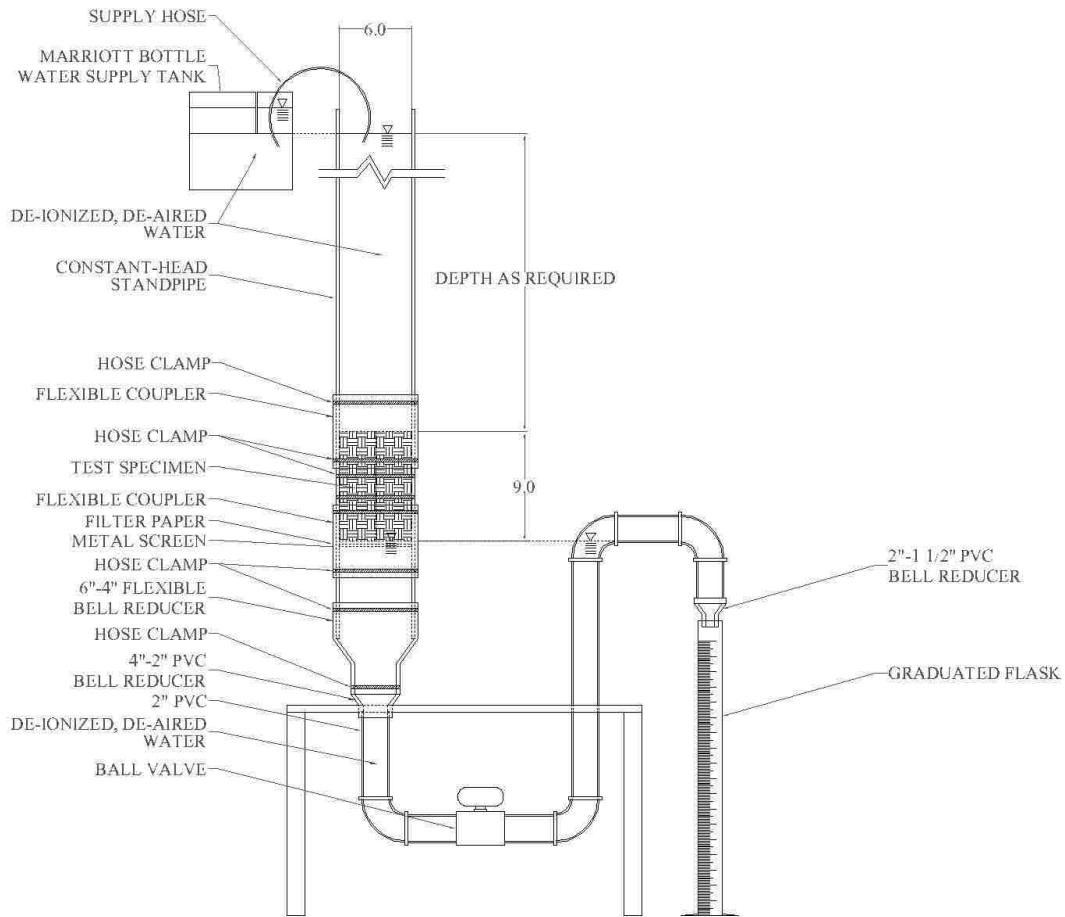
Figure 3-14: Schematic of permeameter.

As shown in Figure 3-14, the lower assembly of the permeameter was designed so that the lower surface of a specimen would be equal in elevation to the flow path in the raised pipe

section downstream of the valve. Water was poured into the pipe system to fill the lower part of the permeameter. The ball valve, located at the lowest point in the system, was then closed to prevent drainage of the water during the specimen soaking process.

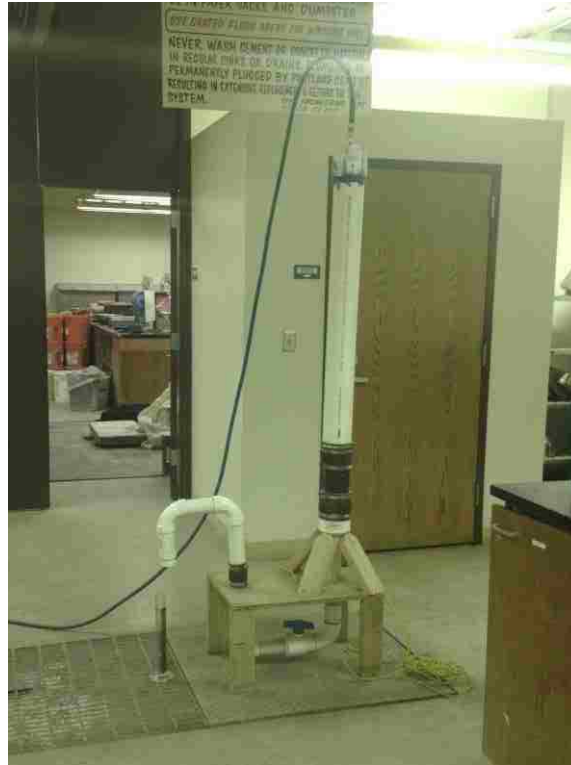
Figure 3-15. Permeability test configuration.

As shown in Figure 3-15, the specimen to be tested was then placed inside a flexible coupler secured by a hose clamp on either end to the upper and lower parts of the permeameter. A metal screen and filter paper were situated immediately beneath the specimen to prevent fines from being washed out of the specimen during testing. The open 60-in. standpipe above the

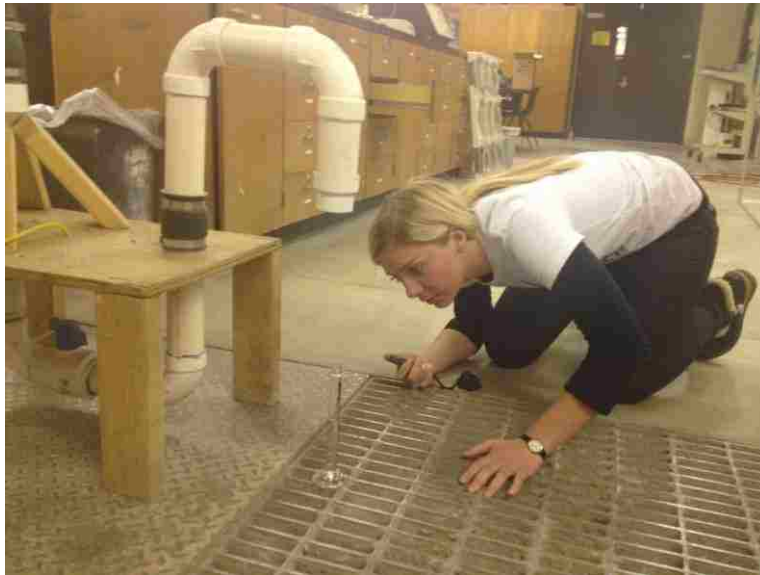
Figure 3-16. Permeability testing of a specimen.

specimen was then filled with water to saturate the specimen over a period of 24 hours. After the conditioning was complete, the pipe above the specimen was re-filled with water, an air-tight lid with an air hose fitting was installed on top of the pipe, an air hose regulated for each specimen at a value ranging from 0 to 10 psi was connected to the fitting to maintain a constant pressure head, the valve in the lower part of the permeameter was opened, and the rate of water flow was allowed to stabilize before several water flow rate measurements were obtained. For measurement of the water flow rate, a graduated cylinder was placed at the exit point of the permeameter, and a stopwatch was used to record the time required to collect a known volume of water in the cylinder. Figure 3-16 shows a test in progress. At least 10 measurements were taken for each specimen. The average permeability, or hydraulic conductivity, was then calculated using Equation 3-2 (43):

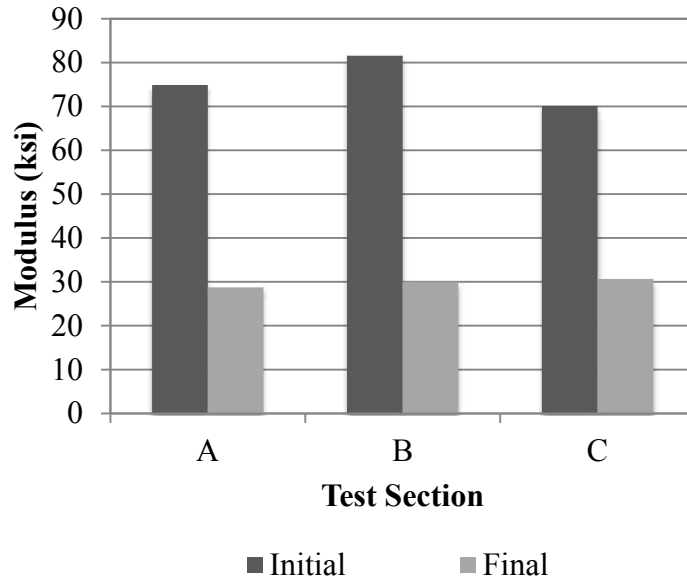
Figure 4-1: Modulus values for Redwood Road.

The results of freeze-thaw testing included both modulus and UCS measurements. The modulus measurements are presented in Figures 4-1 and 4-2 for Redwood Road and 7800 South, respectively. In each figure, the average modulus values measured both before and after freeze-thaw cycling are shown for each test section. For both roads, the specimens experienced decreases in modulus as a result of freeze-thaw damage that occurred during the 12 test cycles. The results show that the specimens representing sections A, B, and C at Redwood Road retained only 38.4, 36.8, and 43.8 percent, respectively, of the initial modulus value after testing, while the specimens representing sections A, B, and C at 7800 South retained 85.9, 31.8, and 79.5 percent, respectively. For each material, a paired *t*-test was performed with the null hypothesis that the initial and final modulus values were equal, the alternative hypothesis that the initial and final modulus values were not equal, and a significance level of 0.05. The paired *t*-test for the

Redwood Road specimens resulted in a p -value of less than 0.0001, with a 95 percent confidence interval of 40.2 to 50.6 ksi, leading to rejection of the null hypothesis. The results from the paired t -test for the 7800 South specimens resulted in a p -value of 0.0148, with a 95 percent confidence interval of 0.6 to 4.7 ksi, also leading to rejection of the null hypothesis.

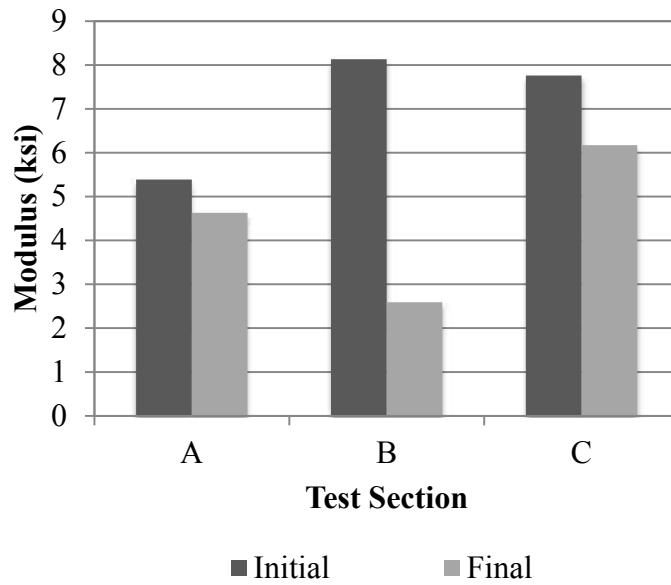
Figure 4-2: Modulus values for 7800 South.

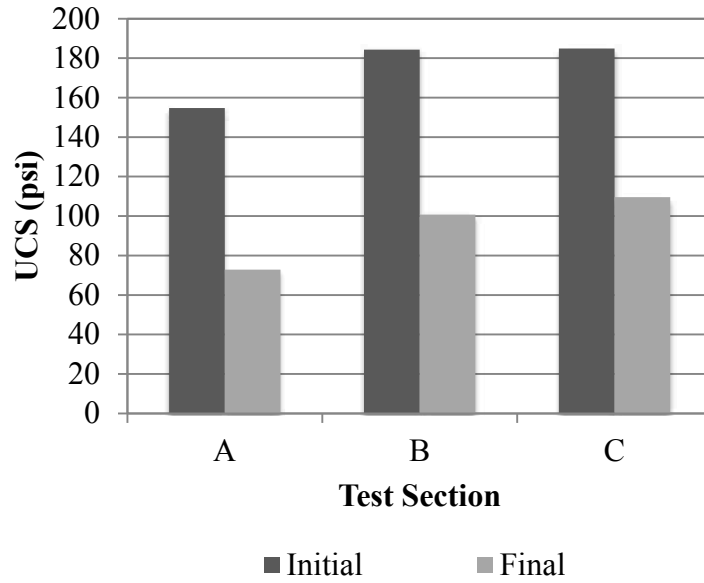
Figure 4-3: Unconfined compressive strength values for Redwood Road.

The UCS results are presented in Figures 4-3 and 4-4 for Redwood Road and 7800 South, respectively. In each figure, the initial UCS values are the averages for the specimens that were not subjected to freeze-thaw cycling, while the final UCS values are the averages for the specimens that were subjected to 12 freeze-thaw cycles. The results show that the Redwood Road specimens experienced decreases in strength as a result of freeze-thaw damage. Specifically, the specimens representing sections A, B, and C at Redwood Road retained only 47.1, 54.7, and 59.3 percent, respectively, of the initial UCS values after testing. However, the 7800 South specimens did not exhibit such strength loss, retaining 99.6, 110.0, and 104.0 percent

of the initial UCS values in sections A, B, and C, respectively. For each material, a paired t -test was performed with the null hypothesis that the initial and final UCS values were equal, the alternative hypothesis that the initial and final UCS values were not equal, and a significance level of 0.05. The paired t -test for the Redwood Road specimens resulted in a p -value of less than 0.0001, with a 95 percent confidence interval of 65 to 94 psi, leading to rejection of the null hypothesis. The results from the paired t -test for the 7800 South specimens resulted in a p -value of 0.3029, with a 95 percent confidence interval of -4 to 1 psi, leading to failure to reject the null hypothesis.

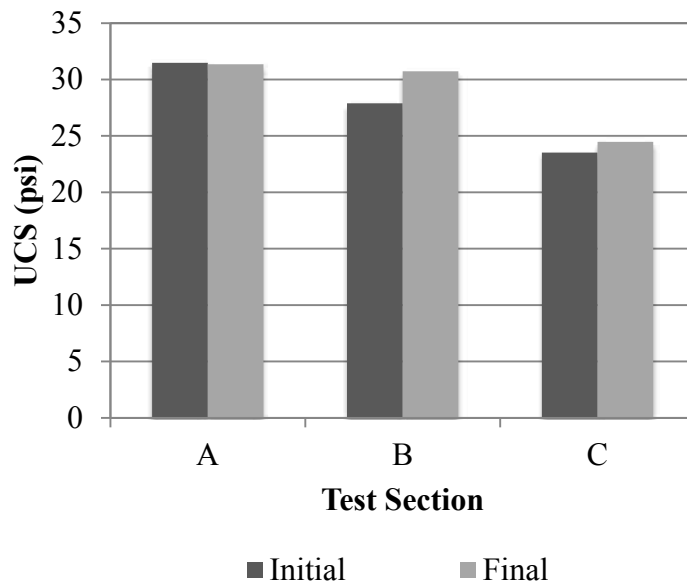
Figure 4-4: Unconfined compressive strength values for 7800 South.

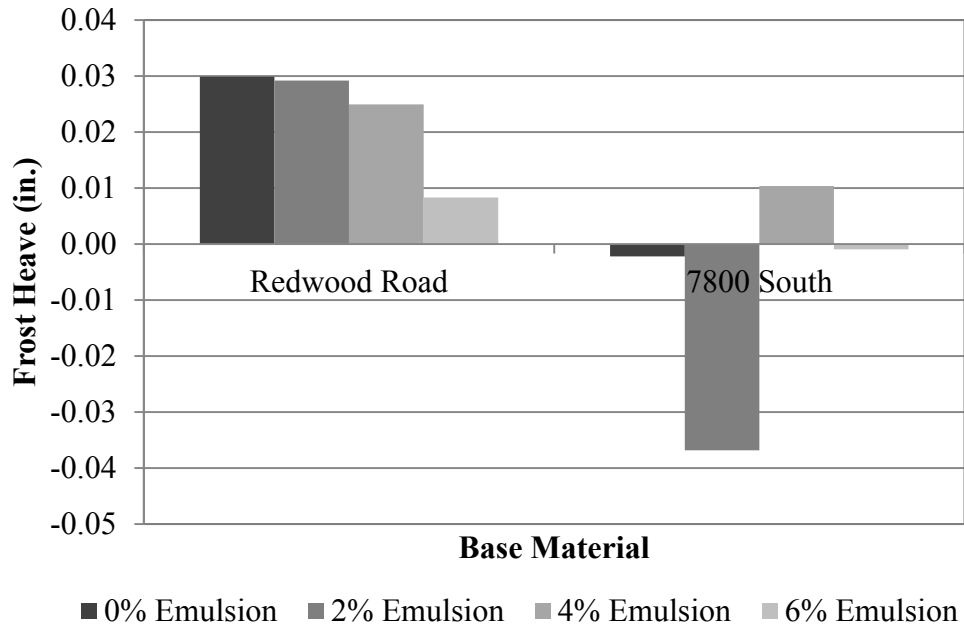
Figure 4-5: Effects of emulsion content on frost heave.

The effects of emulsion content and curing condition on frost heave are presented in Figures 4-5 and 4-6, respectively. In both figures, the frost heave values shown for each test condition are the averages of two specimens and represent the total frost heave over the 10-day test. To statistically compare the results between different emulsion contents, an analysis of variance (ANOVA) was performed on the data. The ANOVA was performed with the null hypothesis that the total frost heave amounts were equal across all emulsion contents, the

alternative hypothesis that the total frost heave amounts were not equal across all emulsion contents, and a significance level of 0.05. The ANOVA for the Redwood Road specimens resulted in a p -value of 0.8103, leading to failure to reject the null hypothesis. The ANOVA for the 7800 South specimens resulted in a p -value of 0.0487, leading to rejection of the null hypothesis. However, for both roads, the data in Figure 4-5 show that the untreated base materials were not susceptible to frost heave, based on the criteria presented in Table 2-1, and that the addition of emulsion, with curing, did not change the frost heave behavior in a practically important way. Negative frost heave amounts, as measured for selected 7800 South specimens, indicate that the magnitude of thermal contraction that occurred upon freezing exceeded that of any subsequent increase in specimen height that may have occurred due to the ingress and freezing of water during testing.

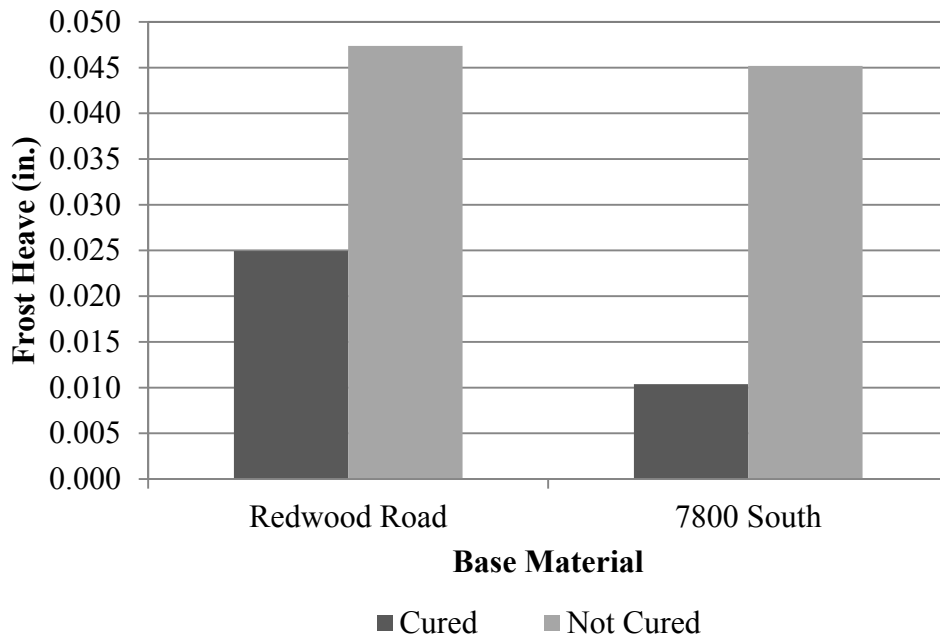
Figure 4-6: Effects of curing on frost heave.

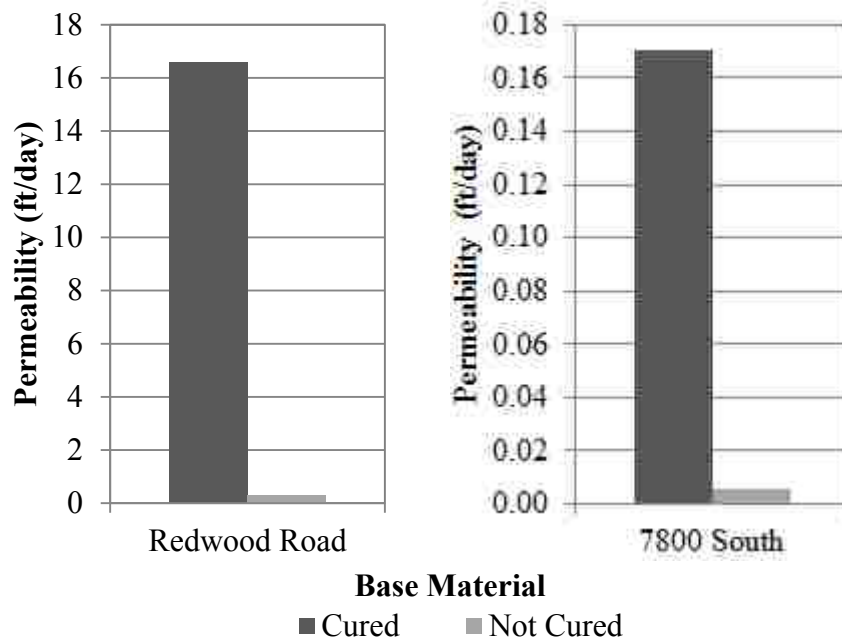
Figure 4-7: Effects of curing on permeability.

Results from the permeability test are shown in Figure 4-7 for Redwood Road and 7800 South. Each column in the figure represents the average of two specimens. The results reveal a significant difference in permeability between the specimens that were cured and those that were not cured. For Redwood Road and 7800 South, respectively, the permeability of the specimens that were cured was, on average, 60 and 29 times larger than the permeability of the specimens that were not cured; the increased permeability of the specimens that were cured compared to those that were not cured is attributable to the coalescing of the asphalt within the emulsion and its adhesion to the aggregate surfaces, thereby opening the middles of the pore spaces for water flow. The larger permeability of the Redwood Road specimens compared to the 7800 South specimens may be explained by differences in the fines contents of the two base materials.

A paired *t*-test was performed on the two data sets with the null hypothesis that the permeability was equal across both curing conditions, the alternative hypothesis that the permeability was not equal across both curing conditions, and a significance level of 0.05. The paired *t*-test for the Redwood Road specimens resulted in a *p*-value of 0.1019, with a confidence interval of -17 to 50 ft/day, leading to failure to reject the null hypothesis. The paired *t*-test for the 7800 South specimens also resulted in failure to reject the null hypothesis, with a *p*-value of 0.0679 and a confidence interval of -0.06 to 0.39 ft/day. Although the small sample size for the *t*-tests led to the difference between cured and not cured samples not being statistically significant for either base material, the large difference is still practically important for this study.

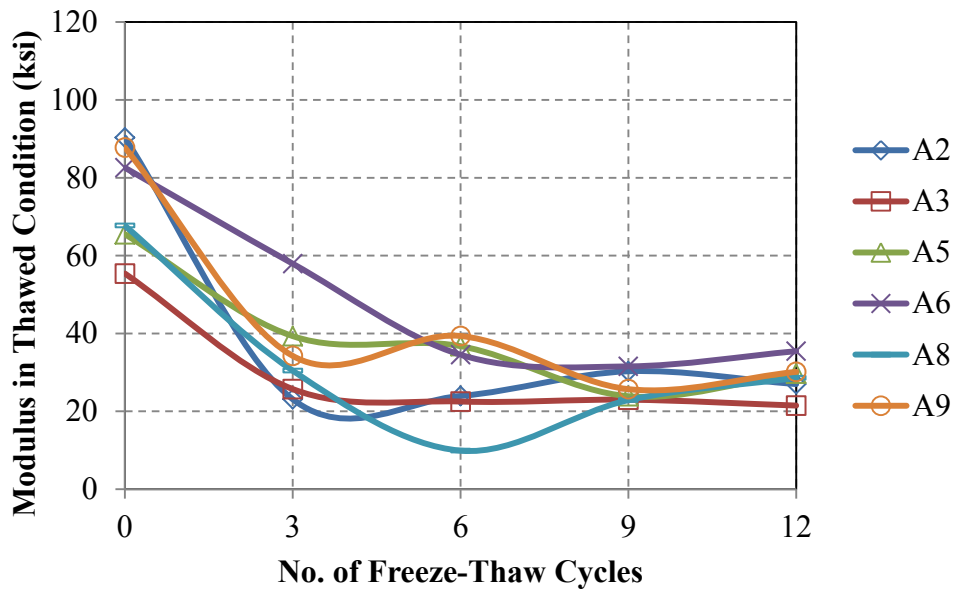
Figure A-1: Modulus values for Redwood Road site A.

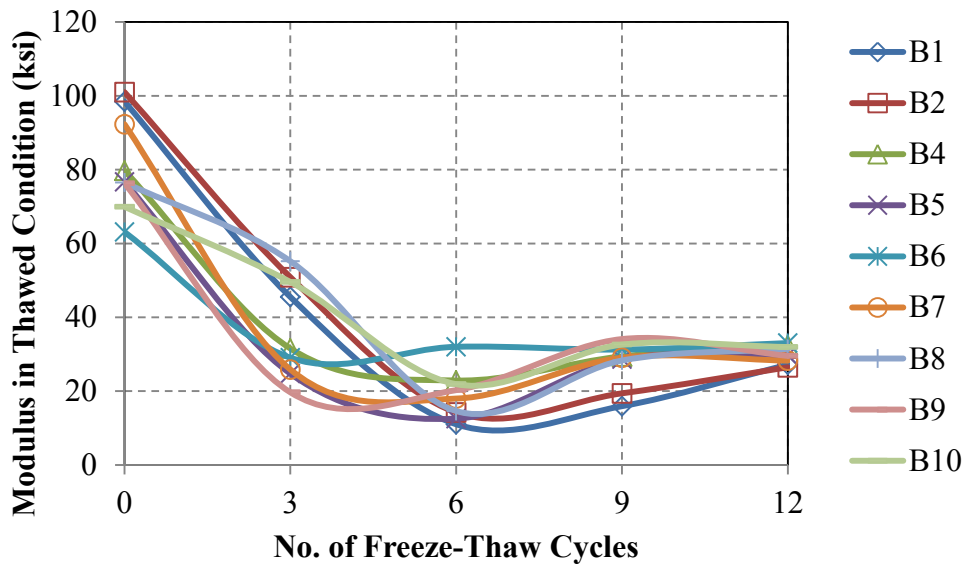
Figure A-2: Modulus values for Redwood Road site B.

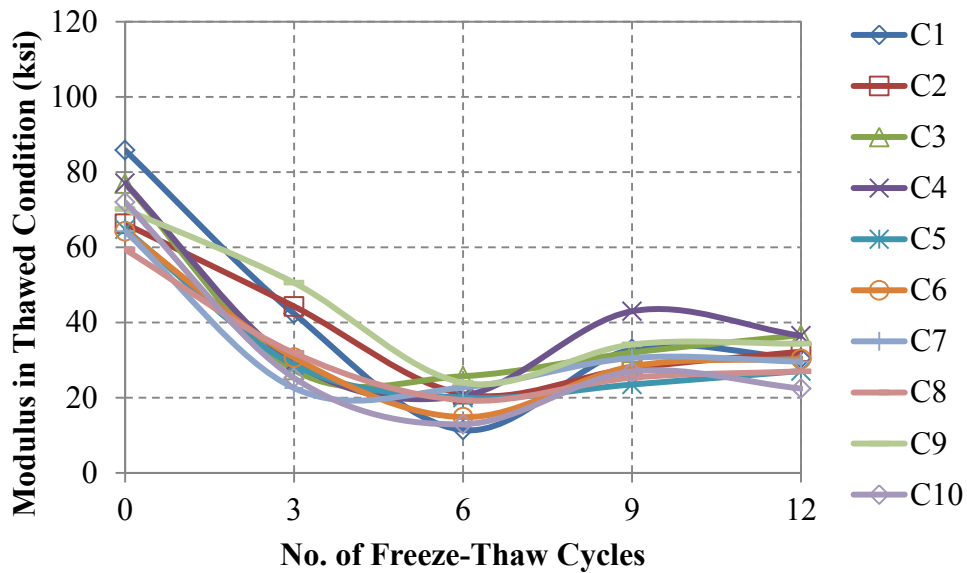
Figure A-3: Modulus values for Redwood Road site C.

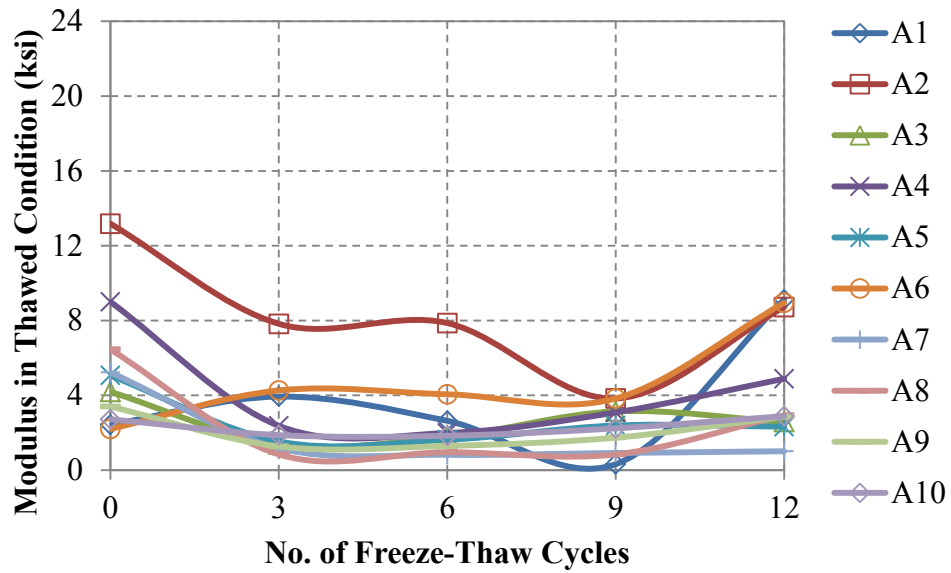
Figure A-4: Modulus values for 7800 South site A.

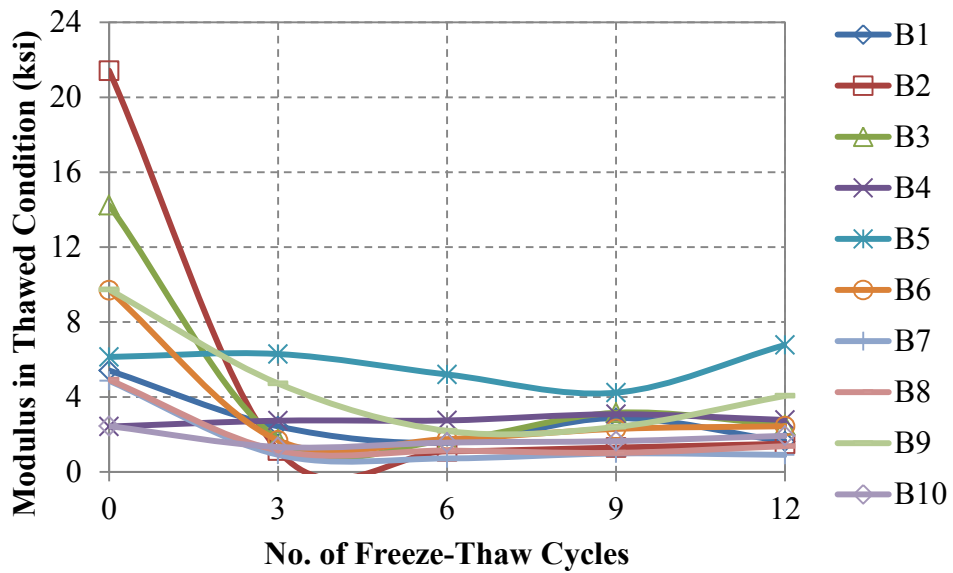
Figure A-5: Modulus values for 7800 South site B.

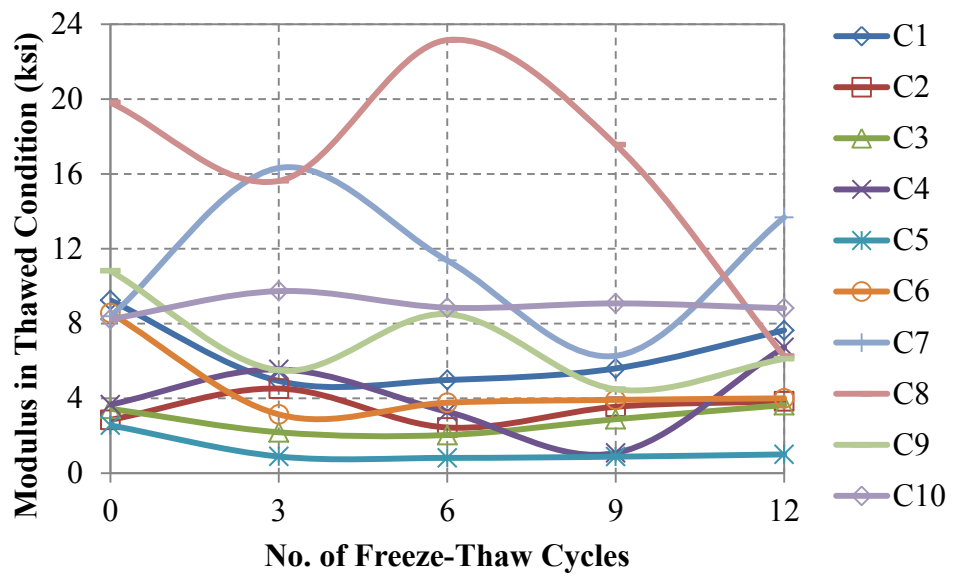
Figure A-6. Modulus values for 7800 South site C.

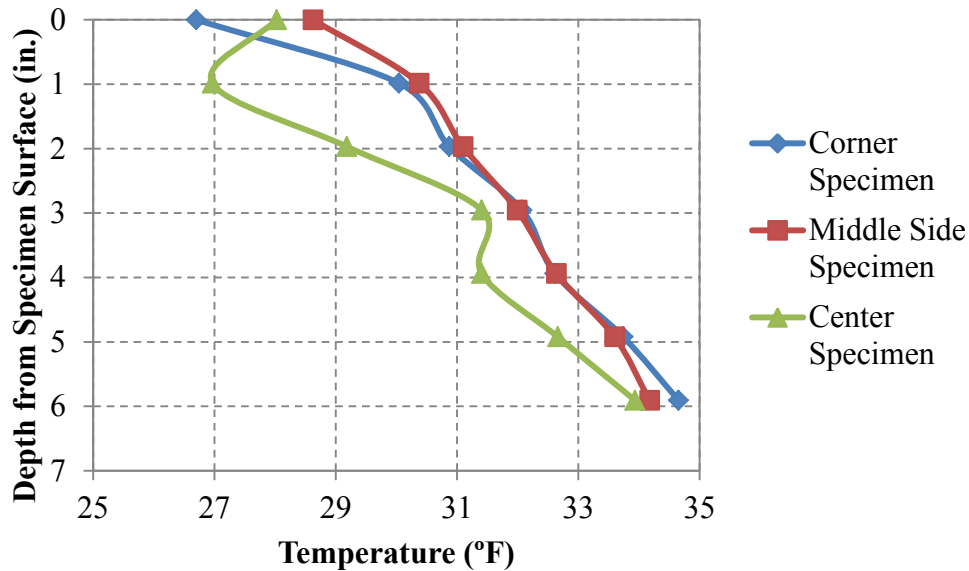
Figure B-1: Steady-state temperature profiles during frost heave testing of Batch 1.

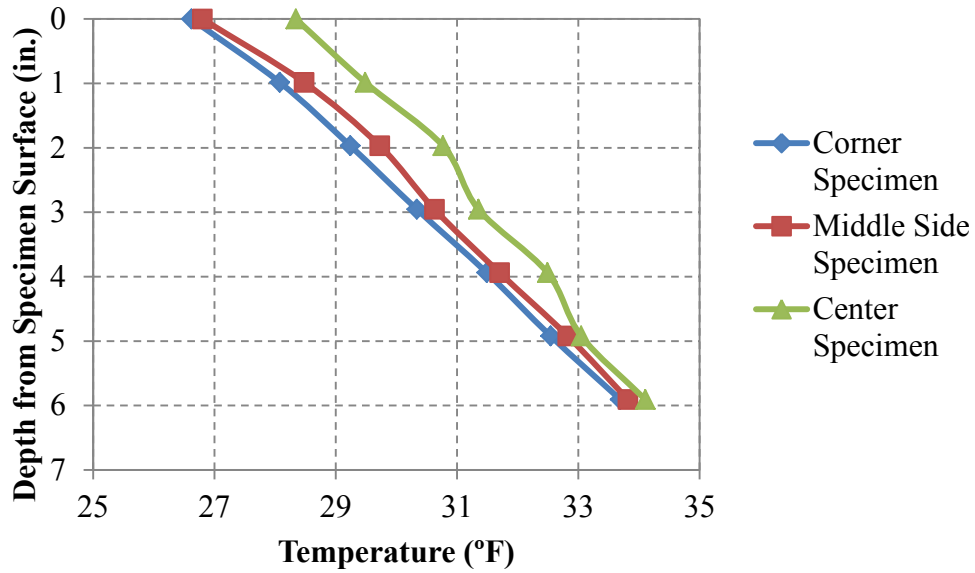
Figure B-2: Steady-state temperature profiles during frost heave testing of Batch 2.

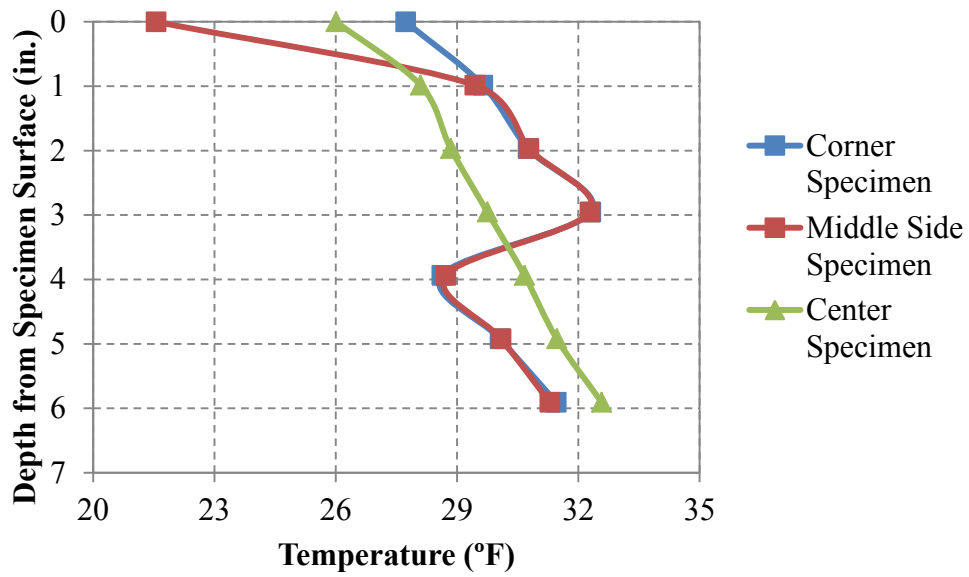
Figure B-3: Steady-state temperature profiles during frost heave testing of Batch 3.
