The Effect of Flowable Fill on the Lateral Resistance
of Soil Surrounding Driven-Pile Foundations

A thesis submitted to the faculty of
Brigham Young University
in partial fulfillment of the requirements for the degree of
Master of Science

Department of Civil and Environmental Engineering
Brigham Young University

December 2009

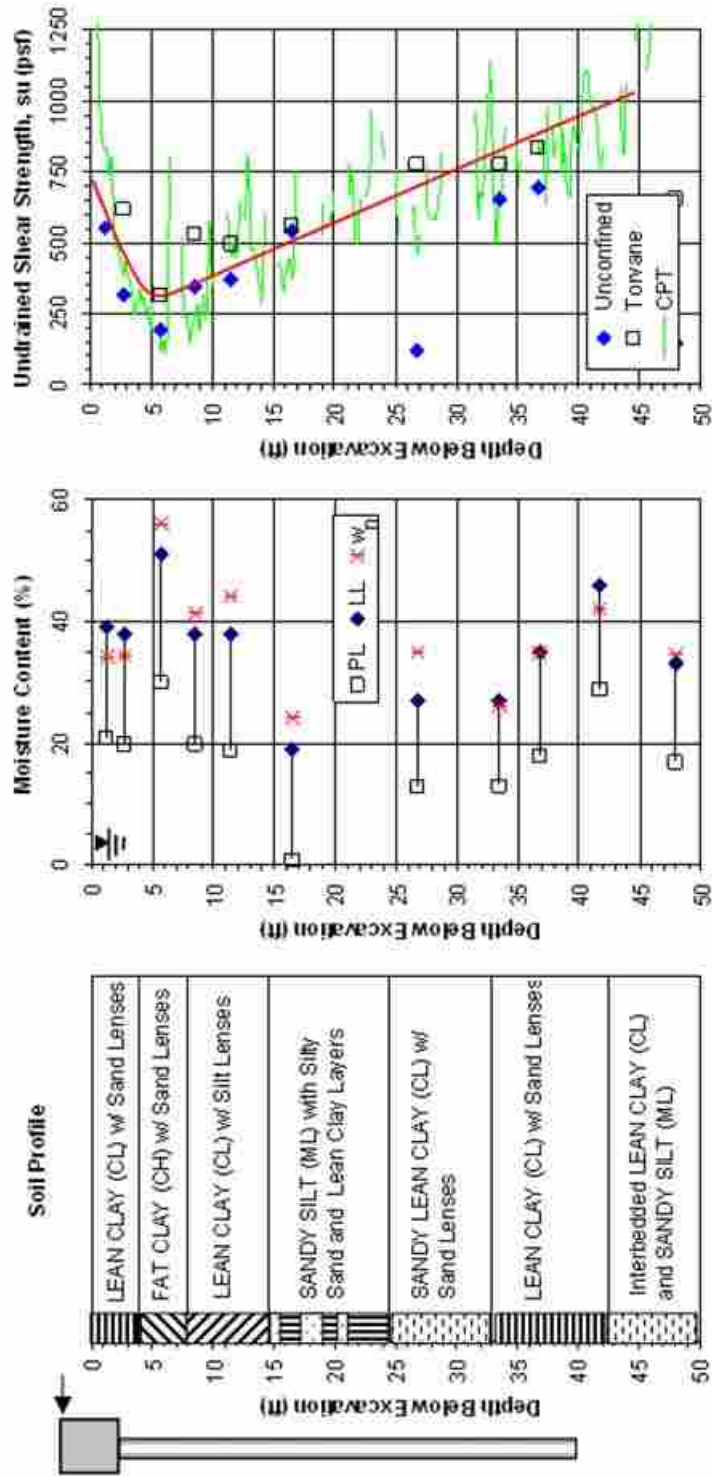
Figure 3-3 Plot of soil profile, atterberg limits and natural water content vs. depth, and undrained shear strength vs. depth Cone Penetration and Seismic Cone testing.

The liquid limit, plastic limit and natural moisture content are plotted in Figure 3-3 (b) at each depth where Atterberg limit testing was performed. The water table is at a depth of 1.5 ft, which is equivalent to a depth of 5.5 ft below the pre-

A close look at Table 3-1 and Figure 3-3 shows that this site meets all three of the above criteria. Therefore, the soil profile information obtained to a depth of 50 ft is sufficient to classify the site as an IBC Site Class E.

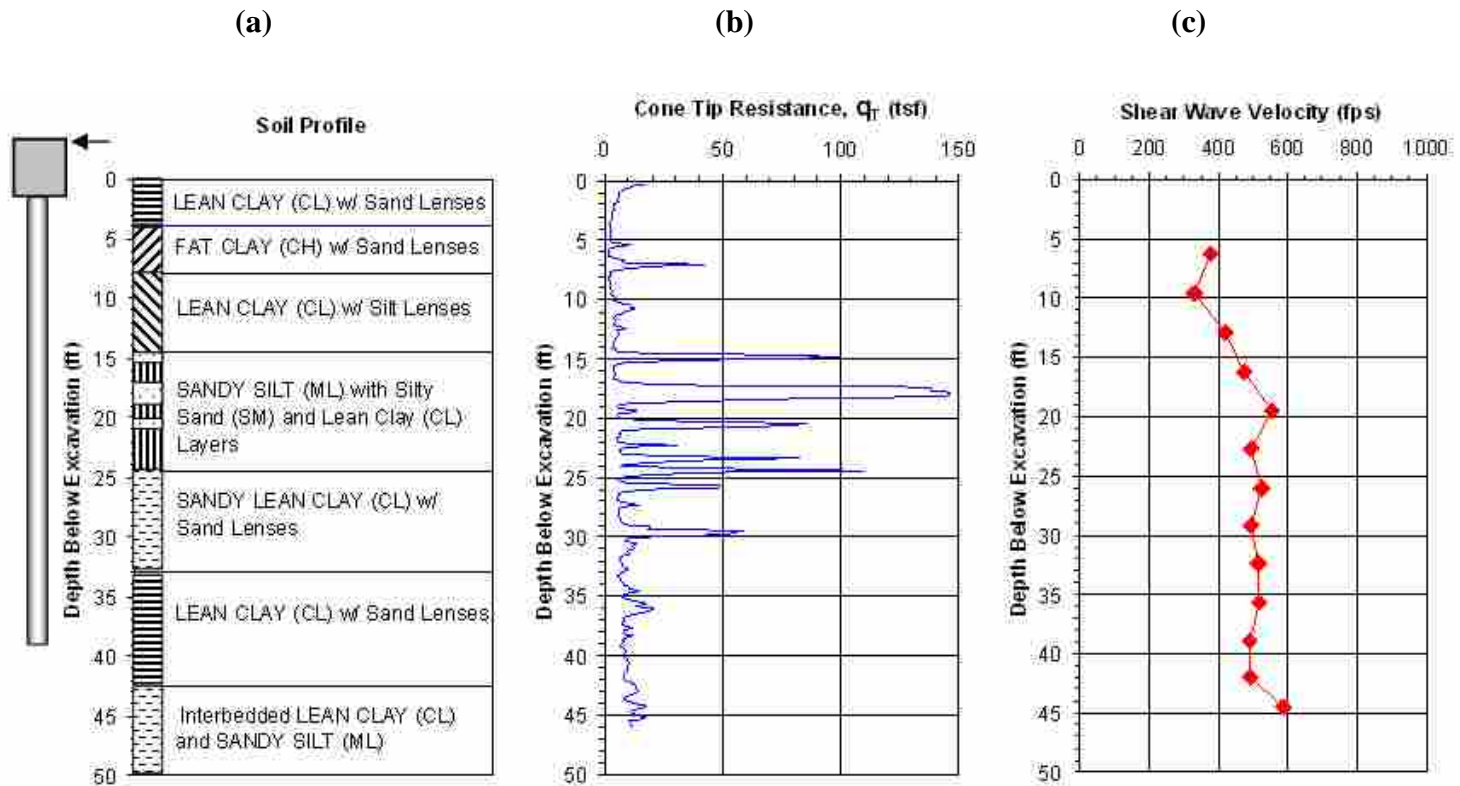
Figure 3-6 Plot of (a) soil profile, (b) cone tip resistance vs. depth, and (c) shear wave velocity vs. depth from seismic cone testing.

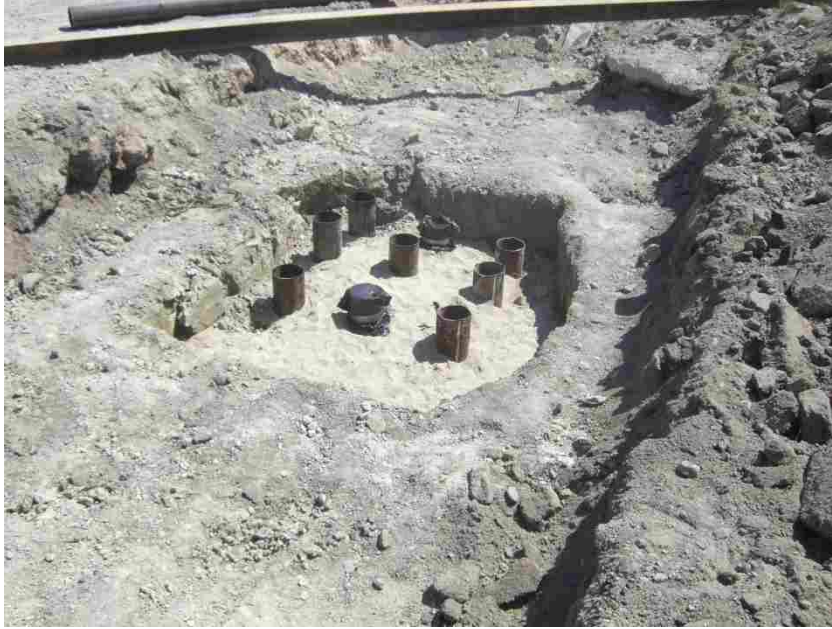
Figure 4-2 Driven pile layout prior to cap construction.

The center piles of each row were instrumented with strain gages prior to installation (see Figure 4-1). (Note: For caps 2 and 4, the middle pile of the center row was not instrumented with strain gages). The strain gages were placed at pre-determined depths of 2, 6, 11, and 13.5 ft below the tops of the piles. Strain gages were placed along the north and south sides of the piles in the direction of loading. The strain gage depths were determined through computer modeling to be the most critical depths in developing bending moment curves for the laterally loaded piles. Figure 4-2 is a photo of an installed pile group.

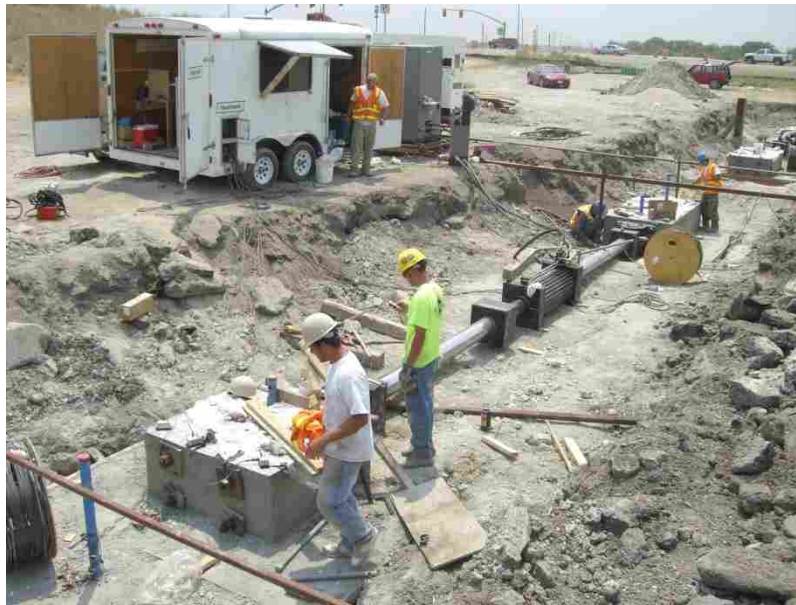
Figure 4-10 Photo of actuator setup between caps 1 & 2.

Most of the tests conducted involved reacting one pile group against another, through applying a lateral load with an MTS actuator with the load centered at a height of 0.92 (11 inches) above the top of the pile cap. Each of the actuators had a capacity of about 600 kips in compression and 450 kips in tension. The pile groups were spaced approximately 32 ft apart edge to edge. This spacing was considered to be large enough to ensure that the volumes of affected soil created by the displacement of each foundation would not significantly interfere with each other. The actuators were fitted with two 8.67-ft extension pieces each made of 8.5 inch outside diameter 69 ksi steel pipe with a wall thickness of 0.75 inches in order to span the distance between the two foundations.

Plates 18x18 inch and 5 inches thick of 36 ksi were welded to the ends of the extensions to connect the extensions to the actuators and the pile caps. The actuators were attached to each corbel using steel tie-rods which extended through PVC sleeves in the corbel and were bolted to the back face of the corbel. The tie-rods were pre-stressed to minimize displacement of the steel during the load tests. A three-dimensional swivel head was located at each end of the actuator to provide a zero moment or “pinned” connection. Each swivel could accommodate $\pm 5^\circ$ of pile cap rotation about a horizontal line (pitch) and $\pm 15^\circ$ of pile cap rotation about a vertical line (yaw). A photo the actuators and extensions positioned between the two piles caps in the field is provided in Figure 4-10.

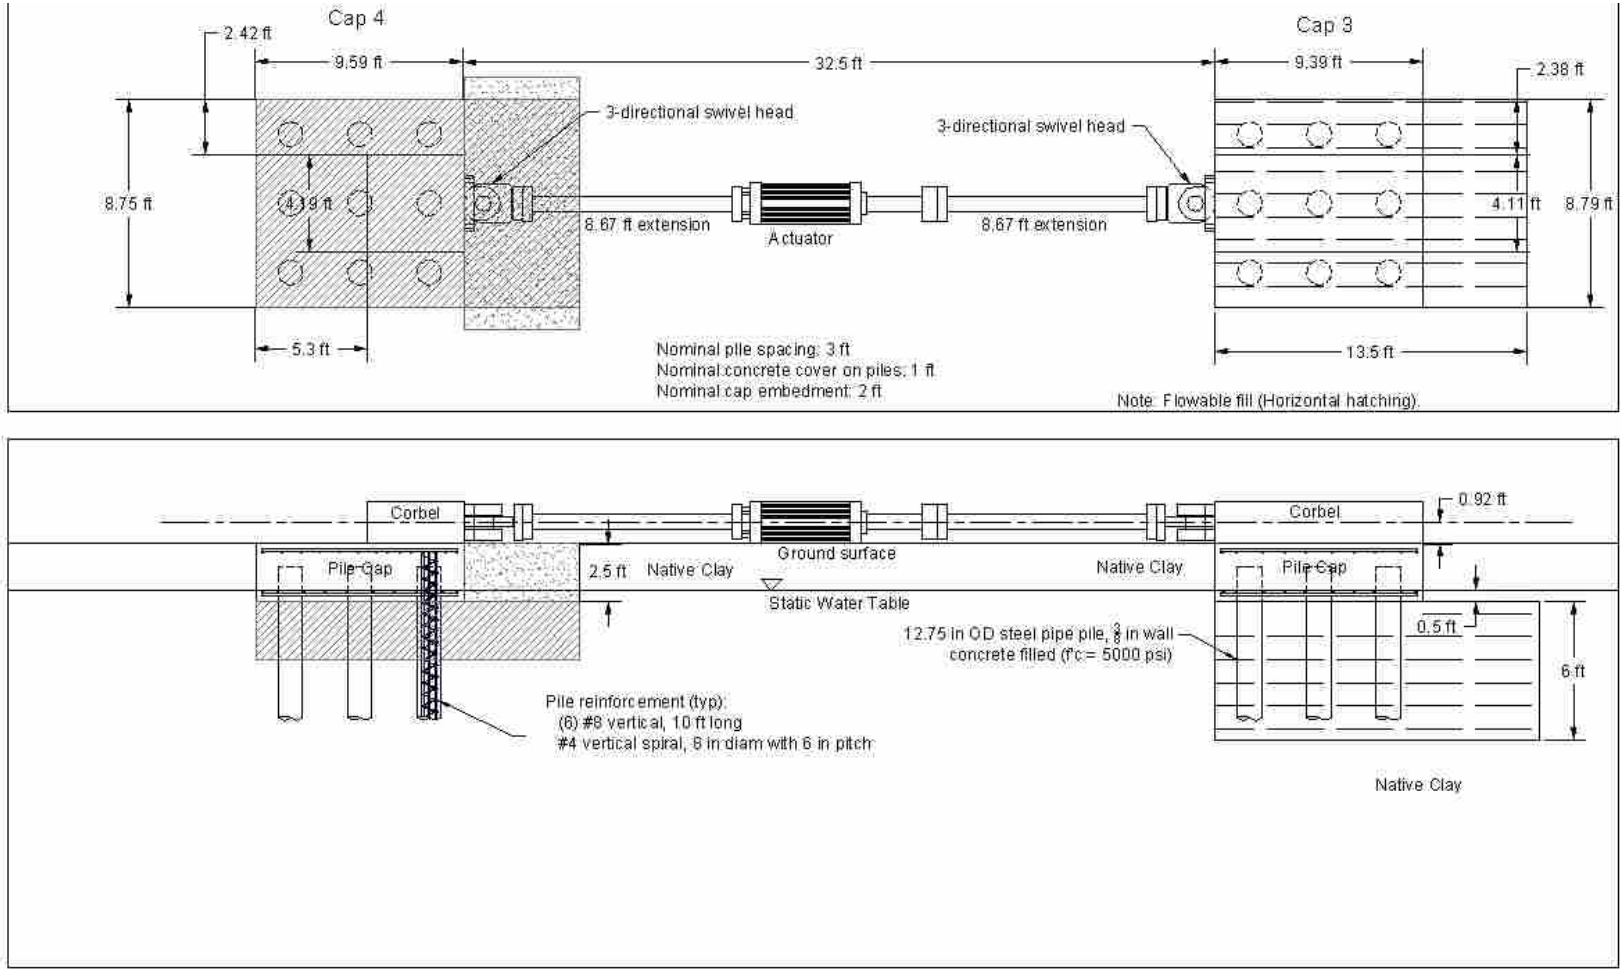
Figure 4-18 Plan and profile views of cap 3 (right) and cap 4 (left) during tests 3 and 5.

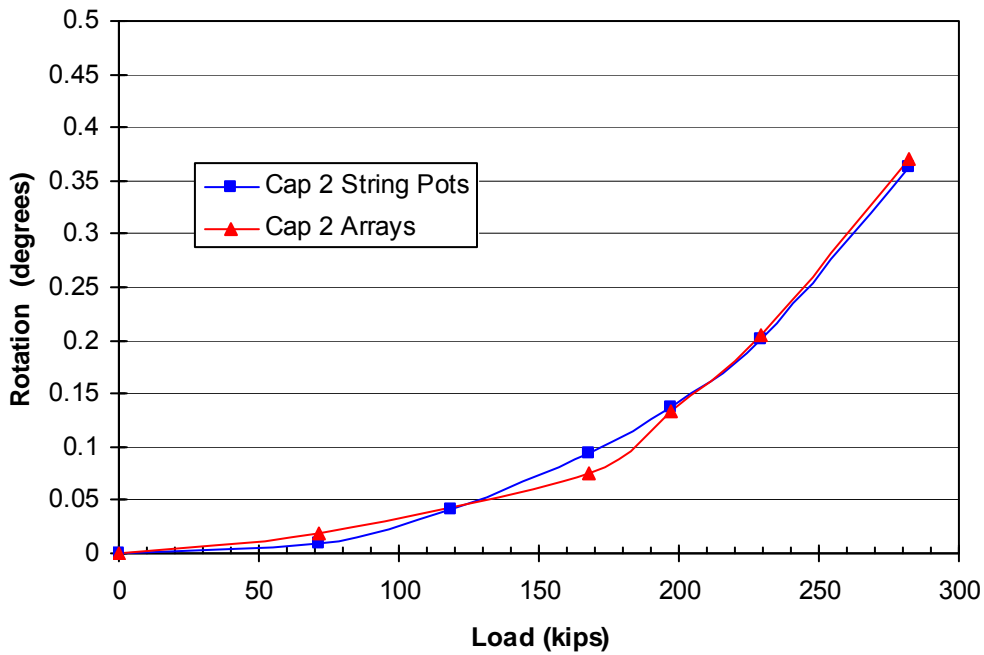
Figure 5-5 Peak pile cap load vs. pile head rotation from the string potentiometers and arrays for cap 2 during test 1.

Cap 2, on the other hand, experiences great agreement between both the string potentiometers and the arrays throughout the test. The curves are fairly linear up to a load of about 170 kips after which the rotation begins to increase more rapidly with load. Measured rotations are fairly consistent for both caps, with the exception of the 282 kip measurement from the string potentiometers on cap 1, which appears to be over estimating the rotation. While pile cap rotation is clearly observed, it is considerably lower than the rotation of the single pile under “free-head” conditions, where rotation is significantly greater.

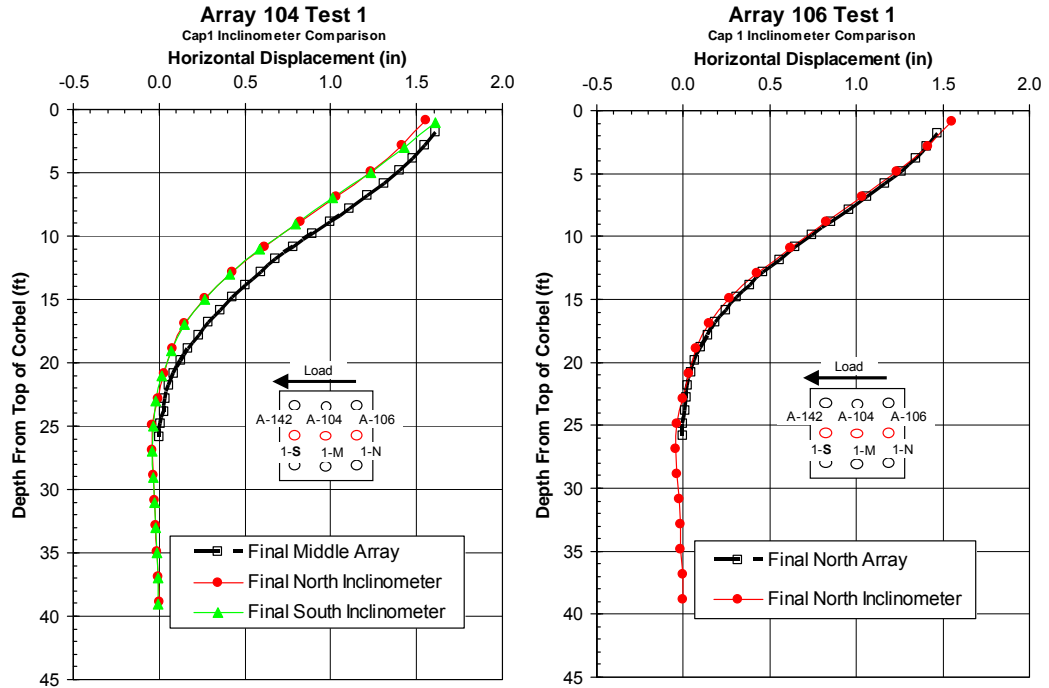
Figure 5-8 Test 1 inclinometer vs. array comparisons for cap 1 at maximum displacement.

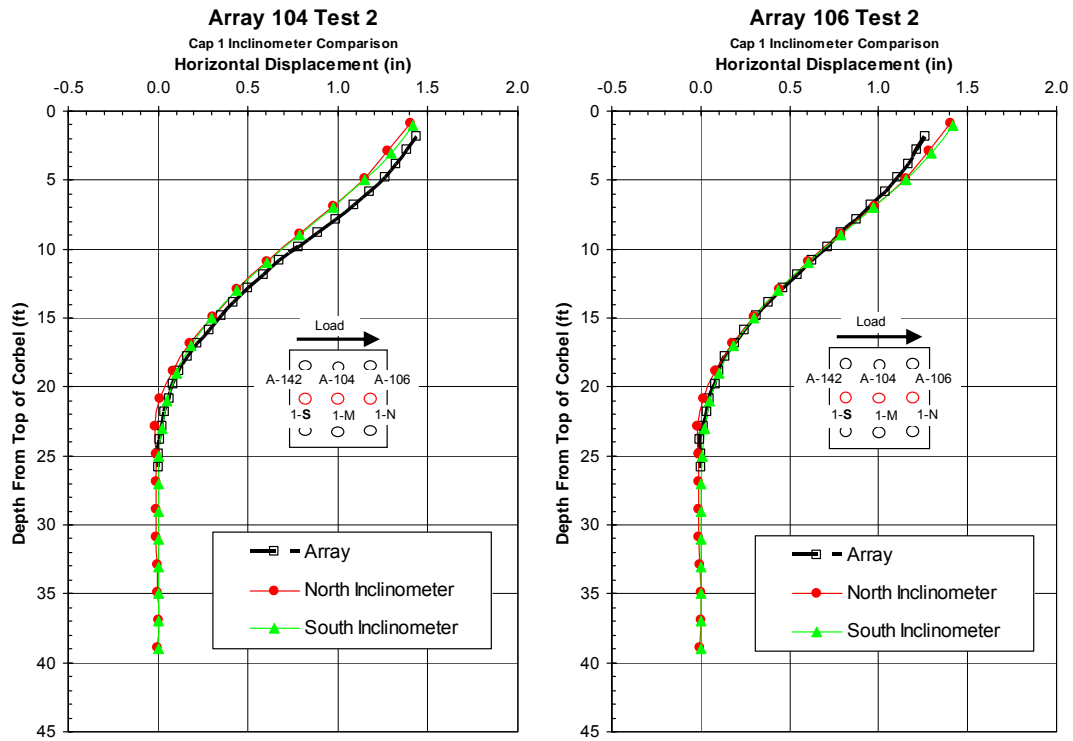
Figure 5-28 Displacement vs. depth profiles measured by shape arrays and inclinometers for the center and north piles in cap 1 during test 2 at maximum displacement.

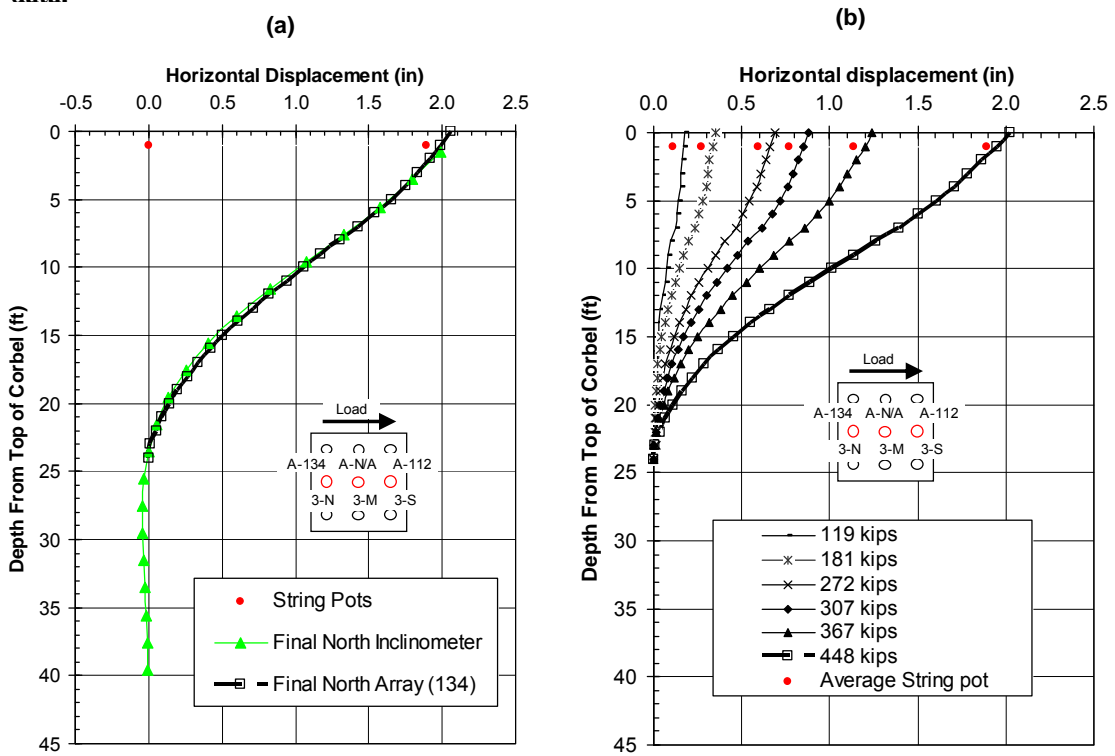
Figure 5-63 Test 10 (a) displacement vs. depth profiles comparing the final inclinometer to north shape array (134). (b) Displacement vs. depth curves comparing shape array to string potentiometer data.

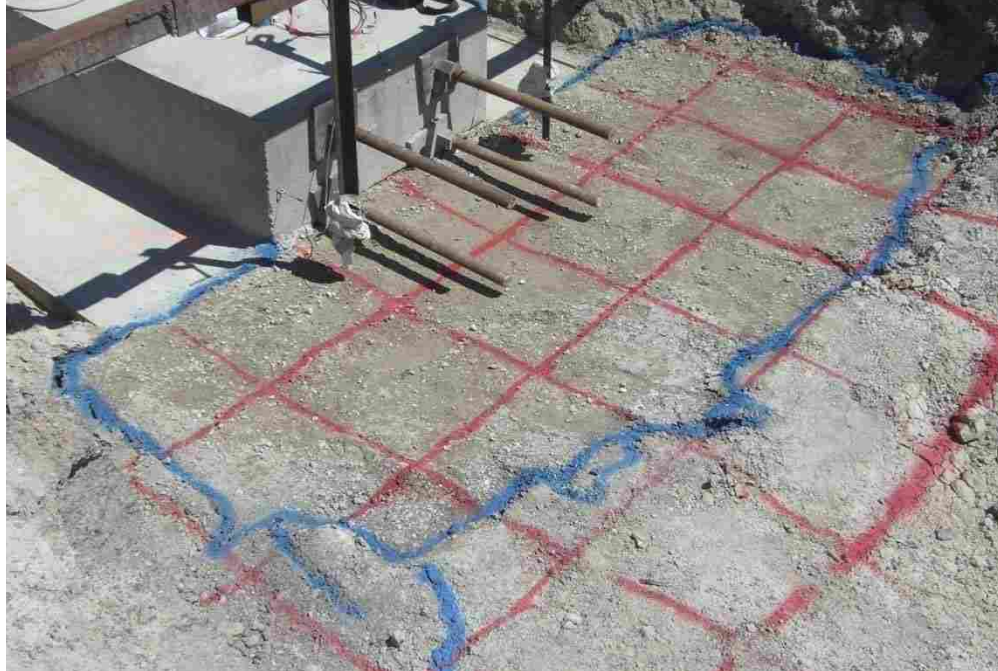
Figure 6-9 Photograph showing the flowable fill surface failure condition and that the zone acted as a rigid soil block.

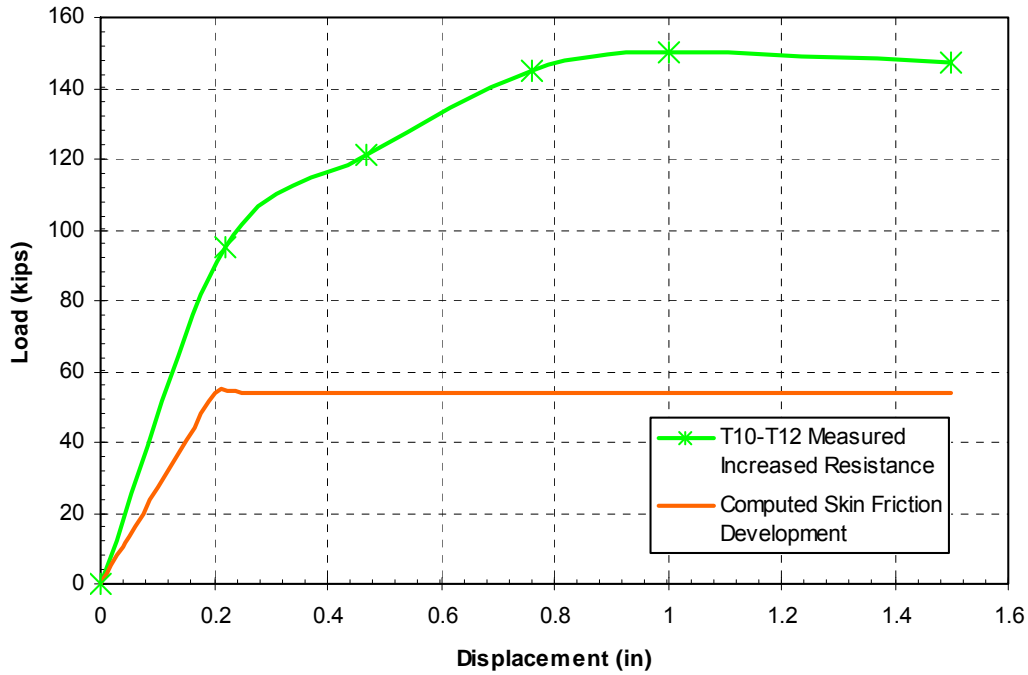
Figure 6-12 The portion of the measured increased total resistance due to side and bottom skin friction of the flowable fill zone as computed by pycap.
