# Strength and Deformation Characteristics of a Cement-Treated Reclaimed Pavement with a Chip Seal

A thesis submitted to the faculty of  
Brigham Young University  
in partial fulfillment of the requirements for the degree of  
Master of Science

Department of Civil and Environmental Engineering  
Brigham Young University

April 2011

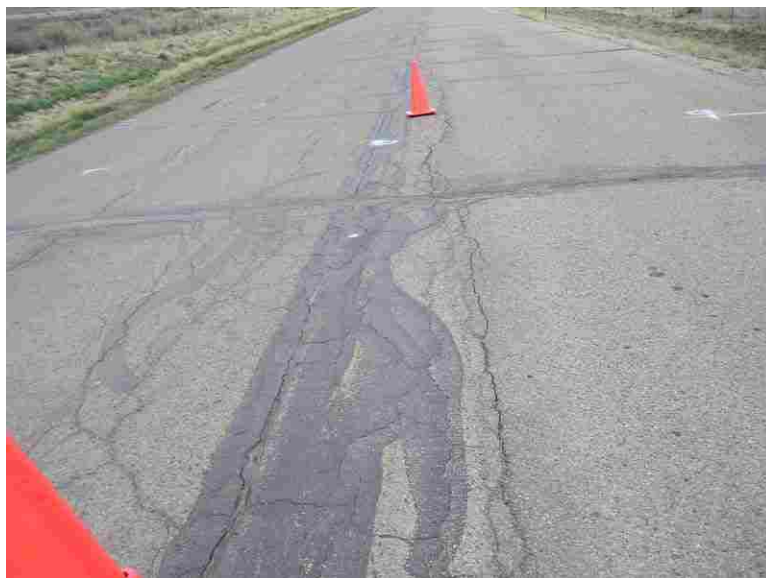
**Figure 3.1 Existing pavement distress.**

Due to the development of high-severity transverse and fatigue cracking and excessive roughness, the original pavement, depicted in Figure 3.1, was reconstructed in August 2009. Because of the low quality of existing pavement materials and the economic benefits inherent in the process, FDR in conjunction with cement stabilization was implemented. The pavement design specified a 9-in.-thick CTB with 4.0 percent Type II cement and a RAP-base ratio of 50:50 by weight. Therefore, the upper 6 in. of HMA was removed by milling, and the remaining approximately 4.5 in. of asphalt and an equal depth of base were then pulverized together with a reclaimer. The required cement, in powder form, was then spread with a distributor truck and mixed with the base material through another pass of the reclaimer as shown in Figures 3.2 and 3.3, respectively. Water was introduced in the pulverizing chamber to bring the material to the optimum moisture content of 9.0 percent. Immediately following mixing, the treated

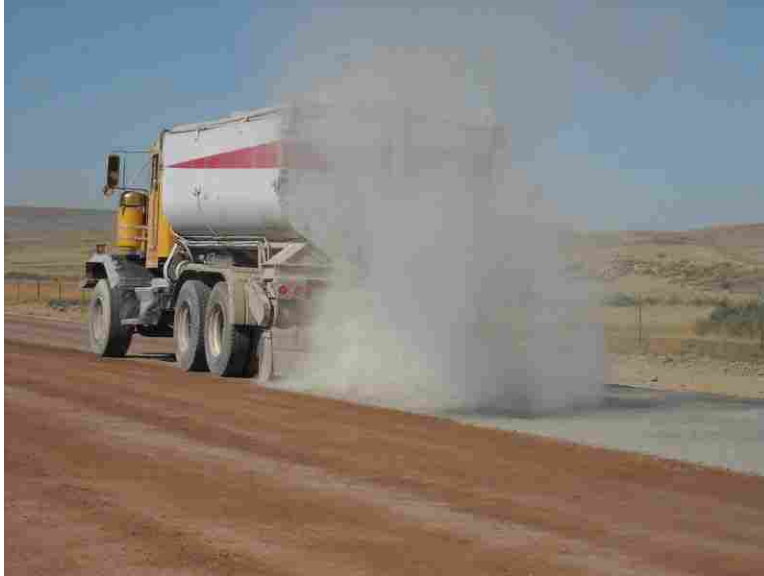
**Figure 3.2 Distribution of the cement with a cement spreader truck.**

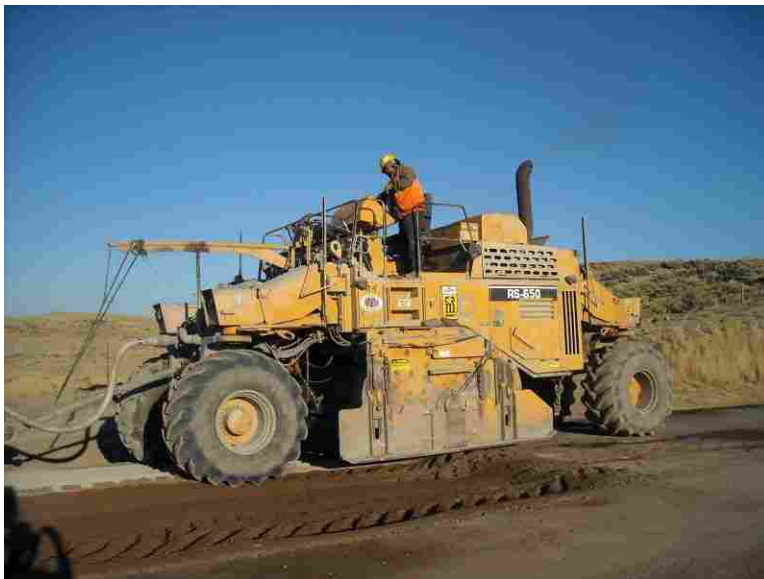
**Figure 3.3 In-situ mixing of the base, RAP, and cement with a reclaimer.**

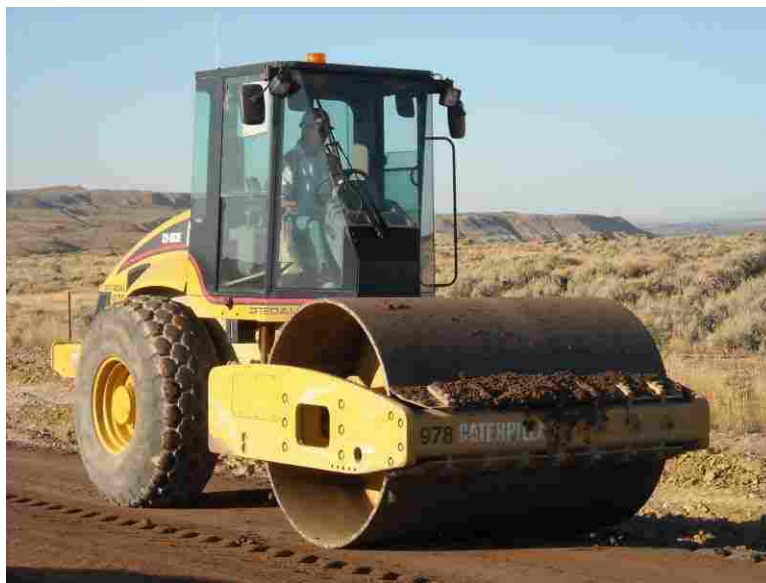
**Figure 3.4** Compaction with a vibratory roller.

material was compacted to a minimum relative density of 95 percent of the maximum dry density of 118.6 lb/ft<sup>3</sup> with a single-drum, 12-ton vibratory roller as depicted in Figure 3.4.

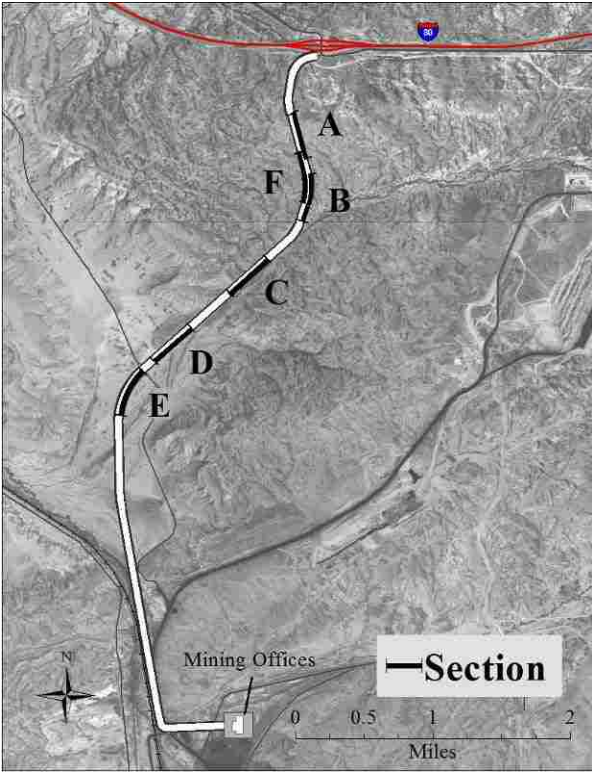
Figure 3.6 Section layout for testing during construction.

Structural testing accomplished during construction was performed on the CTB after 3 days of constant moist curing. The first set of tests was performed to establish a non-microcracked baseline stiffness. Following microcracking, a second set of tests was performed. A total of 61 randomly selected sites were monitored; these sites were distributed among construction sections A through F, as shown in Figure 3.6. As depicted in Figure 3.7, 10 stations were randomly located within each section, except for section E, which had 11 stations.

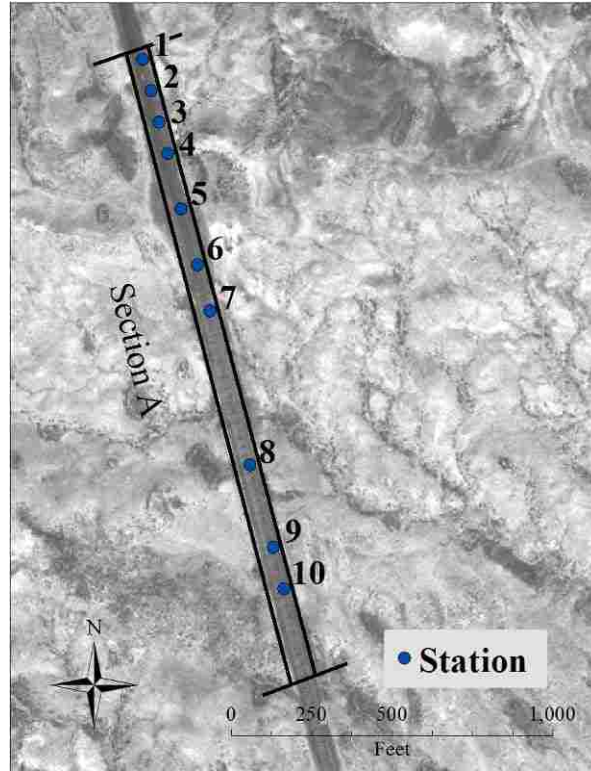
**Figure 3.7 Example station layout for testing during construction.**

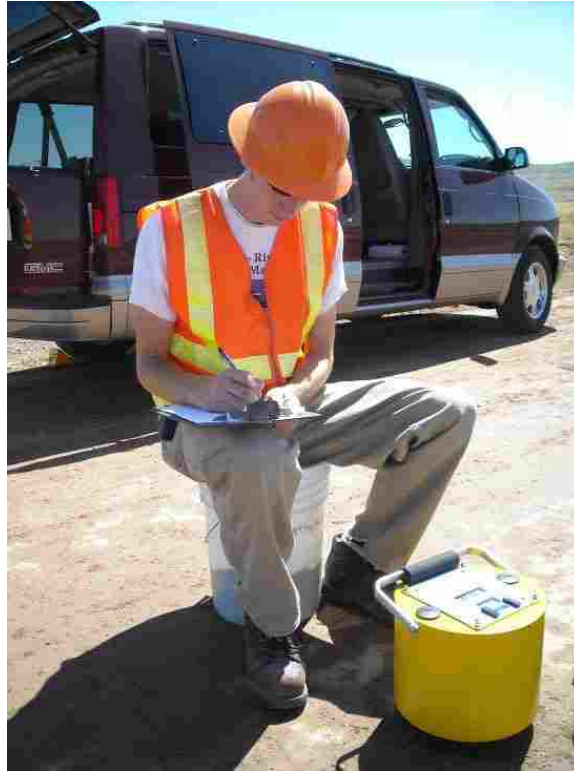
**Figure 3.8 SSG.**

The CTB stiffness testing was performed with a soil stiffness gauge (SSG) and a portable falling-weight deflectometer (PFWD) as shown in Figures 3.8 and 3.9, respectively. The SSG measures the stiffness of a soil by imparting vibrations to the surface while measuring the resulting displacement. The stiffness is determined as the ratio of the force to the displacement. The PFWD evaluates the elastic modulus of pavement layers by imparting a concentrated load of about 4000 lbf and measuring the vertical deflections at specified distances from the center of the load plate. The modulus of each pavement layer can then be estimated from the measured PFWD deflections using backcalculation software. The SSG and PFWD tests were performed in general accordance with American Society for Testing and Materials (ASTM) D6758 (Standard Test Method for Measuring Stiffness and Apparent Modulus of Soil and Soil-Aggregate In-Place by Electro-Mechanical Method) and ASTM E2583 (Standard Test Method for Measuring

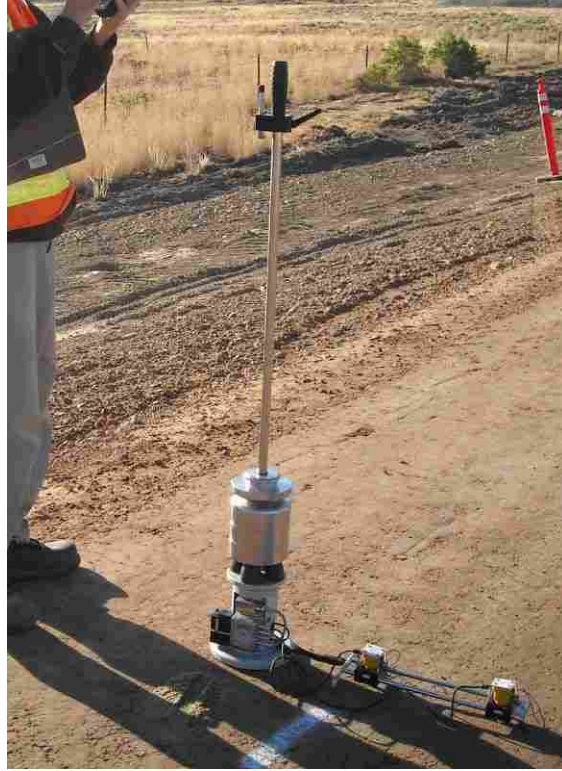
**Figure 3.9 PFWD.**

Deflections with a Light Weight Deflectometer), respectively. The deflections measured by the PFWD were input into BAKFAA to estimate the modulus of the CTB (24). The pavement was assumed to be a two-layer system consisting of CTB and subgrade. Values for the individual inputs used in backcalculation are provided in Appendix A. Three readings from each device were recorded at each site and later averaged.

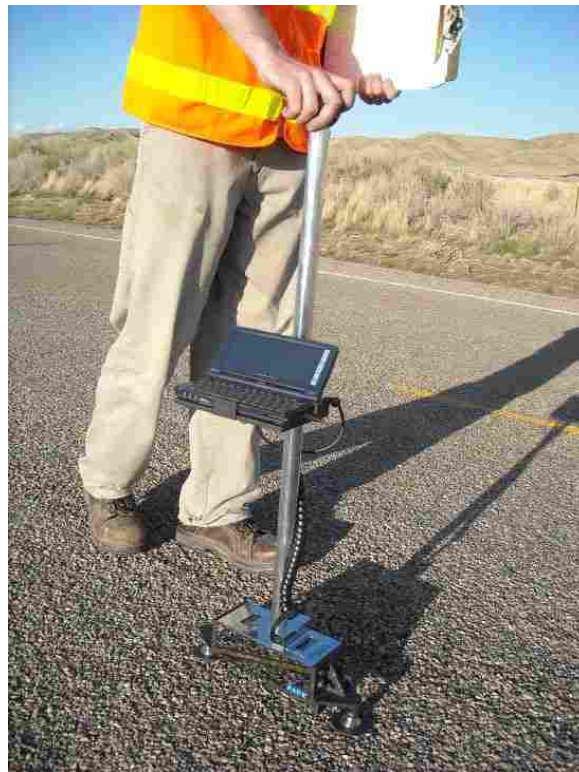
**Figure 3.11 Profilometer.**

Roughness tests were performed with a profilometer as shown in Figure 3.11 to calculate the international roughness index (IRI) of the pavement in and between the wheel paths at each station. The base of the instrument contains a precision inclinometer that measures the height difference between two surface points spaced 1 ft apart; after a given reading is obtained, the instrument is then manually rotated to the next position. When testing of a given profile is completed, an onboard computer calculates the IRI from the collected data. This test was performed in each case along a 100-ft line centered longitudinally at each station. By testing in and out of the wheel paths, the effect of trafficking on pavement roughness could be captured. Testing was accomplished in general accordance with ASTM E1274 (Standard Test Method for Measuring Pavement Roughness Using a Profilograph).

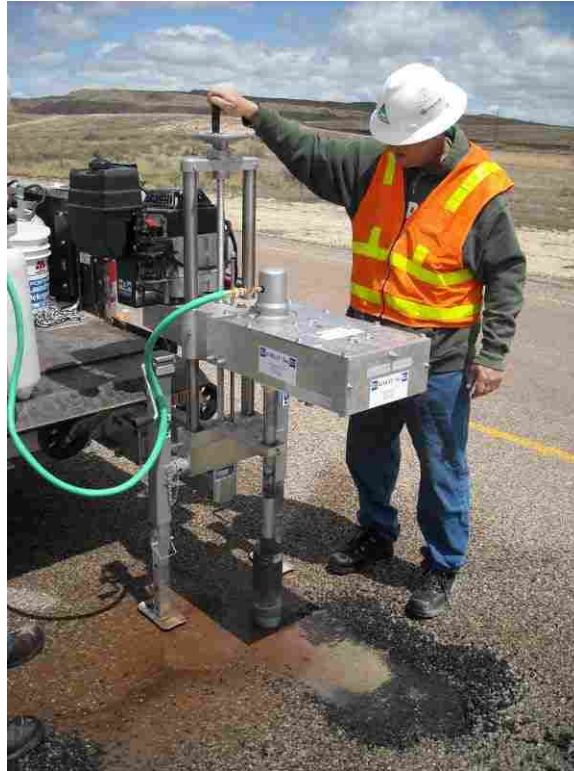
**Figure 3.12 Truck-mounted coring rig.**

Cores of the CTB were extracted from each test station and subjected to laboratory UCS testing to provide another measure of CTB structural condition. A truck-mounted coring rig, as shown in Figure 3.12, was used to extract 4-in.-diameter cores from both in and between the wheel paths at the same locations of PFWD and SSG testing. When a full core could not be extracted due to cracking or degradation of the material during cutting, the CTB pieces were still collected. After being returned to the laboratory, intact cores were used to estimate the UCS of the CTB. The cores were saw-cut to a height of 4.6 in. to achieve the same aspect ratio as the previously prepared modified Proctor specimens. To minimize damage that might occur during saw-cutting, the cores were first frozen. After being cut, the specimens were thawed for 24 hours at room temperature, soaked underwater for 4 hours according to PCA protocols, and then tested.

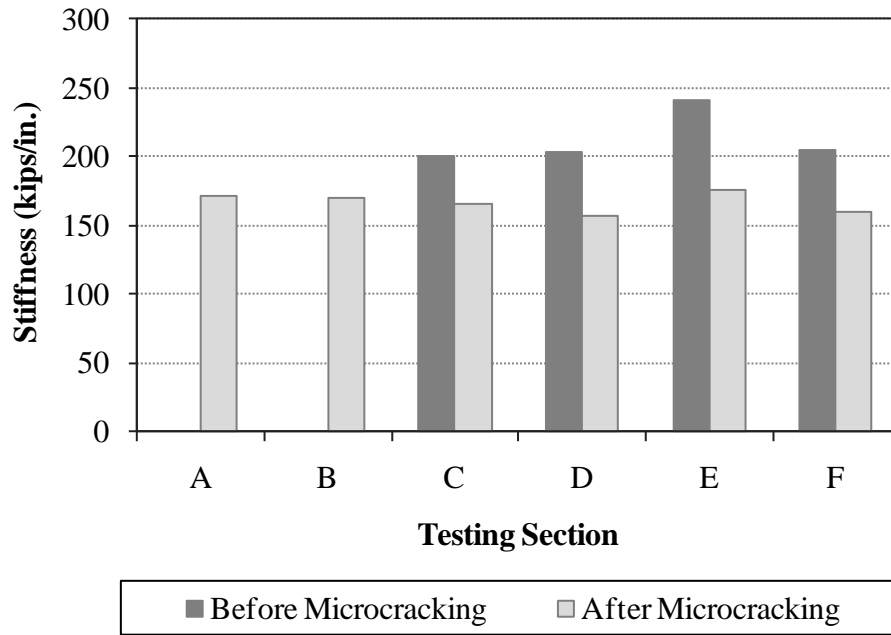
Figure 4.1 Three-day CTB stiffness (SSG).

The average SSG stiffness and PFWD modulus results for each testing section at the time of construction are shown in Figures 4.1 and 4.2, respectively, and are summarized in Table 4.1. Unfortunately, the contact interface between the SSG and the CTB surface was unsatisfactory when measuring the CTB stiffness before microcracking for sections A and B; those values have therefore been omitted. Based on the available SSG and PFWD measurements, the average decreases in stiffness and modulus were computed to be 22 and 37 percent, respectively. The large standard deviations observed in the modulus data are likely attributable to the spatial variability inherent in FDR. The details for both data sets are presented in Appendix A.

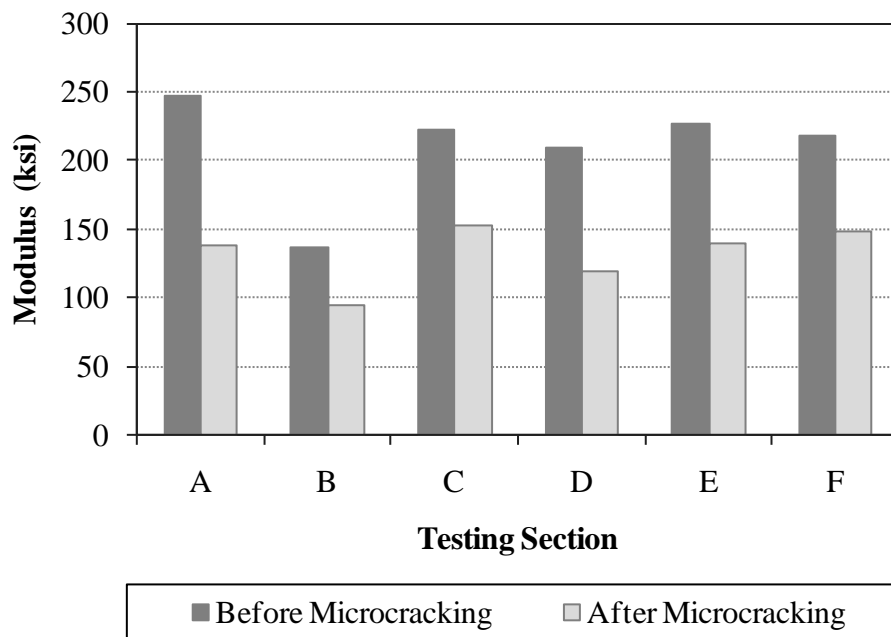
Figure 4.2 Three-day CTB modulus (PFWD).

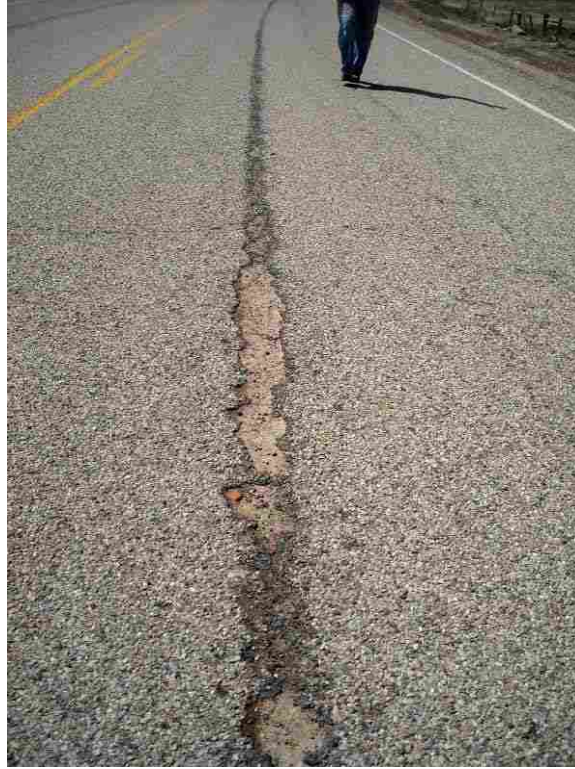
**Figure 4.3 Pothole along chip seal joint.**

each lane of this project was constructed independently, the occurrence of shrinkage cracks was often lane-specific. The average crack spacing within a lane was roughly 50 ft, a comparatively low frequency of shrinkage cracking. However, significant joint failure of the chip seal, characterized by the loss of chips and asphalt emulsion, was evident at over half of the test stations. These failures were caused by poor chip seal construction practices and are not indicative of poor CTB performance. Nonetheless, the importance of the role of the chip seal as a wearing course is made evident by these failures since the exposed CTB often exhibited material loss. Likely, surface water ponded in these joints and facilitated comparatively rapid CTB erosion under traffic loads and freeze-thaw cycling. At stations 1 and 3, the degradation was so severe that long 1-in.-deep potholes had developed as shown in Figure 4.3. Further chip loss would likely lead to continued degradation of the CTB. Longitudinal cracking was evident

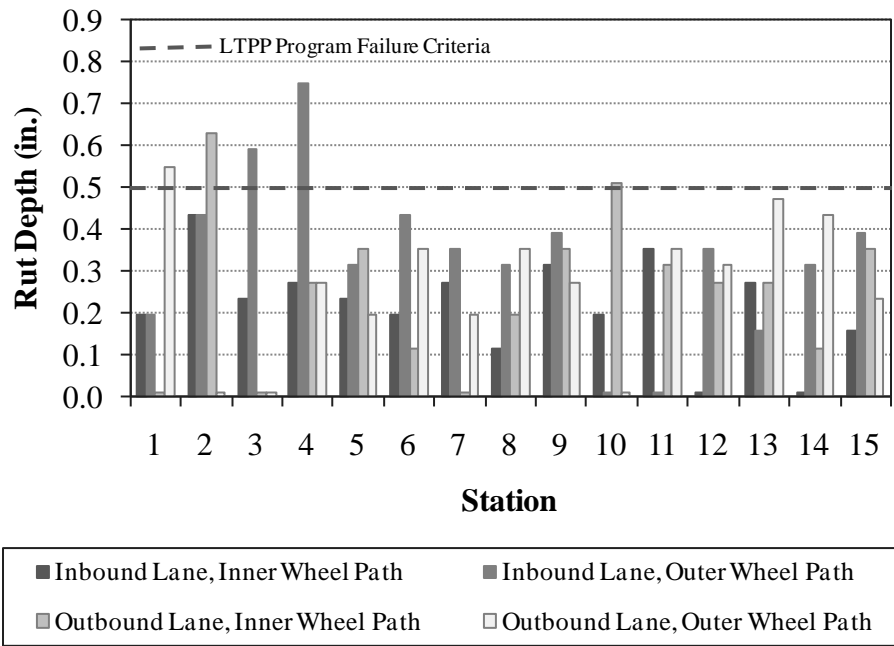
**Figure 4.4** Nine-month CTB rutting.

Rutting measurements are shown in Figure 4.4, and an example of rutting is shown in Figure 4.5. According to the LTPP Program guidelines, pavements with rut depths greater than 0.5 in. are considered failed, as water may pond in the wheel path and facilitate hydroplaning. Five stations exhibited rutting in excess of this limit. The average depth for all ruts was 0.2 in. The observed rutting may have occurred either during or after construction. During construction, as observed by the researchers, premature trafficking likely occurred at stations 1 through 7 in the outbound lane. After construction, rutting occurring in the pavement structure could be

attributable to an overall structural deficiency, caused by the absence of the HMA layer, and therefore inadequate protection of the soft, clayey subgrade beneath the CTB.

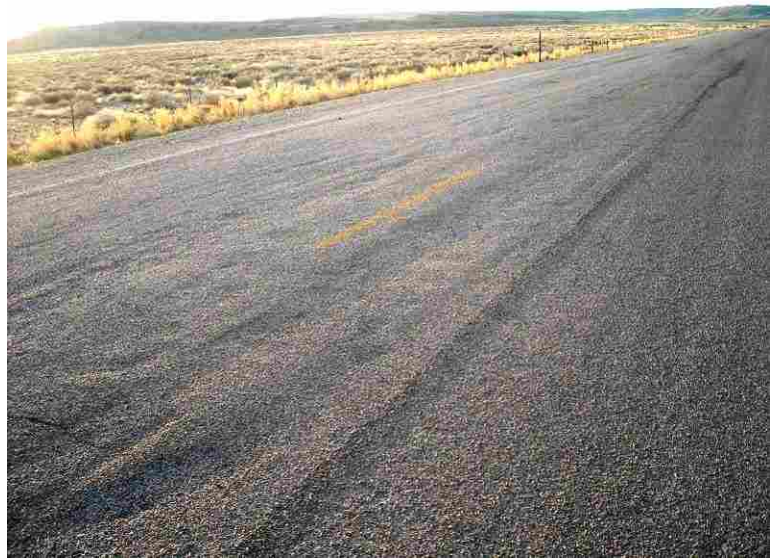
**Figure 4.5** Rutting distress.

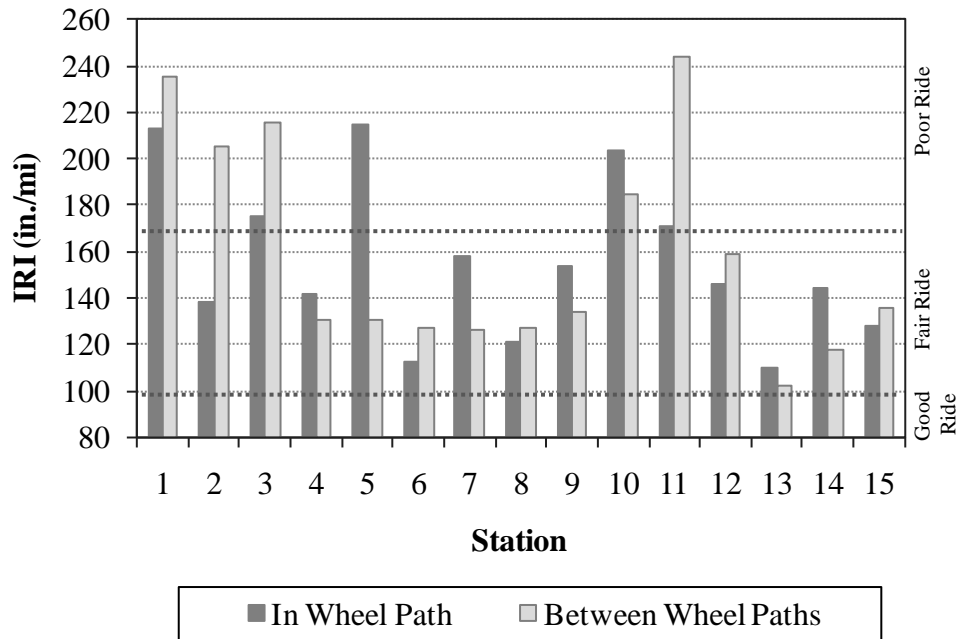
Figure 4.6 Nine-month CTB roughness.

The IRI values measured during testing are shown in Figure 4.6. The rating criteria used for comparison in the figure are those adopted by the Utah Department of Transportation (UDOT) for asphalt roads (25). The average IRI values in and out of the wheel path were 155 and 158 in./mi, respectively. While these averages are in the *fair ride* category, six of the locations had ride qualities in the *poor ride* category. The UDOT criteria, however, are for paved roads and may be inappropriate for the analysis of a CTB surfaced with a chip seal. The IRI in the wheel path was not significantly higher than the IRI between the wheel paths, where the resulting *p*-value was 0.6064. Therefore, the pavement roughness was not likely caused by trafficking but probably resulted from construction or climatic factors. Whether this degree of roughness could have been avoided or not with an HMA surface course is uncertain.

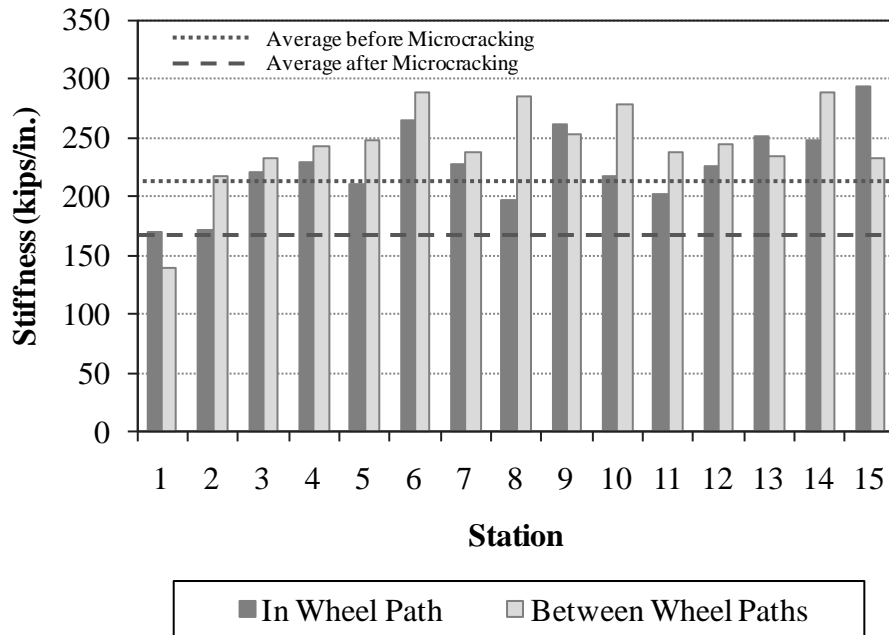
Figure 4.7 Nine-month CTB stiffness (SSG).

The average SSG stiffness values measured during testing are shown in Figure 4.7. The average stiffnesses in the wheel path and between the wheel paths were 226 and 244 kips/in., respectively. These averages are not significantly different from the average CTB stiffness before microcracking but are well above the average stiffness after microcracking. The stiffness in the wheel path was significantly lower than the stiffness between the wheel paths, where the  $p$ -value was 0.0395. According to the SSG test results, 9 months of trafficking was sufficient to cause a significant decrease in CTB stiffness in the wheel paths as compared to that between the wheel paths.

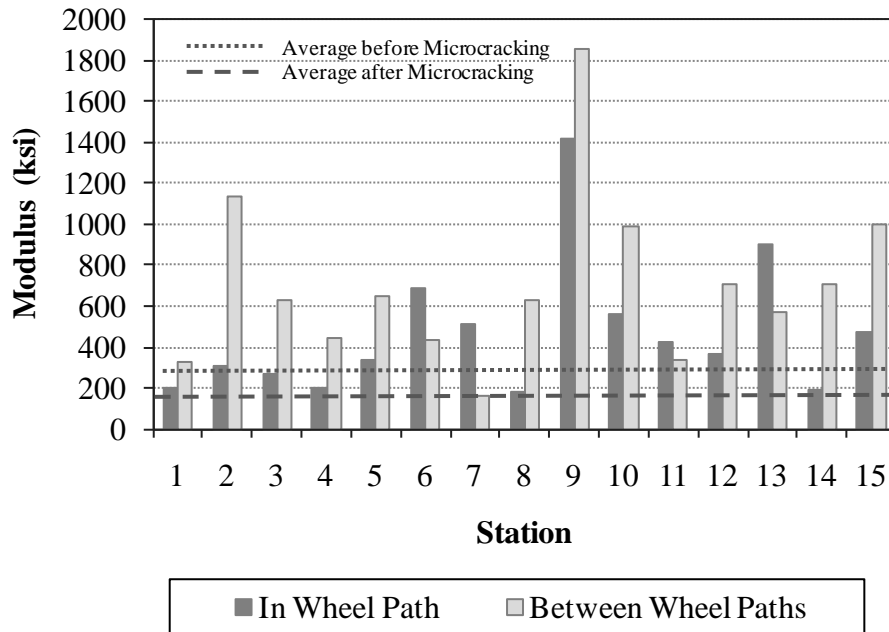
**Figure 4.8 Nine-month CTB modulus (PFWD).**

The average PFWD moduli measured during testing are shown in Figure 4.8. The average moduli in the wheel path and between the wheel paths were 469 and 705 ksi, respectively. These values are well above the average CTB moduli before and after microcracking. The CTB modulus in the wheel path was significantly lower than the

modulus between the wheel paths, where the  $p$ -value was 0.0099. According to the PFWD test results, 9 months of trafficking caused a significant decrease in CTB modulus. Though trafficking had a detrimental effect on modulus that may have been avoided if an HMA surface had been placed, the likelihood of continuing reductions in modulus with future trafficking in the wheel paths is unknown.

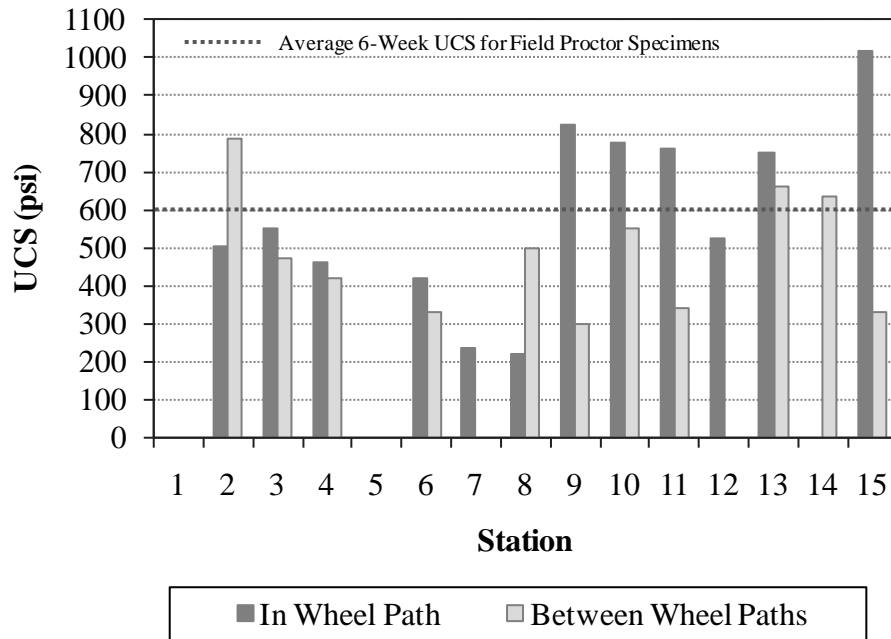
**Figure 4.9 Nine-month CTB UCS.**

The UCS values of cores from in and between the wheel paths are shown in Figure 4.9. Certain cores from in and between wheel paths at locations 1, 5, 7, 12, and 14 could not be extracted intact and were therefore not tested. The average UCS values of the specimens from in the wheel path and between the wheel paths were 587 and 483 psi, respectively. These averages are not statistically different than the average 6-week UCS value of the field-compacted specimens, which represented a theoretical non-microcracked condition. Also, the UCS values of the cores in the wheel path were not significantly lower than the values between the wheel

paths, where the  $p$ -value was 0.9187. That is, insufficient evidence exists to suggest that trafficking caused reductions in UCS.

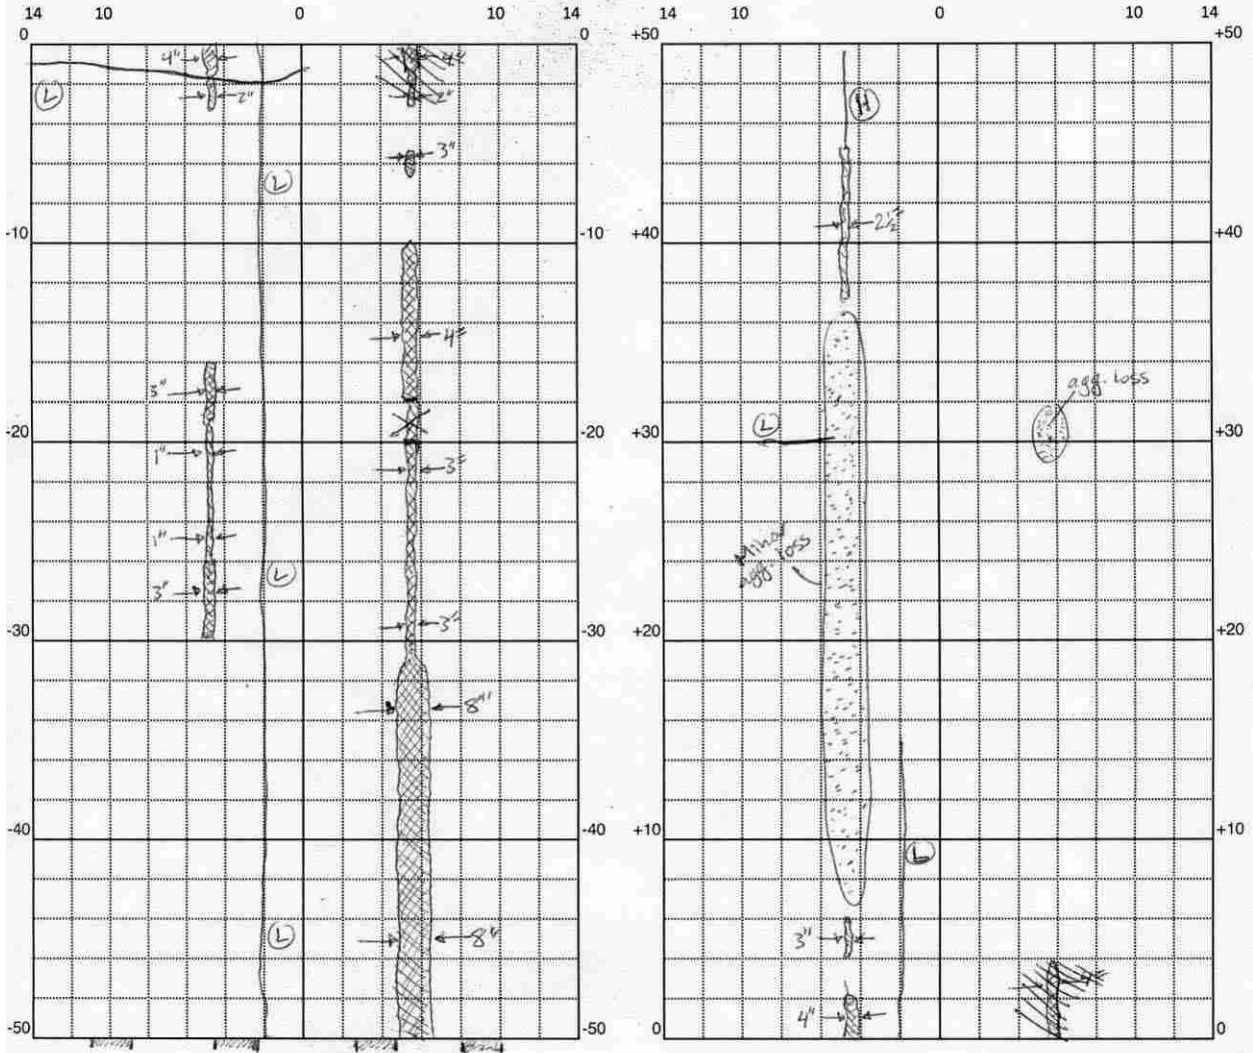
Station	Summary	Surface Temp:
1	Trans: 17 ft L (2) Long NWP: 65 ft L, 5 ft H Long WP = 0 Chip Seal Joint: 21' x 3", 7' x 1", 2' x 2", 8' x 2 1/2", 12' x 4"	85 F

Figure B.1 Nine-month distress survey of station 1.

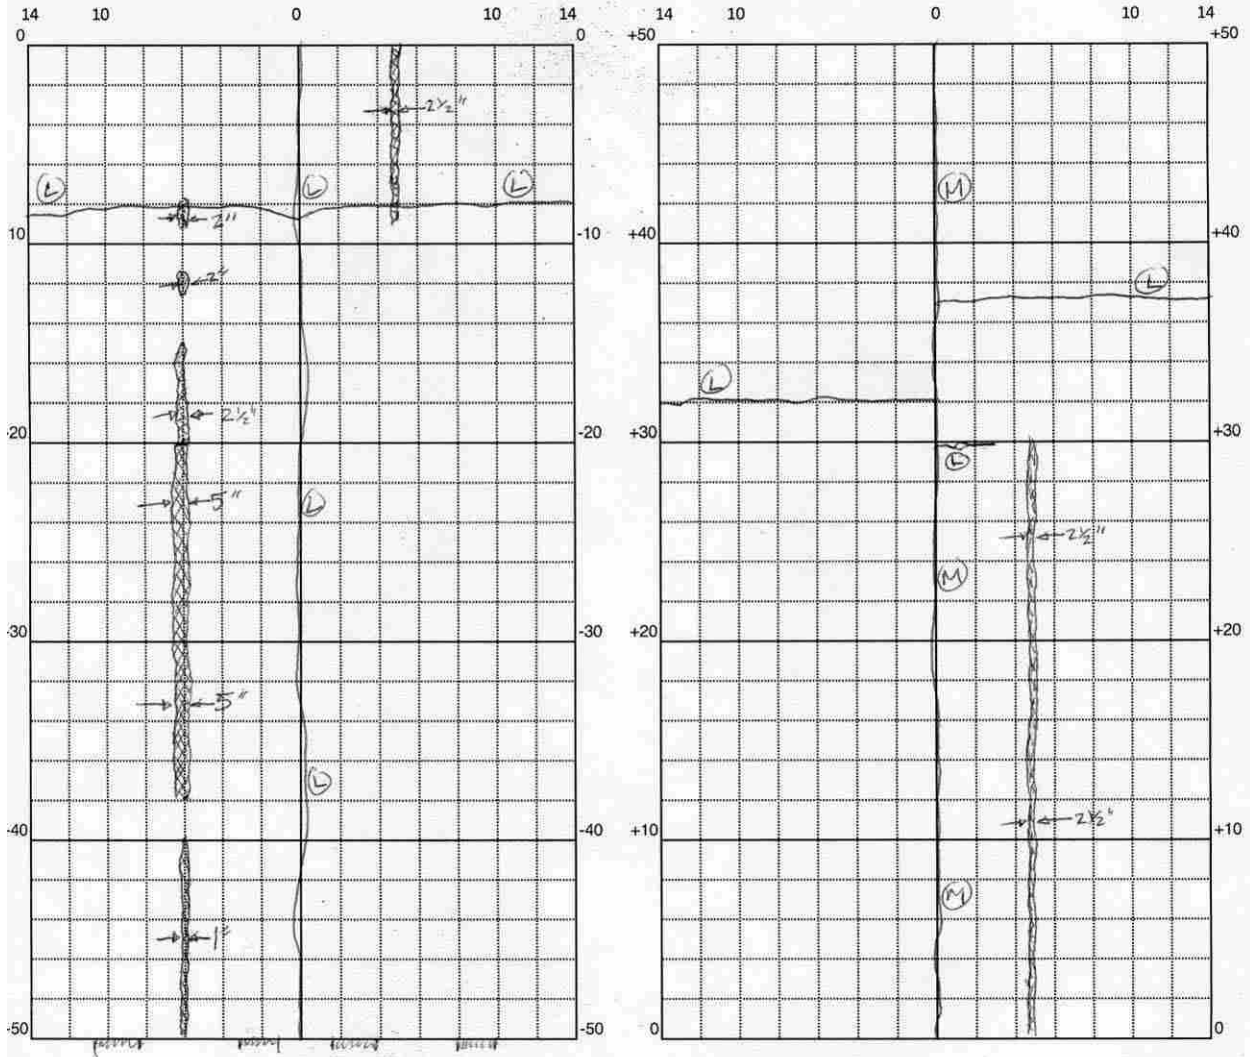
Station	Summary	Surface Temp: 85 F
2	Trans: 59ft L (3) Long NWP: 50 H, 50 H Chip Seal Joint: 10' x 1", 2' x 2", 44' x 2 1/2", 18' x 5"

Comments: Pathhole depth

Figure B.2 Nine-month distress survey of station 2.

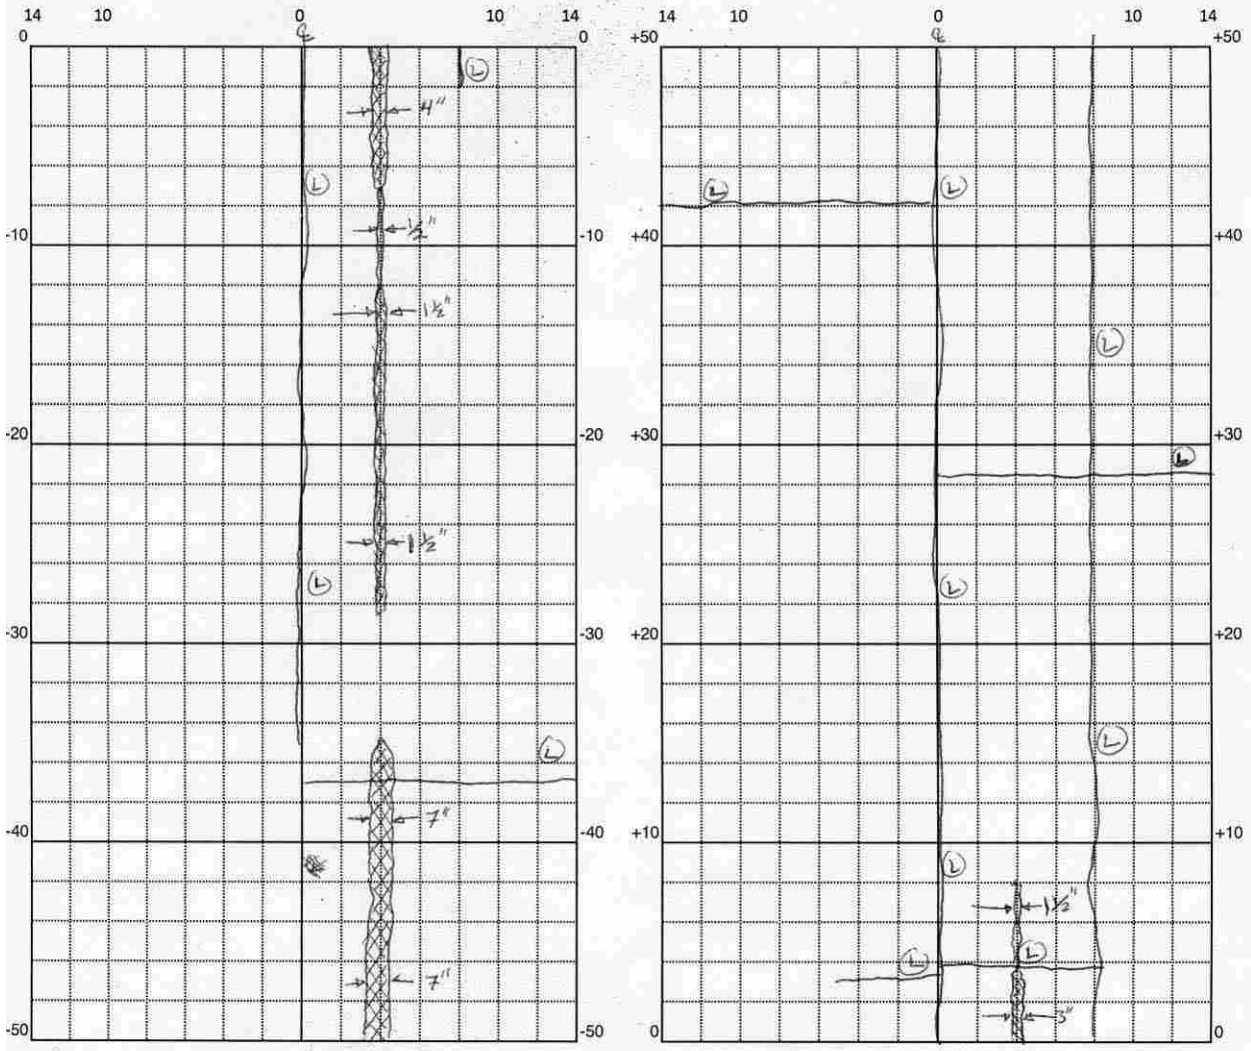
Station	Summary	Surface Temp:
3	NWP Trans: 55 ft (4) Long: 85 ft L Long WP: 52 ft L Chip Seal Joint: 5' x 1/2", 20' x 1/2", 4' x 3", 7' x 4"	75 F

Comments: Longitudinal crack on bound lane is an edge of rutting, not construction joint

Figure B.3 Nine-month distress survey of station 3.

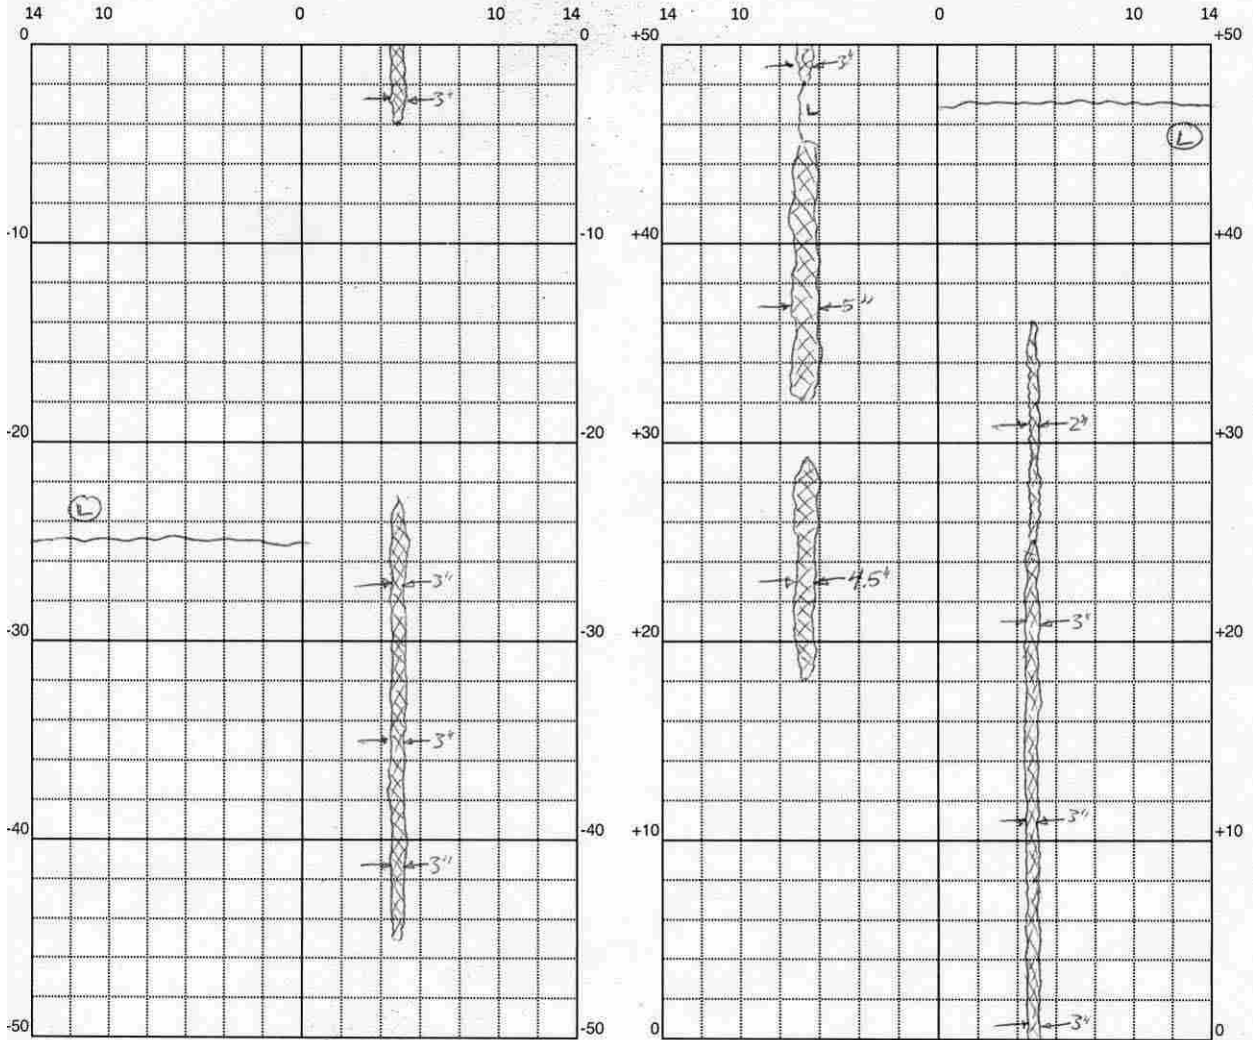
Station	Summary	Surface Temp:
4	Trans: 28 ft L (2) Long NWP: 3 ft L Chip seal Joint: 11' x 2", 53' x 3", 11' x 4 1/2", 13' x 5"	65 F

Figure B.4 Nine-month distress survey of station 4.

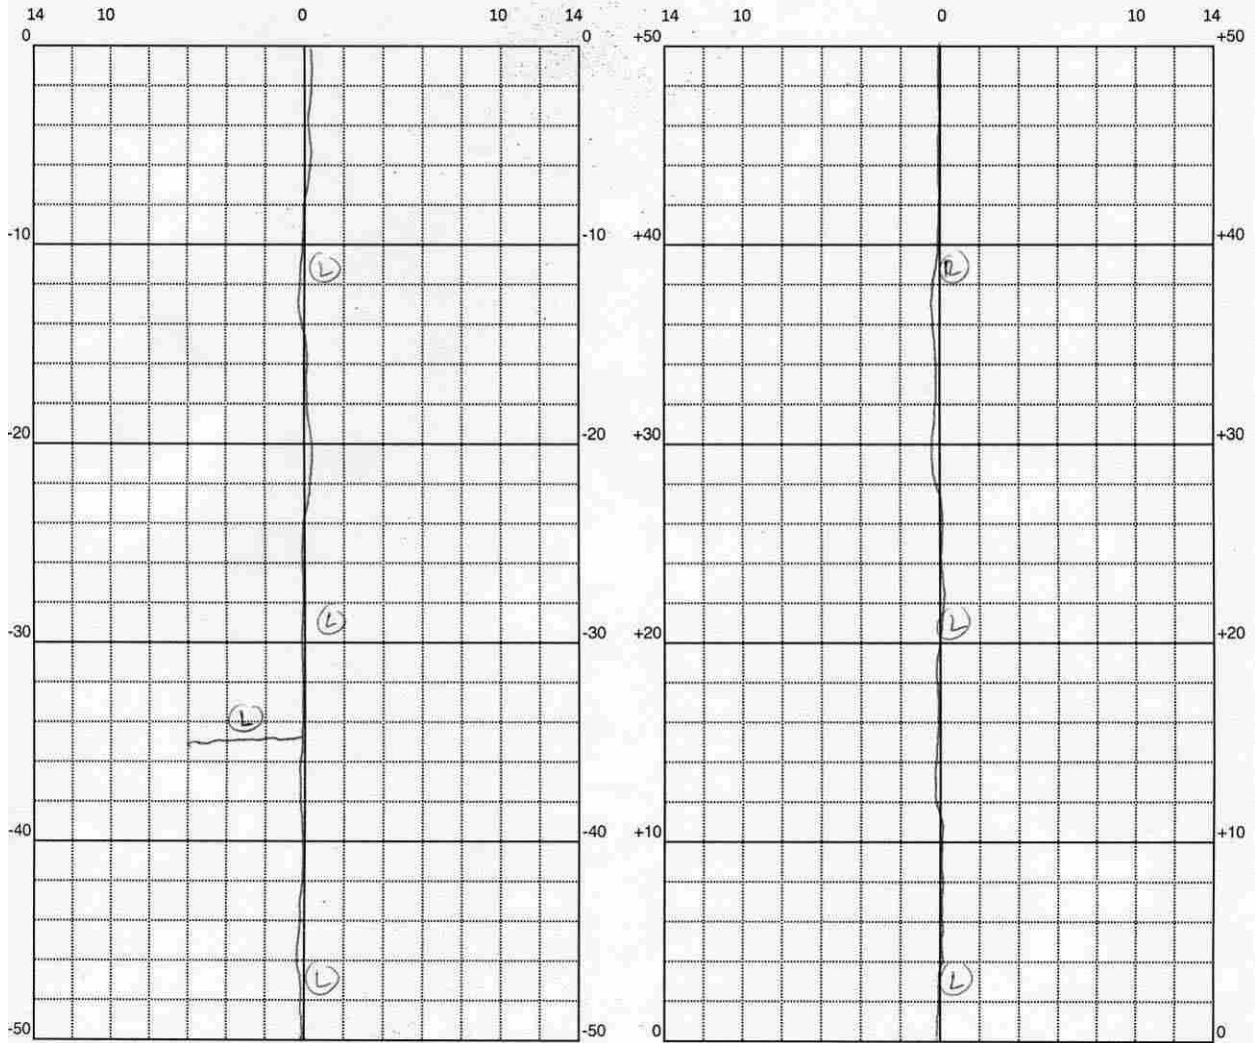
Station	Summary	Surface Temp:
5	Trans: G P+L (1) Long NWP: 100 P+L	67 F

Figure B.5 Nine-month distress survey of station 5.

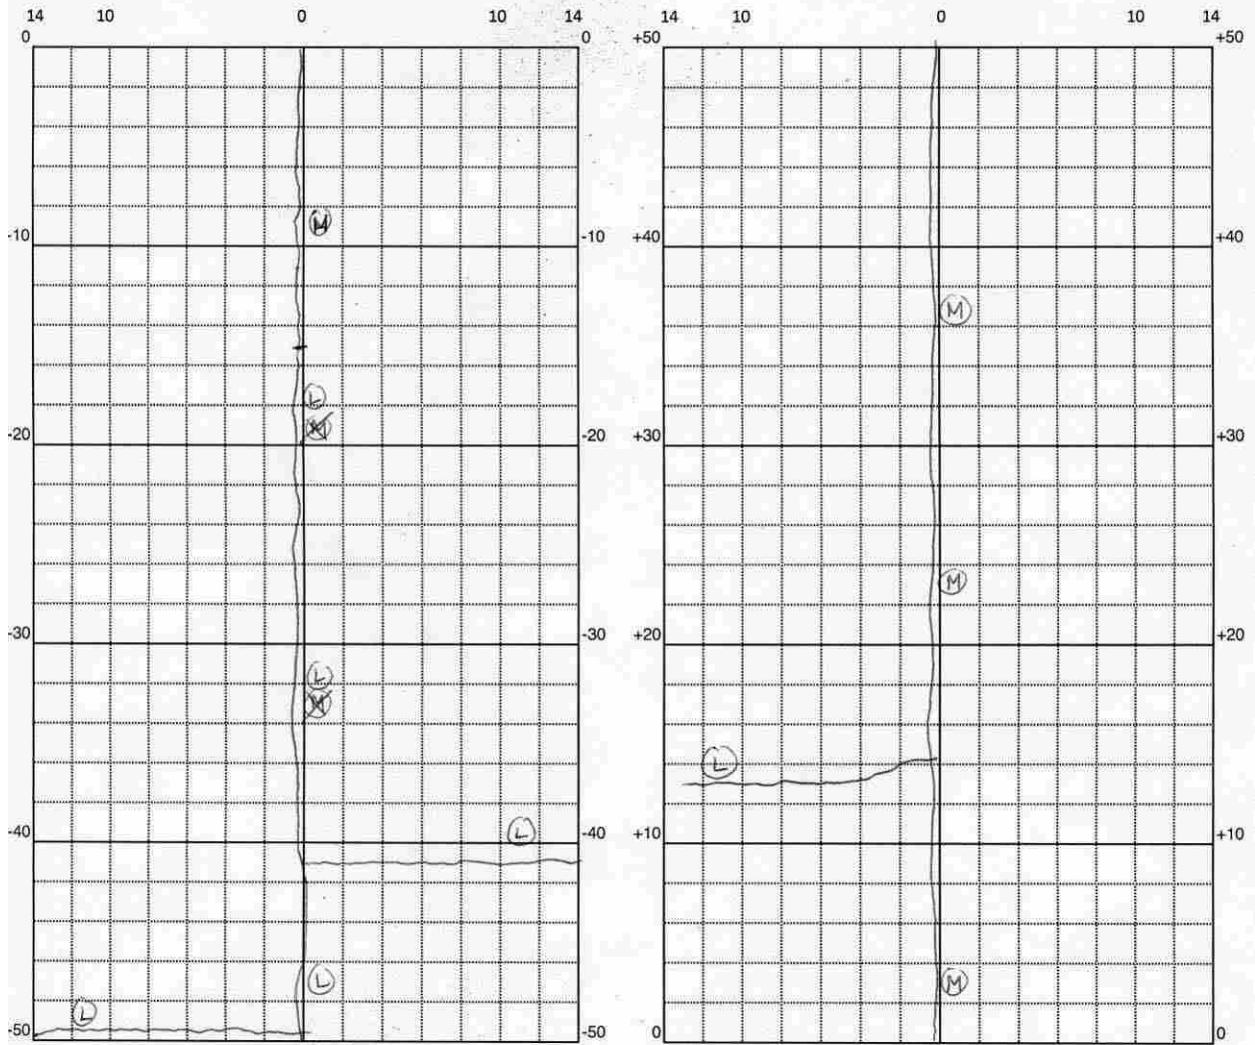
Station	Summary	Surface Temp: 58 F
6	Trans: 41 ft L (3) Long NWP: 35 ft L, 65 ft M

Figure B.6 Nine-month distress survey of station 6.

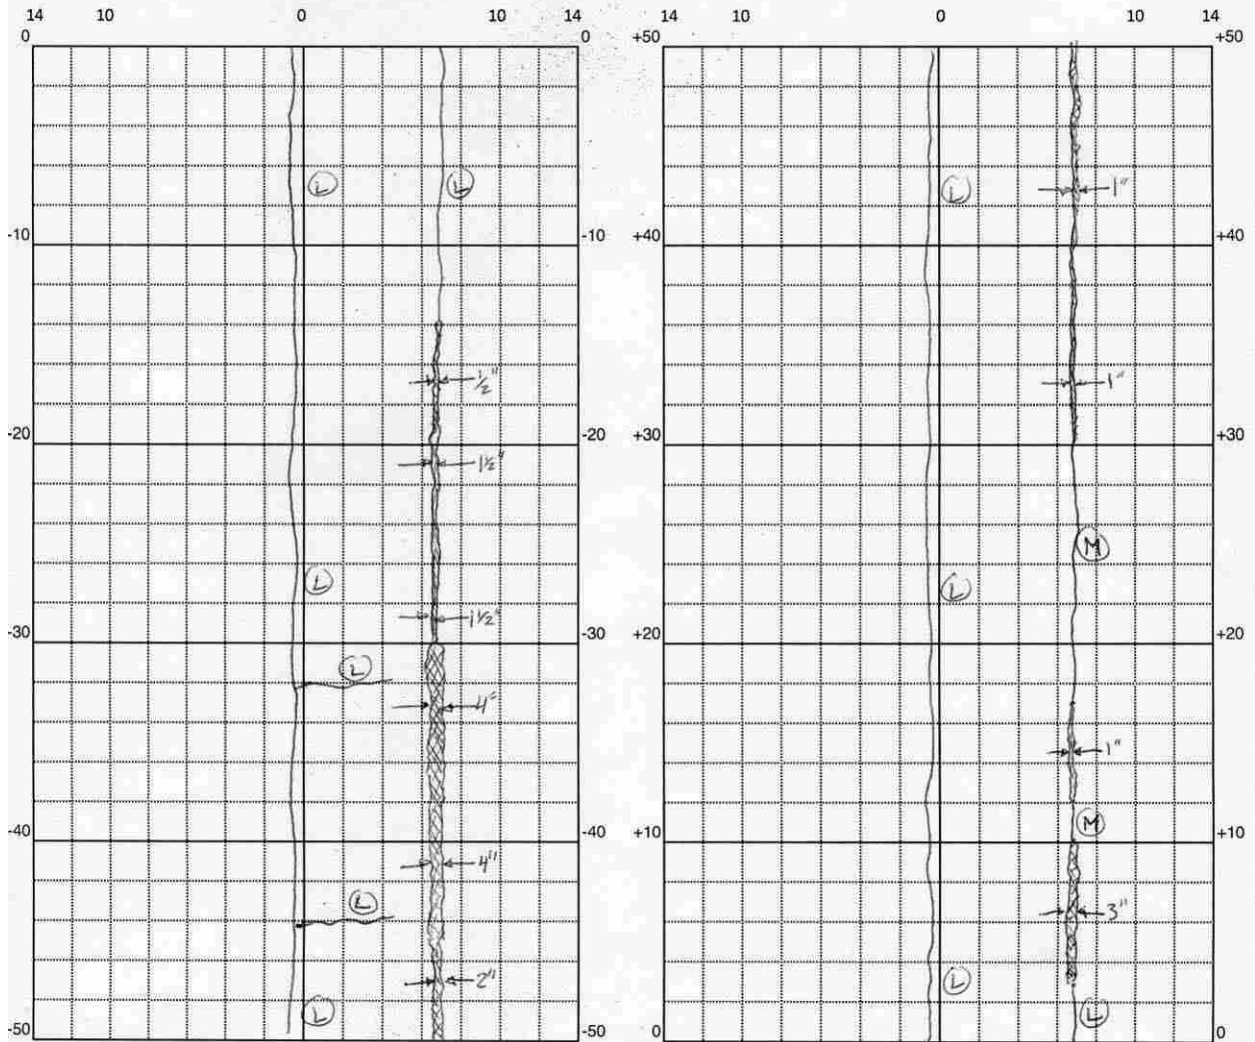
Station	Summary	Surface Temp:
7	Trans: 4 ft L(1) Long NWP: <del>17</del> L, 15 ft M. Chp Seal Joint: 5' x 1/2", 25' x 1", 11' x 1/2", 5' x 2", 7' x 3", 15' x 4"	52 F

Figure B.7 Nine-month distress survey of station 7.
