# Strength and Deformation Characteristics of a Cement-Treated Reclaimed Pavement with a Chip Seal

A thesis submitted to the faculty of  
Brigham Young University  
in partial fulfillment of the requirements for the degree of  
Master of Science

Department of Civil and Environmental Engineering  
Brigham Young University

April 2011

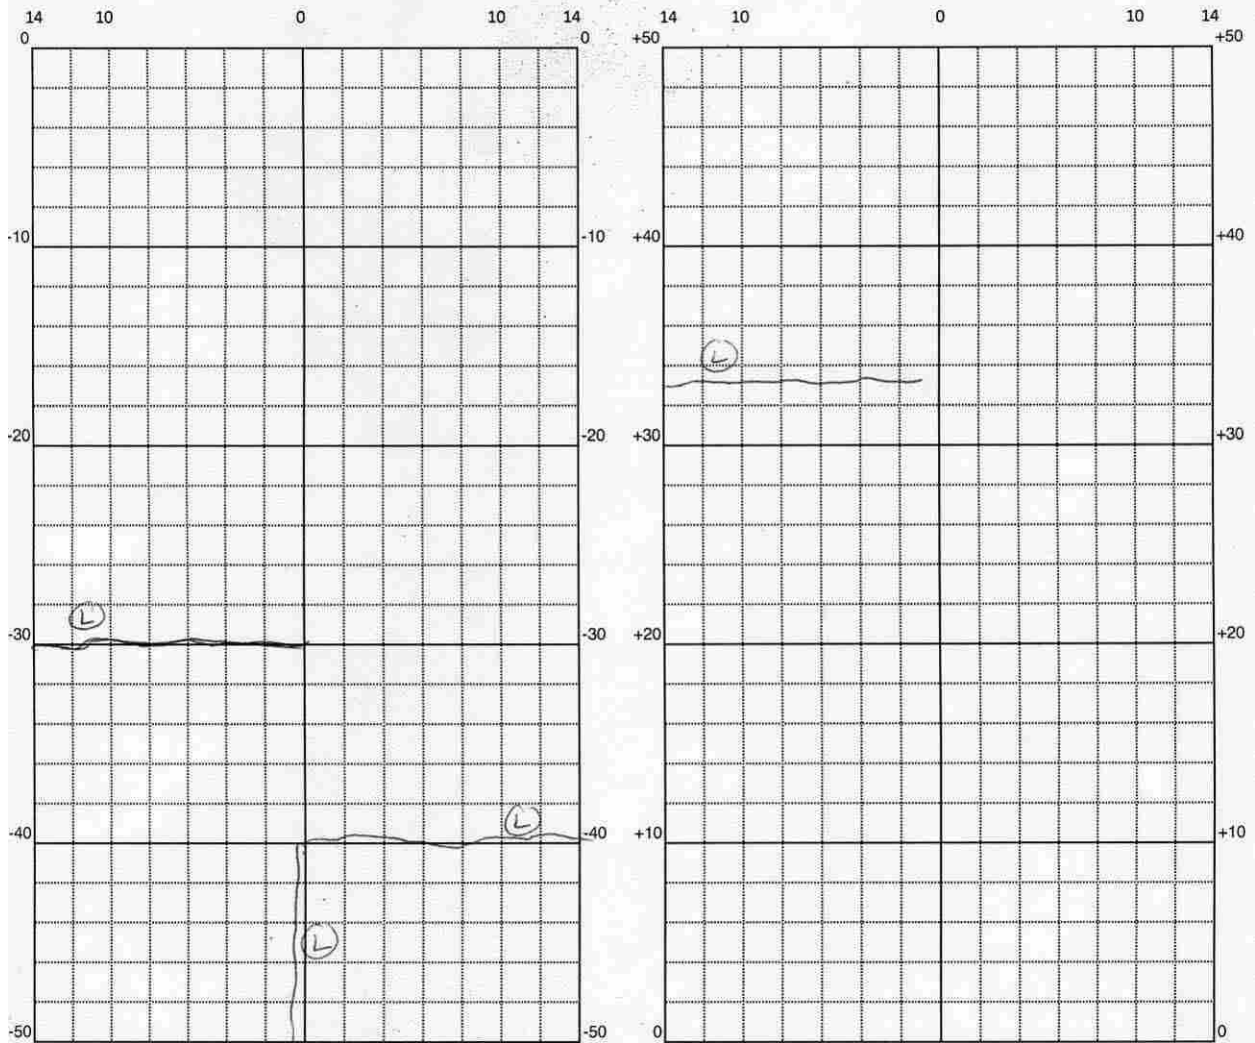
Station	Summary	Surface Temp:
8	Trans: 41 ft L (3) Long NWP: 10 ft L	58 F

Figure B.8 Nine-month distress survey of station 8.

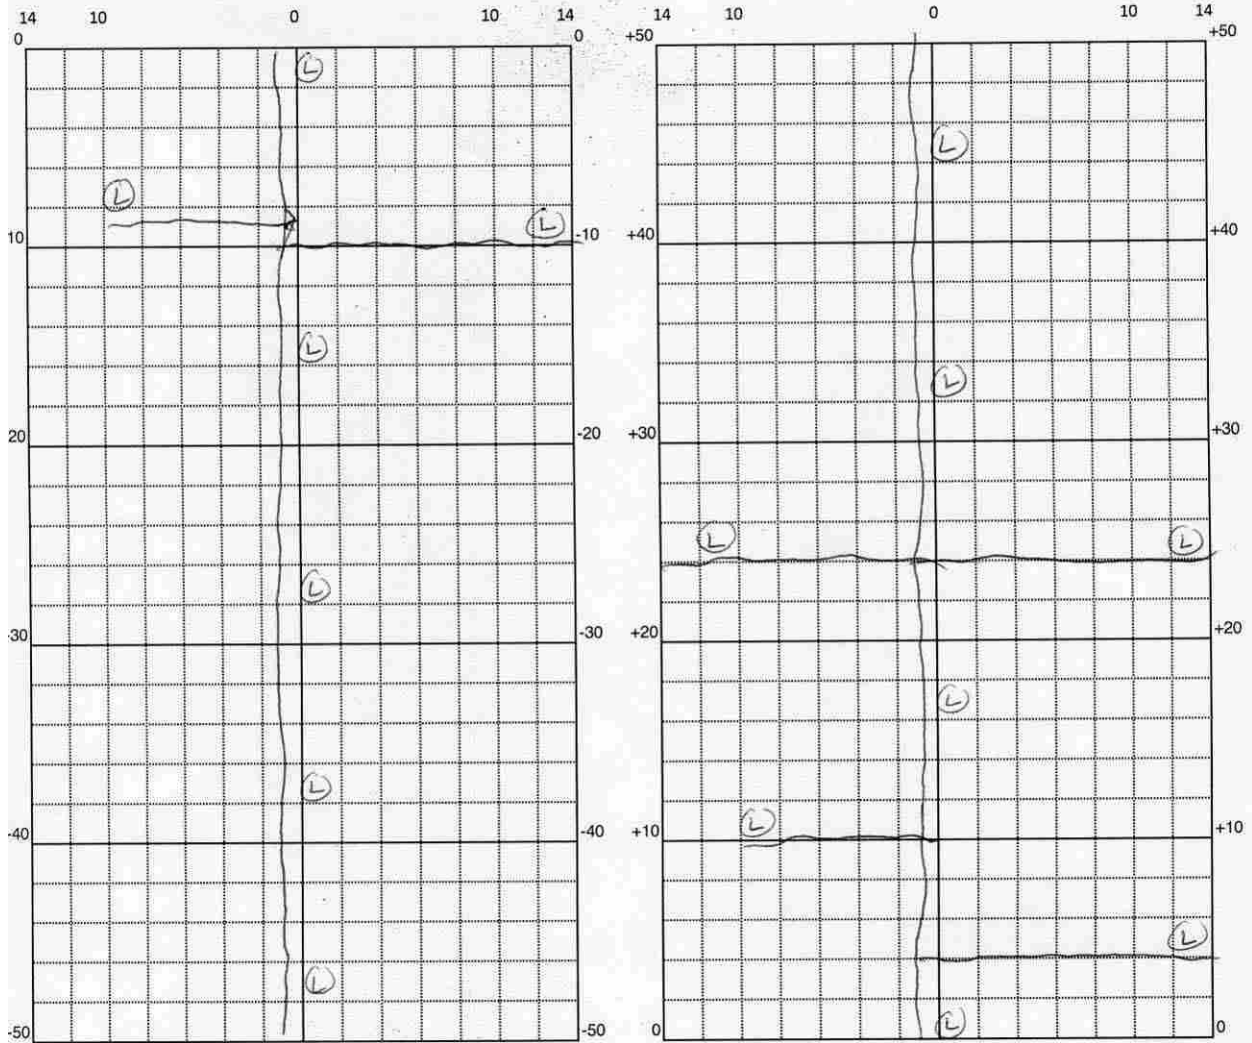
Station	Summary	Surface Temp:
9	Trans: 76 ft L(5) Long NWP: 100 ft L

Figure B.9 Nine-month distress survey of station 9.

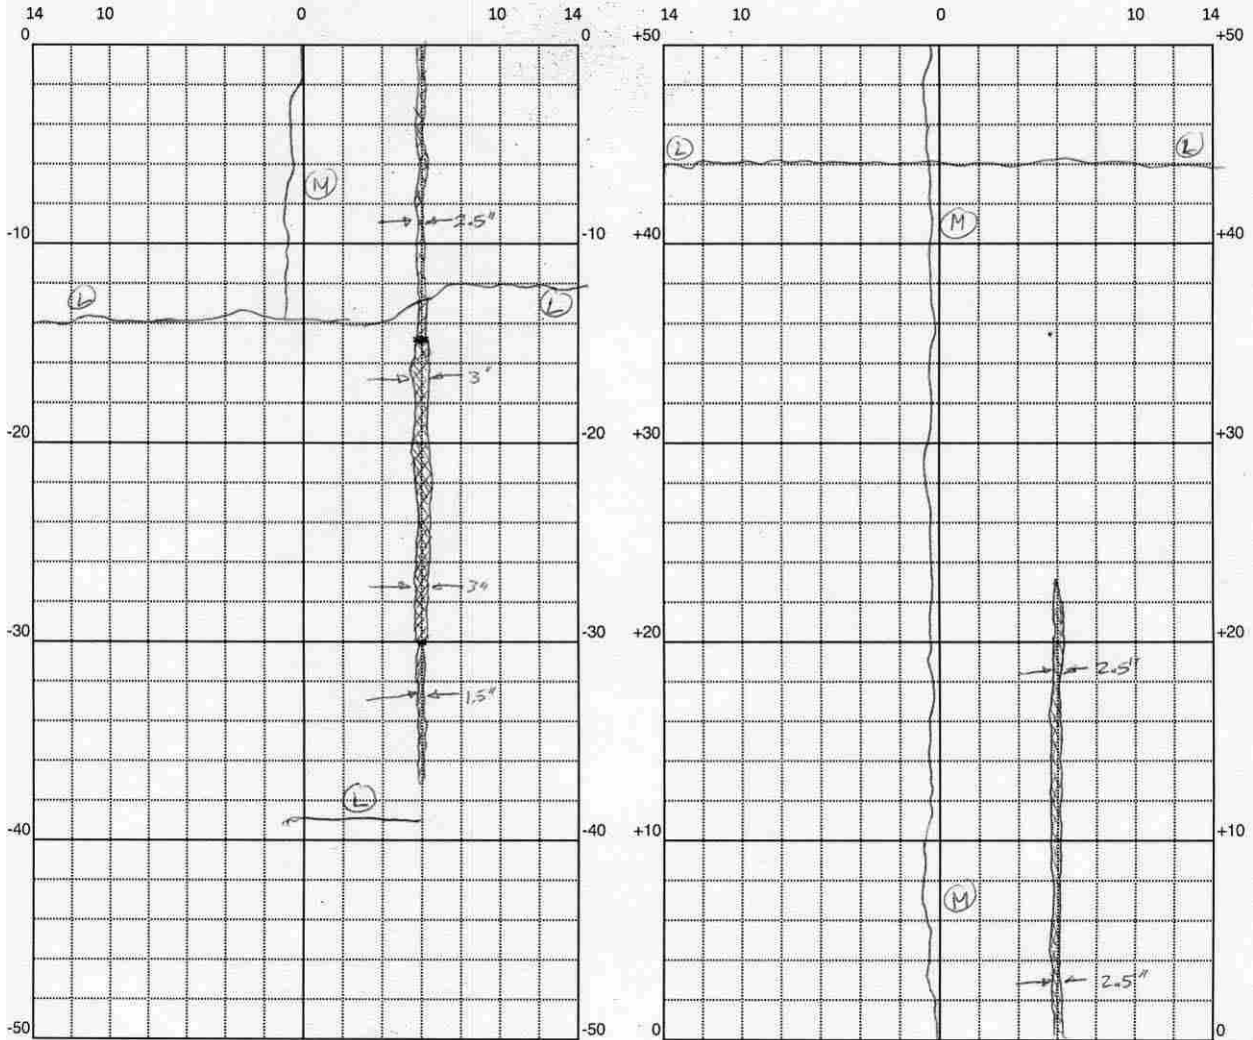
Station	Summary	Surface Temp:
10	Trans: 63 ft L (3) Long NWP: 62 ft M Chip Seal Joint: 7' x 1.5", 38' x 2.5", 15' x 3"	65 F

Figure B.10 Nine-month distress survey of station 10.

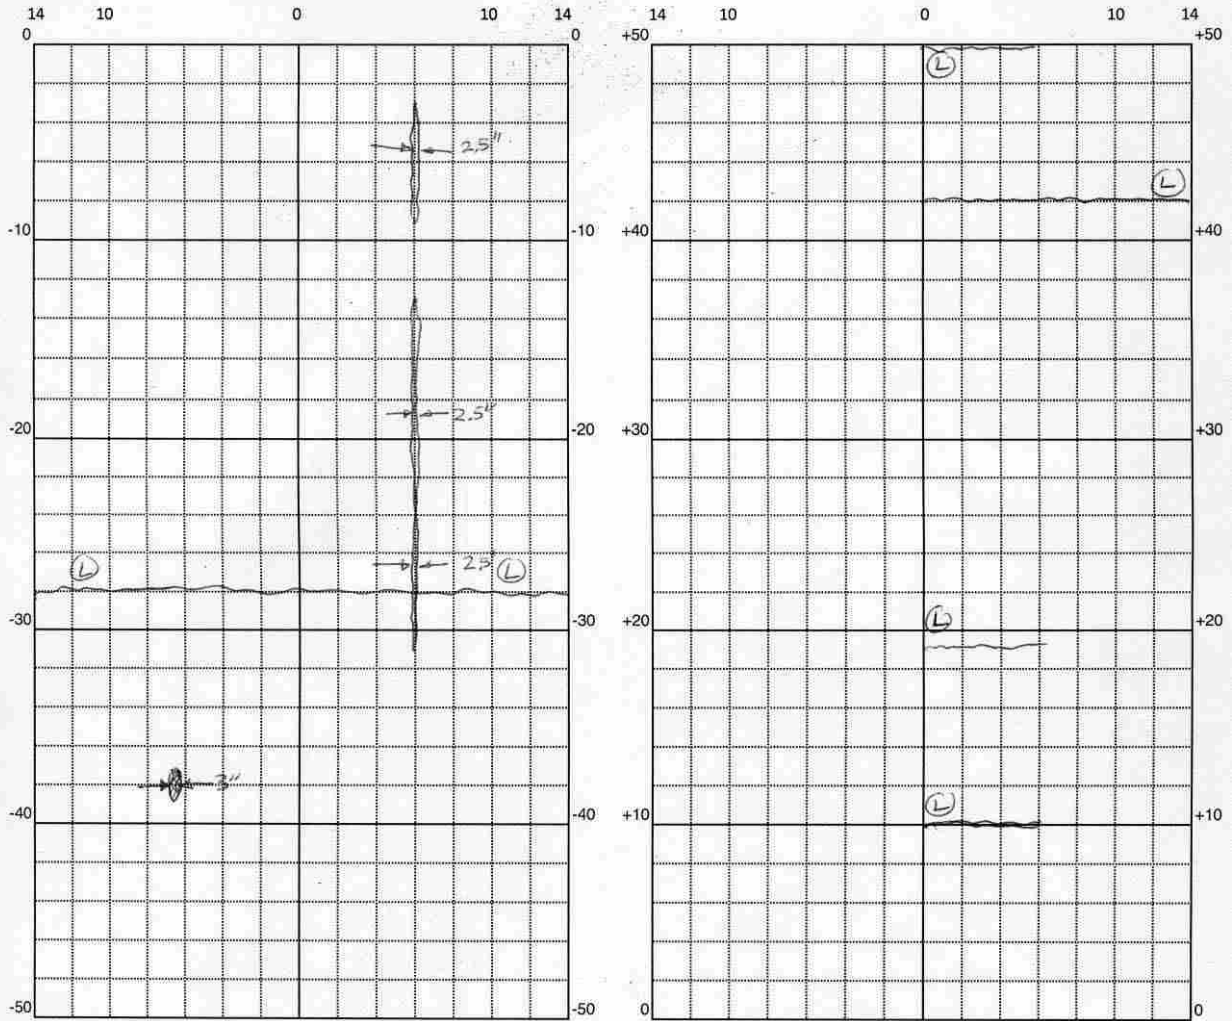
Station	Summary	Surface Temp:
11	Trans: 60 ft L (5) Chip Seal Joint: 24' x 2.5"; 2' x 3"

Figure B.11 Nine-month distress survey of station 11.

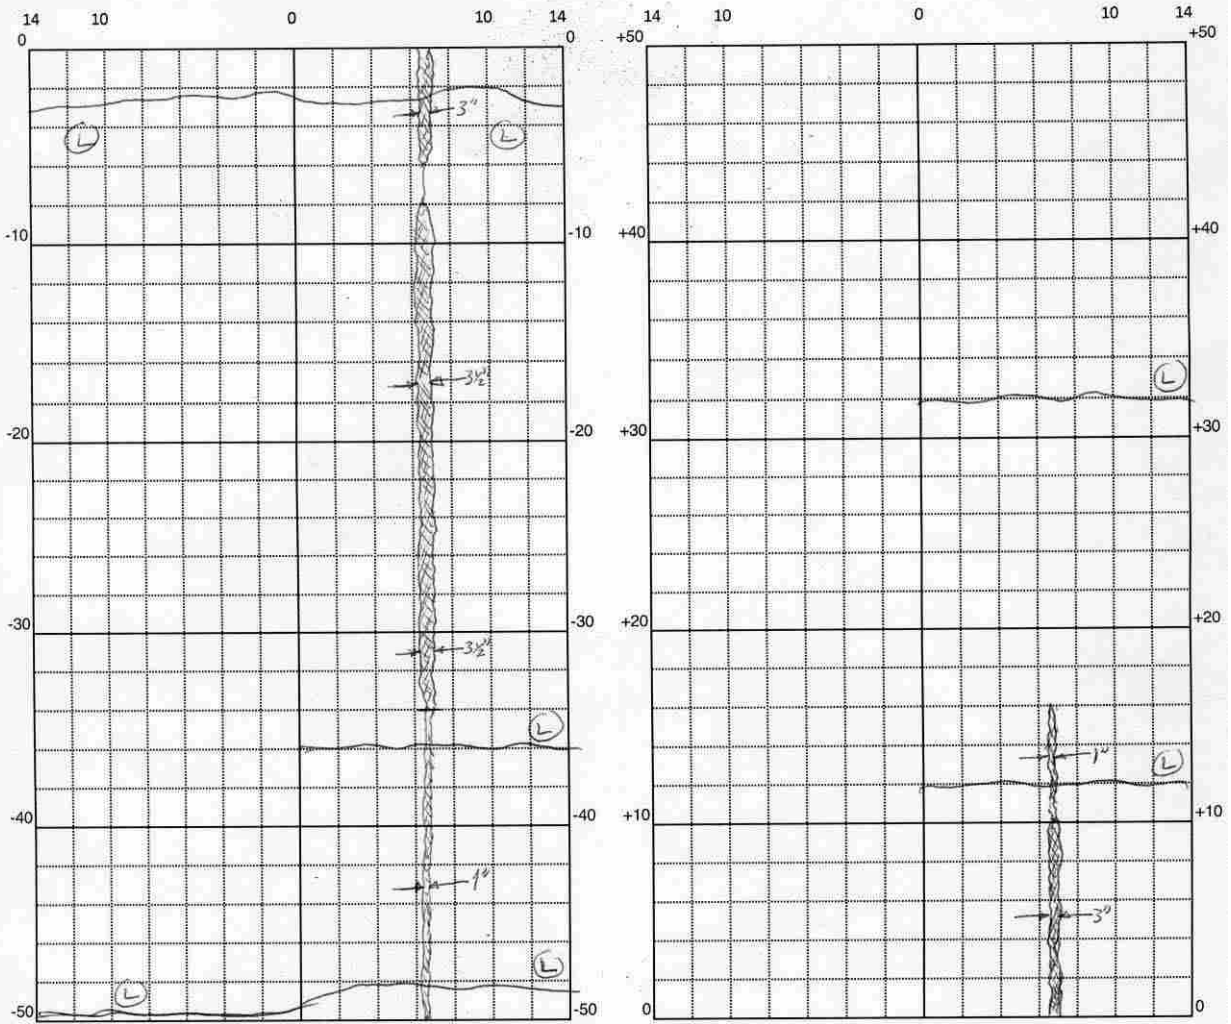
Station	Summary	Surface Temp:
12	Trans: 98 ft L (5) Long NWP: 2 ft L Chip Seal Joint: 22' x 1", 16' x 3", 26' x 3 1/2"

Figure B.12 Nine-month distress survey of station 12.

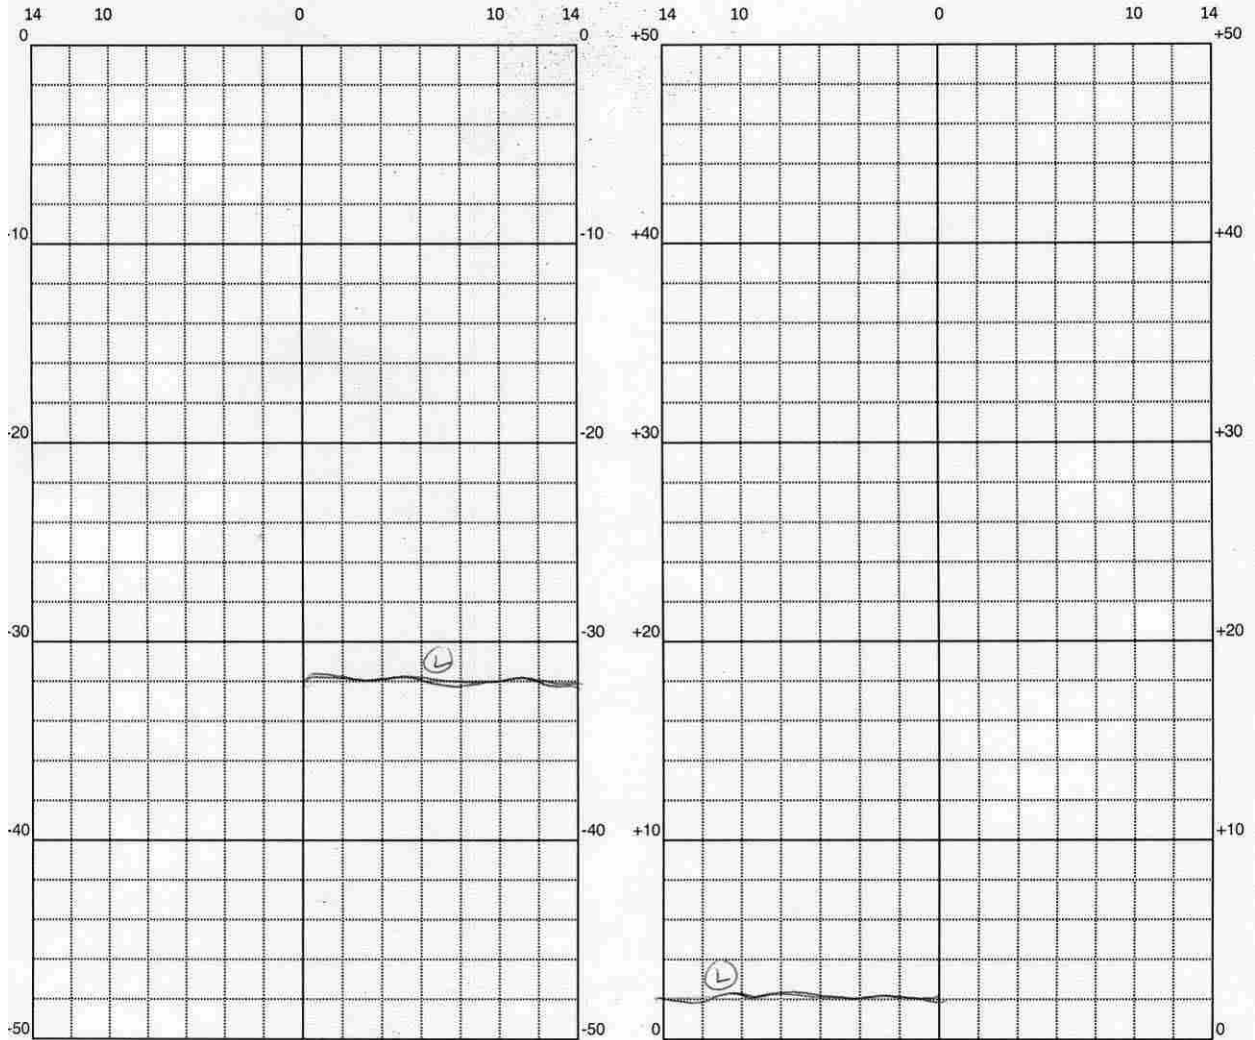
Station	Summary	Surface Temp:
13	Trans: 28 ft L(2)

Figure B.13 Nine-month distress survey of station 13.

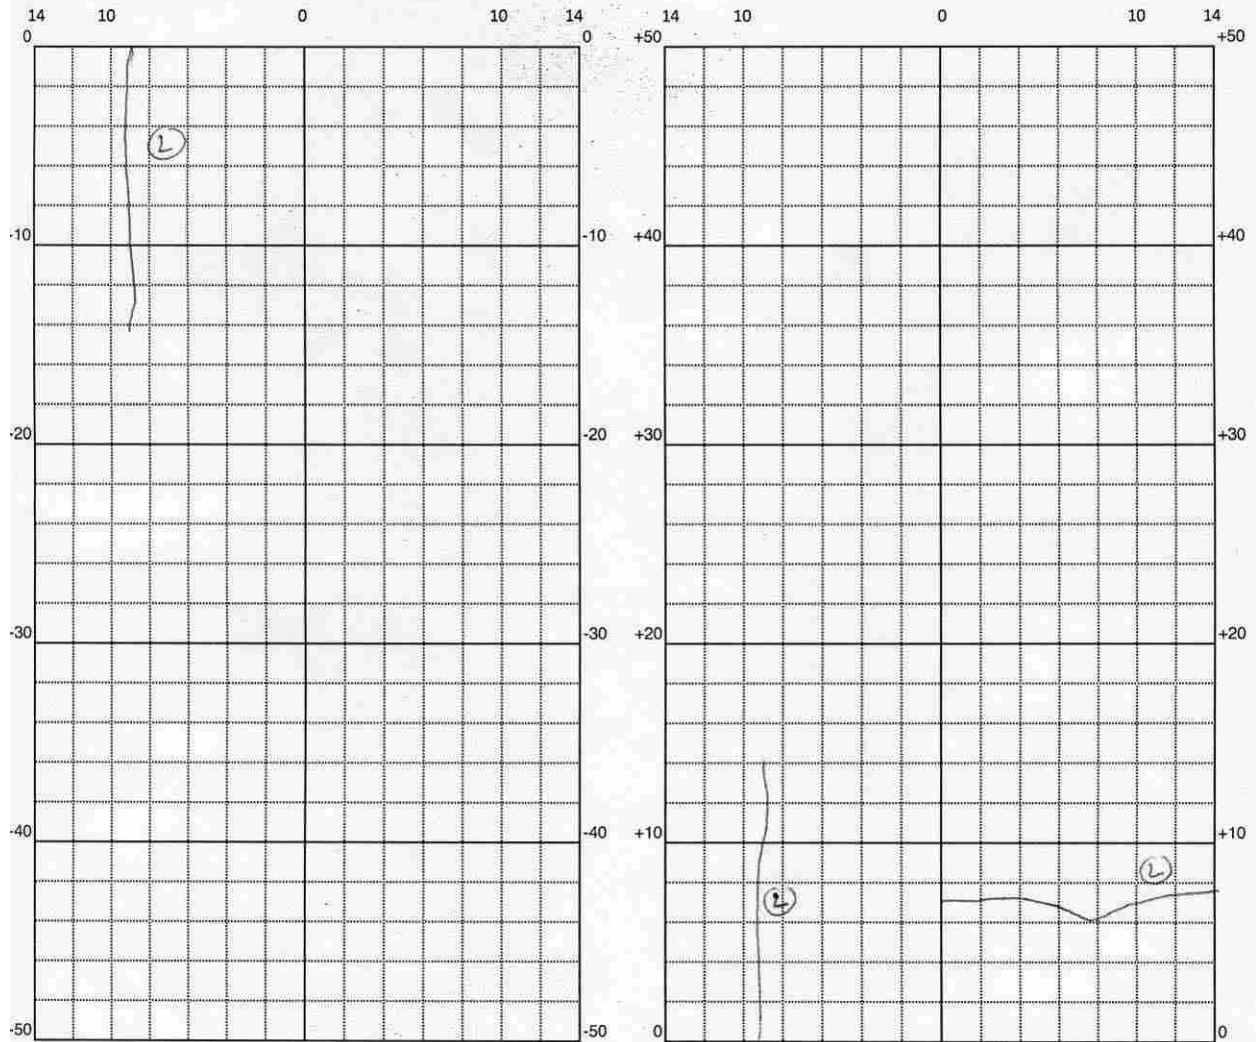
Station	Summary	Surface Temp:
14	Trans: 14 ft (L) Long WP: 28 ft L

Figure B.14 Nine-month distress survey of station 14.

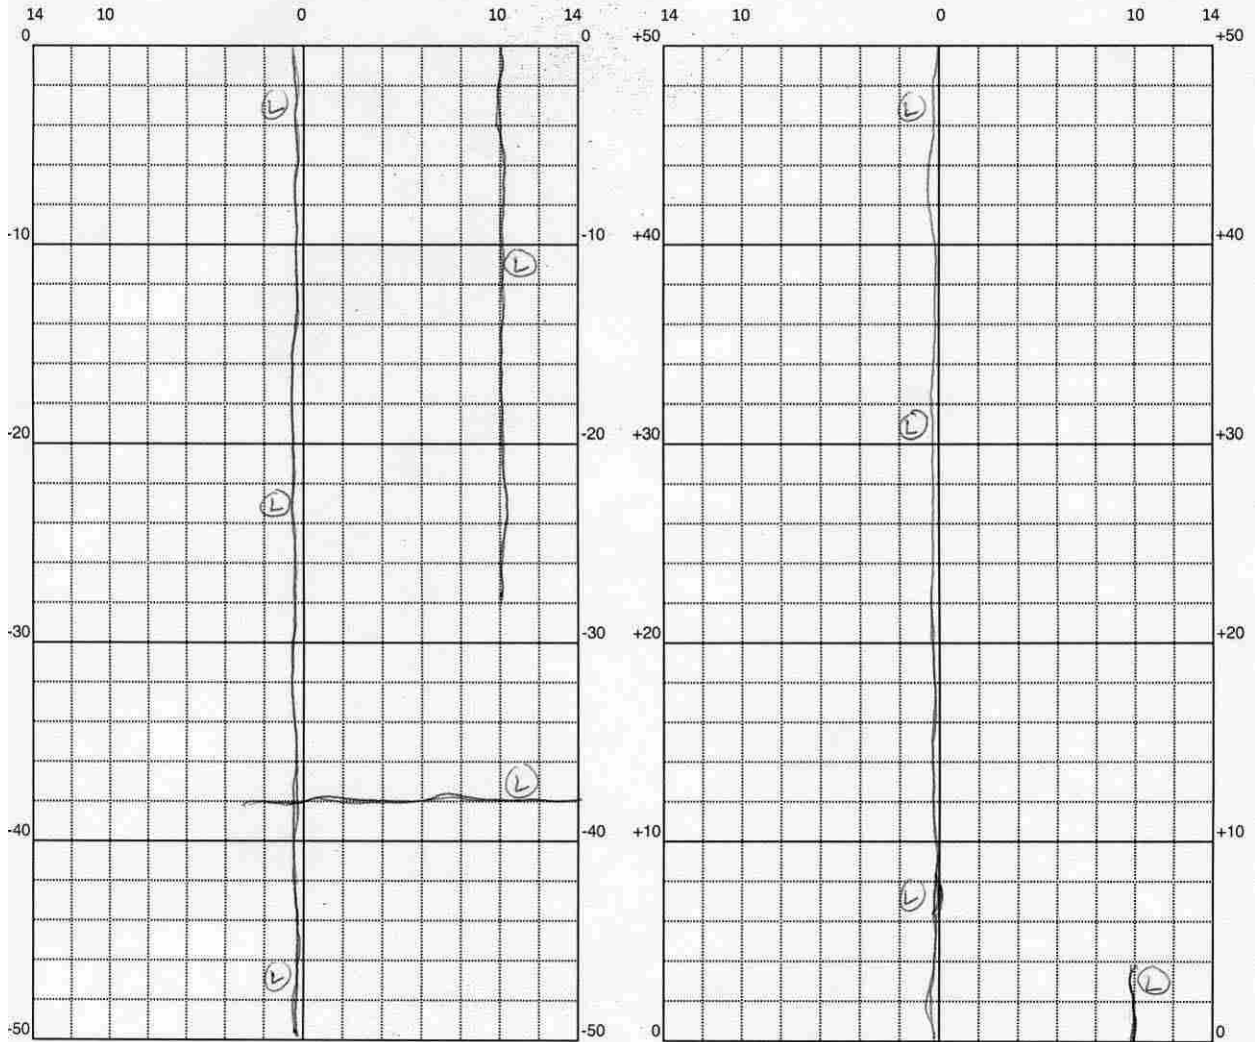
Station	Summary	Surface Temp:
15	Trans: 17 ft L (1) Long NWP: 100 ft L Long WP: 32 ft L

Figure B.15 Nine-month distress survey of station 15.
