# Evaluation of the Effectiveness of a Variable Advisory Speed System on Queue Mitigation in Work Zones

A thesis submitted to the faculty of  
Brigham Young University  
in partial fulfillment of the requirements for the degree of

Department of Civil and Environmental Engineering

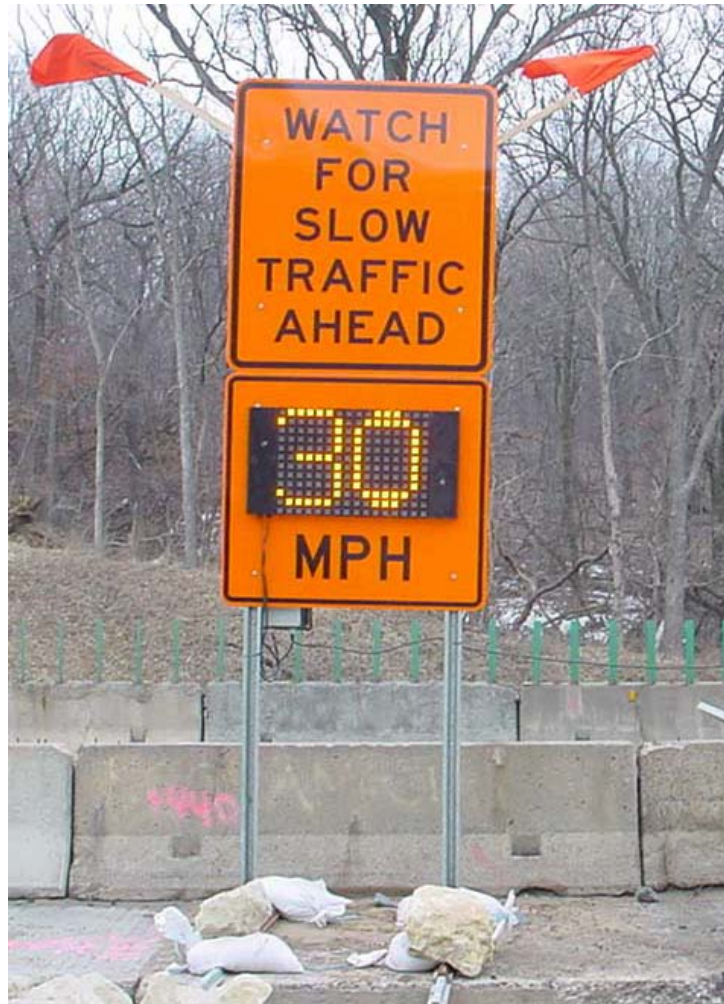
**Figure 2-1 Example of variable message sign on study site (Kwon et al. 2007).**

Most research found during the literature review was done using a VSL system. Although similar in concept a VSL is more restrictive than the scope of the VASS evaluated in this study. Therefore, this study concludes that minimal research has been done on VASSs used for queue mitigation in work zones. Due to the increasing need to find ways to better control traffic flow in work zones more research was needed on the topic of advisory speeds. This study used a VASS in a work zone entrance to evaluate the effectiveness of the VASS at mitigating queues. A similar study was done using the resemblance of advisory speeds (See Figure 2-1) by Kwon et

al. (2007). The use of orange signs instead of white was a step in the right direction. More specific direction on the fact that the speed was advisory would be helpful for drivers. Therefore, in this study on VASSs VMSs will give the drivers the advisory speed for approaching the work zone entrance.

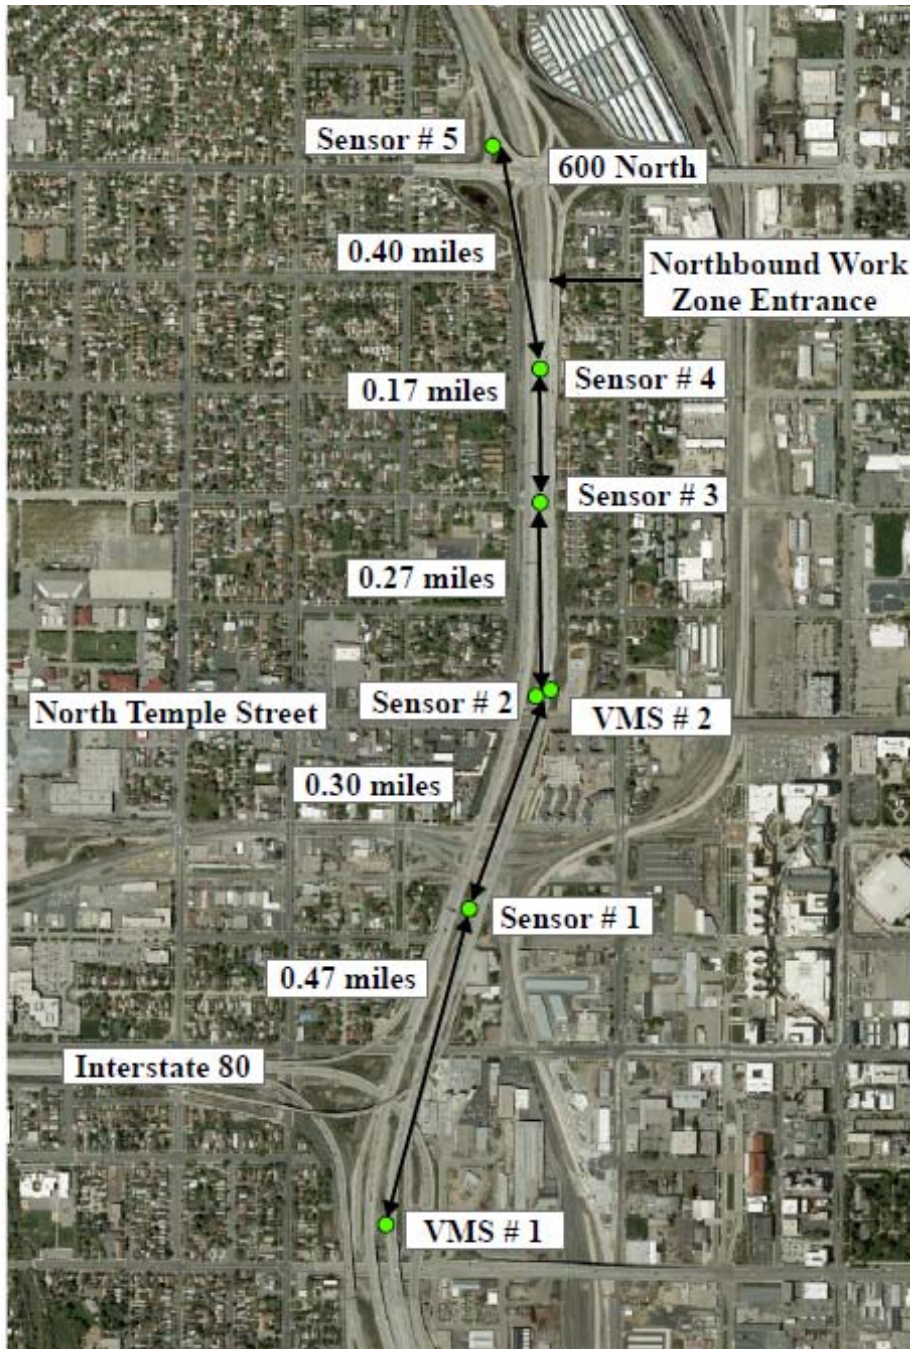
Figure 3-1 Sensor locations (background image by AGRC 2011).

During the site visit on February 23, 2010, general areas were outlined and specific locations for the sensors and VMSs were selected. The layout found in Figure 3-1 was then updated to reflect the actual locations where sensors or VMS boards would be placed. In addition to designating the location of sensors and VMSs the specific locations were painted so it

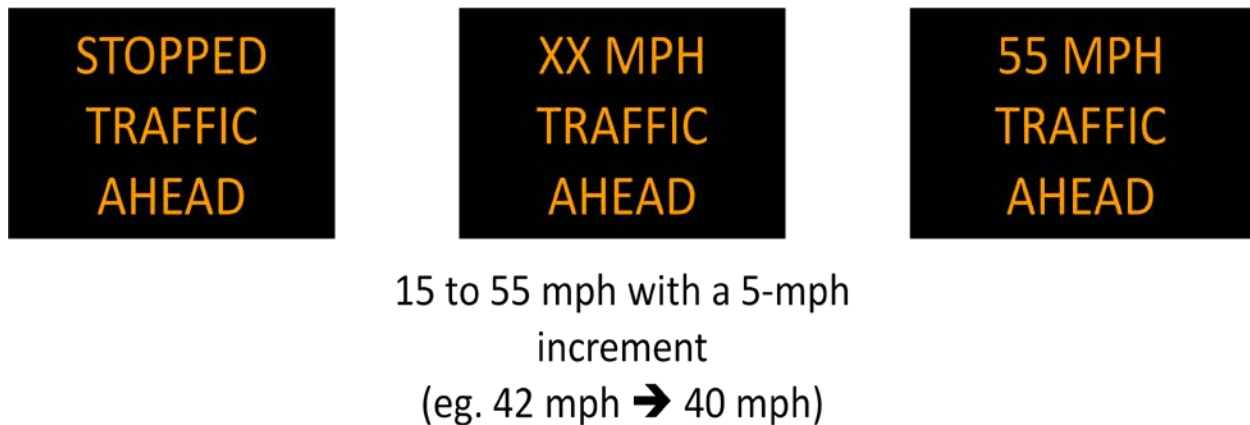
Figure 3-2 Sample of VMS sign images.

In a TAC meeting on February 9, 2010, the decision was made regarding the message that the VMS would display during different degrees of slowdown. It was decided that at speeds at or above 55 MPH the VMS would display, in three lines of text, “55 MPH TRAFFIC AHEAD,” for speeds between 15 mph and 55 mph the message would round down to the nearest 5 mph speed and display, again in three lines, “XX MPH TRAFFIC AHEAD,” where the “XX” represented the lowest average speed rounded down to the nearest 5 mph. For speeds below 15 mph the VMS would display, again in three lines, “STOPPED TRAFFIC AHEAD.” An example of what the VMS would look like is presented in Figure 3-2.

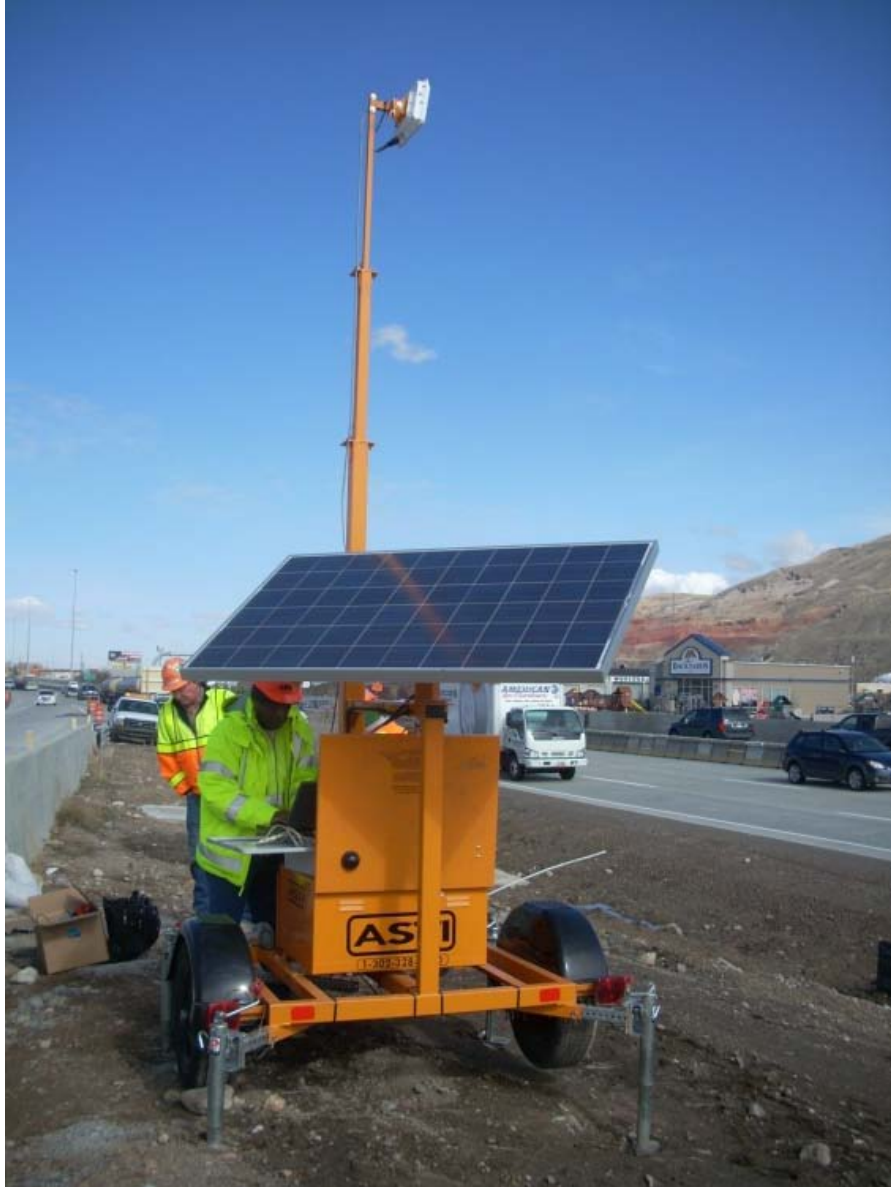
**Figure 3-3 Final location for sensor 5 (taken by Mitsuru Saito).**

After the sensors were placed in the designated locations each sensor had to be aligned, leveled, and calibrated to gather data from only the lanes of active traffic. This was done using software provided by ASTI. The sensors had to be perpendicular to the vehicles that passed by and the software could tell if the sensor was properly aligned. Additionally the sensor trailers were leveled using a carpenter's level. After the sensors were aligned and leveled they then needed to be calibrated to gather only the data from the lanes with active traffic.

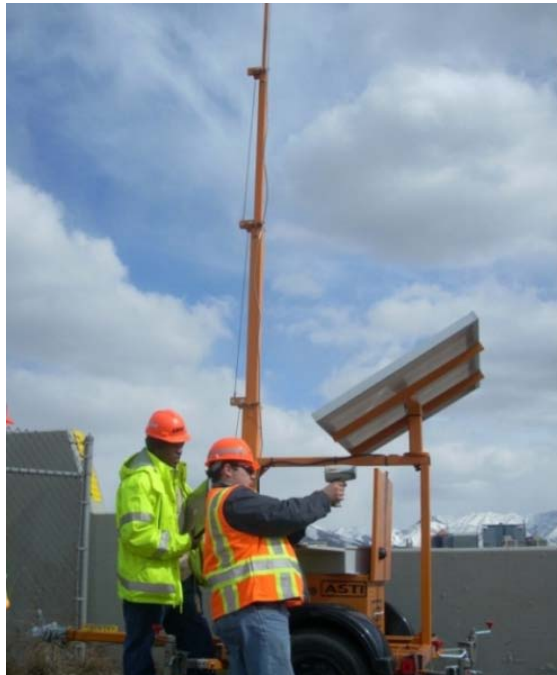
Figure 3-4 Sensor calibration using radar gun (taken by Mitsuru Saito).

The calibration was done by using a radar gun to measure the speed of an approaching vehicle and then verifying the correct speed showed up on the sensor. Figure 3-4 shows the radar gun being used to verify the speed of approaching vehicles. Figure 3-5 shows the lane configuration of sensor 2 during calibration. Using Figure 3-4 and Figure 3-5 as an example, the radar gun was used to measure the speed of a vehicle in lane four traveling about 65 mph and then the lane configuration was monitored on the computer to verify that the sensor recorded a

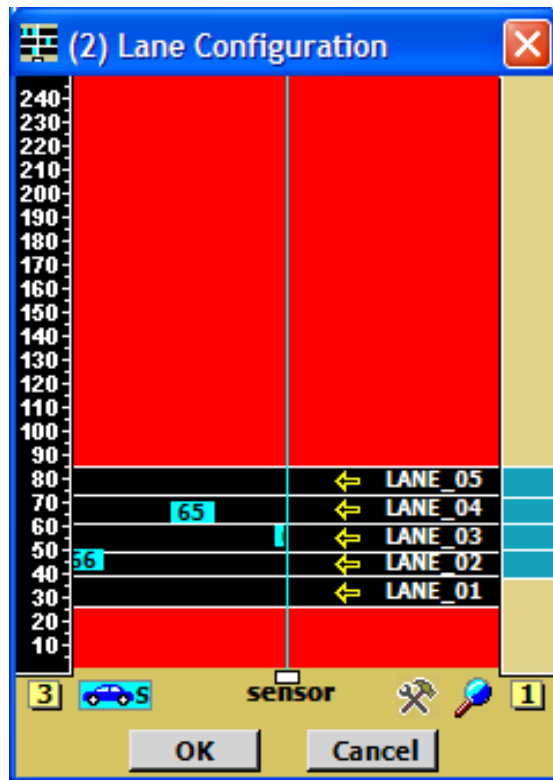
Figure 3-5 Calibration of sensor 2 using computer.

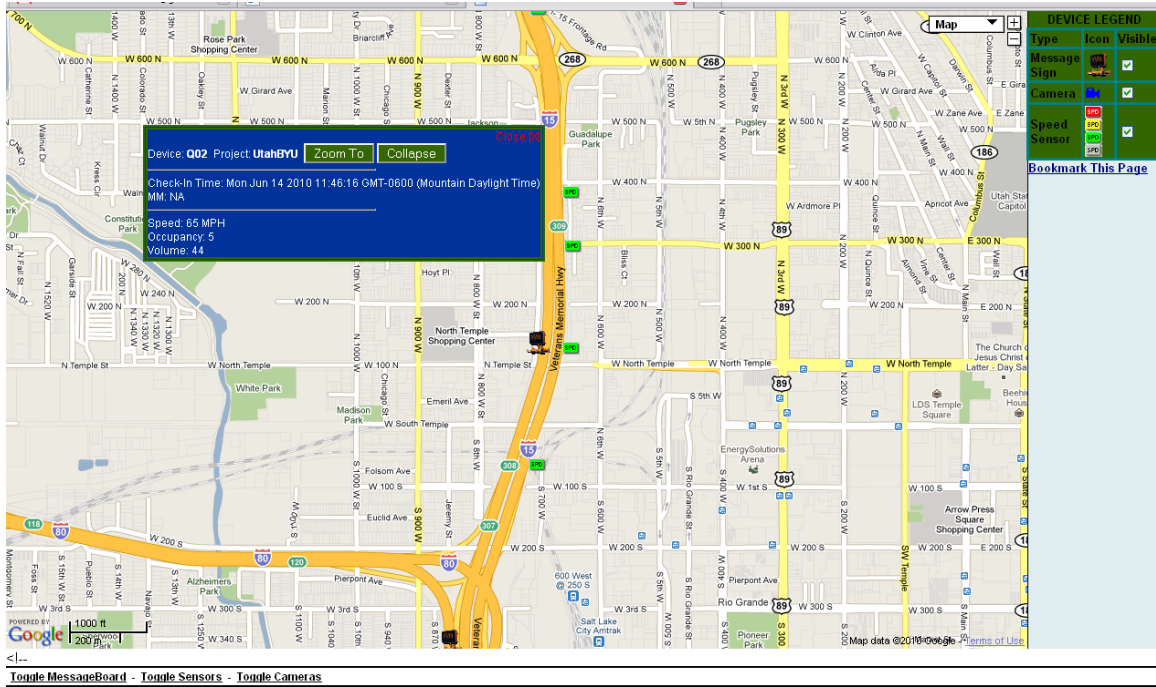
Figure 3-6 Example of system web site for sensor verification.

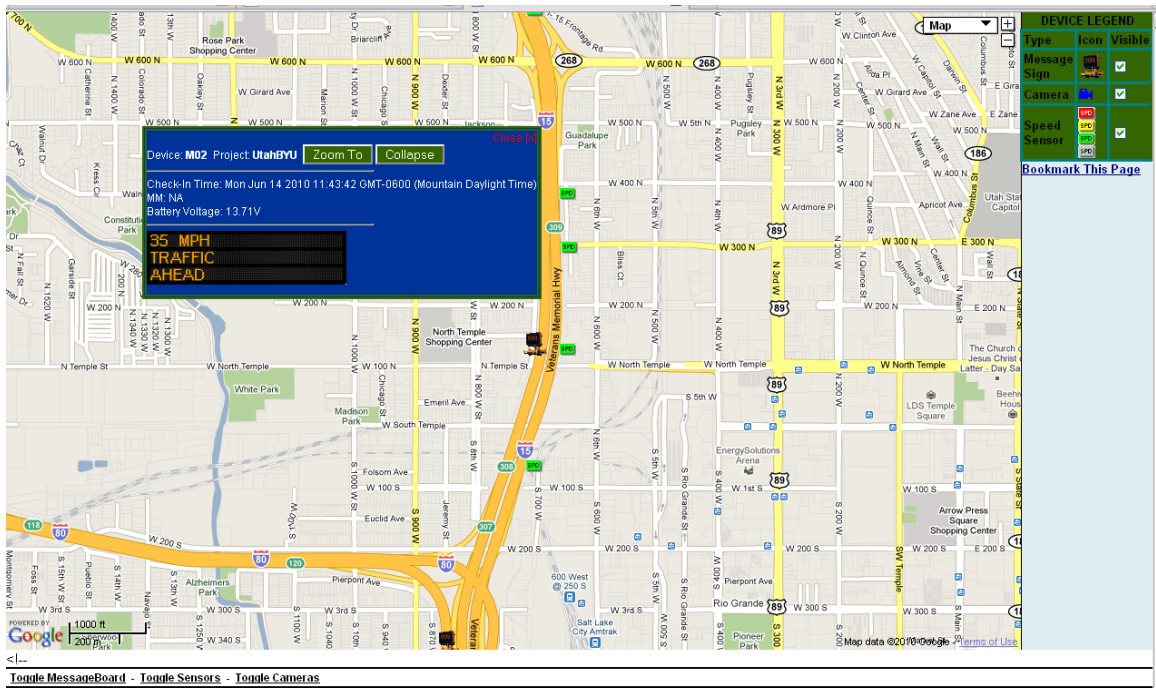
Figure 3-7 Example of system web site for VMS verification.

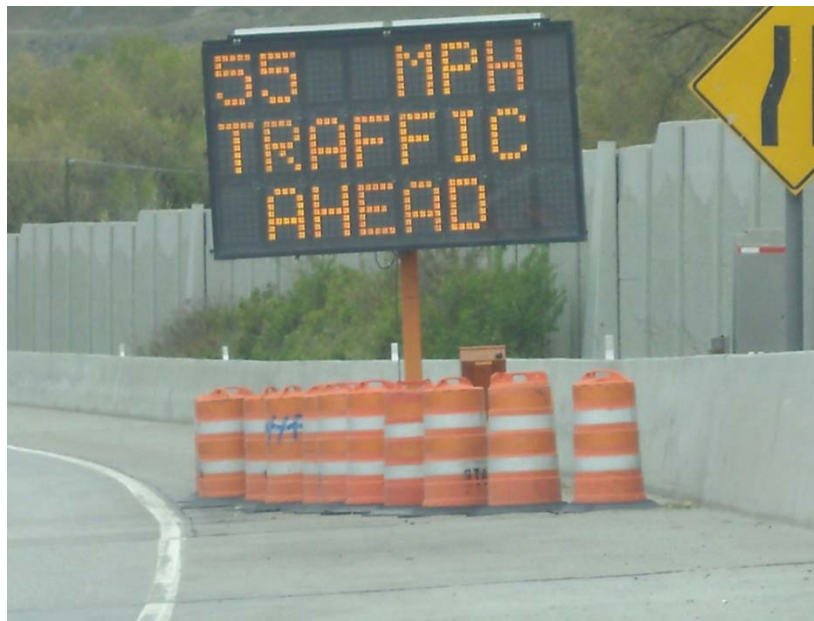
**Figure 3-8 VMS 2 final location (taken by Aaron Wilson).**

The issue of the VMSs being in the best location for drivers came in part to one of the UDOT engineers driving through the construction zone from I-80 Eastbound driving onto I-15 northbound through the study site. As he drove through the study site he found that he never saw the VMSs. This was due to the fact that VMS 1 was located at least 0.5 miles prior to the merge from I-80 eastbound to I-15 northbound, and VMS 2 was placed on the left side of the road to

help keep it safe as the only protection on the east side of the road would be orange barrels. Before simply moving the VMS to the east side of the road the option of placing a third VMS was explored. UDOT offered to place one of its own VMSs and pay for its use if it could be linked to the ASTI system. Attempts were made on several occasions and they were not successful enough to allow the use of UDOTs VMS. This was the last issue to resolve. As a result of this issue VMS 2 was placed on the right shoulder just north of sensor 2, with barrels to protect it. Figure 3-8 shows VMS 2 in its final location with barrels to protect it on the east side of I-15 just north of the bridge over North Temple St.

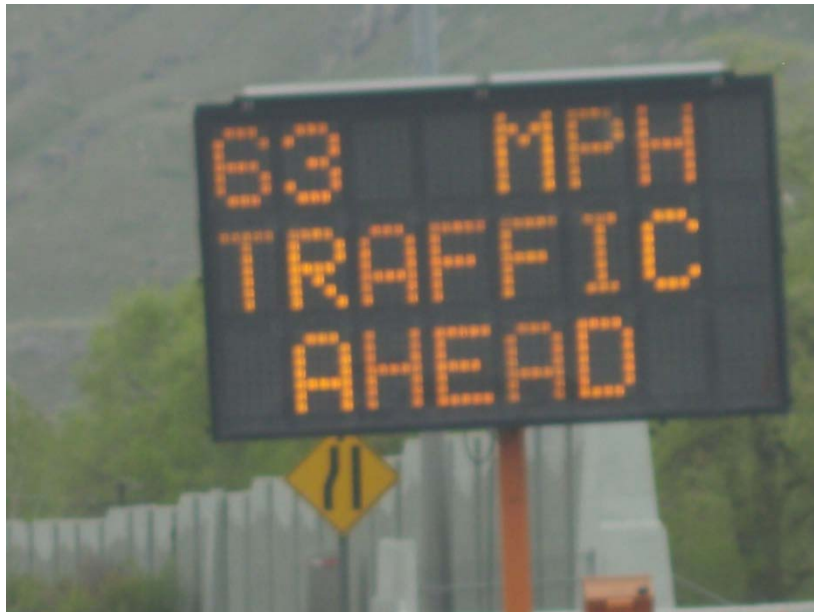
**Figure 3-9** First message displayed on VMS 2 (taken by Aaron Wilson).

Although it was anticipated that the system would be functioning correctly from day one it was quickly determined that there were a couple of things that were not properly communicated to ASTI. The VMS began with a display of “63 MPH TRAFFIC AHEAD,” as shown in Figure 3-9. The issue here was that UDOT and BYU anticipated the speed would be displayed in 5 MPH increments, and when speeds in excess of 55 MPH were seen, at the sensors, the VMS would only show “55 MPH TRAFFIC AHEAD” so as to not encourage drivers to go faster than the posted speed limit. During the time ASTI turned on the message boards one member of the BYU team was in communication with ASTI at the study site. The problem of showing speeds above 55 mph was quickly resolved while it took a few hours before the system was set up, as originally planned, to show only 5 mph increments. Figure 3-10 shows VMS 1 after the problems were fixed and the correct messages were being displayed.

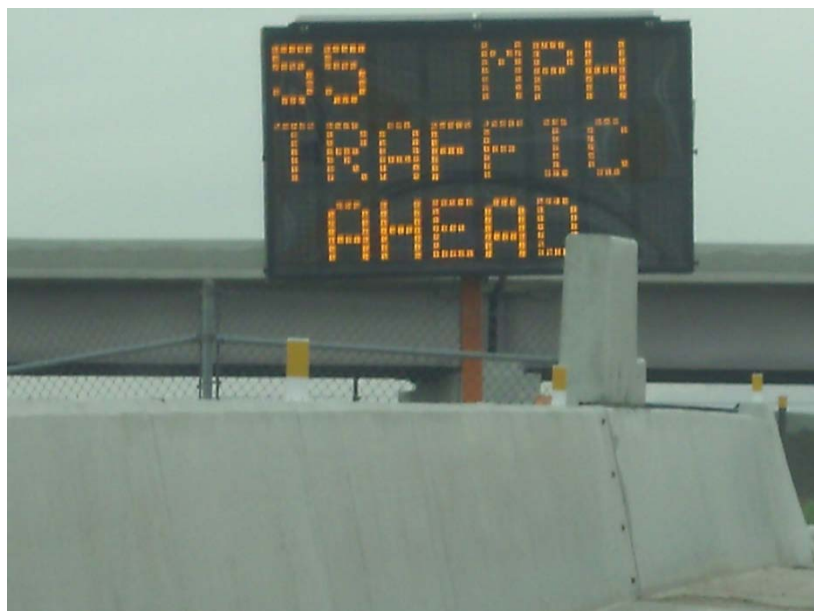
**Figure 3-10** VMS 1 showing correct message (taken by Aaron Wilson).
