Field Evaluation of Asphalt Overlays on State Route 30 in Northern Utah

A thesis submitted to the faculty of
Brigham Young University
in partial fulfillment of the requirements for the degree of
Master of Science

Department of Civil and Environmental Engineering
Brigham Young University
August 2010

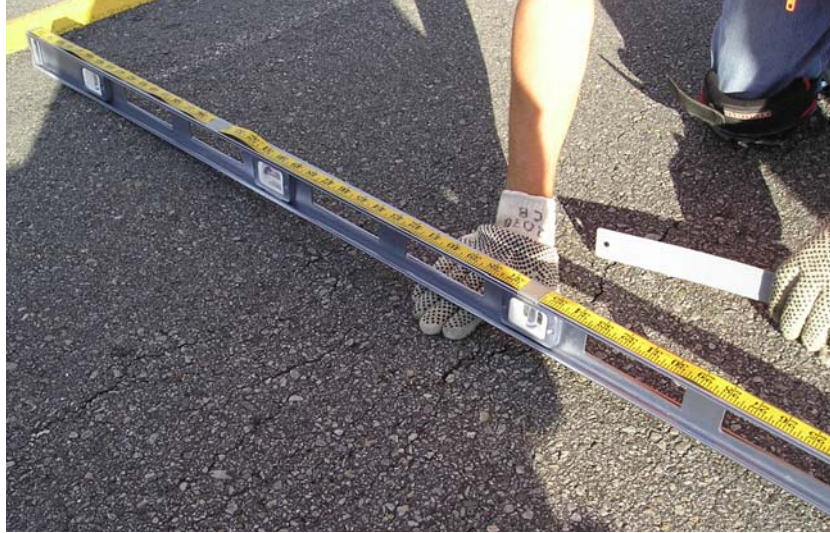
Figure 2.1 Rutting

Rutting is defined as permanent deformation of the pavement surface as a result of subsurface material consolidation and/or lateral shoving of asphalt surface layers under traffic loading. Rutting can be visually identified in the wearing course as a longitudinal depression in the wheel paths (17). Rutting may be more visible after rainfall due to the accumulation of water in the depressions. Severe rutting poses a safety concern because, as rut depth increases, a vehicle is more likely to hydroplane during a severe rain event. An example of rutting is shown in Figure 2.1.

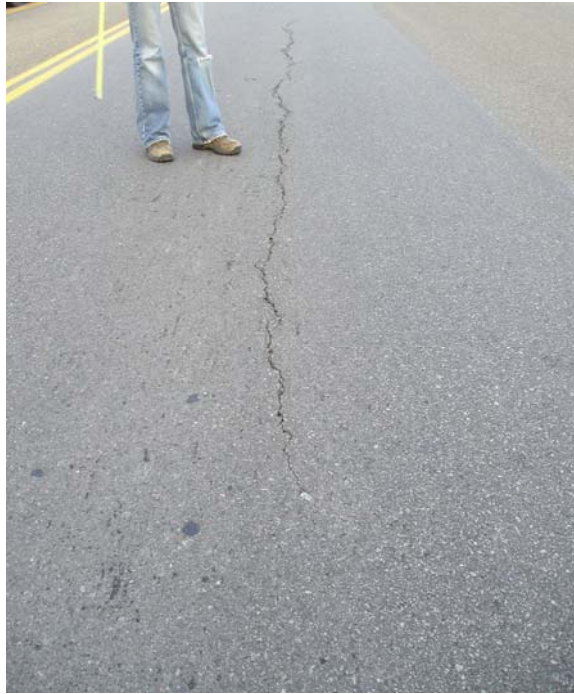
Figure 2.2 Longitudinal Cracking

Longitudinal, transverse, and fatigue cracking are common modes of asphalt overlay deterioration. Longitudinal cracking is defined as cracking predominately parallel to the pavement centerline (16). Longitudinal cracking that occurs in a wheel path is generally load-induced, while similar cracking outside a wheel path is often caused by thermal effects. An example of longitudinal cracking is shown in Figure 2.2. Transverse cracking is defined as cracking predominately perpendicular to the pavement centerline (16). Transverse cracking is caused by thermal expansion and contraction due to rapid temperature changes. An example of transverse cracking is shown in Figure 2.3.

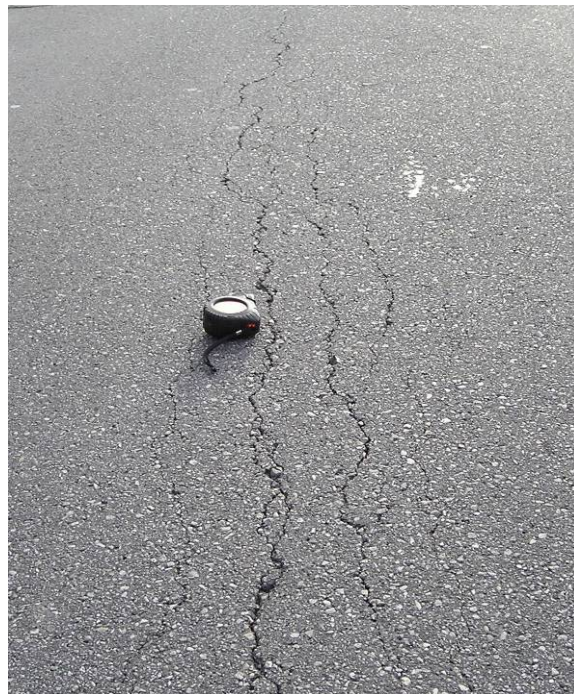
Figure 2.4 Fatigue Cracking

Fatigue cracking is a series of interconnected cracks caused by fatigue failure of the asphalt surface course under traffic loading (16). Fatigue cracks begin at the bottom surface of the wearing course and propagate upward under repeated wheel loading. As depicted in Figure 2.4, the cracks initially form parallel to each other in a wheel path and then interconnect under continued loading to form a pattern that resembles that on the back of an alligator. For this reason, fatigue cracking is often called “alligator” cracking.

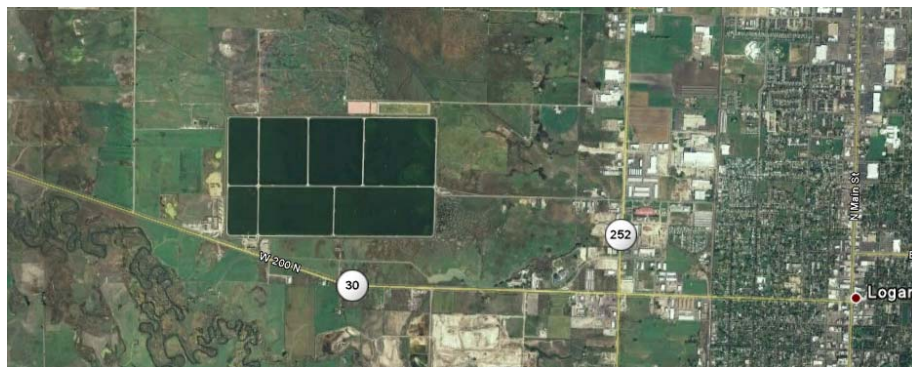
Figure 3.1 Aerial View of State Route 30 near Logan, Utah

The test sections evaluated in this research were constructed in July 2006 on SR-30 west of Logan, Utah, between mile posts 104 and 107; Figure 3.1 shows an aerial view of the site. At this location, SR-30 consists of two lanes oriented in the east-west direction with irrigation canals along both sides of the road. The canal on the north side of the road remains full for most of the spring and summer as shown in Figure 3.2, while the canal on the south side remains

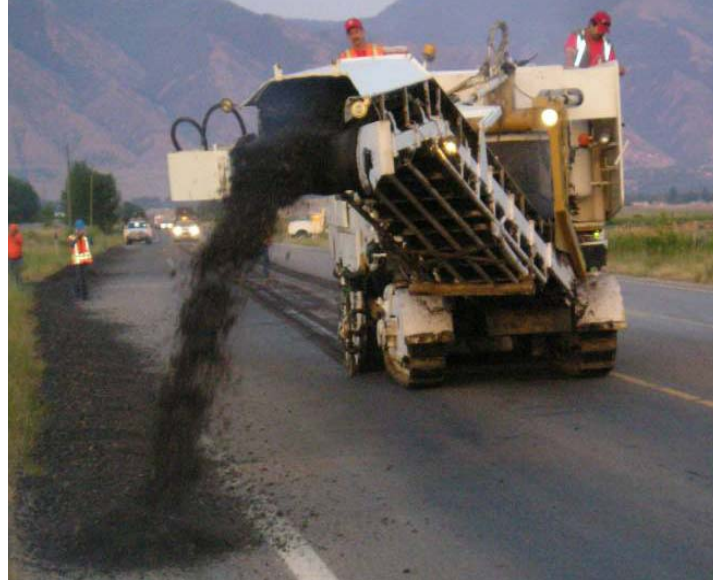
Figure 3.3 Milling of Existing Asphalt Surface

As shown in Figure 3.3, the surface of the road was initially milled to remove deteriorated chip seals and to provide a similar texture through the entire experimental area. After the milling was complete and the milled surface was broomed, the PG 64-34 and AC-10 asphalt overlay materials were paved in a checkerboard pattern such that drivers encountered the AC-10 product first when traveling in either direction. Twenty test stations were randomly selected along each of the east and west segments of the roadway, and survey-grade nails were installed in the pavement surface so that repeated testing could be performed at the same locations. Figure 3.4 shows the general layout of the site.

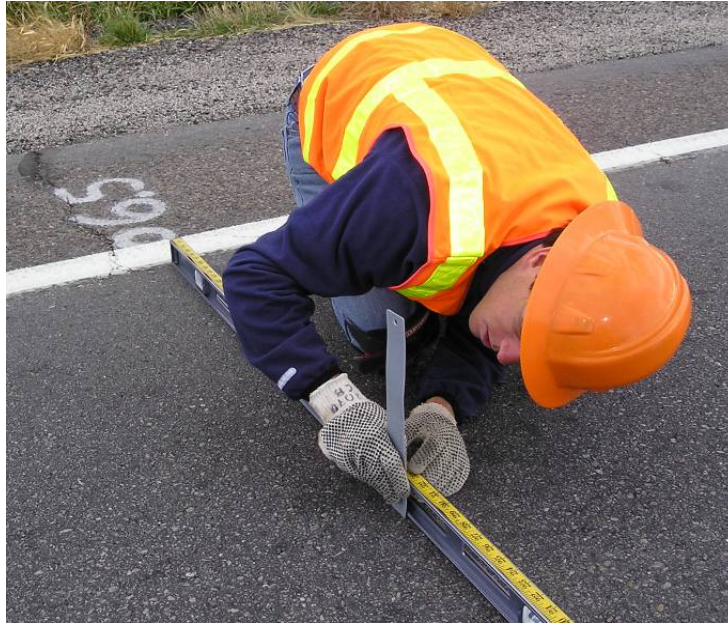
Figure 3.5 Measurement of Rut Depth

Primary data included rutting, cracking, and roughness. Rutting was measured following ASTM E1703 (Standard Test Method for Measuring Rut-Depth of Pavement Surfaces Using a Straightedge) at each of the 20 test stations in each of the four experimental sections. Researchers placed a ruled 6-ft level perpendicular to the roadway centerline, spanning inside and outside wheel paths in turn. A separate ruler held in the vertical direction was then used to measure to the nearest 1 mm the point of deepest rutting within each wheel path, as illustrated in Figure 3.5; any debris present on the pavement surface at the contact points was brushed away to

ensure valid readings. The width of rutting in each wheel path was also recorded to the nearest 1 in. (The use of metric units for measuring rut depth is convenient, as it involves whole numbers, and it is also consistent with the LTPP Program protocols. However, in this research, the rut depths were later converted to units of inches for analysis.)

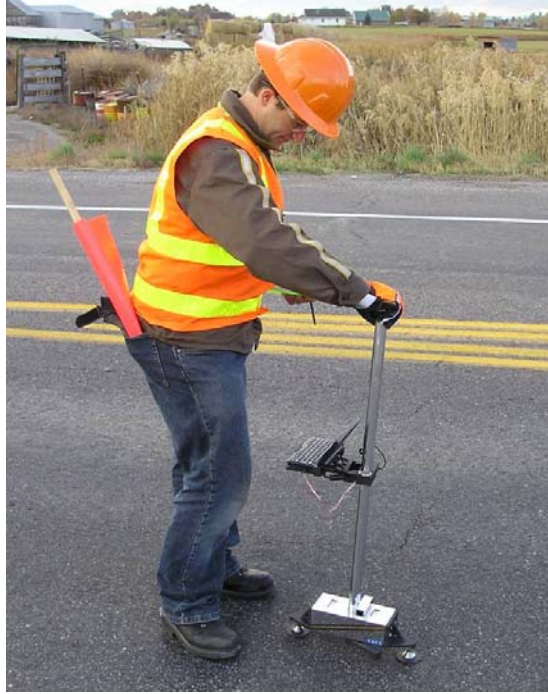
Figure 3.6 Measurement of Roughness

As shown in Figure 3.6, roughness data were collected in the outside wheel path at each of the 20 test stations using a dipstick roadway profiler. Each test line was 40 ft in length, beginning 20 ft before the station marker and ending 20 ft past the station marker. With each

step, the dipstick recorded the grade slope and then computed an IRI value in units of inches per mile from the slope variance associated with the given survey (16). Air and pavement surface temperatures at the time of testing were also collected as part of the primary data set.

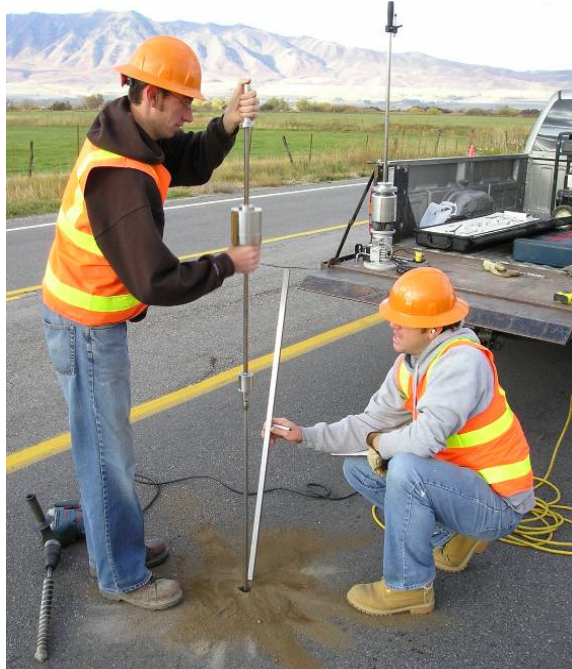
Figure 3.7 Measurement of Penetration Rate

Secondary data included dynamic cone penetrometer (DCP) test results, dielectric and electrical conductivity profiles, and core information. As shown in Figure 3.7, the DCP consists of a slide-hammer assembly mounted to a shaft fitted with a standard cone tip. For this research,

a 1.5-in.-diameter hole was drilled through the asphalt layer at each test station to facilitate DCP testing of the subsurface layers to a depth of approximately 35 in.

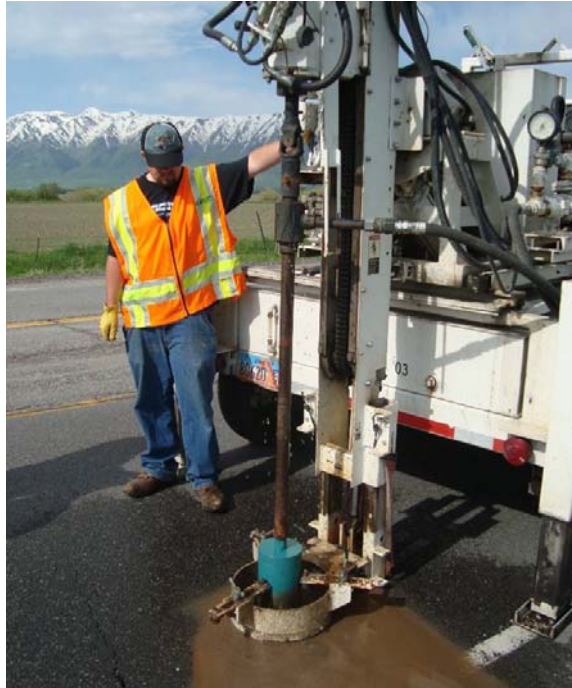
Figure 3.9 Coring of Asphalt Layer

One asphalt core sample was removed from each pavement section using a truck-mounted coring rig as depicted in Figure 3.9. Coring allowed a direct measurement of the asphalt layer thickness and facilitated laboratory testing of the in-situ material. After the core

was removed, a small sample of the base and subgrade was removed to generally characterize each layer.

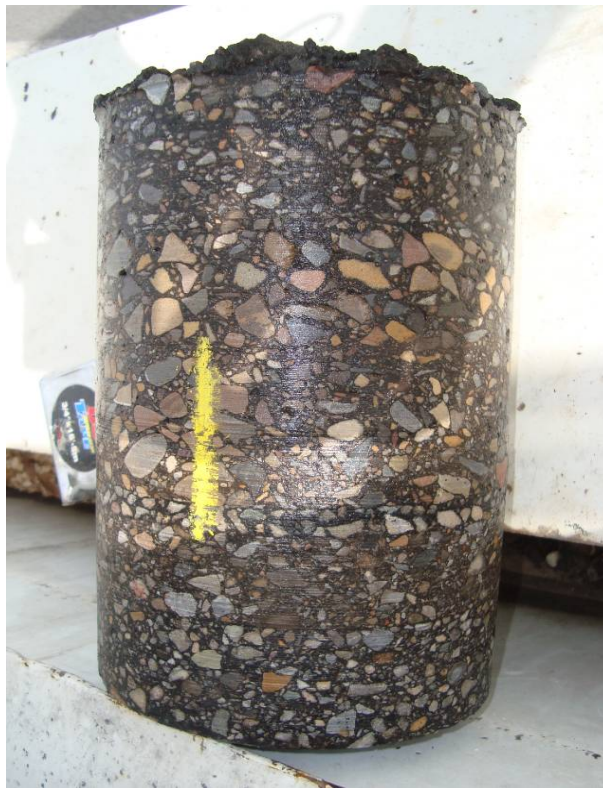
Figure 4.4 Typical Core Sample

Cores removed from the test sections clearly indicated that the roadway had been overlaid several times; multiple asphalt layers are evident in the typical core sample shown in Figure 4.4. Layer thicknesses are provided in Table 4.8, and material properties determined from the core samples are given in Table 4.9. The results of the sieve analyses are shown in Figure 4.5.

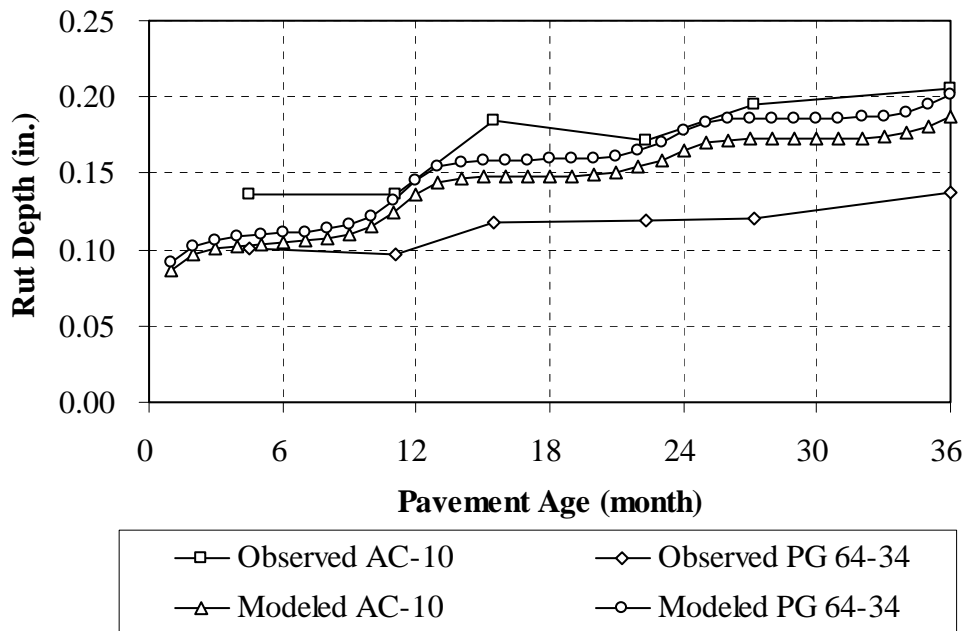
Figure 4.6 Observed and Modeled Trends in Rut Depth

In Figure 4.6, the apparent stepwise development of rutting through time is evident in both the observed and modeled trends; the rate of rutting is higher during summer when the asphalt temperatures are elevated and lower during winter when cold temperatures cause increased asphalt stiffness. Although the MEPDG predictions are within the range of observed rut depths, the MEPDG overestimated the AC-10 rut depth while underestimating the PG 64-34

rut depth. The largest differences between the observed and predicted values of rut depth for the AC-10 and PG 64-34 products are 0.03 and 0.06 in., respectively.

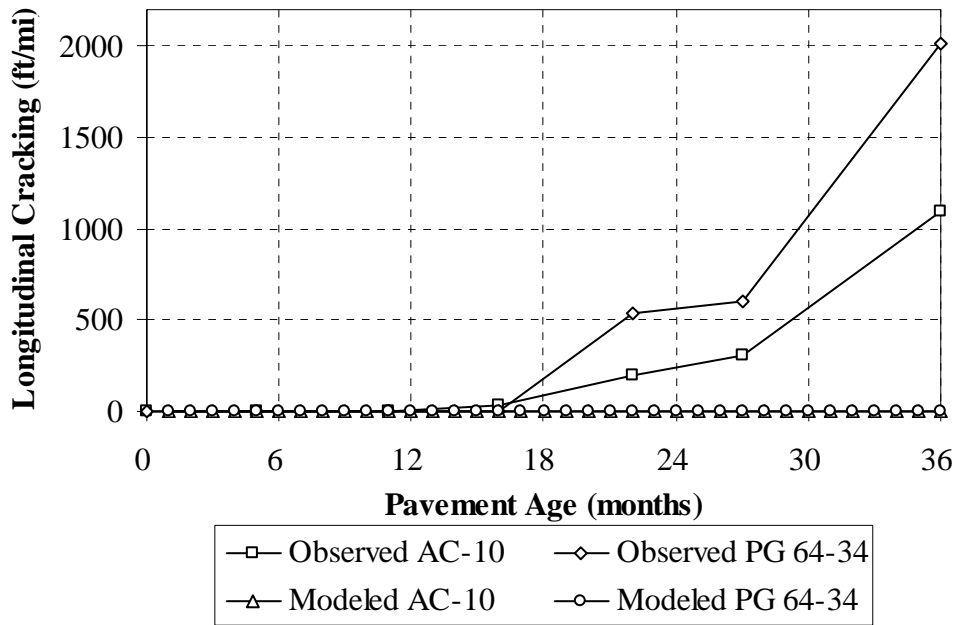
Figure 4.7 Observed and Modeled Trends in Longitudinal Cracking

In Figure 4.7, the observed data trends show the initiation of longitudinal cracking in both types of asphalt overlays after approximately 16 months. Although a widening difference between the AC-10 and PG 64-34 products is suggested by the observed data, the statistical analyses indicated that the apparent difference is not statistically significant. While differences in observed data may not be important, the apparent inability of the MEPDG to predict comparable amounts of longitudinal cracking is concerning; the MEPDG predicted negligible longitudinal cracking for the duration of the 3-year analysis period. With the maximum predicted value from the MEPDG was 0.24 ft/mile, the largest differences between the observed and predicted values of longitudinal cracking for the AC-10 and PG 64-34 products are 1090 and 2011 ft/mile, respectively. The MEPDG longitudinal cracking model therefore appears to be deficient in the context of this research.
