Evaluation of Portable Devices for Monitoring Microcracking of Cement-Treated Base Layers

A thesis submitted to the faculty of
Brigham Young University
in partial fulfillment of the requirements for the degree of
Master of Science

Department of Civil and Environmental Engineering
Brigham Young University
April 2011

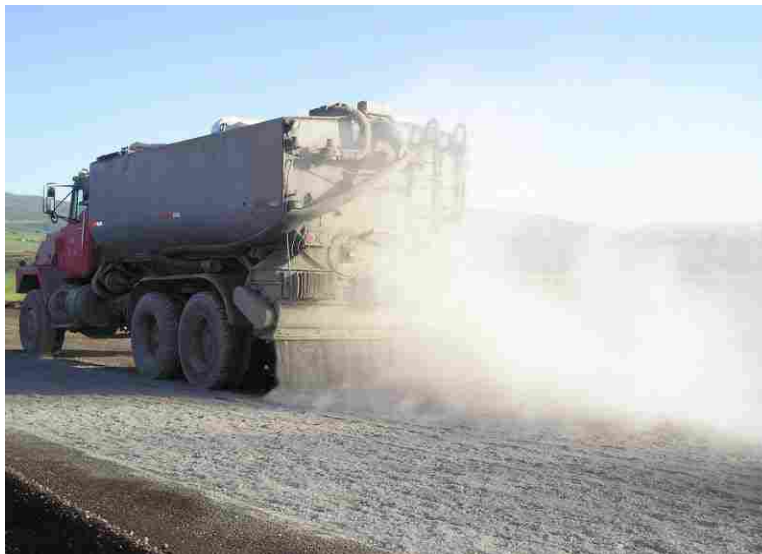
Figure 2-1: Cement powder application.

Cement can be added in two ways: cement powder or cement slurry. Cement powder is spread directly from a cement spreader truck, but the resulting fugitive cement dust can produce unacceptable air quality as shown in Figure 2-1. Cement slurry can be distributed directly out of the chute of a mixer truck as illustrated in Figure 2-2, or a portable slurry spreader may be attached to the chute for more uniform cement distribution as shown in Figure 2-3 (Hope et al. 2004).

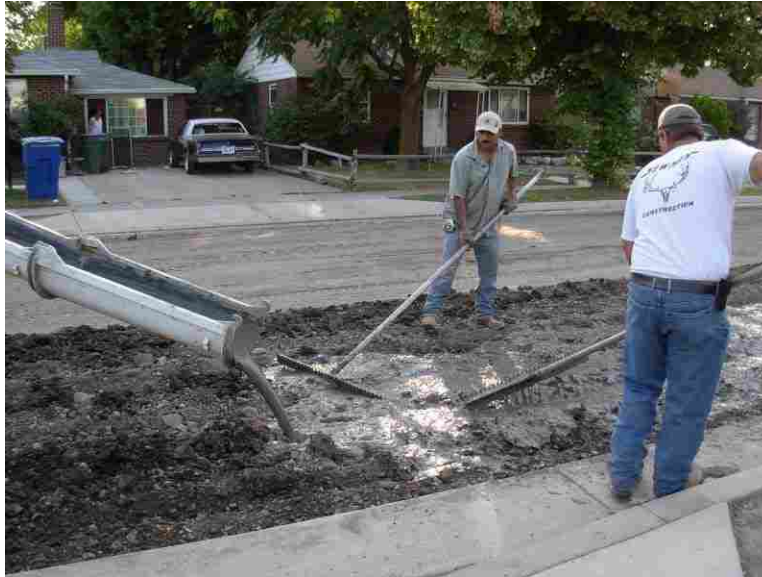
Figure 2-2: Cement slurry application directly from a truck chute.

At Redwood Drive, the cement slurry was distributed onto the RAP-base blend directly from the chute of a mixer truck, as shown in Figure 2-2, and the cement was subsequently mixed into the base material to a depth of 8 in. using a reclaimer. At Dale Avenue and Spanish Fork, the cement slurry was distributed onto the RAP-base blend using a slurry spreader that attached directly onto the chute of the cement truck as displayed in Figure 2-3. The nozzles on the

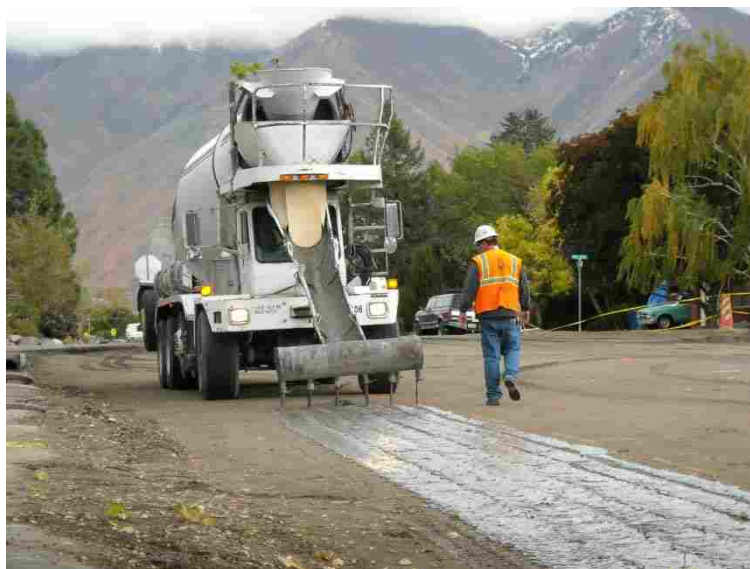
Figure 2-3: Cement slurry application using a cement slurry spreader.

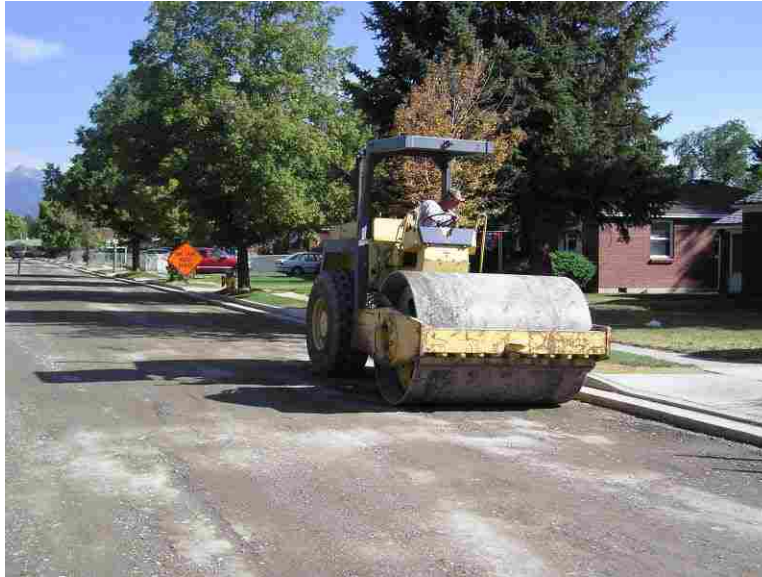
Figure 2-4: Microcracking using a vibratory roller.

The microcracking method involves the application of a vibratory roller to a CTB layer only 2 to 3 days after compaction, as shown in Figure 2-4, to reduce the stiffness of the CTB layer by a target value of 50 to 70 percent as measured using a FWD. The vibratory roller employed for microcracking should be the same or equivalent to the roller used for original compaction of the CTB and should generally be operated at 2 to 3 mph, with vibration at maximum amplitude (Sebesta 2006). Depending on project conditions, the speed of the vibratory roller may need to be adjusted to ensure that the CTB is properly microcracked.

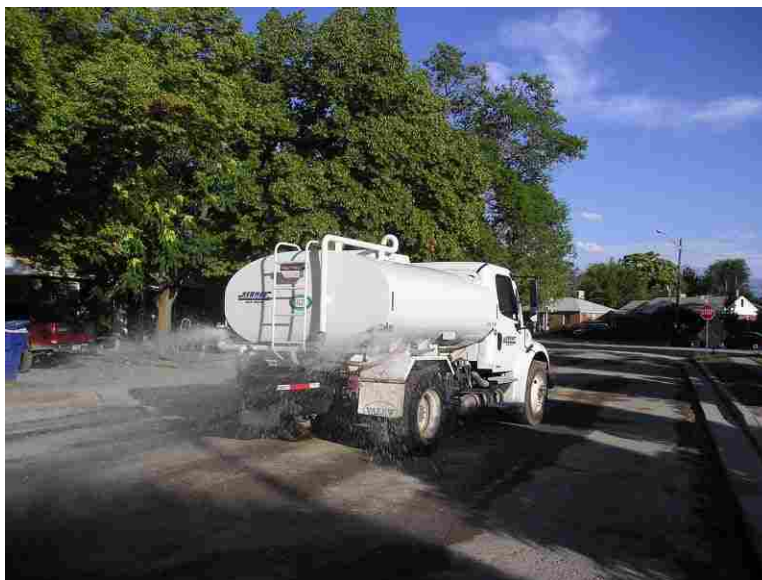
Figure 2-5: Moist curing using a water truck.

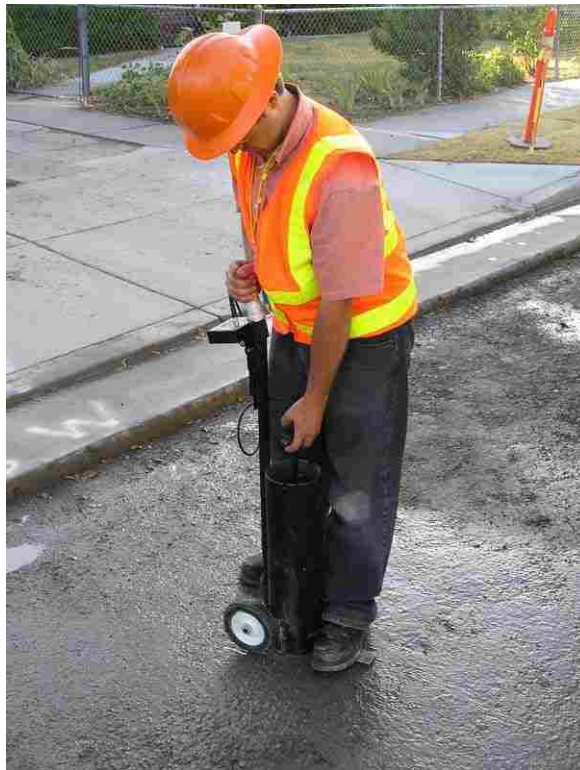
Figure 2-6: CIST testing.

The CIST is a relatively simple instrument comprised of a slide hammer, a guide tube, and an electronic digital readout. Several models of the CIST are available, each with a different hammer weight. Figure 2-6 shows the 44-lb heavy CIST utilized in this research. The diameter of the slide hammer on this instrument is 5 in.

A CIST test is performed by dropping the slide hammer four times at the desired test point. The deceleration of the slide hammer upon impact with the soil is measured by an

accelerometer mounted on top of the hammer, which is connected to a digital readout device. The peak deceleration of the hammer is reported as a Clegg impact value (CIV), where one CIV unit is equal to 10 gravities, or 10 times the acceleration of gravity (Clegg Instruction Manual 1993).

The CTB was tested for stiffness at each of the 10 stations at each site immediately after final compaction using the CIST, PFWD, and SSG, as shown in Figures 2-6 to 2-8, respectively. Three readings from each instrument were recorded at each station.

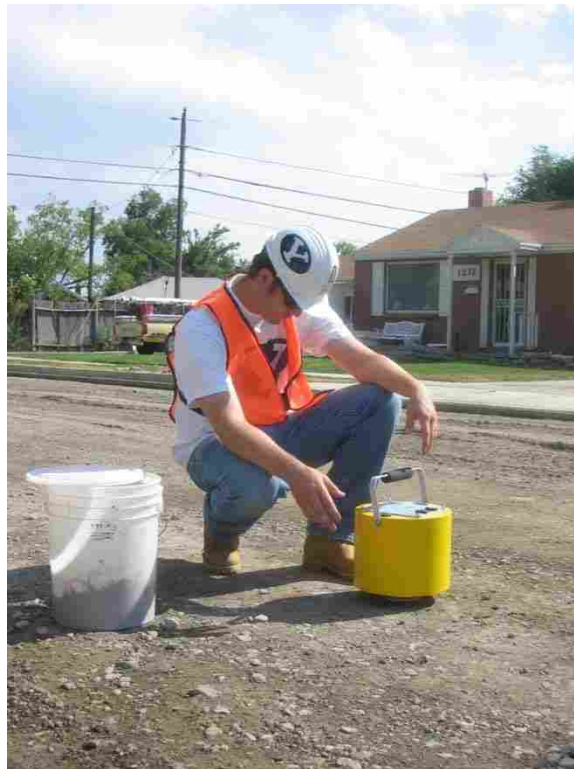
Figure 2-8: SSG testing.

Depicted in Figure 2-8, the SSG is a compact cylindrical device, weighing 22 lbs, with a ring-shaped bottom foot having an outside diameter of 4 in. A rigid column connects an internal force sensor and a shaker located at the center of the instrument; the shaker drives the sensors located in the foot that measure force and displacement. The SSG imparts small displacements to the soil, less than 0.00005 in., at 25 steady-state frequencies between 100 and 196 Hz (Humboldt 2002). The corresponding stress and displacement data are then used to compute the soil stiffness.

The SSG is operated by positioning the foot on a thin bed of fine soil or moist sand to ensure that at least 60 percent of the foot is in direct contact with the soil. Pressing a button on the top of the instrument starts a test, which requires about 60 seconds. The test results are

shown in the digital display on the top of the SSG. Along with the stiffness value, the associated signal-to-noise ratio, which reflects the ambient vibrations in the ground, and the standard deviation, which captures measurement variability, are displayed. The SSG calculates stiffness as shown in Equation 2-1 (Humboldt 2002):

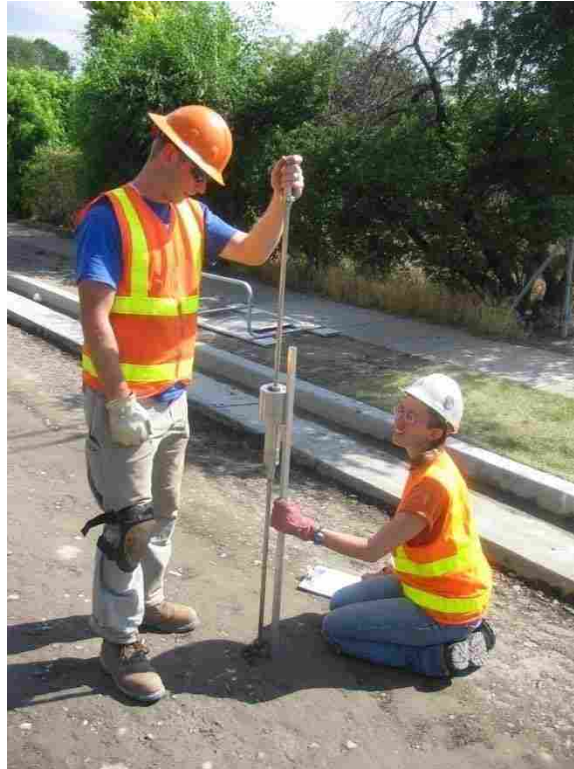
Figure 3-6: DCP testing.

Properties of the original base and subgrade were obtained by testing those layers using a dynamic cone penetrometer (DCP) and by sampling the existing material for laboratory testing. DCP tests were performed before the surface course was pulverized and mixed into the base material. As displayed in Figure 3-6, a DCP consists of a metal rod with a standard cone tip that is driven into the ground by a manually operated slide hammer; the measured DCP penetration rates were used to determine CBRs for both the base and subgrade layers at the time of testing following Equation 3-1 (Webster et al. 1992):

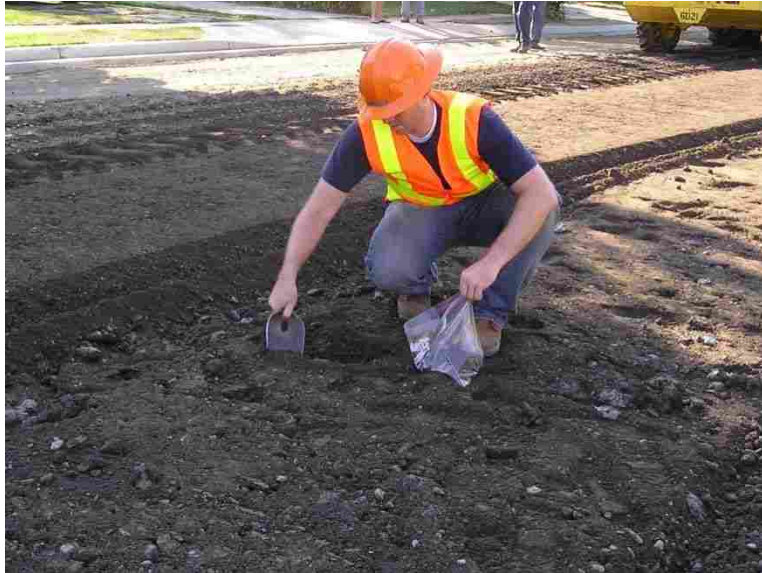
Figure 3-7: Sampling of RAP-base blend.

One neat asphalt sample of the original asphalt surface course was collected from each site, except Spanish Fork, for determining asphalt content in the laboratory. Samples of the reclaimed base material were then obtained from each station immediately before the application of cement at each site. The samples of reclaimed asphalt pavement (RAP)-base blend were placed in plastic bags as depicted in Figure 3-7 and transported to the Brigham Young University (BYU) Highway Materials Laboratory for material characterization testing.

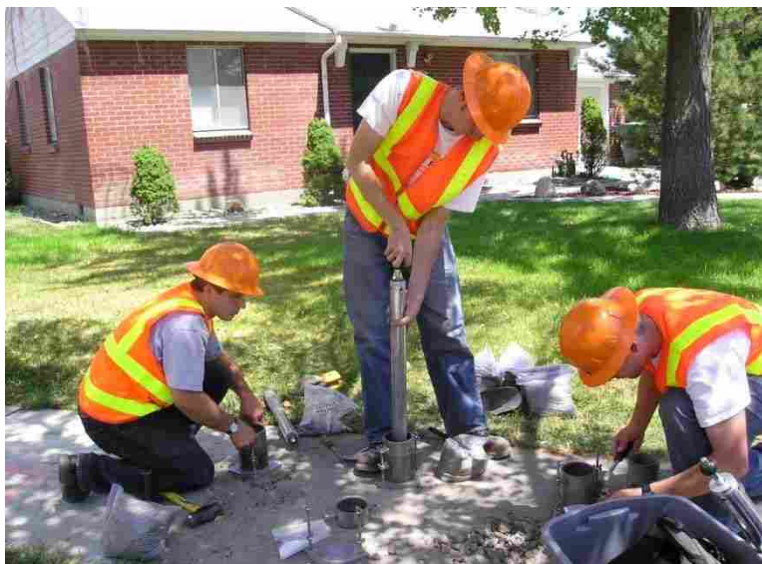
Figure 3-9: Compacting field specimens.

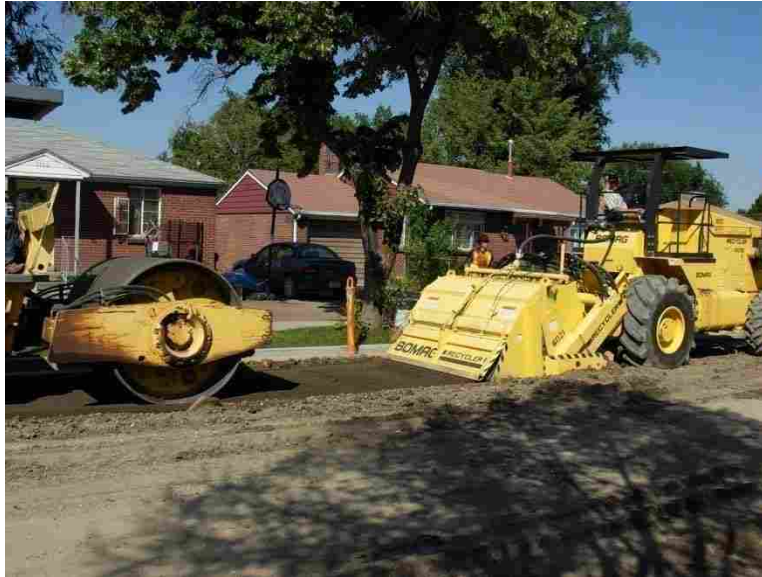
Figure 3-10: Mixing and compacting CTB layer.

After the cement was mixed into the base material, the CTB was compacted using a vibratory roller. The size of the compactor varied with pulverization depth; the CTB materials at the sites in Utah were mixed to a depth of 8 in. and compacted using an 8-ton vibratory roller, while the CTB material at the Wyoming sites was mixed to a depth of 9 in. and compacted using a 12-ton vibratory roller. As illustrated in Figure 3-10, the roller closely followed the reclaimer at each site to ensure that the freshly mixed CTB would be compacted quickly.

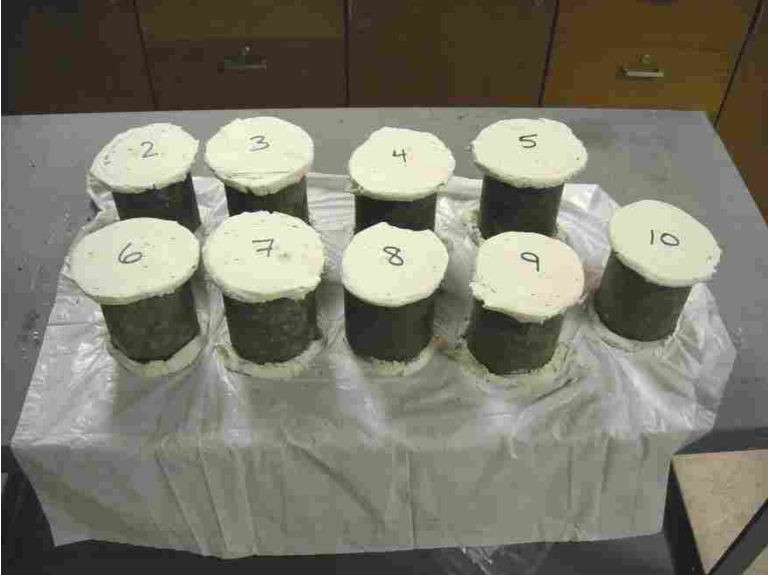
Figure 3-12: Capping field specimens.

The manually compacted field specimens were cured at room temperature in sealed plastic bags for specific curing times corresponding to the day of microcracking of the CTB layer in the field, which ranged from 3 to 5 days after final compaction of the CTB, and 7 days, 28 days, 6 weeks, or 9 months if a sufficient number of compacted specimens remained for additional testing. Curing in this manner was chosen to simulate an ideal condition of moist-curing in the field. After curing, the height and weight of the specimens were measured, and each sample was then capped using high-strength gypsum to create flat and level specimen ends as pictured in Figure 3-12. After the gypsum caps hardened, UCS tests were performed at a constant strain rate of 0.05 in./minute according to ASTM D1633 (Standard Test Methods for Compressive Strength of Molded Soil-Cement Cylinders). A specimen in the compression machine is shown in Figure 3-13. The strength of the specimen was then computed by dividing the maximum measured load by the cross-sectional area of the specimen. Each specimen was then oven-dried at 140°F to enable calculation of moisture content and dry density. For the Utah

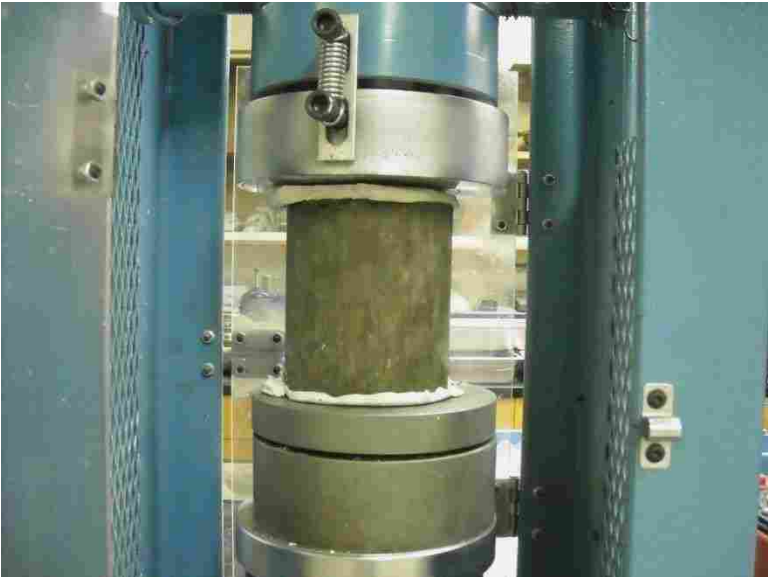
Figure 3-13: UCS testing.

Results of the UCS tests performed on the manually compacted field specimens are presented in Tables 4-21 to 4-24. The 2-, 3-, 4-, or 5-day UCS tests were performed in each case at the same time that microcracking was performed at the given site. At the Spanish Fork site,

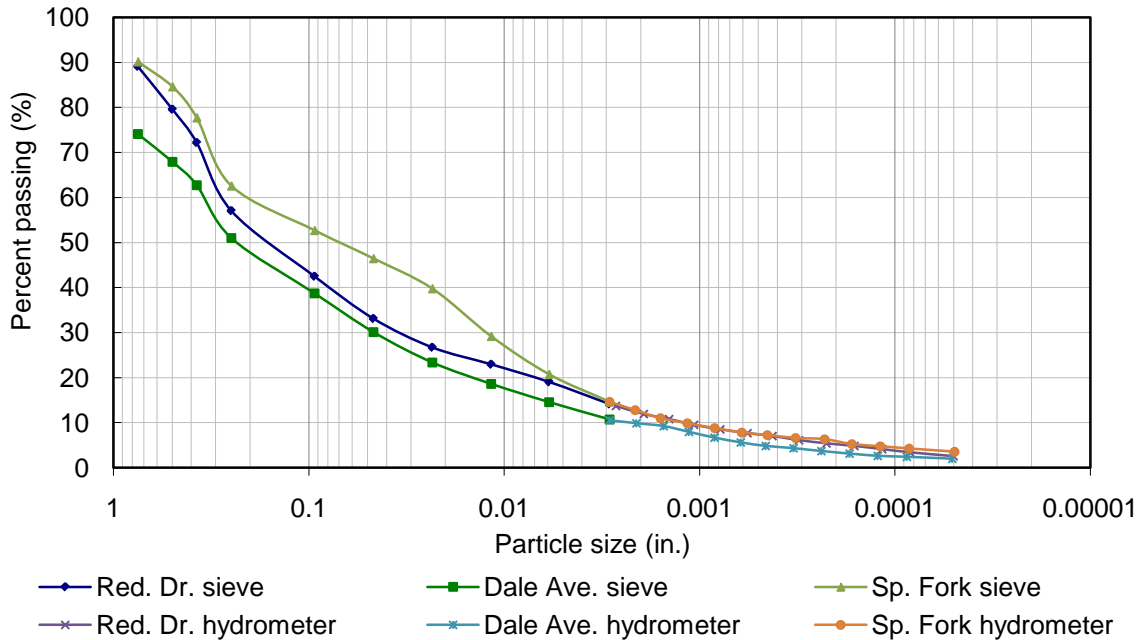
Figure 4-4: Washed sieve analysis and hydrometer data.

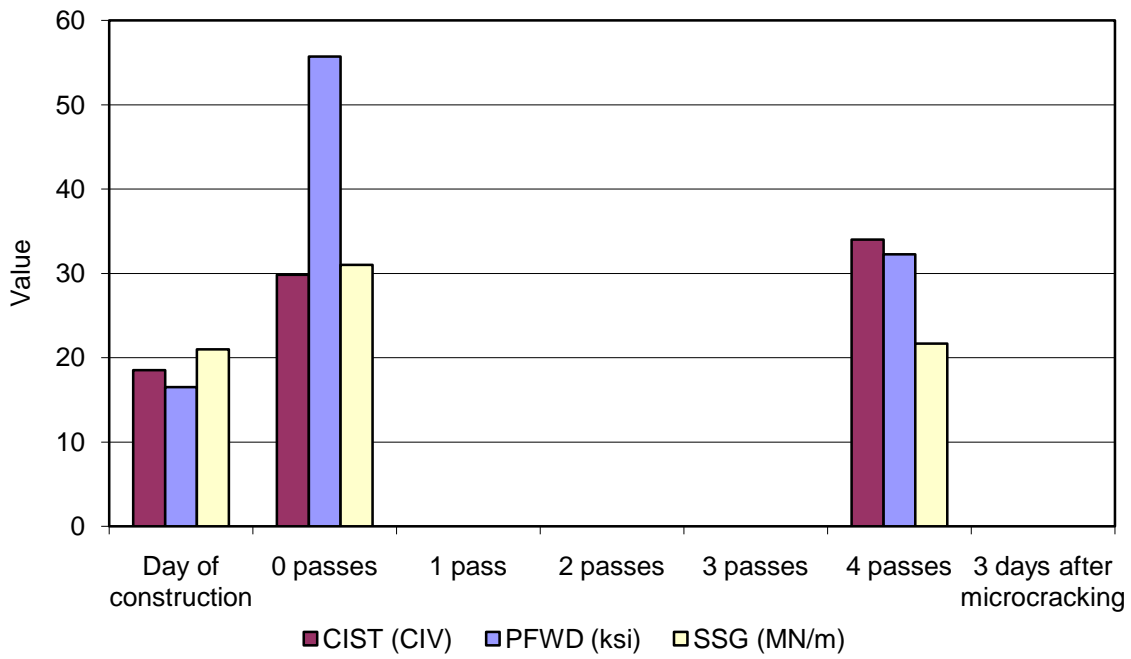
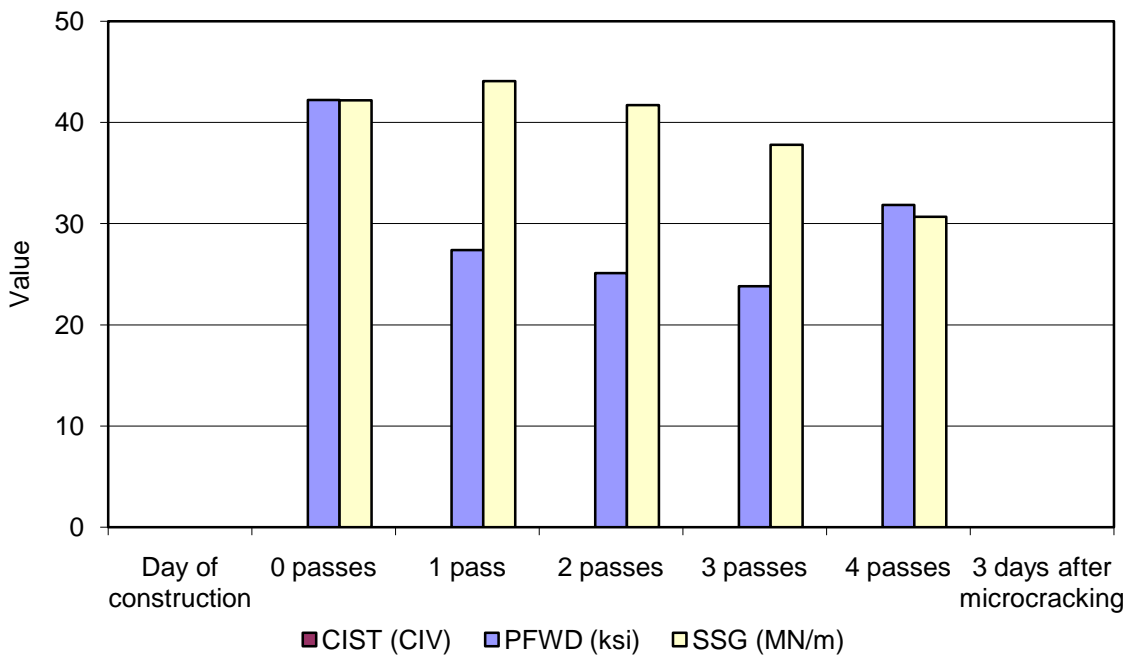
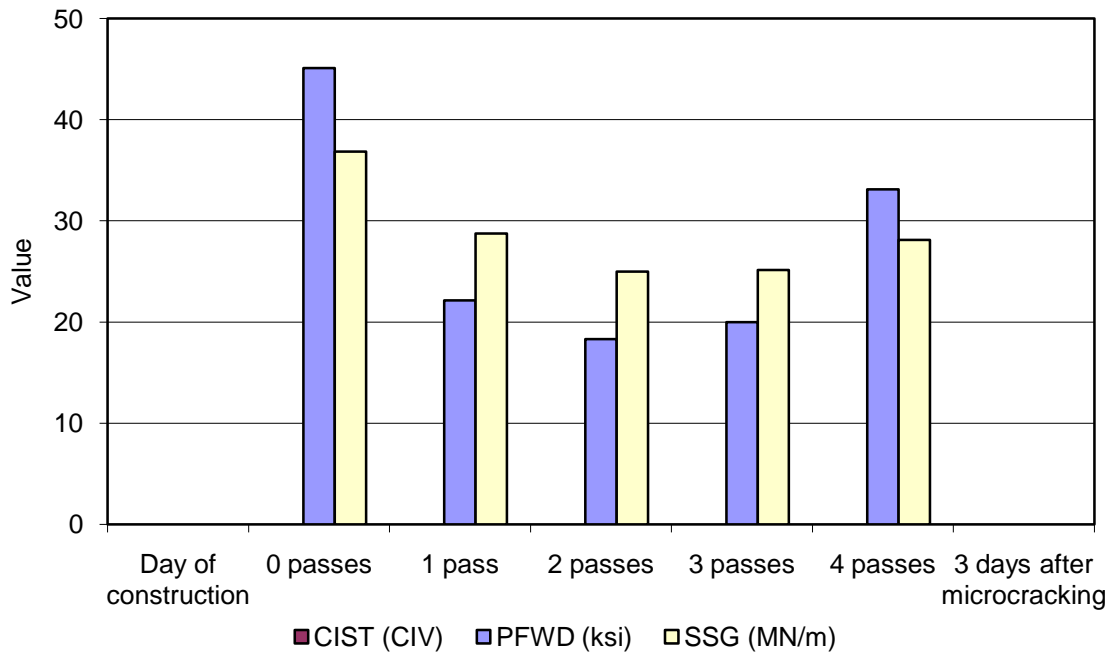
Figure 4-5: Average stiffness measurements at Redwood Drive.

Figure 4-6: Average stiffness measurements at Dale Avenue.

Figure 4-7: Average stiffness measurements at Spanish Fork.

Figure 4-8: Average stiffness measurements at Wyoming A.

Figure 4-9: Average stiffness measurements at Wyoming B.

Figure 4-10: Average stiffness measurements at Wyoming C.

Figure 4-11: Average stiffness measurements at Wyoming D.

Figure 4-12: Average stiffness measurements at Wyoming E.

Figure 4-13: Average stiffness measurements at Wyoming F.

In Figures 4-5 to 4-22, readings taken on the day of CTB construction and 3 days after microcracking are shown where applicable. In each of these cases, the data show that the CTB increased in stiffness during the 3 days following microcracking, indicative of autogenous healing.

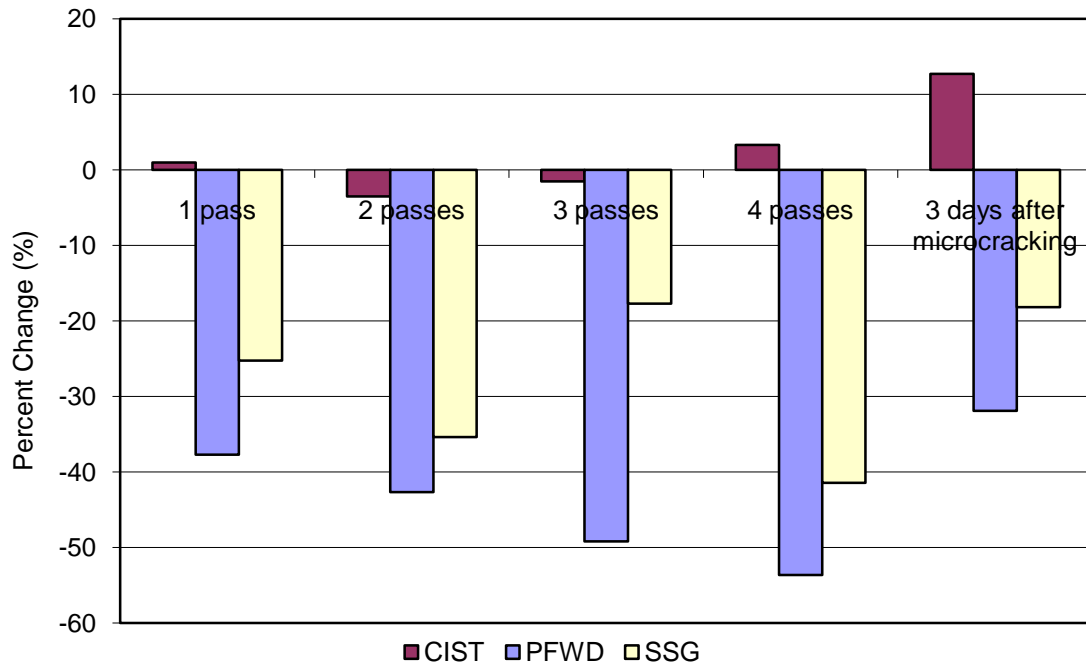
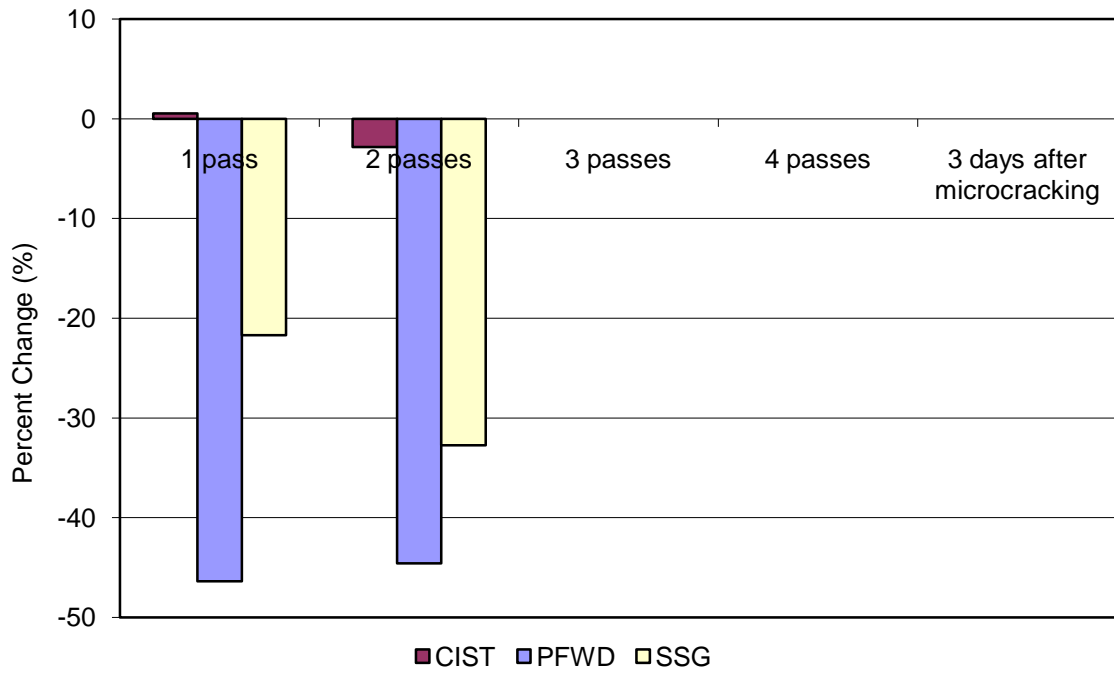
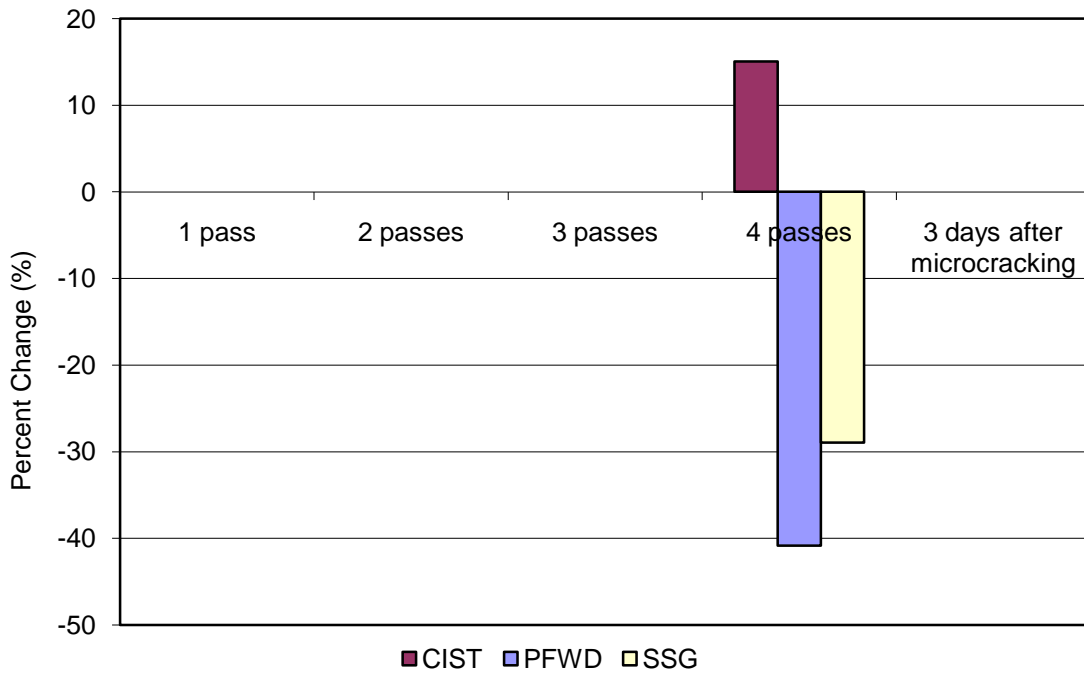
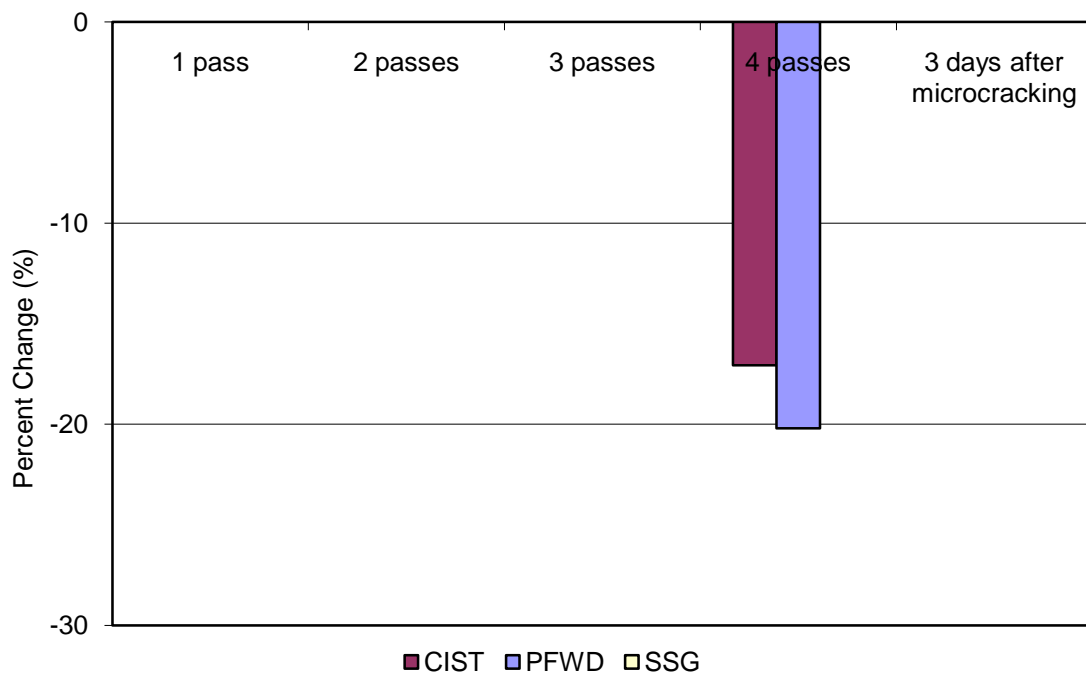
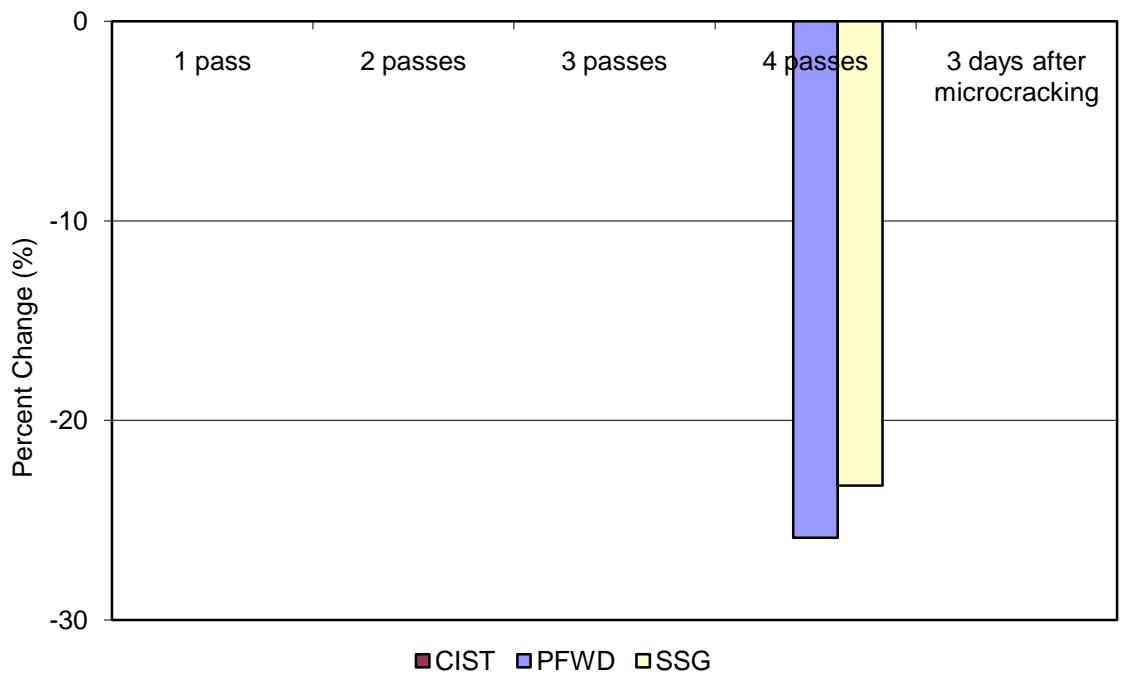
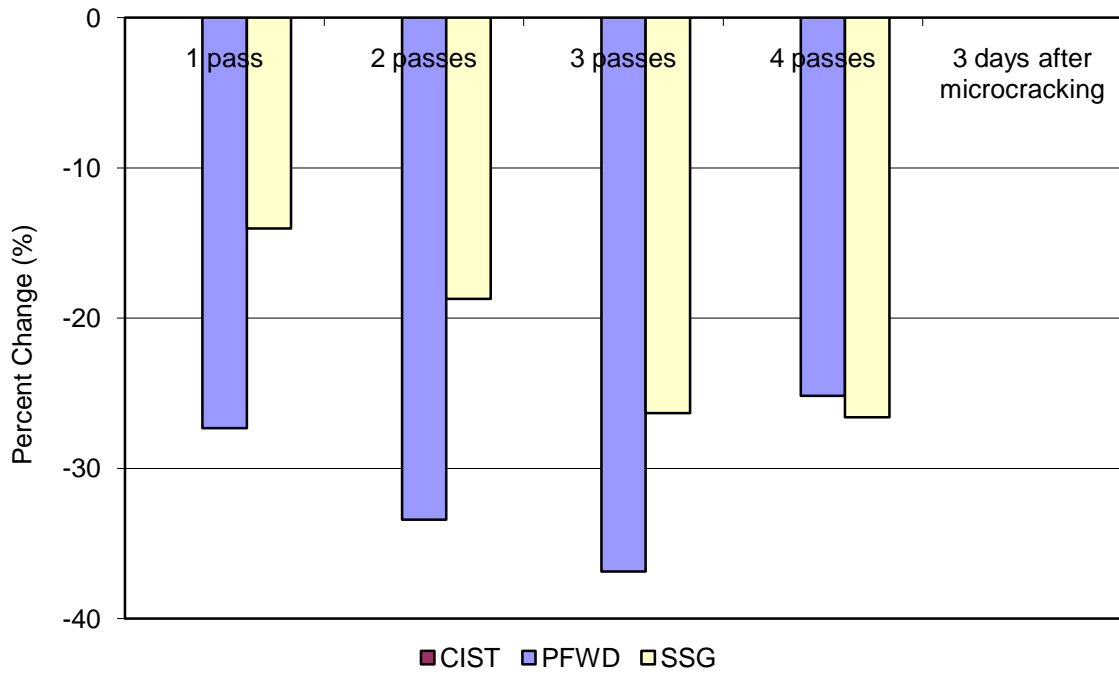
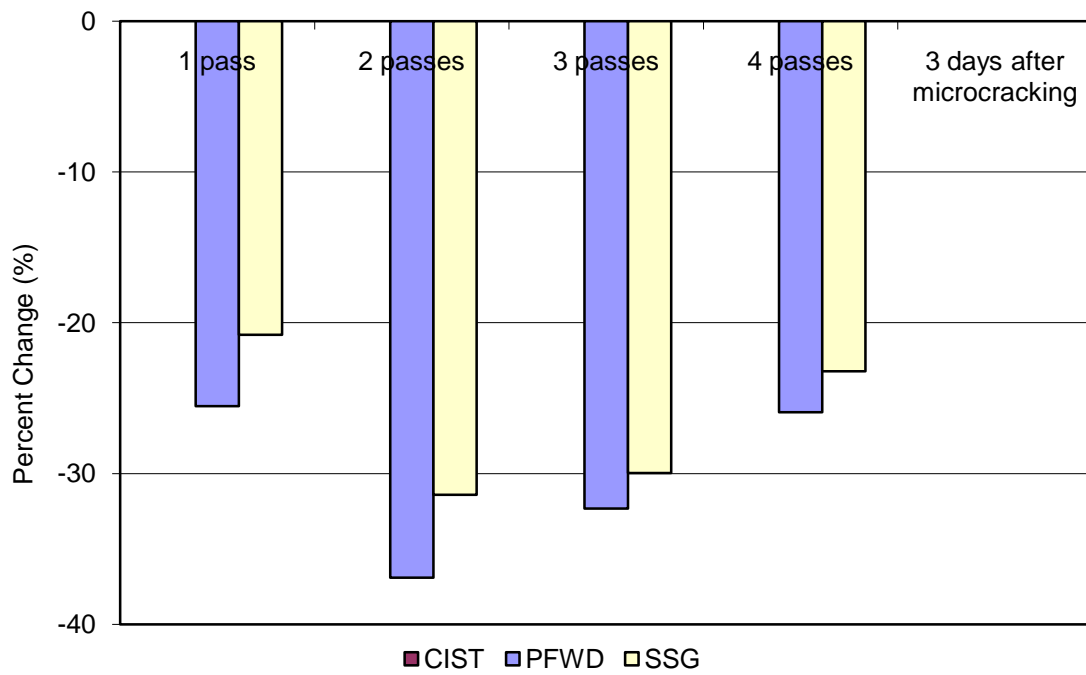
Figure 4-14: Average percent change in stiffness measurements at Redwood Drive.

Figure 4-15: Average percent change in stiffness measurements at Dale Avenue.

Figure 4-16: Average percent change in stiffness measurements at Spanish Fork.

Figure 4-17: Average percent change in stiffness measurements at Wyoming A.

Figure 4-18: Average percent change in stiffness measurements at Wyoming B.

Figure 4-19: Average percent change in stiffness measurements at Wyoming C.

Figure 4-20: Average percent change in stiffness measurements at Wyoming D.

Figure 4-21: Average percent change in stiffness measurements at Wyoming E.

Figure 4-22: Average percent change in stiffness measurements at Wyoming F.

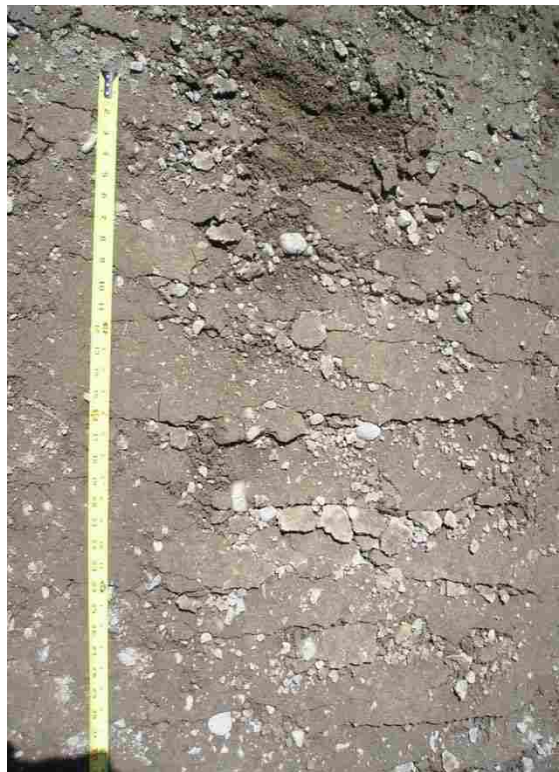
Figure 4-23: CTB surface damage due to slow vibratory roller speed during microcracking.

During the process of microcracking, the researchers looked for signs of excessive damage to the CTB. On a few occasions, visible damage to the CTB surface was observed, as shown in Figure 4-23, which indicated that the speed of the roller was too slow or the amplitude of vibration was too high. In these instances, the equipment operator was instructed to increase the roller speed, decrease the amplitude, or discontinue microcracking. On most occasions, however, only fine cracks were noticeable, as shown in Figure 4-24.

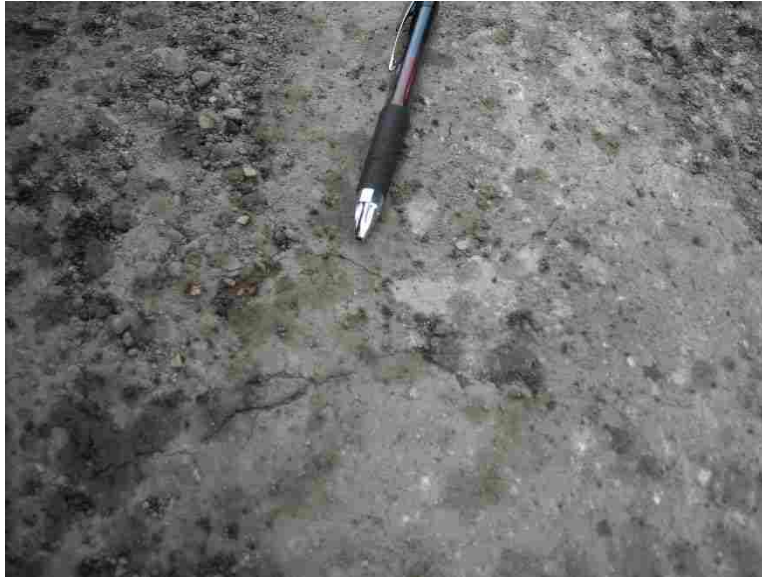
Figure 4-24: Fine cracks in CTB surface after microcracking.

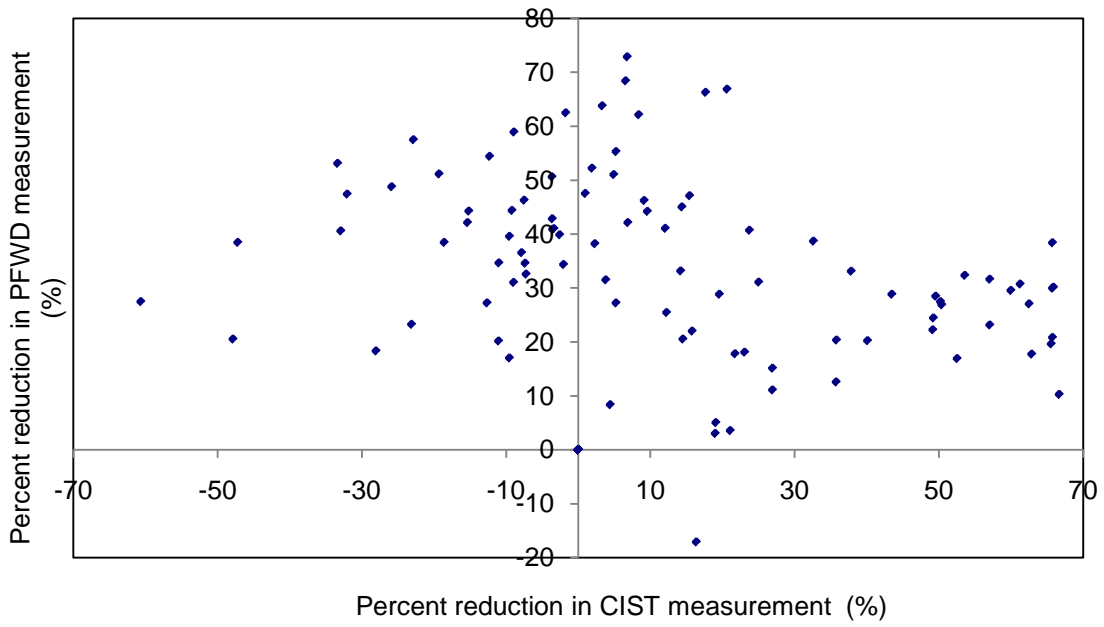
Figure 4-25: Correlation analysis for the CIST and PFWD.

Figures 4-25 to 4-27 show plots of the individual data points used in statistical analyses of the CIST-PFWD, CIST-SSG, and PFWD-SSG correlations, and results from these analyses are presented in Table 4-28. P -values greater than 0.05 indicate that insufficient evidence exists to identify a statistically significant correlation between the given instruments, while p -values less than or equal to 0.05 indicate that a statistically significant correlation exists between the instruments.

As shown in Table 4-28, neither of the instrument correlations involving the CIST have *p*-values less than or equal to 0.05; therefore, neither of those correlations are statistically significant. Only the PFWD-SSG correlation has a *p*-value less than or equal to 0.05. Figure 4-28 provides a graphical representation of this correlation in the form of a chart that can be used by engineers and contractors needing to derive target CTB stiffness reductions for one instrument from specified CTB stiffness reductions measured using the other. For example, a target reduction in CTB stiffness of 40 percent using the PFWD equates to a reduction of 27

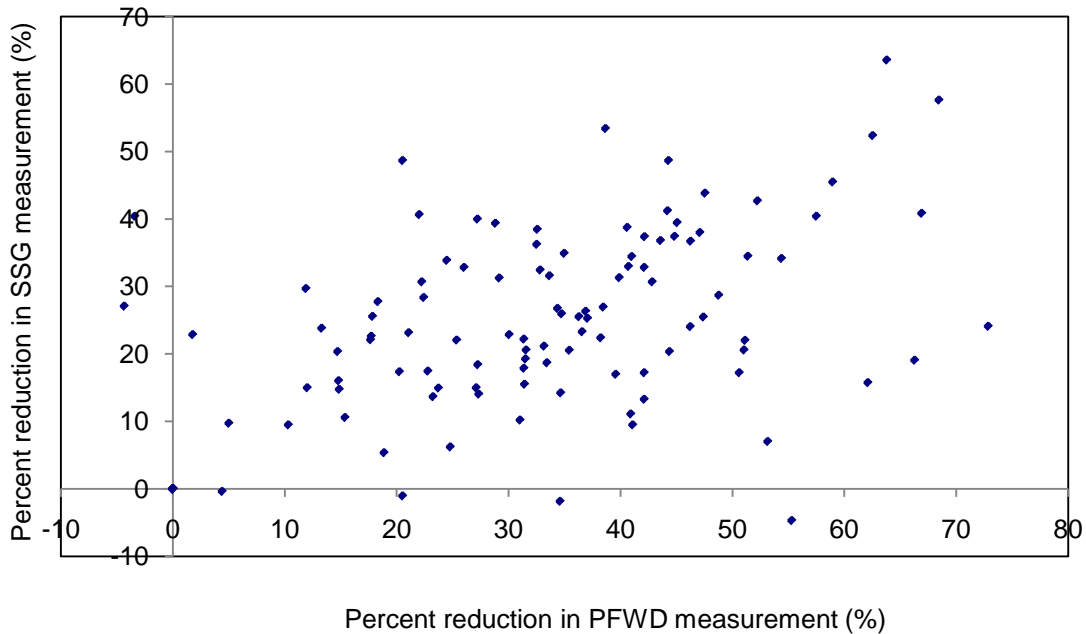
Figure 4-27: Correlation analysis for the PFWD and SSG.

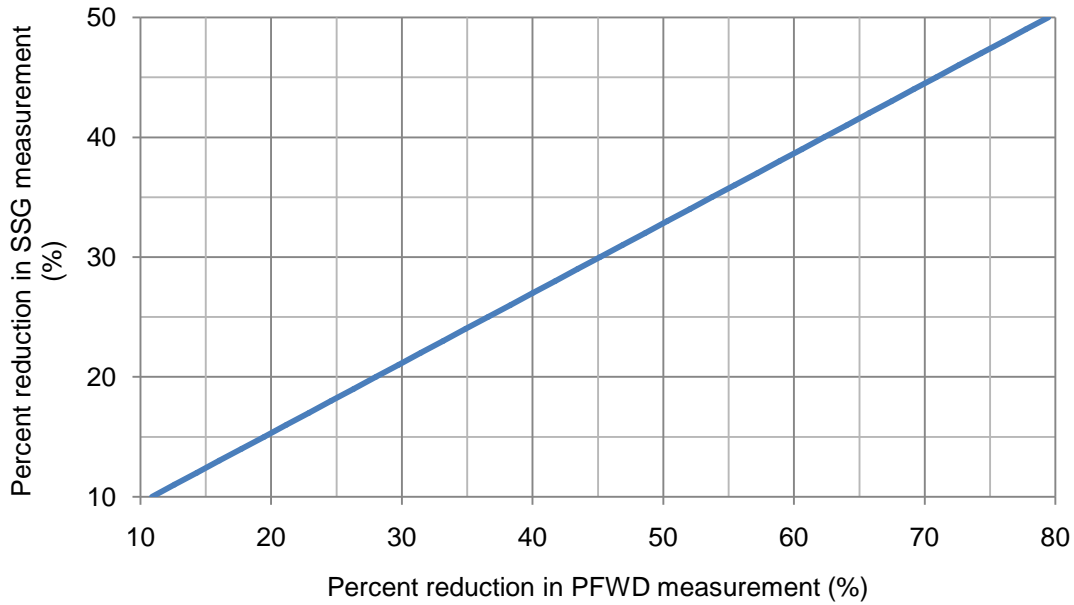
Figure 4-28: Correlation chart for the PFWD and SSG.

percent using the SSG. Use of this chart should enable those with access to only an SSG, which is significantly less expensive than a PFWD, to establish appropriate thresholds for monitoring microcracking with the SSG. The data collected in this research suggest that the heavy CIST should not be used for monitoring microcracking.
