**INVESTIGATION INTO A SYSTEM THAT CAN DETECT
IMPROPER COMBUSTION IN A DIESEL ENGINE BEFORE
SIGNIFICANT DAMAGE CAN OCCUR**

Theo Lawrence Wilcocks

**Submitted in fulfilment of part of the requirements for the degree
of Master of Engineering
in the Faculty of Engineering and the Built Environment**

October 2008

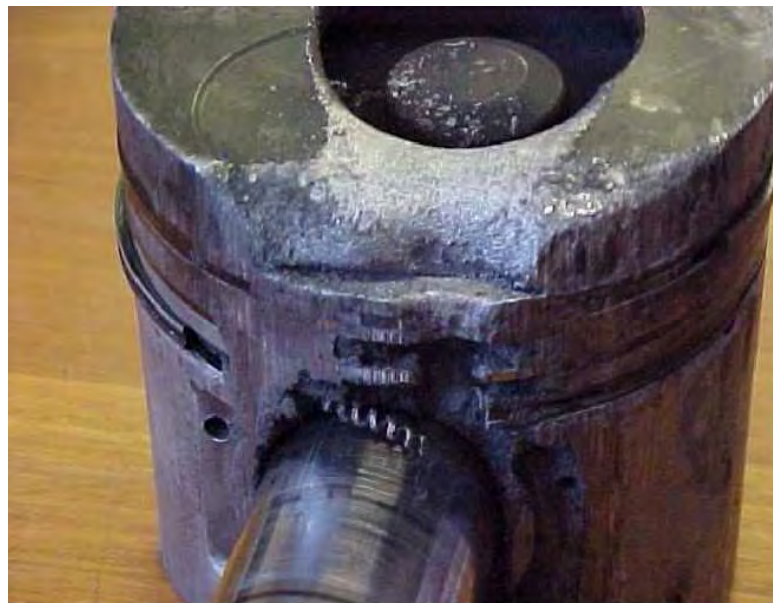
Figure 1-1: Photograph of damage caused to diesel engine piston due to 'hot spot' formation as a result of incorrect spray pattern. (Courtesy AJ von Wielligh & Associates)

It has been found that diesel fuels containing contaminants or diesel fuels with poor lubricity characteristics lead to stickiness of diesel injector needles, which badly affects injector spray patterns. The poor spray patterns and fuel drops lead to melting of piston crown material as can be seen below in Figure 1-1.

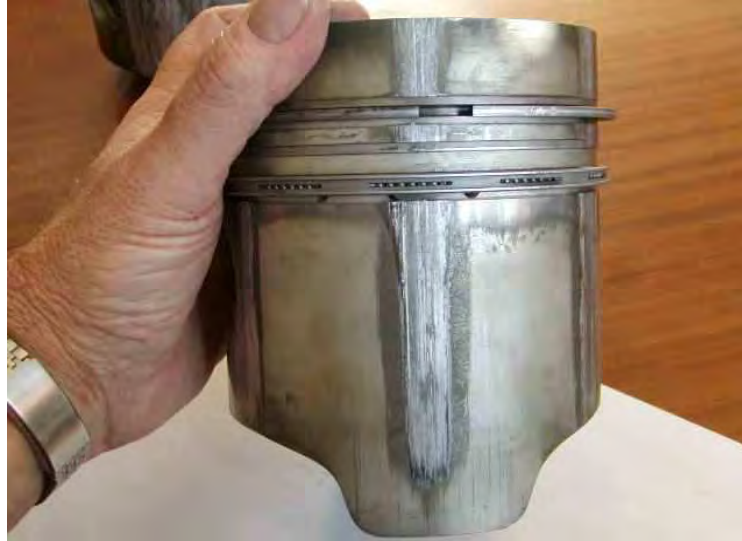
Figure 1-2: Damage caused to diesel engine piston flank due to washing away of the lubrication oil film from the cylinder liner. (Courtesy AJ von Wielligh & Associates)

This effect also results in the washing away of the lubrication film between the piston and cylinder liner materials, bringing about “dry rubbing” and extremely fast wear, resulting in seizing of the pistons within the cylinder liners. Piston damage resulting from this effect is shown in Figure 1-2 above.

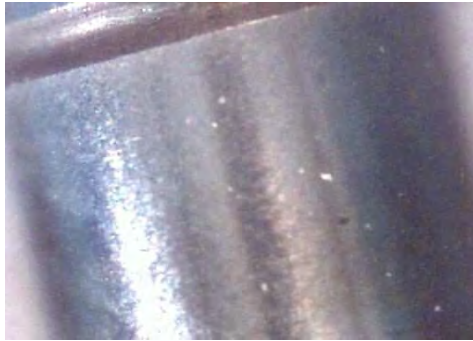
Figure 2-17: 60X magnification of the unscarred surface of a properly operating injector needle. (Courtesy AJ von Wielligh & Associates)

A typical properly functioning injector needle is shown in Figure 2-17.

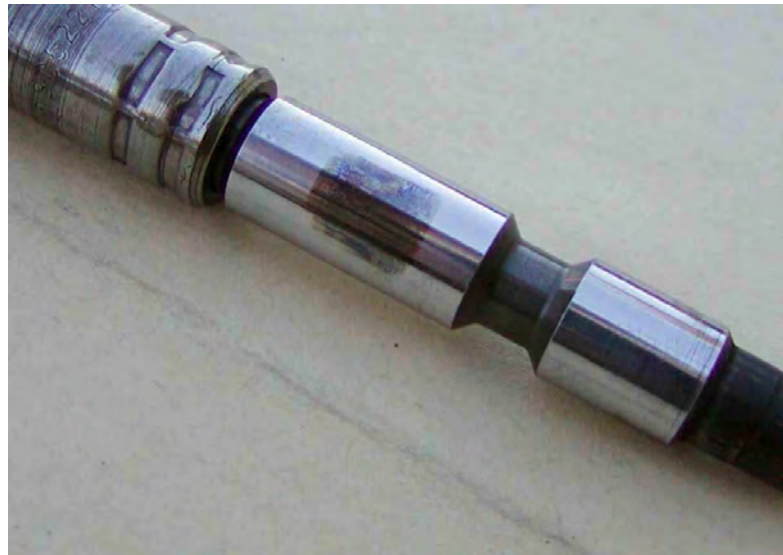
Figure 2-21: Scorch mark damage on injector pump plunger. (Courtesy AJ von Wielligh & Associates)

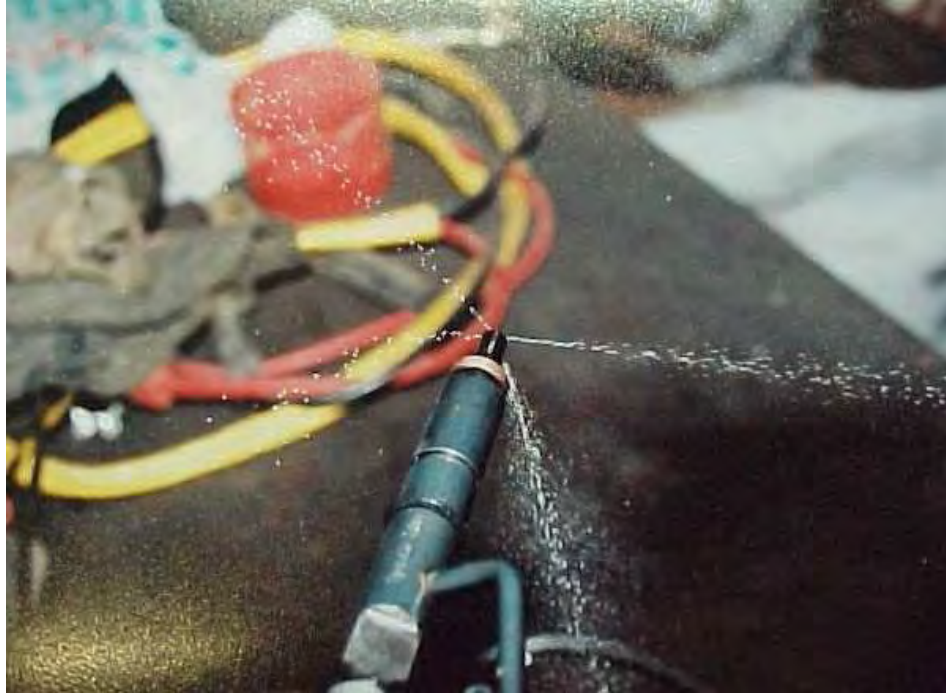
Figure 2-24: Poor spray pattern from a malfunctioning multi-hole injector.
(Courtesy AJ von Wielligh & Associates)

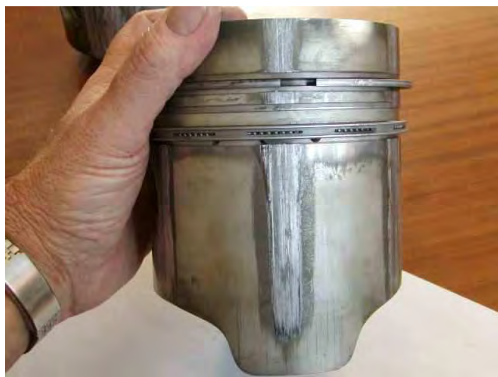
Figure 2-26: With reference to Figure 1-2 Seizing marks indicating unlubricated metal-to-metal contact between cylinder wall and piston. (Courtesy AJ von Wielligh & Associates)

combustion’. Initially this lowers mixing rates and increases emissions of unburned gases, but as the condition of the injector deteriorates so the impingement of liquid fuel worsens. The affected cylinder/s begin to misfire as the ideal mixing ratios are further deviated from and white exhaust smoke becomes visible. Eventually, excessive impingement of liquid fuel jets onto the cylinder walls has the effect of washing away the lubricating oil film from the cylinder walls. This results in piston to cylinder wall seizing as is evident from the damage depicted in Figure 2-26 and Figure 2-27 below.

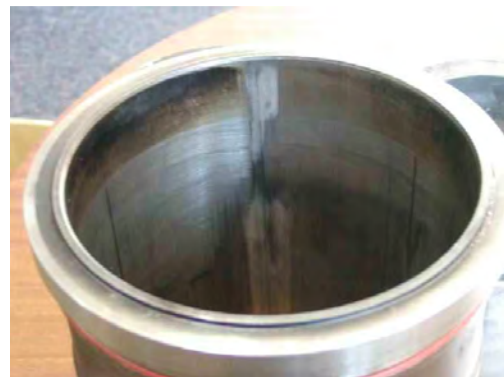
Figure 2-27: Corresponding seizing marks on cylinder wall. (Courtesy AJ von Wielligh & Associates)

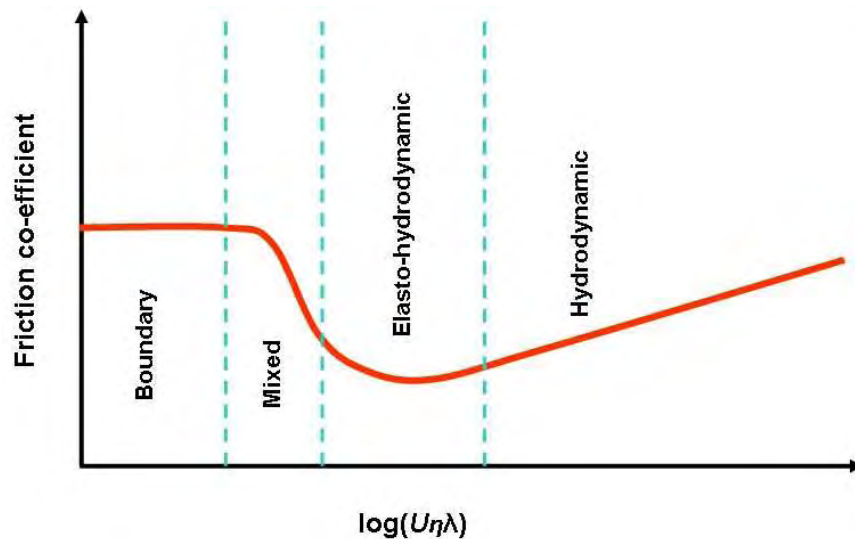
Figure 2-28: Stribeck/Hersey/Gumbel curve relating friction coefficient to film thickness and surface roughness (Spikes, Olver 2005: 6)

1. Hydrodynamic lubrication regime
2. Elasto-hydrodynamic regime
3. Mixed film lubrication regime
4. Boundary lubrication regime

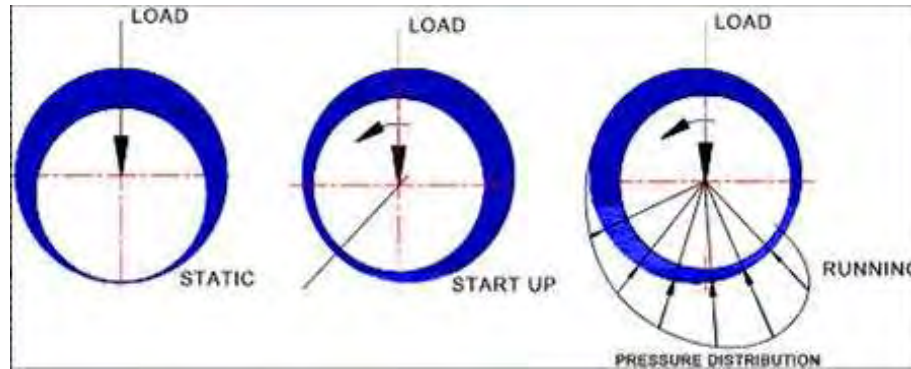
Figure 2-29: Boundary lubrication in a journal bearing (SKF International 2007: 28)

The hydrodynamic lubrication regime relies on a pressurized lubricant film to separate relative surfaces and results in a constant controllable friction coefficient, provided the pressure distribution throughout the lubricant film is maintained. This type of lubrication regime is most commonly found in journal bearings and is depicted in Figure 2-29 below.

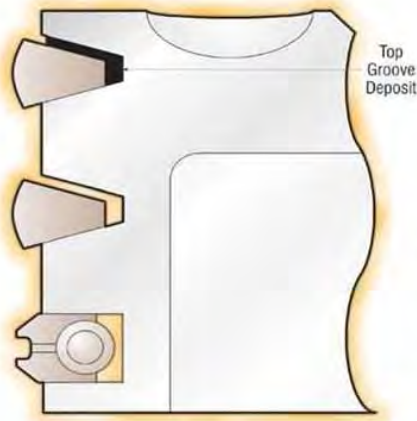
- Top sealing ring = Elastohydrodynamic
- Lower sealing ring = Mixed lubrication
- Oil scraper ring = Boundary lubrication
- Piston skirt = mixed film and boundary lubrication

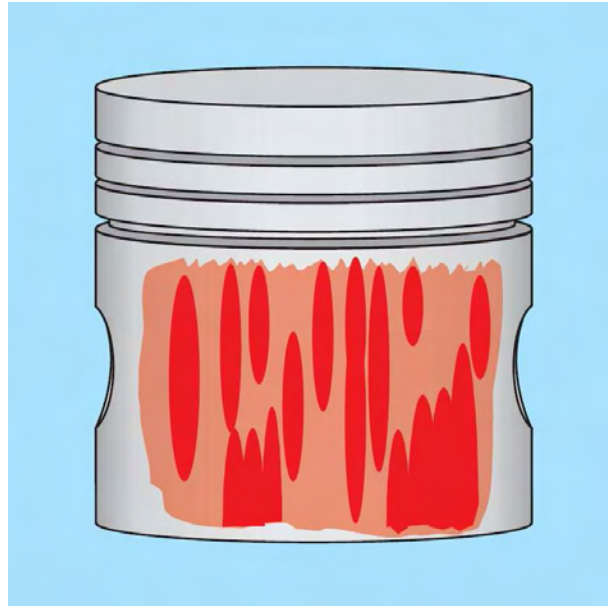
Figure 2-34: Illustration depicting damage zone on piston skirt due to overheating
(Waldhauer, Schilling, Schnaibol, Szopa: 2004: 26)

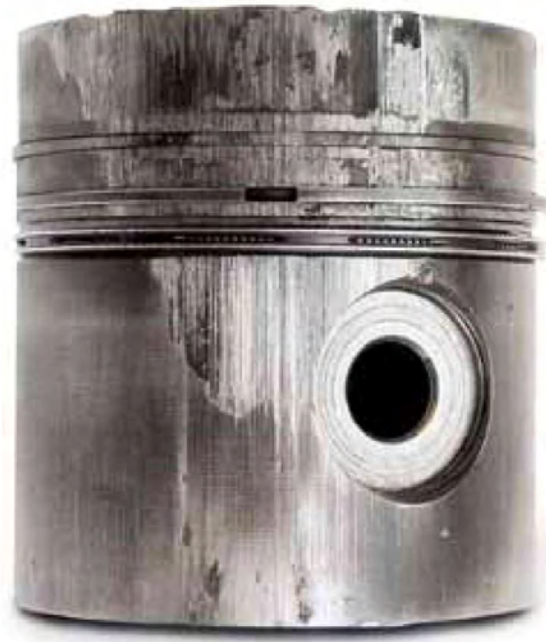
Figure 2-35: Piston skirt damage due to an injector malfunction (Waldhauer, Schilling, Schnaibol, Szopa: 2004: 21)

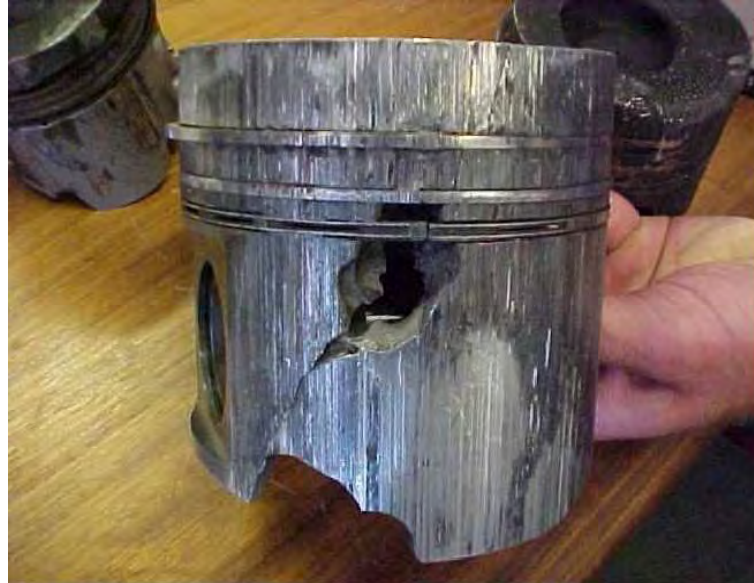
Figure 2-37: Picture of piston damage due to malfunctioning injector. The picture shows the exit point of a hole burnt through from the piston crown, out the side of the piston skirt. (Courtesy AJ von Wielligh & Associates)

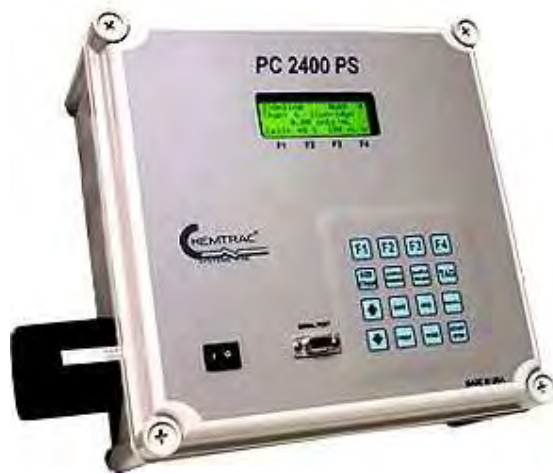
Figure 3-1: Chemtrac Systems portable fuel/oil particle counter.
(Courtesy Chemtrac Systems online catalogue 2004)

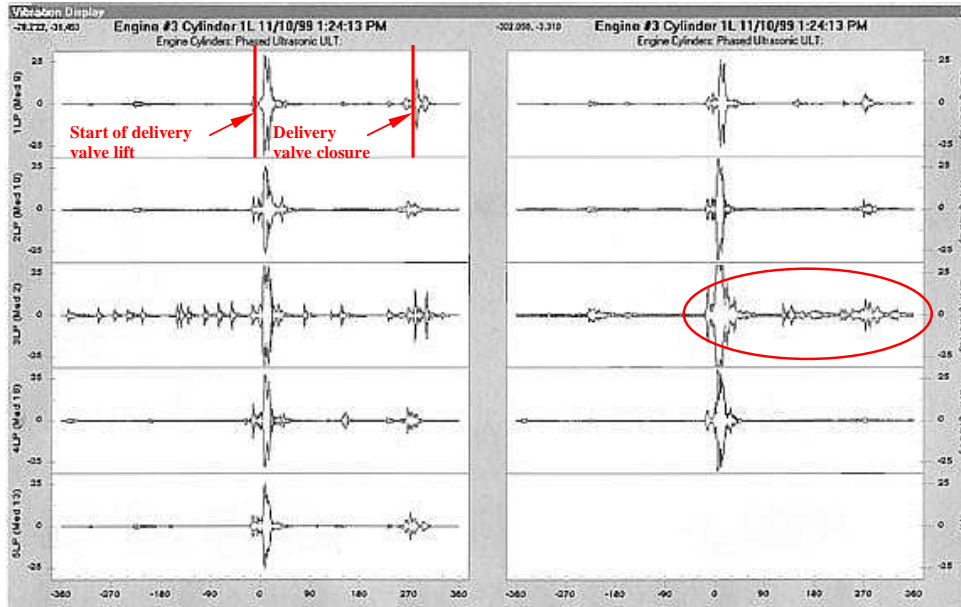
Figure 3-7: Vibration signatures for the 9 pump elements of a medium speed 9 cylinder diesel engine. (O’Connel & Haller 2002: pg 11)

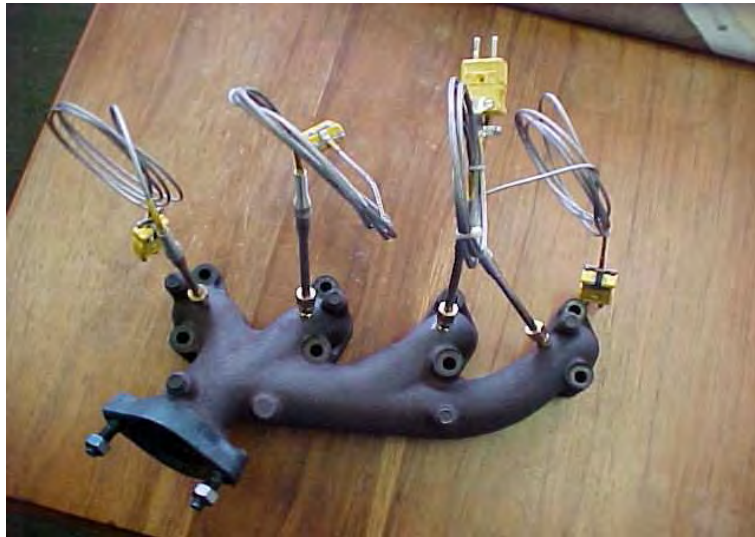
Figure 4-4: Photograph of thermocouple mounting points in exhaust manifold

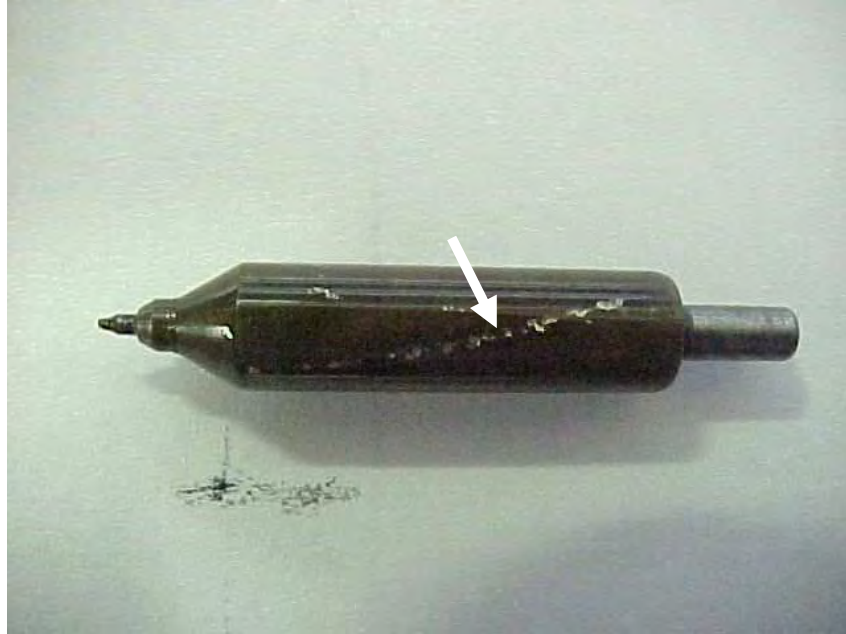
Figure 4-9: The arrow on this photograph indicates a large vertical scratch purposely affected to facilitate seizing of the needle within the injector tip

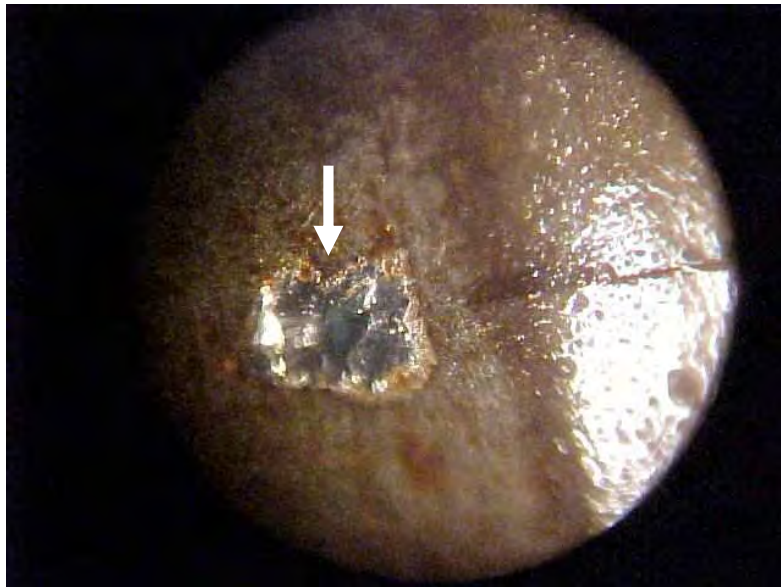
Figure 4-10: A view of the needle damage captured under 100X magnification as indicated by the arrow. Note that small pieces of material were ripped out of the needle surface as it was forced to reciprocate within the needle

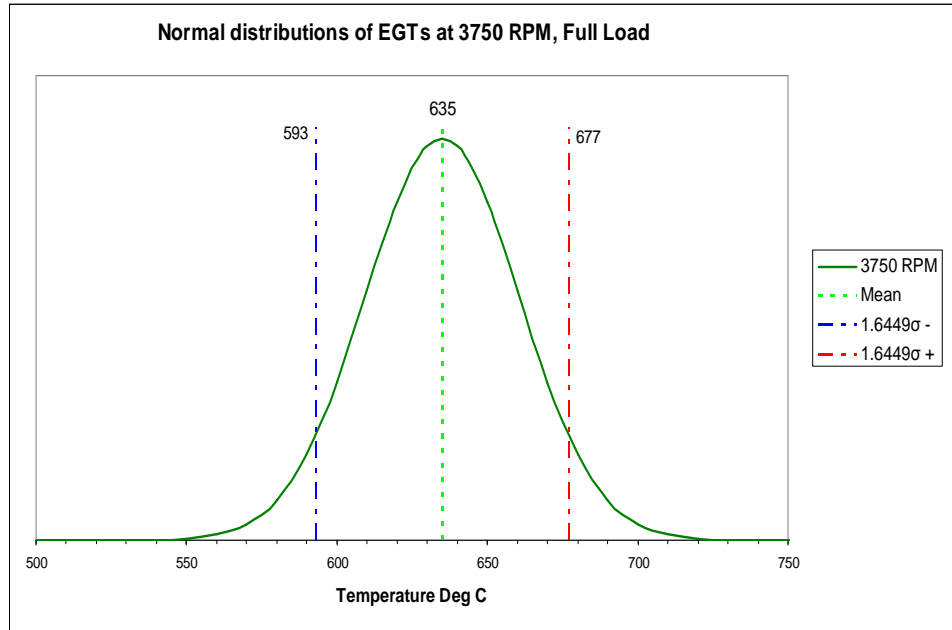
Figure 4-12: Normal distribution across all four cylinders of EGTs for properly functioning injectors at 3 750 RPM

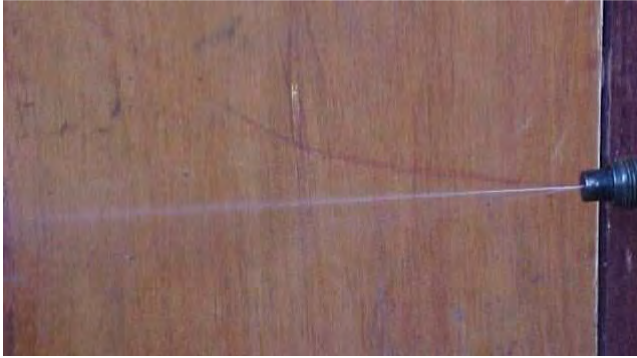
Figure 4-29: Injector number 4 spray pattern

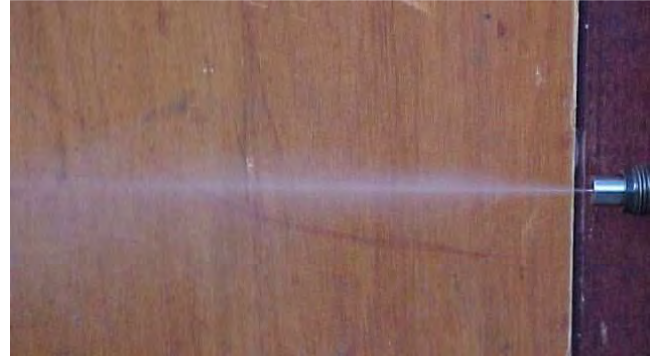
Figure 4-30: Spray pattern of a new injector

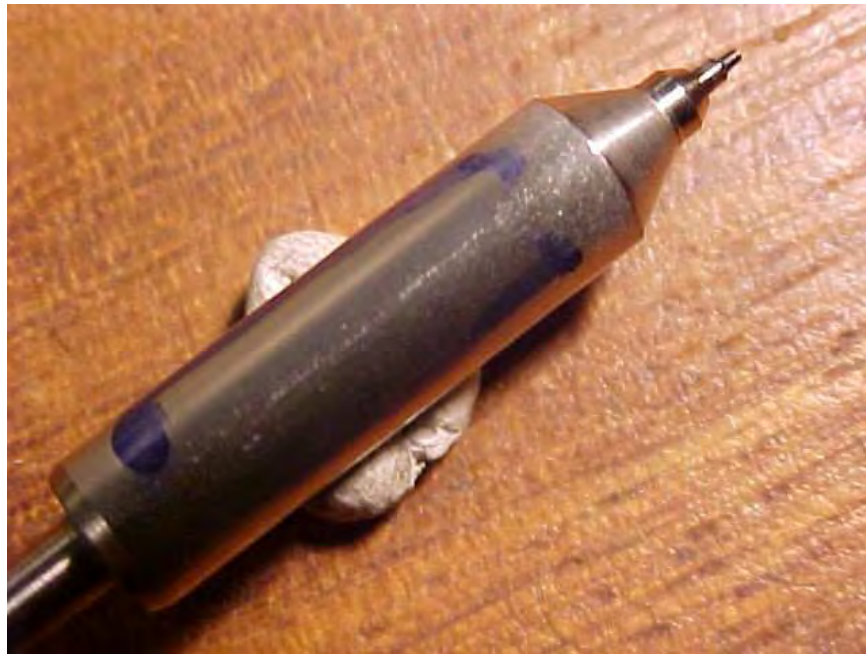
Figure 4-31: Close-up photograph of damage on needle surface

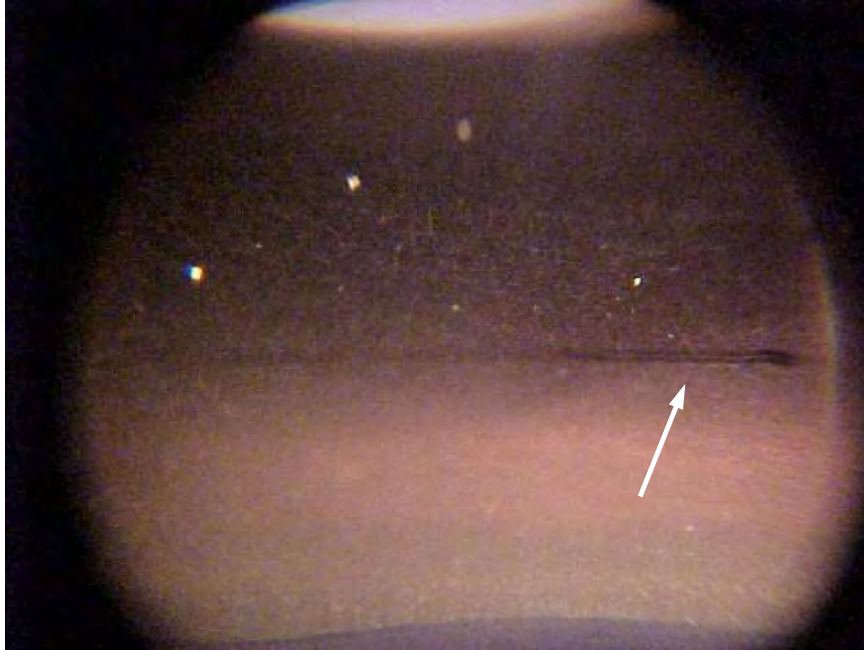
Figure 4-32: 100X magnification of score mark on needle surface

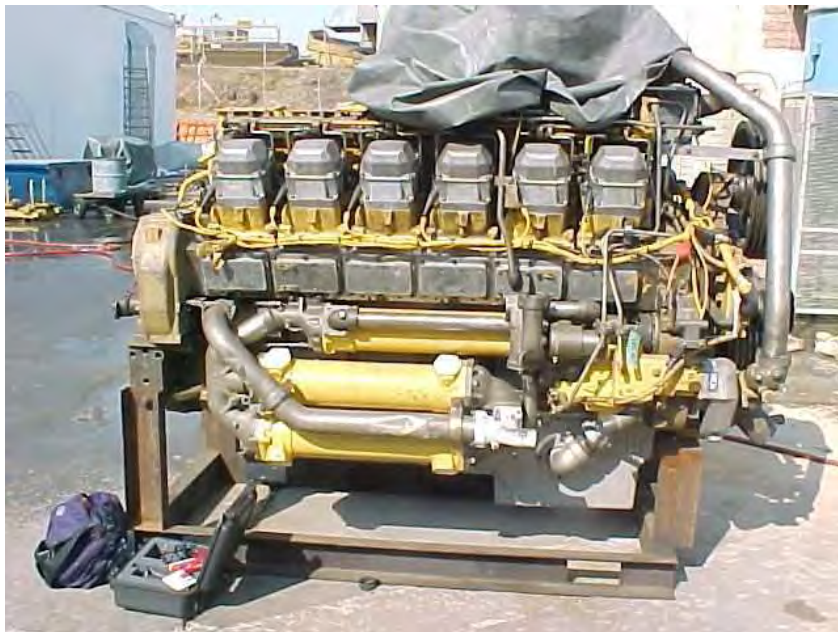
Figure 4-33: Caterpillar 3512 V12 engine on which testing was conducted

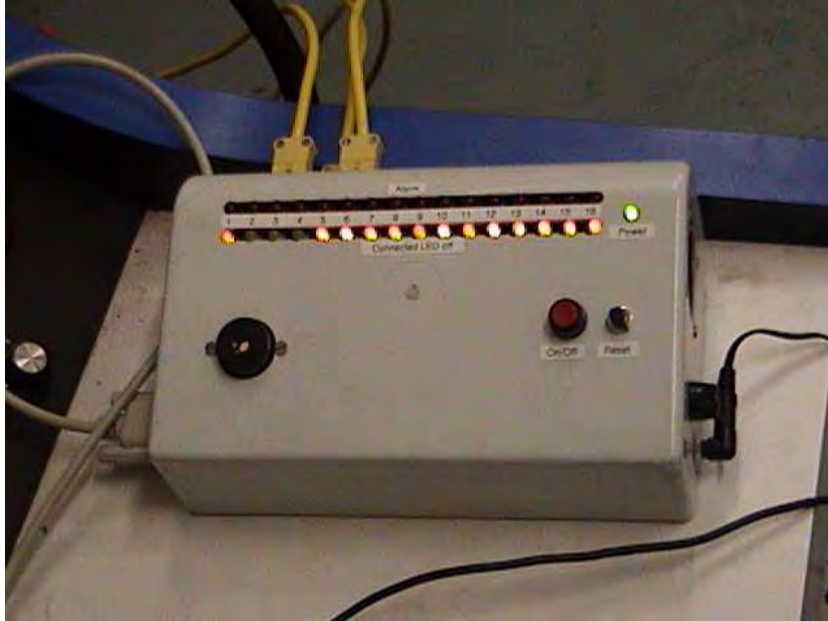
Figure 5-16: CMS display upon thermocouple connection

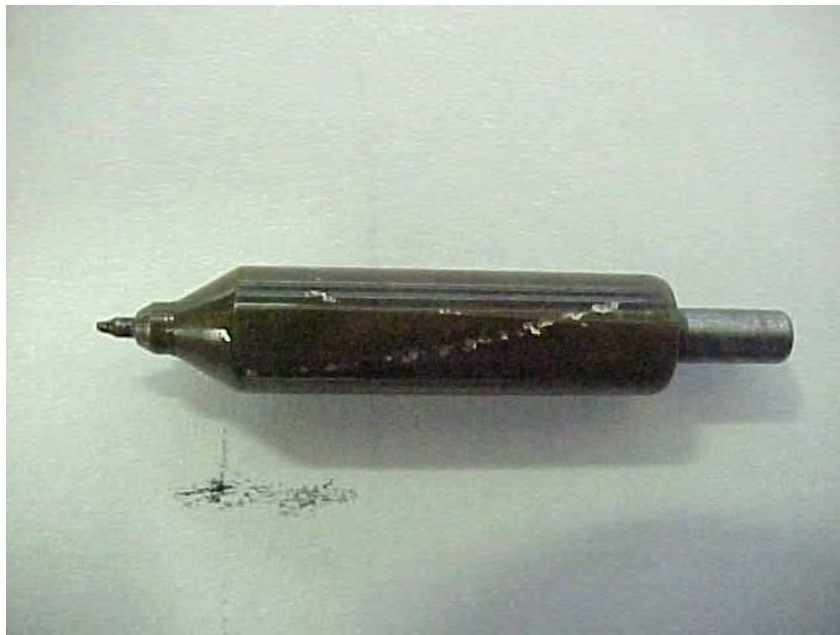
Figure 5-19: Damaged injector test needle
