Impact of Mass Mixing on the Lateral Resistance of Driven-Pile Foundations

IMPACT OF MASS MIXING ON THE LATERAL RESISTANCE
OF DRIVEN-PILE FOUNDATIONS

Master of Science

Department of Civil and Environmental Engineering

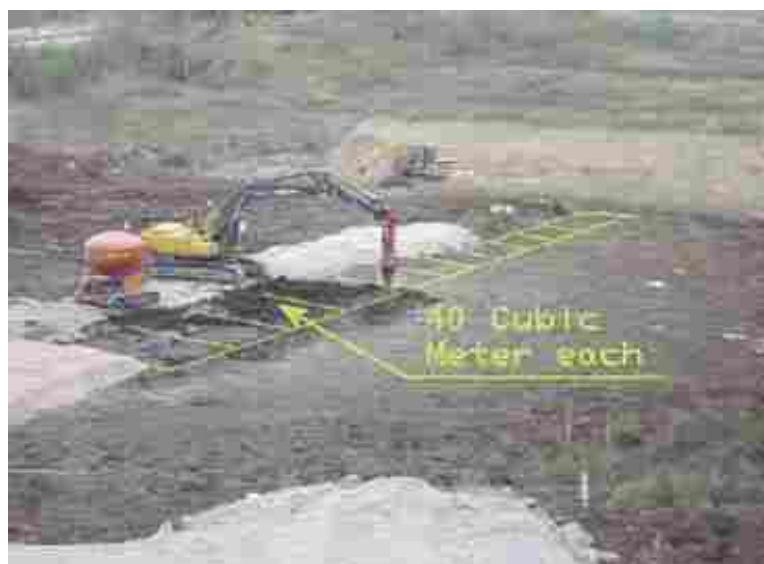
Figure 2-7 - Schematic illustration and photograph of mass stabilization by blocks method (ALLU website 2007).

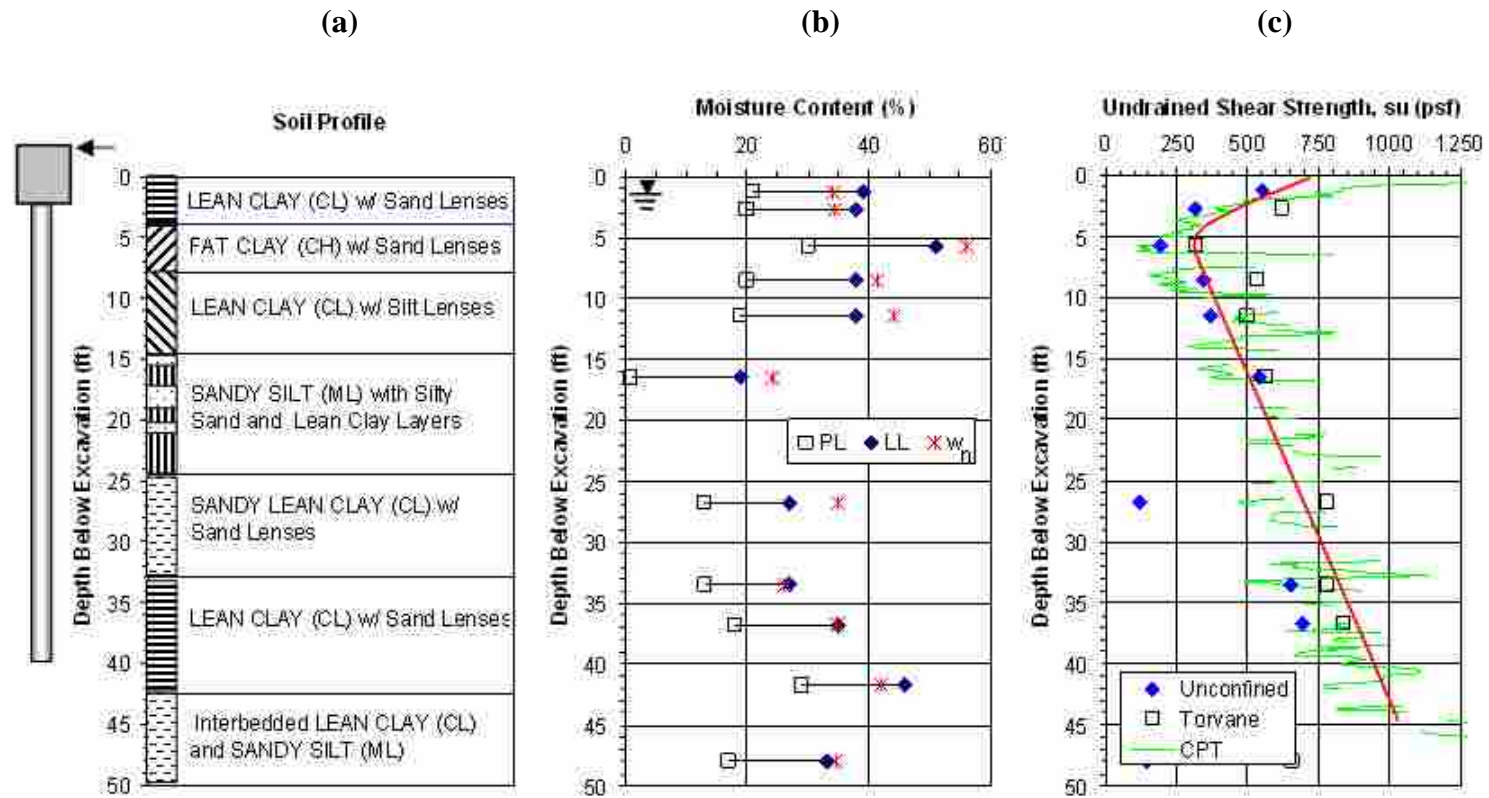
Figure 3-3 Plot of (a) soil profile, (b) Atterberg limits and natural water content versus depth, and (c) undrained shear strength versus depth.

The liquid limit, plastic limit and natural moisture content are plotted in Figure 3-3 (b) at each depth where Atterberg limit testing was performed. The water table is at a depth of 1.5 feet, which is equivalent to a depth of 5.5 feet below the pre-

A close look at Table 3-1 or Figure 3-3 shows that this site meets all three of the above criteria. Therefore, the soil profile information obtained to a depth of 50 feet is sufficient to classify the site as an IBC Site Class E.

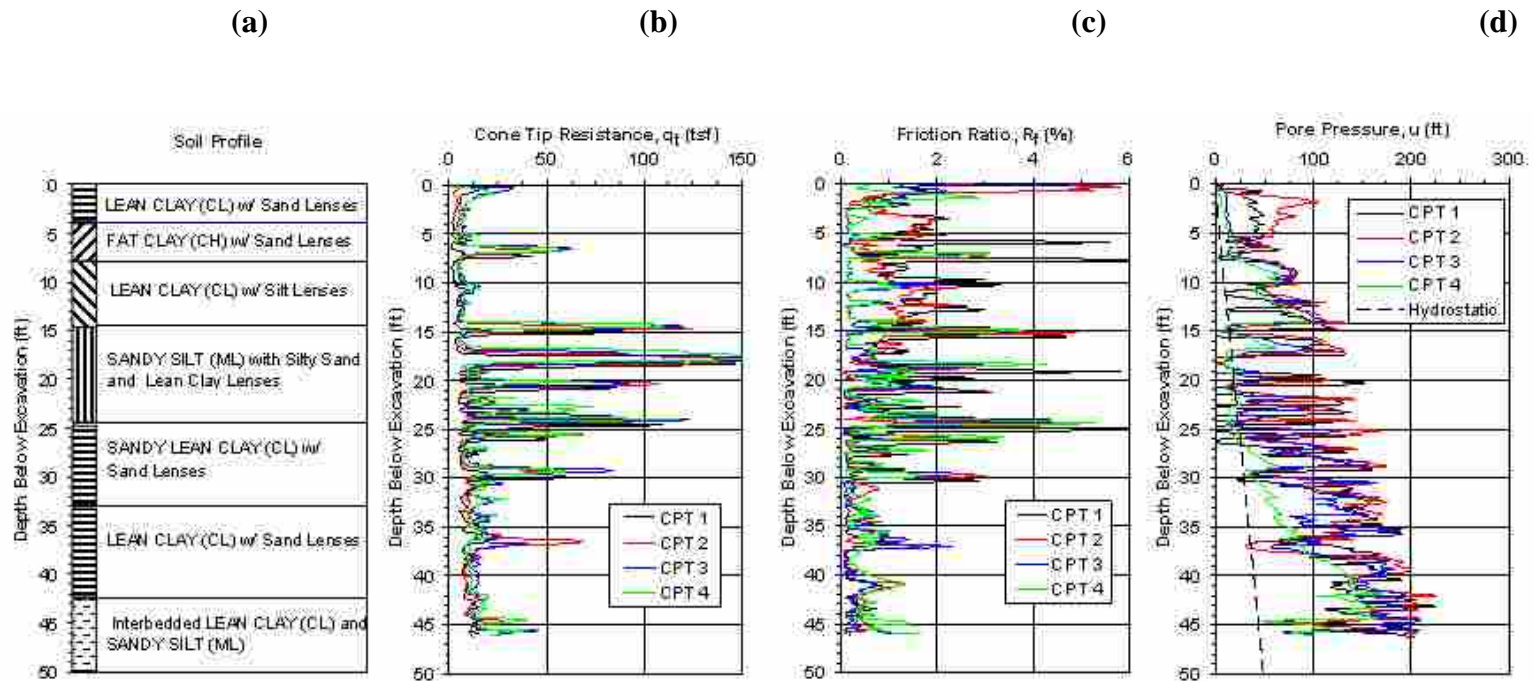
Figure 3-5 - Plot (a) soil profile, (b) cone tip resistance versus depth, (c) friction ratio versus depth and, (d) pore pressure versus depth from all four cone penetration test (CPT) soundings.

Figure 3-5 provides plots of the cone tip resistance, friction ratio and pore pressure as a function of depth for all four of the CPT soundings. The measured parameters and layering are generally very consistent for all four sounding which indicates that the lateral pile load tests can be fairly compared from one foundation to the next.

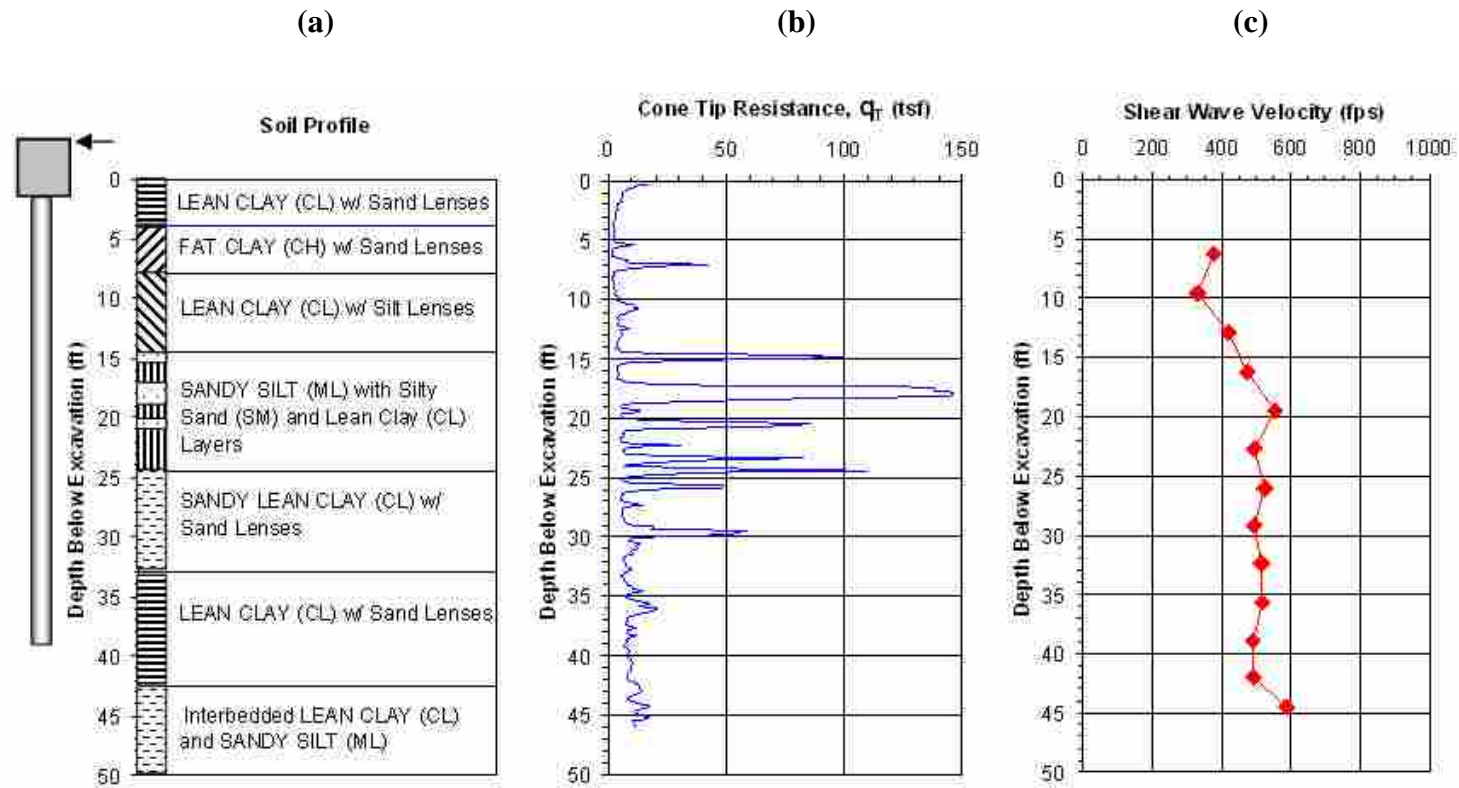
Figure 3-6 Plot of (a) soil profile, (b) cone tip resistance versus depth, and (c) shear wave velocity versus depth from seismic cone testing.

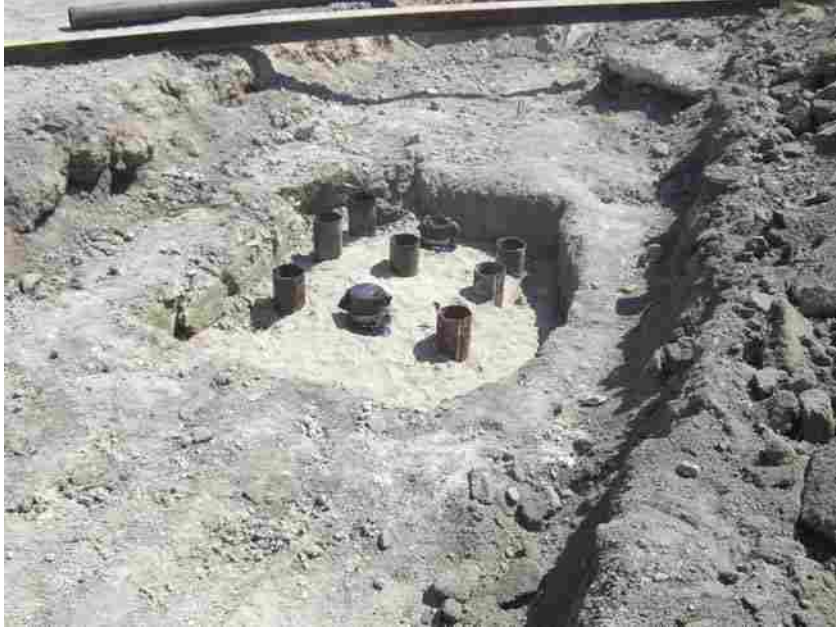
Figure 4-2 - Driven pile layout prior to cap construction.

The center piles of each row were instrumented with strain gages prior to installation (see Figure 4-1). (Note: For caps 2 and 4, the middle pile of the center row was not instrumented with strain gages). The strain gages were placed at pre-determined depths of 2, 6, 11, and 13.5 feet below the tops of the piles. Strain gages were placed along the north and south sides of the piles in the direction of loading. The strain gage depths were determined through computer modeling to be the most critical depths in developing bending moment curves for the laterally loaded piles. Figure 4-2 is a photo of an installed pile group.

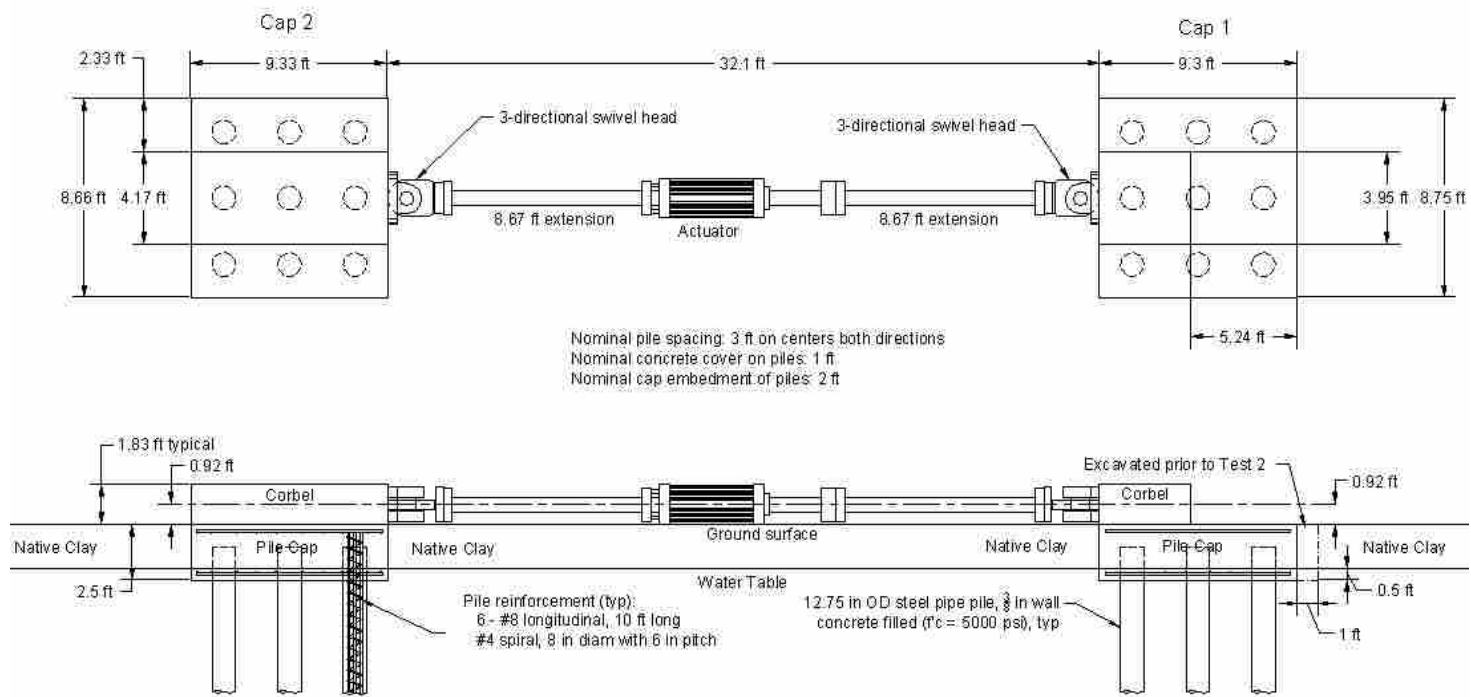
Figure 4-4 Plan and profile drawings of pile caps 1 and 2 during Test 1 when the pile groups were pulled together by the actuator. During Test 2 the soil adjacent to the pile cap was excavated to the base of the cap and the pile caps were pushed apart by the actuator.

A corbel was constructed on each cap to allow the actuator to apply load above the ground surface without affecting the soil around the pile cap. The corbel extended the full length of the pile cap for caps 2 and 3 to allow the actuators to be attached to both sides of the caps. Alternatively, the corbel only extended about half of the pile cap length in cap 1 and 4 as only one sided was needed for the actuator attachment. This is shown in Figure 4-4 which illustrates the corbel configuration on top of caps 1 and 2. The corbel was designed using the traditional ACI design method found in section 11.9 of the ACI code. The corbel was reinforced with #5 bar hoops and #9 bars as the main reinforcement as shown in Figure 4-7 and Figure 4-8. Also included in Figure 4-9 is a cross sectional view of the corbel steel looking at the interface where the actuator connects to the corbel. Design calculations and more detailed steel reinforcement drawings are provided in Appendix A.

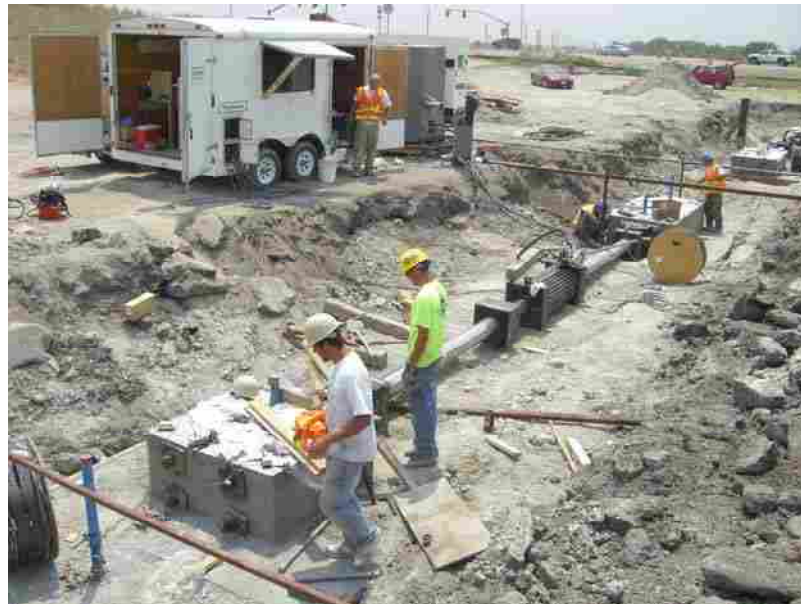
Figure 4-10 - Photo of actuator setup between caps 1 & 2.

Most of the tests performed involved reacting one pile group against another, through applying a lateral load with an MTS actuator with the load centered at a height of 0.92 (11 inches) above the top of the pile cap. Each of the actuators had a capacity of about 600 kips in compression and 450 kips in tension. The pile groups were spaced approximately 32 feet apart edge to edge. This spacing was considered to be large enough to ensure that the volumes of affected soil created by the displacement of each foundation would not significantly interfere with each other. The actuators were fitted

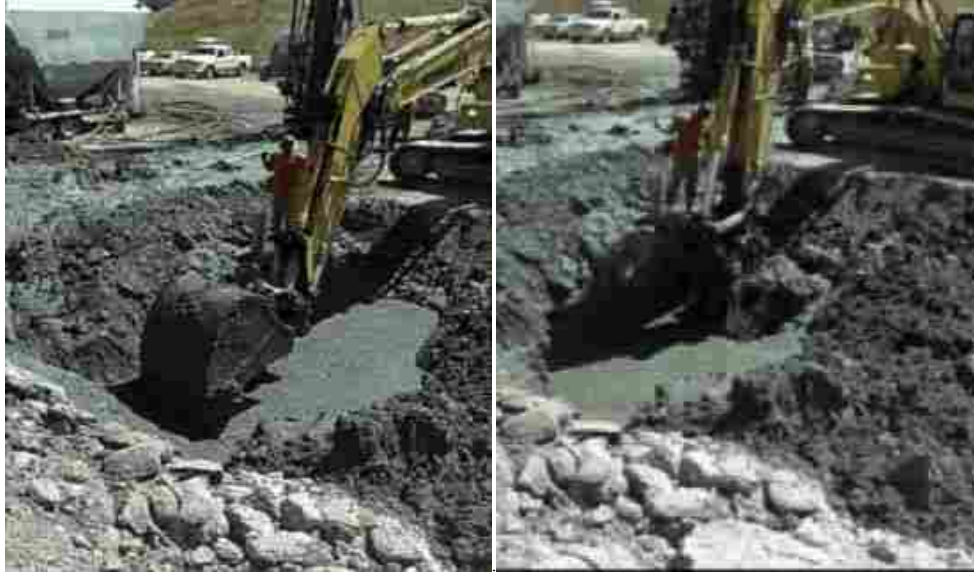
Figure 4-12 – The process of mixing the insitu soil with the jet grout spoils.

Mixing was accomplished by repeatedly stirring the native soil and grout spoil until the consistency of the mixture became relatively homogeneous and no large blocks were obvious in the mixture. This process required approximately 10 to 15 minutes of mixing and provided a 1 to 1 ratio of soil to grout spoil mixture. Photographs of the mixing process are provided in Figure 4-12. A photograph of the finished mass mixed zone is also provided in Figure 4-13, in which the final dimensions of 11 feet long and 4 feet thick can be seen.

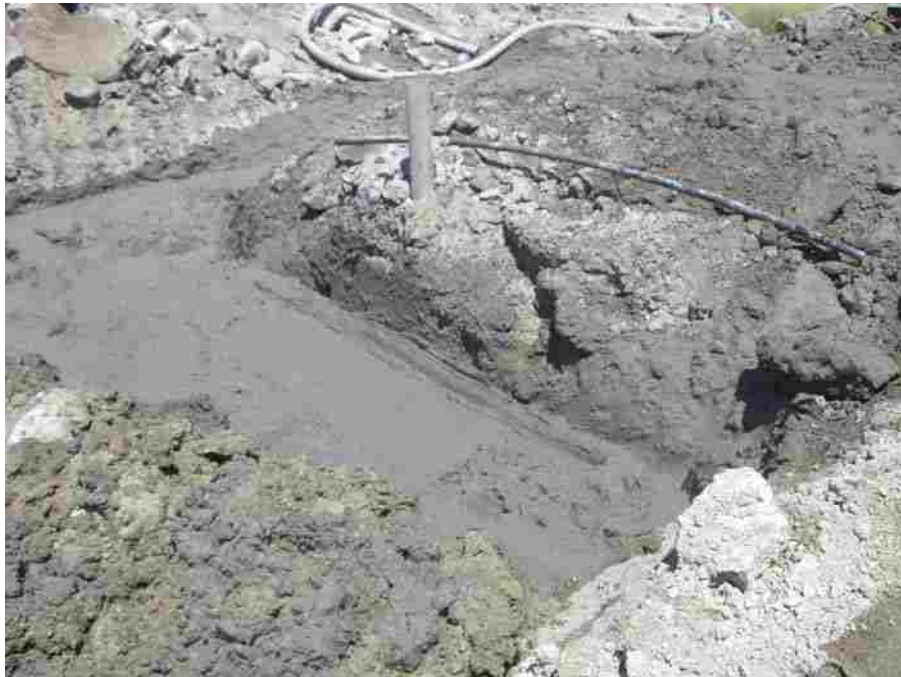
Figure 4-13 – Photograph of the finished mass mixed zone.
