Laterally Loaded Pile Cap Connections

LATERALLY LOADED PILE CAP CONNECTIONS

Master of Science

Department of Civil and Environmental Engineering

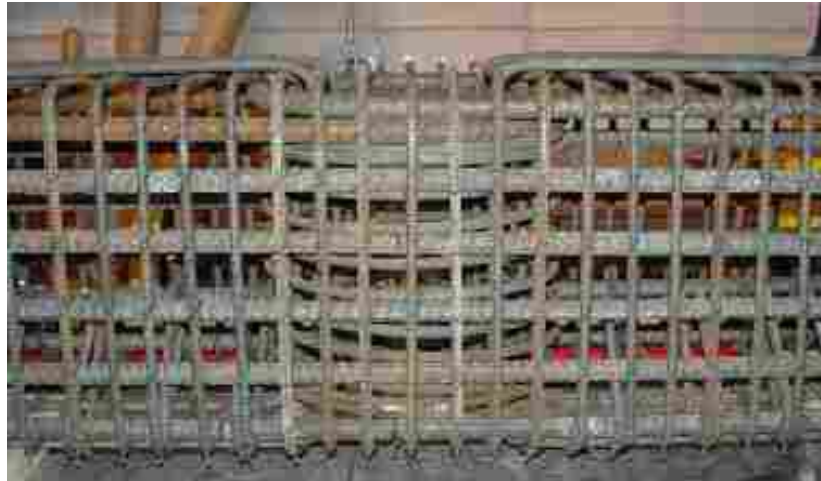
Figure 2-4 Reinforcing cage for pile cap Model 4 Montana State University.

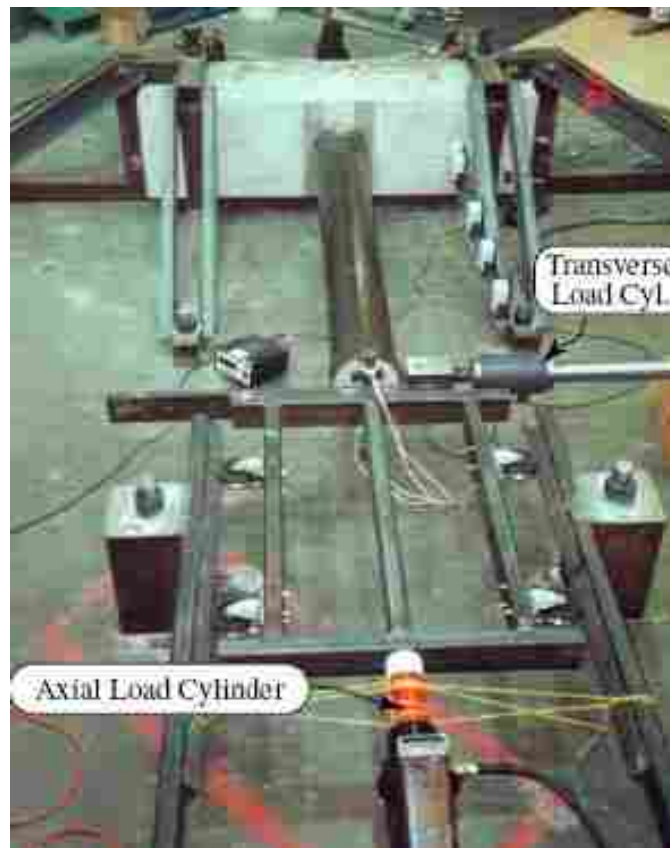
Figure 2-5 Pile and cap setup for testing at Montana State University.

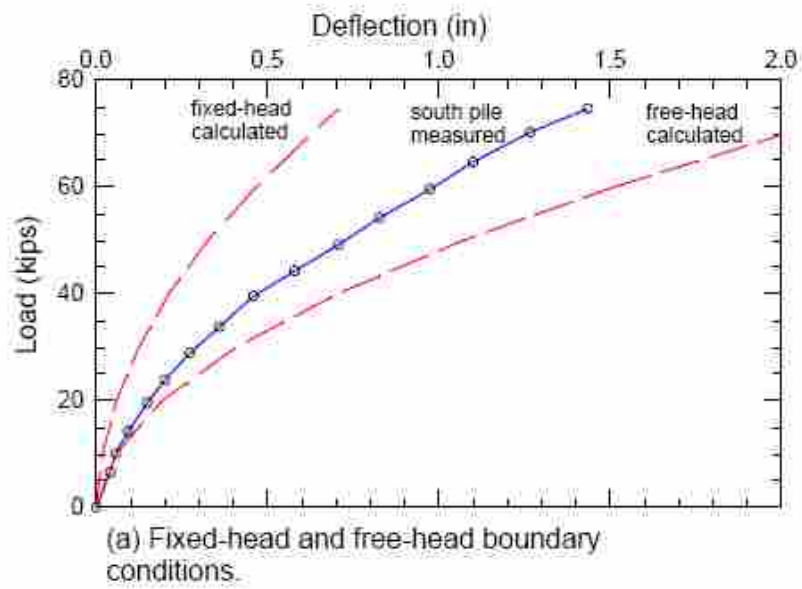
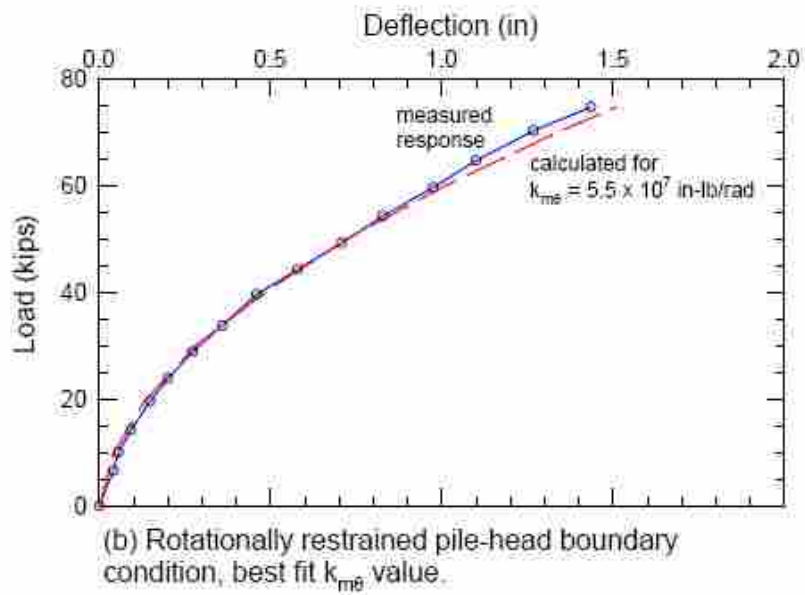
Figure 2-7 Load vs. Deflection curves comparing boundary conditions.

Figure 2-7 shows one of the load-deflection curves from testing and compares them to the curves predicted using fixed-head and free-head conditions as well as the rotationally restrained stiffness defined using equation 2-4.

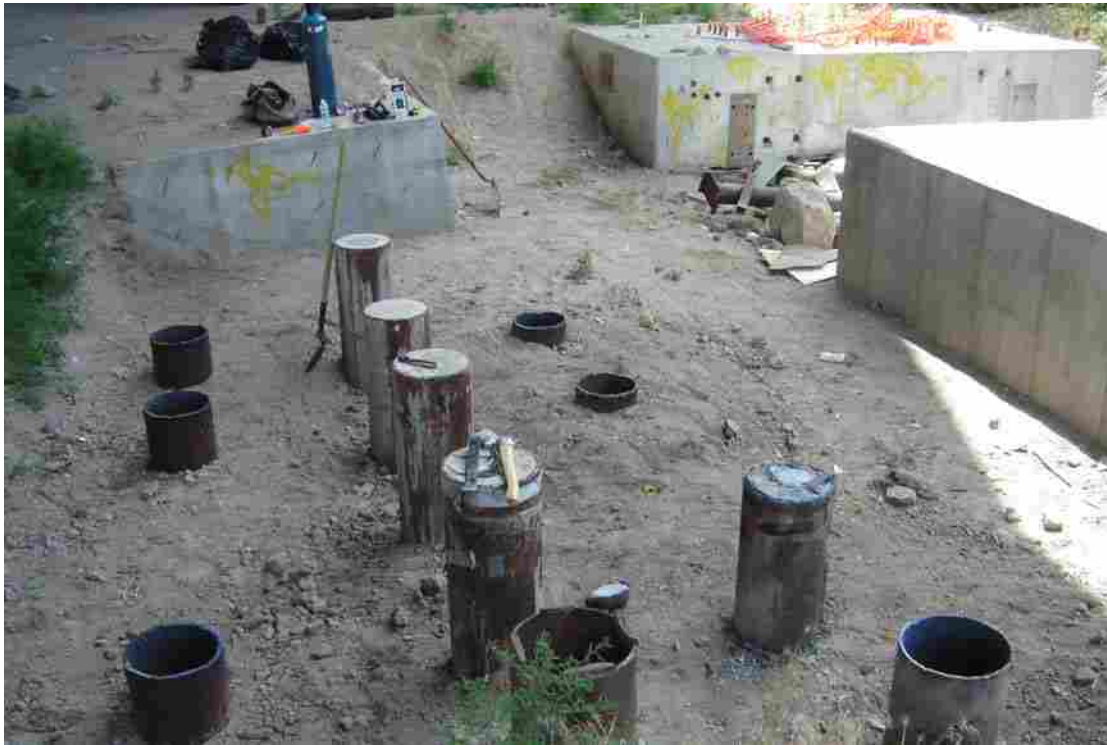
Figure 3-2 Photograph of the South Temple, Salt Lake City Test Site.

water table was located at a depth of approximately 1.07 m during the time of the testing. The piles extended through an underlying soft clay layer and into a stiffer clay layer below. A picture of the site prior to construction of the pile caps is provided in Figure 3-2.

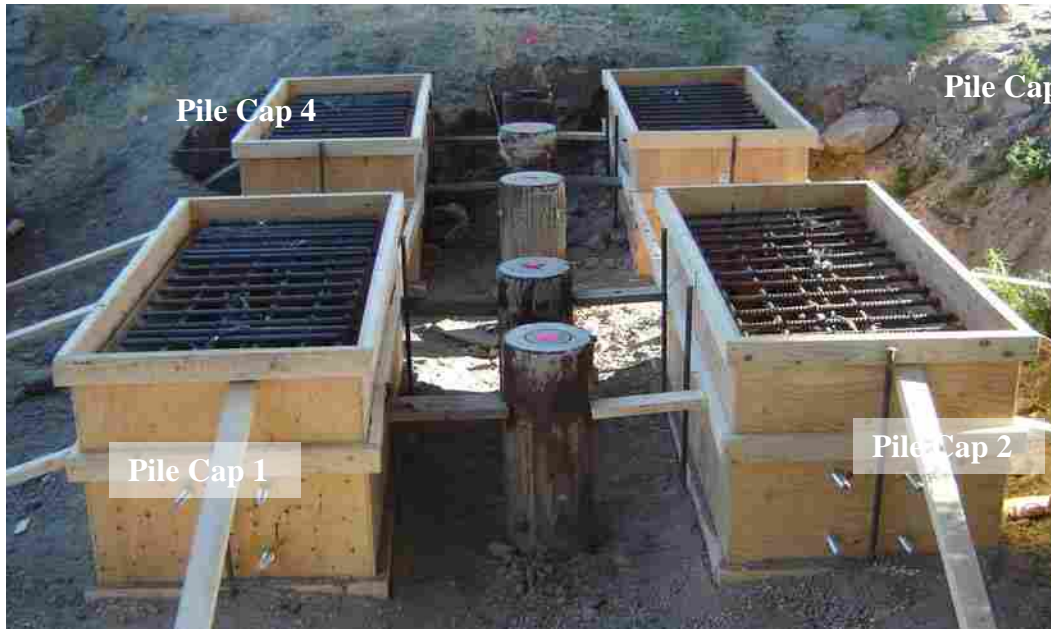
Figure 3-4 Photograph of the South Temple, Salt Lake City Test Site.

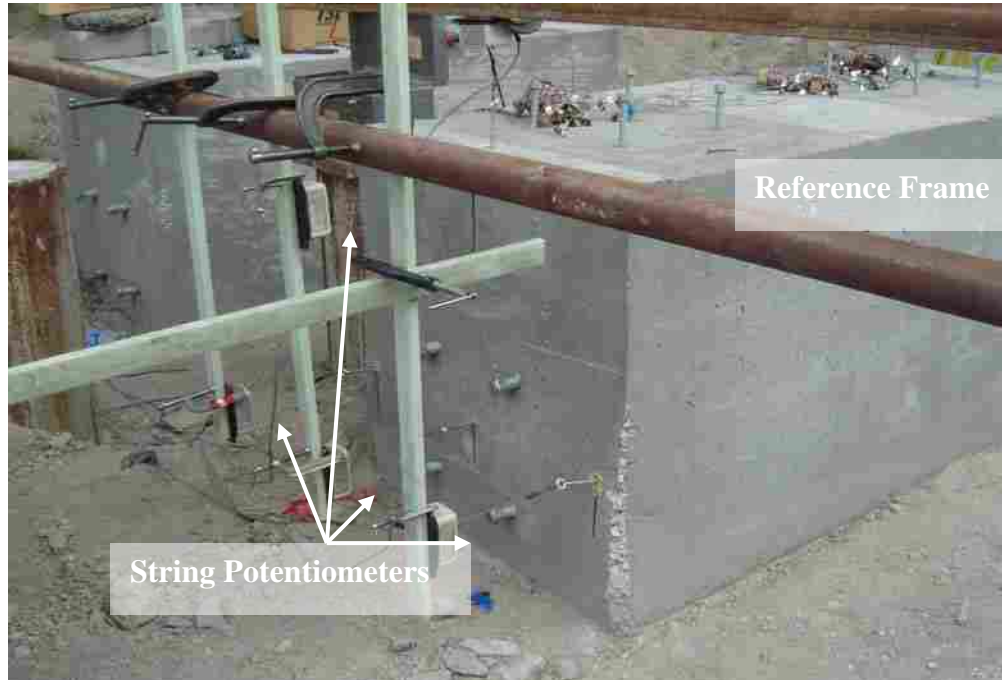
Figure 3-10 Photograph of string potentiometers setup (typical all caps).

To determine the displacement and rotation of each cap as a function of the applied force, six string potentiometers (string pots) were installed on the exterior of each cap to be tested. Two were placed on the top of the cap at a center location and spaced six feet apart so that they were approximately 3 inches from the front and back edges of the cap as shown in Figure 3-9. These two string potentiometers measuring displacements made it possible to calculate the pile cap rotation.

Along the front of the cap four additional string potentiometers were installed as shown in Figure 3-9. Three were placed at the elevation of the loading point, one foot above grade with one potentiometer at the center of the cap and two spaced at a distance of 3 inches from the edge of the cap on either side. The last string pot was located 21 inches directly above the center string potentiometer which placed it about

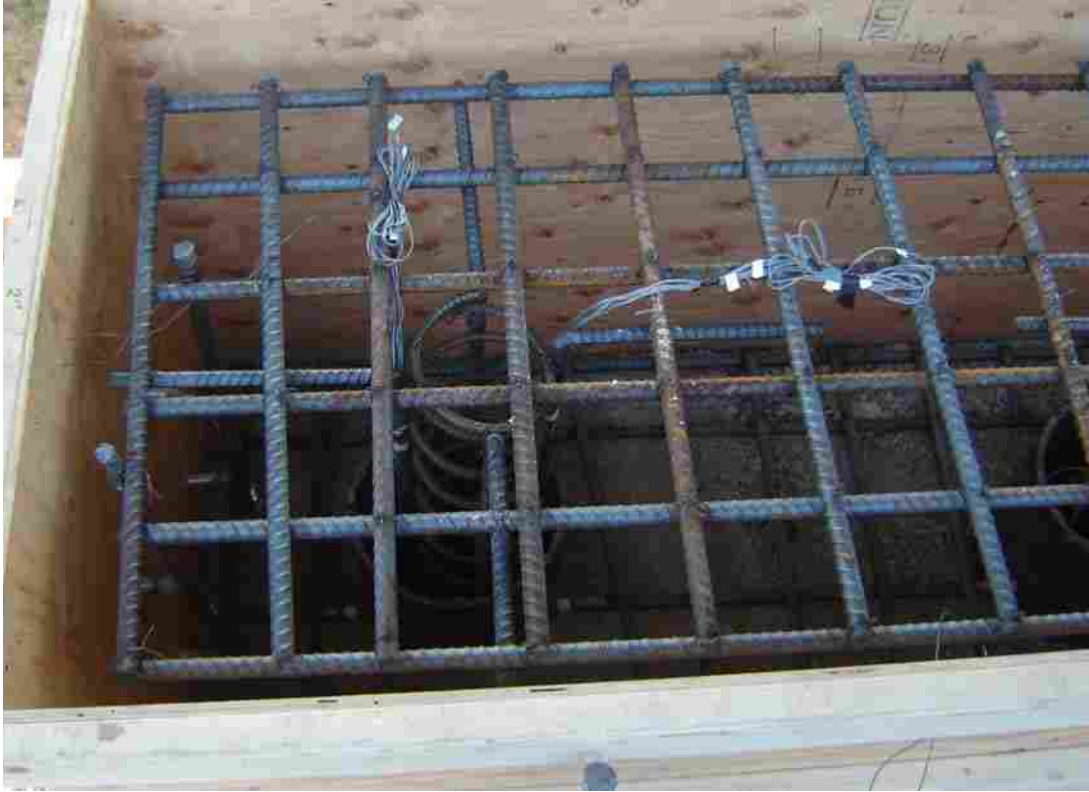
Figure 3-13 Photograph of Pile Cap 1 reinforcing.

In the first test, an embedment length of 6 inches was provided along with a reinforcing bar connection detail consisting of a #4 spiral at a 6 inch pitch with 4 #6 longitudinal bars embedded 4 feet down into each pile and extending 33 inches above grade. Each vertical bar included a one foot section after a 90° bend which was tied to the top reinforcement grid. Both piles were filled with concrete. This is a standard UDOT connection detail and a cross section can be seen in Figure 3-11, with Figure 3-12 showing a cross section of the front elevation. A photograph of the connection provided for Pile Cap 1 is presented also in Figure 3-13. Twenty quarter bridge, resistance type strain gauges (Texas Measurements Group type FLA-6-11) were installed on test cap 1: four along the bottom reinforcing grid, six on each of the

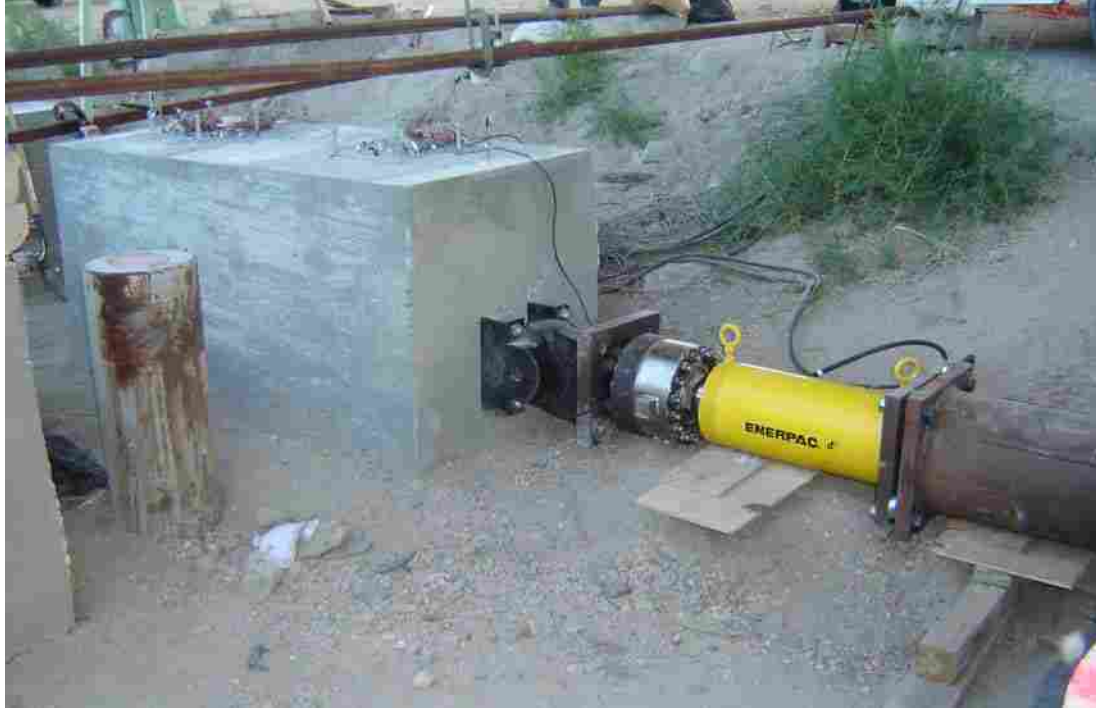
Figure 3-16 shows a photograph of the test setup for Test Cap 2, the same connections were utilized and the Geo pier (not pictured) was used again as a fixed base at which to counter the applied force.

Figure 3-16 Photograph of test set-up for Pile Cap 2.

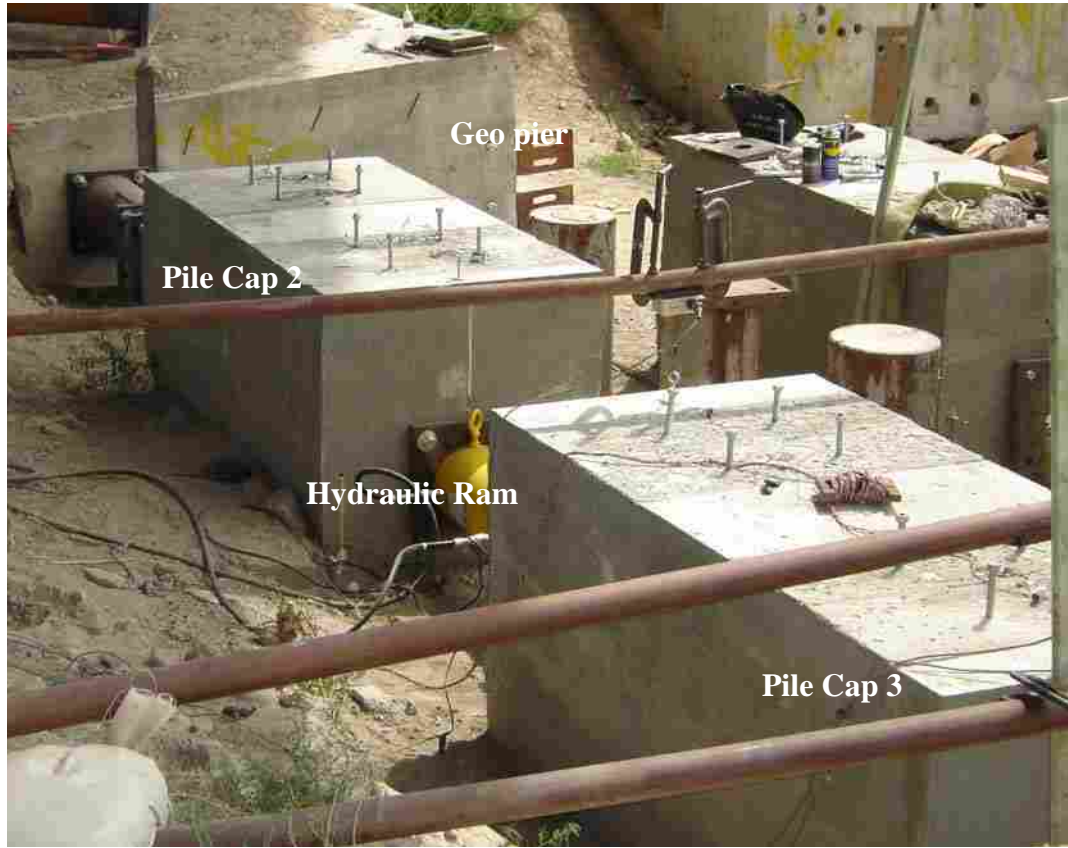
Figure 3-18 provides a photograph of the pile cap, hydraulic ram set-up and reference frame during the test on Pile Cap 3. The Geo pier cap was again used to provide the reaction for the load test by placing a steel strut between Pile Cap 2 and the Geo pier Cap. Figure 3-19 shows a closer view of the test setup for Pile Cap 3 including the positions and anchoring used for the string potentiometers. A more compact swivel head was used due to the space constraints between the pile caps.

Figure 3-18 Photograph of equipment arrangement for test on Pile Cap 3.

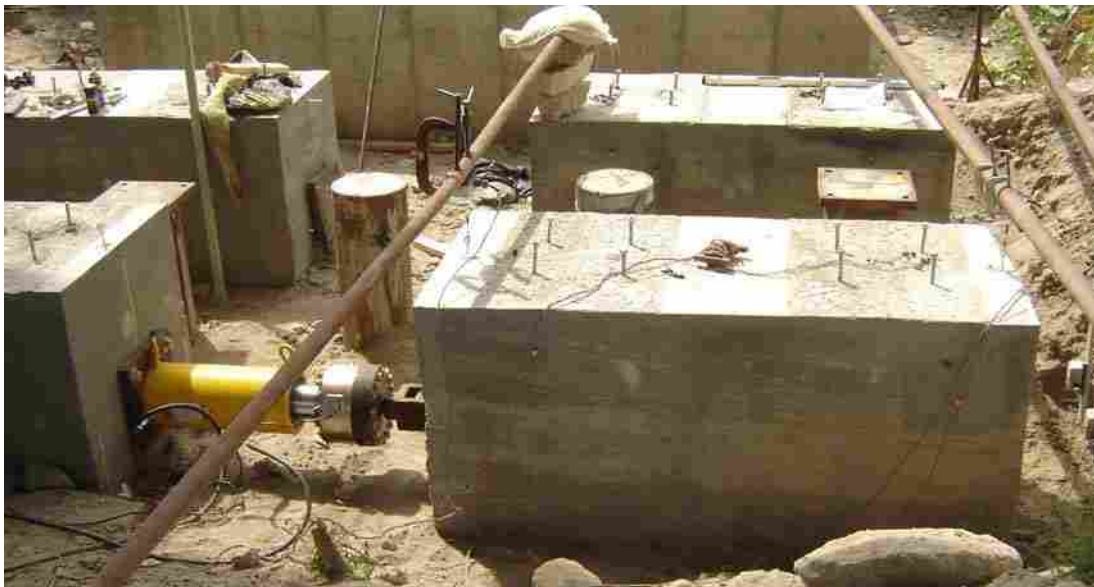
Figure 3-19 Side view of test setup prior to loading Pile Cap 3.

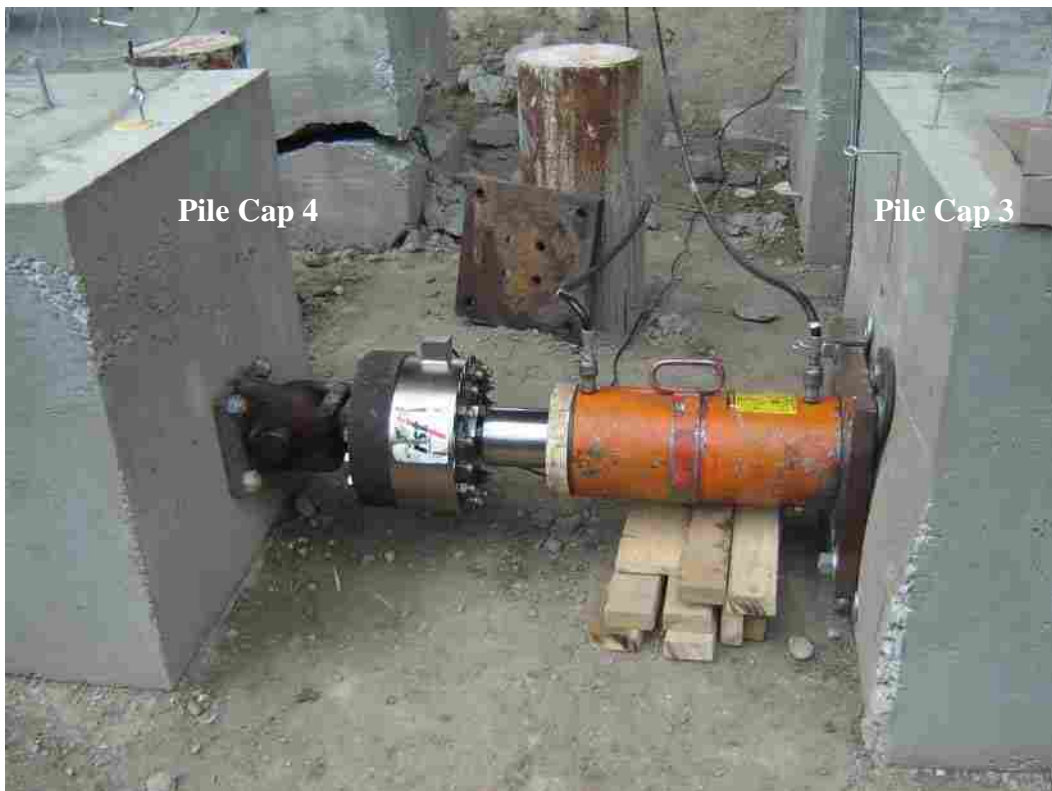
Figure 3-20 Photograph of test layout for test on Pile Cap 4.

Figure 3-20 shows the loading arrangement for the test of Pile Cap 4. A different hydraulic jack was used, and a strut was placed between Pile Cap 1 and the Geo pier cap to provide the reaction for the test.

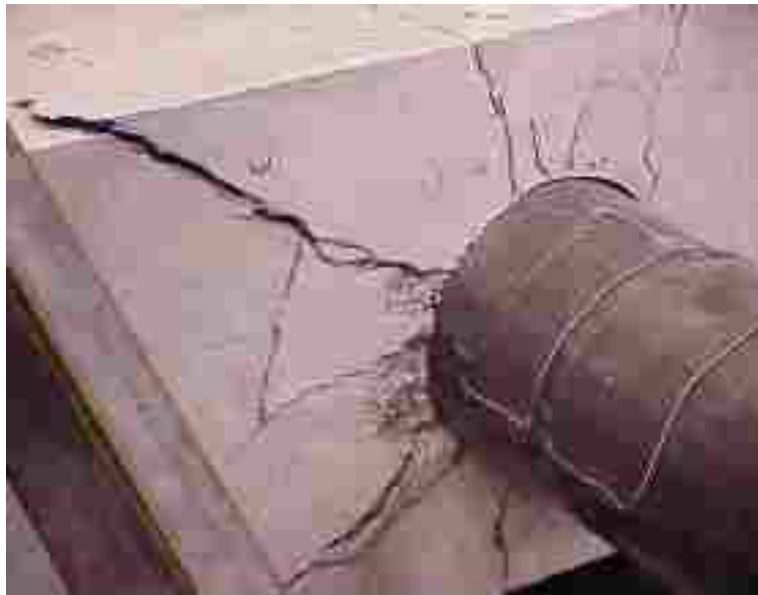
Figure 4-2 Failure of pile caps tested at Montana State University.

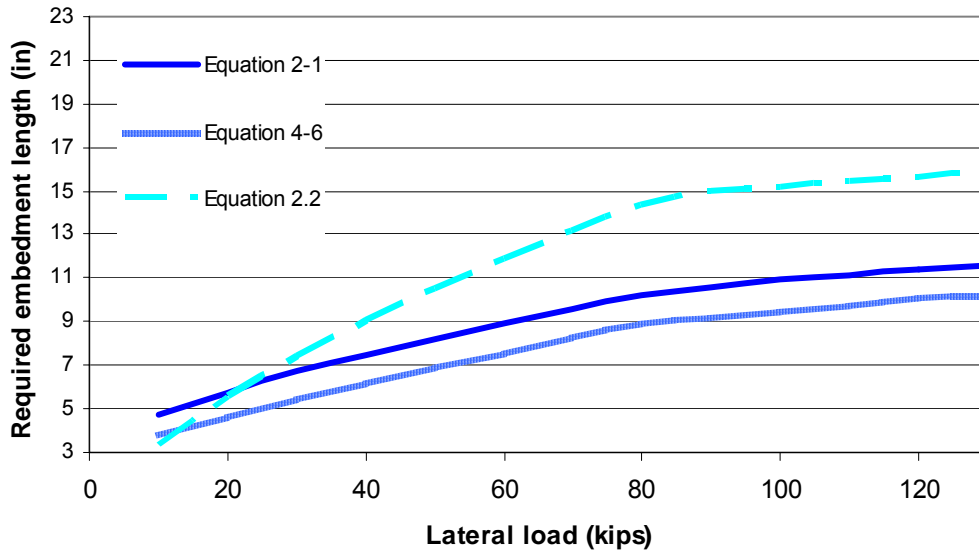
Figure 4-4 Required embedment using moment and load from GROUP.

Using equations 2-1, 2-2, and 4-8 charts have been developed and are presented in Figure 4-3 and Figure 4-4 which compare the required embedment lengths as a function of concrete cracking. As shown in Figure 4-3 and Figure 4-4; Pile Cap 1 having only a 6 inch embedment length had a high possibility of failure in the connection interface area for applied loads greater than about 60 kips, while Pile Cap 2 and Pile Cap 3, both with 12 inches of embedment length also pose a threat of failure. However since the tests in this study involve a pile cap that is able to displace and rotate, the applicability of these equations are suspect.

As noted previously, the equations used to develop Figure 4-3 and Figure 4-4 were developed through a series of tests in which the embedded steel received the force while the concrete in which the steel was embedded remained fixed. This would

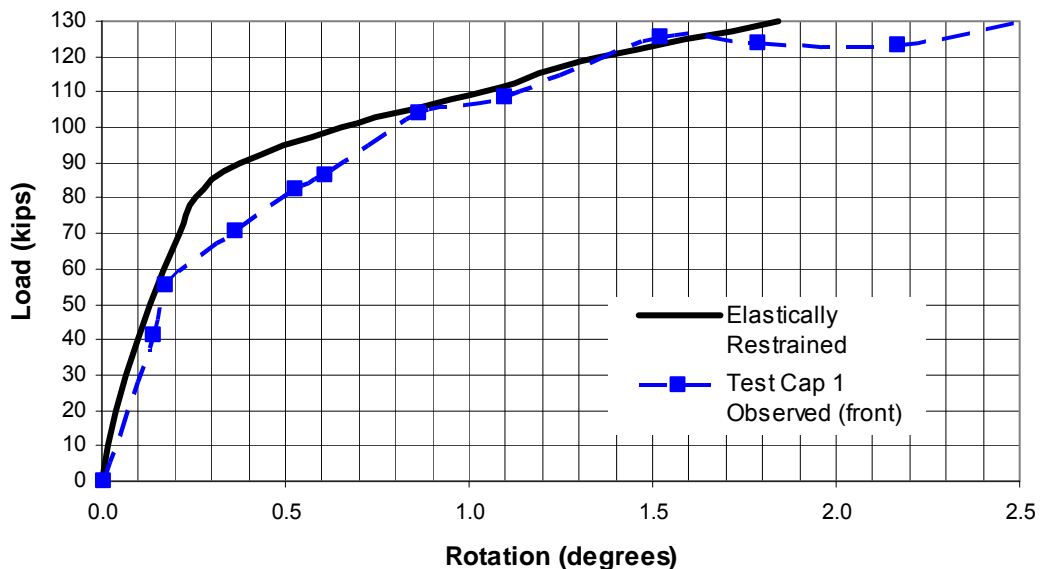
Figure 5-5 Pile Cap 1 observed vs. computed rotation.

The load-rotation curve computed prior to testing using GROUP is also plotted in Figure 5-5 and it compares favorably with the measured curve. As GROUP predicted, pile cap rotation increased significantly at a lateral load of 80 kips as was observed in the experimental data. According to the strain gauge readings plotted in Figure 5-6 the tensile strain in the back pile also increased significantly as the lateral load increased to 100 kips. This behavior is also consistent with an increase in axial pile force which led to pile pullout. Although the strain level is far below the tensile capacity of the bars, Figure 5-6 confirms the need for some type of connection between the pile and cap. It explains that as the load is transferred the reinforcing bars pull the piles out of the ground. As will be shown later in this report, if a proper connection is not provided the pile cap rotates while the pile remains in the ground with little or no disturbance to the piles.

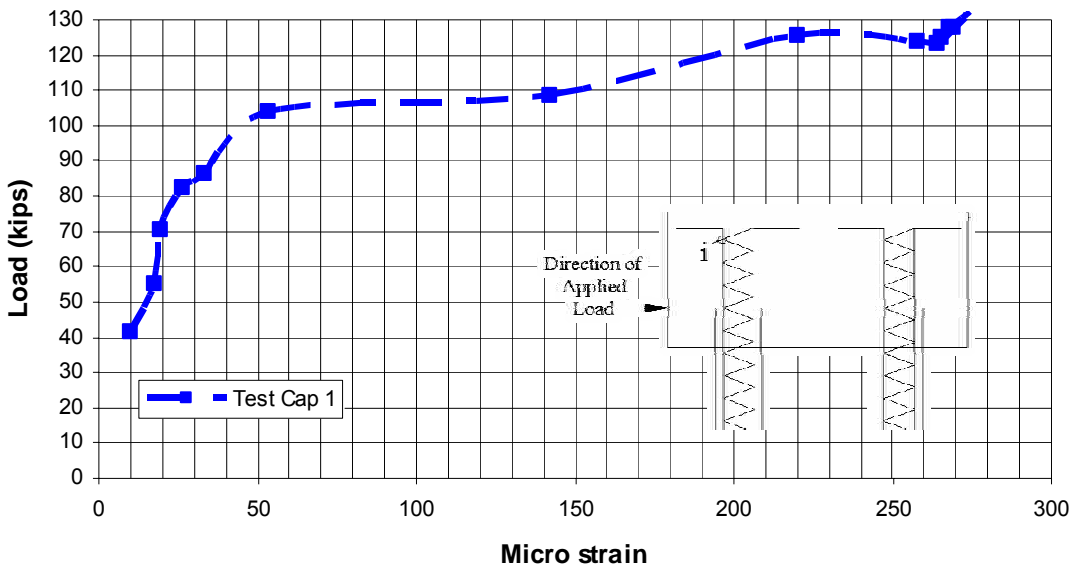
Figure 5-6 Observed micro strain at location i on vertical reinforcement.

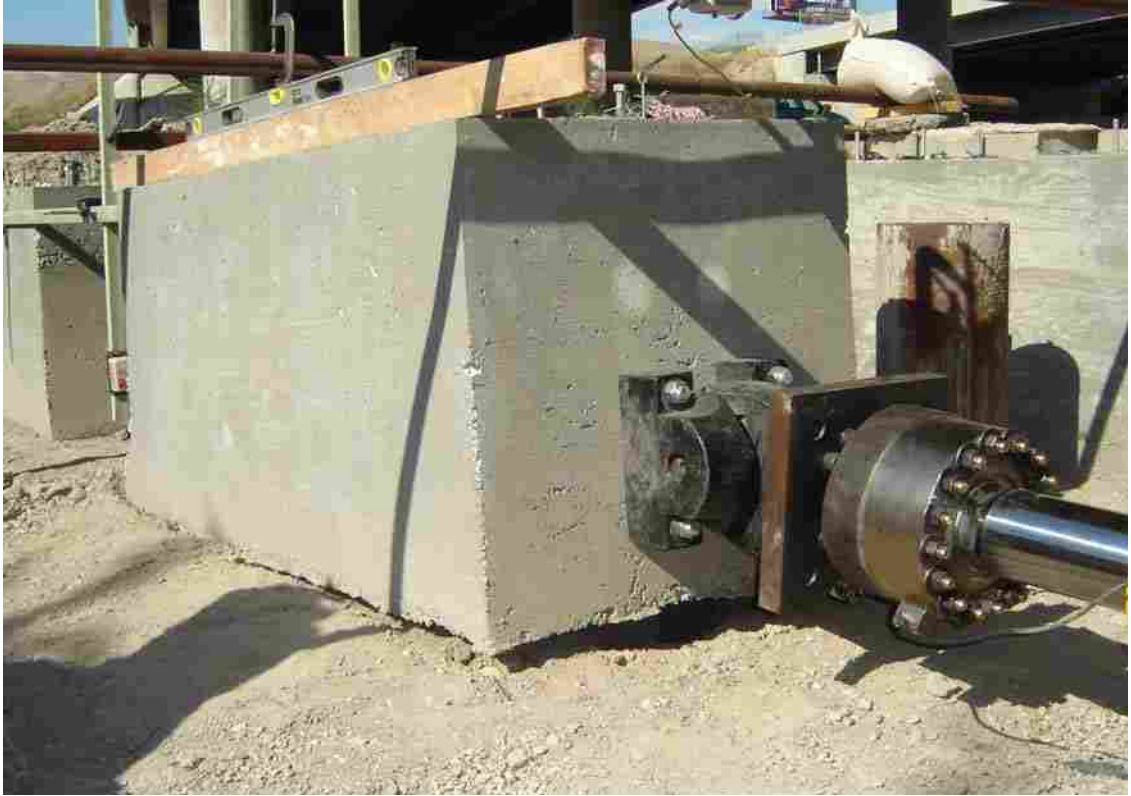
Figure 5-7 Photograph of Test Cap 1 at failure.

While the pile cap and connection remained essentially elastic throughout the loading sequence, the failure was considered to fall under the category of excessive deflection. This was due to the piles pulling out of the ground. As shown in Figure 5-4 GROUP was used to produce load-deflection curves assuming three connection boundary head conditions; completely fixed, elastically restrained, and pinned. The value for the rotational stiffness in the elastically restrained case was calculated using equations developed from Mowka, and Duncan (2003) and was considered to be the most accurate for analysis. However, in this case, the load-deflection curve for the fixed-head condition were nearly identical to that for the elastically restrained condition. GROUP was observed to predict very accurately the test results with regards to rotation and deflection as shown in Figure 5-4 and Figure 5-5. It was thus concluded that for the testing performed that the connection detail was adequate.

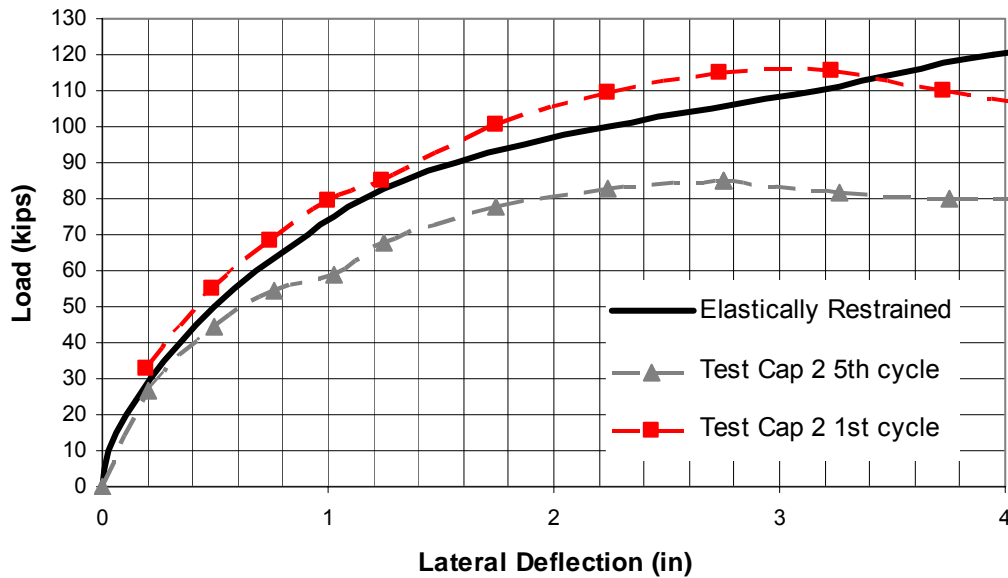
Figure 5-8 Observed vs. estimated deflection Test Cap 2.

The measured load-deflection curve from the test on Test Cap 2 is shown in Figure 5-8. Also shown is the predicted load-deflection computed by GROUP. The same general trends are observed as with Test Cap 1. Initially, the response is relatively stiff and linear and the deflections are small. However, at a load of about 80 kips there is a significant change in slope as the back pile begins to pull out of the ground at which point the lateral deflections increased. The load-deflection curve observed during the test on Test Cap 1 was slightly higher than predicted by GROUP while the curve for the test on Test Cap 2 was slightly lower. However, the percent difference from GROUP in load for a given deflection for Test Cap 2 was typically less than about 5% as was shown with Test Cap 1.

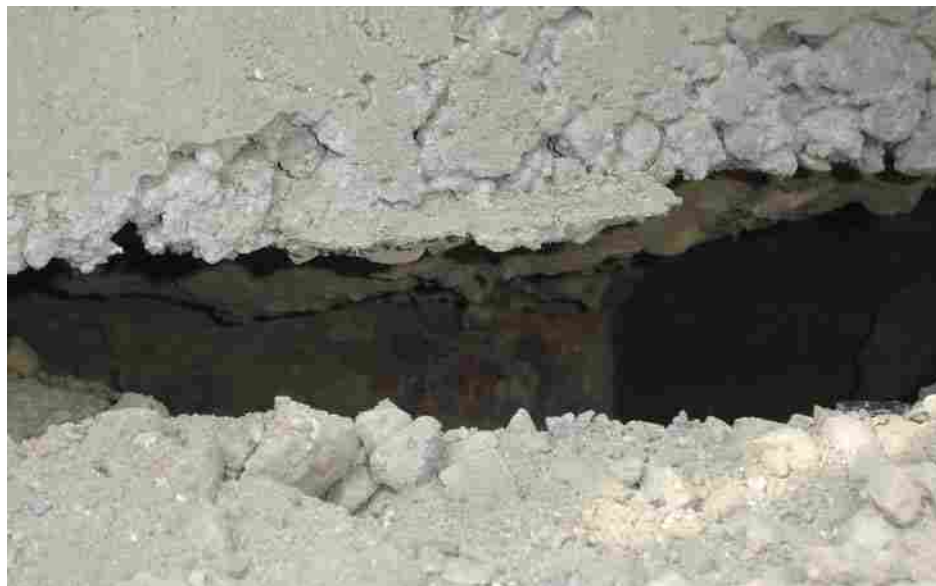
Figure 5-11 Test Cap 2 failure in pullout.

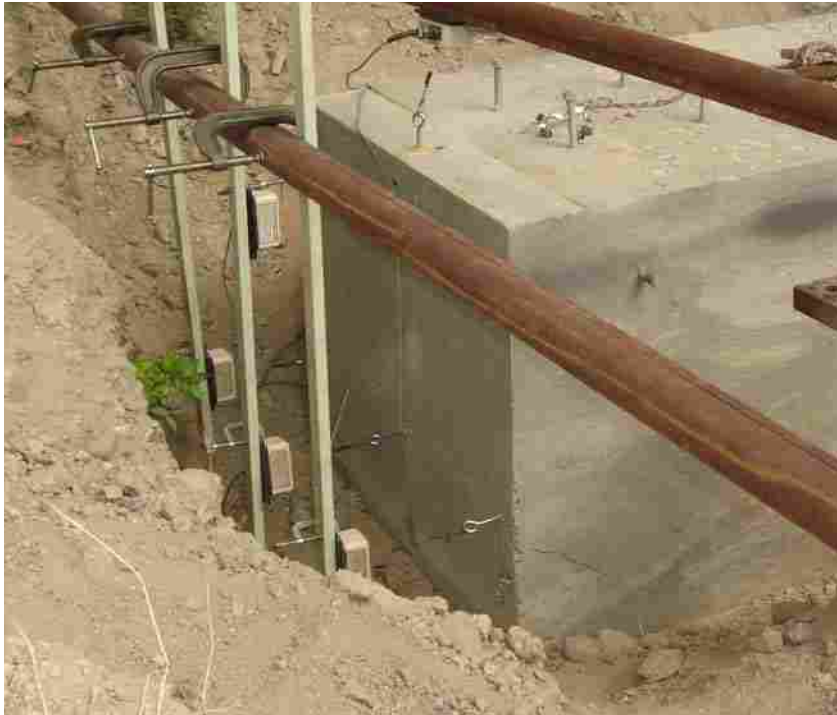
Figure 5-12 Initial cracking on the front face and size of Pile Cap 3.

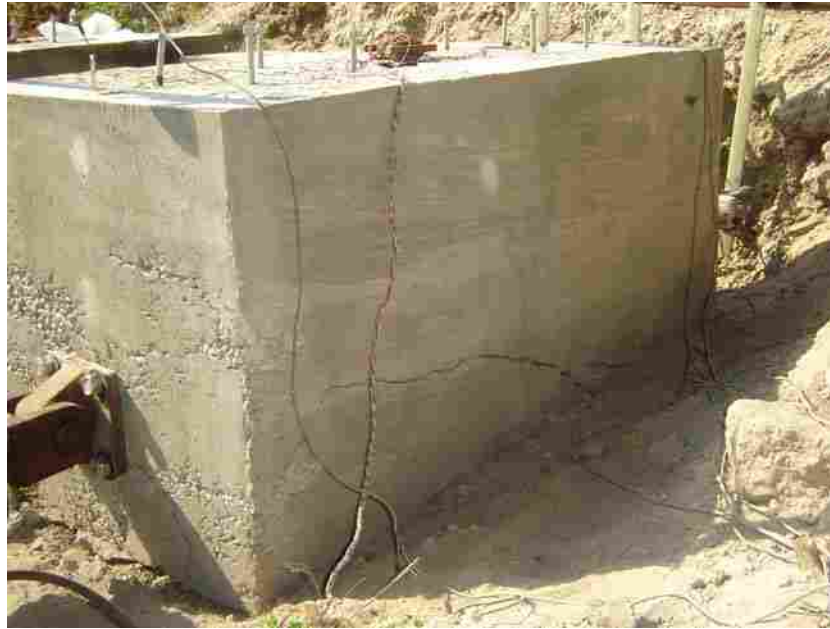
Figure 5-13 Cracking at a 90 kip load on the back and side of Test Cap 3.

pile as it was during the other tests due to the lack of vertical reinforcement with the center section of the pile cap. The cracks shown in Figure 5-13 continued to propagate until failure occurred as shown in Figure 5-14.

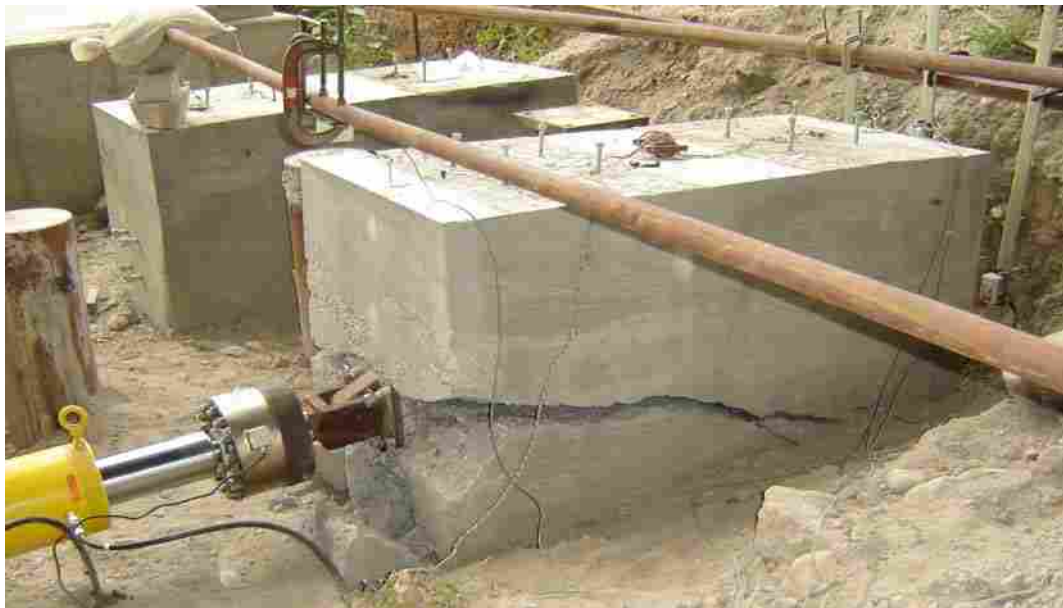
Figure 5-14 Test Cap 3 at failure.

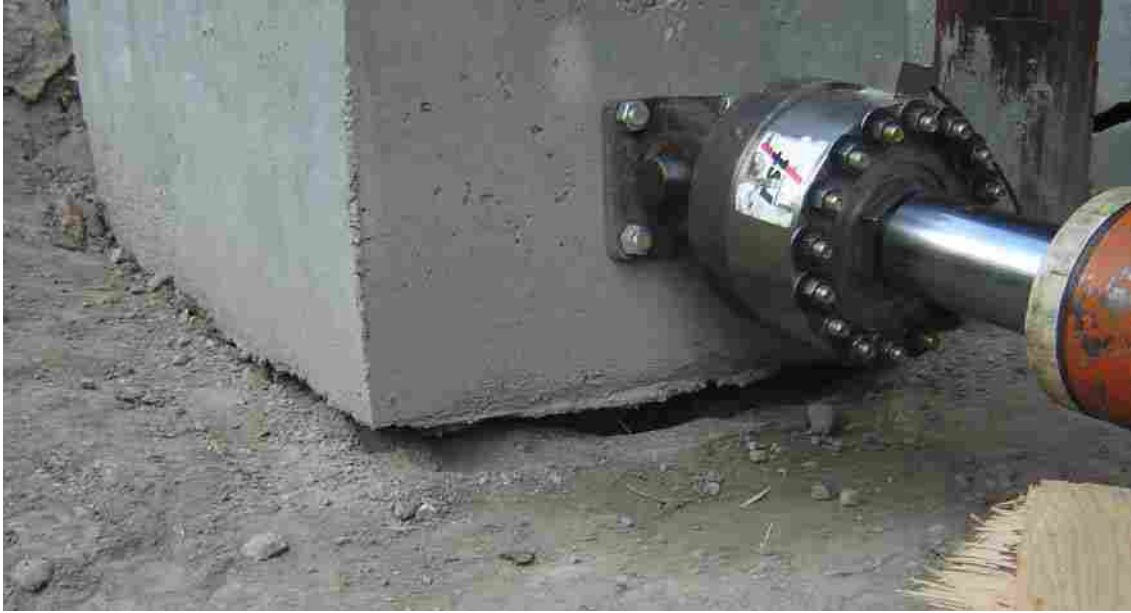
Figure 5-18 Test Cap 4 at failure.

5-17, respectively. Figure 5-18 shows how the back pile lifted up and out of the ground causing the deflection and rotation.
