Evaluating Shallow-Flow Rock Structures as Scour Countermeasures at Bridges

EVALUATING SHALLOW-FLOW ROCK STRUCTURES AS
SCOUR COUNTERMEASURES AT BRIDGES

Department of Civil and Environmental Engineering

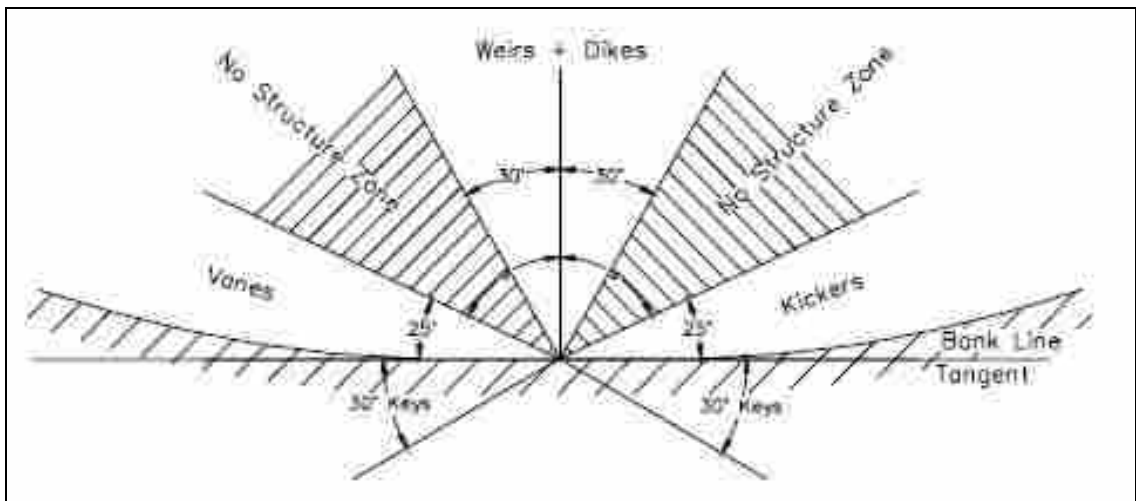
Figure 2-3. Bendway Weir and Vane Variations.

There are two variations with respect to bendway weirs and vanes. The variations of bendway weirs (barbs) and vanes can best be described using Figure 2-3 from *Stream Investigation, Stabilization and Restoration* (SISR) (Freeman 2005¹).

Variations of bendway weirs relate to the orientation of the structures with respect to the streambank. Bendway weir (barb) placement ranges from perpendicular to the bank or up- and downstream 30° from perpendicular. Vane orientation is always upstream as shown in Figure 2-3. Kickers are the mirror reflection of a vane from perpendicular as shown in Figure 2-3. See Figure 2-4 and Figure 2-5 for illustrations of a bendway weir and vane, respectively. Vane theory and design methodologies are found in *Stream Investigation, Stabilization and Restoration (SISR)* (Freeman 2005^{1,2}) and Johnson et al. (2001).

Vanes are oriented upstream 20° to 30° from the bank whereas bendway weirs are perpendicular to the bank give or take 30° (see Figure 2-3). Vanes, for the purposes of this study, have separate design criteria from bendway weirs, but by definition are the same. See the definition for bendway weir and Figure 2-9 for vane weir theory. (Freeman 2005¹). Further, Johnson et al. (2001) described the similarities between vanes and bendway weirs, “bendway weirs are low elevation stone sills similar to vane structures.”

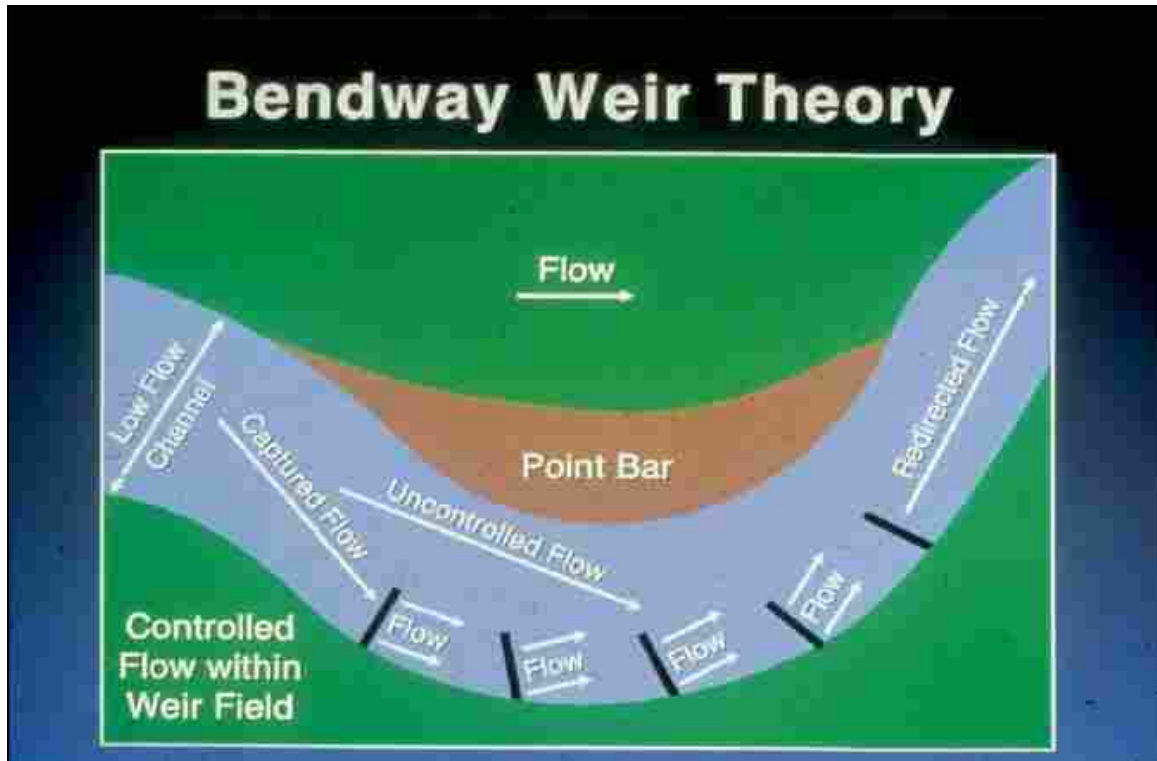
Figure 2-8. Bendway Weir Theory.

As water passes over a bendway weir, it is redirected downstream perpendicular to the structure as illustrated in Figure 2-8. (Freeman 2005²).

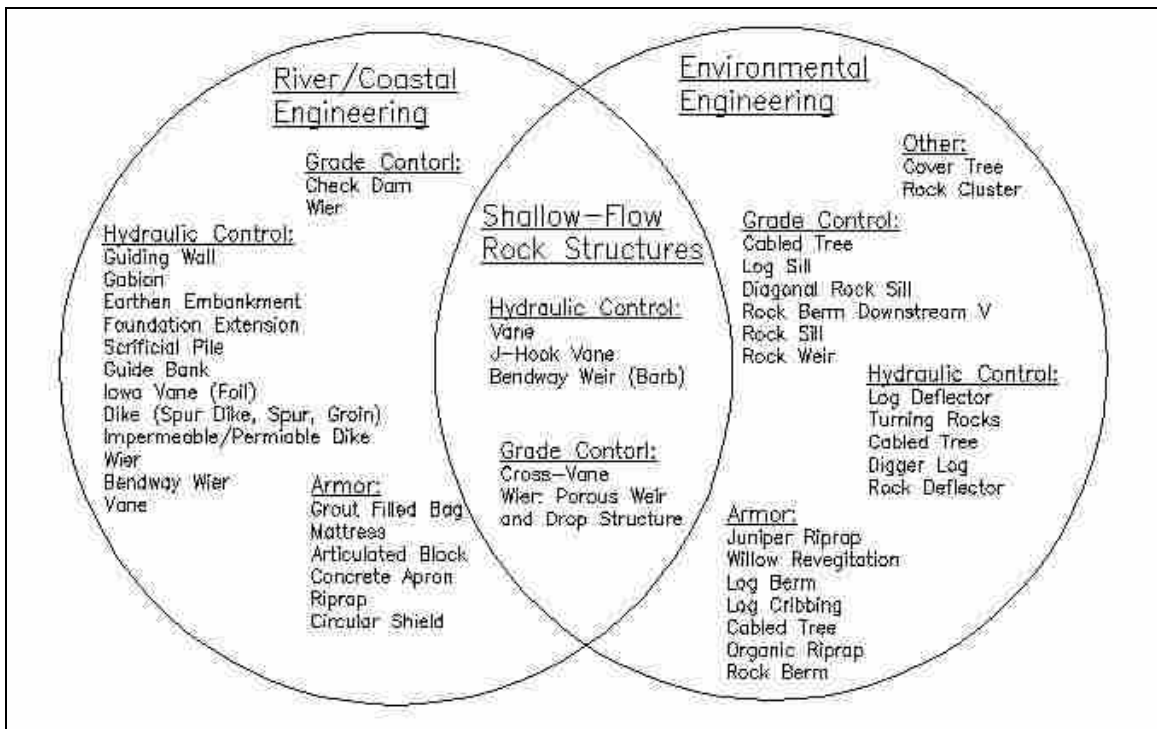
Figure 2-10. Shallow-Flow Structures and River and Environmental Engineering Structures.

In some cases environmental engineering structures are used as scour countermeasures and can be classified in a similar manner. Scour countermeasures mitigate the erosion induced by horizontal and vertical movement of waterways. Shallow-flow structures are defined in section 2.2 and can be viewed as an intersection of river and environmental structures. Shallow-flow structures include: vanes, j-hook vanes, bendway weirs, vortex weirs, and cross-vanes. See Figure 2-10 for an illustration of how shallow-flow rock structures are related to river and environmental engineering structures.

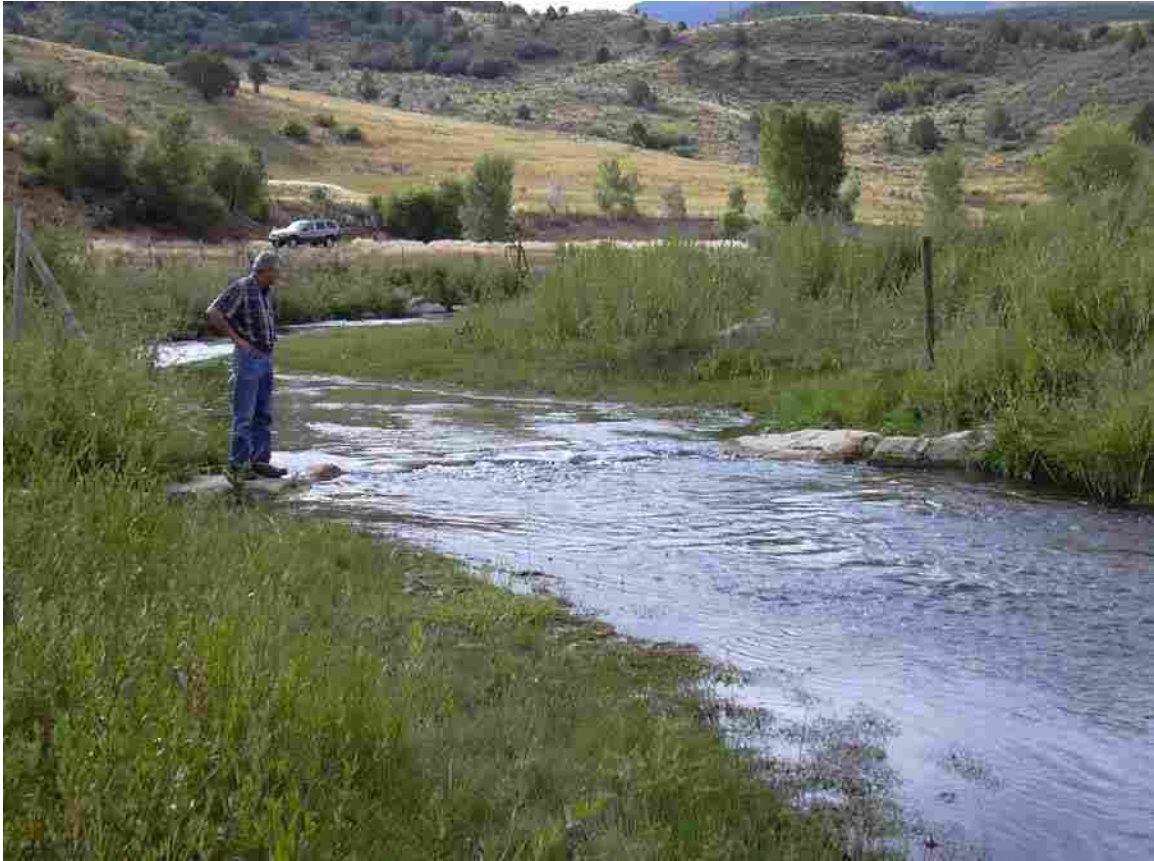
Figure 3-3. Cross-Vane Structure Observed and Modeled.

The site chosen for modeling includes many structures including: two cross-vanes, one j-hook and a number of vanes. Figure 3-3 shows the cross-vane modeled. Note the flow approaches the structure mostly on the right side of the channel and moves across the structure. This is reflected in the results of the numerical model.

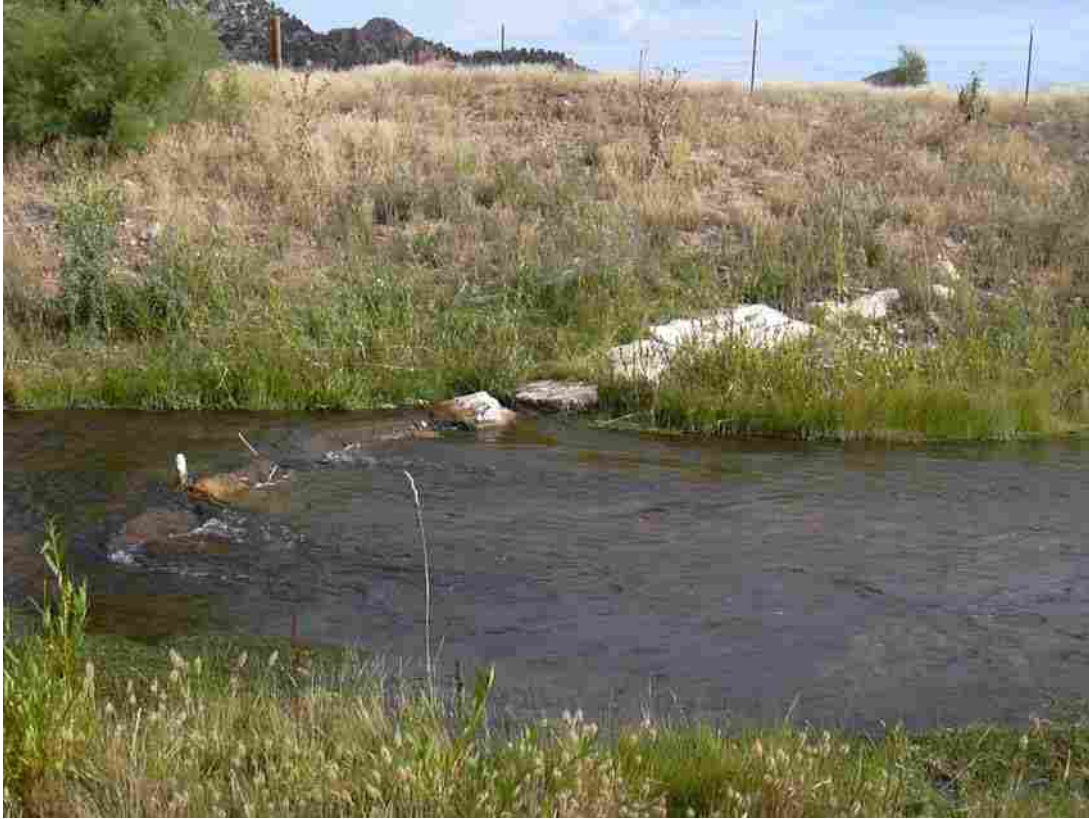
Figure 3-4. J-Hook Structure Observed and Modeled.

Figure 3-4 shows the j-hook structure modeled. Flow is from left to right in the picture. This structure is just downstream around a meander bend from the cross-vane. There is another cross-vane between these two structures on the meander bend. This is part of an ongoing restoration after the mudslide near Thistle, Utah. Also of note in this area is one of four experimental installations (in the study group for this paper) of SFS at bridges. The existing installation is located at Utah County State Park upstream of the Spanish Fork River and Diamond Fork confluence. SFS are installed upstream of a pedestrian-trafficked bridge. Figure 3-5 and Figure 3-6 show the relationship of a j-hook being constructed next to this footbridge.

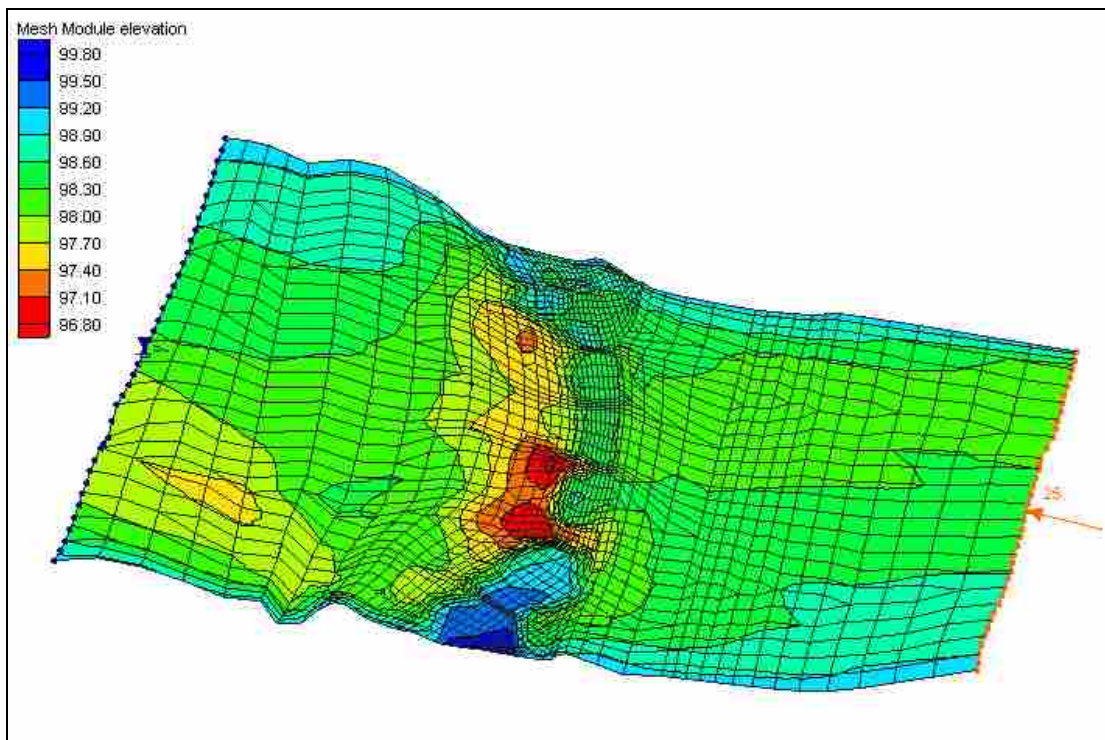
Figure 3-7. Layout of Mesh for the Cross-Vane Model.

The Thistle Creek site modeled includes two separate finite element meshes. They represent two reaches of the stream that are very close together. The first includes a cross-vane structure and the second includes a j-hook. Figure 3-7 and Figure 3-8 show the meshes constructed around the cross-vane and the j-hook, respectively. The color keys in the upper left-hand corners indicate elevations. The resolution around the structure is very high, defining the elevation of each boulder, the elevation of the chutes between boulders and the pools upstream and downstream of the chutes are also illustrated.

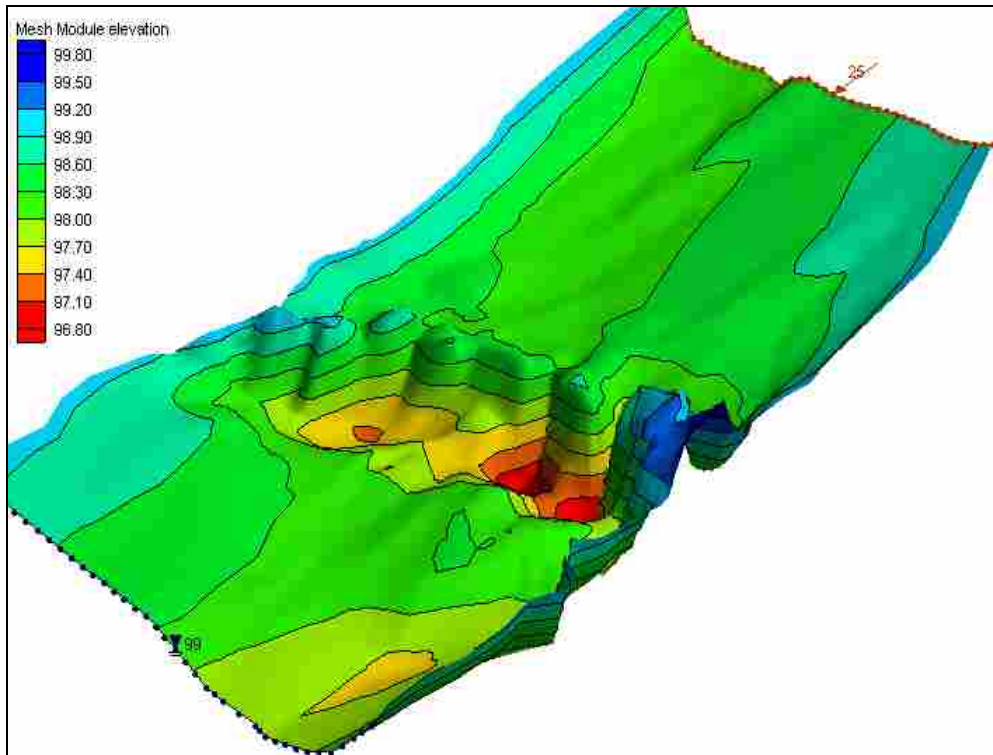
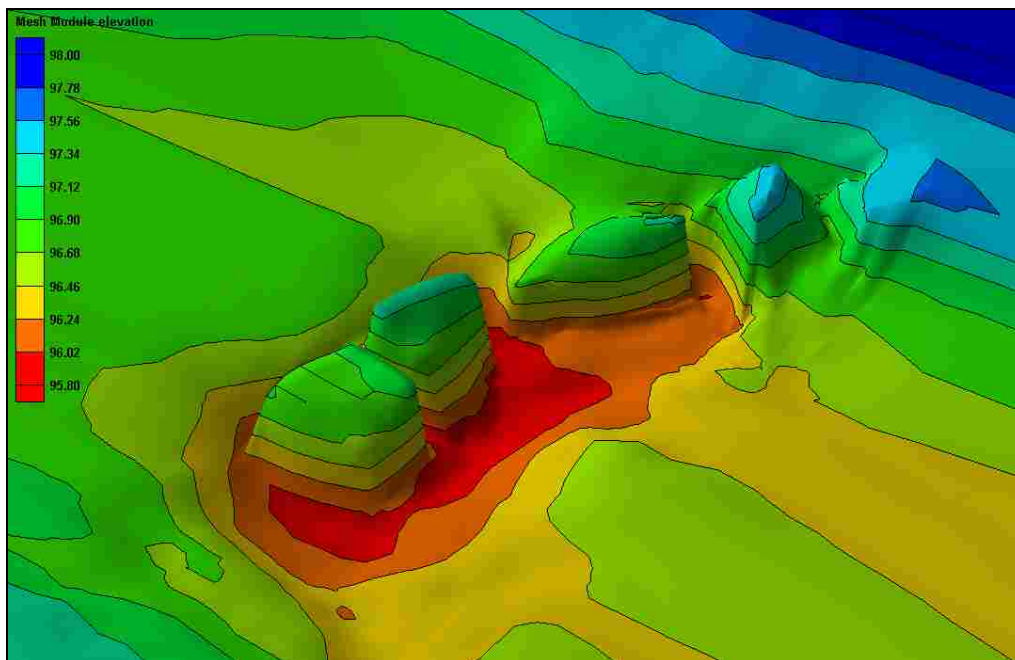
Figure 3-9 and Figure 3-10 show the geometry of the meshes from an oblique view. This view accentuates the scour holes that are developing downstream of the structures. Results shown later in this chapter illustrate additional scour has occurred during the year of phase one monitoring. Also note the scour occurring upstream on the j-hook. Field observations support that failure of SFS occurs not only by downstream scour, but also by an upstream erosion mechanism. The initial elevations came from the survey data that are displayed along with contours of the survey points in Figure 3-11 and Figure 3-12.

Figure 3-9. Oblique View of Geometry of the Cross-Vane Structure.

Figure 3-10. Oblique View of Geometry of the J-Hook Structure.

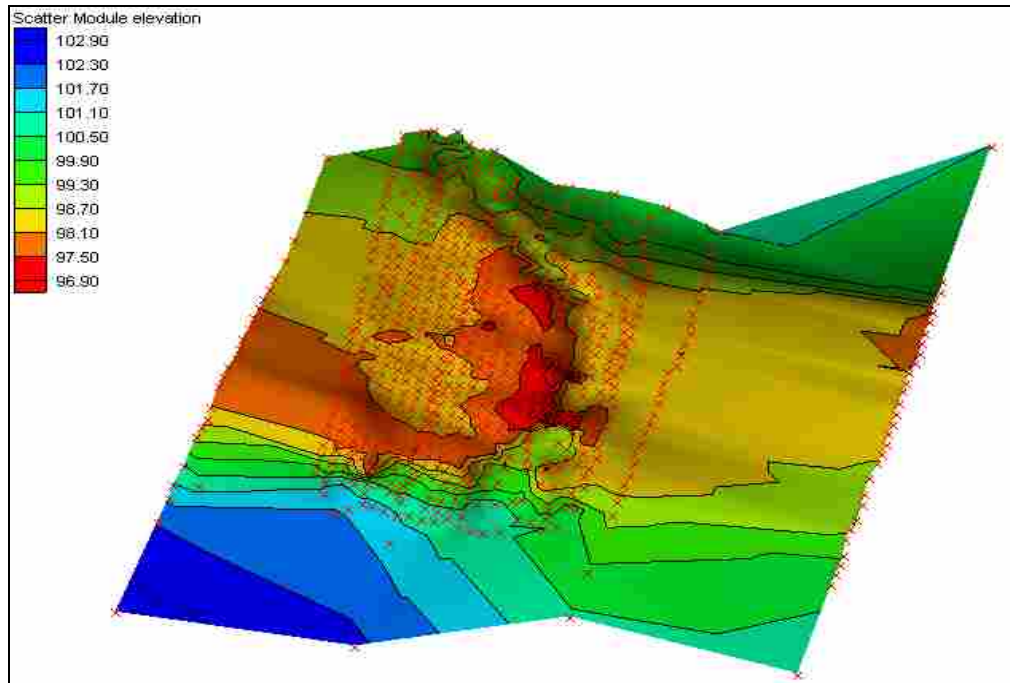
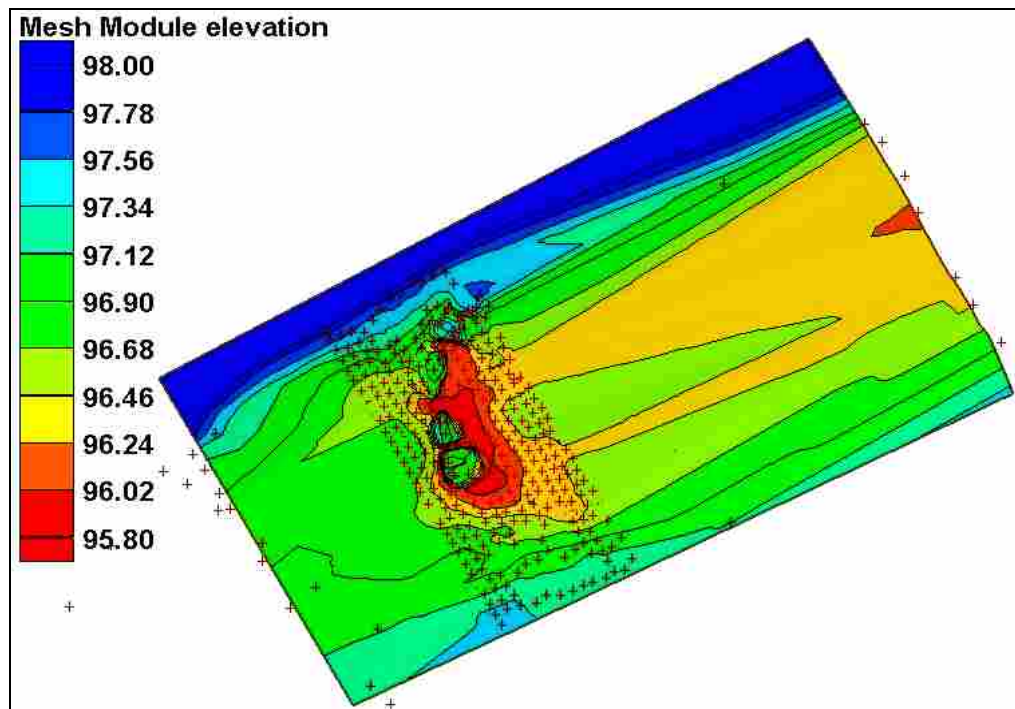
Figure 3-11. Survey Data of Cross-Vane.

Figure 3-12. Survey Data of J-Hook.

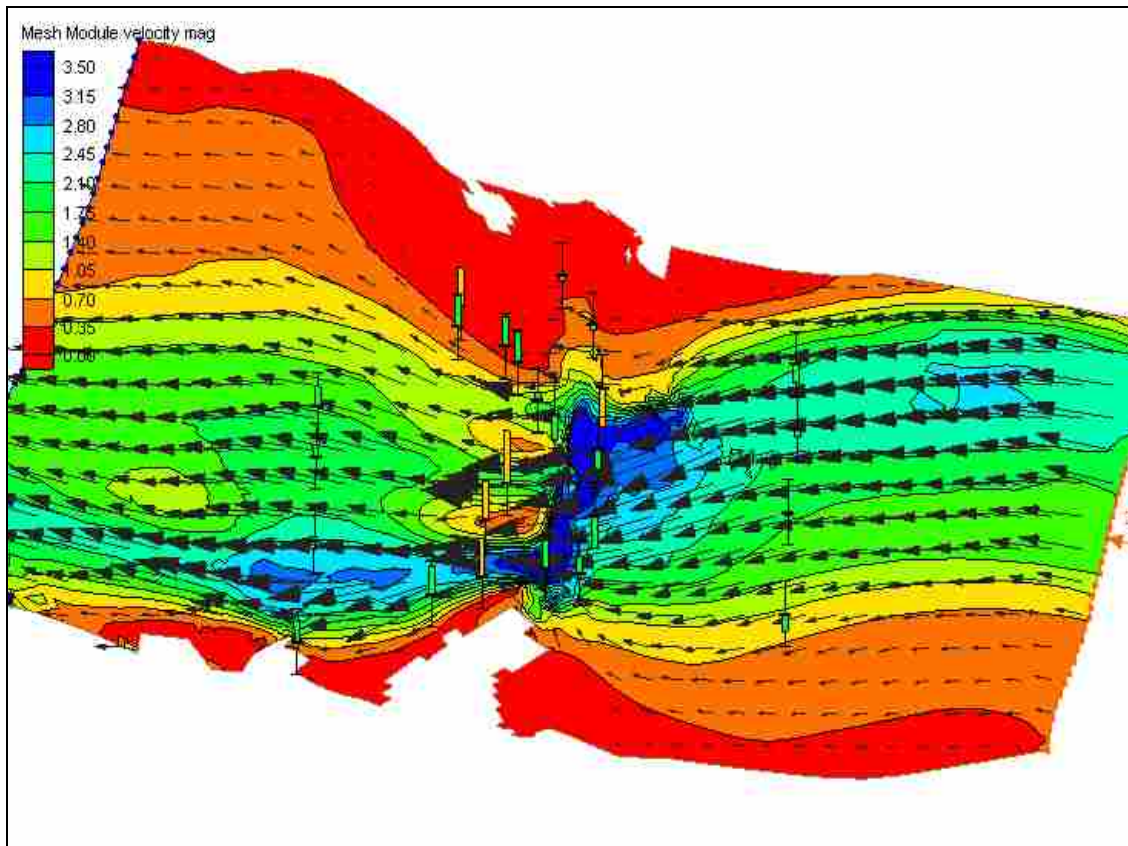
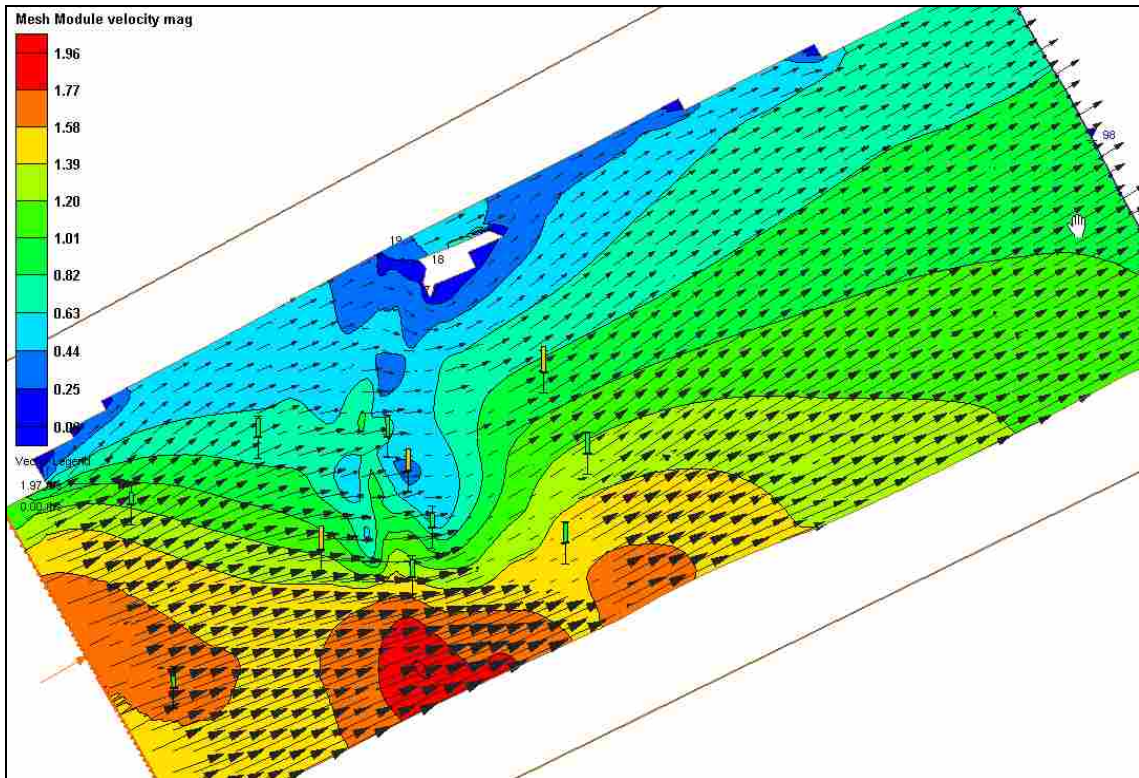
Initially, a flow of 25 cfs was simulated through the two meshes. This corresponds to the flow rate computed from the date when the original survey data was gathered. In addition to bathymetric data at 1-foot intervals, velocity samples were obtained across the cross section and at several points around the structure. The following images display the computed flow directions and magnitudes computed by the model. Note that the model has dried out portions of the rocks and reproduced the flow conditions coming from the right side of the channel and crossing over to the left at the structure.

Figure 3-13. Velocity Magnitudes Computed for Cross-Vane.

Figure 3-14. Velocity Magnitudes Computed for J-Hook.

Figure 3-13 and Figure 3-14 also show the calibration targets at various sample points. Any target showing a green staff indicates a computed velocity magnitude within .26 ft/sec of the measured value. A yellow staff indicates a computed value within .52 ft/sec of the measured value. The data sets were calibrated using the measured velocities and depths gathered at the site. Based on the calibration results and flow conditions observed during data gathering, it appears that the models are performing reasonably well to predict flow conditions. This includes water depths and flow velocities from which scour forces can easily be computed.

The asymmetrical cross-vane also has erosion problems illustrated in the photos taken in the fall of 2003 and the summer of 2004 during spring runoff (Figure 3-16 and Figure 3-17). In Figure 3-16, two large boulders are visible on the far bank. Figure 3-17 illustrates that due to erosion around the boulder, the left of the two boulders on the bank has shifted and broken. That is why the boulder is not visible in this figure. The erosion is caused by the water moving across the structure from the upstream (north) to the downstream (south) side. The velocity of the water is increased as it runs over the structure and is redirected to the south bank as seen in Figure 3-13.

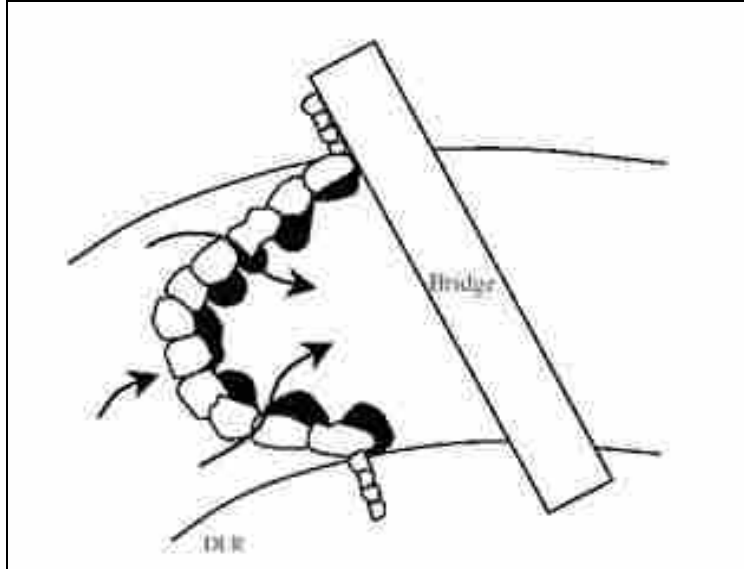
Figure 3-15. Proposed Design Methodology for Cross-Vane Installation at a Bridge.

See Figure 3-15 for Rosgen’s (2001) proposed cross-vane installation upstream of bridges.

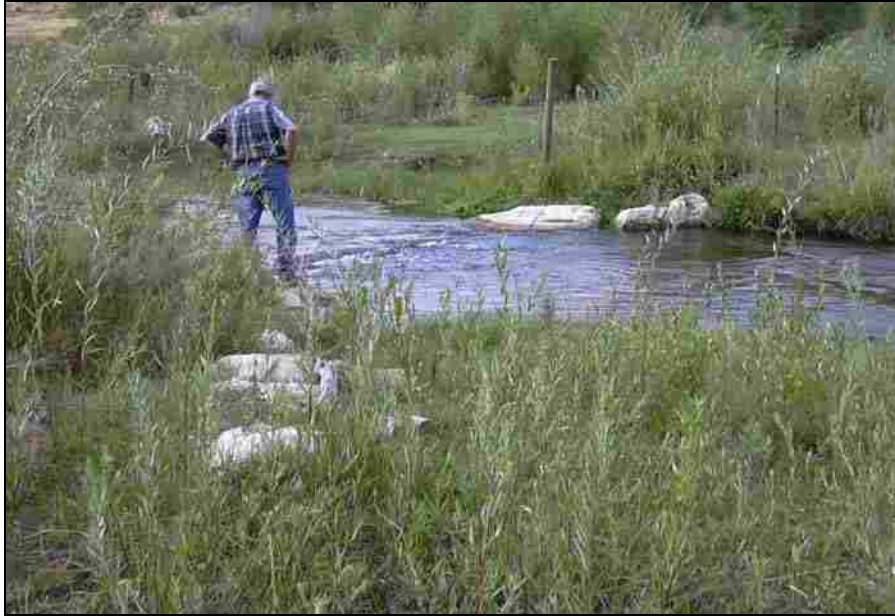
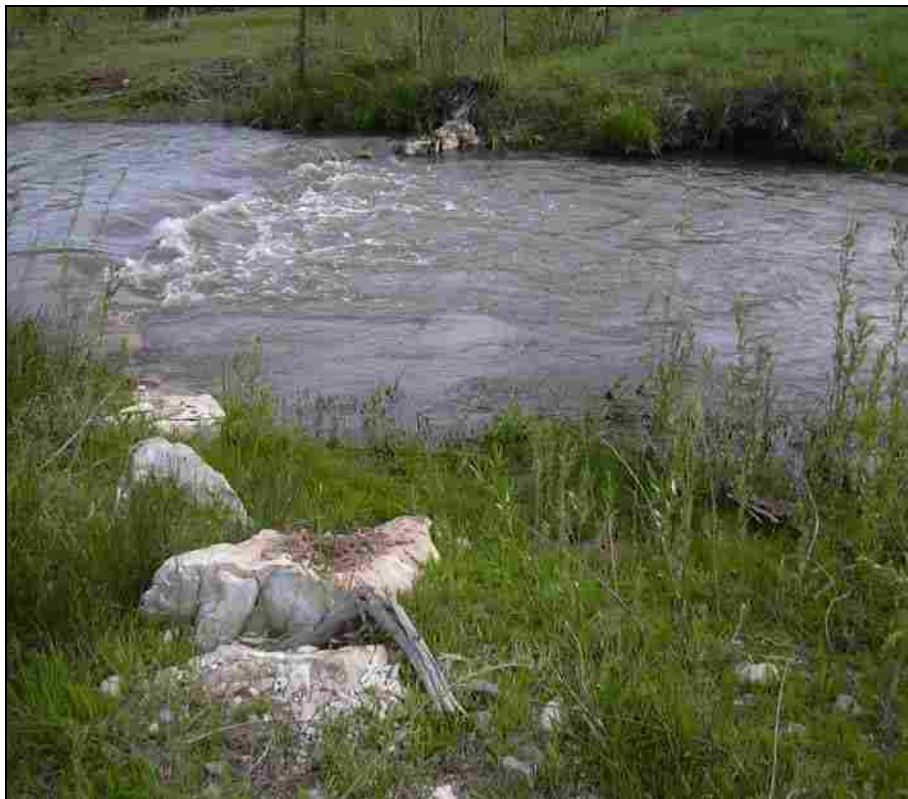
Rock decay was also observed during the study. As noted above, one of the main boulders broke after shifting due to erosion. The crumbling rock in the foreground of Figure 3-17 illustrates the inferior quality of these materials.

Figure 3-16. Cross-Vane Photo Taken Before Spring Runoff 2004.

Figure 3-17. Cross-Vane Photo Taken During Spring Runoff 2004.

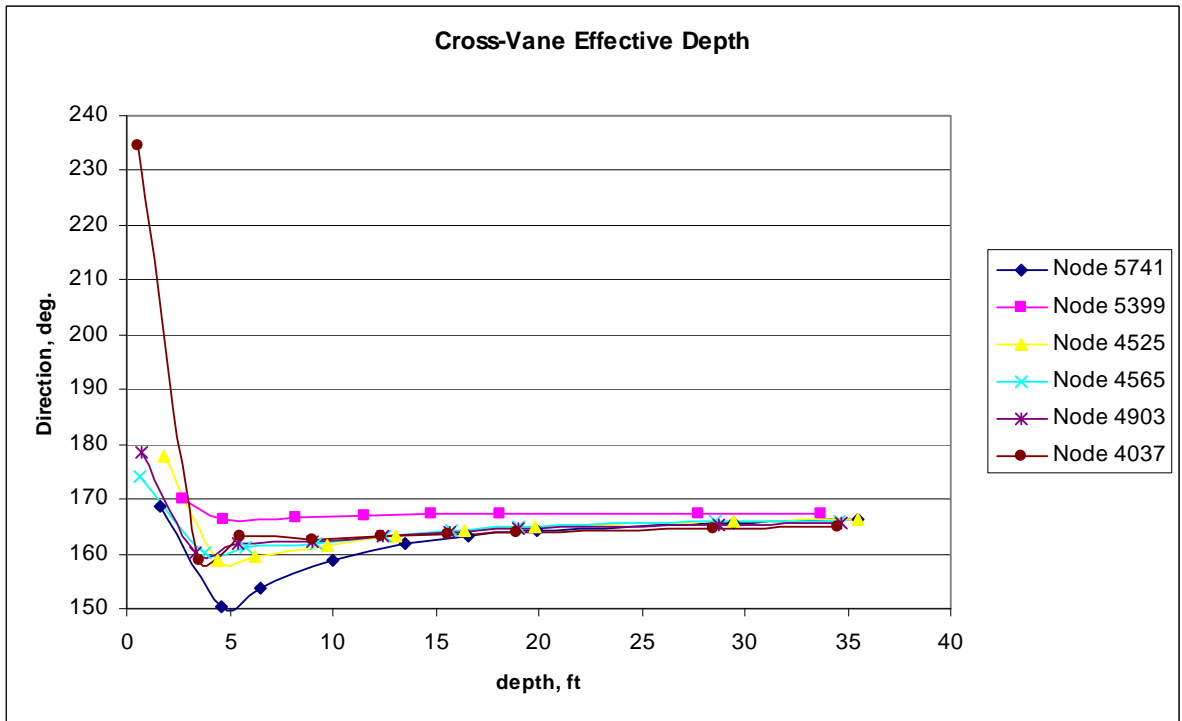
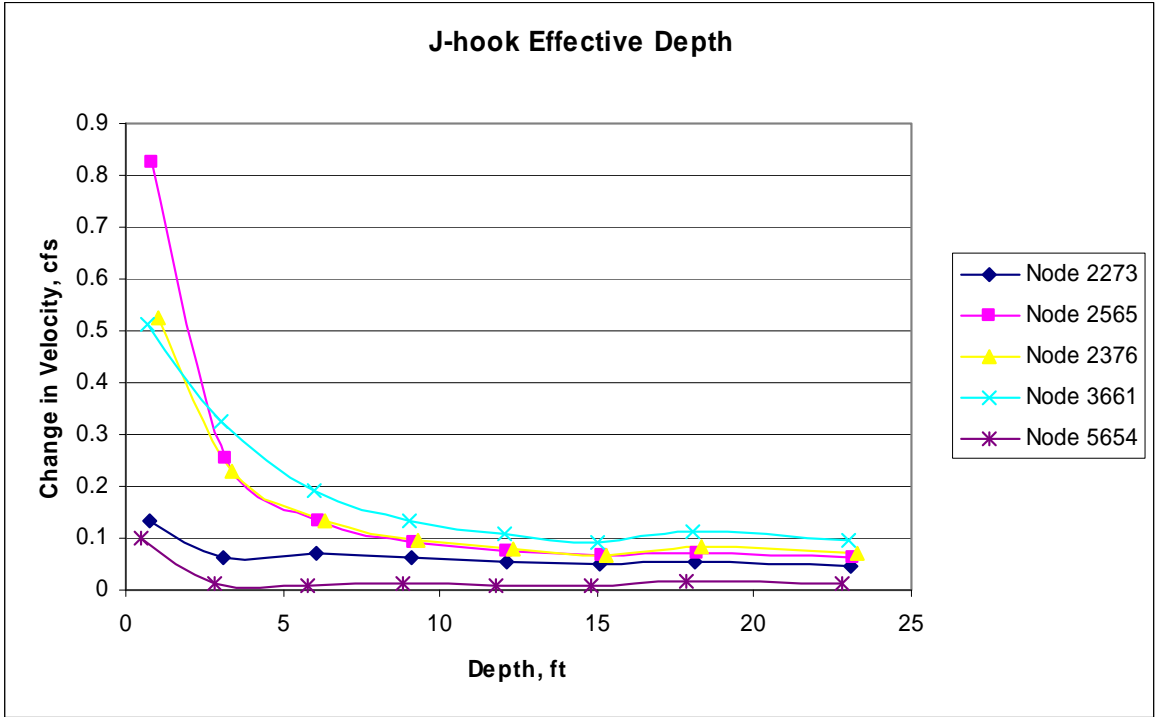
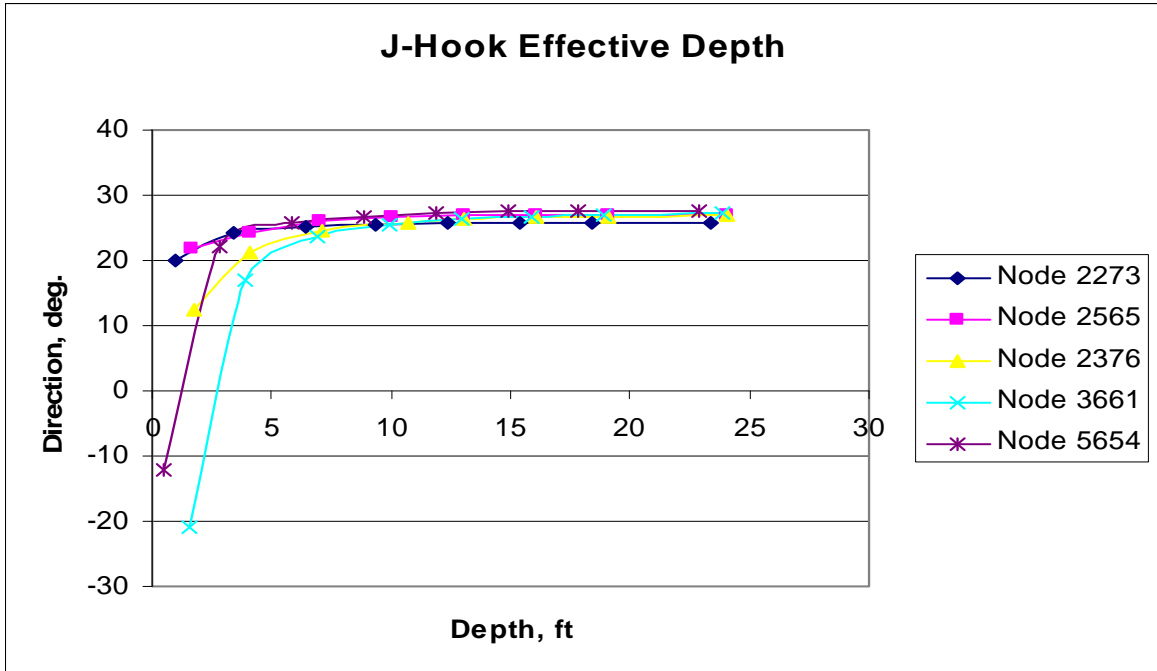
To view the depth verses flow direction, data points were selected across the structure. The depths and directions at that point were recorded for each flow rate. The results are presented in Figure 3-19 and Figure 3-21. To view the change in velocity versus depth, an additional data point was chosen just upstream to correspond with each of the points along the structure. The depth of the upstream point was plotted against the change of velocity between the upstream and downstream points. The results for the second set of data are illustrated in Figure 3-18 and Figure 3-20.

Figure 3-18. Cross-Vane Effective Depth from Change in Velocity Magnitude.

Figure 3-19. Cross-Vane Effective Depth from Change in Flow Direction.

Figure 3-20. J-Hook Effective Depth from Change in Velocity Magnitude.

Figure 3-21. J-Hook Effective Depth from Change in Flow Direction.

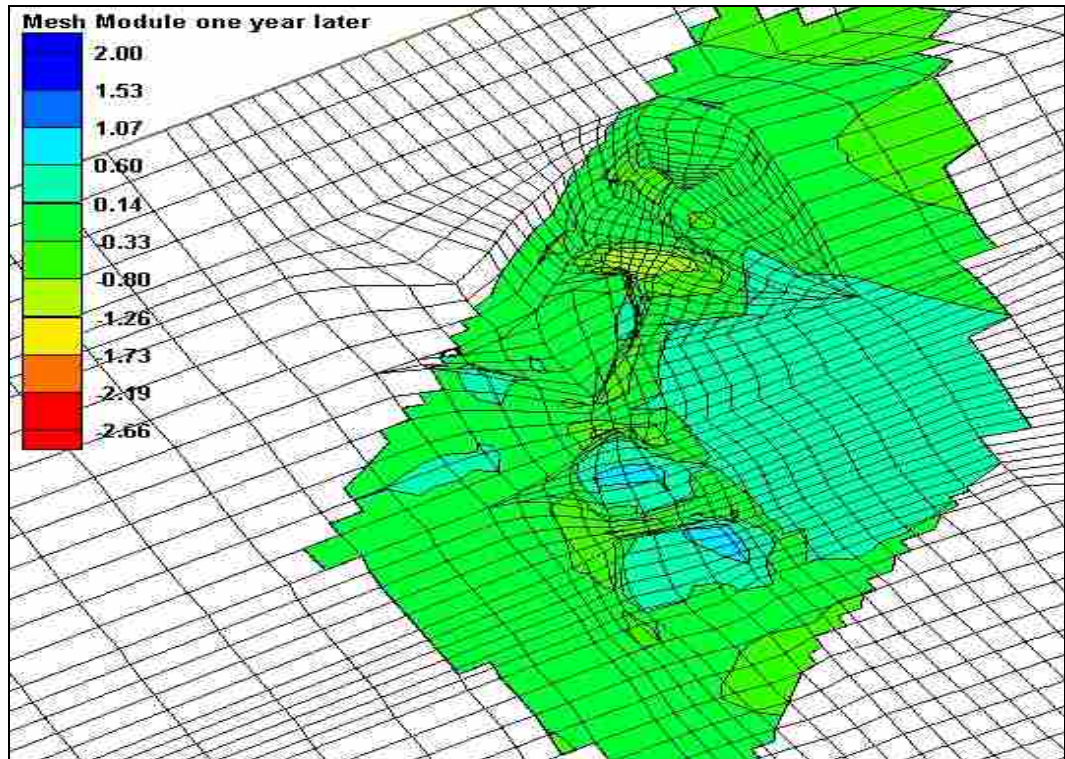
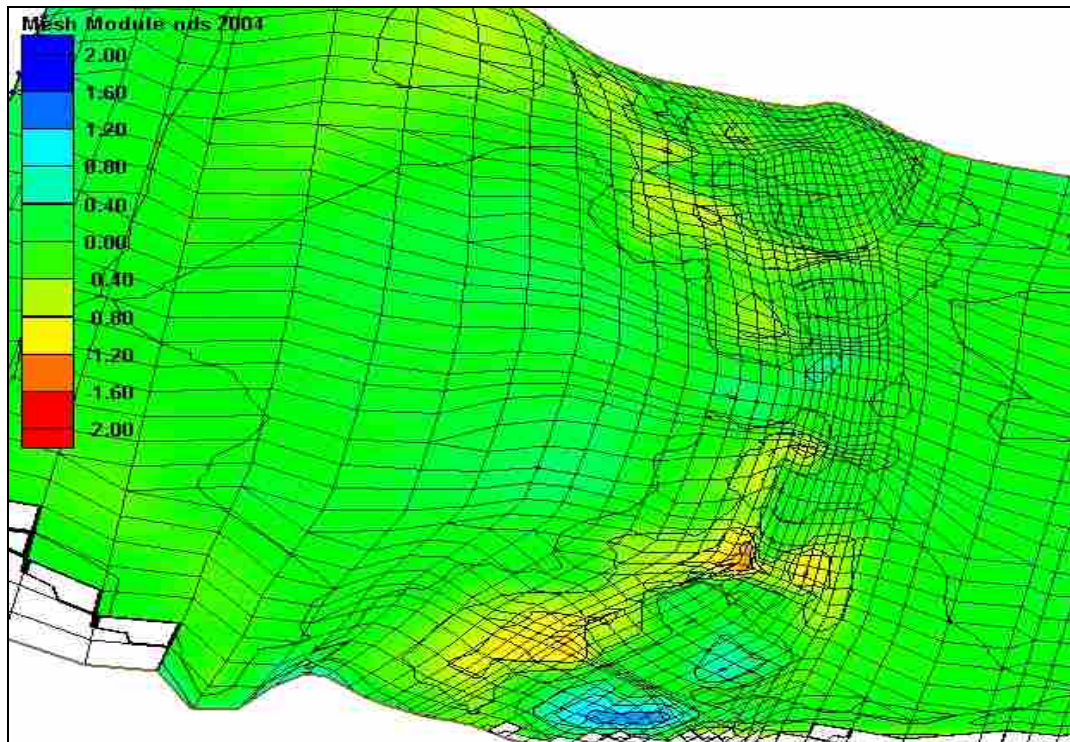
A fourth observation can be made by evaluating the erosion that took place over the year of monitoring at this site (2003-2004). To do this, bathymetric data from the fall of 2003 is compared to post spring runoff measurements in 2004. The results are shown around the vicinity of the structures themselves.

Figure 3-22. Erosion of J-Hook at Thistle Creek Site Between 2003-2004.

Figure 3-23. Erosion of Cross-Vane at Thistle Creek Site Between 2003-2004.

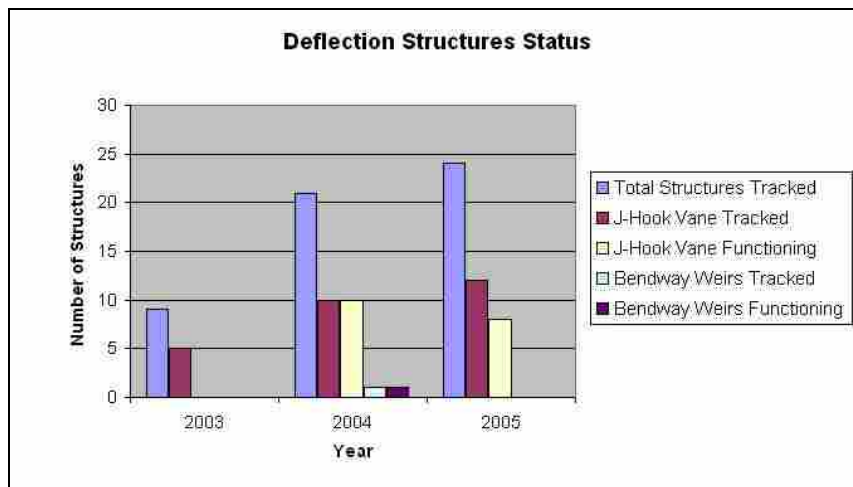
Figure 4-16. River Training Structure Status.

The year 2005 was an average-water year and mixed results were found for the 24.5% of the monitored structures. In 2005, a total of seven cross-vanes were monitored. Only four were still functioning as designed after spring runoff for a 57.1% success rate. There were a total of 12 j-hook vanes, of which eight were still functioning as designed after spring runoff for a 66.7% success rate. There were a total of five weirs of which one was still functioning as designed after spring runoff for a 20.0% success rate. Overall 54.2% of the structures monitored in 2005 had not failed during that year.

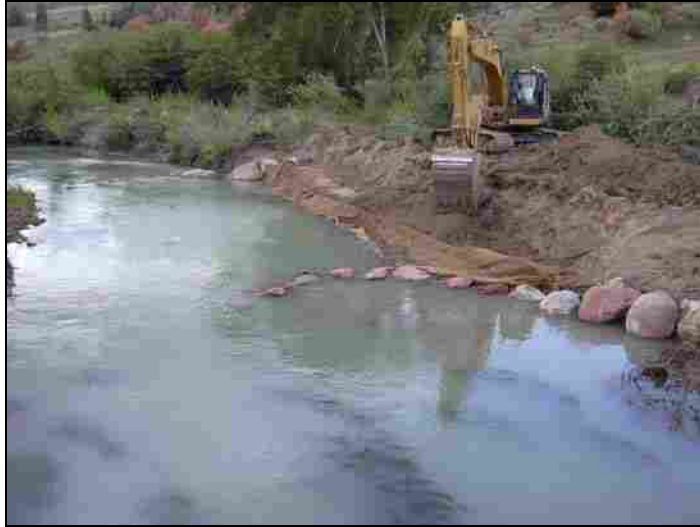
Figure 4-18. Utah County Park Before Runoff.

Three structures were placed upstream of a pedestrian bridge at Utah County State Park on the Spanish Fork River in an uncontrolled section of the river. The structures are j-hook vanes. At least one of these structures failed as four of twelve rocks were displaced in the water year of 2004.

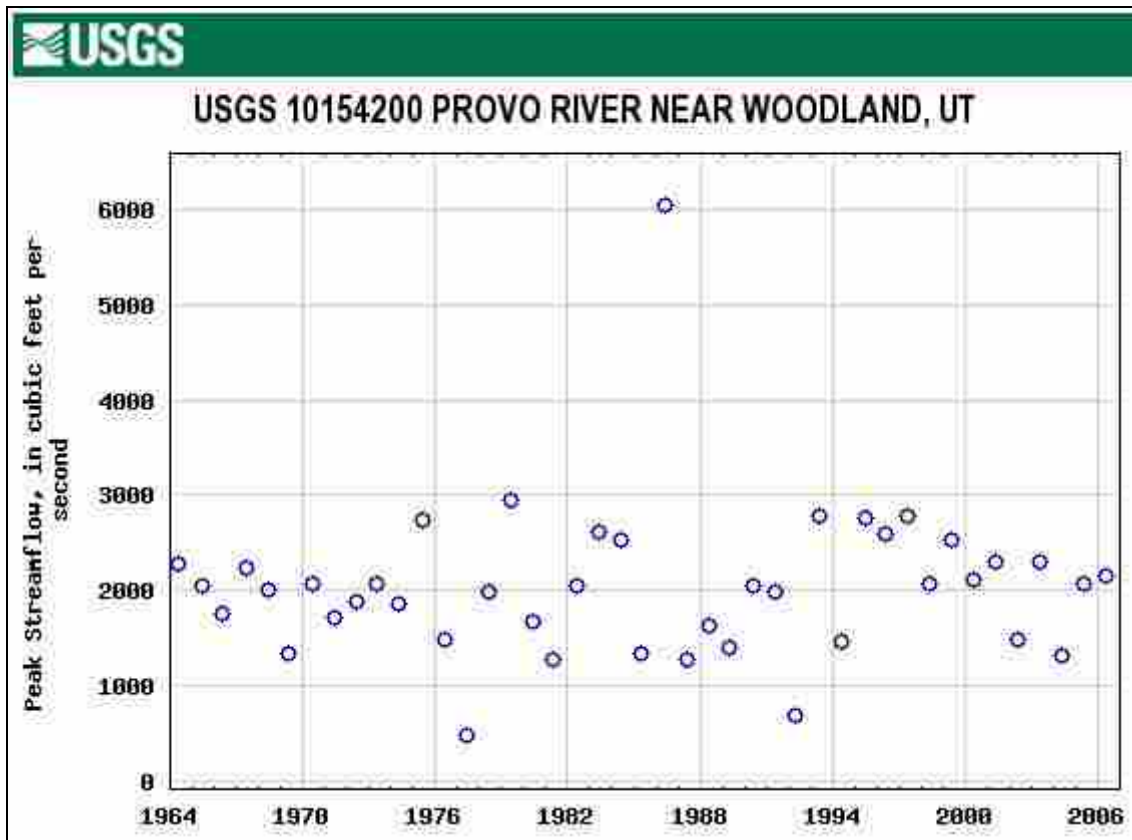
Figure 4-20. Stream Gauge Data for North Fork of the Provo River Site.

Spring runoff in 2005 was an average event based on data from the U.S. Geological Survey (USGS). The closest monitoring gauge is approximately 9,100 meters downstream (obtained from ArcView in the database) of the site. June gauge records indicate that the peak flow was 2,070 cfs and the mean monthly discharge for the same month was 1,052 cfs. See Figure 4-20 for peak stream flows downstream of the site and Flow Data Record No. 3 in Table 4-2 for stream characterization data.

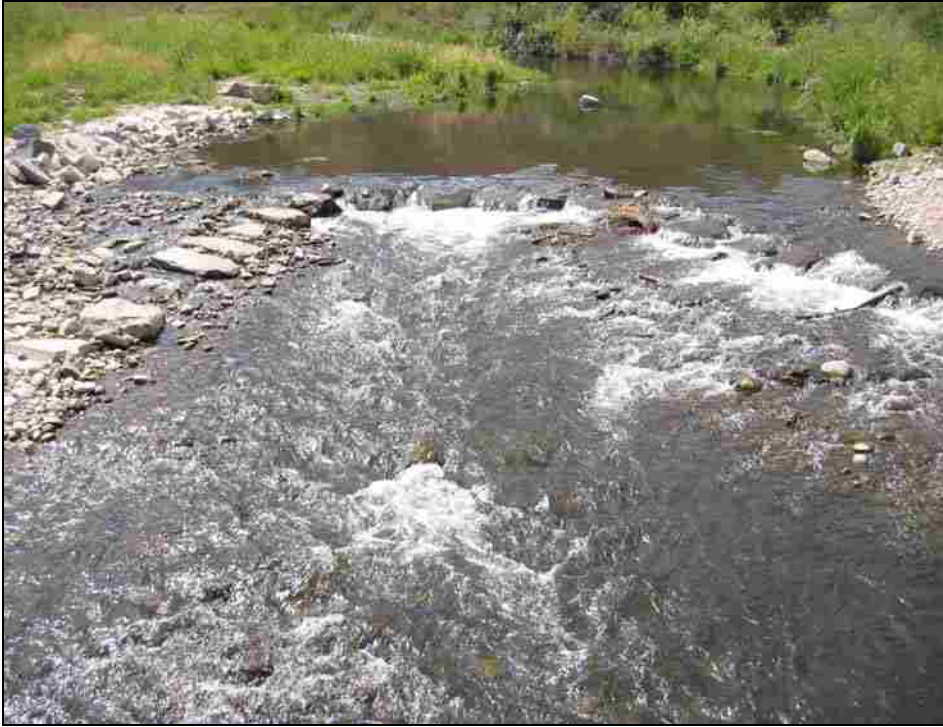
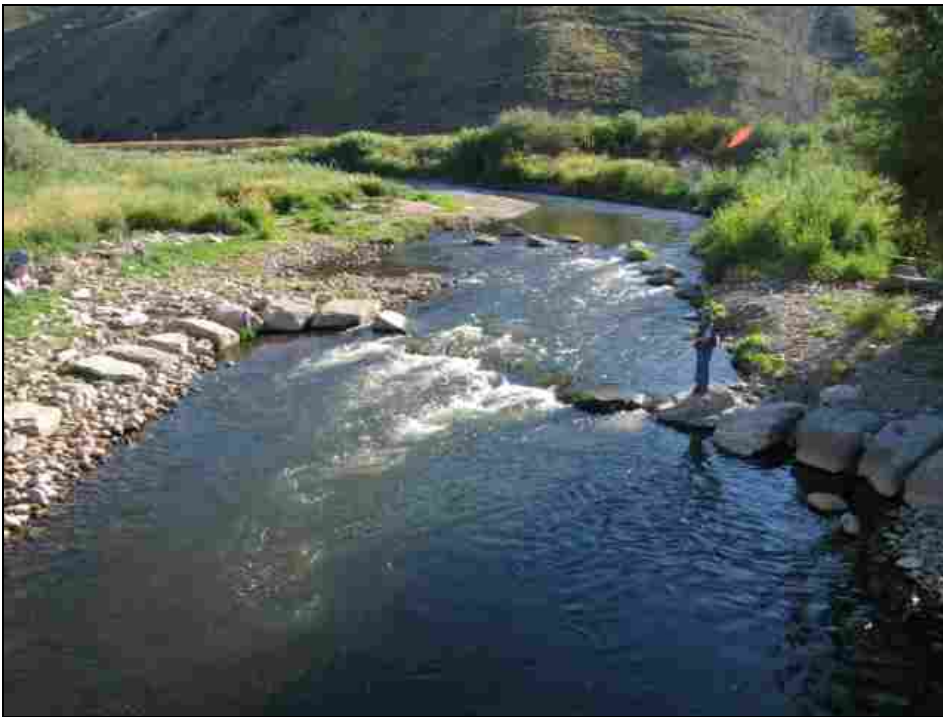
One structure was placed upstream of the bridge at Rockport State Park on the Weber River as shown in Figure 4-25 and Figure 4-26. The structure is a cross-vane placed just upstream of the bridge. The installation did not conform to Rosgen Design Methodology, which dictates the vane arms slope down at a slight angle upstream. In this installation, the vane arms were installed at a slight upstream angle.

Figure 4-25. Rockport Before Runoff.

Figure 4-26. Rockport After Runoff.
