Evaluating Shallow-Flow Rock Structures as Scour Countermeasures at Bridges

EVALUATING SHALLOW-FLOW ROCK STRUCTURES AS
SCOUR COUNTERMEASURES AT BRIDGES

Department of Civil and Environmental Engineering

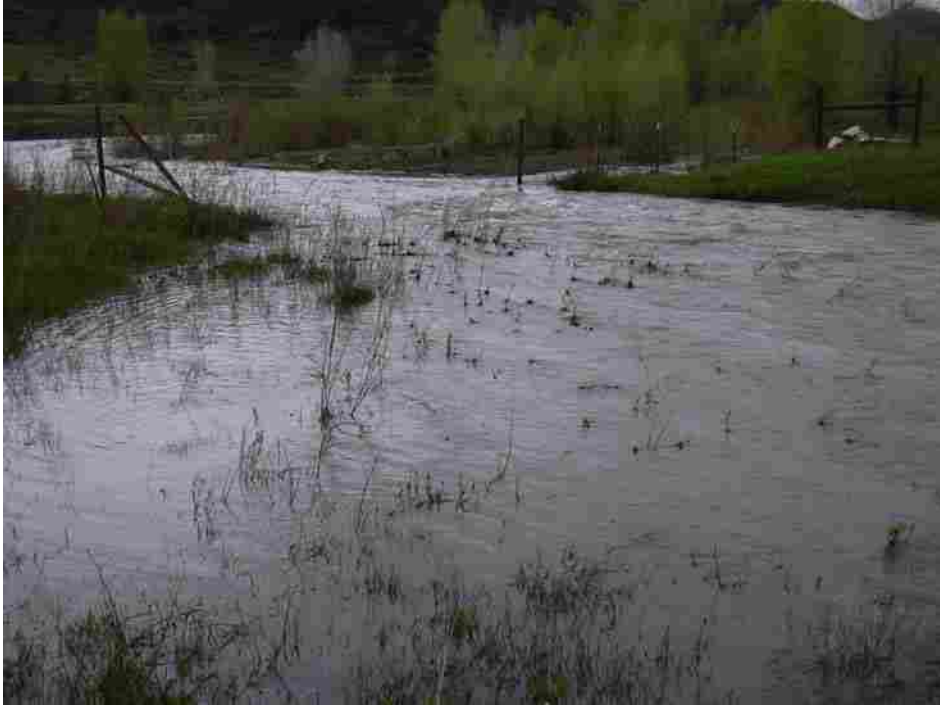
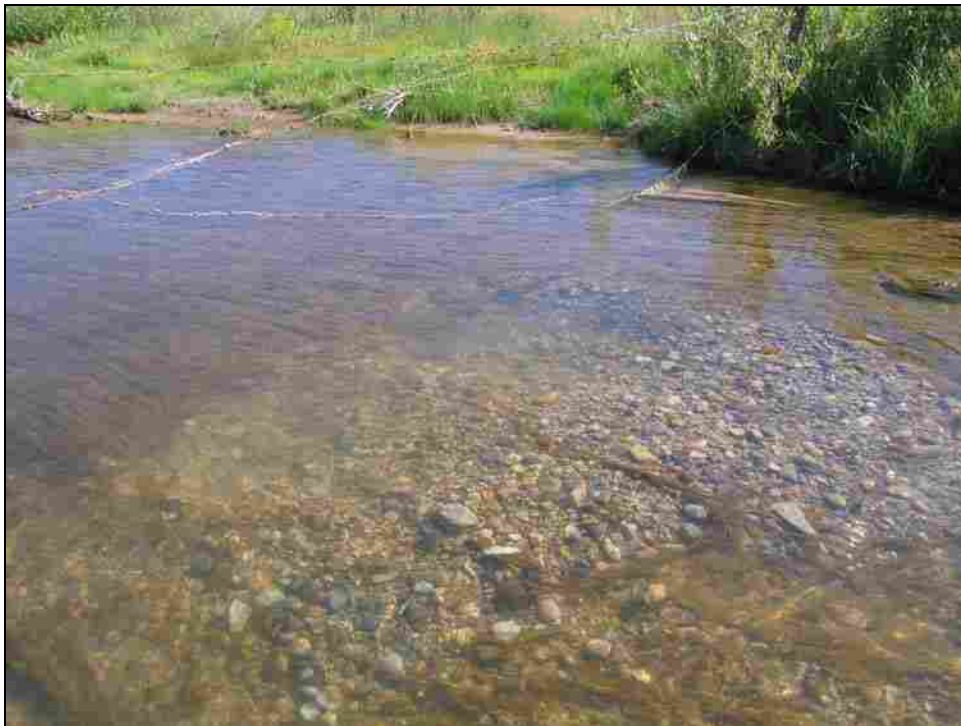
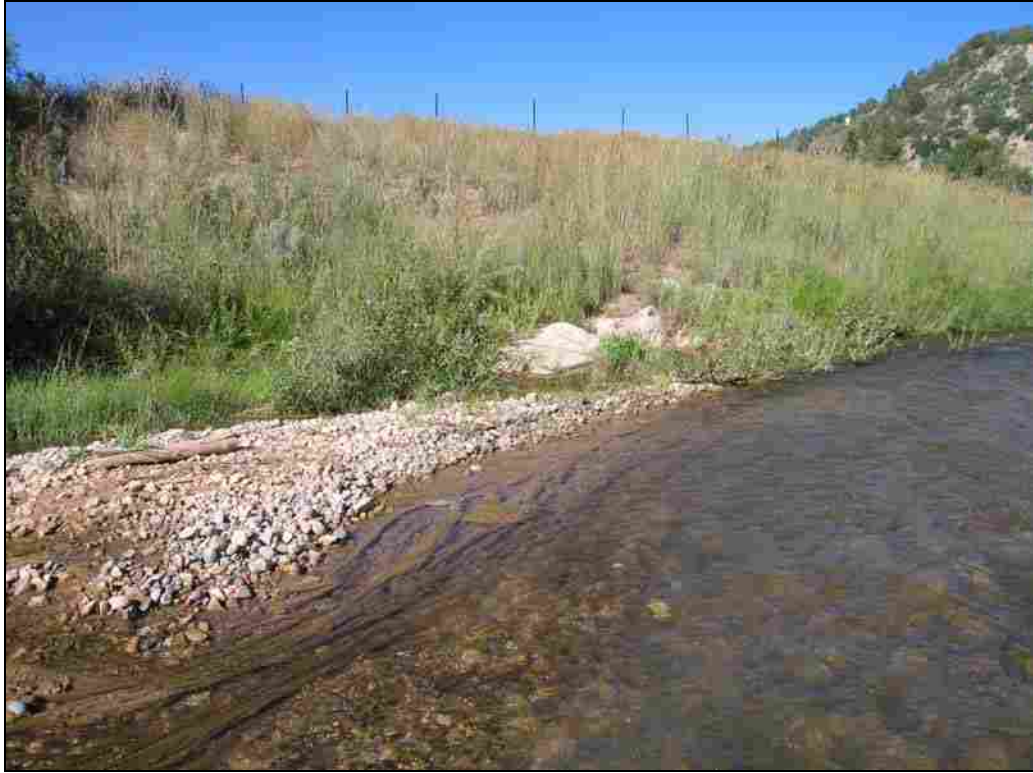
The response of the j-hook and cross-vane was unremarkable under normal flow conditions as compared to spring flows of 2005. In 2005, under average spring flows, both structures were active as water was breaking over the top of them. See Figure 4-27 for cross-vane during 2005 spring runoff. Figure 4-28 and Figure 4-29 were photos taken after 2005 spring runoff.

Figure 4-27. Cross-Vane at Thistle Creek During 2005 Runoff.

Figure 4-28. Cross-Vane at Thistle Creek After Runoff.

Figure 4-29. J-Hook at Thistle Creek After Runoff.
