EFFECT OF JET GROUTING ON THE LATERAL RESISTANCE OF SOIL
SURROUNDING DRIVEN-PILE FOUNDATIONS

A thesis submitted to the faculty of
Brigham Young University
in partial fulfillment of the requirements for the degree of

Department of Civil and Environmental Engineering

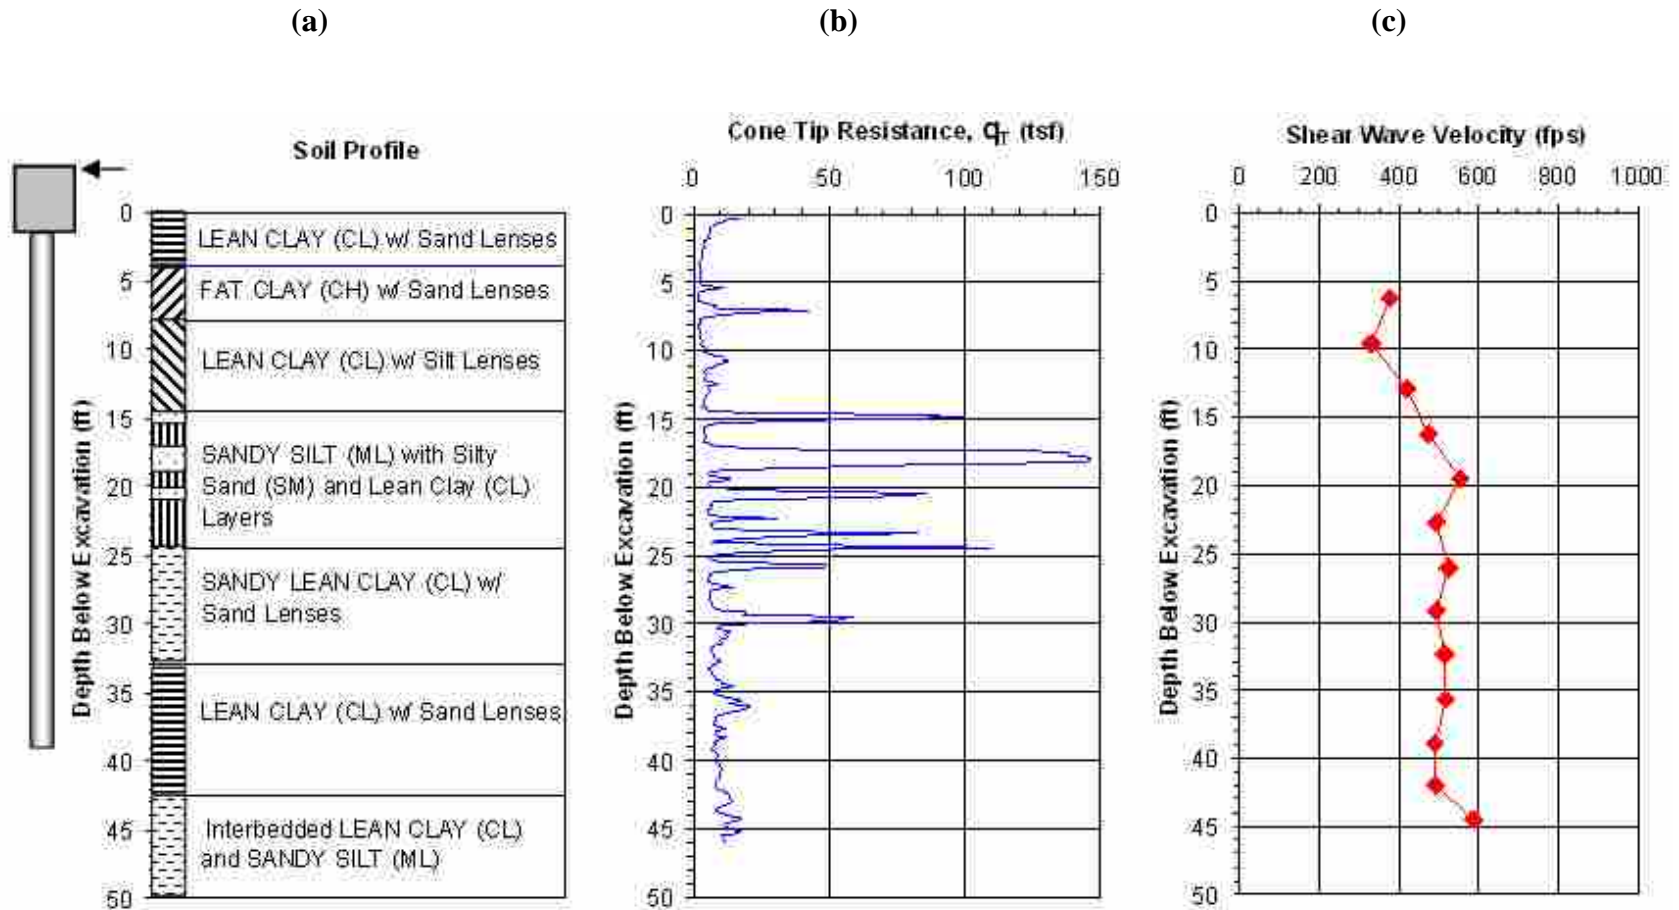
Figure 3-6 Plot of (a) soil profile, (b) cone tip resistance vs. depth, and (c) shear wave velocity vs. depth from seismic cone testing.

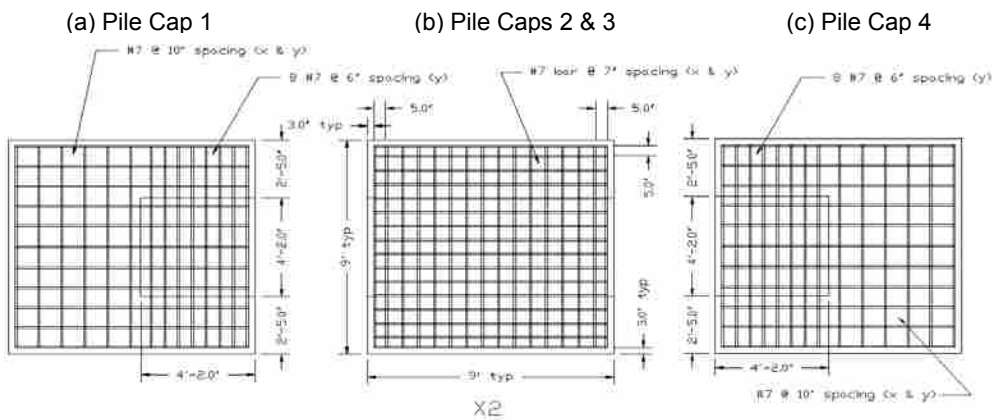
Figure 4-6 Layout of top reinforcing mat for the test pile groups.

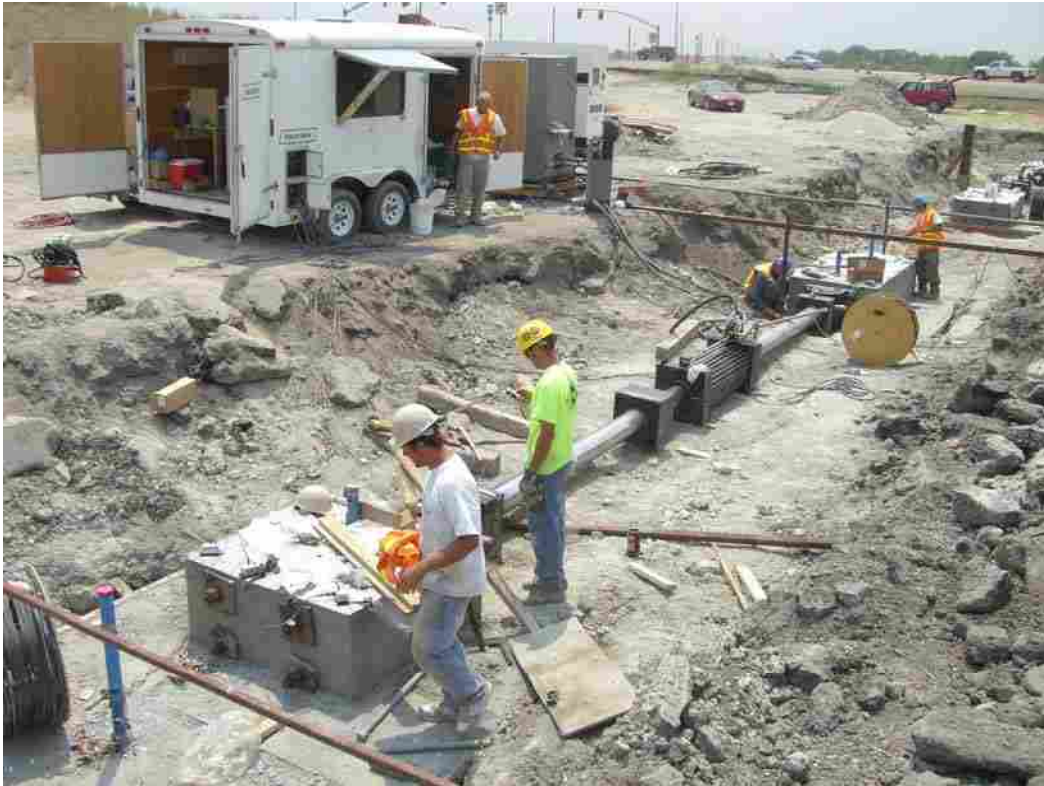
Figure 4-10 Photo of actuator setup between caps 1 & 2.

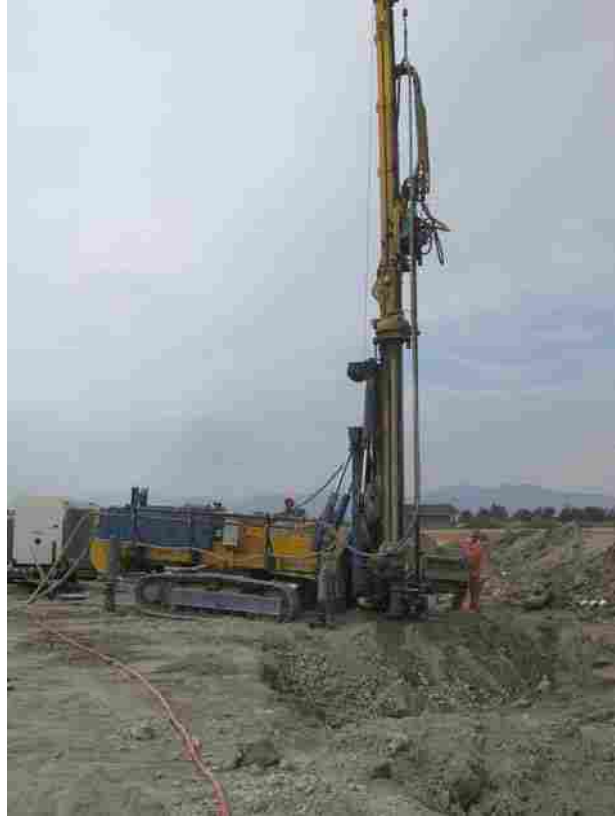
Figure 5-1 Photo of drill rig in position above buried foundation.

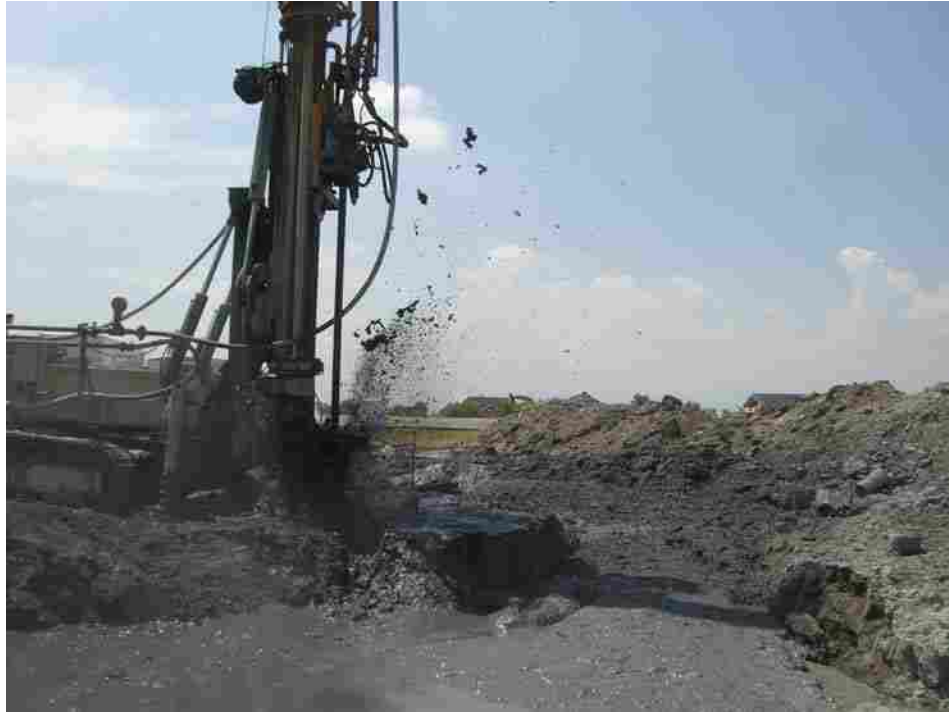
Figure 5-4 Photo of jet grout drill rig in position above buried foundation with spoil being ejected and washing down into the storage area.

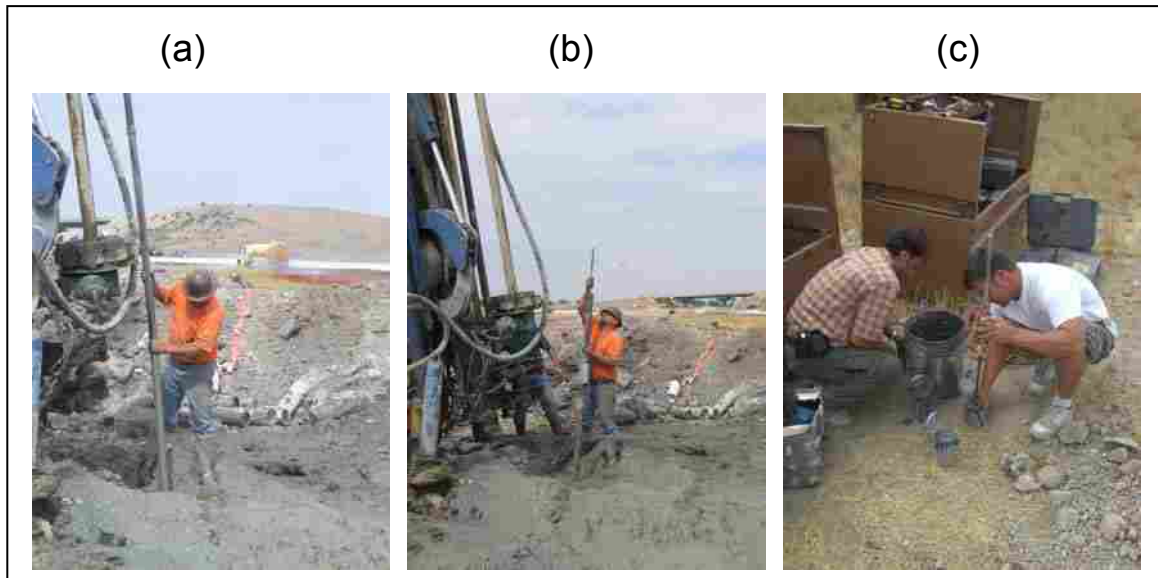
Figure 5-8 Photos taken during (a) insertion of sampling pipe to desired depth, (b) extrusion of small pipe connected to the sampling pipe plug , and (c) rodding of wet grab samples in plastic molds.

samples were taken from random soilcrete columns during each of the three days of installation. To obtain samples, a plugged 3-4 inch diameter PVC pipe was inserted into the wet soilcrete column. The plug was attached to a smaller diameter pipe which was inserted through the sampling pipe and extruded about 2 feet out of the top of the sampling pipe. Once the pipe was inserted to the desired depth, the plug was pulled up 2 to 3 feet from the end of the sampling pipe and secured. The sampling pipe was then pumped up and down to fill the un-plugged end of the pipe with soilcrete. The sampling pipe was then pulled from the hole and the soilcrete sample was extracted. The sample was then placed in a bucket and stirred until it reached an even consistency. The sample was then placed in a capped, 3-inch diameter plastic mold with a height to diameter ratio of about 2.0. The samples were placed in the molds in three lifts, with 25 rods per lift with a 0.25 inch diameter rod to consolidate the samples. Photos taken during the various phases of wet-grab sampling are found in Figure 5-8. In addition, two 4-inch diameter core samples were obtained from the upper 2 ft of the jet grouted columns 13 and 14 near pile cap 1 about one month after jet grouting. The samples were capped with either sulfur capping mortar or plaster, and were compression tested at various curing times to evaluate the strength gain with time. The vertical strain rate during compression testing was 0.05 in/min.

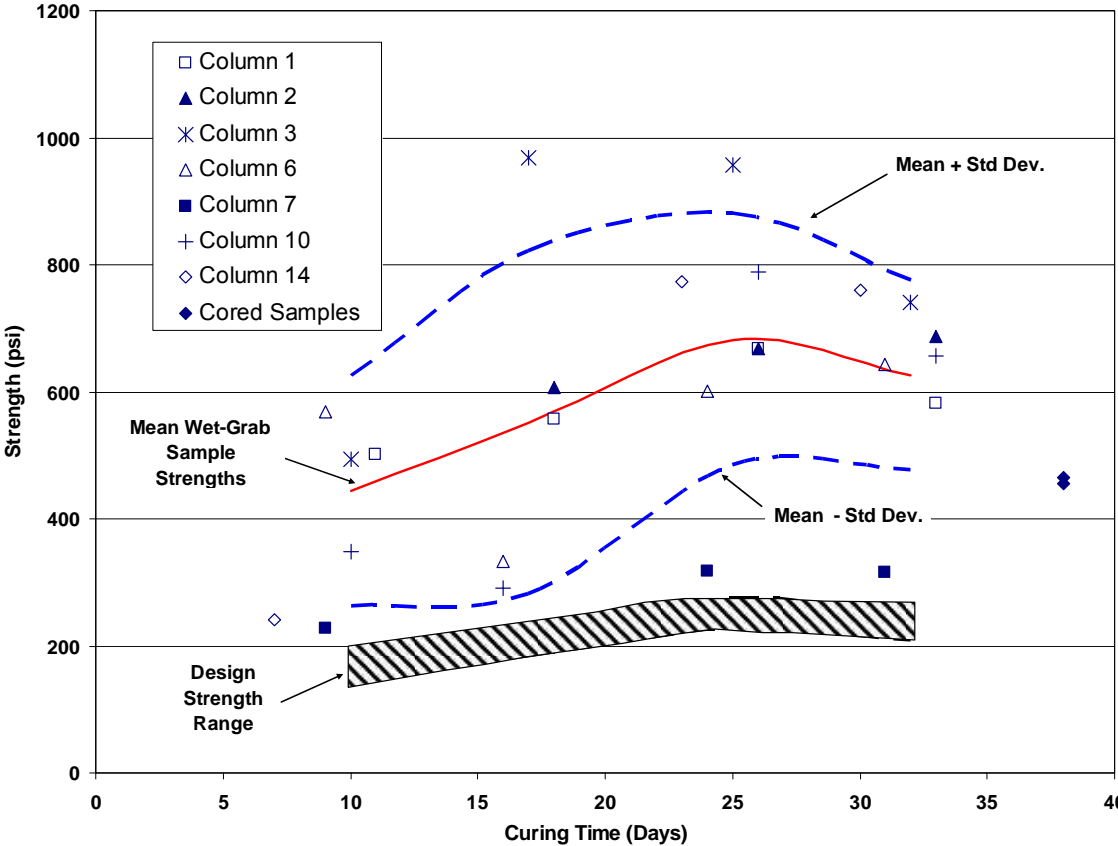
Figure 5-9 Compressive strengths of installed soilcrete columns.

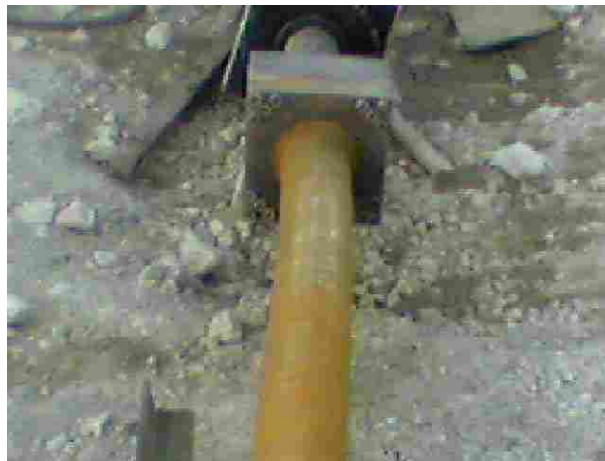
Figure 9-6 Picture of bent actuator extension.

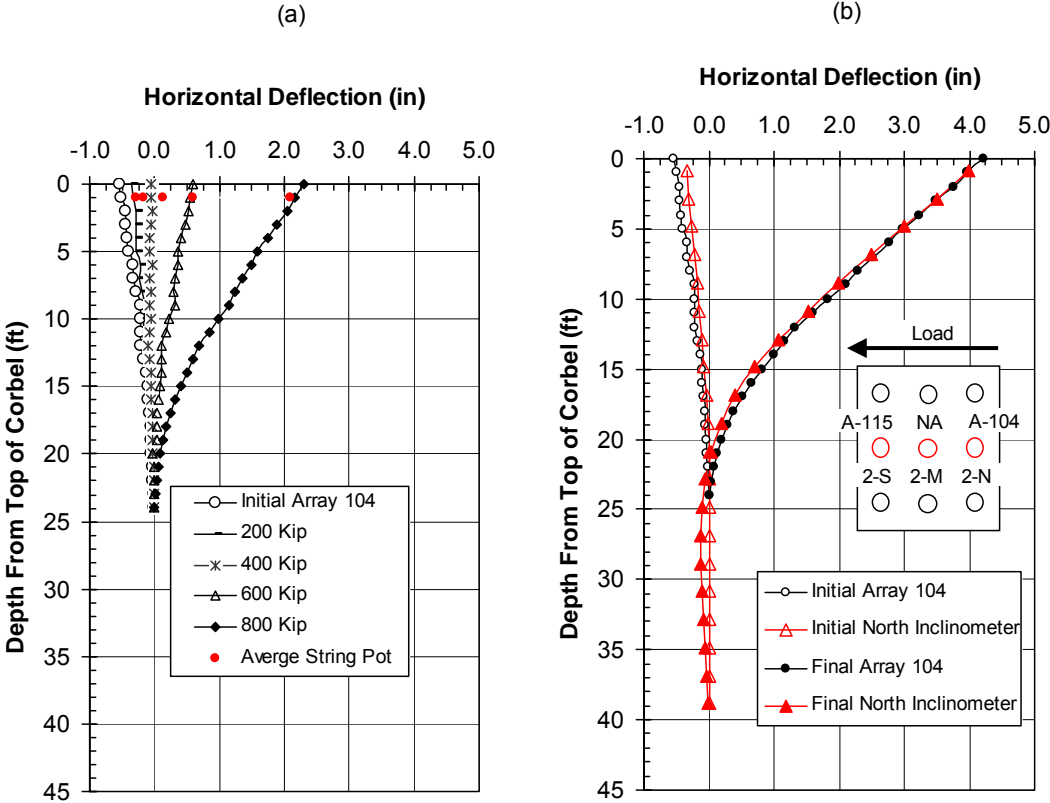
Figure 10-8(a) Deflection vs. depth curves for the north center pile of pile cap 2 (2-N) from shape array 104 for each increment of test 4, with pile head displacements from the string potentiometers also shown. (b) Comparison of depth vs. deflection curves for the north center pile of pile cap 2 (2-N) from shape array 104 and the north inclinometer of pile cap 2 during test 4.

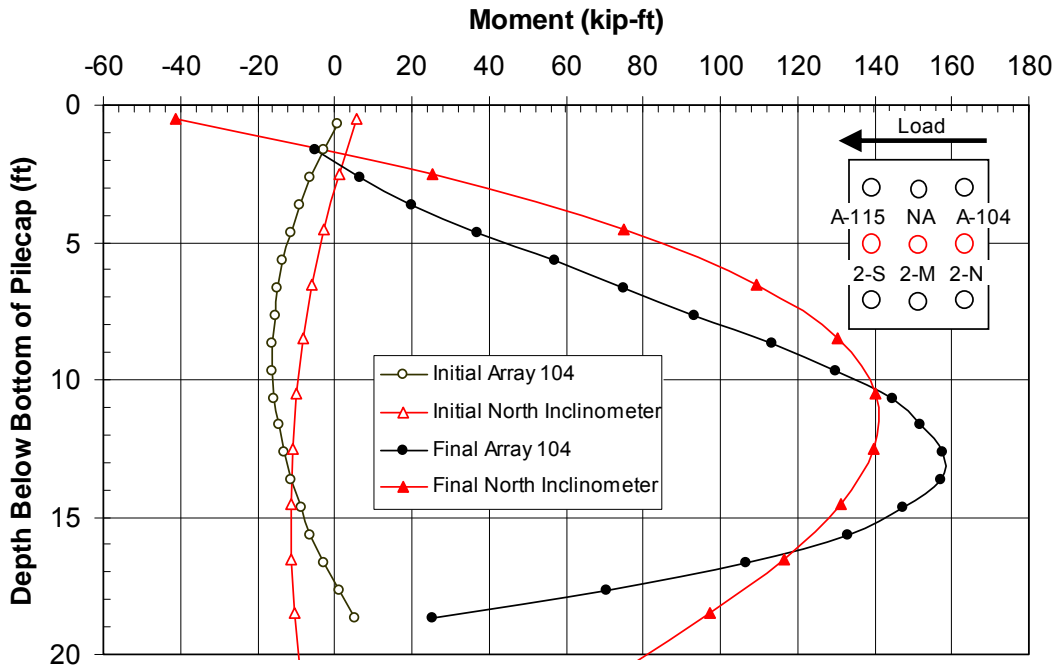
Figure 10-13 Moment vs. depth comparison for the north center pile of pile cap 2 (2-N) based on deflections measured from the north inclinometer and shape array 104 for test 4.

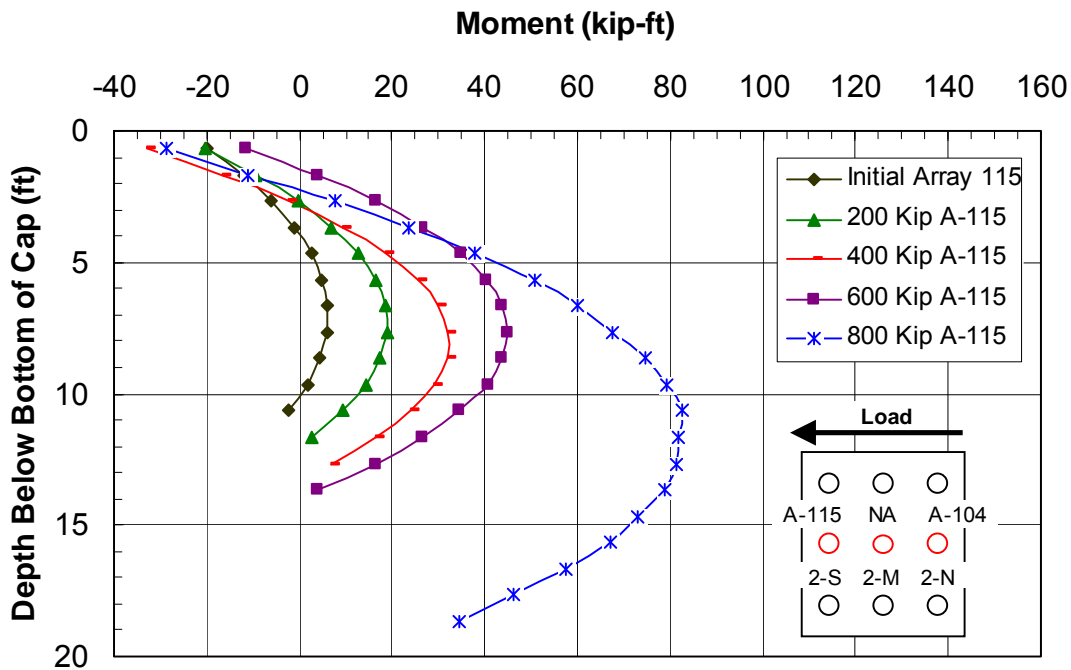
Figure 10-14 Moment vs. depth curve for the south center pile of pile cap 2 (2-S) based on incremental deflection vs. depth curves measured from shape array 115 during test 4.

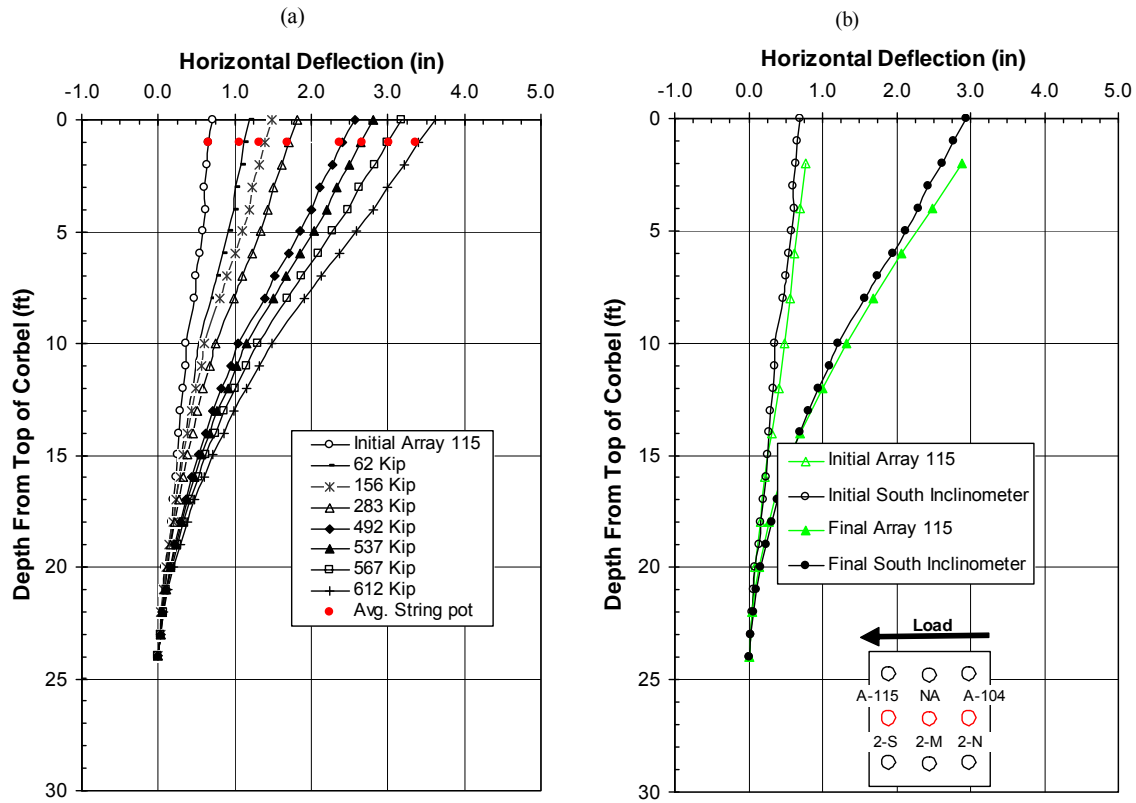
Figure 12-9(a) Deflection vs. depth curves for the south center pile of pile cap 2 (2-S) from shape array 115 for each increment of test 6, deflections at the point of loading measured from the string potentiometers are also shown (b) comparison of depth vs. deflection curves for the north center pile of pile cap 2 (2-N) from shape array 104 and the north inclinometer of pile cap 2 during test 6.

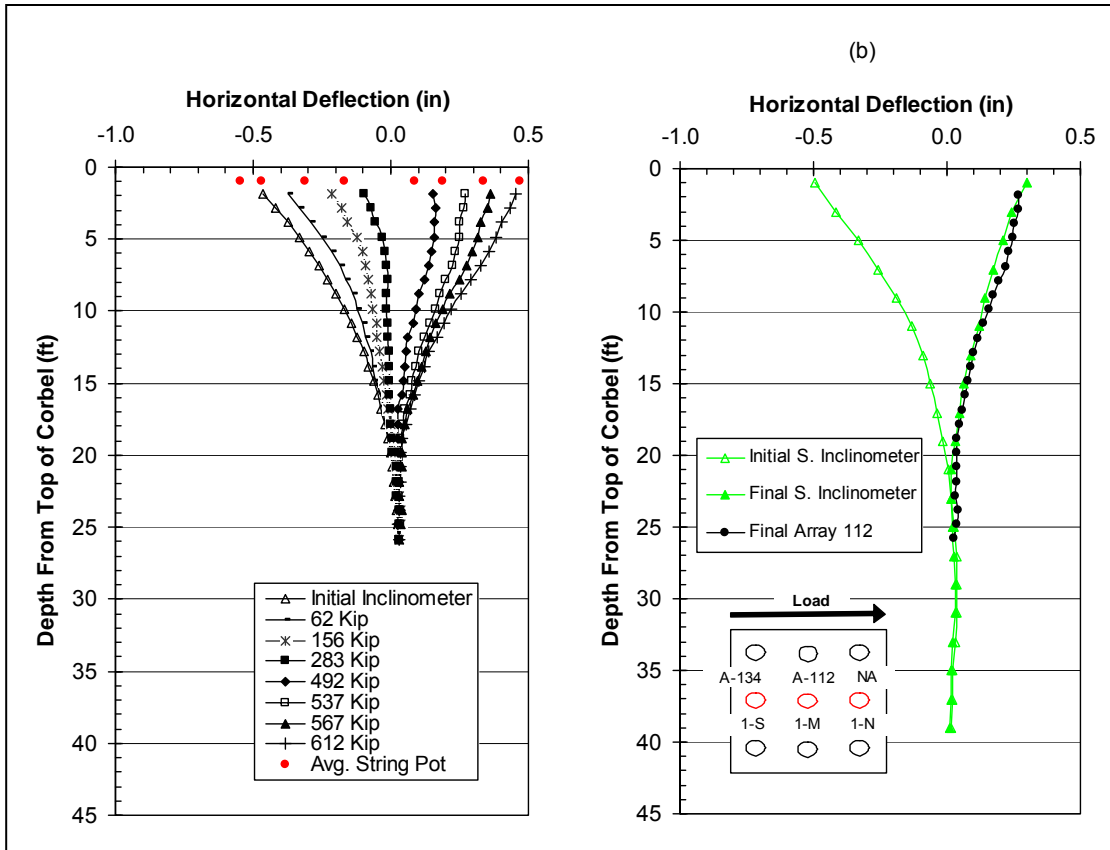
Figure 12-11 (a) Deflection vs. depth curves for the middle center pile of pile cap 1 (1-M) from shape array 112 for each increment of test 6, deflections at the point of loading measured from the string potentiometers are also shown (b) Comparison of depth vs. deflection curves for the middle center pile of pile cap 2 (1-M) from shape array 112 and the south inclinometer of pile cap 1 during test 6.
