Dry Stacked Surface Bonded Masonry - Structural Testing and Evaluation

DRY STACKED SURFACE BONDED MASONRY – STRUCTURAL
TESTING AND EVALUATION

Department of Civil and Environmental Engineering

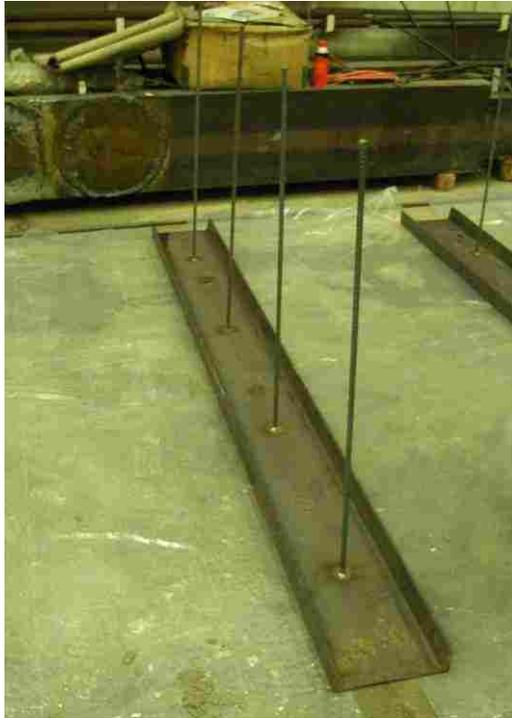
All block walls to be tested were built on C10x15.3 steel channels. The purpose of this channel was to provide support as the walls were moved into the test frame. Vertical rebars used in the first lift were welded to the channel before placement of the block. This was done to provide stability and strength as the walls were moved. The welded rebars also simulate the fixity of the reinforcement that would extend out of a concrete foundation or footing in a field application. Then a layer of mortar was placed in the steel channel so that the block would have a level bearing surface. The initial setup of the steel channel and welded reinforcement is shown in Figure 4.1.

Figure 4.1 Rebar and Steel Channel

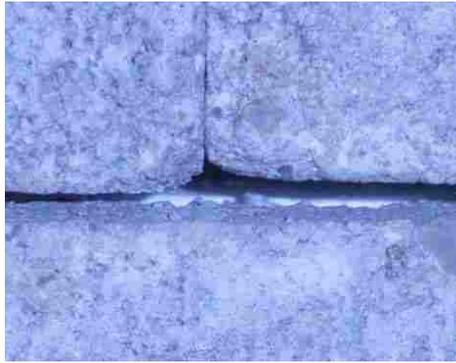
Figure 4.2 Gap in Wall Created by Non-Uniform Block Heights

The walls constructed with the thin set mortar between courses were stacked in a similar manner as the dry stacked walls. The mortar compensated for variations in block height and created a level bearing surface for the block. One of the chief advantages of using mortar between the courses of blocks is that the gaps created by blocks that are not uniform heights are filled. When dry-stacking the blocks, gaps such as the one shown in Figure 4.2 can form in the wall.

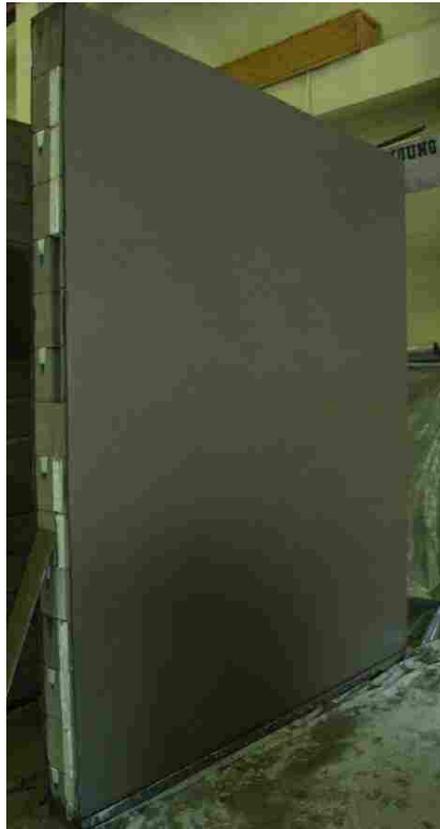
ENDURA Block system is a proprietary mix that basically consists of sand, cement, lime, and water with glass fibers mixed in. Before the structural coat was applied, the walls were pre-moistened in order to prevent premature drying and crumbling of the surface bond. A four foot long “darby” tool was used to apply the surface bond material to the face of the wall. The darby tool also helped insure that an even coat approximately 1/8” thick was applied. A masonry trowel was used next in order to smooth the finish left by the darby tool. After the surface bond was in place the walls were kept moist for the following 24 hours so that moisture would be available for the surface bond to cure properly. A finished wall after the structural coating had been applied is shown in Figure 4.3.

Figure 4.3 Finished Wall

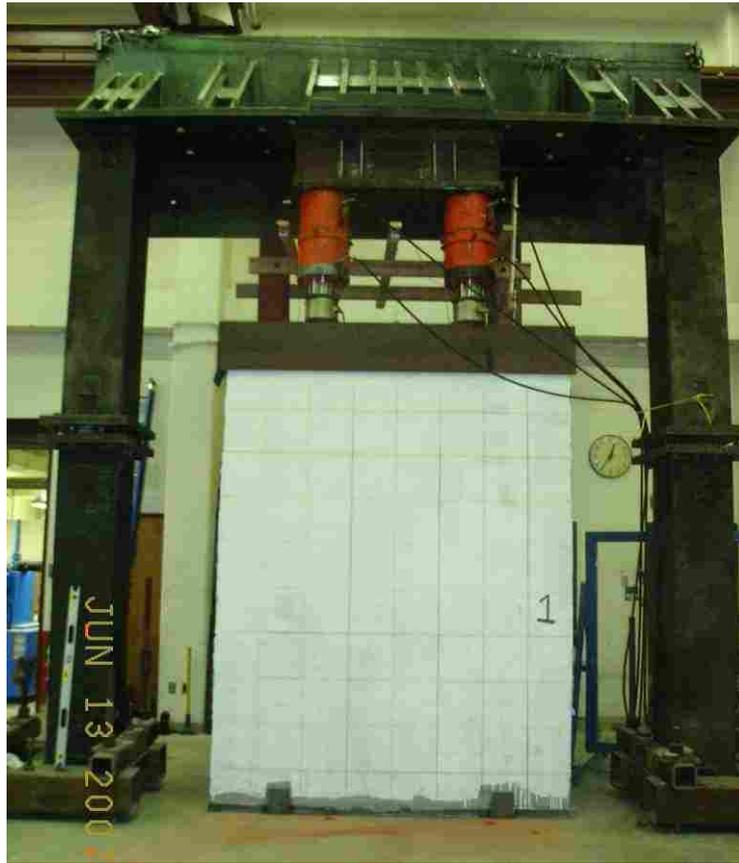
A steel reaction frame was assembled on the strong floor of the BYU structural laboratory. DYWIDAG bars which connected the steel frame to the strong floor were post-tensioned to the strong floor in order to minimize frame movement. The reaction frame and wall #1 are shown in Figure 4.4.

Figure 4.4 Steel Frame and Specimen 1

The frame was estimated to have a vertical testing capacity of 2000 kips. Two hydraulic jacks, each with a capacity of approximately 1000 kips were attached to the horizontal beam of the frame. A W12x79 deep steel beam, with web stiffeners added to

prevent web buckling and localized flange failure, was attached to the bottom of the hydraulic jacks. The beam served to spread the load evenly over the length of the walls. A neoprene pad was placed between the steel beam and the top of the wall in order to account for minor irregularities in the top of the wall.

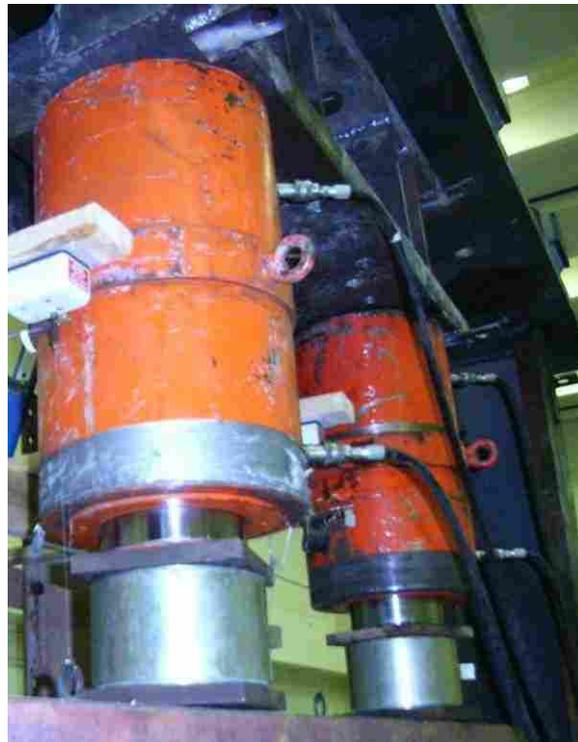
Three types of data were collected during the testing: applied vertical load, vertical deflection of the specimen, and horizontal deflection of the specimen at mid-height. The applied load was obtained from loads cells that were mounted between the hydraulic jacks and the steel beam. The hydraulic jack and load cell assembly is shown in Figure 4.5.

Figure 4.5 Hydraulic Jacks and Load Cells

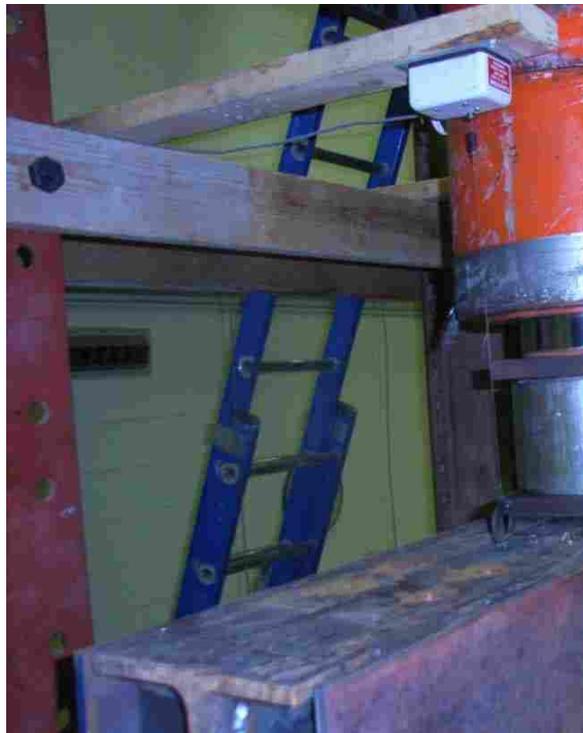
The vertical wall deflection was measured using string pots. Three string pots were mounted on a wood frame which was independent from the steel frame and masonry walls. The strings were then attached to the top of the steel beam. During testing, the east side string pot was damaged and was replaced by an LVDT. The assembly used to measure vertical deflection is shown in Figure 4.6.

Figure 4.6 String Pot Attachment

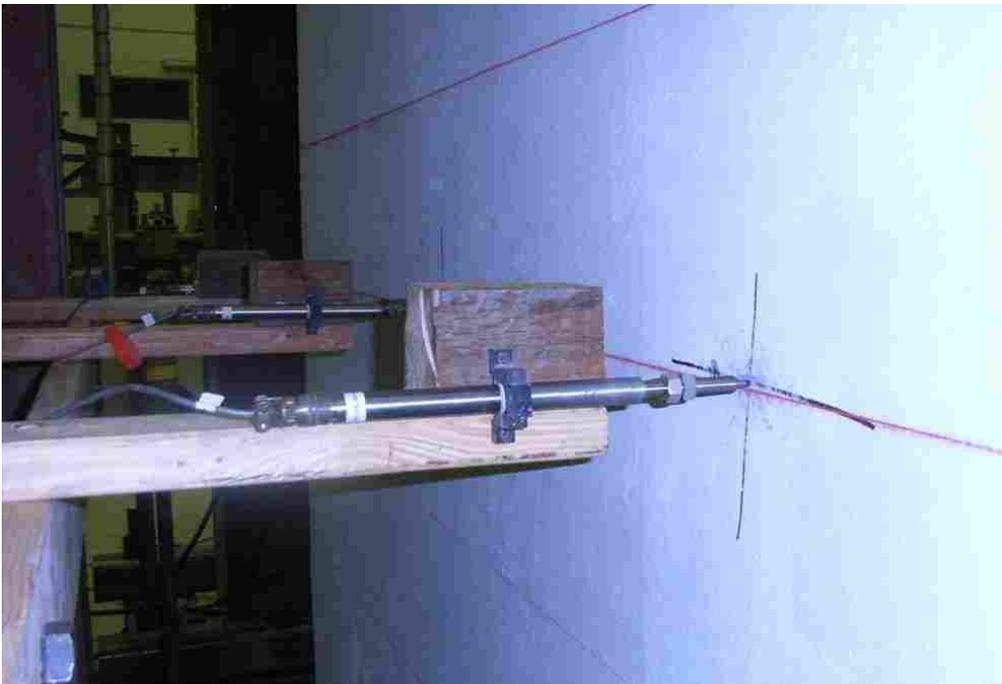
The horizontal deflection at mid-height of the wall was measured using three Linear Variable Displacement Transformers (LVDTs). The LVDTs were also mounted on the wood frame which was independent from the steel frame and masonry walls. The setup of the LVDT's used to measure horizontal deflection is shown in Figure 4.7.

Figure 4.7 LVDT Placement

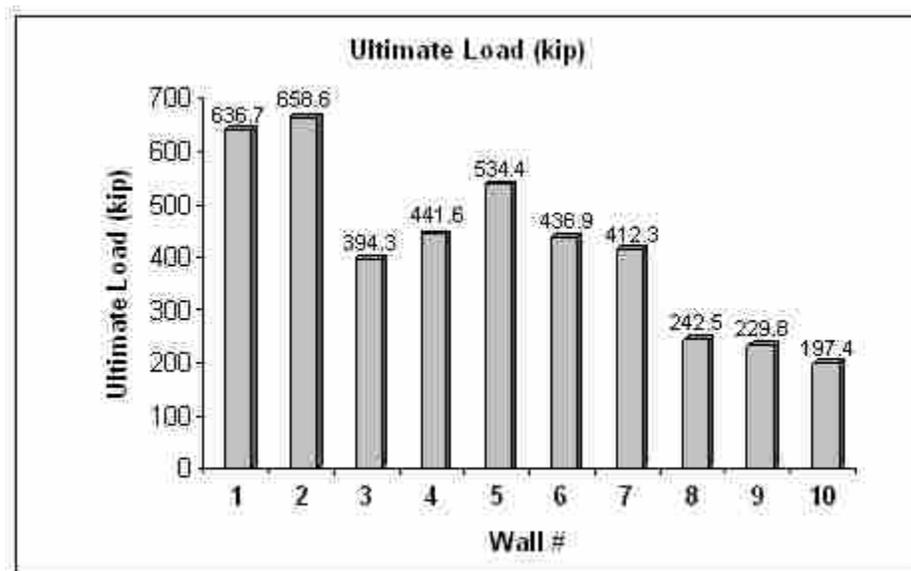
The goal of this testing was to find the axial capacities of walls built using the ENDURA block system. The ultimate capacity of each wall is shown in Figure 5.1.

Figure 5.1 Wall Capacity

The ultimate axial capacities of the walls were normalized in two different ways. First, the axial capacities were divided by the structural bearing area. Structural bearing area is being defined as the sum of the bearing area of grout, concrete block, and reinforcement. Second, the axial capacities were normalized by only the grout bearing area, meaning bearing area not including void area, concrete block area, or area of

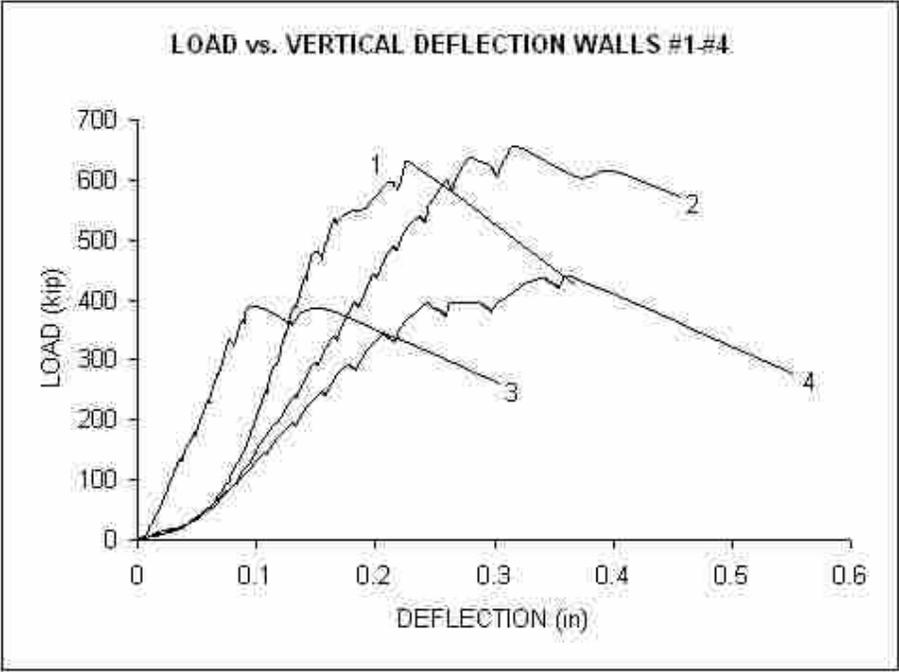
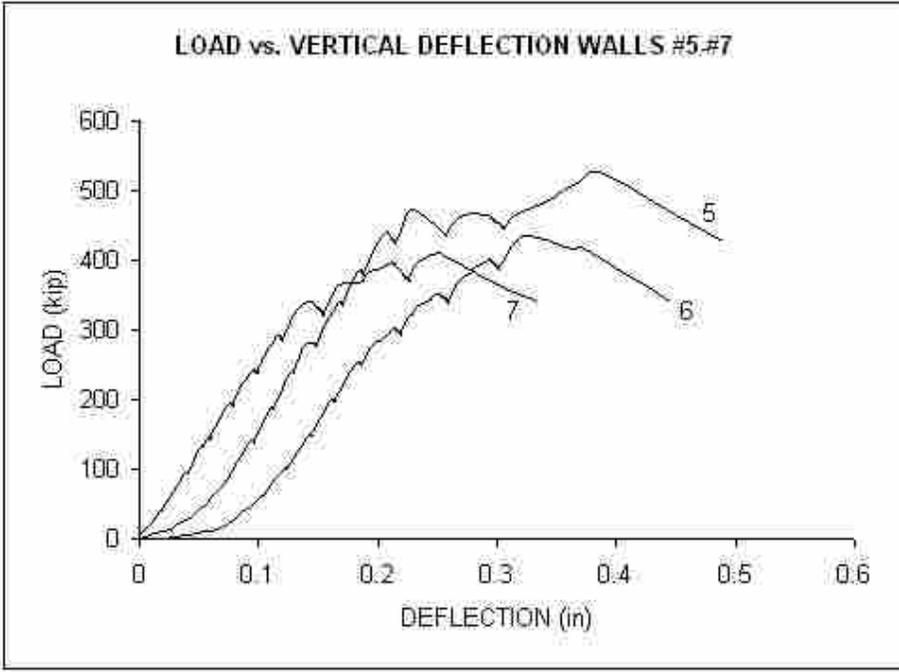
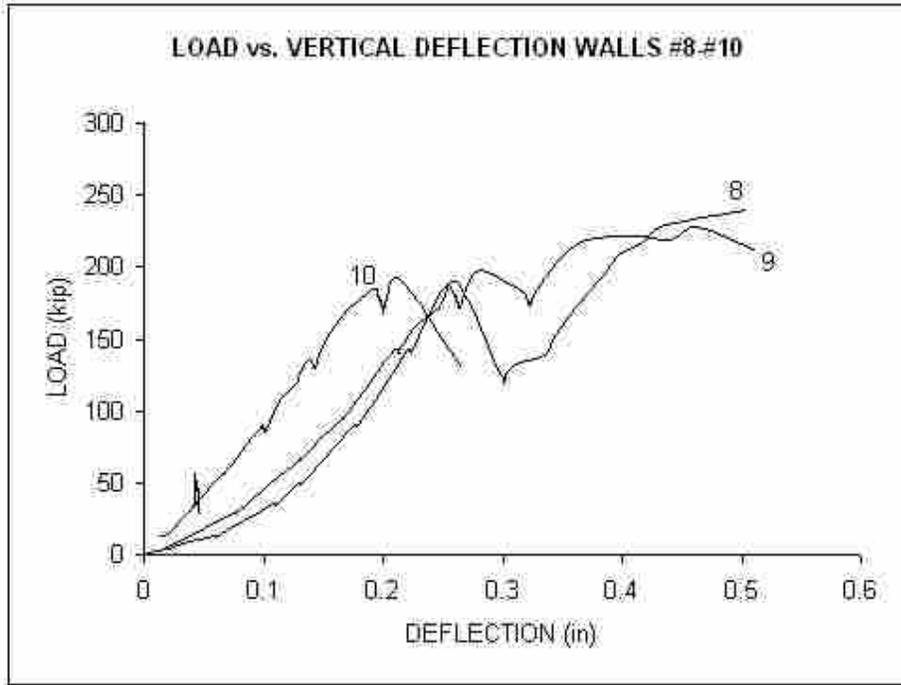
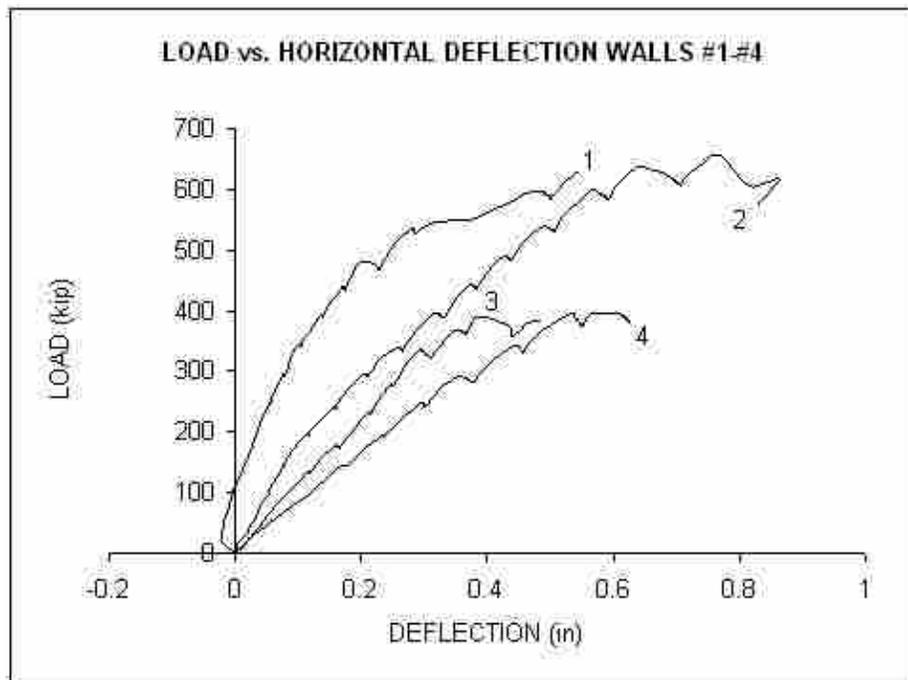
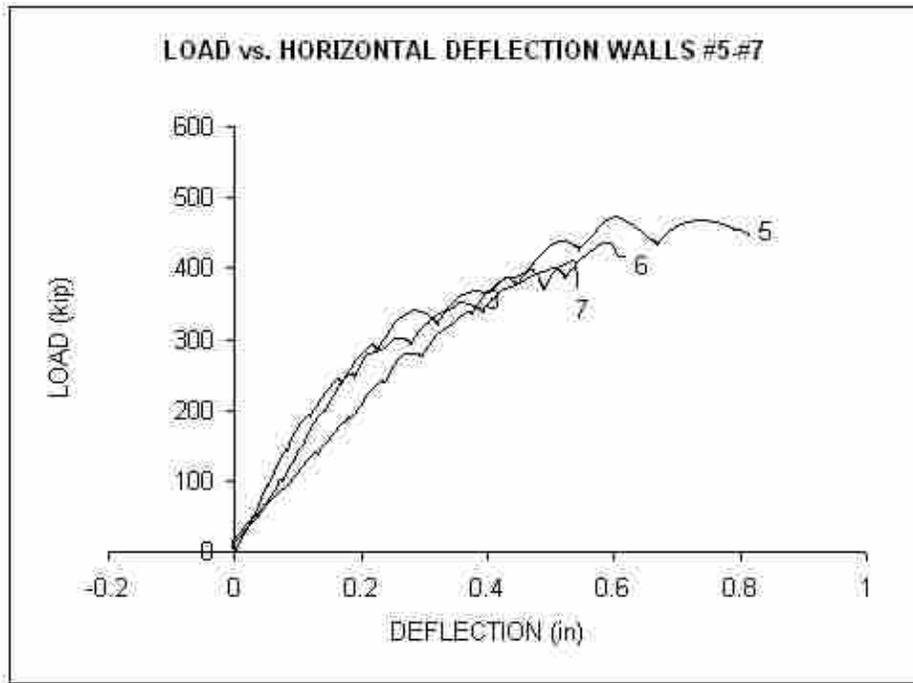
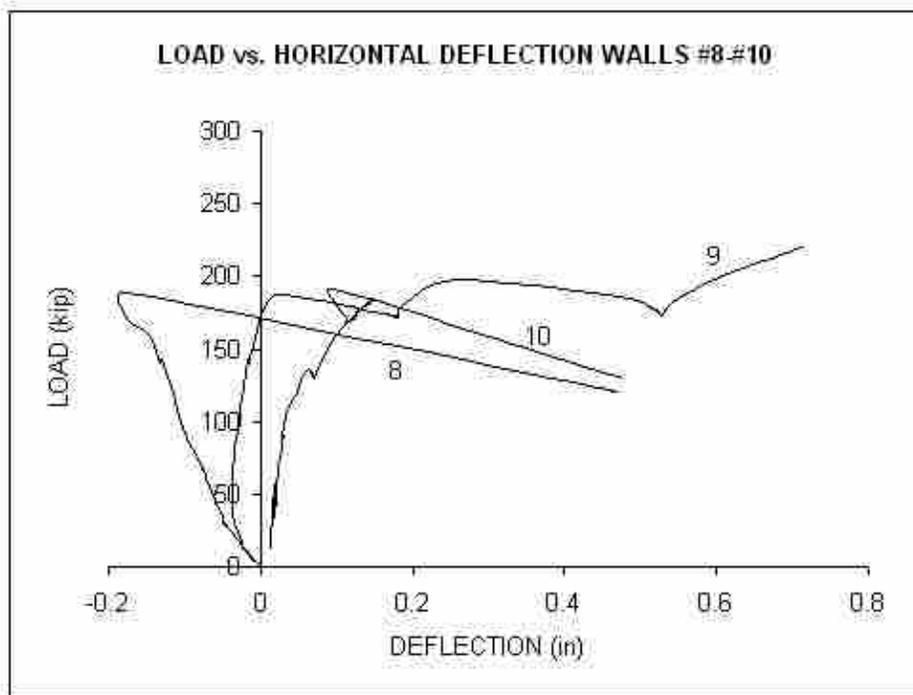
Load versus deflection graphs also provide a means of evaluating the performance of the walls tested. Plots of load versus deflection for walls using corner blocks only are shown in Figure 5.2 and Figure 5.5. Plots of load versus deflection for walls using corner and stretcher blocks are shown in Figure 5.3 and Figure 5.6. Plots of load vs. deflection for walls built using stretcher blocks only are shown in Figure 5.4 and Figure 5.7.

Figure 5.2 Vertical Wall Deflection #1-#4

Figure 5.3 Vertical Wall Deflection #5-#7

Figure 5.4 Vertical Wall Deflection #8-#10

Figure 5.5 Horizontal Wall Deflection #1-#4

Figure 5.6 Horizontal Wall Deflection #5-#7

Figure 5.7 Horizontal Wall Deflection #8-#10

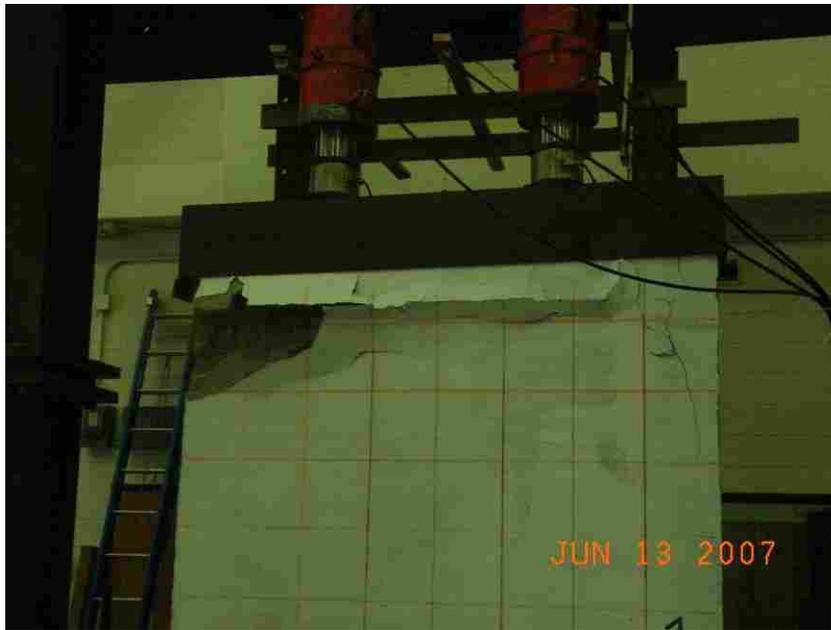
Wall #1 was solid grouted and heavily reinforced. Researchers therefore expected that this wall would have the greatest axial capacity; however this was not the case. At failure, Wall #1 experienced crushing in the top two to three courses of block while the rest of the wall was still entirely intact. This wall had a high ratio of grout strength to overall wall strength. As has been suggested in previous research this high ratio is often accompanied by crushing at the top of the wall. (Uzoegbo, 2007) A photograph of wall #1 at failure is shown in Figure 6.1.

Figure 6.1 Wall #1 at Failure

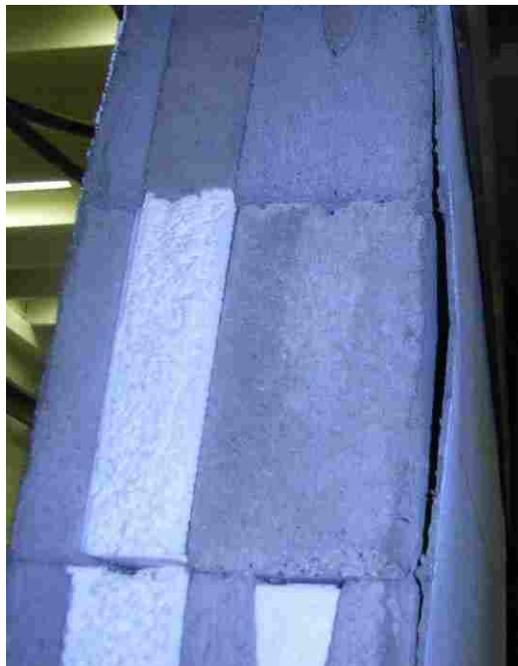
vertical cracking. When failure occurred, the top west corner of the wall gave way first. There a couple of possible explanations for such occurrence. First, the blocks used to build the wall were manufactured in different plants and the height of the blocks may have varied more than more than typically expected, making it difficult to level the top of the wall. Thus, if the west side of the wall was slightly taller than the east side it could crush first. The second possibility is that the hydraulic jack may have loaded the wall unevenly, applying slightly more load on the west side. There were also significant portions at the lower front and upper rear of the wall where the structural coating bubbled out and separated from the wall as shown in Figure 6.2. The separation of the structural coating was a common occurrence in almost all of the walls as ultimate loads were approached.

Figure 6.2 Bubbling of Structural Coating

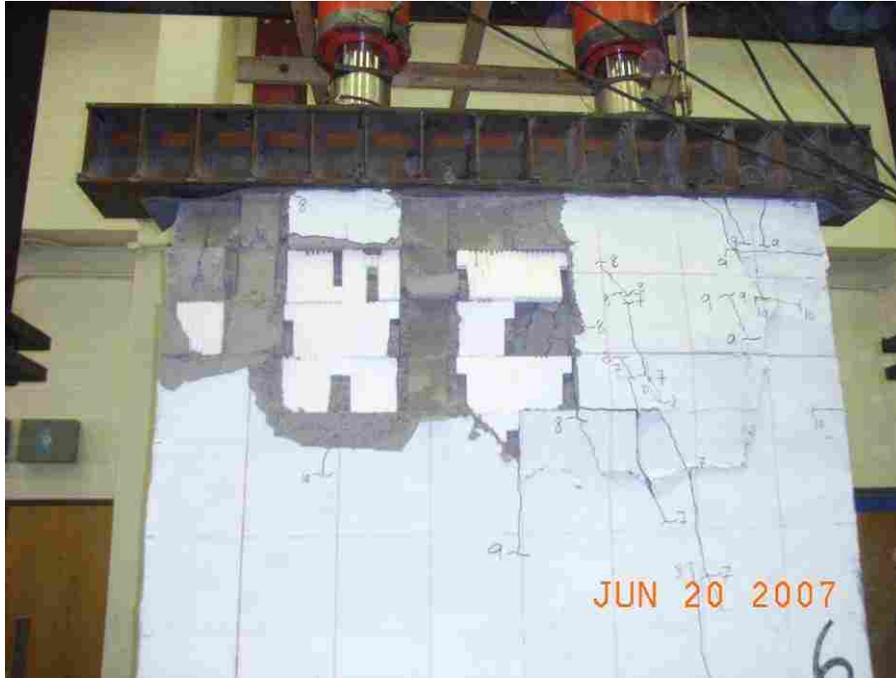
Wall #6 experienced fairly uniform crushing across the length and height of the wall. The east side of the wall appeared to fail first but the west side was very close to failure as well. At the top half of the wall the blocks split and the face of the block separated and fell forward as shown in Figure 6.3. There also may have been some slight buckling towards the top half of the wall.

Figure 6.3 Wall #6 at Failure

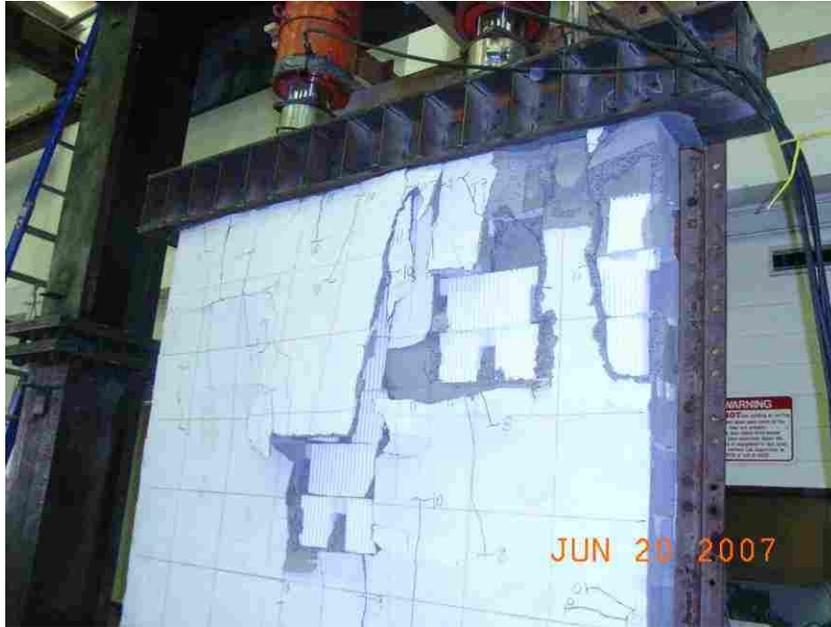
Wall #7 was the last wall tested. This wall performed quite similarly to wall #6 experiencing fairly uniform crushing throughout the wall and an ultimate load capacity similar to that of wall #6. Such response was expected since the only design difference between wall #6 and wall #7 was that wall #7 had the thin set mortar between all courses of blocks. Figure 6.4 shows wall #7 at failure.

Figure 6.4 Wall #7 at Failure

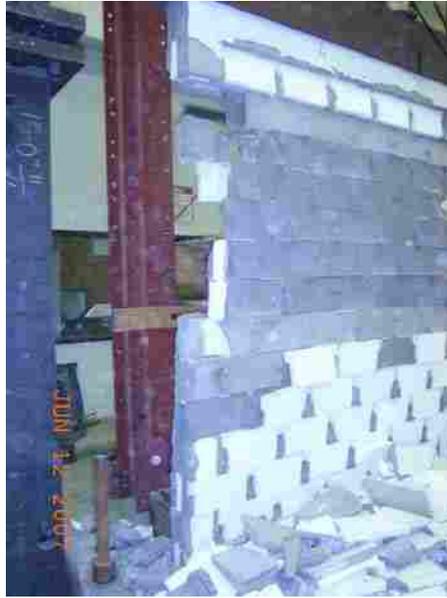
eccentrically loaded wall. The first cracks that developed were horizontal cracks directly above and below the bond beam in the center of the wall, which suggests that the wall was experiencing some out of plane bending. At failure the ungrouted face of the block separated completely from the grouted cells and fell forward as shown in Figure 6.5.

Figure 6.5 Wall #8 at Failure

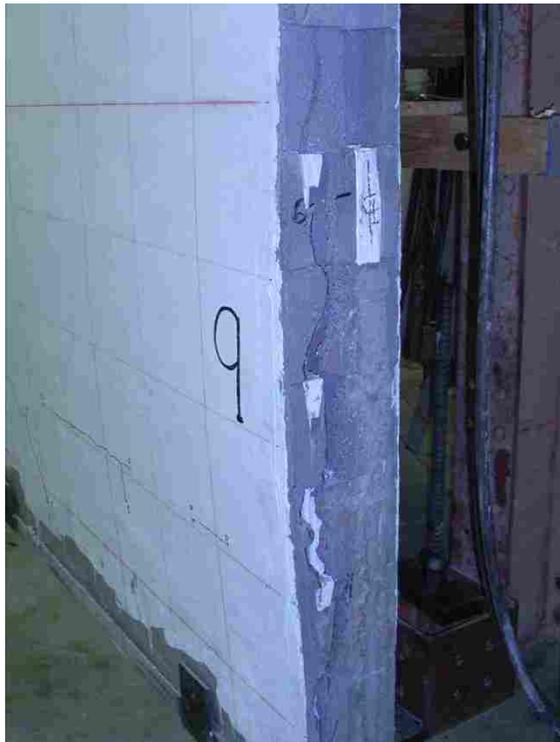
Wall #9 performed similarly to wall #8 as was expected since the only design difference between the two walls was that wall #9 did not have the thin set mortar between courses. At failure the ungrouted face of the block separated and fell forward in a similar manner as that of wall #8. Vertical cracks, separating the grouted and ungrouted faces of the blocks developed just prior to failure as shown in Figure 6.6.

Figure 6.6 Cracks Separating Grouted and UngROUTED Faces of the Blocks

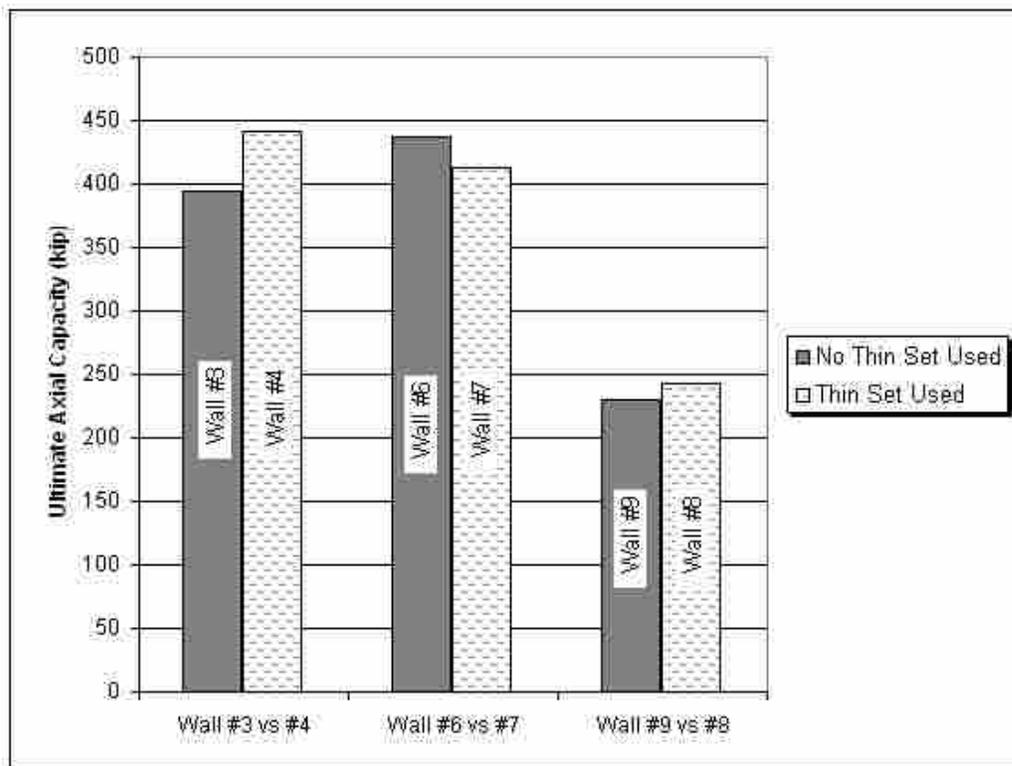
There were three pairs of walls built for which the only variable was whether or not a layer of thin set mortar was used between courses of blocks. These pairs and their respective axial capacities are shown in Figure 6.11 which shows that the performance doesn't seem to be correlated with the use of mortar. The variation in axial capacities is less than 10 percent when wall pairs constructed with and without thin set mortar are compared. These small differences in axial capacity may be explained by factors other than the mortar such as imperfections generated during construction or the application of load not being exactly uniform from one wall to the next.

Figure 6.11 Effect of Thin Set Mortar on Axial Capacity

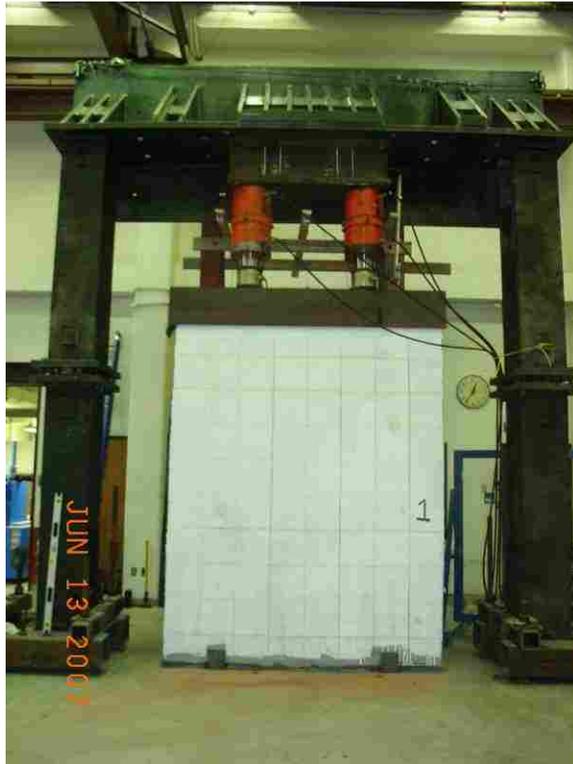
Prior to Testing (wall #1)

The following is a list of notes and pictures taken during the testing of wall #1:

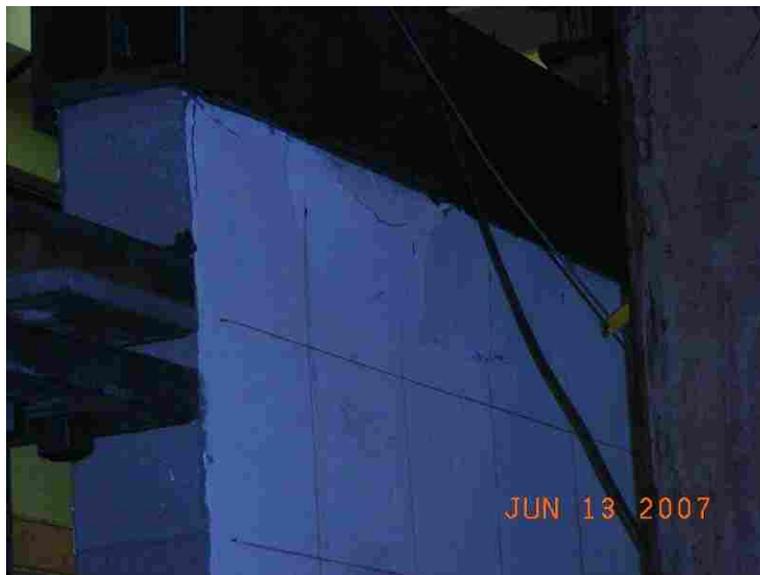
Top Course Crushing (wall #1)

- At 200 kip some measurable horizontal deflection began to occur.
- At 400 kip some popping within the wall could be heard.
- At 550 kip popping sounds continued but there are still no visible cracks.
- At 600 kip the structure coat began to buckle at the top course and horizontal deflection is up to about 0.5 in.
- At 630 kip failure occurred. The top two courses crushed leaving the rest of the wall almost completely intact.

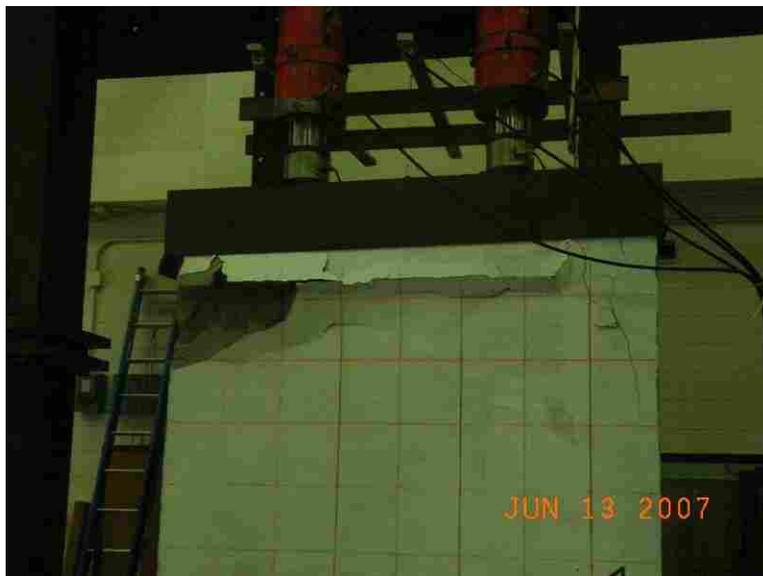
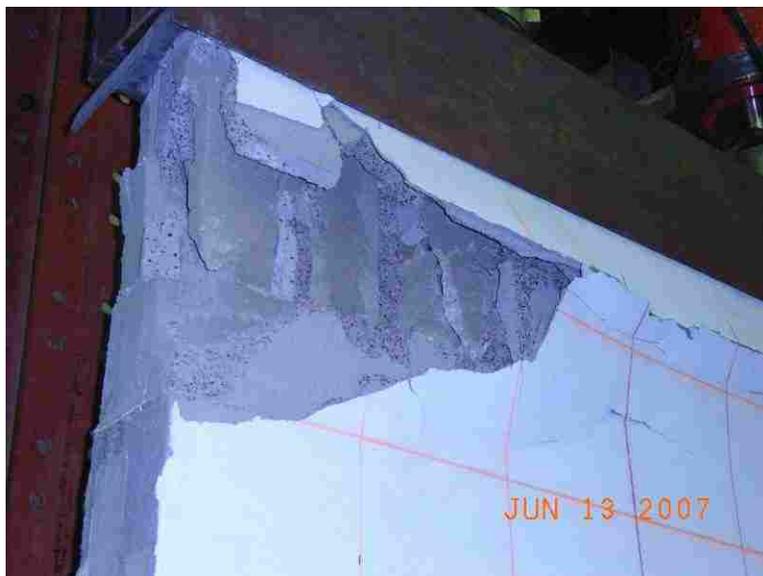
Failure (wall #1)

Close-up of Failed Section (wall #1)

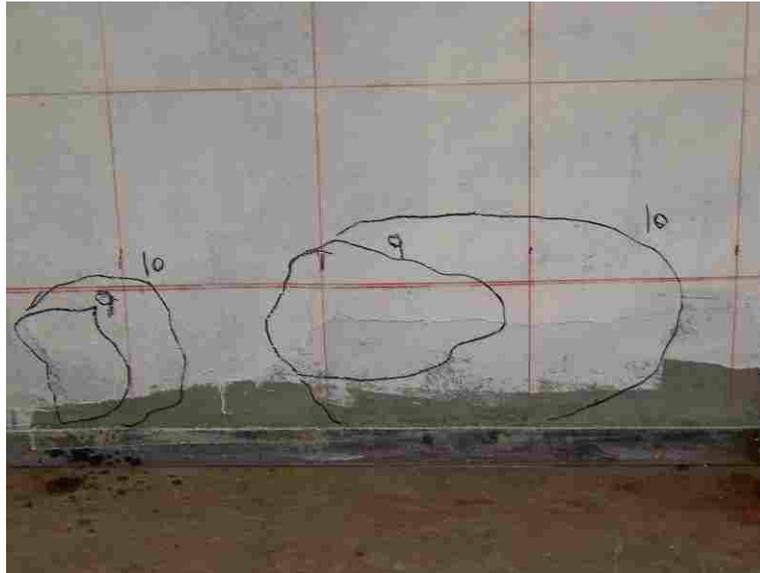
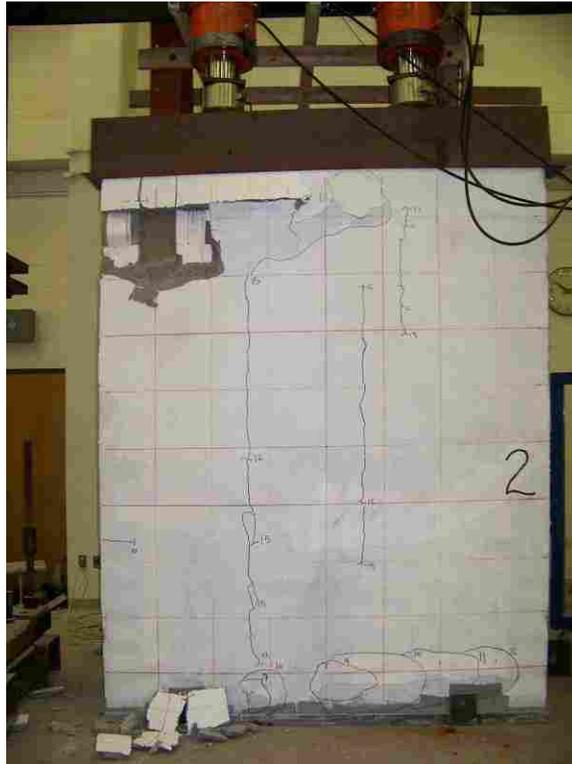
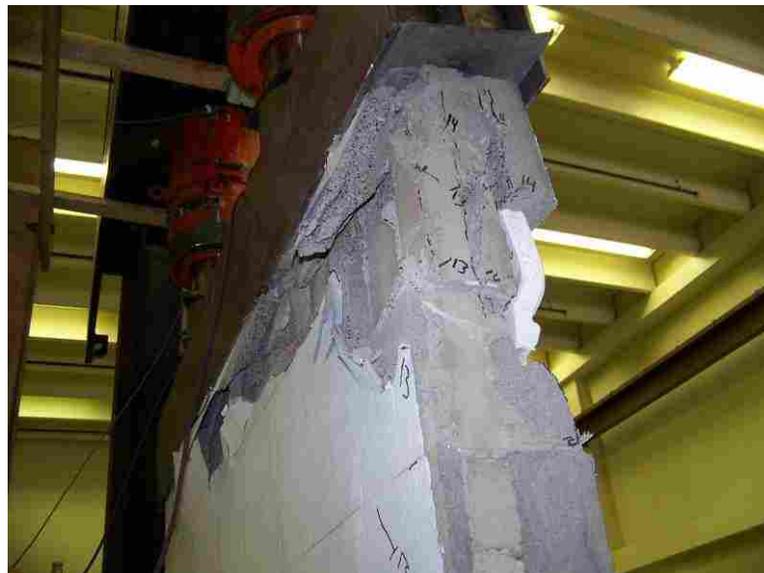
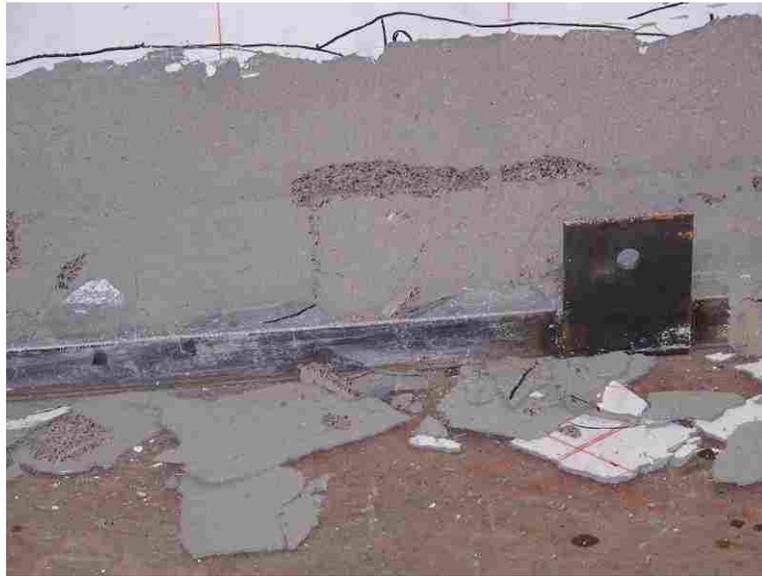
- At 250 kip small cracks develop at top course possibly due to a high spot in wall.
- At 350 kip the structure coat at the bottom of the wall buckled. Small vertical cracks began to develop at the middle to top of the wall approximately 2-3' long.
- At 400 kip the structure coat continued to buckle and separate from the block. Vertical cracks continue to propagate.
- At 550 kip long vertical cracks on interior and exterior sides developed. The structure coat continued to buckle at the top and bottom of the wall. A horizontal crack developed between the top two courses.
- At 600 kip the top of the wall began to crush and crumble. More small cracks developed throughout the wall.
- At 650 kip failure occurred. The top two to three courses crushed. The failure occurred almost entirely on the east end of the wall. The bottom course was also extensively cracked.

Buckling of Structure Coat (wall #2)

Failure (wall #2)

Close-up View of Failed Section (wall #2)

Separation of Structure Coat at Failure (wall #2)

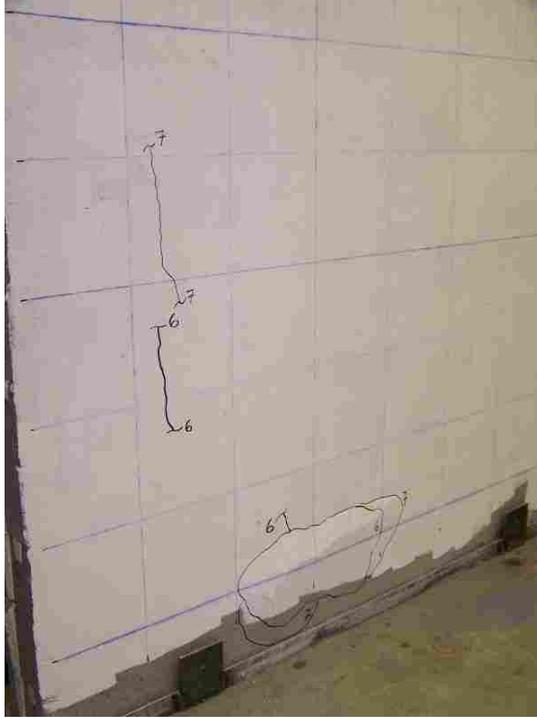
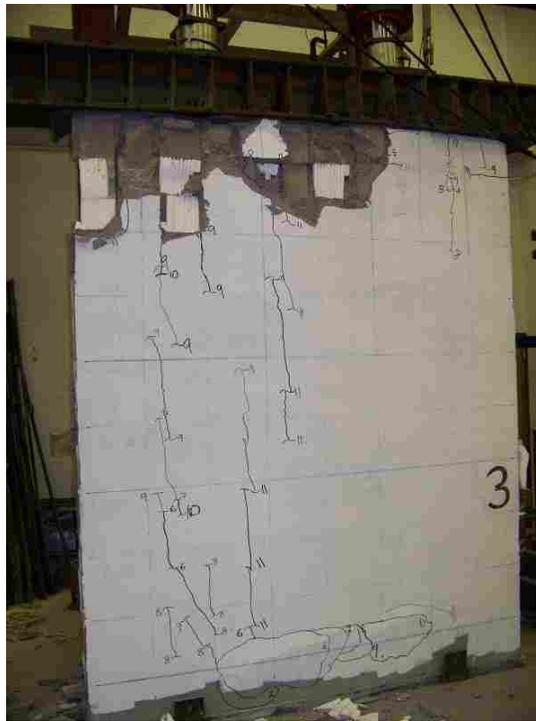
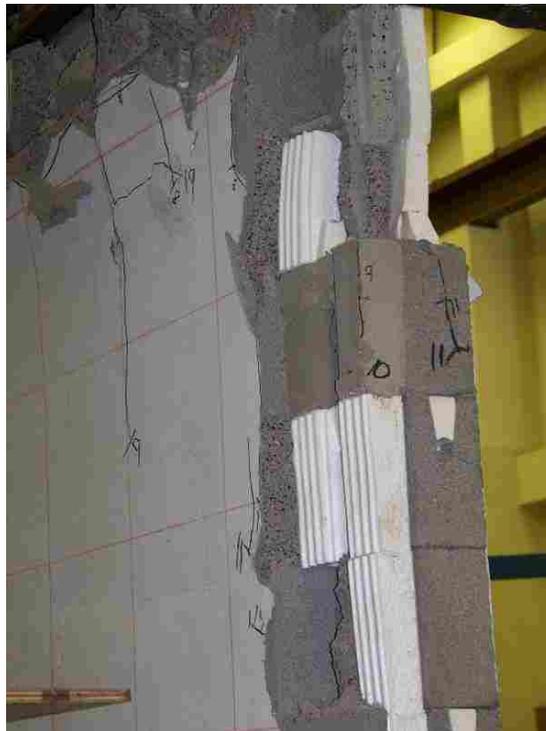
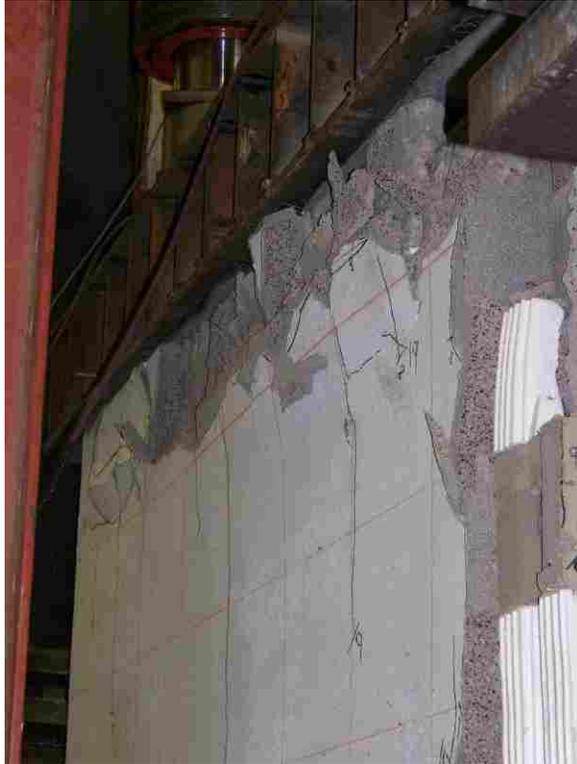
- At just below 400 kip there was extensive cracking at both the top and bottom of the wall. There was severe buckling of the structure coat as the wall began to fail. There was extensive cracking, mostly vertical, throughout the wall at failure.

Buckling of Structure Coat at Bottom of Wall (wall #3)

Failure (wall #3)

Close-up View of Failed Section (wall #3)

Top Course Crushing (wall #3)

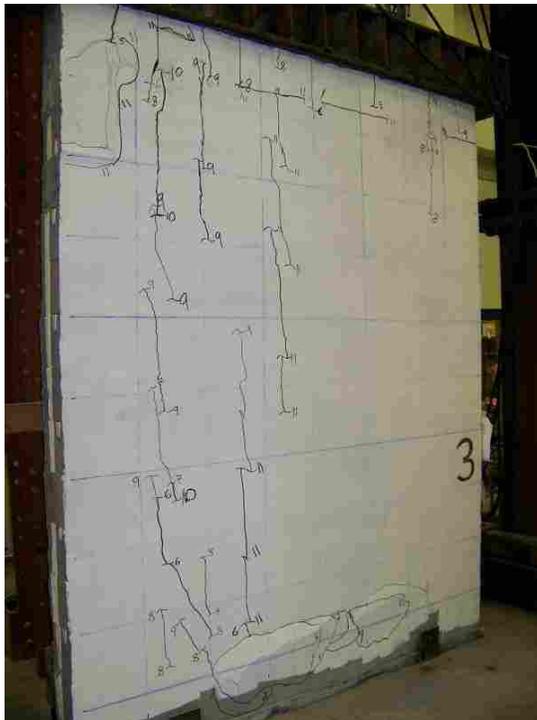
During Testing (wall #3)

As wall #3 was loaded to failure vertical cracking started to develop at approximately 16" o.c. suggesting that cracking was occurring between ungrouted blocks. Reinforcement, which was also placed at 16" o.c., may have played a role in this

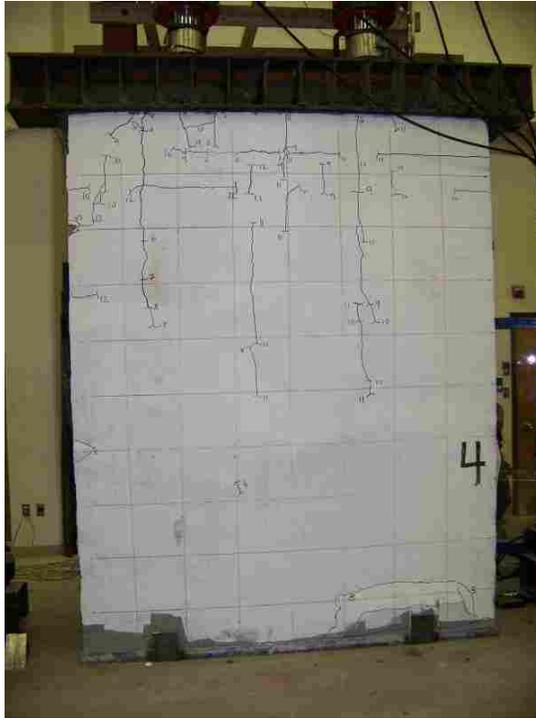
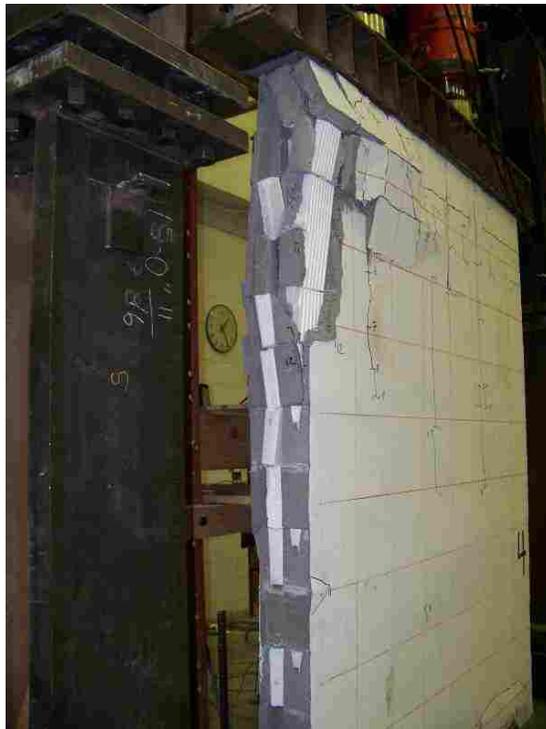
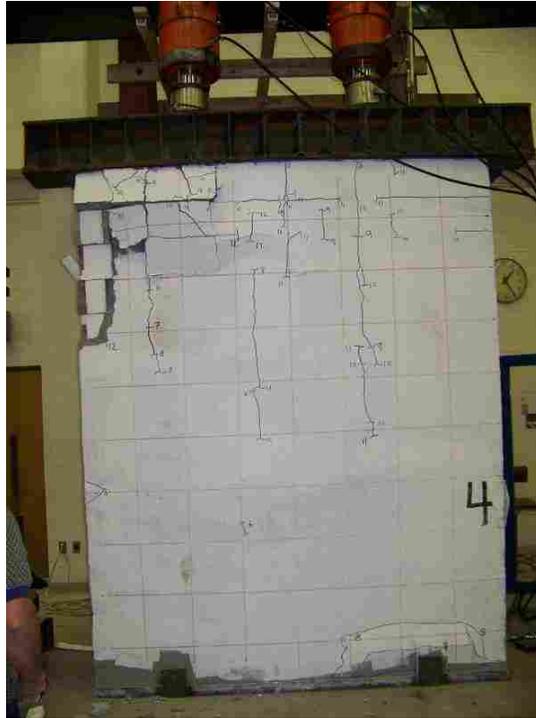
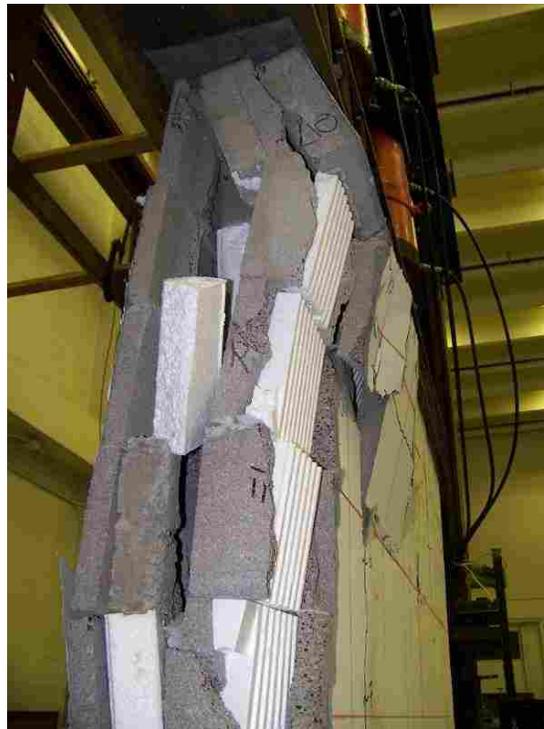
- At 150 kip the first small cracks at the top course developed.
- At 200 kip the small cracks continue to propagate down from the top of the wall.
- At 300 kip the structure coat at the bottom interior side of the wall buckled.
The vertical cracks continue to get longer.
- At 400 kip new long cracks developed on both sides of the wall in the center.
Some horizontal cracking began at the top of the wall. Several small vertical cracks became visible at the top of the side of the wall.
- At just before 450 kip failure occurred. Failure was fairly uniform across the length of the wall. Most of the cracking occurred at the top half of the wall.

During Testing (wall #4)

Side View at Failure (wall #4)

Failure (wall #4)

Close-up View of Failed Section (wall #4)
