Dry Stacked Surface Bonded Masonry - Structural Testing and Evaluation

DRY STACKED SURFACE BONDED MASONRY – STRUCTURAL
TESTING AND EVALUATION

Department of Civil and Environmental Engineering

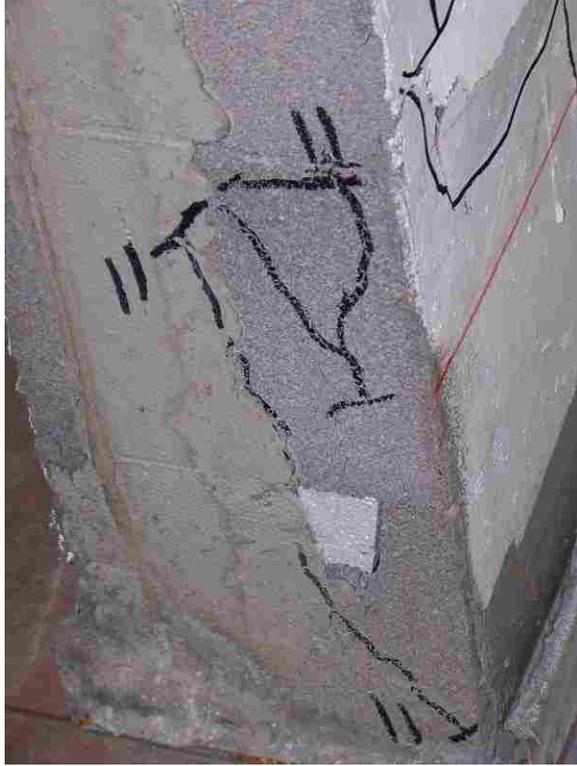
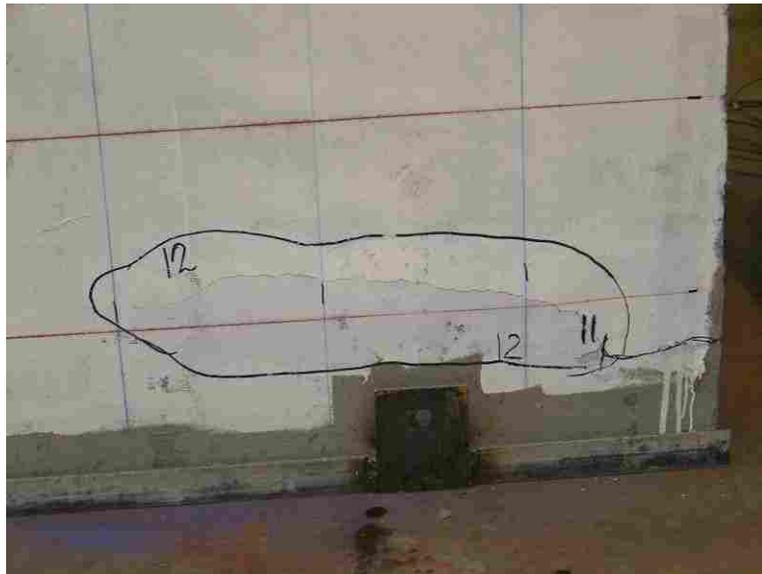
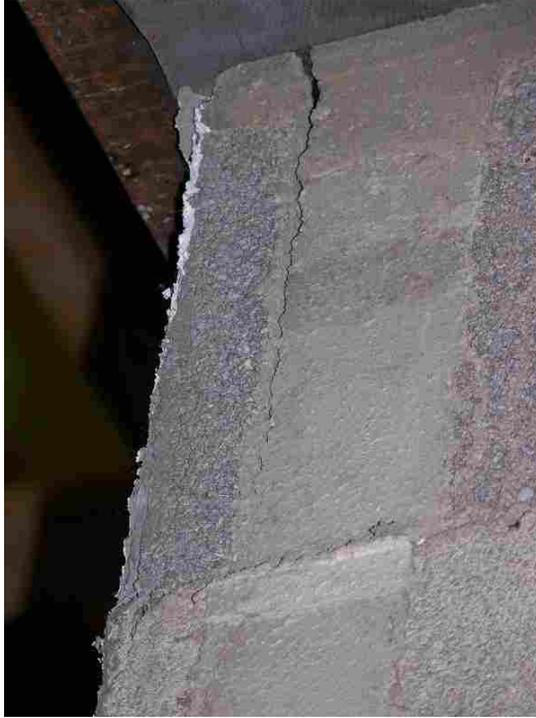
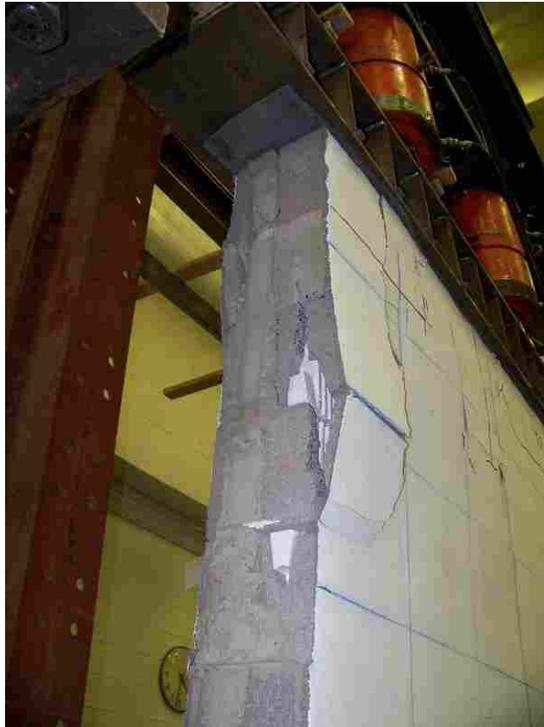
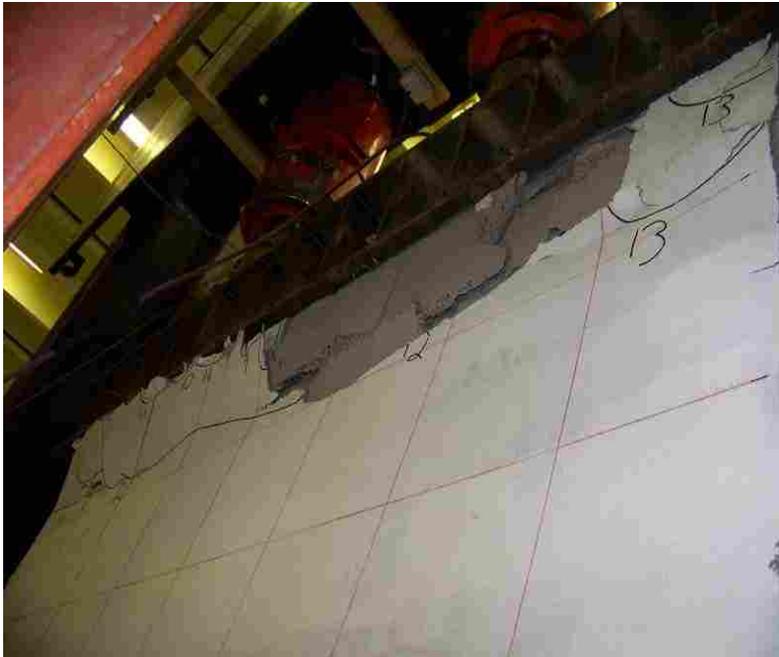
- At 150 kip the first small horizontal cracks became visible at the center.
- At 300 kip the structure coat on the interior face at the top of the wall buckled.
- At 350 kip small vertical cracks began to appear. Popping sounds could be heard but cracking was still minimal.
- At 450 kip a horizontal crack at the bottom course appeared. Horizontal cracks at the top courses also appeared. The structure coat at the top of the interior face began to buckle.
- At 500 kip the bubbling of the structure coat continued. Long vertical cracks appeared on both sides of the walls. Horizontal cracking continued to propagate.
- At 530 kip failure occurred. The top course of block was completely crushed. There was extensive cracking throughout the wall as well as continued buckling of the structure coat.

Cracking at Side of Wall (wall #5)

Buckling of Structure Coat (wall #5)

Failure (wall #5)

Failure at Top Course of Wall (wall #5)

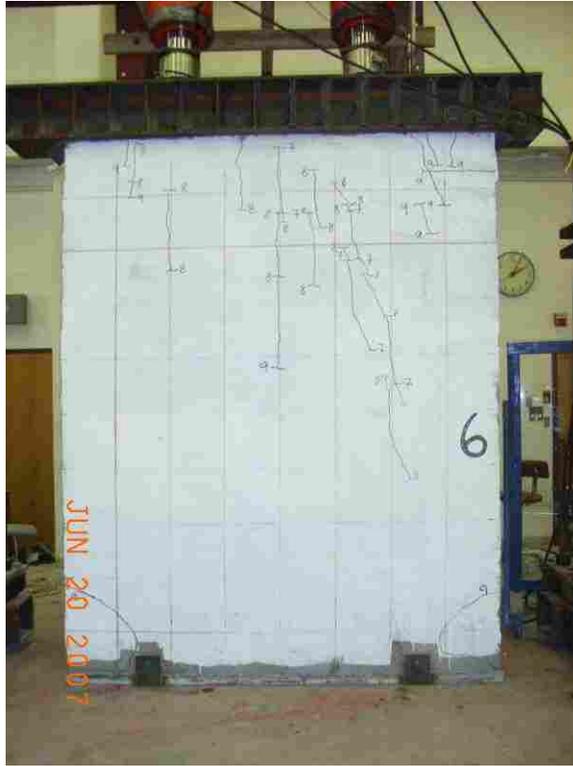
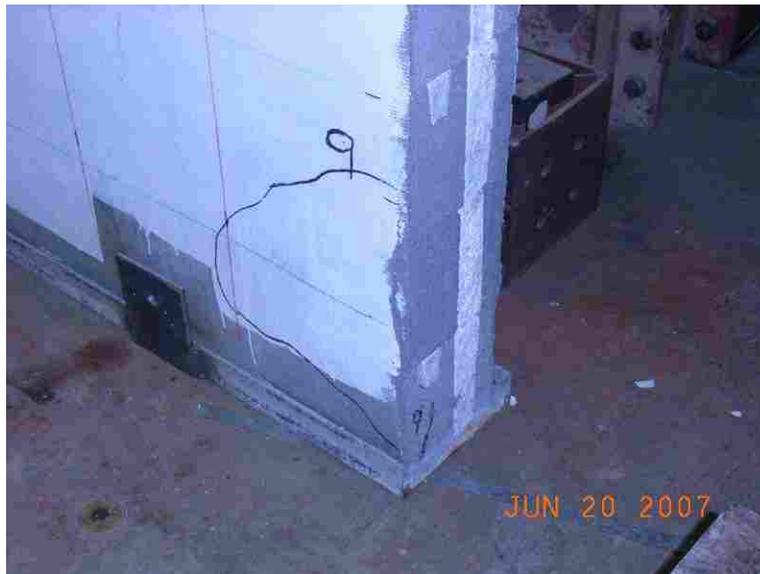
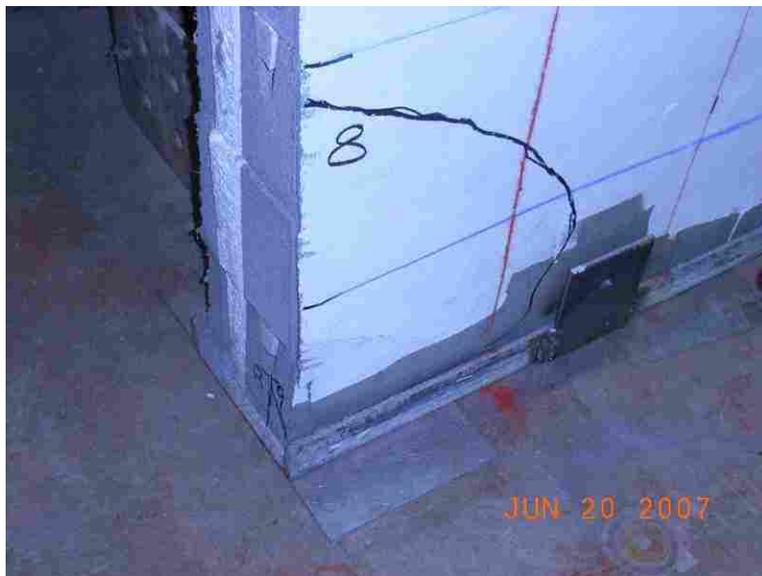
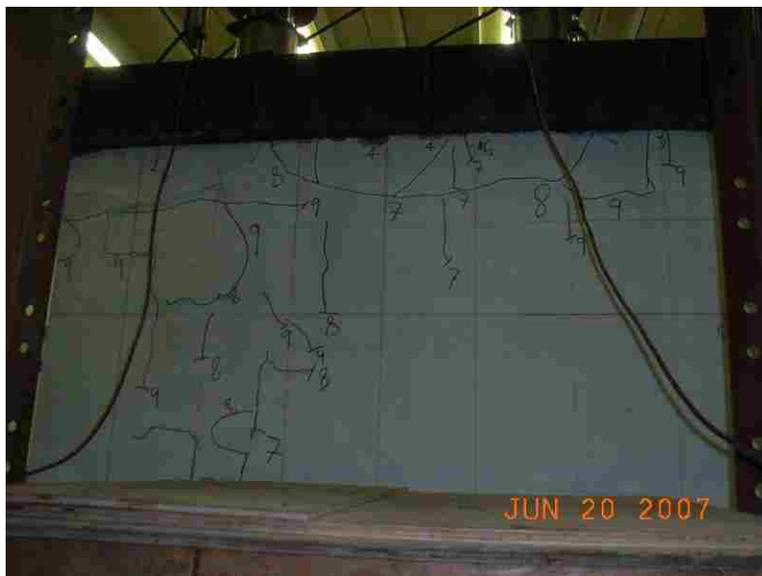
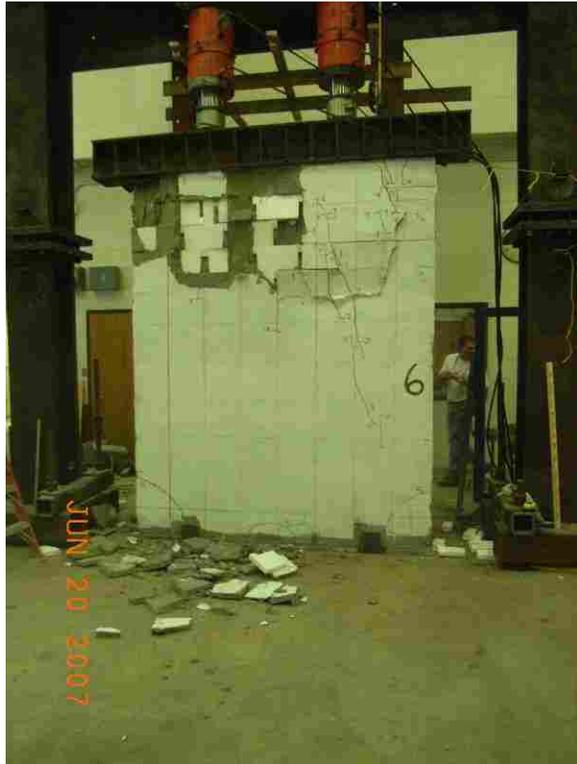
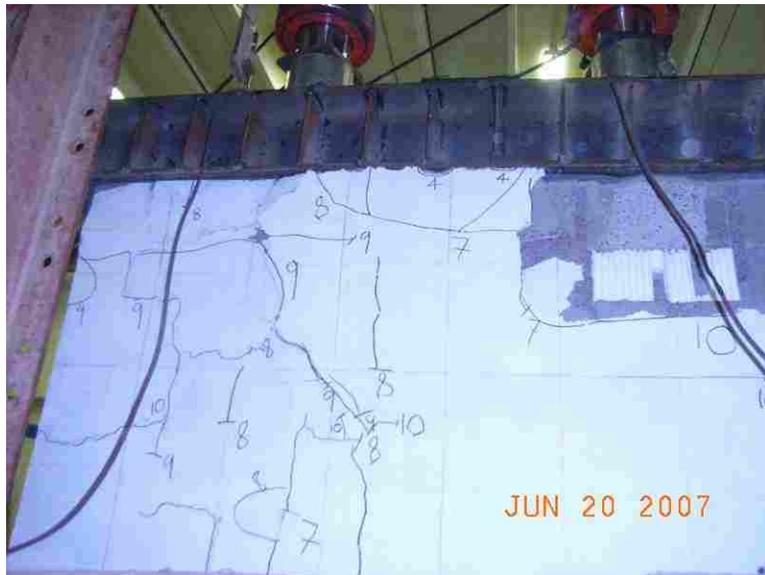
- At 300 kip a large bubble in the structure coat appeared at the interior lower east corner of the wall. More vertical cracking and some buckling of the structure coat also appeared at the top of the wall on the exterior side between the hydraulic jacks.

- At 350 kip existing cracks continue to propagate. Crushing and buckling occurred at the top west interior side of the wall. More buckling of the structure coat occurred. The bottom corner block at the west end of the wall has some damage.

During Testing (wall #6)

Damage at Lower West Corner (wall #6)

Damage at Lower East Corner (wall #6)

Exterior Side of Wall during Testing (wall #6)

Failure (wall #6)

Close-up of Failed Exterior Section (wall #6)

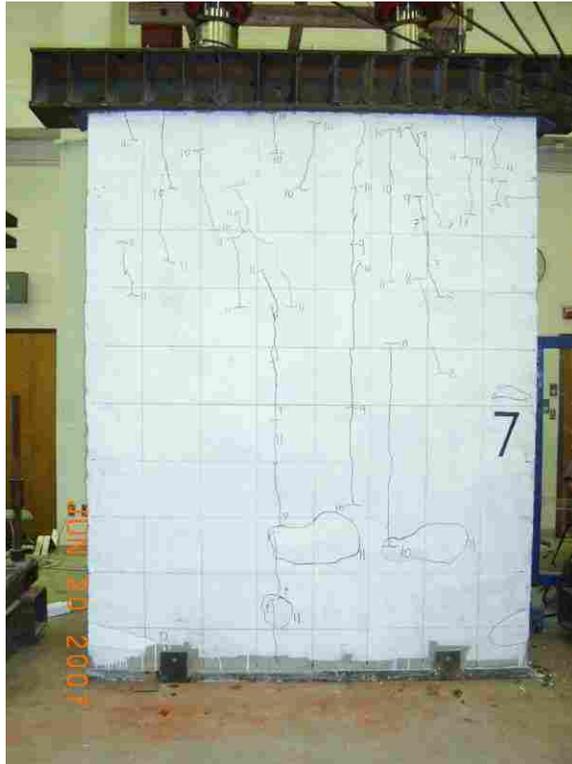
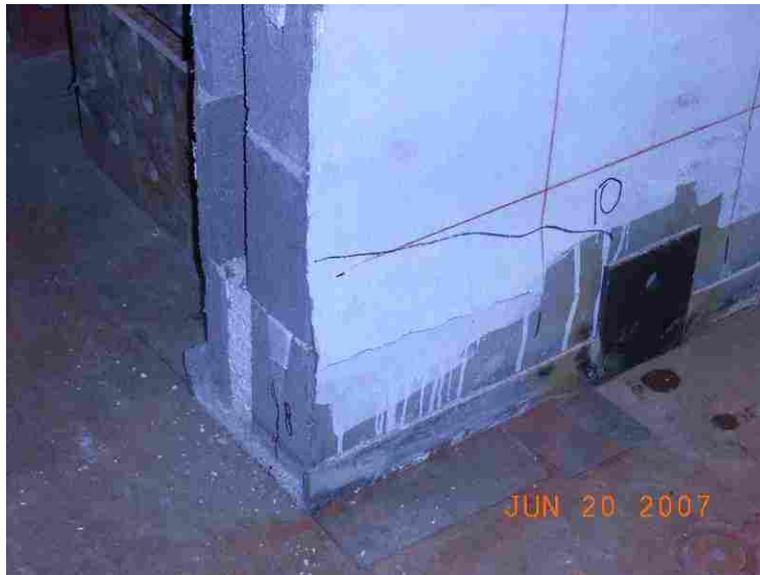
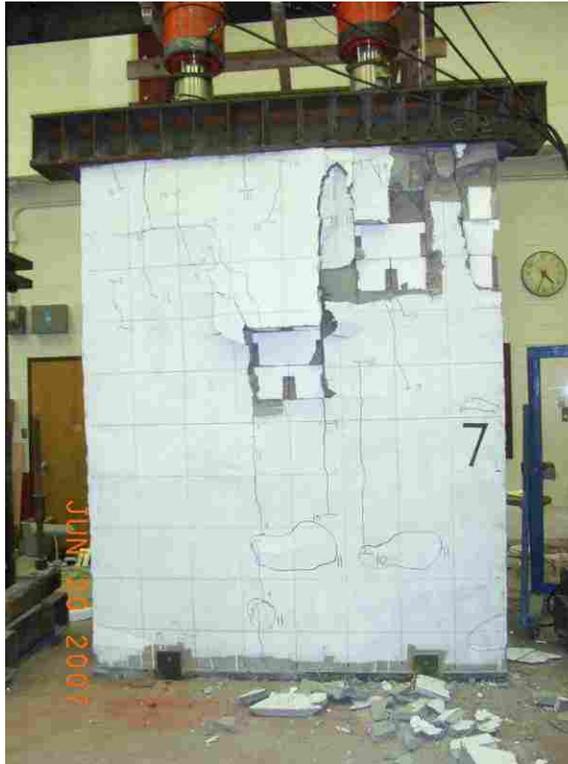
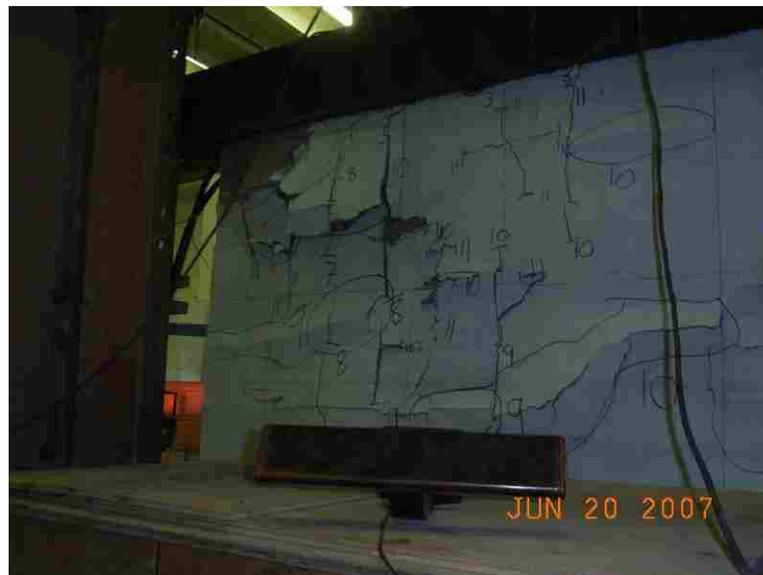
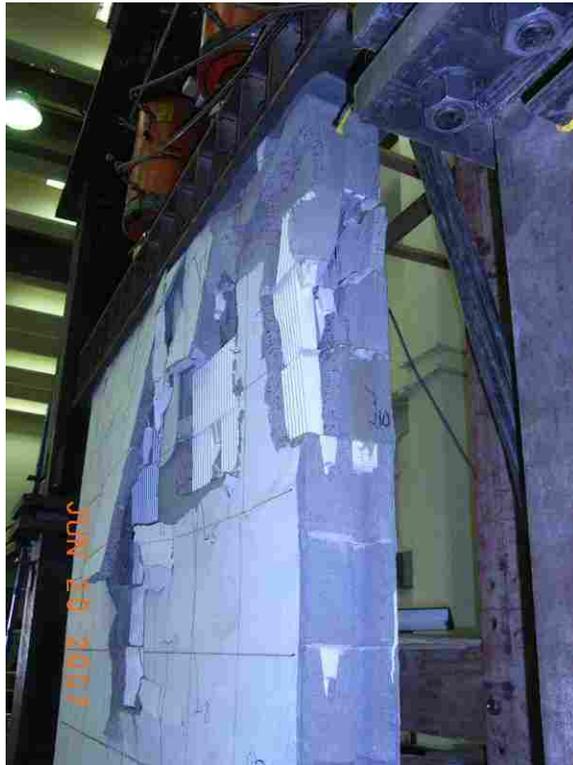
- At 60 kip some damage occurs at the top of the wall possibly due to a high spot in the wall.
- At 250 kip the first significant cracking develops. This cracking is vertical directly under the east hydraulic jack.
- At 300 kip more vertical cracking appeared. Existing crack continued to propagate and new vertical cracks appeared under the west hydraulic jack. There was also some minor buckling of the structure coat on the exterior side of the wall.
- At 350 kip more vertical cracking appeared mostly at the top half of the wall.
- At 400 kip the top half of the wall on both the interior and exterior sides has experienced severe and extensive cracking.
- At 410 kip failure occurred. The top west corner of the wall failed first however it appeared that the east side was also extensively damaged.

During Testing (wall #7)

Damage at East Corner Possibly Due to Low Spot in Floor (wall #7)

Failure (wall #7)

Failure at Exterior Side of Wall (wall #7)

Close-up of Failure at West Side of Wall (wall #7)

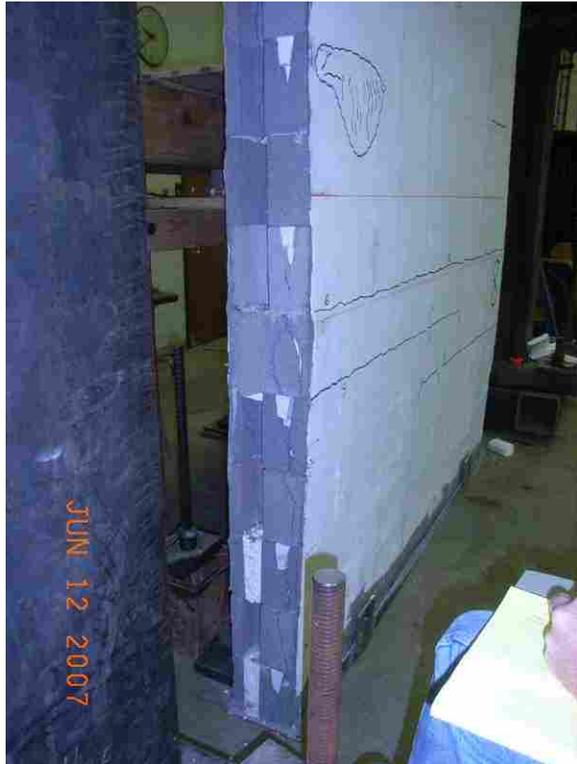
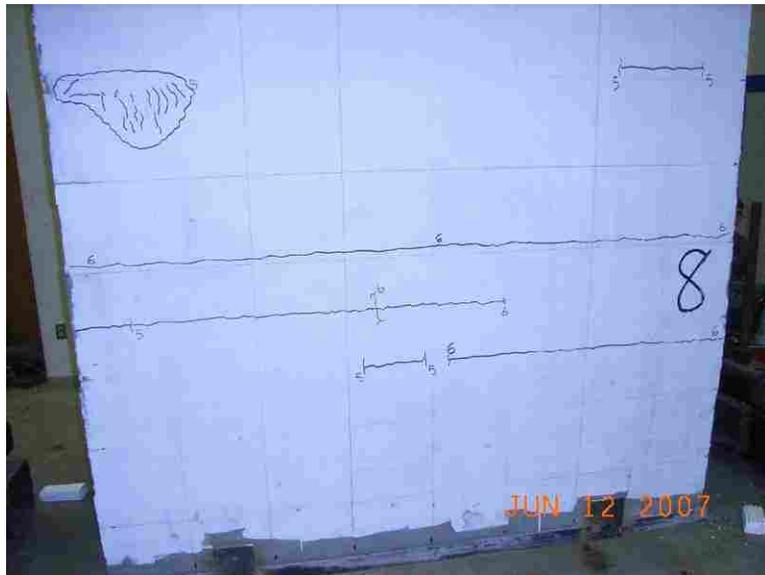
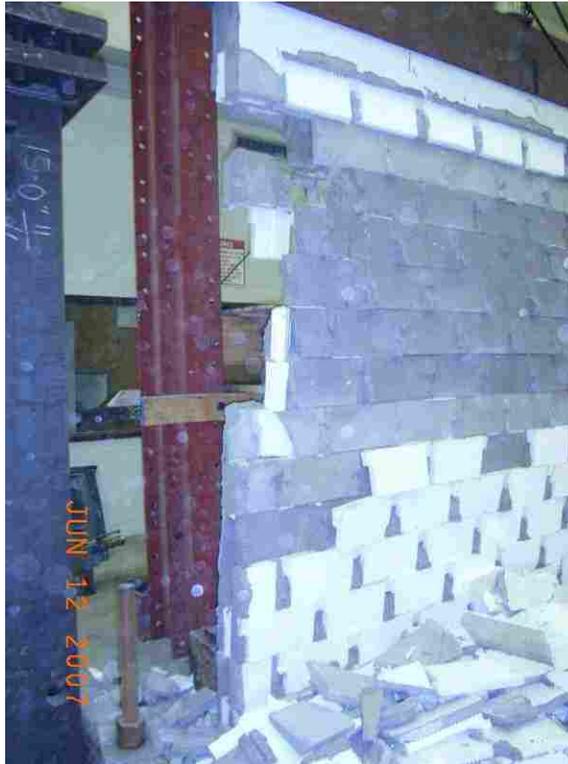
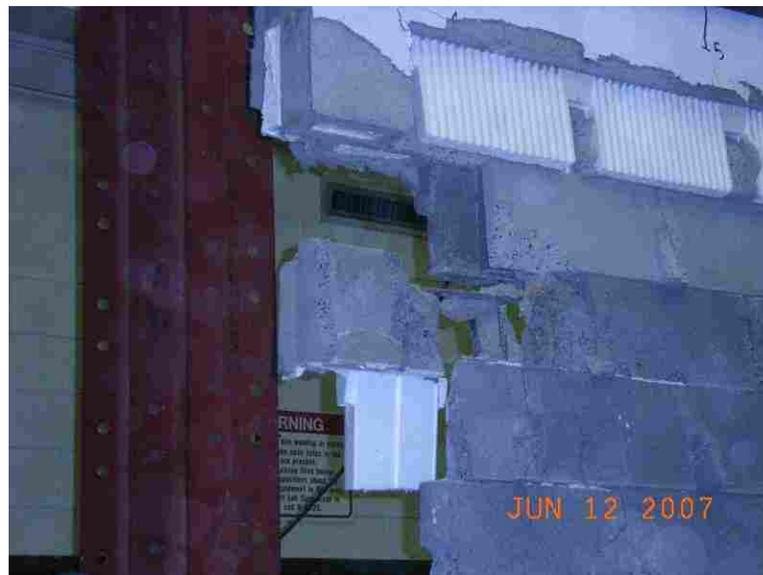
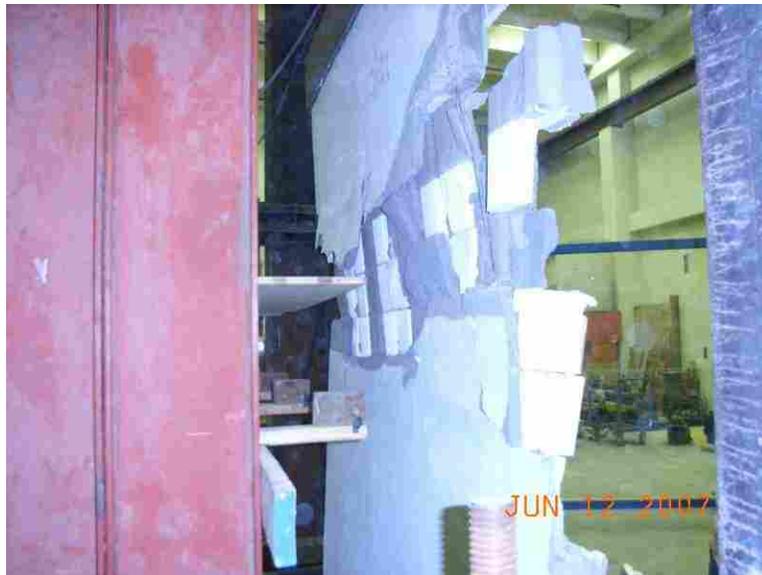
- At 100 kip the first cracking appeared. Cracking was horizontal at the interior face of the wall at approximately mid-height.
- At 150 kip there was more horizontal cracking at mid-height. At this load the cracking had extended the full width of the wall.
- Between 150 kip and 200 kip extensive cracking developed in the sides of the walls, this was a precursor to the failure mechanism.
- At 240 kip catastrophic failure occurred. Failure was very sudden. The interior face of the blocks completely fell off onto the floor. Some buckling of the wall could be seen. The wall bowed out toward the interior face of the wall.

Cracking in the Sides of the Wall (wall #8)

Horizontal Cracking (wall #8)

Failure (wall #8)

Close-up of East end of Wall at Failure (wall #8)

Buckling of Wall at Failure (wall #8)

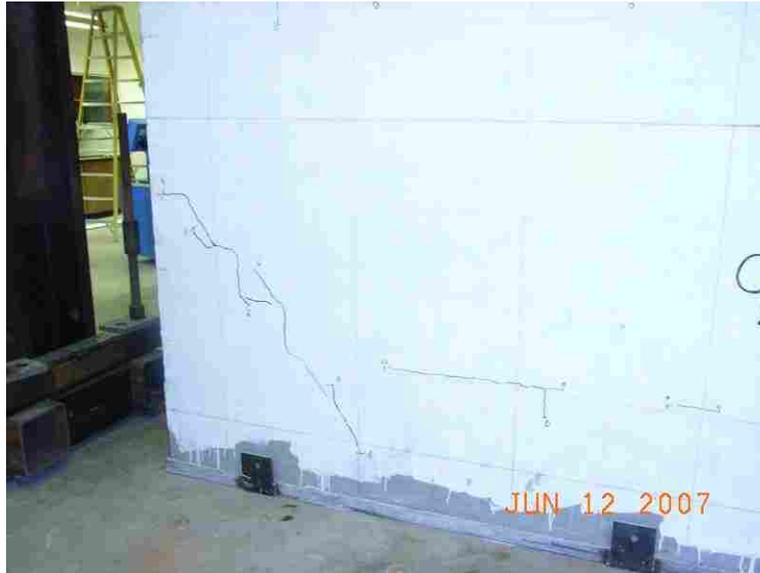
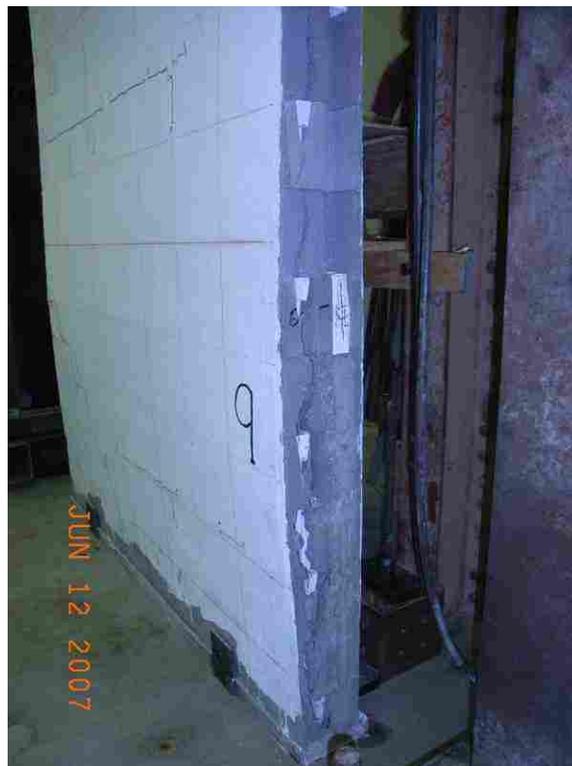
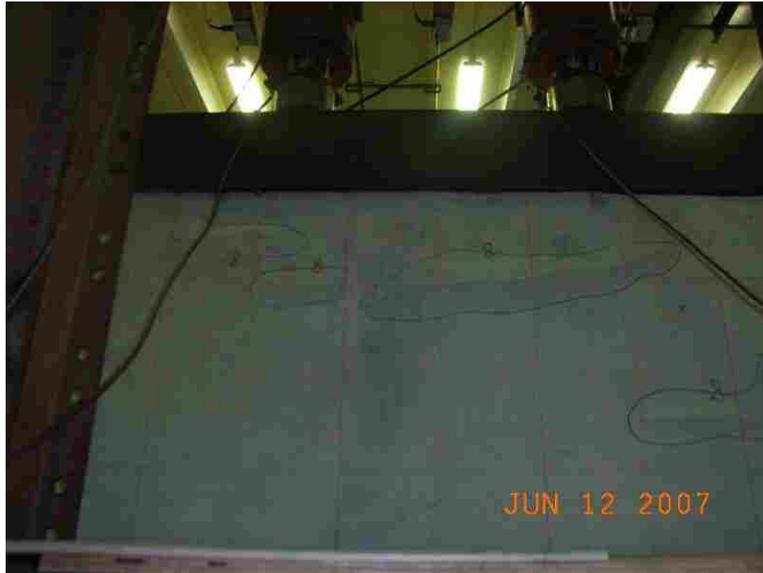
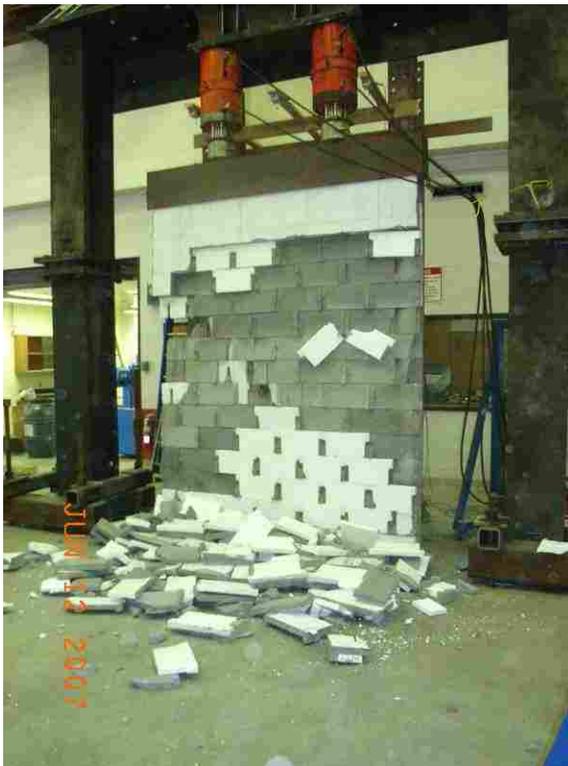
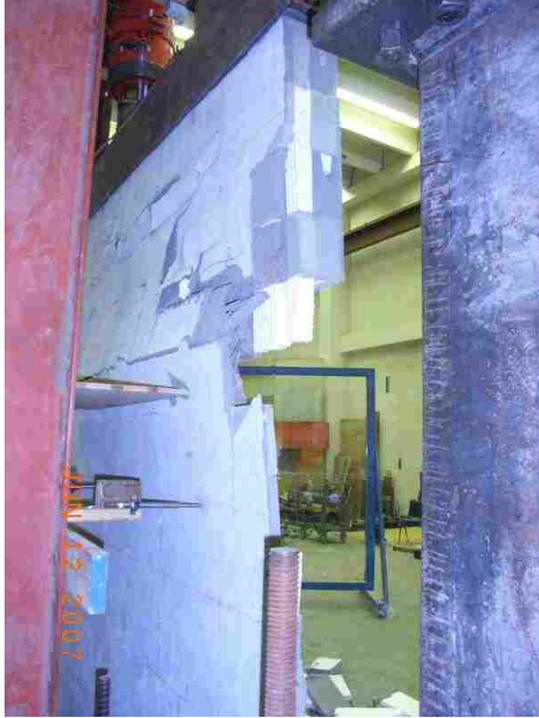
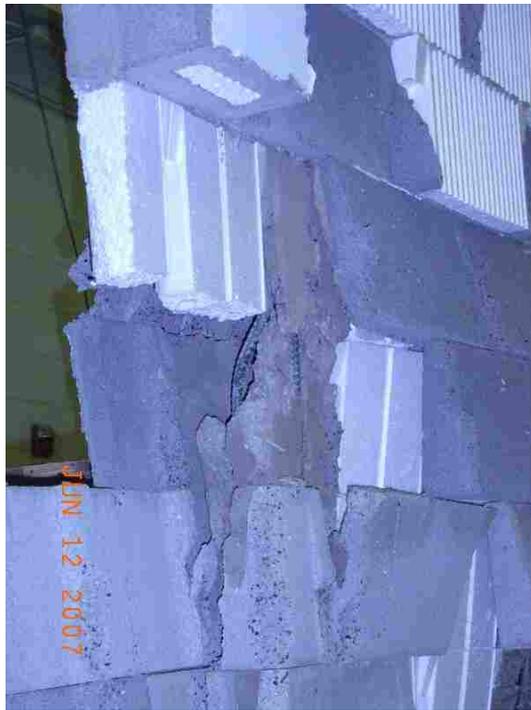
- At 100 kip the first small crack appeared. This crack was a short vertical crack at the bottom west side of the wall.
- At 150 kip some diagonal cracking appeared at the lower east side of the interior face of the wall.
- At 200 kip horizontal cracking developed at the first bond beam level of the wall at the interior face. There was also some buckling of the structure coat at the top section of the exterior face of the wall. There were large vertical cracks in the sides of the wall.
- At 230 kip catastrophic failure occurred. The interior face of almost all of the blocks fell to the floor. The failure was very sudden.

Diagonal Cracking at East Side of Wall (wall #9)

Vertical Cracking in Sides of Wall (wall #9)

Bubbling of Structure Coat (wall #9)

Failure (wall #9)

Buckling of Wall at Failure (wall #9)

Rebar Buckling at Failure (wall #9)

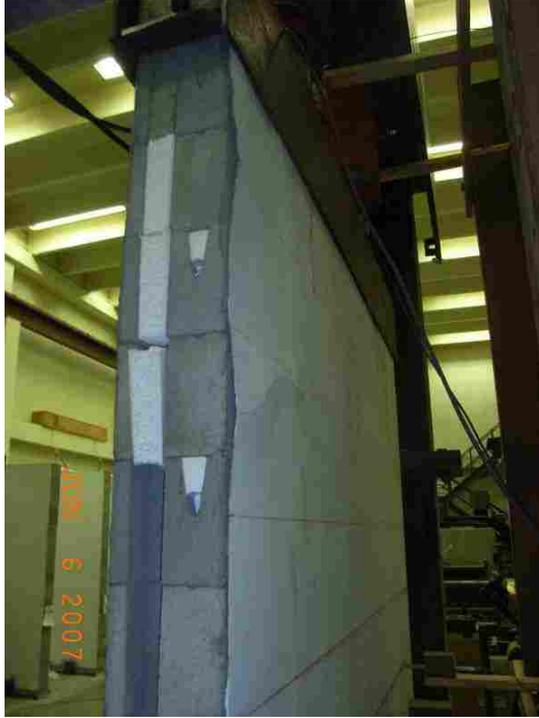
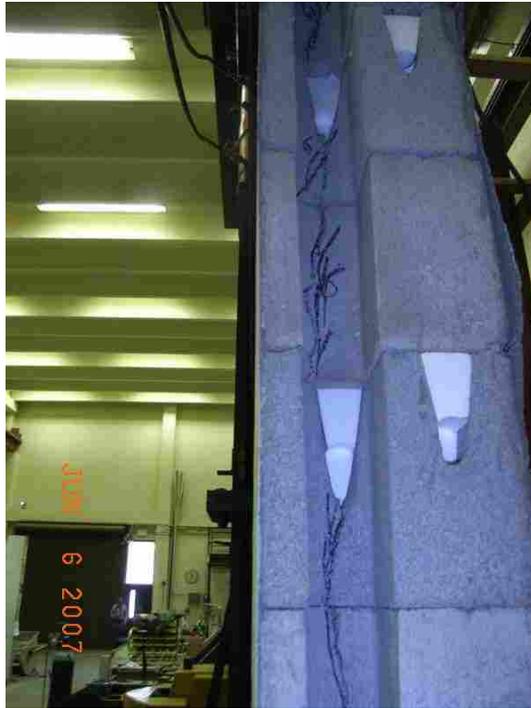
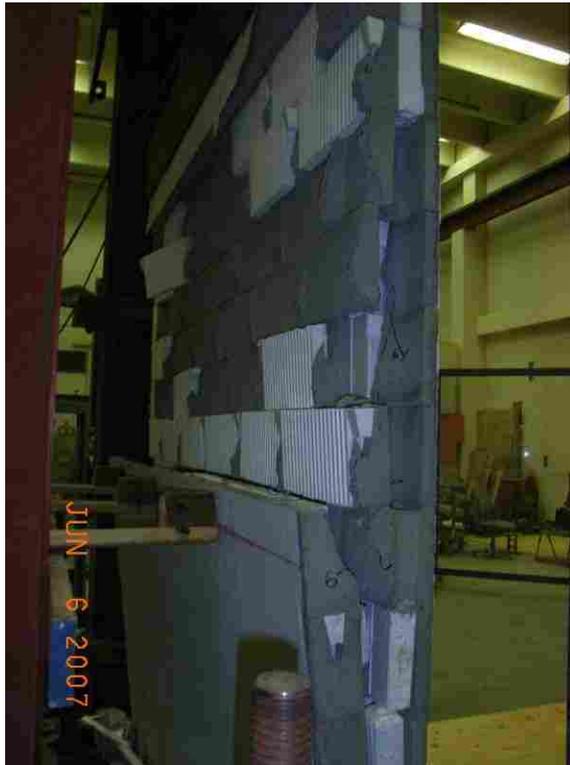
- At 80 kip some small vertical cracks appeared at the top of the wall just below the hydraulic jacks.
- At 100 kip the structure coat began to bubble at the upper west portion of the interior face of the wall. There was also some bubbling of the structure coat at the low middle portion of the exterior face of the wall.
- At 150 kip more cracking appeared on both sides of the upper portion of the wall. Vertical cracks in the sides of the wall also appeared.
- At 200 kip failure occurred. The interior face of the blocks sheared away from the remainder of the wall. The lower half of the wall buckled out against the LVDTs which were set up to record horizontal deflection. The failure was sudden.

Bubbling of Structure Coat (wall #10)

Vertical Cracks in Sides of Wall (wall #10)

Failure (wall #10)
