Use of the Clegg Impact Soil Tester to Assess Rutting Susceptibility of Cement-Treated Base Material Under Early Trafficking

USE OF THE HEAVY CLEGG IMPACT SOIL TESTER
TO ASSESS RUTTING SUSCEPTIBILITY OF
CEMENT-TREATED BASE MATERIAL
UNDER EARLY TRAFFICKING

Master of Science

Department of Civil and Environmental Engineering

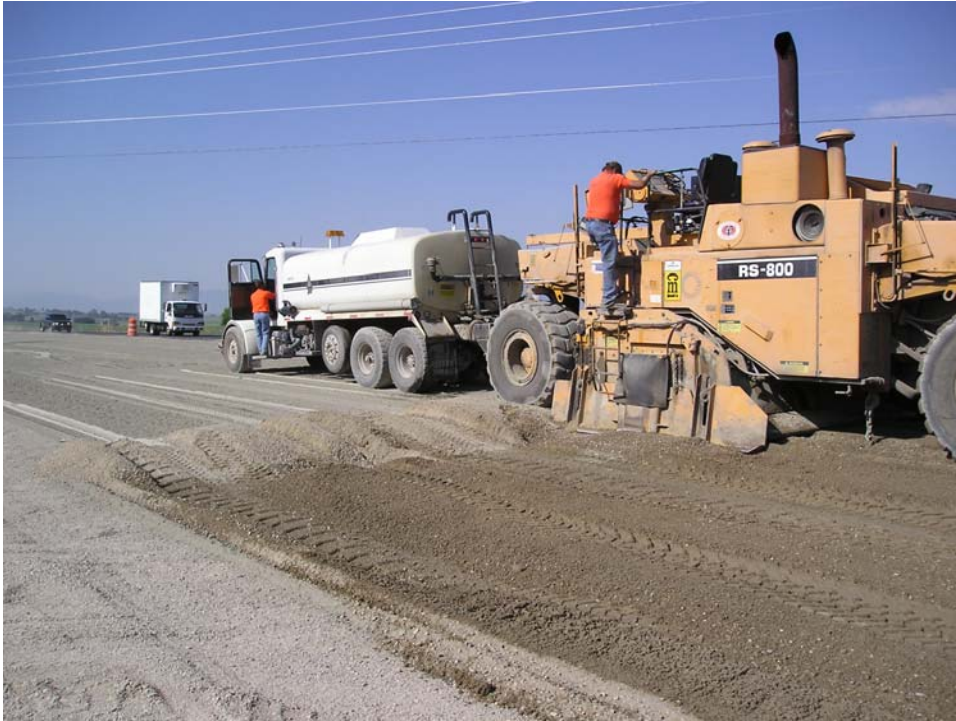
FIGURE 2.1 Reclaimer and water truck.

In the field, cement in powder or slurry form is spread directly onto the aggregate base layer. A single traverse-shaft rotary mixer, or reclaimer, is often used to mix the cement into the base material (7, 8). Water from a water truck working in tandem with the reclaimer can be added directly into the mixing chamber of the reclaimer when the in situ water content is lower than the OMC. Figure 2.1 shows a reclaimer and water truck in operation at one of the US-91 reconstruction sites included in this research.

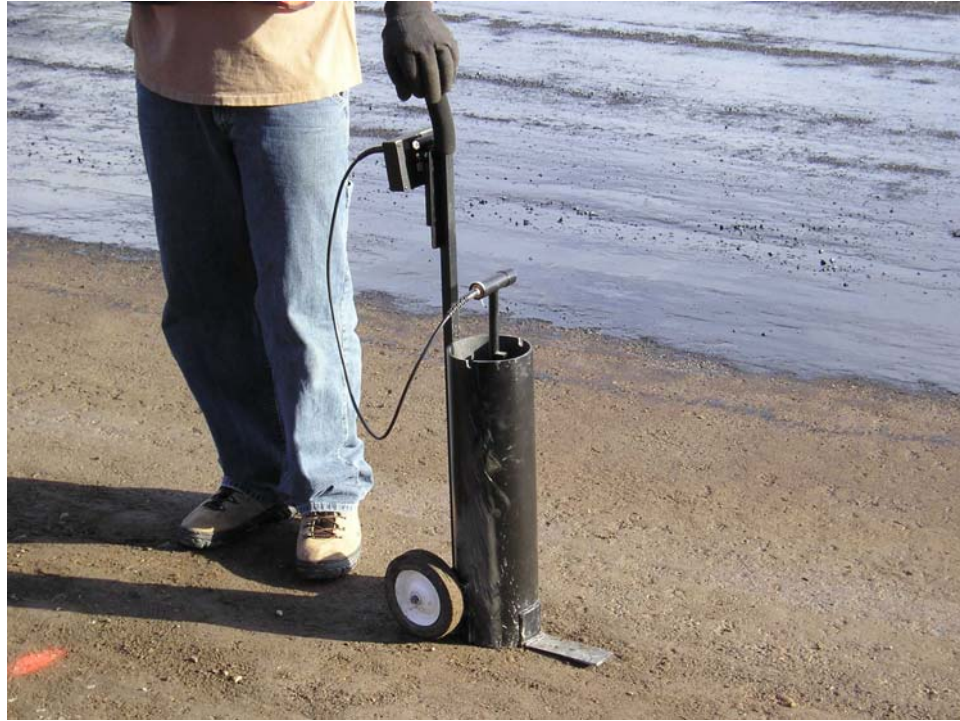
FIGURE 2.2 CIST on CTB.

CISTs are available in three primary configurations: the standard CIST, the light CIST, and the heavy CIST. The standard CIST was developed first and consists of a 10-lb weight that falls a distance of 18 in (13, 14). The light CIST is available in two versions consisting of either a 2.5-lb or a 5.0-lb weight that falls a distance of 12 in. The heavy CIST, which is the focus of this research, is comprised of a 44-lb drop weight that falls a distance of 12 in. Due to its higher weight, the heavy CIST is recommended for evaluating compacted aggregate base and subgrade materials (13, 14). The depth of interrogation may be estimated to be about two times the diameter of the drop weight, or about 12 in. for this hammer (2, 11). The heavy CIST is shown in Figure 2.2.

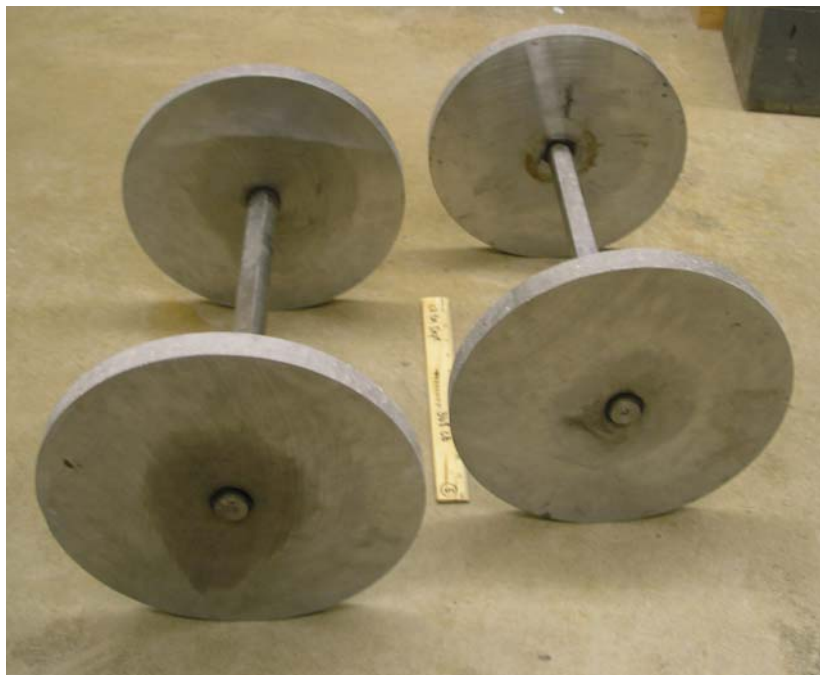
FIGURE 3.1 HWRDs.

The HWRD weighs approximately 60 lbs without any weights placed on the axle. However, during use, a set of four 35-lb soil consolidometer weights are hung from the axle to produce a total load of 200 pounds; this configuration is depicted in Figure 3.2. Assuming the footprint of each of the HWRD wheels is approximately 1 in.² when placed on a CTB surface, the pressure imparted to the CTB is approximately 100 psi, equal to the contact pressure associated with an ESAL. The HWRD creates depressions in the CTB as it is manually rolled over the CTB surface in a series of successive passes. For example, the lower portion of Figure 3.2 shows the shallow ruts created by the HWRD at that test location.

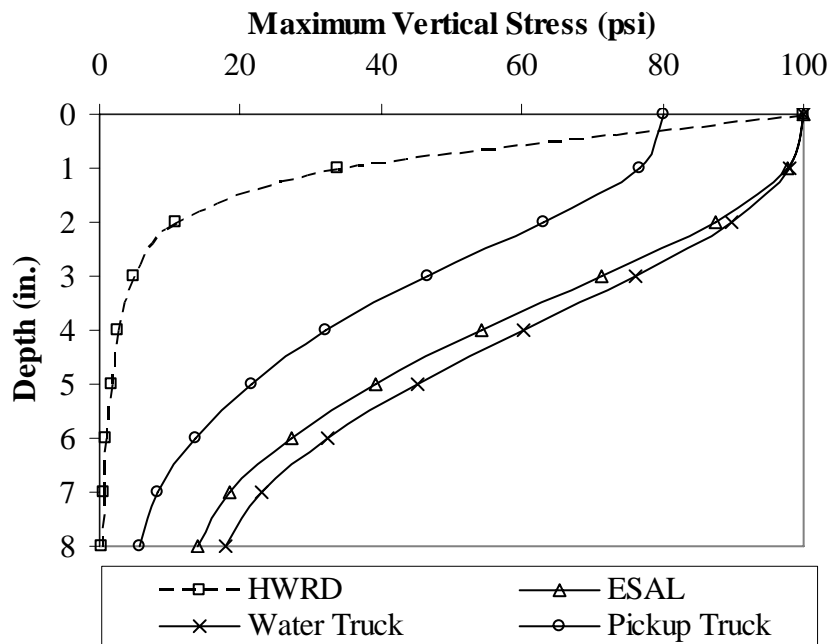
FIGURE 3.3 Vertical stress profiles in CTB.

displays the vertical stress profiles associated with the HWRD and an ESAL. The stress profiles were computed using KENLAYER software and assuming a modulus and Poisson's ratio of 200 ksi and 0.15, respectively, for the CTB (29). In previous research conducted on US-91, this level of stiffness was achieved by the CTB after 2 or 3 days of curing and is equivalent to a CIV of approximately 25 (2). Because of their relevance to this research, the vertical stress profiles for a water truck and a standard pickup truck are also shown in the figure. In this case, the wheel load and contact pressure were assumed to be 6,000 lbs and 100 psi, respectively, for the water truck and 2,000 lbs and 80 psi, respectively, for the pickup.

Although the vertical stress profiles displayed in Figure 3.3 show that the HWRD does not produce the same level of stress as typical heavy traffic loads, they do show that the vertical stresses induced by the HWRD are between those induced by an ESAL and a pickup truck within the upper 0.5 in. of CTB, where rutting is most likely to occur.

Because a single wheel of an ESAL carries a load of 4500 lbs compared to a load of 100 lbs carried by a single wheel of an HWRD, the distributions of vertical stress become increasingly different with increasing depth below the CTB surface. Figure 3.3

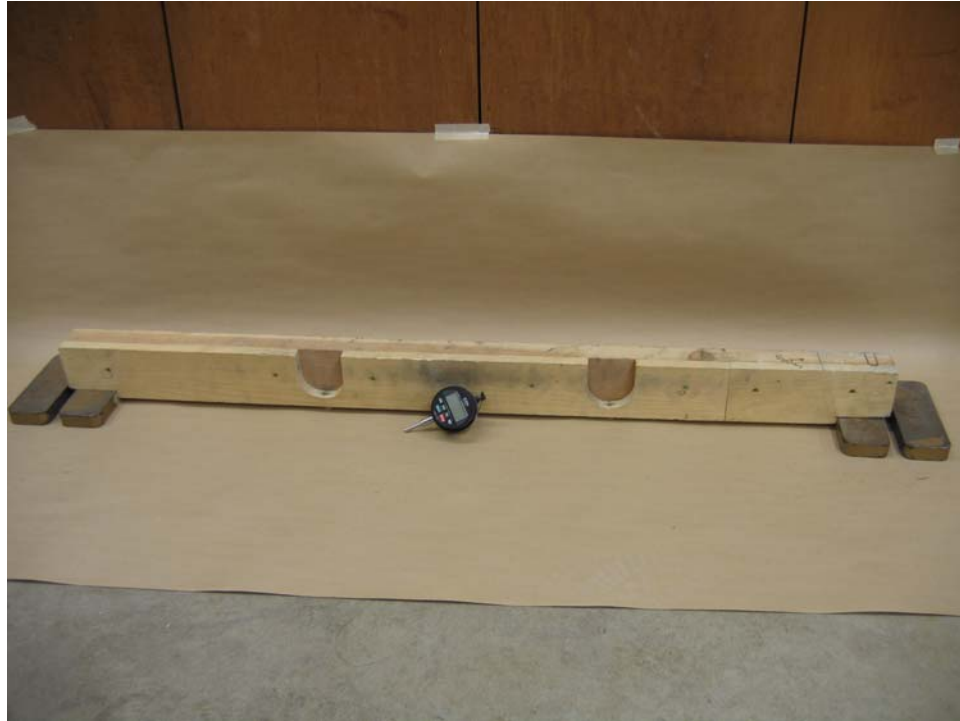
FIGURE 3.4 MBS components.

To facilitate consistent and precise measurements of rut depth, a special measuring board system (MBS) was constructed for this research. The MBS consists of a wooden beam about 4 ft in length with a cross-section having dimensions of approximately 4 in. by 4 in., metal support blocks for the ends of the beam, a micrometer having a resolution of 0.001 in., and approximately 0.5-in.-diameter metal disks for placement in the bottom of the rut to prevent penetration of the tip of the micrometer into the CTB during testing. The beam rests horizontally on the support blocks as shown in Figure 3.4, and the micrometer is mounted in the beam, in turn, at two locations corresponding to the locations of the ruts made by the HWRD wheels. The support blocks remain in their original positions during each test setup to ensure a constant datum, but the beam is removed to facilitate successive passes of the HWRD over the test site immediately between the blocks. When a measurement of rut depth is desired, the beam is returned to its place on the blocks, and the micrometer is used to measure the distance from its place in the beam to the top surface of each circular disk, as demonstrated in Figure 3.5. The disks are removed and replaced between sets of passes,

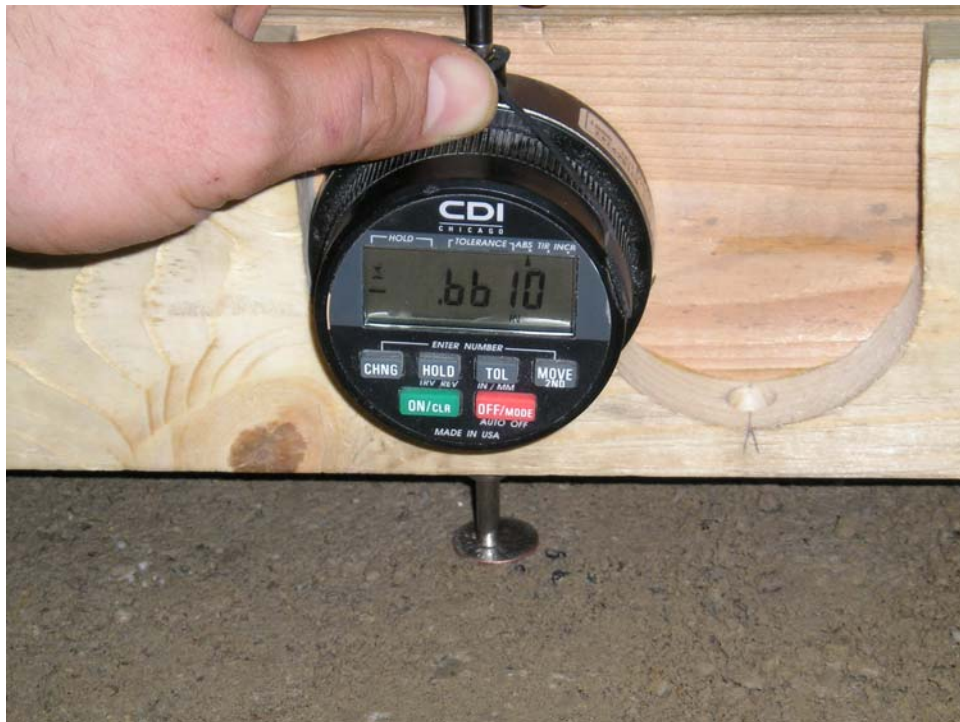
FIGURE 3.5 Micrometer with metal disk.

and actual rut depths are computed for each wheel path by subtracting the original micrometer reading from each successive micrometer reading.

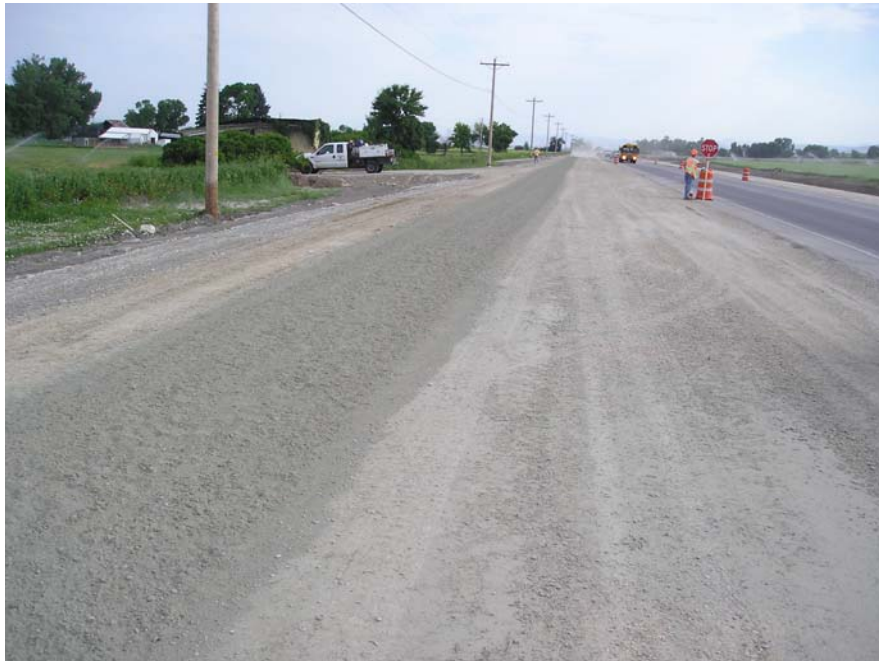
FIGURE 3.6 US-91 site picture.

Field testing was conducted at several sites along US-91 between the cities of Smithfield and Richmond in northern Utah during the summer of 2005. A photograph of a typical site is shown in Figure 3.6, and a map of the facility in this region is given in Figure 3.7. The weather at the test sites was mostly sunny during testing, with average daytime temperatures between 81°F and 89°F and relative humidity between 33 and 40 percent.

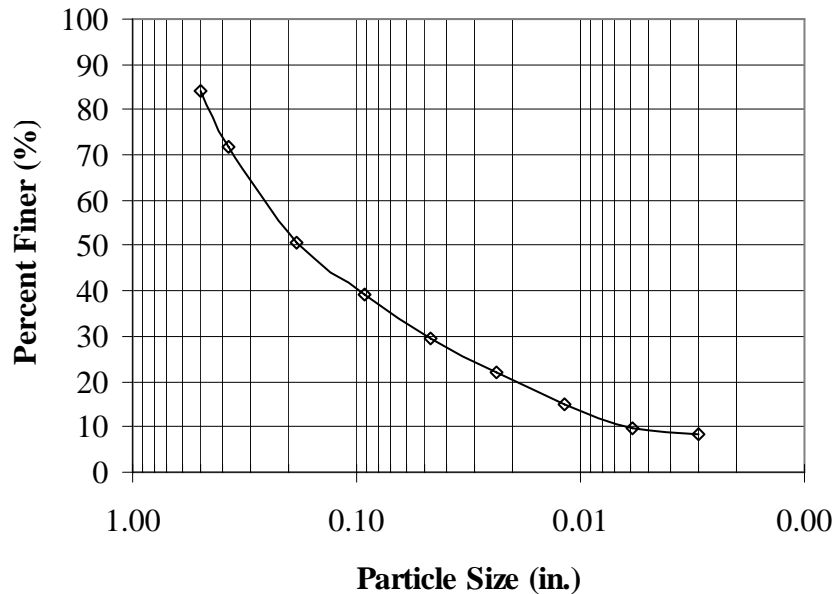
FIGURE 3.8 Particle-size distribution for limestone base material.

Once the excavation was completed, the rubblized concrete was bladed back onto the roadway, compacted on top of the newly exposed subgrade, and overlain with an 8-in. layer of comparatively high quality limestone base material. This material is classified as A-1-a according to American Association of State Highway and Transportation Officials M-145 (Standard Specification for Classification of Soils and Soil-Aggregate Mixtures for Highway Construction Purposes) and as SW-SM (well-graded sand with silt and gravel) according to ASTM D 2487 (Standard Classification of Soils for Engineering Purposes (Unified Soil Classification System)). The washed particle-size distribution for the limestone is given in Figure 3.8. Following initial

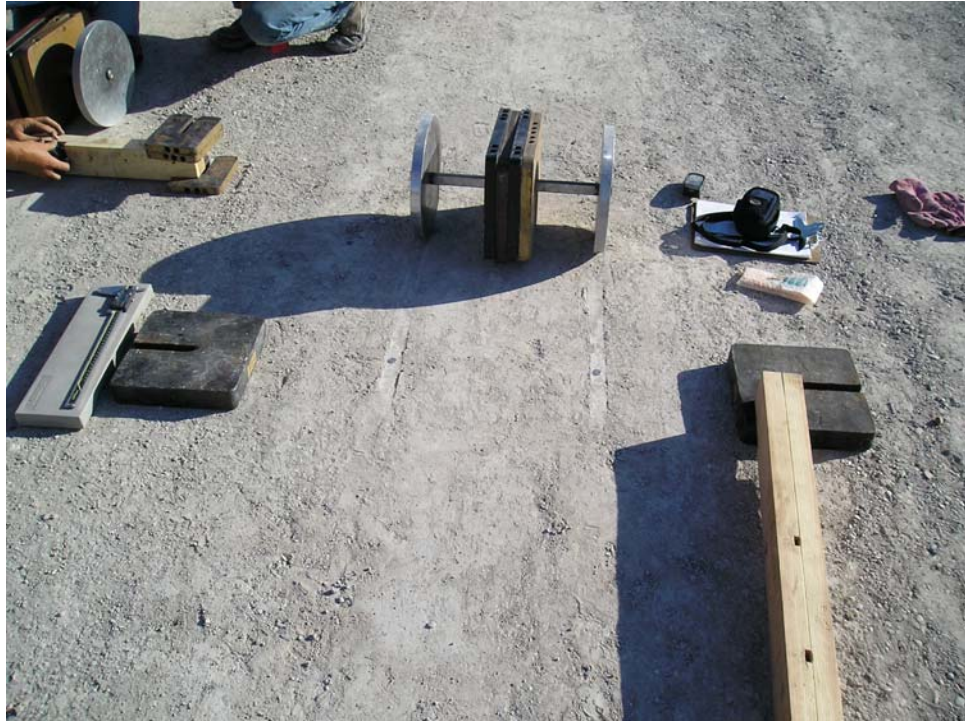
FIGURE 3.9 Layout of field test site.

In cooperation with the construction contractor, the researchers selected several CTB test sites, some freshly compacted and others having cured for a few days, to ensure that the testing would yield a full range of results. Sample CIVs were measured at potential sites to evaluate the suitability of each location prior to conducting rut testing. When a suitable location was identified, two teams of two persons each set up the testing equipment, including a HWRD with weights and an MBS, at each of two testing sites as depicted in Figure 3.9. The researchers were careful not to disturb intended test sites by avoiding walking on or rolling the HWRD or CIST over them during the process of unloading equipment.

To perform the testing, researchers situated the support blocks on either side of the intended test site and aligned the wooden beam along marks on the top surfaces of the blocks. The metal disks were placed directly beneath the micrometer mounting locations in the beam, and initial micrometer readings were recorded, with two replicate measurements taken in each wheel path. The loaded HWRD was then rolled up to the MBS so that the wheels were aligned with the micrometer mounting locations in the beam. With the HWRD properly situated, the beam was removed, and the HWRD was manually rolled over the surface in sets of 10 passes each. A pass consisted of one traverse of the wheels. One operator propelled the HWRD, while the other steadied the weights so that they did not drag on the ground. Both operators were careful to ensure that the wheels stayed in their designated paths throughout the rutting process.

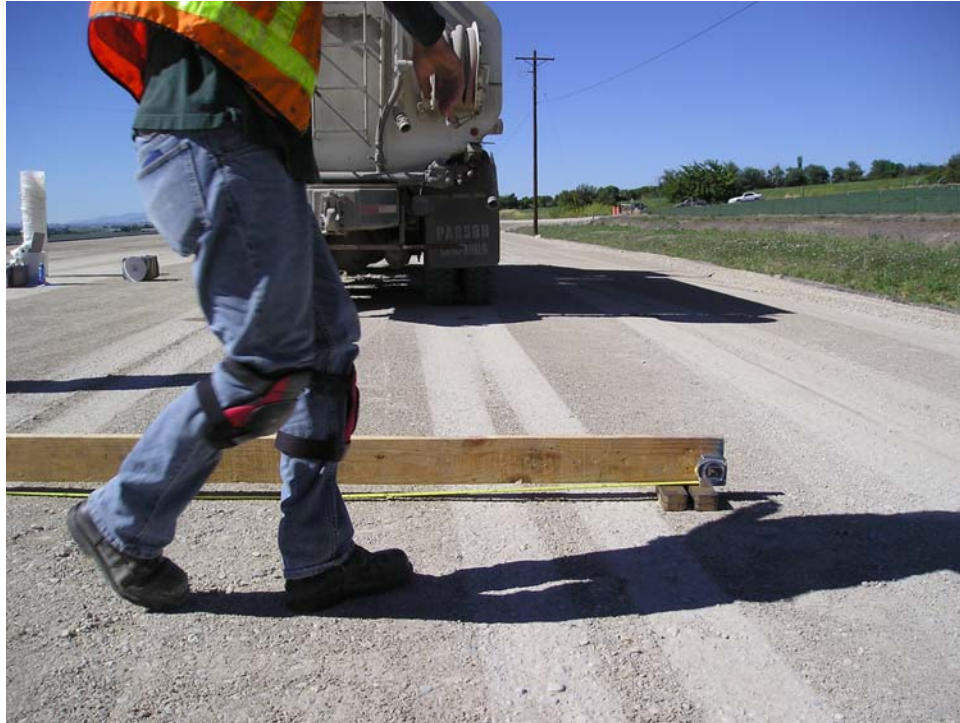
FIGURE 3.10 Water truck test setup.

In addition to testing using the HWRD, rut testing was also performed using both a water truck and a standard pickup truck. The water truck weighed approximately 60,000 lbs. The front axle of the truck was assumed to carry 12,000 lbs, while the remaining 48,000 lbs was assumed to be distributed over the tandem rear axles consisting of a total of eight wheels. The pickup truck had four wheels and weighed approximately 7,000 lbs, with the front axle carrying nearly 4,000 lbs. The testing procedure for these vehicles was similar to that developed for the HWRD. Because both vehicles were wider than the length of the MBS, however, a longer wooden beam was utilized instead. After the initial micrometer readings were recorded at each site, the operators drove the trucks back and forth until 10 passes were completed. Due to limited availability of contractor assistance for this task, rut depths resulting from more than 10 passes of the trucks were not evaluated. Figures 3.10 and 3.11 depict the water truck and pickup truck setups, respectively. The longer MBS utilized in each case is displayed in the figures.

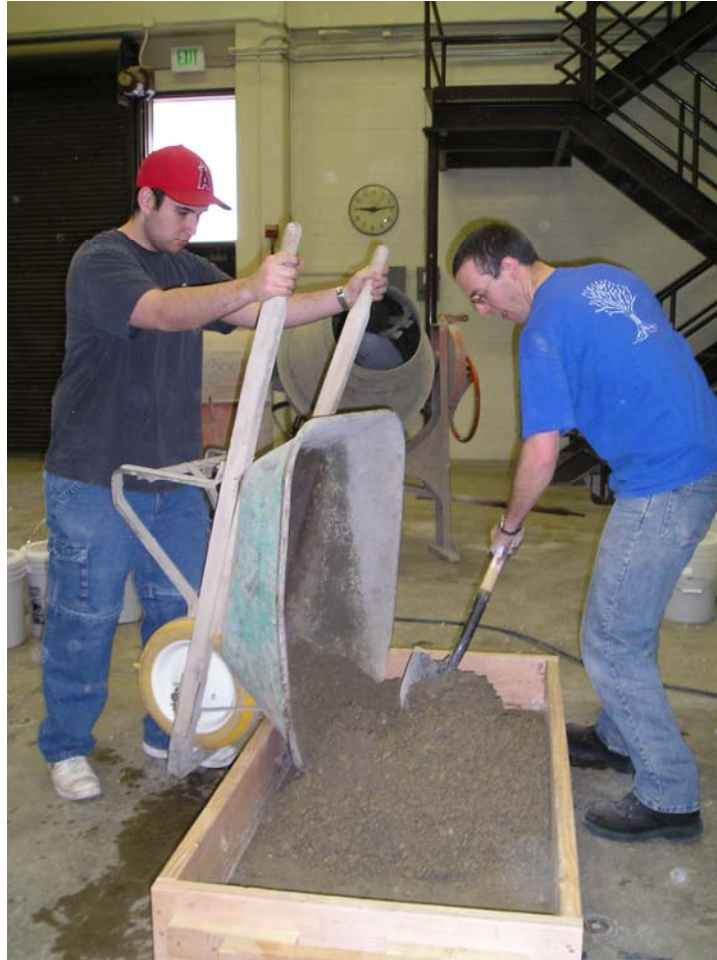
FIGURE 3.12 Preparation of laboratory box specimen.

Once the material was uniformly distributed in the box, the CTB was densified using a jumping-jack compactor, and manually operated modified Proctor hammers were utilized to compact the material along the edges of the box where the jumping-jack compactor was not as effective. To ensure a smooth surface on the final lift, small steel blocks were used to strike down any irregularities in the CTB surface. A sheet of plastic was then placed over the CTB to ensure adequate curing, which occurred at an ambient laboratory temperature of approximately 70°F.

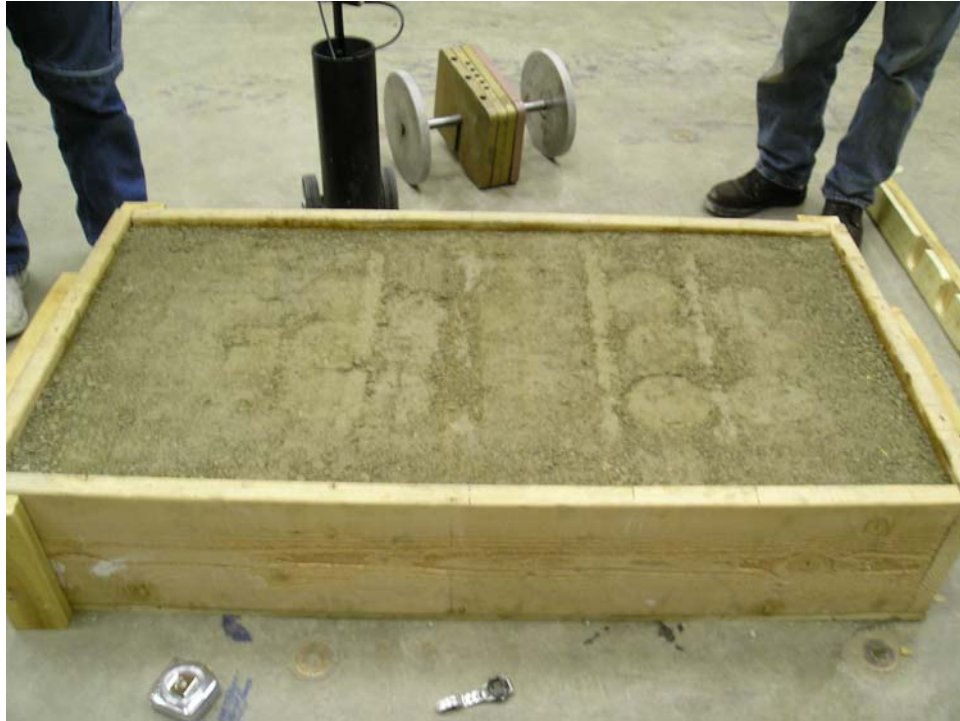
FIGURE 3.14 Tested laboratory box specimen.

Figure 3.14 shows the laboratory box specimen after the testing was completed. Following the rutting and CIST testing, a nuclear density gauge was used to measure the spatial variability in density within the CTB specimen. Six locations were tested and showed a satisfactory range in relative density of 96 to 98 percent of the MDD.

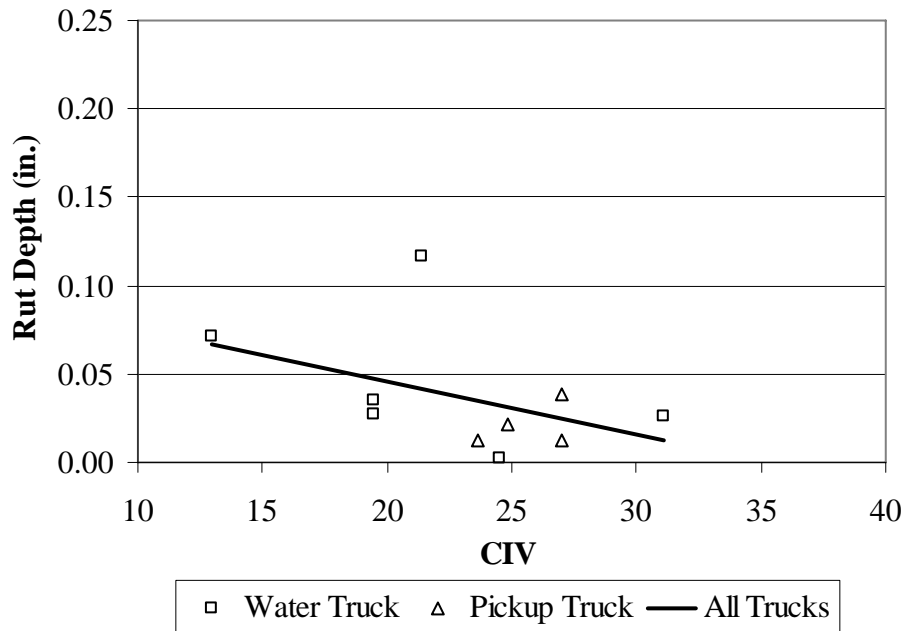
FIGURE 4.5 Truck data.

Figure 4.5, which includes 10 data points, presents a summary of the data collected using a water truck and a standard pickup truck. For both truck types, rut depths were measured after 10 wheel passes in the field. Again, linear regression was utilized to define the trend in the data. Although limited in quantity, the truck data display a relationship between rut depth and CIV similar to that demonstrated in both the field and laboratory HWRD data.
