# Pile Downdrag During Construction of Two Bridge Abutments

PILE DOWNDRAW DURING CONSTRUCTION OF  
TWO BRIDGE ABUTMENTS

Department of Civil and Environmental Engineering

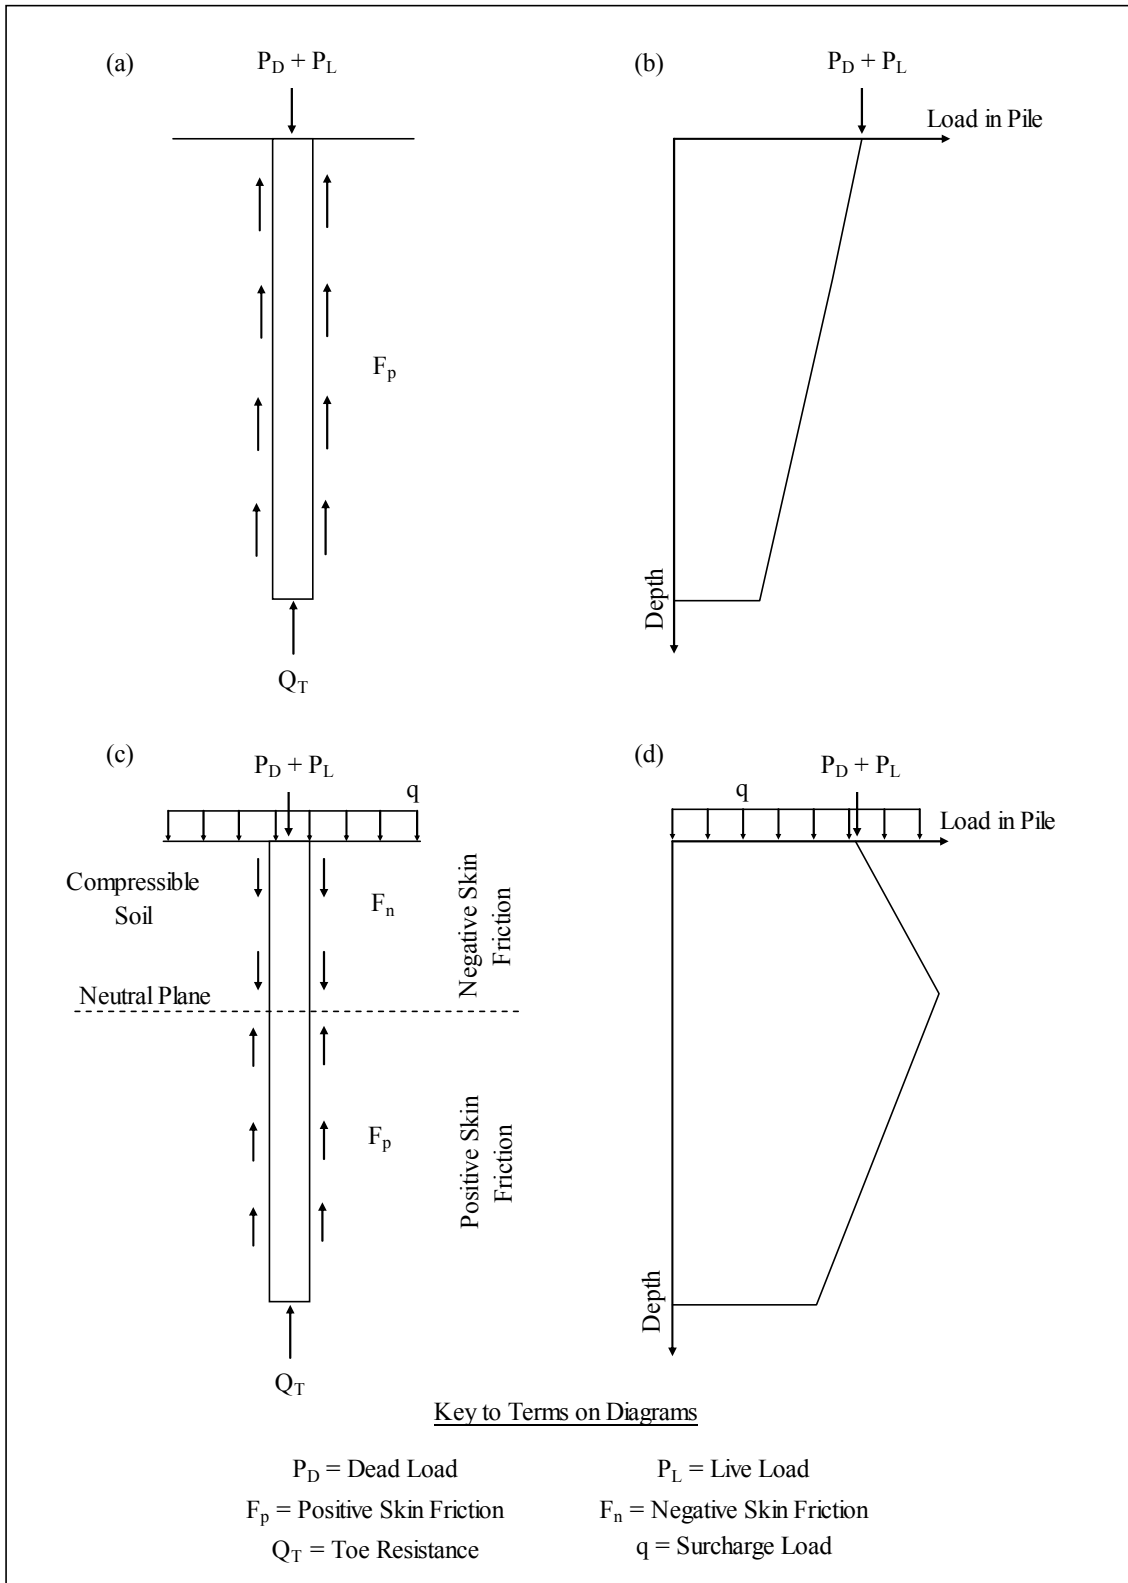
A depiction of the development of skin friction, both positive and negative is shown in Figure 1-1. In Figure 1-1(a), dead and live loads imposed on a pile foundation by a bridge or building are typically resisted by positive skin friction acting on the side of the pile and by toe resistance acting at the toe of the pile. As load is applied to the pile, it

**Figure 1-1 Illustration of (a) Forces Acting on a Pile and (b) Load in the Pile for Typical Case Involving Positive Skin Friction along with (c) Forces Acting on a Pile and (d) Load in the Pile for Case Involving Negative Skin Friction**

As illustrated in Figure 1-1(c), the maximum load in the pile for the downdrag loading condition would occur at the neutral plane. In addition, Fellenius recommends that the pile settlement be evaluated when the pile is subjected to the dead load and dragload combined to ensure that settlements are within tolerable limits.

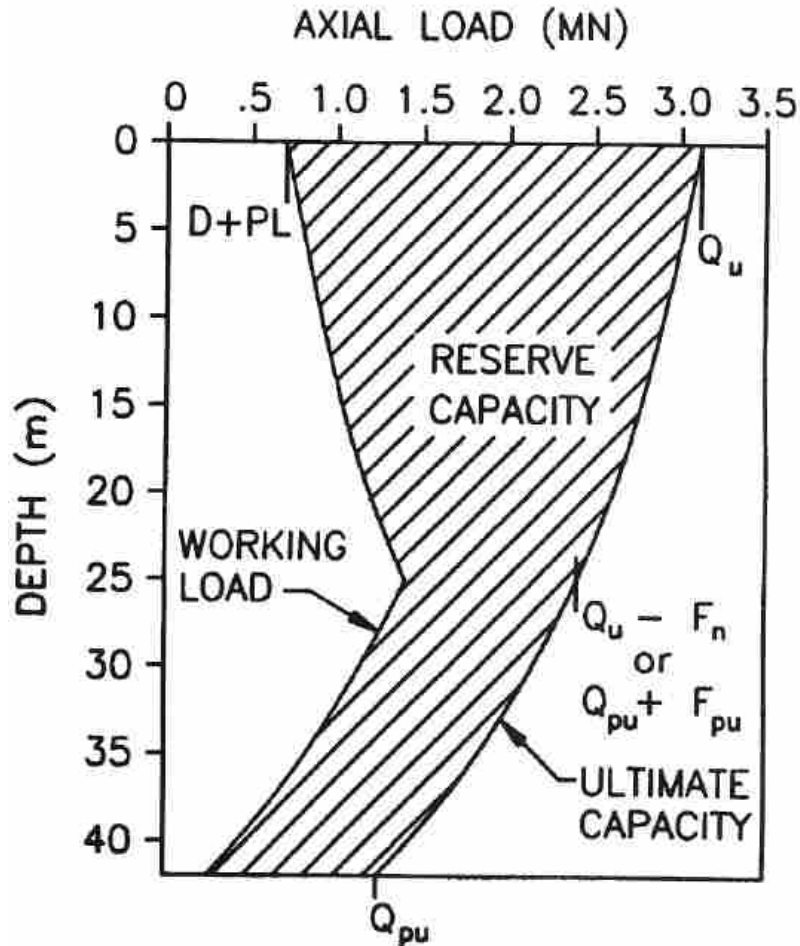
The load distribution along the length of the pile after the development of dragload and at the ultimate state is illustrated in Figure 1-2. This figure highlights the concept that at the ultimate state, an increased amount of reserve capacity (remaining capacity before failure of the pile) could be developed due to negative skin friction changing to positive and toe resistance becoming fully developed. In Figure 1-2,  $D$  is the applied dead load,  $PL$  is the permanent live load,  $Q_u$  is the ultimate soil capacity,  $F_n$  is the

**Figure 1-2 Illustration of Potential Reserve Capacity at the Ultimate State due to Reversal of Skin Friction from Positive to Negative after Initial Development of Dragload due to Negative Skin Friction (Briaud and Tucker, 1997)**

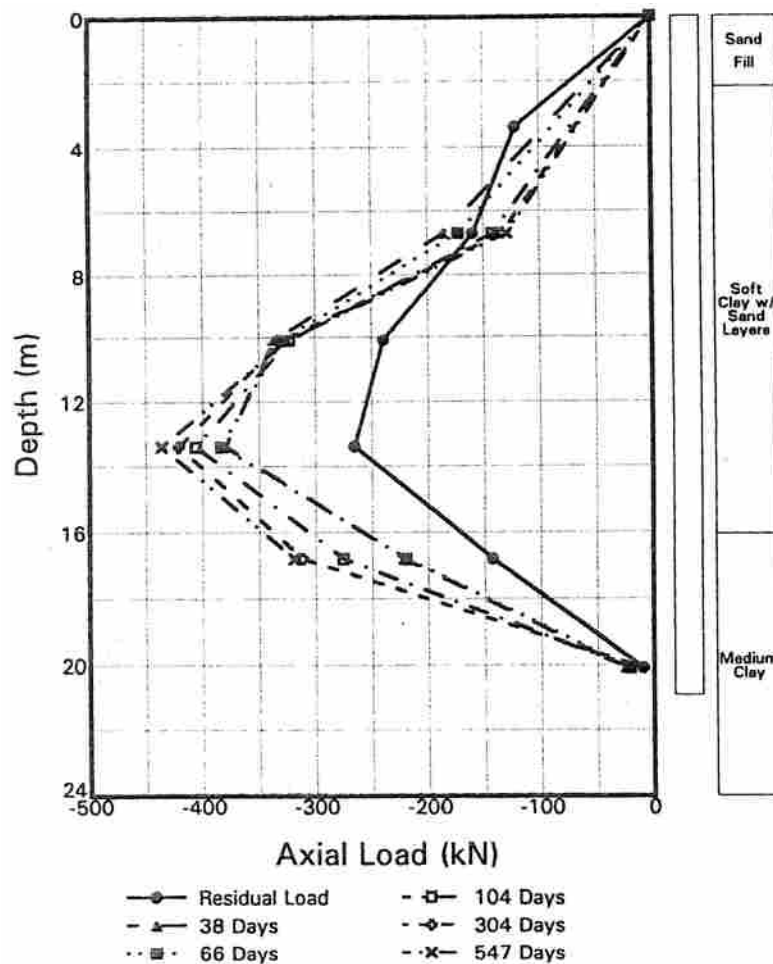
Downdrag loads on the uncoated pile reached about 340 kN and the other two coated concrete piles had observed downdrag loads of 900 to 1000 kN. Instrumentation on all three timber piles malfunctioned and no results were available. Downdrag loads on the uncoated steel pile reached about 440 kN while the coated pile experienced only about 60 kN of downdrag forces. Loads on the uncoated and coated piles are shown in Figure 2-5 and Figure 2-6, respectively. Ground surface settlement (approximately 220 mm) and pile settlement relative to the soil were observed and recorded.

Figure 2-5 Loads in Uncoated Pile from Study Conducted by Bush and Briaud (1994)

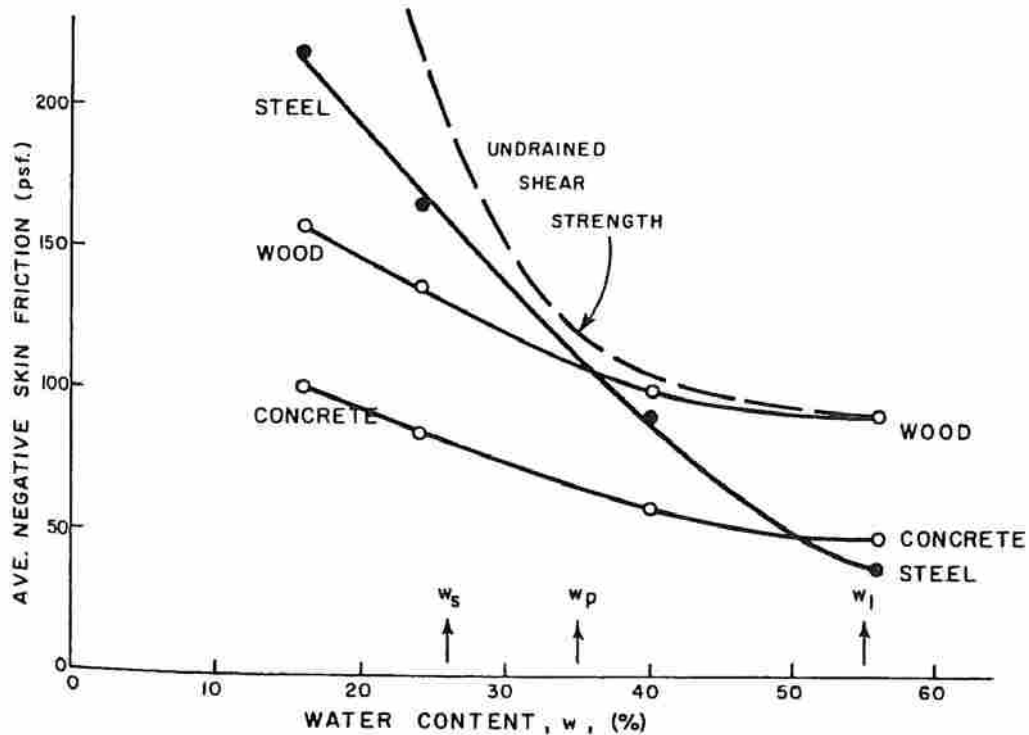
Tests on pile material were inconclusive, although tests showed that steel tends to follow the undrained shear strength curve until the water content becomes greater than the plastic limit. Concrete and wood begin lower, but tend to become parallel to the undrained shear strength curve with wood developing the full shear strength at the liquid limit. As was expected, the downdrag decreased as the water content increased due to the soil becoming less stiff as shown in Figure 2-9. This is expected because the soil loses shear strength as the water content increases.

Figure 2-9 Plot to Show Relationship between Water Content, Pile Material and Downdrag Force (Koerner and Mukhopadhyay, 1972)

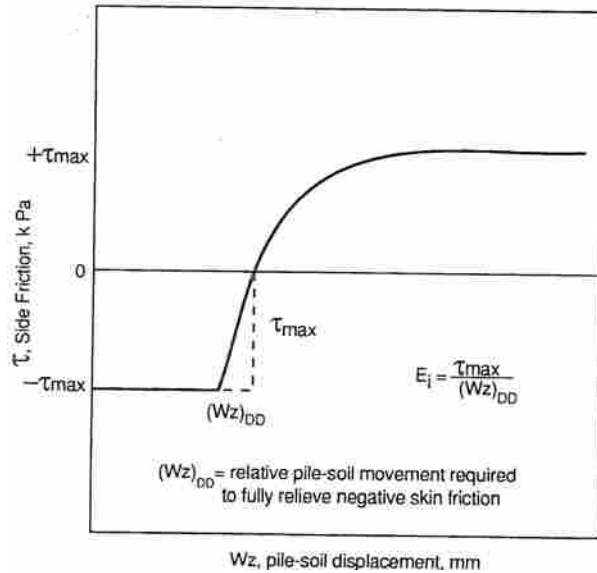
Figure 2-10 Depiction to Show Process of Obtaining  $E_i$  as Used in Method by Leifer (1994)

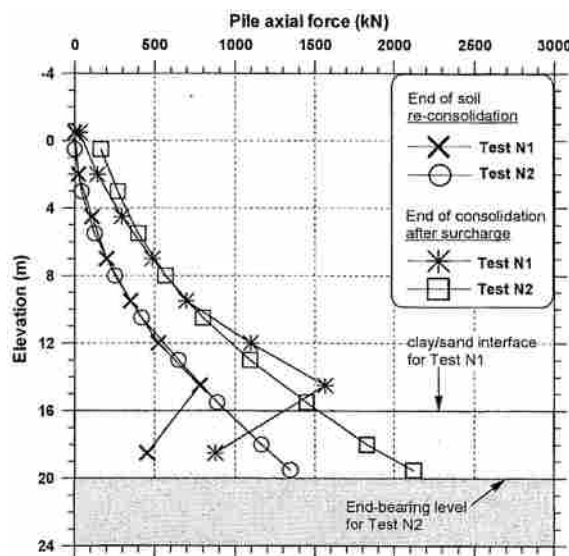
Figure 2-13 Comparison of Downdrag Loads Due to End-Bearing (from Leung et al. 2004)

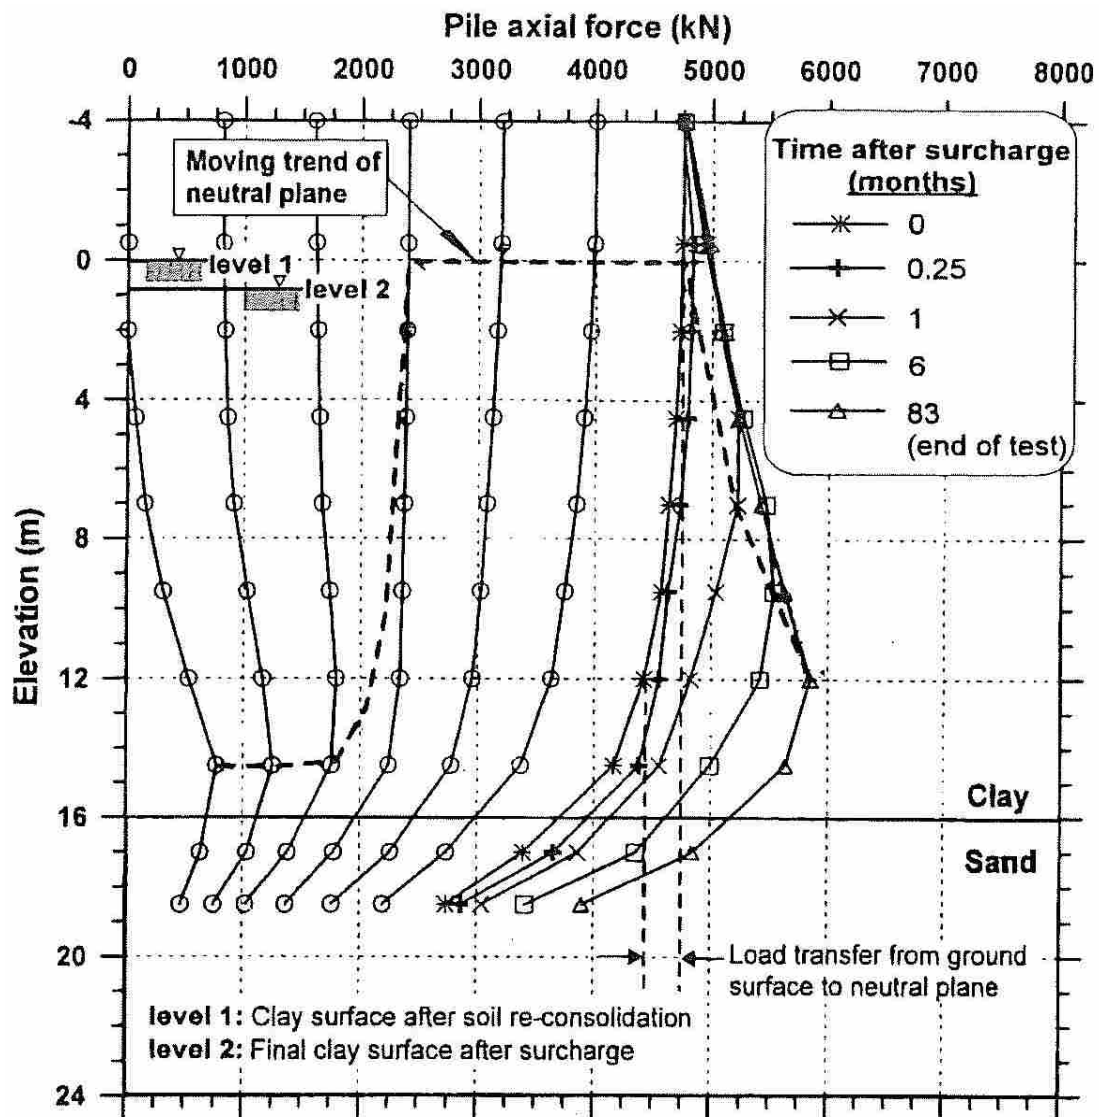
The next series of tests looked into the effects of applied loads. After self-weight consolidation had been achieved, yielding a dragload very close to that found in the first test, a load was applied gradually to the pile head. The dragload already in place on the pile was slowly overcome and at a load three times the dragload was finally overcome completely. This was seen as the neutral plane shifted from near the bottom of the pile to the surface of the clay layer. After the full load, half of the ultimate pile capacity, was applied, the sand surcharge layer was again placed and the model spun to achieve additional consolidation of the clay. During this process, dragloads gradually overcame the applied load and the neutral plane returned to near the base of the pile (see Figure 2-14).

Figure 2-14 Effects of Applied Load on Location of Neutral Plane (from Leung et al. 2004)

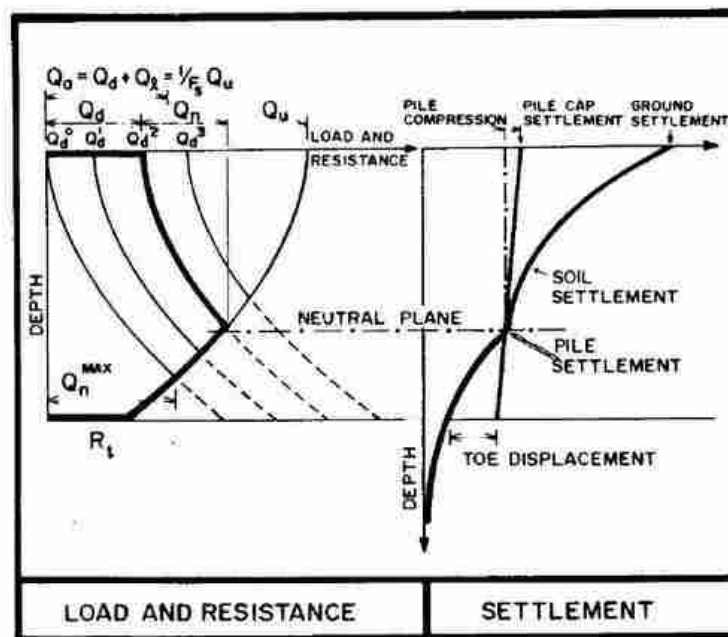
the neutral plane in this manner requires the assumption that the full end-bearing resistance has been mobilized. After the dead load and end bearing have been placed to scale on the top and bottom of the pile respectively, curves are drawn to represent the positive and negative skin friction. It is assumed that the slope of the lines for both friction cases is equal for a given soil layer. The approximate slope of these lines can be obtained by using shear strength properties. The location where the two curves intersect is the location of the neutral plane. As more dead load is placed on the pile, the neutral plane will move up.

**Figure 2-16 Depiction of Procedure for Locating the Neutral Plane According to the Unified Design Approach (Fellenius, 1989)**

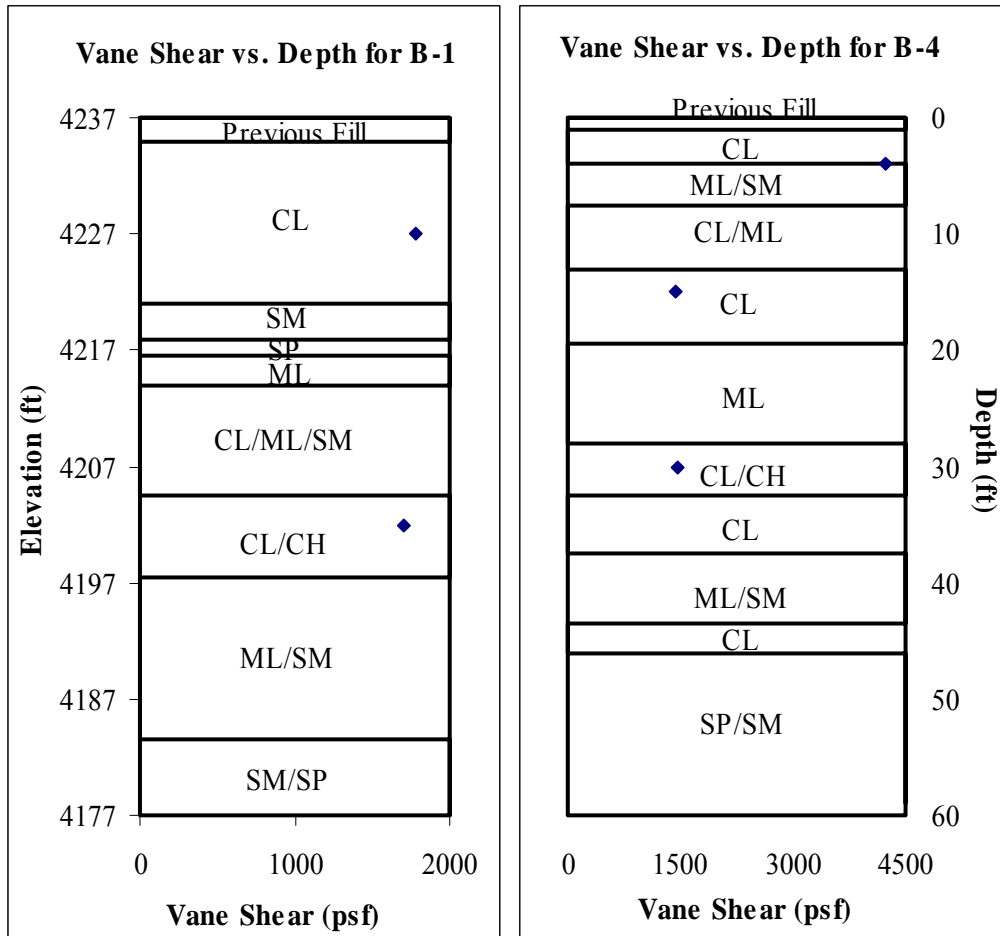
A total of five vane shear tests were completed in the laboratory by AMEC for boreholes B-1 and B-4. Two were taken from borehole B-1 and the other three from borehole B-4. Measured undrained shear strength ranges from a maximum of 4225 psf to a minimum 1438 psf. However the maximum value is located above the water table only four feet from the surface and consists of sandy silt and silty sand. Therefore, this test has been ignored. The undrained strength of the lean clays tends to range from 1500 to 1800 psf. Plots of the vane shear strength results versus depth are provided for both boreholes in Figure 3-8. This figure also shows the stratigraphy for each borehole with the original ground surface at a depth of zero feet. For more details, refer to Error! Reference source not found. for the information on borehole B-4 and the appendix for information on borehole B-1.

**Figure 3-8 Undrained Shear Strength Profile vs. Depth Based on Laboratory Vane Shear Tests for Boreholes B-1 and B-4 Completed by AMEC for Redwood Road and SR-201**

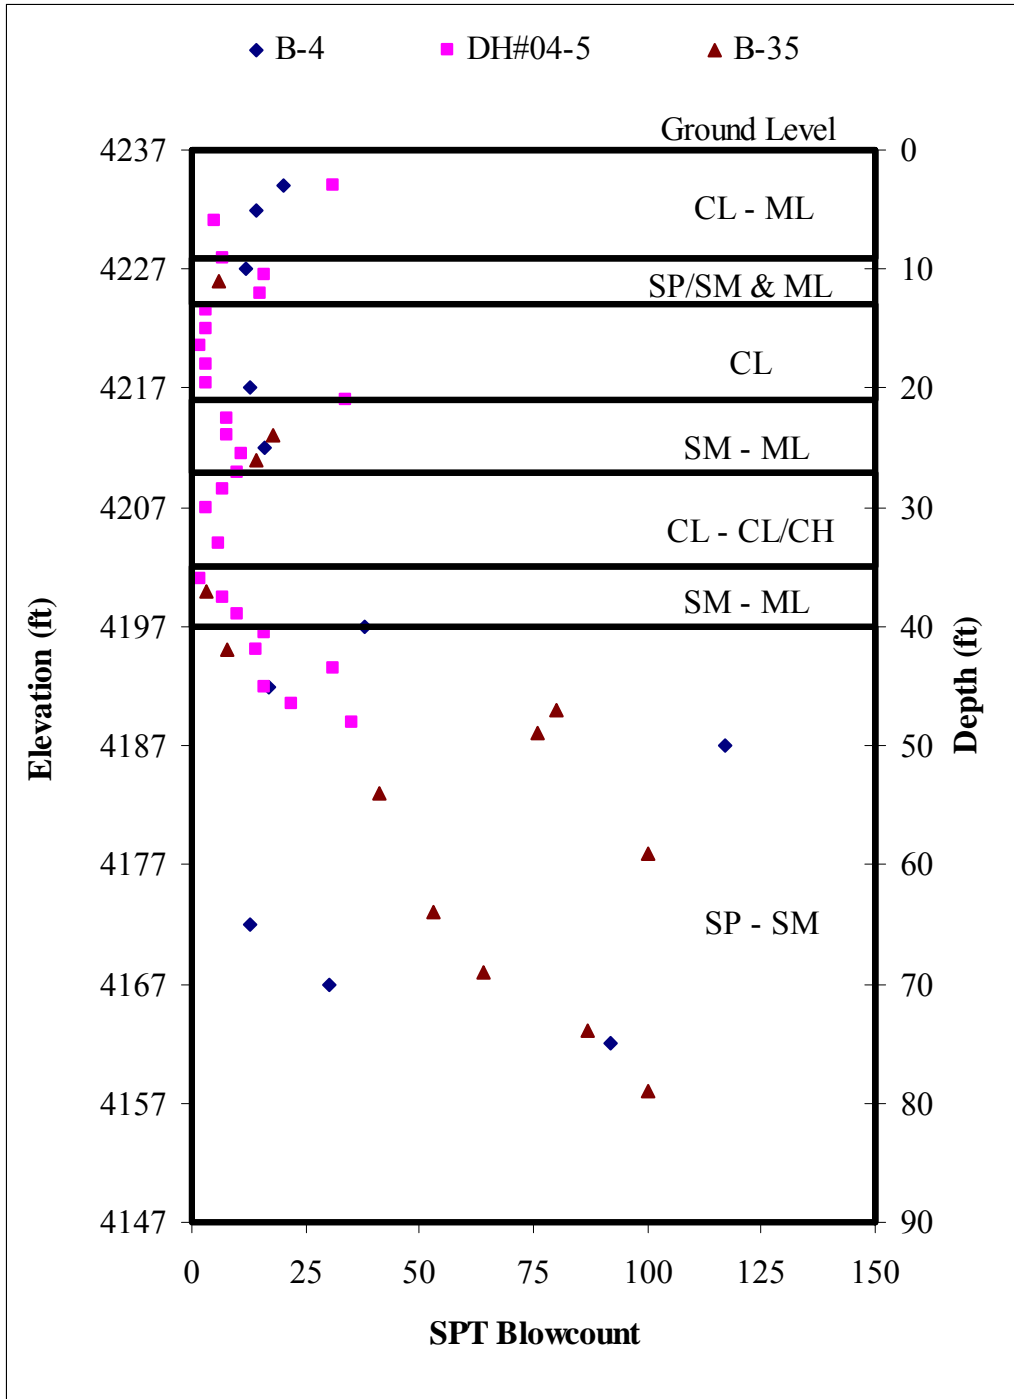
underlying silty sand layer. Figure 3-9 shows a comparison plot of the uncorrected SPT N values versus elevation for the three boreholes nearest to the test pile location.

Figure 3-9 Uncorrected SPT Blowcount Comparison for Boreholes Nearest to Test Pile Location

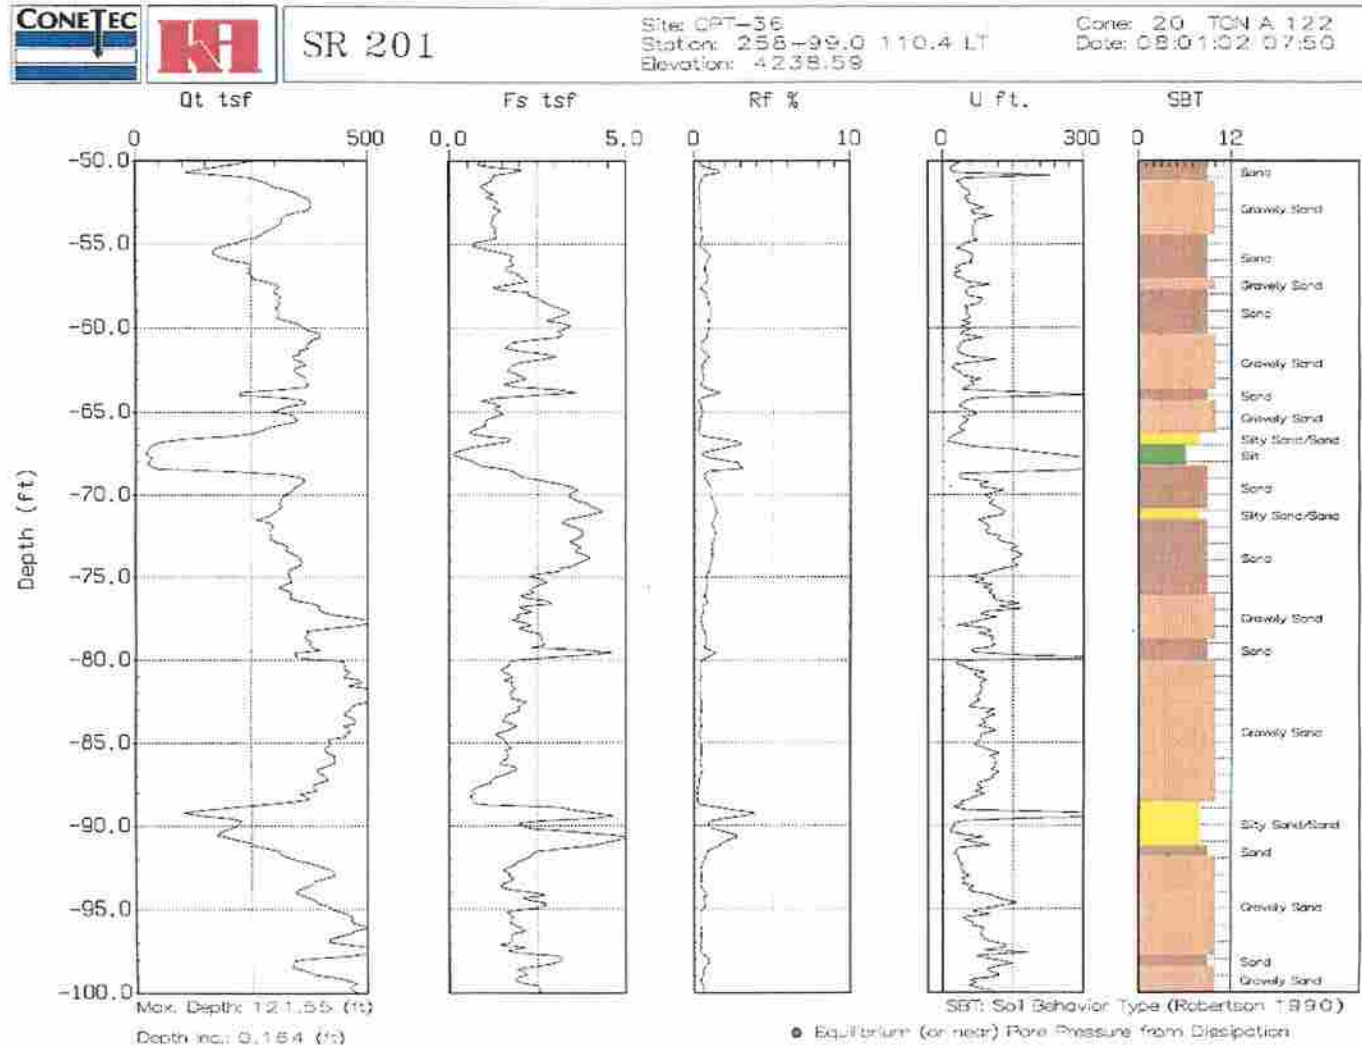
Figure 3-10 Log of CPT Sounding for CPT-36 at Redwood Road and SR-201 Site

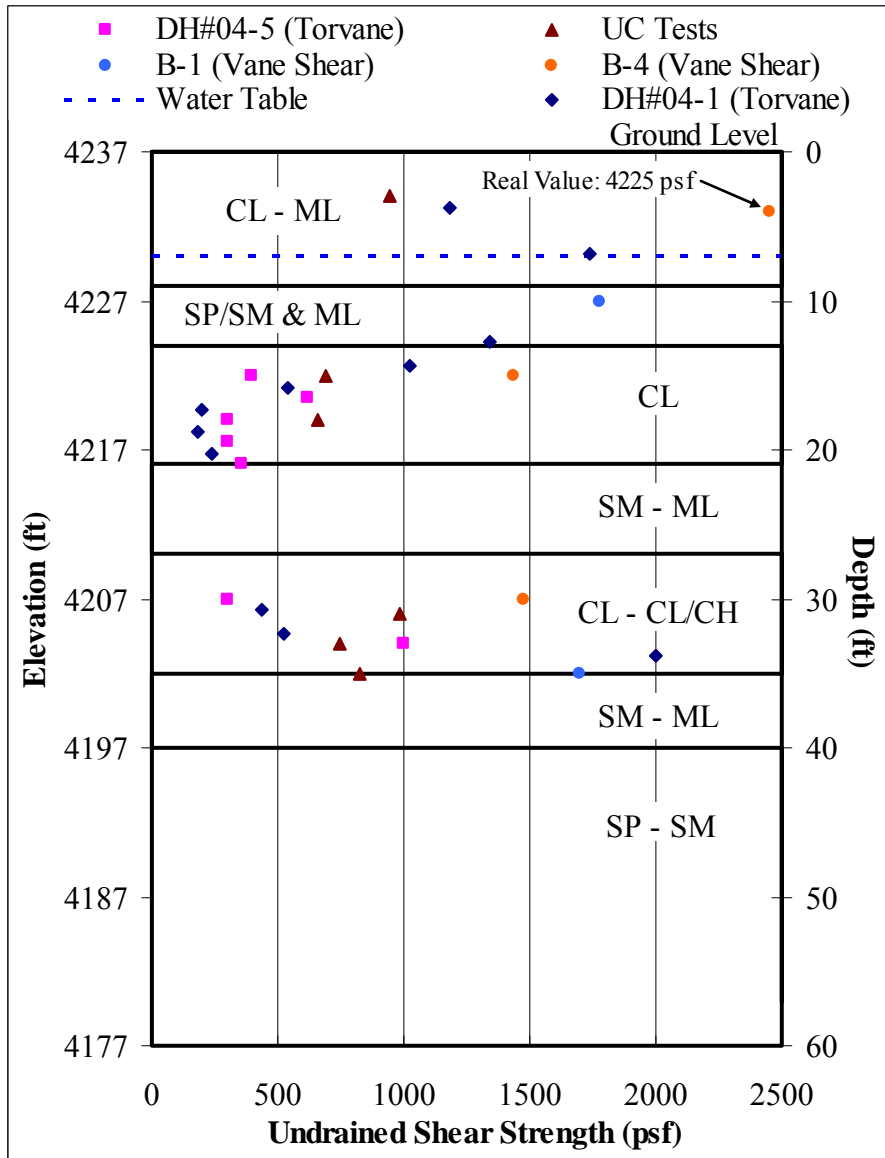
**Figure 3-11 Undrained Shear Strength Values from Torvane, Unconfined Compression and Vane Shear Tests for Boreholes Near Test Pile Location**

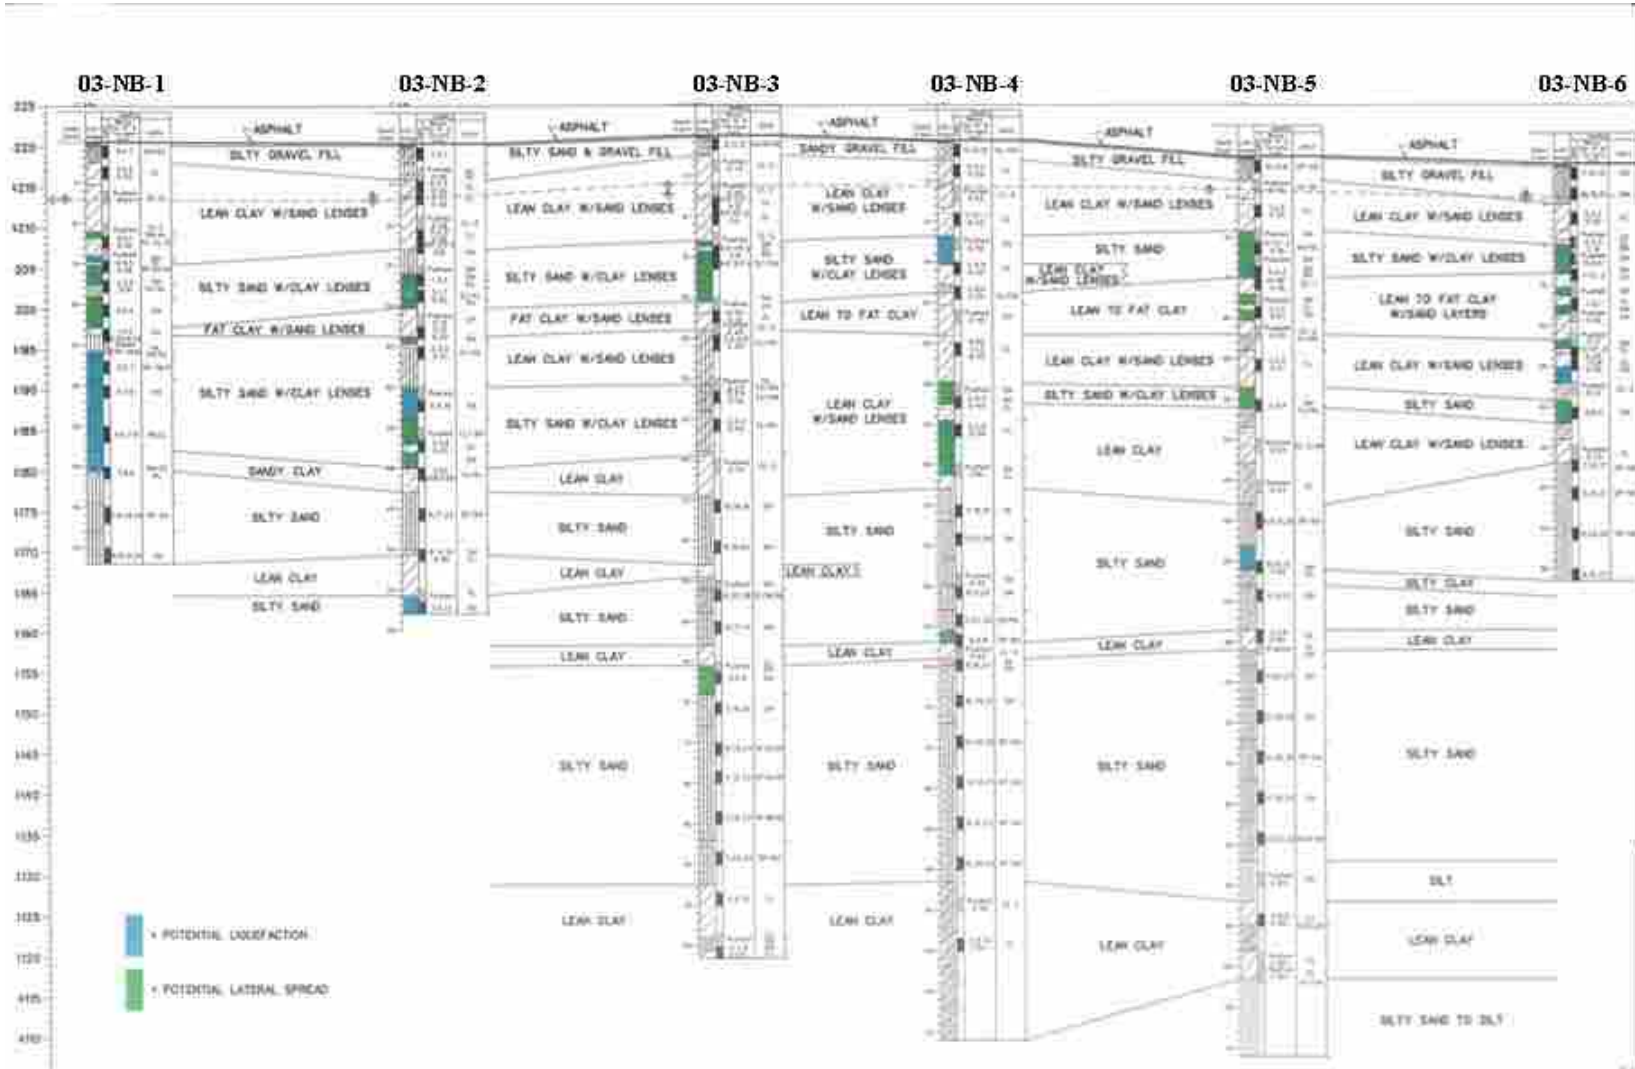
For the non-plastic samples, gradation testing shows the absence of gravel and, in most cases, quantities of sand in excess of 50%. It is common to see ratios of about 2/3 sand and 1/3 fines. Table 3-4 contains a breakdown of the grain size distribution found for the samples from boreholes 03-NB-3, 4 and 5.

Figure 3-14 Fence Diagram of Borehole Logs Near Test Site

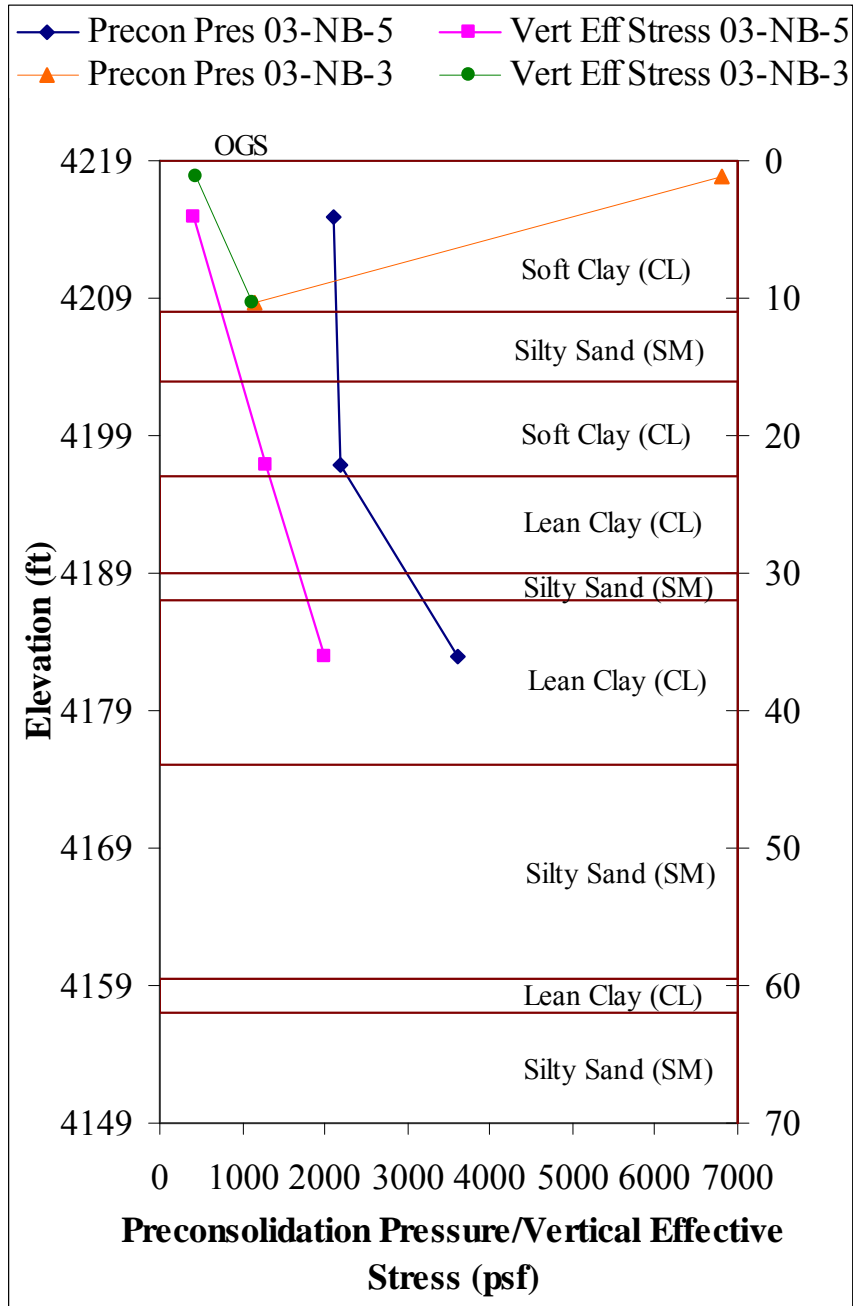
cohesive soils in the upper 40 feet of the profile due to the construction of the 27 ft high approach fill at this site.

Figure 3-17 Plot of Preconsolidation Pressure and Vertical Effective Stress vs. Elevation and Depth for Borehole 03-NB-5

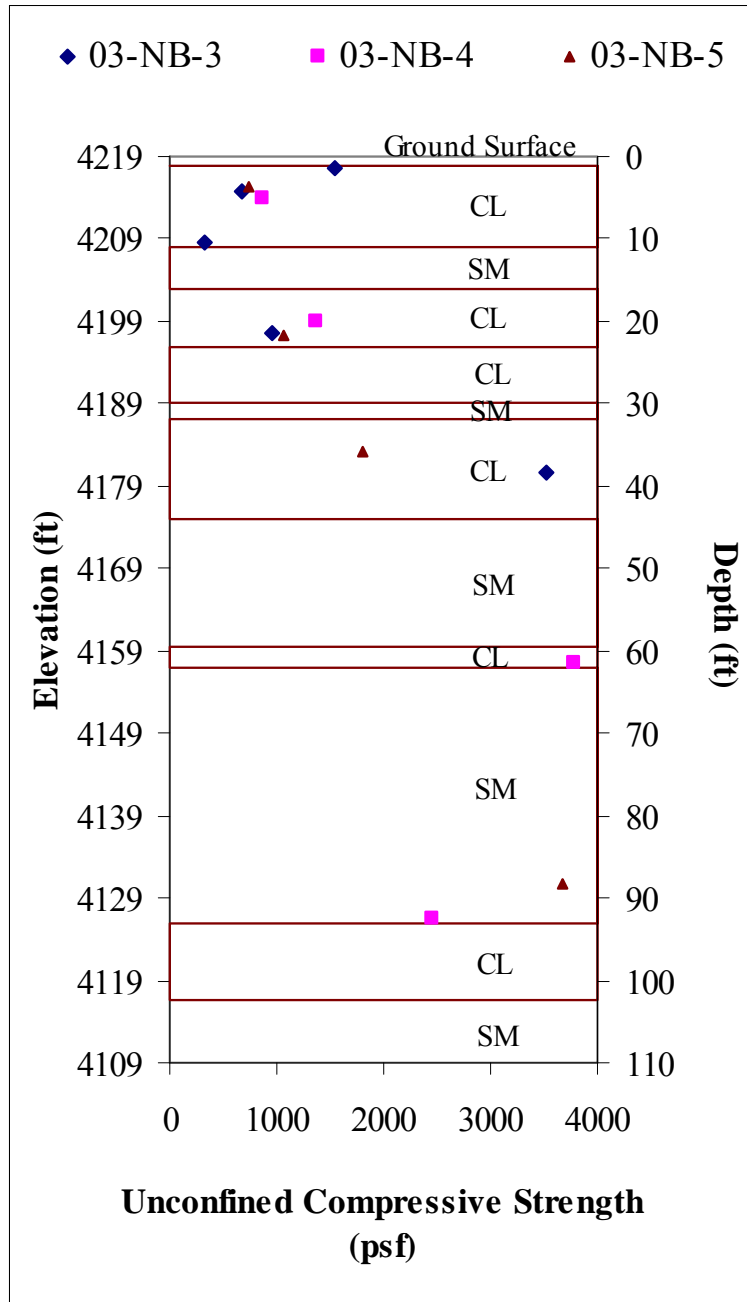
Figure 3-18 Plot of Unconfined Compressive Strength vs. Elevation and Depth for Boreholes 03-NB-3, 4, & 5 at SLCIA Site

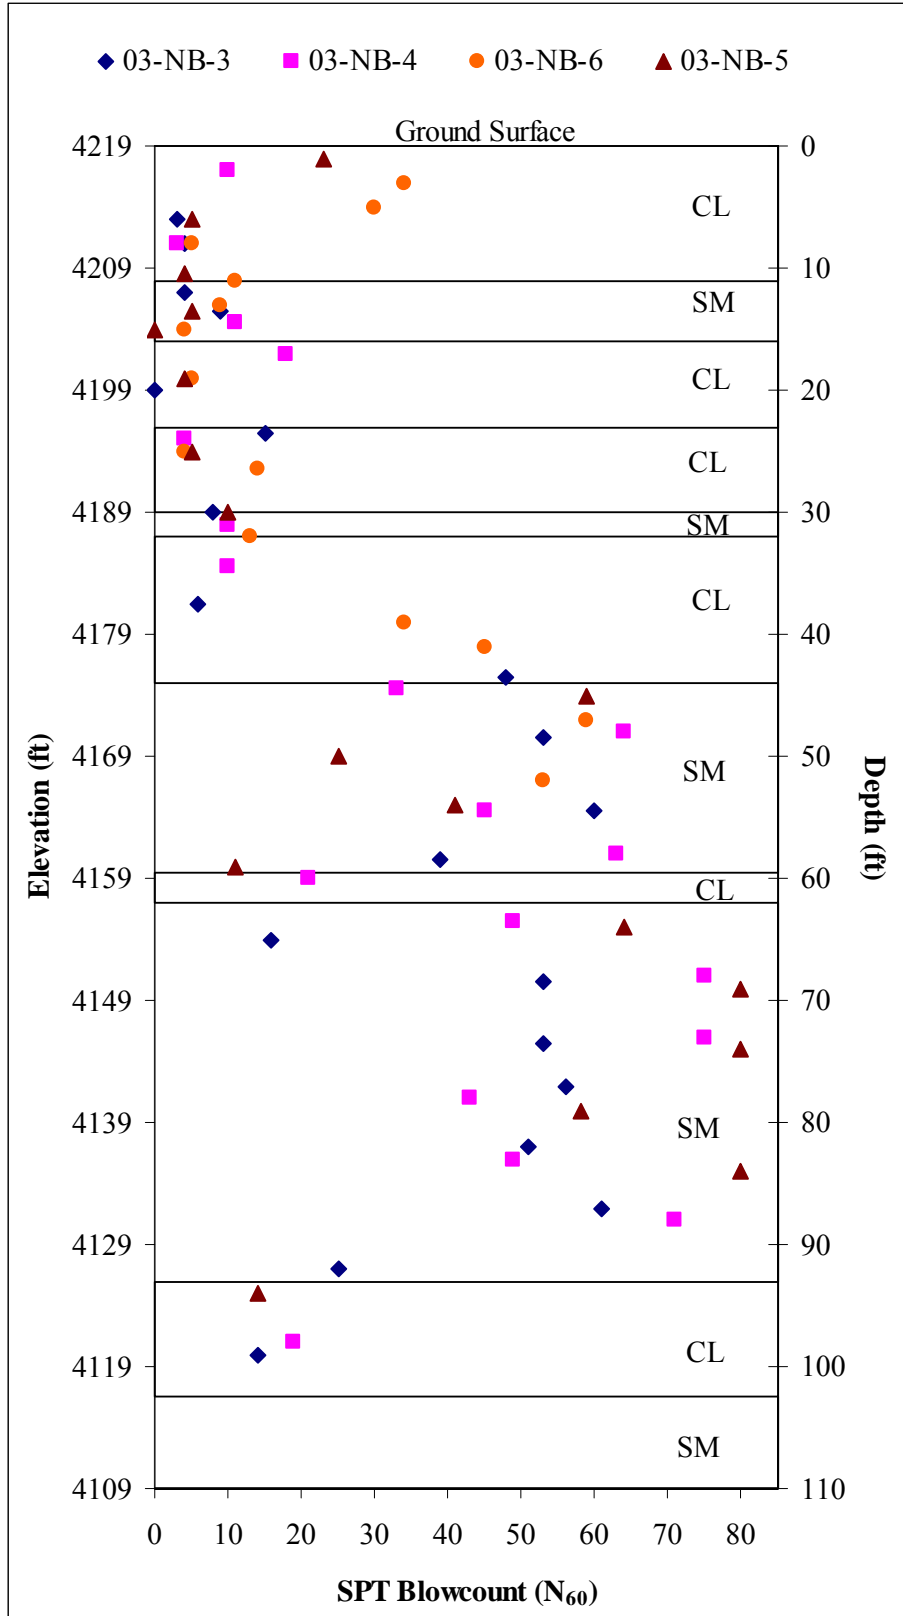
Figure 3-19 SPT  $N_{60}$  Blowcount Values vs. Elevation for Boreholes 03-NB-3, 4, 5 & 6 for SLCIA Site

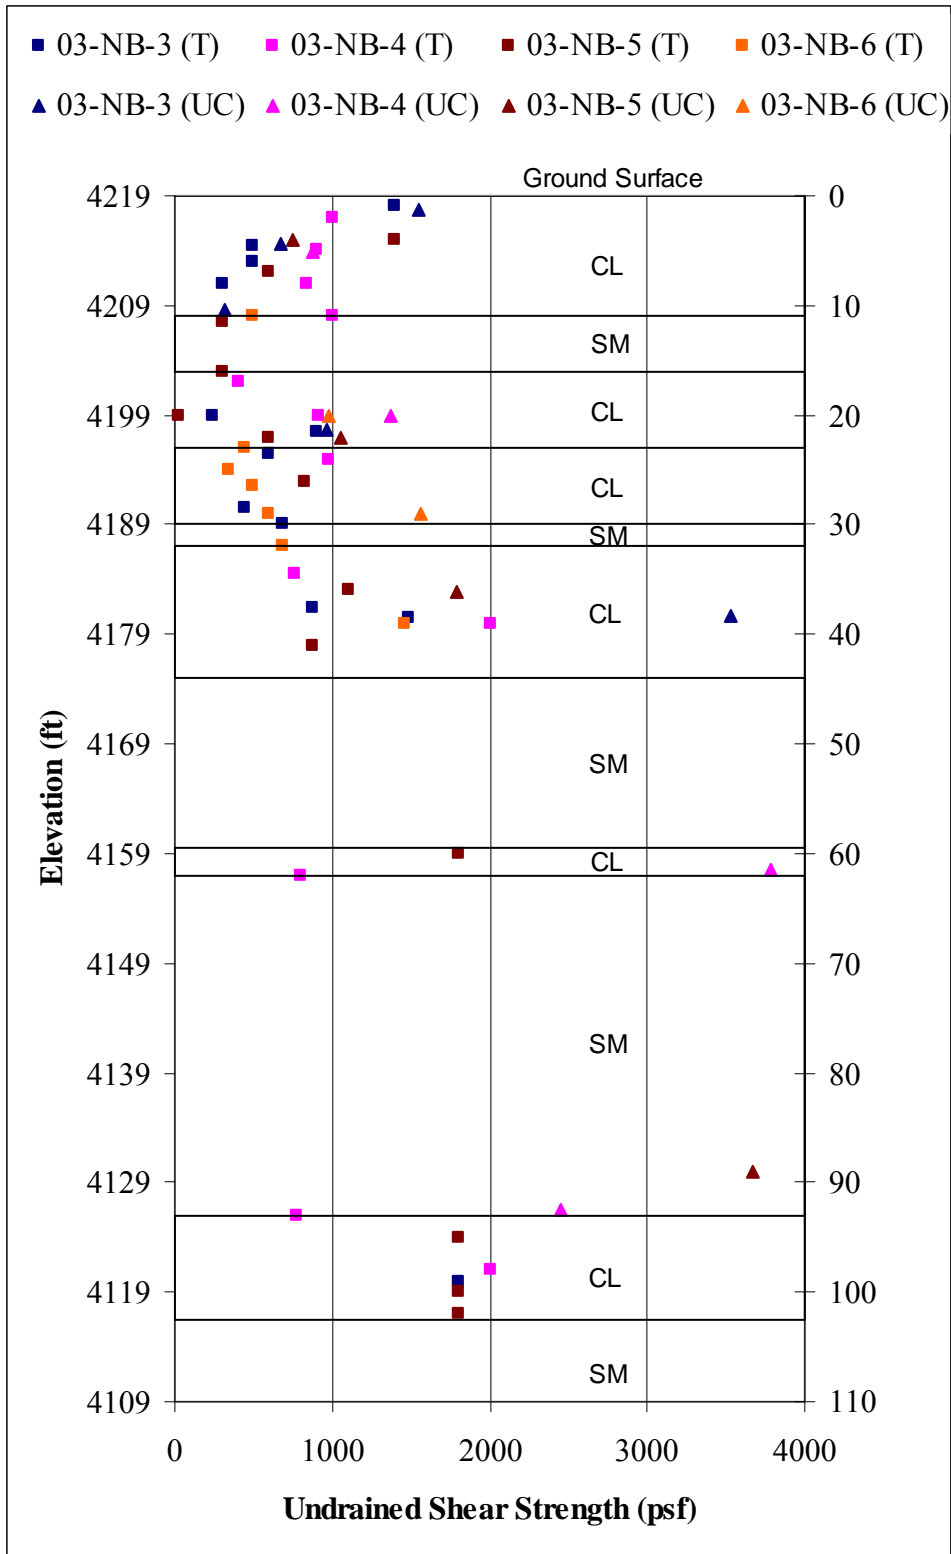
Figure 3-20 Undrained Shear Strength Values from Torvane and Unconfined Compression Tests for Borehole 03-NB-3, 4, 5 & 6 from SLCIA Site

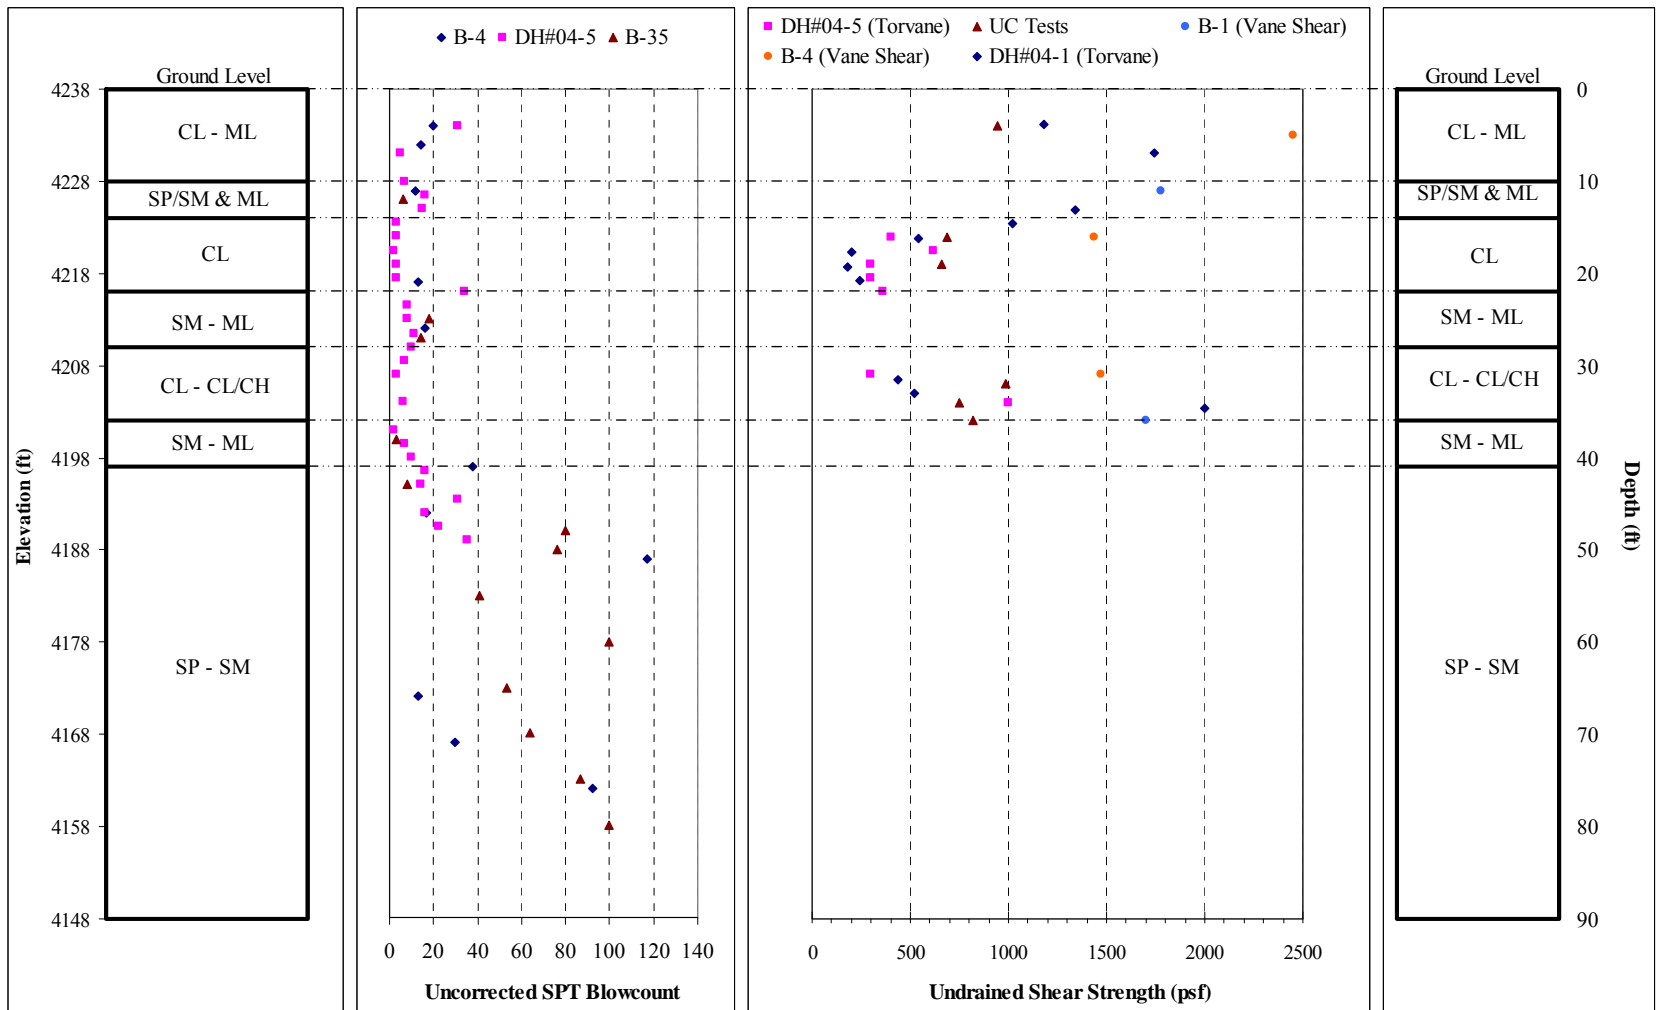
Figure 3-21 Summary of Uncorrected SPT Blowcount and Undrained Shear Strength Values for Redwood Road & SR-201 Site
