# Pile Downdrag During Construction of Two Bridge Abutments

PILE DOWNDRAW DURING CONSTRUCTION OF  
TWO BRIDGE ABUTMENTS

Department of Civil and Environmental Engineering

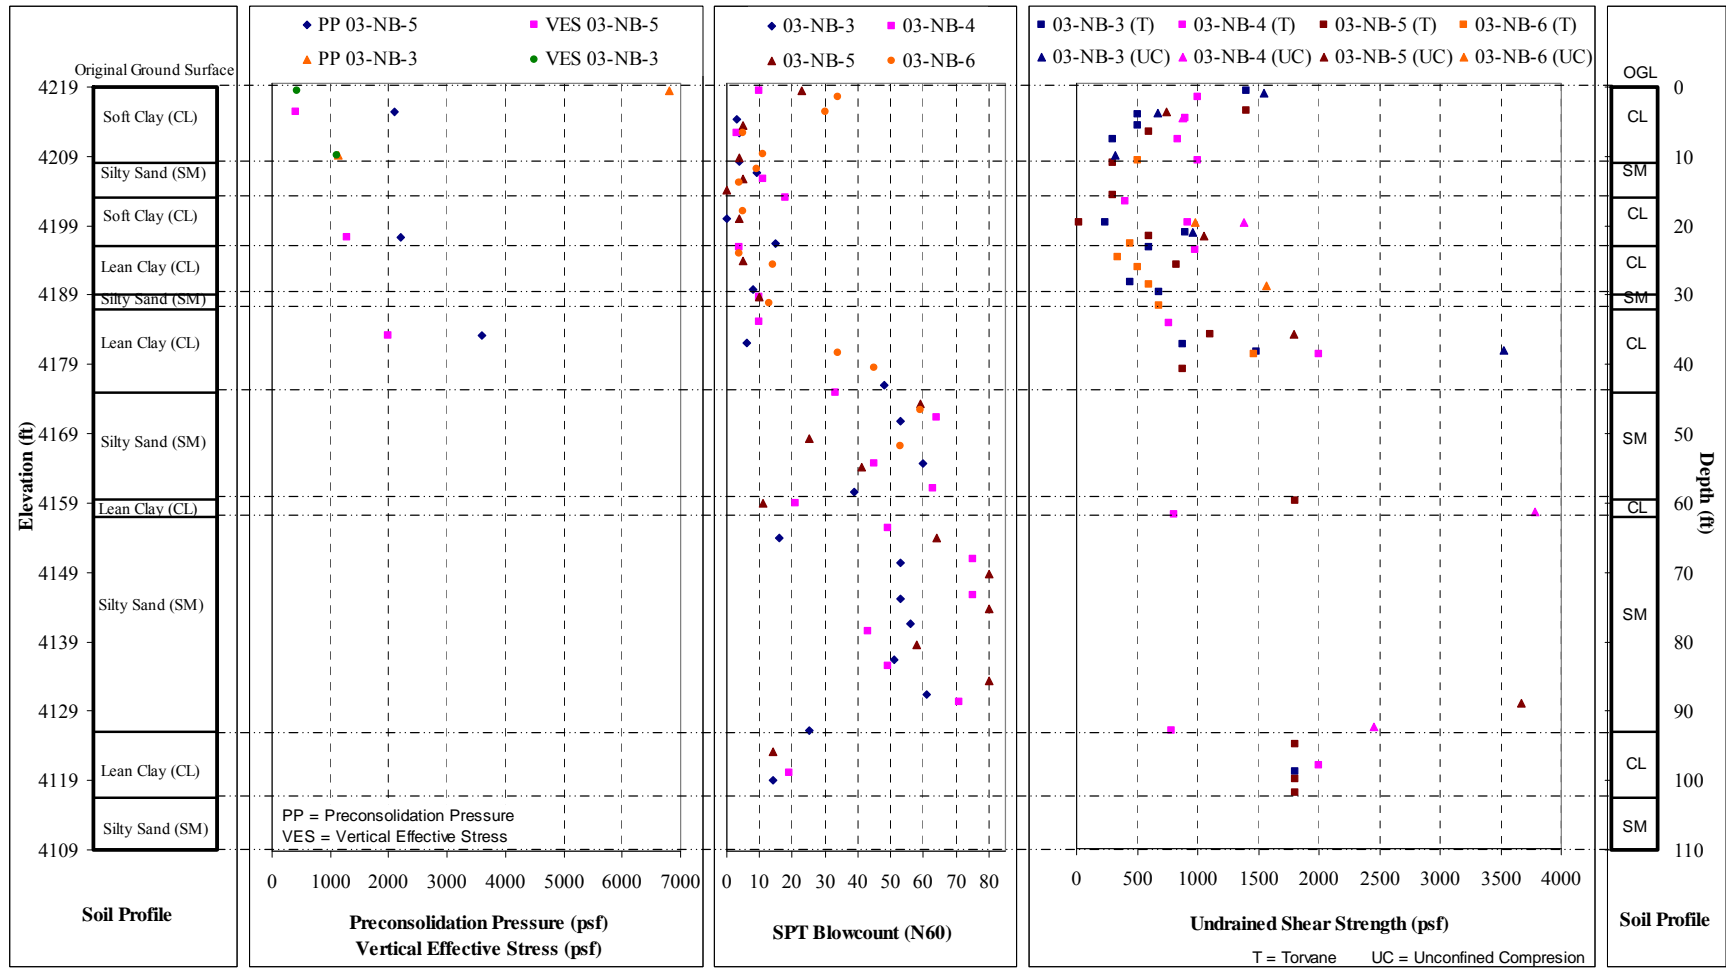
The SPT testing done shows low blowcounts (below 10) for the first 40 feet, then increasing to an average value of 38 for the next 20 feet. After this a thin, weak layer was encountered and then values climbed back up to a higher average of 49 down to a depth of 93 feet. Figure 3-22 shows a side-by-side comparison of the preconsolidation pressure, vertical effective stress, undrained shear strength parameters (includes unconfined compression strength and torvane tests), and SPT  $N_{60}$  blowcount values for the SLCIA site.

Figure 3-22 Summary of Consolidation Parameters, Undrained Shear Strength Parameters and SPT N<sub>60</sub> Blowcount Values for SLCIA Site

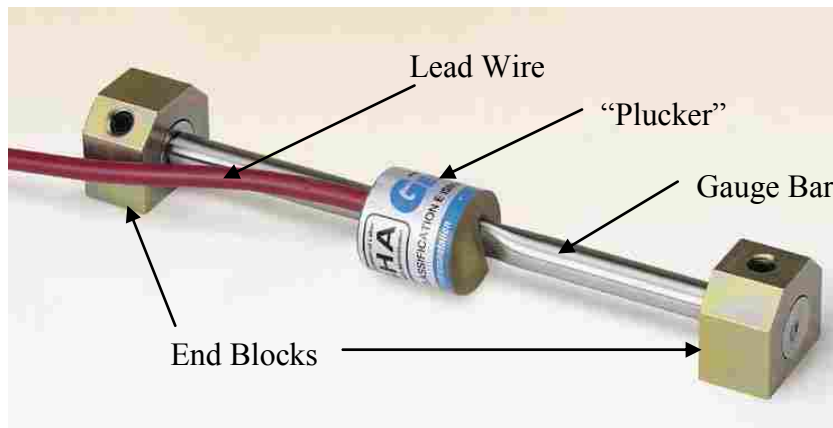
which gives a reading in microstrain. The amount of compression or tension can be found by comparing latter readings to the initial reading.

**Figure 4-1 Series 4000 Vibrating Wire Strain Gauge (from company website, [www.geokon.com](http://www.geokon.com))**

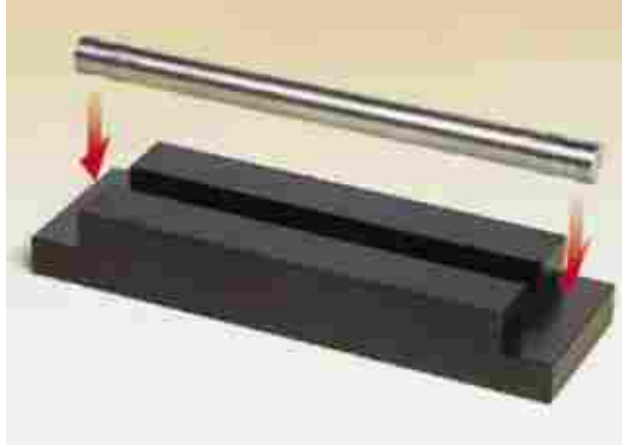
**Figure 4-2 Spacing Bar and Welding Jig Provided to Assist in Correct Placement of End Blocks for Welding (from company website, [www.geokon.com](http://www.geokon.com))**

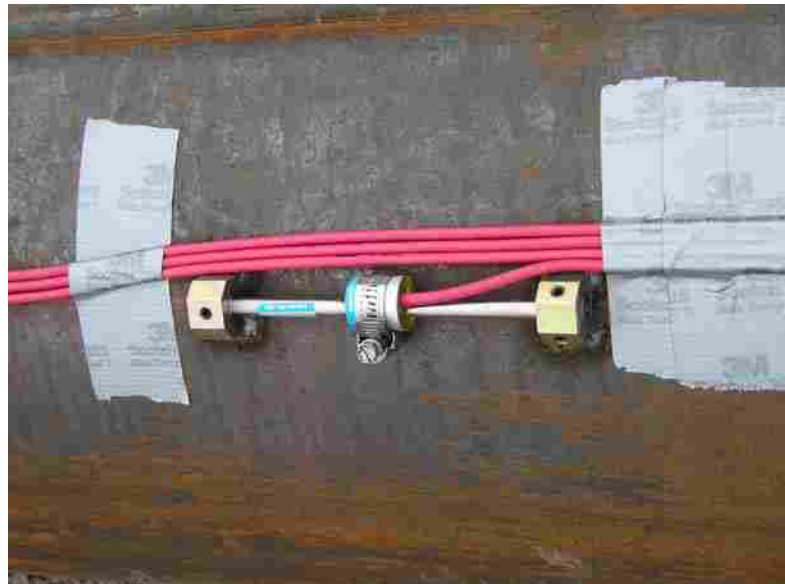
**Figure 4-4 Placement of Gauge and Wires along Pile**

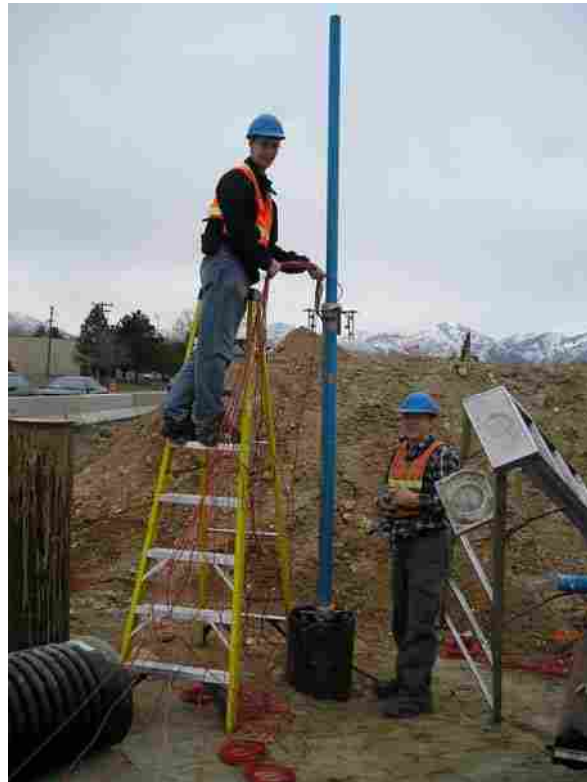
**Figure 4-8 Installing Pipe Sections One at a Time at Redwood Road and SR-201 (author photo)**

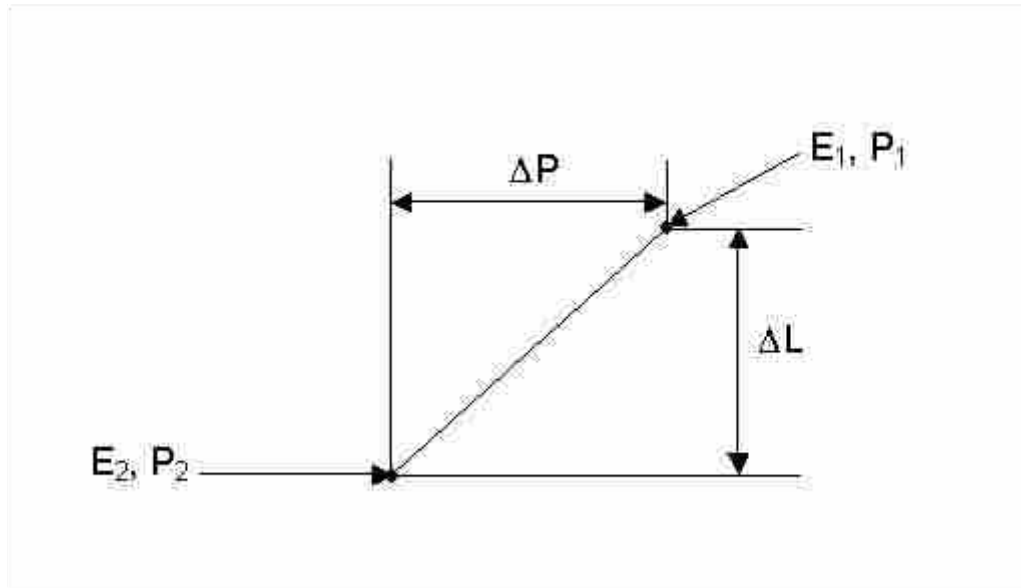
**Figure 4-12 Depiction of Single Segment Method for Calculating Unit Skin Friction**

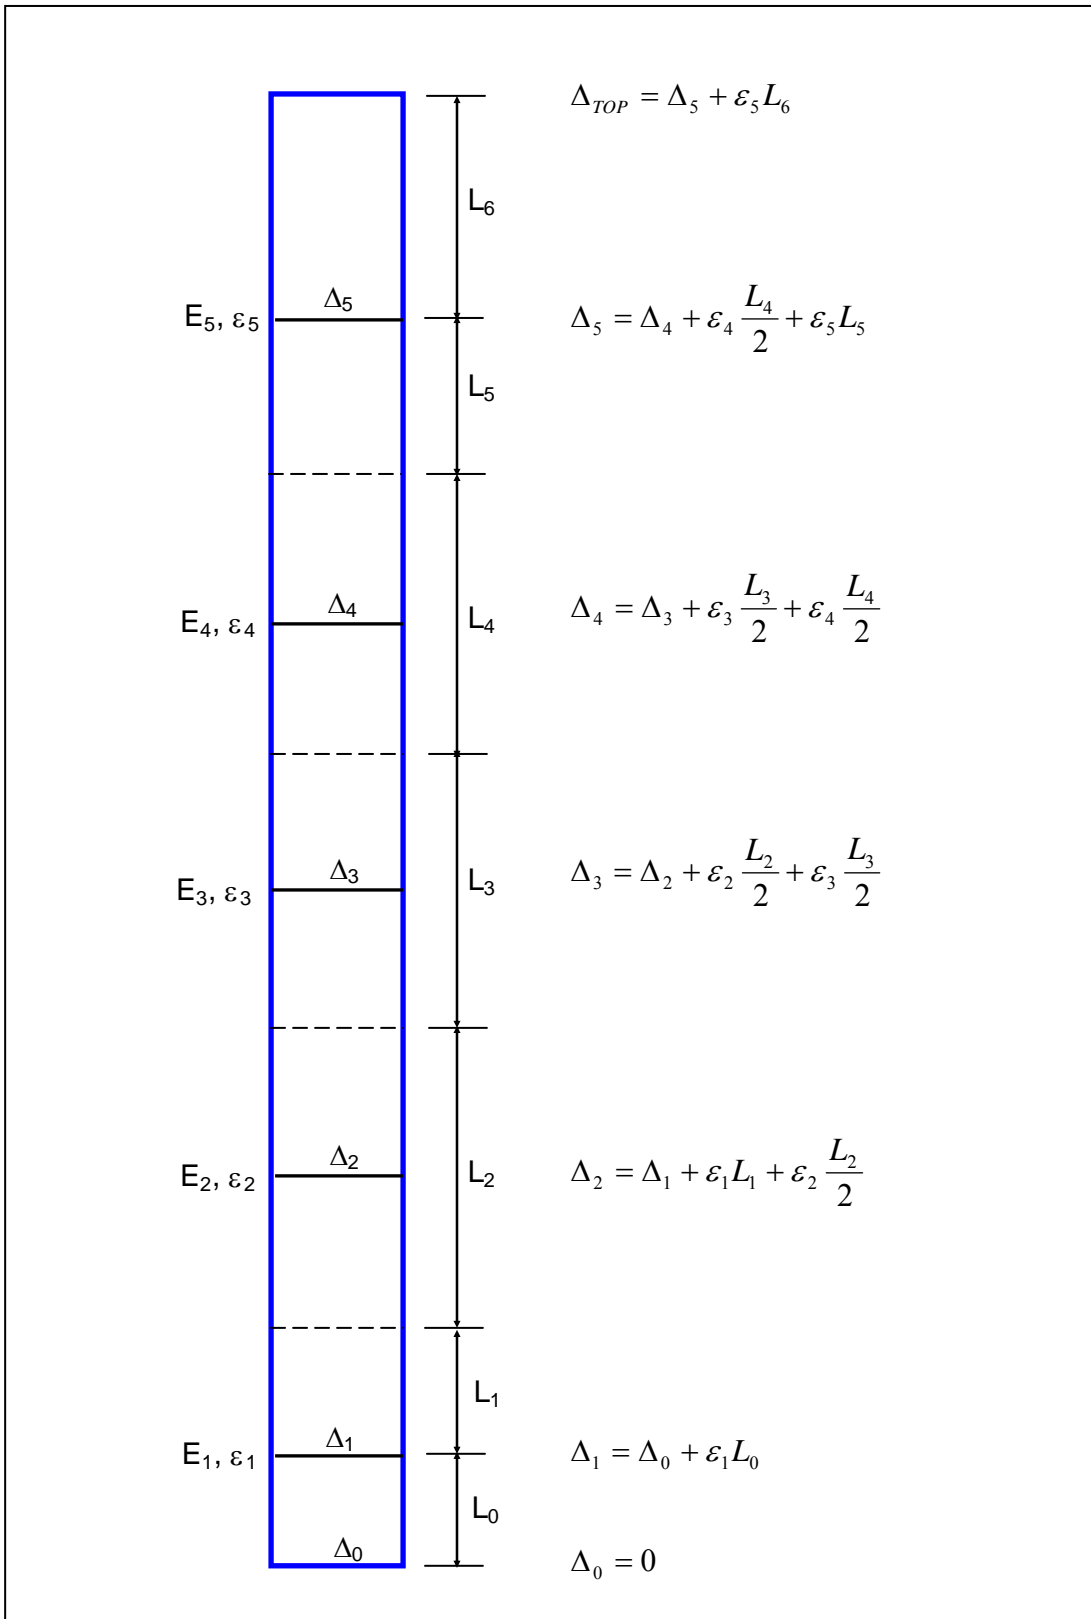
Figure 4-13 Depiction of Calculating Pile Compression at Gauge Elevations

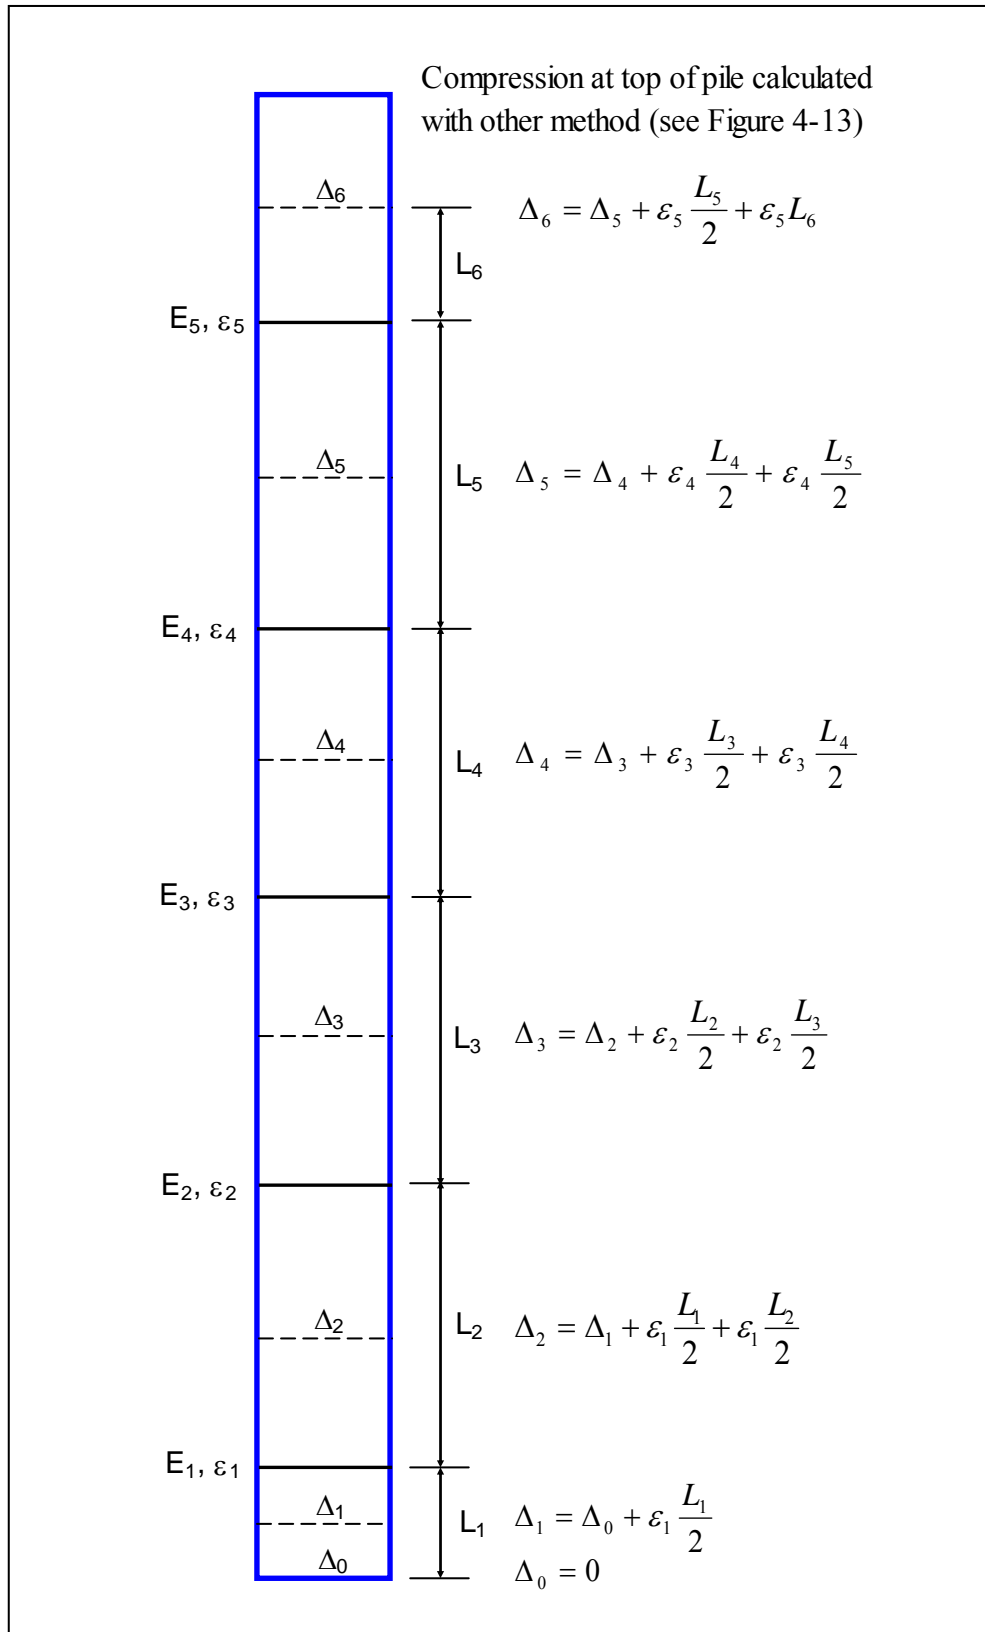
Figure 4-14 Depiction of Calculating Pile Compression at Midpoint of Gauges

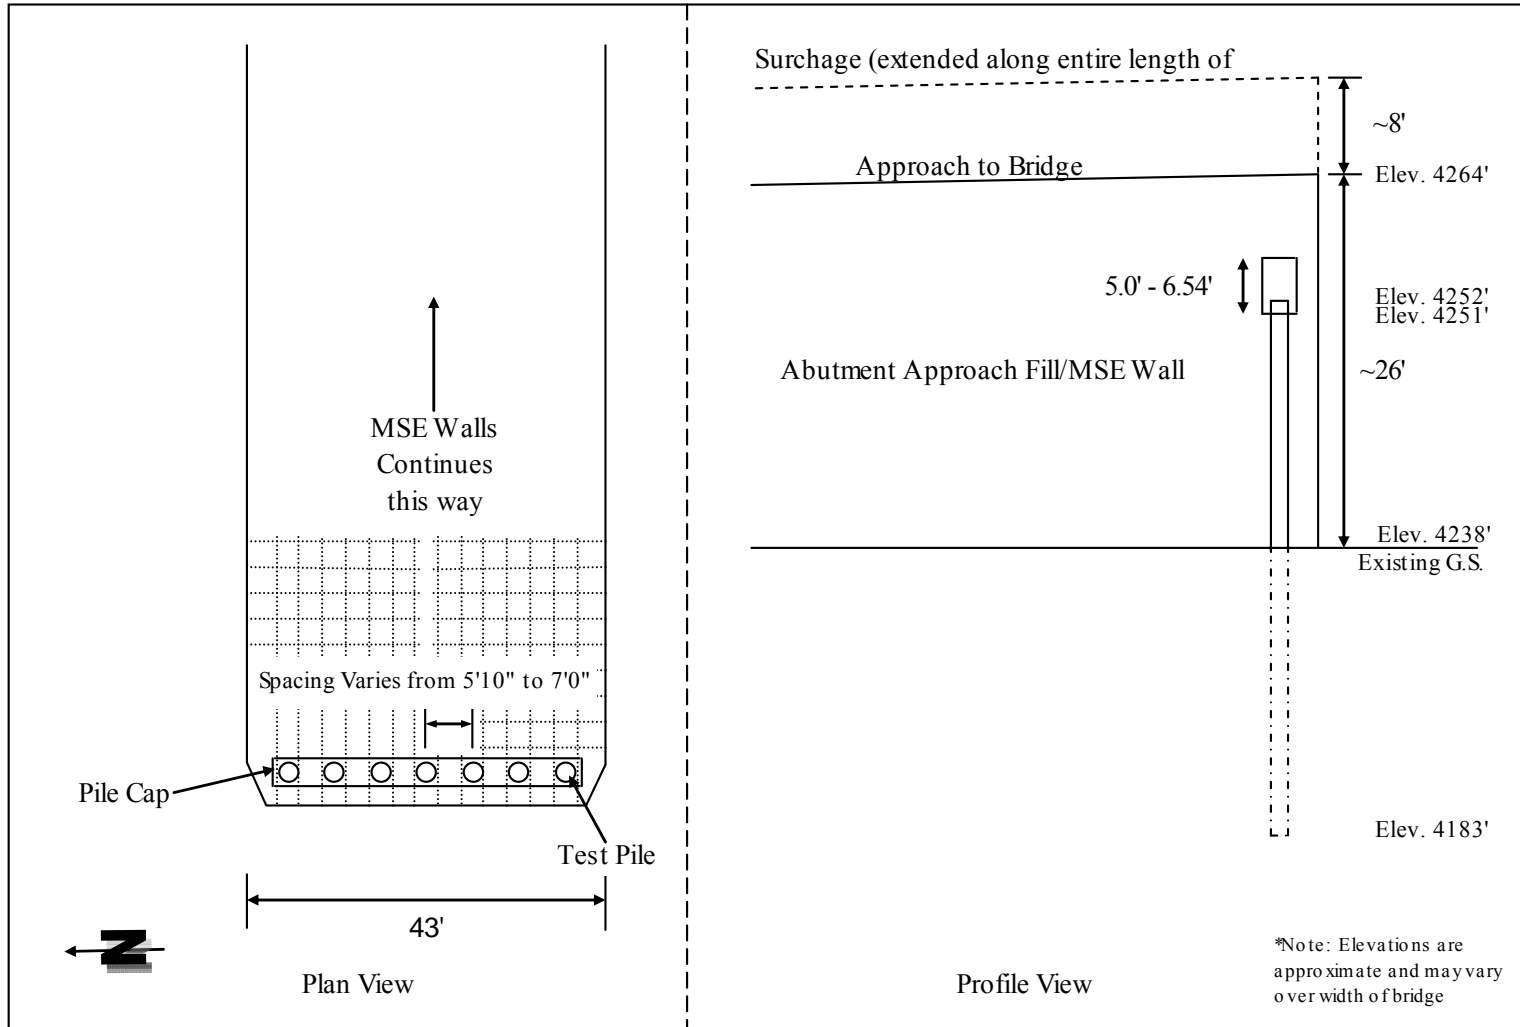
Figure 5-1 Schematic of East Abutment and Approach Fill at Redwood Road and SR-201 Site

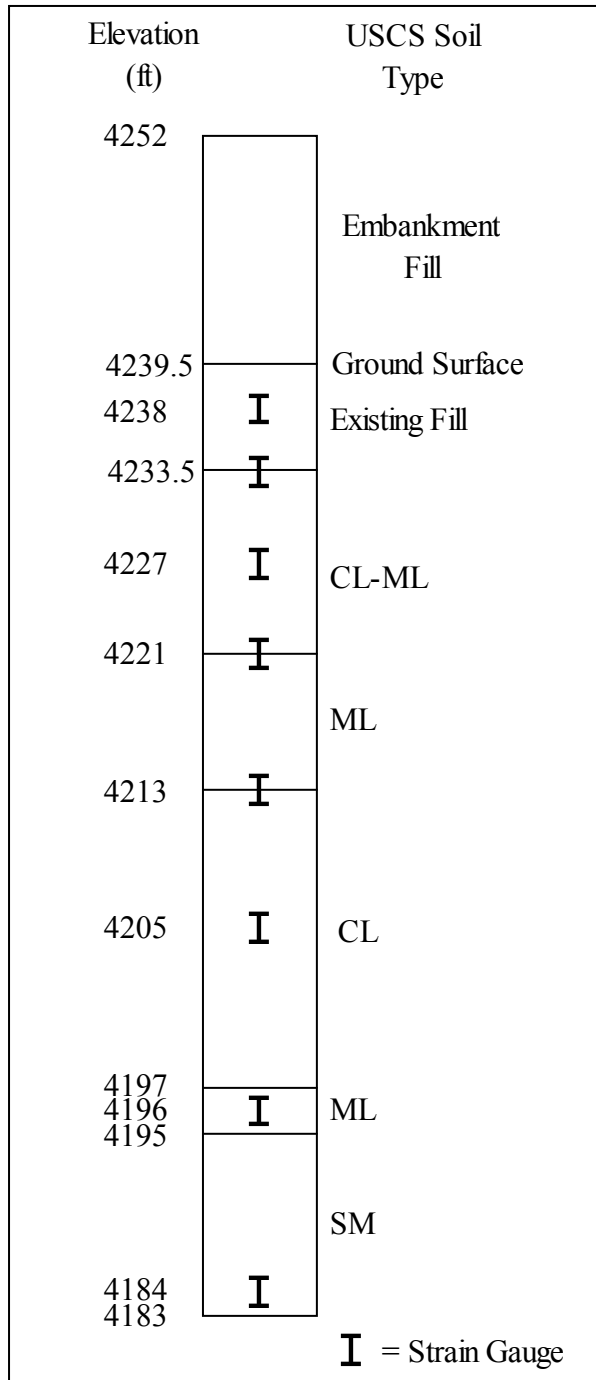
**Figure 5-3 Location of Gauges on Test Pile at Redwood Road & SR-201**

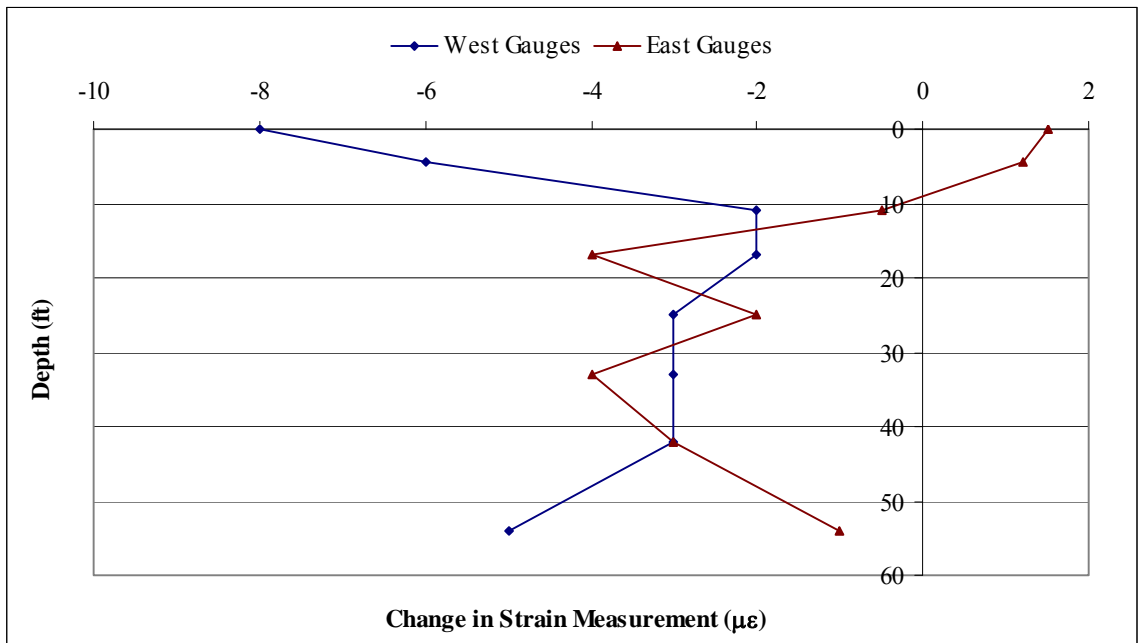
**Figure 5-6 Comparison of Change in West and East Gauges between Readings on 1 July and 14 July 2005**

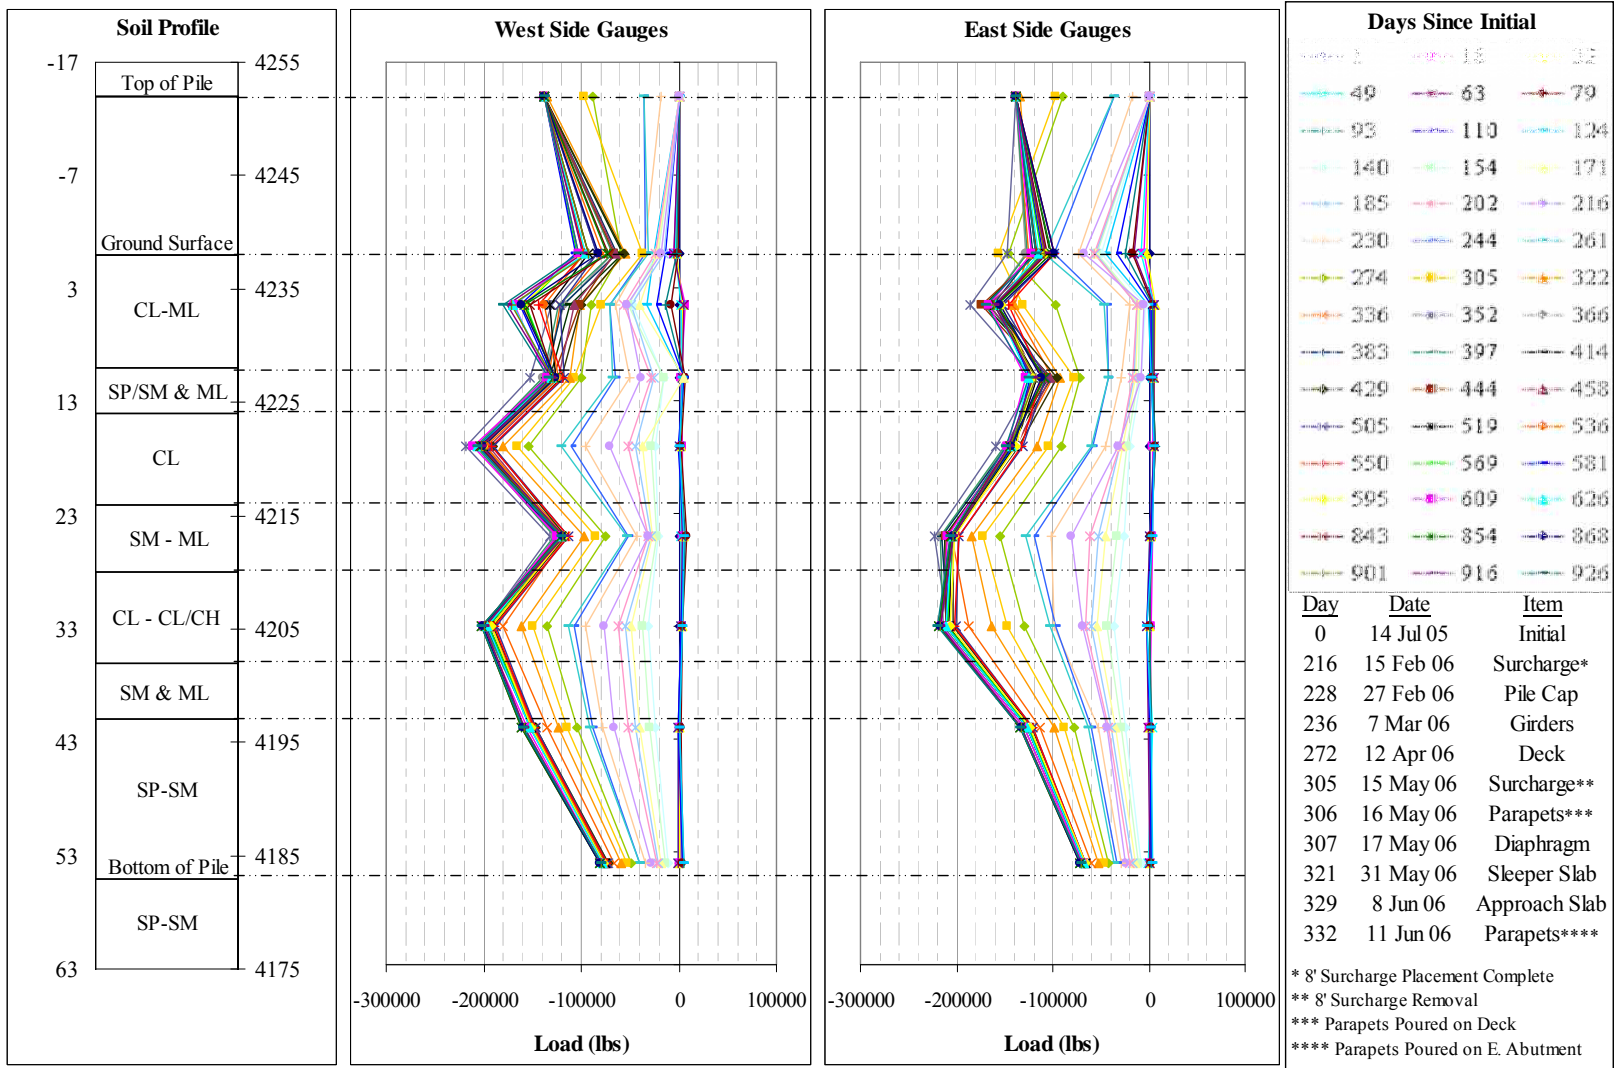
Figure 5-7 Comparison of West and East Gauges for Redwood Road and SR-201 Site

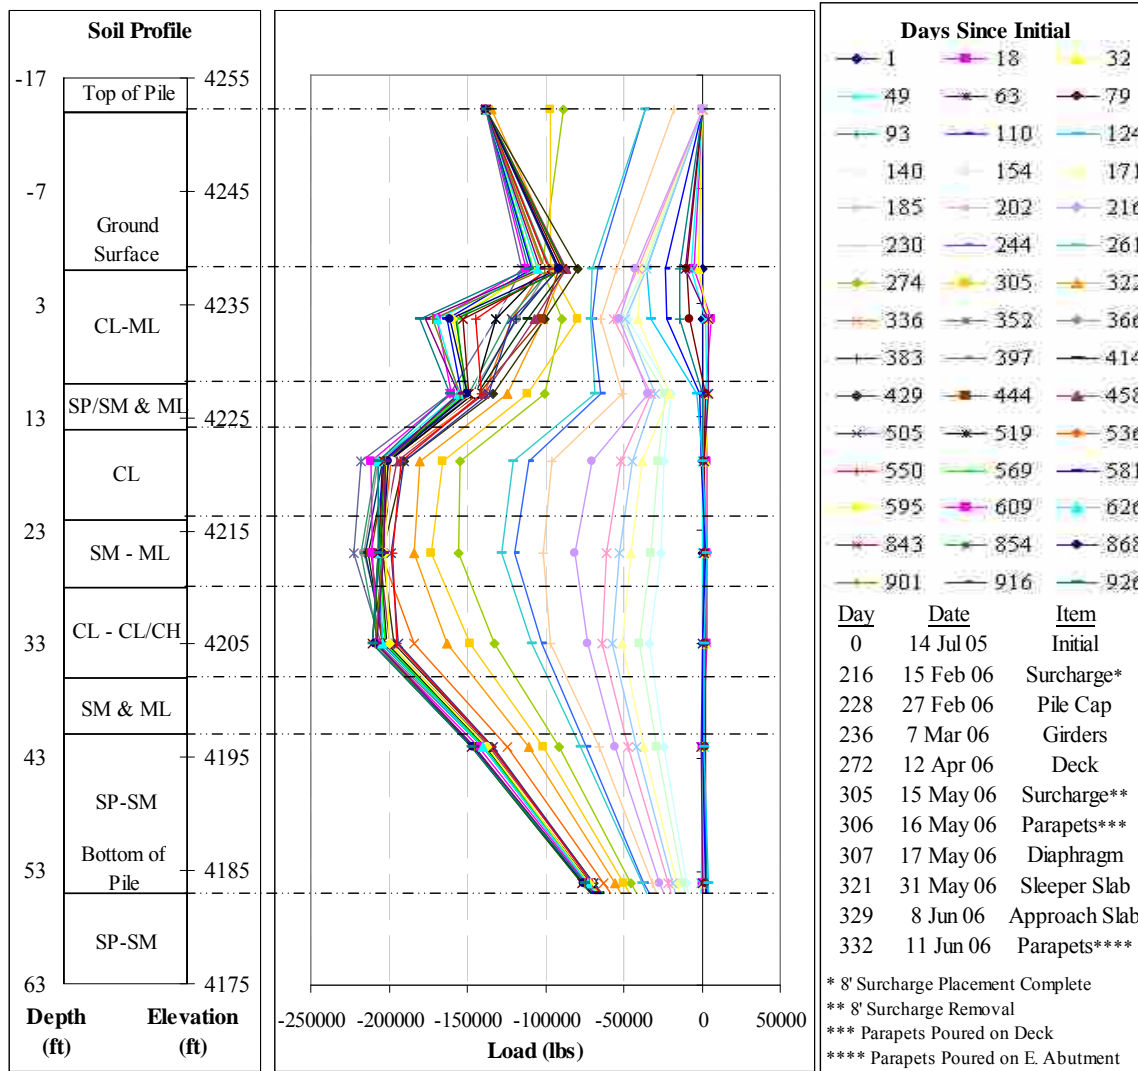
**Figure 5-8 Plot of Axial Load vs. Depth and Time using Best Combination of Gauges for Redwood Road and SR-201**

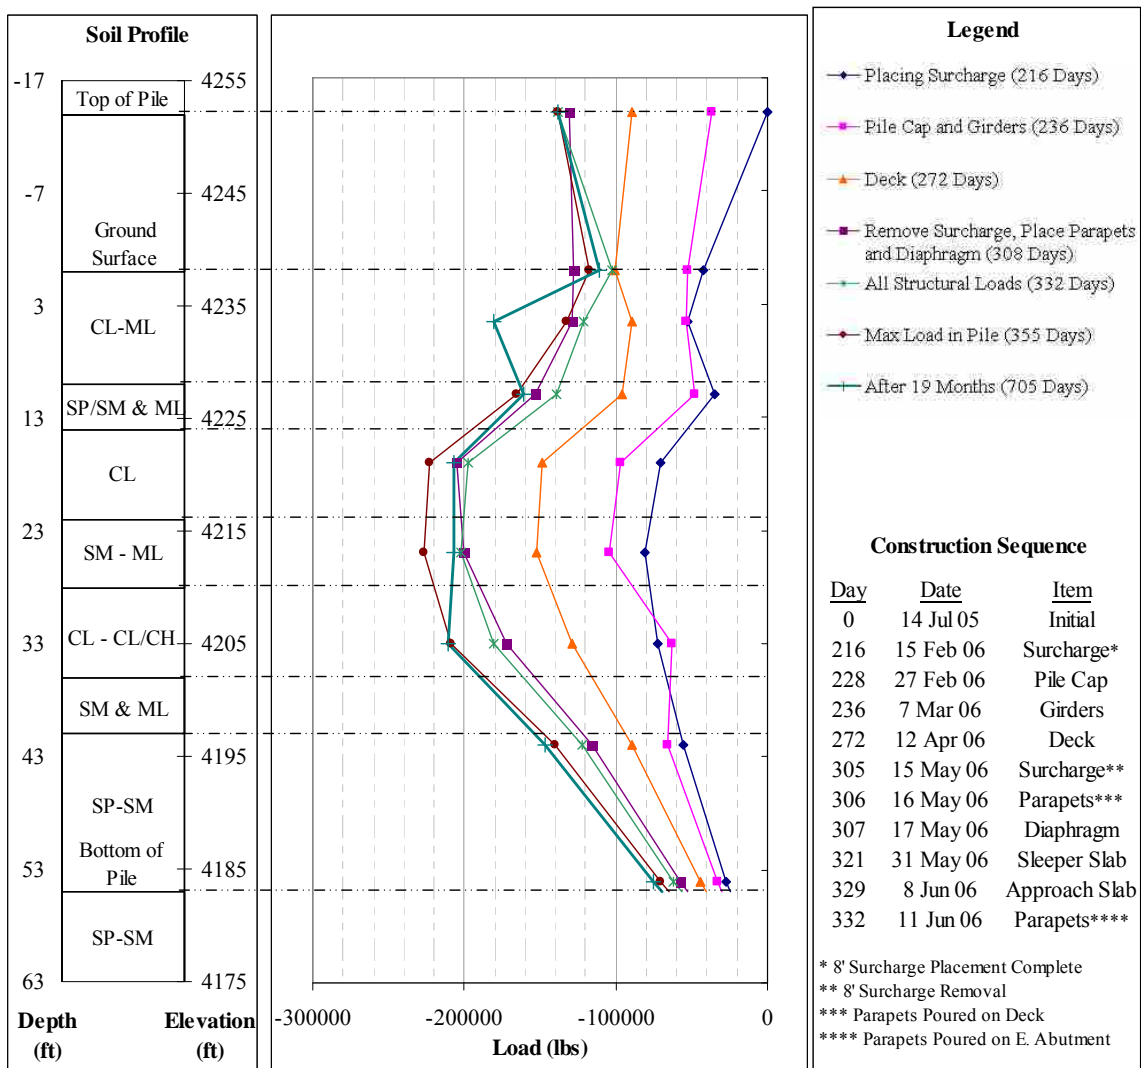
Figure 5-9 Simplified Plot of Axial Load vs. Depth and Time for Redwood Road Site

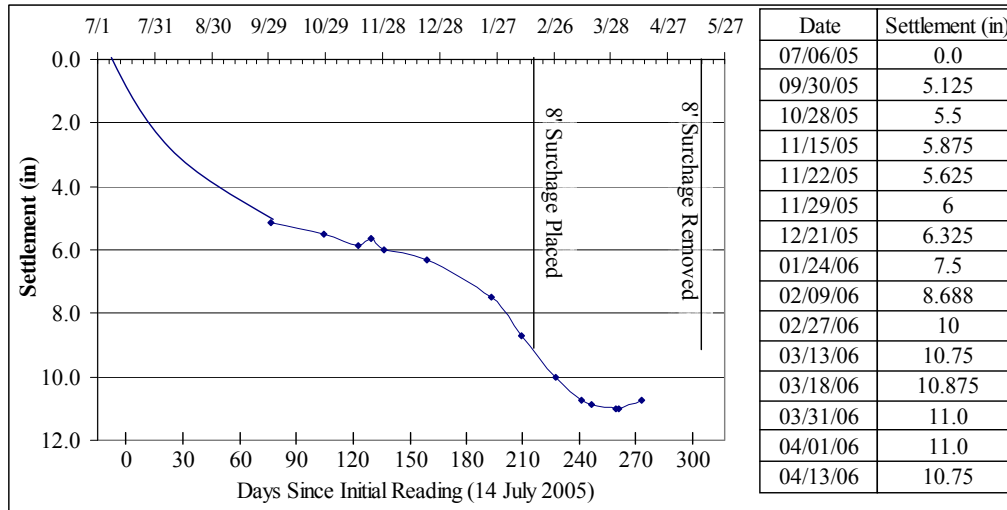
**Figure 5-11 Settlement Time History Near East Abutment for Redwood Road and SR-201 Site**

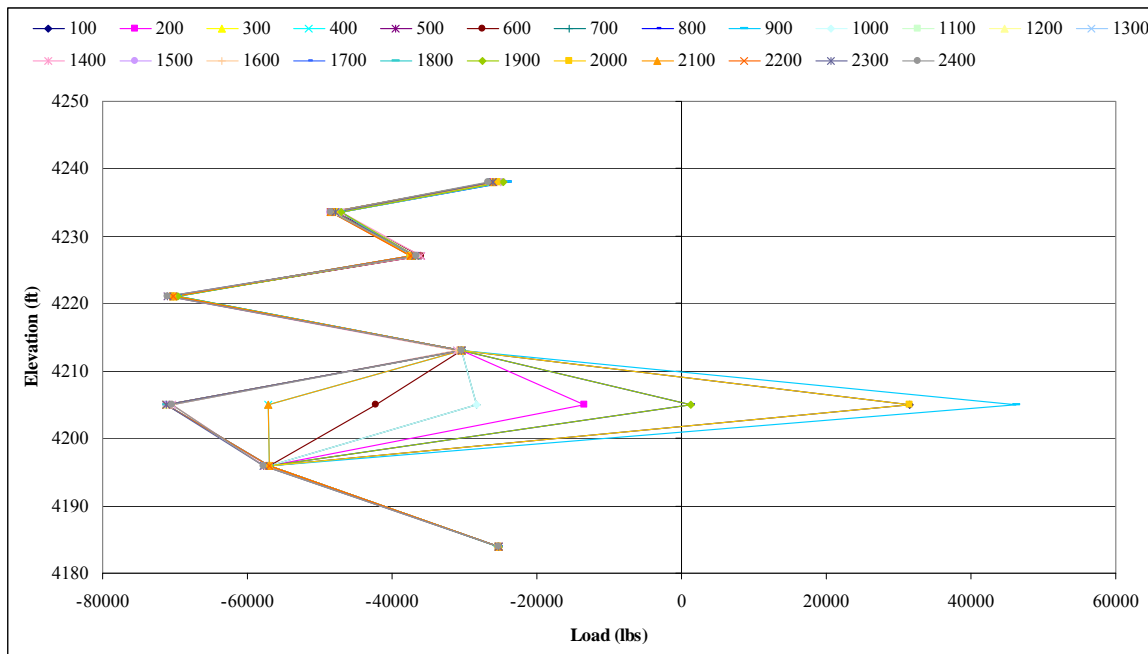
Figure 5-12 Plot of Hourly Readings for West Gauge on 28 February 2006

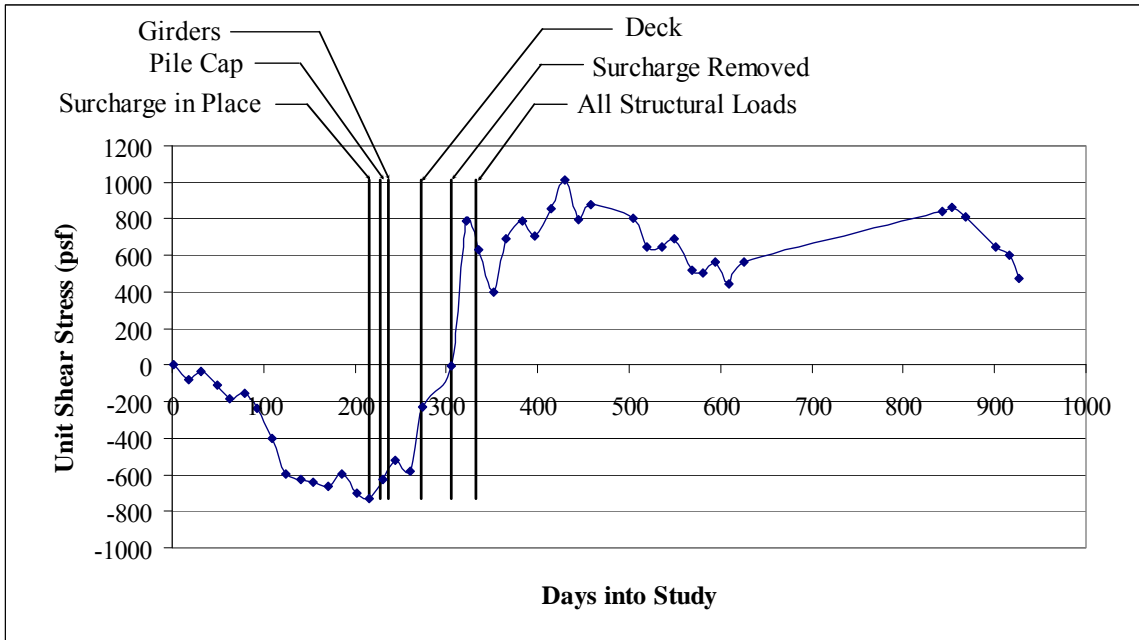
**Figure 5-16 Shear Stress on Pile at Redwood Road & SR-201 from El. 4252 to El. 4238 (Within Approach Fill)**

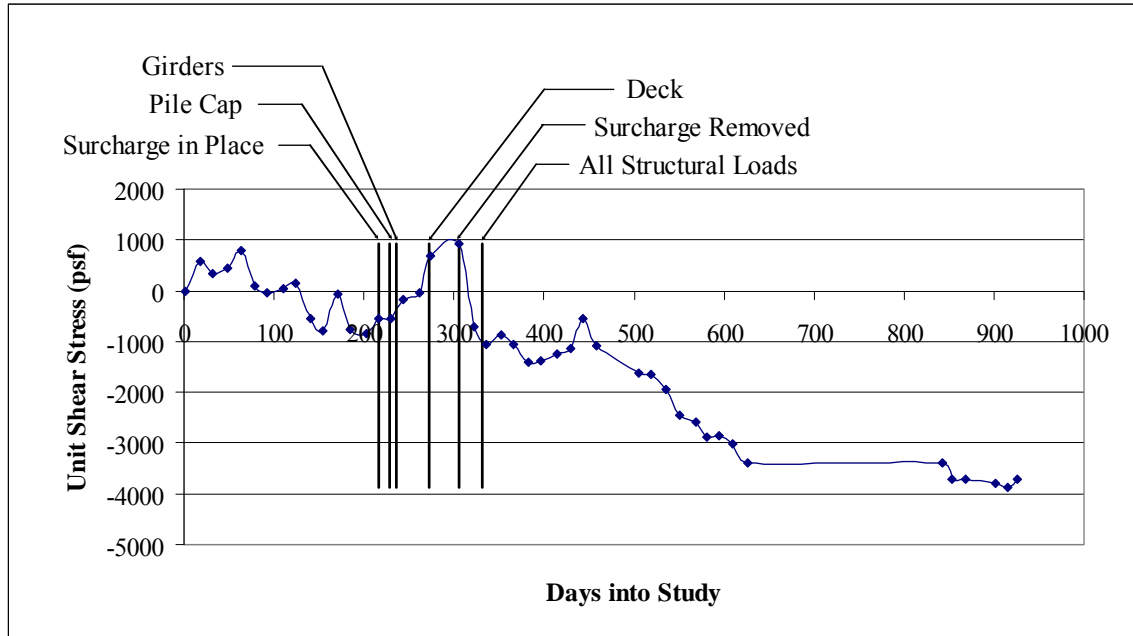
Figure 5-17 Shear Stress on Pile from El. 4238 to El. 4233.5

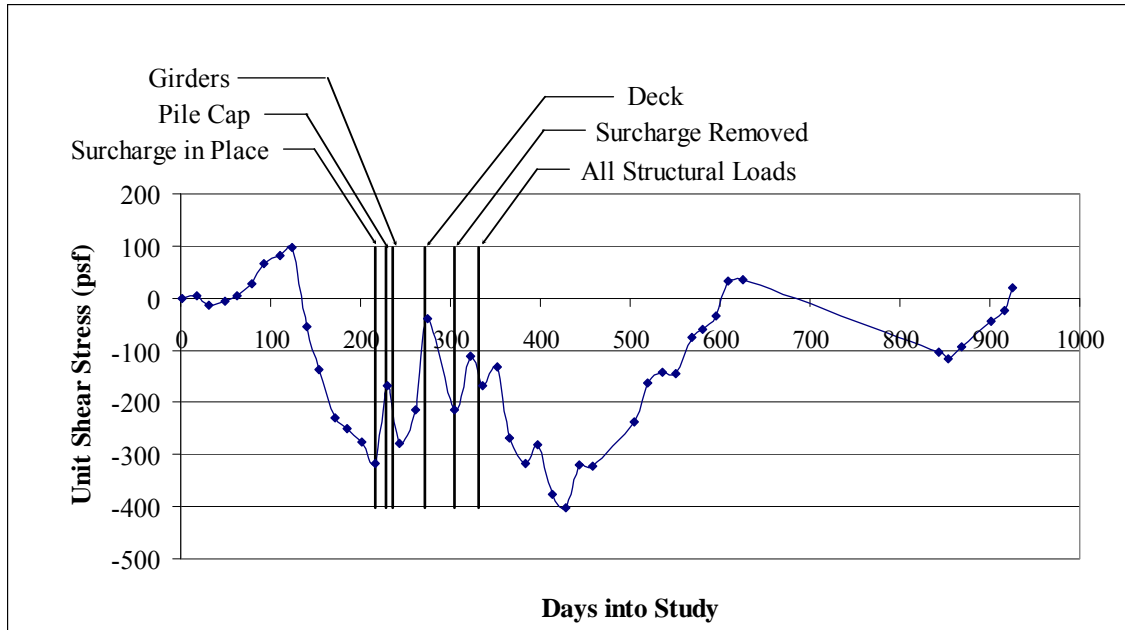
**Figure 5-20 Shear Stress on Pile from El. 4221 to El. 4213**

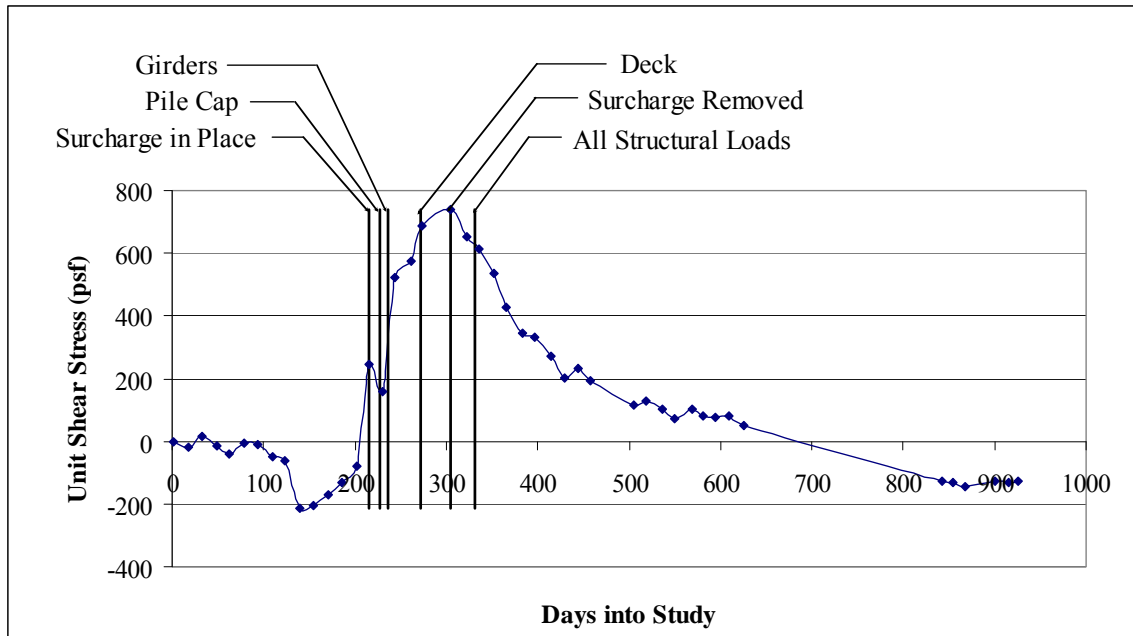
**Figure 5-21 Shear Stress on Pile from El. 4213 to El. 4205**

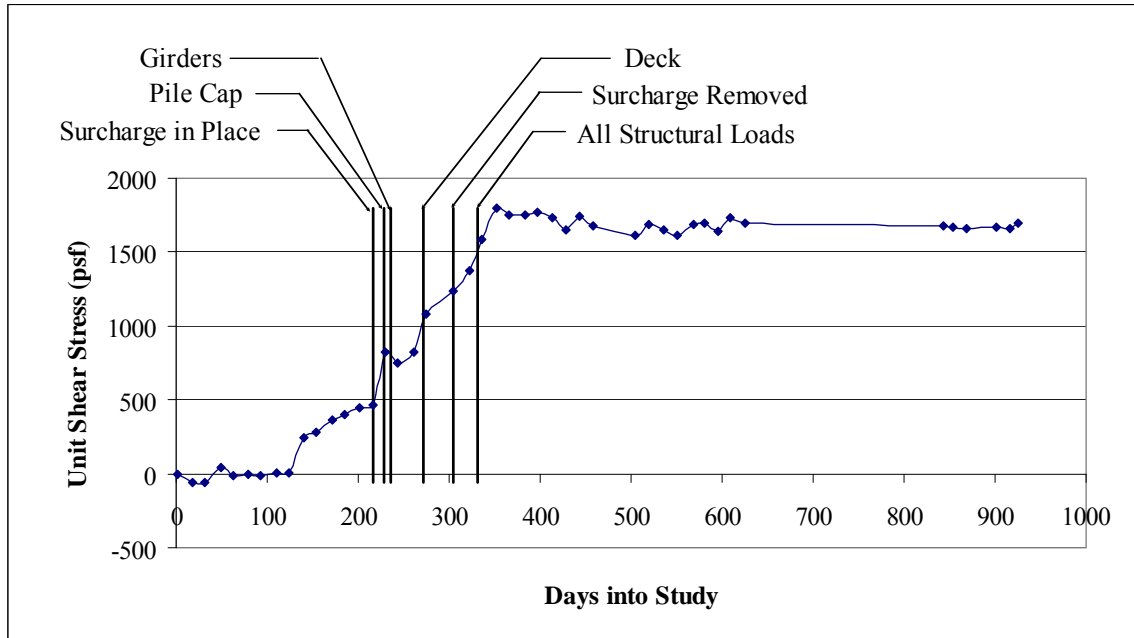
Figure 5-22 Shear Stress on Pile from El. 4205 to El. 4196

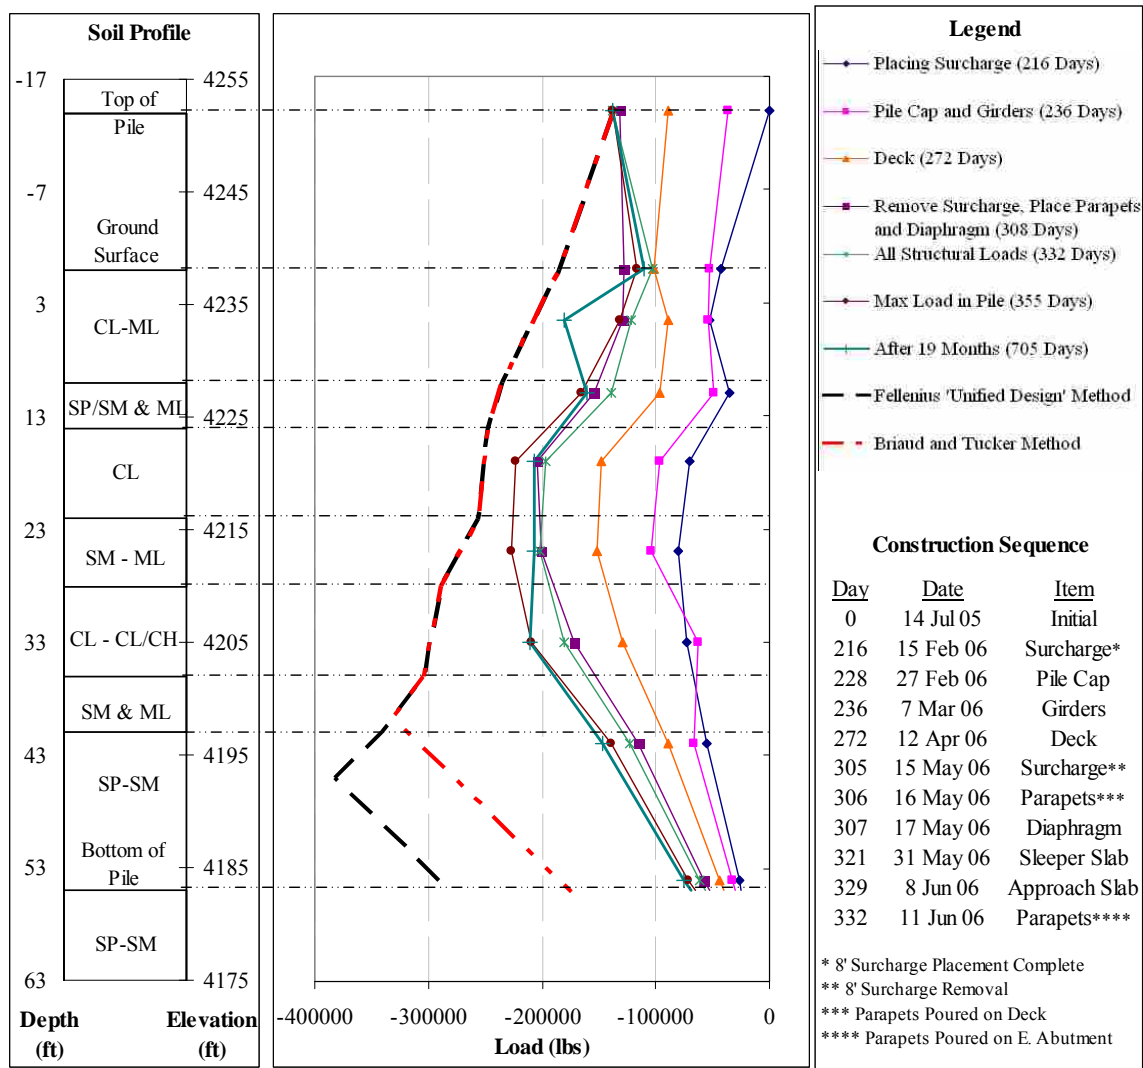
**Figure 5-25 Plot of Select Load vs. Depth Curves for Redwood Road and SR-201 Site Showing Comparison of Estimated Load in Pile from Methods by Fellenius (1989) and Briaud and Tucker (1997)**

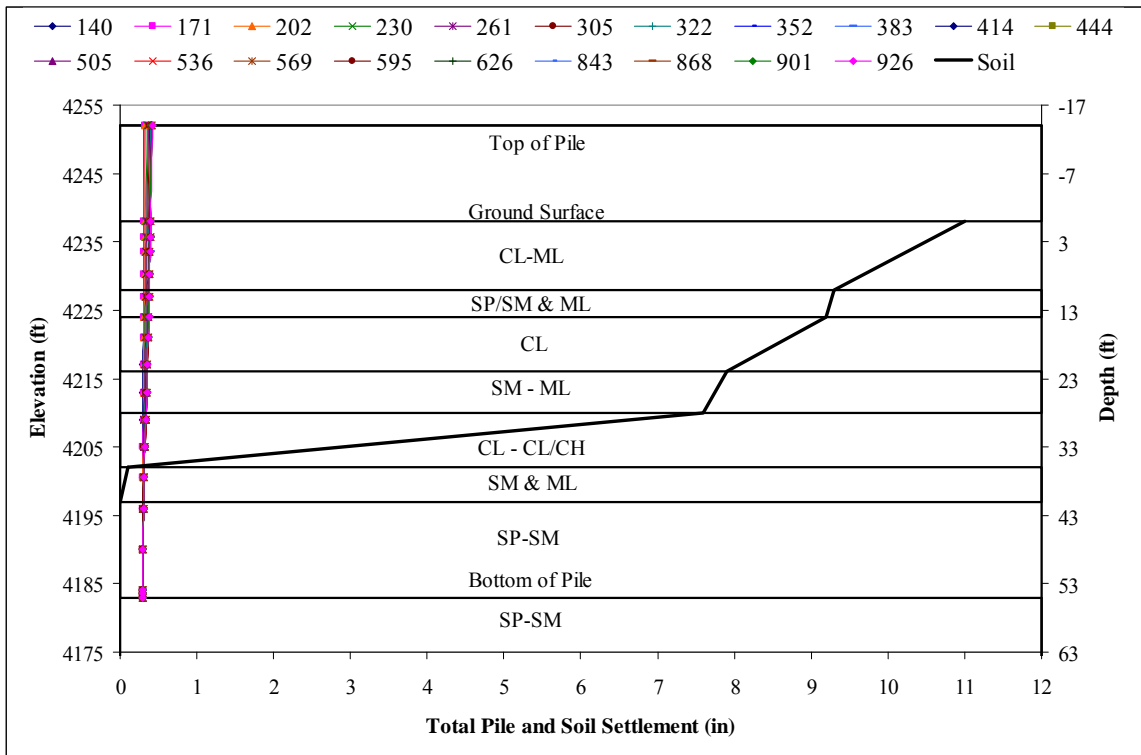
**Figure 5-26 Settlement of Pile and Soil for Redwood Road and SR-201**
