# Pile Downdrag During Construction of Two Bridge Abutments

PILE DOWNDRAW DURING CONSTRUCTION OF  
TWO BRIDGE ABUTMENTS

Department of Civil and Environmental Engineering

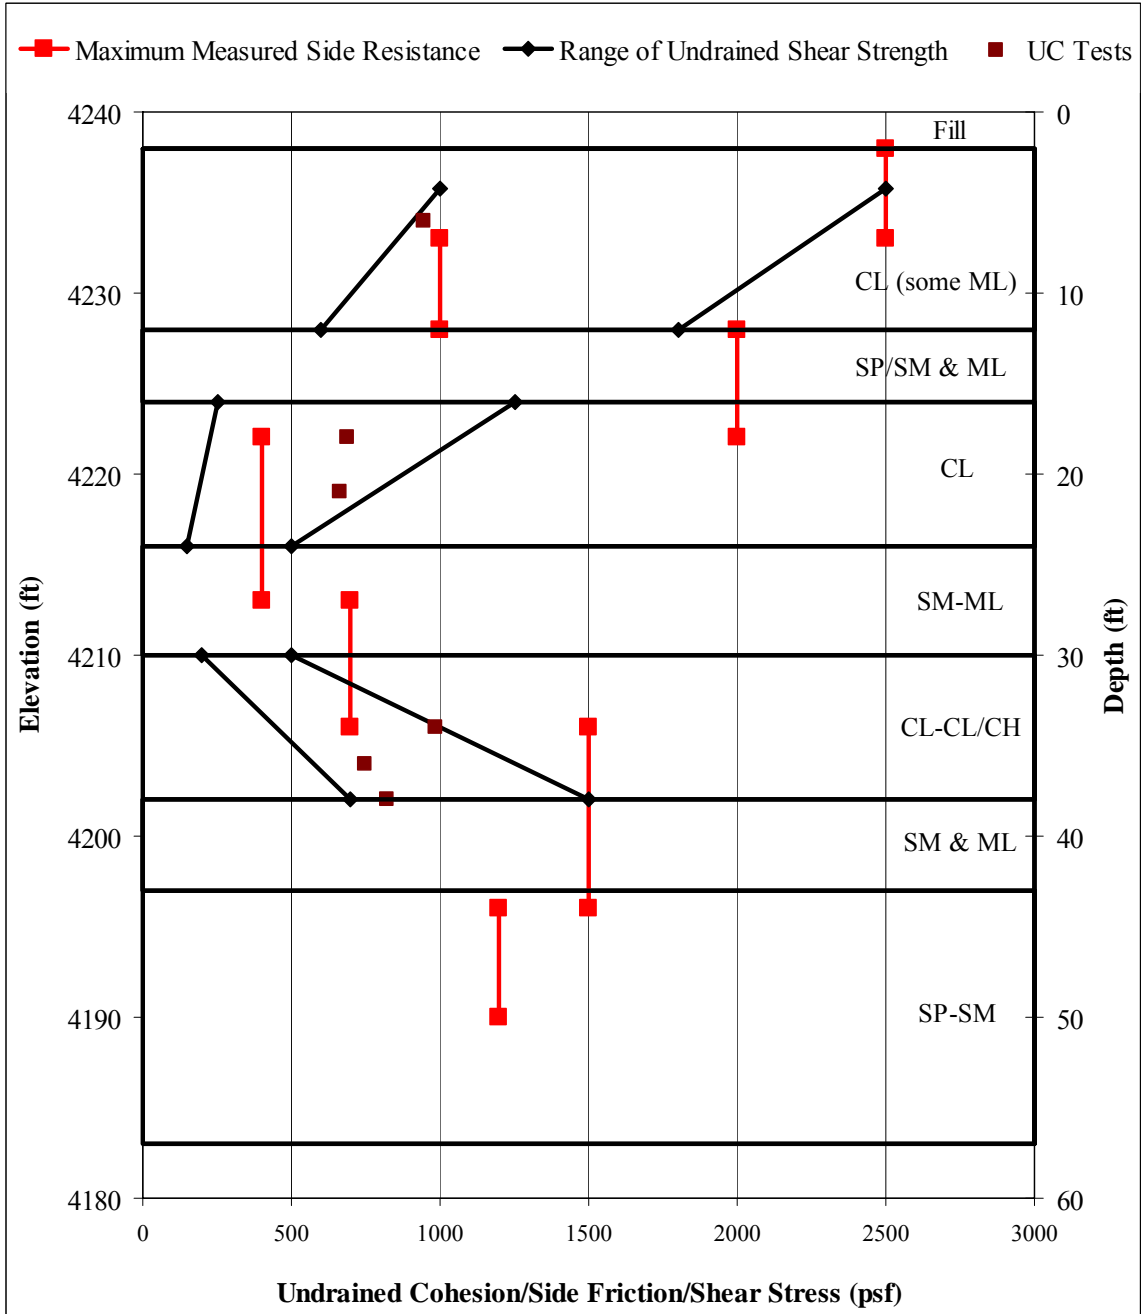
**Figure 5-28 Comparison Plot of Measured Undrained Cohesion or Calculated Side Friction and Maximum Measured Shear Stress vs. Depth for Redwood Road and SR 201 Site**

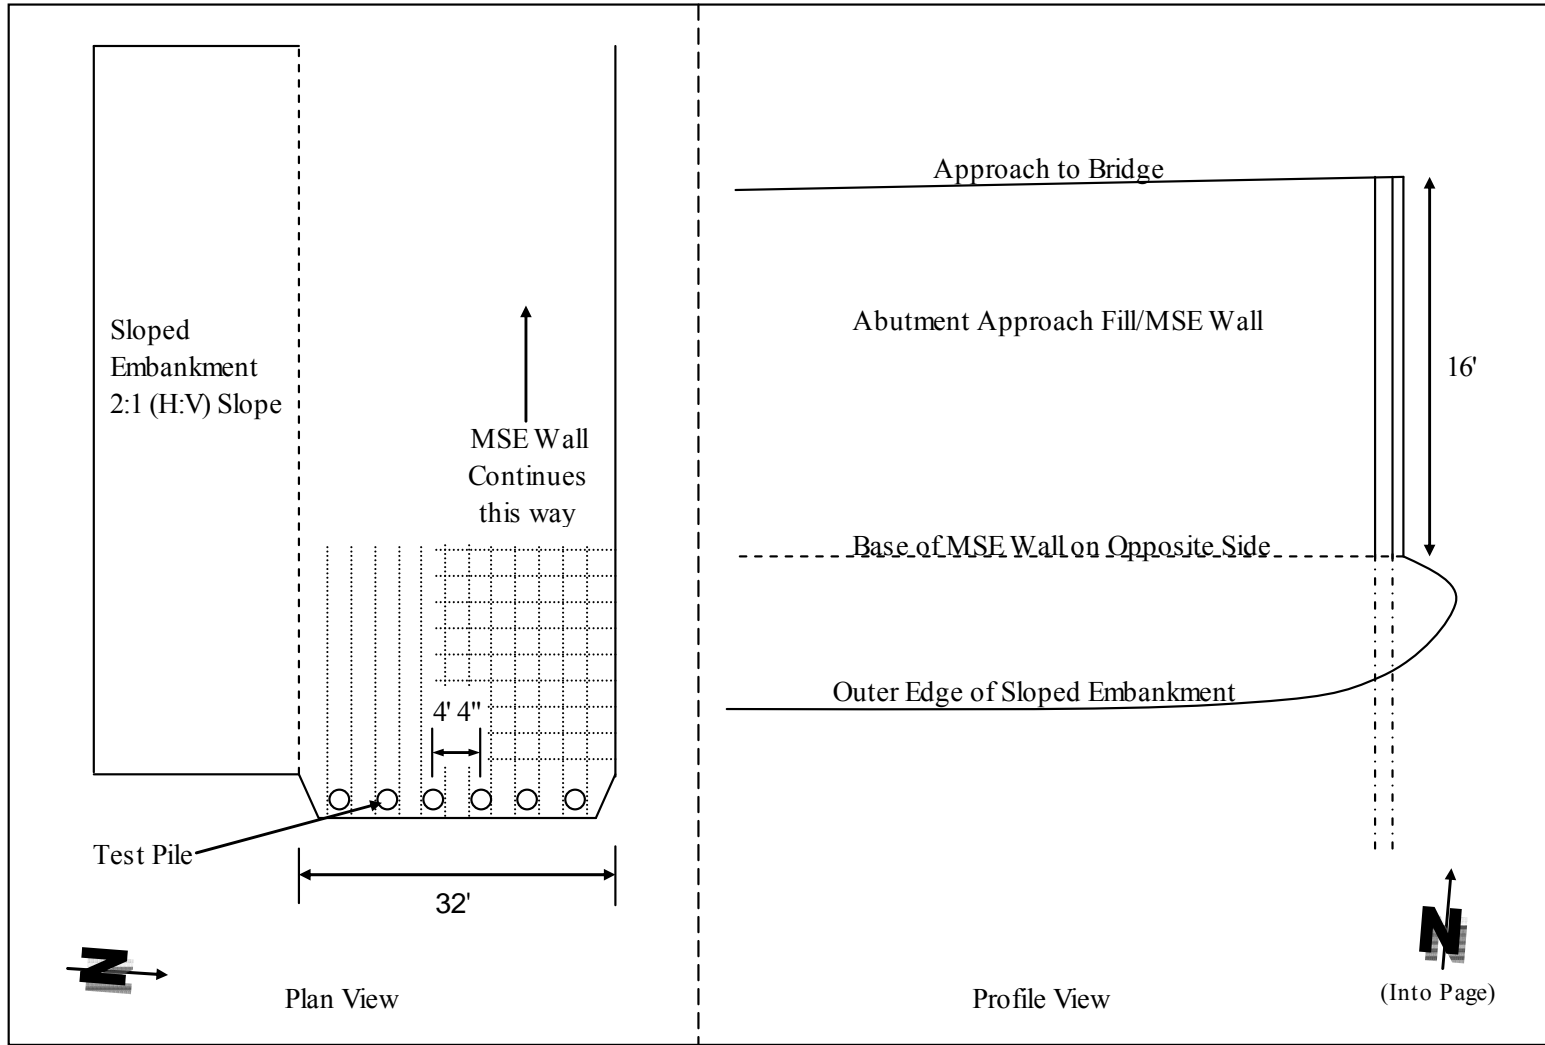
Figure 6-1 Plan and Profile View of West Abutment at SLCIA Site

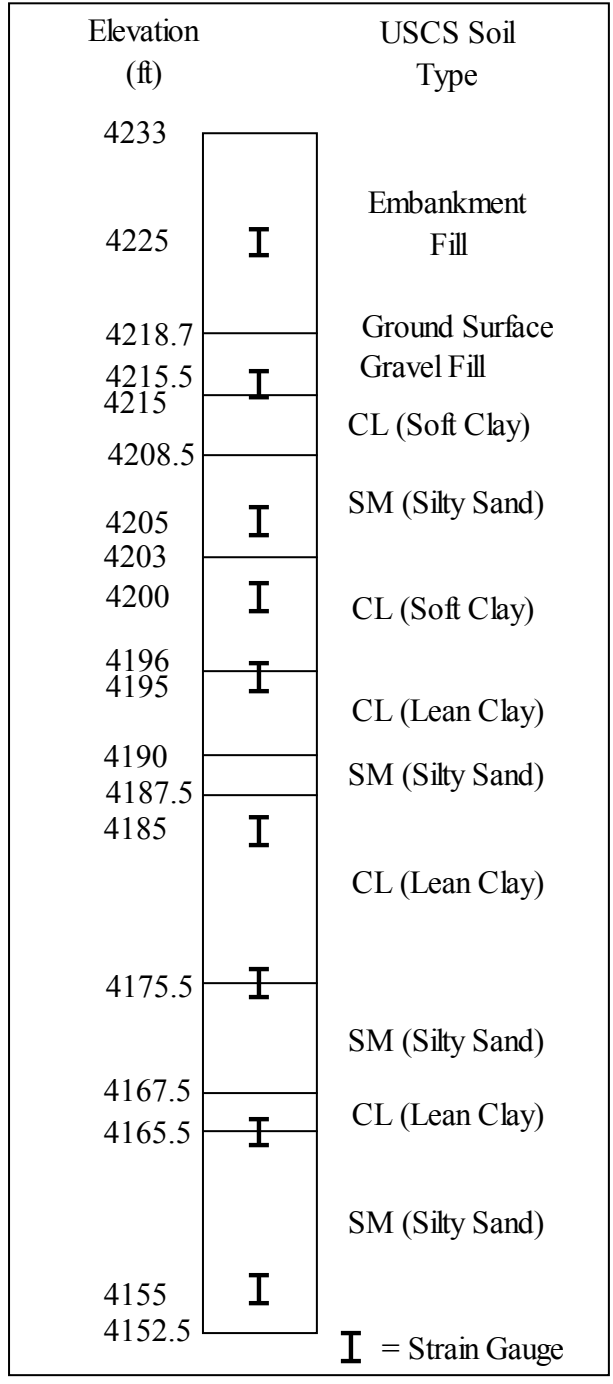
Figure 6-2 Location of Gauges on Test Pile at SLCIA Site Relative to the Soil Layering

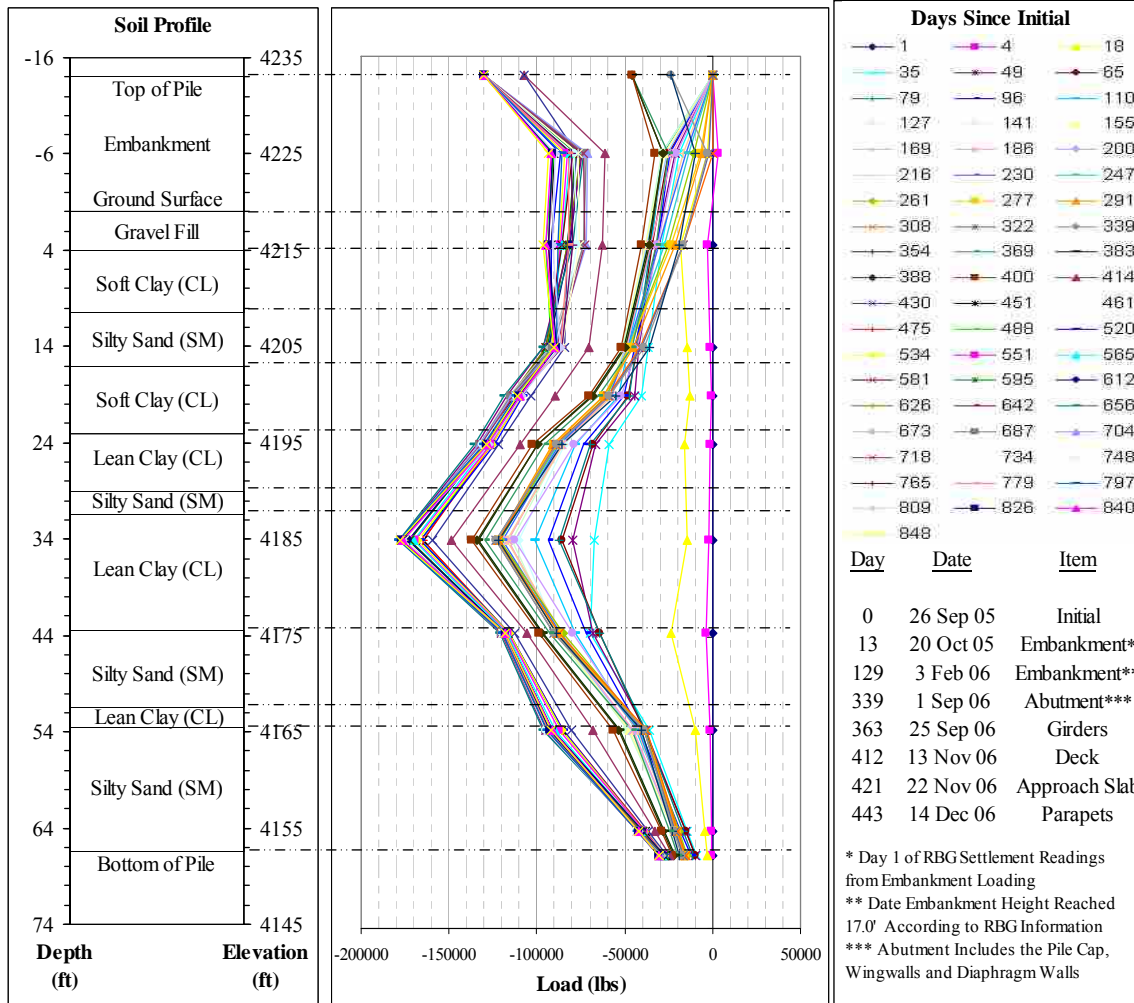
**Figure 6-4 Plot of Axial Load vs. Depth and Time using Best Combination of Gauges for SLCIA Site**

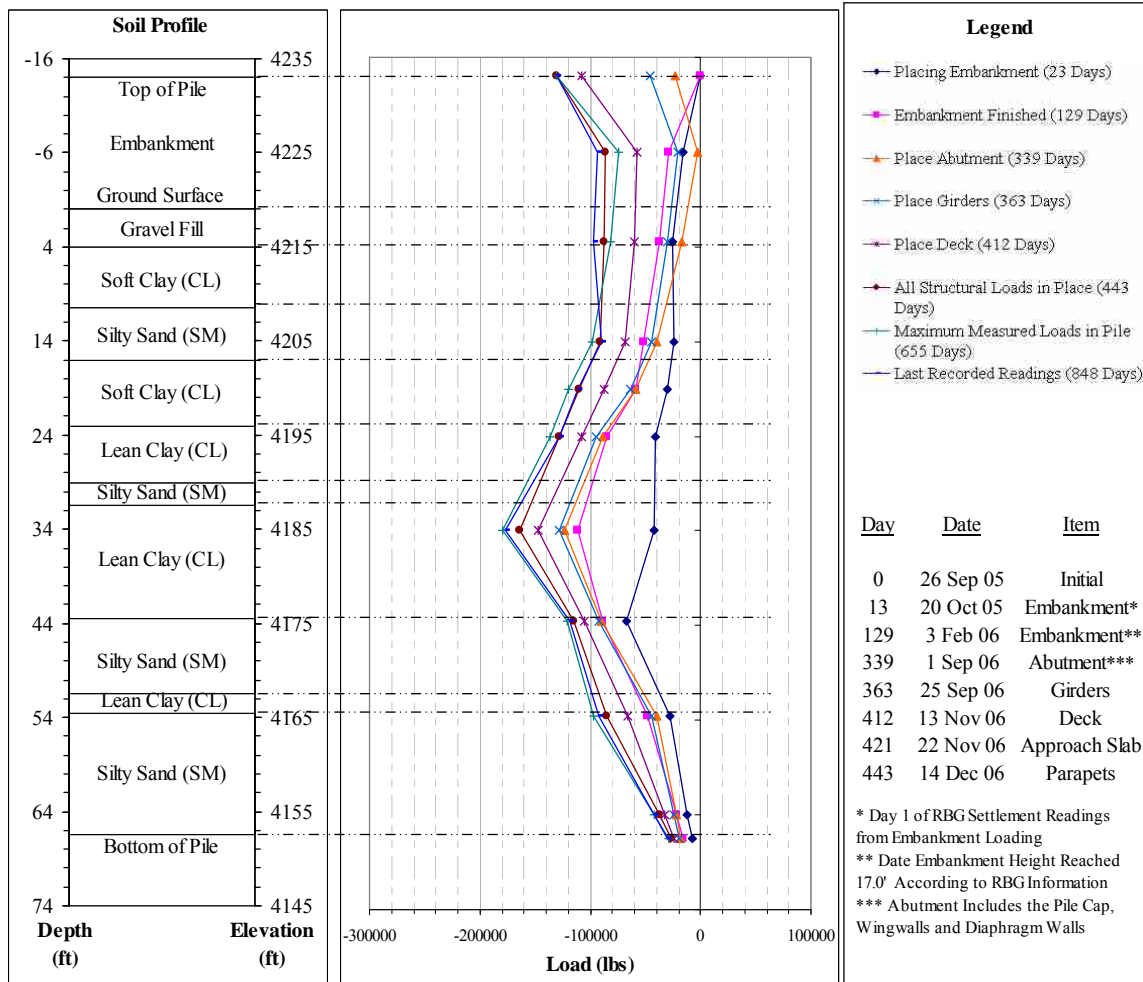
Figure 6-5 Simplified Plot of Axial Load vs. Depth and Time for SLCIA Site

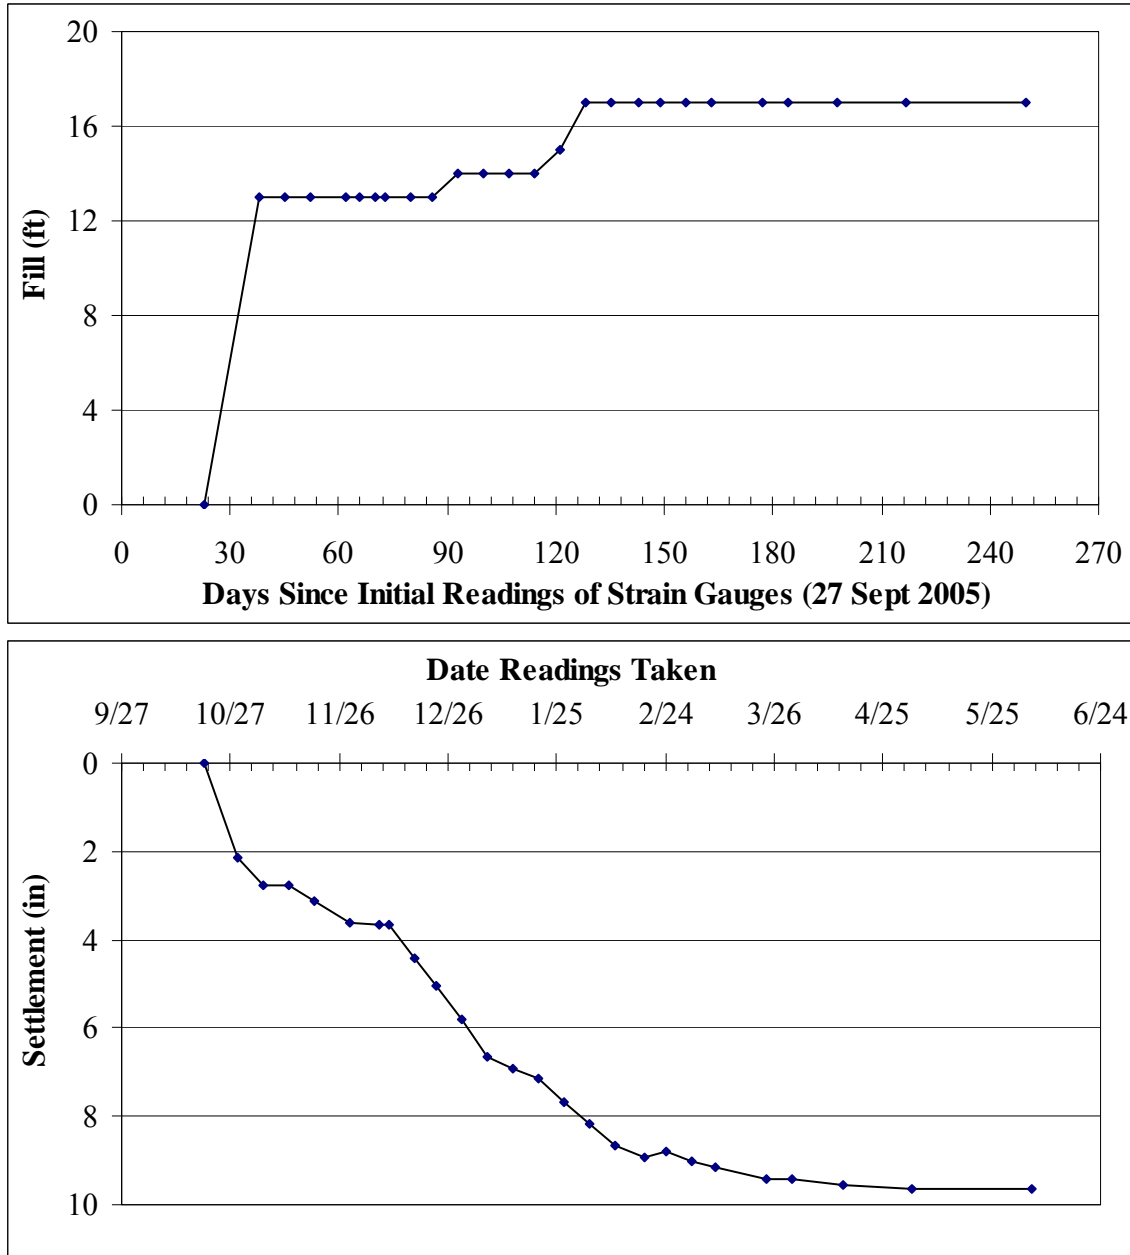
Figure 6-6 Settlement vs. Fill Height for SLCIA Site (data provided by RB&G Engineering)

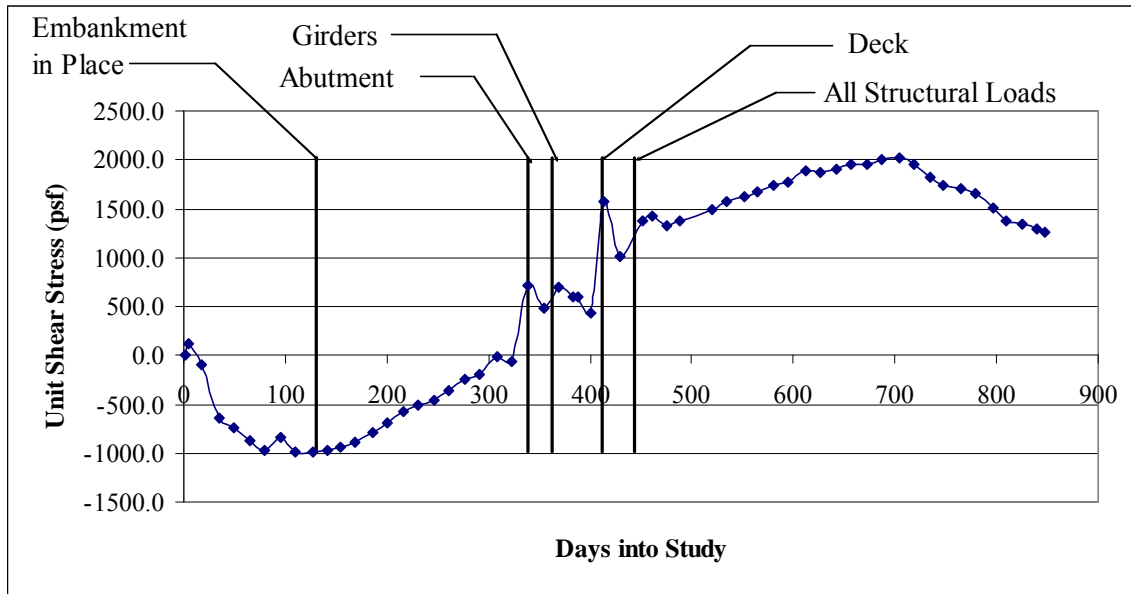
**Figure 6-8 Plot of Shear Stress between El. 4233 and El. 4225**

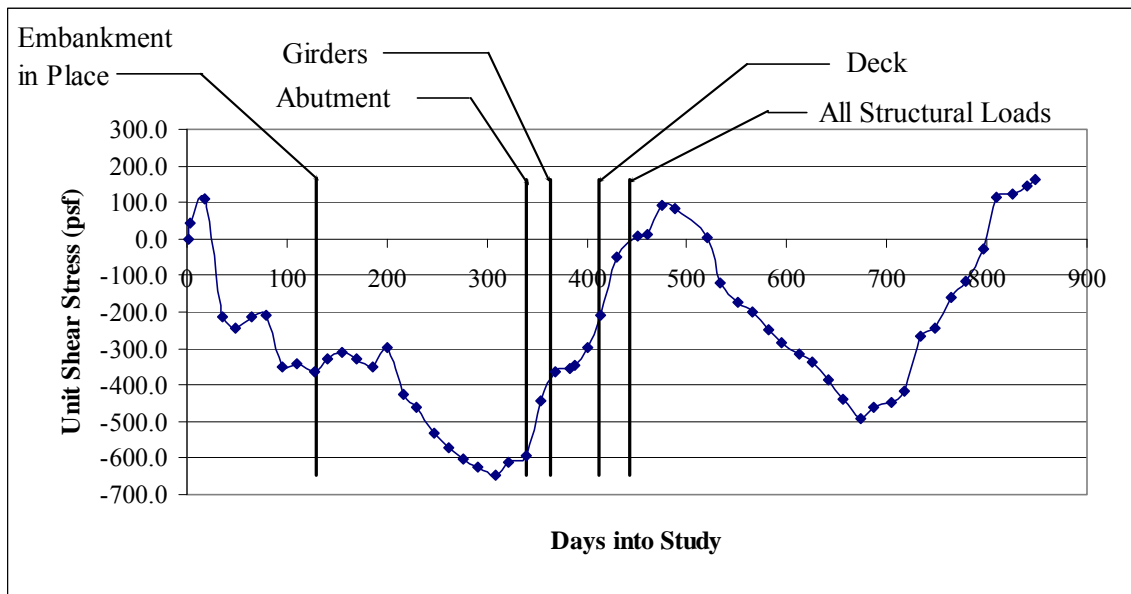
Figure 6-10 Plot of Shear Stress between El. 4215.5 and El. 4205

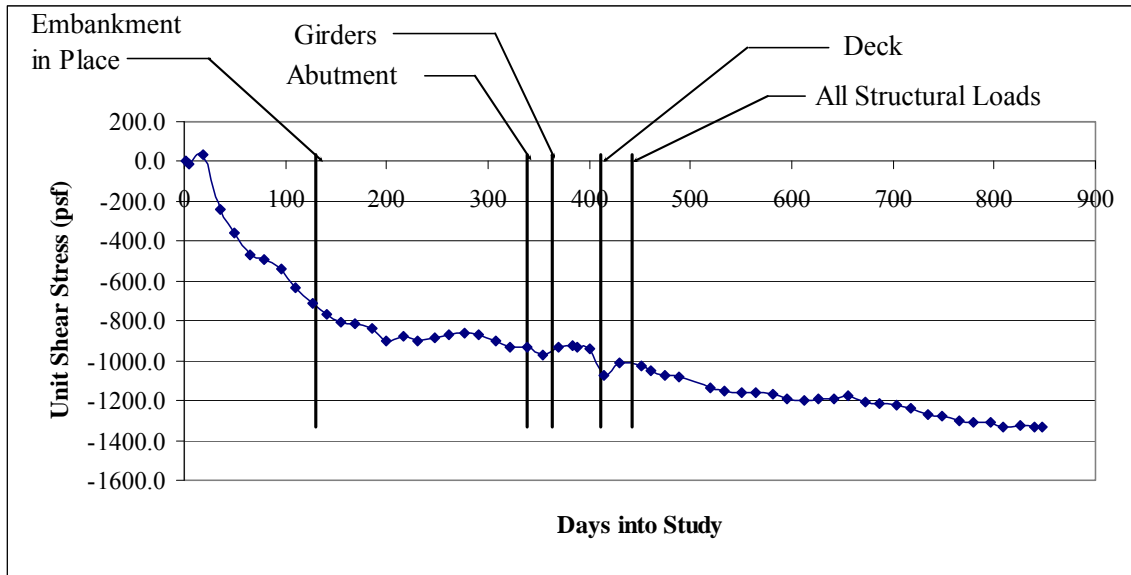
**Figure 6-13 Plot of Shear Stress between El. 4195 and El. 4185**

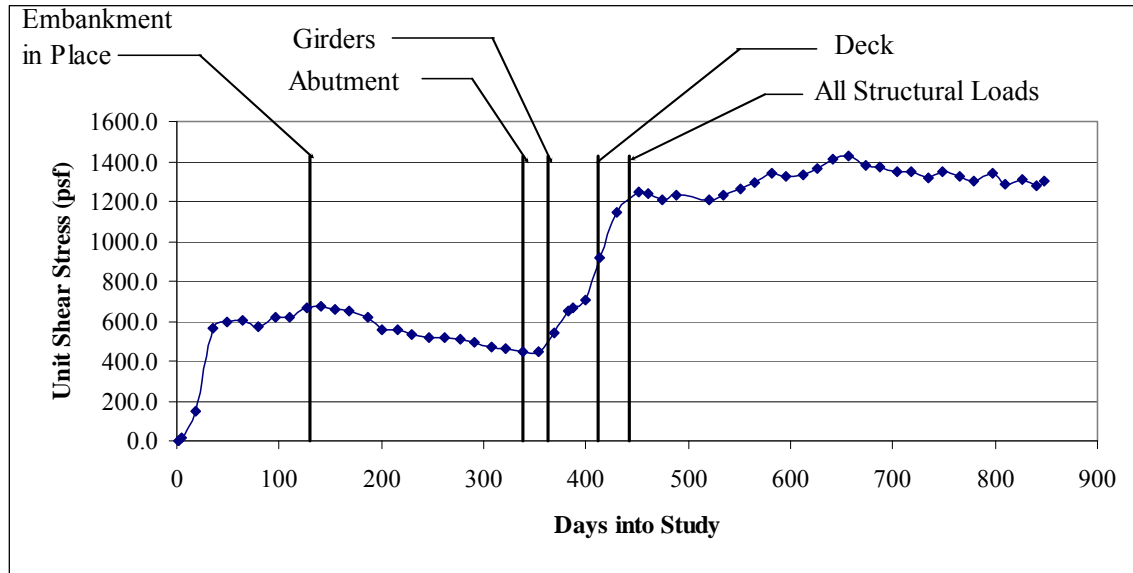
Figure 6-16 Plot of Shear Stress between El. 4165.5 and El. 4155

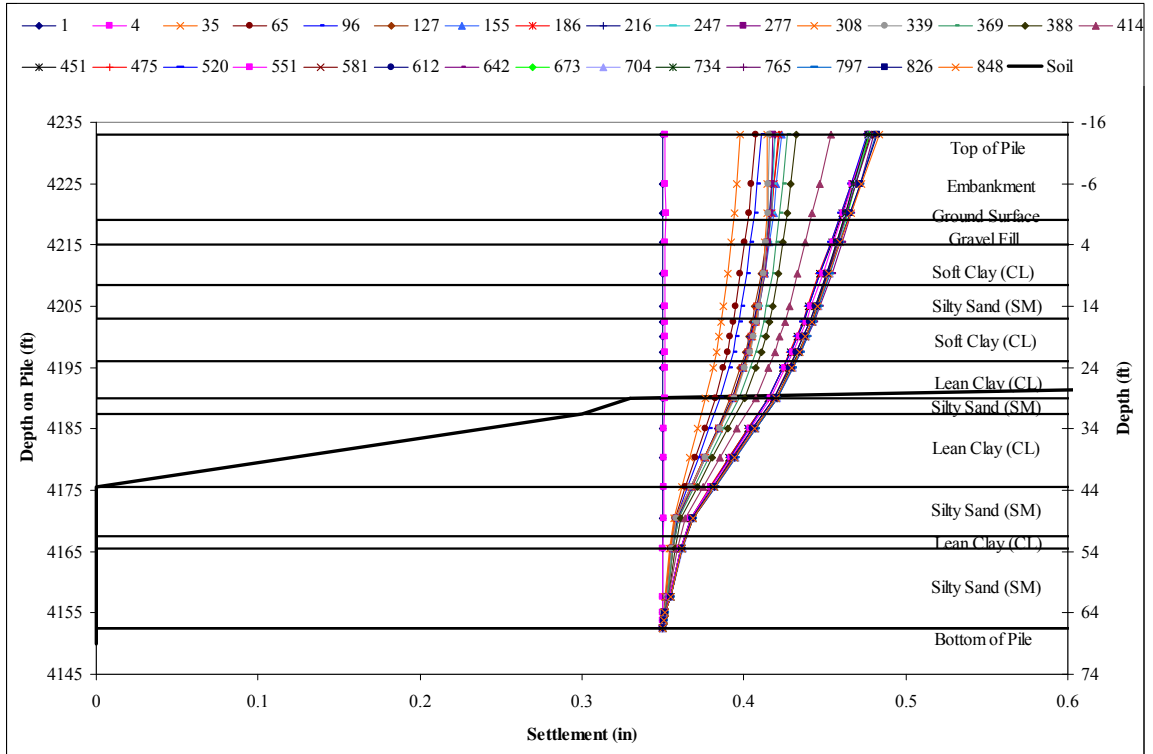
Figure 6-20 Close-up of Soil and Pile Settlement for SLCIA Site

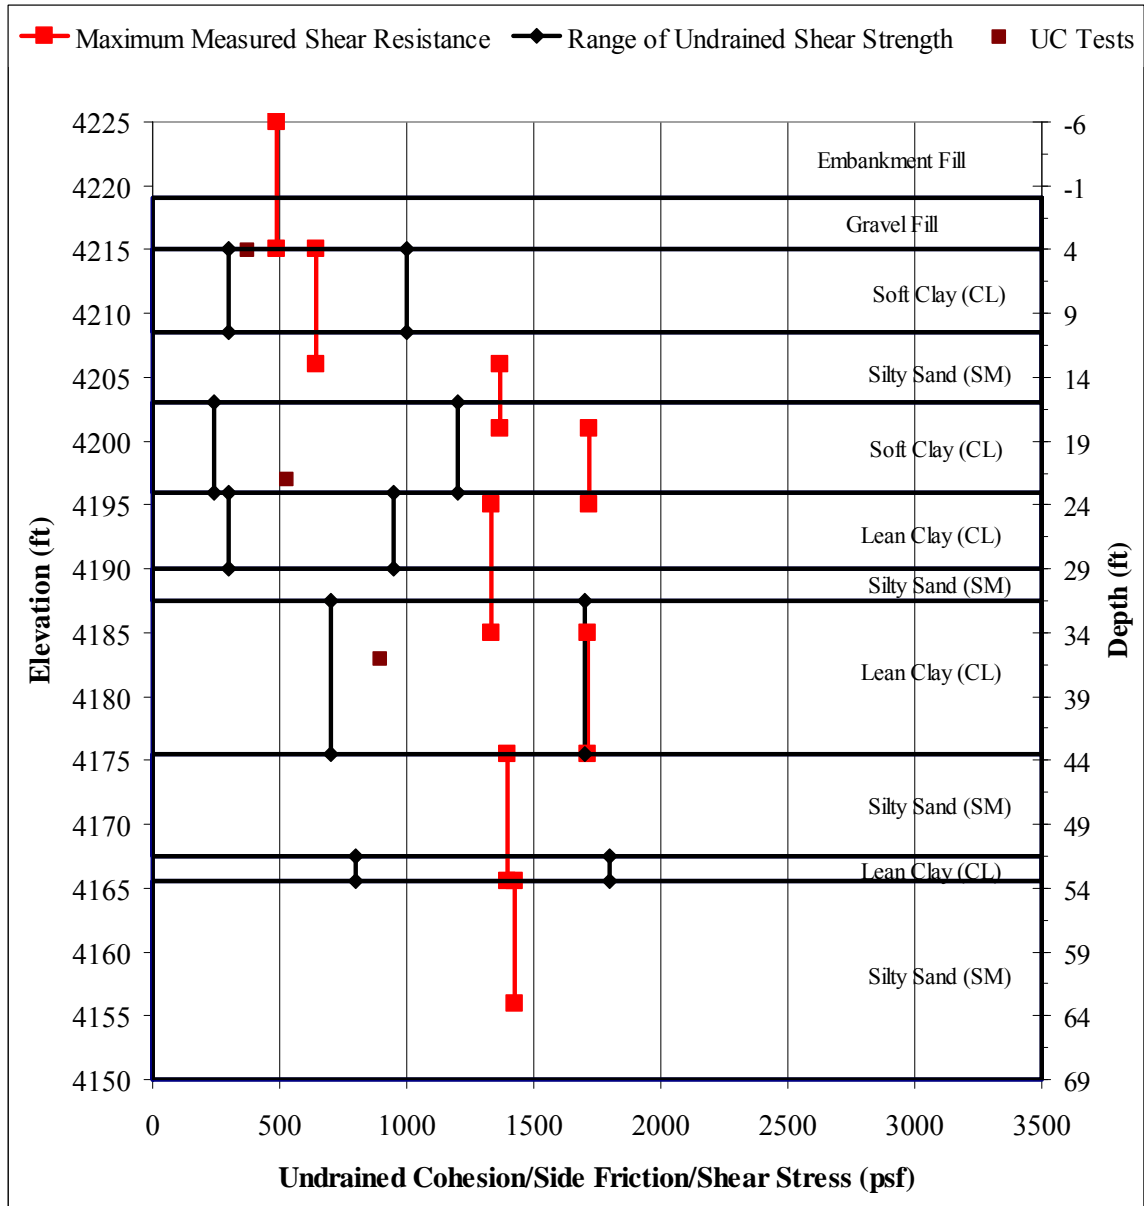
**Figure 6-21 Comparison Plot of Measured Undrained Cohesion or Calculated Side Friction and Maximum Measured Shear Stress vs. Depth for SLCIA Site**
