Investigation of steel stringer bridge superstructures

Jeremy Craig Koskie

Major: Civil Engineering (Structural Engineering)

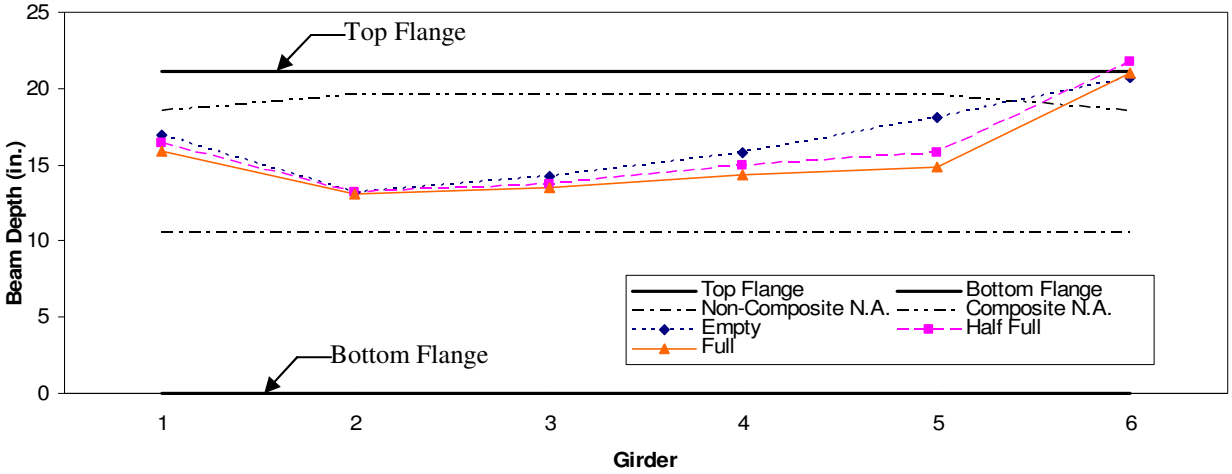
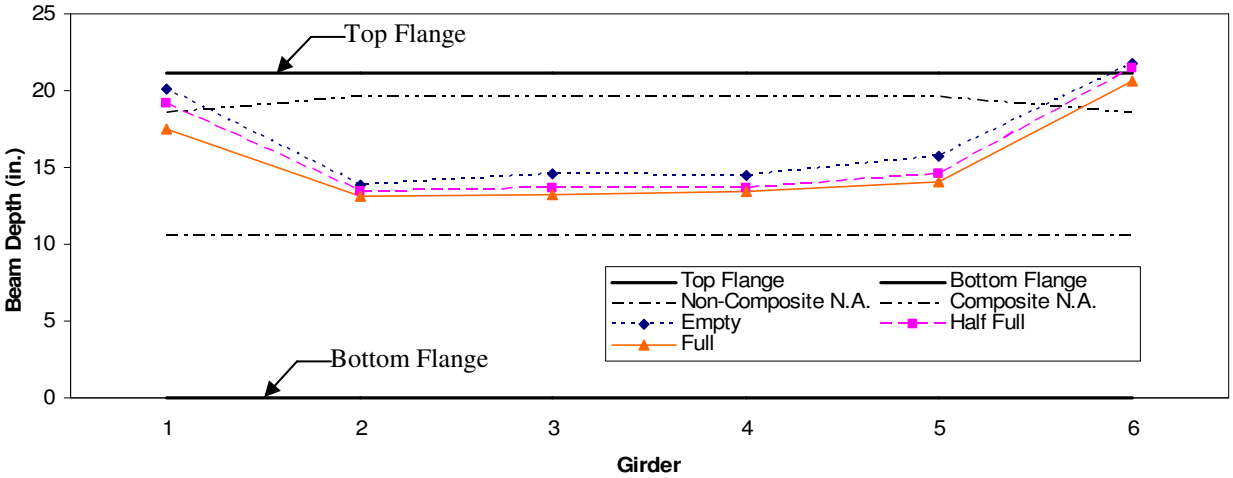
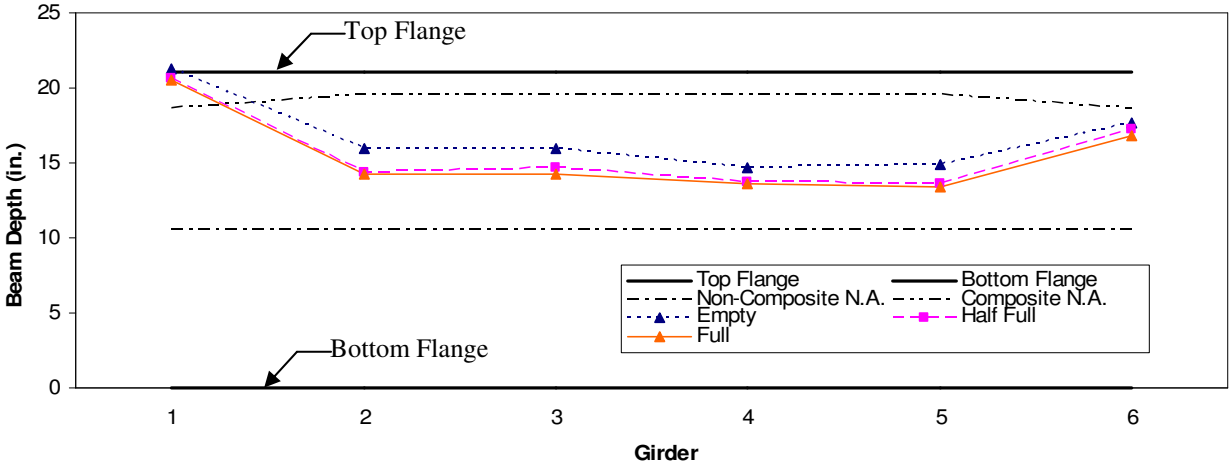
Figure 3.19. BCB Neutral Axis Locations.

The neutral axis locations, shown in Figure 3.19, were determined by interpolating between the top and bottom flange strains to determine the location on the girder where the strain was equal to zero. Partial composite action, shown simply by the location of the neutral axes being located between the theoretical composite and non-composite neutral axis locations, was observed in all of the girders for each of the three lanes loaded. The partial composite action deteriorated with increased loading; this can be seen in Figure 3.19 by the neutral axis location moving toward the non-composite neutral axis location with the increased loading.

A neutral axis location above the top flange, as observed in Figure 3.19(a) and (b) for Girder 6, indicates the neutral axis for the girder was located in the concrete deck. The two exterior girders exhibited considerably higher stiffnesses than the interior girders as determined by a much higher neutral axis location which is indicative of a composite section. When directly loaded, the neutral axis of the exterior girders was close to that of a fully composite girder, but when the load was on the opposite side of the bridge, the neutral axis location was above the theoretical composite neutral axis location. This can be attributed to the very small top flange strain values (1 and 0 microstrain in Lane 1 and Lane 3, respectively as displayed in Table 3.3) observed in the girders that were on the opposite side of the bridge as the loading. The increased stiffness can be attributed to the concrete curb and the steel railing which were not included in the calculation of the composite neutral axis location. Neutral axis profiles for Lane 1 and Lane 3 were close to the mirror images of each other which demonstrate bridge symmetry.

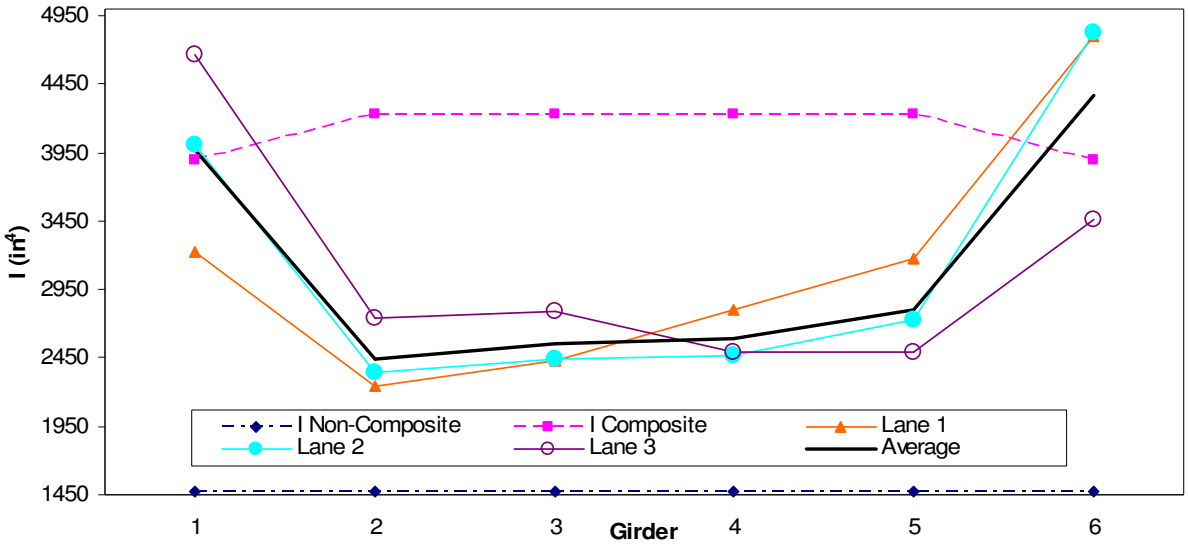
Figure 3.21. BCB Effective Moments of Inertia.

The non-composite moment of inertia for the steel girder is 1,480 in^4 and the composite moment of inertia for the girder with an effective flange width equal to the girder spacing is 4,230 in4 for the interior girders and 3,890 in4 for the exterior girders. The moment of inertia for the exterior girders does not consider the curb or the railing in the calculation. Including the curb alone would result in a moment of inertia for the exterior girders larger than that of the interior girders. The interior girders had moments of inertia that were between those calculated for the composite and non-composite sections; the exterior girders had considerably higher moments of inertia than those calculated for the

composite section. As was the case with the neutral axis locations in the exterior girders that did not have the load directly above them, the relatively small strains observed in the top flanges of the girders caused the moment of inertia to be larger than those calculated from the larger strain values. The increased stiffness of the curb and railing that were not accounted for in the composite moment of inertia calculations account for the difference. The moments of inertia for each girder and lane loading are shown graphically in Figure 3.21 along with the values for the non-composite and composite neutral moments of inertia. An average moment of inertia for the three lane loadings is also provided in this figure.

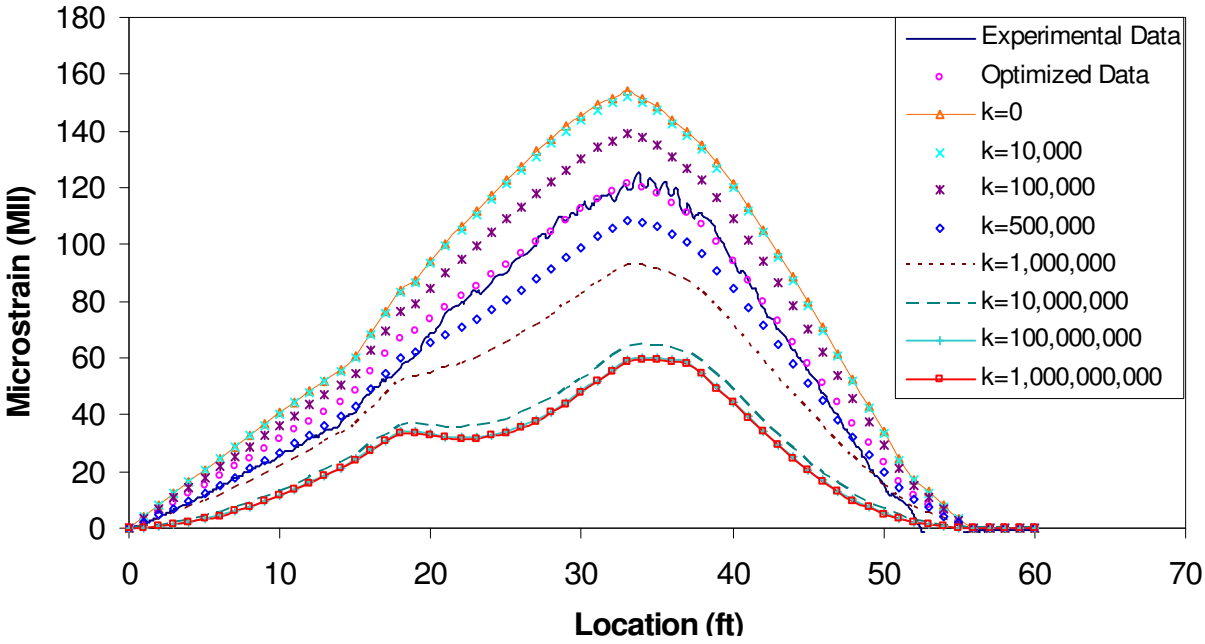
Figure 3.28. BCB Spring Constant Comparison for Lane 1 Girder 1.

The optimized spring constants show that the bridge is neither completely simply supported nor completely fixed. Based on the results for the spring constant comparison, a value of 10 million kip-in/rad for the spring constant represents a condition of 95% fixity and the increase from a spring constant of 100 million to 1 billion kip-in/rad was insignificant. This was determined by comparing the maximum strain in the bridge with a spring constant of 10 million to the maximum strain for a spring constant of zero and the maximum strain for a spring constant equal to 1 billion. From Figure 3.29, it can be observed that the optimized spring constants result in a condition of 35% fixity; therefore, the optimized model will

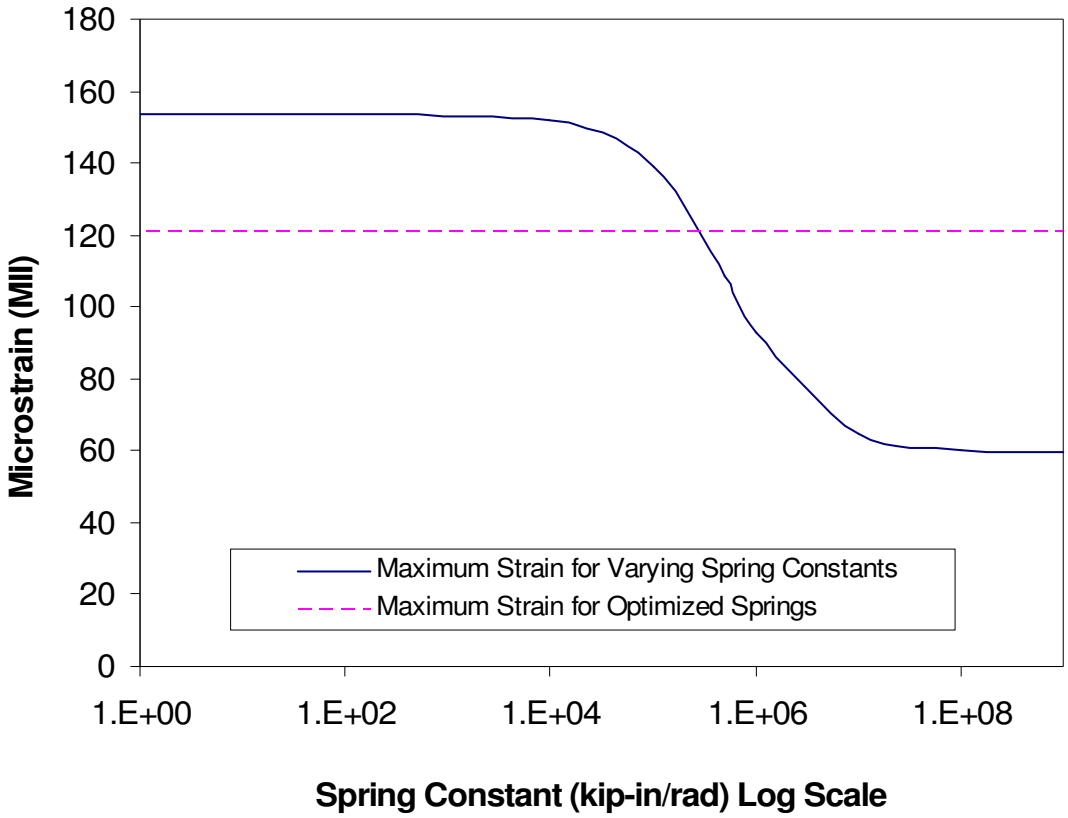
Figure 3.29. BCB Girder 1 Lane 1 Maximum Strain for Varying Spring Constants.

To obtain a better understanding as to the effect of the rotational springs on the bridge performance, the optimized concrete deck modulus of elasticity and the moments of inertia for each girder were input into the model. Then, using the modified model, the spring constants for all spring locations were held constant and simultaneously increased from 0 kip-in/rad to 1 billion kip-in/rad. A separate bridge analysis, using the original BCB test truck crossing the bridge, was conducted for each spring constant increment. The comparison between the spring constants to the actual and optimized test data for the Lane 1 loading in Girder 1 is provided in Figure 3.28. Note that the aforementioned optimized spring constants were not the same on both the north and south ends of each girder but were the same for this investigation. A log based graphical representation comparing the maximum strain observed to the spring constant is provided in Figure 3.29.

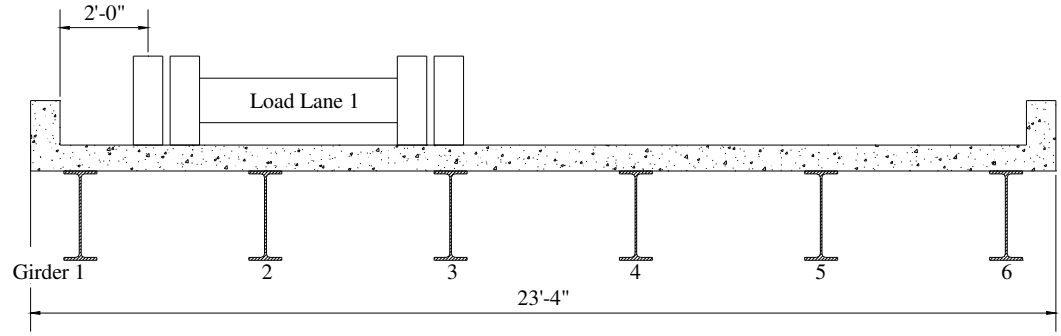
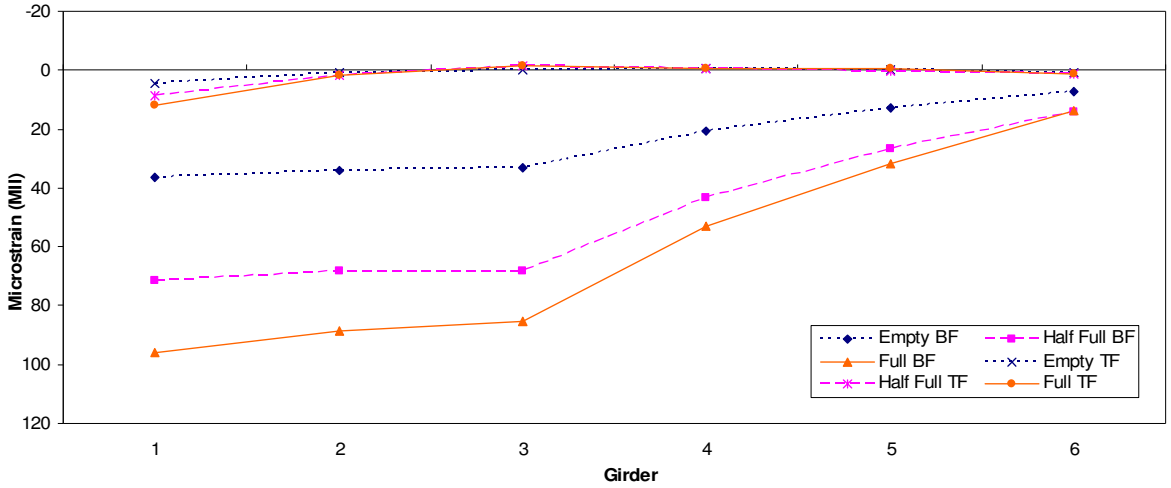
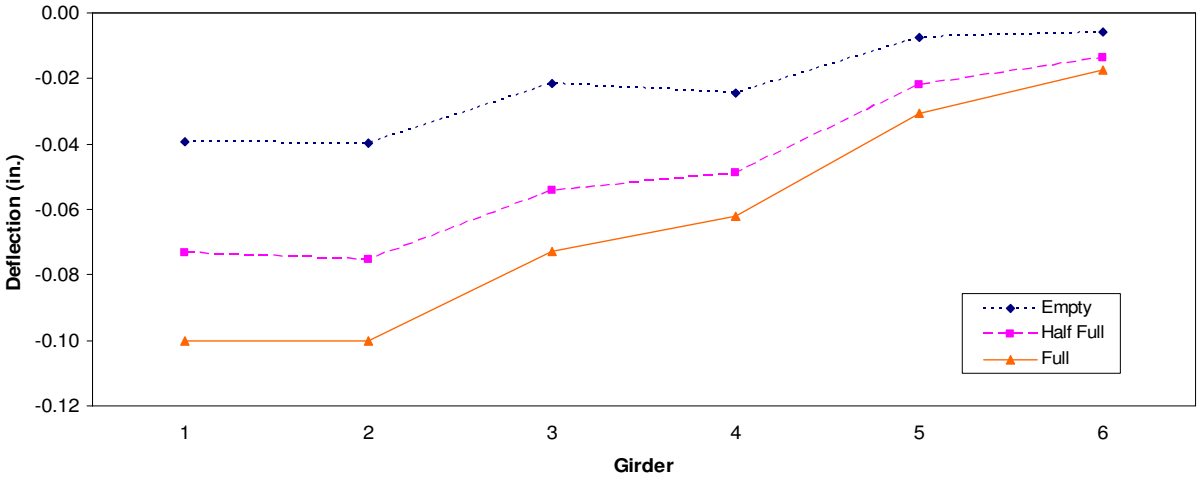
Figure 4.12. MCB Lane 1 Strains and Deflections.

(Section 4.3.2). The maximum tensile strains observed in Lane 1, Lane 2, Lane 3, and Lane 4 were 96, 88, 87, and 104 microstrain, respectively and the maximum deflections measured were 0.100, 0.090, 0.086, and 0.107 inches, respectively. The neutral axis locations for each lane and load increment are provided in Figure 4.16.

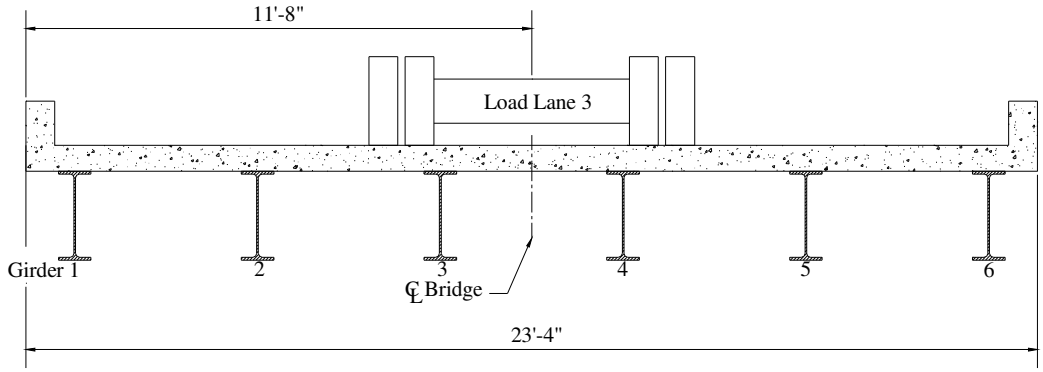
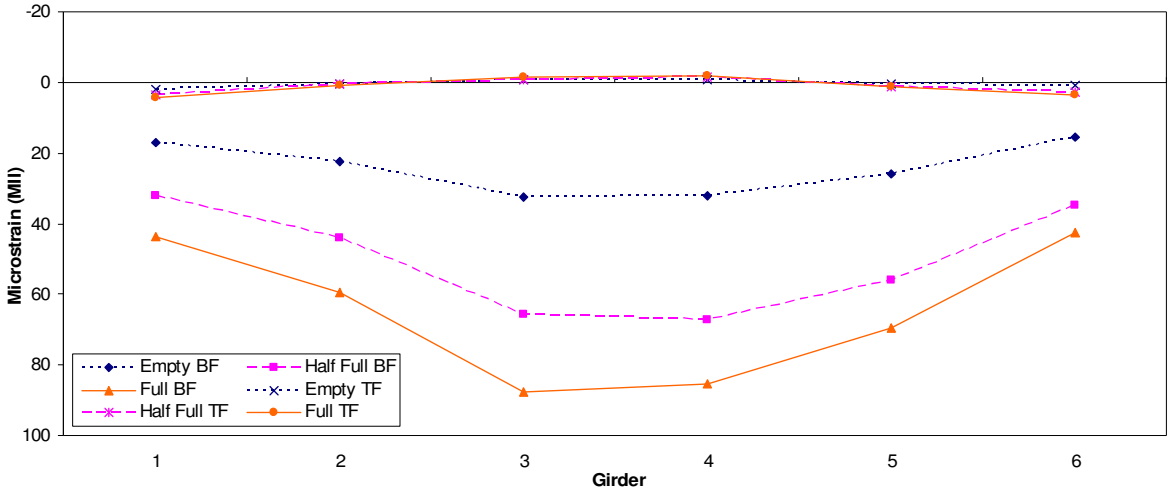
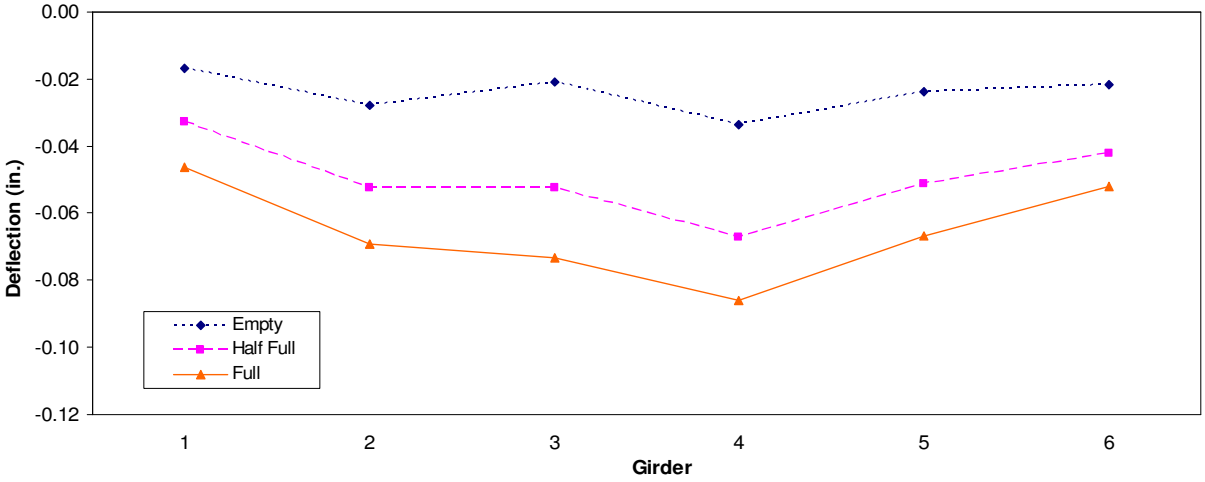
Figure 4.14. MCB Lane 3 Strains and Deflections.

In the four figures, TF and BF refers to the top and bottom flange strains, respectively. The deflection profiles follow the same general shape as the bottom flange strain profiles. As can be seen in Figure 4.14, there was symmetry in the strain profile for the truck centered on the bridge and, with the exception of the deflection in Girder 3, the deflection profile also exhibited symmetry. Based on a visual inspection of Girder 3, Girder 3 strains relative to the strains in the other girders and the Girder 3 deflections relative to the deflections in the other girders seem to be less than they should be. Quantification of the observed difference in the deflection profile will be discussed in more detail in the load distribution section

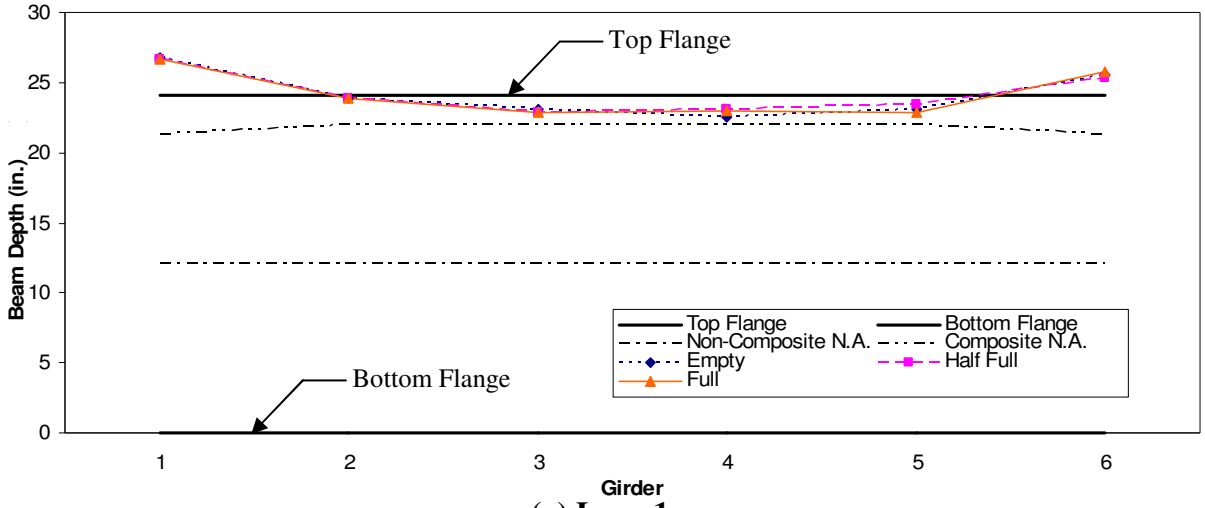
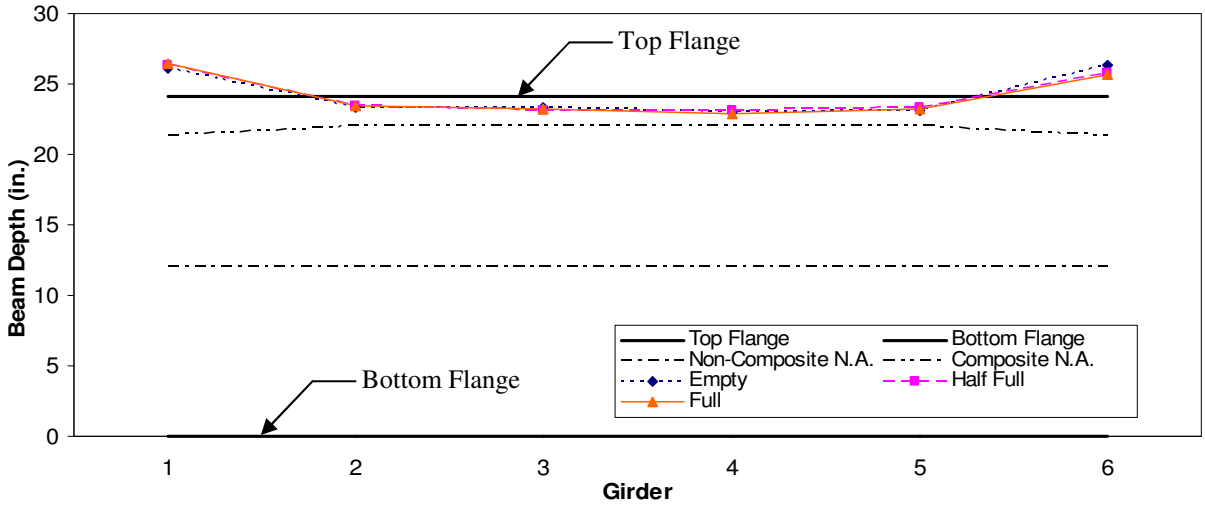
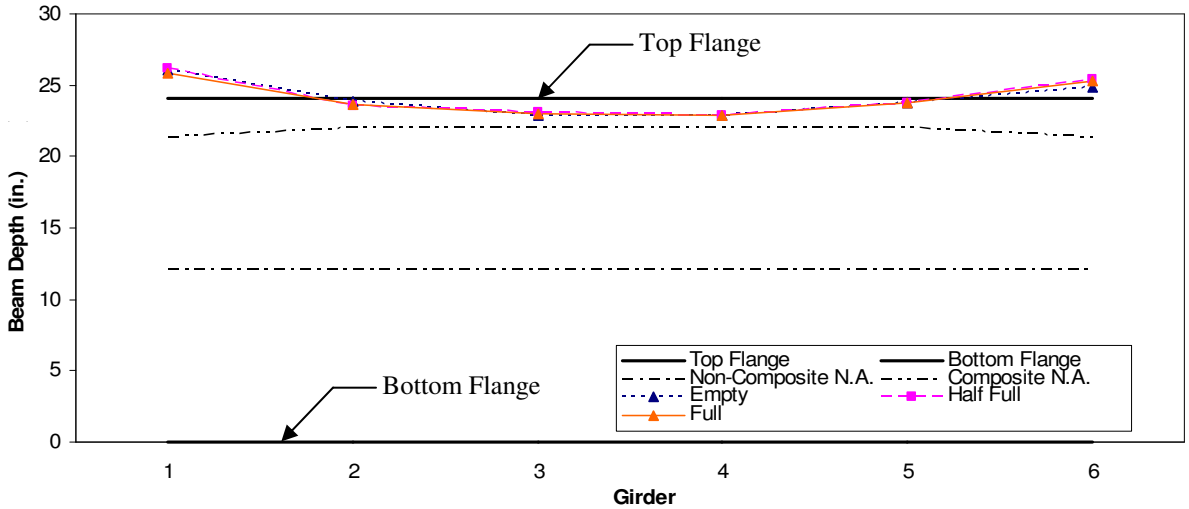
Figure 4.16. MCB Neutral Axis Locations.

The neutral axis locations, shown in Figure 4.16, were determined by interpolating between the top and bottom flange strains to determine the location on the girder where the strain was equal to zero. Composite action, shown simply by the location of the neutral axes above the theoretical composite neutral axis location, was observed in all of the girders for each of the lanes loaded. The amount of composite action did not change with the increased loading as was the case with the BCB, but instead the neutral axis locations are all very close to being the same. All of the interior girders had neutral axis locations between the top of the top flange and the calculated composite neutral axis location, while the exterior girders had neutral axis locations above the top flange of the girders and therefore into the concrete deck.

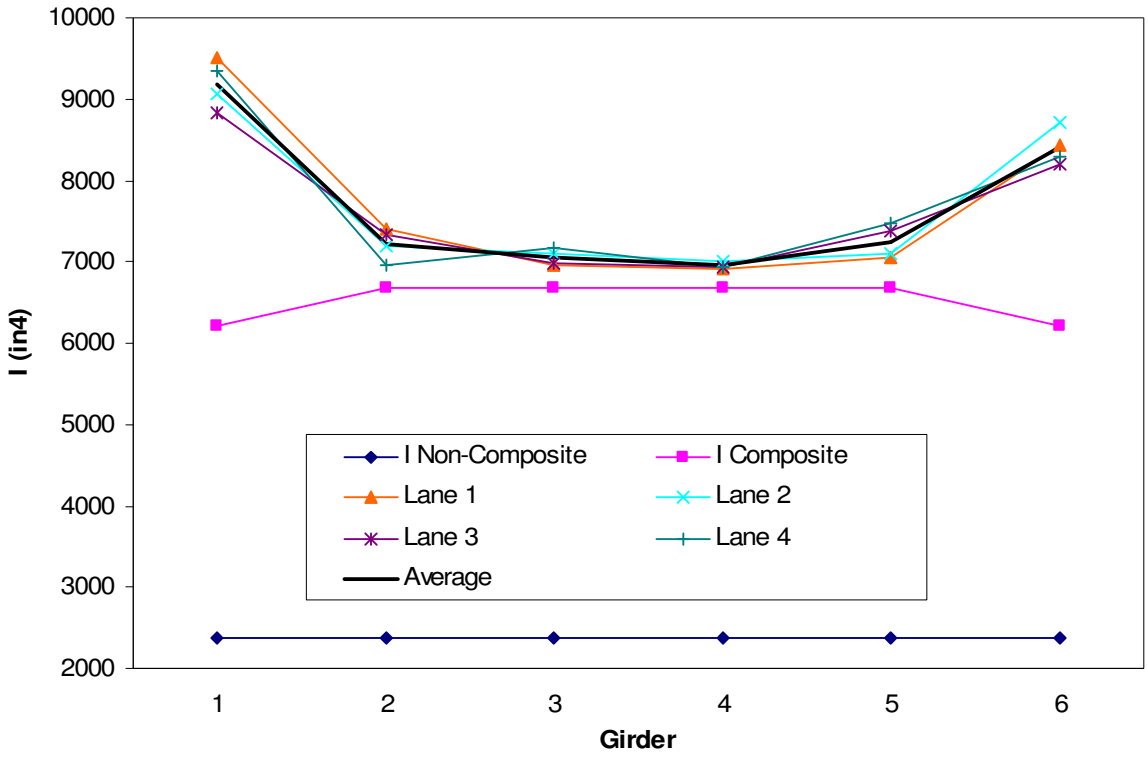
Figure 4.18. MCB Effective Moments of Inertia.

The non-composite moment of inertia for the girder is 2,370 in^4 and the composite moment of inertia for the girder with an effective flange width equal to the girder spacing is 6,680 in^4 for the interior girders and 6,220 in^4 for the exterior girders for which neither the curb nor railing were considered in the calculation. With the location of the neutral axis being higher than the theoretical composite neutral axis location, the calculated moments of inertia for each girder are also larger than those calculated assuming a composite section. A graphical comparison of the moments of inertia for each girder to the theoretical composite and non-composite moments of inertia is provided in Figure 4.18. Also shown in Figure 4.18

is the average moment of inertia for each girder. The moments of inertia for the interior girders are very close to the same with an overall average of 7,120 in^4 and a standard deviation of 185 in^4. There is more scatter in the calculated moments of inertia for the exterior girders with an average of 8,800 in^4 and a standard deviation of 480 in^4. The edge stiffness observed in the exterior girders of the BCB was also observed in this bridge with much larger moments of inertia in the exterior girders.

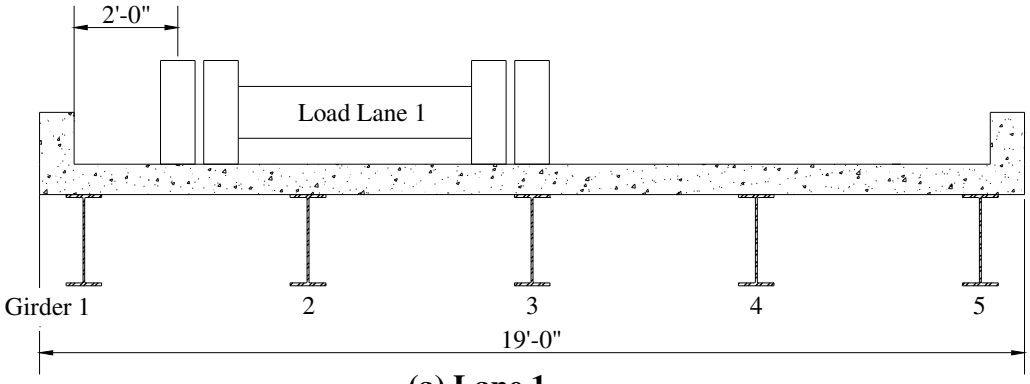
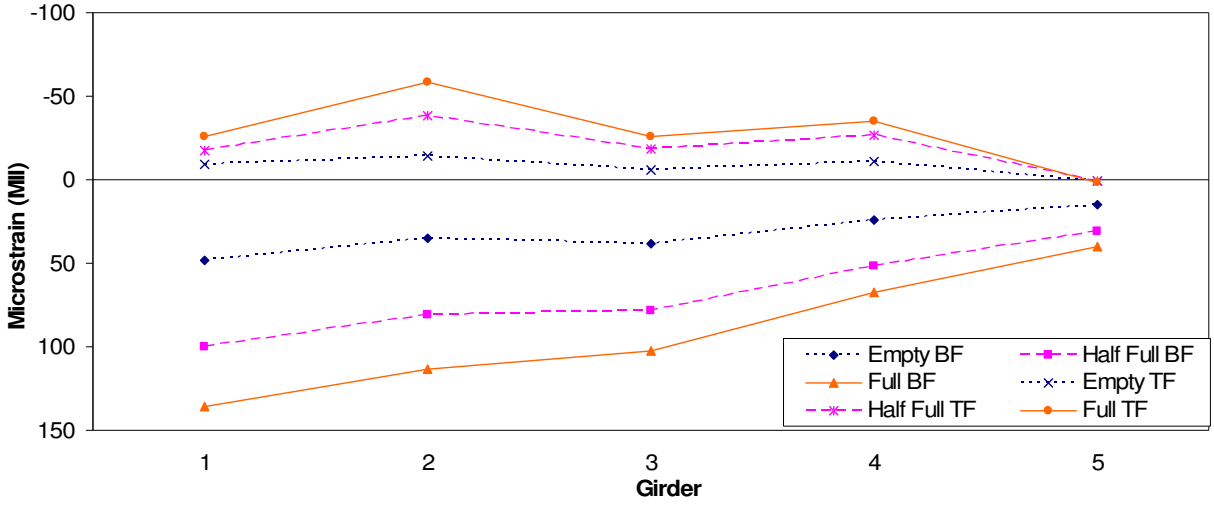
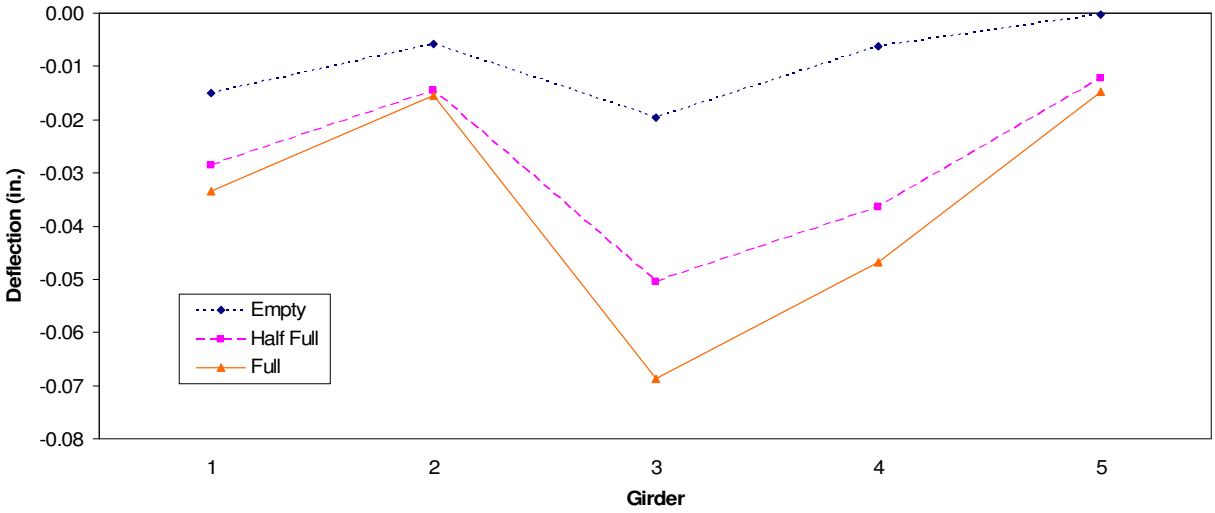
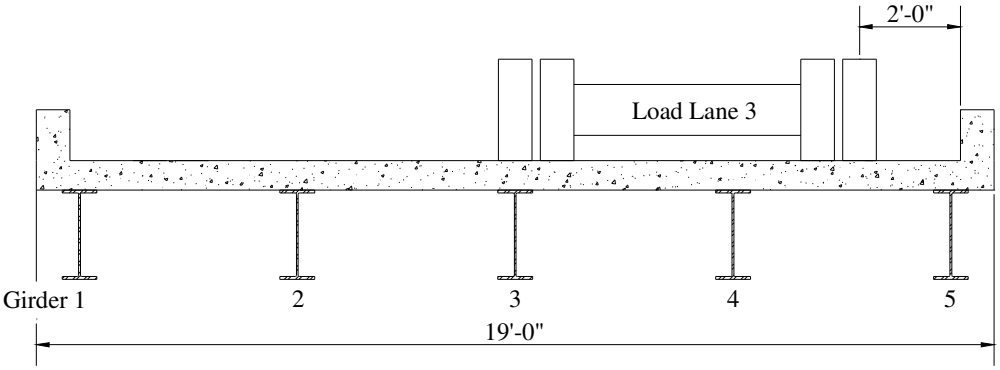
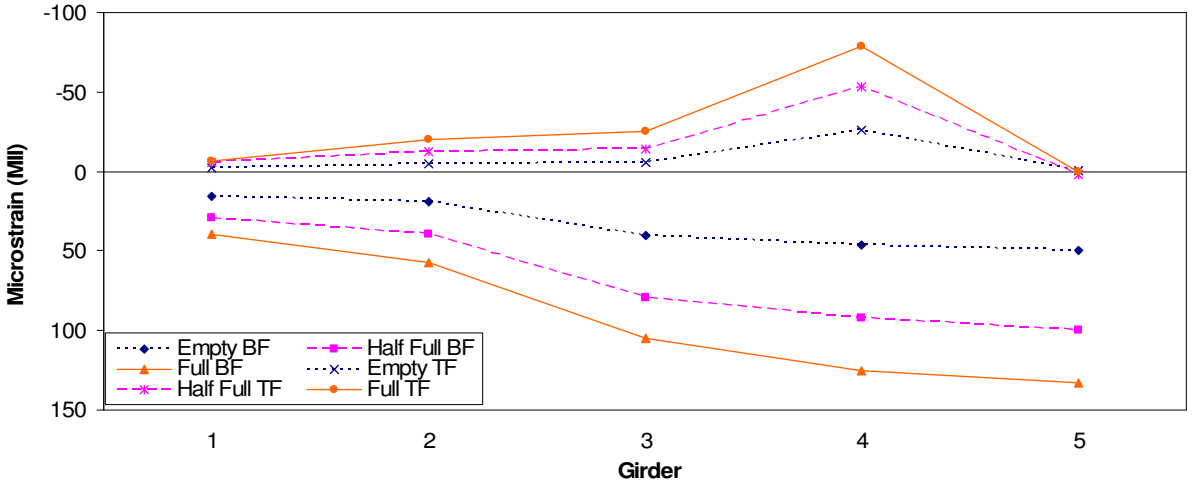
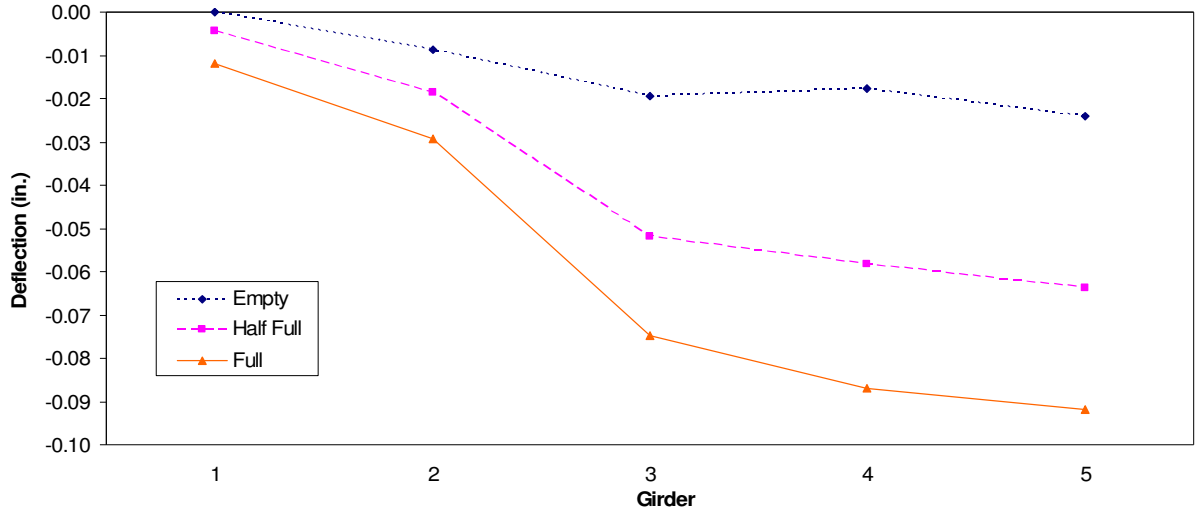
Figure 5.10. KCB1 Lane 1 Strains and Deflections.

The bridge was designed as a non-composite simple span bridge and common with most bridges of this type, there were details that could increase the flexural capacity of the bridge. Shown in Figure 5.10 through Figure 5.12 are the top and bottom flange strains and deflections with the loading in Lane 1 through Lane 3, respectively. In the previous figures, TF and BF refers to the top and bottom flange strains, respectively. The deflection profile for the Lane 3 loading follows the same general shape as the bottom flange strain profiles; deflection profiles for Lanes 1 and 2, however, do not follow the same shape as the bottom flange strain profiles. Deflections for Girders 1 and 2 from Lanes 1 and 2 loading are roughly 1/3rd the deflections of Girders 4 and 5 under Lane 2 and Lane 3 loading, respectively. The deflection in Girder 3 was the largest for Lane 1 loading but the maximum strain was observed in Girder 1 under the same loading. Girder 2 deflections were lower than the Girder 4 deflections under symmetrical loading whereas the strain profiles maintained symmetry under symmetrical loading as shown in Figure 5.11b. Both the top and bottom flange strain profiles exhibited symmetry as can be observed in Figure 5.11 as well as in Figure 5.10 and Figure 5.12 which are mirror images of each other. Other than the possibility of instrument

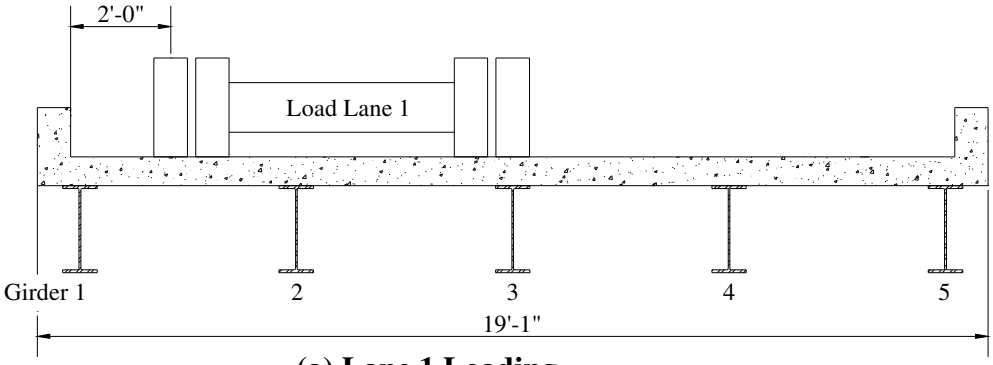
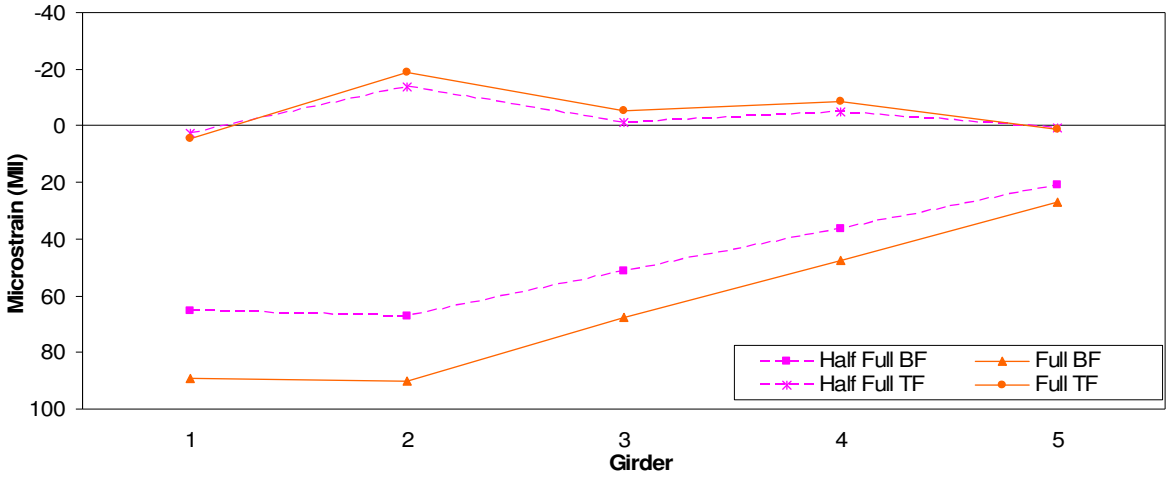
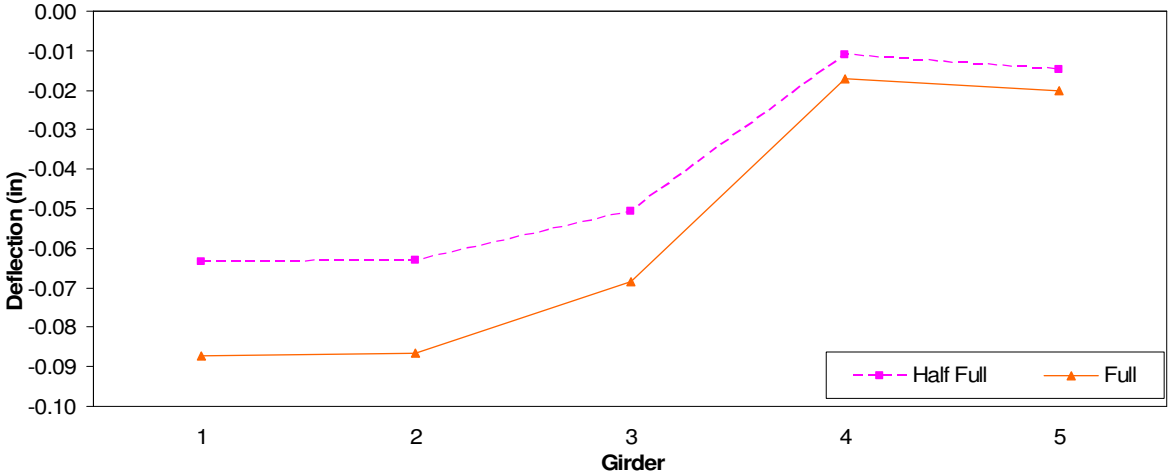
Figure 7.10. KCB2 Lane 1 Strains and Deflections.

described above, TF and BF refers to the top and bottom flange strains, respectively. The deflection profiles do not follow the same shape as the bottom flange strain profiles for any of the five lanes. Deflections for Girder 4 from the Lane 5 loading are approximately 1/3rd the deflections in Girder 2 with the loading in Lane 1. The deflection in Girder 3 was the largest for Lane 5 loading but the maximum strain was observed in Girder 5 under the same loading. Girder 4 deflections were lower than the Girder 2 deflections under symmetrical loading whereas the strain profiles maintained symmetry under symmetrical loading as shown in Figure 7.12b. Both the top and bottom flange strain profiles exhibited symmetry as can be observed in Figure 7.12 as well as in Figure 7.10 and Figure 7.14 which are mirror images of each other. As was the case with the KCB1 Girder 2 deflections, it was not determined why the KCB2 Girder 4 deflections were so much smaller than the other girders but was likely due to poor instrumentation.

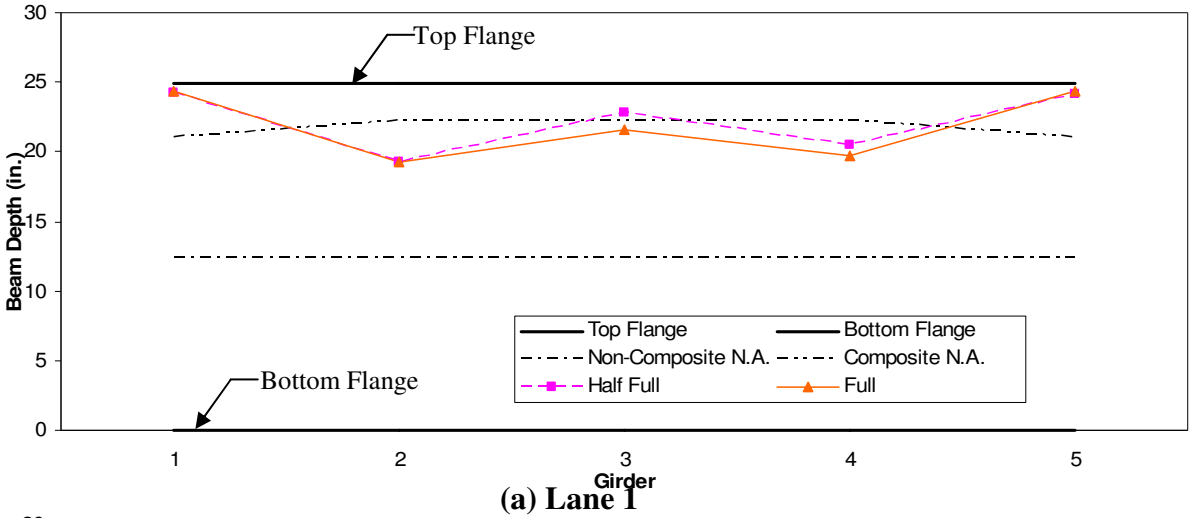
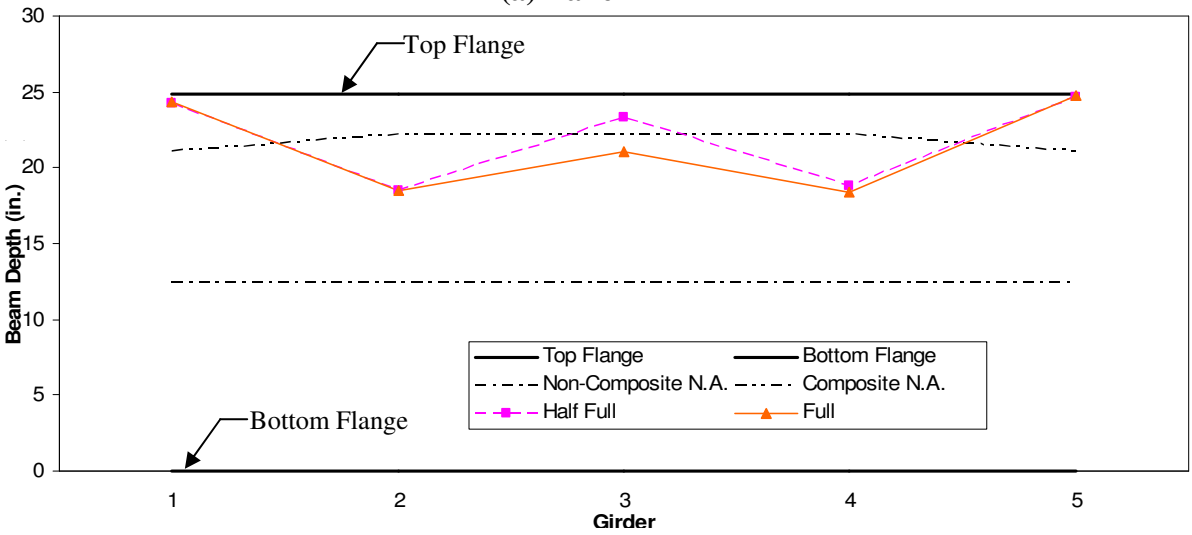
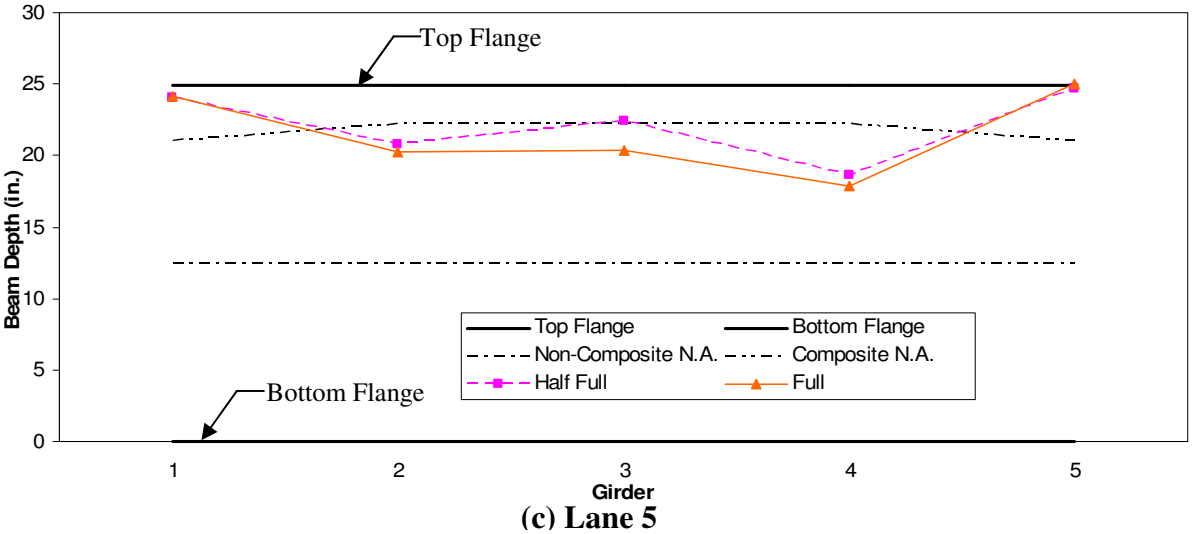
Figure 7.15. KCB2 Neutral Axis Locations.

The neutral axis locations, shown in Figure 7.15, were determined by interpolating between the top and bottom flange strains to determine the location on the girder where the strain was equal to zero. Partial composite action, shown simply by the location of the neutral axes between the theoretical composite and non-composite neutral axis locations, was observed in all of the girders for each of the lanes loaded. The amount of partial composite action deteriorated with increased loading; this can be seen in Figure 7.15 where the neutral axis location shifts toward the non-composite neutral axis location with increased loading. This deterioration was the most noticeable in Girder 3 and the least noticeable in both exterior girders. The neutral axes of Girders 2 and 4 are also much closer to the non-composite neutral axis location than in the other girders.
