Investigation of steel stringer bridge superstructures

Jeremy Craig Koskie

Major: Civil Engineering (Structural Engineering)

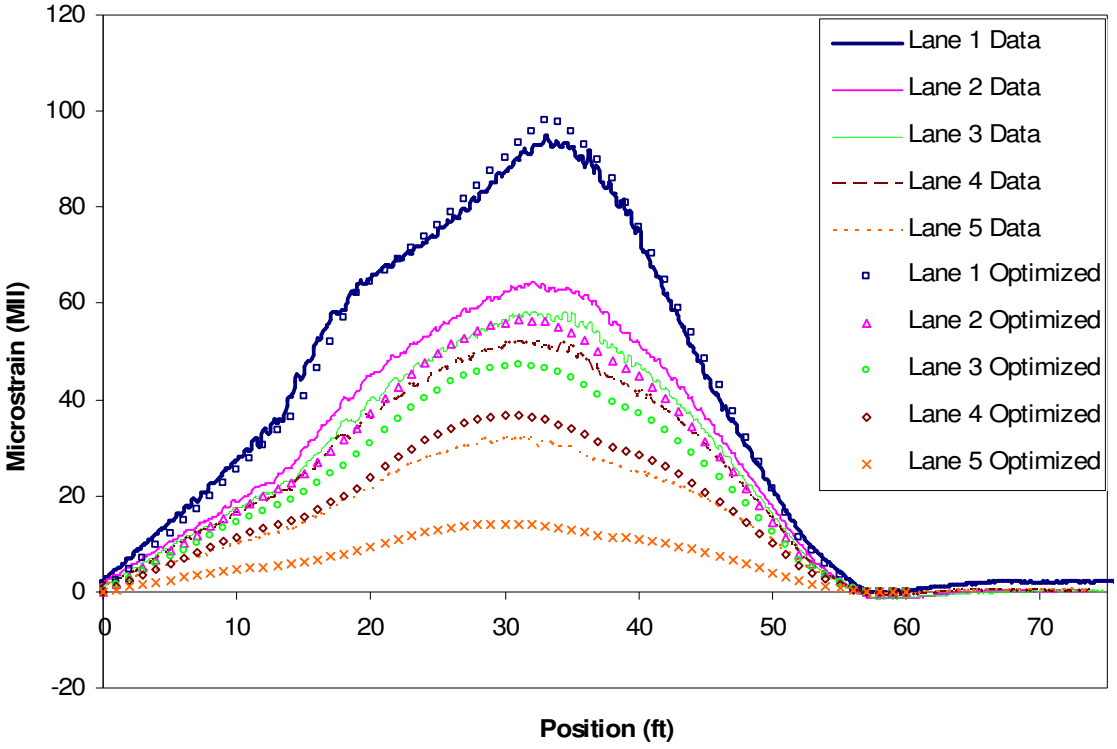
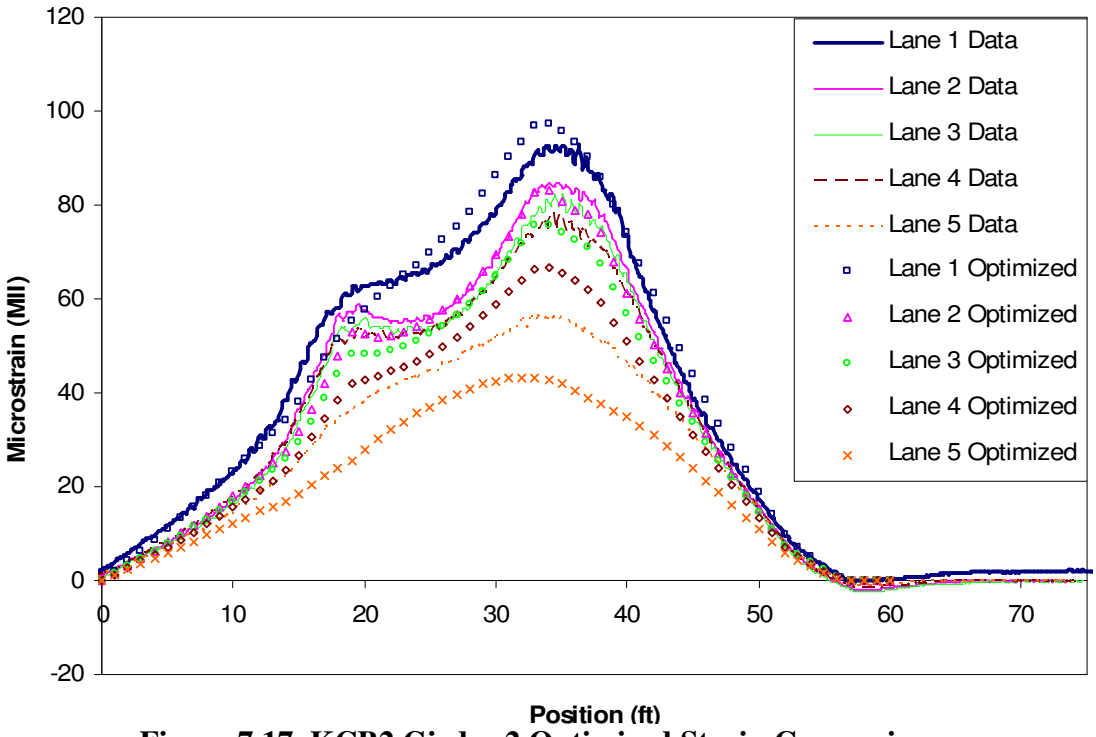
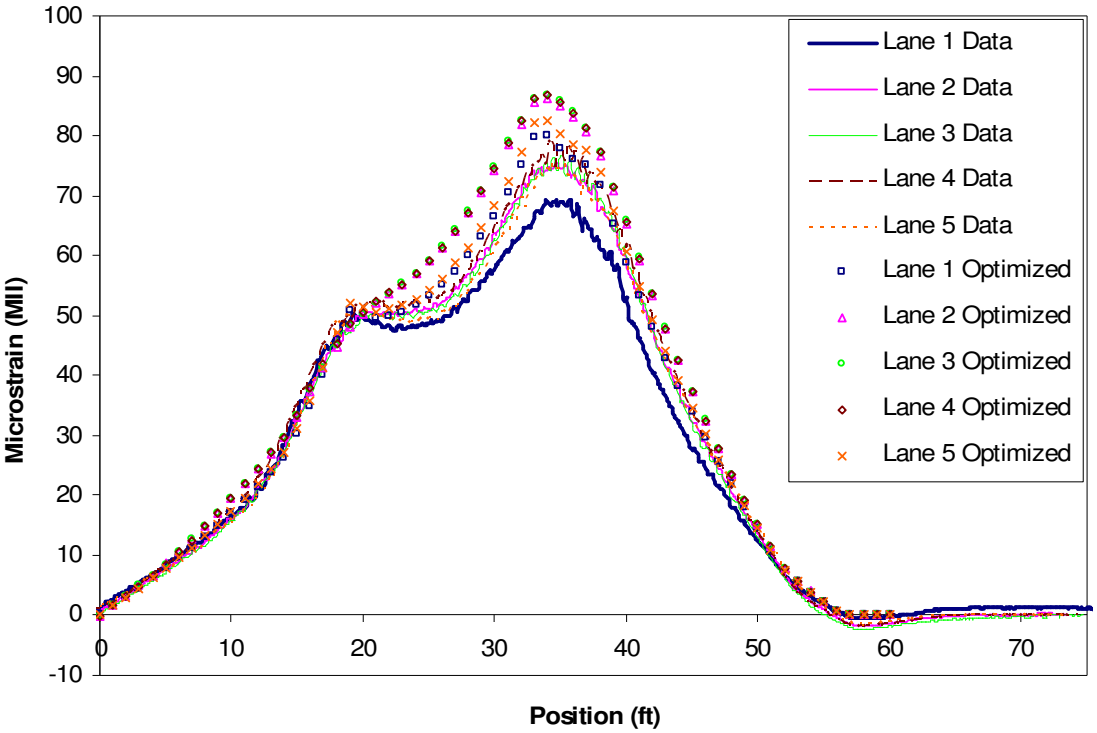
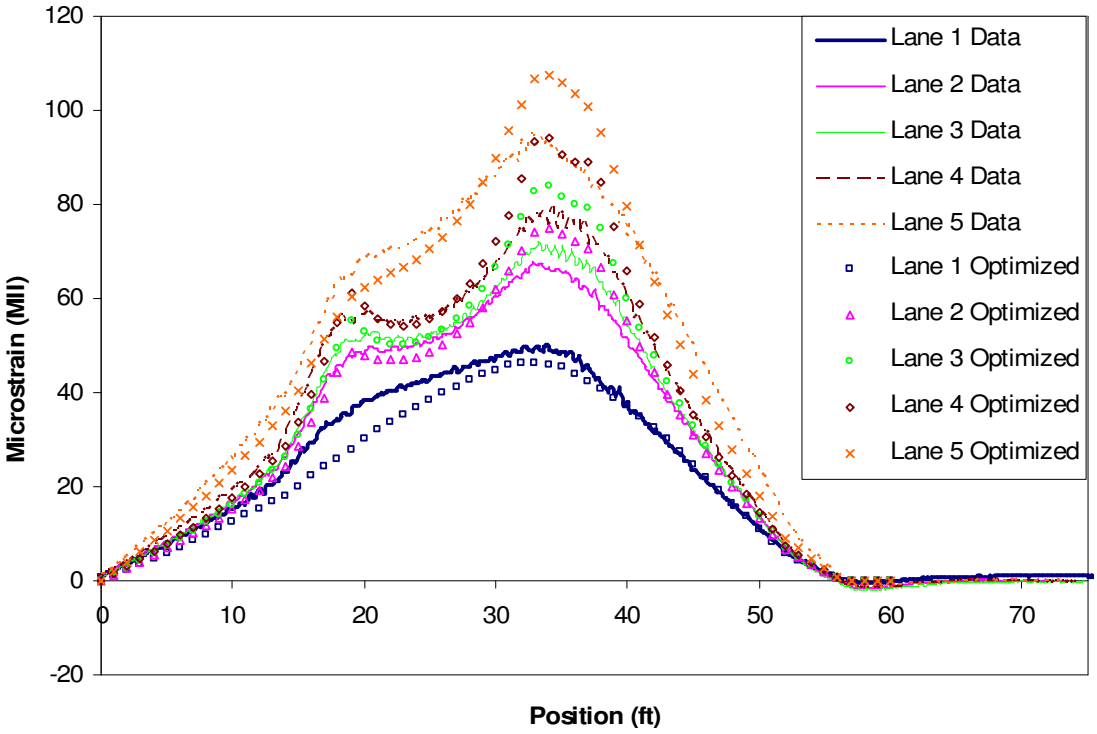
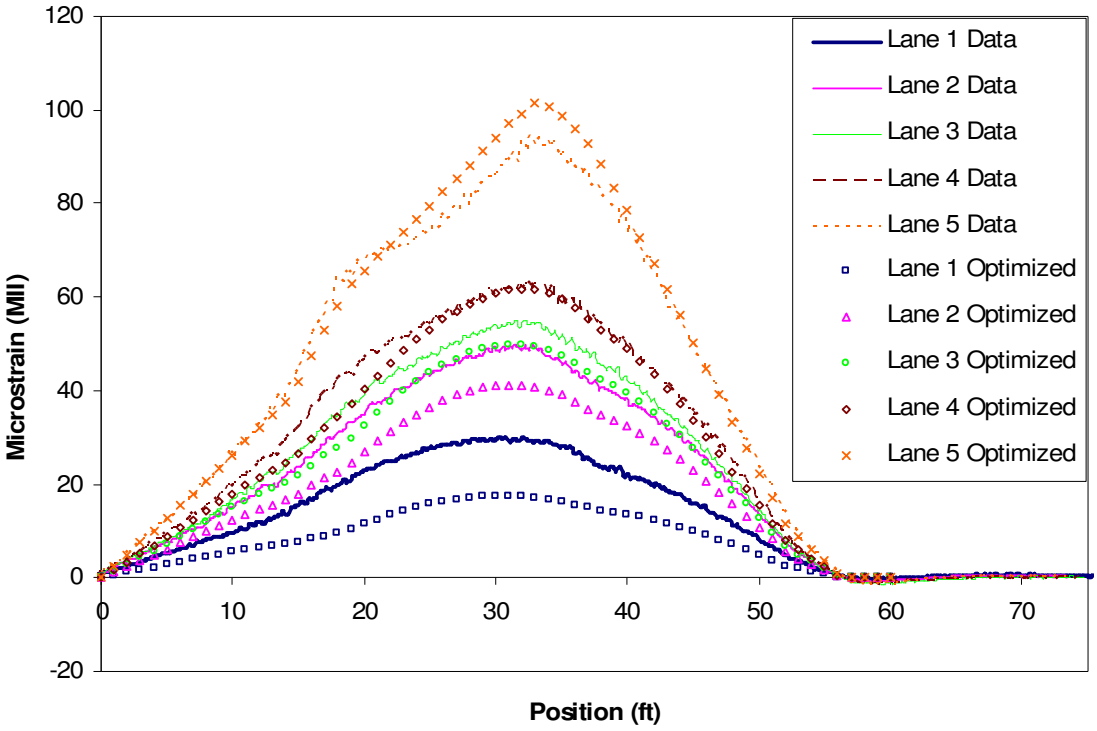
The apparent symmetry observed in the neutral axis, deflection profile and strain profile plots previously presented was not observed in the optimized girder moments of inertia. Comparing the optimized moment of inertia in the geometrically symmetric Girders 2 and 4 shows that the optimization was not symmetrical as the optimized values were 7,730 and 4,460 in^4, respectively. Optimized values obtained for the interior spring constants were relatively close to each other but were not very close to the values for the exterior spring constants. The upper bound for the deck modulus of elasticity was increased to 5,700ksi because the initial optimization yielded a modulus of elasticity very close to the initial upper bound of 5,500 ksi. As shown in Table 7.7, the optimized concrete modulus of elasticity was slightly larger than the initial upper bound. A graphical comparison of the optimized strains

for each loading path are compared to the actual strains induced by the test truck in Girder 1 through Girder 5 are presented in Figure 7.16 through Figure 7.20, respectively.

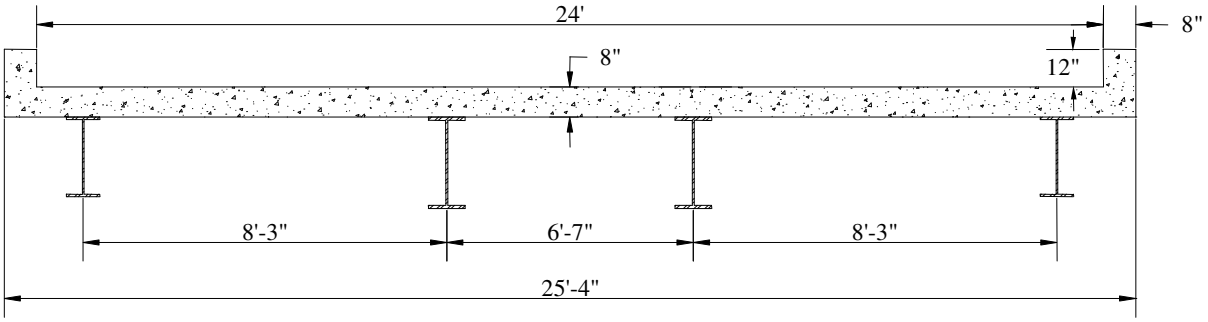
Figure 8.3. Cross Section of HCB Looking West.

The superstructure, a cross section of which is shown in Figure 8.3, is a four girder system with two W24x74 girders on the exterior and two W24x94 girders on the interior. There is an eight inch thick cast in place concrete deck and an asphalt overlay of five inches. There are C-channel diaphragms at the 1/3 points of the bridge, concrete curbs eight inches wide by one foot tall, and railings on both sides of the bridge.

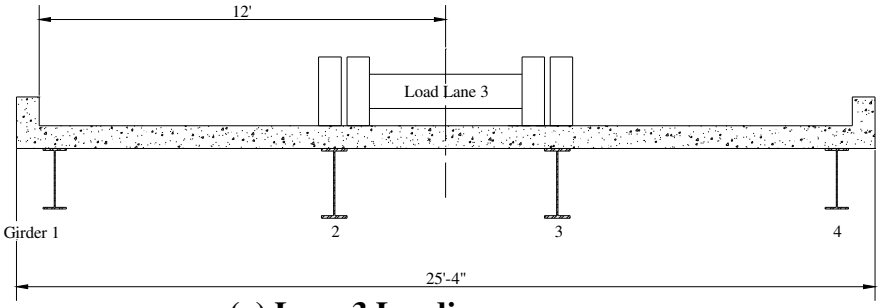
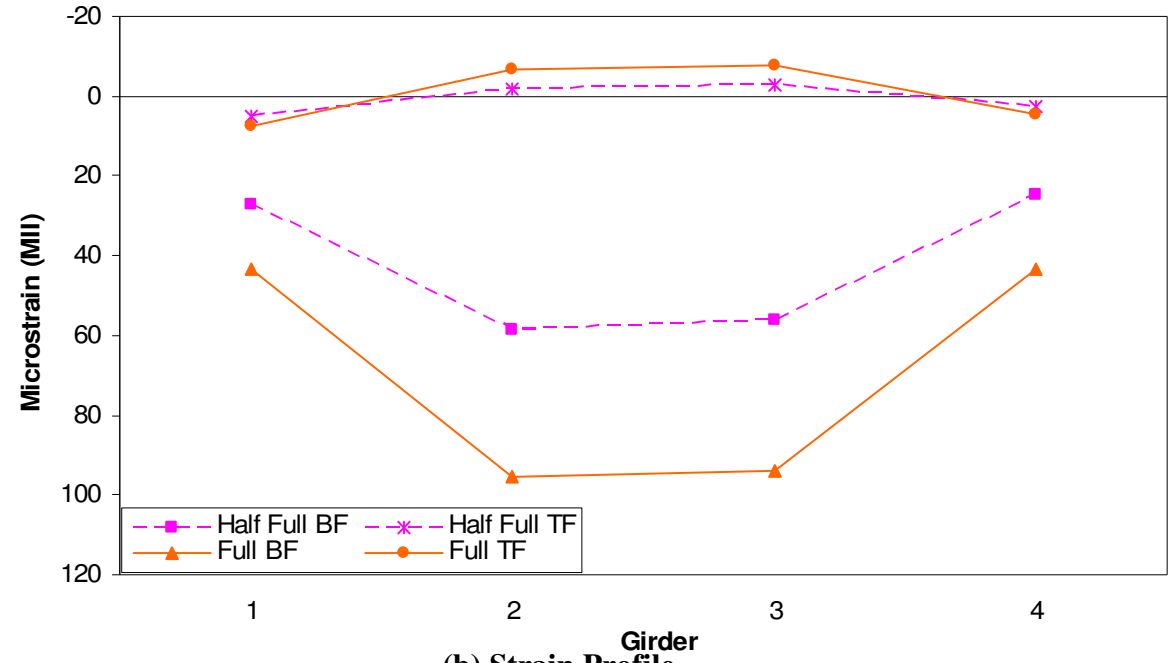
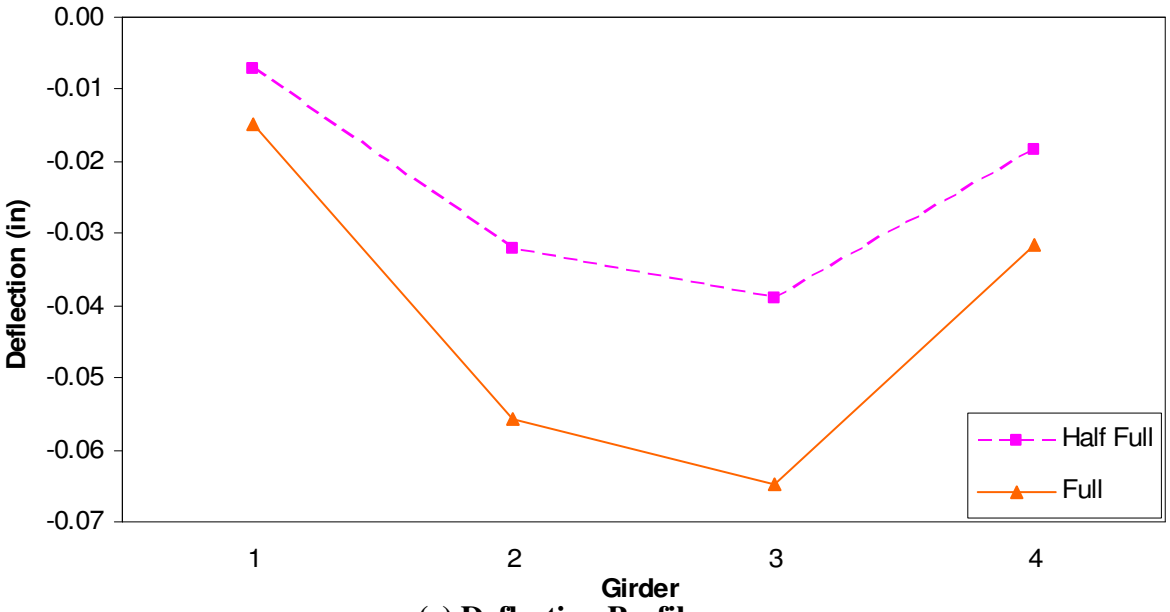
Figure 8.13. HCB Lane 3 Strains and Deflections.

There was very good symmetry shown in both the top and bottom flange strain profiles. This symmetry can be observed in Figure 8.13 with both sets of girders, Girders 1 and 4 as well as Girders 2 and 3, having similar strain values under symmetrical loading. Symmetry can also be observed in the two sets strain profiles, Lanes 1 and 5 as well as Lanes 2 and 4, having mirror images of each other.

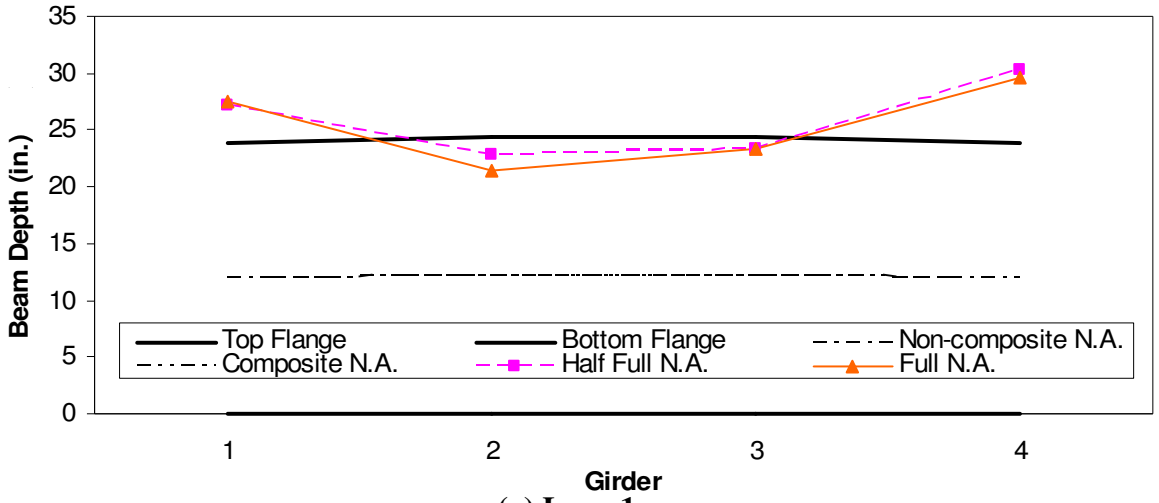
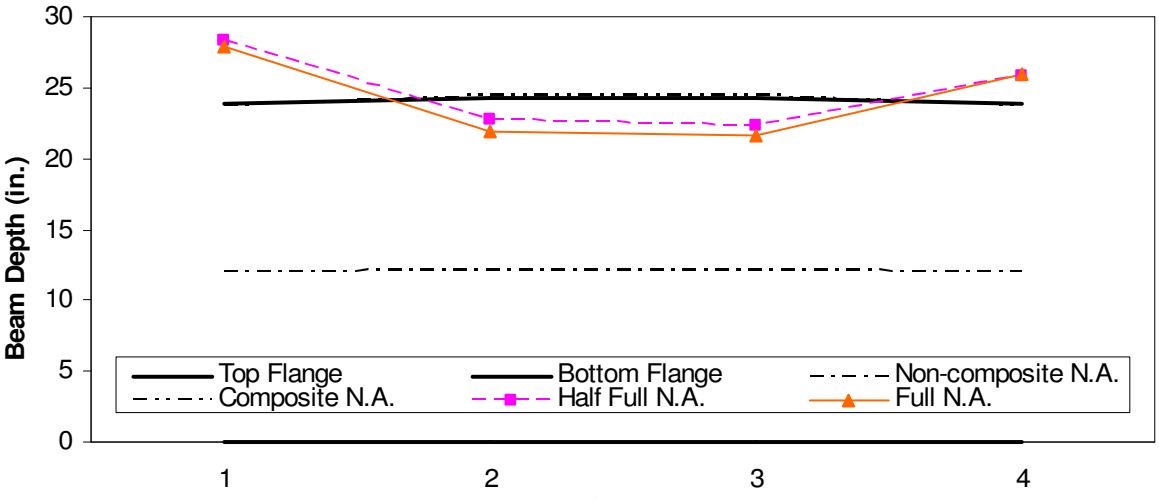
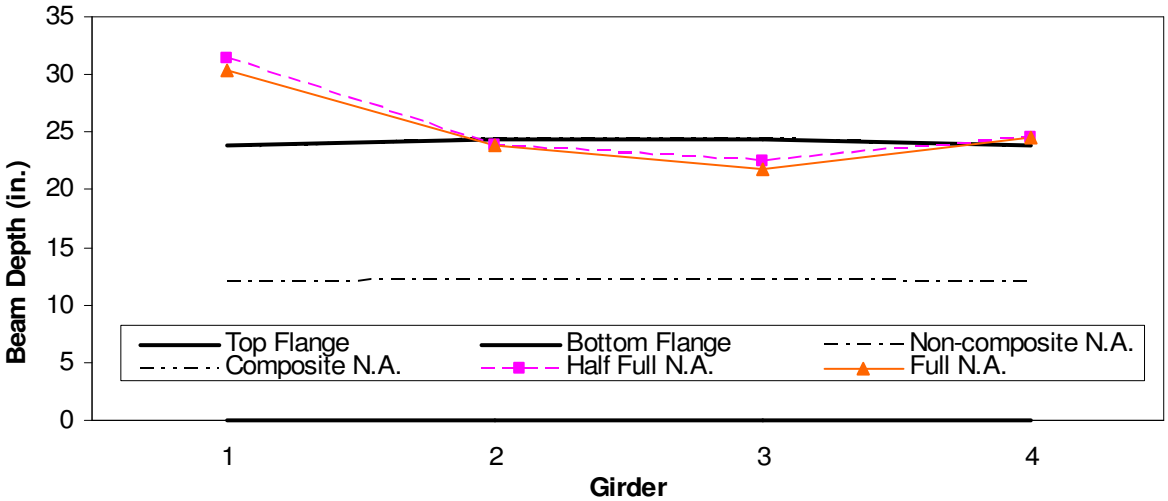
Figure 8.16.HCB Neutral Axis Locations.

The neutral axis locations, shown in Figure 8.16, were determined by interpolating between the top and bottom flange strains to determine the location on the girder where the strain was equal to zero. Partial composite action, shown simply by the location of the neutral axes being located between the theoretical composite and non-composite neutral axis

locations, was observed in all of the girders for each of the lanes loaded. The amount of partial composite action deteriorated with increased loading for all of the girders.

Neutral axis locations in the exterior girders were well within the concrete deck; this displays the edge stiffening effect that was prevalent in the previously tested bridge. The increased edge stiffness can be attributed to the concrete curb and steel railing which were not included in the calculation of the composite neutral axis location. The theoretical composite neutral axis locations, shown in Figure 8.16, were located within the concrete deck and within the top flange of the girder for the exterior and interior girders, respectively. As discussed for the BCB, the high neutral axis locations result from very small strain measurements in the top flange. The neutral axis profiles were fairly symmetric; the exterior girder neutral axis locations varied based on the transverse location of the test truck but the neutral axis locations for the two interior girders remained relatively unchanged.

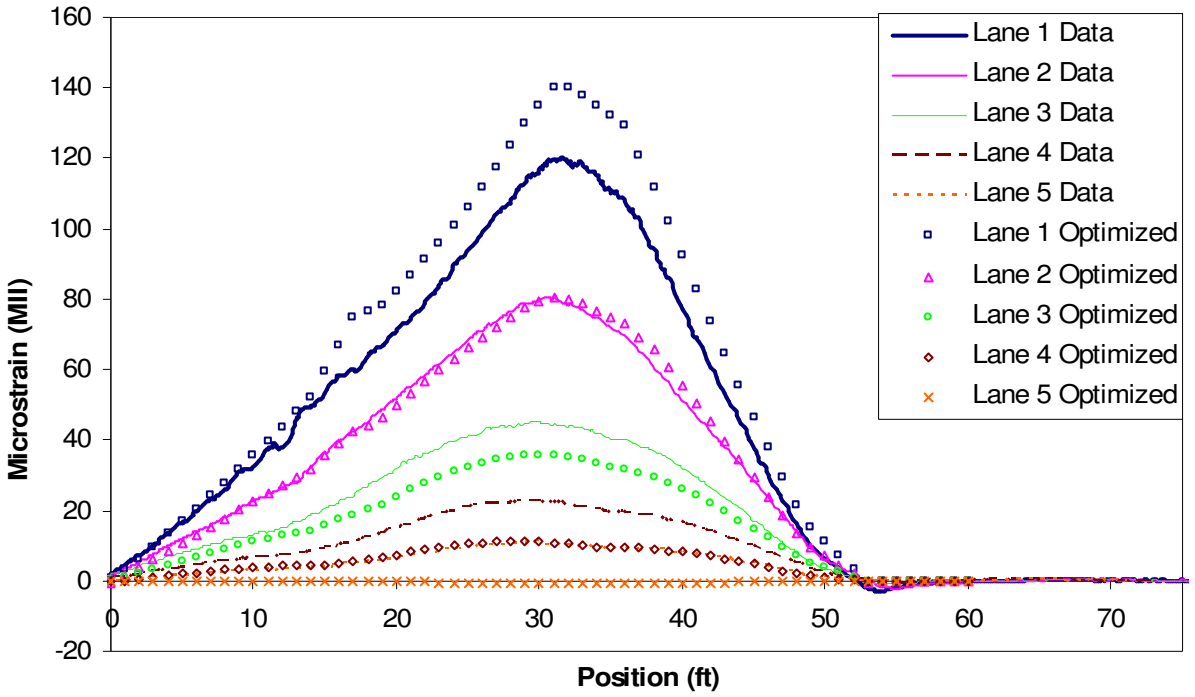
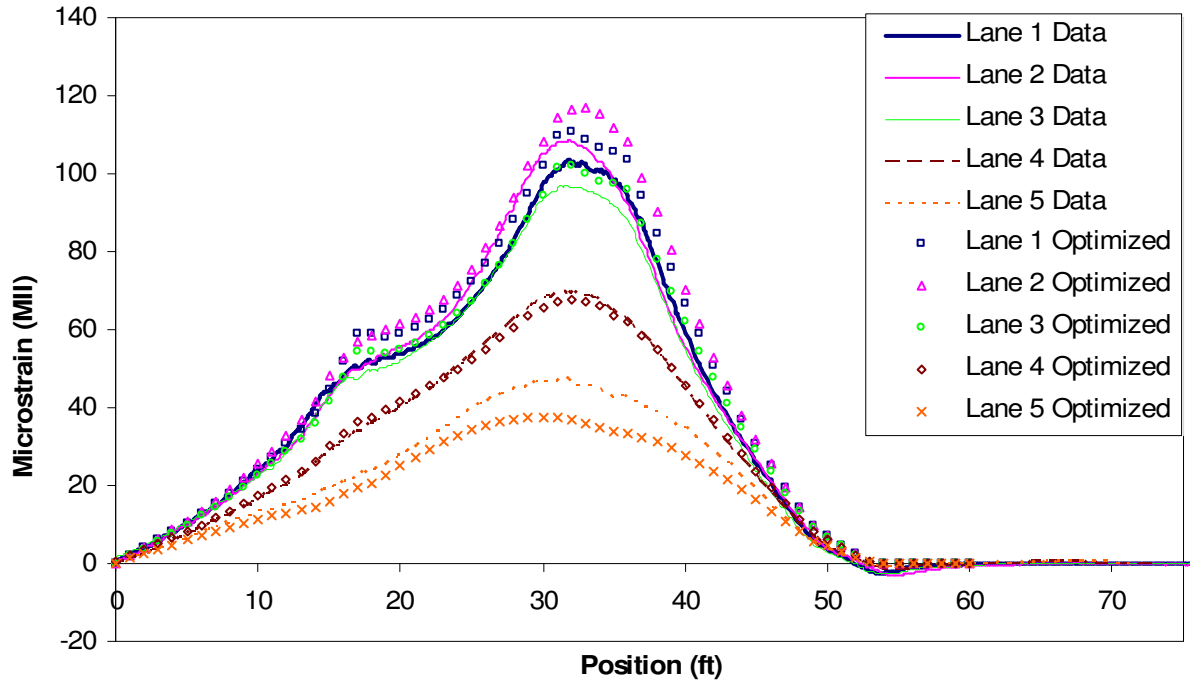
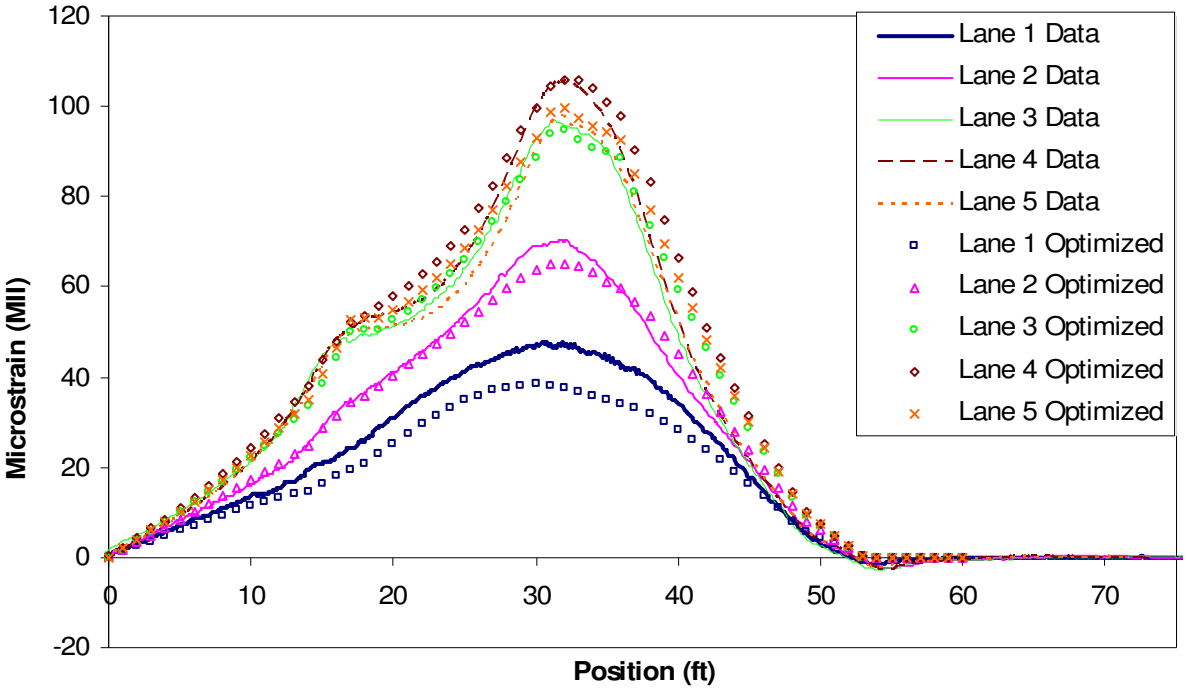
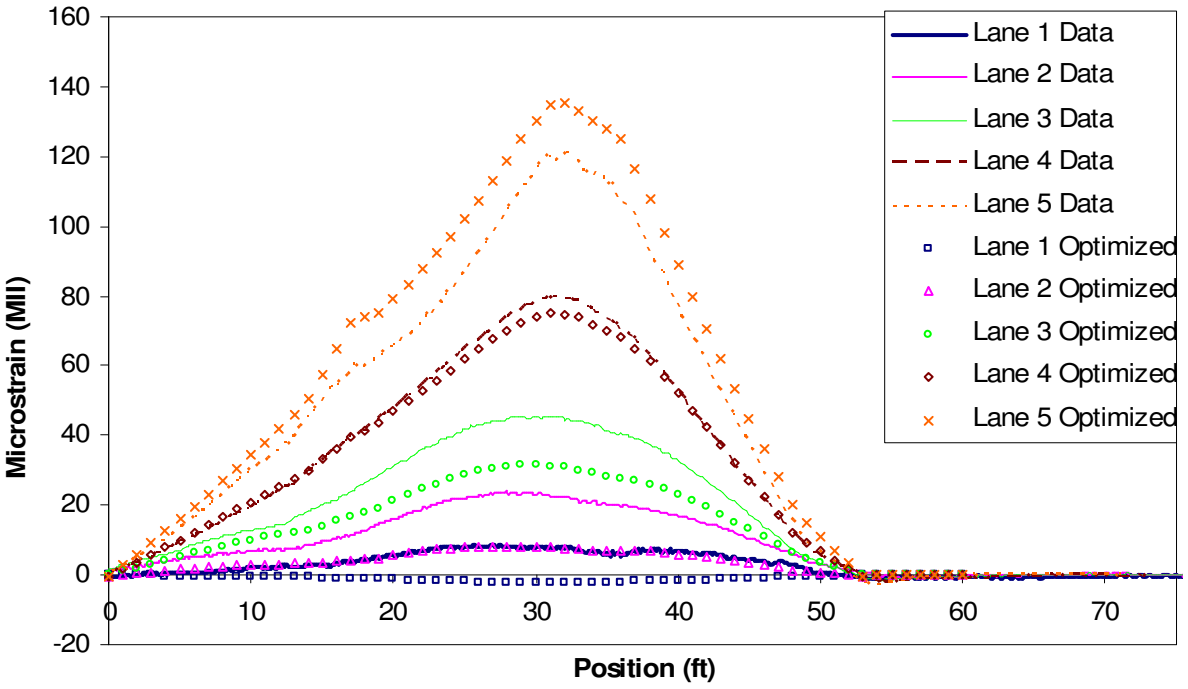
Though there was symmetry observed in the neutral axis profile and strain profile plots, there was not symmetry observed in the optimized girder moments of inertia for the interior girders; the optimized moments of inertia for the exterior girders were symmetrical though with the exact same optimized value. Comparing the optimized moment of inertia in the geometrically symmetric Girders 2 and 3, did not show symmetry with the values

differing by 2480 in^4. Optimized values obtained for the spring constants also did not maintain symmetry ranging from about 380,000 to 820,000 kip-in/rad. A graphical comparison of the optimized strains for each loading path are compared to the actual strains induced by the test truck for Girder 1 through Girder 4 are presented in Figure 8.17 through Figure 8.20, respectively.

error of only 4.0%, a 4.2% reduction from the original optimization model using all of the steel girder strains. The correlation values provided in Table 8.8 did not change in the new analysis.

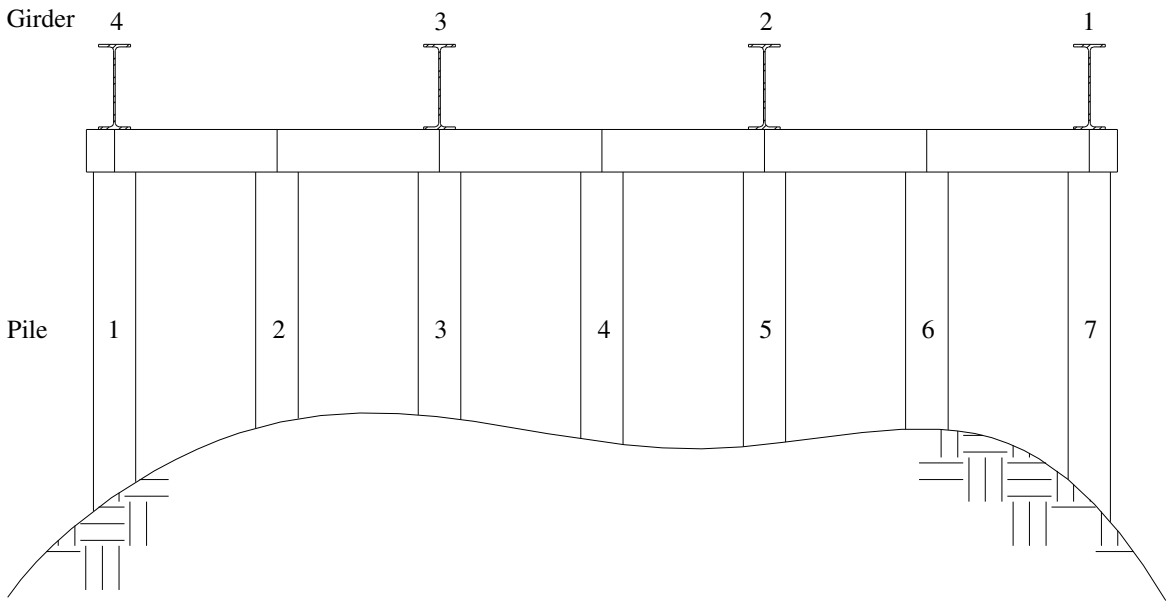
Figure 8.21. HCB East Abutment Cross Section.

The same loading vehicle was used for the destructive testing as was used for the non-destructive testing previously described. Both substructure and superstructure elements were instrumented simultaneously, thus there were a limited number of BDI transducers available for installation on the superstructure. The superstructure was instrumented with BDI transducers on the bottom flanges at the midspan of each girder and two feet from the edge of the east abutment. There were a total of 8 BDI transducers installed on the superstructure. Only Lanes 1, 3, and 5 from the rating process (refer to Figure 8.6 for clarification) were used in the destructive testing. The test truck was the same geometry as the test truck provided in Figure 8.5 and was fully loaded with a gross weight of 51,640 lbs. A cross section of the east abutment is provided in Figure 8.21 showing the seven piles. Only sections of piles in the east abutment were removed.

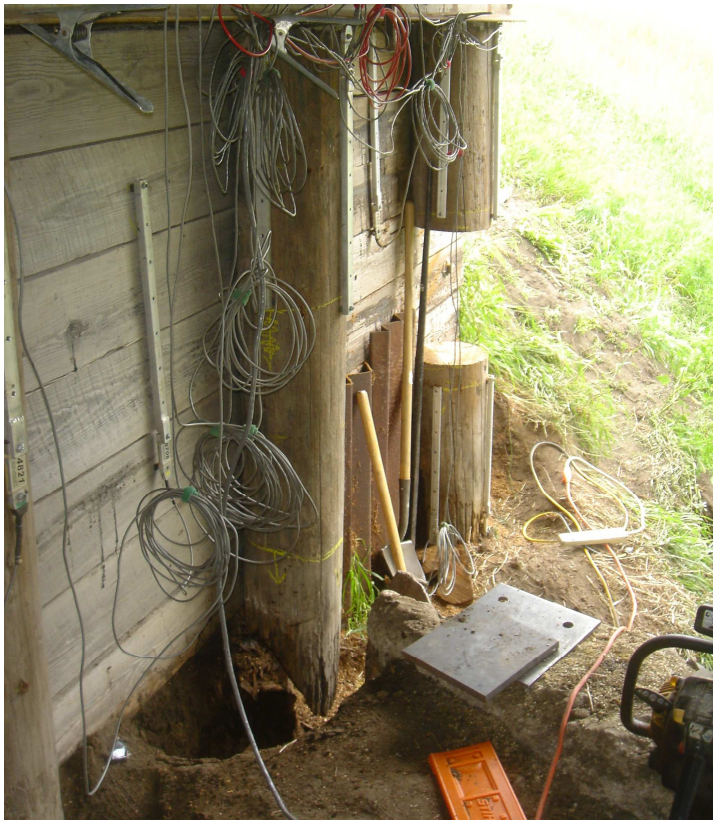
Figure 8.23. Photograph Showing Sections of Piles 6 and 7 Removed from HCB.

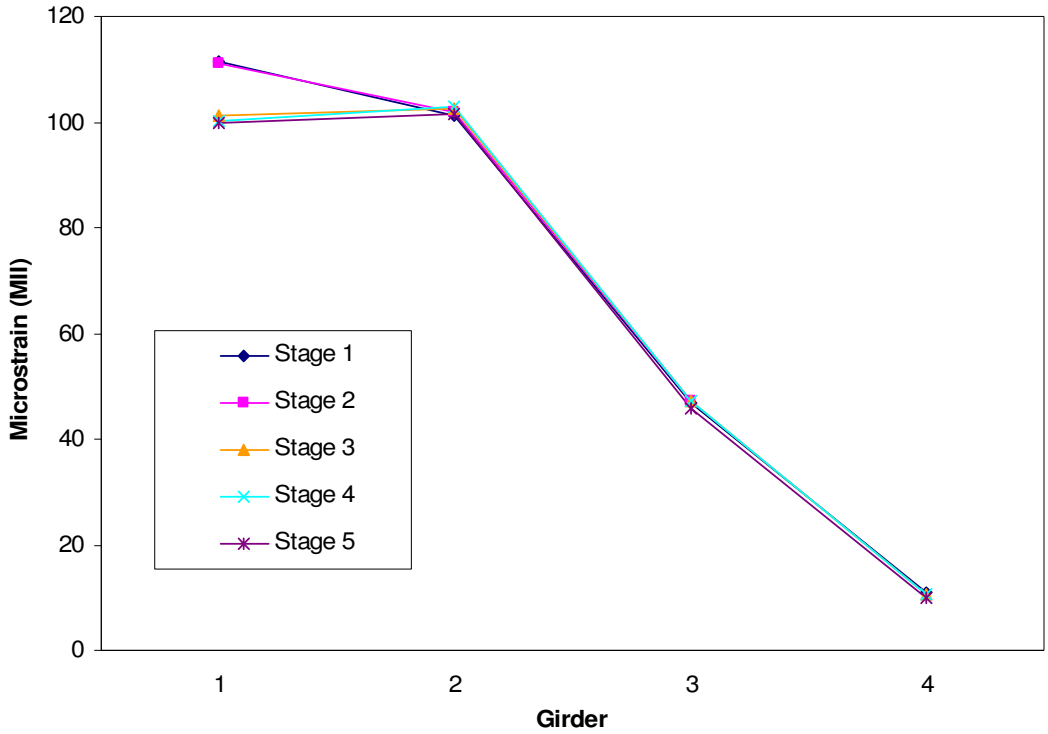
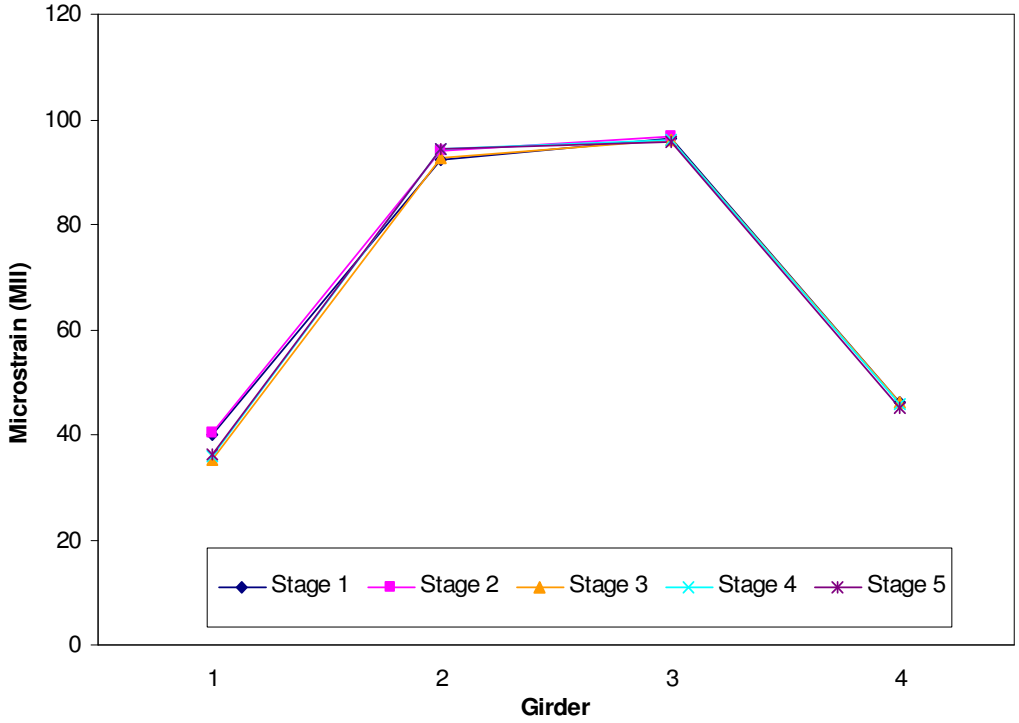
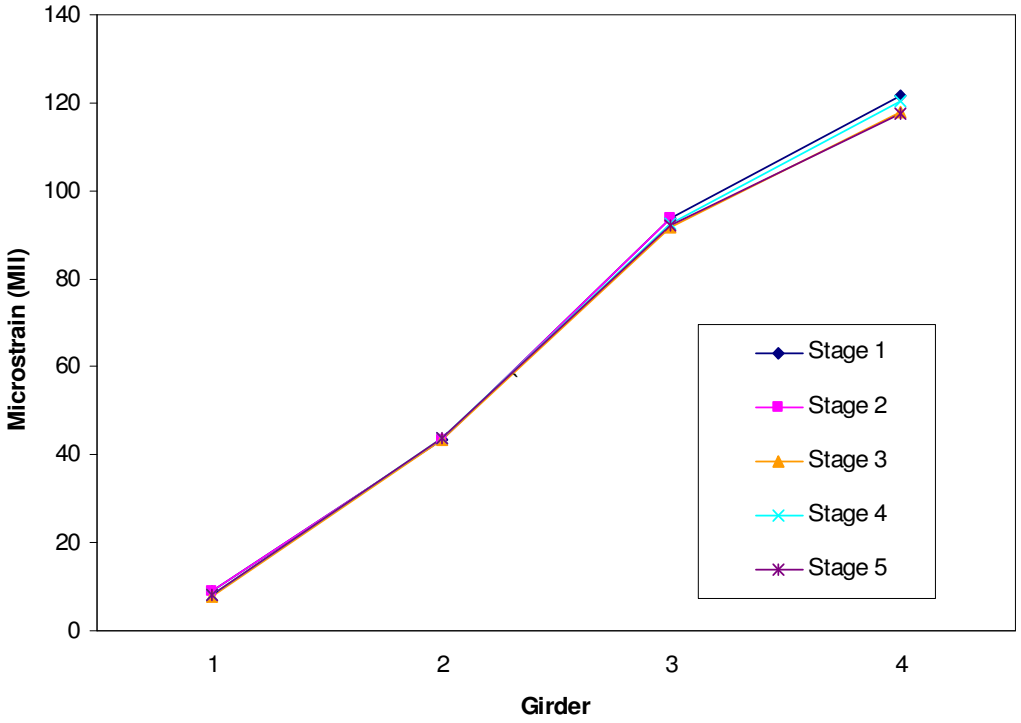
The strain profile results due to the removal of various pile elements are summarized in Figure 8.24 through Figure 8.26. There was a problem with the strain transducer on the bottom flange of Girder 1. After the first two test stages, the transducer malfunctioned and would not zero properly and the strain transducer located on Girder 2 near the abutment was moved to the midspan of Girder 1. There was a small change in strains (a difference of about 10 microstrain) due to substituting a second transducer for the original transducer. The change was not noticeable in the other two lane loadings.

As shown in Figure 8.24 through Figure 8.26, the removal of the piles on the east abutment had essentially no effect on the critical midspan strains. To determine whether the removal of the piles may have had an effect on the bearing restraint, data from the transducers located near the abutment were also investigated. The maximum strain in the bottom flange of the girders near the abutment varied slightly from girder to girder but the maximum occurred when the centroid of the rear tandem axles on the test truck was located at approximately the 1/8 span location in the bridge. The strain distribution located near the east abutment are presented in Figure 8.27 through Figure 8.29. Note, as previously mentioned, the transducer located on the bottom flange of Girder 2 was moved to the midspan of Girder 1 after Stage 2.

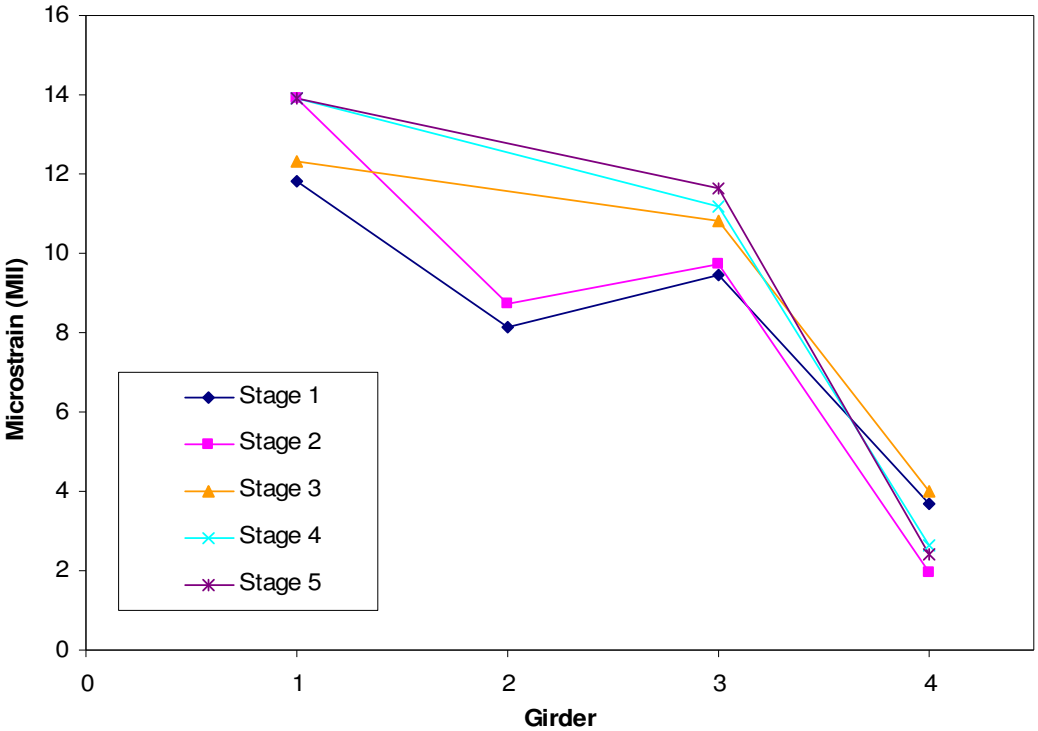
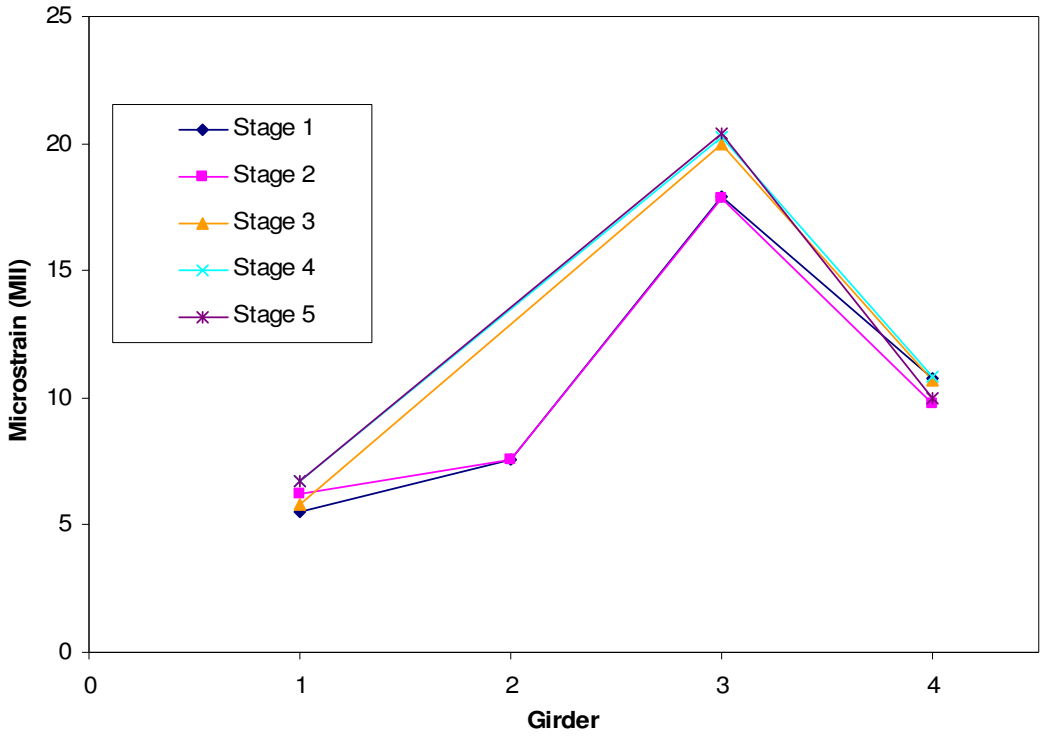
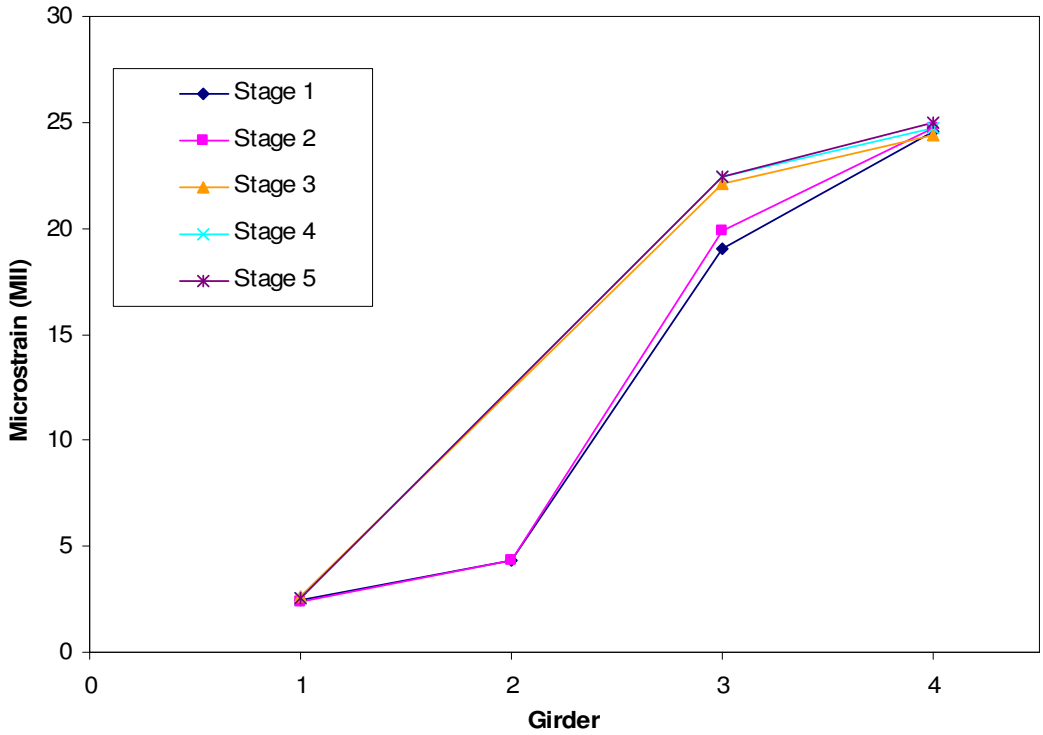
The difference in strains observed when the truck tandem centroid was located at the 1/8 span location for each girder was very minimal and therefore determined to be negligible. The fact that the strains observed at both the midspan and near the east abutment did not change with the removal of the pile elements indicated that the bearing restraint initially observed also remained essentially unchanged.
