Experimental validation of an integrated FRP and visco-elastic hardening, damping, and wave-modulating system for blast resistance enhancement of RC columns

Brian Henry Wood

MASTER OF SCIENCE IN CIVIL ENGINEERING

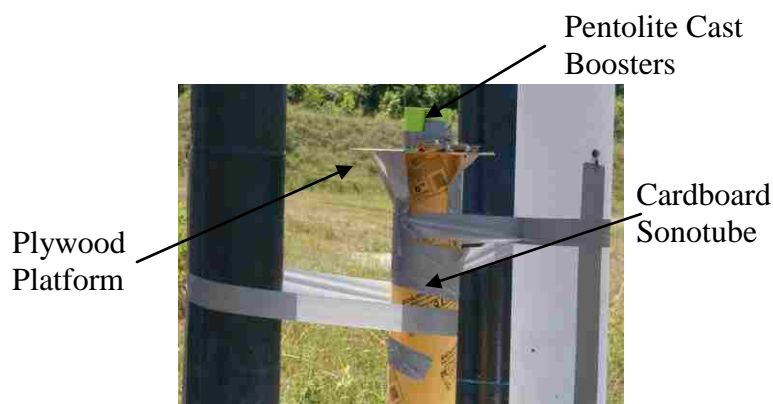
Figure 5.12. First 4 lbs Charge

The first charge was placed on a piece of plywood which was sitting on a cardboard Sonotube, as shown in Figure 5.12.

After the first blast, all the columns were inspected. It was determined that the plywood had caused some of the damage to Column 3. While debris damage would be a normal occurrence during a blast, it was not considered in this study due to difficulty in prediction. Therefore, the second 4 lbs charge and the 10 lbs charge were suspended from the top slab. The ANFO used for the 30 lbs charge was put in a bag and placed on top of a cardboard Sonotube (with no plywood).

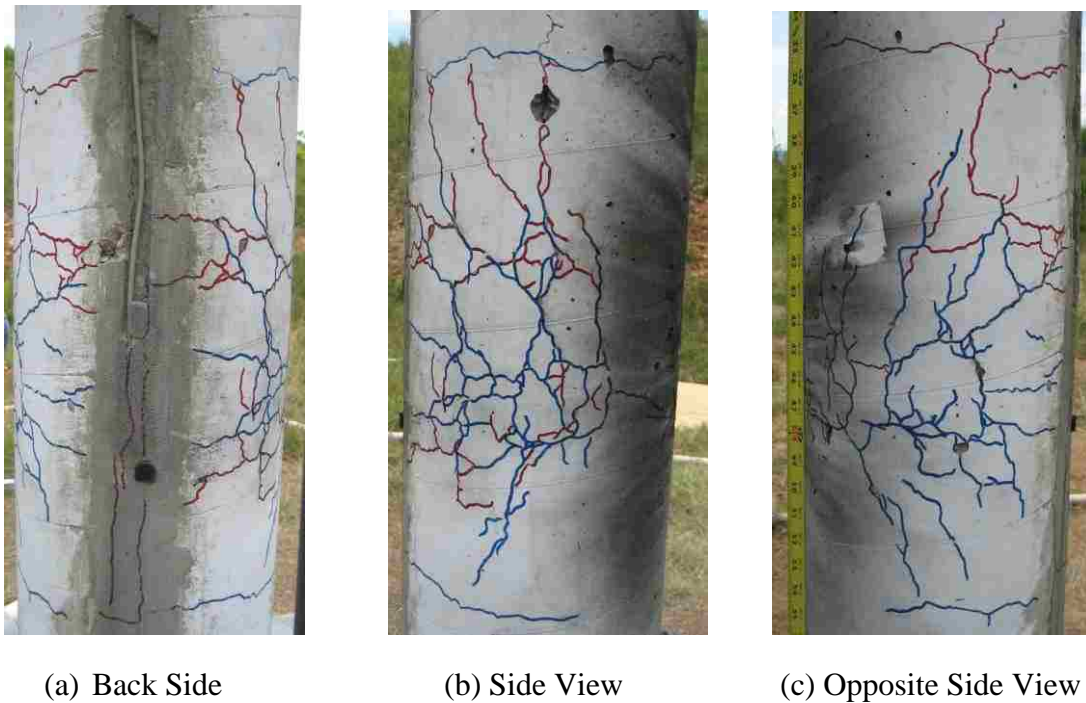
as is shown in Figure 6.6 (a) through (c) below. This could be a result of redistribution of moments caused by damage from the initial 4 lbs blast. Significant cracks at both ends of the column from the first blast allowed the release of end moments from the second blast. The cracking sustained from the second blast is shown in red, while the blue lines indicate the locations of cracks sustained from the first blast.

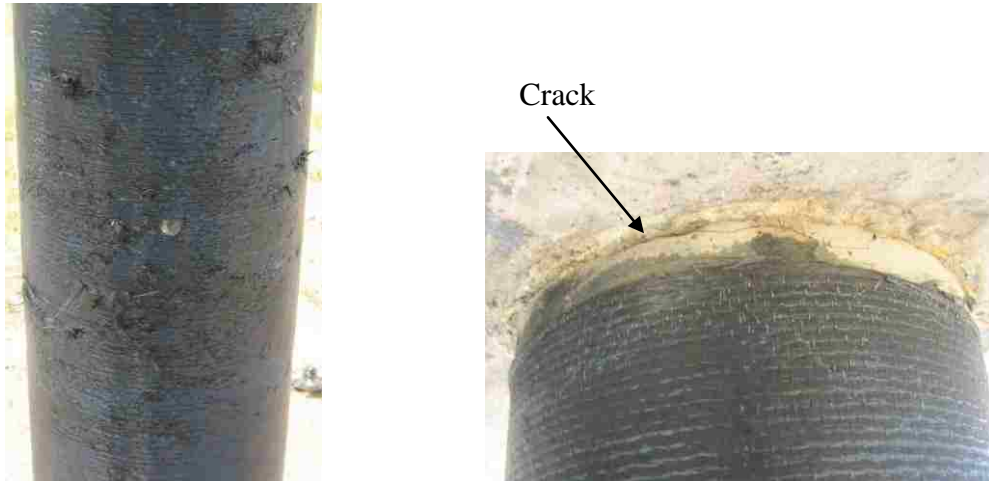
however, a crack that developed at the top of the column directly where the column joins the top slab. Figure 6.7 (a) and (b) show the damage to Column 2.

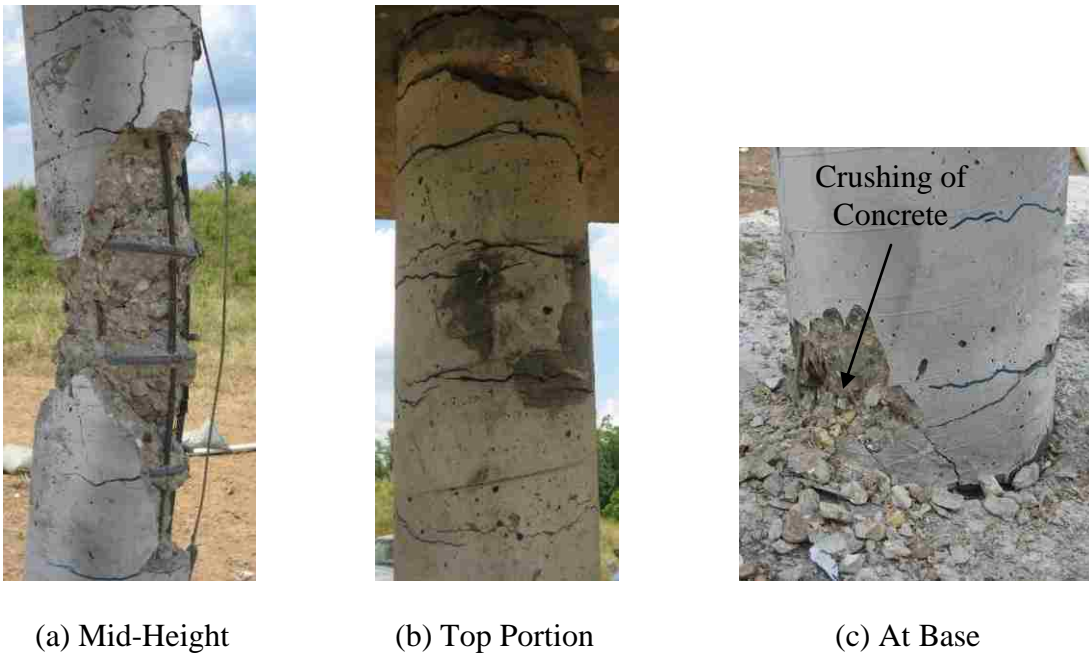
Figure 6.12. Damage to Column 1 after 30 lbs Blast

As noted previously, the 30 lbs blast resulted in flexural failure of all three columns by creating a hinge at the mid-height of each member. It was noticed, however, that Column 3 did not have as much permanent deflection as Columns 1 and 2. Since it is very difficult to measure this deflection in the field, pictures were taken of each column and the deflection was estimated. Figure 6.17 shows a comparison of the three columns and their respective deflections following the 30 lbs. blast.

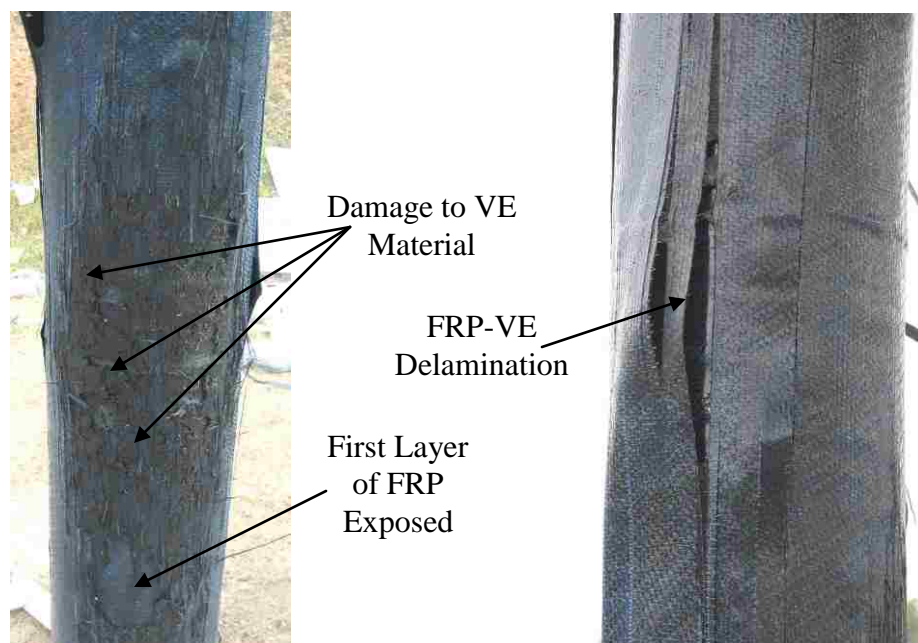
Column 3 sustained similar damage to Column 2. On the front side of the column close to the charge, as shown in Figure 6.14 (a), a significant portion of the VE layer had been either punctured or melted due to high temperature effects, but all of the concrete and inner FRP sheet on the column were still intact. On the back side of the column, as shown in Figure 6.14 (b), some of the outer FRP layer and VE layer had become delaminated from the inner FRP layer. These delaminations were likely caused by the reflected tensile wave generated when the blast wave reached the rear surface of the column. The column had hinged at the mid-height, but did not have as much permanent deflection as the other two columns, as will be discussed in the next section. Since the column had failed at the mid-height, it could be concluded that it was unsafe structurally. Figure 6.14 (a) and (b) show different views of the damage.

(a) VE Damage on Front Side   (b) FRP and VE Delamination on Back Side

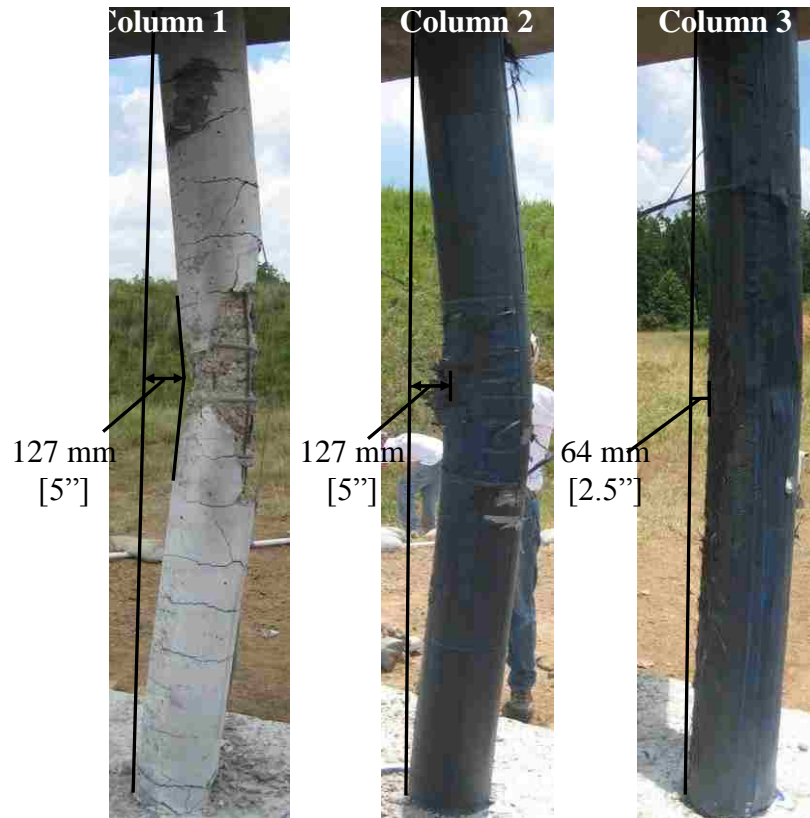
Figure 6.17. Comparison of Permanent Deflections

It can be seen from Figure 6.17 that after the blast, Column 3 had 50% less permanent deflection than the other two columns. This means that a significant amount of the energy generated by the blast was dissipated. Columns 2 and 3 both had a layer of FRP designed to confine the concrete. This confining action increases the ductility of the section, thereby dissipating energy when significant inelastic deformations are present. However, since Columns 2 and 3 had the same confinement FRP layer, and Columns 1 and 2 had approximately the same amount of permanent deflection, this additional energy dissipation could only be explained by the addition of the VE material. This alone provides evidence that this FRP-VE strengthening system adds a significant amount of
