Hydrologic Evaluation of Established Rain Gardens in Lincoln, Nebraska Using a Storm Runoff Simulator

A THESIS

Major: Environmental Engineering

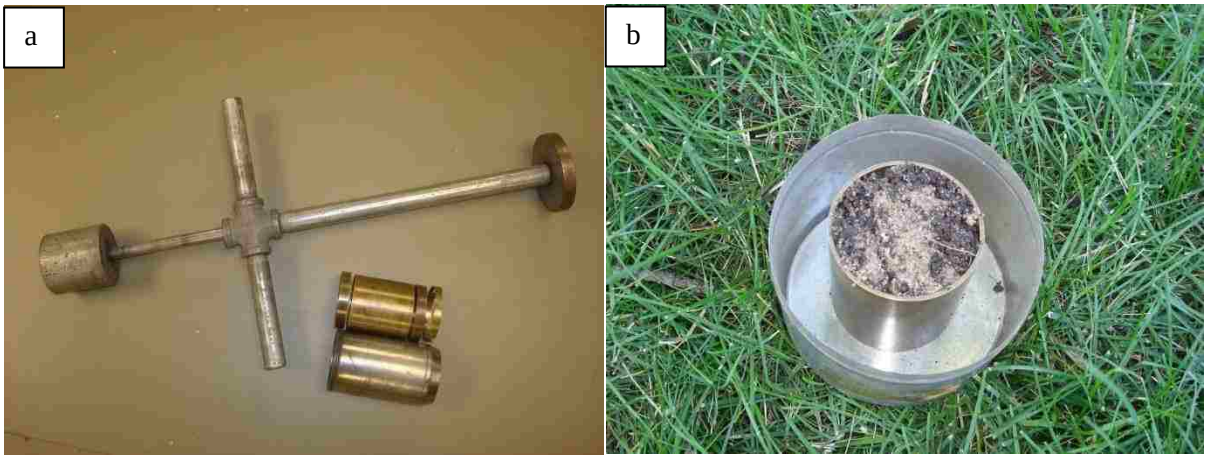
Figure 7. (a) Drop hammer and sharpened steel core with inner sampling ring for bulk density measurement. (b) Shaved soil core using collection equipment. Note the high sand content of the core indicates amendments were added.

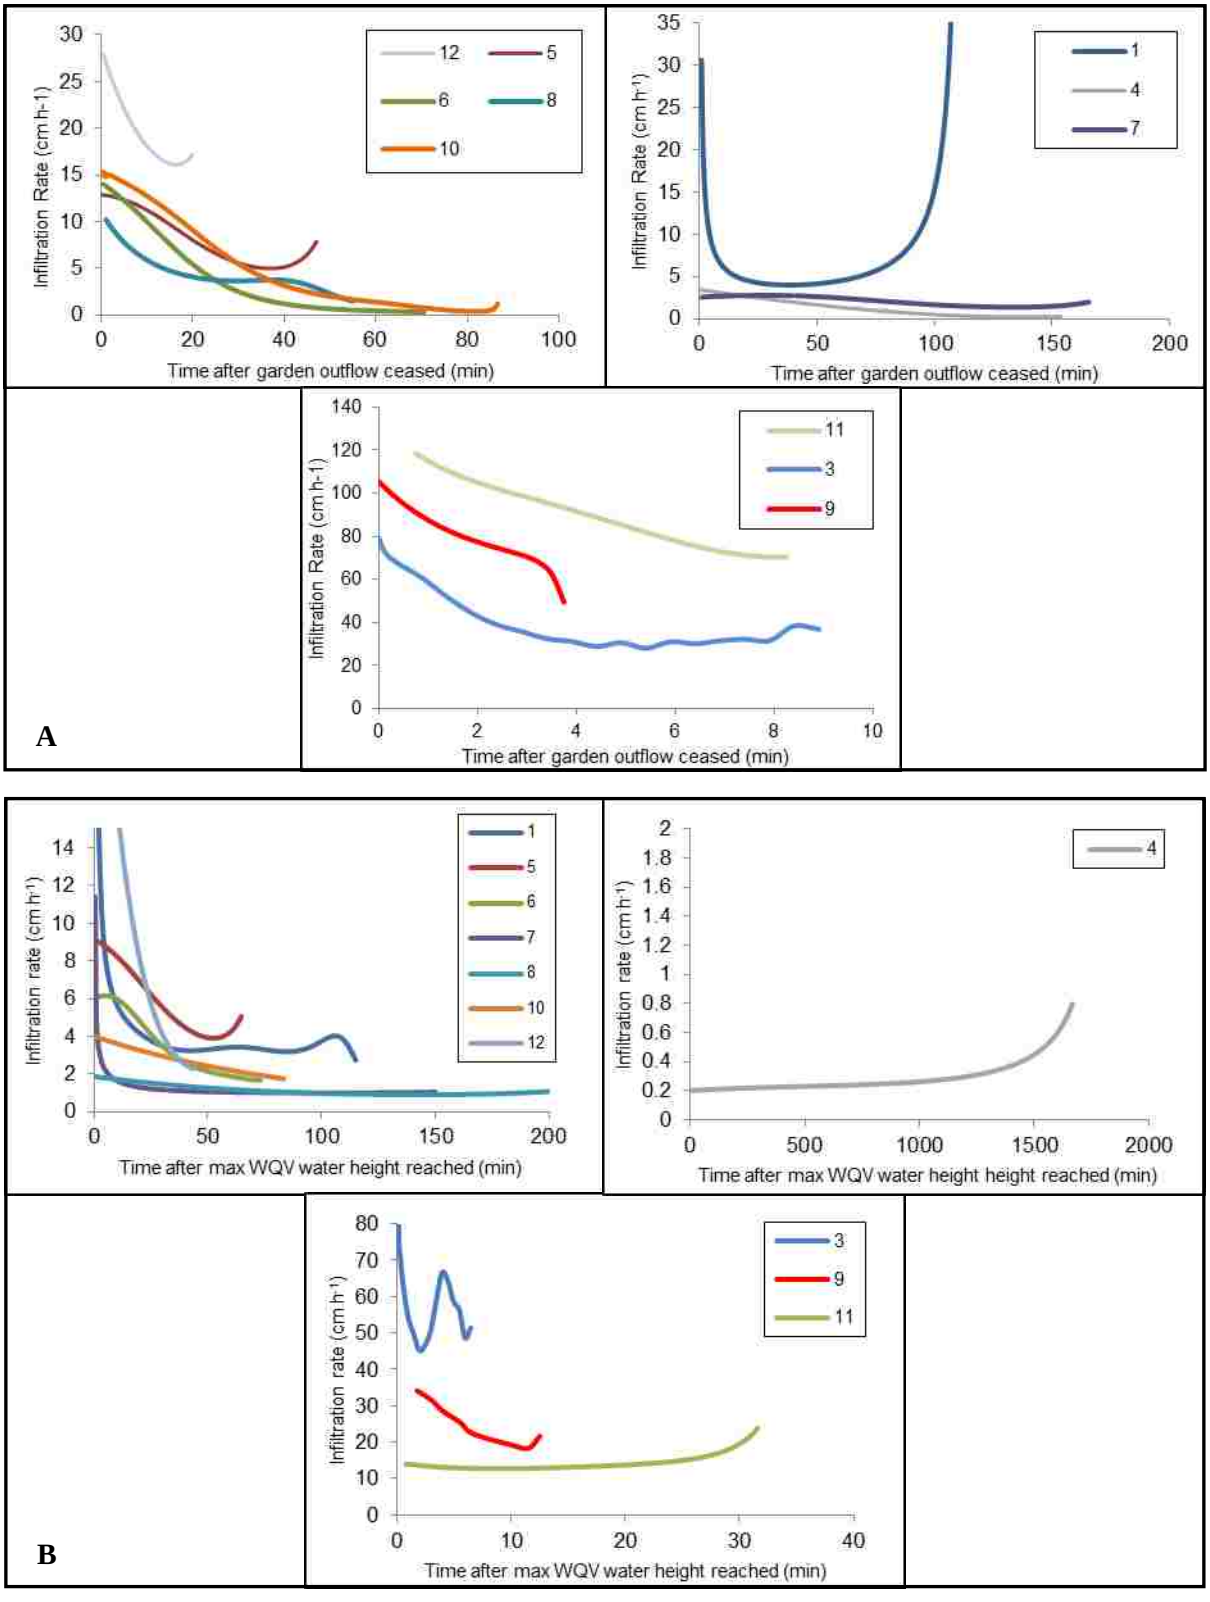
Infiltration rate curves were developed for each site and for each event except site 2 (Figure 17). Site 2 had almost no storage capacity, and thus did not have the same drawdown observational treatment applied to it as did the rest of the sites. Because the applied design storm washed out in the same fashion as an overflow storm at the remaining sites, an overflow storm was not applied. The unusual increase in infiltration rate seen on the curve for site 1 is likely due to increased error in the stage-storage and surface-area storage fits as ponding depth approaches zero. The infiltration rates generally follow a decreasing trend, with infiltration rate greatest at the beginning of the drainage period and decreasing with time (Willeke, 1966). Despite the decrease to a lower pseudo steady-state rate, 82% of minimum infiltration rates for all events (22 events) exceeded minimum NebGuide design standards for rain gardens. The variation at the end of the drainage event can be explained by a decreased ability for the surface area-based regression fits to describe physical surface area changes accurately.

Figure 17. Infiltration rate curves of each rain garden for design storm (A) and overflow storm (B). Three figures per event are used to provide some comparison for gardens with similar time scales. (Site # in legend).

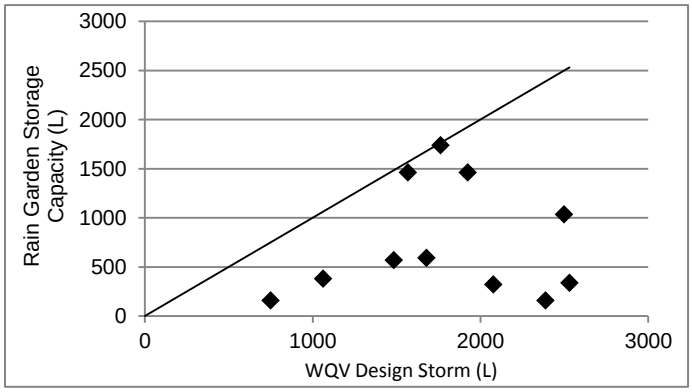
None of the rain gardens evaluated were able to completely hold the water quality volume storm before overtopping the berm, although sites 1 and 12 were able to accept over 90% of the WQV before overflow occurred (Table 7). The other ten gardens were well below the capacity needed to contain the WQV. On average, there was a wide range of storage capacities observed (Figure 20).

Figure 20. Determined rain garden volume capacity vs design storm volume for each rain garden (blue diamonds). The 1:1 line represents successful capture of WQV.

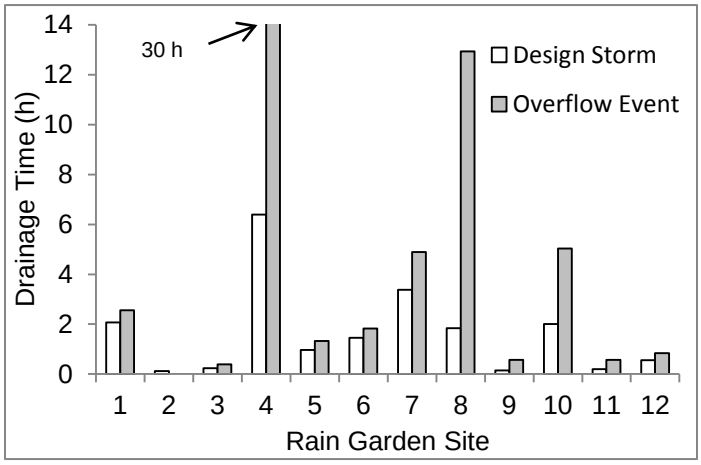
The mean drainage times (±SD) for the WQV event and the overflow event were 1.61 h (±1.81) and 5.54 (±8.90), respectively, with a maximum time recorded of 30 h. The measured drainage times of the twelve rain gardens are plotted in Figure 21. No overflow event was simulated for site 2; because of the lack of storage volume for the WQV, the decision was made to forego the second test and collect all necessary data in one event. All drain times were less than the 48 hour recommended maximum drainage time allowable in bioretention (EPA 1999; Franti and Rodie, 2007; Wisconson Department of Natural Resources, 2003).

Figure 21. Comparison of measured drain times obtained from two simulated runoff tests. The overflow event for site 4 is 30 h, but was cut off to allow visual comparison of lower drain time values.

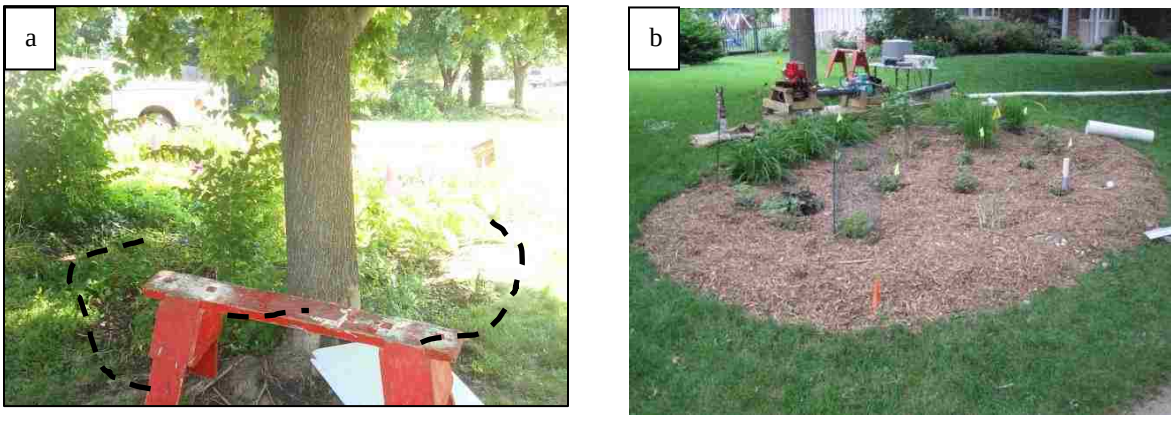
plants depends on many factors including soil moisture, proper grading, mulch cover, time-of-planting, initial maintenance (including weeding and watering), proper sun exposure, amount of compost, and how well plants interact with other species in the garden (Wisconsin Department of Natural Resources, 2003). Some inappropriate plant placement and performance was observed. The rain garden at site 10, which had previously been a standard garden with a rock water feature, had an established tree touching the berm (Figure 22a). In the midwest, trees can disrupt the root growth of native perennial shrubs and grasses. They also restrict sunlight that reaches native plants in the rain garden basin, thus inhibiting growth during the growing season (Franti and Rodie, 2007; University of Wisconson, 2003). Another site had almost no direct sunlight available to the rain garden due to multiple trees in the owner's yard as well as neighboring yards (Figure 22b). Plant growth was severely restricted at this site (Site 3). Four sites excessively large regions of unplanted open space in the rain garden.

Figure 22. (a) Site with tree near poorly-defined berm (black dashed line). (b) Garden with poor plant density possibly due to under-utilized space and excessive tree shade.

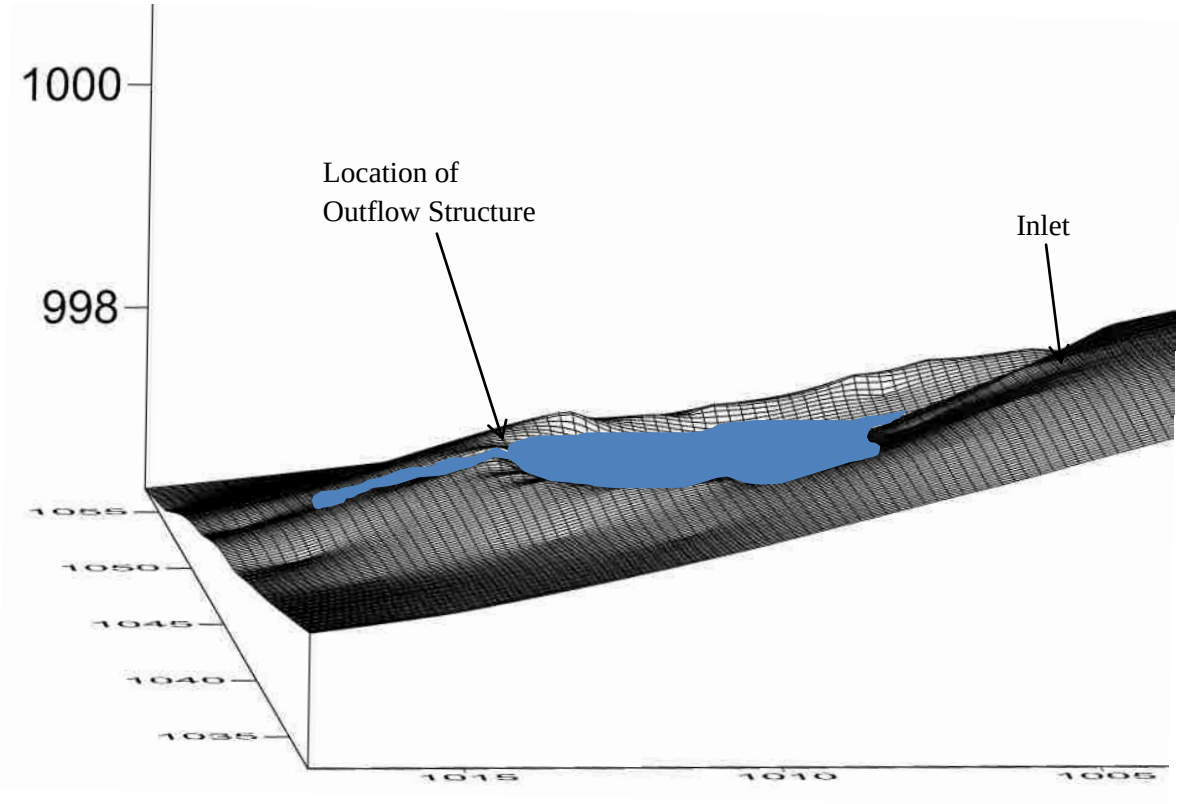
A consistent theme at the twelve rain gardens was inadequate berm grading. While an overflow may be installed with enough rock and be at the right location, a breach or low point in the berm at another location resulted in a less effective storm water retention structure, much like the situation at site 6 (Figure 25). More care by the designers and installers should result in more retention of volume.

Figure 25. Three-Dimensional wireframe surface of rain garden 6 with water drawn in to show outflow occurs before entire basin can fill. The grading of the upslope half of the rain garden prevents maximum volume capture.

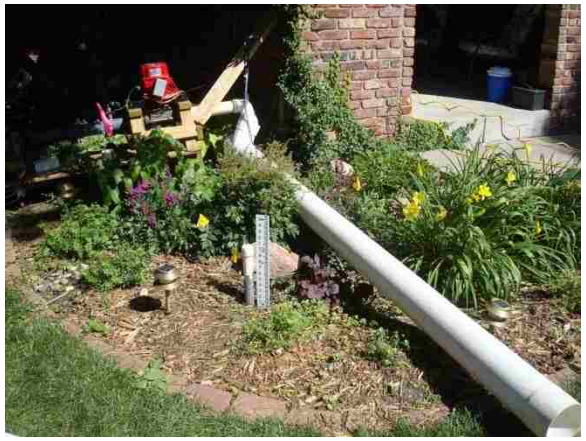
SITE 7

Figure 37. Rain garden close to the foundation which receives influent from vine-covered downspout on brick wall. White pipe directs water leaking from valve out of garden before test is conducted.

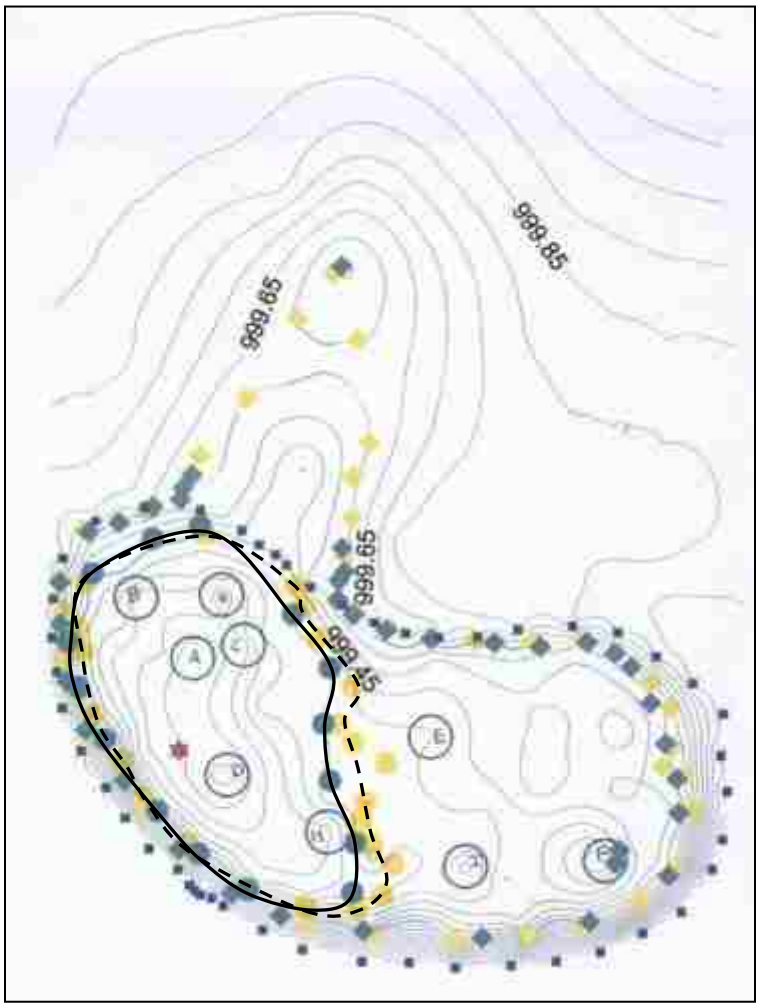
Each day consisted of two simulation runs—one "water quality" (0.8 inch) event hydrograph followed by a run meant to fill up the entire garden before overflow was witnessed. The furthest advance of water was marked with flags for all four events, and represents the perimeter of the maximum ponded depth. The photo below shows the various colored flags marking the ponded water outline. These flags were surveyed and are shown together in the figure below (left). Evident in the left figure is the similarity in water depth reached by both water quality events. This indicates that antecedent moisture of the soil did not have a dramatic effect on surface storage capacity. An important thing to note is that only about half the garden was filled by the design storm.

———	Design Storm Event – Day 1
– – – –	Design Storm Event – Day 2
