# Comprehensive Analysis and Evaluation of Fukushima Daiichi Nuclear Power Station Unit 2

**Abstract** — Estimation and understanding of the state of the fuel debris and fission products inside the plant comprise an essential step in the decommissioning of Tokyo Electric Power Company Holdings' Fukushima Daiichi nuclear power station (1F). However, because of the plant's high-radiation environment, direct observation of the plant interior is difficult. Therefore, in order to understand the plant's interior conditions, comprehensive analysis and evaluation based on various measurement data from the plant, analysis of plant data during the accident progression phase, and information obtained from computer simulations for this phase are necessary. These evaluations can be used to estimate the conditions of the interior of the reactor pressure vessel (RPV) and the primary containment vessel (PCV). This paper addresses 1F Unit 2 as the subject to produce an estimated map of the fuel debris distribution from data obtained about the RPV and PCV based on comprehensive evaluation of various measurement data and information obtained from the accident progression analysis, which were release

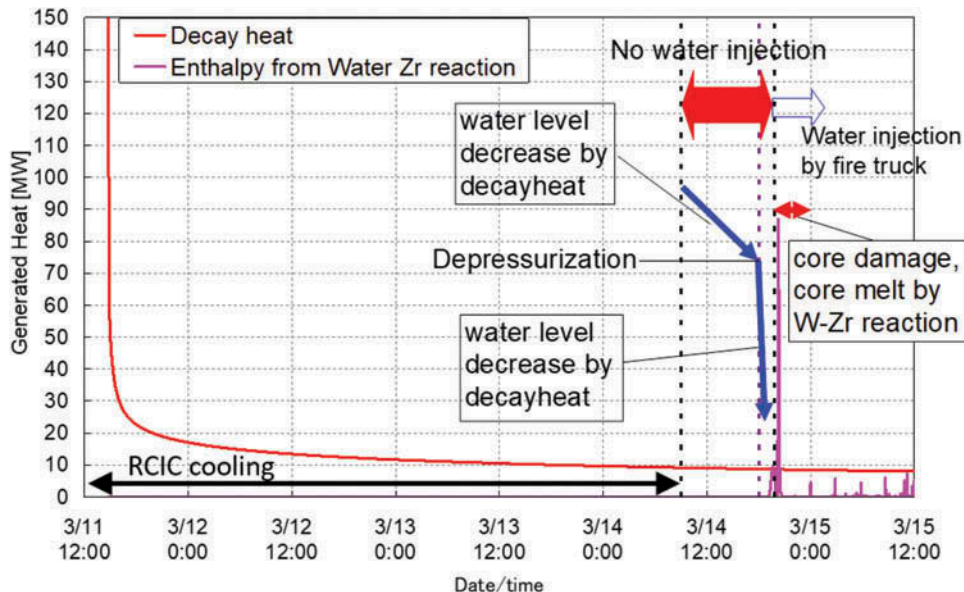
Figure 1 (Ref. 1) shows the relationship between the decay heat of Unit 2 and the heat generated via the zirconium-water reaction. At Unit 2, the reactor core isolation cooling (RCIC) system continued to function for approximately 3 days after the accident, which continued the cool-down of the fuel until the decay heat began to decrease. After the failure of the RCIC system, the water level decreased because of the decay heat. The RPV was rapidly decompressed by manually opening the main safety relief valve (SRV) when the water level reached the top of the fuel, and this caused decompression boiling and a further decrease of water level, which is assumed to have eventually exposed the fuel. By the time the fire engines started to inject water into the RPV, the fuel was already exposed. This exposure suggests that the zirconium-water reaction began when water vapor came into contact with the heated fuel, causing the fuel to melt.

Fig. 1. Relationship between the decay heat of Unit 2 and the heat generated via zirconium-water reaction.<sup>1</sup>

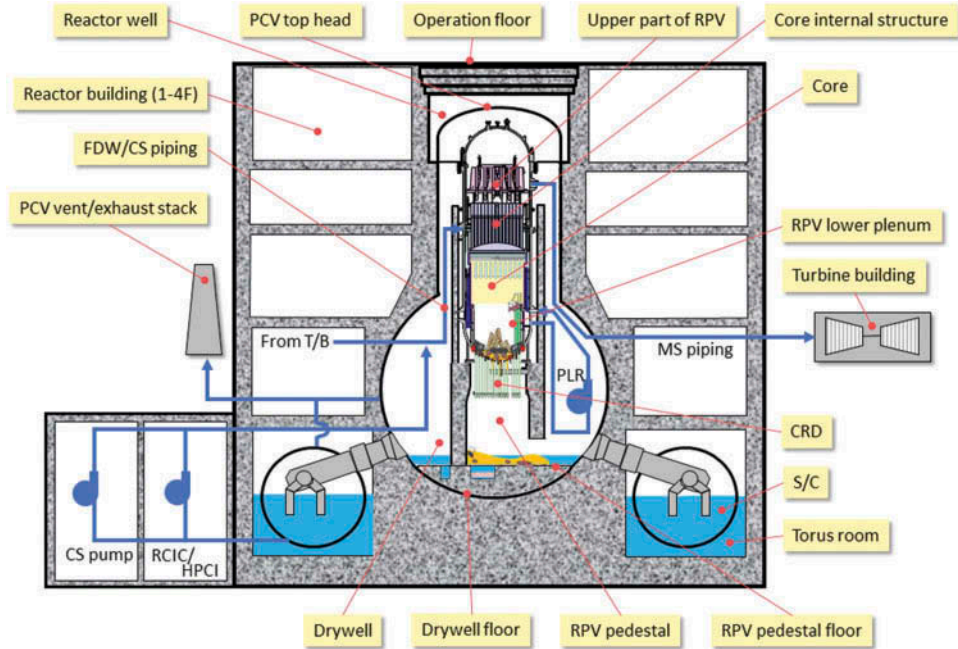
Figure 2 (Ref. 2) and Table I (Refs. 3 through 47) show the collected information that contributes to the estimation of the fuel debris distribution in the RPV and PCV of Unit 2. The information shown in Table I (Refs. 3

Fig. 2. Unit 2 information aggregation.<sup>2</sup>

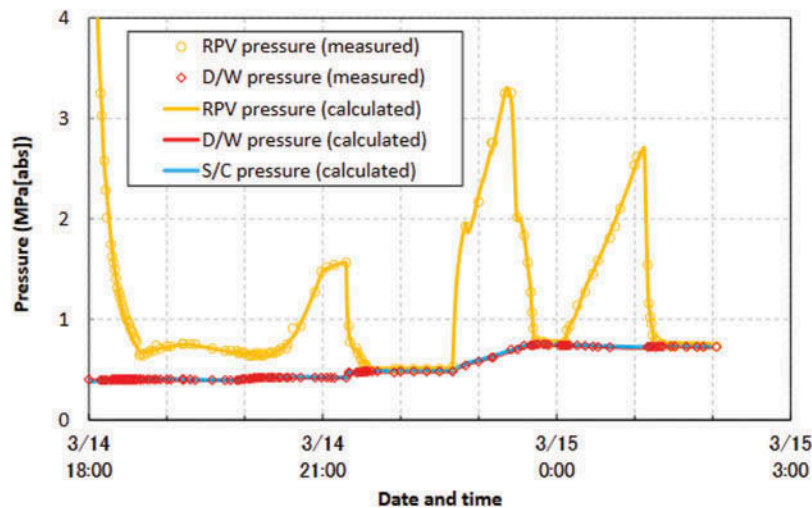
Fig. 5. Comparison of measurements of RPV/PCV pressure with the result of the GOTHIC analysis.<sup>1,48</sup>

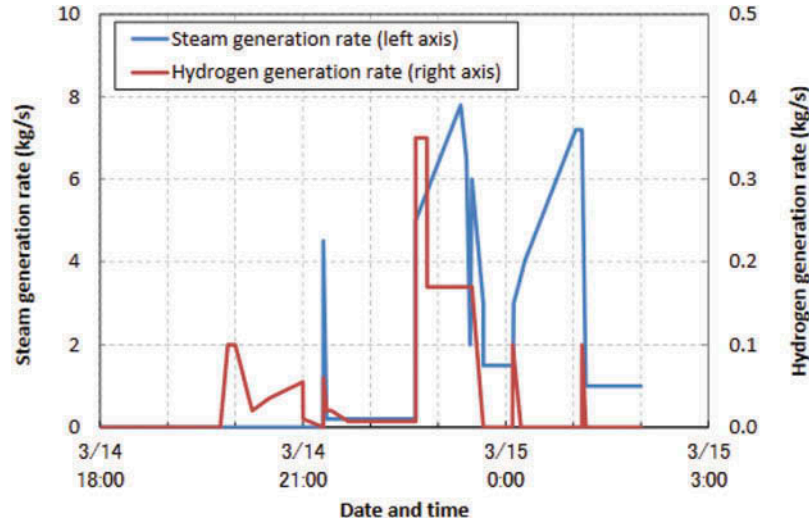
Fig. 6. Setting of the amount of generated vapor and hydrogen by the GOTHIC analysis.<sup>1,48</sup>

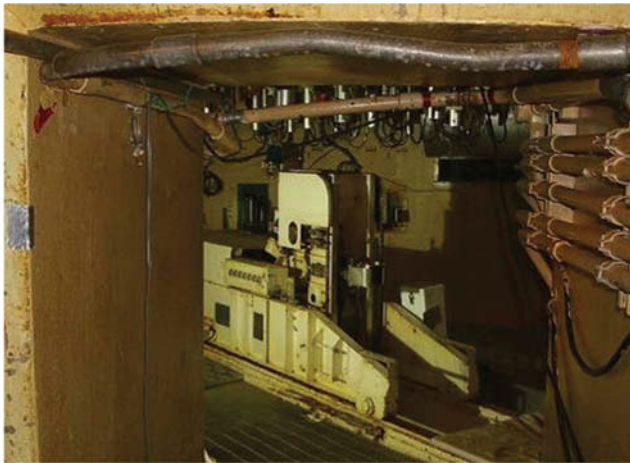
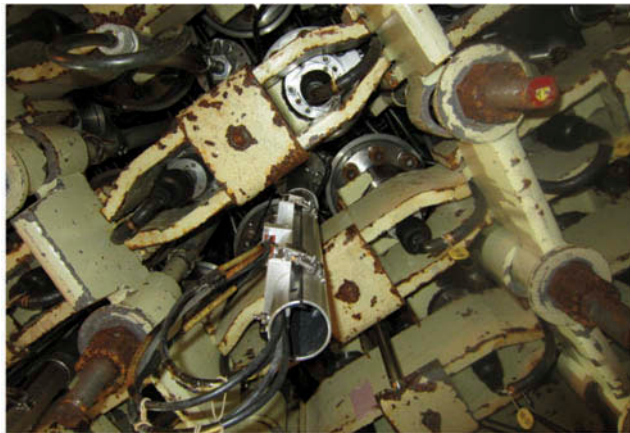
Fig. 13. Interior of the Unit 5 pedestal.<sup>30</sup>

As shown in Fig. 12 (Ref. 30), a research device entered from the X-53 penetration zone in August 2013 to study the exchange rail of the control rod drive mechanism (CRDM) and the area near the opening of the pedestal. A U-shaped cable appears in the photograph captured from the point indicated by “(3)” in Fig. 12 (Ref. 30), while the device was facing the inside of the pedestal. Next, Fig. 13 (Ref. 30) shows the state of the interior of the pedestal of Unit 5. Figure 13(a) was captured from the same angle as the photograph shown in Fig. 12 (Ref. 30), Fig. 13(b) shows a view from below, and the U-shaped cable resembles the one observed in Unit 2.

(a) Observing the inside of the platform from the pedestal opening

(b) Observing the bottom of the RPV

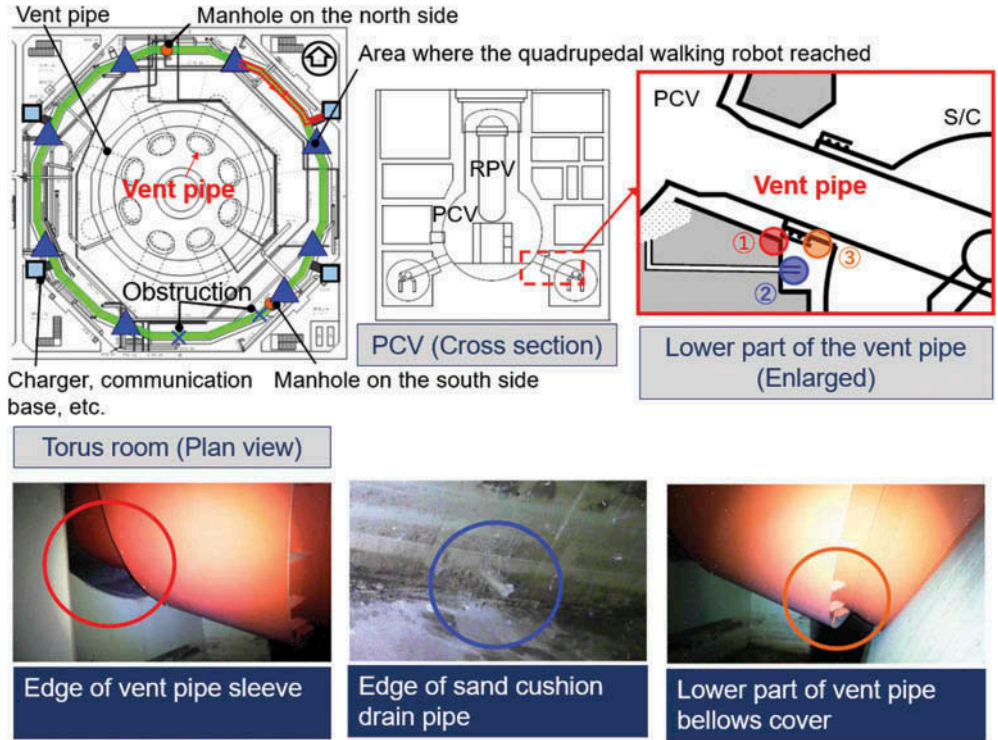
The inspection of the torus room interior conducted at Unit 2 showed no evidence of the damage to the containment shell, such as leakage from the sand cushion drain pipe, which was observed in Unit 1. As shown in Fig. 18 (Ref. 47), verification of the leakage from the area around the lower part of the suppression chamber (S/C) vent pipe using a quadruped walking robot was conducted in December 2012 and April 2013. These inspections were conducted at “①” the vent pipe sleeves, “②” the ends of the sand cushion drain pipes, and “③” the

lower parts of the vent pipe bellows that cover the eight vent pipes as shown in Fig. 18 (Ref. 47), and no leakage was found [Fig. 19 (Ref. 47)]. Thus, it is inferred that even if the fuel debris that fell in the pedestal reacted with the concrete, it occurred within a limited area.

Fig. 18. Sections of the lower part of the vent pipe to be inspected.<sup>47</sup>
