Comprehensive Analysis and Evaluation of Fukushima Daiichi Nuclear Power Station Unit 2

Takuya Yamashita, Ikken Sato, Takeshi Honda, Kenichiro Nozaki, Hiroyuki Suzuki, Marco Pellegrini, Takeshi Sakai & Shinya Mizokami

Abstract — Estimation and understanding of the state of the fuel debris and fission products inside the plant comprise an essential step in the decommissioning of Tokyo Electric Power Company Holdings' Fukushima Daiichi nuclear power station (1F). However, because of the plant's high-radiation environment, direct observation of the plant interior is difficult. Therefore, in order to understand the plant's interior conditions, comprehensive analysis and evaluation based on various measurement data from the plant, analysis of plant data during the accident progression phase, and information obtained from computer simulations for this phase are necessary. These evaluations can be used to estimate the conditions of the interior of the reactor pressure vessel (RPV) and the primary containment vessel (PCV). This paper addresses 1F Unit 2 as the subject to produce an estimated map of the fuel debris distribution from data obtained about the RPV and PCV based on comprehensi

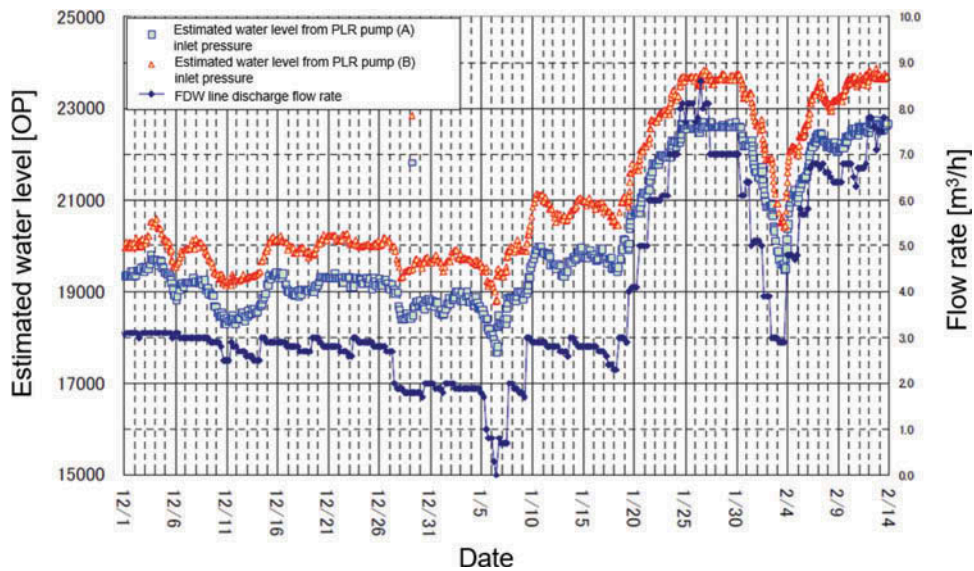
Figure 9 (Refs. 1 and 50) shows the relationship between the amount of the water injection from the feedwater (FDW) system and the annulus water level estimated from the entry pressure of the primary loop recirculation (PLR), as recorded between December 2011 and February 2012. As the amount of water injection from the FDW system changed, the water outside the shroud increased. This relationship suggests the following two possibilities. First, the damage to the shroud may have been small so that water accumulated outside the

Fig. 9. Relationship between the amount of water injection from the FDW system and the annulus water level estimated from the entry pressure of the PLR system from December 2011 to February 2012 (Refs. 1 and 50).

first possibility is more likely, and it is unlikely that the shroud was extensively damaged.
