# Environmental Site Assessment and Hydrogeologic Impacts to Groundwater at St. Ignatius, Montana and Hanford, Washington

# ENVIRONMENTAL SITE ASSESSMENT AND HYDROGEOLOGIC IMPACTS TO GROUNDWATER AT ST. IGNATIUS, MONTANA AND HANFORD, WASHINGTON

The first chapter, titled "An Environmental Site Assessment, St, Ignatius, Montana", is a Phase I commercial property environmental site assessment (ESA) report, completed on behalf of Pioneer Technical Services, Missoula, Montana (Carter, 2011). The chapter describes the purpose of the environmental assessment, limiting factors, site conditions, and results of visual observations at the site, findings, and conclusions. The entire report is included in this portfolio paper verbatim with minor edits for clarity. Research was focused on whether the property development had affected the local environment. This report touched on many of my academic interests including policy research, property development, and externalities impacting human and environmental health. This report was the first site assessment and characterization I completed since beginning my professional work in the environmental arena.

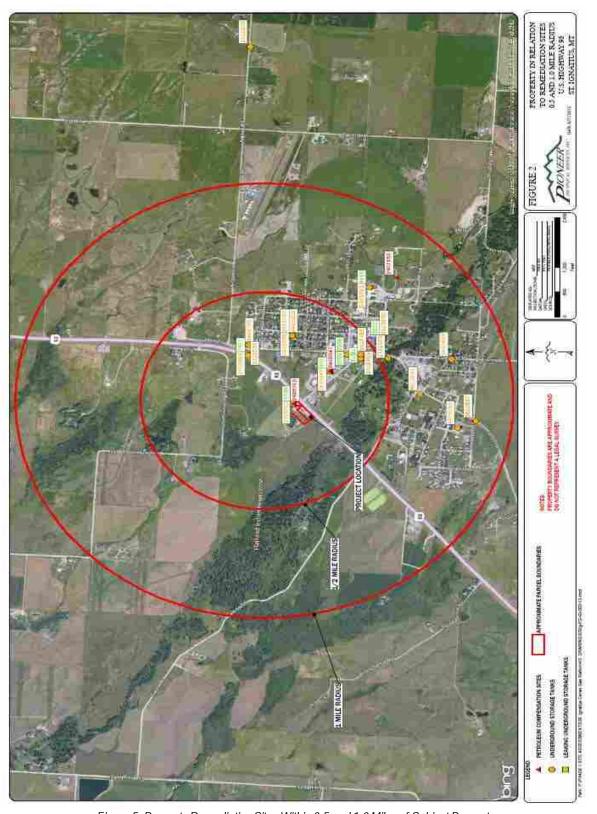
Figure 5. Property Remediation Sites Within 0.5 and 1.0 Miles of Subject Property

Pioneer reviewed the DEQ LUST site list. There are 37 active LUST sites listed in Lake County. Two of the LUST sites are located within the 1.0-mile radius of the subject property (Figure 5). The closest is an active LUST site at 240 Mountain View Drive at Stuart's Service Center that was resolved in 1995 by removing the contaminated soil to a regulated landfill site outside of the county.

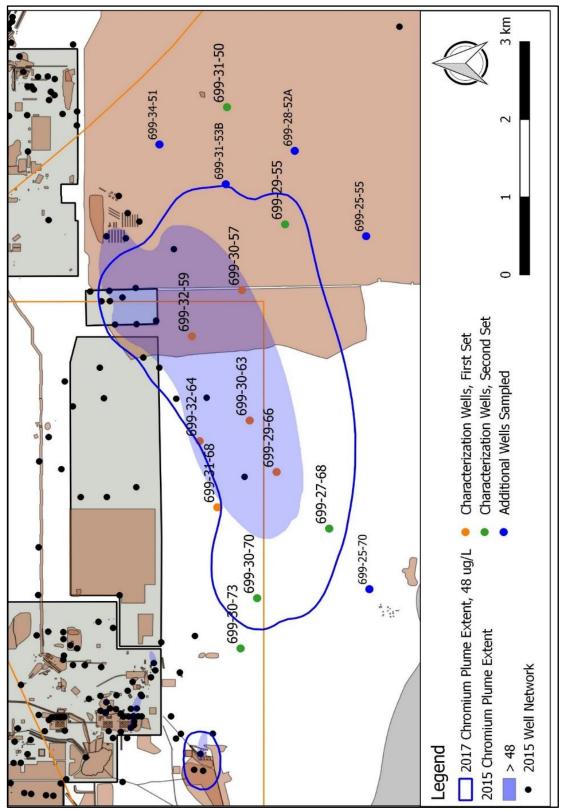
Figure 15. Locations of the Eleven Southeast Chromium Plume Remedial Design Investigation Wells

Initially, six characterization wells were planned to further define the nature and extent of the southeast chromium plume to support remedial design. These six wells were located based on the extent of the 2015 plume, shown on Figure 15, which was the latest interpretation at the

start of the drilling program. Chromium concentrations at the two northern wells (699-31-68 and 699-32-64) were consistent with the 2015 plume, but the relatively high concentrations in the three southern wells (699-29-66, 699-30-63, and 699-30-57) indicated that the plume above the 48 µg/L cleanup level extended farther south. The U. S. Department of Energy, Richland, Washington Operations Office (DOE-RL) and the U.S. EPA representatives met on January 19, 2017 to review the findings from the first six wells and agreed to install and sample four additional characterization wells in 2017. These four wells were located to investigate the eastern (699-31-50), southeastern (699-29-55), southwestern (699-27-68) and western (699-30-70) extent of the plume. DOE-RL and EPA also agreed to collect four quarters of groundwater samples from each of the initial six wells to evaluate the groundwater monitoring data for temporary reducing conditions affecting chromium concentrations. Results of the four quarters of monitoring were submitted to DOE-RL in April 2018.

In well 699-30-70, chromium concentrations during drilling were relatively high (average of 91  $\mu$ g/L), indicating that the plume extended farther to the west. DOE-RL and EPA met on July 20, 2017 and agreed to drill an eleventh well (699-30-73) to define the western extent of the plume closest to the 216-S-10 complex source. Concurrence was reached that 11 wells would be sufficient to define the nature and extent of the southeast chromium plume for remedial implementation, support completion of the Draft A remedial design investigation report, and satisfy the remedial design investigation requirement of Tri-Party Agreement (TPA) milestone M-16-193 for the southeast chromium plume.
