# Nondestructive evaluation of a carbon fiber wing spar using air-coupled ultrasound

Adam Howard Kite  
*Iowa State University*

A thesis submitted to the graduate faculty  
in partial fulfillment of the requirements for the degree of  
MASTER OF SCIENCE

Major: Aerospace Engineering

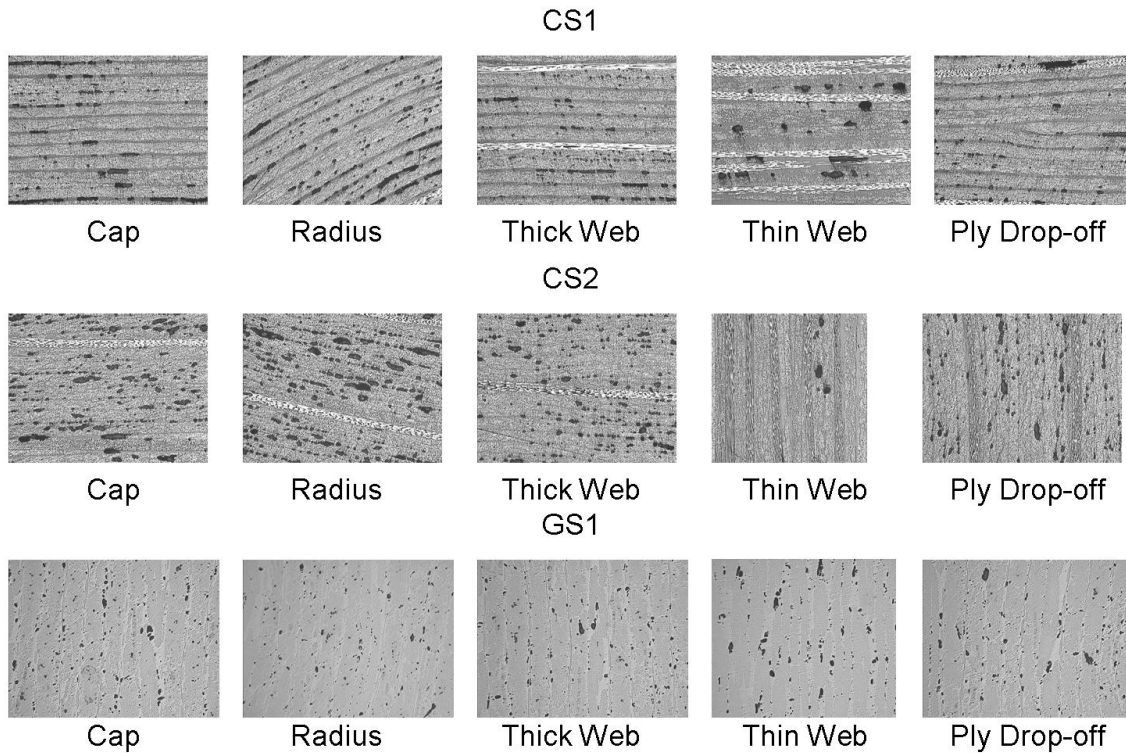
Micrographs were taken from each of the five areas at 50x magnification. The porosity was readily visible as dark black regions while viewing a large area of the sample. These images provided a very rough estimate of the amount of porosity present in the test samples. The porosity levels present in the test articles do not represent the characteristics of the production spars in any way. A representative micrograph from each area can be seen in Fig. 2.5. During the porosity investigation an image processing method was developed to estimate the porosity levels present in the test samples. This method analyzes micrograph images of the test sample and is presented in more detail in the following chapter.

Figure 2.5 Porosity images from each area of the three spar sections.

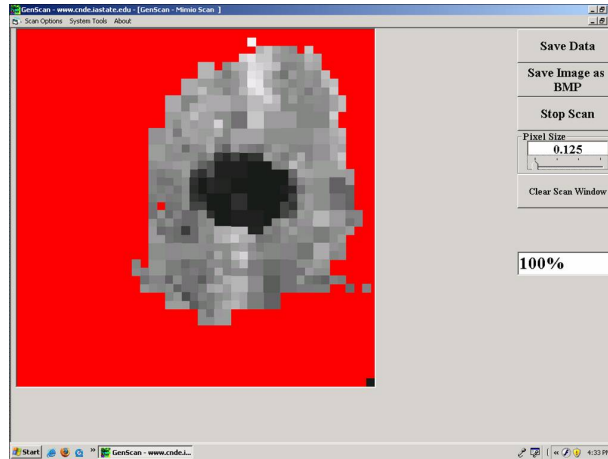
Figure 4.2 The GenScan image of an impact damage as seen by the user.

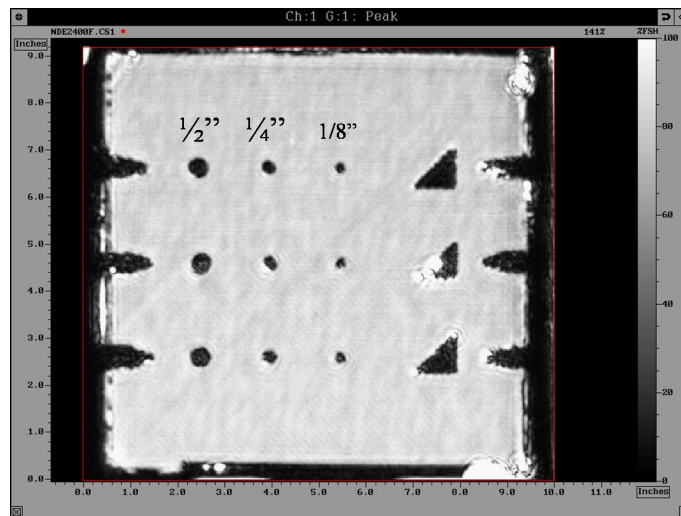
Figure 4.7 C-scan image with engineered defects produced from QMI 400 kHz focused transducers through a 10-ply solid laminate.

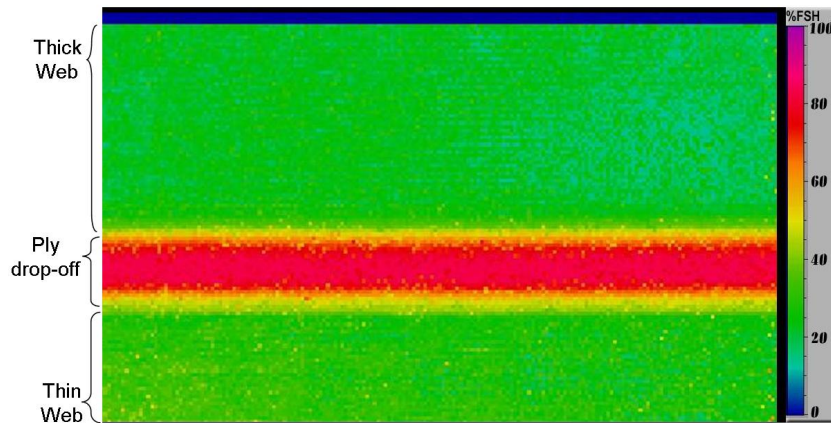
Figure 5.9 C-scan of the acrylic test panel using the Epoch 4 with the receiver tilted to 12.5 degrees.

Amplitude C-scans were made with the Epoch 4 and the Ultrason 200 kHz transducers with the SONIX scanning frame. The first scan image was made with the receiver tilted nearly normal to the ply drop-off, 12.5 degrees off vertical, shown in Fig. 5.8. This maximizes the signal through the ply drop-off area but slightly reduces the effective signal through the thick and thin web, see Fig. 5.9.

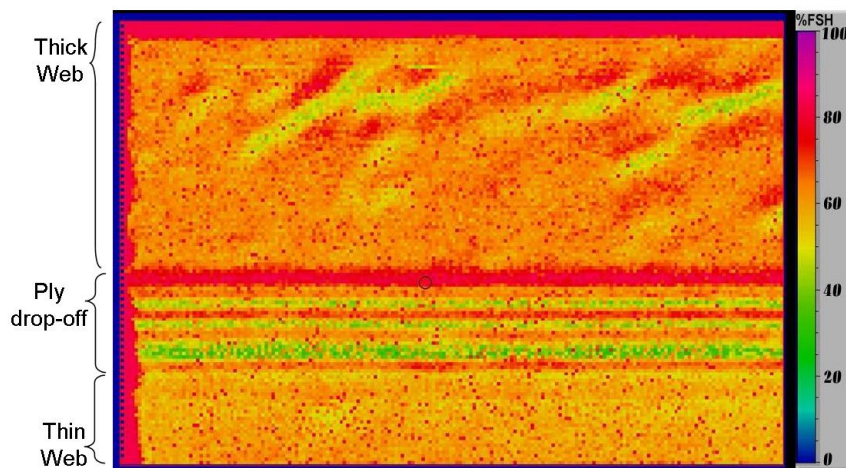
Figure 5.10 Image of the acrylic sample with receiver tilted 2 degrees off normal.

Since tilting the receiver to 12.5 degrees maximized the signal in the ply drop-off region but reduced the signal in the thick and thin web, it was decided to find a tilt angle that would give good signal penetration through all three web areas. It was found that by tilting the receiver two degrees off the normal vertical axis, good signal strength could be obtained in all three areas of the web. The image produced from this setup can be seen in Fig. 5.10. The scanning of the acrylic spar model provided insight into possible scanning techniques for use in testing the carbon spar samples.

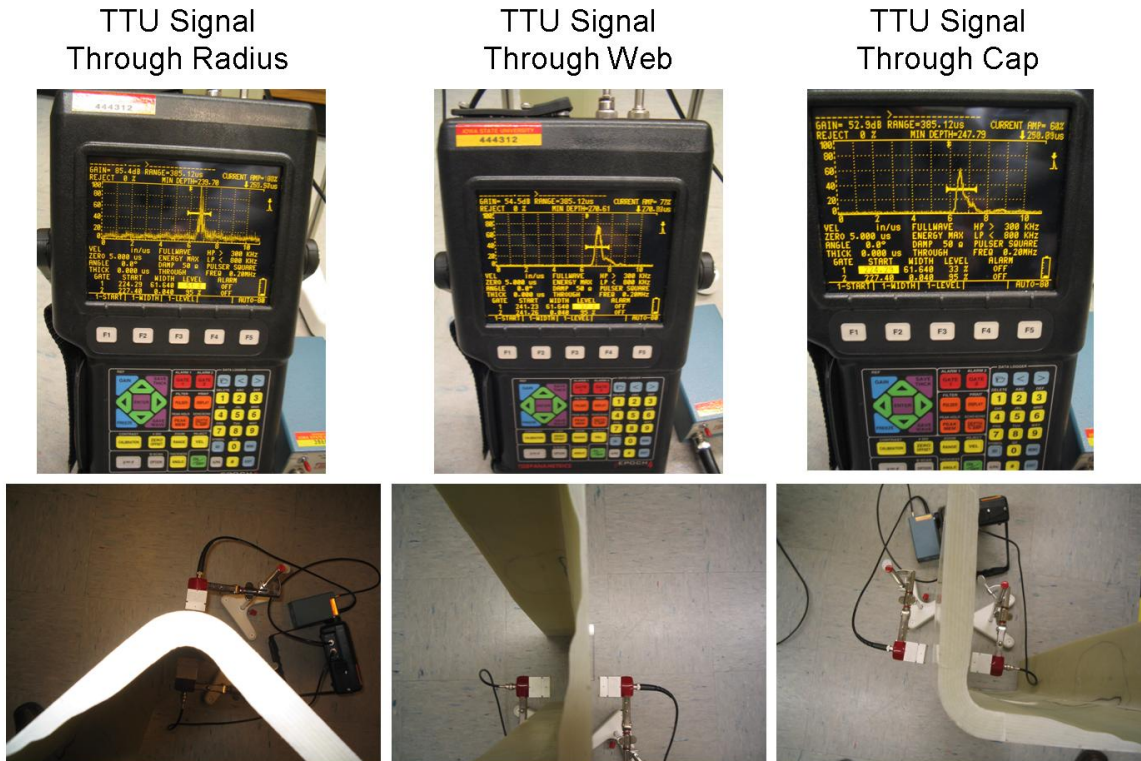
Figure 5.11 Signal produced through three critical portions of the GS1 spar using the Epoch 4.

The Epoch 4 flaw detector was used to power the Ultran 200 kHz transducers for a TTU test on several regions of GS1. The tests were performed in the cap, thin web, and radius of the spar. All three positions produced a suitable signal with good signal to noise ratio as seen in Fig. 5.11. This test shows that a suitable signal for scanning can be obtained from such low cost equipment(19) as the Epoch 4.

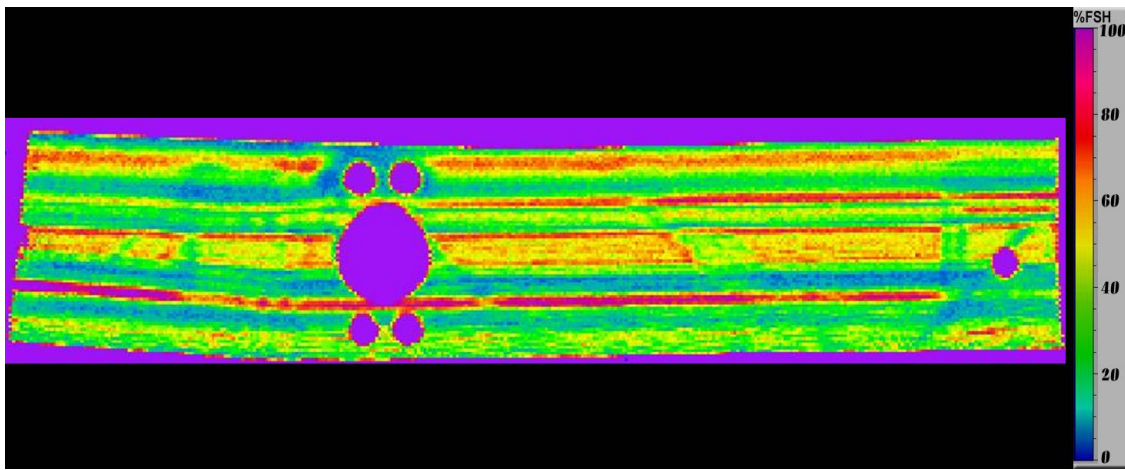
The GS1 spar was set up in the SONIX scanning frame to be scanned with the Ultran transducers at a frequency of 200 kHz as demonstrated in Fig. 5.12. The transducers were powered by the Panametrics 5058 pulser-receiver with the Panametrics preamp in the receiver line. The amplitude C-scan image produced from the web of GS1 is shown in Fig. 5.13. The six circular holes show as high intensity regions in purple. There seems to be banding along the ply drop-off areas and a ply overlap is visible crossing the thin web at a 45 degree angle to the right of the large hole.

Figure 5.13 The C-scan image produced from the whole web of GS1. This 33" by 10" scan of GS1 shows the two ply drop-off regions with the machined holes as well.

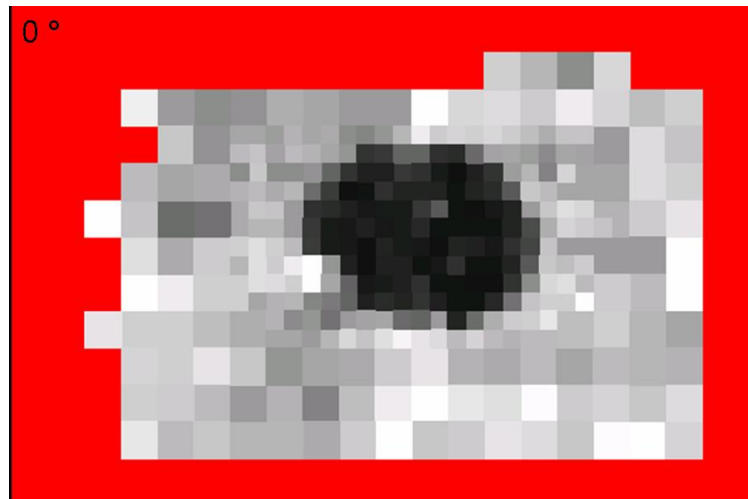
Figure 7.1 Pitch-catch amplitude C-scan image produced with Epoch 4 and GenScan with transducer at 0 degrees.

The pitch-catch system was first demonstrated by finding impact damage in a woven glass fiber laminate. The 24-ply laminate had been impacted by 16.6 Joules of energy with a 0.5" diameter impactor. The initial amplitude C-scan of this damage was created with the long dimension of the transducer holder along the horizontal axis of the scan and can be seen in Fig. 7.1. The Rayleigh wave transducers in the holder with a nose-to-nose configuration have a rectangular footprint. The unsymmetrical shape of this configuration will distort the appearance of a damaged region in the amplitude C-scan image. The distortion is dependent on the orientation of the transducer and the elongation effects are seen in Fig. 7.2. The orientation of the transducers is measured from the horizontal axis of the scan. Black represents the lowest signal amplitude while white represents the highest amplitude.

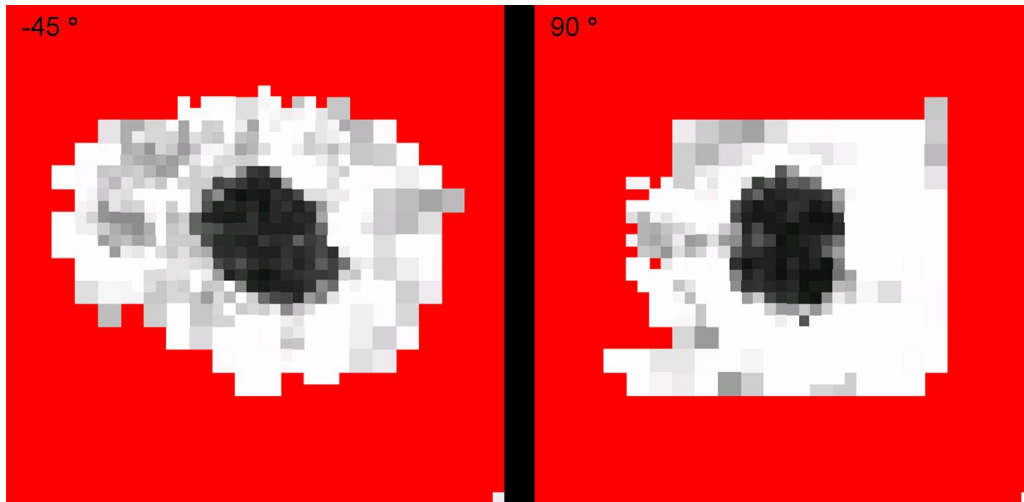
Figure 7.2 Amplitude C-scan images produced with Epoch 4 and GenScan of 16.6 Joule impact area in the 24-ply woven glass panel with transducers at -45 and 90 degrees.
