Constructability Testing of Folded Plate Girders

CONSTRUCTABILITY TESTING OF

FOLDED PLATE GIRDERS

CONSTRUCTABILITY TESTING OF COMPOSITE FOLDED PLATE GIRDERS

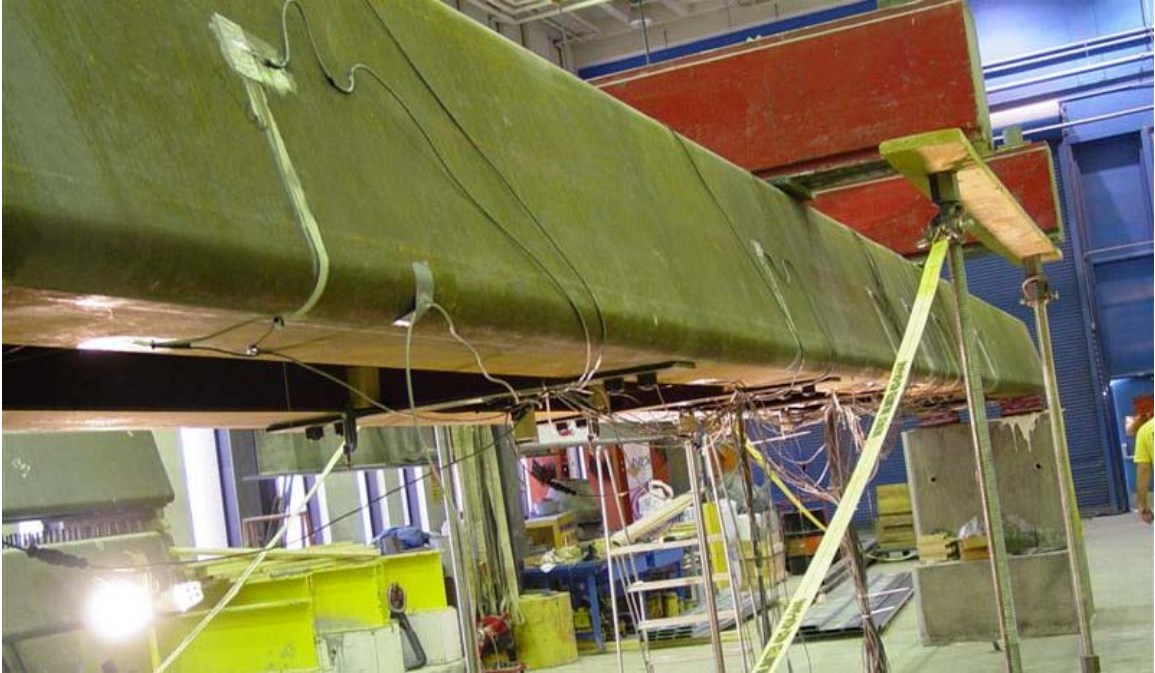
Figure 3-4 Specimen A before testing

Figure 3-4 through Figure 3-9 show the girder before and after the top flange and web buckle. Figure 3-10 shows the buckling of the top flange and web from inside the girder.

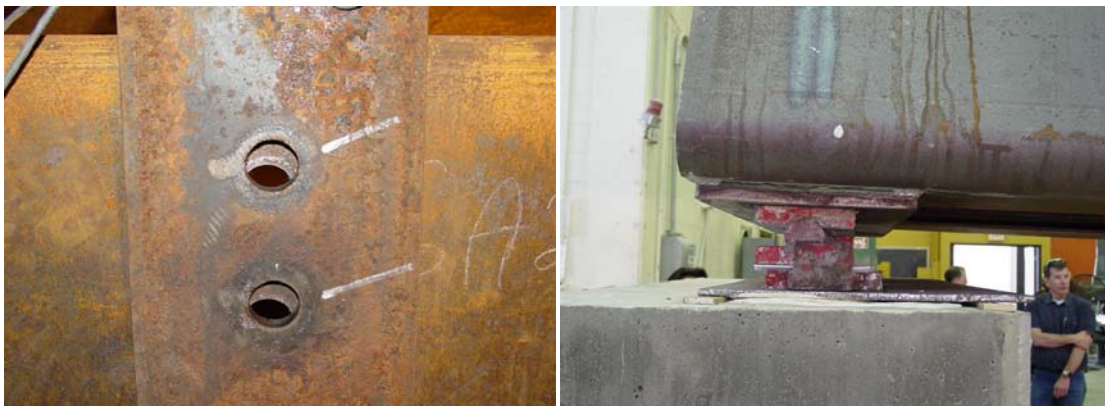
Following the three load sequences, the tie plates at sections D, F, and H were removed and the ultimate test was performed. Figure 3-17 shows the girder deformation after testing was concluded. The bolt holes in the bottom flange and tie plate, which were once aligned, are now offset because of bottom flange separation.

Figure 3-17 (left) Flange and tie plate bolt hole alignment after loading, (right) girder movement at support.

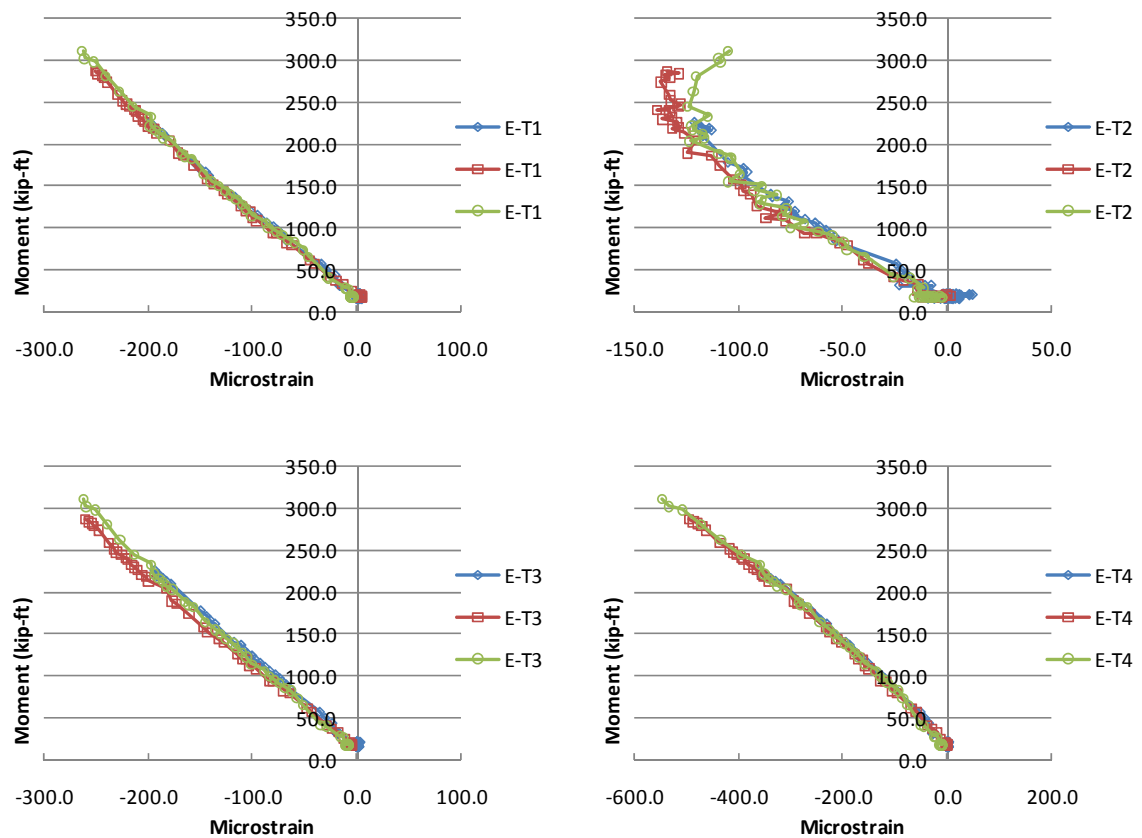
Figure 3-20 Section E top flange strains

Figure 3-20 shows the moment vs. strain curves for the top flange of section E. The strains in the top flange of section E were not affected by the presence of tie plates. It can also be seen that none of the graphs show linear behavior. This is the result of the buckling of the top flange. E-T2, which is located at center on top of the top flange, most clearly illustrates the affect of the top flange buckling. It is also important to note that the strains returned to initial levels each time the specimen was unloaded. That means that the buckling was not affecting the elastic behavior of the beam at these load levels. Note from previously that the construction moment was around 190 kip-ft.

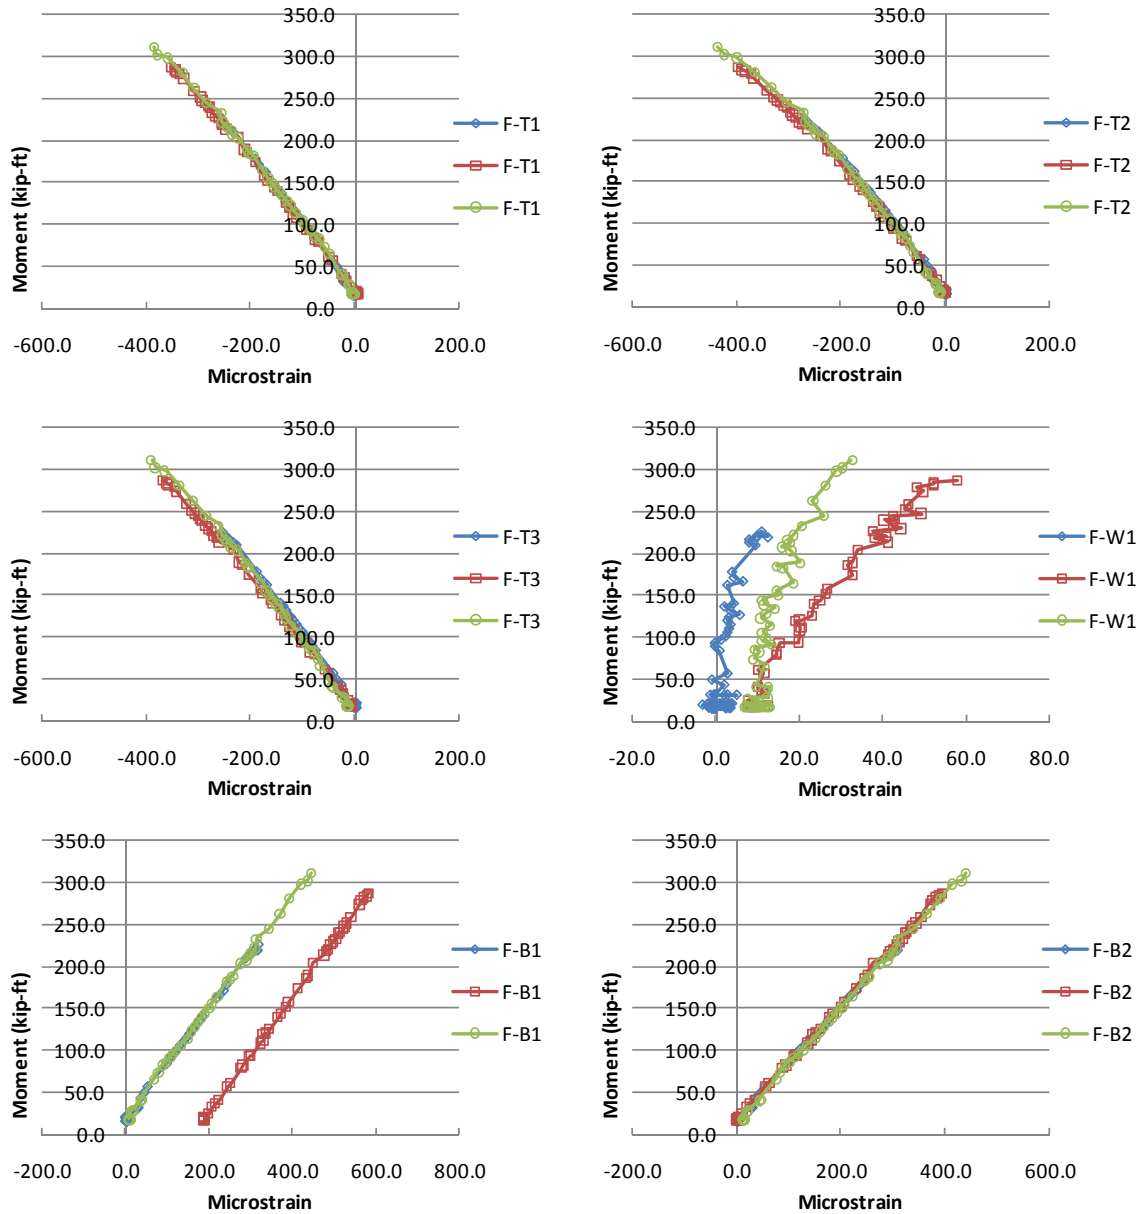
Figure 3-22 shows the strains at section F which is at mid-span of the girder. Again, there was non-linear behavior in the top flange caused by buckling but no affect on the magnitude of the strains related to the presence of tie plates.

Figure 3-22 Strains at section F

The web gage and one gage on the bottom flange, F-W1 and F-B1 respectively, show the affect of tie plates while the other bottom flange gage, which is located on the other flange and is symmetric to the first, shows no affect from the tie plate removal.

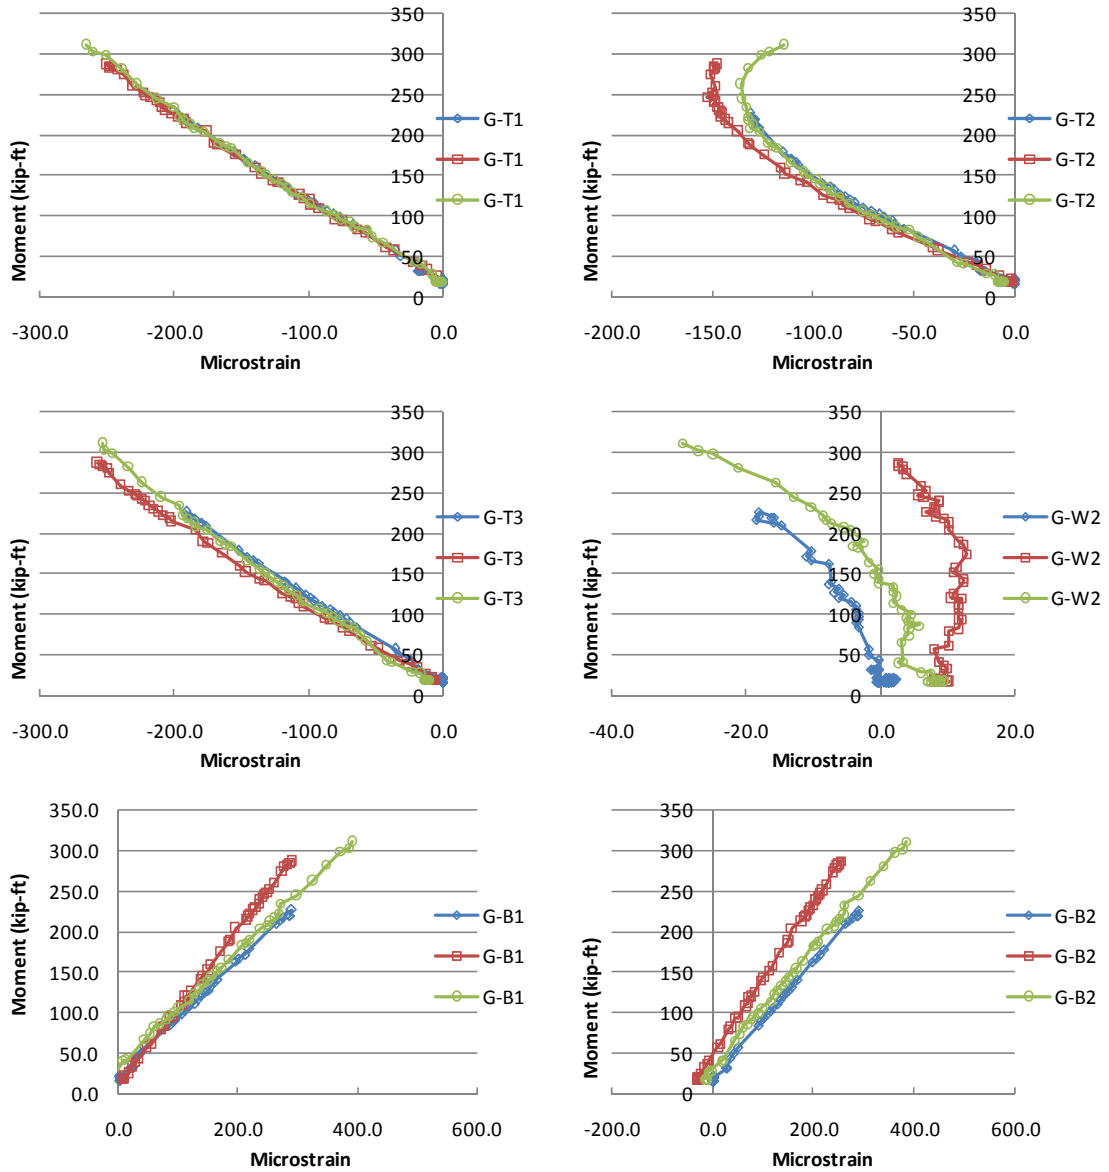
Figure 3-23 Strain at section G

Figure 3-23 shows the strains at section G. Section G shows very clearly the affect of top flange buckling. The two gages located near the webs, G-T1 and G-T3, are linear, while G-T2, which is located in the middle of the top flange, is greatly affected by the buckling of the top flange and slightly affected by the absence of tie plates.

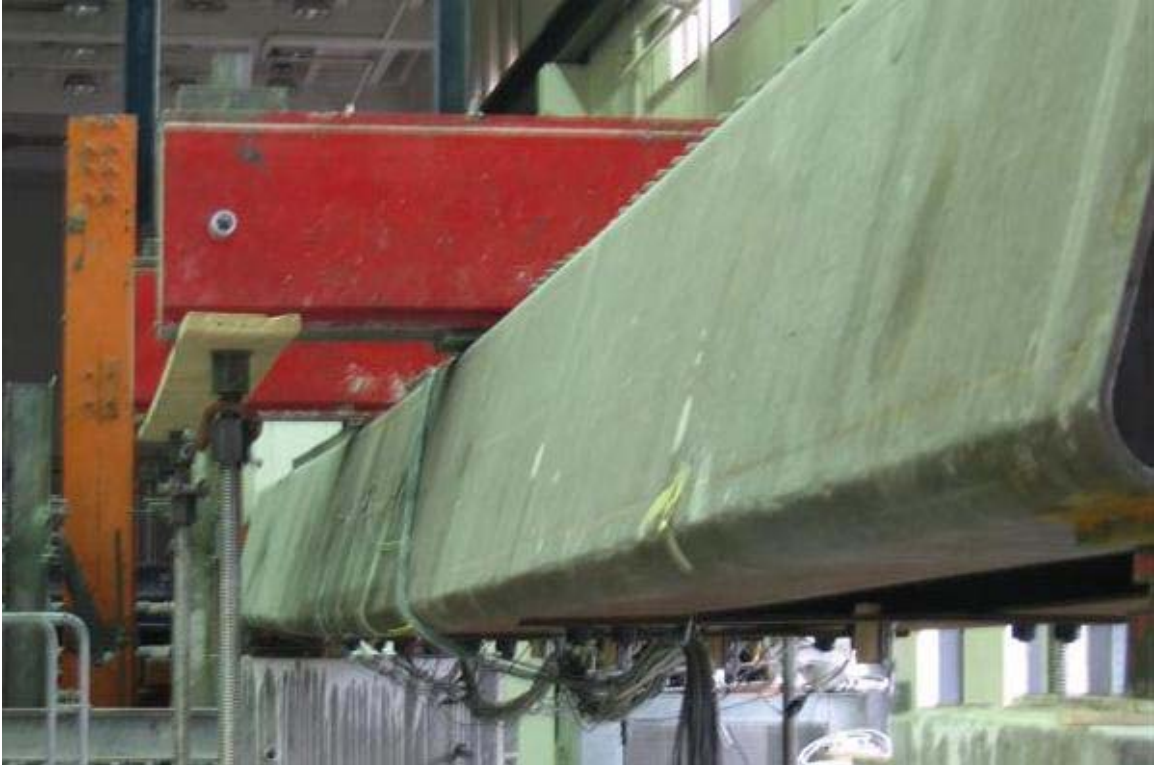
Figure 3-38 Test B1 at 106 kip

The top flange is beginning to buckle slightly. The leaning shear studs are the best indicator of the top flange deformation.

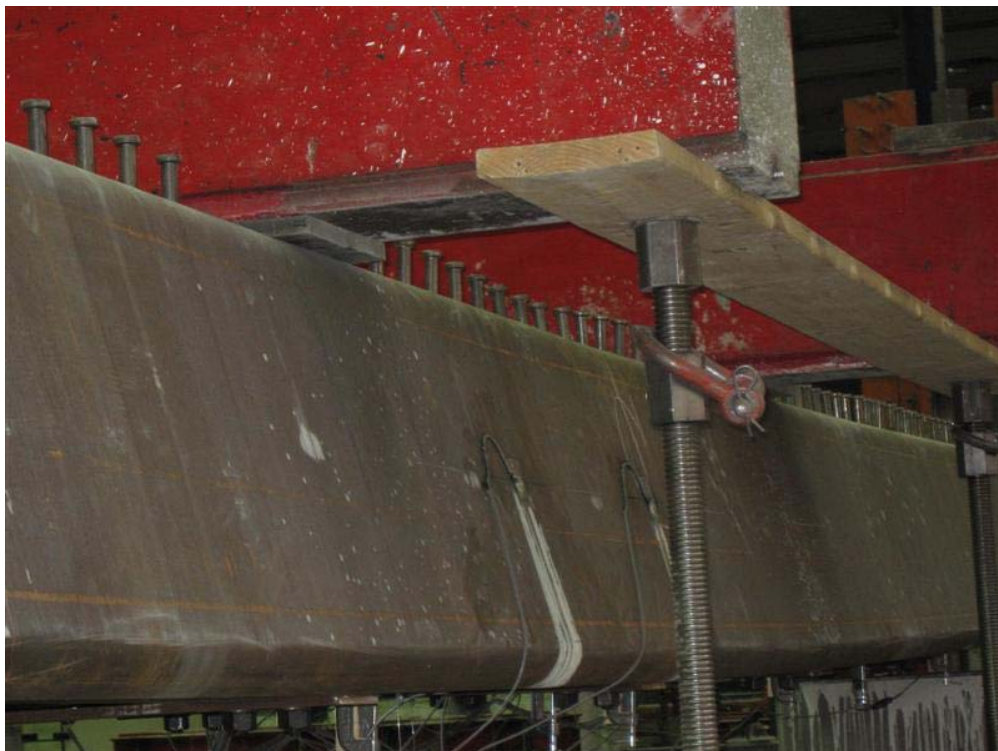
Figure 3-40 Test B1 web at 140kip

Figure 3-39 shows the top flange at 120kips; the deformation of the top flange is becoming more apparent. Figure 3-40 through Figure 3-43 show different parts of the beam at 140kips of load. This is within five kips of the ultimate load, when the girder begins to fail. Figure 3-41 shows that the deformation of the girder is actually bending the tie plate. Figure 3-42 is a picture taken from the west end of the girder looking down the top flange towards the spreader beam. Near that spreader beam, the top flange is buckling downwards. Figure 3-43 shows the deformation of the top flange between the load points.

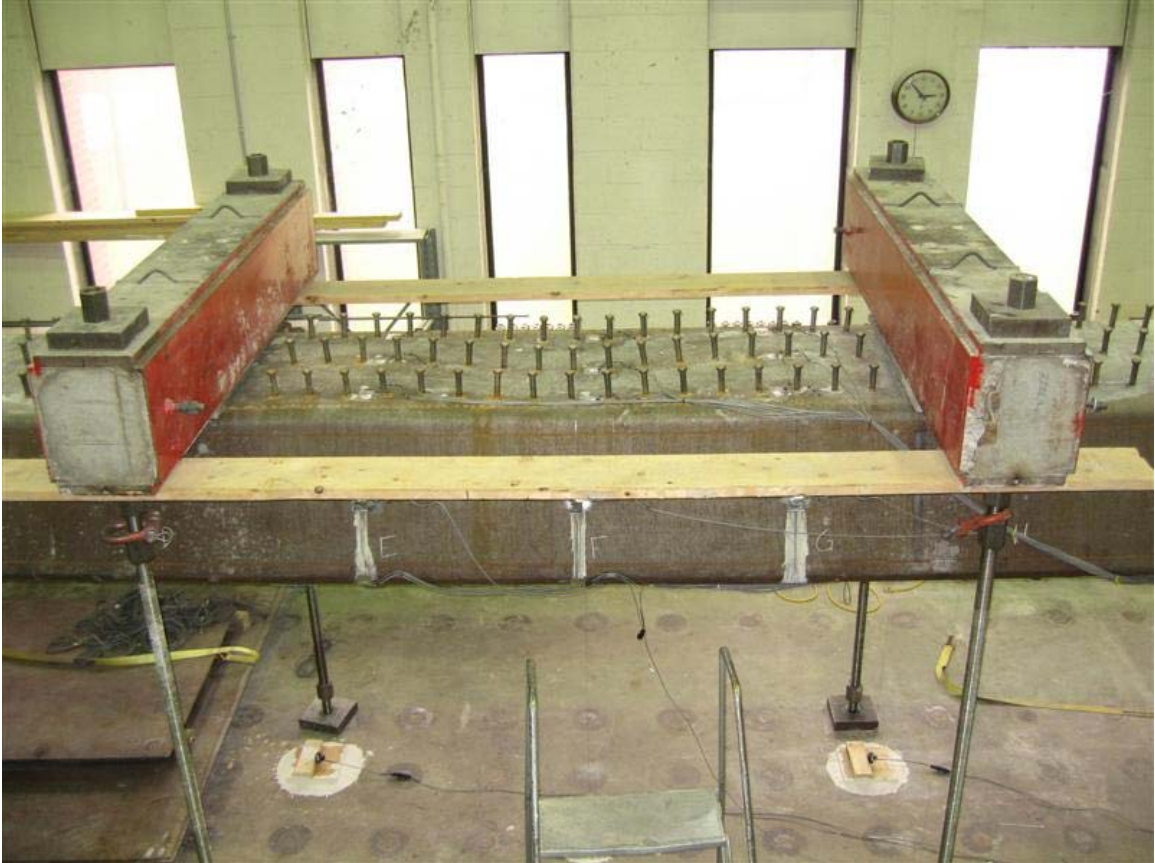
Figure 3-43 140kip

Shortly after these pictures were taken the girder reached its ultimate capacity and began to fail. Figure 3-44 shows the top flange when loading is at 137kips as the girder continues to fail. Figure 3-45 shows the girder outside of the load points also at 137kips. These two figures show a difference in the amount of buckling taking place in between the load points compared to outside of the load points.

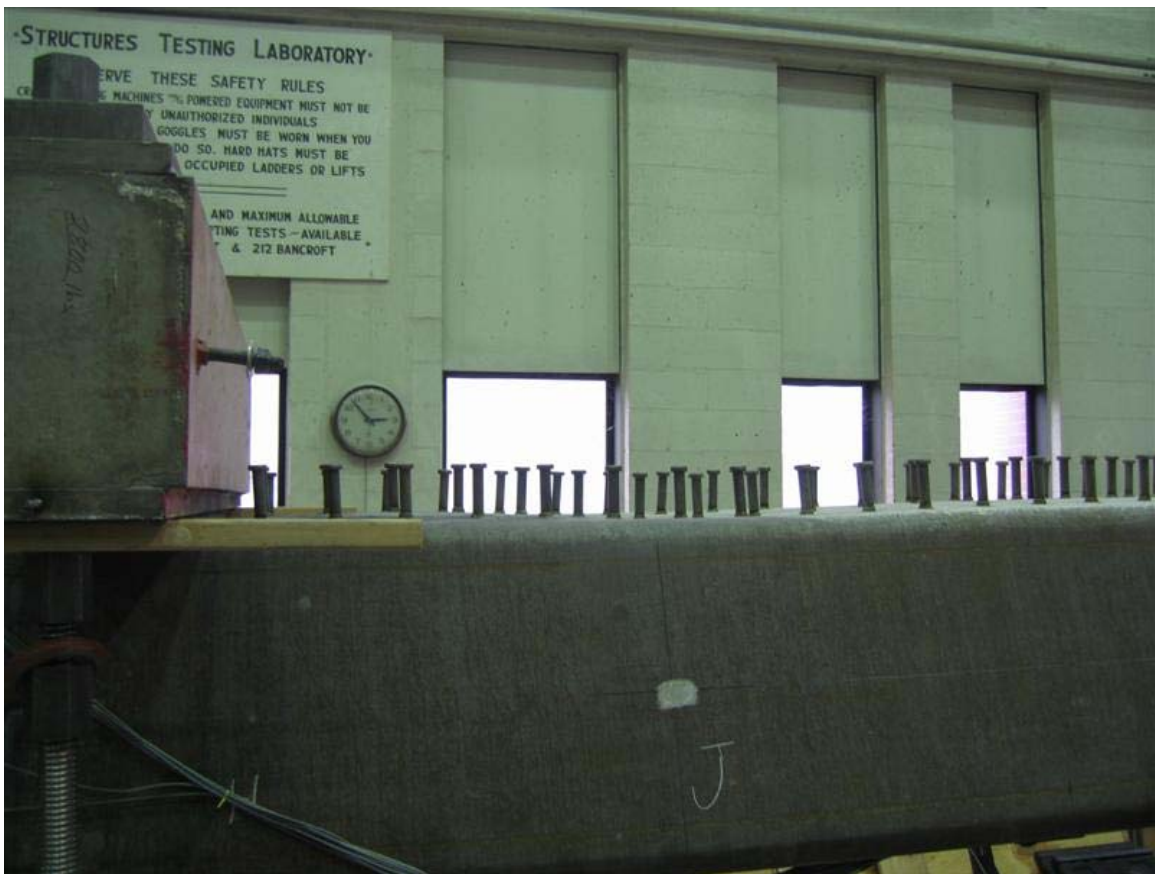
Figure 3-45 Girder outside load points at 137 kip on way back down

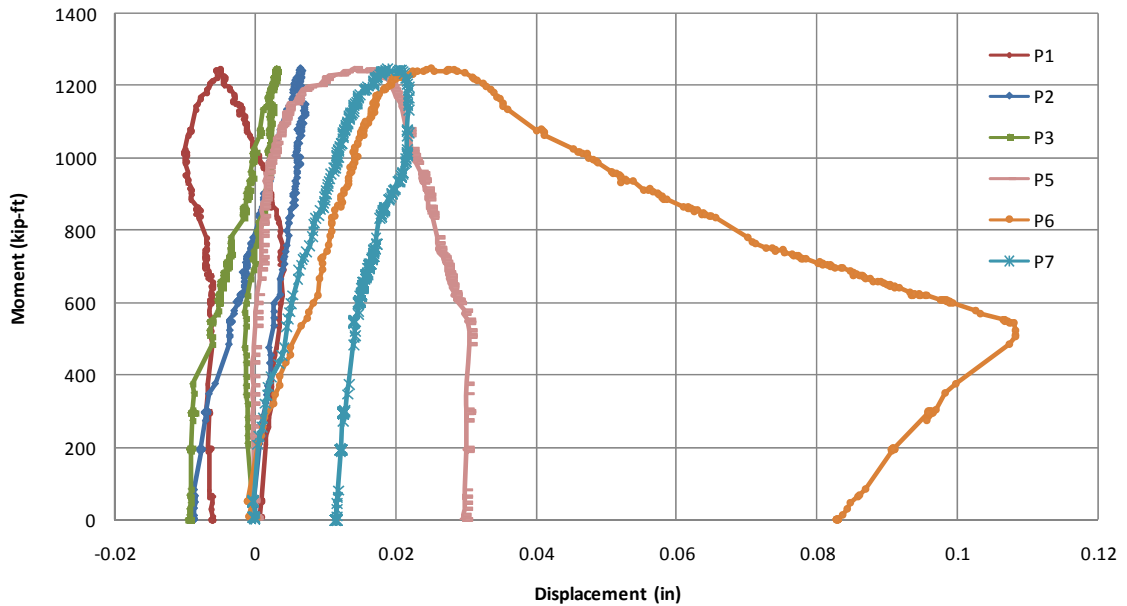
Figure 3-51 Flange separation moment-displacement graph

The stiffener plates that were present at the load points provided bracing to the girder that assisted the tie plates at section D and section H. At the construction moment, the largest flange movement was at mid-span and that was 0.0012 inches. Even up to ultimate capacity, all flange separation was less than .02 inches. Figure 3-52 shows the moment vs. strain curve for the tie plates at section F and D for the second test. At the construction load moment of 187 kip-ft, the strains in both tie plates are less than 25 micro strain. That is about 1% of the yield strain of the steel. The strains in the tie plates are in opposite directions. The flanges at section F are trying to separate while the flanges at section D are trying to come together. The stiffener plates create a point in the girder that acts like a support. On one side of the support, the flanges are separating and as a result, the flanges on the other side are moving in the opposite direction. The graph also shows that when the girder fails, the buckling can greatly

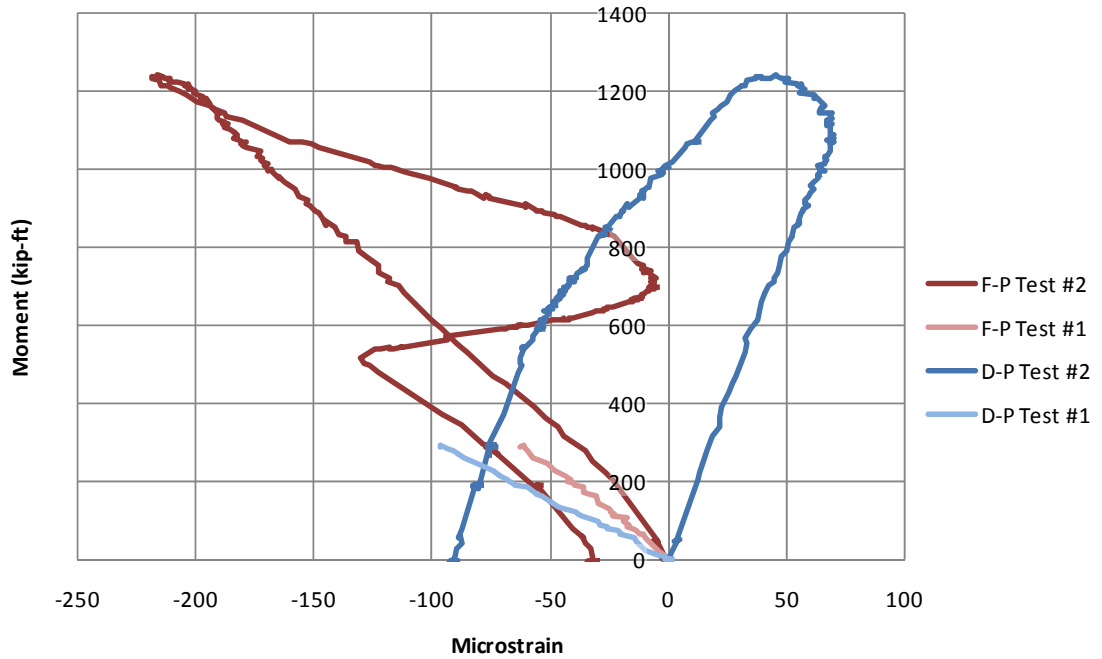
Figure 3-53 Compares data from the same tie plates in the two different tests. The only difference between the two tests at this point is the presence of stiffener plates at the load points. The data shows that the stiffener reduces the stress that the tie plates experience during loading by both holding the flanges in place and reducing the buckling

of the top flange, which is the primary cause of separation of the flanges. The data also shows that the tie plates are the reason that the strains are in the opposite direction in test B1.

Figure 3-53 Comparison of tie plate strain data from Test A1 and Test B1
