April 2018

Investigations on FRP-Concrete Bond

A dissertation submitted in partial fulfillment
of the requirements for the degree of
Doctor of Philosophy
Department of Civil and Environmental Engineering
College of Engineering
University of South Florida

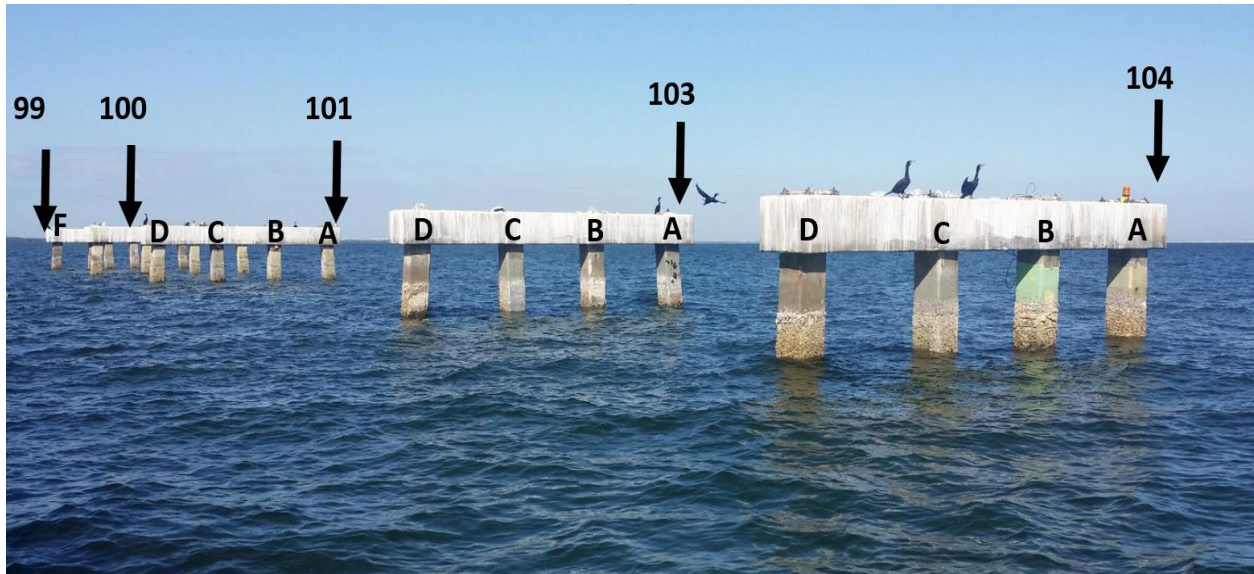
(a) Friendship Trail Bridge- view of pile bents evaluated during demolition

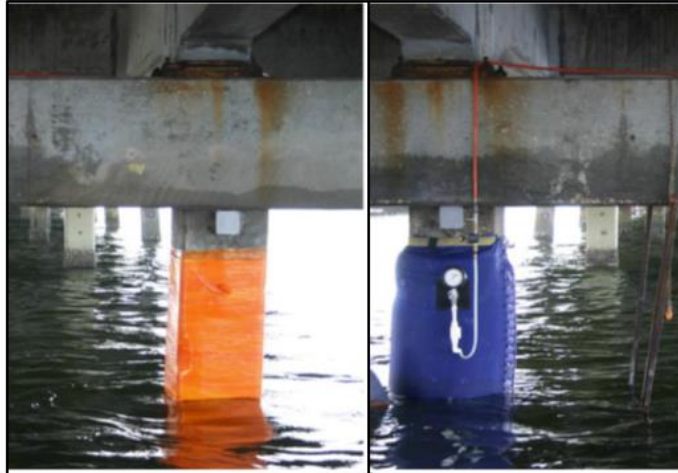
Figure 10.2 Shrink wrap (left); pressure bag (right)

In-situ bond measurement of piles repaired in 2003-04, showed that conventional installation practice of using shrink wrap during curing (Figure 10.2) led to significant bond variability, (Sen, et al., 2007). Laboratory studies indicated this variability could be lowered by using pressure or vacuum bagging to reduce voids while the epoxy cured, (Winters, et al., 2008), (Aguilar, et al., 2009). Pressure bagging involves the use of a pressurized cuff which surrounds and restrains the FRP wrap during curing. This configuration was found in a previous study to be a more effective tool for enhancing bond in piles than vacuum bagging since an airtight envelope is not required around the FRP. The effect of pressure on voids was also numerically modeled by (Grunenfelder, et al., 2010). In essence, uniform pressure increased interfacial frictional resistance in repairs of vertical elements that prevented the resin-saturated fabric from slipping. All USF pile repairs conducted after 2004 were pressure bagged.

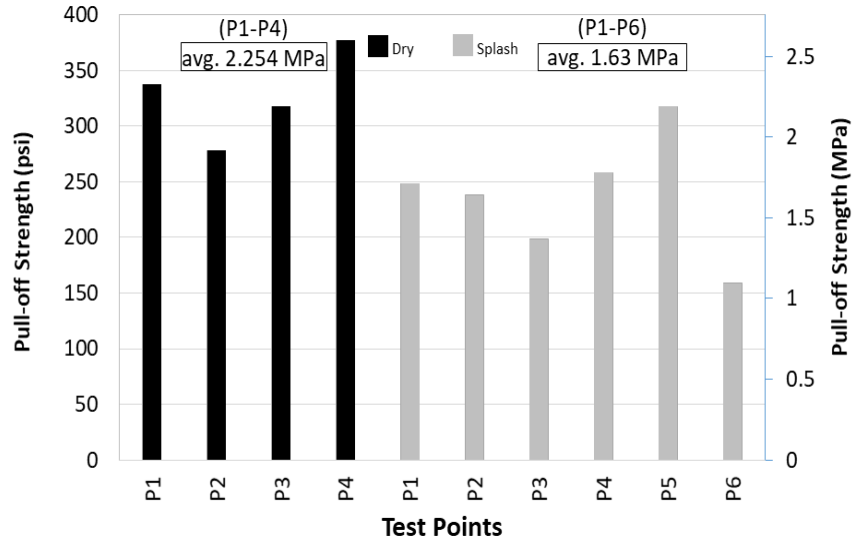
Figure 10.8 Pull-off values for concrete (pile 99A)

A total of ten tests were carried on the control pile (99A) – four in the dry region and six in the splash zone. The measured salt concentration in the cover for this pile is given in Table 10.2. The average pull-off strength reported in Figure 10.8 was 28% lower in the splash zone compared to that in the dry region. The cyclic effect of tidal cycles may have led to a degradation in concrete

properties in the splash. According to ACI 318-14 section 14.5.2.1, the tensile strength of plain concrete can be taken as $5\sqrt{f'_c}$. This translates to a concrete compressive strength of 29.5 MPa (4,290 psi) for the dry region and 15.4 MPa (2,237 psi) for the splash zone. This is consistent with the specified concrete strength for the piles of 27.6 MPa (4,000 psi).

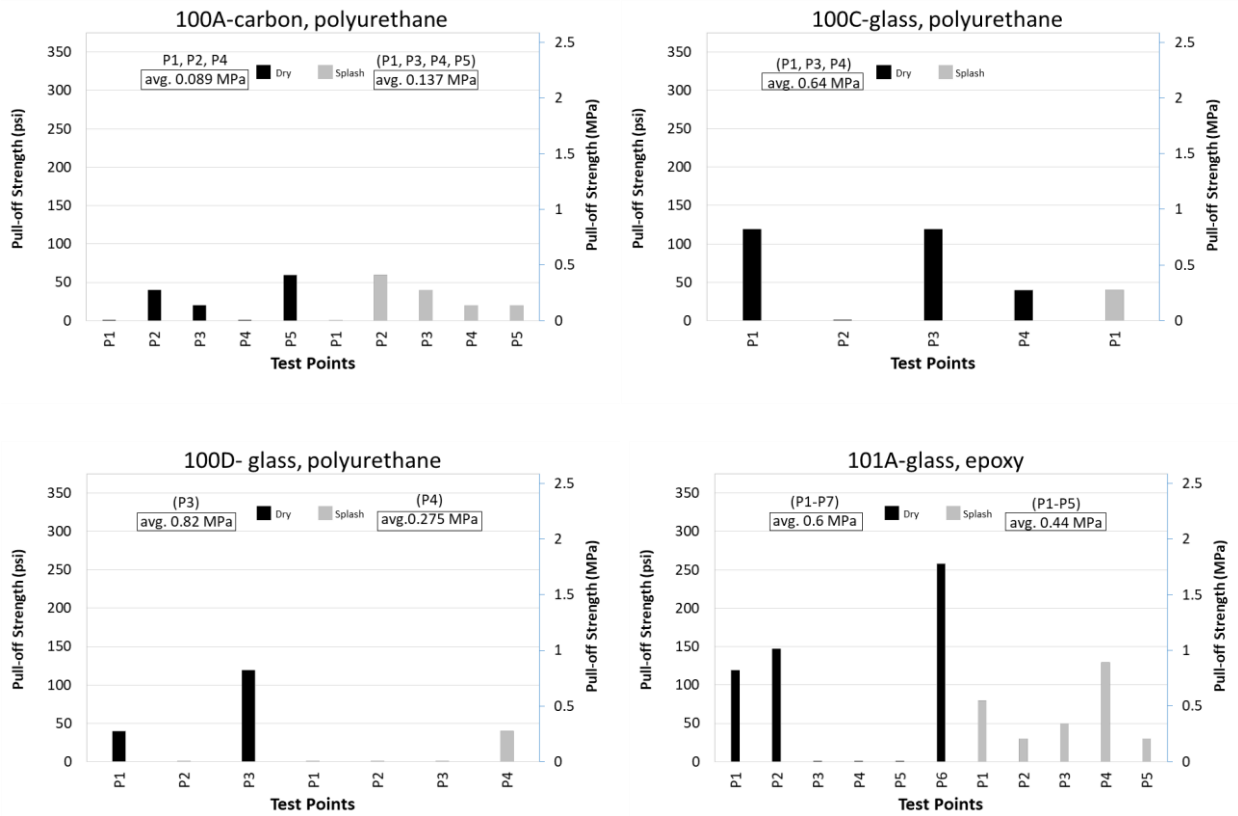
Figure 10.9 Pull-off test results for repairs conducted in 2003-04

Five of the eight zero values in the polyurethane system were a subset of ten interlayer failures – all in the polyurethane resin system. The average residual bond for these failures ranged from 0.05 (8) to 0.3 (46) MPa (psi) Table 10.6.

Since interlayer failures do not reflect FRP bond with the concrete substrate, they are excluded in the calculation of average residual values included in Figure 10.9. The interlayer failures suggest insufficient resin had been applied in the prepreg system.

Epoxy repairs were carried out in 2004, 2006 and 2008. Results (Figure 10.9 and Figure 10.10) were comparatively poorer in 2004 (installed when conditions were cool) and 2006 (when conditions were hot) and likewise improved in 2008 (Figure 10.11) when conditions were moderate (see Table 10.5). Thus, the performance mirrored ambient condition at the time the two parts of the epoxy were mixed.

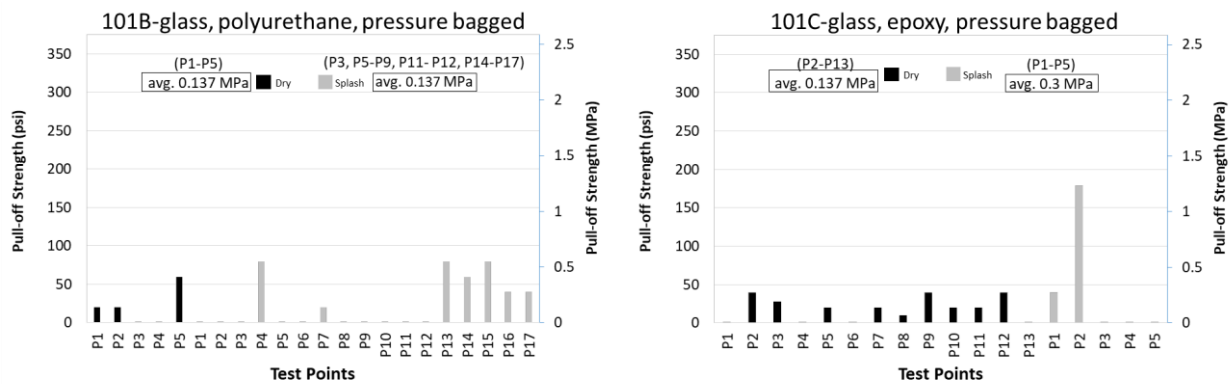
Figure 10.10 Pull-off test results for repairs conducted in 2006

Both piles – one epoxy and one polyurethane - repaired in this series were pressure bagged. Visual inspection (Figure 10.4) had suggested a high relative residual bond in these piles. A total of 40 tests were conducted – 22 for the polyurethane and 18 for the epoxy. There were 19 zero

bond values (12 for polyurethane and 7 for epoxy) and 6 interlayer failures (5 for polyurethane and 1 for epoxy). As before, interlayer failures are not included in the average values given in Figure 10.10. The highest residual bond was 0.41 MPa (60 psi) (101B – polyurethane) in the dry zone and 1.2 MPa (179 psi) in the splash zone (101C - epoxy).

Whereas limited improvement was expected for the polyurethane resin because it released carbon dioxide during the curing process, the epoxy resin was expected to deliver superior results. The reason for the poor outcome became evident from the failure mode that showed that not enough epoxy had been applied (discussed later). The results indicate that visual inspection is not a reliable method for identifying poor bond locations.

The performance of both piles pressure bagged in 2006 was worse than expected (Figure 10.10). For epoxy this was attributed to hot ambient conditions as discussed. For polyurethane it was likely due to pressure creating voids by trapping gases and preventing their escape during cure.

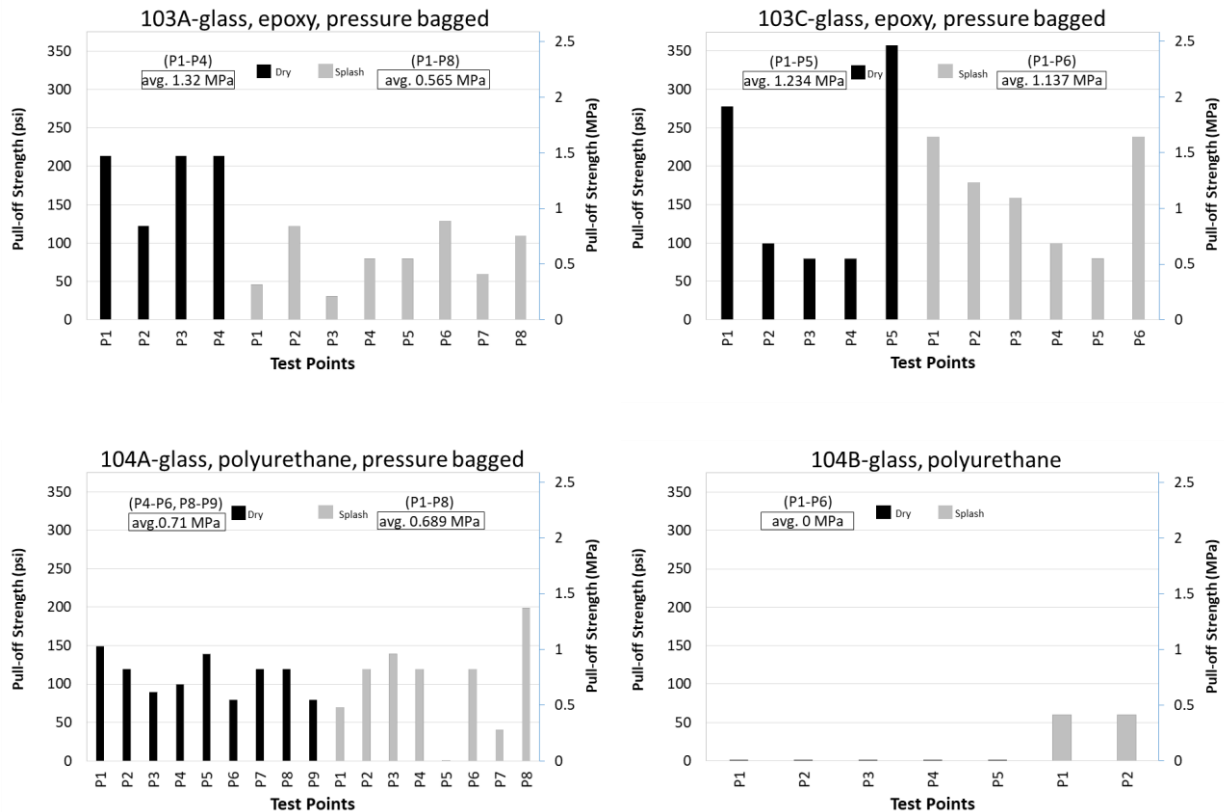
Figure 10.11 Pull-off test results for piles repaired in 2008

bagged piles was superior compared to the non-pressure bagged pile (104B). The average residual bond for epoxy (103A, 103C) was higher in the dry zone (1.3 MPa (191 psi), 1.2 MPa (179 psi)) vs 0.7 MPa (103 psi) for polyurethane (104A) and comparable in the splash zone (0.5 MPa (82 psi)), 1.1 MPa (165 psi) vs 0.7 MPa (100 psi) for polyurethane. Even though pressure bagging was used, there were four interlayer failures in the polyurethane system (excluded in the calculated average value included in Figure 10.11). However, the average residual bond (Table 10.6) for these failures was relatively high (0.8 MPa (119 psi)).

The performance of the non-pressure bagged pile 104B was distinctly poorer. The average bond was zero from five points in the dry zone but higher (0.4 MPa (60 psi)) in the splash zone where both failures were interlayer. As discussed, the latter tests were conducted on land and the mean value did not satisfy statistical criterion (see Table 10.7).

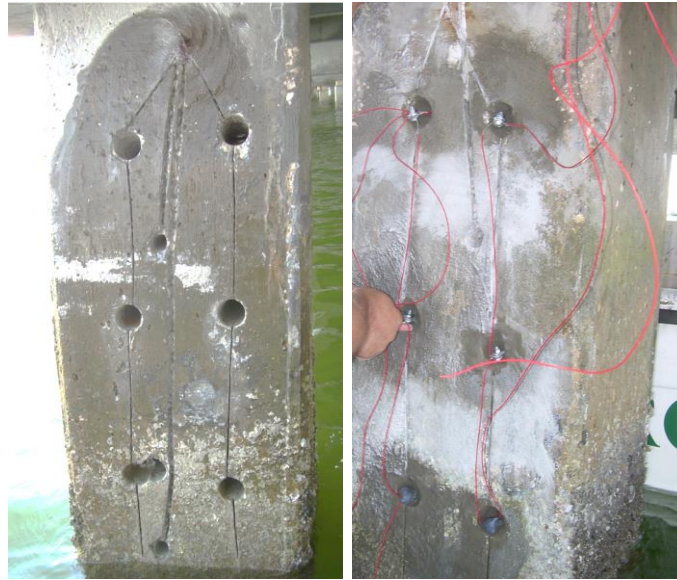
Figure 10.13 Instrumented face for hybrid FRP-CP Pressure bagged repair (2008)

Research has proven that water intrusion is the most likely reason for poor bond in epoxy-based systems, e.g. (Judd, 1977), (Myers, 2007), (Dolan, et al., 2009) (Sen, 2015). The extent to which water can diffuse to the bond line or between FRP layers is a function of surface preparation, workmanship and the type of resin. Since the same surface preparation and the same resin was used in all the applications their effect can be discounted. The highest strengths were in piles pressure bagged in 2008 where the bonding surface was heavily scarred to install sacrificial anodes and reference electrodes (see Figure 10.13).

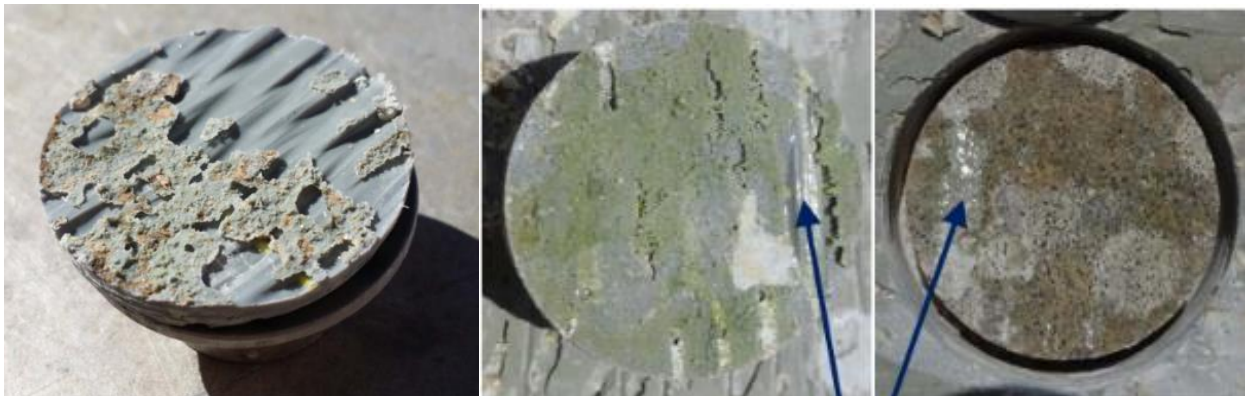
Figure 10.14 shows three photos providing evidence of water intrusion at the bond line and incomplete fabric saturation. They were taken from different piles. The first picture (Figure 10.14a) shows moisture in the bond plane; the second, water stored between two layers being drained during scoring (pile 101A repaired in 2004). The accumulation of water between layers led to marine growth and voids between layers (Figure 10.14b). Figure 10.14c shows incomplete fabric saturation in specimen 101C that was pressure bagged in 2006. There was no

Cool conditions under which the epoxy was mixed for pile 101A inevitably delayed curing thereby allowing moisture to diffuse and accumulate between layers over time (Figure 10.14a). Conditions were hot and humid when pile 101C was pressure bagged. Illig (2016) reported the pot life to be as little as 10-15 minutes for repairs conducted on the nearby Sunshine Skyway Bridge in 2007. This was also the experience of USF researchers. Using ice to extend pot life (as used in the Sunshine Skyway repair) was not a viable option. The limited time available led to incomplete saturation of the FRP material (Figure 10.14c). Conditions were more favorable in 2008 when the ambient temperature was 75F (24C). There was sufficient time to saturate the fabric and place it on the pile. Measured residual bond was notably higher for piles 103A, 103C (Figure 10.11).

(c) Fiber not fully impregnated by epoxy; second and third photos are at the same location and show the dolly and the concrete surface to which it was bonded. Arrows point to locations with no epoxy. Dark regions point to regions with trace of epoxy.

- Bond was poor in epoxy-based systems when the two part resin was mixed in unfavorable conditions (Table 10.5). This reduced pot life or increased cure time and adversely impacted performance (Figure 10.9, Figure 10.10 and Figure 10.14). It is recommended to cool resins before mixing.
- Epoxy-based systems outperformed polyurethane-based systems in both the dry and splash zones (Table 10.8).
- Pressure bagged piles repaired in 2008 performed best for both resin systems (Figure 10.11).
- Epoxy-based, pressure bagged installations are comparably durable even when mixed in-situ and applied to wet surfaces in a marine environment.

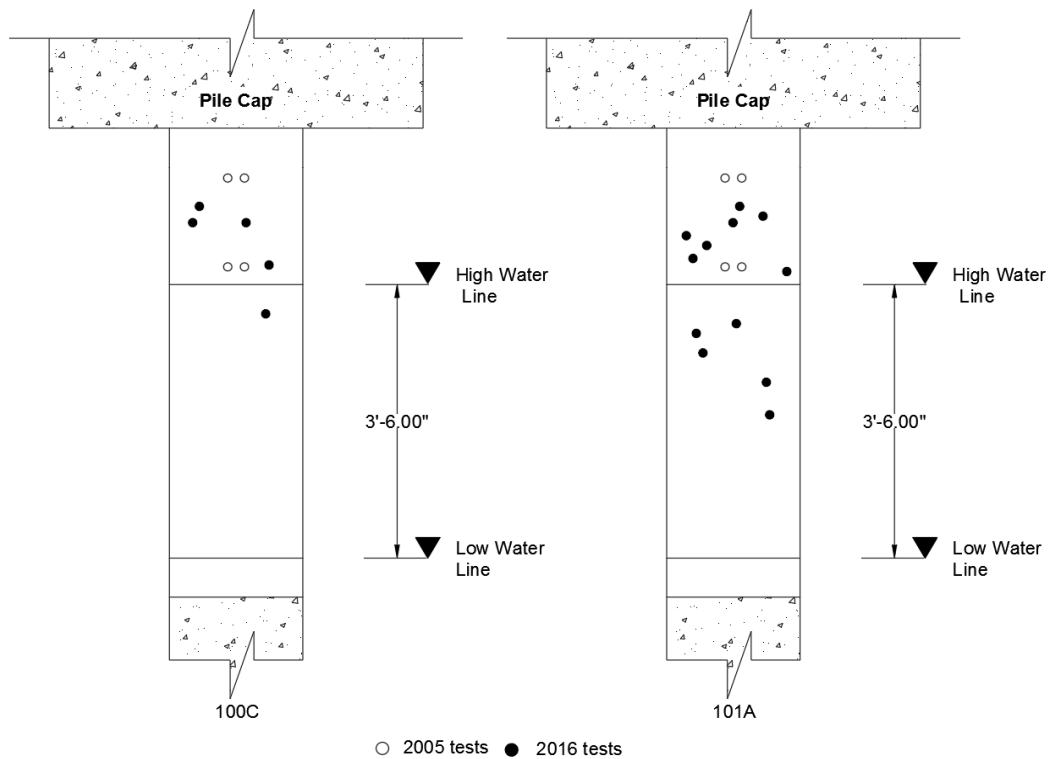
Figure 10.15 Spatial location of pull-off tests in 2005 and 2016

tests, this was only met for pile 101A, not 100C. For the latter pile, five tests were carried with only one in the splash zone. The spatial distribution showing the location of the tests for piles 100C and 101A is mapped in Figure 10.15.

All failures in 100C (prepreg) in 2005 were inter-layer. In 2016, two of the five failures were inter-layer for the same pile. In contrast, failures in the epoxy pile 101A were adhesive, mixed mode or cohesive in both 2005 and 2016.

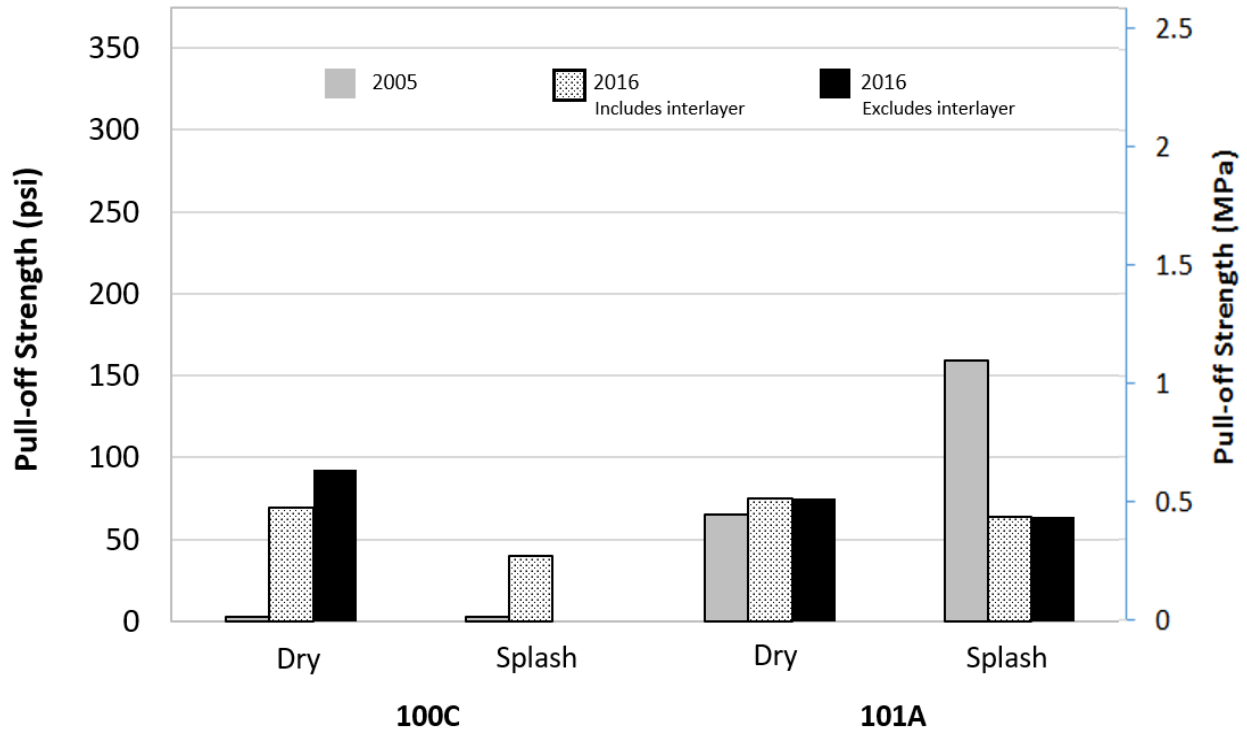
Figure 10.16 Results for piles tested in 2005 and 2016

Figure 10.16 plots values of the residual bond for the two piles tested. This shows averages that include and exclude inter-layer failures for the 2016 tests. Since the tests were not conducted at the same locations there are differences in the measured values. Values were higher in the 2016 tests that were conducted closer to the rounded edges because of increased confinement. Because of the disparate failure modes, comparisons show increases in the dry zone in both piles. In

contrast, values in the splash zone were higher in 2005. The results portray the random variation in bond strength in non-pressure bagged piles. No underlying trend can be discerned.
