Investigation of an alternative gravel roads rejuvenation method

Ziliang Zhang

Major: Civil Engineering (Construction Engineering and Management)

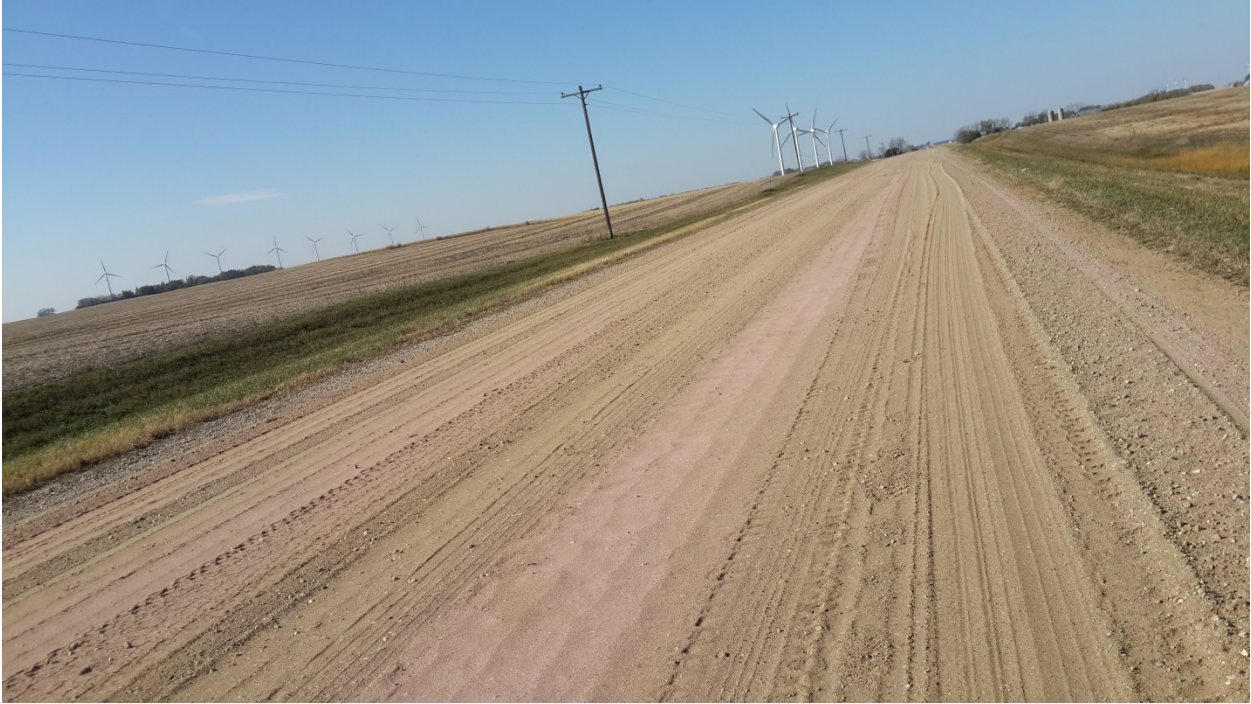
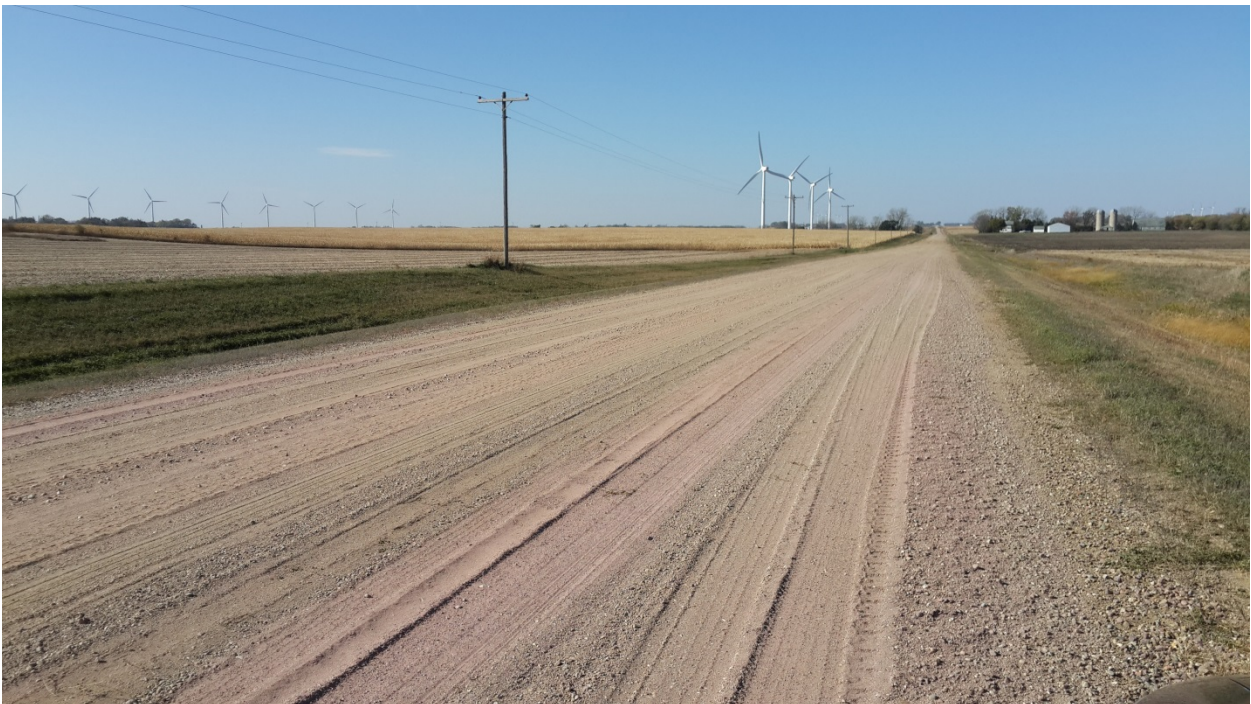
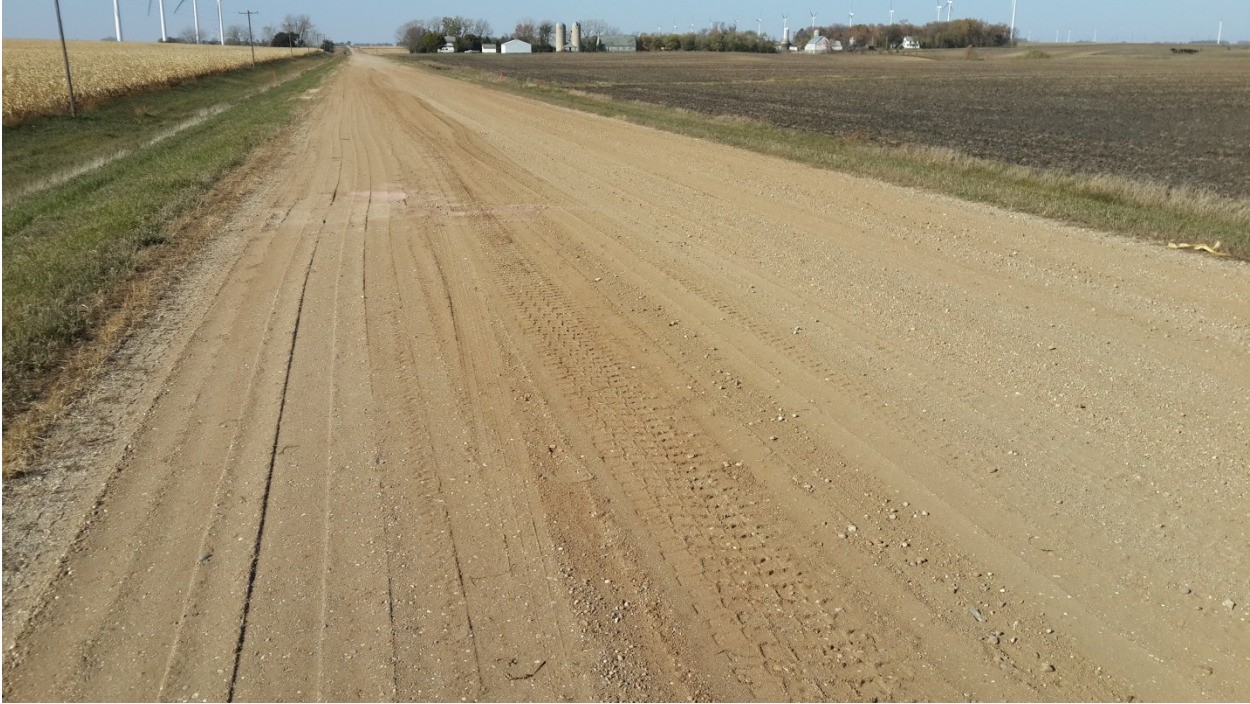
Figure 28 Jackson County Road 76 East Test Section (Photo by the Author)

Figure 29 Jackson County Road 76 Mid Test Section (Photo by the Author)

Figure 30 Jackson County Road 76 West Test Section (Photo by the Author)

It is noticeable that the two experimental sections looked differently from the control section. Reddish path along the road suggests the concentration of crusher dust. More passes of blading or more crusher dust seem necessary to evenly distribute the crusher dust across the road surface.

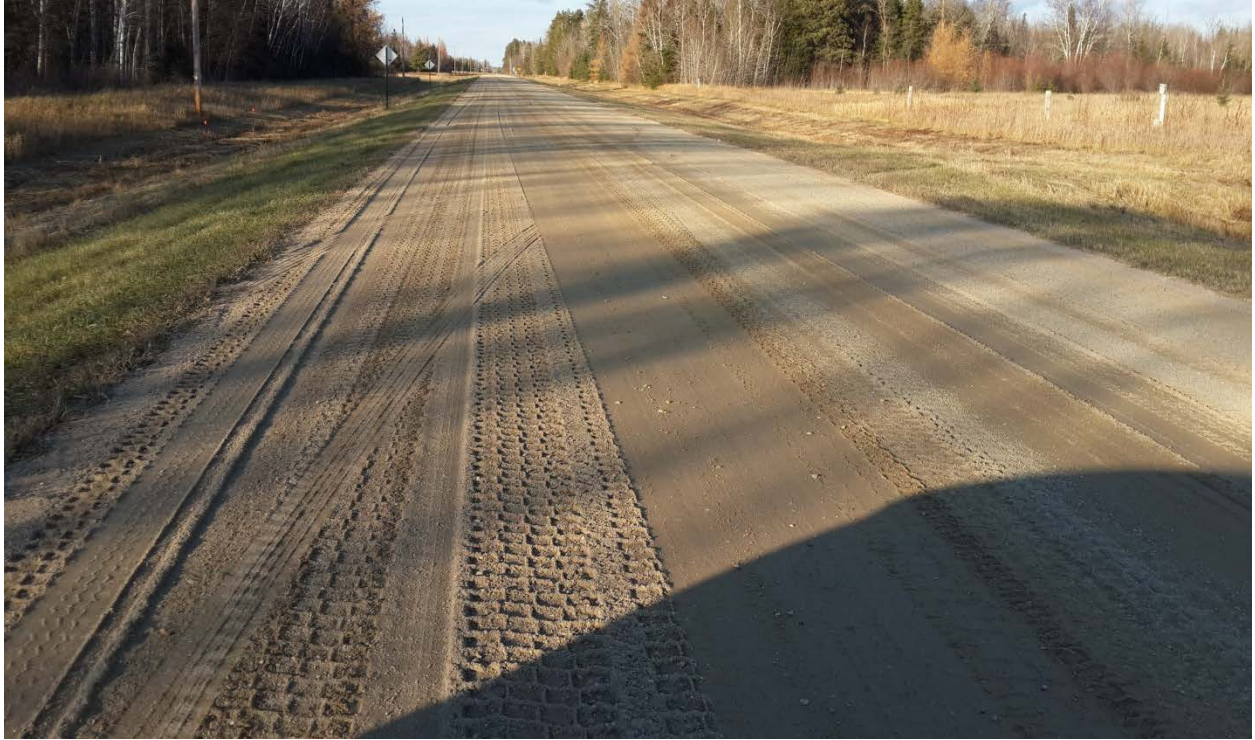
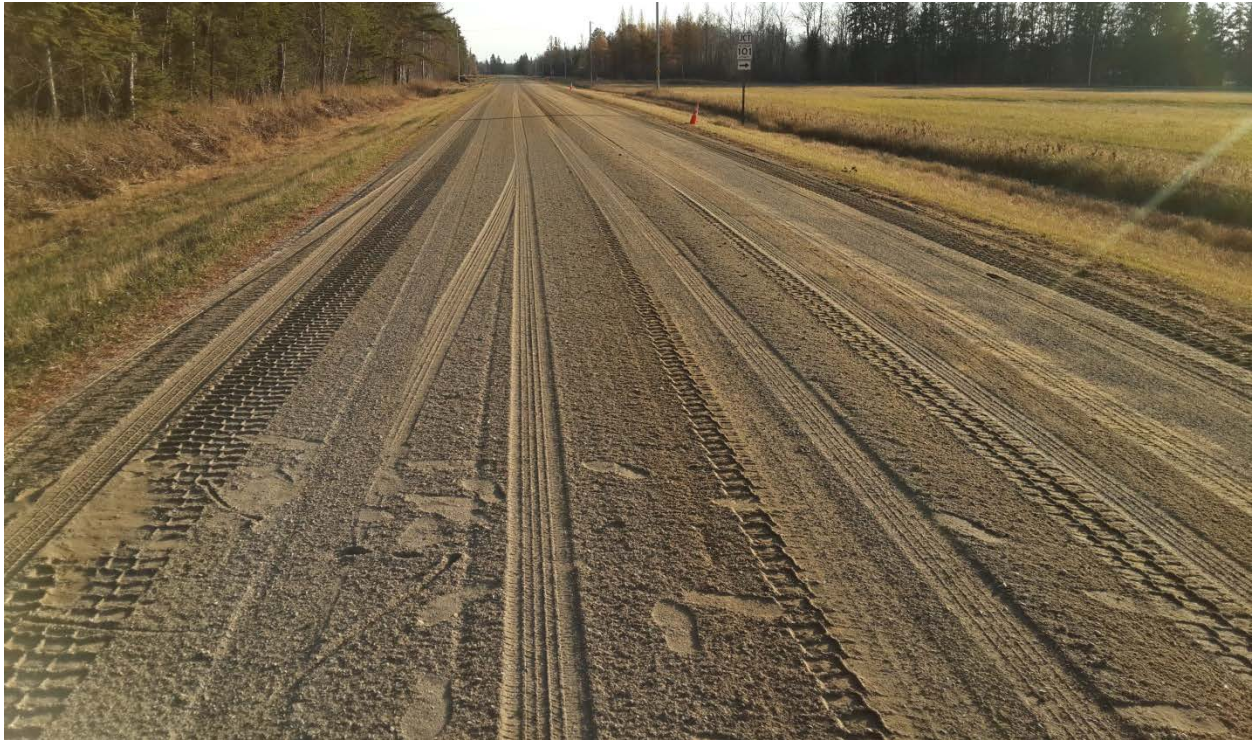
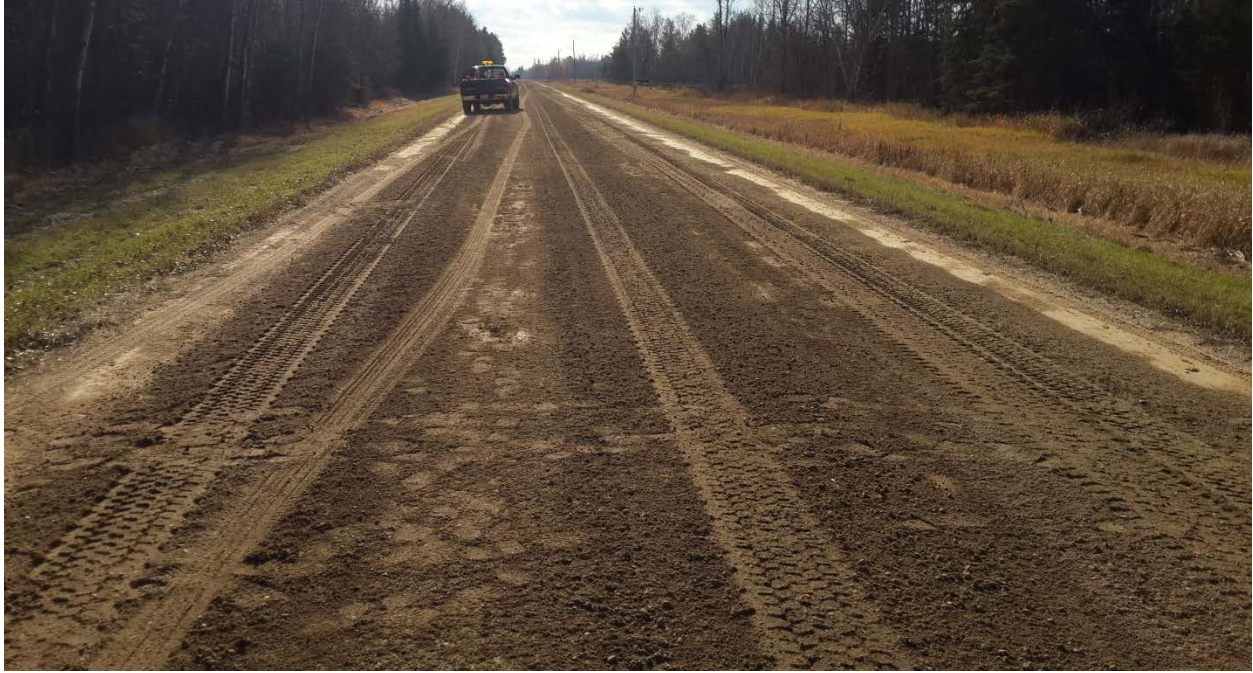
Figure 31 Beltrami County Road 23 South Test Section (Photo by the Author)

Figure 32 Beltrami County Road 23 Mid Test Section (Photo by the Author)

Figure 33 Beltrami County Road 23 North Test Section (Photo by the Author)

The two experimental roads looked quite different as one of the crew pointed out for its lighter surface color. Crusher dust was evenly distributed across the width of the road on the two sections.

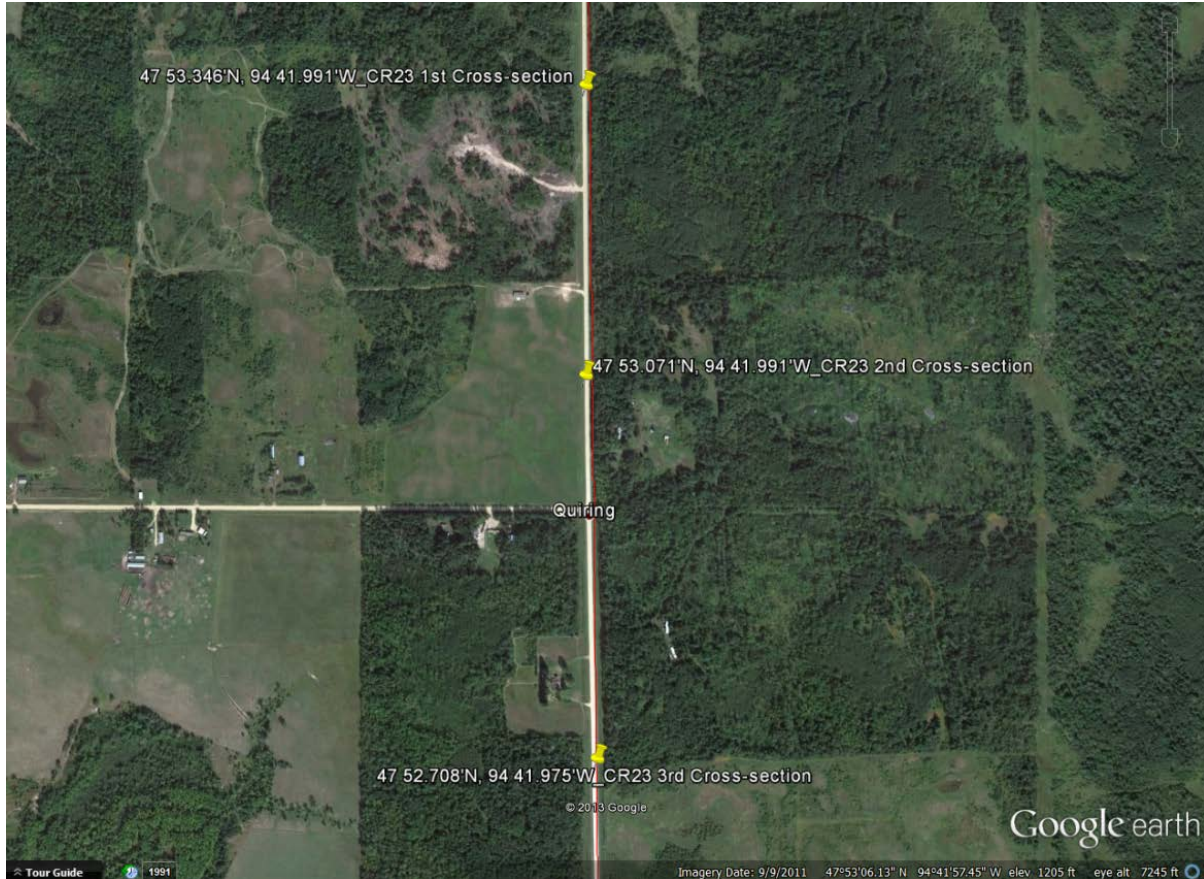
Figure 38 Plan View of Beltrami County Road 23 Cross-sections

The location of CR 23 is shown in Figure 38. Three test sections were established on CR 23, Beltrami County. CR 23 had longitudinal slope ranging from -0.8% to 1.1%. Likewise, two experimental sections and one control section were established, 1/3 mile for each section, see Figure 38. The control section used MnDOT specified Class 1 aggregate which is used in the area for surfacing. The two experimental sections used crusher dust derived from granite. See Table 2 for the amount of aggregate used in each section. The source of dust was from Knife River Material and Class 1 aggregate was originated from Poxleitner Pit.

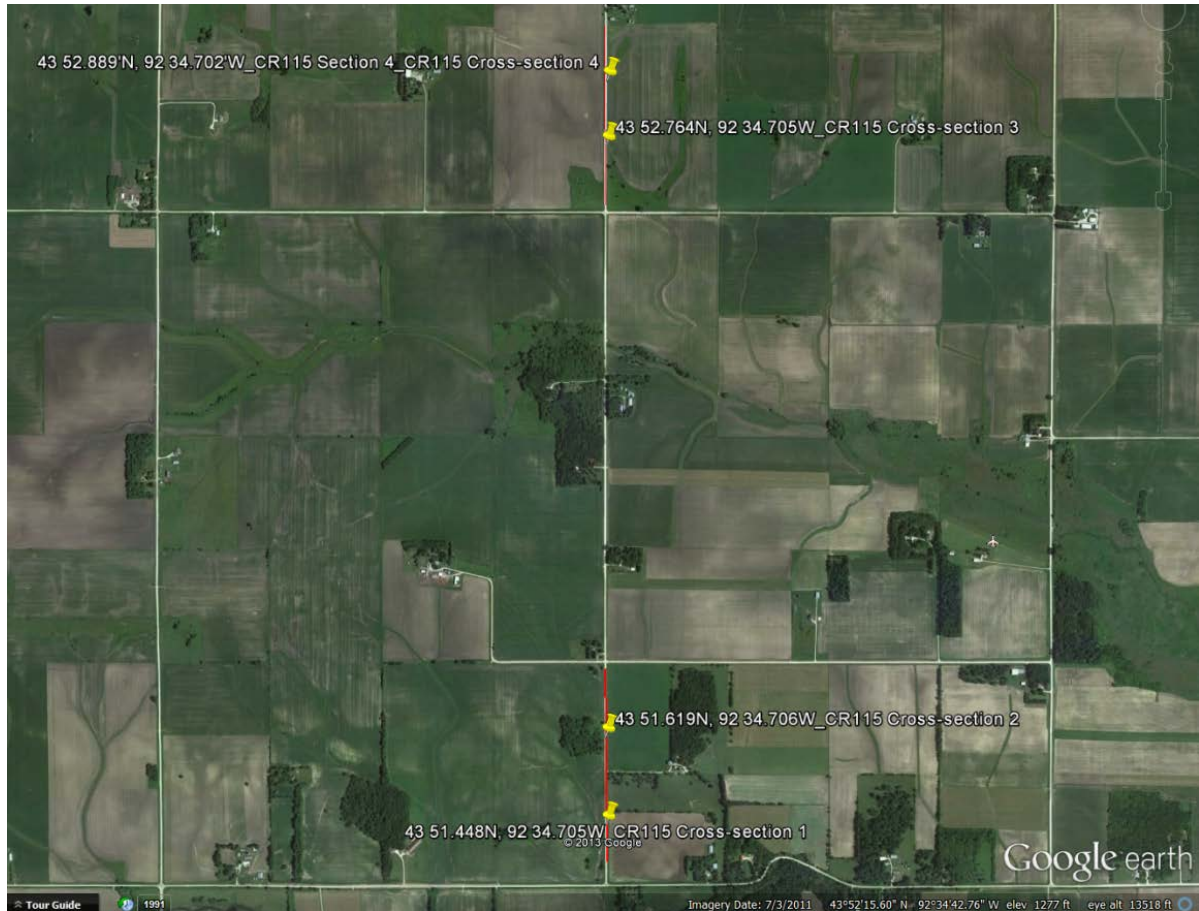
Figure 40 Plan View of Olmsted County Road 115 Cross-sections

The location of CR 115 is shown in Figure 39. There were four test sections established on CR 115. The four test sections could not be laid out adjacent to each other due to the geometry of the road and intermittent application of stabilization additive along the road. Figure 40 shows location of the four test sections. The four sections were established on the segments of the road where it is flat and no dust palliative was applied.

Length of 1st to the 4th test section was 1005ft, 1148ft, 1000ft and 1010ft, respectively. Section 1 used standard Class 5 virgin material was used for Section 1. Standard Class 5 virgin material mixed with one-third lime was used for Section 2. A 1:1 mix of standard Class 5 and standard Class 2 virgin material was used for Section 3. Standard Class 2 virgin material was used for Section 4. Amount of material placed is tabulated below in Table 3.

Therefore, the project had two control sections, being Sections 1 and 4, and two experimental sections, being Sections 2 and 3. In total, four test sections were established. Recall that the test sections on County Road 115 were not laid out continuously, as shown in Figure 40. Section 1 and 2 were located at the south end of CR 115 and sections 3 and 4 were located at the north end of CR 115.

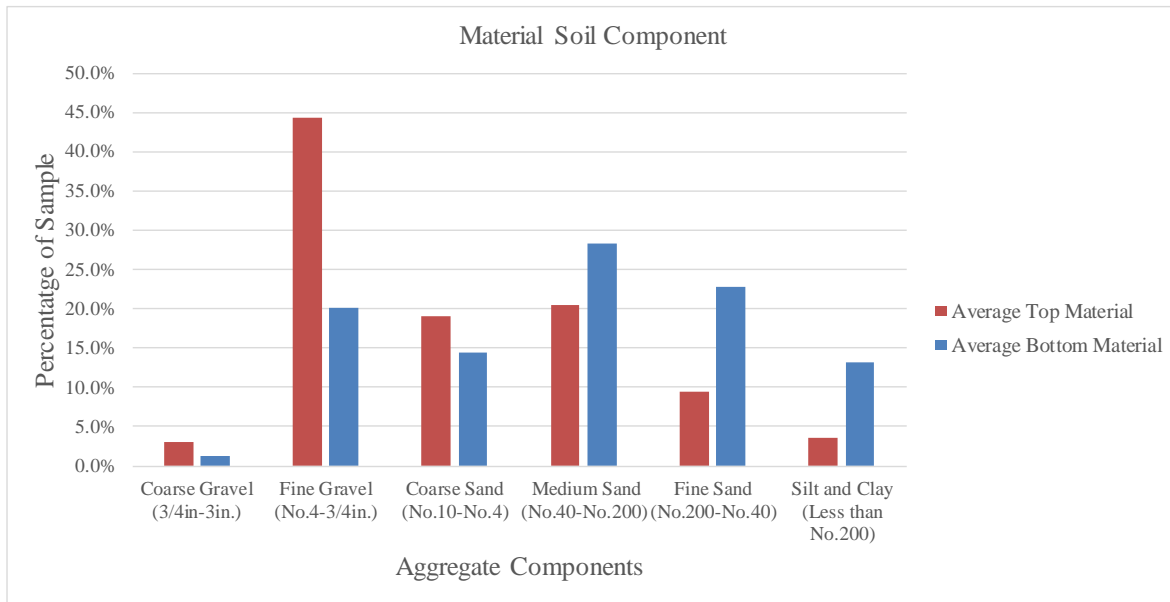
Figure 41 Comparison in Soil Classification

The research team conducted an extensive investigation regarding the gradation difference between the top and bottom layers of aggregate. In addition to samples collected in Minnesota, samples were also collected in Boone and Story Counties in the State of Iowa from roads that were considered to be having issues with loose aggregate, though the level of severity varied. In total 19 pairs, representing both bottom and top material were collected from various roads. An independent t-test was performed to detect statistically significant differences in content percentage for each soil classification comparing the top and bottom layers. A bar chart comparison for each soil classification is shown below, in Figure 41.

The test result suggests that for all categories, except for coarse gravel, a statistically significant difference was detected. The proportion of silt and clay particles, which serve as binder for unpaved roads, was about 3.6 times higher in the bottom layer in comparison to the top layer. The bottom layer also has higher percentage in medium sand and fine sand. Not surprisingly, for the top layer, fine gravel that has size ranging from No.4 (4.75mm) to $\frac{3}{4}$ inch (19mm) dominates and makes up nearly 45% of the composition. The absence of fine sand and silt and clay by a considerable amount is a likely explanation for the segregation that is a common occurrence on aggregate roads. The bar chart visually exhibits the composition difference between the top and the bottom layers.

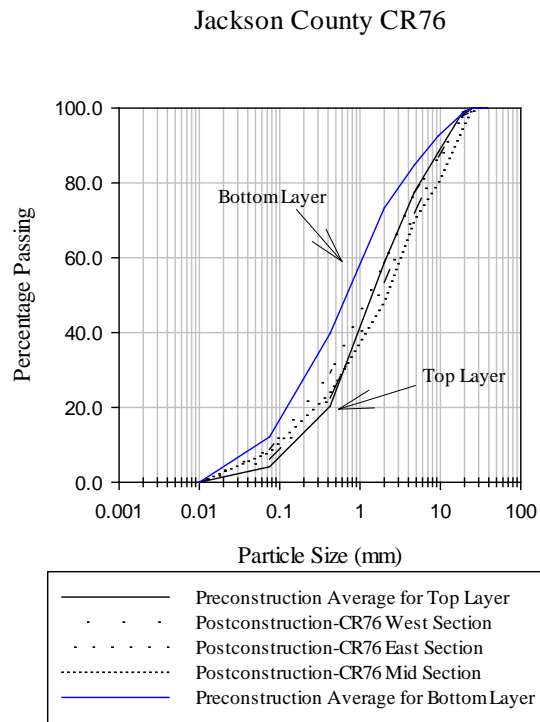
Figure 42 PSD of Material-Jackson County CR 76

The particle size distributions (PSD) of material before and after construction are presented below in Figure 42. Two solid lines represent the PSD curve for top and bottom layers of material, as

indicated. PSD curve for three test sections lies in between the two solid lines at their left tails, indicating the gradation of the top layer has been modified and become finer.

Detailed material properties are summarized in Table 8. The proportion of #200 fine particles increased after crusher dust was mixed in. However, the crusher dust has zero plasticity.

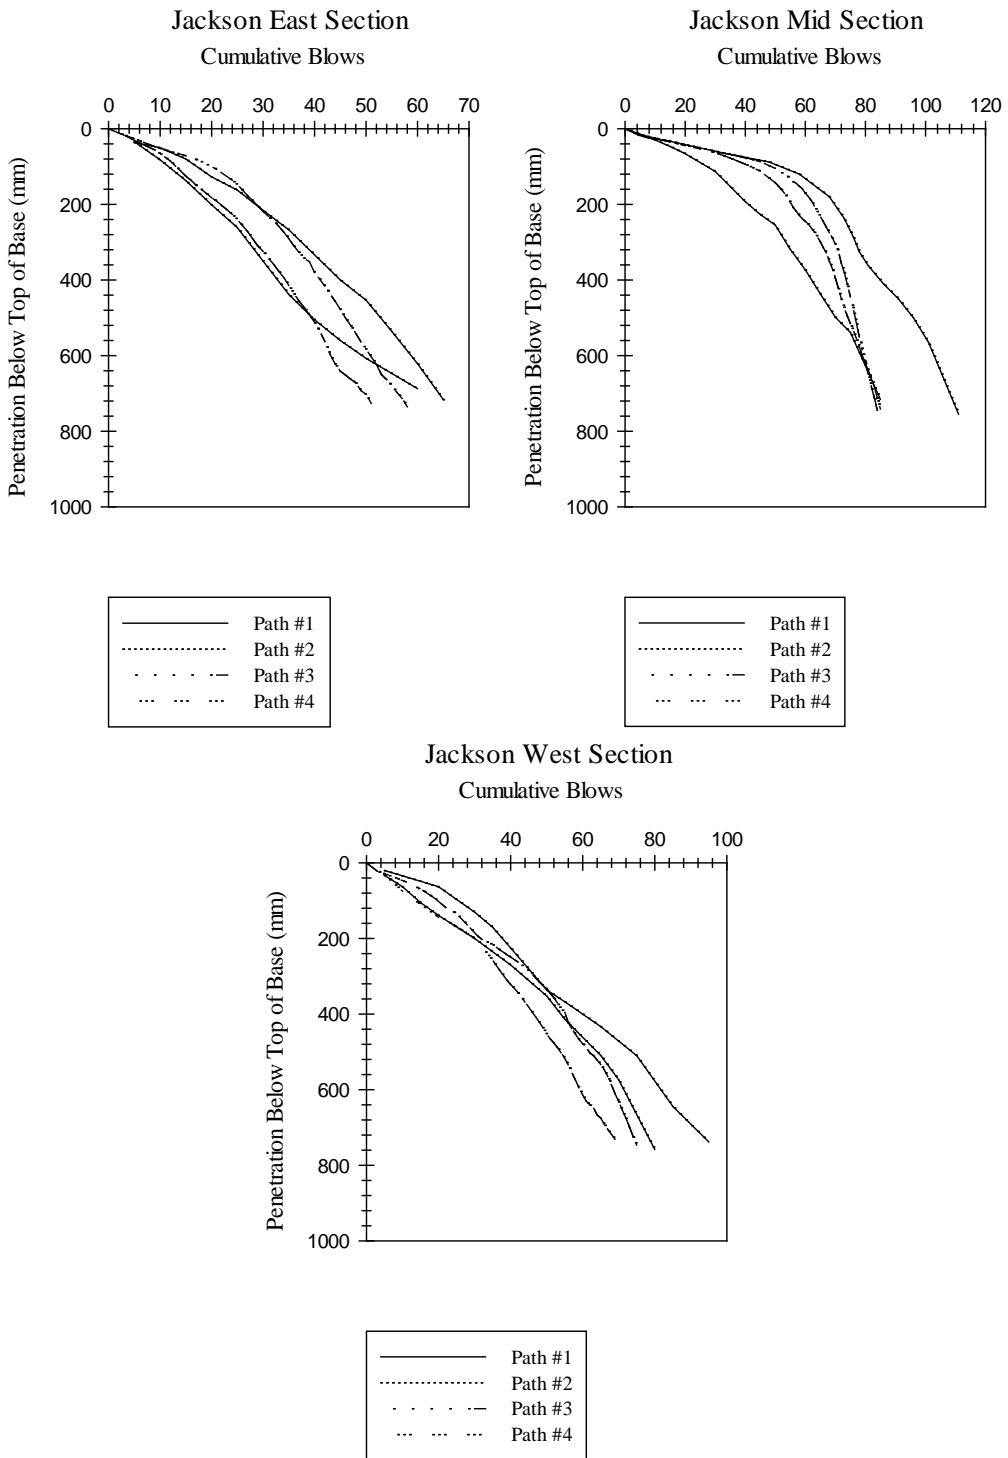
Figure 43 Cumulative Depth against Cumulative Blow-Jackson County (6/21/2014)

Figure 43 reveals that the surface and the subgrade materials are rather consistent with regard to stability since penetration rate (PR) does not change, except for the Middle Section. From the plot for the Middle Section, a pronounced downturn is seen at about 120mm (4.7in) from the surface, suggesting heterogeneity of subgrade material. California Bearing Ratio (CBR) appears to be comparable between West and East Section. However, according to some measurements, the CBR increases to 300 within the wearing surface in Middle Section. Plots are shown in Figure 44.

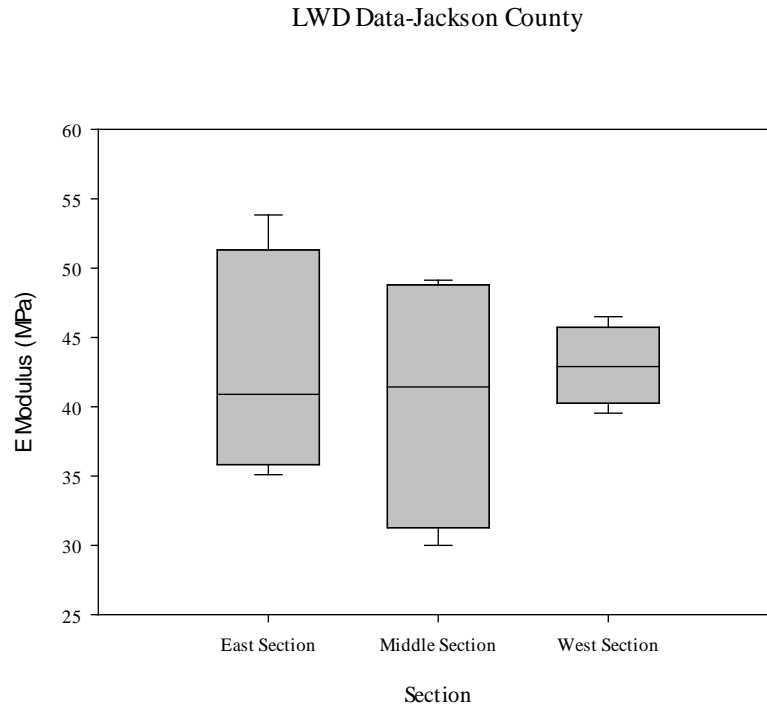
Figure 45 Boxplot of LWD Readings-Jackson County (Test Date: 6/21/2014)

LWD test again shows a consistency in E-modulus readings for the three sections, as shown in Figure 31. The East Section has the highest E modulus value of 45.2MPa.

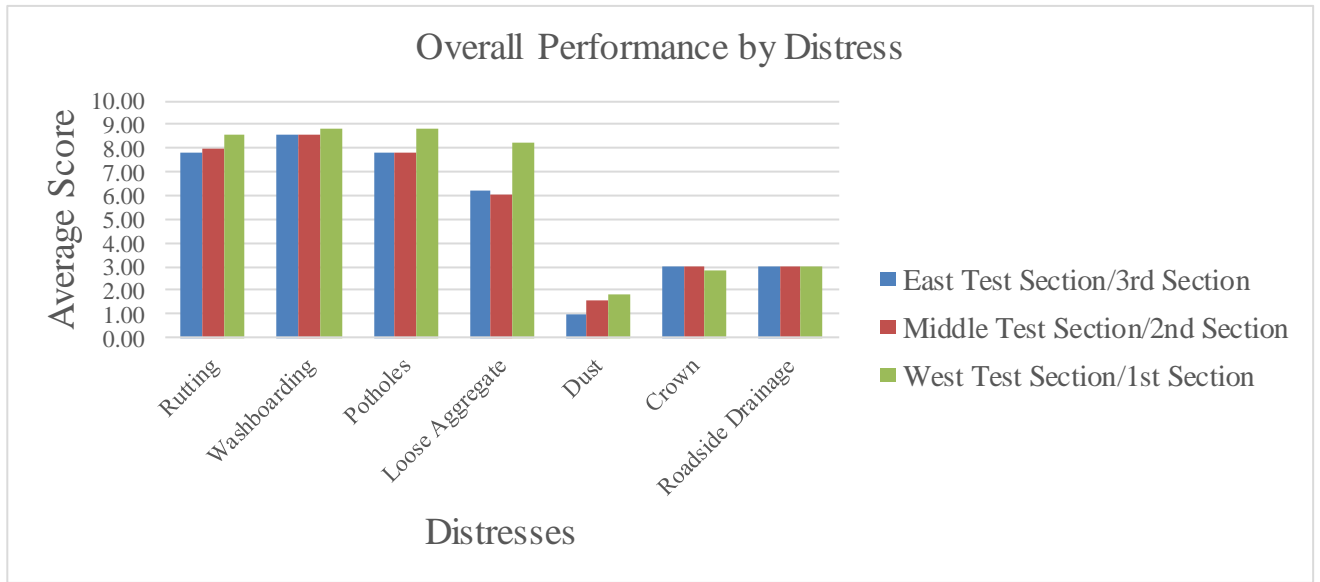
Figure 46 Pavement Condition Rating Result by Distresses-Jackson County

County personnel monitored the road since the completion of construction and provided ratings of road performance. A rating chart with scoring criteria was used by the raters to assist in documenting the condition of the road on the day of the visit. Additional remarks were made to descriptively record the observation. Figure 46 shows that rutting, washboarding (corrugation) and potholes were rated as “Good” or “Very Good”, indicating a relatively low level of such distresses. For the above three distresses, the conditions were very comparable since they lie within the same severity level. For the distress of loose aggregate, however, the West Section/1st Section outperformed the other two sections. The West Section/1st Section fell in the “Good” category in terms of condition of loose aggregate. The other two sections were rated as “Fair”. In addition, for dust emission, the East Section/3rd Section was rated as “Medium”. Dust loss is the major source of material loss.

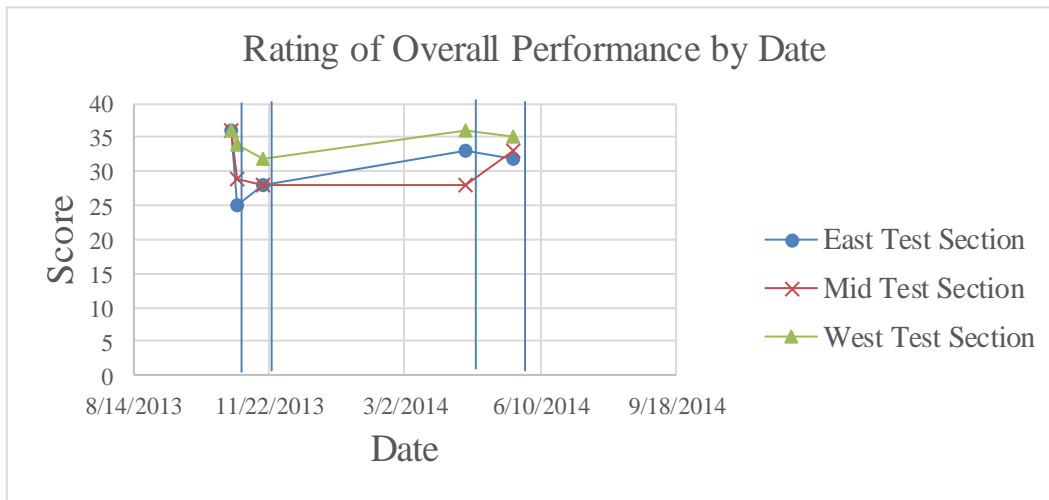
Figure 47 Pavement Condition Rating Result by Data-Jackson County¹

Overall performance rating also indicated that throughout the observation period, the West Section/1st Section outperformed the other two sections, shown in Figure 47. Necessary maintenance activities were implemented during the period of observation. Rating were carried out before the maintenance activities.

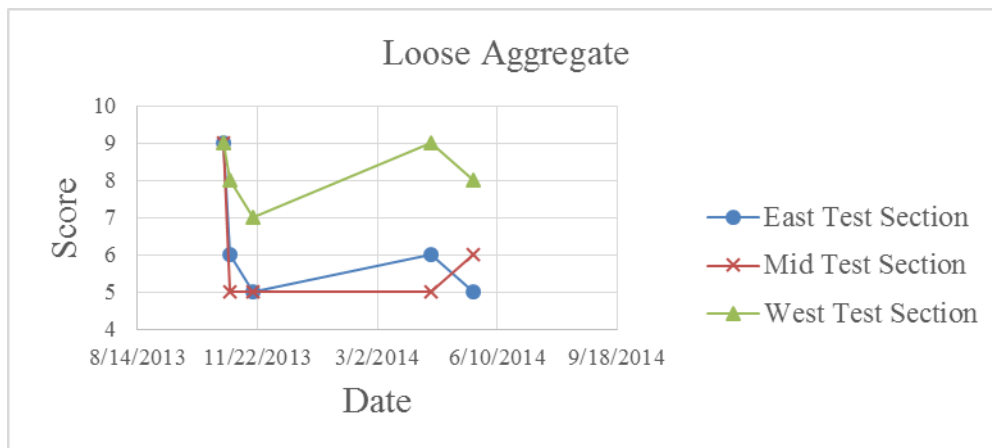
Figure 48 Rating for Loose Aggregate-Jackson County

Figure 48 shows that the two experimental sections suffered from loose aggregate soon after construction and the problem remained since then. Segregation resulted generated a large amount of loose aggregate that compromised the performance of the experimental sections.

Remarks from the county employee who served as the observer reflected his concern that the surfacing material was not binding. In the April, 2014, soon after the maintenance activities

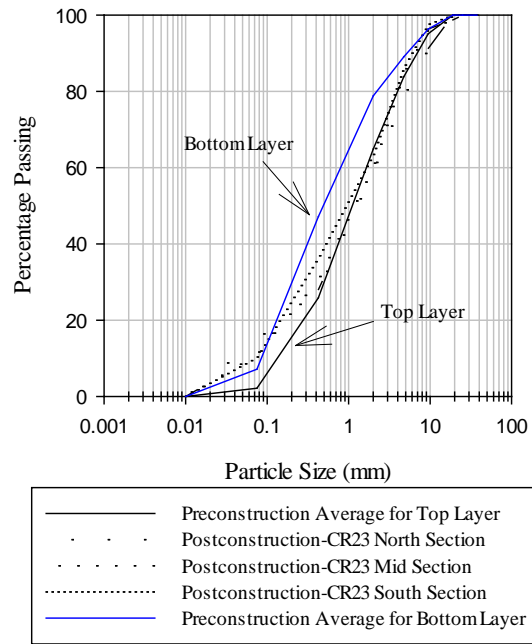
Figure 50 PSD of Material-Beltrami County CR 23

The addition of crusher dust successfully boosted the fine content of the in-situ loose aggregate on the surface, see Figure 50. The north Section has the highest fine content among the three sections.

Detailed material properties are summarized in Table 9. Unlike the resulting material in Jackson County, the resulting material in Beltrami County contains clayey soil which possesses some binding capacity. Although the plasticity index does not seem to be within the typical range recommended by the specification, the road surface in Beltrami County constructed with the plastic material provides a better, smoother surface in comparison to that of Jackson County.

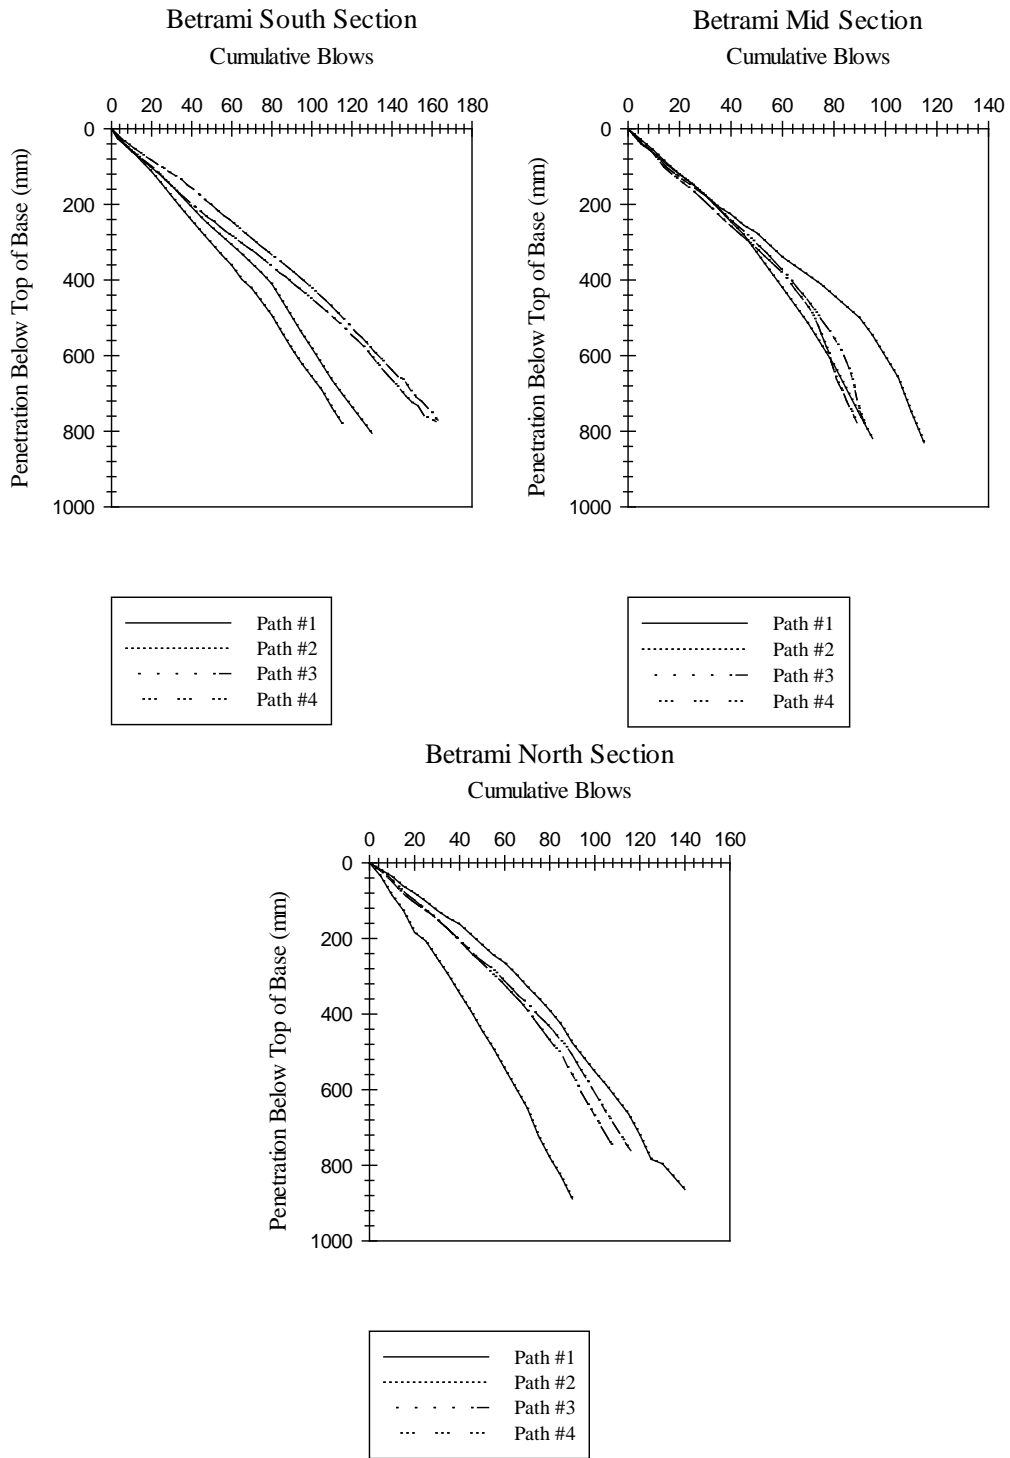
Figure 51 Cumulative Depth against Cumulative Blow - Beltrami County (6/22/2014)

From the Penetration-Cumulative Blows plots, Figure 51, it is apparent that the various layers of road surface and subgrade material are consistent with regard to stability because the penetration per blow is relatively constant. Penetration-CBR plots, Figure 52, show CBR value for the each section along the depth of the pavement. The CBR value for the top 200 mm has an average value of 46.18 for the north section/1st Section, 40.26 for the Middle Section/2nd Section and 50.26 for the South Section/3rd Section.

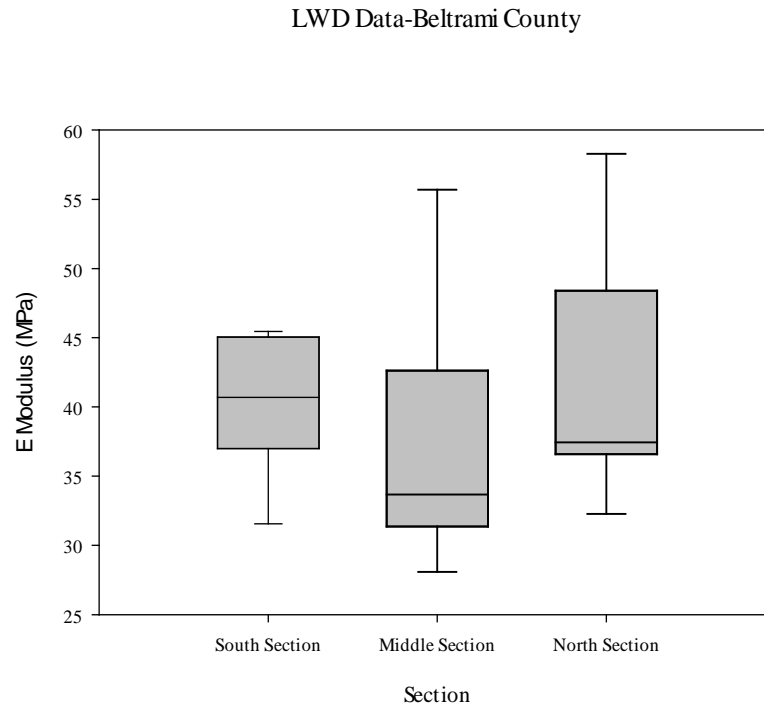
Figure 53 Boxplot of LWD Readings-Beltrami County (Test Date: 6/22/2014)

LWD data shows comparable stiffness across test sections as Figure 53 shows that data in the range between 25th and 75th percentile overlaps.

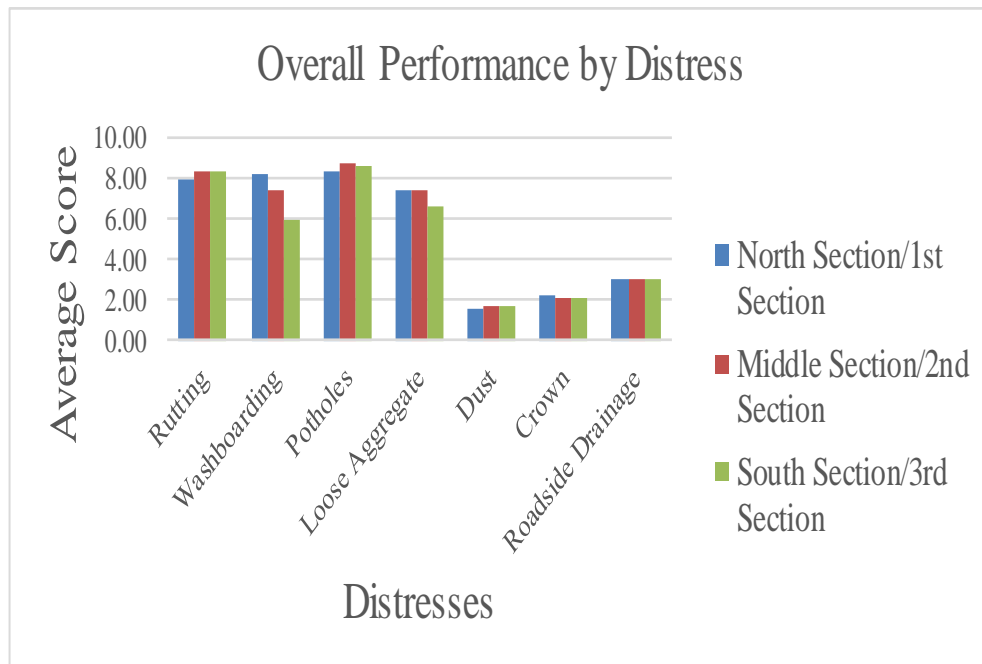
Figure 54 Pavement Condition Rating Result by Distresses-Beltrami County

The South Section/3rd Section was rated “Fair” for the distress of washboarding, which reflects the lasting distress observed in this section. Fair level of washboarding suggests that 10%-25% of roadway appears to suffer from corrugations that are generally 1”-2” deep and vehicle control is compromised. The Middle Section/2nd Section particularly performed well by having few pothole distress. See Figure 54 below.

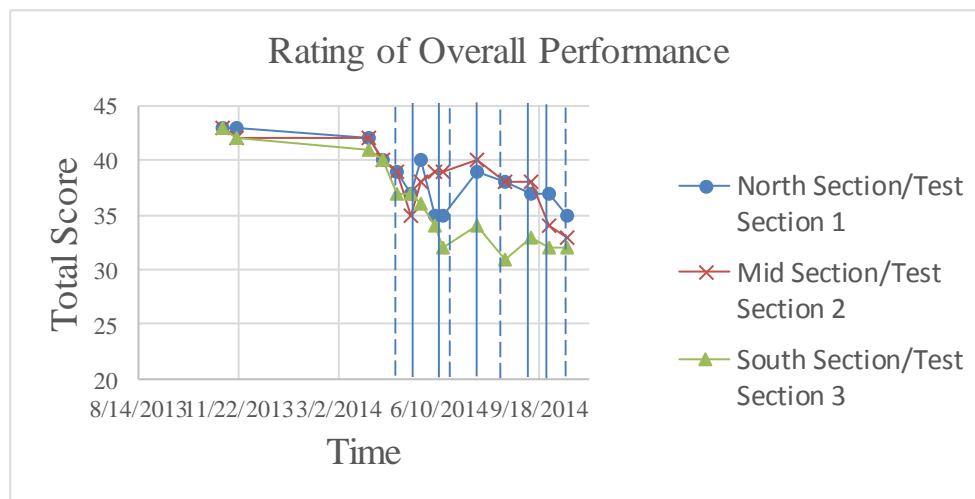
Figure 55 Pavement Condition Rating Result by Date-Beltrami County²

Considering that the scores assigned to the distresses of dust, crown and roadside drainage were very close, if not exactly the same, the overall performance according to the rating would be highly depending on the rest of the distresses that have not been previously mentioned in this sentence. Figure 55 shows that even though the north Section/1st Section were assigned the highest scores at the beginning of the observation period, the Middle Section/2nd Section caught up later in time. This can most likely be attributed to the relatively good performance in terms of rutting and potholes. The South Section/3rd Section remained at the lowest score level for the majority of the observation period, even though that the south section/3rd section received higher frequency of maintenance activity.

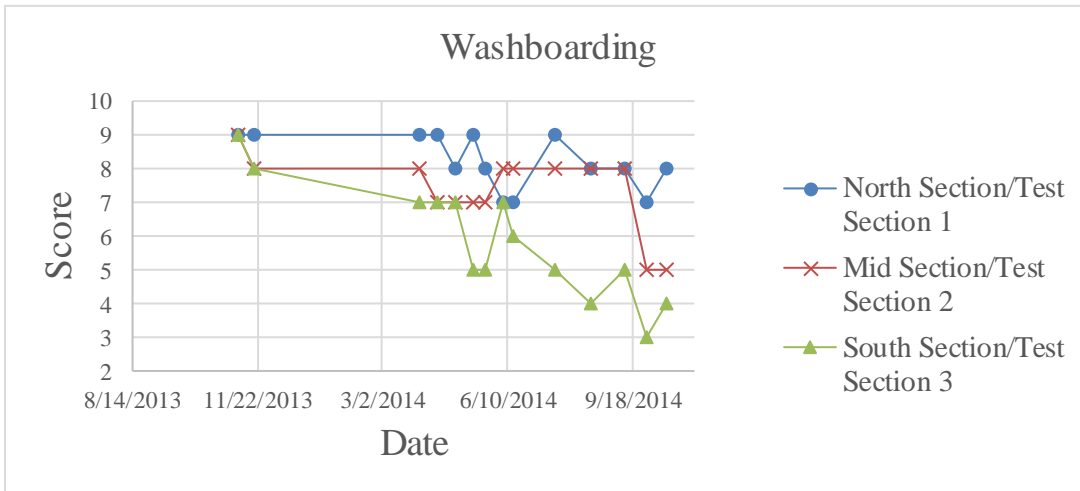
Figure 56 Rating for Washboarding-Beltrami County

The South Section/3rd Section started to deteriorate noticeably beginning in late May as it was entering into a dryer summer season. The deterioration is most pronounced in terms of washboarding, Figure 56.

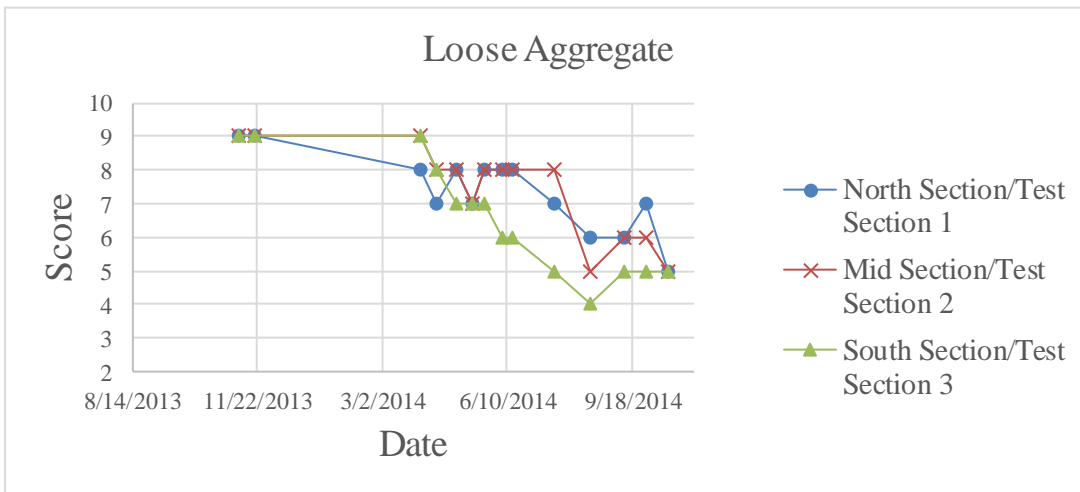
Figure 57 Rating for Loose Aggregate-Beltrami County

Loose aggregate issues started to occur in May as well, and were the worst for the South Section/3rd Section, Figure 57.

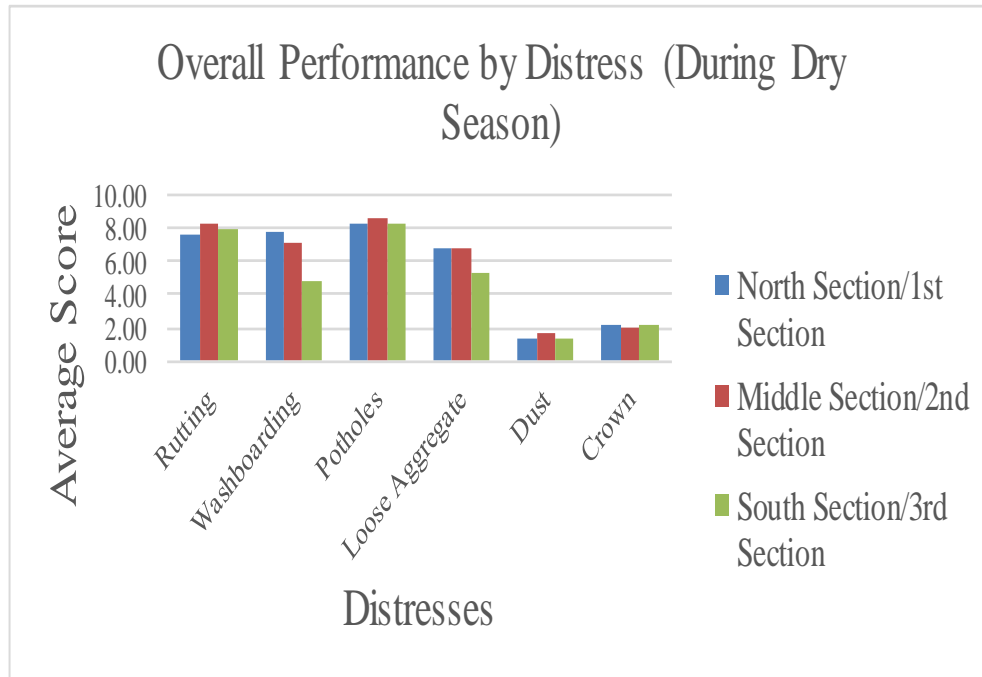
Figure 58 Overall Rating by Distress during Dry Season-Beltrami County

It is of interest to reveal how all the sections were performing during the dry season, in this case, after late May; this can be done by examining distress in detail. Figure 58 shows that the ratings for washboarding and loose aggregate for the South Section/3rd Section have dropped substantially,

Figure 54, while the ratings for both the North Section/1st Section and Middle Section/2nd Section exhibit a noticeably less substantial drop.

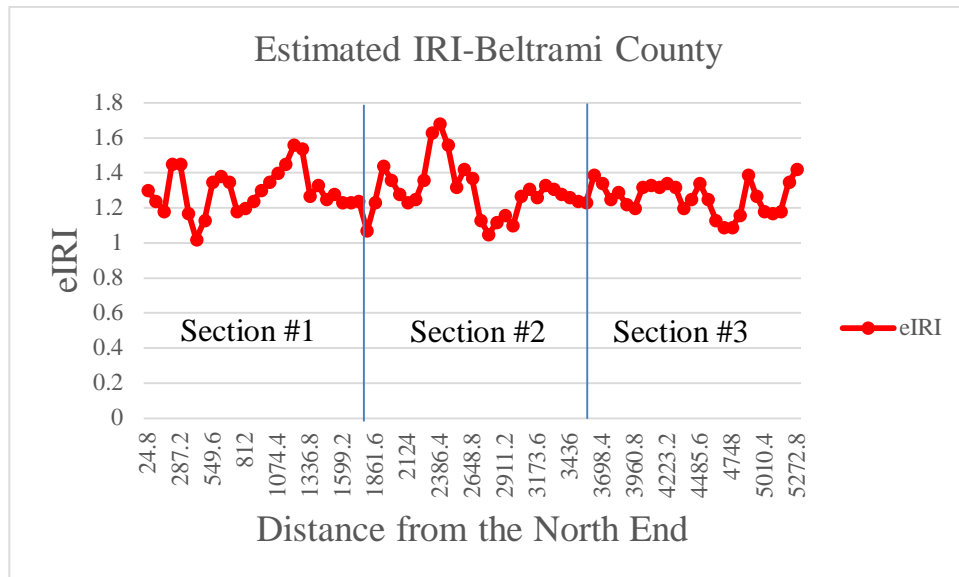
Figure 59 Estimated IRI-Beltrami County³

Roadroid generated estimated IRI as shown in Figure 59. From the graph, although it appears that some segments of the north Section/1st Section and the Middle Section/2nd Section were rougher than the rest of the road, the three test sections generally provide a good riding quality as the estimated IRI is smaller than 2.2.

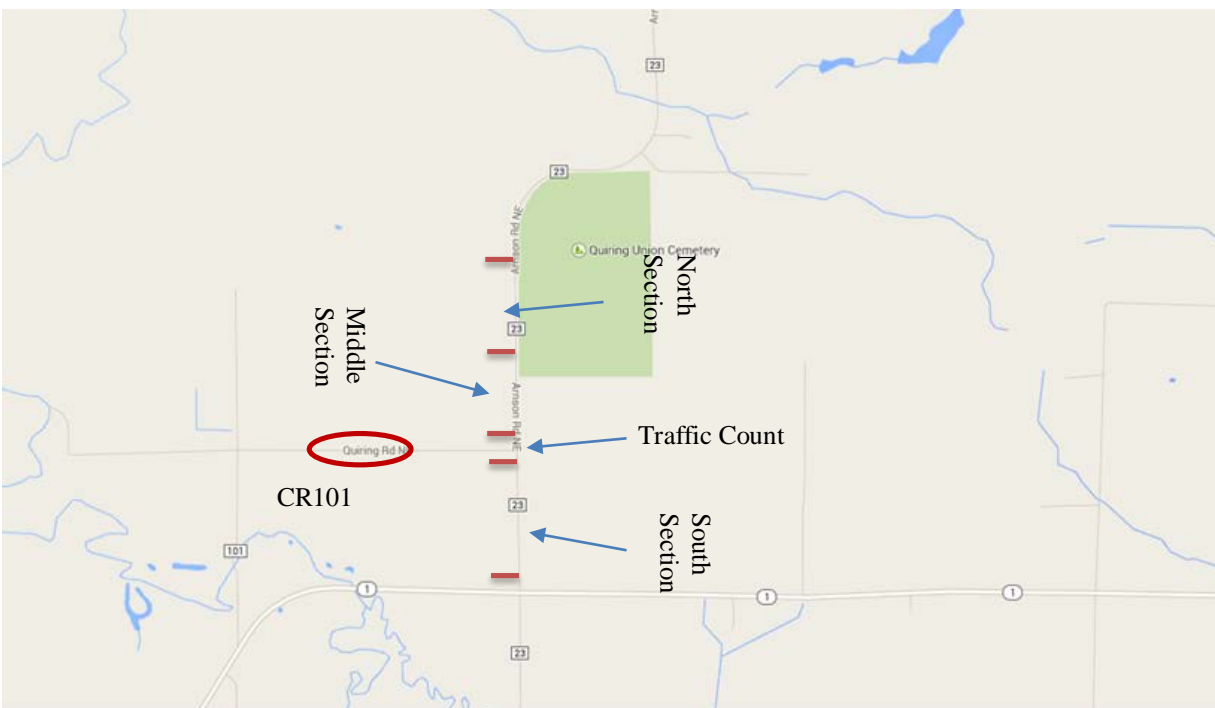
Figure 62 Traffic Count Location

personnel. Figure 62 indicates the location of traffic count as well as the three test sections. The result revealed that South Section/3rd Section serving 17 vehicles while the Middle Section/2nd Section and the north Section/2nd Section were serving 18 vehicles. The fair performance of the South Section/3rd Section was attributed to the lower amount of crusher dust that was mixed in as binder in comparison to Middle Section/2nd Section, slight corrugation was seen near the intersection. No corrugation was seen in the North Section/1st Section.
