Investigation of an alternative gravel roads rejuvenation method

Ziliang Zhang

Major: Civil Engineering (Construction Engineering and Management)

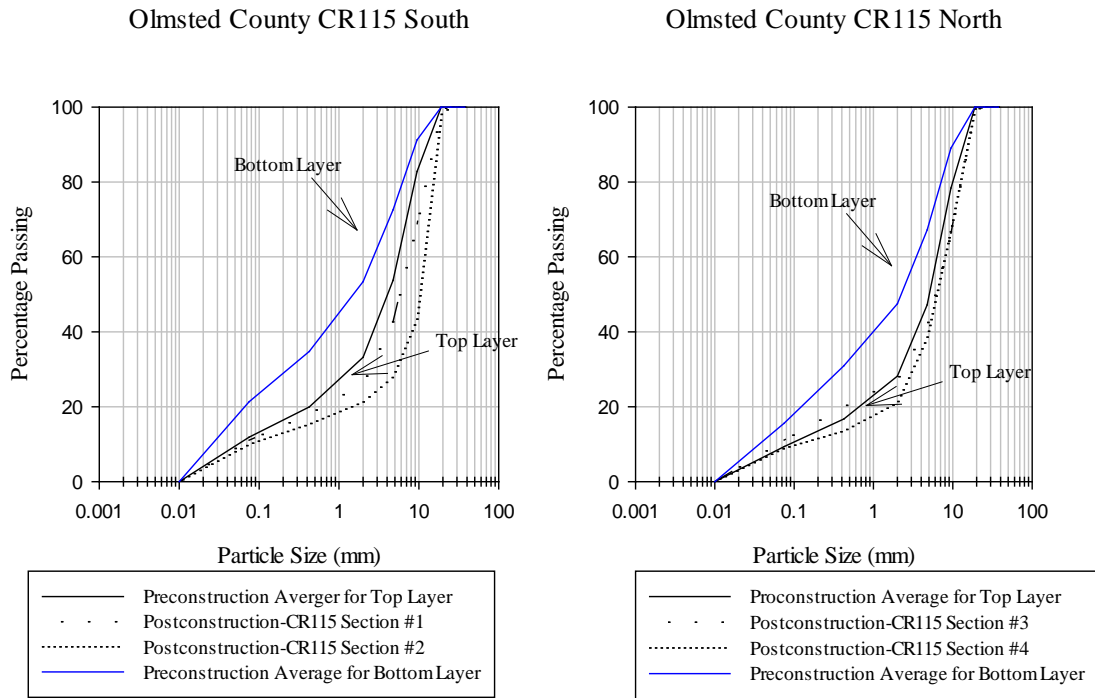
Figure 63 PSD of Material-Olmsted County CR 115

PSD plots are shown in Figure 63. It is interesting to note that the resulting gradation of the newly placed material was coarser than that of the top material. All material was determined to non-plastic as shown in Table 10.

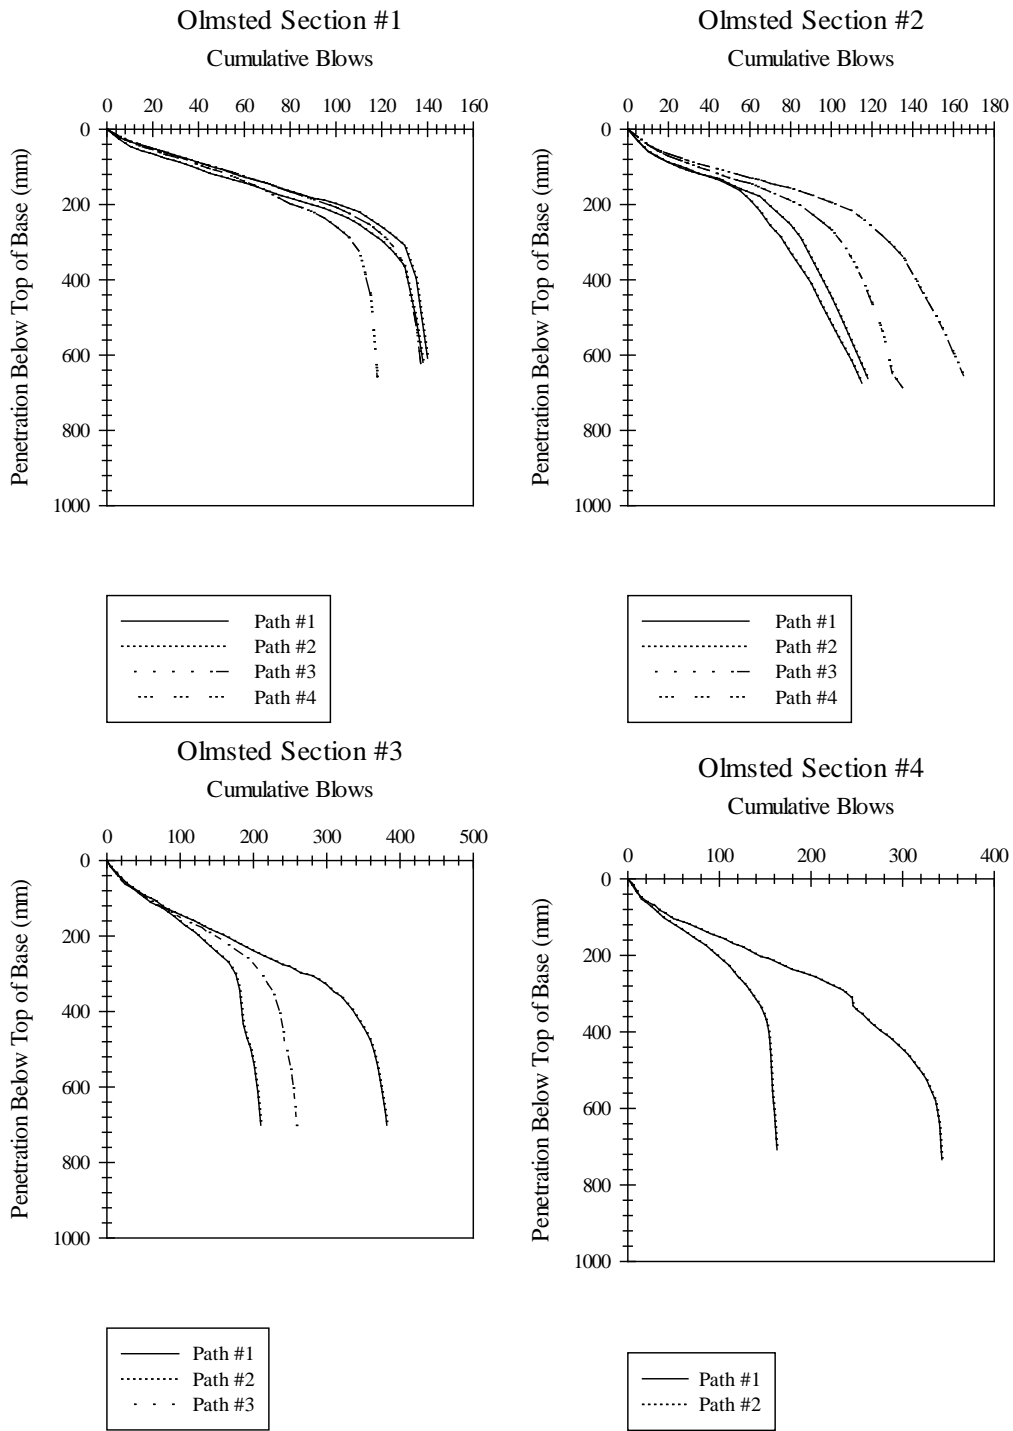
Figure 64 Cumulative Depth against Cumulative Blow-Olmsted County (6/20/2014)

Figure 64 shows a clear indication of the location of the interface between crushed rock layer and subgrade layer. The crushed rock of test sections had various depths ranging from 200mm (7.9 inches) to 300mm (11.8 inches). Figure 65 shows comparable CBR value that is close or higher than 200 within the gravel layer.

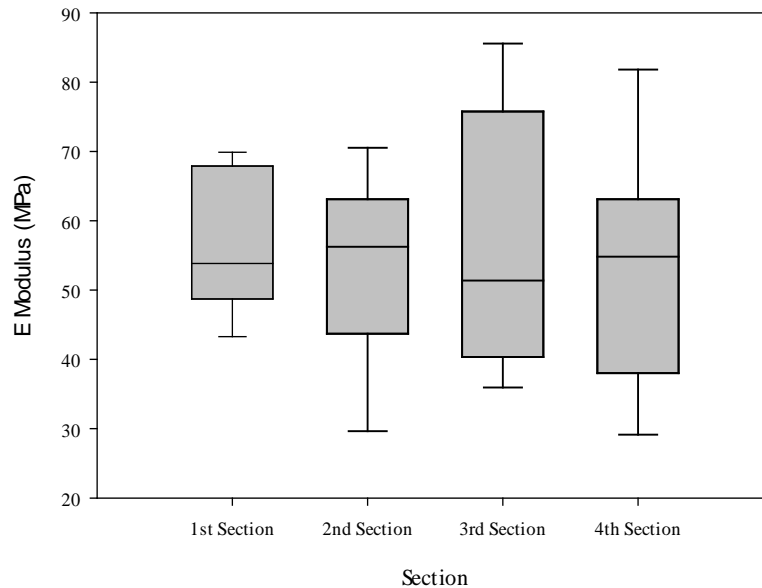
Figure 66 LWD Readings-Olmsted County (6/20/2014)

Figure 66 shows comparable LWD readings. In other words, no noticeable difference was discovered in the stiffness of the road surfacing materials for the four test sections.

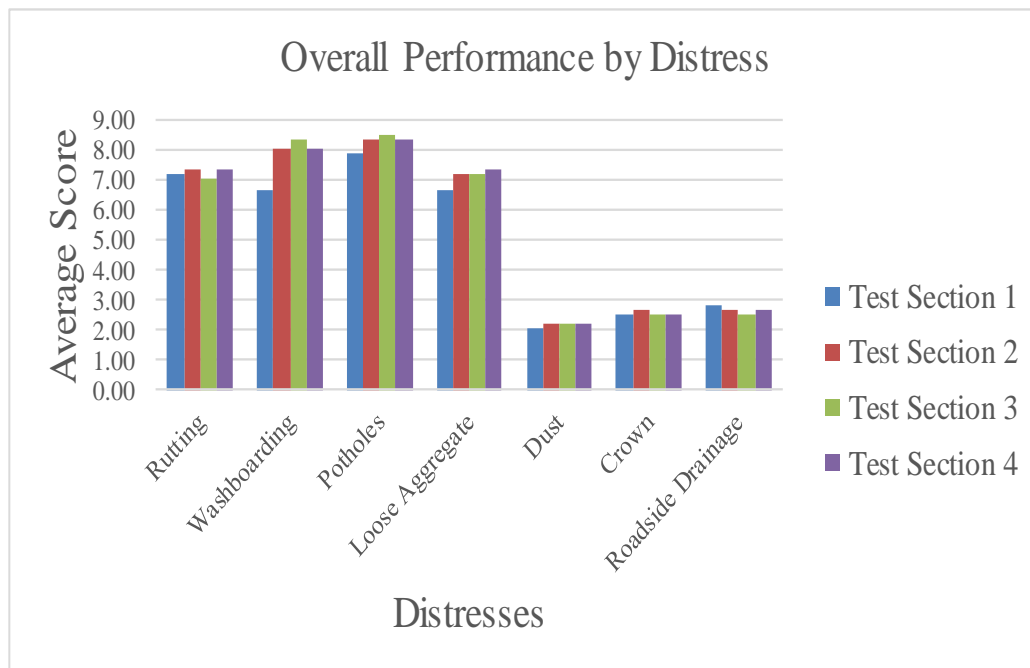
Figure 67 Pavement Condition Rating Result by Distresses-Beltrami County

All four test sections were considered to be performing reasonably well, except that Section 1 received rating of “Fair” with respect to loose aggregate while the other sections were rated “Good”. In addition, Section 1 had more severe corrugation in comparison to the other sections, probably due to the proximity to an intersection. Figure 51 shows the rating result by distress

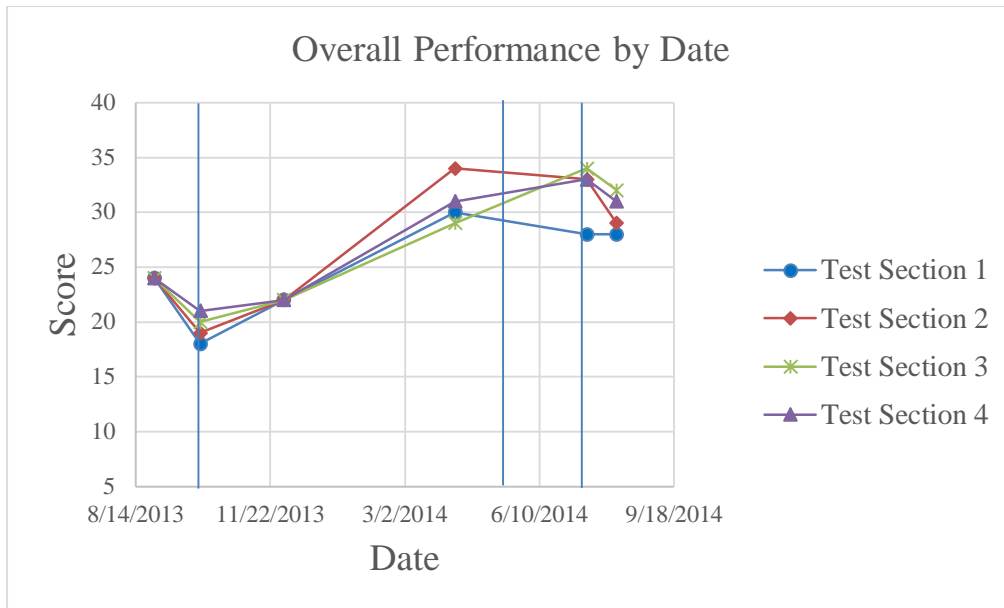
Figure 68 Pavement Condition Rating Result by Data-Jackson⁴ County

Considering that same score was given to distresses of dust, crown and roadside drainage, differences in the overall rating must be due to difference in distress rating not previously mentioned in this sentence. Figure 68 shows the rating outcomes by date. The sudden jump resulted

from the addition of the distress of washboarding. Washboarding was not expected to be problematic, since the test sections were located some distance away from intersections. During dry season, there was not a significant difference in performance among sections.
