Rehabilitation of Precast Deck Panel Bridges

Atiq H. Alvi
University of South Florida

A thesis submitted in partial fulfillment
of the requirements for the degree of
Master of Science in Civil Engineering
Department of Civil and Environmental Engineering
College of Engineering
University of South Florida

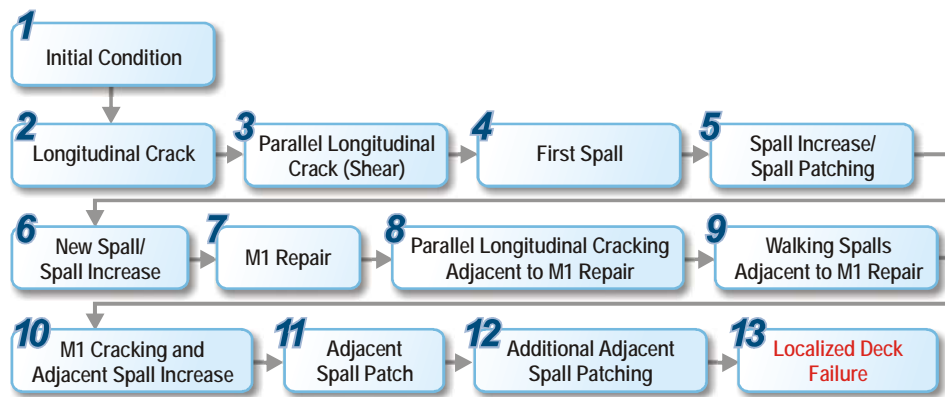
Figure 2.1 Deterioration Model

The simplified model indicates that longitudinal cracks first develop along the girder lines. This is followed by occasional reflective transverse cracking. Such defects appear within 5 years of construction. These cracks may not change for nearly 10 years after which there is more widespread transverse cracking. Longitudinal and transverse

cracking result in spalling and delamination that require repair. This is an important stage in the deterioration process because the type and quality of repair will dictate if the long-term performance of the bridge is satisfactory or poor. In most cases, such damage occurs in regions where the panel is improperly supported on fiberboard bearing material. Where deck repairs are combined with proper panel bearing (e.g., by placing non-shrink grout or injecting epoxy), repairs are satisfactory. Where this is not carried out, and repairs are limited to surface repairs, there is progressive degradation as shown in Figure 2.1, which can lead to failure. In several instances, failures occurred at locations where temporary repairs had not been replaced.

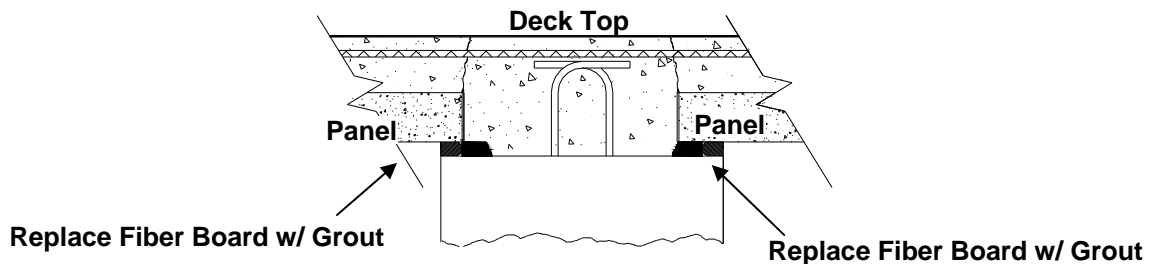
Figure B.5 Bearing Detail after Grout Packing Repair

port is that the lack of positive panel bearing is clearly the main factor responsible for the occurrence of major deck deterioration such as cracking, delamination, spalling, failing repairs, and in the worst case localized punch-through deck failures. Hence, grout packing is a good method of repair. The fiber board bearing material is replaced with non-shrink Portland cement grout or epoxy grout to provide positive bearing, (see Figure B.5).

Grout packing is one of the most effective repair methods used to extend the service lives of precast deck panel bridges. It is very cost effective in comparison to other effective repair methods and it does not cause any interruption in traffic to the facility carried by the structure because the work can be performed utilizing a bucket truck or scissor lift underneath the bridge.

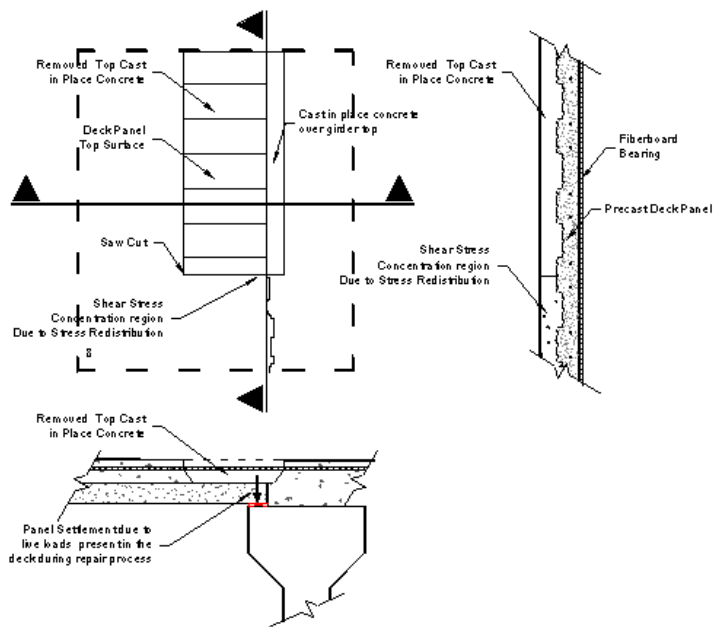
Figure B.6 M1 Repair Procedure (Stage #7)

Unlike localized repairs, the depth of the M1 goes to the top of the precast panel. Although the M1 repairs hold up better than localized repairs, again due to the bridge deck system not acting compositely, they start separating at the edges and walking spalls start occurring in front of these repairs.

Generally, after several patch and re-patches, an M1 repair is done in the affected area. The M1 repair is used to repair longitudinal spalling along the edge of a beam as illustrated in Figure B.6. The M1 and M2 were FDOT's recommended methods of repair in the 1980s [B.4].

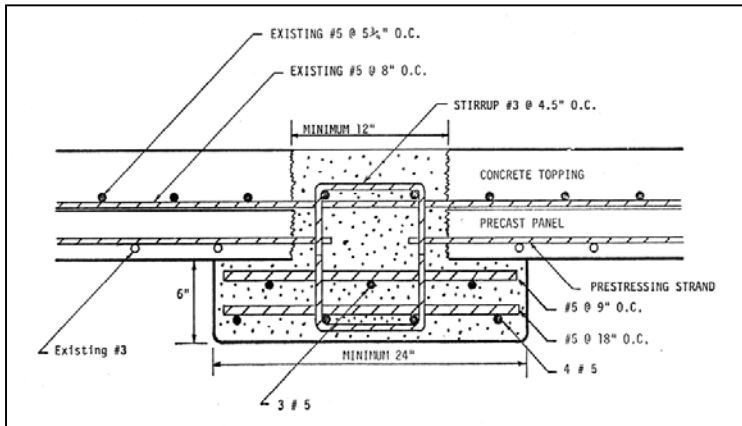
Figure B.7 M2 Repair Procedure [3]

The M2 repairs are costly relative to other repair methods and cause impact to the traveling public.

Although the M2 repair method was not encountered in any of the authors inspections or failures listed in Tables 2.1 and 3.1, it deserves to be mentioned because it was prescribed as a good method of repair by the FDOT in the 1980s [B.3]. The M2 repair, shown in Figure B.7, is used to fix the problem of cracking and spalling along the transverse joints of the precast panel. The unsound material is removed approximately six inches on each side of the transverse joint and an inverted T-beam is formed with the bottom of the precast panel sitting on the flange of the inverted T-beam. The flange of the T-beam is required to be at least 24 inches wide. The inverted T-beam needs to be provided with positive bearing on the girders [B.3].
