# Evaluating CFRP-Masonry Bond Using Thermal Imaging

Joseph Christopher Ross

A thesis submitted in partial fulfillment  
of the requirements for the degree of  
Master of Science in Civil Engineering  
Department of Civil and Environmental Engineering  
College of Engineering  
University of South Florida

Date of Approval:  
October 18, 2013

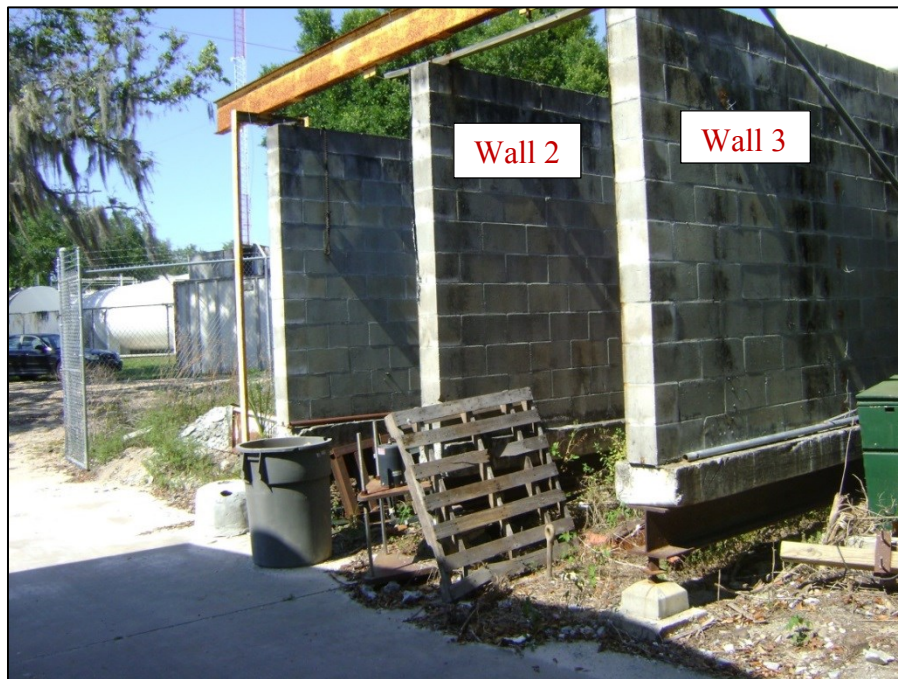
end that overhangs dissipates heat differently than the end that is in contact with the ground. The overhanging portion cannot dissipate heat as readily and therefore is hotter, whereas the grounded end can transfer heat to the ground and can cool down more efficiently. The thermal image in Figure 16 also illustrates this same thermal pattern.

**Figure 17: Overhanging End of Walls**

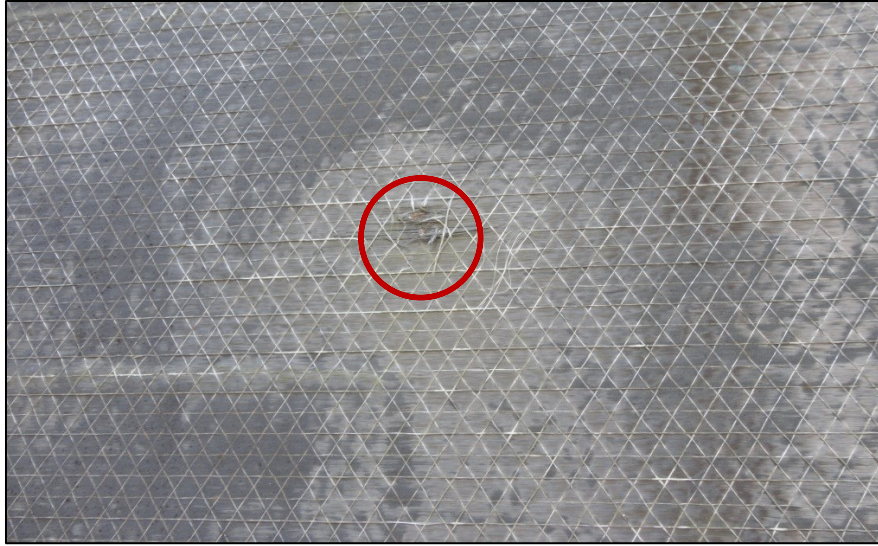
**Figure 48: Tear in Fabric on North Side of Wall 3**

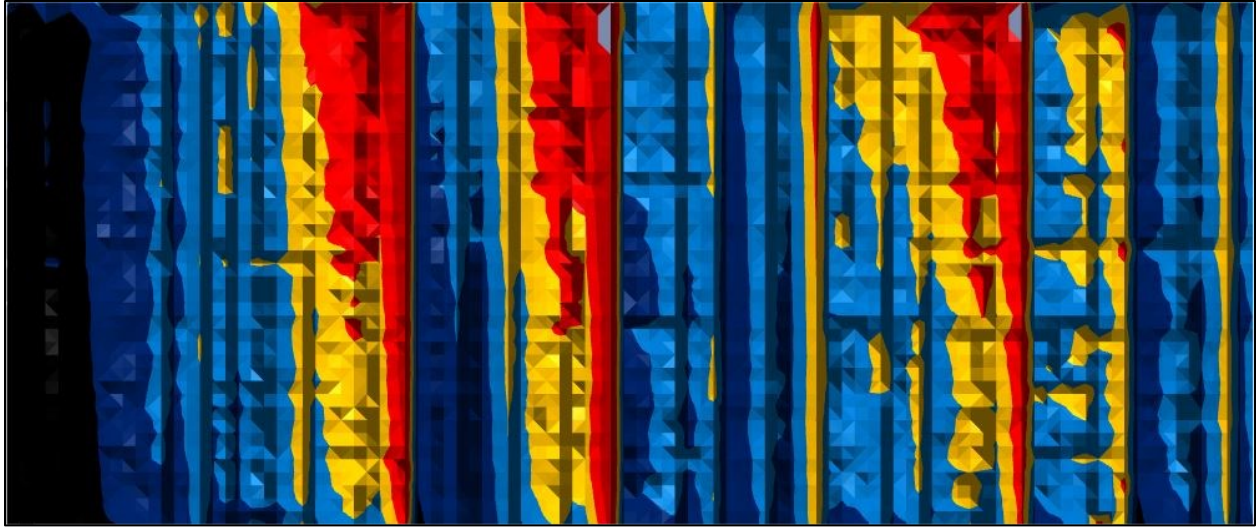
Figure 58: Wall 3 Scan Results Prior to Post Processing

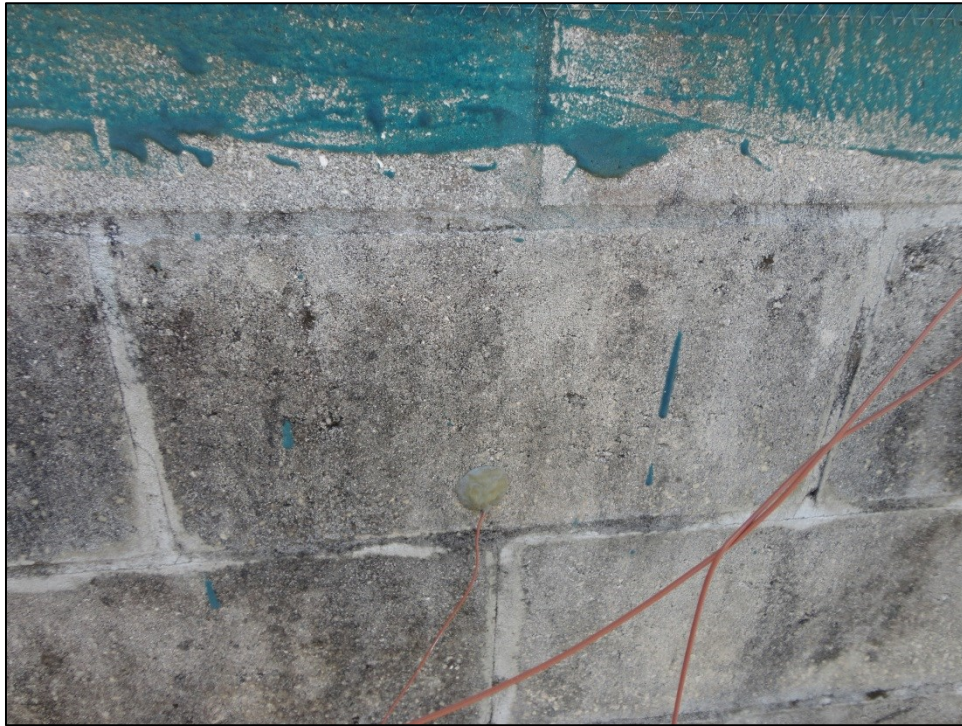
**Figure A63: Photo at Location 20 (North Side of Wall 2)**

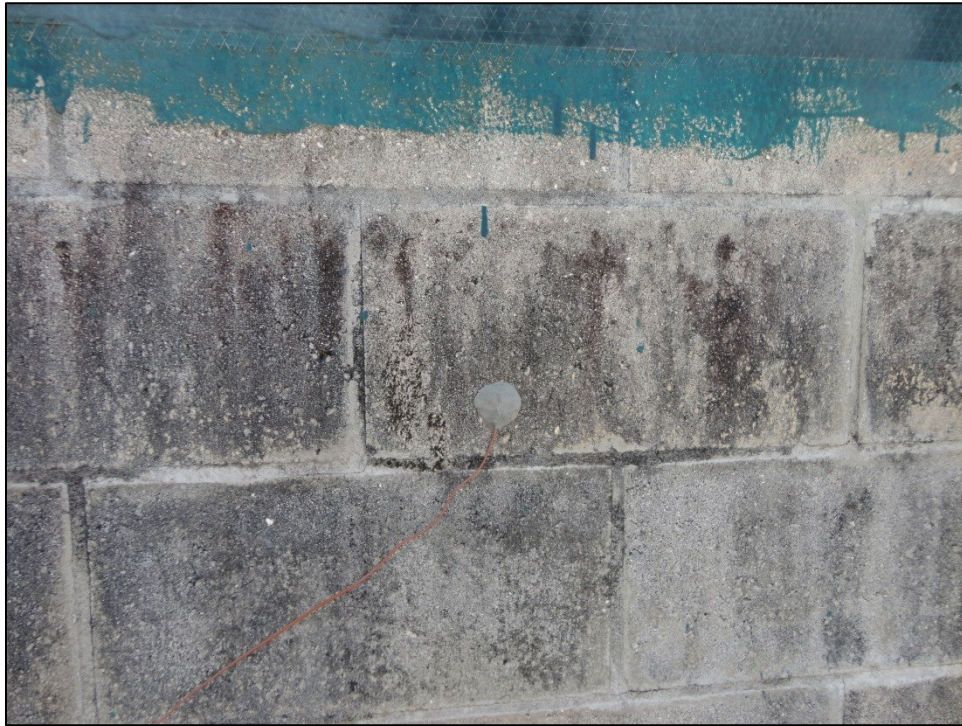
**Figure A75: Photo at Location 24 (North Side of Wall 2)**
