Detection and characterization of impact damage in carbon fiber aircraft fuselage structure

**DETECTION AND CHARACTERIZATION OF IMPACT
DAMAGE IN CARBON FIBER AIRCRAFT FUSELAGE
STRUCTURE**

THESIS

**Master of Science
Civil Engineering**

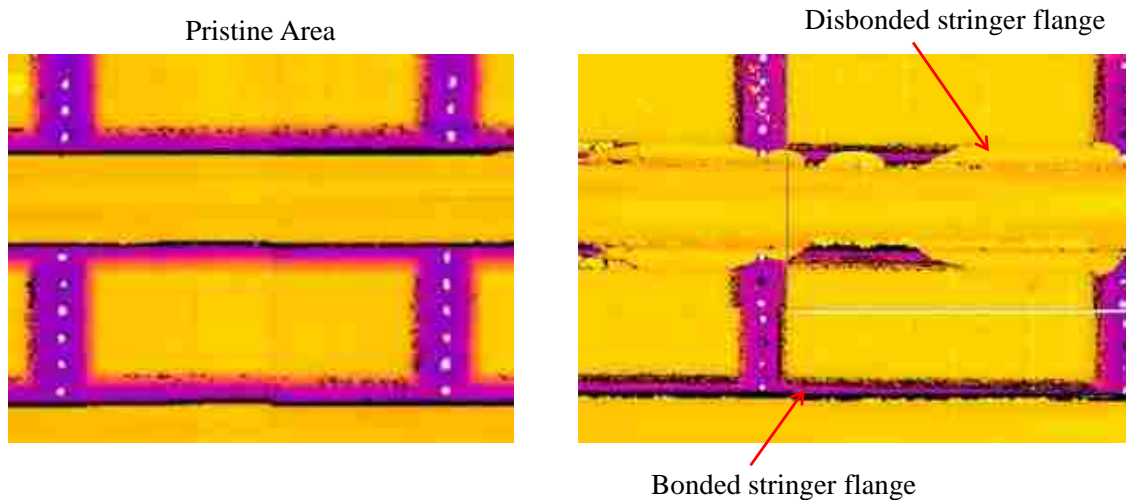
Figure 4-5: Ultrasonic Time of Flight (TOF) C-Scan Showing Delaminated Stringer Flanges

Although it is fairly clear to detect delaminated stringer flanges using the amplitude C-scans, additional, less obvious delaminations could be detected when analyzed side-by-side with time of flight C-scans. An example of a TOF C-scan demonstrating the clear difference between a bonded and delaminated stringer flange is shown in Figure 4-5. The purple areas in the figure are fully bonded flanges. The yellow/orange areas of the flange

are the same depth as the back wall of the skin of the panel, indicating a delamination at the skin-flange interface.

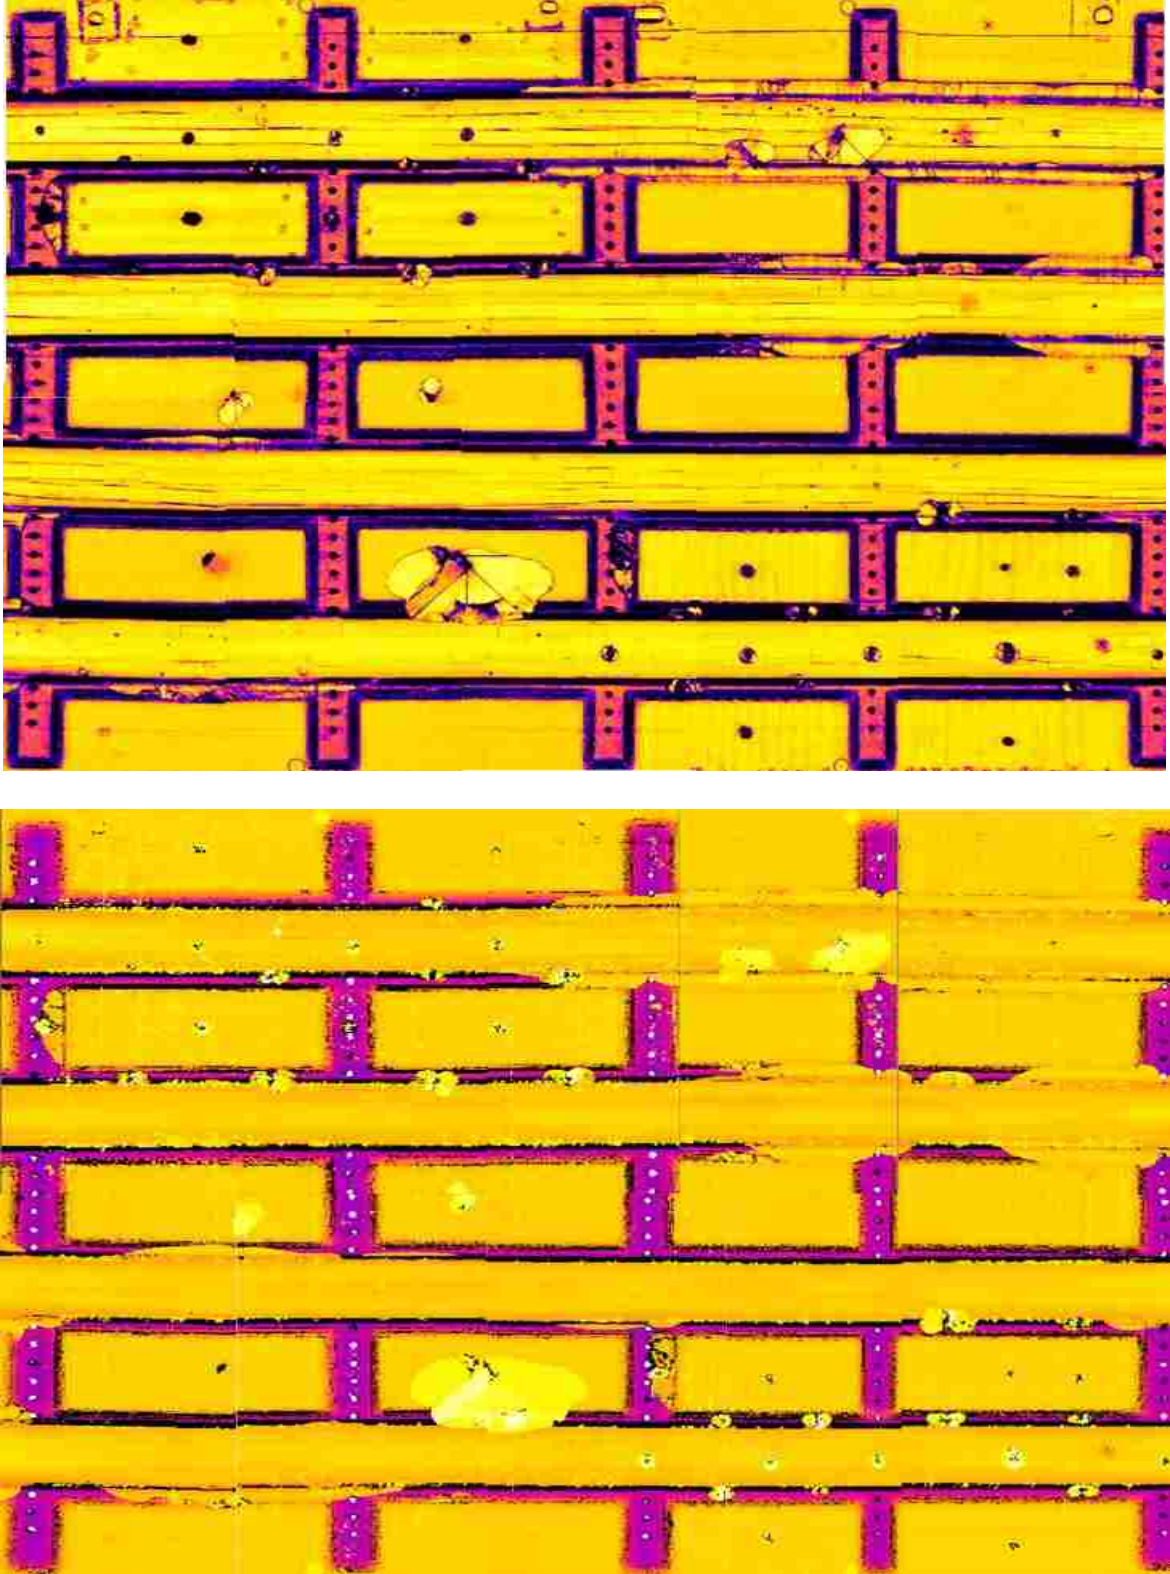
Figure 4-6: Panel A - Ultrasonic Amplitude (top) and Time-of-Flight C-Scans (bottom) C-Scans

Full panel pulse echo ultrasonic inspections of panel A and B are shown in Figure 4-6 and Figure 4-7. The upper left and lower right sides of the panel inspections in Figure 4-6 show the two areas of panel A that were impacted with the drop weight, spherical tip impactor. The upper right and the lower left quadrants are the two areas that were impacted with simulated hail. Similarly, Figure 4-7 shows the pulse echo ultrasonic full panel inspection results for panel B. The top left and bottom right are pristine, untested areas of the panel and the upper right and lower left were quadrants tested with simulated hail. Much greater inspection detail including exact impact location, energy levels and damage area can be found in Appendix B for ice impact tests and Appendix C for the hard impact tests.

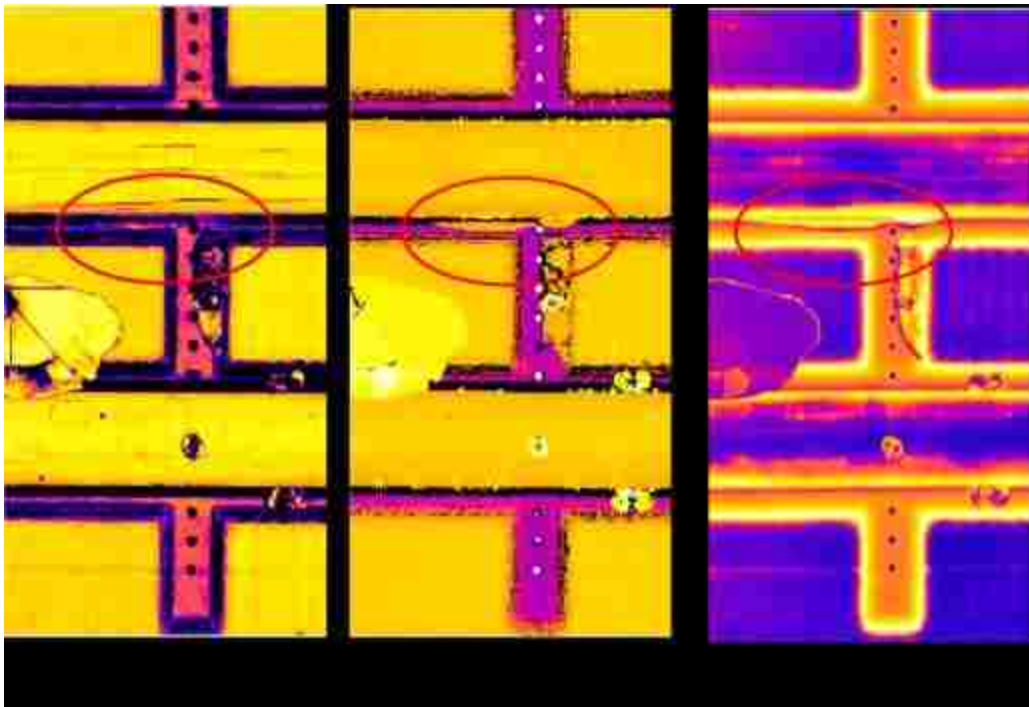
Figure 4-8: Comparison of UT Amplitude, TOF and Resonance

Ultrasonic resonance C-scans were composed using the MAUS V scanning system with a 330 KHz resonance probe. In general, the resonance inspection technique detected the same damage as the pulse echo ultrasonic method. Similar to TOF scans, resonance indicated areas where substructure is disbonded from the skin more clearly than PE-UT amplitude. This can be observed in Figure 4-8, where the small stringer flange disbond in the circled area is detected in the TOF and resonance inspections, but not amplitude.

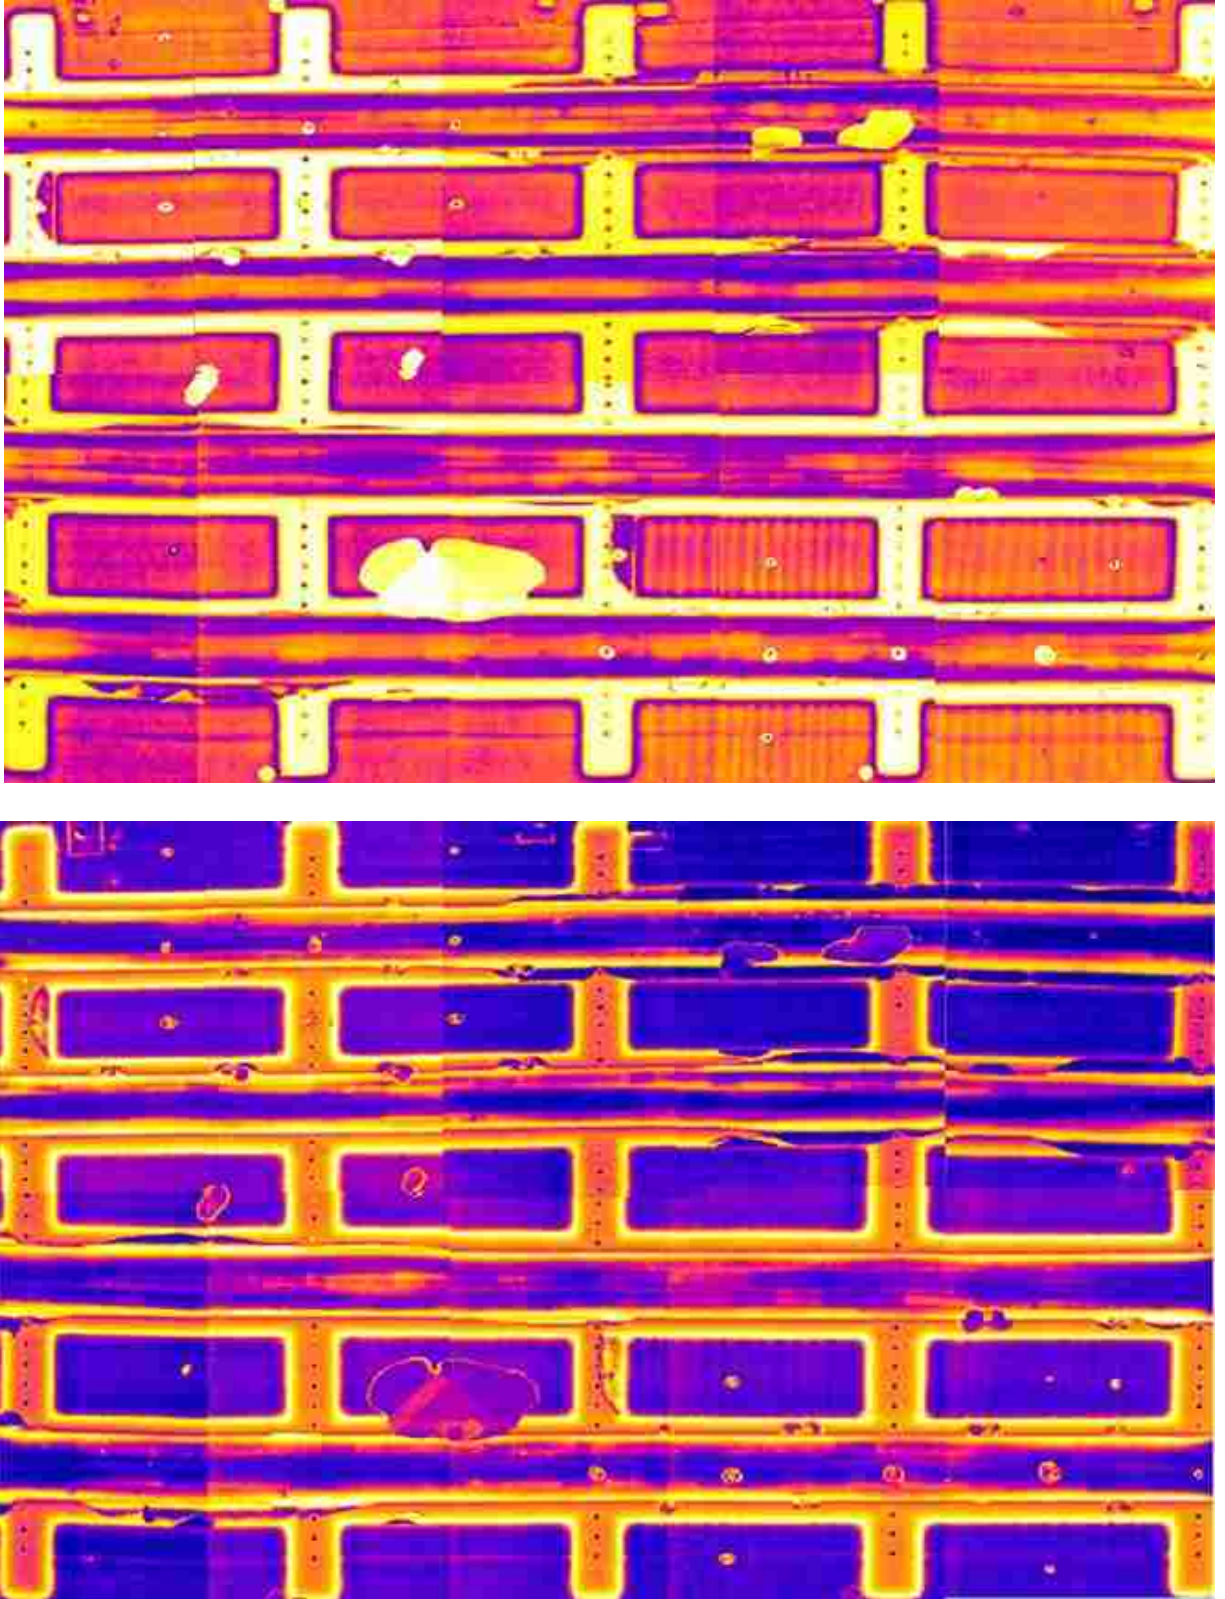
Figure 4-9: Panel A - Resonance Amplitude X plot (top) and Phase Y plot (bottom) C-Scans

Fully assembled resonance scans of panels A and B are shown in Figure 4-9 and Figure 4-10, respectively. There is a slight difference in the color pallet between panel A and B because of the way the resonance inspection technique is zeroed, or nulled. The probe was nulled on a pristine location on each panel, then the inspection was performed. There was a slight difference in the initial null settings between the two panels creating the difference in pallet.

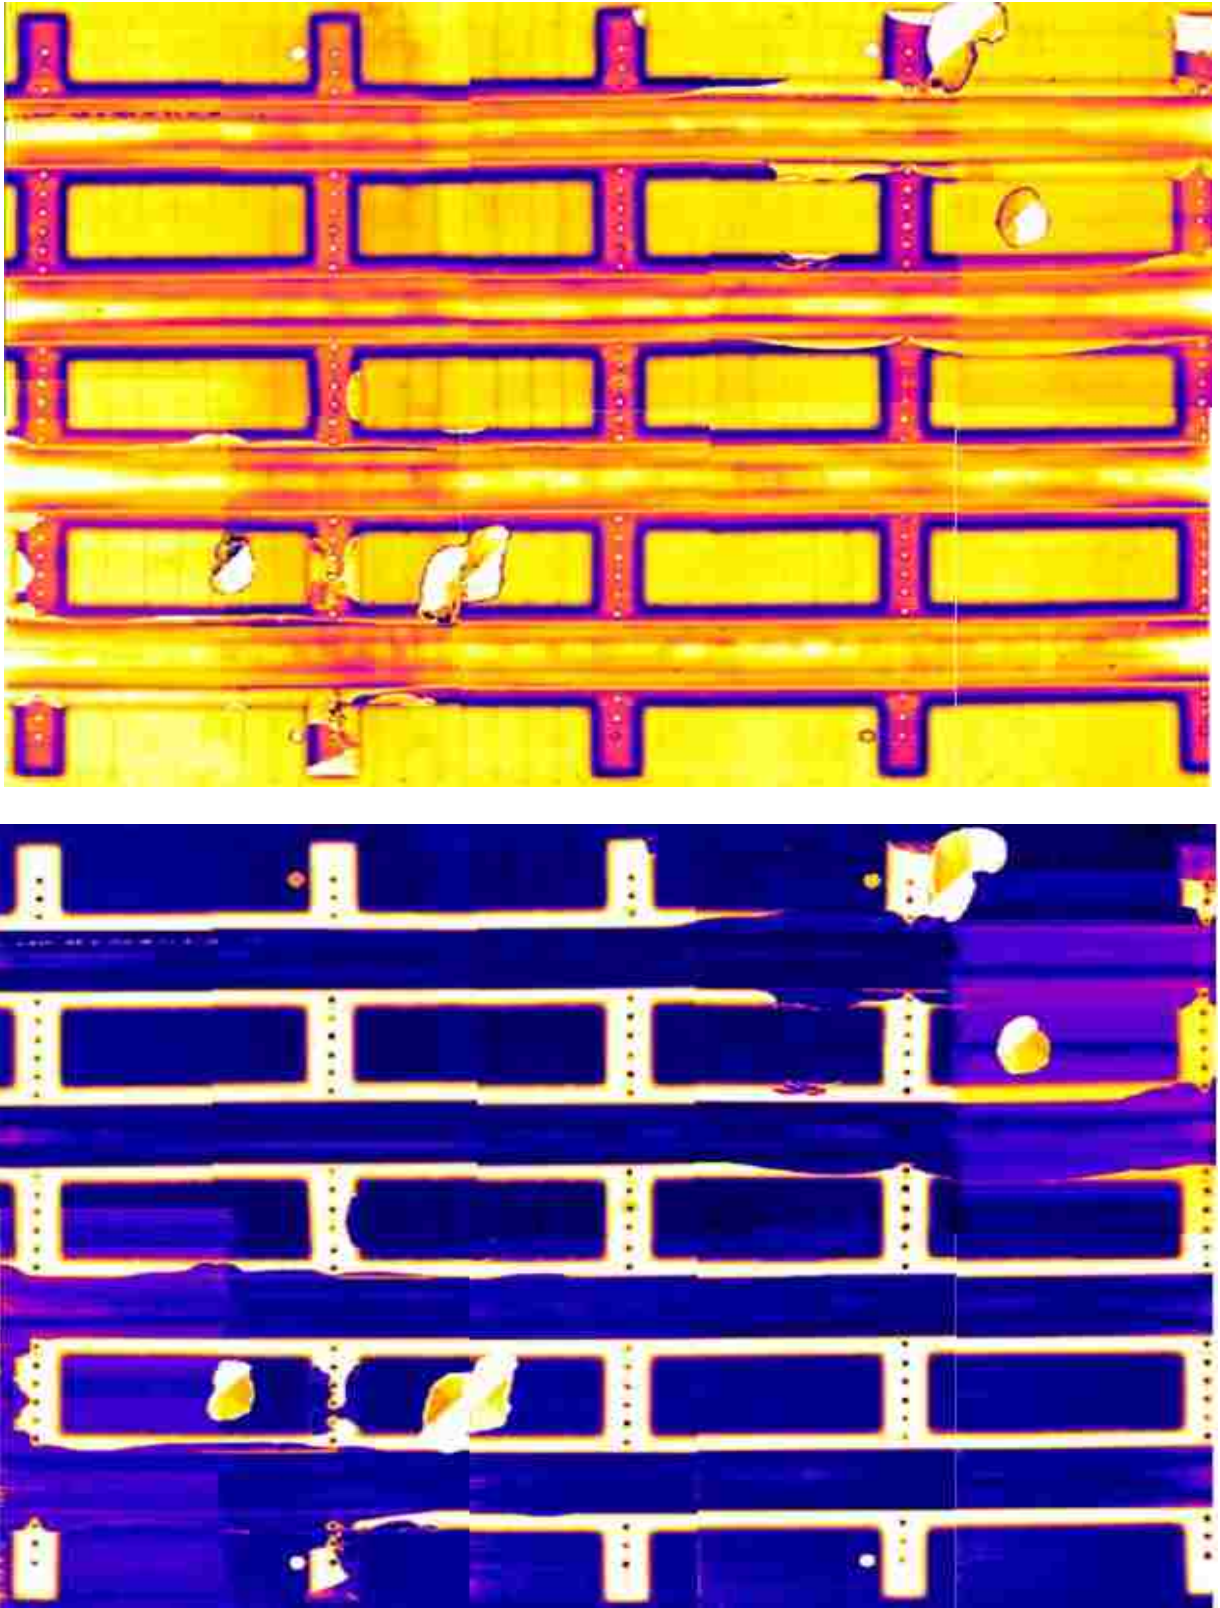
**Figure 4-10: Panel B - Resonance Amplitude X plot (top) and Phase Y plot (bottom)
C-scans**

The clear difference between bonded and disbonded stringer flanges can be seen by comparing the upper right and upper left sides of panel B. The upper left side of the panel was not impact tested and all of the substructure elements are still bonded. By comparison, disbonded stringer flanges can easily be detected on the upper right and lower left sides of the resonance scans in Figure 4-10, as well as interply delaminations in the skin.

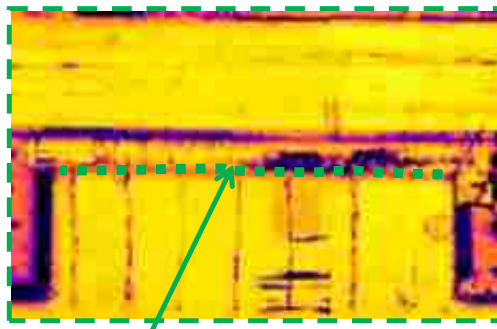
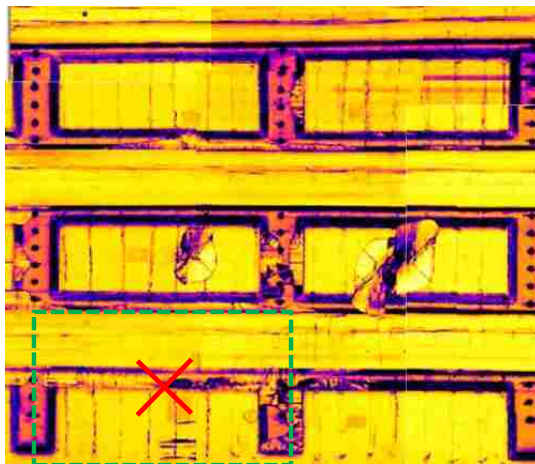
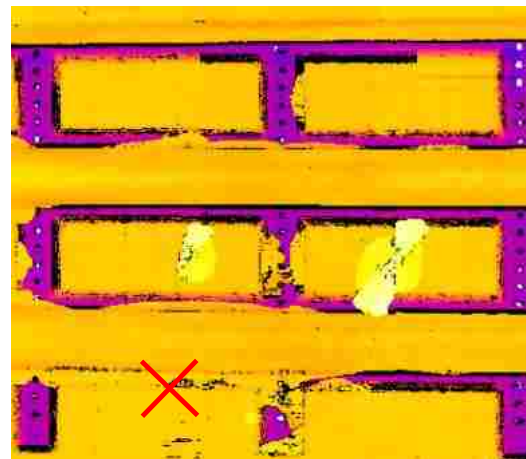
Figure 4-12: Damage Created by Ice Impact at Location 7B (Edge of Stringer Flange) on Panel B

An example of a damage induced by an ice impact at the edge of stringer flange is shown in Figure 4-12. It can be seen in the quadrant view C-scan at the bottom of the figure that the impact was directed mid-way between two shear ties at the edge of a stringer flange. The impact energy of the ice ball was 278.9 Joules and caused the stringer flange to fully disbond. The two shear tie built-up pad sections helped to resist the flange disbonding from continuing farther. Additionally, there was a visible crack at the flange-skin interface along the length of the stringer. This is indicated in the center UT amplitude scan with a green dashed line on the stringer.

Visual Indication: No front side surface visual indication, 17.5” stringer flange crack visible

Damage Area: Interply Delamination 0.0 in², Substructure Disbond 23.16 in²

Type of Damage: Full stringer disbond, no interply delamination detected

Full Stringer Disbond

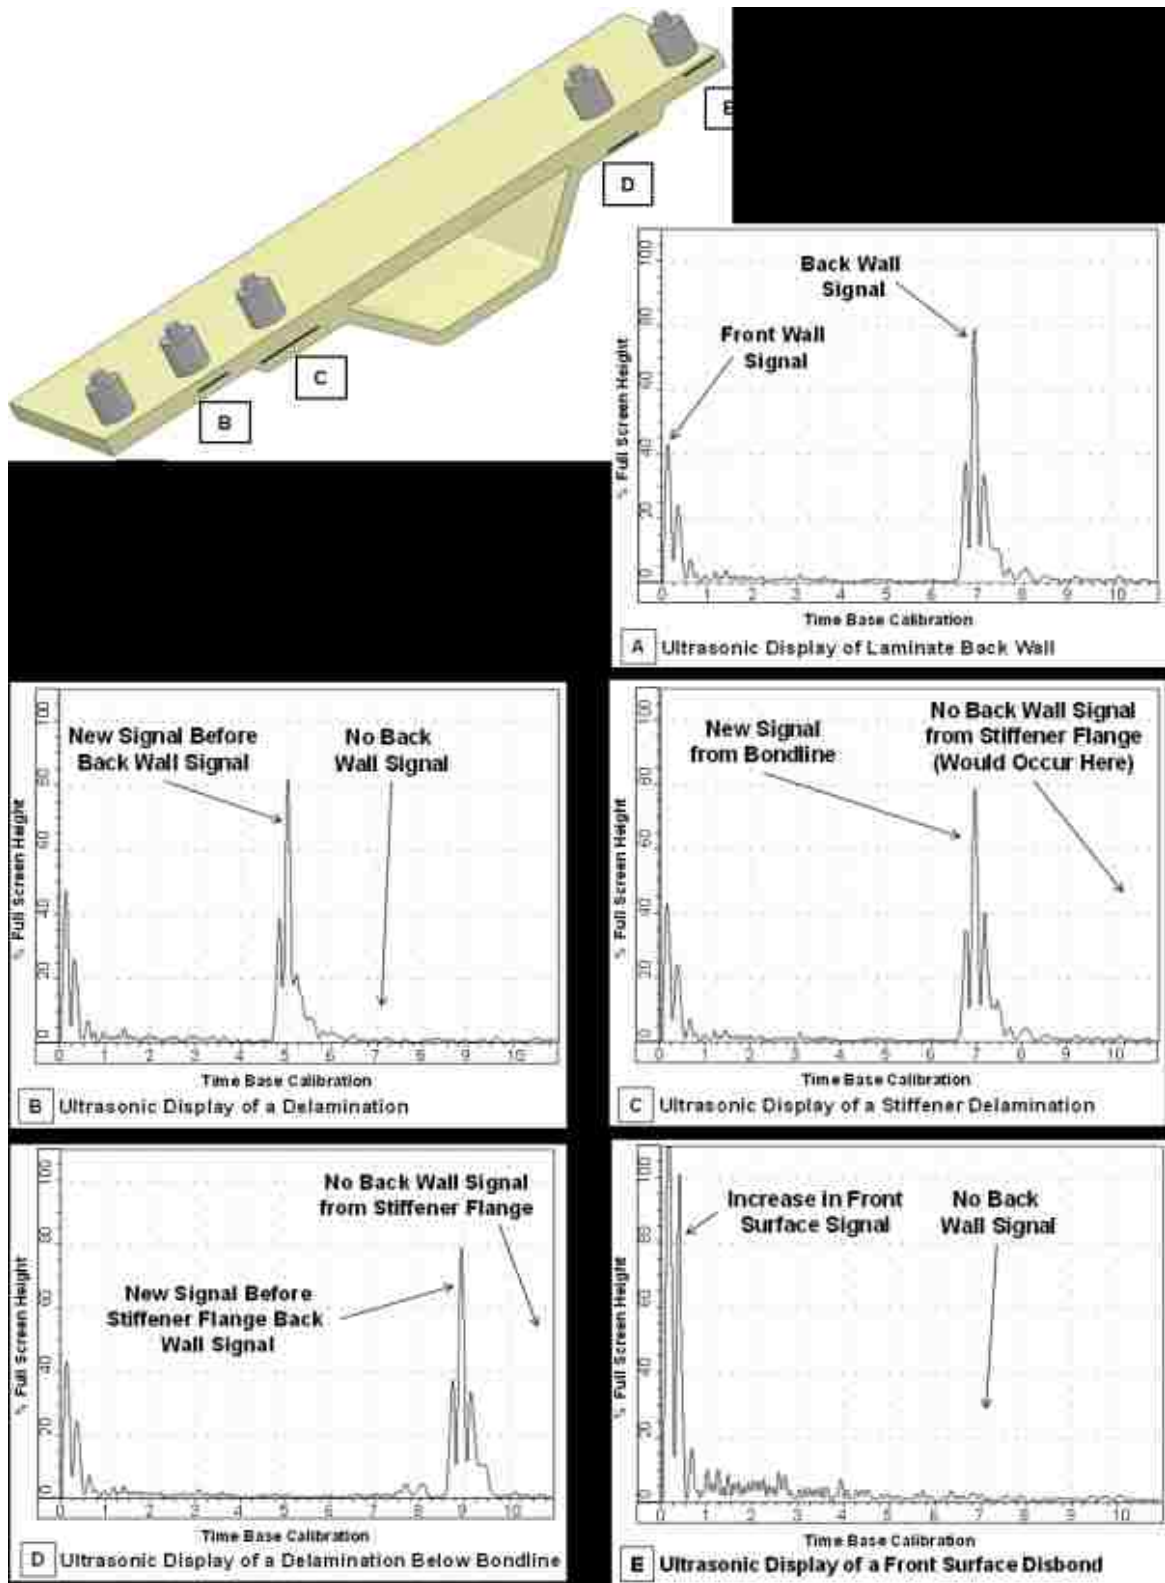
Figure 4-13: Example A-Scan Signals Over Different Structural Elements and Damage

Damage was assessed by interpreting information gathered through the nondestructive inspection techniques on a structural level, not a materials failure level. Example A-scans showing how the return signals change depending on the type and depth of damage are shown in Figure 4-13. A clear back wall signal over the skin laminate is shown in A, an A-scan over a skin interply delamination is shown in B, a co-cured stringer flange disbond is shown in C, an interply delamination in the flange of the stringer is shown in D, and a near surface skin damage is shown in E. A complete loss of back wall signal with no appearance of an intermediate signal was interpreted as near surface fiber fracture or matrix crushing and was typically observed in hard impacts.

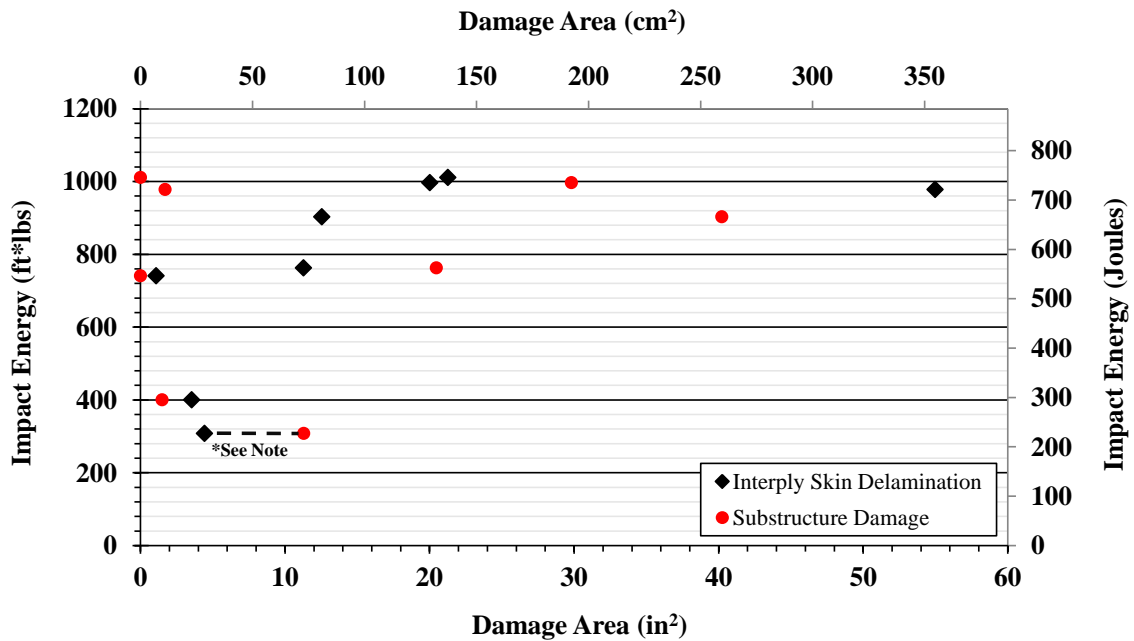
Figure 4-17: Substructure and Skin Delamination Damage Area Created by Simulated Hail, Mid-Day Skin Impacts (Type I1)

Damage created by mid-bay hail skin impacts included both substructure and interply skin delaminations. Figure 4-17 plots the hail impact energy verses the resulting damage size. The calculated damage area associated with each impact can be found in the tables in Appendix A, while the information for each impact and the corresponding inspection images are contained in Appendix B. It can be observed as a general trend that the interply delamination created by mid-bay skin impacts increases with impact energy, but not linearly (black diamonds), and is not a very strong trend. Sometimes mid-bay skin impacts caused stringer flange delamination, but not all the time.

*Interply delamination and substructure damage on same horizontal line were produced by the same impact

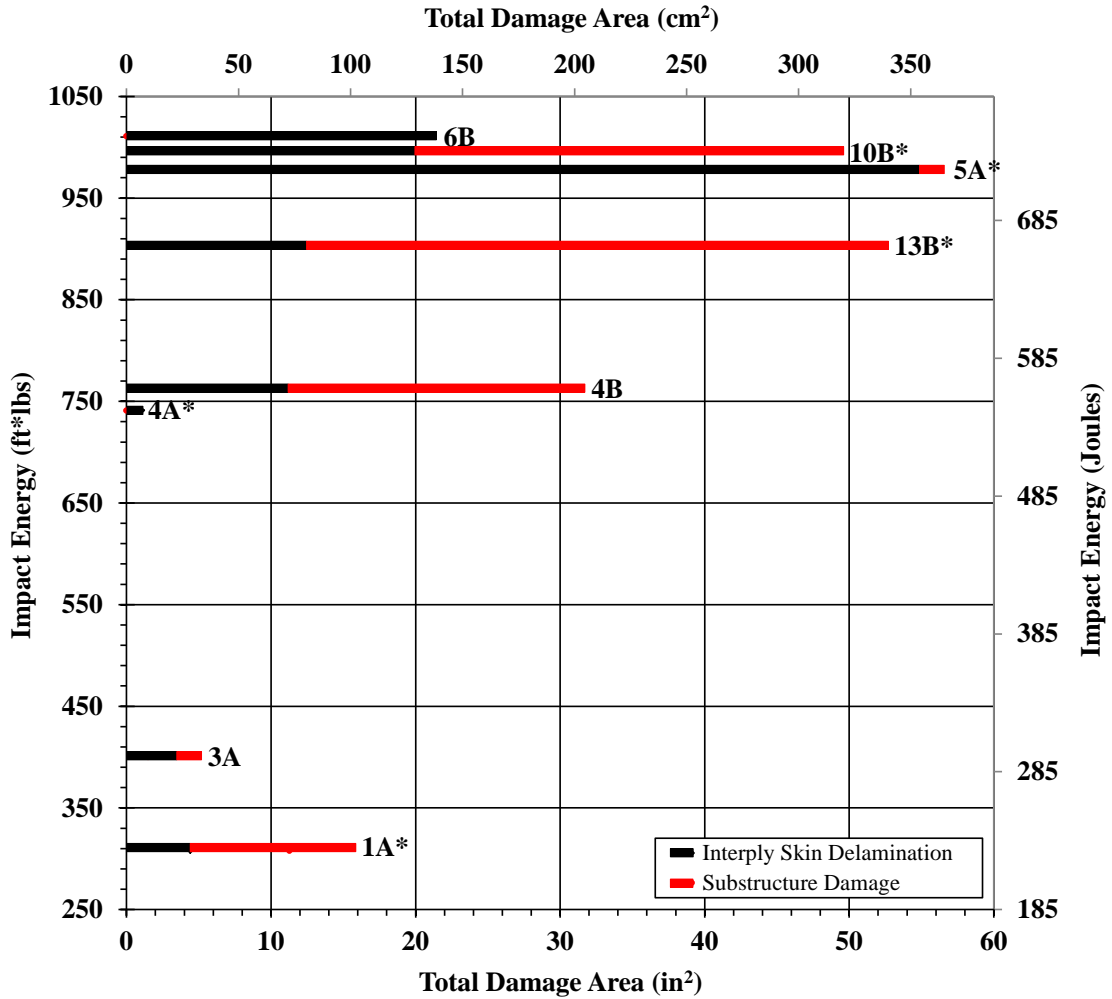
Figure 4-18: Total Damage Area Created by Simulated Hail, Mid-Day Skin Impacts (Type II)

The total damage area, or combination of substructure and interply delamination is charted in Figure 4-18. The black bar in the chart indicates the damage contributed by interply delamination in the skin and the red bar shows the damage contribution from substructure delamination. It can be observed in the chart that it is difficult to determine when substructure disbonding will occur. There is not a set energy threshold that when increased from this threshold substructure delamination will occur.

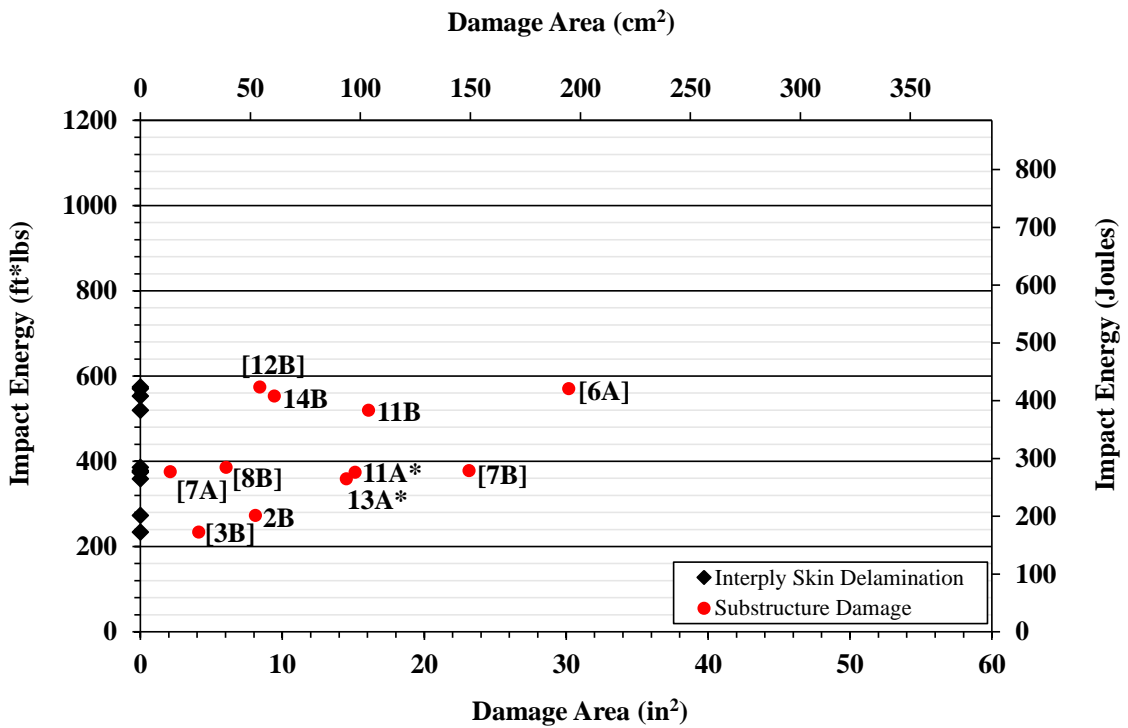
Figure 4-20: Substructure and Skin Delamination Damage Area Created by Simulated Hail, Stringer Flange Impacts

This study investigated impact on both stiffened and unstiffened fuselage structural elements. Impacts conducted at locations over stringer flanges initiated damage at lower levels than impacts over unsupported skin impacts. Figure 4-20 plots the damage area in both substructure and skin elements induced by simulated hail impact over the stringer flange. The plot consists of both 2a and 2b type impacts and was combined for both panels. It was noted that none of the stringer flange impacts caused any type of interply delamination in the 16 ply skin. All of the damage area caused by these impacts was substructure disbonding and typically increased with impact energy. This most likely occurred because of the high peeling stresses that are generated at the edges of the flange when the skin of the panel bends during the impact event. The energy induced into the panel is absorbed through flange delamination and therefore does not lead to interply skin delamination. The total area damage plot for these impacts is not provided because it is the same as the substructure delamination area plot (red dots).

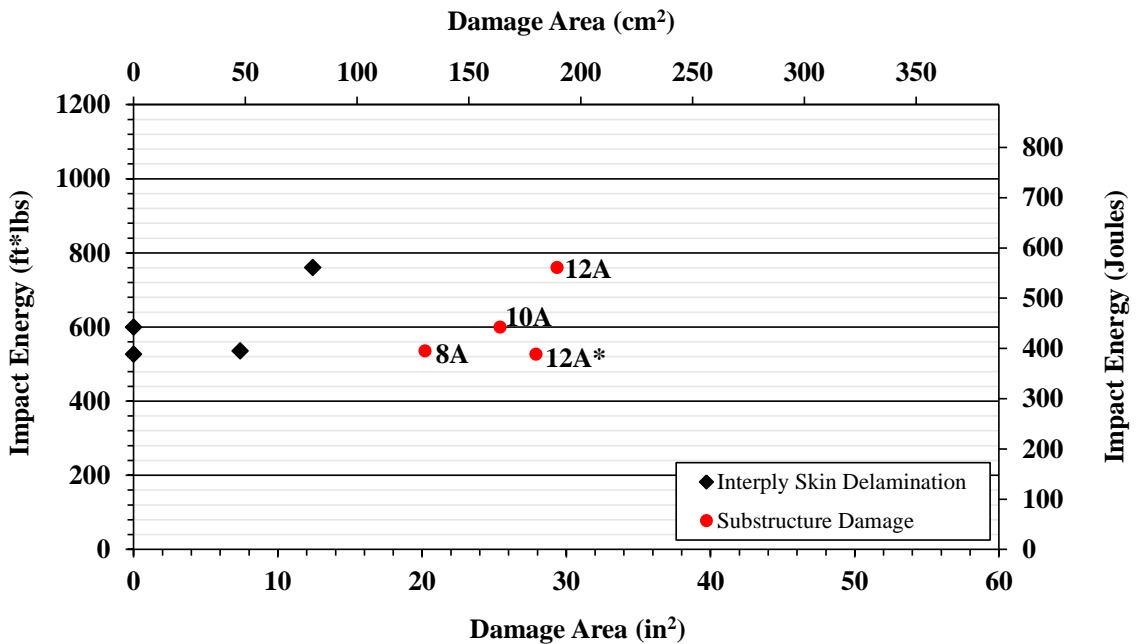
Figure 4-23: Substructure and Skin Delamination Damage Area Created by Simulated Hail, Mid-Stringer Impacts (Type I3)

Damage area induced from mid-stringer hail impacts for both substructure and skin delamination is plotted in Figure 4-23. Similar to mid-bay skin impacts, two of the four mid-stringer impacts generated both interply delamination and stringer flange delamination. To initiate damage at the mid-stringer location, more impact energy was needed than the energy level that produced damage for a mid-bay impact and direct stringer flange impact.

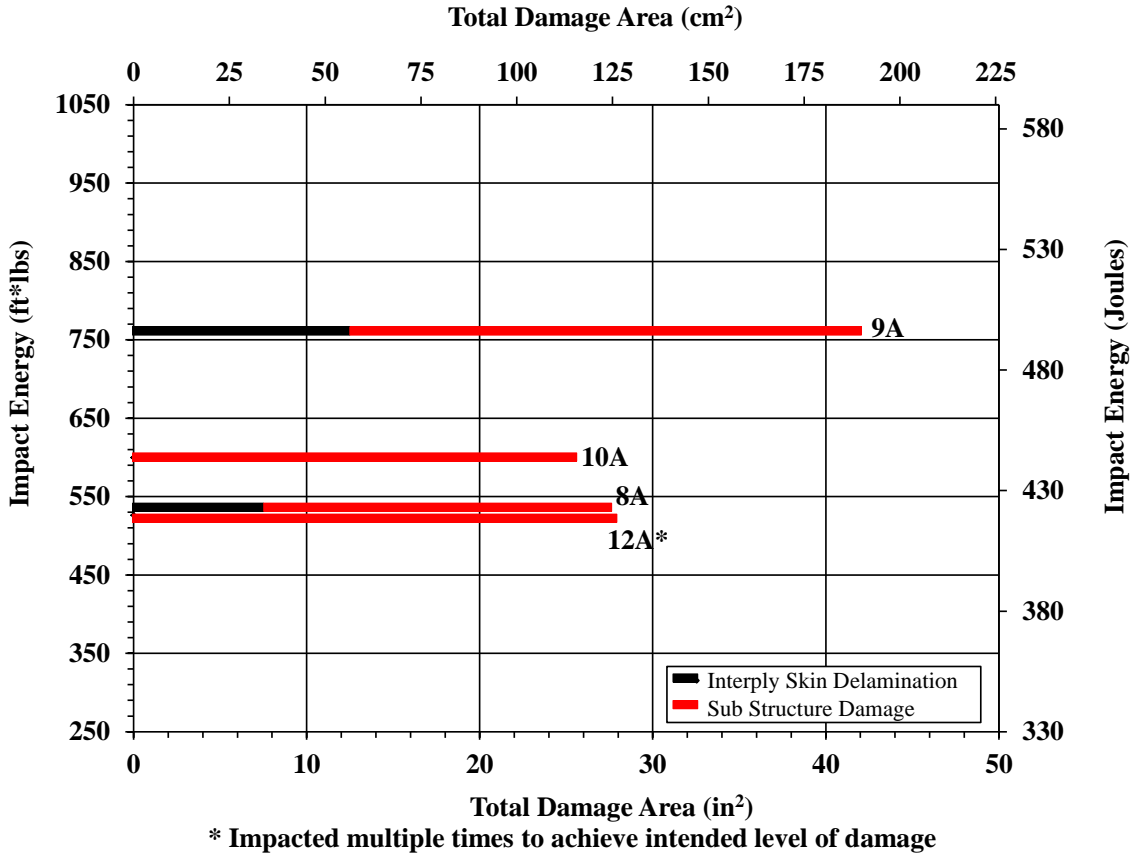
Figure 4-24: Total Damage Area Created by Simulated Hail, Mid-Stringer Impacts (Type I3)

The total damage generated by mid-stringer impacts is shown in Figure 4-24. Although interply skin delamination did occur in two of these impacts, a majority of the damage was caused at the skin to flange substructure interface. Because impacts 8A, 9A and 10A were conducted on the same stringer, the first damage-inducing impact may have had an effect on subsequent, nearby impacts.

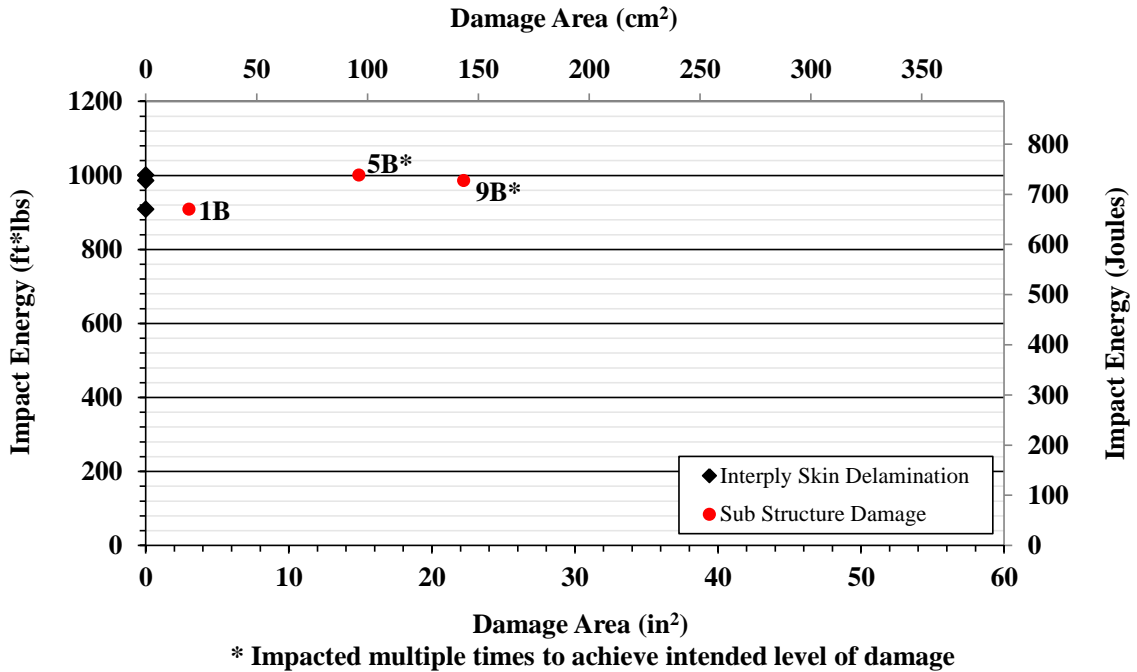
Figure 4-26: Substructure and Skin Delamination Damage Area Created by Simulated Hail, Shear Tie Impacts (Type I4)

Damage induced by hail impacts directly on the shear ties consisted mainly of substructure damage or delaminations in the built-up pad sections. Figure 4-26 shows that there were no interply skin delaminations associated with direct shear tie impacts. Visual inspections revealed that all three of these impacts cracked the shear tie located beneath the impact location (see Figure 4-16). All three of the shear tie impacts also produced visually detectable indication of damage on the outer surface. These visual

indications were either paint scuffing, paint chipping, or cracking in the paint around the fasteners. Additional details regarding the cracked shear ties and visual indications are provided in Appendix B.

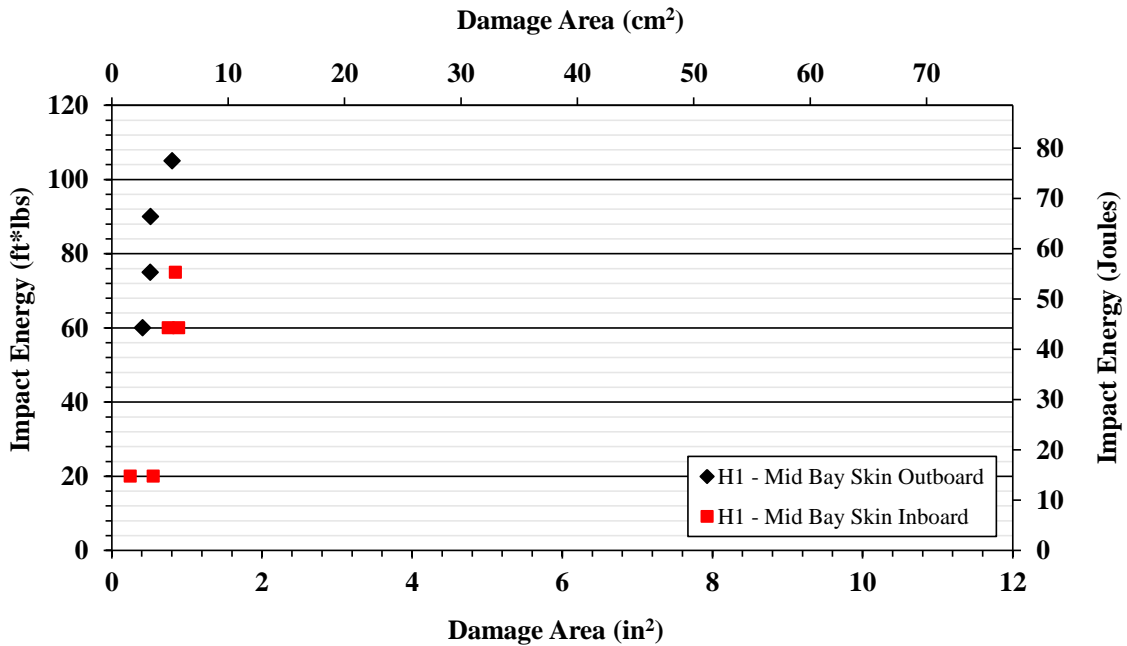
Figure 4-28: Damage Area Created by 2” Diameter Spherical Tip Mid-Bay Skin Impacts (Type H1)

Damage created by mid-bay skin impacts with the 2” diameter spherical tip included near surface fiber crushing and some interply skin delamination. Damage area verses impact energy for these impacts is shown in Figure 4-28. About half of the impacts were conducted on skins that were stiffened by a single stringer on one side (outboard impacts). This resulted in decreased stiffness of the overall outboard skin and damage from impacts in these regions created less damage than mid-bay skin impacts, inboard of stringers two and four. This phenomena is shown in the Figure 4-28 plots and can be attributed to slightly different boundary conditions between the impacts.

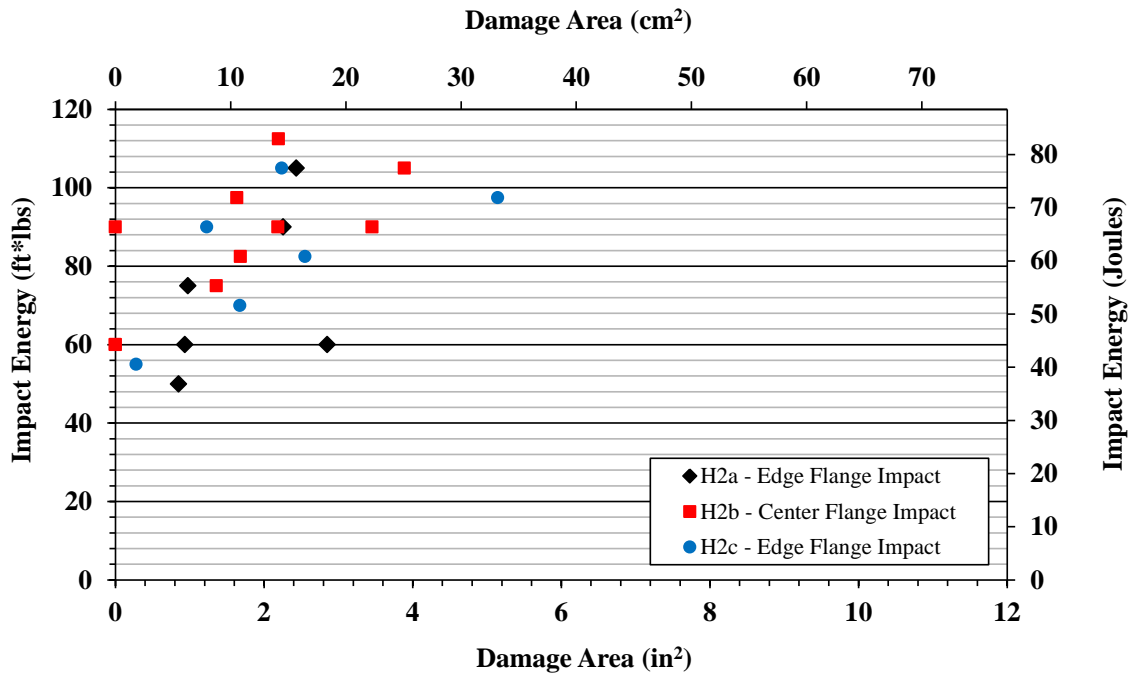
Figure 4-29: Damage Area Created by 2” Diameter Spherical Tip Stringer Flange Impacts (Type H2)

Damage area produced by the 2” diameter, hard spherical impact tip at the three different stringer flange impact locations are shown in Figure 4-29. As discussed before, the plot is not divided into substructure damage and skin delamination damage because unlike hail impact damage, it was not possible to determine the amount of damage in the skin and the substructure separately. Instead, the plot displays the damage area as it relates to each stringer flange impact location (2a, 2b and 2c). In general, damage area increases with impact energy. Two obvious deviations from this are the two, 2b impacts (red squares) that produced zero damage. This may not actually be the case. These two impacts created very small visual dents, but in the C-scan images used to determine damage area did not indicate any damage. This may have been due to a masking effect caused by the stringer flange, hiding the very small level of damage.

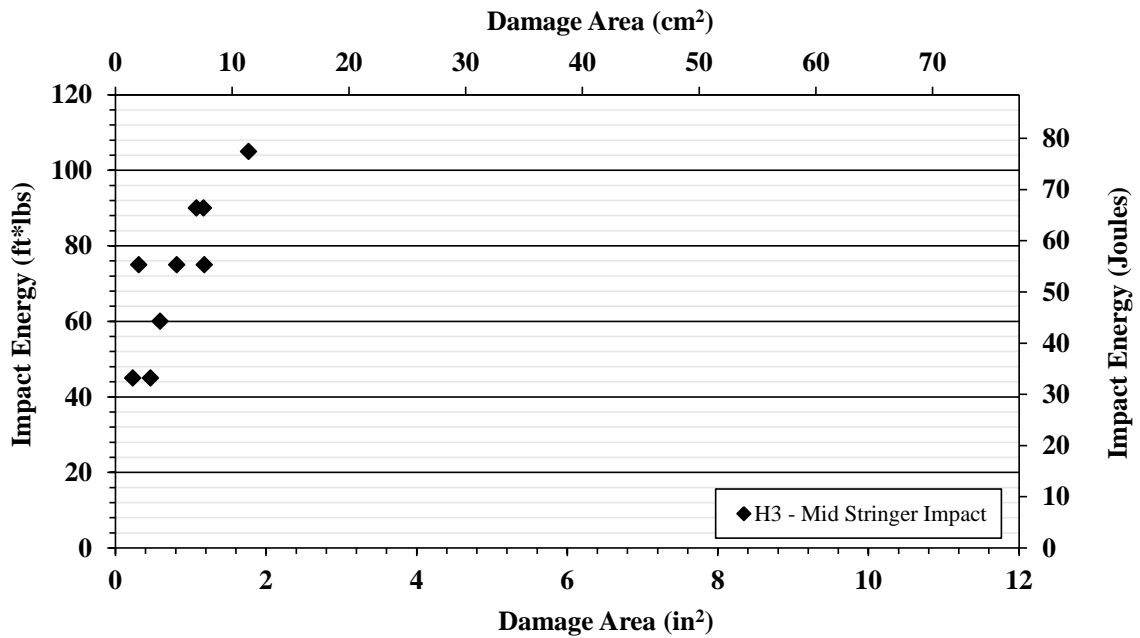
Figure 4-30: Damage area Created by 2” Diameter Spherical Tip Mid-Stringer Impacts (Type H3)

Figure 4-30 plots the mid-stringer impact (between stringer flanges – H3) damage area versus impact energy. These impacts created near surface fiber crushing and some interply delaminations in the skin. No substructure disbonds were observed as a result of these impacts. This particular impact location had the most consistent boundary conditions and therefore resulted in the best trending data.

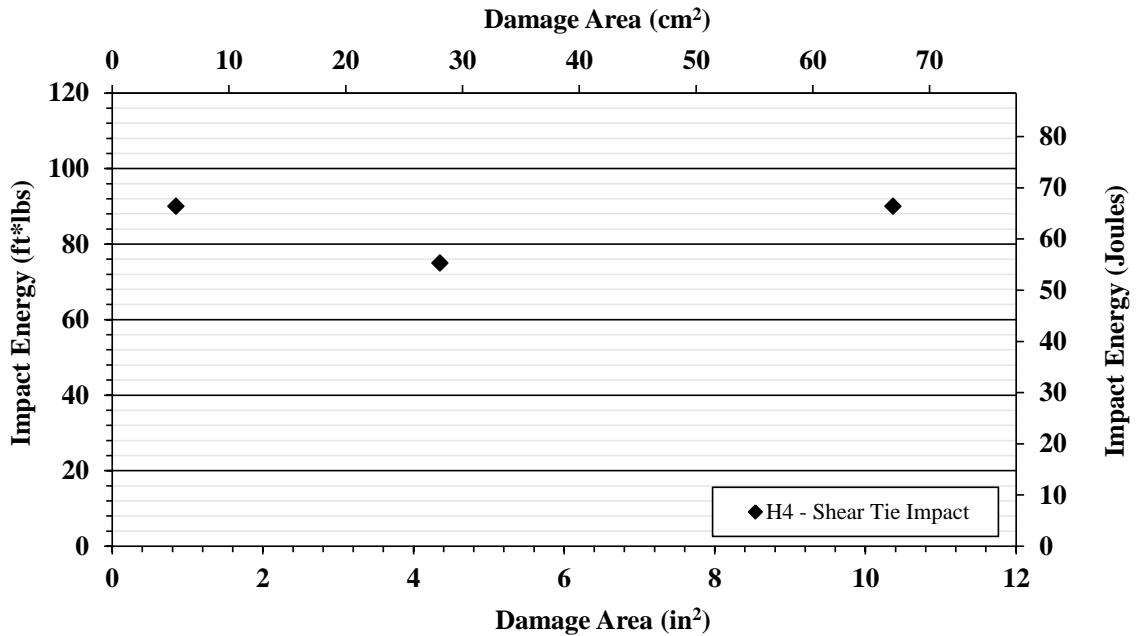
Figure 4-31: Damage Area Created by 2” Diameter Spherical Tip Shear Tie Impacts (Type H4)

Damage area from the three shear tie impact tests (H4) are displayed in Figure 4-31. The two impacts that created approximately 4 in² and 10 in² of damage were located at the edge of the shear tie. The high shear stresses developed during the impact caused the tapered built-up section to delaminate from the skin. The inspection results from the shear tie edge impacts and shear tie center impact clearly show the difference in damage level (see impacts 8, 19, and 23 in Appendix C).

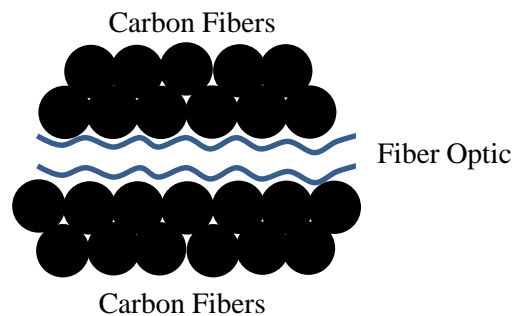
Figure 4-33: Micro Bending of Embedded Fiber Optic Causing Light Attenuation

An initial interrogation of the embedded fiber revealed that there was significant light attenuation within the fiber and that light could not be transmitted through the length of the fiber. The majority of the fiber optic was run in the 90 degree fiber direction and the fiber toes on either side of the embedded fiber were run at -45 degrees and 0 degrees. When the panel was cured under high pressure in the autoclave, the carbon fibers were pressed tightly inducing micro bending along the length of the fiber. Micro bending of the fiber optic is illustrated in Figure 4-33. The initial intention in selecting a fiber for this application was to select a fiber with a high numerical aperture. Fibers with a high numerical aperture are less susceptible to light attenuation due to micro bending. The particular fiber used may not have had as high of a numerical aperture as intended.

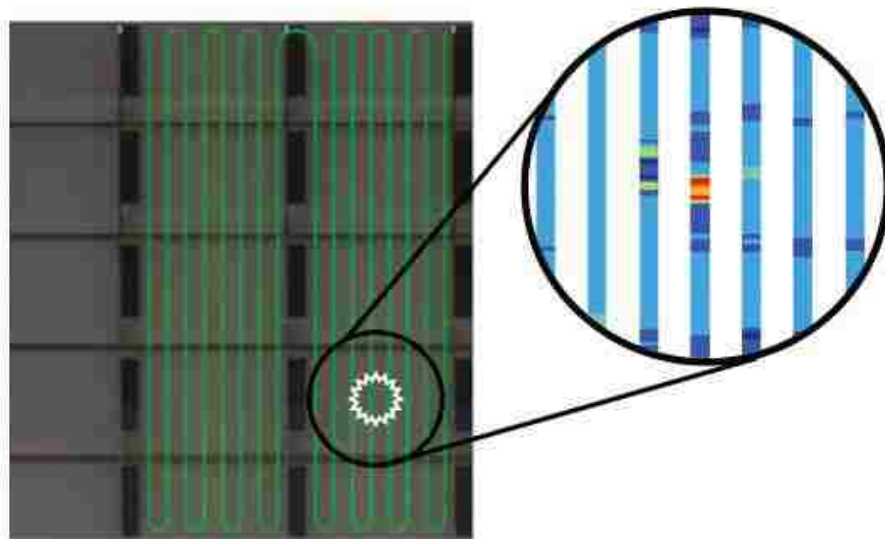
Figure 4-34: Strain Map of First Impact Damage Performed on Panel A, Only Result Obtained From Embedded Fiber Optic

the fiber could be interrogated for approximately the first 5 vertical runs of fiber, but was only successful for the first impact test Figure 4-34. A major factor contributing to the lack of data obtained from the embedded fiber optic was the use of high power flash lamps during the impact tests. The lamps were used to illuminate the area for the high speed cameras to capture video during each impact. This had an inverse effect on the detection ability of the fiber optic strain sensing system because the flash lamps increase the surface temperature of the panel. Baseline measurements were taken prior to impact and were obtained at ambient temperature with the flash lamps off. When the data was later interpreted it was clear that the heat from the lamps induced global strain changes in the panel and swamped out any indication of impact damage. A color strain map result from the first impact test conducted on panel A is shown in Figure 4-34.
