Detection and characterization of impact damage in carbon fiber aircraft fuselage structure

**DETECTION AND CHARACTERIZATION OF IMPACT
DAMAGE IN CARBON FIBER AIRCRAFT FUSELAGE
STRUCTURE**

THESIS

**Master of Science
Civil Engineering**

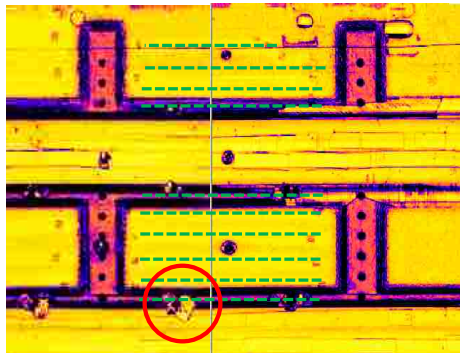
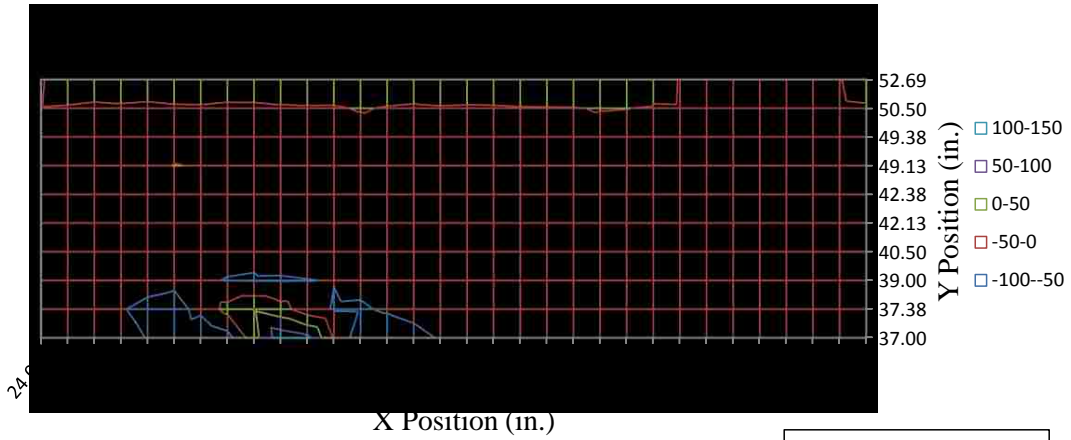
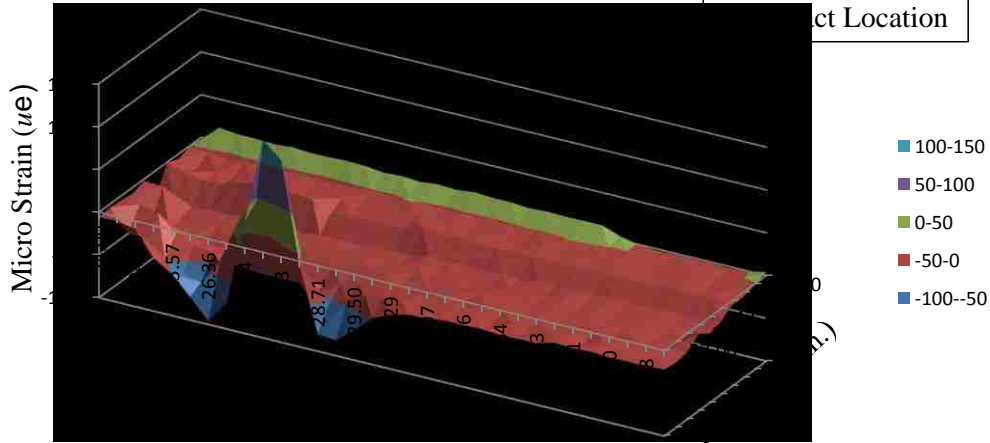
Figure 4-39: Example Fiber Optic Strain Map of Stringer Flange Impact

A sample result constructed using the fiber orientation in bay 2 is shown in Figure 4-39. This particular impact was successfully detected using the bonded fiber optic. A noticeable strain indication of around 120 micro strain is shown in the 3D strain map at the bottom of the figure. It can also be seen in the 3D strain plot that there is a noticeable compressive strain on either side of the impact location, with a positive strain at the center of the impact. This is typical of a dent where the center of the impact corresponds to the peak positive strain of the dent and the compressive strains on either side correspond to the base (reverse bending) of the dent. The full set of strain map results for this fiber orientation and the vertical fiber orientations used in the hard tip spherical impact tests is contained in Appendix C.

Center of Stringer Flange
Impact Energy: 90 Ft lbs
Damage Area: 3.46 in²
Type of Damage: Interply delamination
Strain Indication: Yes, clear detectable strain indication

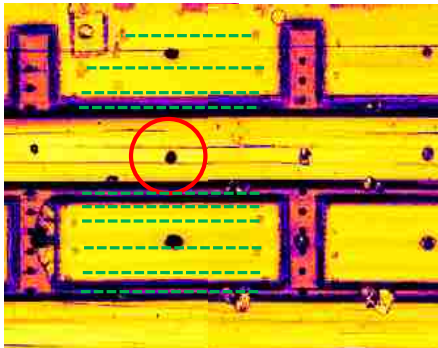
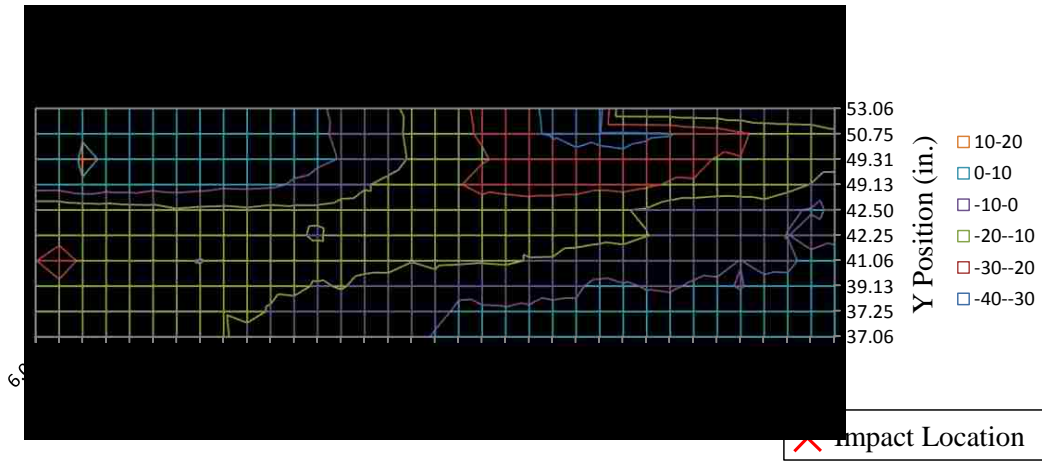
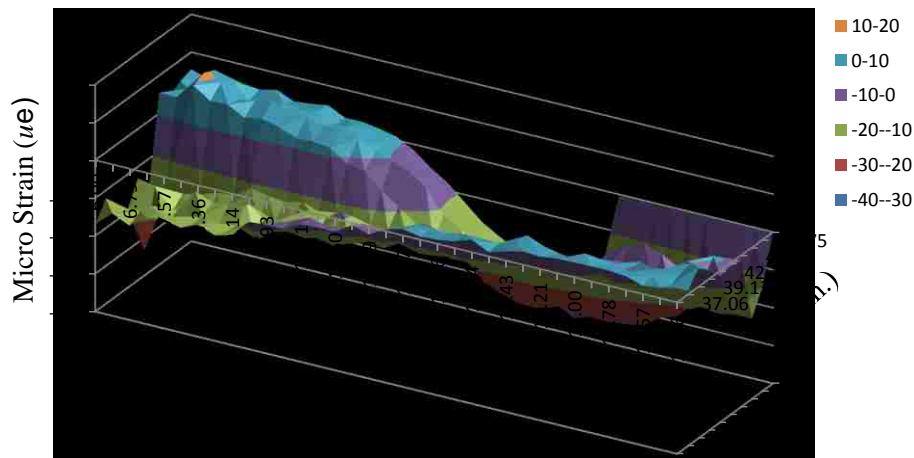
Figure 4-40: Impact at Mid-Stringer Between Flanges that was Not Detectable with the Fiber Optic

Global changes in the strain field were occasionally noticed in some of the post impact strain plots. This may have been attributed to shifts in temperature between the initial baseline measurement and the post impact measurement, or movement of the panel during testing. Typically these were observed in tests where there was not a detectable strain indication of damage and the maximum strain over the length of the fiber was relatively low. An example of a non-detectable impact damage and the resulting strain field measurements is shown in Figure 4-40. This impact was conducted on the skin between the stringer flanges. It can be seen in the impact schematic in the top right of the figure that significant deformation at the impact site including stringer flange disbonding would have to occur in order for the FO to detect the strain change from this impact. It can also be seen in the ultrasonic amplitude C-scan at the top left side of the figure that there was very little damage induced by the impact (0.47 in² of near surface fiber crushing).

Mid-Stringer Between Flanges
Impact Energy: 45 Ft lbs
Damage Area: 0.47 in²
Type of Damage: Near surface fiber crushing
Strain Indication: No, possible temperature shift or change in panel loading

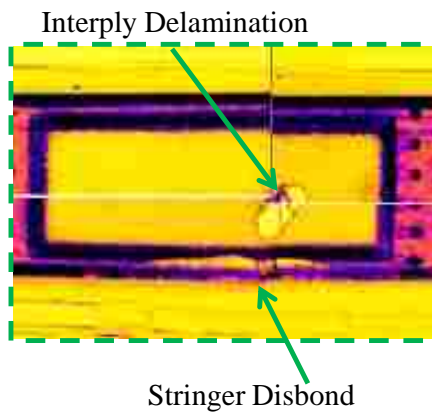
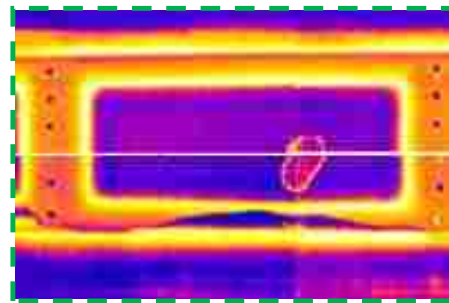
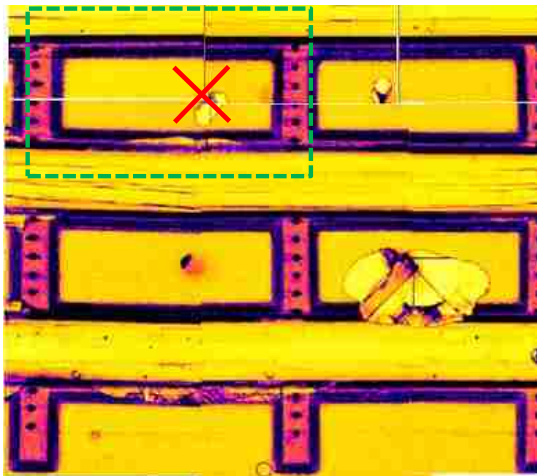
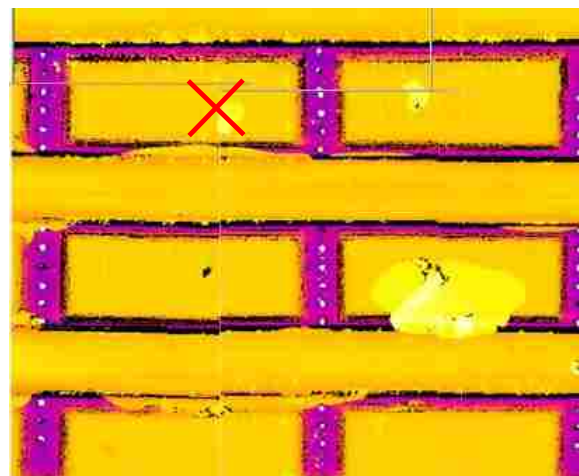
Damage Area: I.D. 4.43, S.D 11.29 in²

Type of Damage: Interply delamination, stringer flange disbonding

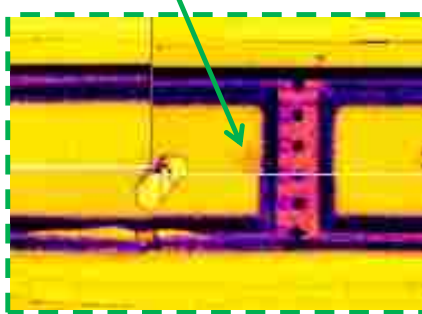
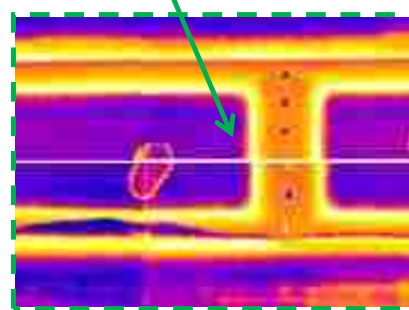
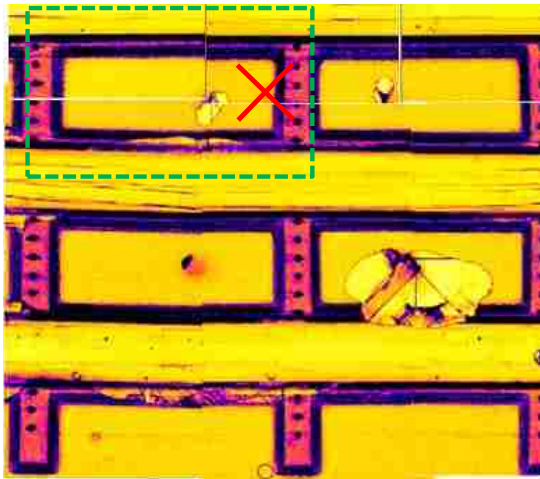
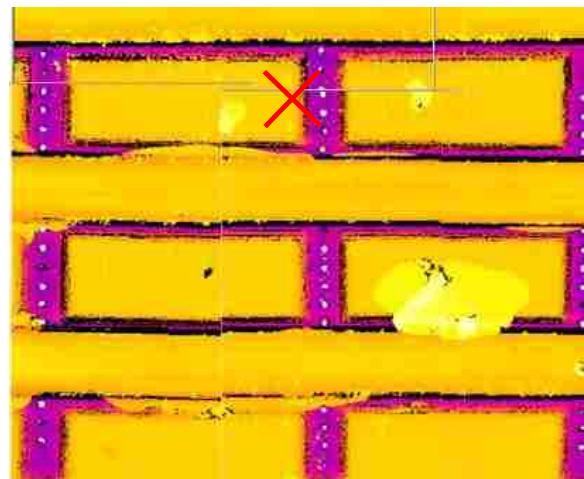
Damage Area: None

Type of Damage: Slight loss in amplitude could indicate micro cracking in matrix at impact location

Slight Increase in Attenuation
(not noticeable in TOF)

No Indication

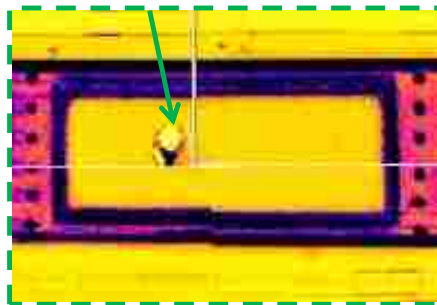
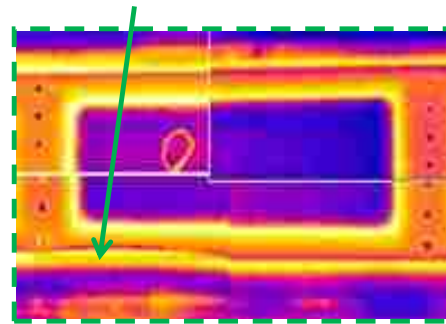
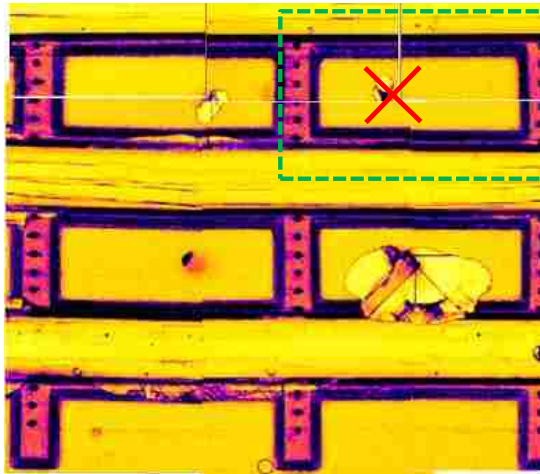
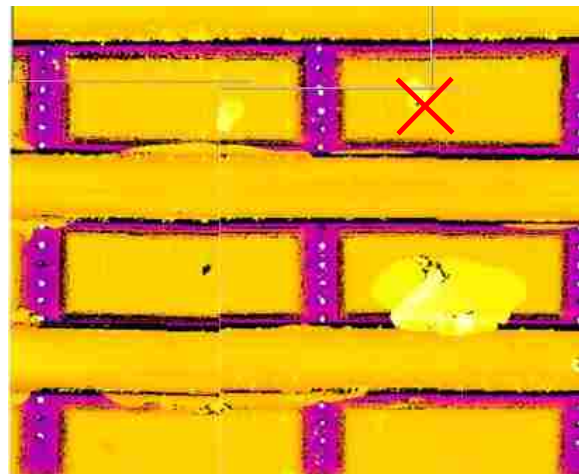
Damage Area: I.D. 3.55, S.D 1.50 in²

Type of Damage: Interply delamination and stringer disbond. Stringer disbond was not detected in UT amplitude, but was in TOF and resonance.

Interply Delamination

Stringer Disbond

Stringer Delamination not detected in amplitude

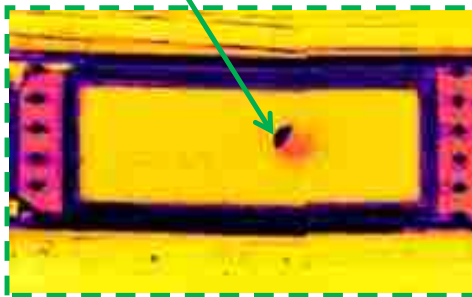
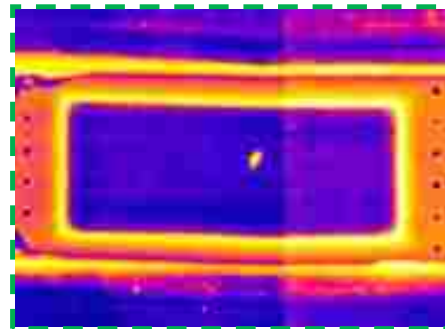
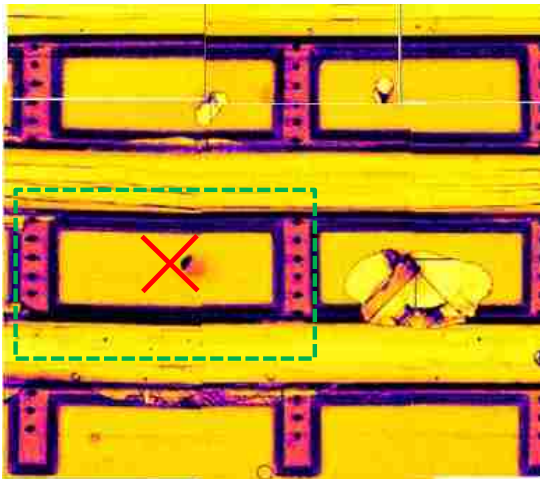
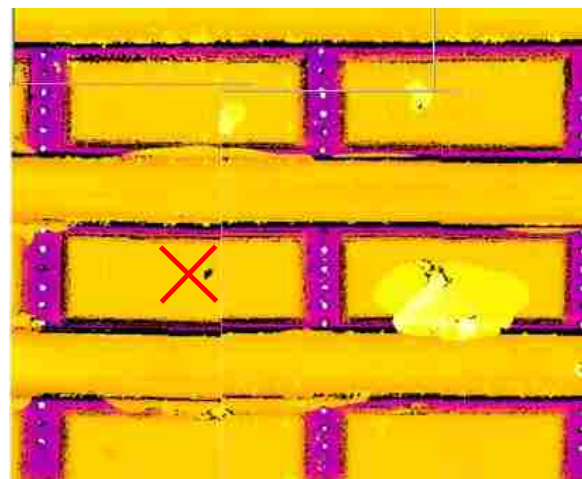
Damage Area: I.D. 1.09, S.D. 0.0 in²

Type of Damage: Near surface fiber crushing, small interply delamination

Small Interply Delamination

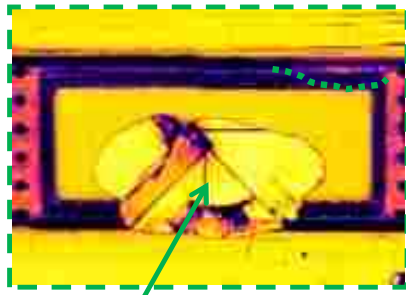
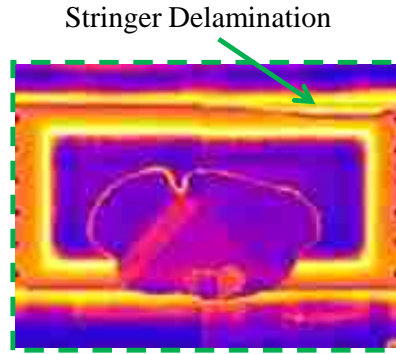
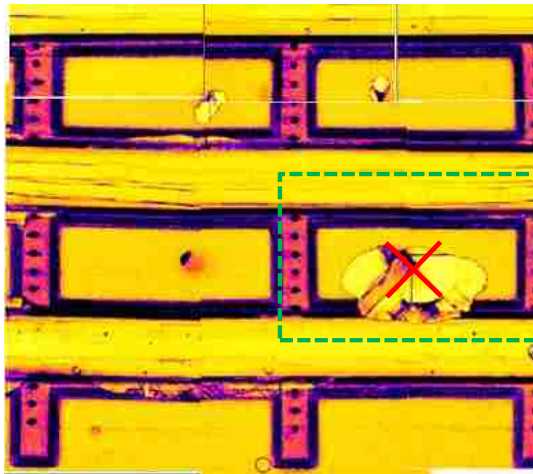
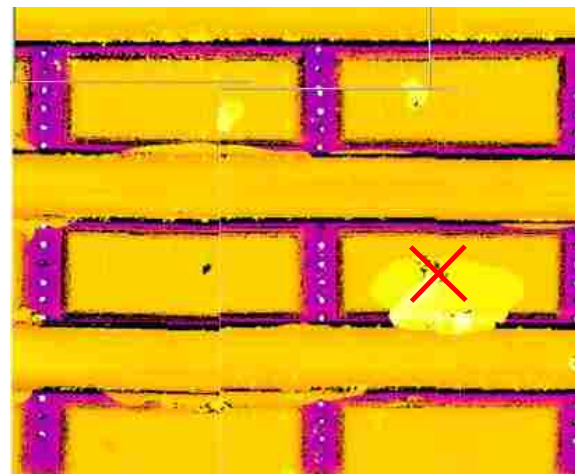
Visual Indication: No front side visible indication, small 2” stringer flange crack detectable on backside

Damage Area: Interply Delamination 54.97 in², Stringer Disbond 1.70 in²

Type of Damage: Mostly interply delamination, small stringer disbond to the upper right of the impact area not detected in amplitude scan

Interply Delamination

Stringer Delamination

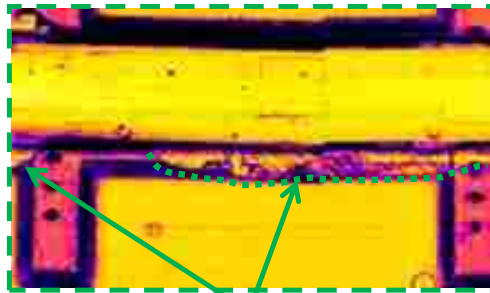
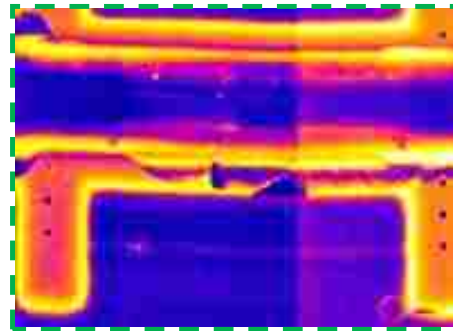
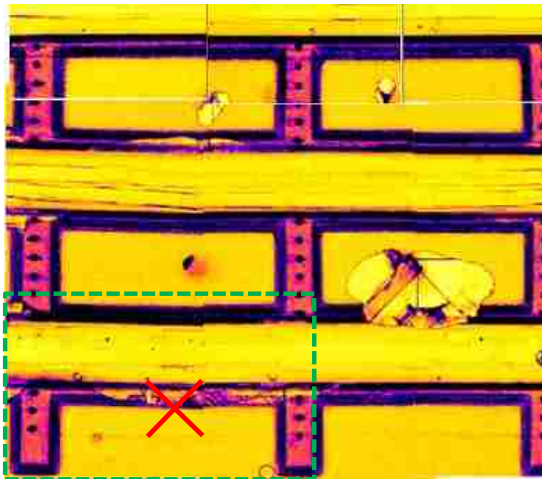
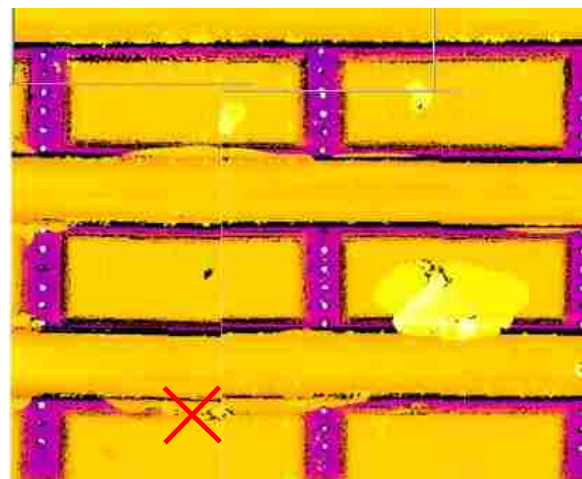
Visual Indication: No front side visible indication, large, 11" long crack visually detectable on back side of stringer at impact location

Damage Area: I.D. 0.0, S.D 30.18 in²

Type of Damage: Cracked through tapered flange at point of impact, un-zipped (disbonded) stringer flange from shear tie to shear tie

Stringer Disbond

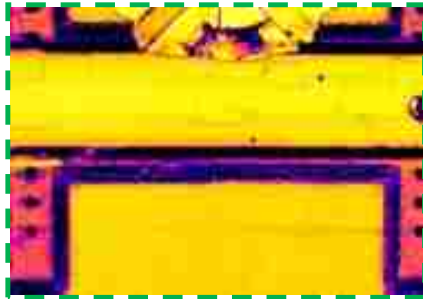
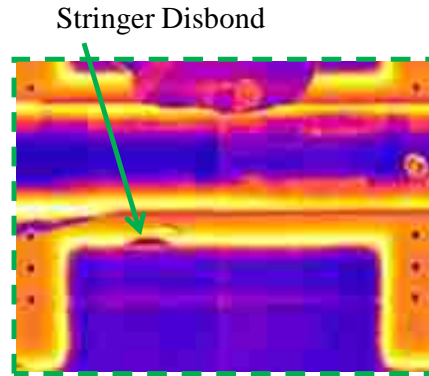
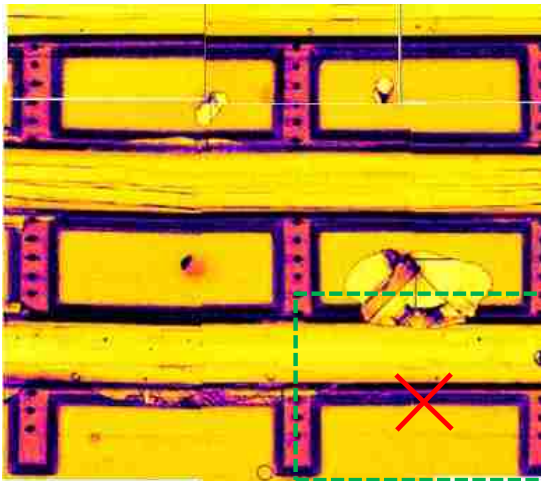
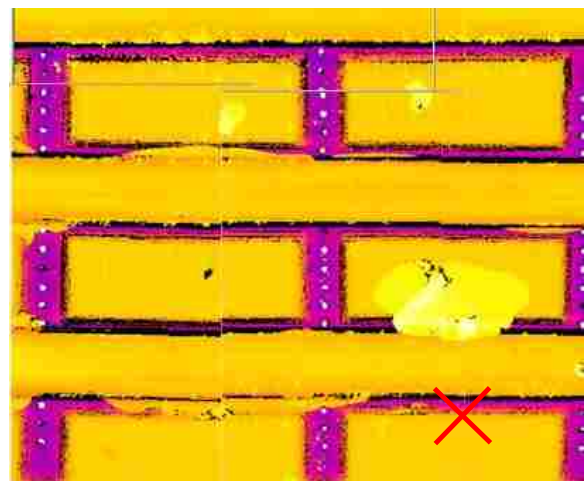
Damage Area: I.D. 0.0, S.D. 2.10 in²

Type of Damage: Small stringer disbond detected in resonance and TOF, but not amplitude

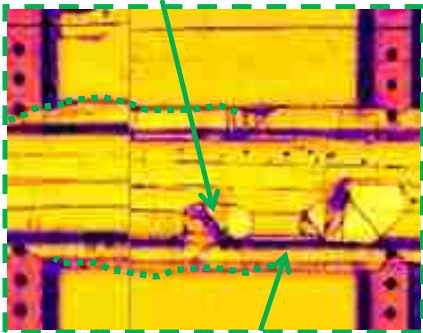
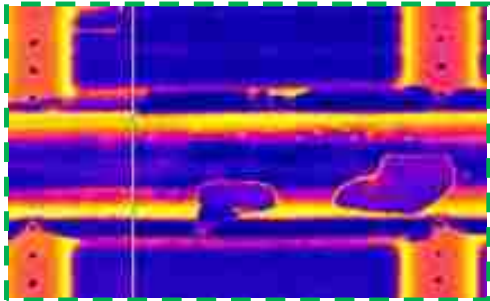
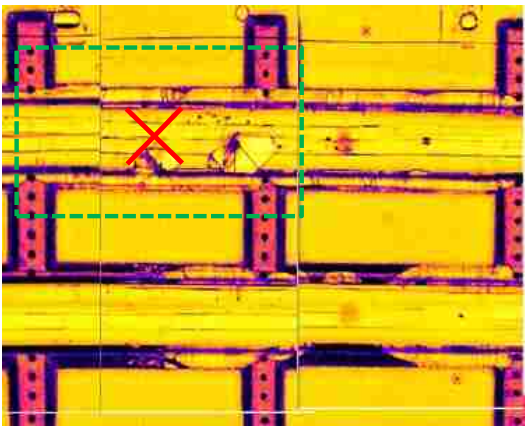
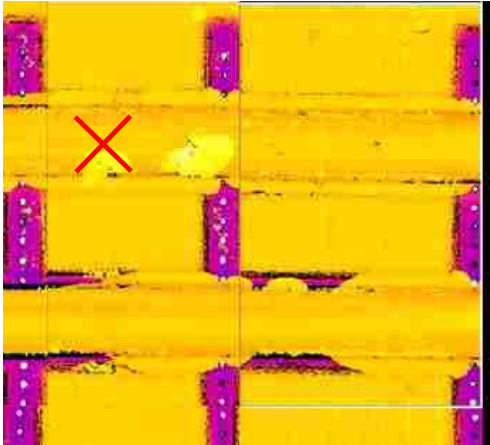
Center of Stringer Between Flanges
Max Impact Energy: 535.4 ft lbs, 394.9 Joules
Max Impact Velocity: 286.7 ft/s, 87.4 m/s
Visual Indication: No front side surface visual indication, 10.5” stringer delamination detectable on top stringer flange, full length bottom stringer flange delamination detectable
Damage Area: I.D. 7.39, S.D. 20.21 in²
Type of Damage: Full stringer disbond on both flanges, interply delamination at impact location

Interply Delamination

Full Stringer Disbonds

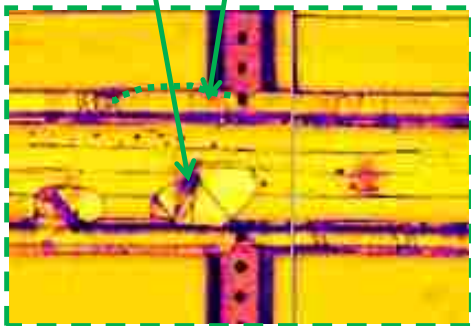
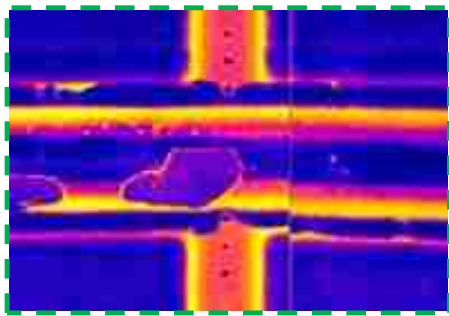
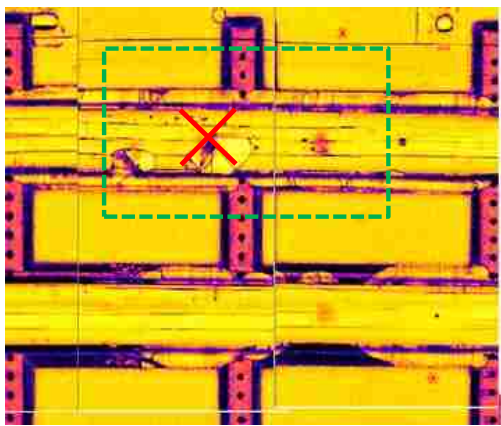
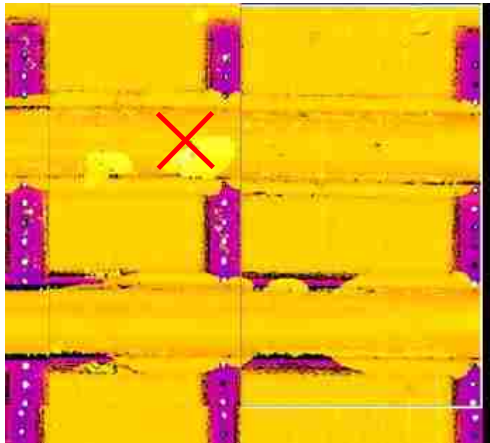
Damage Area: I.D. 12.42, S.D. 29.37 in²

Type of Damage: Disbonded stringers on both sides of impact, interply delamination

Interply Delamination

Stringer Disbonds

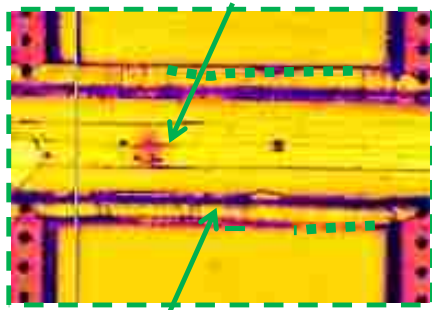
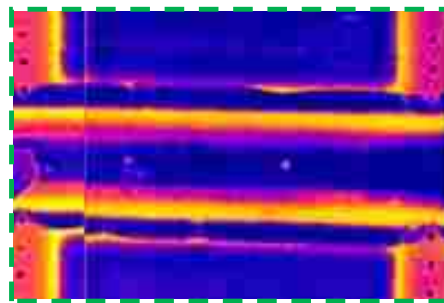
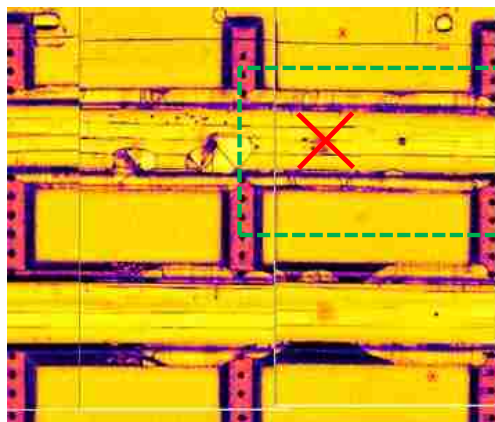
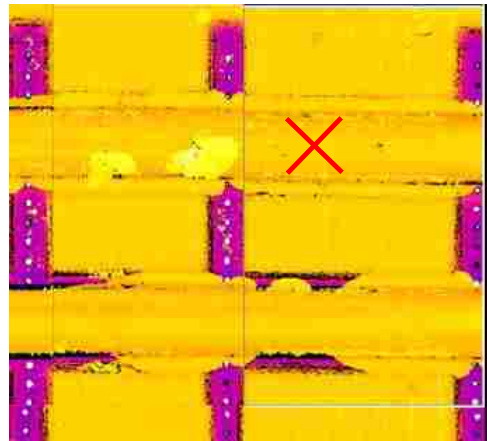
Visual Indication: No front side surface visual indication, 9" stringer delamination detectable on top stringer flange, two small visual cracks in the bottom stringer flange (1" and 4")

Damage Area: I.D 0.0, 25.41 S.D. in²

Type of Damage: Stringer disbonds, micro cracking in matrix at impact location detected as drop in amplitude

Decrease in Amplitude

Full Stringer Flange Disbondss

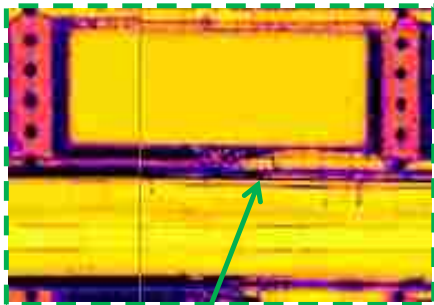
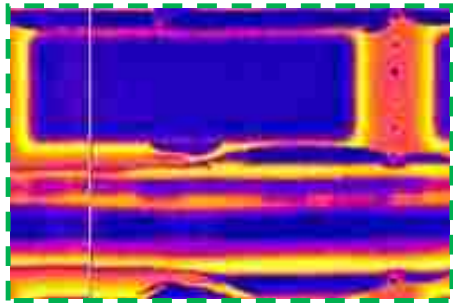
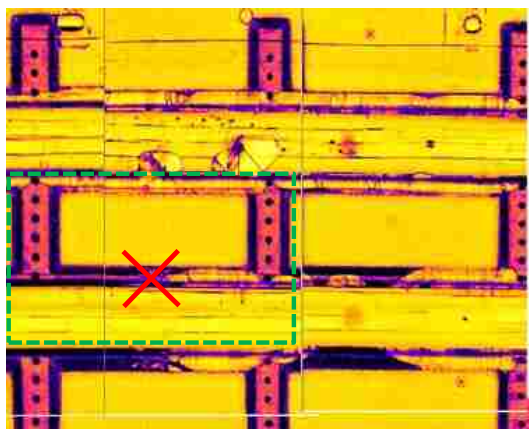
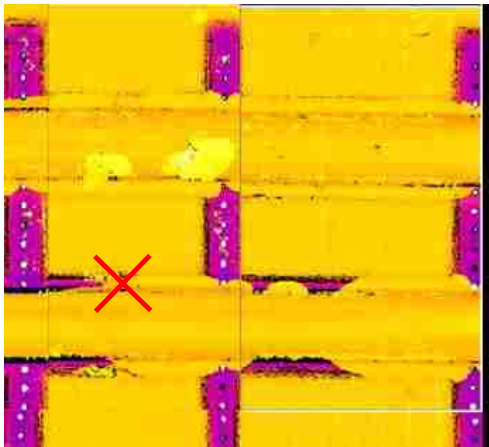
Center of Stringer Flange
Max Impact Energy: 373.9 ft lbs, 275.8 Joules
Max Impact Velocity: 236.5 ft/s, 72.1 m/s
Visual Indication: No visual indication on front or back side of panel, small tactile lip at the skin to string flange interface can be felt with hand at impact location
Damage Area: I.D. 0.0, 15.14 S.D. in²
Type of Damage: Stringer disbond detected in amplitude, TOF and resonance, no interply delamination detected in the skin

Stringer Disbond

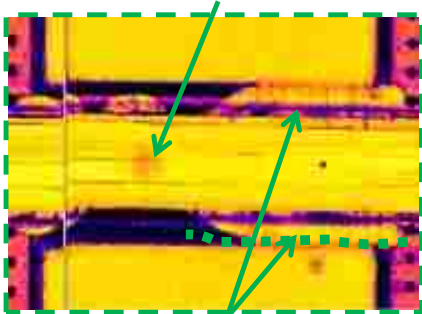
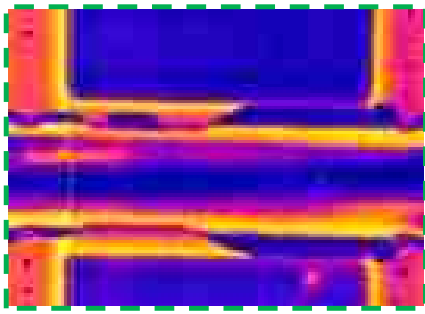
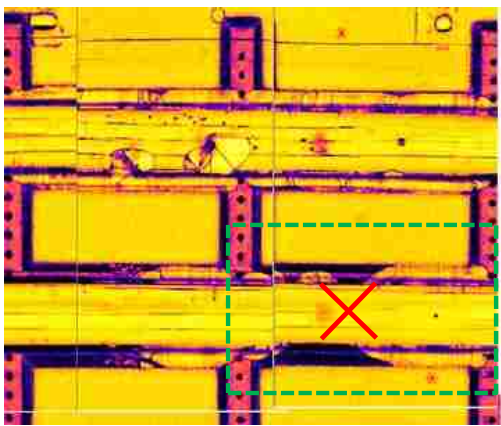
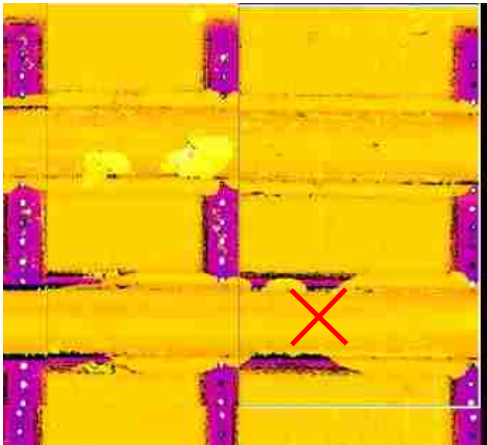
Center of Stringer Between Flanges
Max Impact Energy: 526.2 ft lbs, 388.1 Joules
Max Impact Velocity: 284.1 ft/s, 86.6 m/s
Visual Indication: No front side surface visual indication, 10.5” stringer flange crack detectable on bottom stringer flange
Damage Area: I.D. 0.0, S.D. 27.90 in²
Type of Damage: Stringer disbond, micro cracking in matrix at impact location detected as drop in amplitude

Decrease in Amplitude

Stringer Disbonds

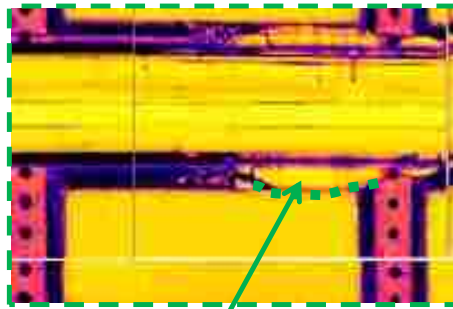
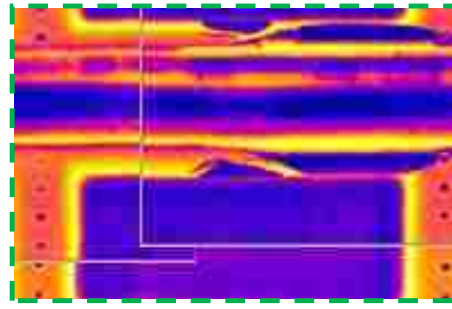
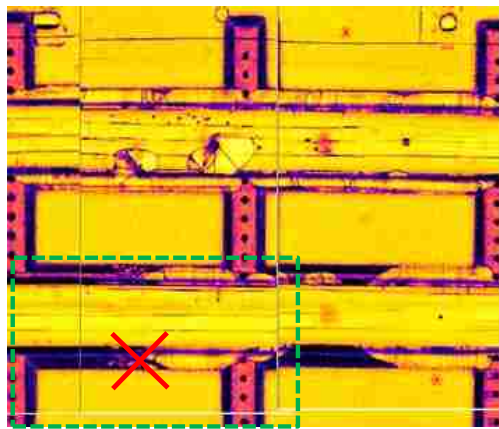
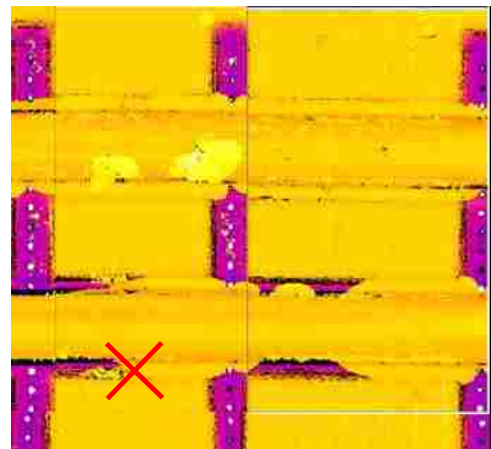
Damage Area: I.D. 0.0, S.D. 14.52 in²

Type of Damage: Stringer disbond

Stringer Disbond

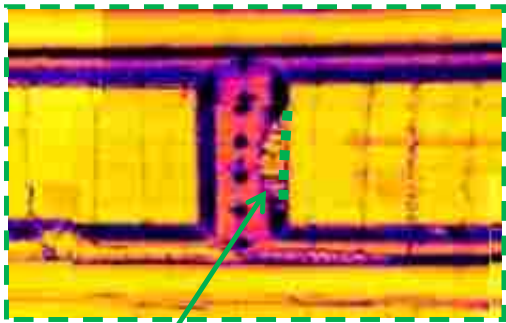
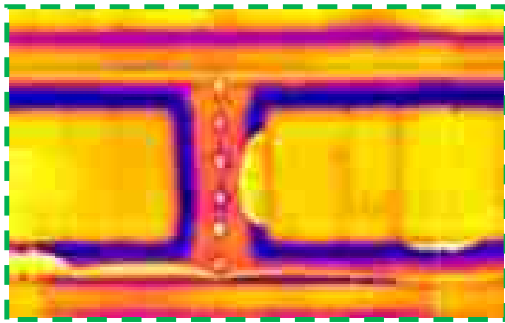
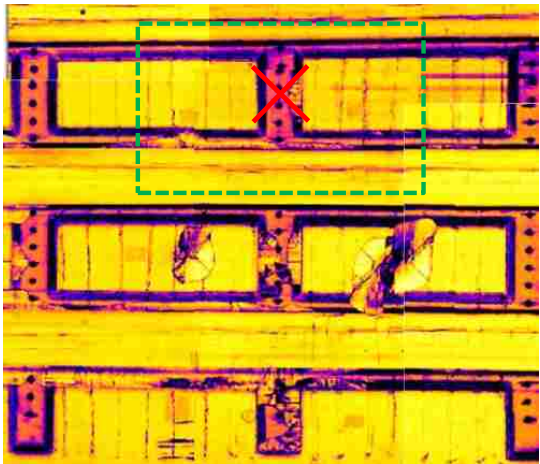
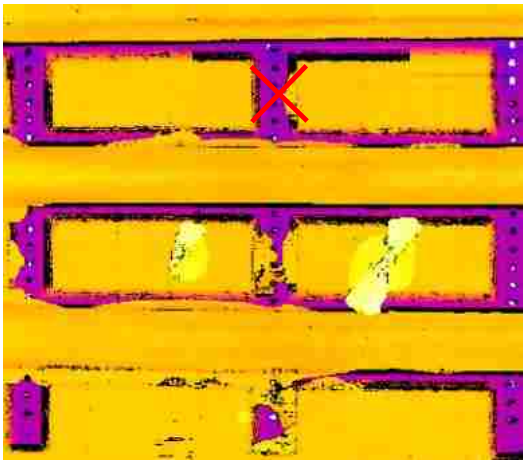
1B – B1/2-SK3-ST0-I4

Visual Indication: Small paint crack around one fastener, 2” crack in built-up pad section, 1” crack in corner bend radius of shear tie.

Damage Area: I.D. 0.0, S.D 3.03 in²

Type of Damage: Shear tie built-up pad section delamination, cracked shear tie

Delamination

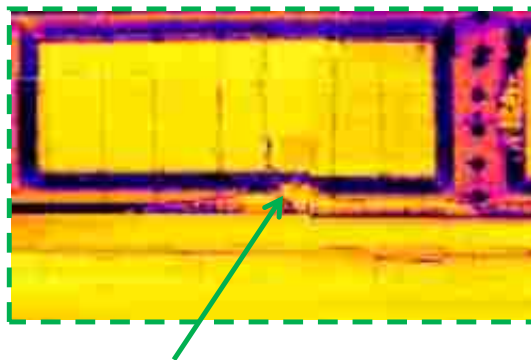
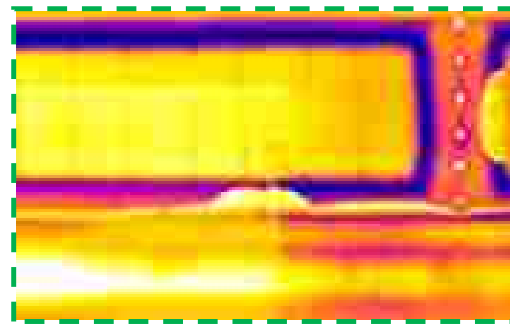
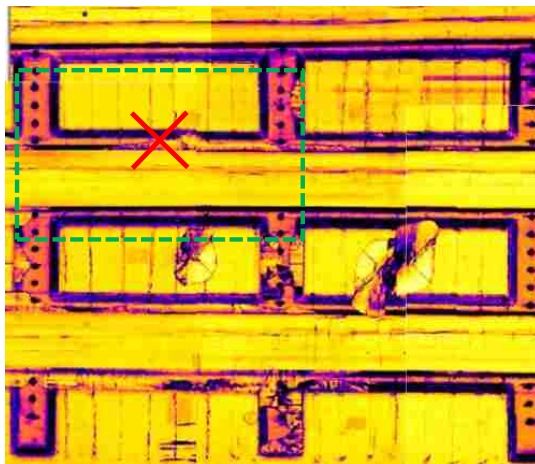
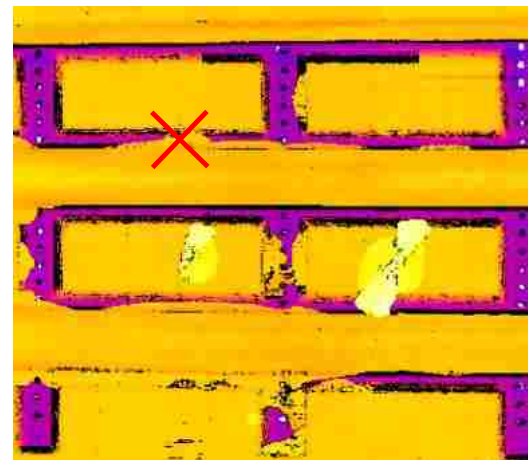
Damage Area: I.D. 0.0, S.D. 8.12 in²

Type of Damage: Stringer disbond detected in amplitude, TOF and resonance, no interply delamination detected in the skin

Stringer Disbond

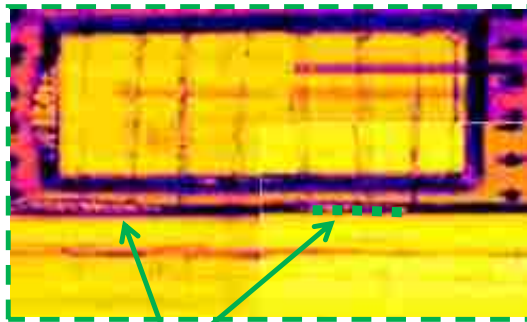
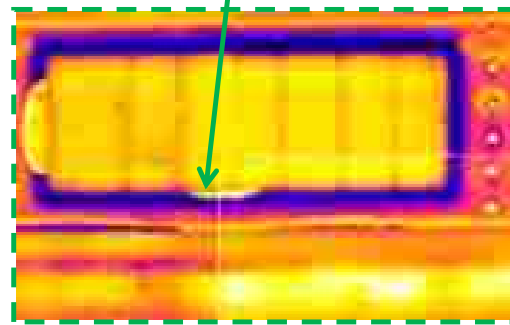
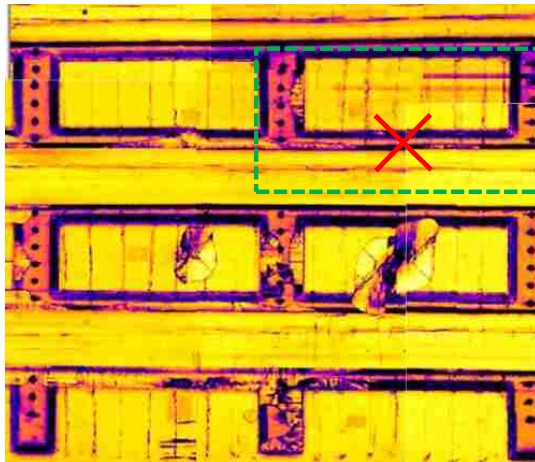
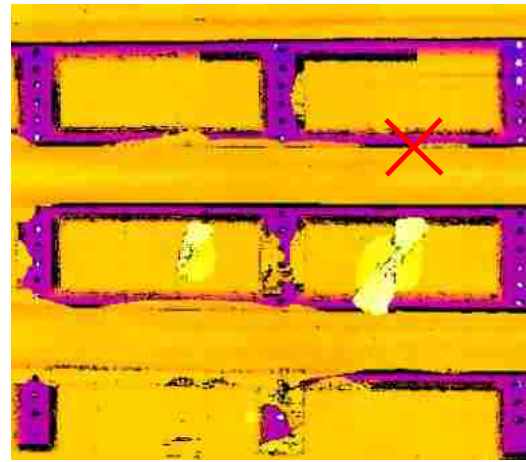
Visual Indication: No front side surface visual indication, 2.5” crack visible on backside of panel at the flange skin interface

Damage Area: I.D. 0.0, S.D. 4.12in²

Type of Damage: Small stringer disbond detected in amplitude, TOF and resonance, no interply delamination detected in the skin

Small Stringer Disbond

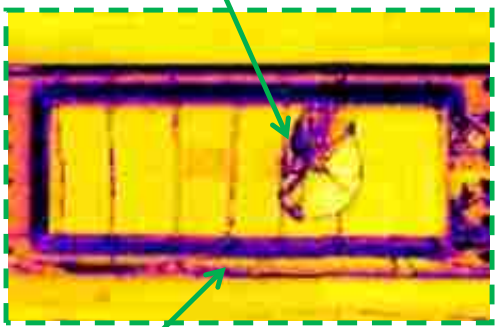
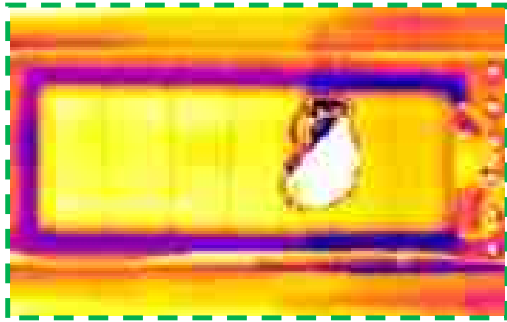
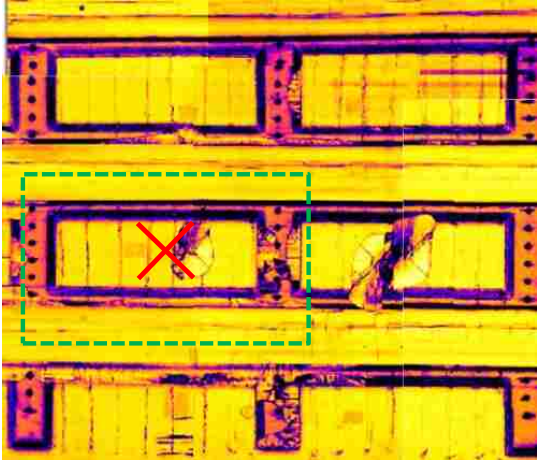
Damage Area: I.D. 11.28, S.D. 20.48 in²

Type of Damage: Interply delamination at impact location, edge of stringer disbond on stringer side.

Interply Delamination

Stringer Disbond

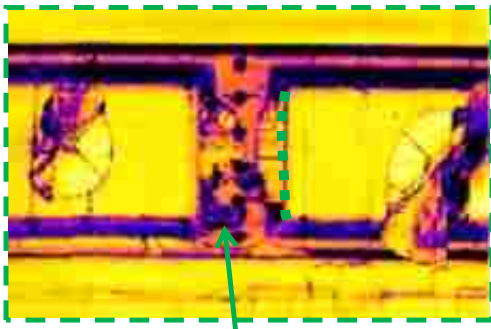
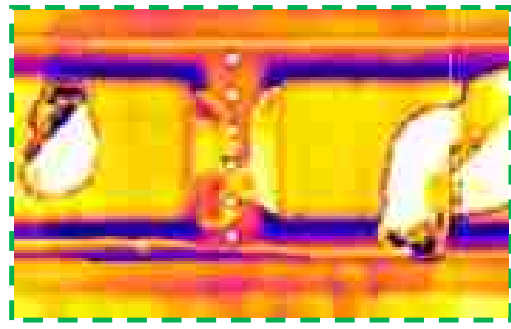
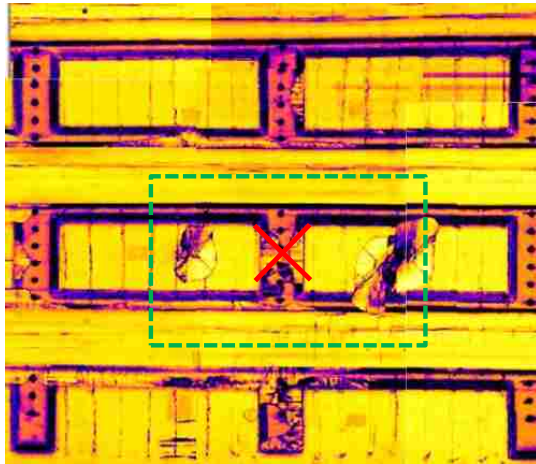
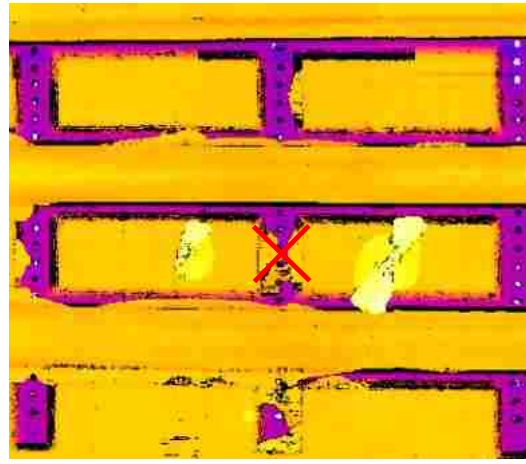
Built-up Section Delamination

Visual Indication: Paint crack around circumference of fastener, 4.5” crack at the skin to built-up pad section interface, 4” crack in the corner bend of the shear tie

Damage Area: I.D. 0.0, S.D. 14.90 in²

Type of Damage: : Delamination of built-up pad section at shear tie, cracked shear tie

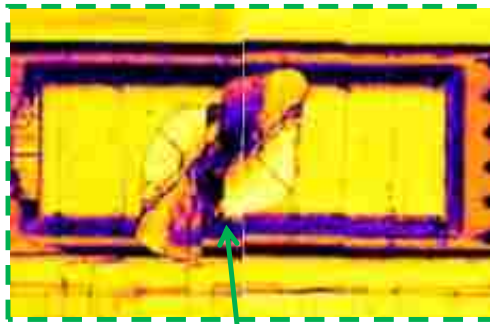
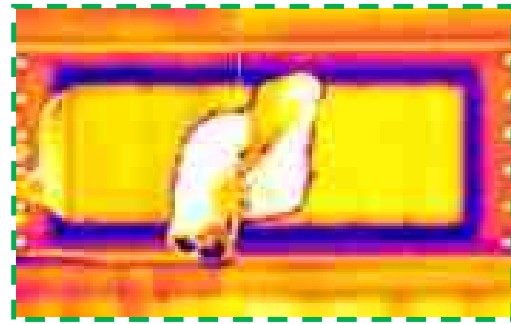
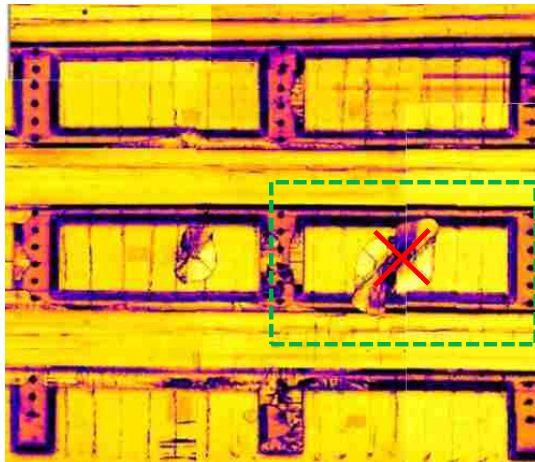
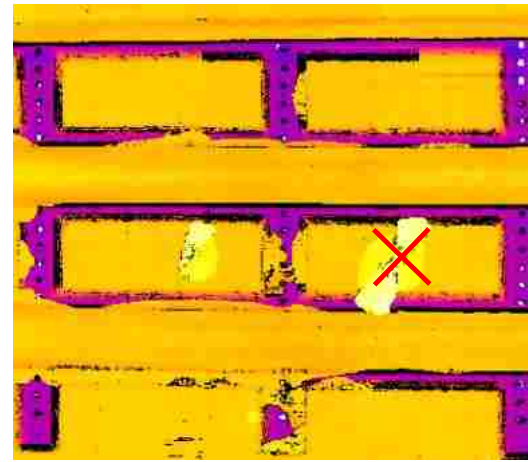
Interply Delamination

Damage Area: I.D. 21.27, S.D. 0.0 in²

Type of Damage: Interply delamination in the skin

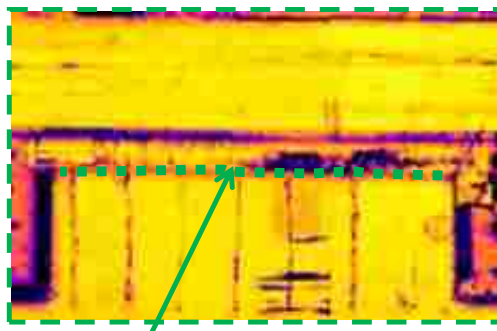
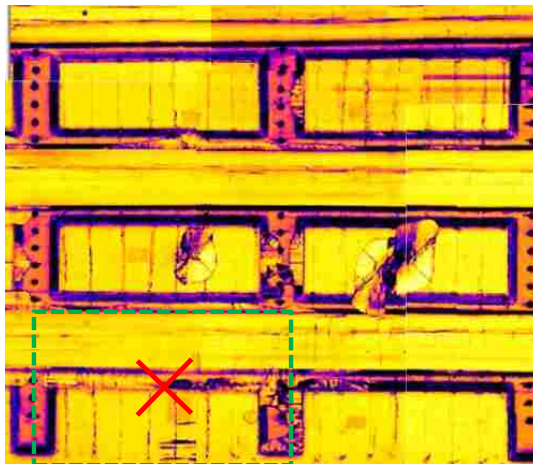
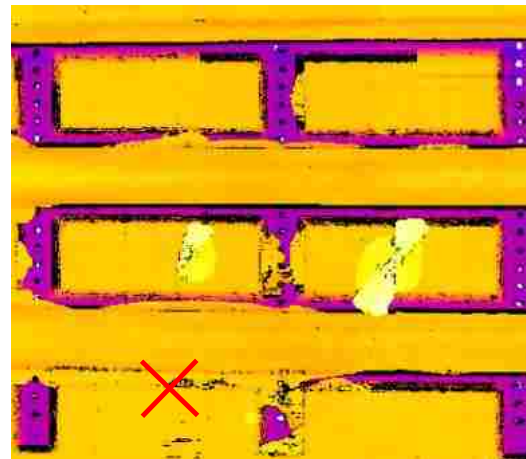
Full Stringer Disbond

Visual Indication: No front side surface visual indication, 17.5” stringer flange crack visible

Damage Area: Interply Delamination 0.0 in², Substructure Disbond 23.16 in²

Type of Damage: Full stringer disbond, no interply delamination detected

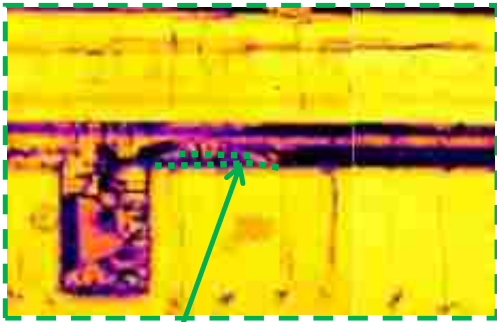
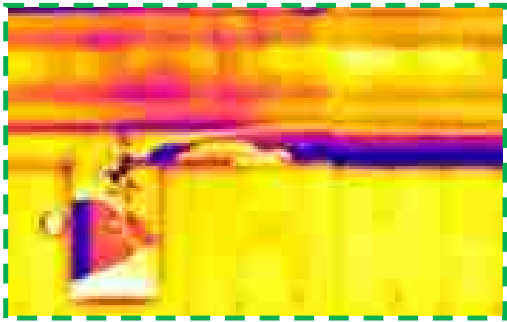
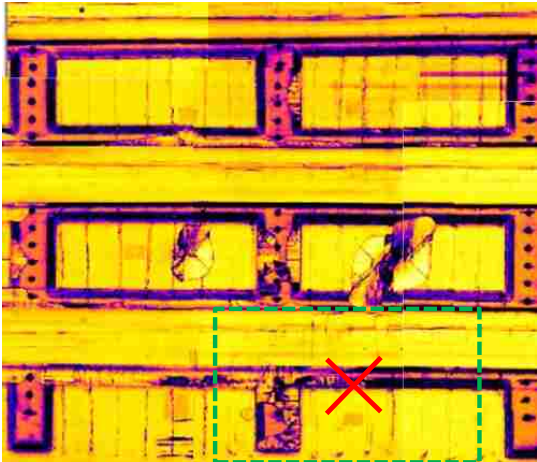
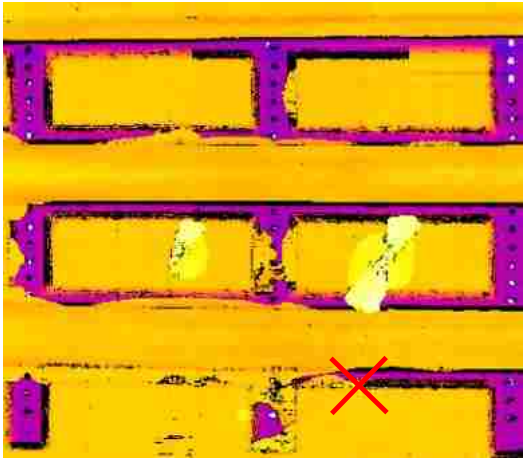
Partial Stringer Disbond

Visual Indication: No front side surface visual indication, multiple cracked plies in the tapered flange ranging from 1” to 2.5”.

Damage Area: I.D. 0.0, S.D. 6.05 in²

Type of Damage: Partial stringer disbonding

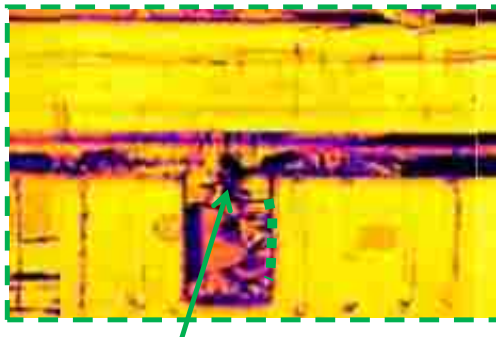
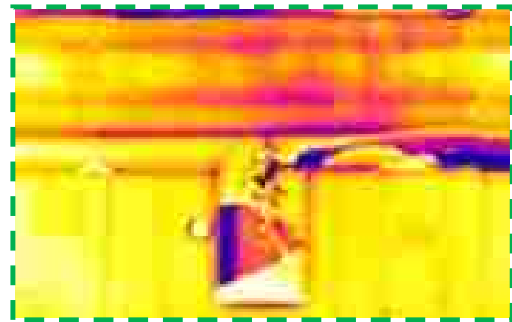
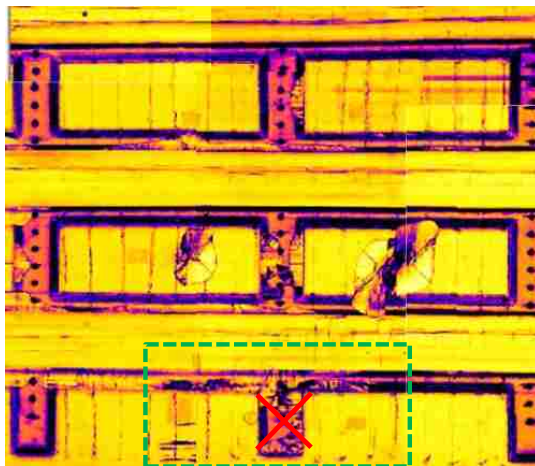
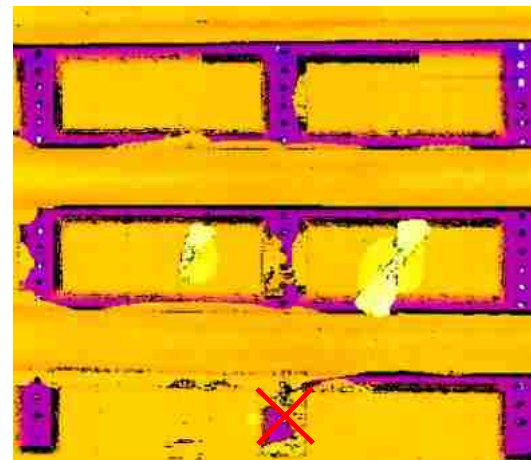
Built-up section Delamination

Visual Indication: Paint chip on surface of panel, 1” diameter permanent paint scuff, 2” crack at the built-up pad-to-skin interface, 4.5” crack in the corner bend of the shear tie

Damage Area: I.D. 0.0, S.D. 22.34 in²

Type of Damage: Shear tie built-up pad section delamination

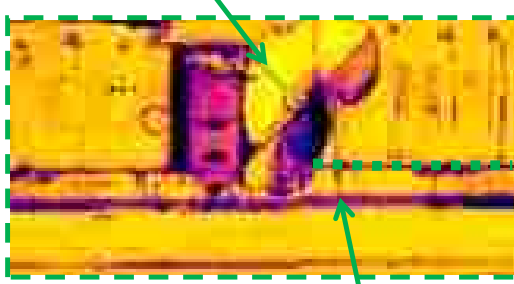
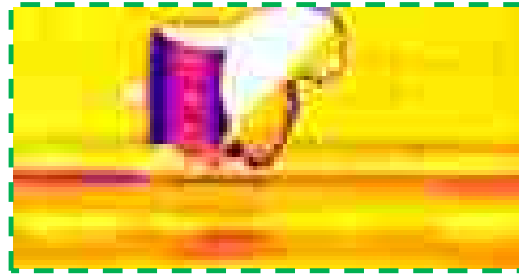
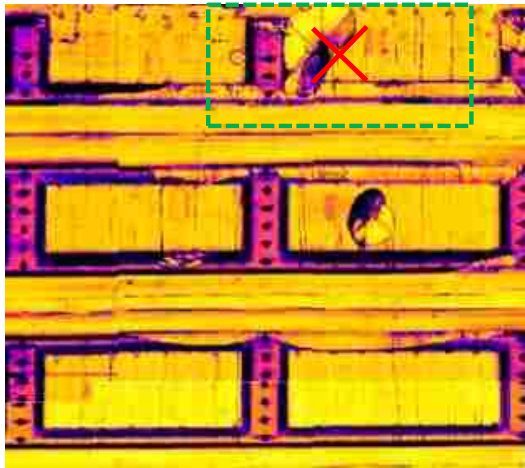
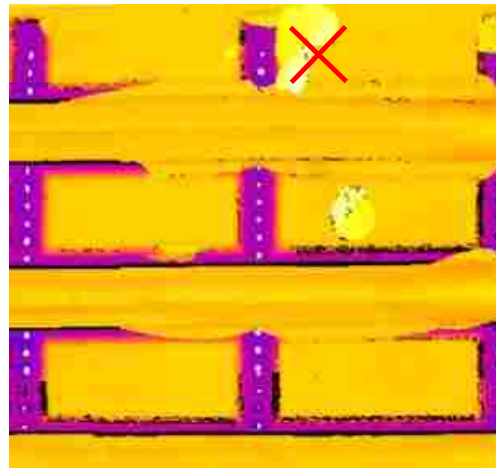
Interply Delamination

Visual Indication: No front side surface visual indication, 17.5” stringer delamination crack visible on backside

Damage Area: I.D. 20.01, S.D. 29.82 in²

Type of Damage: Interply delamination in the skin, full length stringer disbond, and partial delamination in the shear tie built-up pad section
