Detection and characterization of impact damage in carbon fiber aircraft fuselage structure

**DETECTION AND CHARACTERIZATION OF IMPACT
DAMAGE IN CARBON FIBER AIRCRAFT FUSELAGE
STRUCTURE**

THESIS

**Master of Science
Civil Engineering**

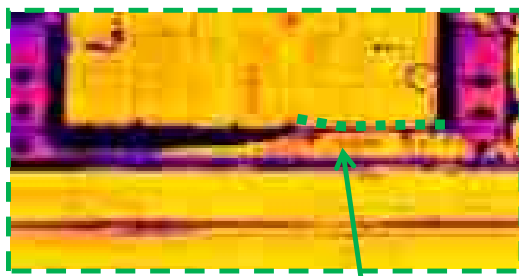
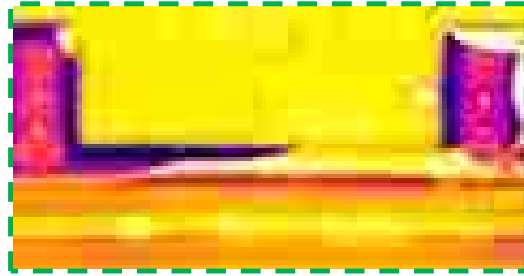
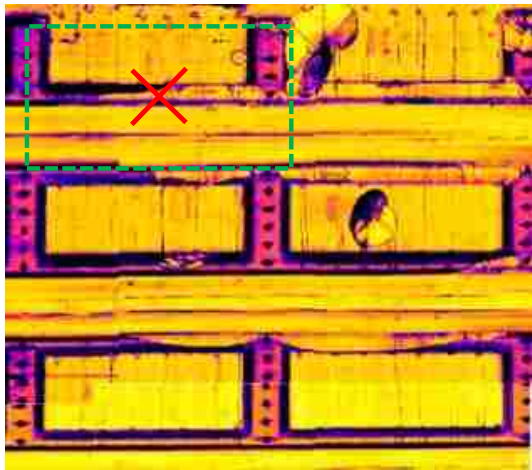
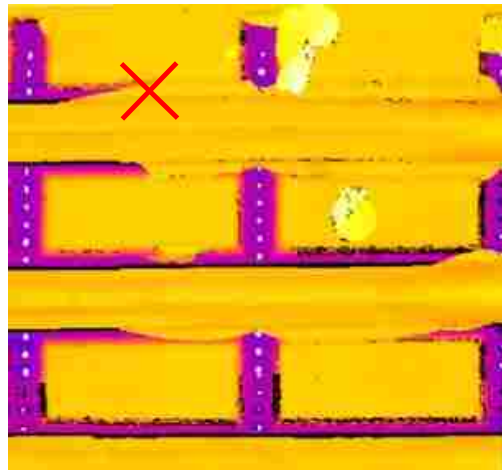
Stringer Disbond

Visual Indication: No front side surface visual indication, 6" stringer flange crack visible on backside of panel

Damage Area: I.D. 0.0, S.D. 16.09 in²

Type of Damage: Stringer flange disbond

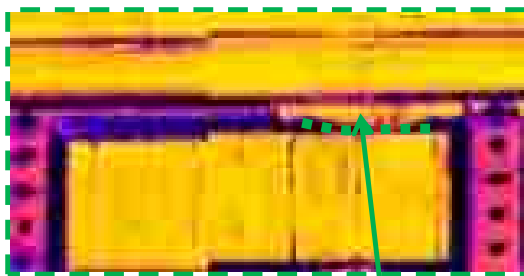
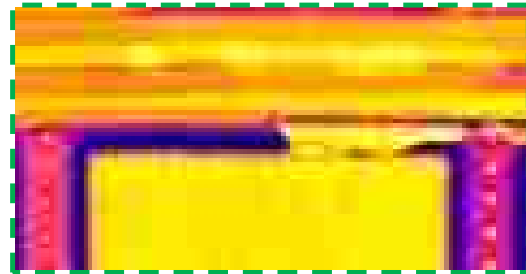
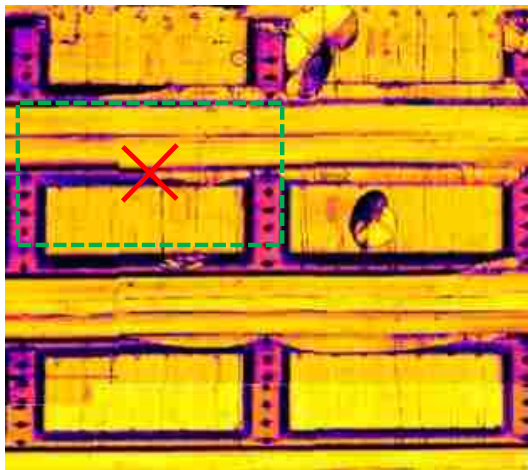
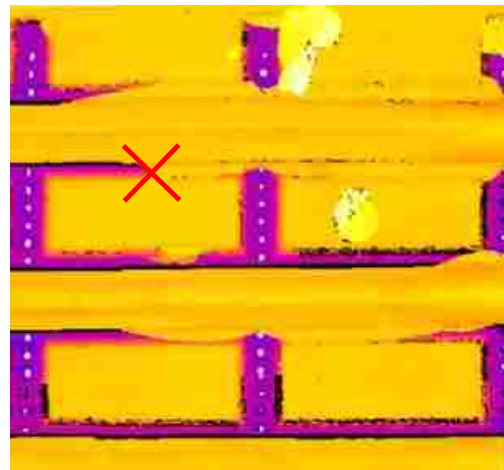
Stringer Disbond

Visual Indication: No front side surface visual indication, 4.5” stringer flange crack visible on backside of panel

Damage Area: I.D. 0.0, S.D. 8.41 in²

Type of Damage: Stringer flange disbond

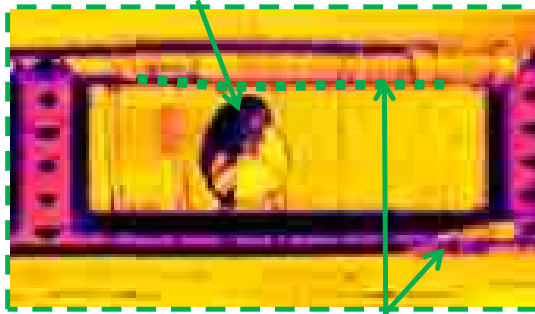
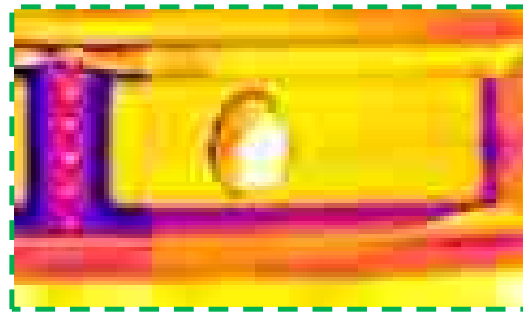
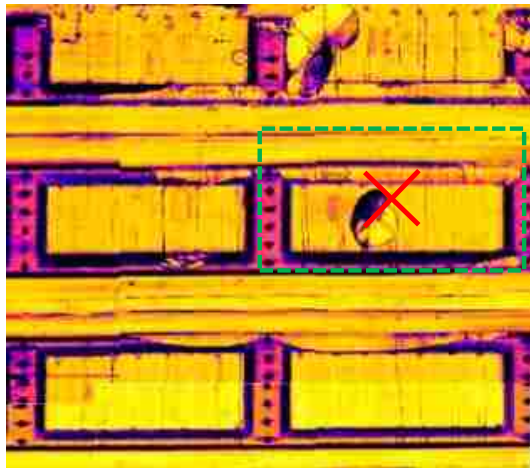
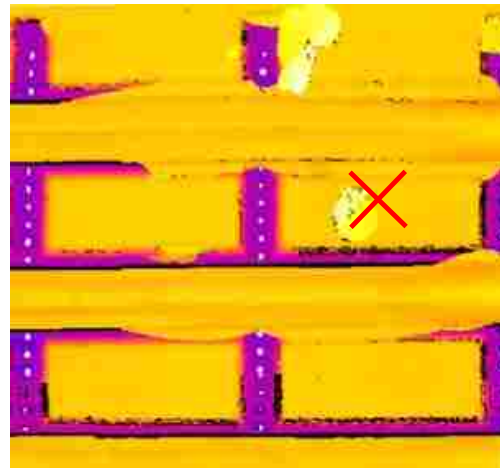
Interply Delamination

Visual Indication: No front side surface visual indication, 15.5” stringer flange crack visible on backside of panel

Damage Area: I.D. 12.55 , 40.23 S.D. in²

Type of Damage: Interply delamination in the skin, full length stringer disbond

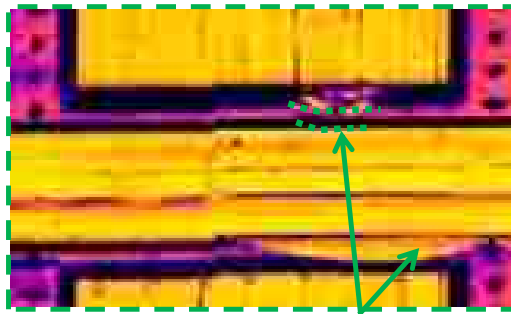
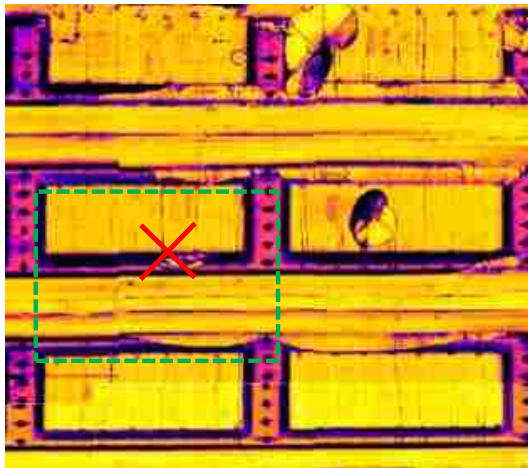
Stringer Disbond

Visual Indication: No front side surface visual indication, two, 2.5” stringer flange cracks visible on backside of panel

Damage Area: I.D. 0.0, S.D. 9.45 in²

Type of Damage: Stringer flange disbond

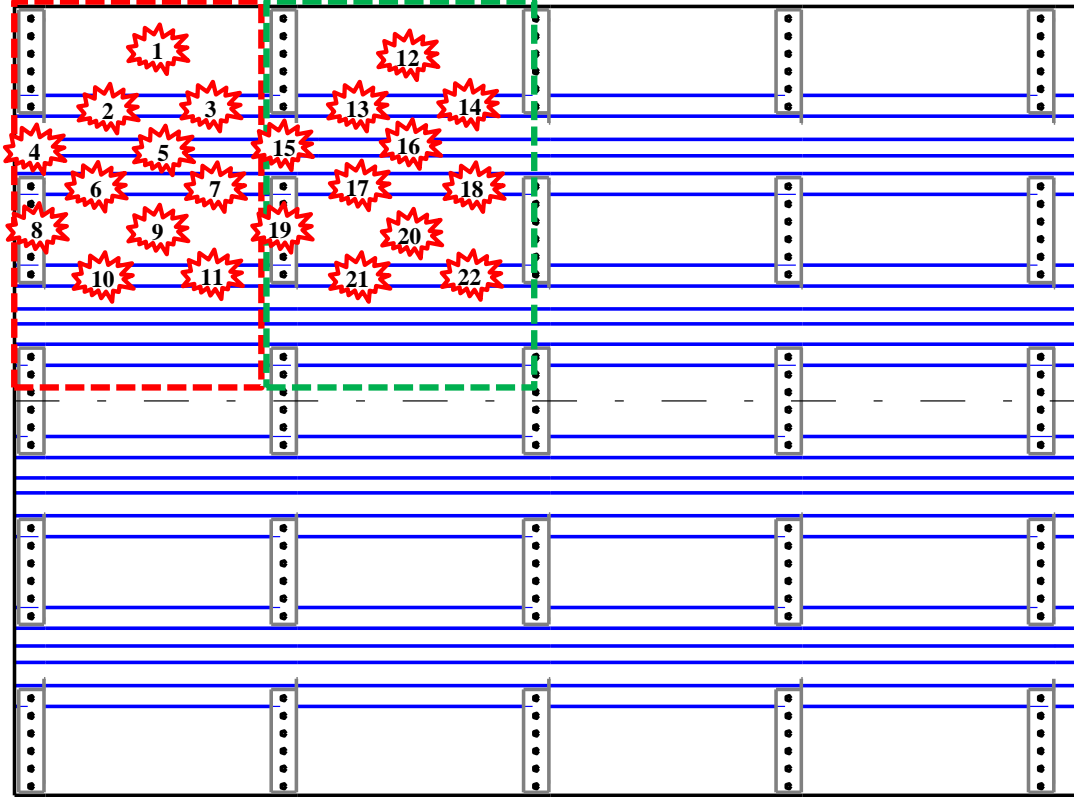
Panel A (Bay 1&2) – Hard Impacts

- 1 – B1-SK1-ST0-H1
- 2 – B1-SK1-ST1L-H2b
- 3 – B1-SK1-ST1R-H2b
- 4 – B1-SK0-ST1L-H3
- 5 – B1-SK0-ST1-H3
- 6 – B1-SK2-ST1L-H2c
- 7 – B1-SK2-ST1R-H2c
- 8 – B1-SK2-ST0-H4
- 9 – B1-SK2-ST0-H1
- 10 – B1-SK2-ST2L-H2b
- 11 – B1-SK2-ST2R-H2b

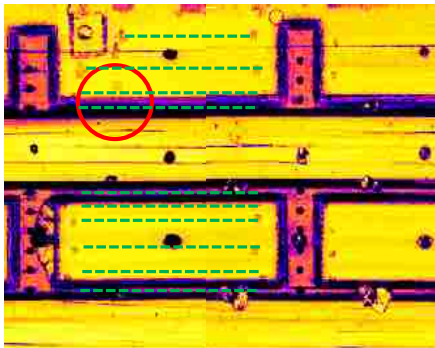
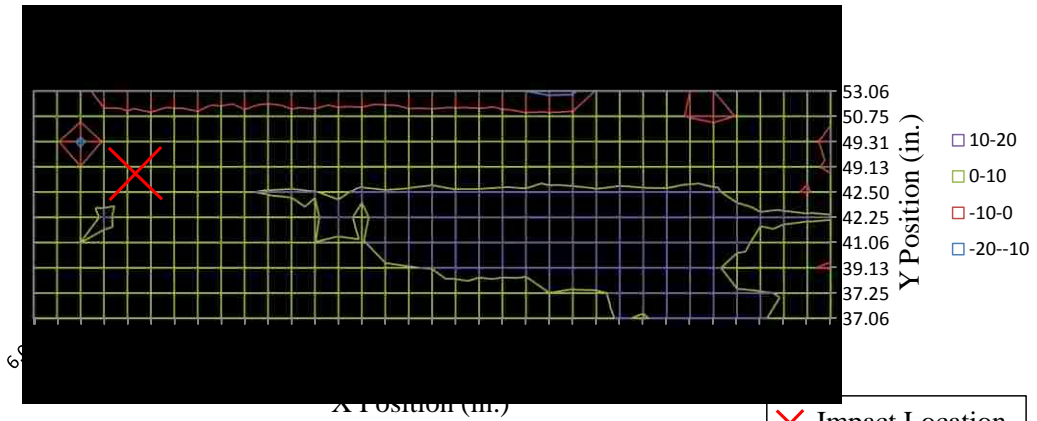
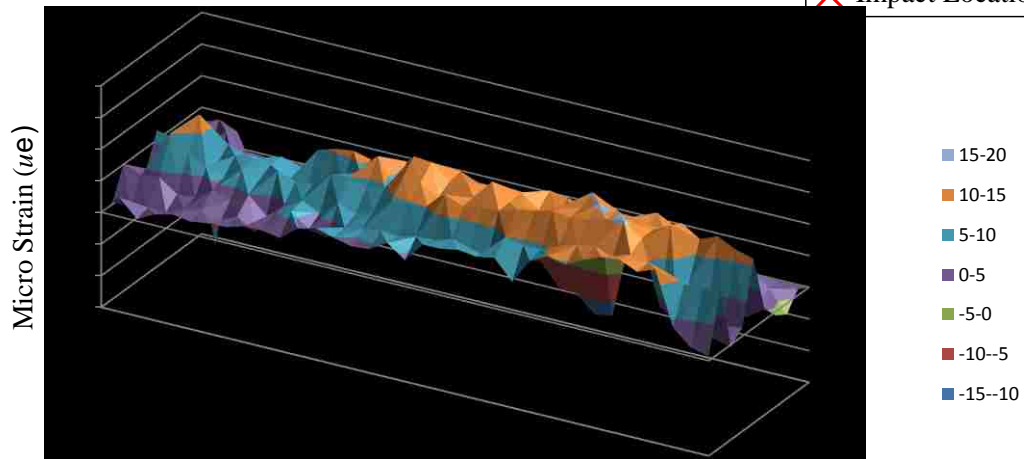
2 - B1-SK1-ST1L-H2b

Center of Stringer Flange
Impact Energy: 45 Ft lbs
Damage Area: Could not determine, masked by co-cured flange
Type of Damage: None
Strain Indication: No

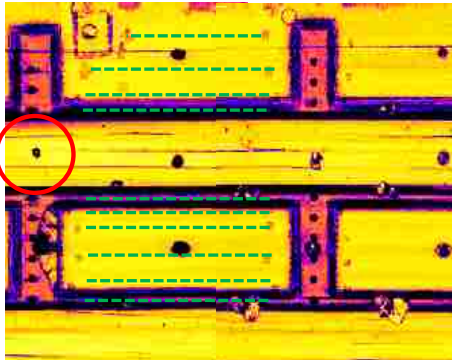
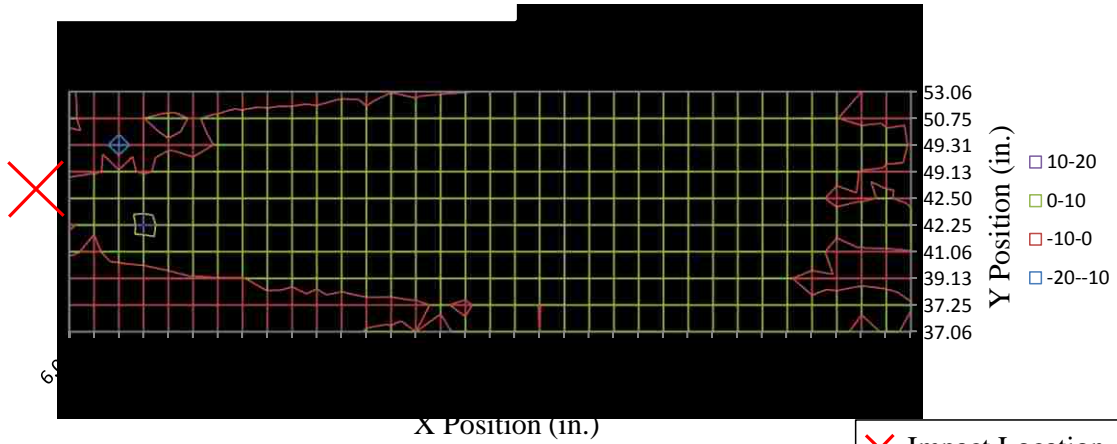
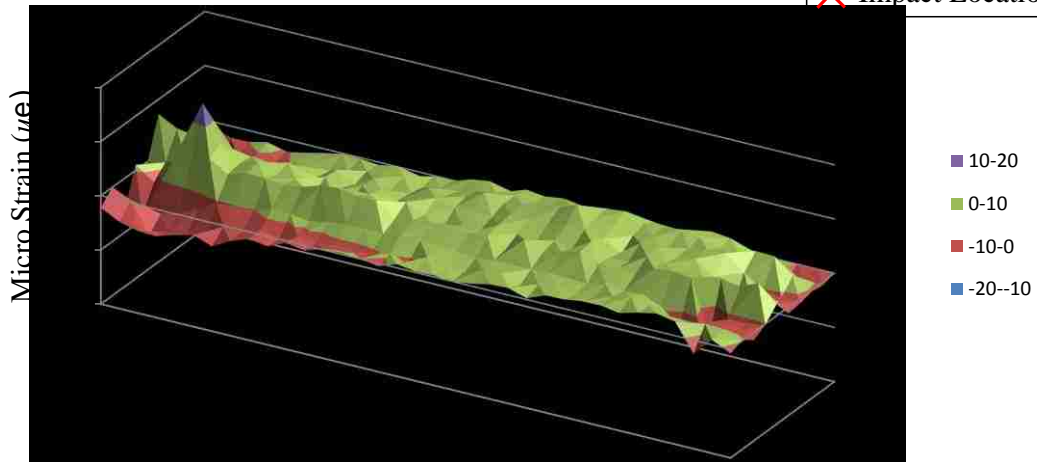
Mid-Stringer on Skin, Between Shear Ties
Impact Energy: 45 Ft lbs
Damage Area: 0.23 in²
Type of Damage: Near surface fiber crushing
Strain Indication: Some strain indication at edge of stringer flange, not detectable

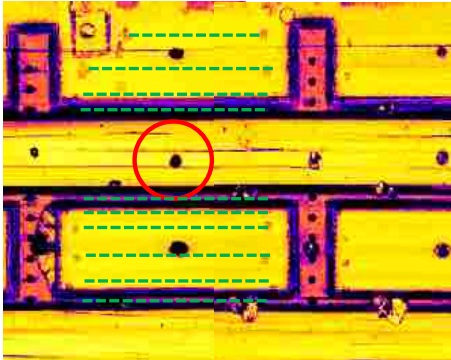
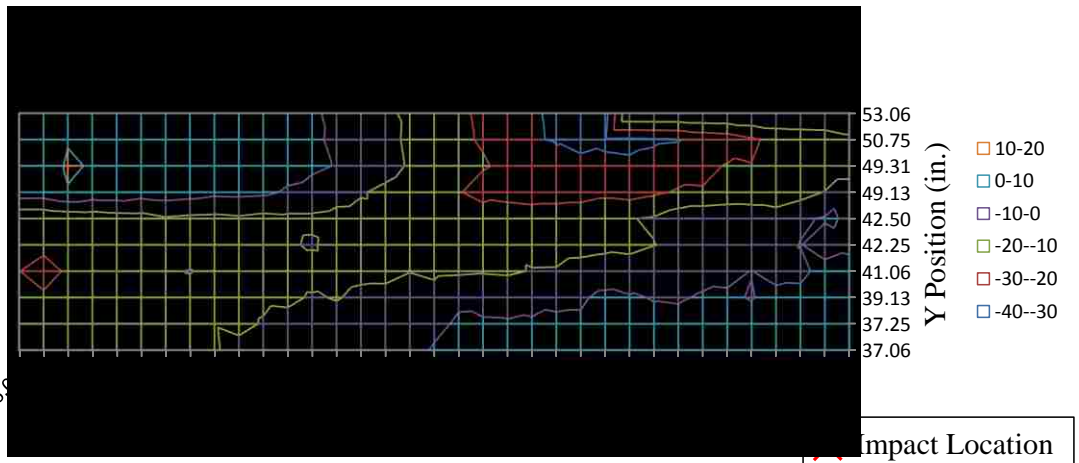
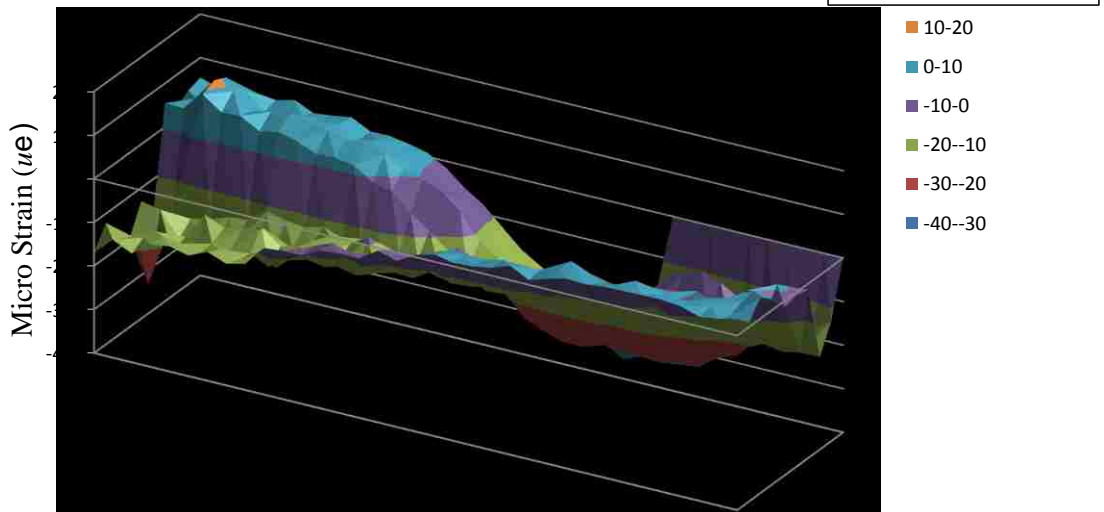
5 - B1-SK0-ST1-H3

Mid-Stringer Between Flanges
Impact Energy: 45 Ft lbs
Damage Area: 0.47 in²
Type of Damage: Near surface fiber crushing
Strain Indication: No, possible temperature shift or change in panel loading

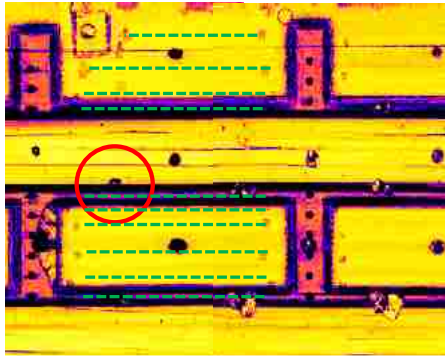
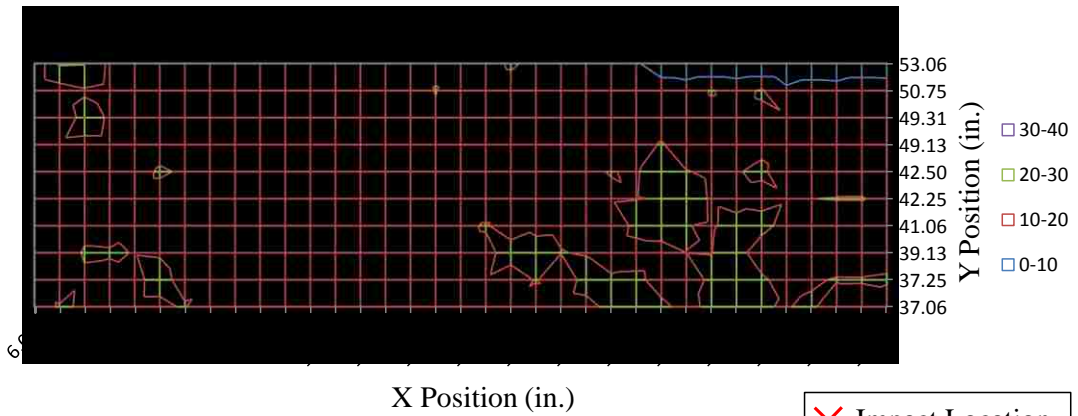
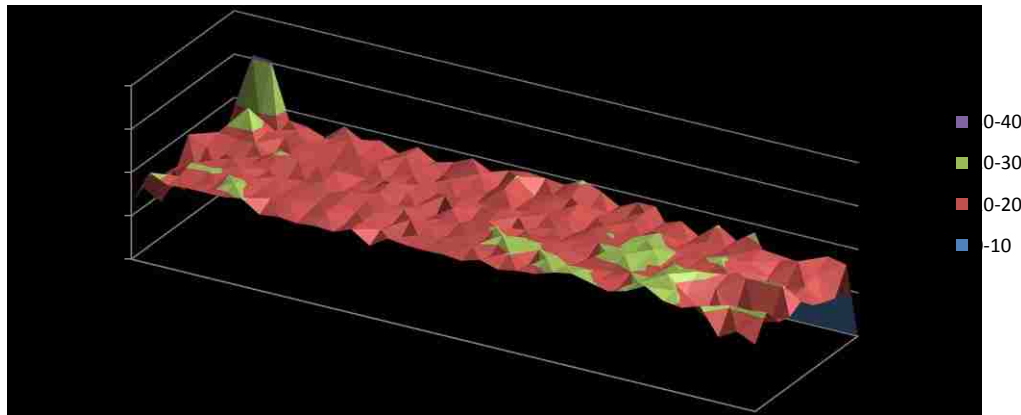
6 - B1-SK2-ST1L-H2c

Edge of Stringer Flange (Not Stringer Side)

Impact Energy: 55 Ft lbs

Damage Area: 0.28 in²

Type of Damage: Near surface fiber crushing

Strain Indication: Minor, local strain increase, not detectable

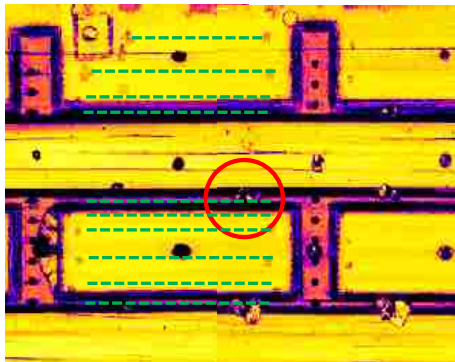
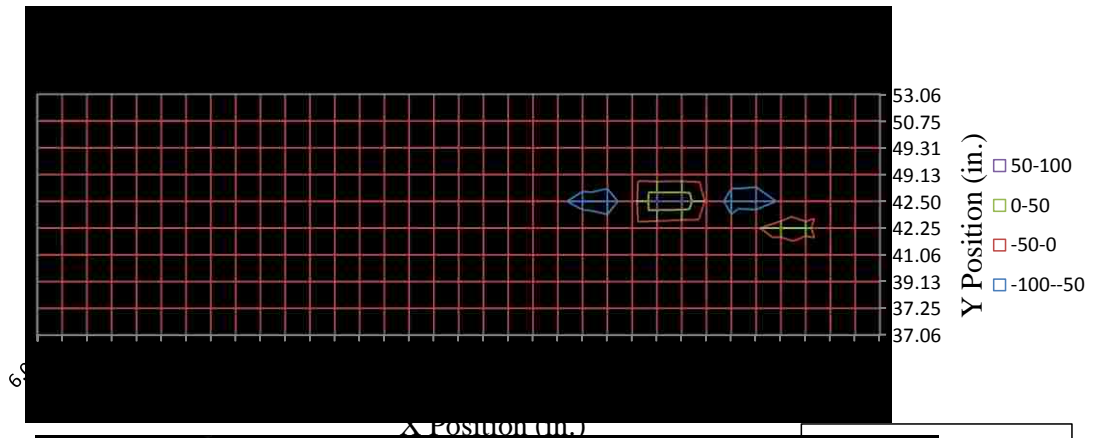
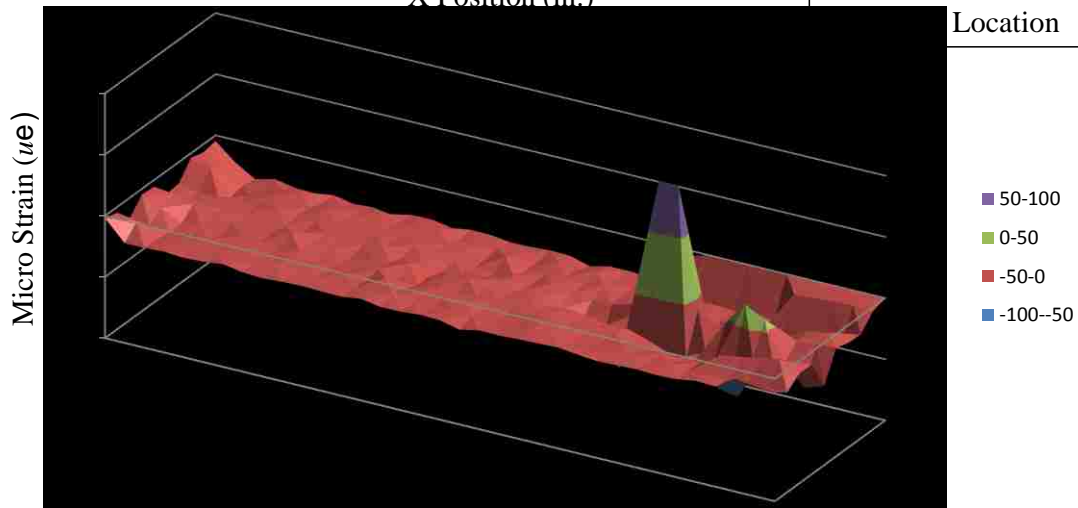
7 - B1-SK2-ST1R-H2c

Damage Area: 1.67 in²

Type of Damage: Interply delamination

Strain Indication: Yes, Detectable Strain Indication

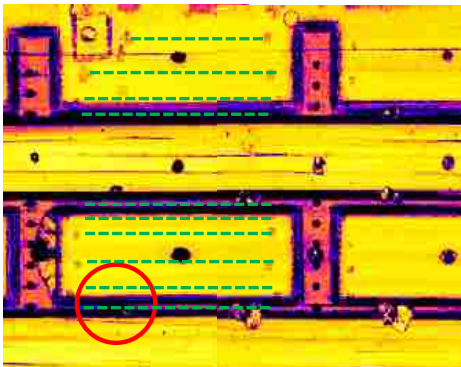
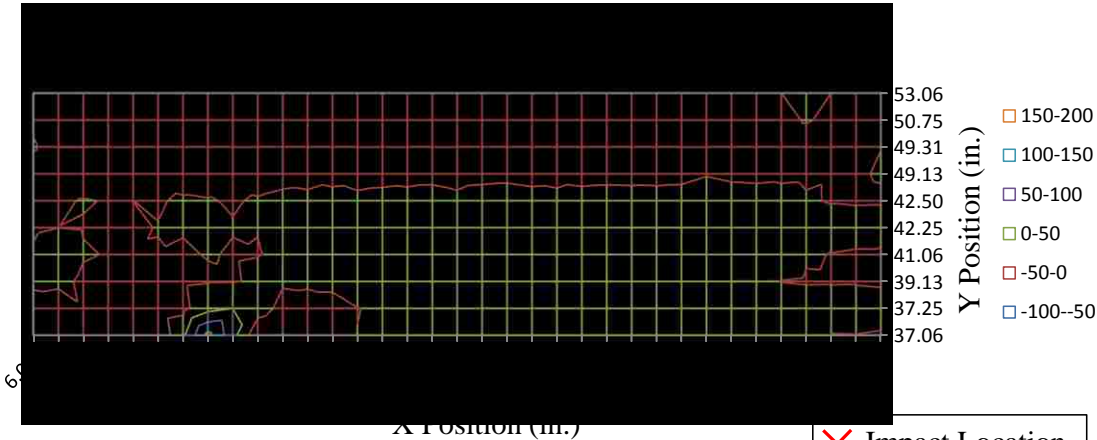
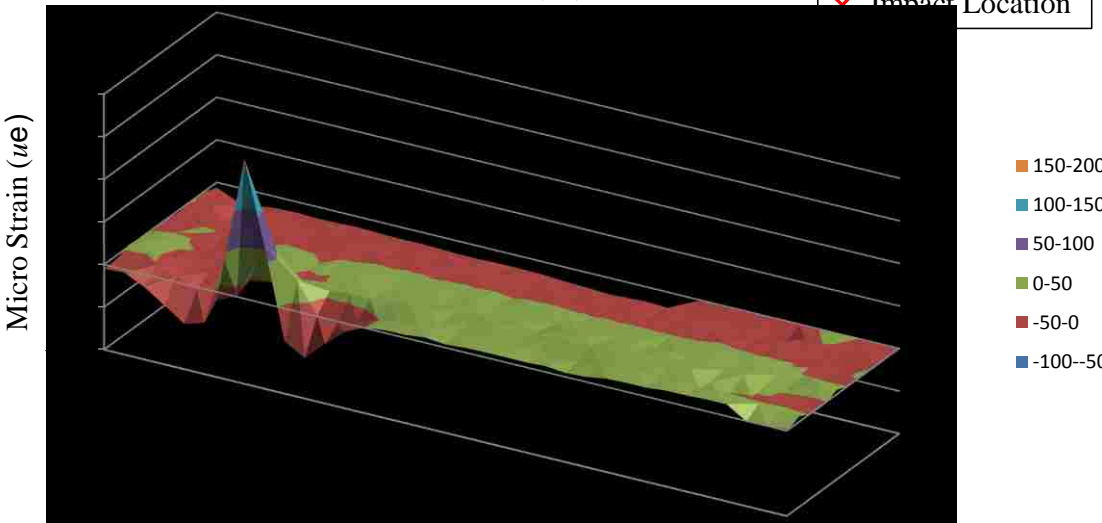
10 - B1-SK2-ST2L-H2b

Center of Stringer Flange
Impact Energy: 75 Ft lbs
Damage Area: 1.36 in²
Type of Damage: Stringer flange delamination
Strain Indication: Yes, detectable strain indication

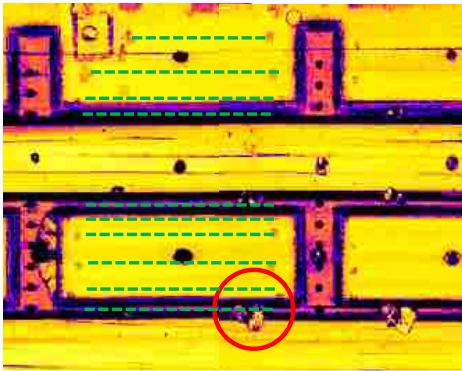
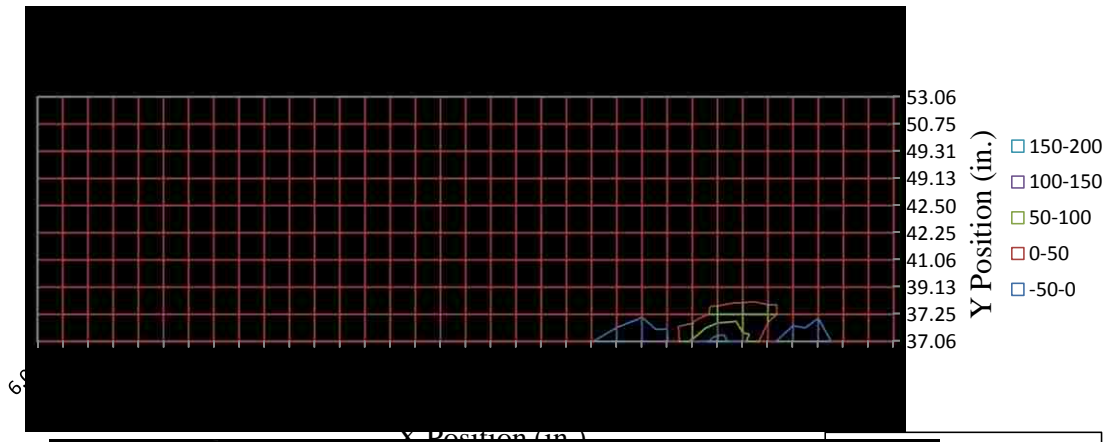
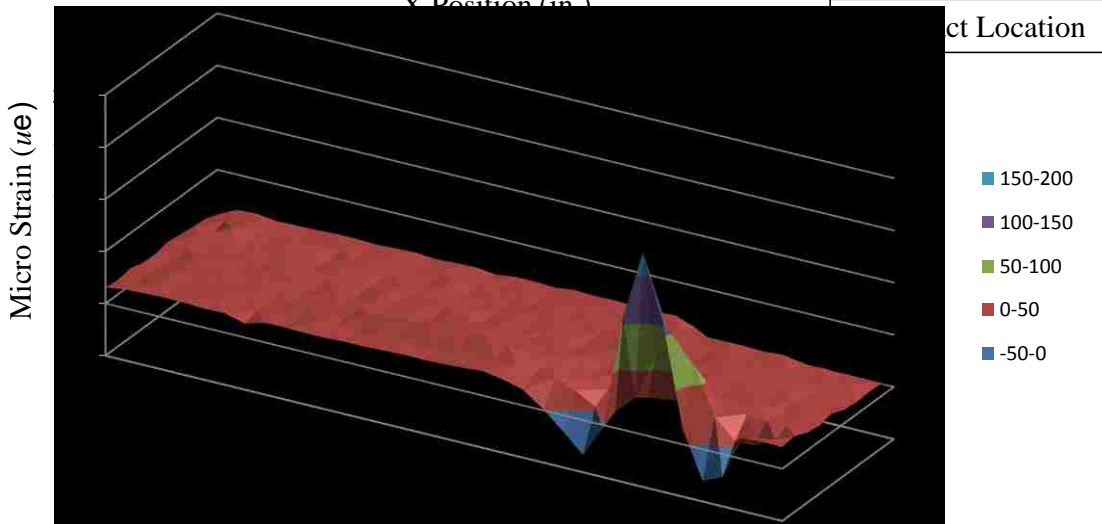
11 - B1-SK2-ST2R-H2b

Damage Area: 2.19 in²

Type of Damage: Interply delamination

Strain Indication: Yes, detectable strain indication

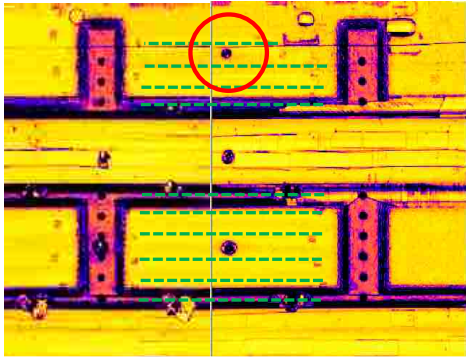
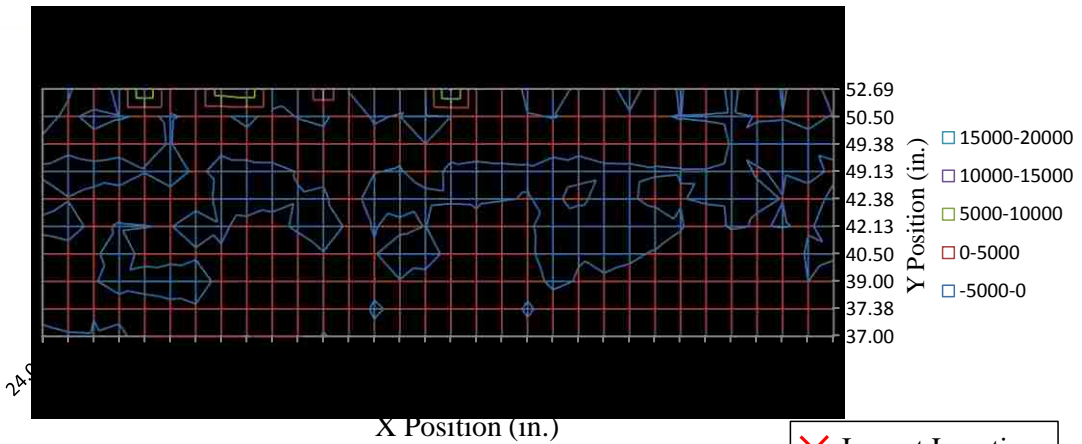
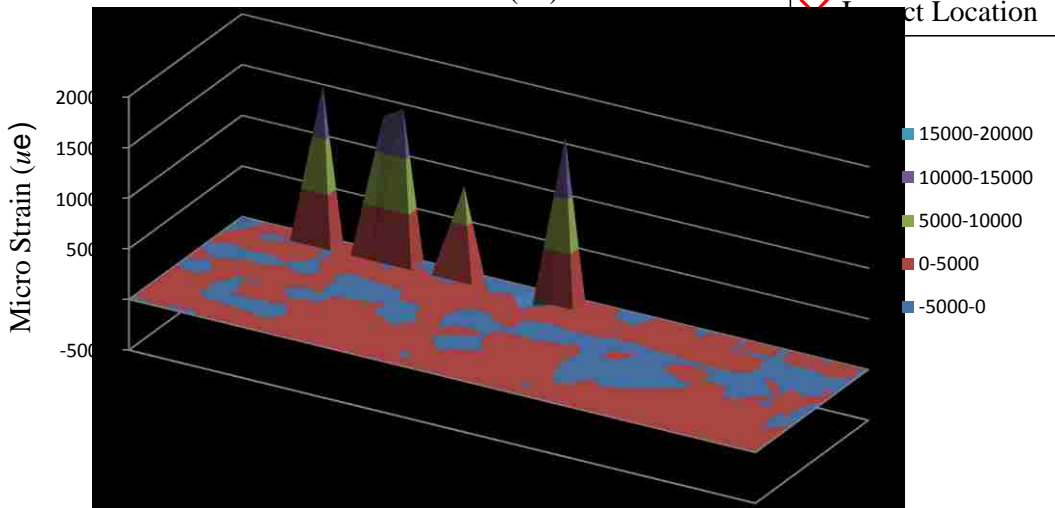
Skin Impact
Impact Energy: 60 Ft lbs
Damage Area: 0.45 in²
Type of Damage: Near surface fiber crushing
Strain Indication: Yes, but caused other indications as well due to high strain levels in the fiber

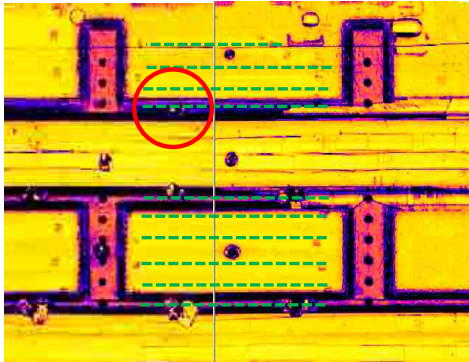
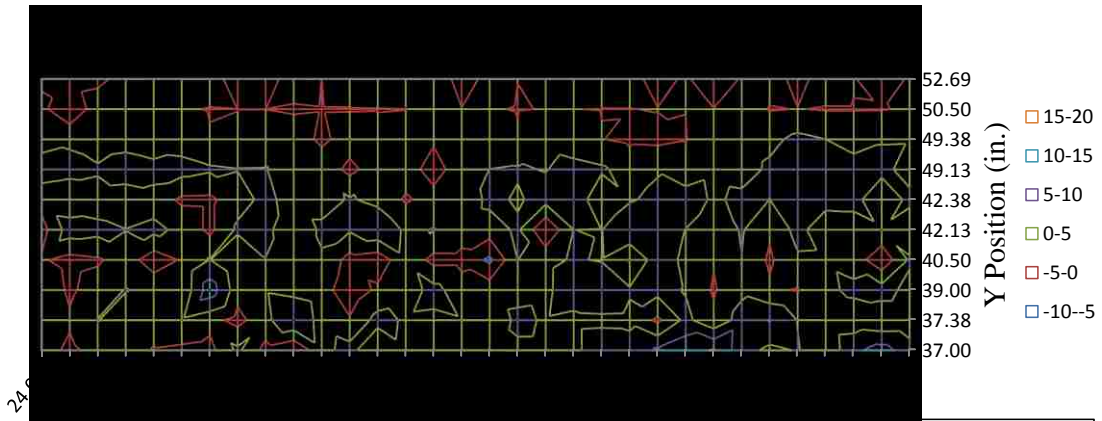
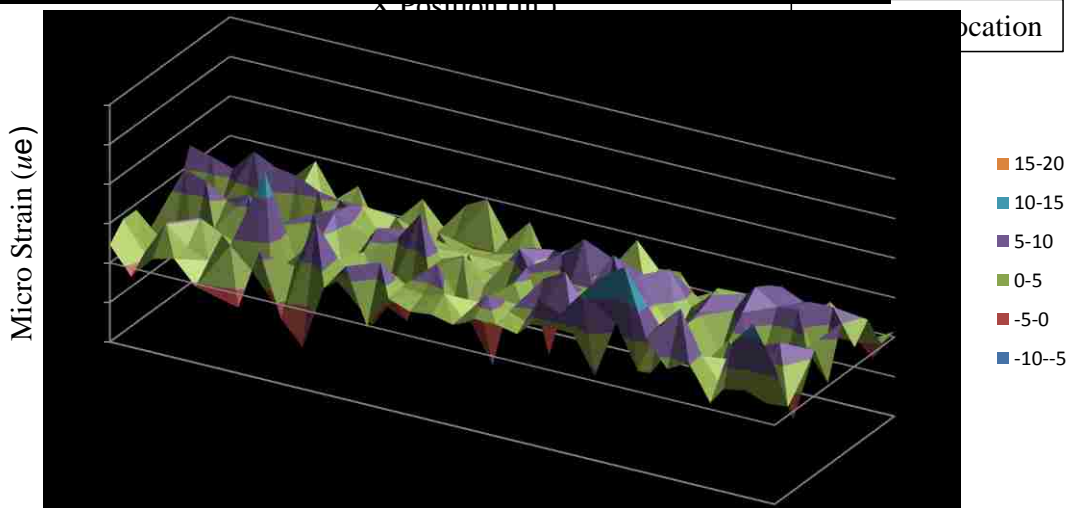
13 - B2-SK1-ST1L-H2a

Edge of Stringer Flange (Not Stringer Side)
Impact Energy: 60 Ft lbs
Damage Area: 0.93 in²
Type of Damage: Stringer flange delamination
Strain Indication: No

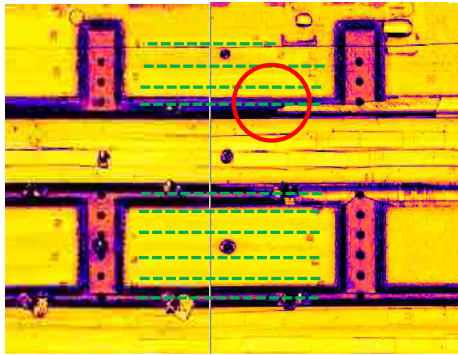
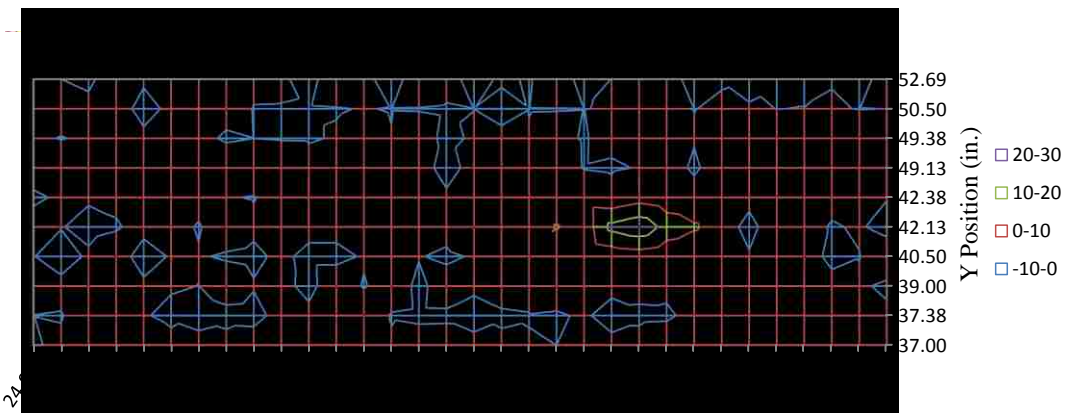
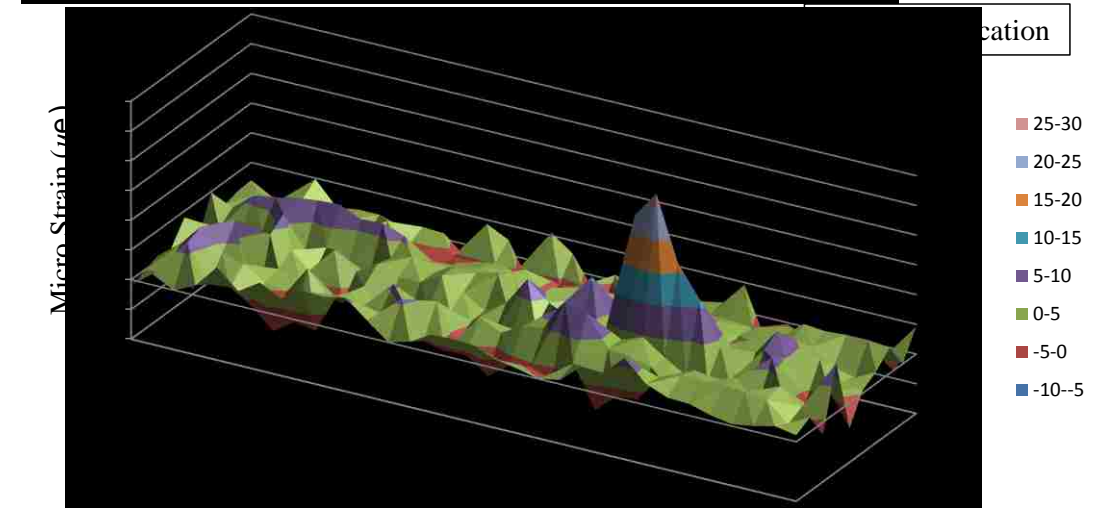
14 - B2-SK1-ST1R-H2a

Edge of Stringer Flange (Not Stringer Side)
Impact Energy: 75 Ft lbs
Damage Area: 0.98 in²
Type of Damage: Interply delamination, and near surface fiber crushing
Strain Indication: Yes, detectable strain indication, but in the other stringer fiber

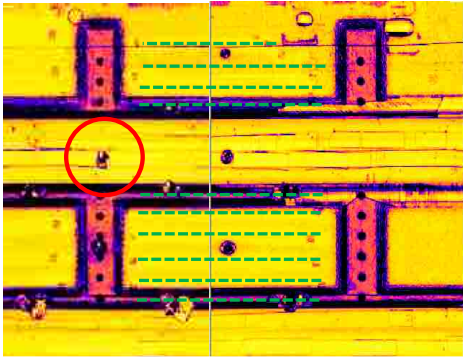
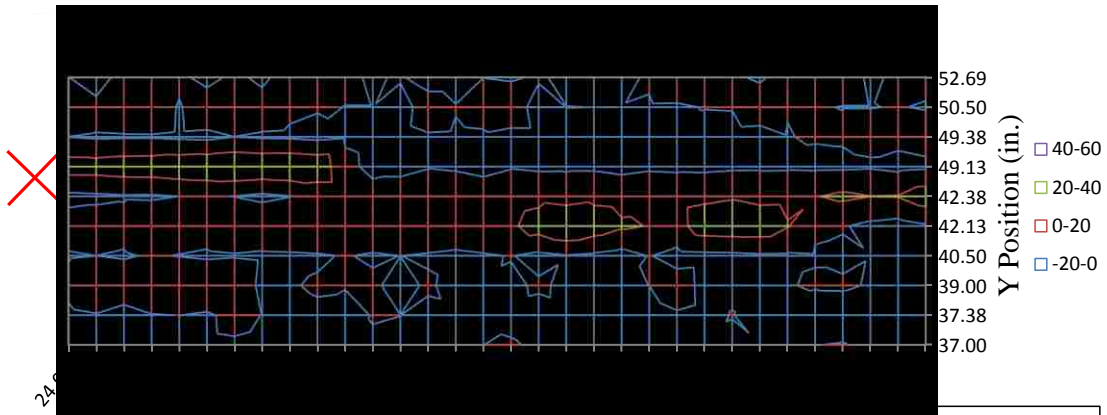
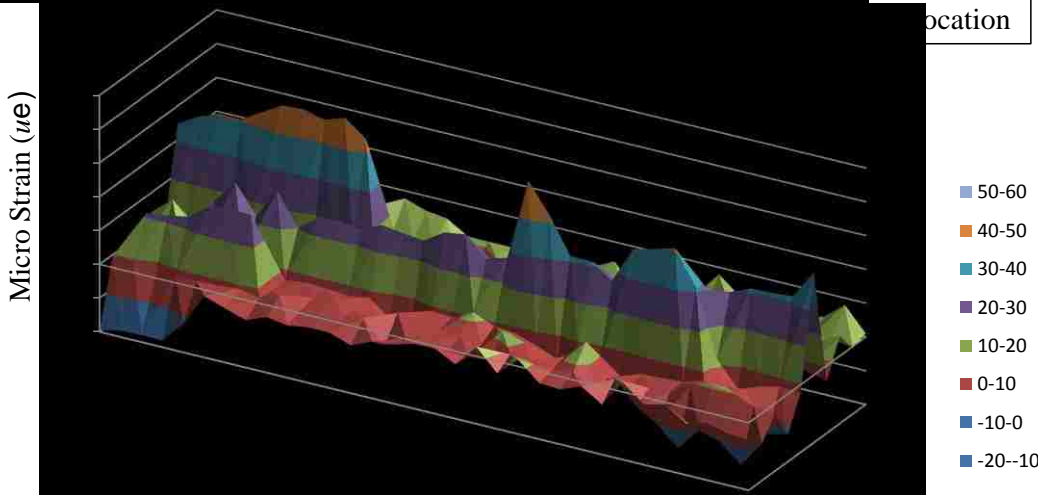
Damage Area: 0.93 in²

Type of Damage: Near surface crushed fibers and interply delamination

Strain Indication: Higher strains indicated on stringer flange fibers, not detectable

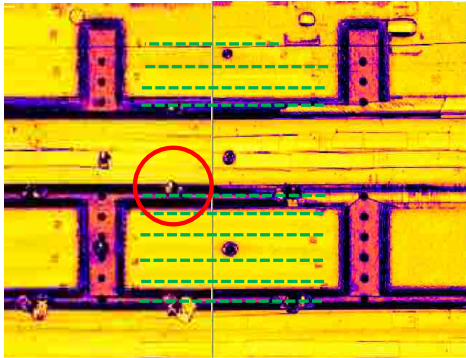
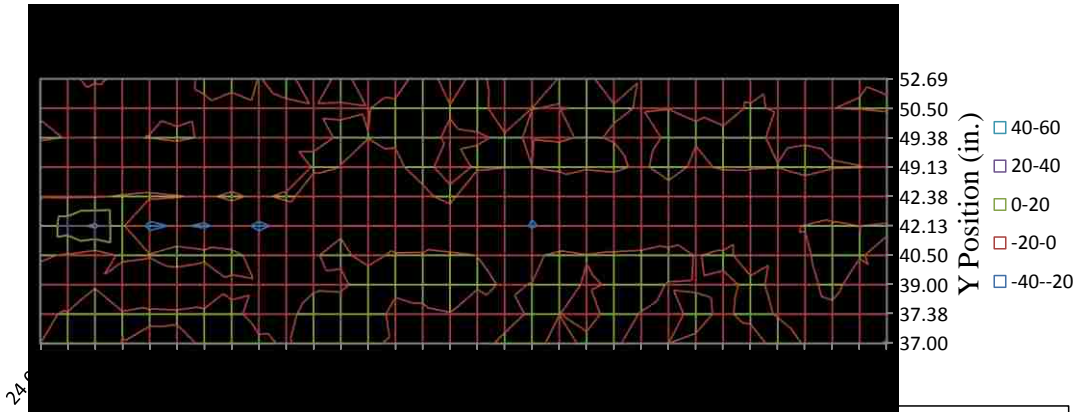
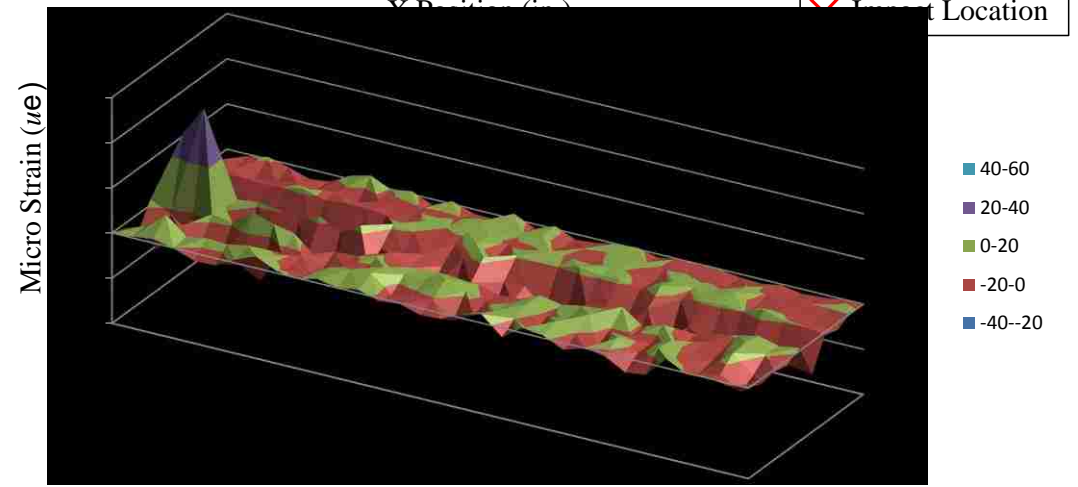
17 - B2-SK2-ST1L-H2c

Edge of Stringer Flange (Stringer Side)
Impact Energy: 90 Ft lbs
Damage Area: 1.23 in²
Type of Damage: Interply delamination
Strain Indication: Yes, spikes in strain data (negative and positive) adjacent to impact location

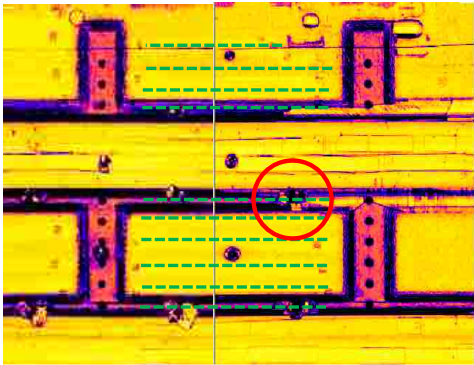
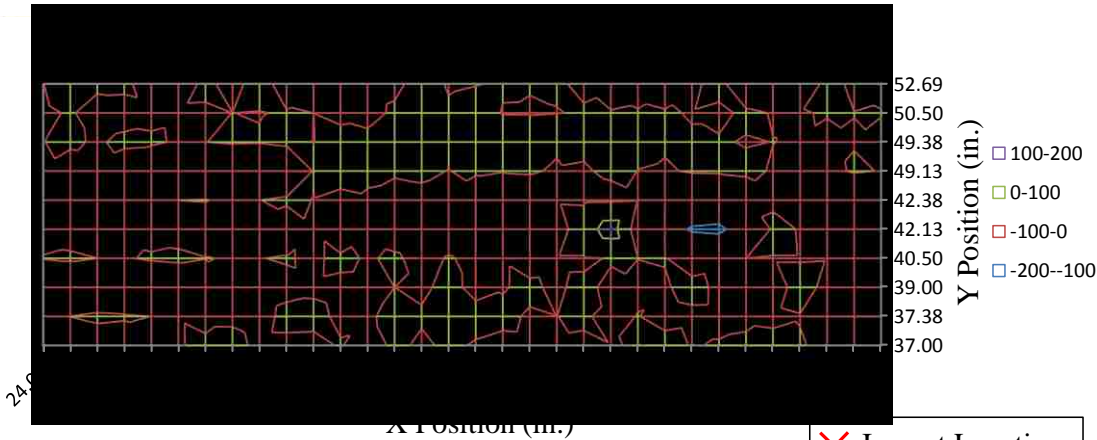
Edge of Stringer Flange (Stringer Side)

Impact Energy: 105 Ft lbs

Damage Area: 2.24 in²

Type of Damage: Stringer flange delamination

Strain Indication: Yes, clear strain decrease and subsequent increase at impact location

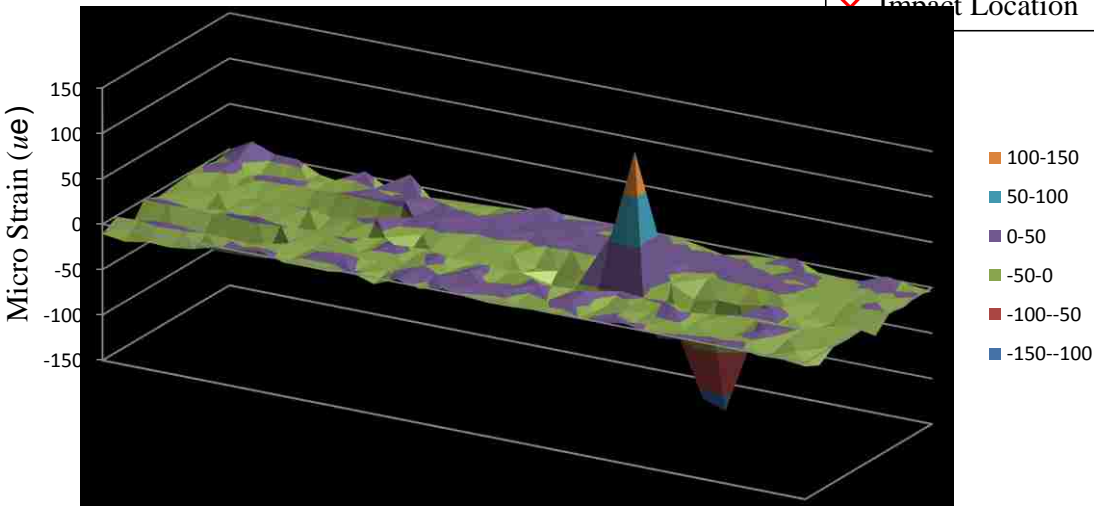
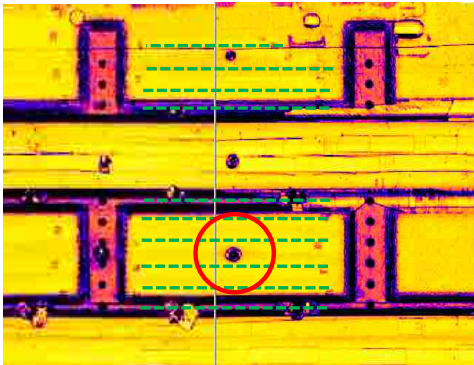
Center Bay Over Skin
Impact Energy: 60 Ft lbs
Damage Area: 0.75 in²
Type of Damage: Near surface fiber crushing and slight interply delamination
Strain Indication: No

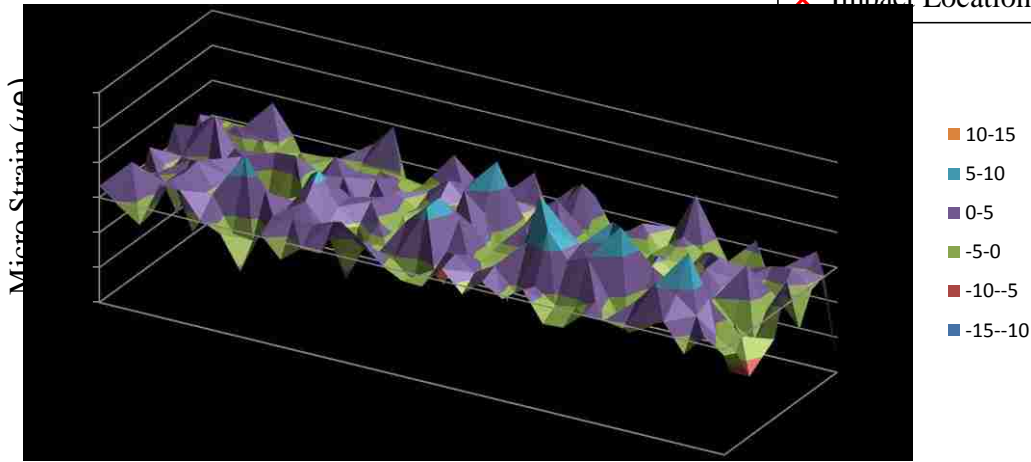
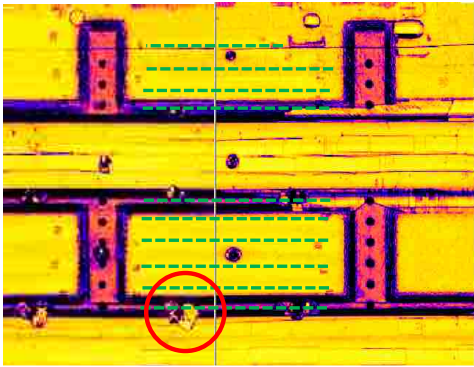
21 - B2-SK2-ST2L-H2b

Center of Stringer Flange
Impact Energy: 90 Ft lbs
Damage Area: 3.46 in²
Type of Damage: Interply delamination
Strain Indication: Yes, clear detectable strain indication

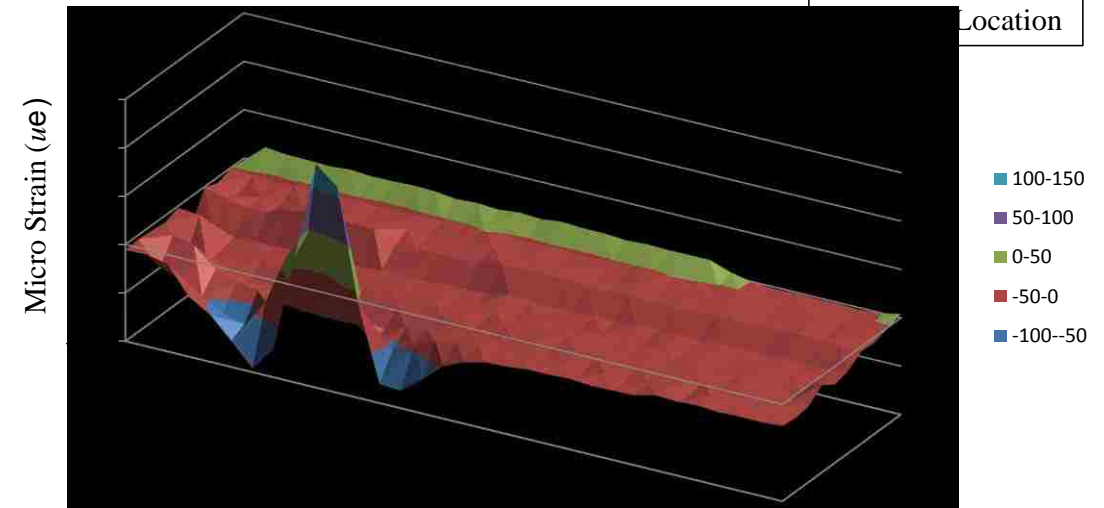
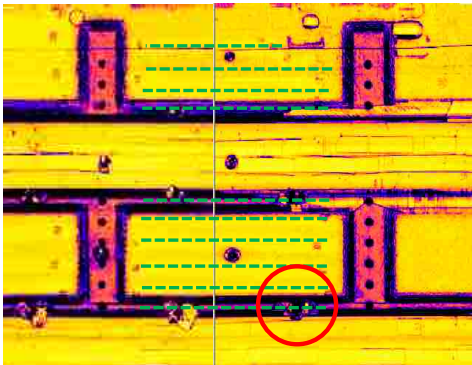
Center of Stringer Flange
Impact Energy: 112.5 Ft lbs
Damage Area: 2.19 in²
Type of Damage: Interply delamination
Strain Indication: High strains detected at impact location (strains much higher than typically observed), not detectable

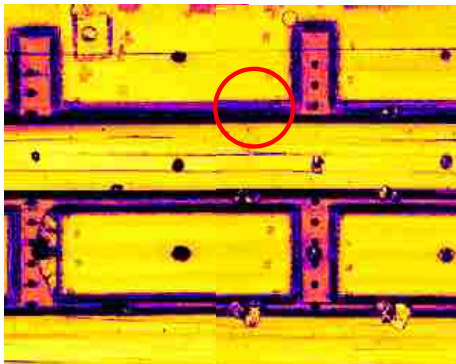
3 - B1-SK1-ST1R-H2b

Center of Stringer Flange
Impact Energy: 60 Ft lbs
Damage Area: Could Not Determine, masked by co-cured flange
Type of Damage: None

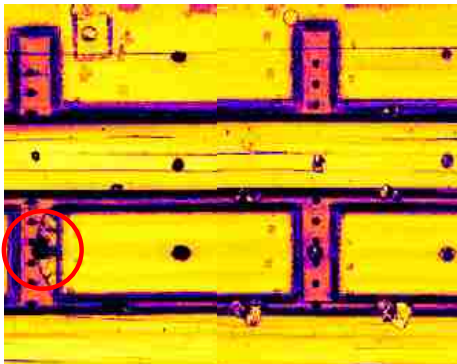
8 - B1-SK2-ST0-H4

Center of Shear Tie
Impact Energy: 75 Ft lbs
Damage Area: 4.35 in²
Type of Damage: Delamination of shear tie tapered section build up to skin interface

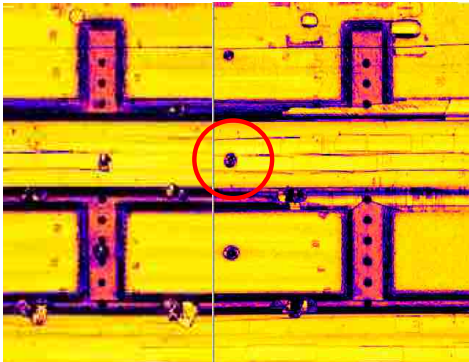
16 - B2-SK0-ST1L-H3

Center of Stringer Between Flanges

Impact Energy: 75 Ft lbs

Damage Area: 0.81 in²

Type of Damage: Near surface crushed fibers, small interply delamination

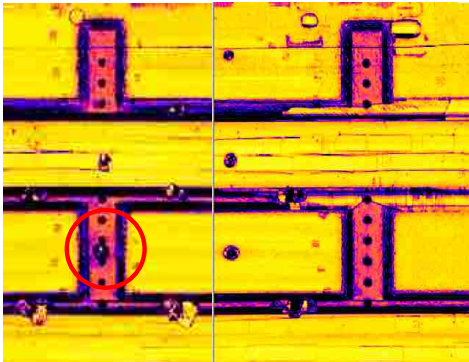
19 - B1/2-SK2-ST0-H4

Center of Shear Tie

Impact Energy: 90 Ft lbs

Damage Area: 0.85 in²

Type of Damage: Interply delamination

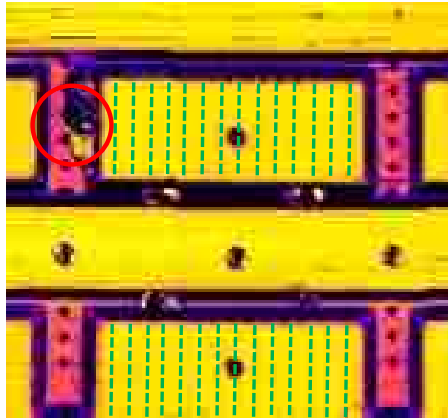
23 – B2/3

Edge of Shear Tie

Impact Energy: 90 Ft lbs

Damage Area: 10.37 in²

Type of Damage: Delamination at the shear tie built-up skin interface. Back side visible crack at interface.

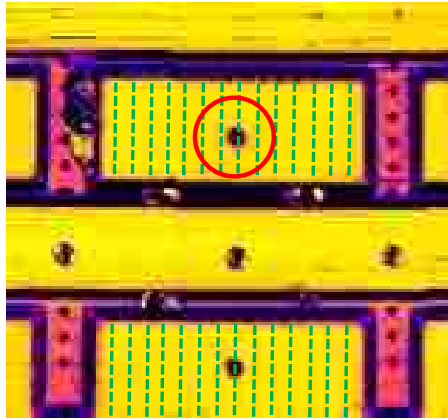
24 - B

Damage Area: 0.89 in²

Type of Damage: Near surface fiber crushing

Strain Indication: Yes, strain indication, but second indication not at the location of interest also was induced.

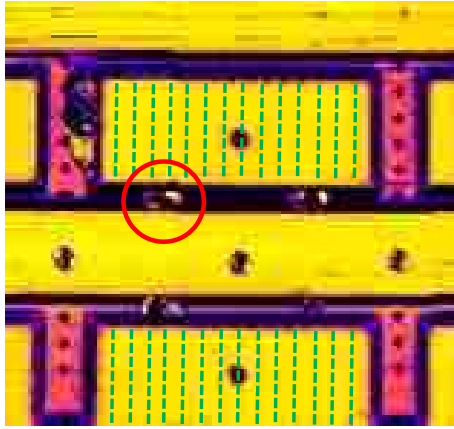
25 – B3-S

Edge of Stringer Flange (Not Stringer Side)
Impact Energy: 60 Ft lbs
Damage Area: 2.85 in²
Type of Damage: Flange delamination
Strain Indication: Yes, compressive strain indication
